## Failure Prevention in Ground Transportation Systems

Proceedings of the 31st Meeting of the  
Mechanical Failures Prevention Group,  
held at the National Bureau of Standards,  
Gaithersburg, MD, April 22-24, 1980

These proceedings consist of 18 submitted entries (16 papers and 2 abstracts) from the 31st meeting of the Mechanical Failures Prevention Group which was held at the National Bureau of Standards, Gaithersburg, Maryland, April 22-24, 1980. The theme of the symposium was failure prevention in ground transportation systems. Areas of interest included rail vehicles and structures, highway and road bridges, pipeline transportation systems, and motor carriers.

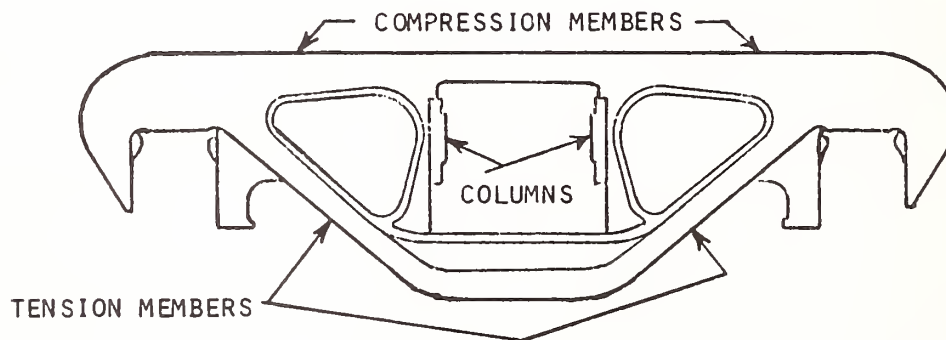
The development of a fatigue crack on a side frame is a relatively rare occurrence. The most common locations are through the tension member (see Fig. 2) or through the column. The tension member crack is the

FIGURE 2 SIDE FRAME NOMENCLATURE

most critical because the propagation of the crack through the member can lead to the collapse of the side frame. On relatively rare occasions fatigue cracks develop in the compression member near the point where it joins the tension member above the pedestal opening.

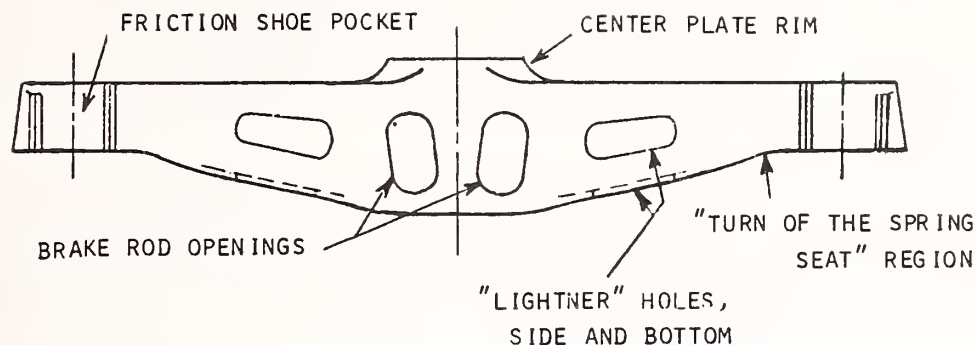
Bolsters are also subject to the development of fatigue cracks. The most serious location of the initiation of a fatigue crack is on the bottom surface because these cracks eventually propagate up the side and lead to its collapse. These cracks often originate at one of the bottom lightner holes and propagate up to one of the side lightner holes (see Fig. 3).

FIGURE 3 TRUCK BOLSTER NOMENCLATURE

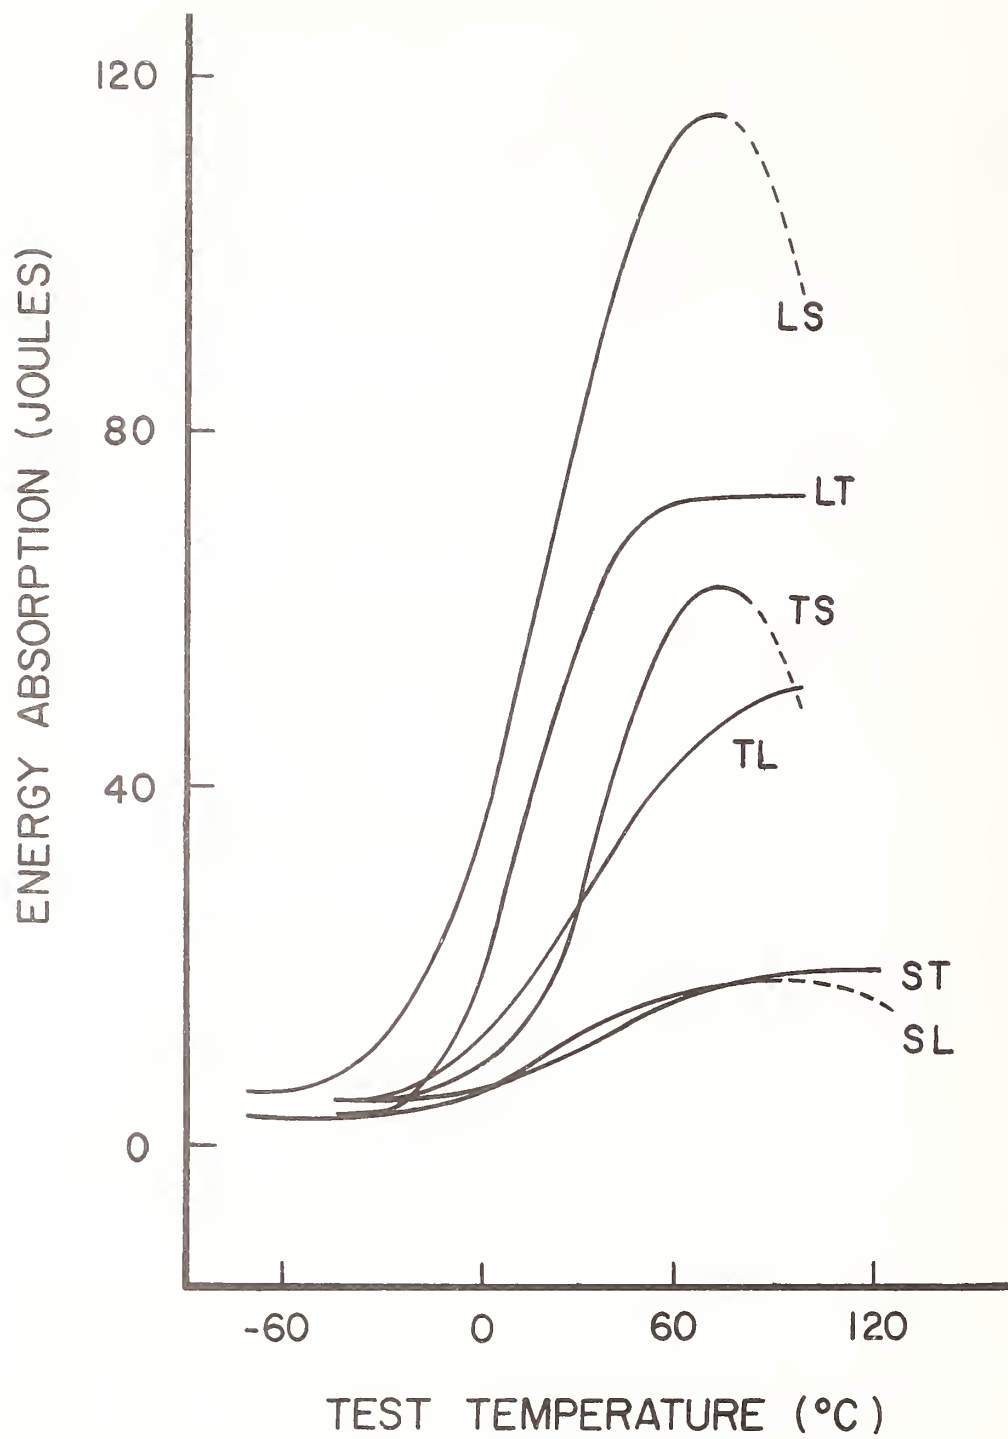
Figure 1. CVN impact test results for six orientations of AAR TC128-B steel specimens.

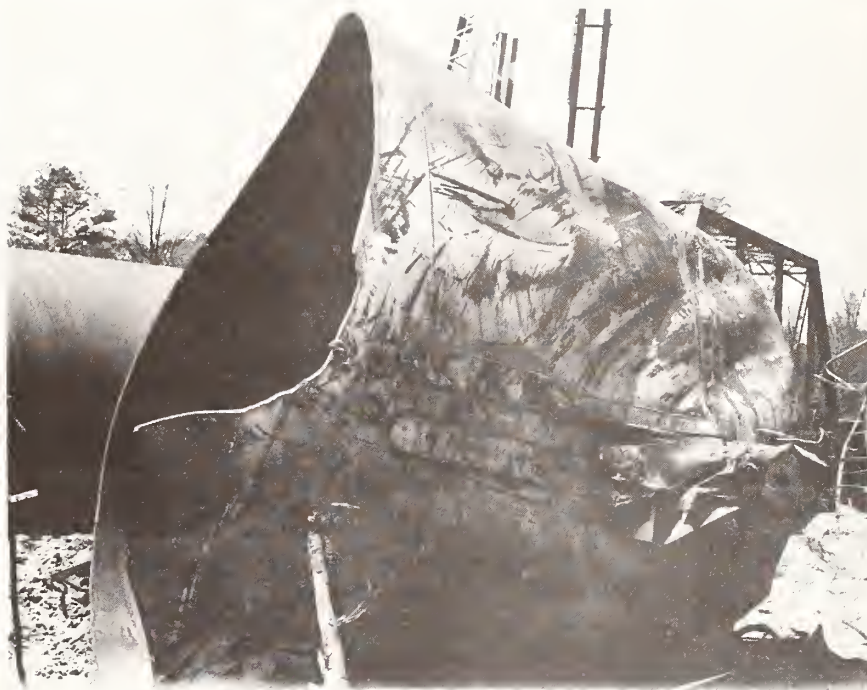
Figure 3. A tank car failed at elevated temperatures showing a circumferential crack propagation.

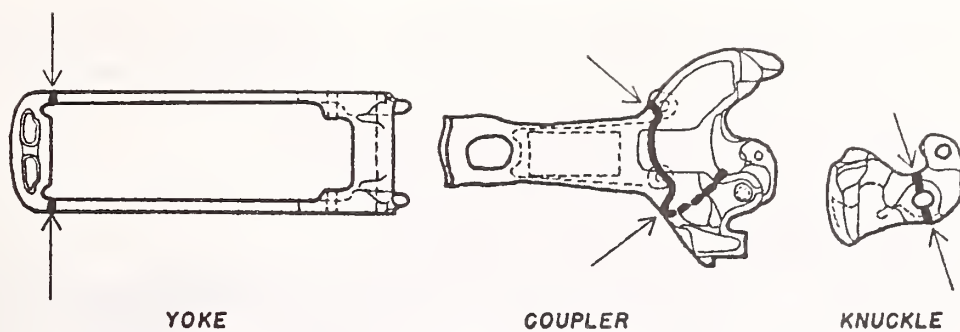
An attempt was made to identify the locations of fracture origins, and it was observed that most of the fractures started at high stress concentration areas, as is schematically shown in figure 1 and demonstrated in figure 2.

Figure 1: Location of fracture in couplers (A-03), yokes (B-05) and knuckles (D-18).

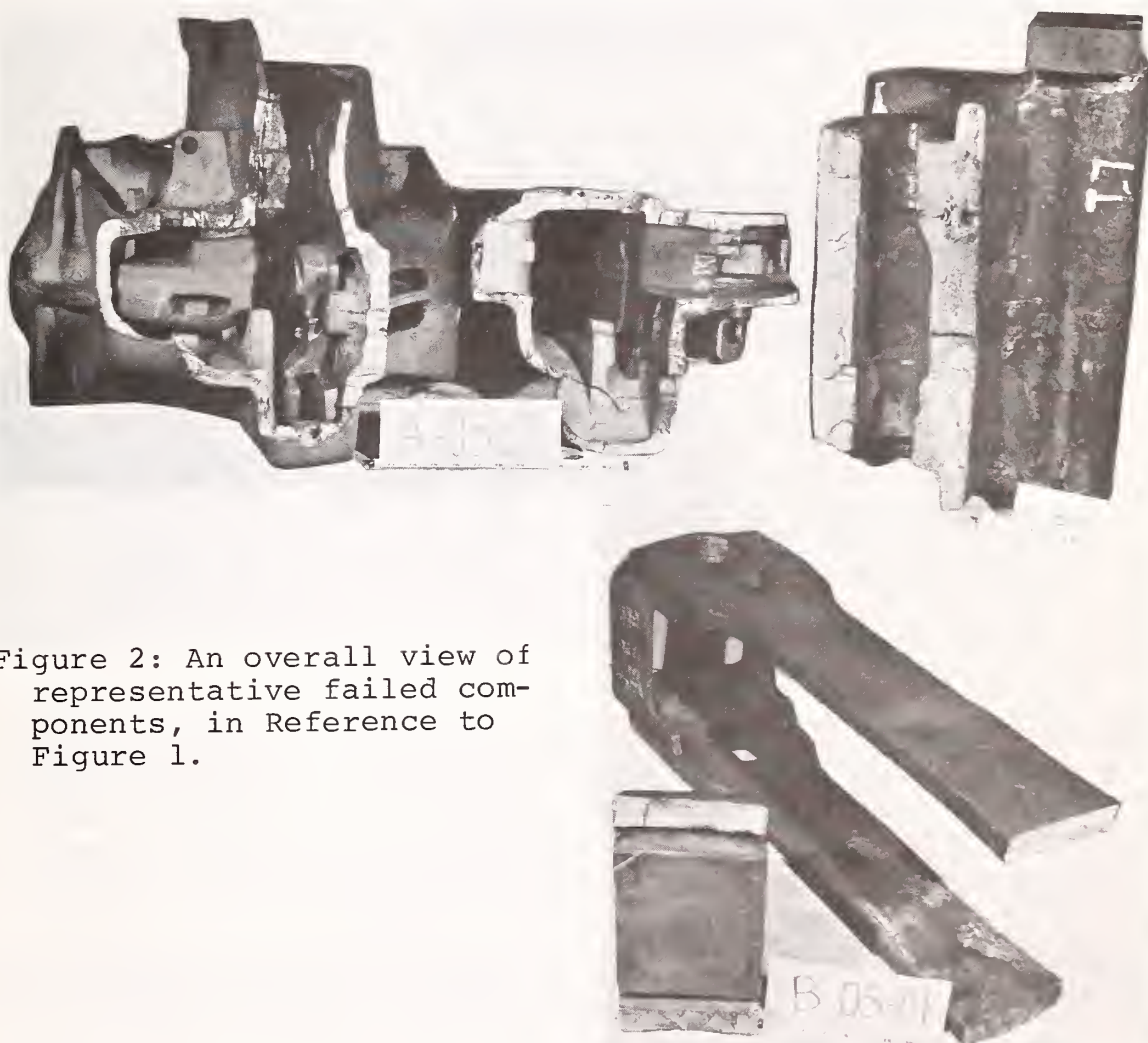
Figure 2: An overall view of representative failed components, in Reference to Figure 1.

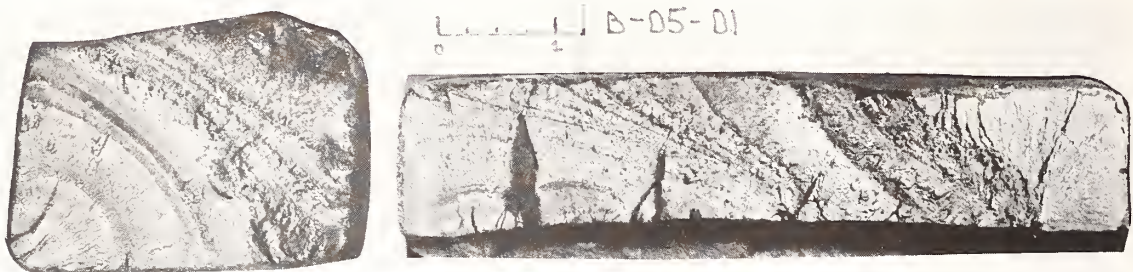
As indicated, most of the failed components showed some amount of fatigue crack growth. Huge fatigue cracks, as large as 80% of the cross section, can be seen in figure 3, whereas shallow, multiple-origin cracks are shown in figure 4.

Figure 3: Large fatigue cracks in failed coupler (A-01) and yoke (B-05).

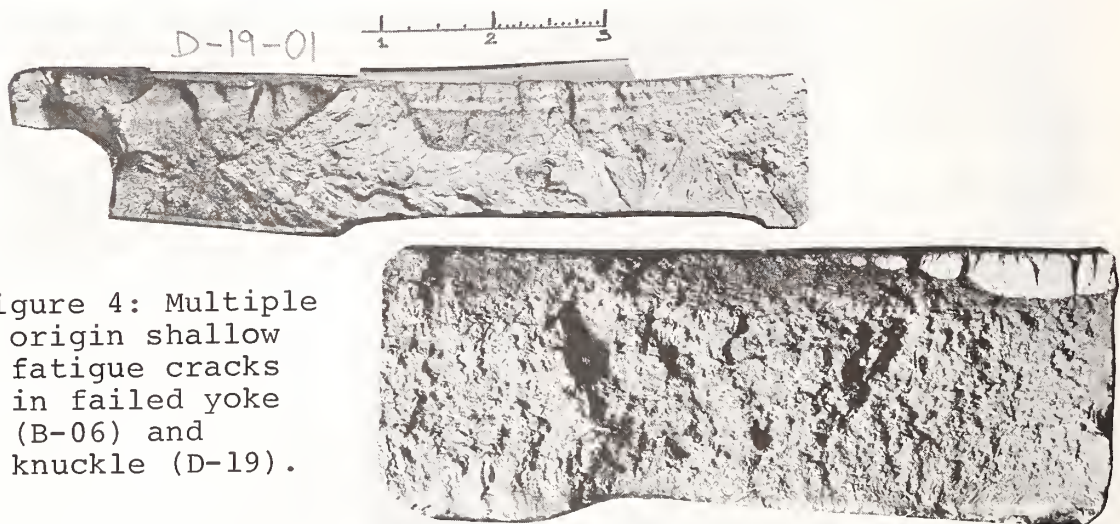
Figure 4: Multiple origin shallow fatigue cracks in failed yoke (B-06) and knuckle (D-19).

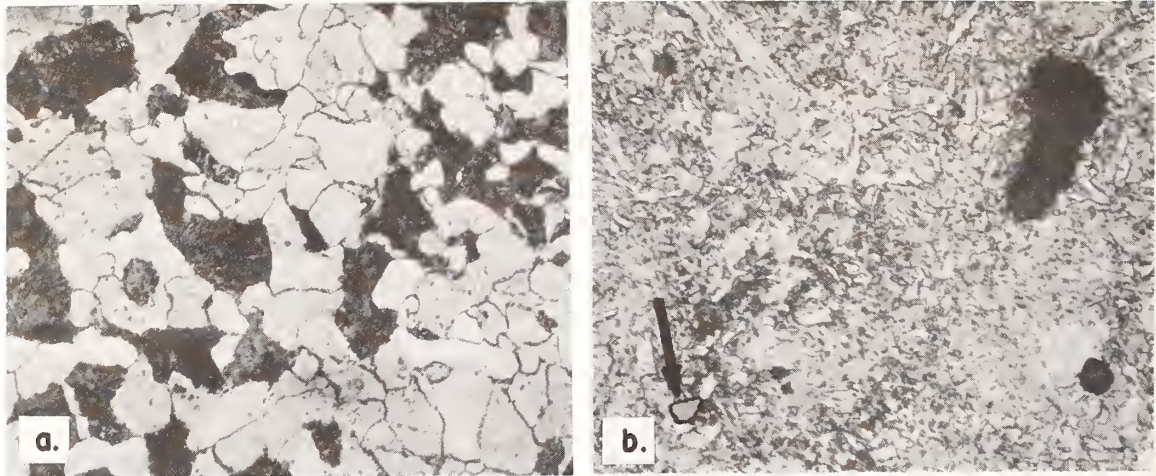
The C(N&T) grade, having primarily a pearlitic structure, shows slightly different patterns of microstructure from part to part, depending on cooling rates (TTT diagrams), the manufacturer, and more so, the position in the heat treatment load. This variability repeats itself in the CVN data (discussed later). The C(Q&T) grade, having a martensitic structure, did not show any anomalies. Typical porosity and inclusions, as seen in figure 6b, were found in most parts and are

Figure 6: Typical microstructure of: (a) C(N&T) grade, B-05 yoke, and (b) C(Q&T) grade, B-06 yoke, (X500).

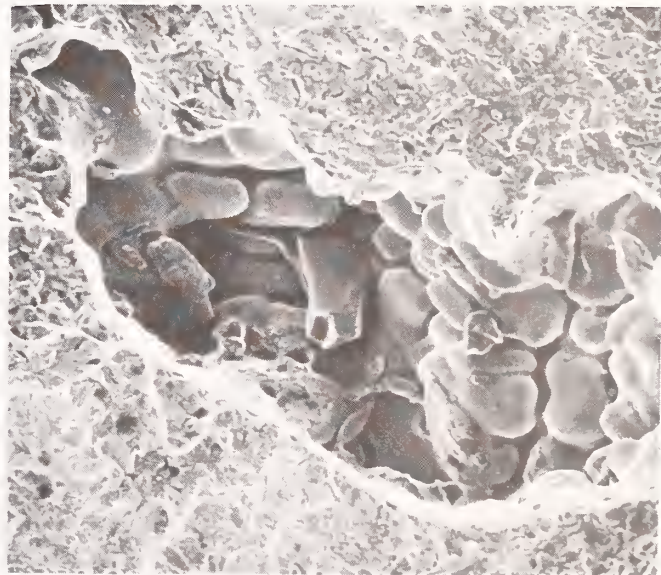
Figure 8: Shrinkage cavity on a fracture path, C(Q&T) grade, B-06 yoke (X100).

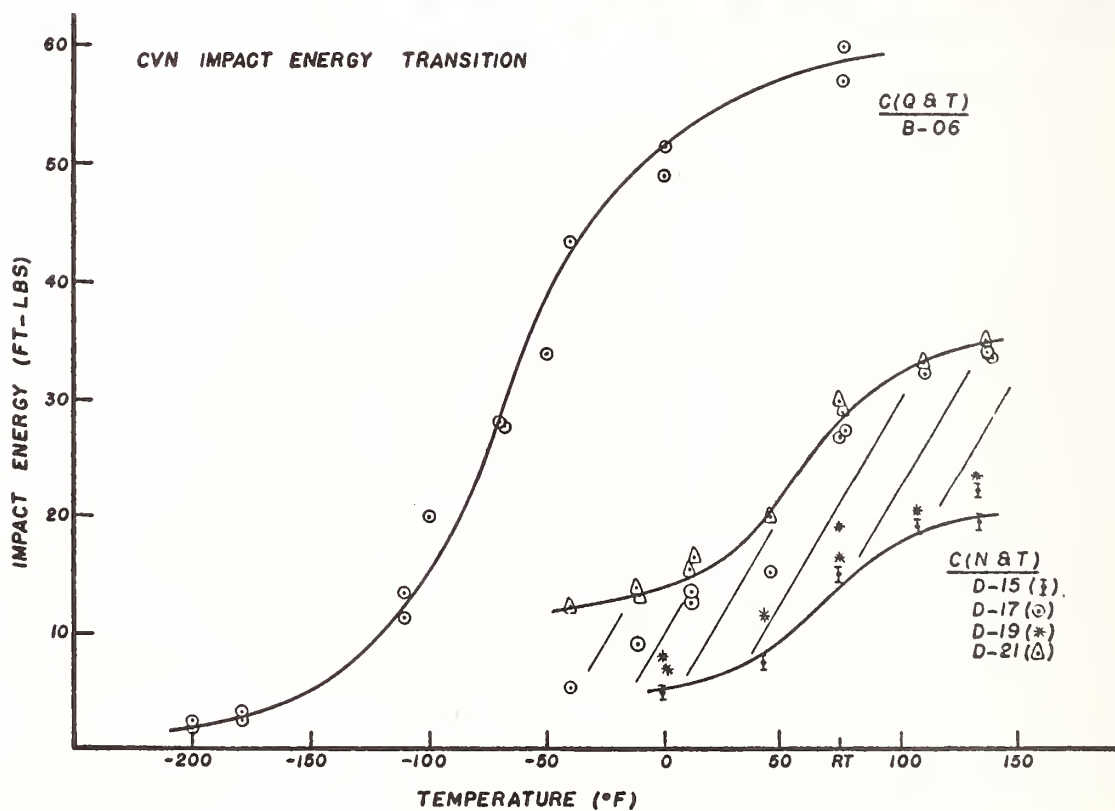
Figure 10: CVN transition impact energy for both grades.

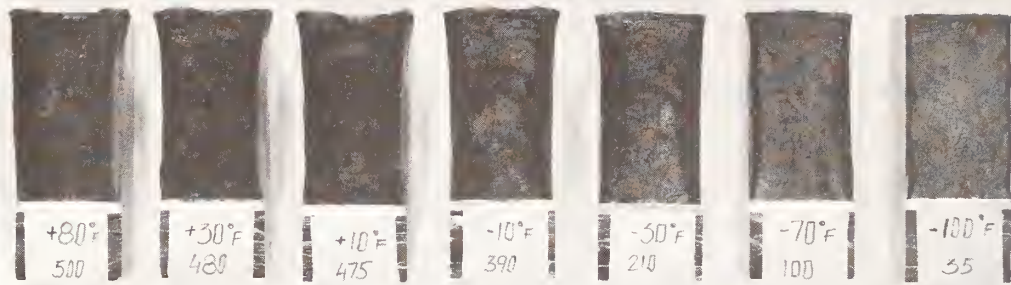
Figure 13: Percentage shear of C(Q&T), B-06 yoke in the DT test. Temperature and energy (ft-lbs.) are listed.

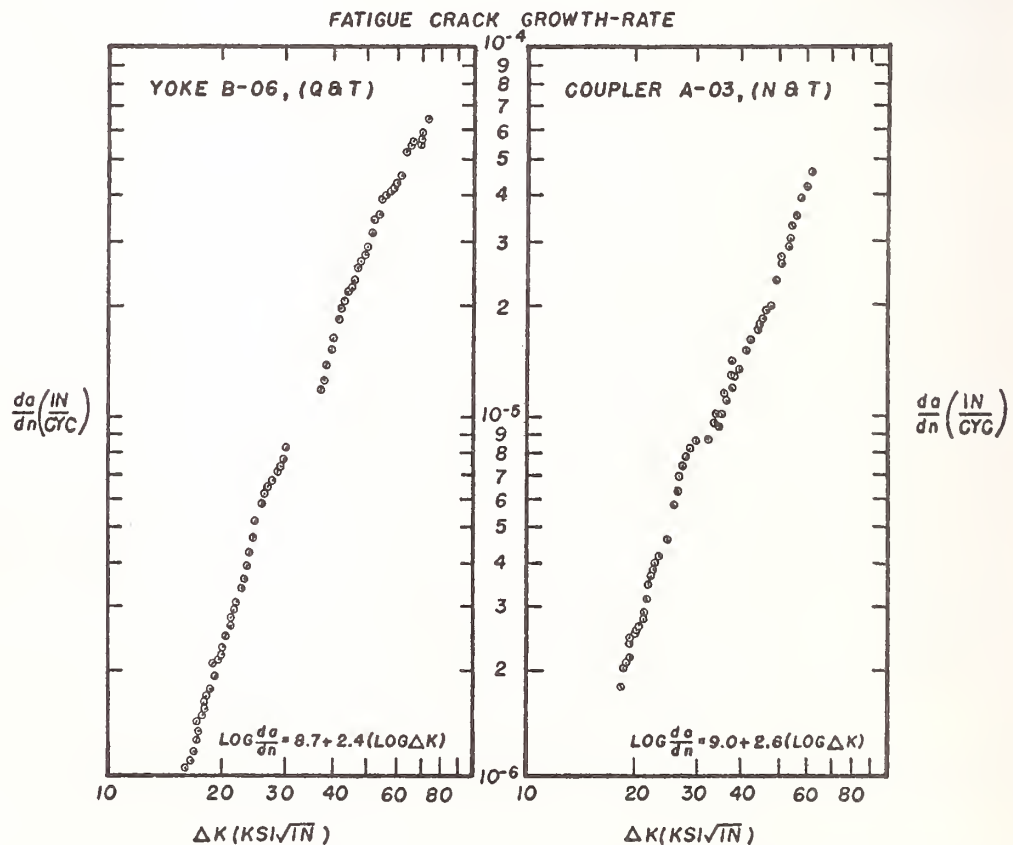
Compact tension specimens were tested to determine fatigue crack growth rates. Data from these tests are shown in figure 14. As expected, no significant differences arise between the two grades. In figure 15, which shows CT fatigue specimens, cavities and porosity can be seen in

Figure 14: Fatigue crack growth rates for both grades resulting in almost identical rate equations.

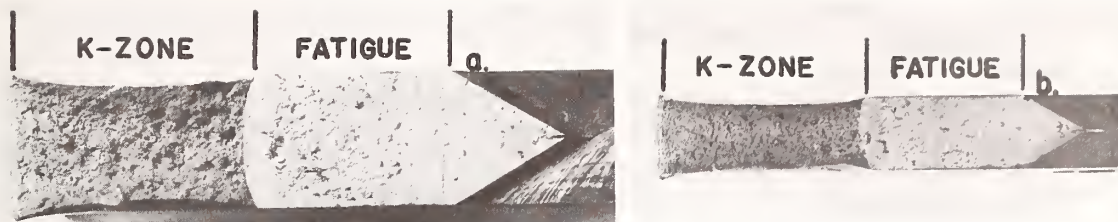
Figure 15: CT specimens fracture surfaces of: (a) C(N&T) grade (A-03) coupler, and (b) C(Q&T) grade (B-06) yoke.

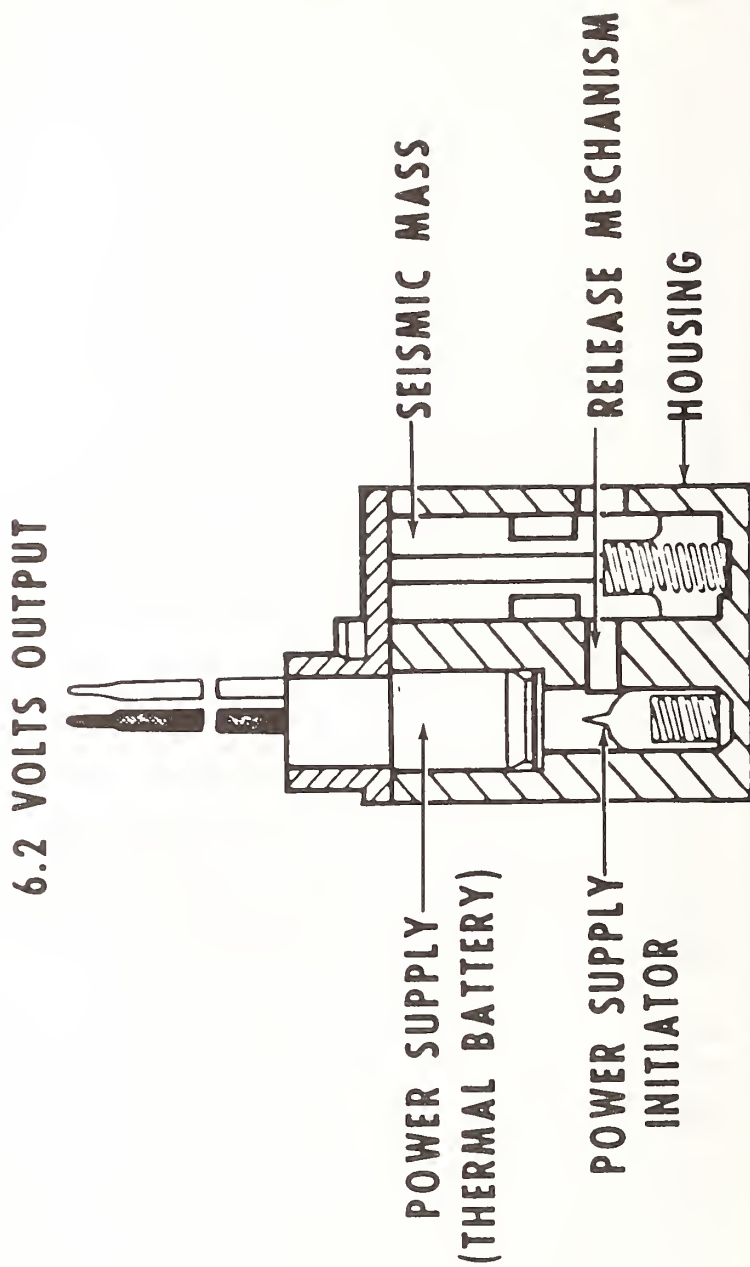
Fig # 5

# G - SENSING DERAILMENT DETECTOR

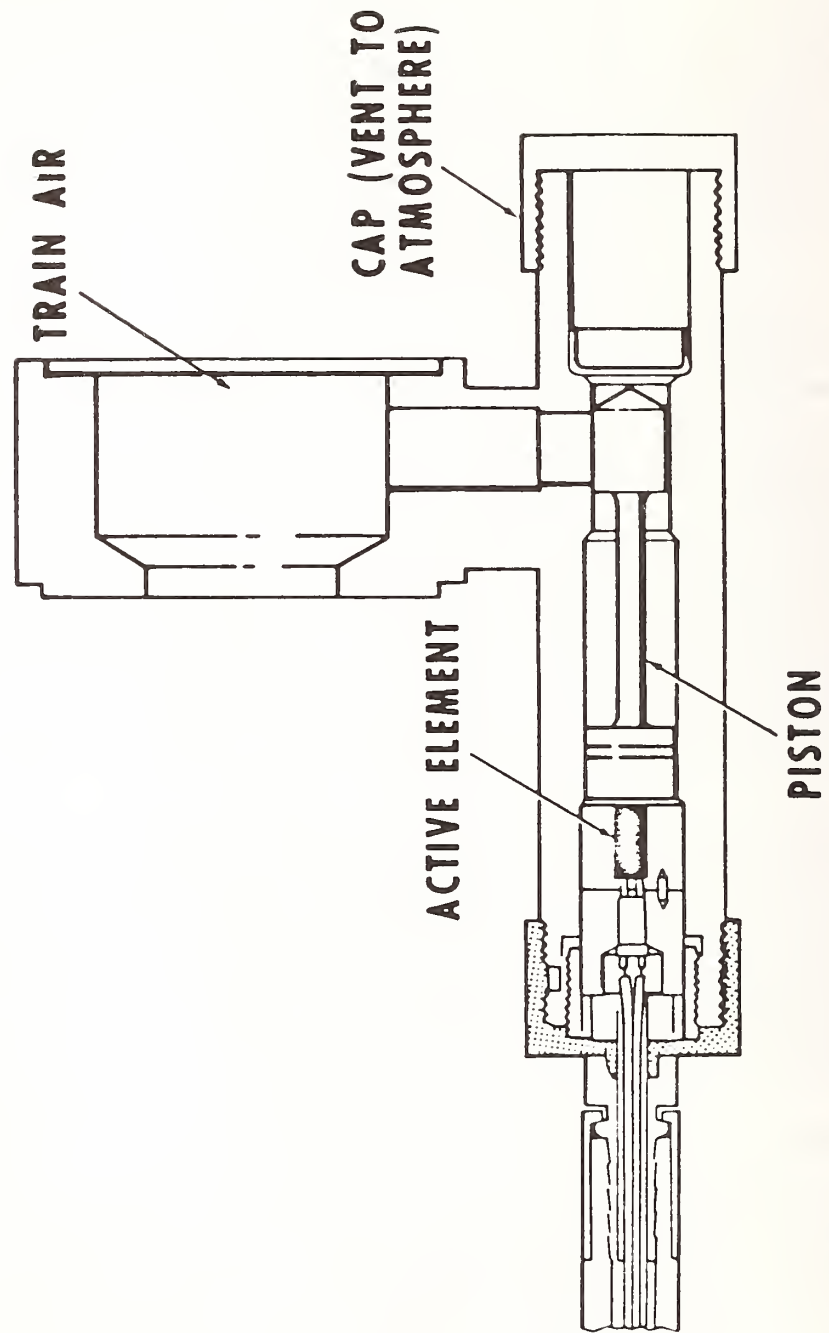
# BRAKE CONTROL

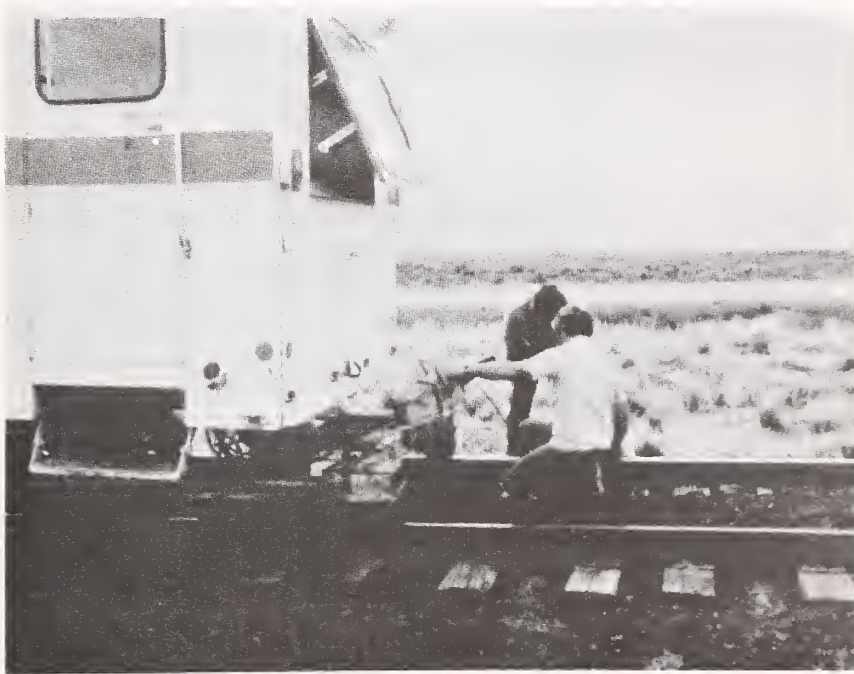
FIGURE 1. HAND MAPPING FOR DEFECT VERIFICATION

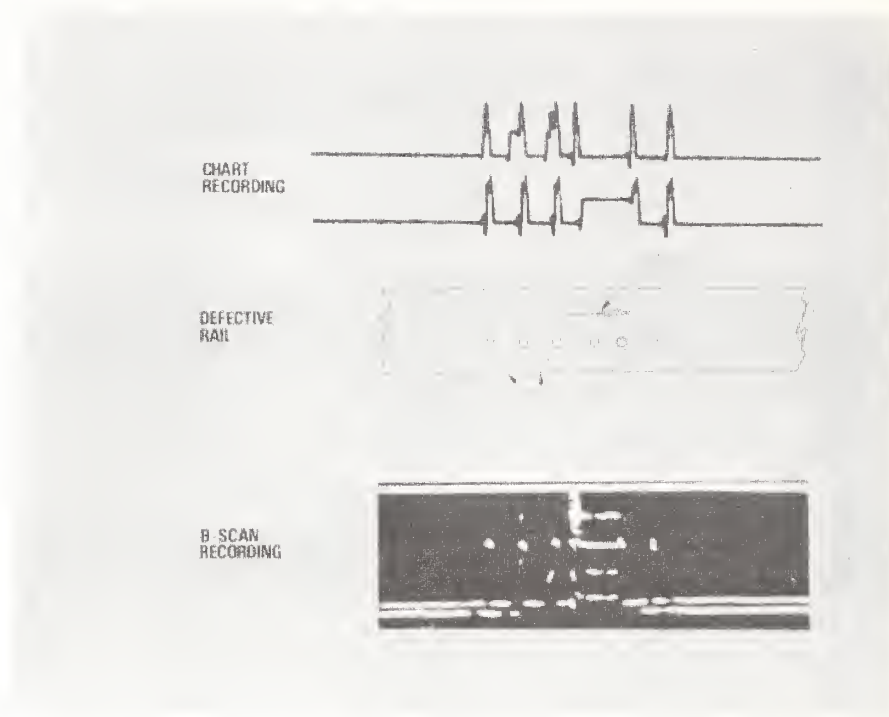
FIGURE 3. COMPARISON OF CHART RECORDING AND B-SCAN PRESENTATIONS

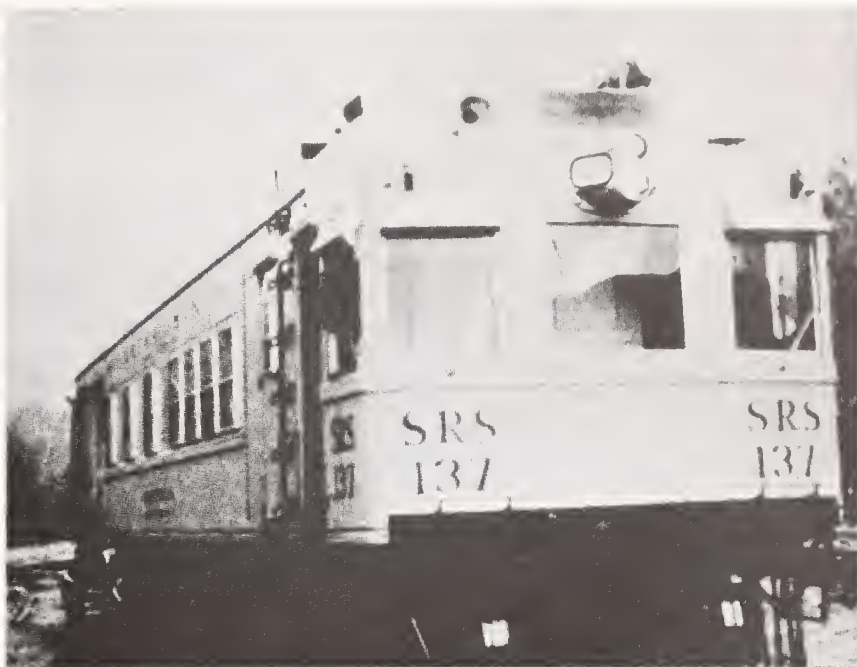
(A) RAIL BOUND DETECTOR CAR OWNED AND OPERATED BY SPERRY RAIL SERVICE

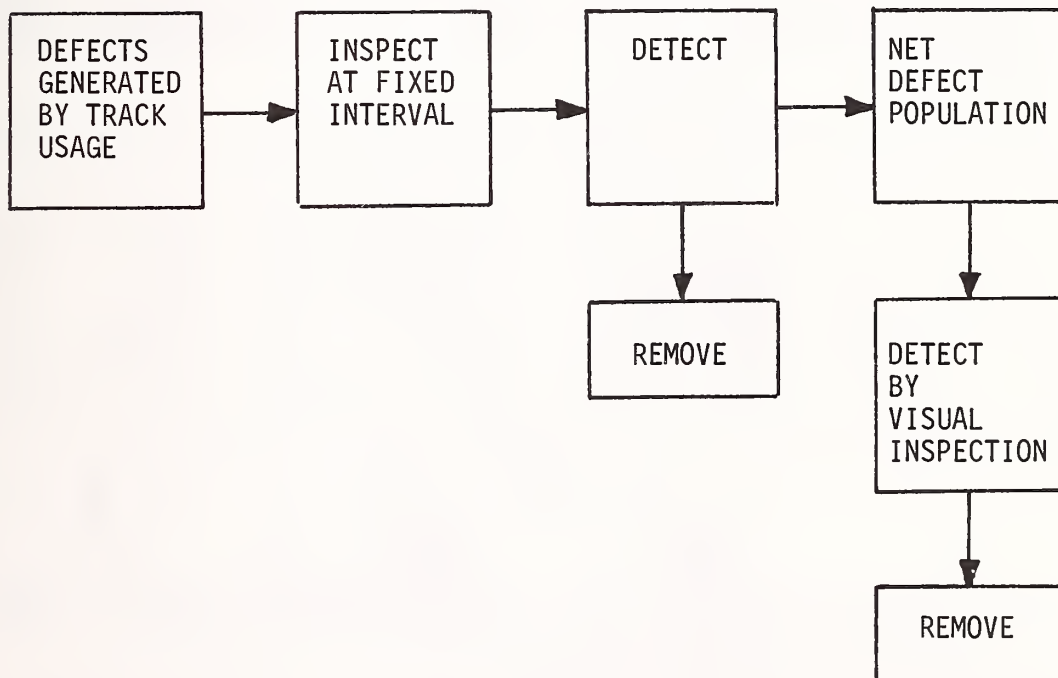
Minimum inspection requirements embodied in the current Track Safety Standards take an open-loop approach to control of the net population, as shown schematically in Figure 5. The simplicity of this approach is administratively advantageous. The scheme is technically disadvantageous because it requires that inspection resources be committed uniformly, regardless of variations in the numbers of defects occurring at different track locations, unless a railroad possesses the resources to conduct more than the minimum required inspections.

FIGURE 5. CURRENT APPROACH TO CONTROL OF RAIL DEFECTS

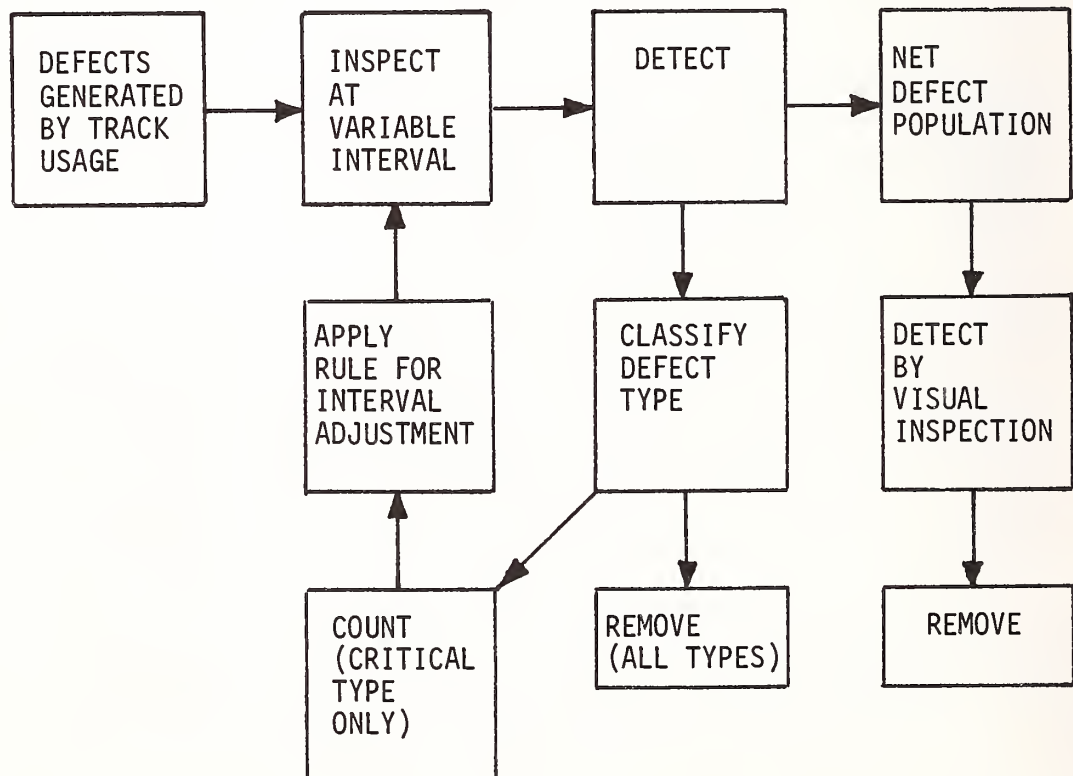
The proposed approach is administratively complex, but it offers a potential for flexible allocation of resources away from "well behaved track" toward track that is beginning to generate increasing populations of defects. It is hoped that this closed-loop approach will lead to reduction of the net defect population without any significant increase in total inspection resources. However, it remains to be seen whether the inspection interval adjustment scheme is practical and whether it will allow a railroad to react to changing track usage.

FIGURE 6. PROPOSED APPROACH TO CONTROL OF RAIL DEFECTS

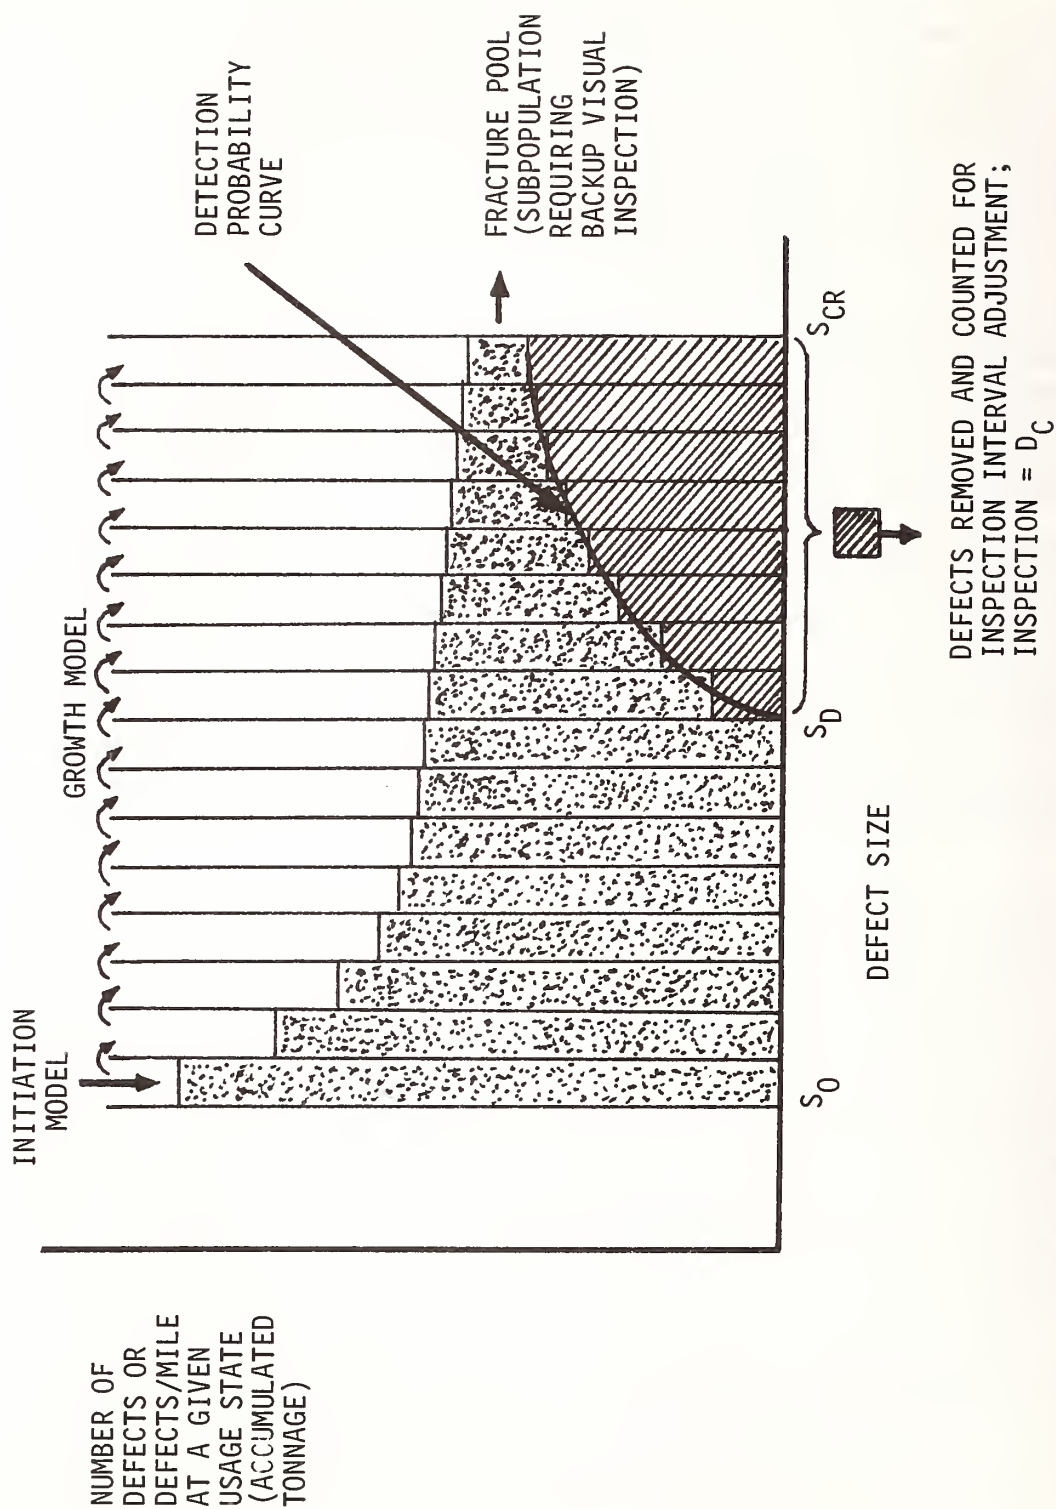
FIGURE 7. DEFECT POPULATION DYNAMICS MODEL

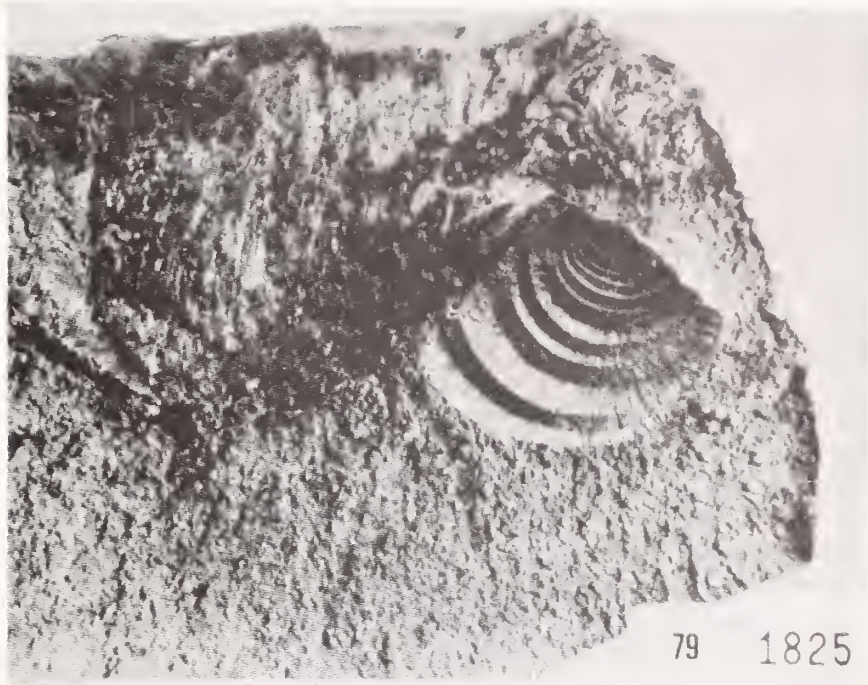
Use of the population dynamics model will be illustrated with data which approximate very roughly the behavior of detail fractures. Figure 8 illustrates a detail fracture that grew in a rail in the Facility for Accelerated Service Testing (FAST) at the DOT Transportation Test Center. The detail fracture is considered to be a critical

FIGURE 8. EXAMPLE OF DETAIL FRACTURE AT TTC FACILITY  
FOR ACCELERATED SERVICE TESTING

(Note: Detail fractures in revenue track generally exhibit a smooth fracture face, rather than the "clamshell" pattern shown here.)

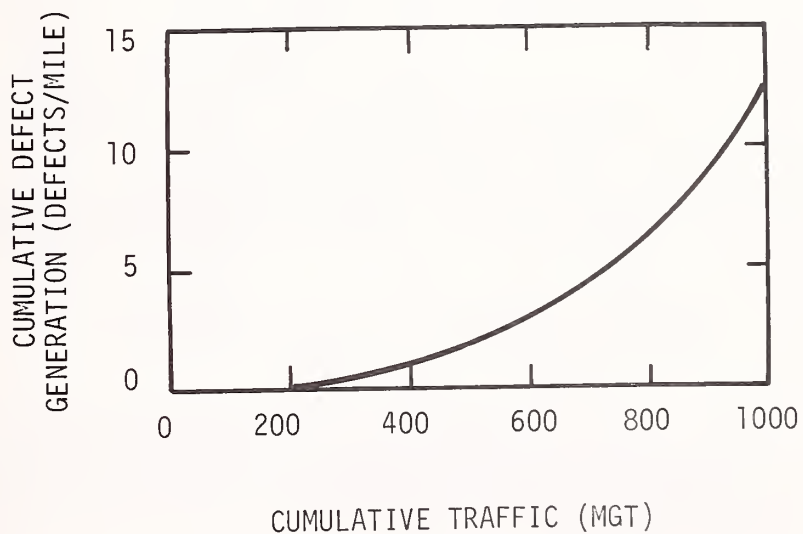
FIGURE 9. TYPICAL DEFECT GENERATION BEHAVIOR

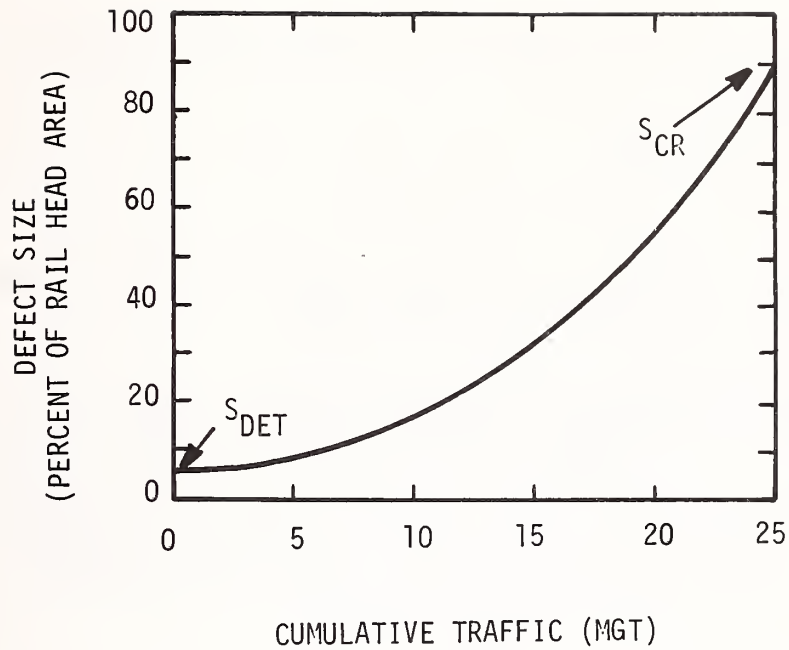
FIGURE 10. ASSUMED DEFECT GROWTH BEHAVIOR

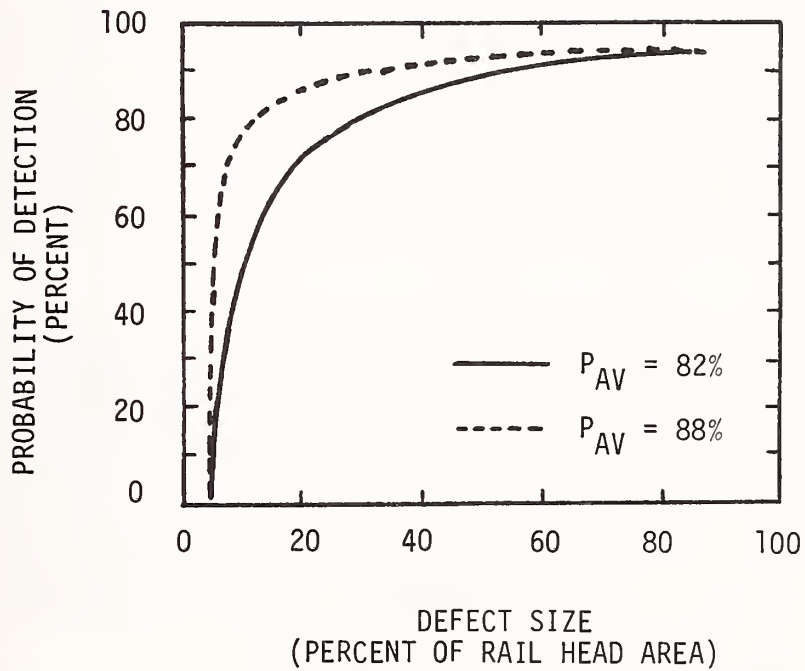
FIGURE 11. ASSUMED PROBABILITY OF DEFECT DETECTION

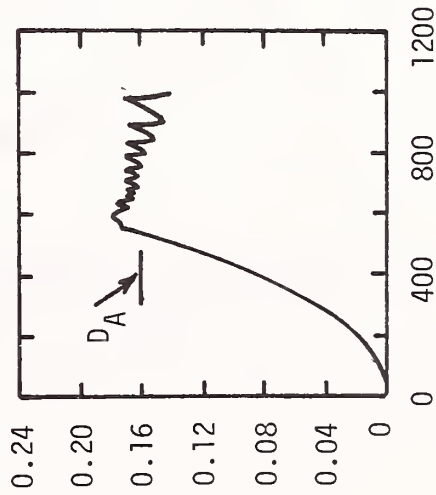
(A) DEFECTS DETECTED  
COUNTED AND REMOVED  
PER INSPECTION

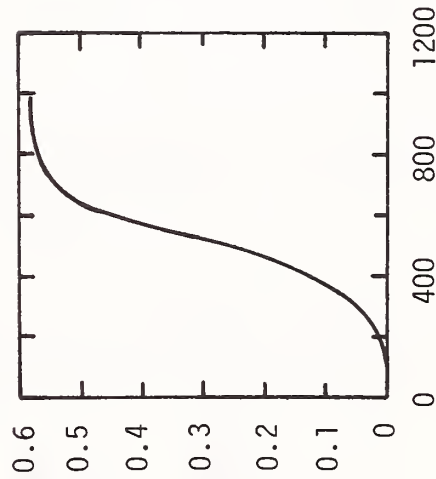
(B) CUMULATIVE UNDETECTED  
DEFECTS ATTAINING  
IMMINENT BREAKOUT SIZE

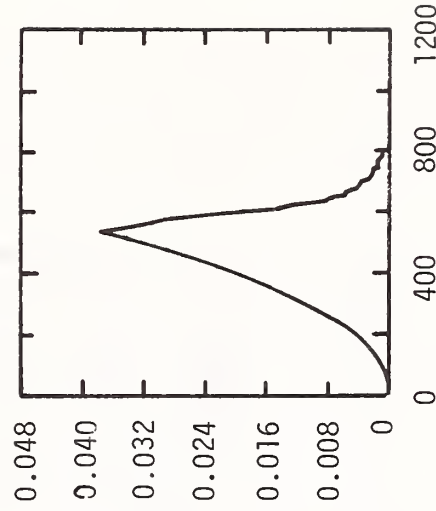
(C) NUMBER OF SUBCRITICAL  
DEFECTS WHICH WILL REACH  
IMMINENT BREAKOUT SIZE  
BEFORE NEXT INSPECTION

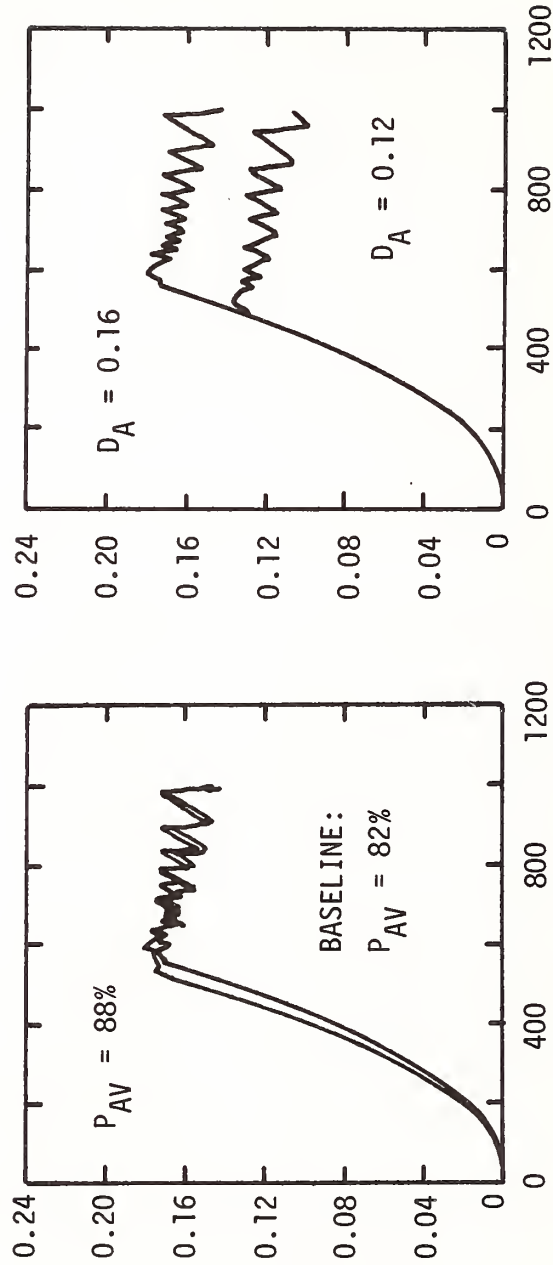
(A) EFFECT OF 7 PERCENT IMPROVEMENT IN DETECTION PROBABILITY ( $D_A$  FIXED AT 0.16)

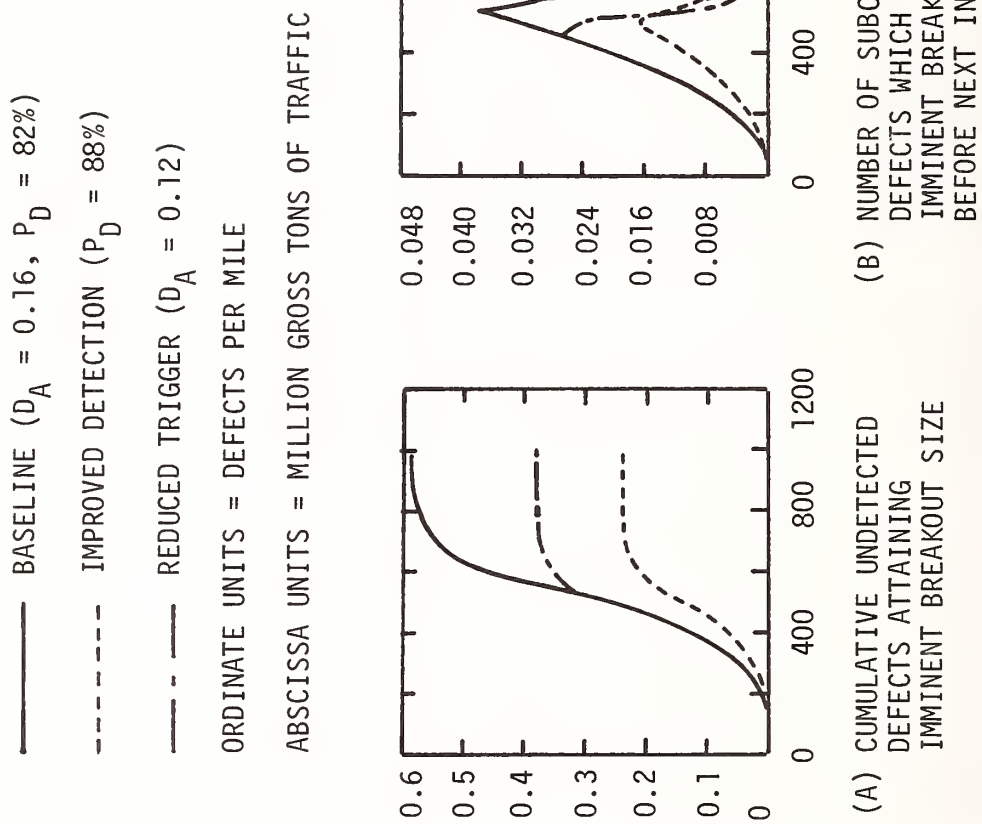
FIGURE 14. RESPONSE OF FRACTURE POOL TO IMPROVED DETECTION OR LOWER ACTION THRESHOLD

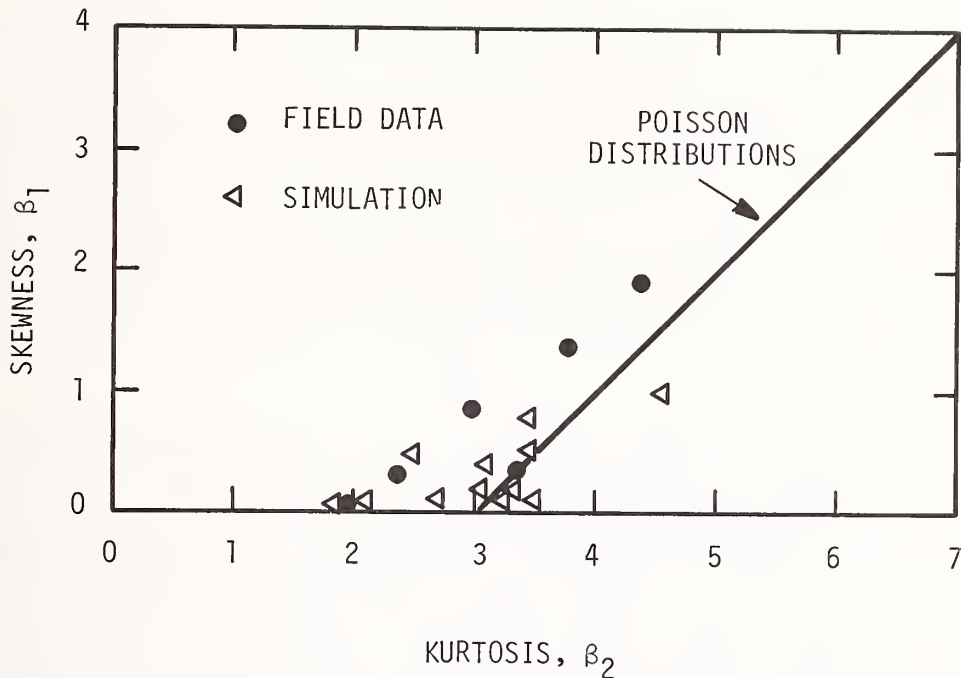
Figure 15 compares the Poisson model relationship with estimates of  $\beta_1$ ,  $\beta_2$  computed from the field data, and from a simulation run with a random number generator known to produce Poisson data. Comparison of the simulation and field data indicates that the field data scatter can be attributed to a finite sample-size effect. Therefore, the Poisson distribution appears to provide an appropriate spatial model.

FIGURE 15. SHAPE DESCRIPTORS FOR POISSON DISTRIBUTION AND DATA HISTOGRAMS

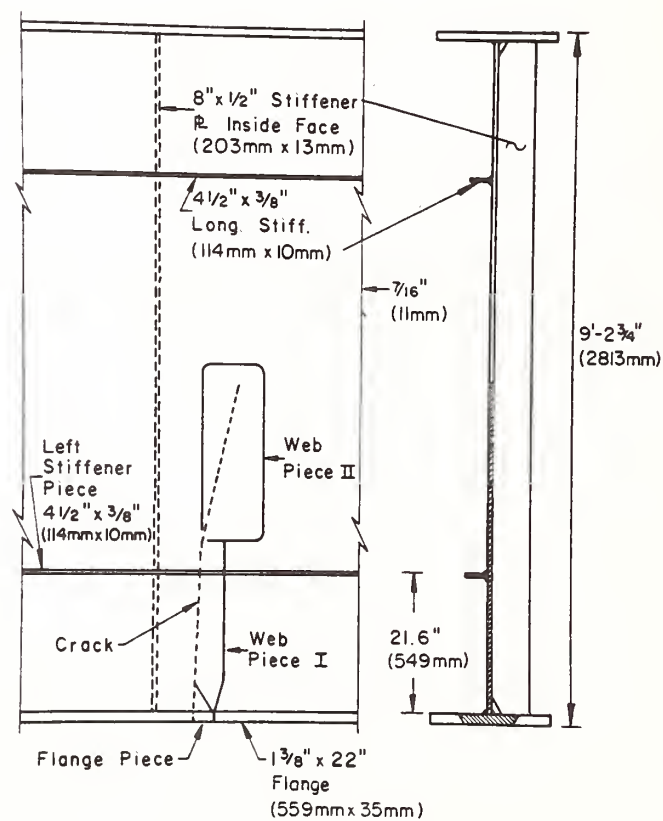
Fig.2 Schematic of the Girder at the Crack Location

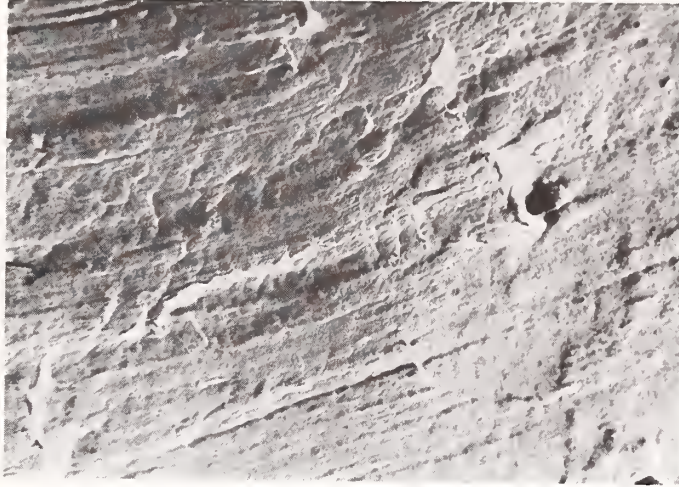
Fig. 3 Fracture Surface in Web Adjacent to Longitudinal Stiffener Showing Striation Markings (49125X)
