## Failure Prevention in Ground Transportation Systems

Proceedings of the 31st Meeting of the  
Mechanical Failures Prevention Group,  
held at the National Bureau of Standards,  
Gaithersburg, MD, April 22-24, 1980

These proceedings consist of 18 submitted entries (16 papers and 2 abstracts) from the 31st meeting of the Mechanical Failures Prevention Group which was held at the National Bureau of Standards, Gaithersburg, Maryland, April 22-24, 1980. The theme of the symposium was failure prevention in ground transportation systems. Areas of interest included rail vehicles and structures, highway and road bridges, pipeline transportation systems, and motor carriers.

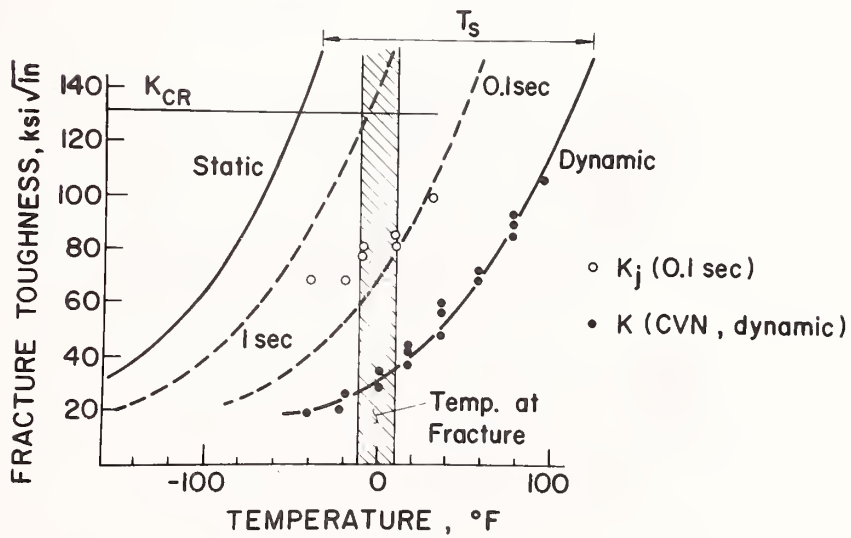
Fig. 4 Fracture Toughness and Stress Intensity Factor at Fracture

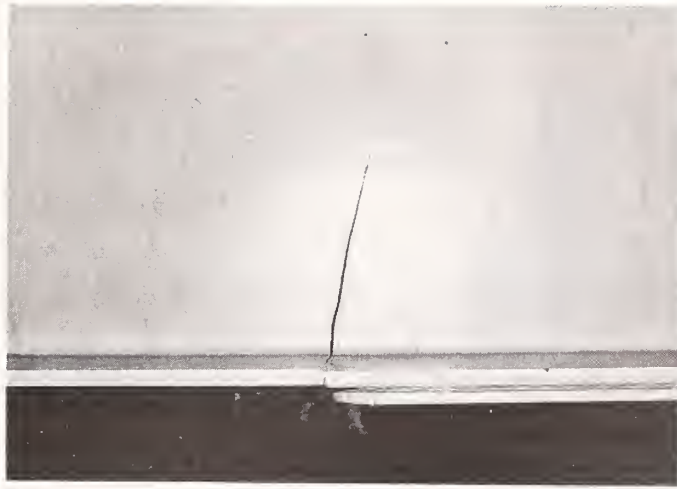
Fig. 7 Fractured Girder Discovered in 1970

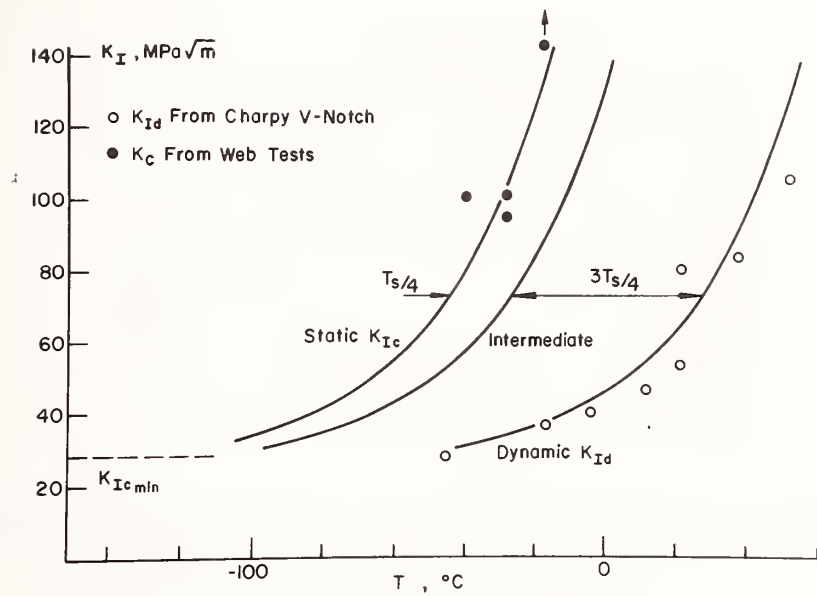
Fig. 8 Fracture Toughness, Flange Material

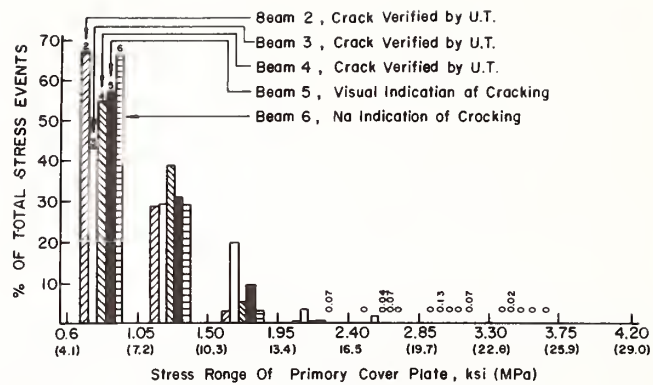
Fig. 9 Stress Range Histogram; West Ends of Eastbound Span 10, 1971

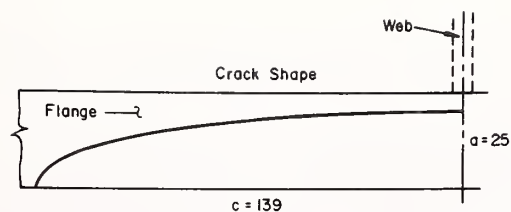
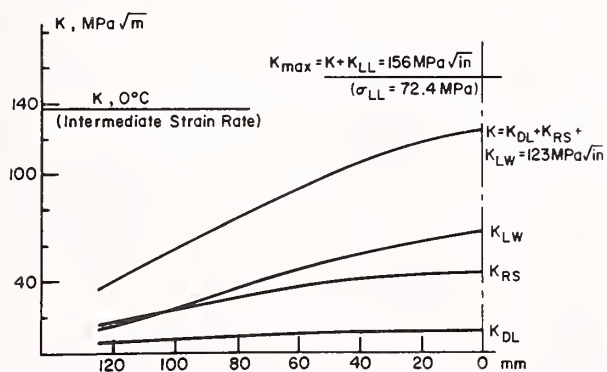
Fig. 11 Stress Intensity Factor  
for  $a = 25 \text{ mm}$ ,  $c = 139 \text{ mm}$

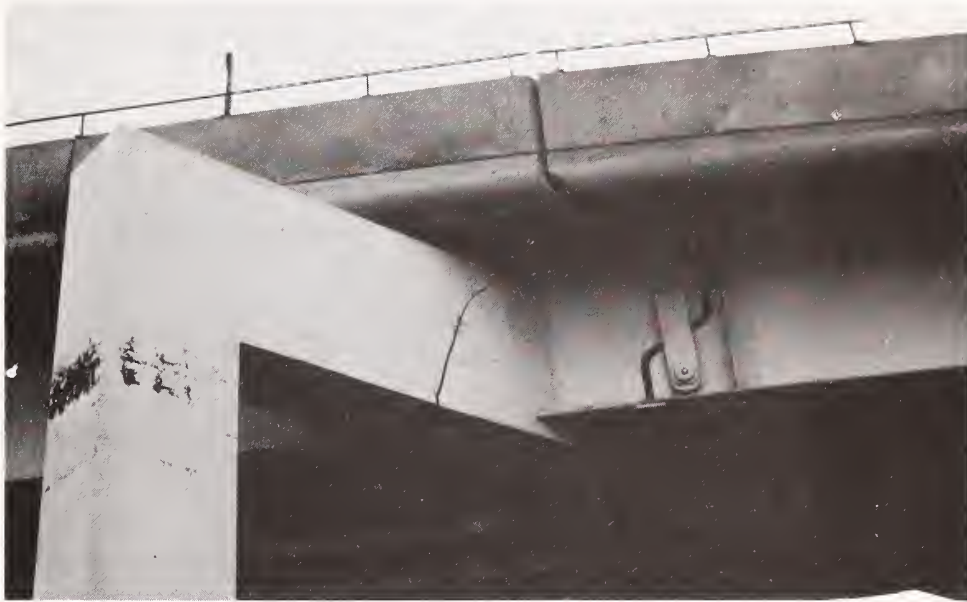
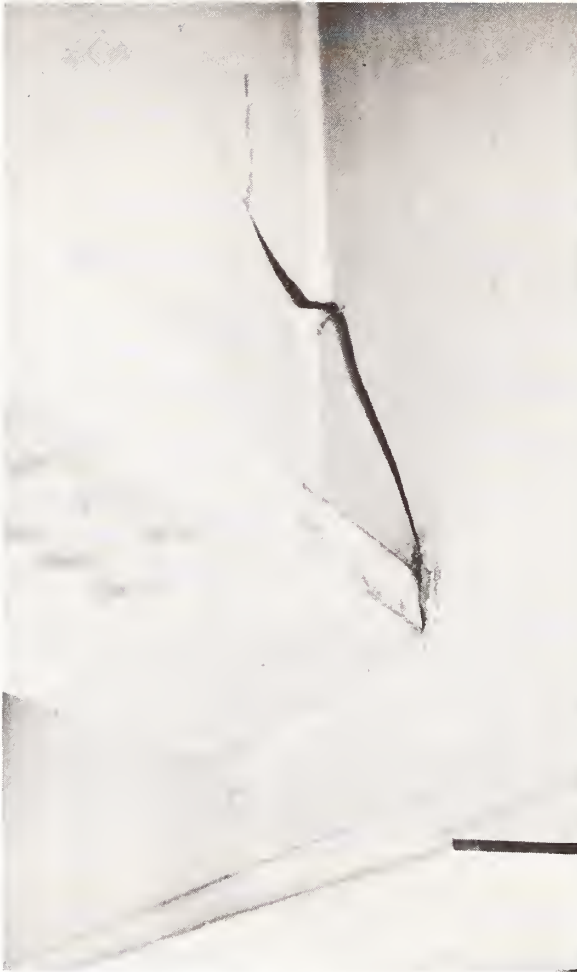
a) Side of bent

Fig. 1 - Views of crack in Bent No. 24

b) Other side, showing  
origin of fracture

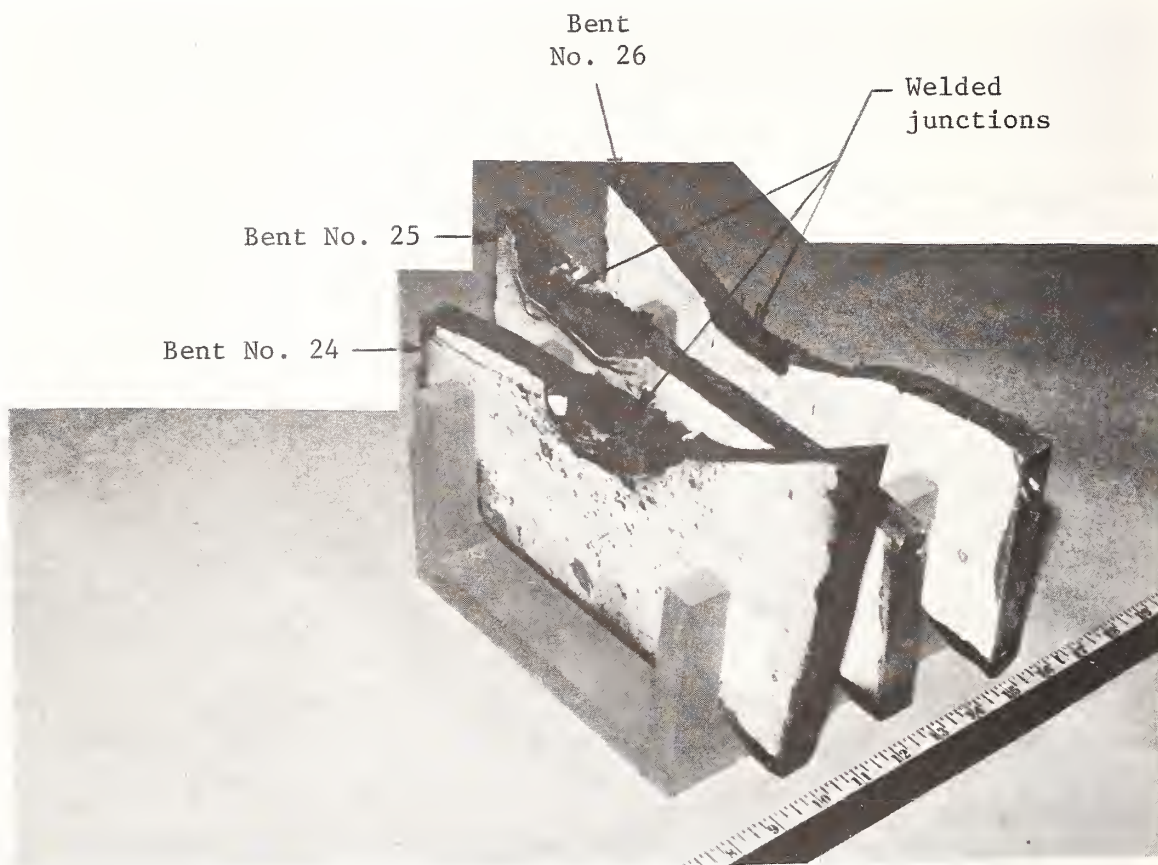
Fig. 2 - View of pieces cut from side plate  
of Bent Nos. 24, 25 and 26

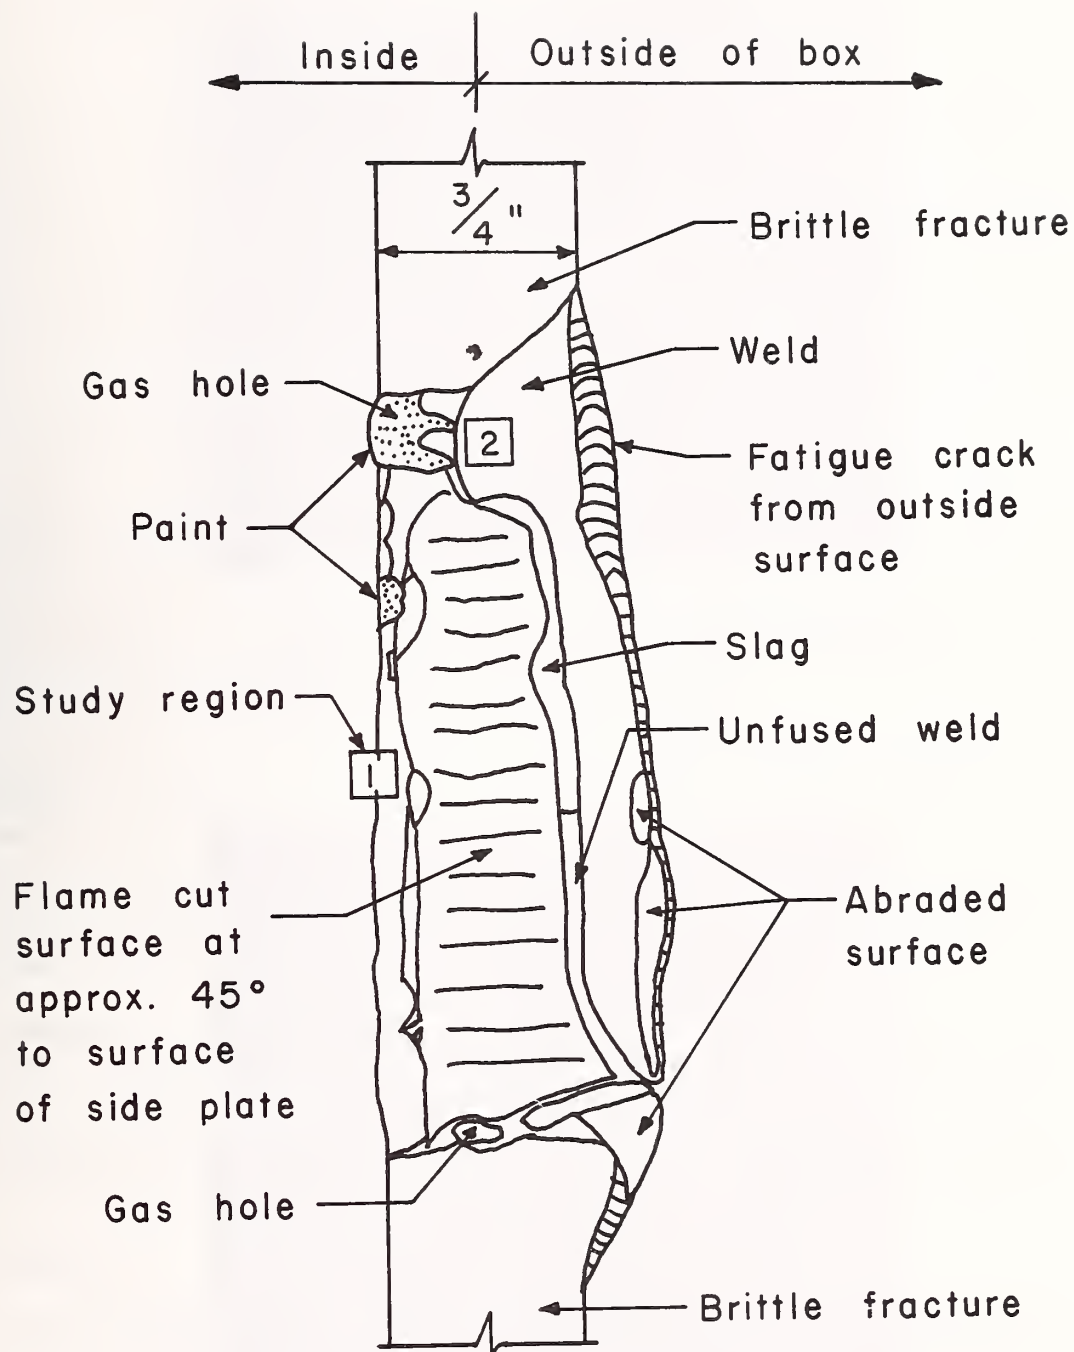
Fig. 3 - Schematic of origin of fracture in Bent No. 24

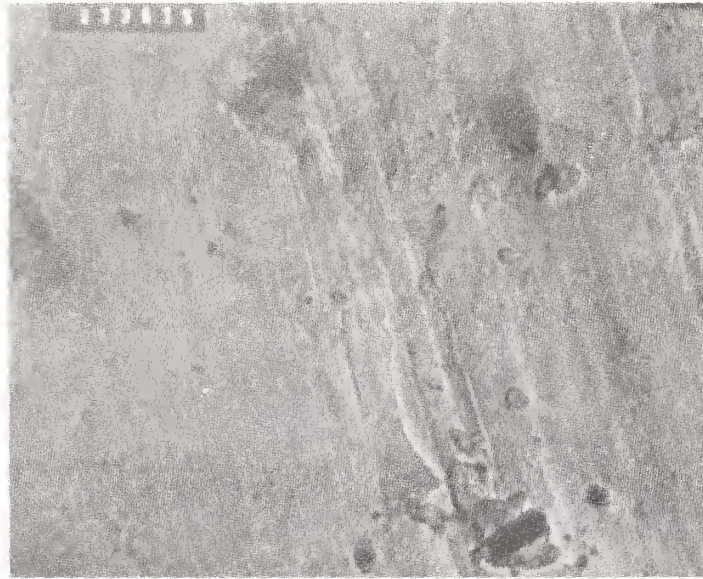
Fig. 4 - Fatigue crack growth striations  
of Study Region No. 2, Bent No. 24  
(By John Fisher, Lehigh University, X13,000)

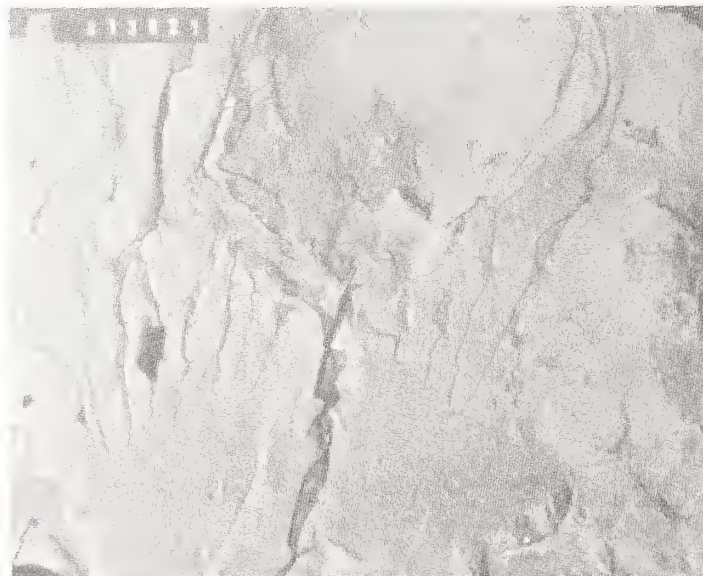
Fig. 5 - Cleavage fracture pattern at top  
of Study Region No. 2, Bent No. 24  
(By John Fisher, Lehigh University, X4000)

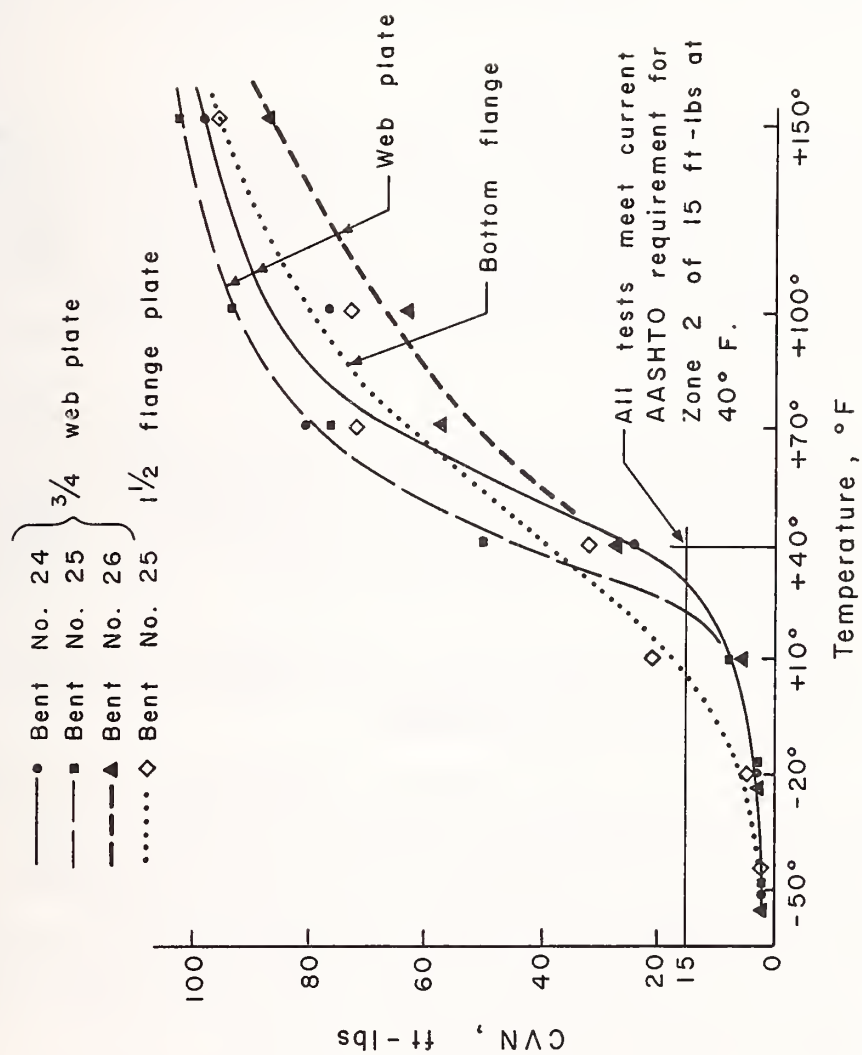
Fig. 6 - CVN Test Results (By Materials Research Laboratory, Inc., Glenwood, Illinois)

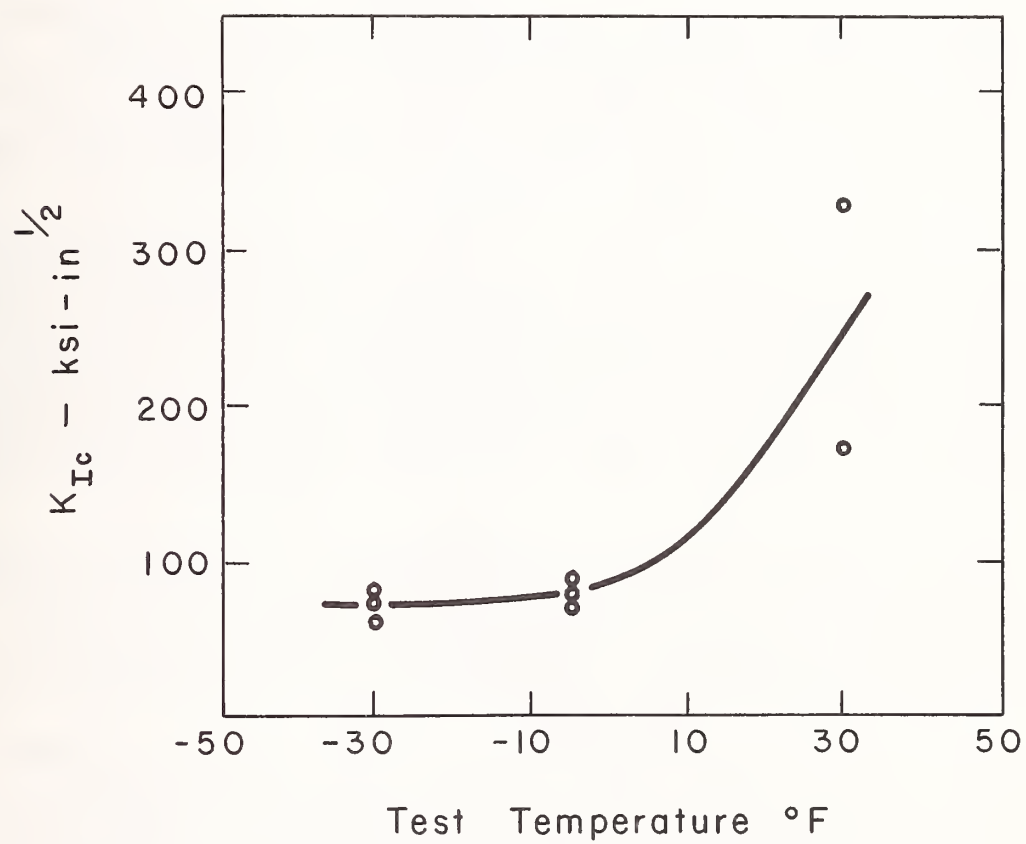
Fig. 7 -  $K_{Ic}$  Test Results (By Materials Research Laboratory, Inc., Glenwood, Illinois)

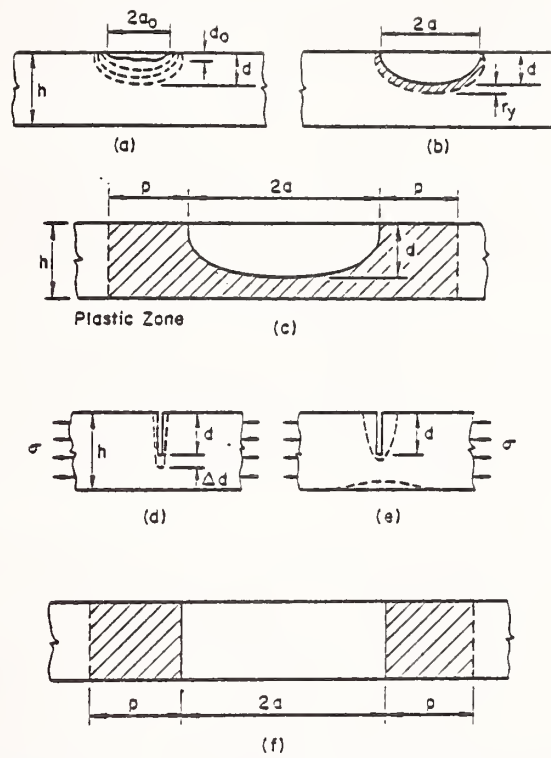
At the third and fourth stages of the fracture process (Figures 1 c, d, and e) it is understood that prior to net ligament rupture the pipe wall around the crack would undergo large scale plastic deformations. Consequently, the elasticity solutions would not be adequate to study these phases of the fracture phenomenon. In a large group of important structures in which the thickness to radius ratio is relatively small, the last phases of fracture usually involve relatively long and deep surface cracks with full plastic deformations along the entire net ligament and through the container wall around the crack tips. Particularly in structures such as the great variety of straight and bent piping and pressurized containers used in transportation in which fluctuating bending stresses are superimposed on stresses caused by the internal pressure, relatively long surface cracks before rupture appear to be a rule rather than an exception. By making two major assumptions the fracture problems arising in the failure analysis of such structures may be brought under control and treated analytically. The first assumption is that because of the relatively long crack length and small thickness-to-radii ratios the structure can be adequately modeled as a "shell". The second assumption involves the use of a modified version of the conventional plastic strip model to account for the plastic deformations in the crack region. In a structural component undergoing ductile fracture which involves progressive crack growth, it is generally agreed that the size of the energy dissipation zone  $R_D$  shown in Figure 2 is an increasing function of the crack length. Consequently, in the case of slow progressive ductile fracture the fracture resistance of the solid increases with the increasing crack length (hence, the concept of "crack extension resistance curve" or the R-curve). In progressive ductile fracture one may generally distinguish four different regions in the material, namely the basic energy dissipation zone  $R_D$ , the wake region of the residual stresses  $R_W$ , the crack

Figure 1. Evolution of a through crack

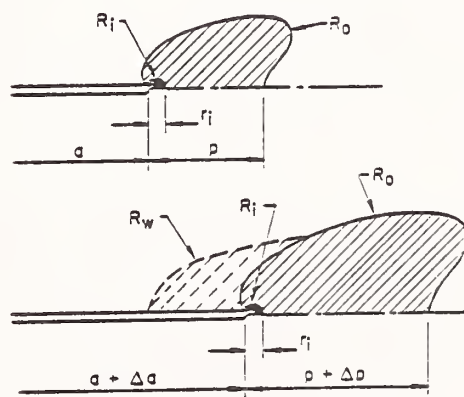
Figure 2. Progressively growing ductile fracture

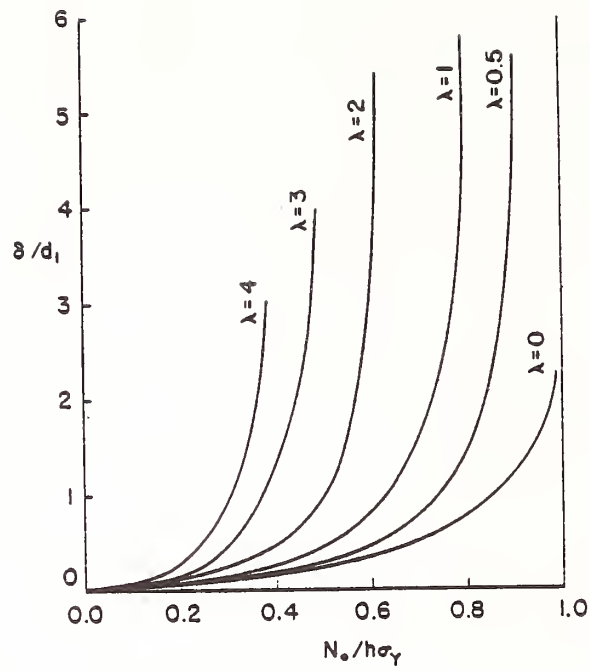
Figure 3. Crack opening stretch at the tip of an axial through crack in a cylindrical shell.

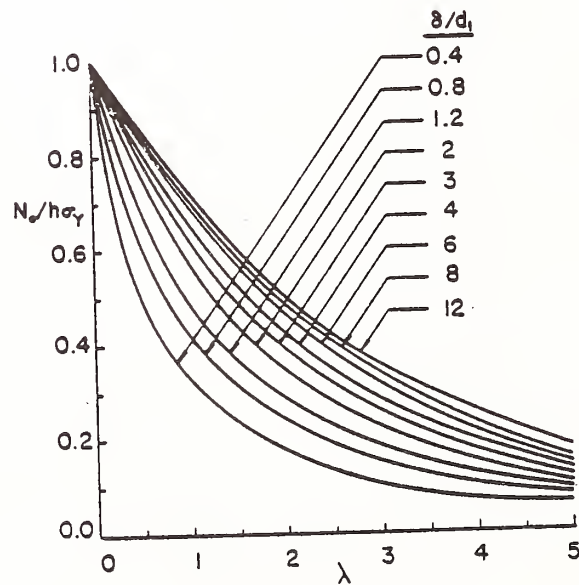
Figure 4. Load carrying capacity of a pressurized cylindrical shell with an axial through crack against crack initiation.

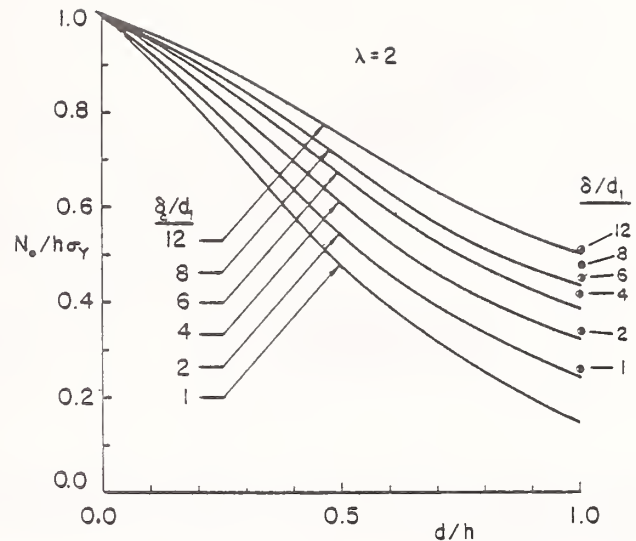
Figure 5. Load carrying capacity of a pressurized cylinder with an axial part-through crack.

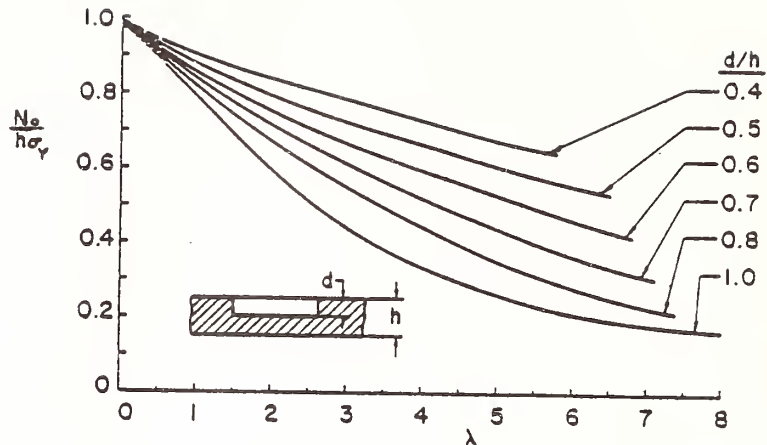
Figure 6. The instability load  $N_0 = R p_0$  for a pressurized cylinder with a progressively growing part-through crack ( $d < h$ ) or a through crack ( $d = h$ ).

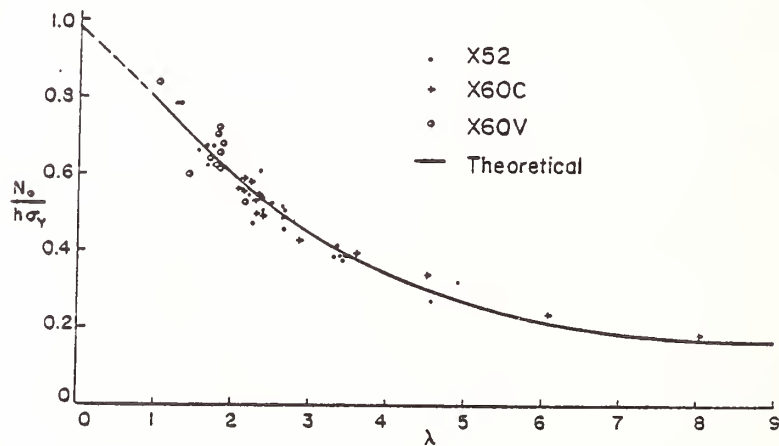
Figure 7. Comparison of calculated (Figure 6) and experimental [8] instability loads in steel pipes with an axial through crack.

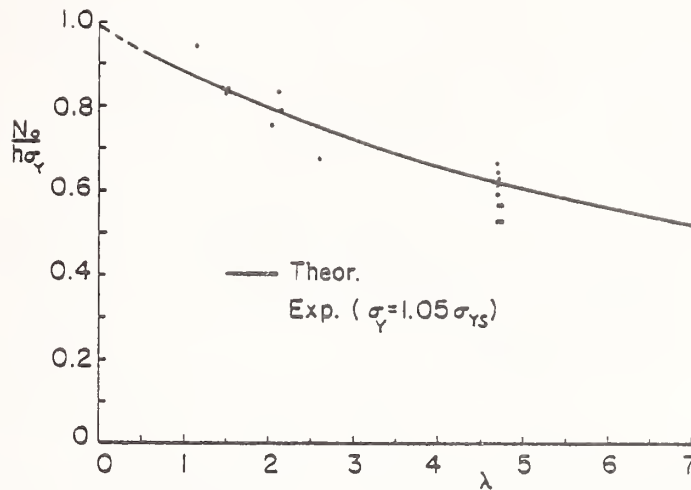
Figure 8. Comparison of calculated (Figure 6) and experimental [8] instability loads in pipes with an axial part-through crack.

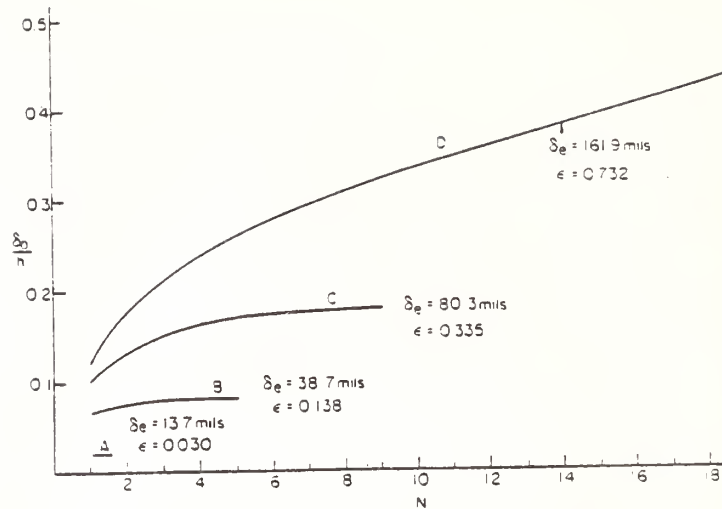
Figure 9. Results of the successive approximation calculations to determine the burst pressure ( $N$  is the number of iterations).

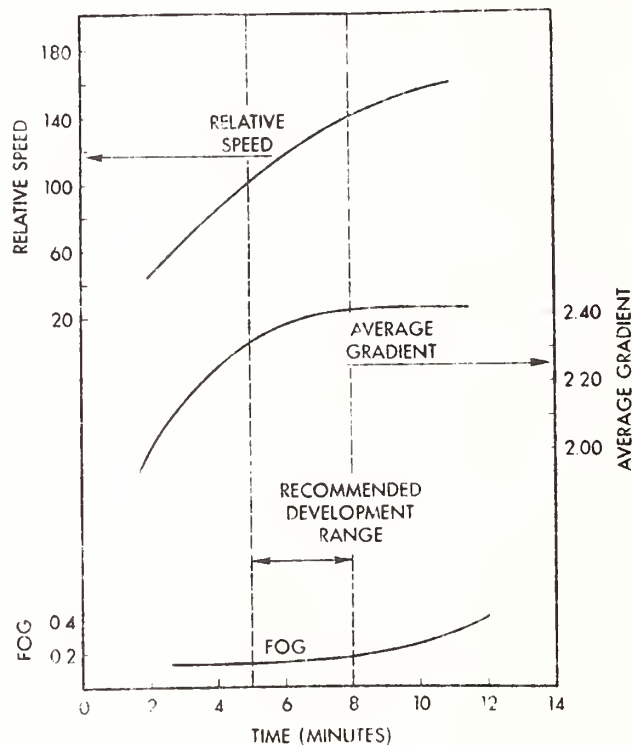
Fig. 3. Relative speed, average gradient, and fog level as a function of manual processing time for a typical film. Reference "Radiography in Modern Industry".

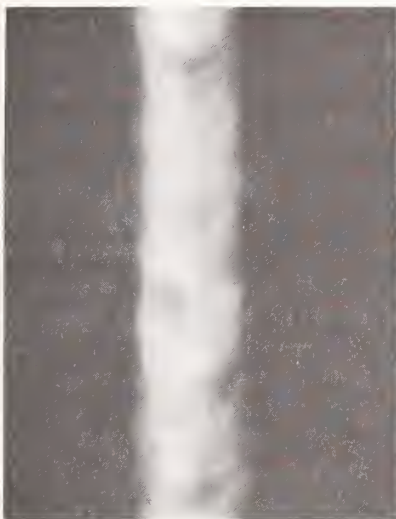
Fig. 4. Photo of typical section of a field radiograph. There is a crack in this area.
