NIST Special Publication 1000-5

June 2004
Progress Report on the
Federal Building and Fire Safety
Investigation of the
World Trade Center Disaster

June 2004

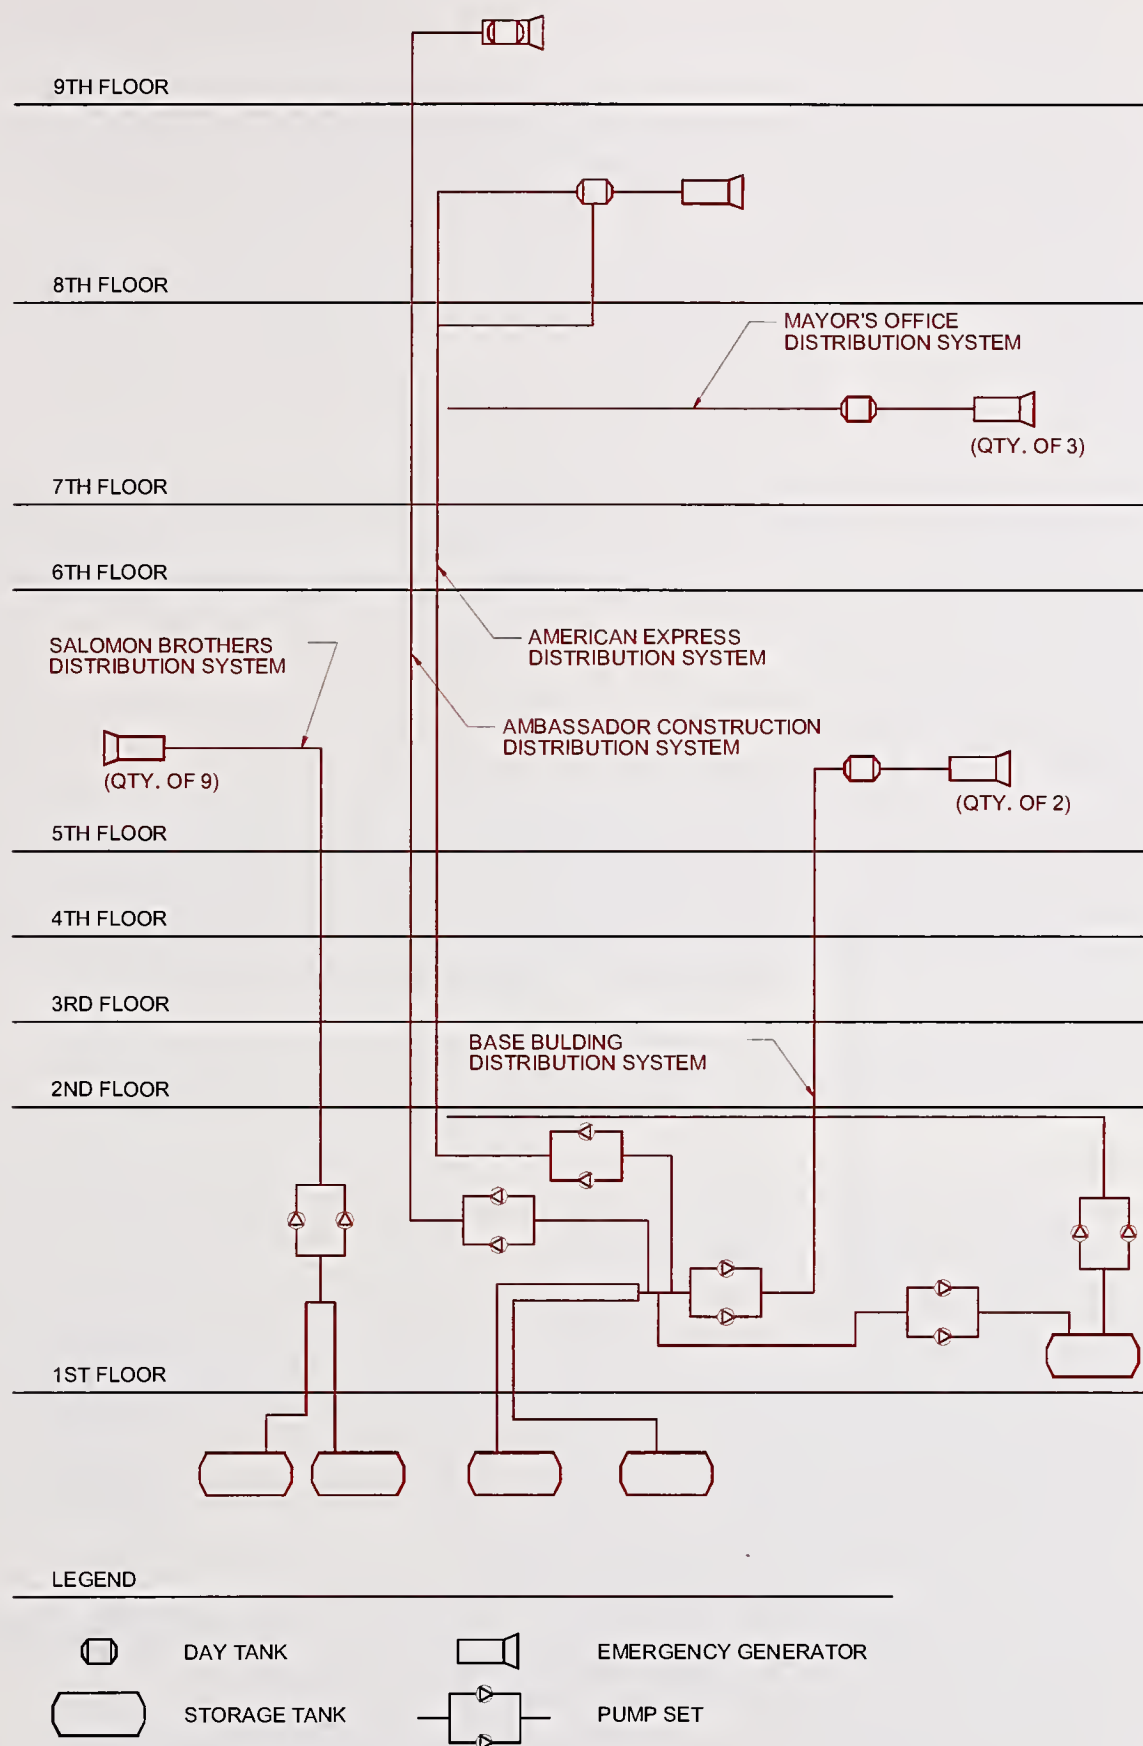
Figure 2-1. Locations of emergency generators and fuel tanks in WTC 7.

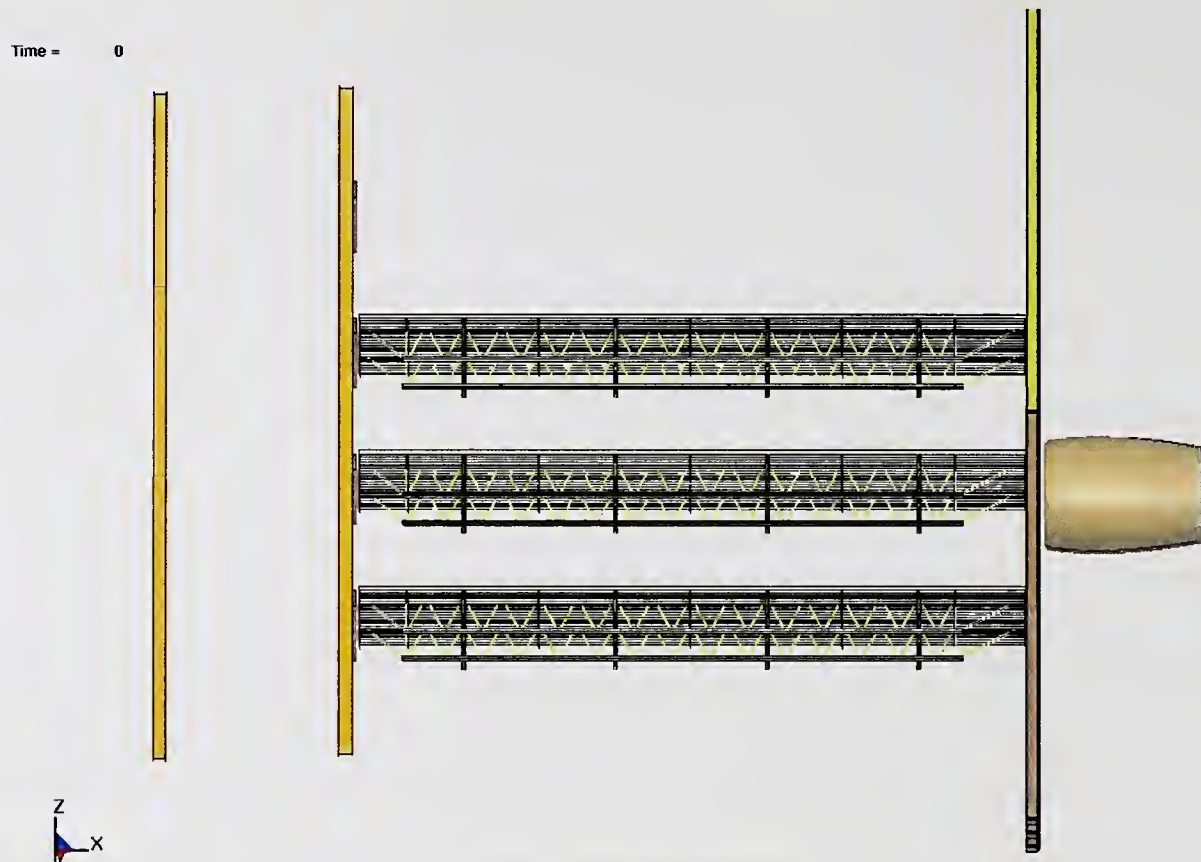
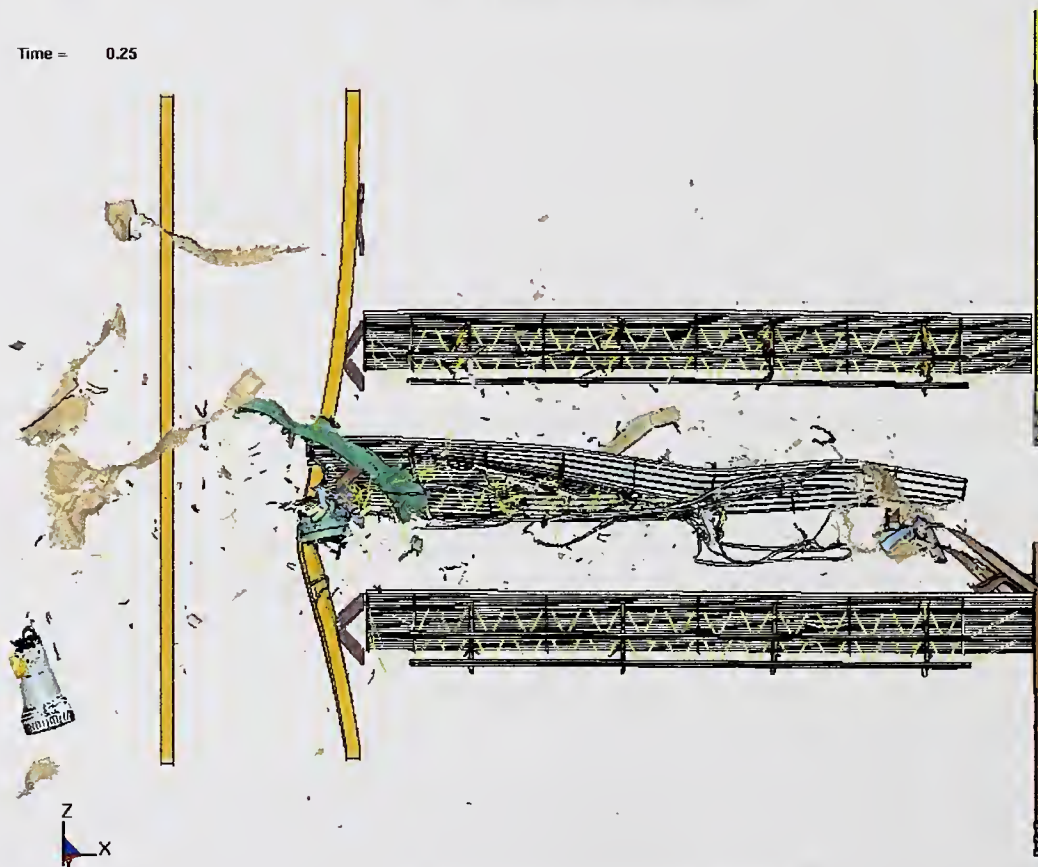
(a) Initial configuration

(b) Impact response at 0.25 s

Figure 2–2. Example engine impact subassembly analysis.

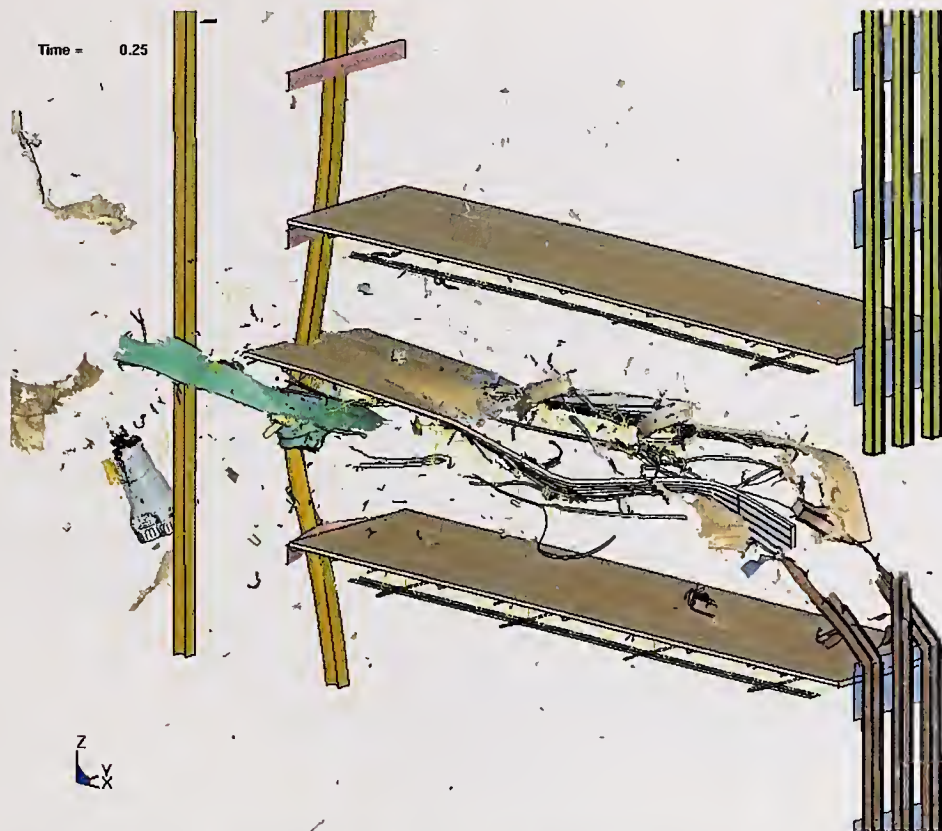
Figure 2-3. Oblique view of the subassembly engine impact damage.

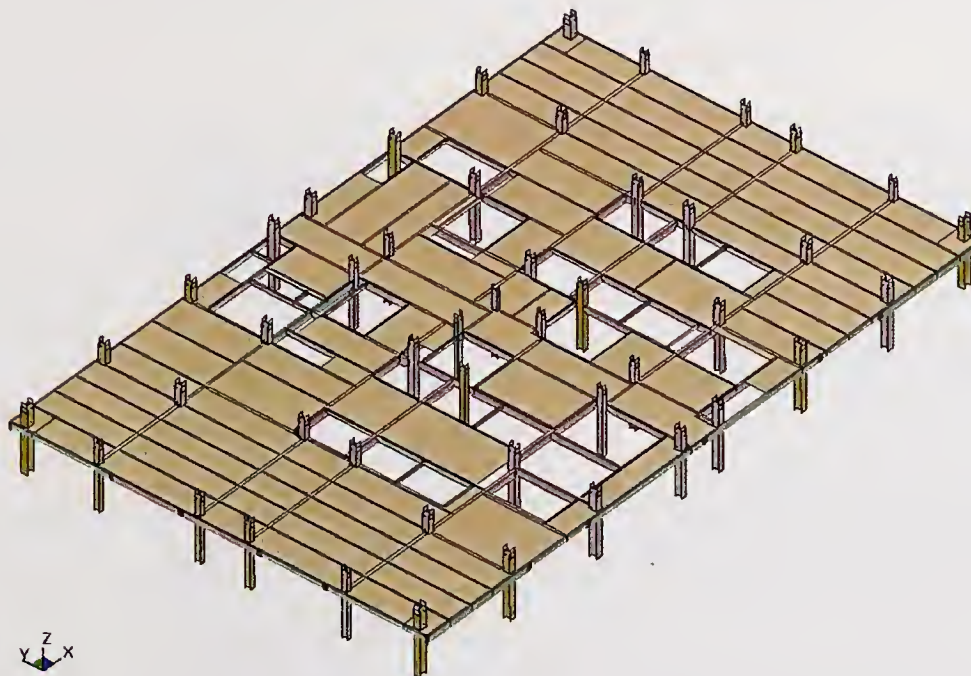
Figure 2-4. Model of the 96th floor and columns of WTC 1.

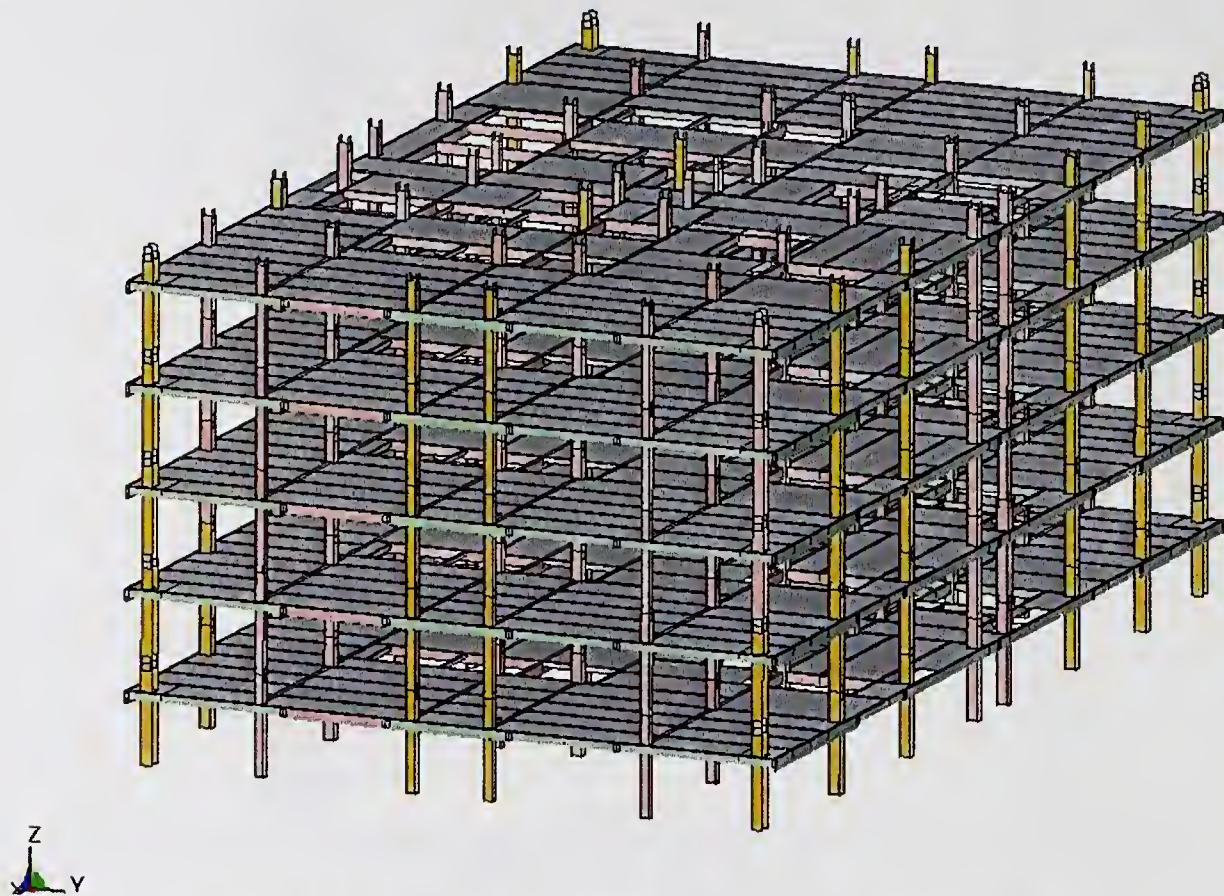
Figure 2-5. Model of the core of WTC 1, floors 94-98.

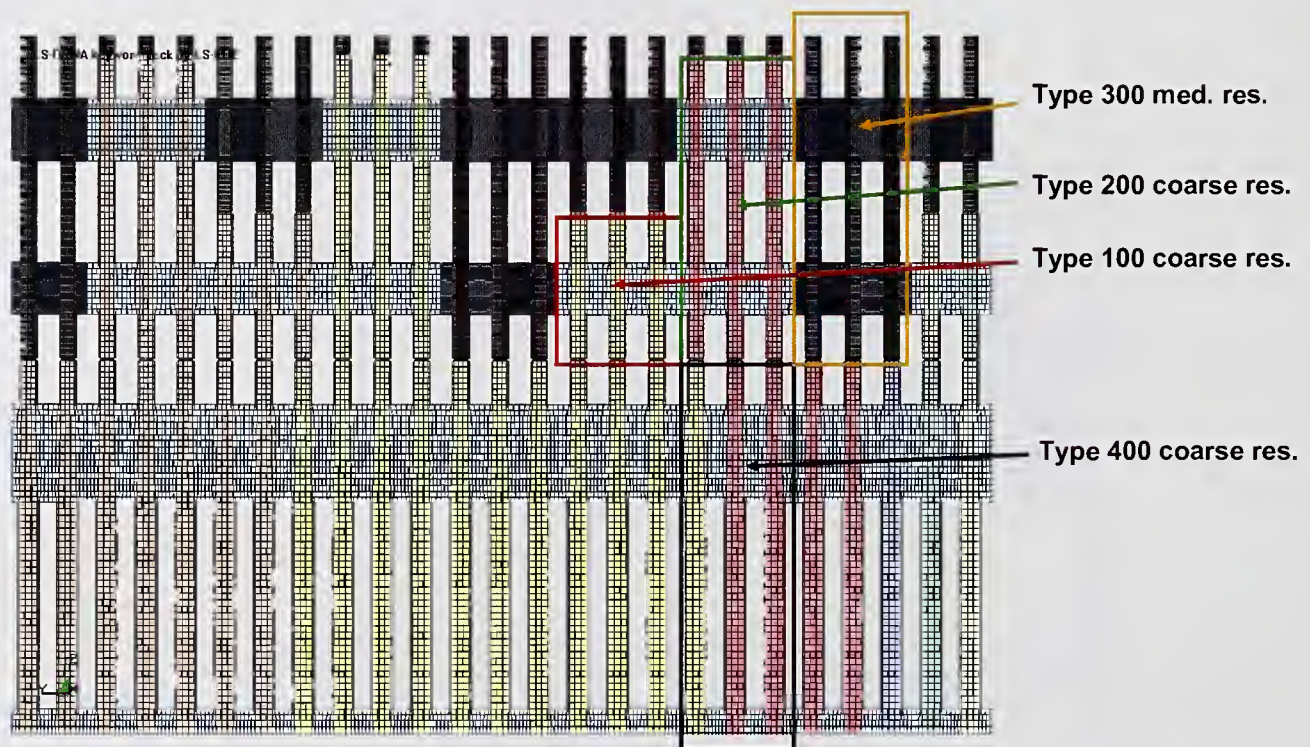
Figure 2-6. Detail of the WTC 2 impact zone exterior column panels.

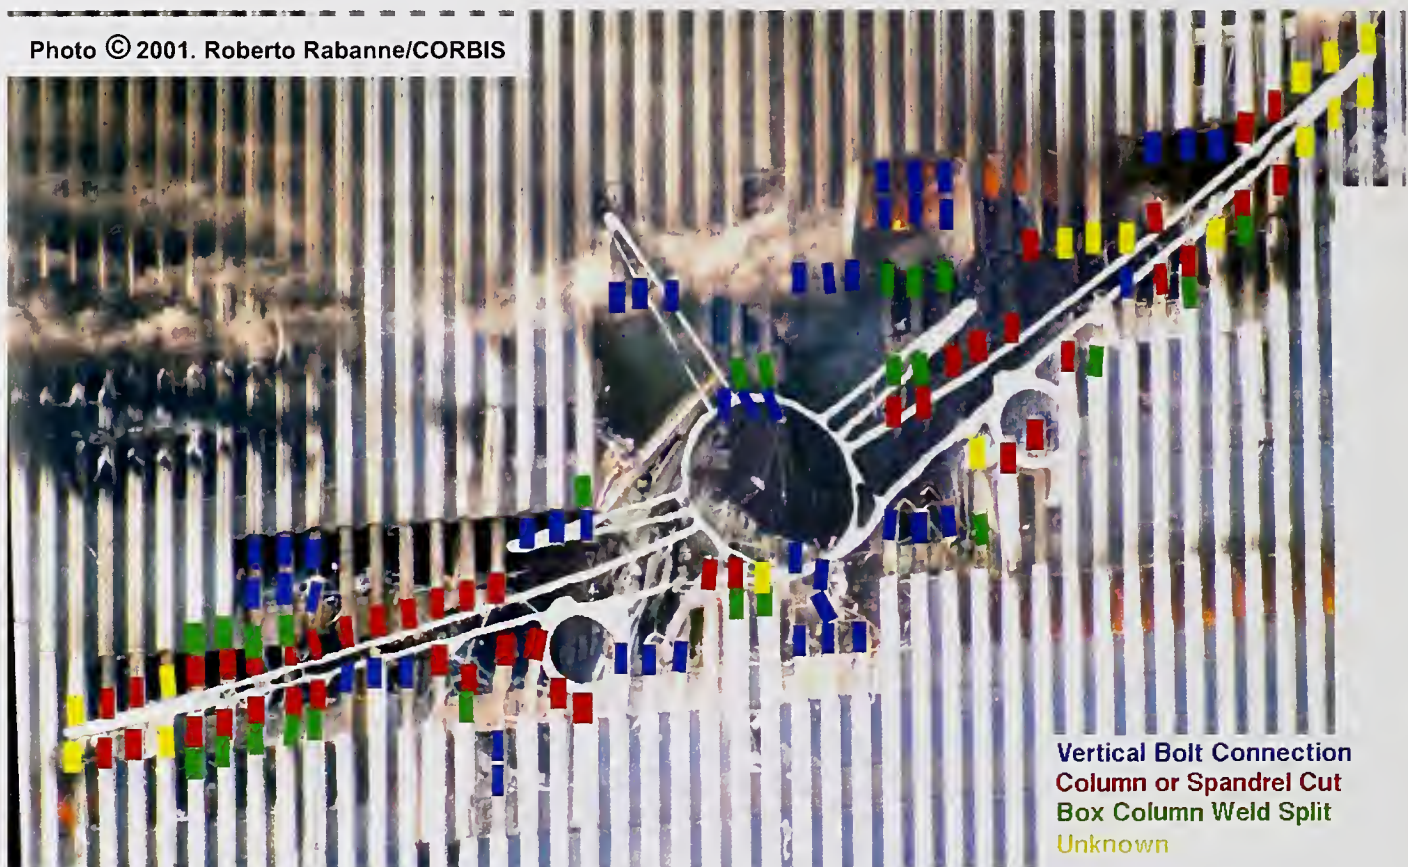
Figure 2–7. Enhanced precollapse image of the north face of WTC 1 with superimposed outline of the Boeing 767. Likely failure modes of damaged columns are indicated.

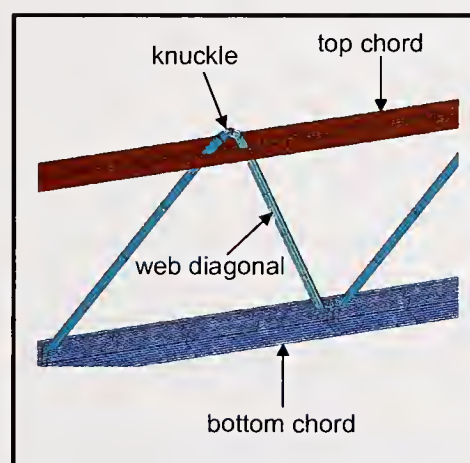
- Shear connector between the truss and concrete slab, referred to as a knuckle, shown in Figure 2–9
- Truss-to-column bearing seats
- Truss section, including composite floor slab, knuckles, and truss seat connections to columns
- Single-story exterior column for a 9-story height
- Exterior wall subsystem consisting of a 3-by-3 panel section of the exterior wall, where a panel is 3 columns wide and 3 stories long
- Full floor subsystem including the concrete slab, truss seat connections to columns, and core floor area

Figure 2–9. Features of truss model.

The truss section model (see Figs. 2–9 and 2–10) includes the following:

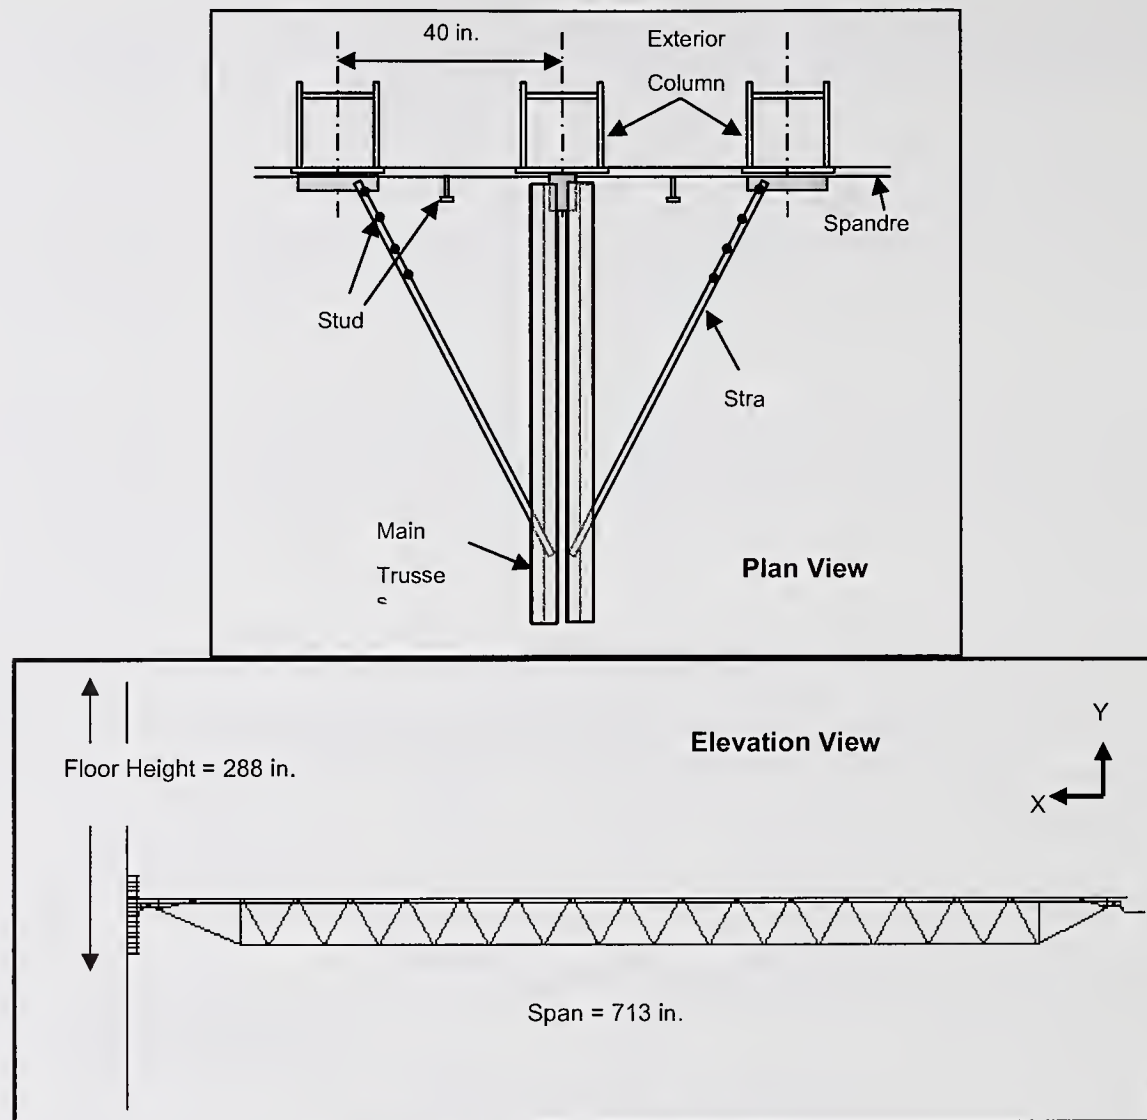
Figure 2-10. Truss model.

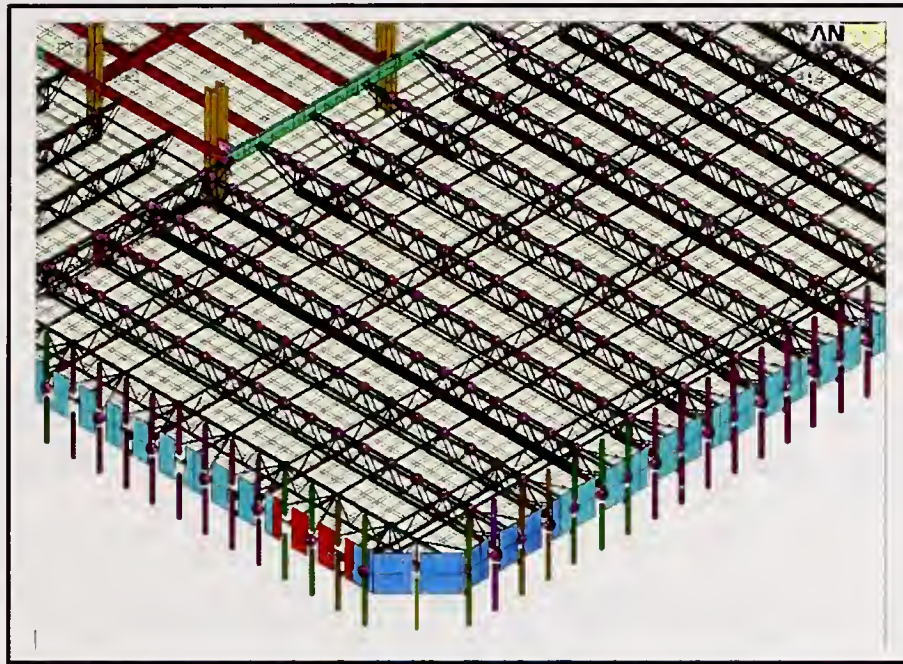
The model was developed by translating a SAP2000 full floor model developed under Project 2 into ANSYS format and validating the analysis results against the SAP2000 model for design loads. A corner of the full floor model is shown in Fig. 2-11.

Figure 2-11. Converted ANSYS model of floor 96.

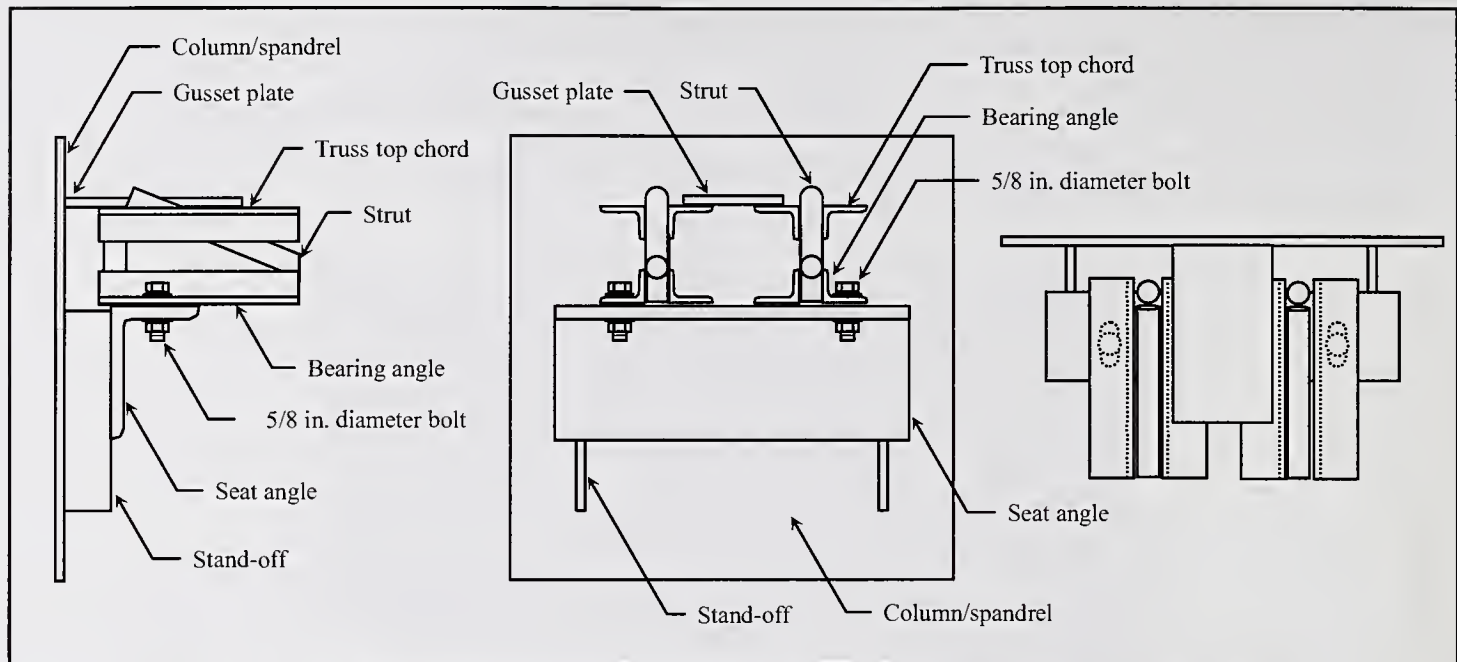
Figure 2-12. Exterior connection of the floor truss to the spandrel plate.

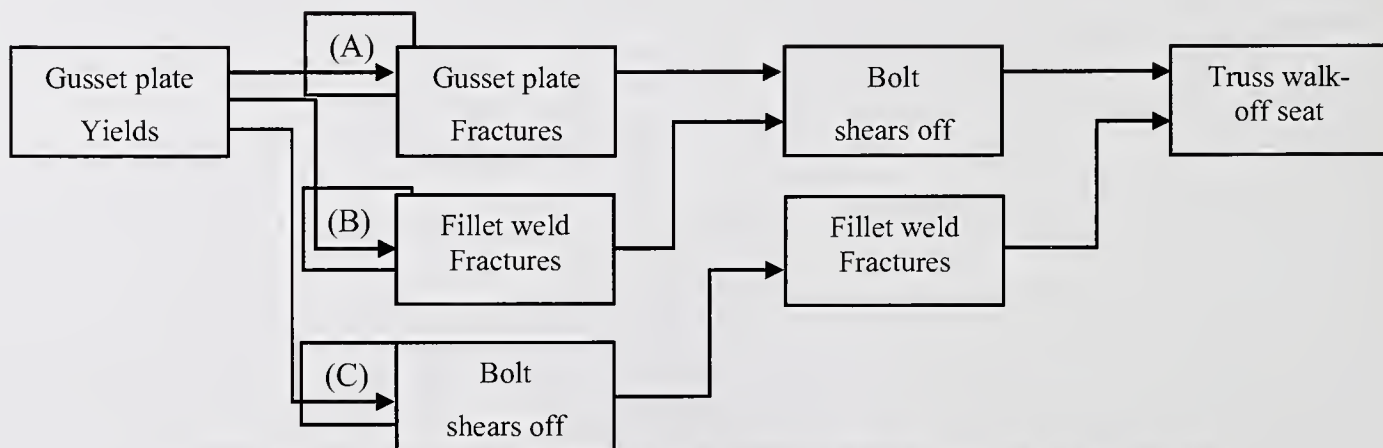
The failure modes considered for the truss-to-column connections are: (1) failure of the groove weld between gusset plate and spandrel, (2) failure of the fillet weld between the gusset plate and the truss top chord, (3) tensile failure of the gusset plate, (4) bolt shearing off, (5) bolt bearing, (6) bolt tear-out, and (7) block shear failure. Possible failure sequences are illustrated in Fig. 2-13. Of the seven exterior connections types that were analyzed, path A is the failure sequence most frequently followed, which is described as follows: first the gusset plate yields across its section and then fractures, followed by truss sagging and deformation and the bolts slipping until they bear against the edge of the slotted hole, then the bolt shears off, and finally the truss walks off the seat. The travel distance for the truss to walk-off of the seat is 4 5/8 in. Sequence (A) and typical tensile force resistance for an exterior seat is shown in Fig. 2-14.

Figure 2-13. Failure sequence of exterior seats for tensile forces.

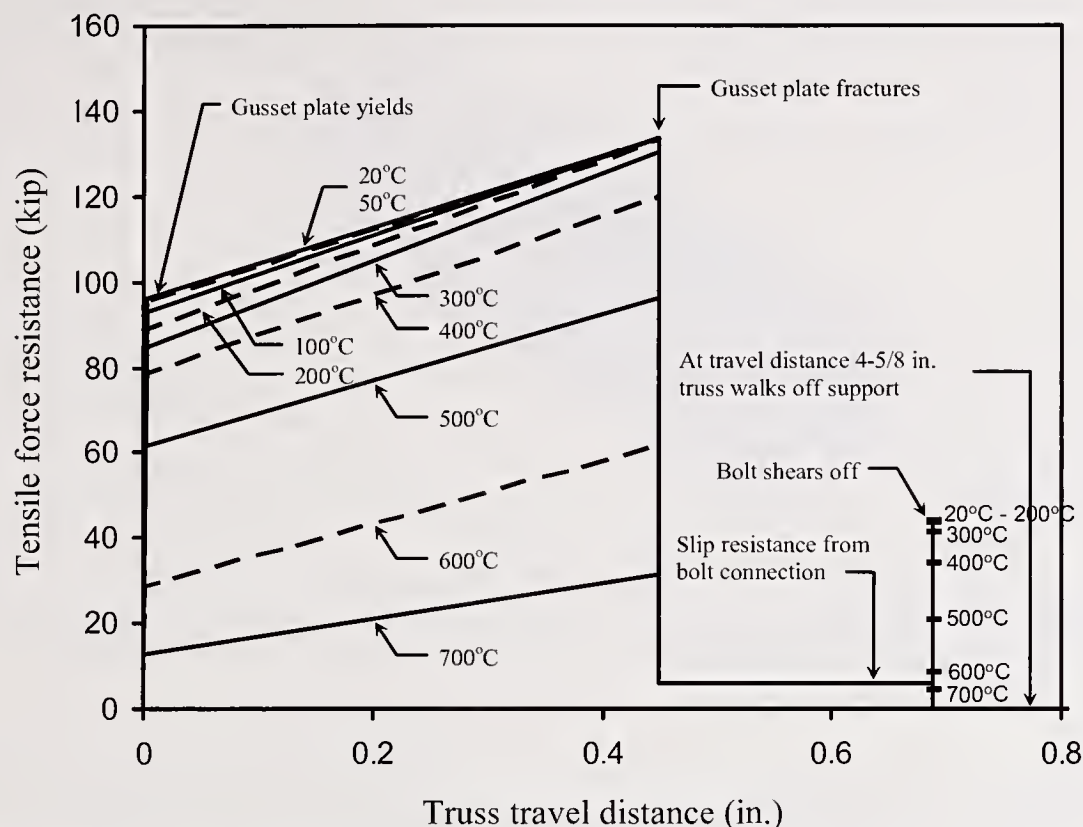
Figure 2-14. Typical tensile force resistance of exterior seat connection.

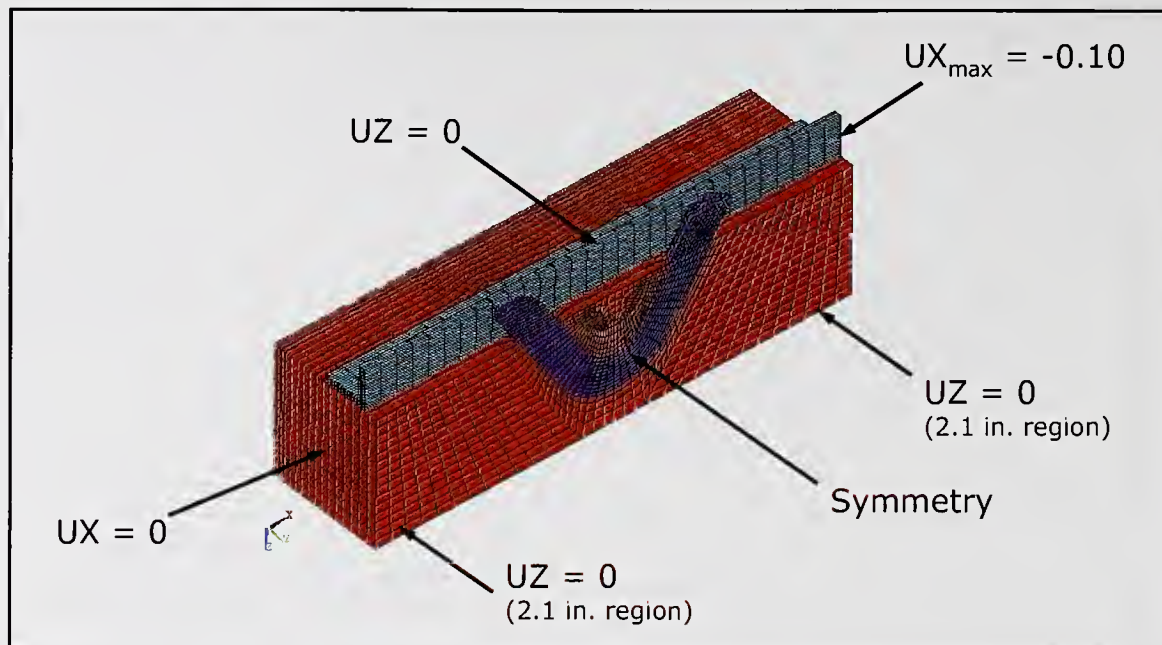
Figure 2-15 shows the FEM of the longitudinally loaded knuckle, representing one quarter of the knuckle test specimen. The ANSYS LS-DYNA program, which is part of the ANSYS software package for explicit nonlinear structural analysis, was used for the analysis of the knuckle tests as it had a concrete material model for nonlinear behavior. Solid steel elements were used for the knuckle and channel members and the Pseudo Tensor material model in LS-DYNA was used for the concrete. The knuckle-to-concrete interface was modeled as a bonded or no-friction contact. The finite-element analysis results of the knuckle capacity depended on the steel-concrete interface assumption of bonded or no-friction contact.

Figure 2-15. Finite element model of transversely loaded knuckle.

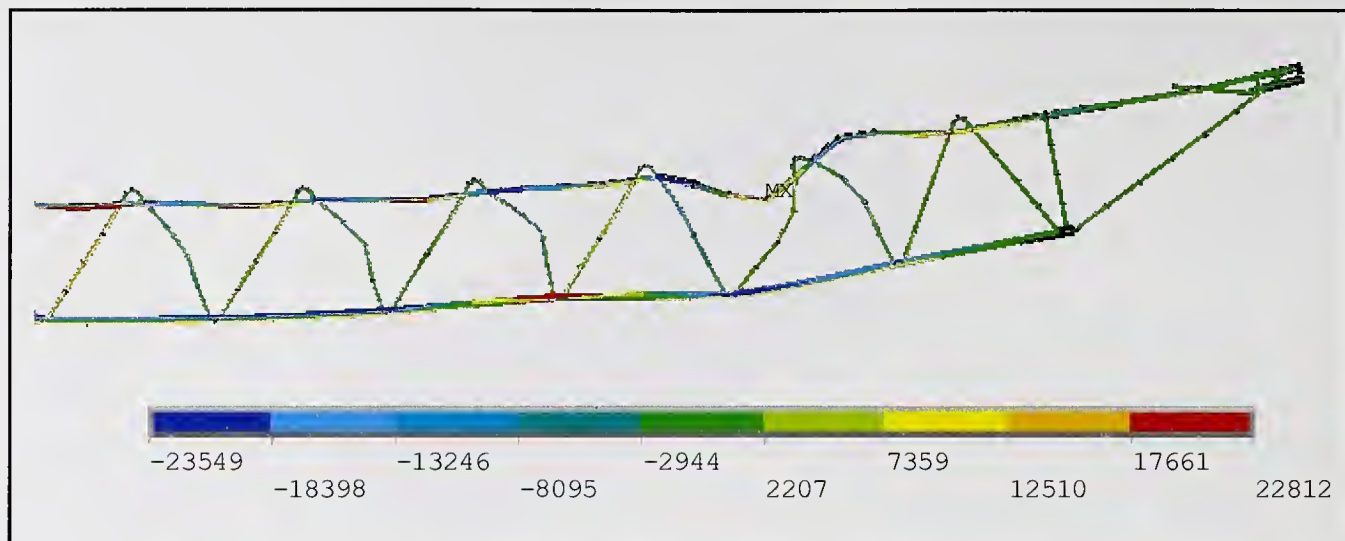
Figure 2–16 shows that the top chords of the truss yield in compression beyond 300 °C (for clarity, the concrete floor slab is not shown). This is due to a significant difference of coefficients of thermal expansion (CTE) between concrete and steel. At 500 °C, the CTE of steel is twice that of light-weight concrete. Bottom chords remain in the elastic range throughout the thermal loading. Web diagonal buckling starts around 350 °C and, as seen in the figure, some diagonals are bent significantly in the plane of the truss by high axial force and end moments.

Figure 2–16. Finite element solution for floor truss under gravity and temperature loads.

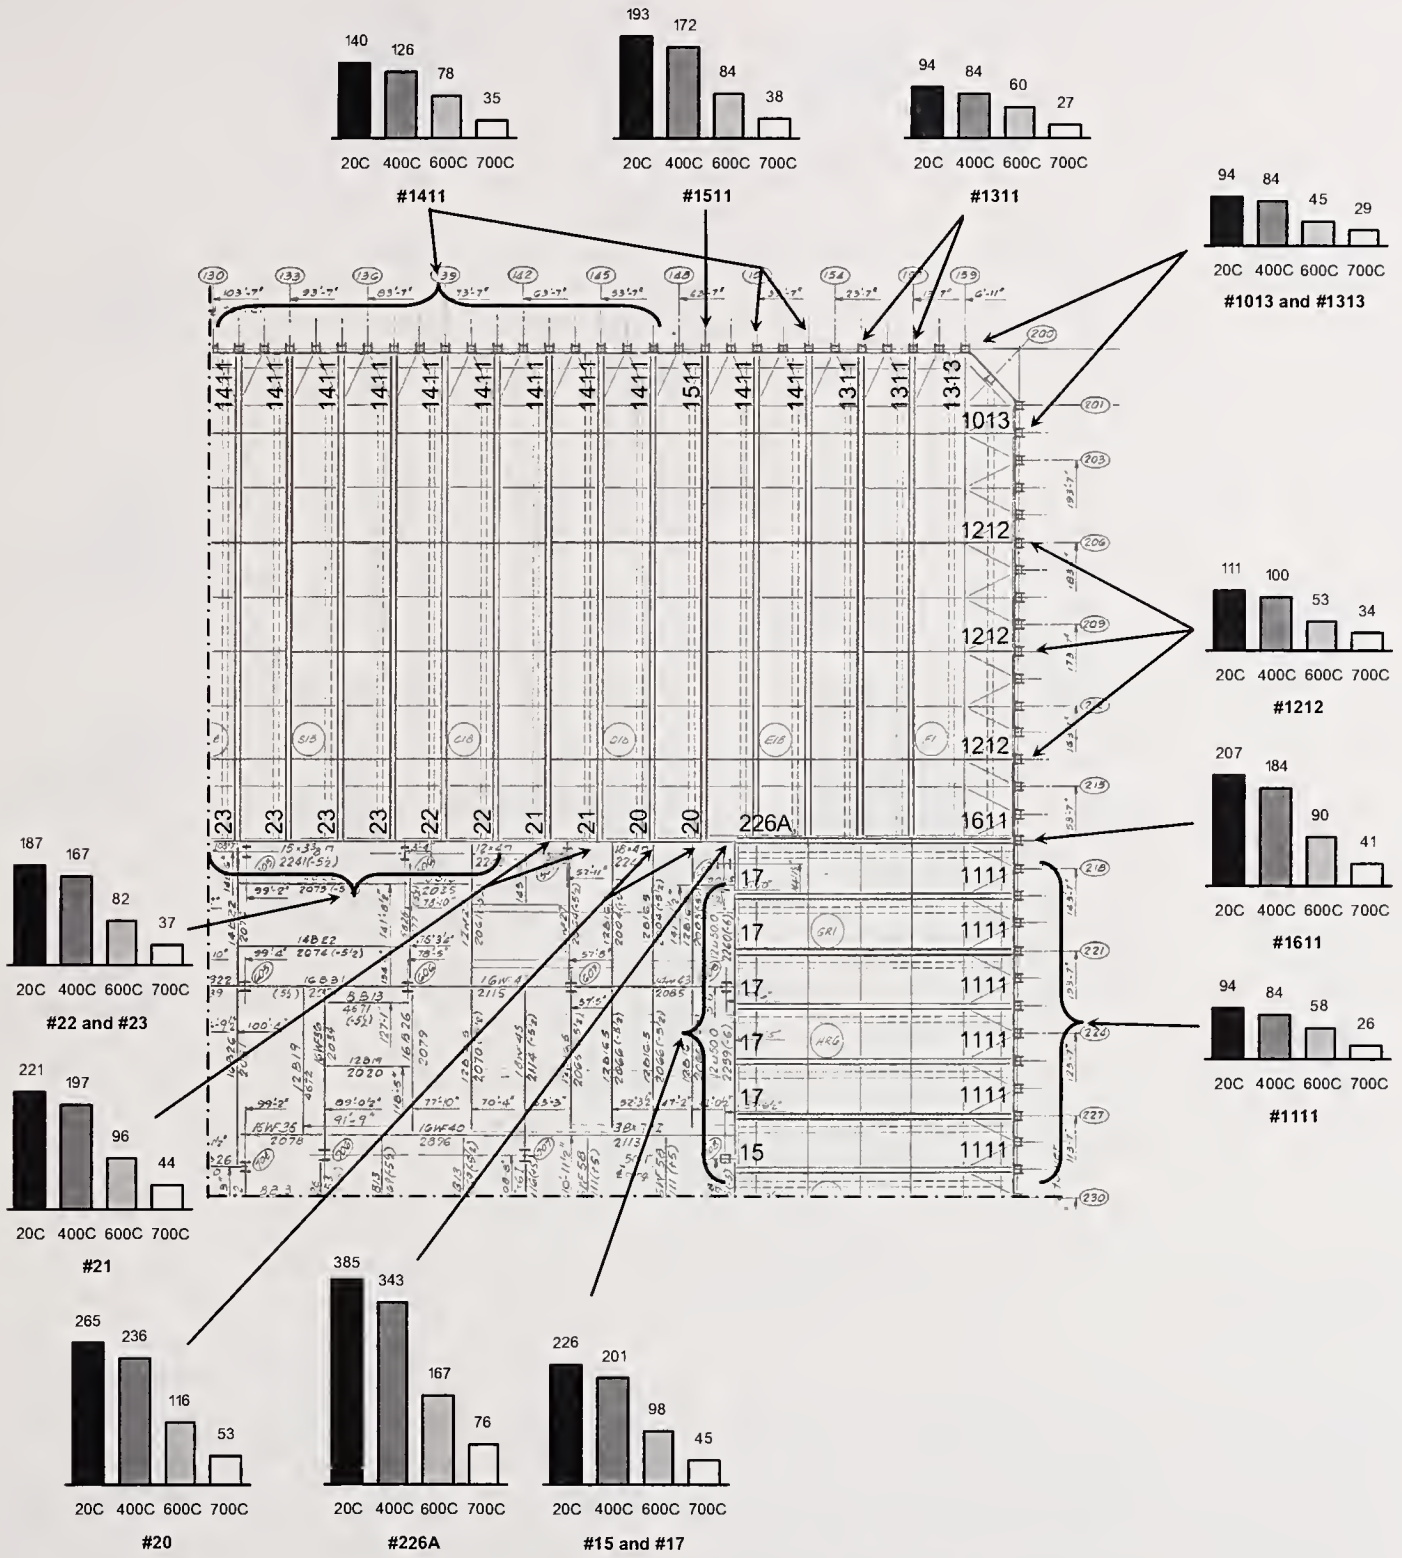
Failure mode of the interior truss seat for vertical force is the fracture of the fillet welds at the seat-to-channel beam connection. Failure mode of the exterior truss seat for vertical force is fracture of the fillet welds at the stand-off-to-spandrel connection. Preliminary findings of connection capacities for vertical bearing forces at room temperature (20 °C), 400 °C, 600 °C, and 700 °C are summarized in Fig. 2–17.

Figure 2-17. Truss seat capacity for vertical forces.

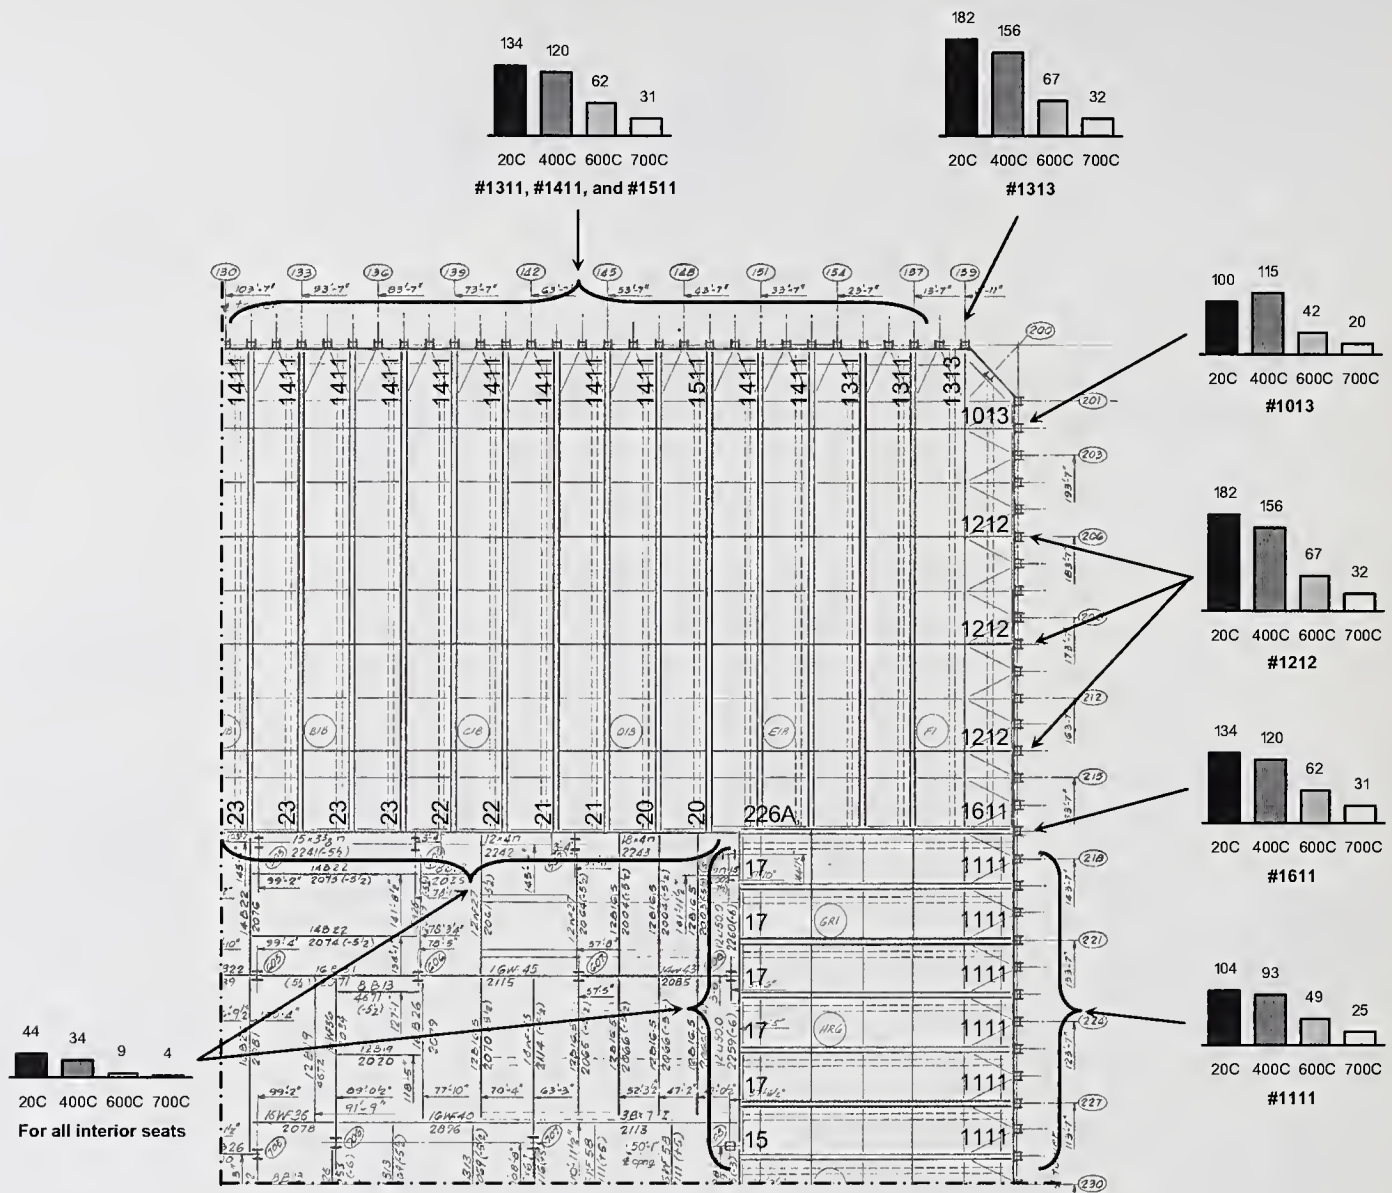
Similarly, connection capacities for horizontal tensile forces at the same temperatures are shown in Fig. 2–18. For interior truss seat connections, the shear strength of the two bolts controls the horizontal tensile capacity. The connection capacity of exterior truss seats that follow failure sequence (A), as shown in Fig. 2–13, equals the failure load for the tensile capacity of the gusset plate. Note that the strength of the truss seat #1013 increases by approximately 38 percent at a temperature of 100 °C. For temperatures less than 100 °C, the horizontal capacity is controlled by the gusset fillet weld strength, and for temperatures above 100 °C, the bolt bears against the edge of the slotted hole and increases the capacity of the connection.

Figure 2-18. Truss seat capacity for horizontal forces.

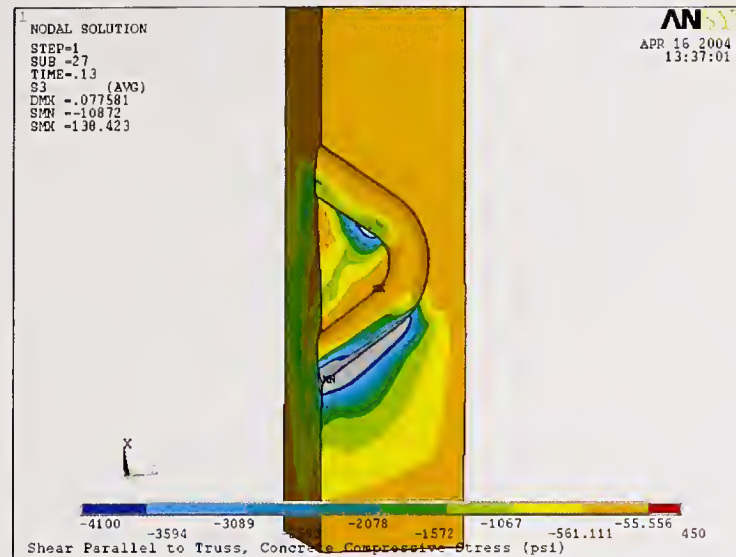
FEA results of the knuckle under longitudinal loading are shown in Fig. 2-19. Displacement results shown in Fig. 2-20 indicate a significant dependence on the characteristic of the interface between the steel and concrete. Results show that each knuckle has a capacity in the range of 15 klb to 35 klb, depending on the steel-to-concrete interface assumption. Results of longitudinal shear tests conducted by Laclede Steel in 1967, using normal weight concrete with an average compressive strength of 3,707 psi, indicate an average shear capacity of approximately 28.3 klb per knuckle. After adjusting for the strength of in-place light-weight concrete of 4,100 psi (i.e., multiplying 28.3 klb by the ratio of 4,100 to 3,707 psi), the longitudinal shear capacity of the knuckle is approximately 31 klb per knuckle. This is consistent with the finite element solution for the fully bonded case shown in Figure 2-21 (note results are for two knuckles). A shear capacity of approximately 30 klb per knuckle is used for subsequent analyses of the floor truss.

Figure 2-19. Compressive stress in longitudinal shear.

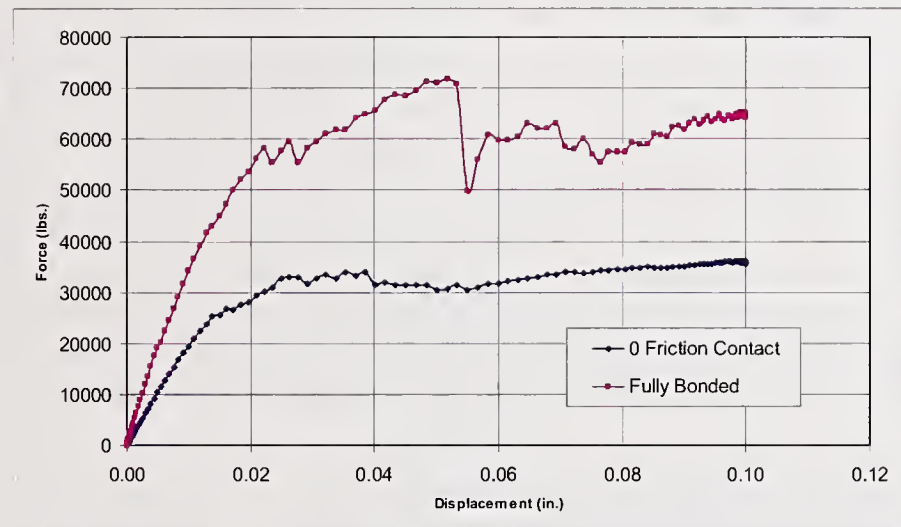
Figure 2-20. Shear force versus displacement for two knuckles under longitudinal shear.

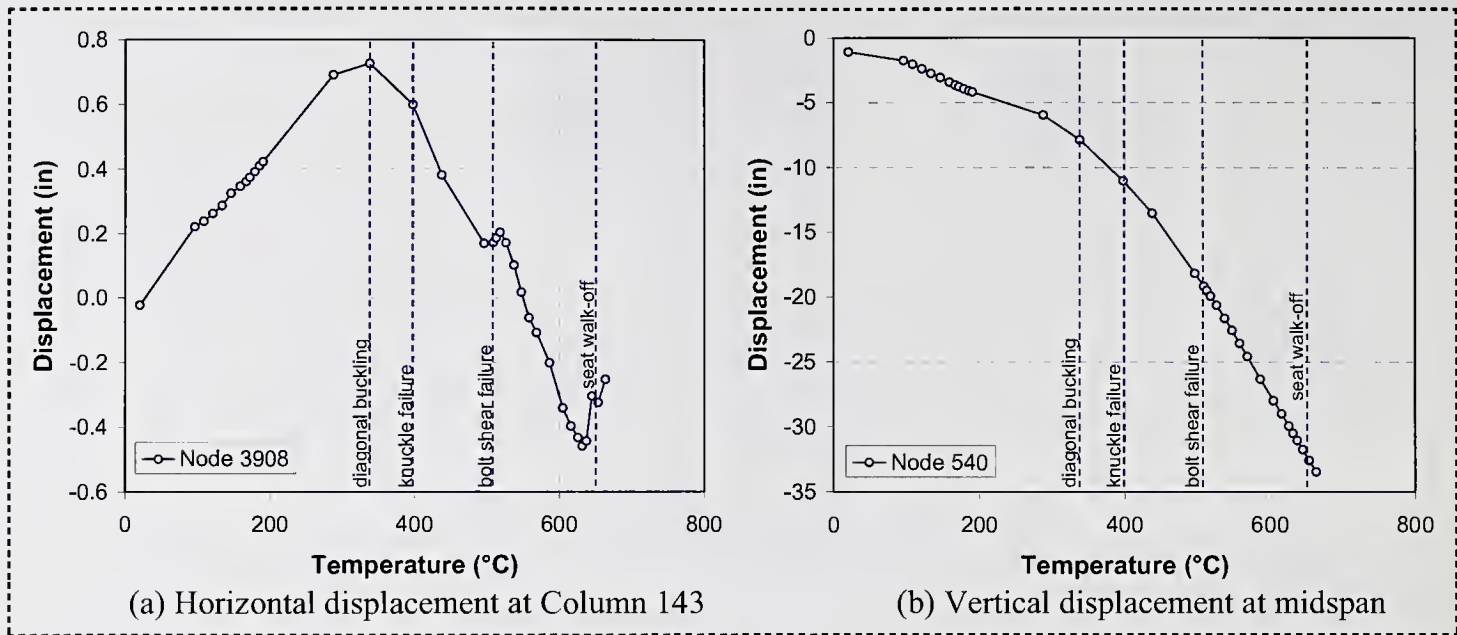
The floor truss analysis was carried out dynamically with 5 percent Rayleigh damping and a temperature ramp set to 1.0 s. The floor slab had only gravity loads applied; no other loads related to floor diaphragm action were included. The analysis of truss behavior under the gravity plus thermal loading proceeded to a temperature of $T=663^{\circ}\text{C}$. Figure 2-20 shows the horizontal displacement of the column and the vertical midspan displacement of the truss. A positive horizontal displacement indicates that the exterior columns are pushed out, and a negative vertical displacement indicates that the truss is deflected downward.

Figure 2–21. Floor truss response due to gravity load and uniform heating.

As the truss and floor slab heat up, the column is pushed outward by thermal expansion. The truss top chord begins to yield in compression around 300 °C due to the difference in coefficient of thermal expansion between steel and lightweight concrete. At approximately 340 °C, web diagonals begin to buckle and the horizontal displacement at the exterior column reverses and begins to decrease. At 400 °C, knuckles start to fail sequentially from both interior and exterior supports toward the center. With the loss of composite action, the floor begins to sag at an increasing rate. Eventually, at about 500 °C, with the truss sagging almost 20 in., the bolts at the interior connection are found to shear. At 560 °C, the exterior columns begin to displace inward, and the truss begins to act as a catenary. At 650 °C, the truss walks off the interior seat while the interior end of slab remains intact and continues to carry vertical load. For the truss to walk off the interior seat, the truss must shorten by 4 in. This shortening is caused mainly by the significant plastic deformation of the top chord of the truss (Fig. 2–14), resulting from differences in the thermal expansion of the top chord relative to the slab and the failure of the first two knuckles near the interior seat. At roughly 660 °C, the gusset plate fracture at the exterior end which precipitates vertical failure of the exterior seated connection.
