NIST Special Publication 1000-5

June 2004
Progress Report on the
Federal Building and Fire Safety
Investigation of the
World Trade Center Disaster

June 2004

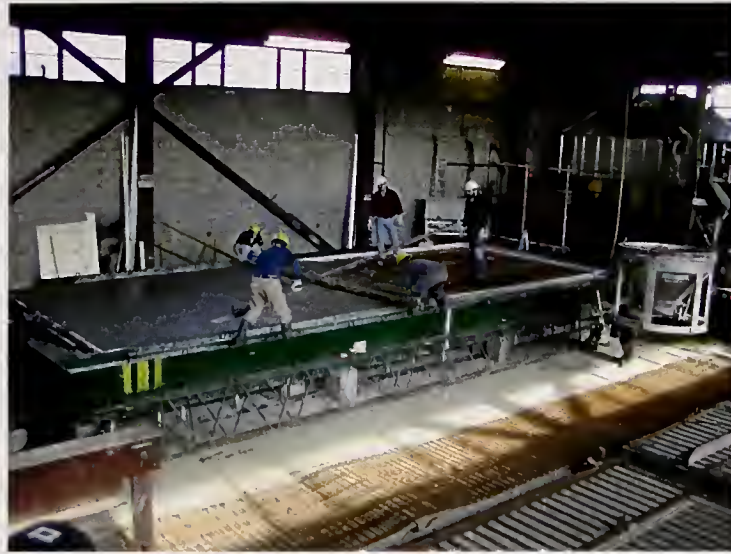
The test assemblies have been fabricated as shown in Fig. 2-22, and at this time, the concrete floor slabs are drying to the ASTM E 119 specified moisture condition under controlled conditions to obtain concrete design strength. The specimens are currently drying in a temperature/humidity controlled environment to achieve the ASTM E 119 prescribed moisture equilibrium.

Figure 2–22. Fabrication of 35 ft span ASTM E 119 test assembly.

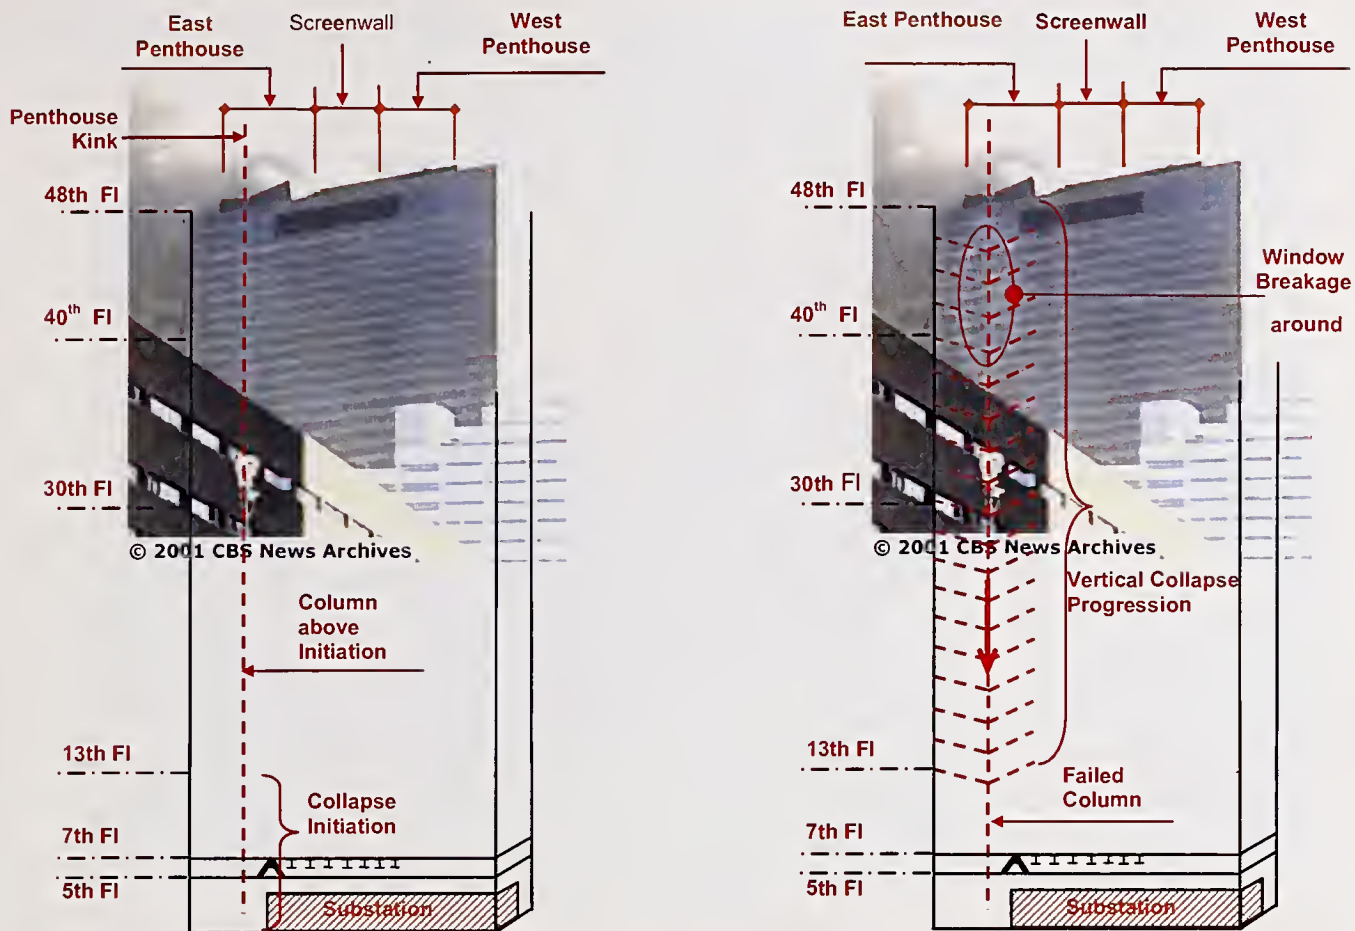
- Interior columns 79, 80, and 81, were located directly below the east penthouse on the roof and supported large tributary areas. The tenant floor areas on the east side of the building had spans of approximately 50 ft between columns. Their failure would likely result in failure of the tributary floor system, as analysis indicates that the floors would not be able to redistribute their loads. This failure mechanism would progress vertically upward within the failed bay to the roof level, and would not be visible from the exterior until the east penthouse lost support, as shown in Fig. 2–23. Available information on the floor-to-column connections indicate that the connections would fail under this scenario without significantly damaging the perimeter or interior columns.

Figure 2-23. Collapse initiation and vertical progression on the east side of WTC 7.

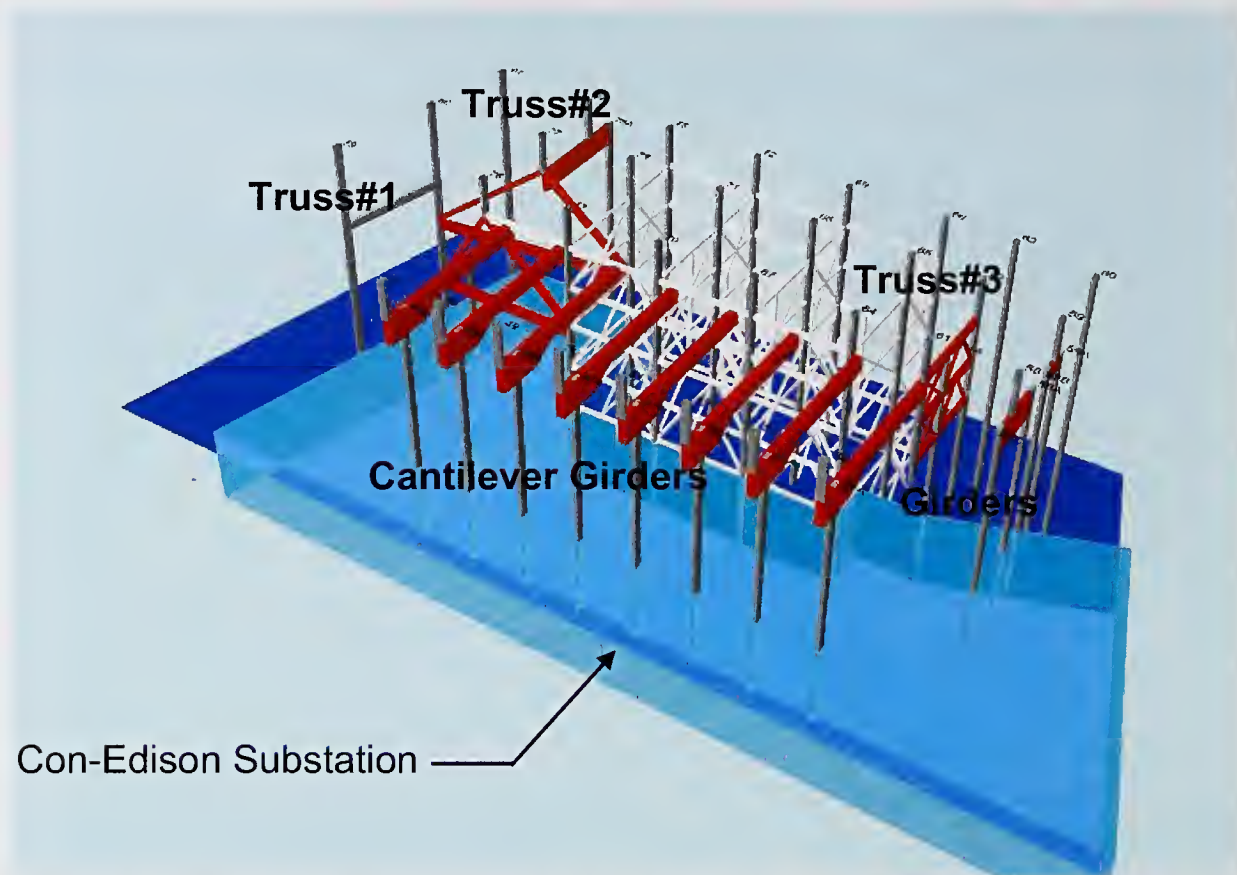
Figure 2-24. Transfer trusses and girders between the fifth and seventh floors.

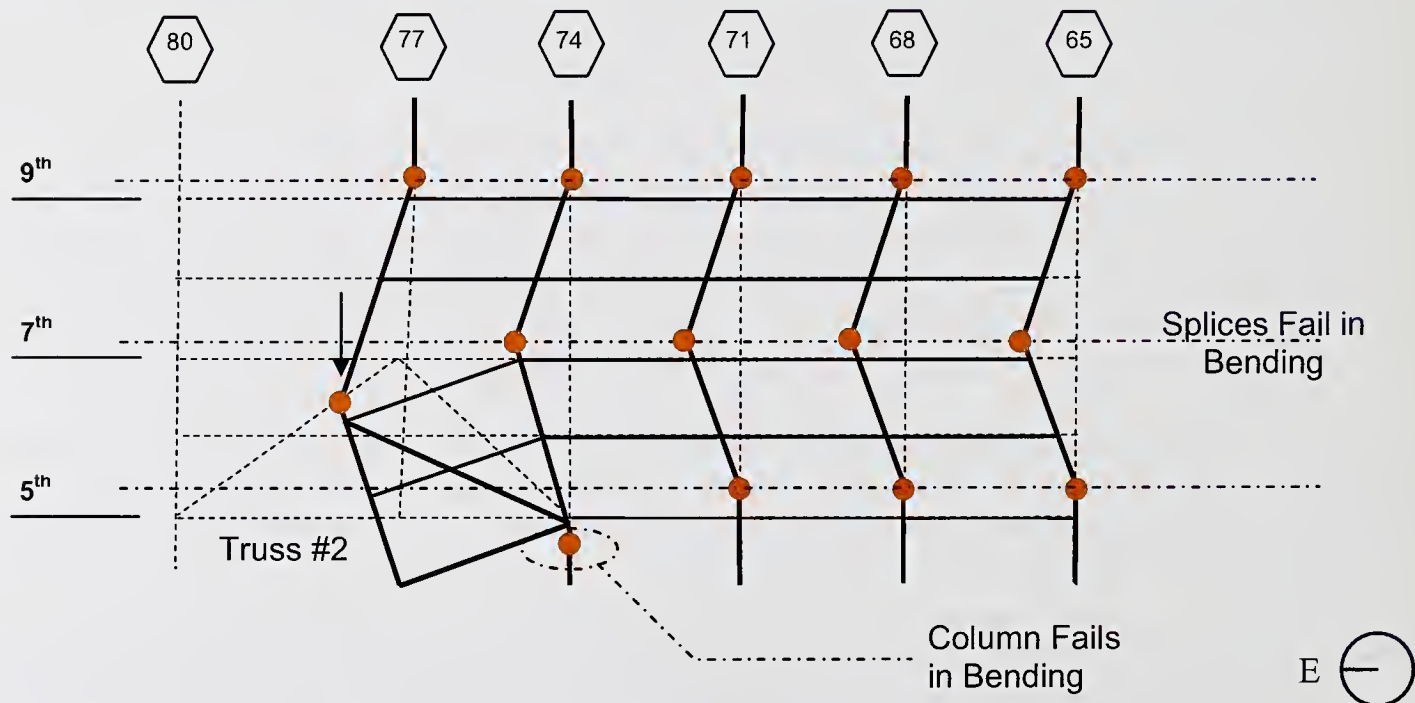
- The debris pile from a vertical failure progression on the east side of the building would damage or sever transfer girders and trusses between the fifth and seventh floors, shown in Fig. 2-24. Two system responses to this secondary damage have been postulated and are being further investigated. (1) The columns supported by these transfer components would become unstable, and their loads would transfer to adjacent core columns. If the columns could not support the transferred loads, the column instability would progress sequentially to adjacent core columns. (2) The floor-to-column connections in the fifth and seventh floors are strong enough to impose lateral displacements upon the other core columns, particularly in the center of core where there were elevator areas without reinforced concrete slab. Such a horizontal pull would fail the columns at their connection near the seventh floor, as shown in Figs. 2-25 and 2-26.

Figure 2-25. Example of horizontal progression of failure in core columns following damage to transfer components on the east side of the building.

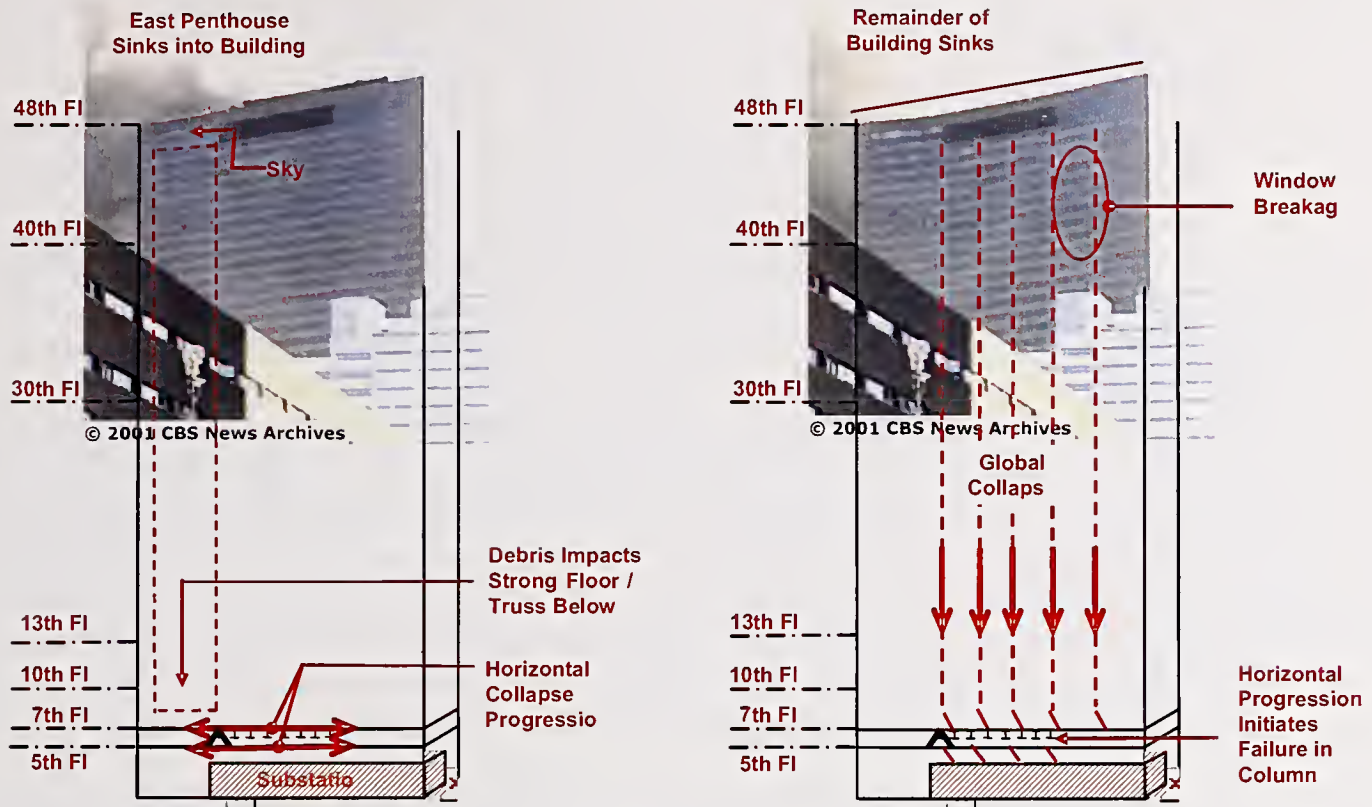
Figure 2-26. Horizontal progression to the west side of WTC 7.

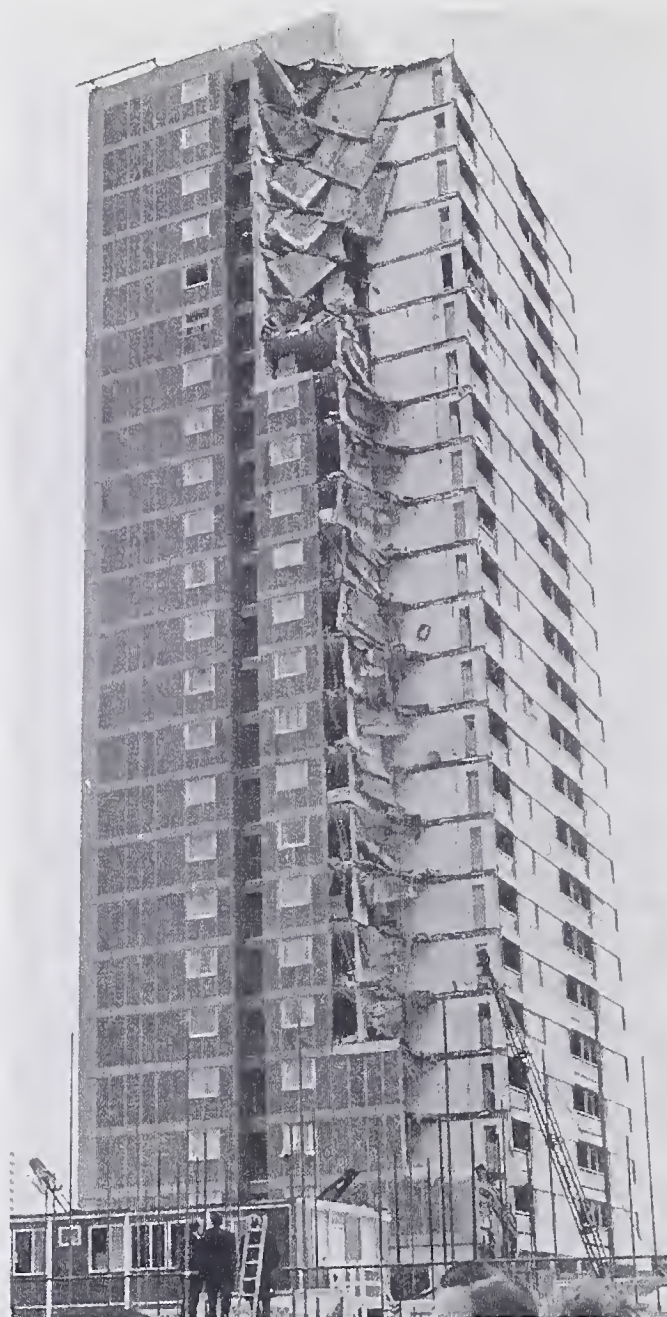
Figure 3–1. Ronan Point Collapse in 1968.

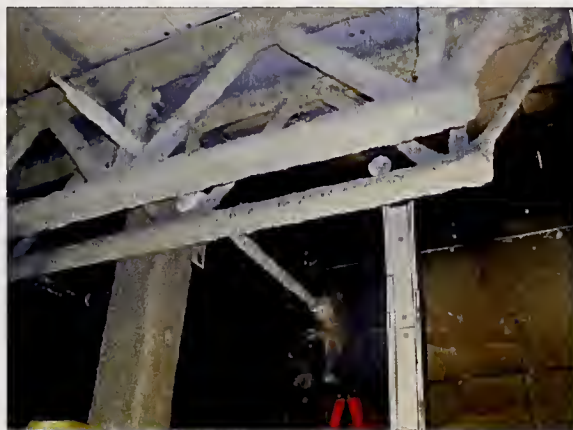
Figure 3–2. Insulated steel trusses, steel rod and steel column inside the NIST large-scale fire laboratory.

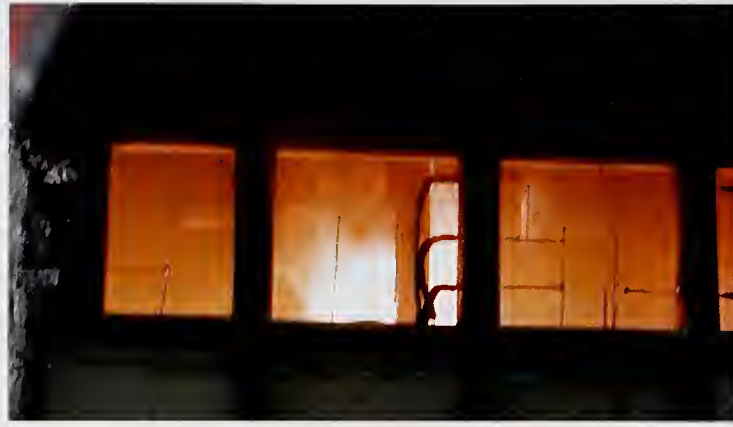
Figure 3–3. View of fire compartment from air exhaust outlet several minutes after the start of a fire test. Note: the flame impingement on the steel trusses and bar.

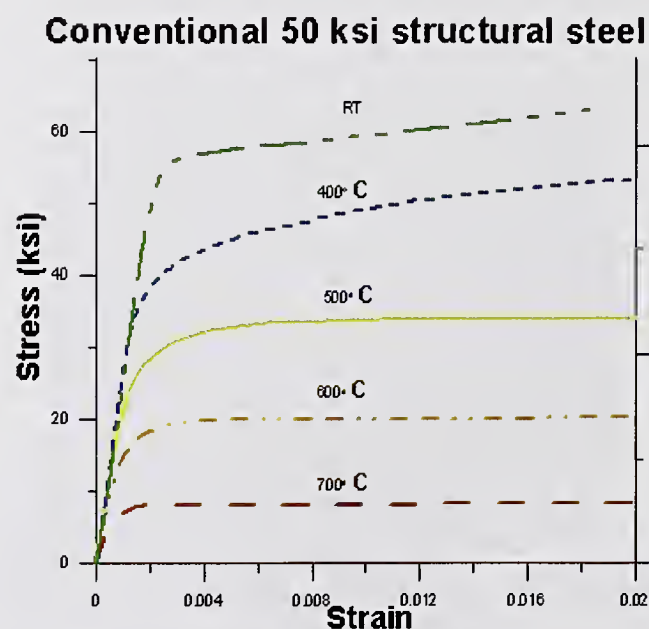
Structural steel loses strength at building fire temperatures, leading to the need for fireproofing (see Fig. 3–4). Fireproofing adds costs and can be damaged or removed from the structure in a blast situation or unanticipated impact. In contrast, a new class of fire-resistant steels is specifically designed to retain more of the design strength at high temperature. These steels are being produced in Japan and Europe, and are now in use, either with or without additional fire protection. The use of fire-resistant steels leads to cost savings and schedule benefits during construction when application of fire protection can be avoided, and enhanced performance when protection is applied in the case of damage to the insulation. Unfortunately, the benefits of fire-resistant steel are not adequately tested under the standard U.S. structural fire standards (ASTM E 119), and thus, are not currently used in the U.S.

Figure 3–4. Stress-strain curves of a conventional structural steel, showing degradation of properties at high temperature.

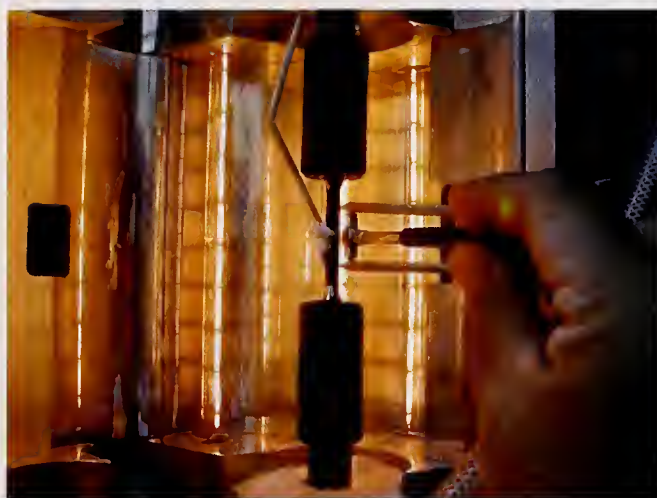
A project has been initiated to ascertain which properties of steel are critical for efficient use of fire-resistant steels, such as high temperature strength and creep (see Fig. 3–5). Conventional steels and fire-resistant steels are being characterized to determine these critical properties. Our goals include both provision of accurate data on fire-resistant steels and development of quick and accurate tests for measuring relevant high temperature properties.

Figure 3–5. High temperature tensile tests to measure performance of structural steel at temperatures found in building fires.

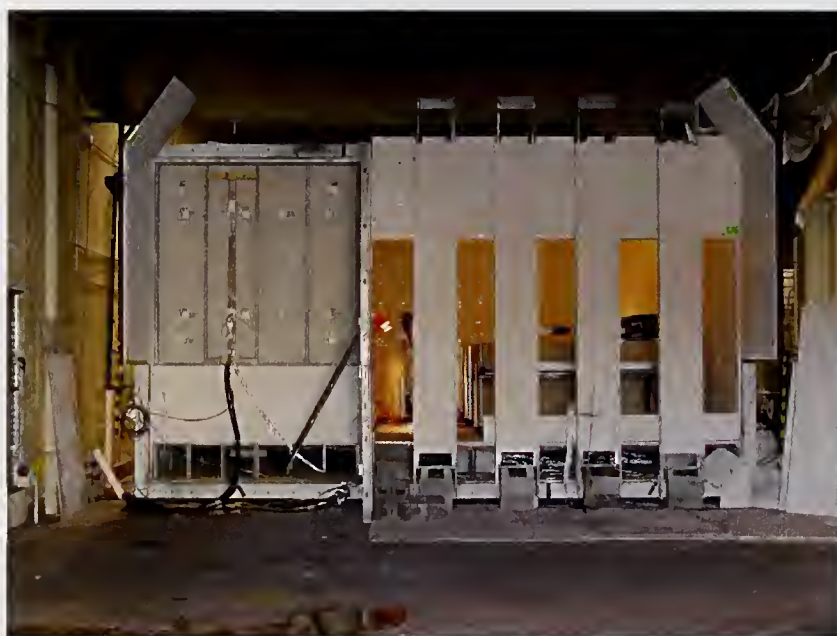
A series of real-scale compartment tests is providing information on the phenomenology of partition response and failure and also quantitative information to guide the model development (see Fig. 3–6). Various wall assemblies 2.44 m x 2.44 m were exposed to intense fires from the time of ignition to beyond flashover. Flux meters provided time histories of the energy incident on the walls. Thermocouples and infrared videos provided data on the transport of heat through the walls and on the progress toward perforation.

Figure 3–6. NIST measured the thermal behavior of gypsum/steel wall assemblies subjected to severe fire conditions.

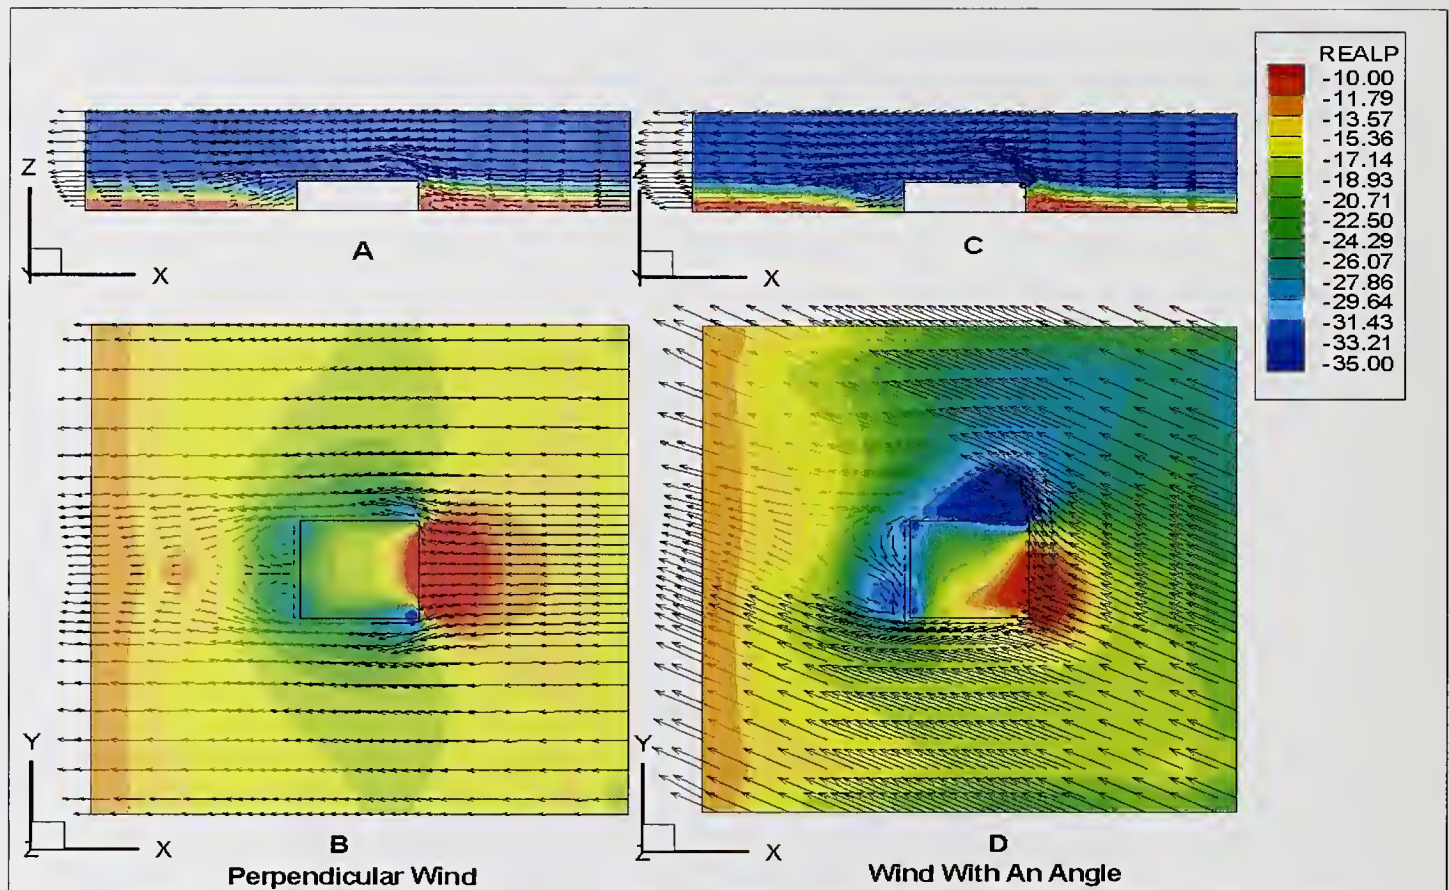
models to CONTAM and allow detailed analyses of the impact of an exterior release on indoor concentrations. In addition, CONTAM version 2.1 has improved models of particulate contaminants and has added fan and damper transients to the ability to simulate controls. The updated CONTAM model is now being used by an increasing number of researchers and practitioners in their evaluation of specific buildings and of technologies with the potential to increase building protection (see Fig. 3–7).

Figure 3–7. Exterior flow field as input to CONTAM model of building.
