Technical Study of the Sofa Super Store Fire - South Carolina, June 18, 2007 - Appendices

Technical Study of the Sofa Super Store Fire - South Carolina, June 18, 2007

*Fire Research Division
Engineering Laboratory
National Institute of Standards and Technology*

March 2011

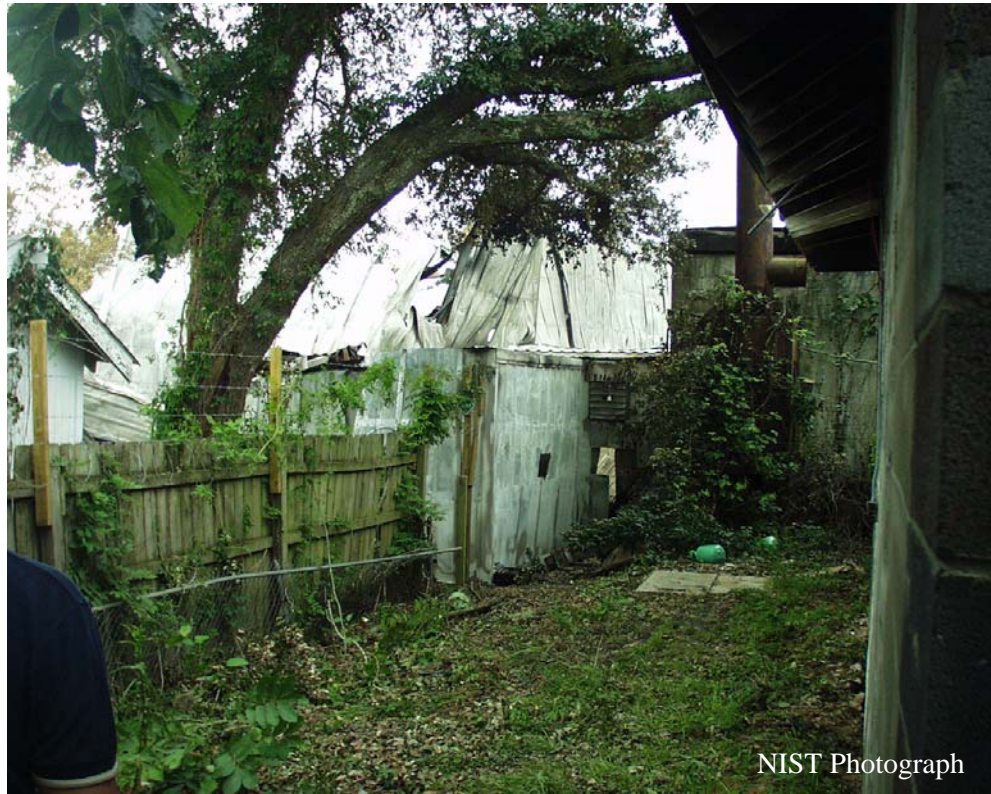
Figure D-8. Area behind main showroom. Rear wall of main showroom is visible on right side of photograph. North wall of repair shop is visible in center of photograph. Fence separates store from private residences located behind store.

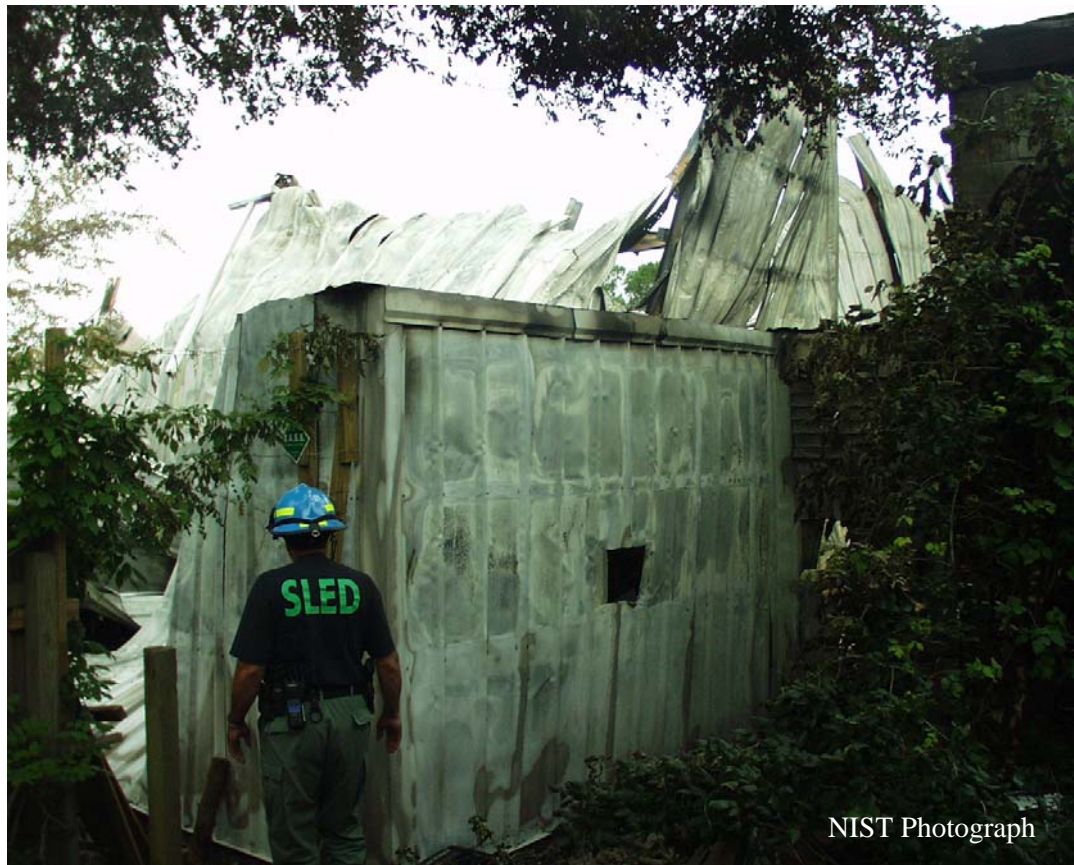
Figure D-9. North east corner of repair shop. Collapsed warehouse is visible in background.

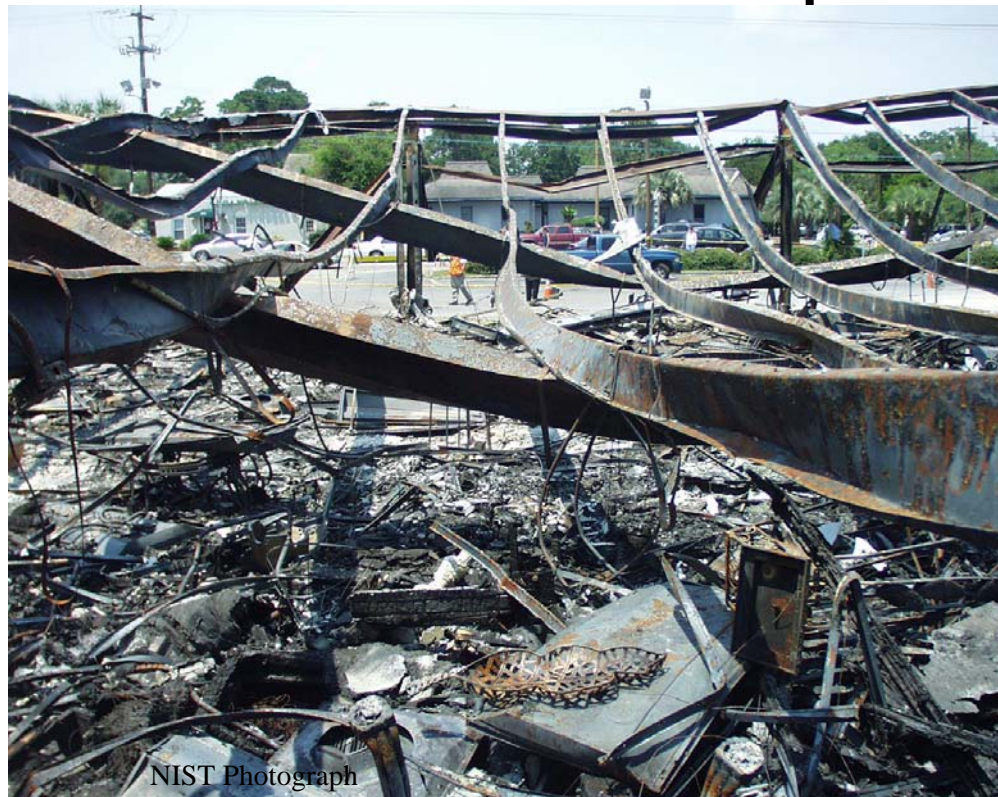
Figure E-30. Interior of west showroom looking toward front of showroom. Portions of two (left to right) I-beam steel supports and nine Z-channel roof supports are visible. Exposure to high temperatures caused I-beam and Z-channel to sag within 1 m (3.3 ft) of showroom floor.

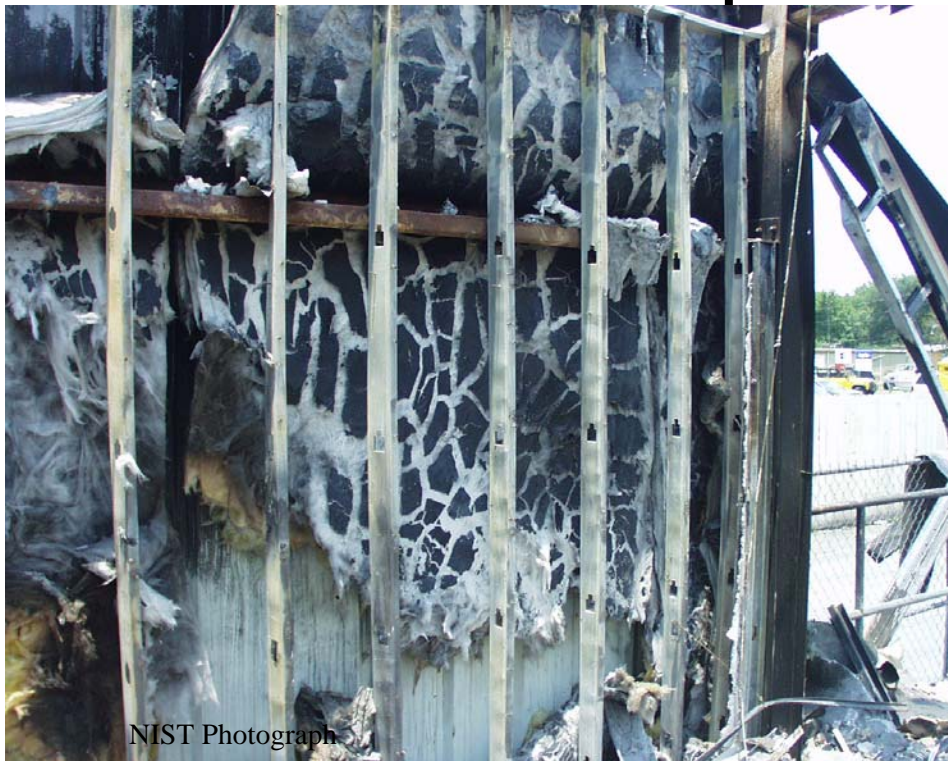
Figure E-31. Interior of west showroom looking at west wall near front of store. Exterior metal wall attached to exterior side of horizontal channel. Metal studs attached to inside face of horizontal channel. Gypsum wall board was installed over metal studs to form interior wall. Metal stud/gypsum wall appeared to extend approximately 0.3 m (1 ft) above suspended ceiling along west wall. Fiberglass insulation is visible between metal studs and exterior metal siding.

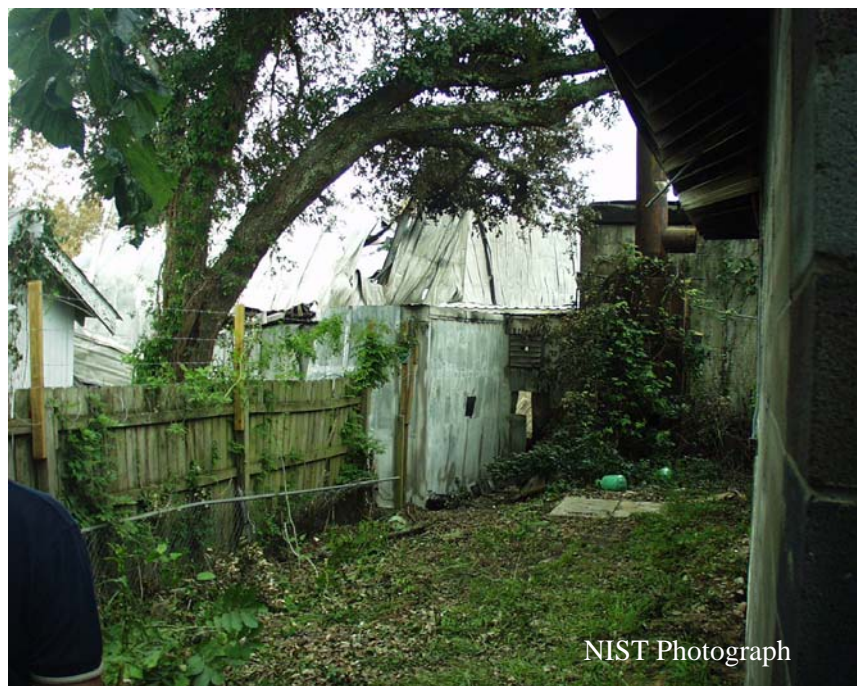
Figure H-1. North wall of repair shop looking toward warehouse from rear of main showroom. Small window-mount style air conditioner was installed in rectangular hole in center of wall.

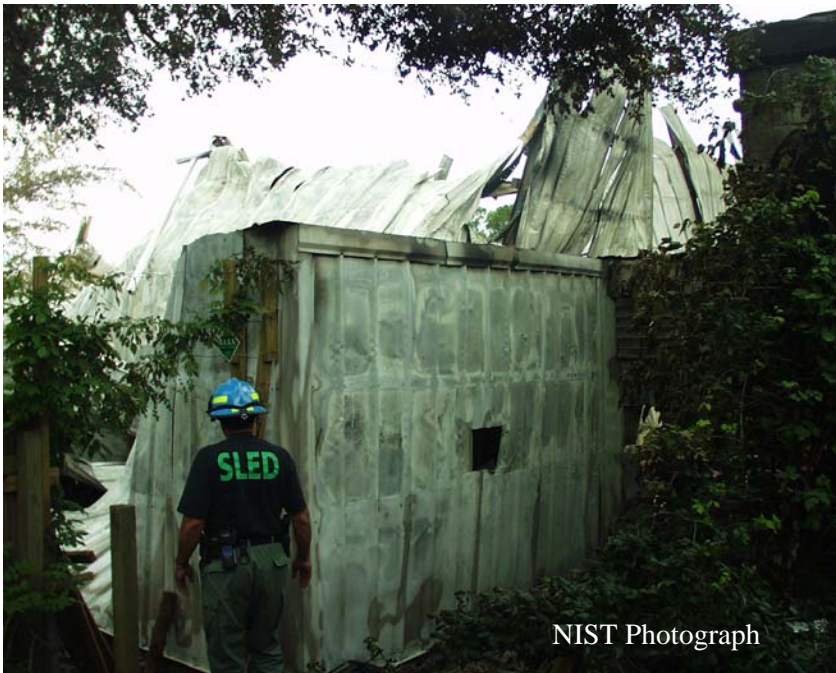
Figure H-2. North wall of repair shop looking toward warehouse, from rear of main showroom. Air conditioner was mounted in small rectangular hole in center of wall.

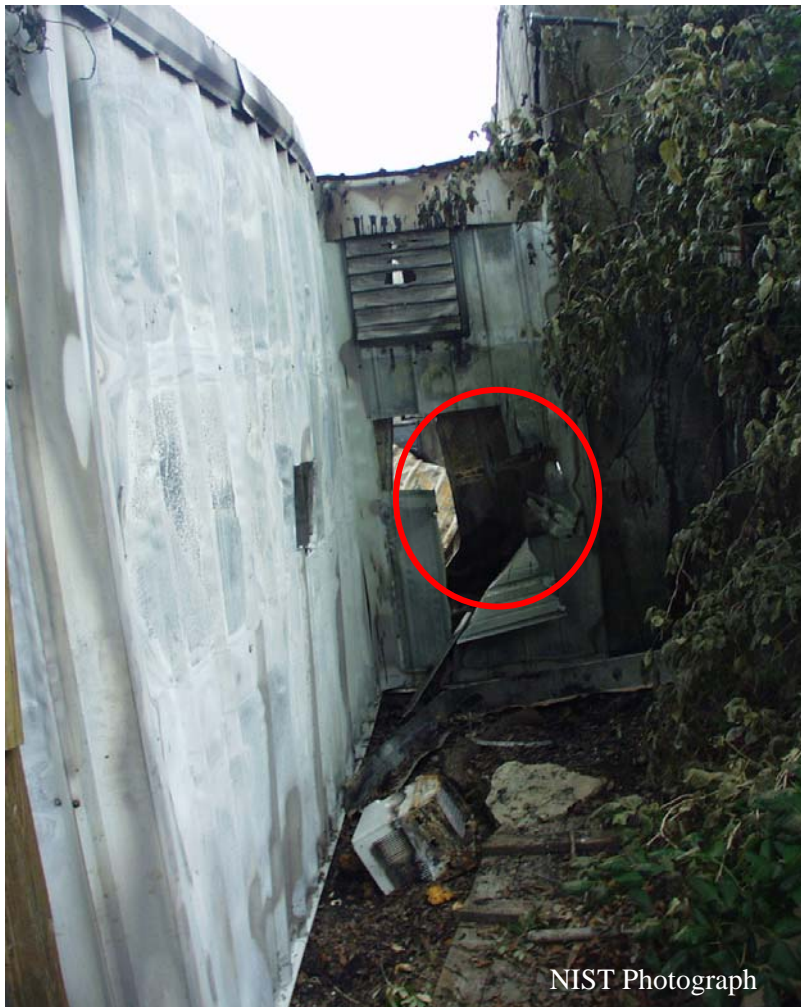
Figure H-3. Intersection of walls of two repair shops with rear wall of main showroom. Trapped employee was extracted from opening in metal siding visible in center of photo (circled area). Air conditioner which had been mounted in rectangular opening in wall fell out and was on ground below opening.

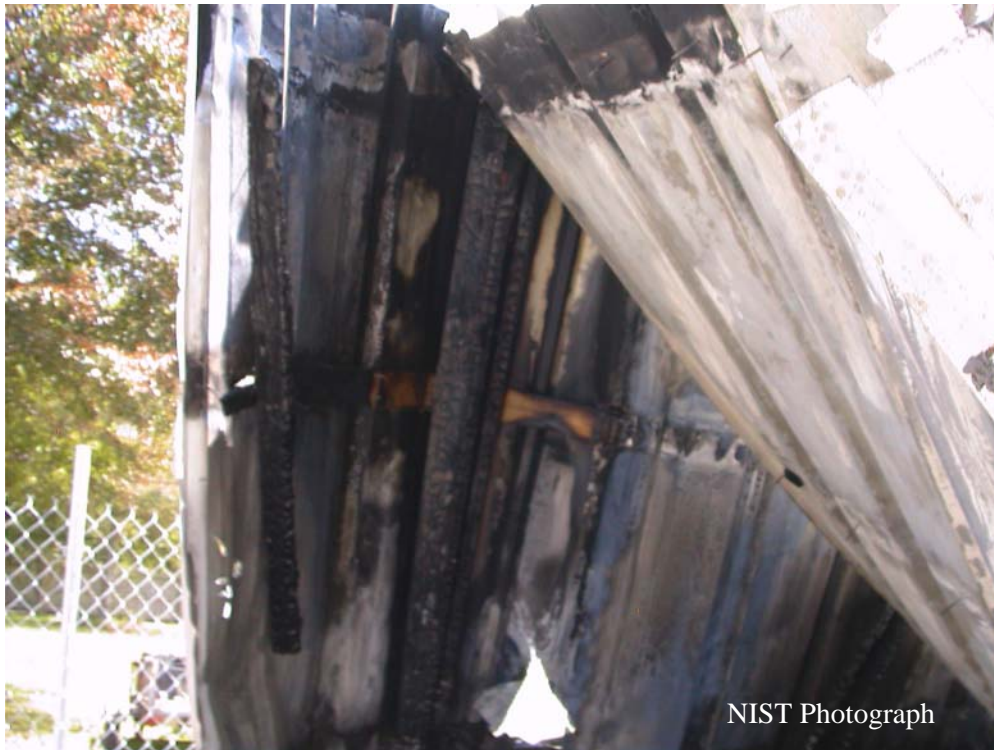
Figure H-6. Wood frame of repair shop.

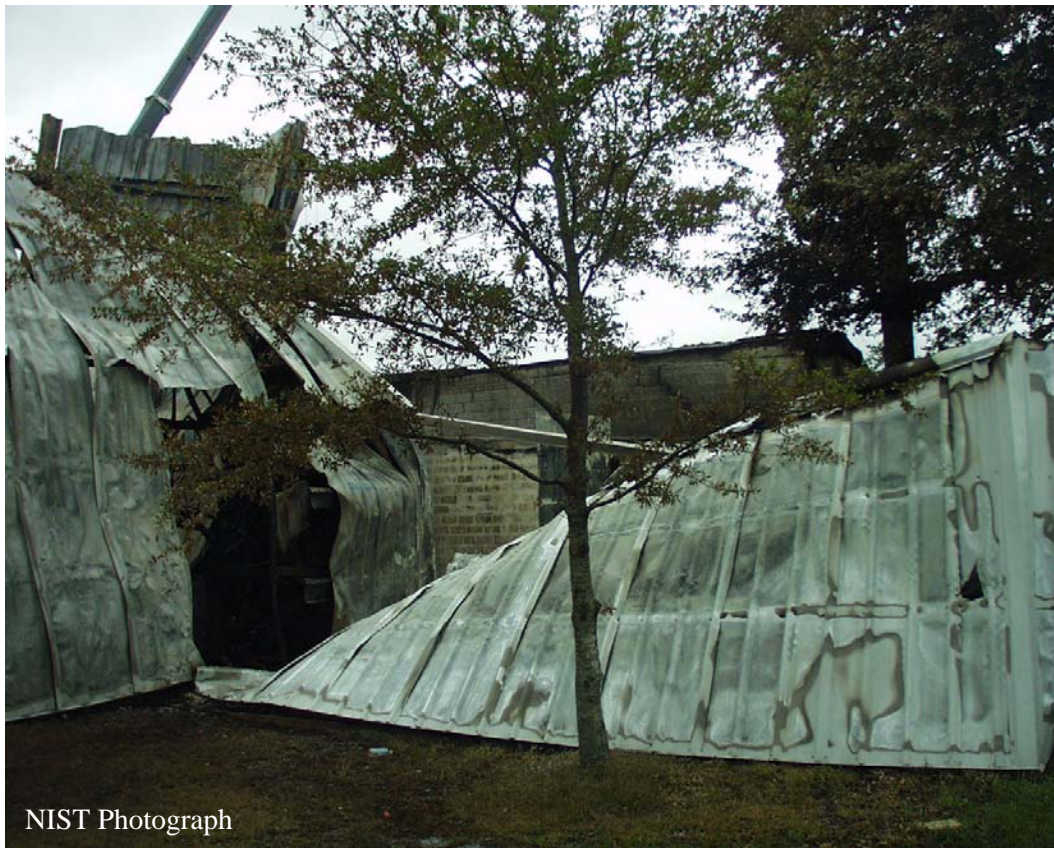
Figure H-7. South wall of repair shop. Rectangular opening was doorway from repair shop to warehouse.

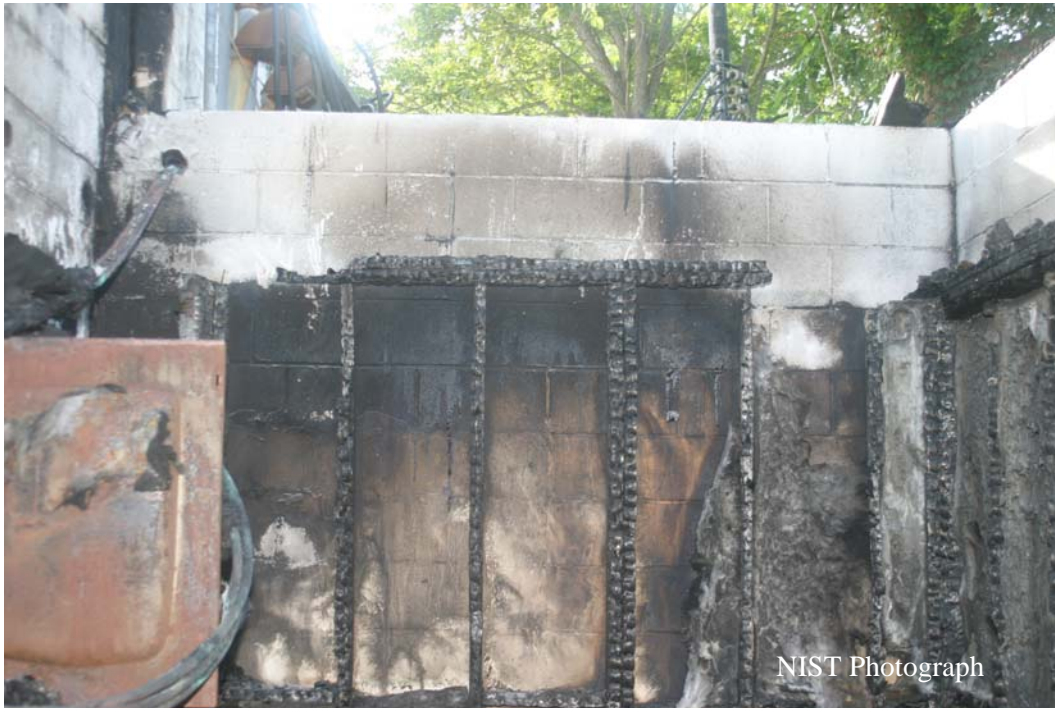
Figure I-6. Interior view of enclosed area at rear of main showroom. Doorway that was filled with concrete block is located beyond rusty metal electrical panel cover in left of photograph.

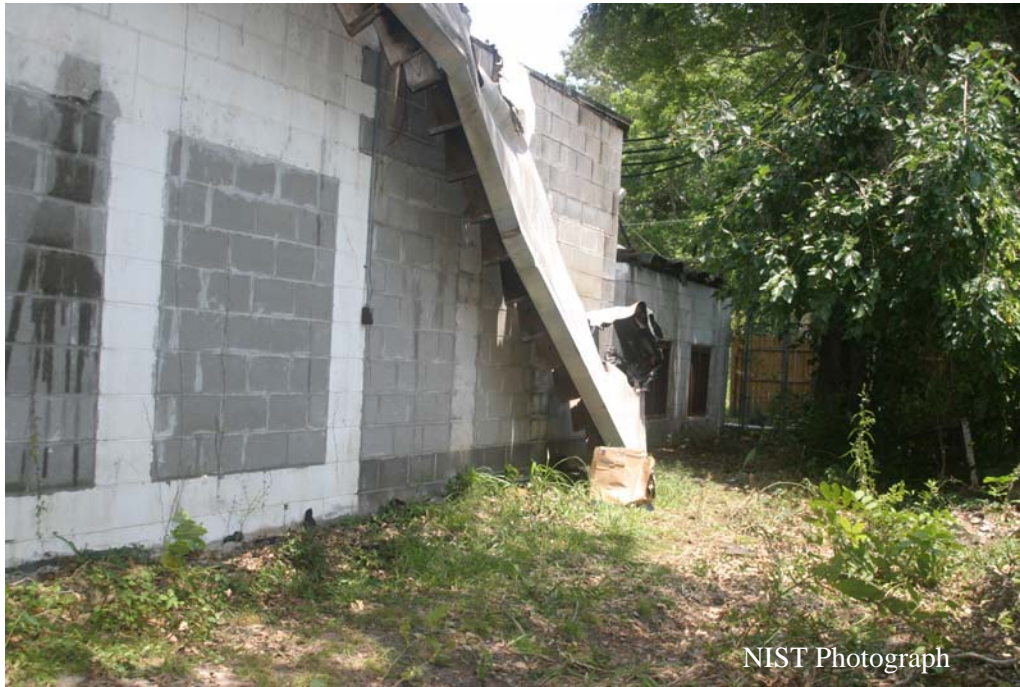
Figure I-7. Rear wall of main showroom. Openings in wall have been filled with concrete block. Wood fence is visible in center right of photograph.

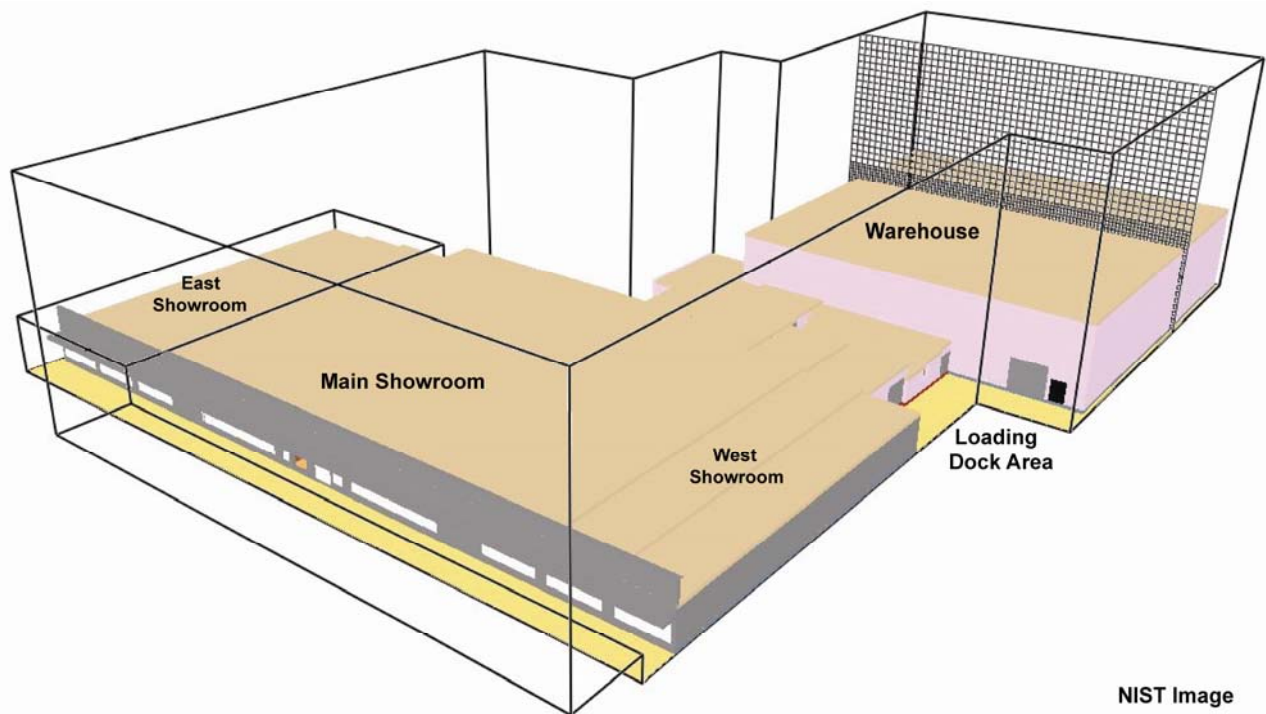
Figure K-1. Computational domain of the Sofa Super Store. Image rendered by Smokeview.

The computational domain for the incident simulation consisted of a total of 1,102,382 cells that encompassed a total volume of approximately 140,000 m³ (5 million ft³). Figure K-1 shows an isometric view of the structure with cells to show relative scale. The black lines surrounding the structure indicate bounds of the volume within the computational domain. This outer perimeter reflects the computation of the fire and smoke within the building. It also includes the outdoor conditions that might have affected

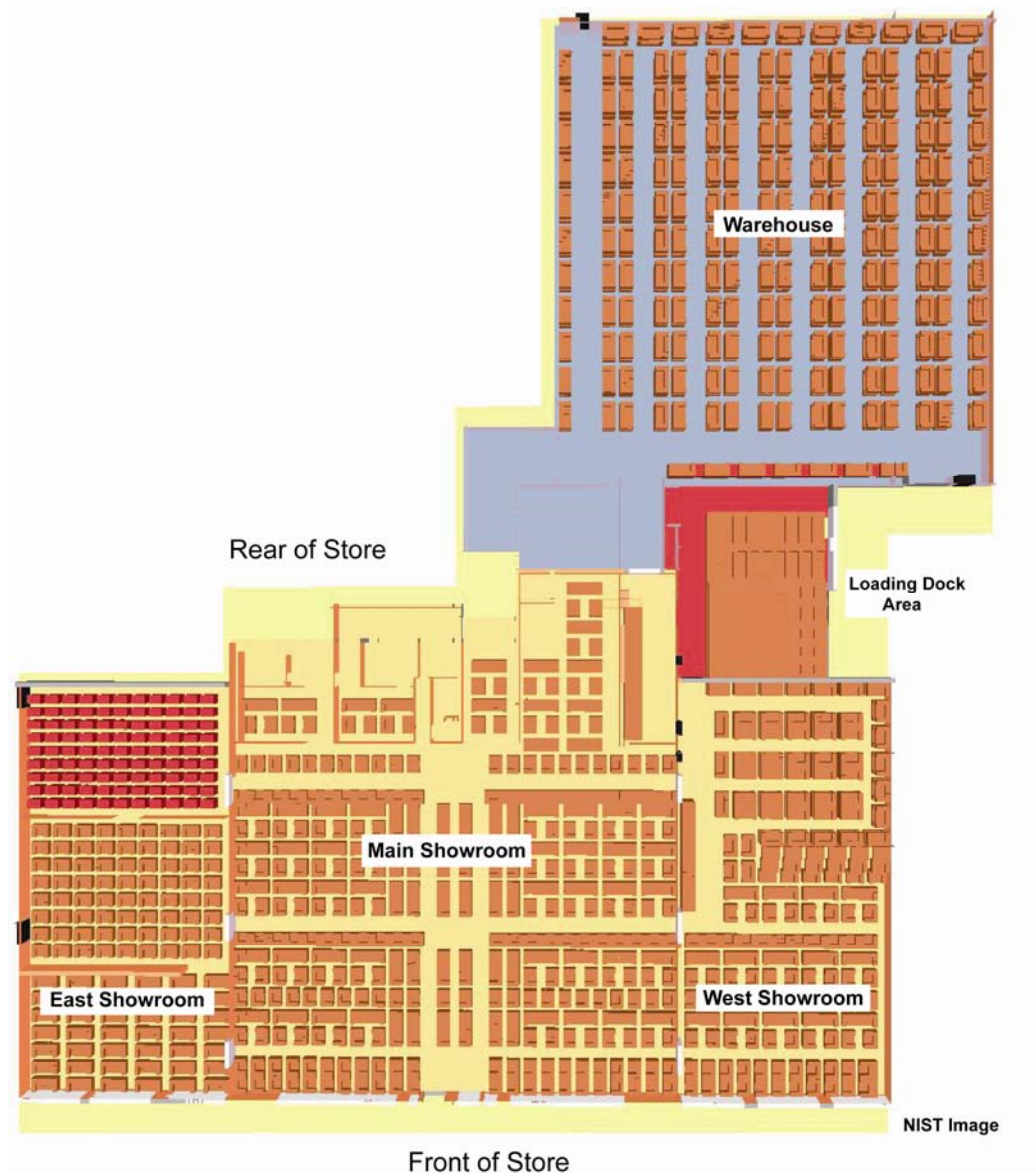
Figure K-4. Overhead view showing furniture layout used in the FDS simulations.

Figure K-4 is a plan view of the Sofa Super Store, as rendered by Smokeview, showing a layout of the furniture and walls. Furniture in the main showroom was consumed almost completely by the fire (see Figures B-15 to B-17, and Figures D-20 to D-25). There was some remaining furniture in the west showroom, primarily in the rear (south) end of the building (Figures E-17 to E-25). This area of the showroom stored sleep sofas in displays that were stacked two high on wood-framed racks. The damage in the east addition was much less severe because the roll-down doors closed when their fusible links released (Figures F-11 to F-16). The rear roll-down fire door between main and east showrooms was partially blocked by a coat rack and did not close completely. The warehouse contained multiple rows of high-rack storage. The fire consumed nearly all furniture in the warehouse (see Figures G-15 to G-17) and loading dock (see Figures B-4 to B-6). The consumption of fuel in the main and west showrooms was so extensive that the furniture layout used in the model was based largely on witness accounts. Witnesses described the showrooms as being “crowded” with furniture. The general description of the main showroom placed aisles down the center of the room, from the front door to the rear office area. Further, three aisles stretched across the showroom, east to west, aligned approximately with the roll-down doors. The remaining floor space was filled with upholstered furniture laid out tightly in typical rectilinear configurations. Because the exact layout was not known, furniture in the simulation was arranged in rows. Some of the rows were created by arranging furniture in “U” shaped configurations with a sofa and two chairs. In other places, rows consisted of single furniture items. The rear of the west addition was arranged in a manner that was similar to what could be discerned from the furniture that was in place during the post-fire scene examination.

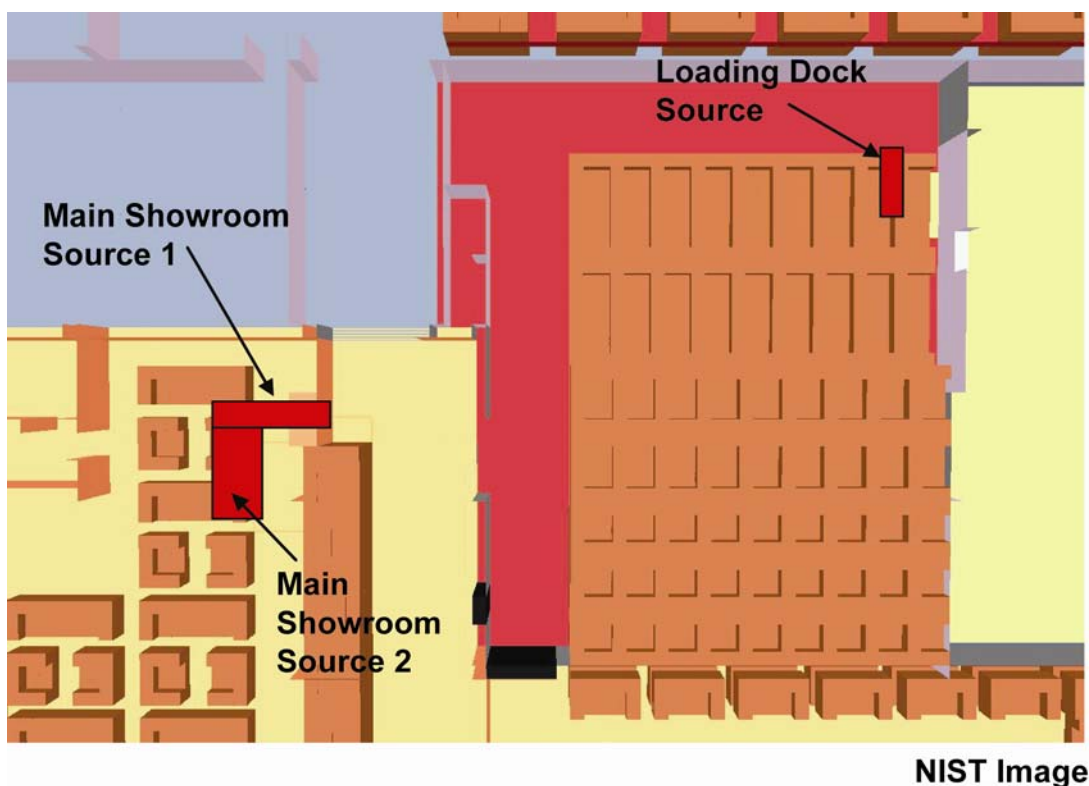
Figure K-10. Diagram showing locations of initiating fire sources in the loading dock and rear of main showroom.

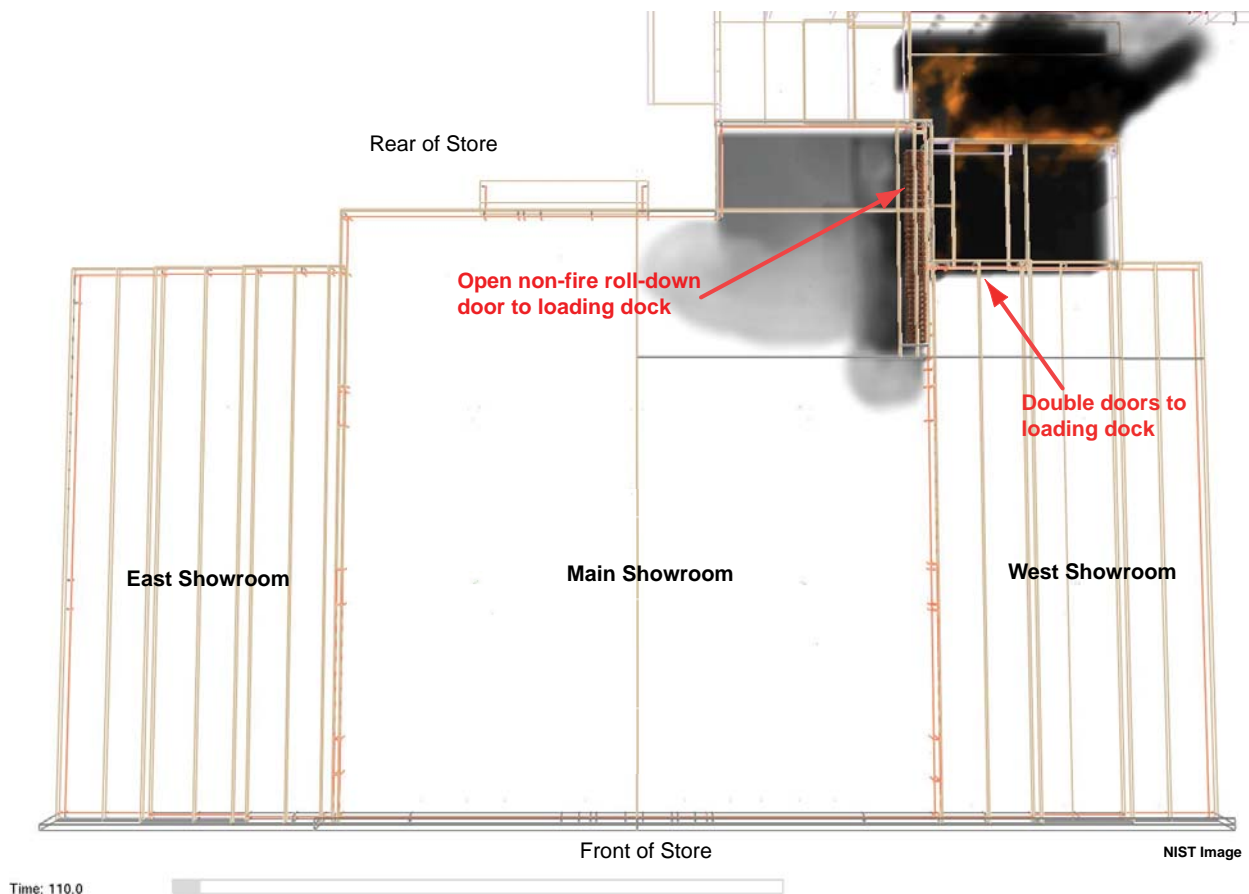
Figure K-14. Smoke filling in void space above main showroom. Image was rendered 110 s into the simulation.

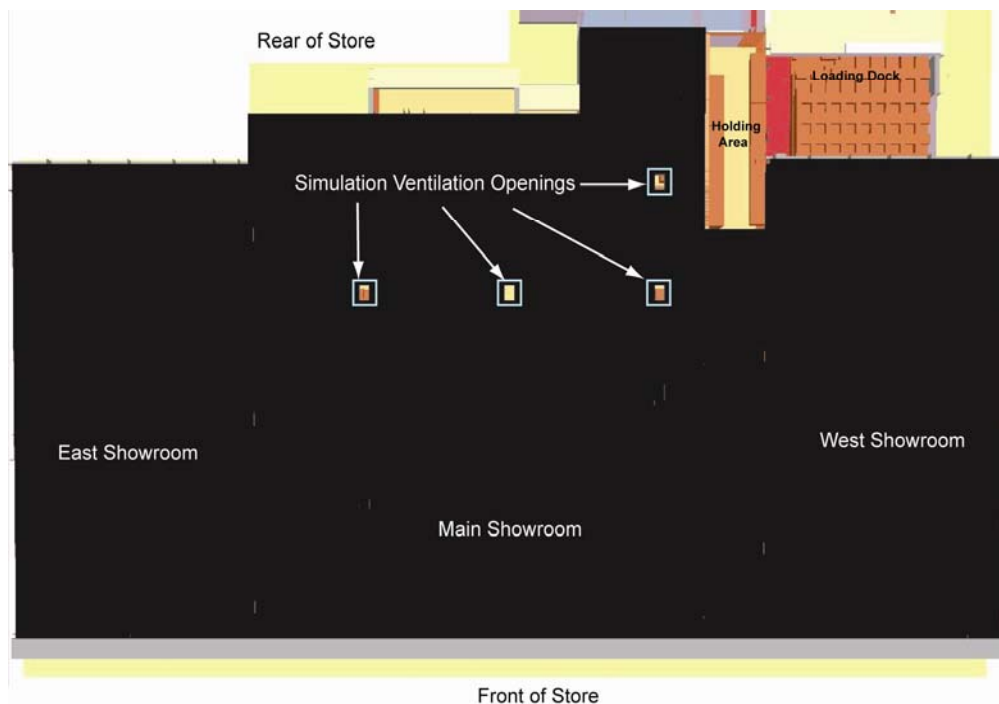
Figure K-17. Overhead image rendered with roof removed, showing locations of ceiling openings in main showroom to account for leakage.

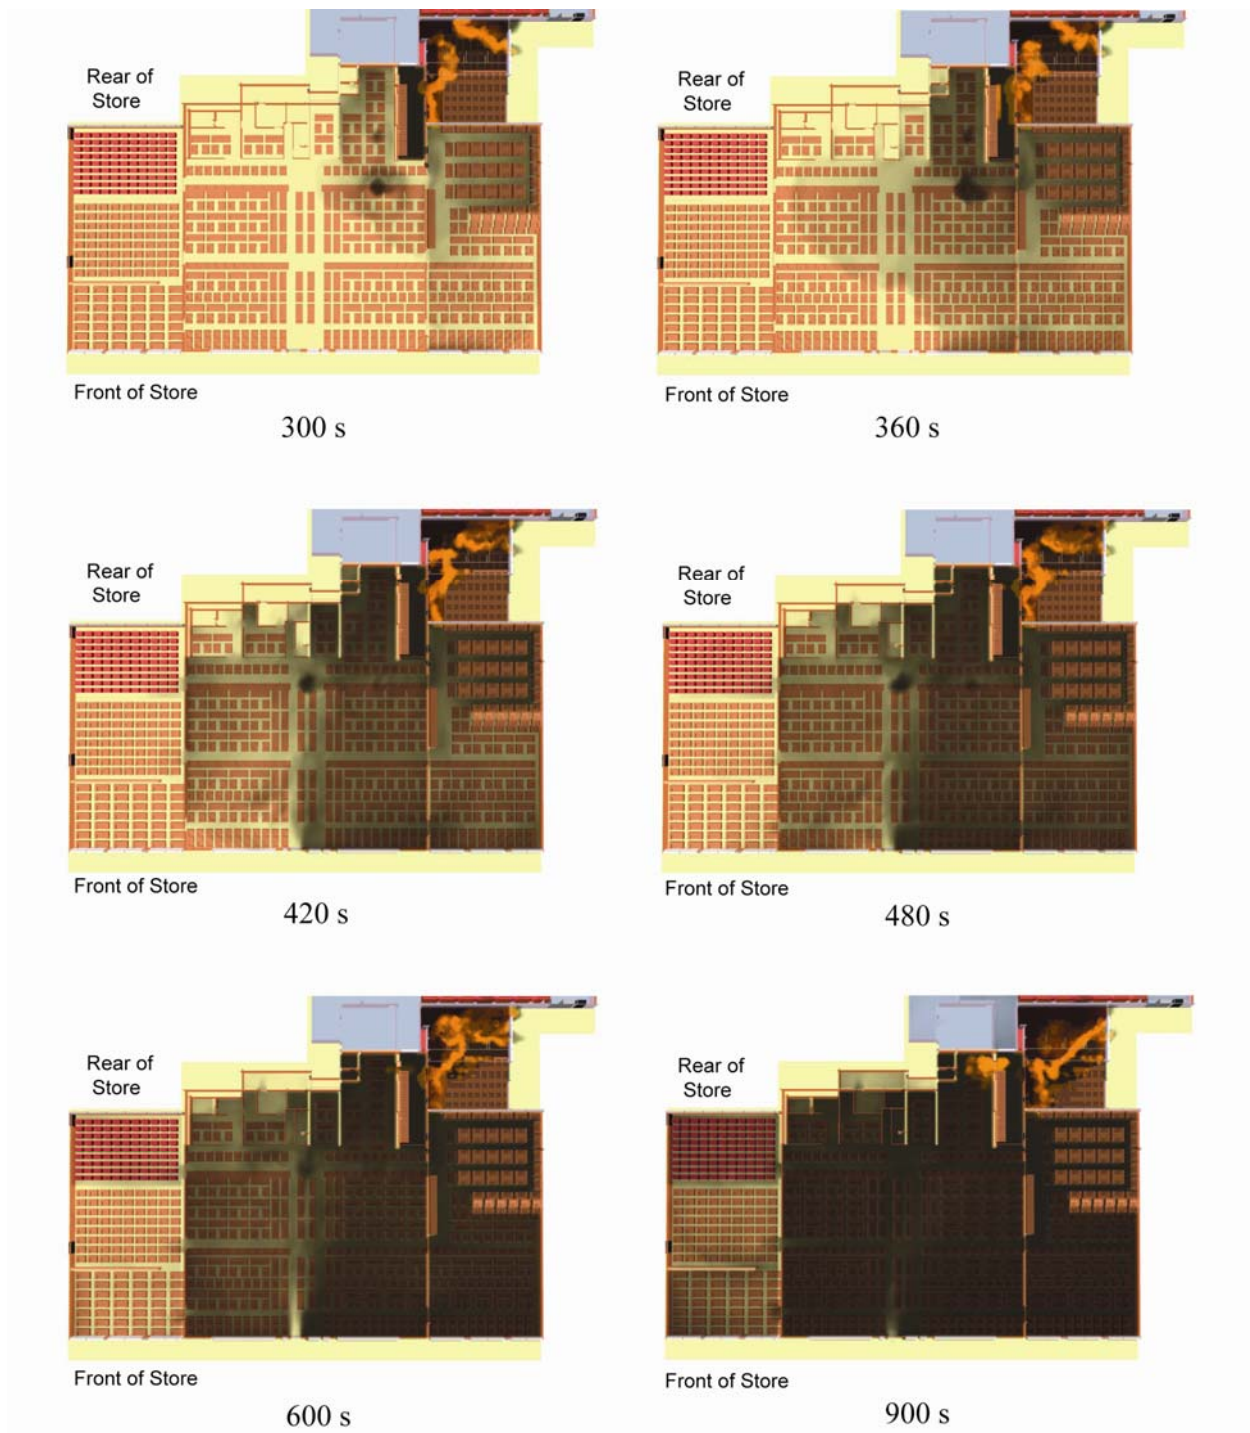
Figure K-18. View of fire and smoke progression from above the showrooms from 300 s to 900 s (7:15:53 p.m. to 7:25:53 p.m.). The images are clipped to view conditions below the ceiling.

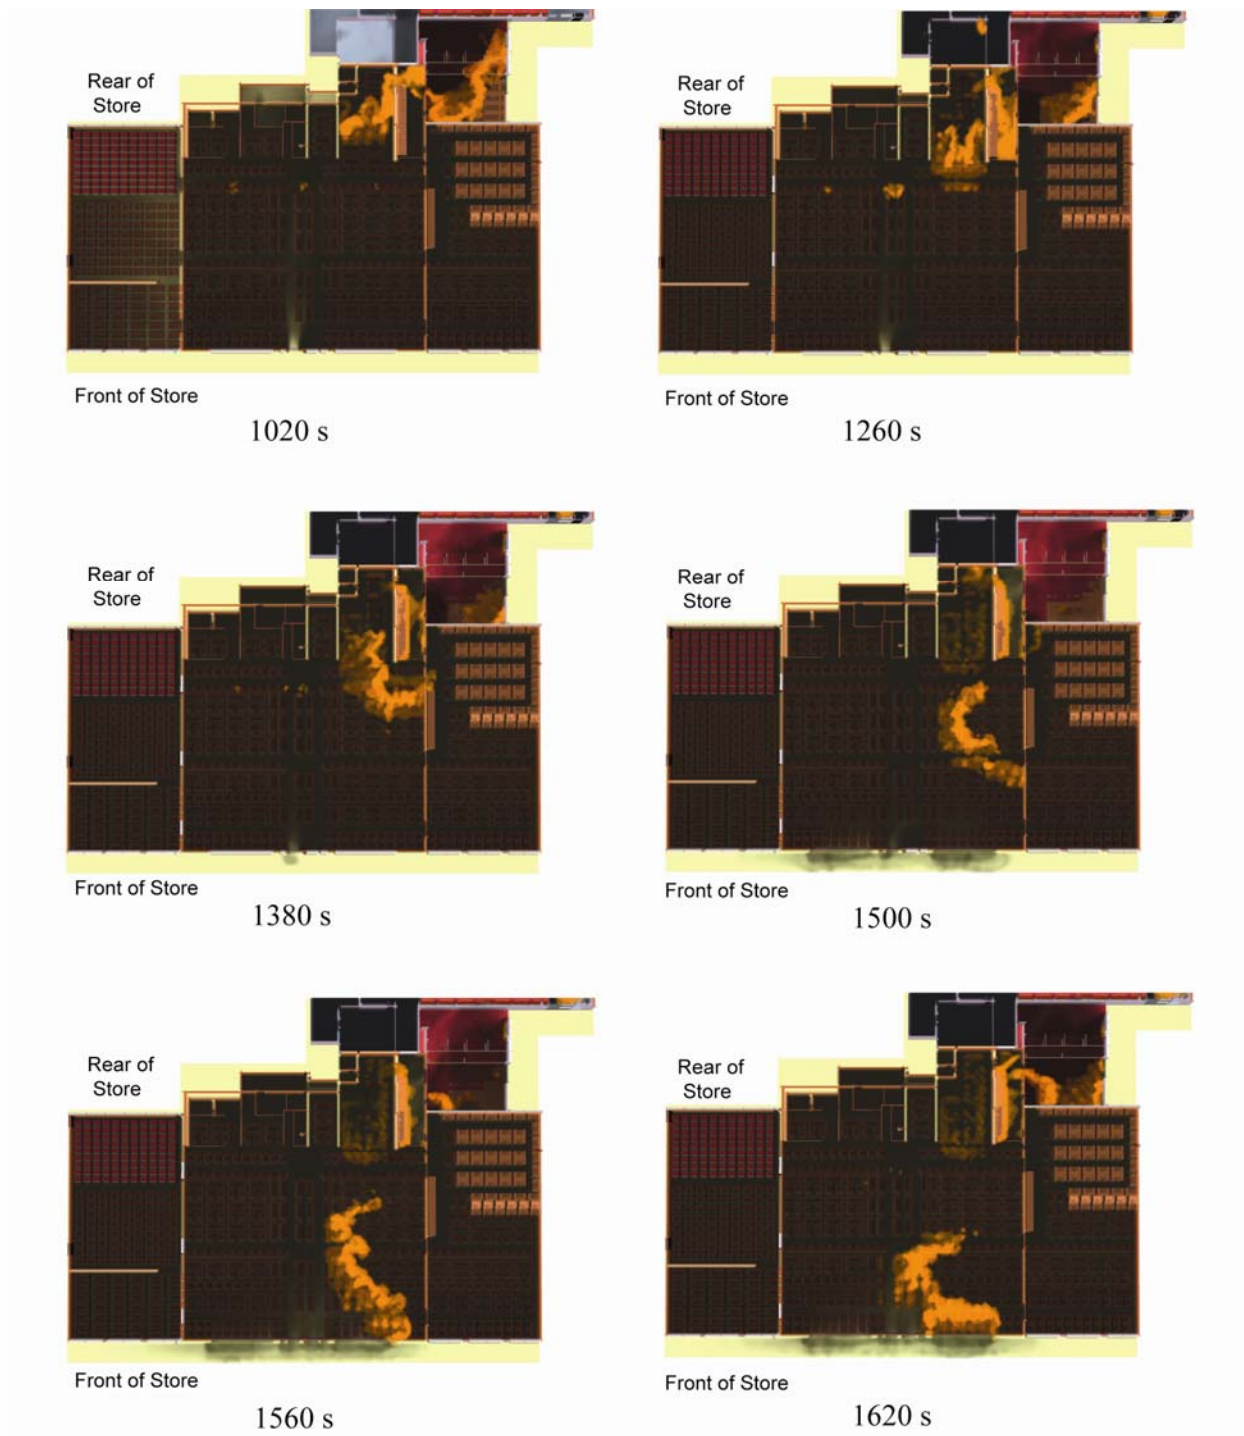
Figure K-22. View of fire (orange color indicates stoichiometric boundary) and smoke progression from above the showrooms from 1020 s to 1620 s (7:27:53 p.m. to 7:37:53 p.m.). The images are clipped to view conditions below the ceiling.

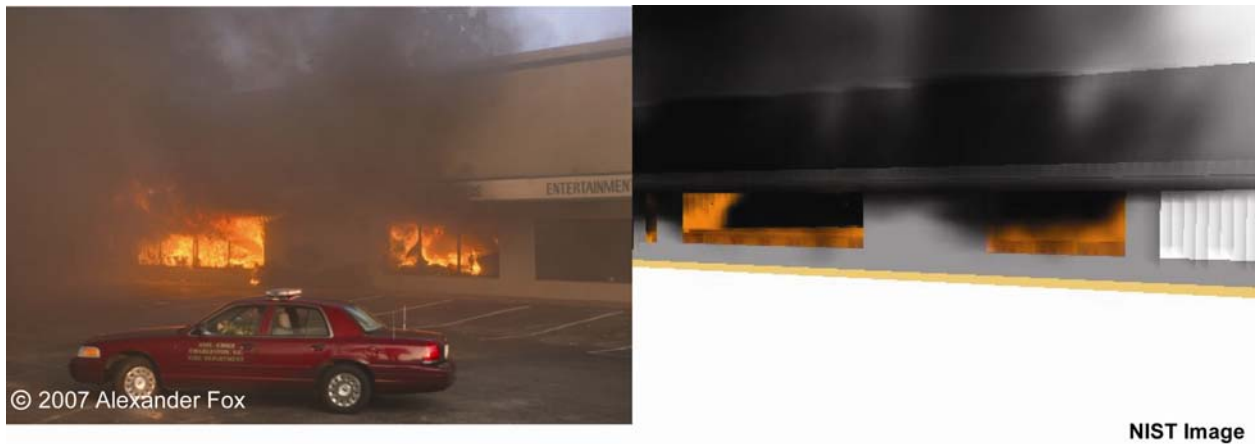
Figure K-26. Comparison between photo and rendered image from the simulation at 1686 s (7:38:59 p.m.). The view is of the front of the main showroom. Photo used with permission of Alexander Fox.

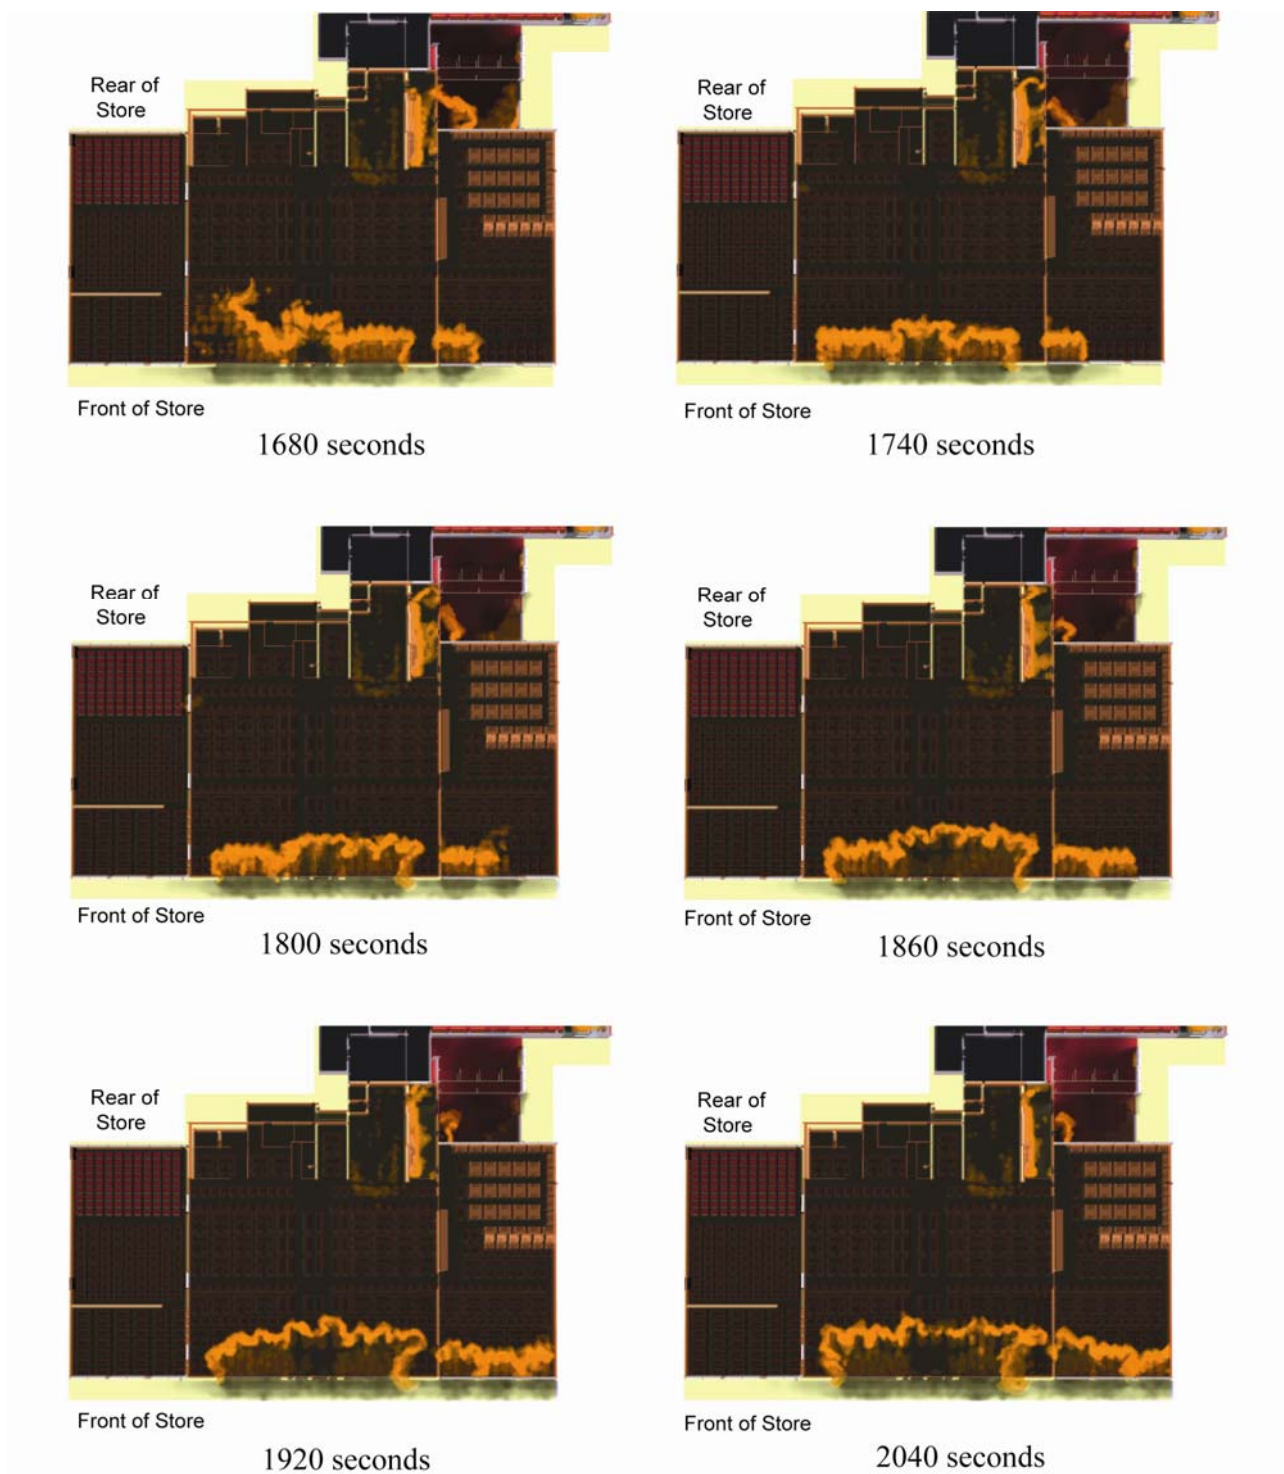
Figure K-28. View of fire and smoke progression from above the showrooms from 1680 s to 2040 s (7:38:53 p.m. to 7:44:53 p.m.). The images are clipped to view conditions below the ceiling.

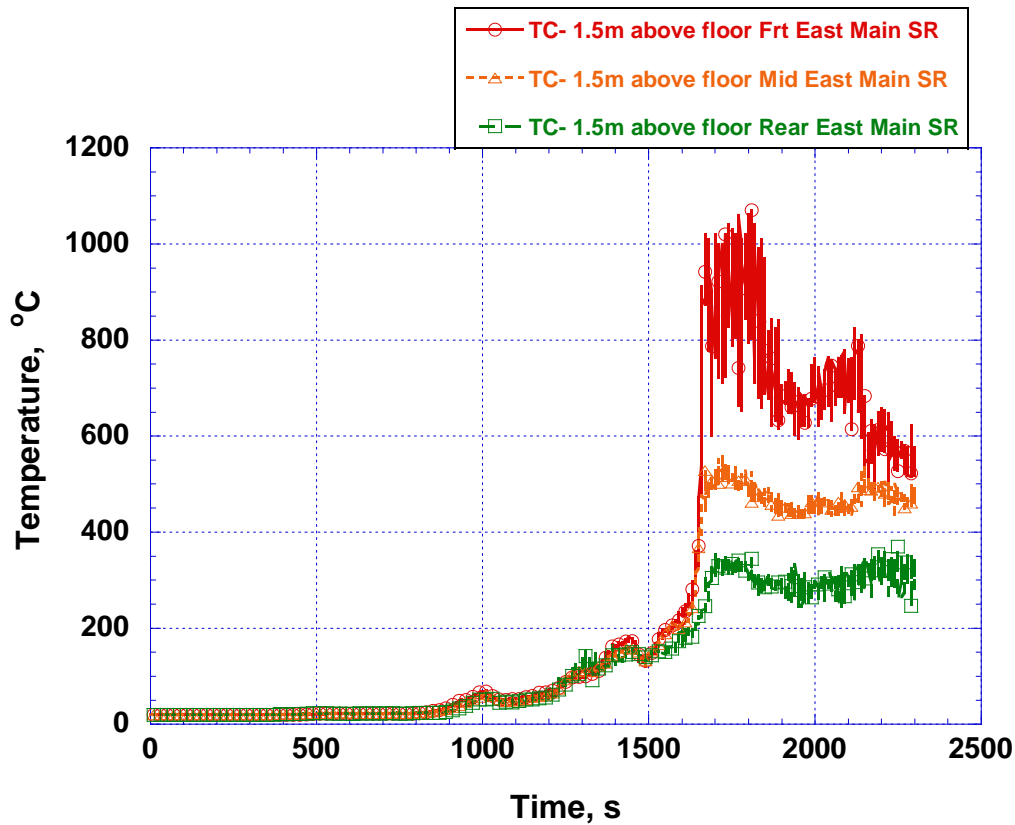
Figure K-35. Main showroom (east) temperatures for 1.5 m (5 ft) from floor.
