Technical Study of the Sofa Super Store Fire - South Carolina, June 18, 2007 - Appendices

Technical Study of the Sofa Super Store Fire - South Carolina, June 18, 2007

*Fire Research Division
Engineering Laboratory
National Institute of Standards and Technology*

March 2011

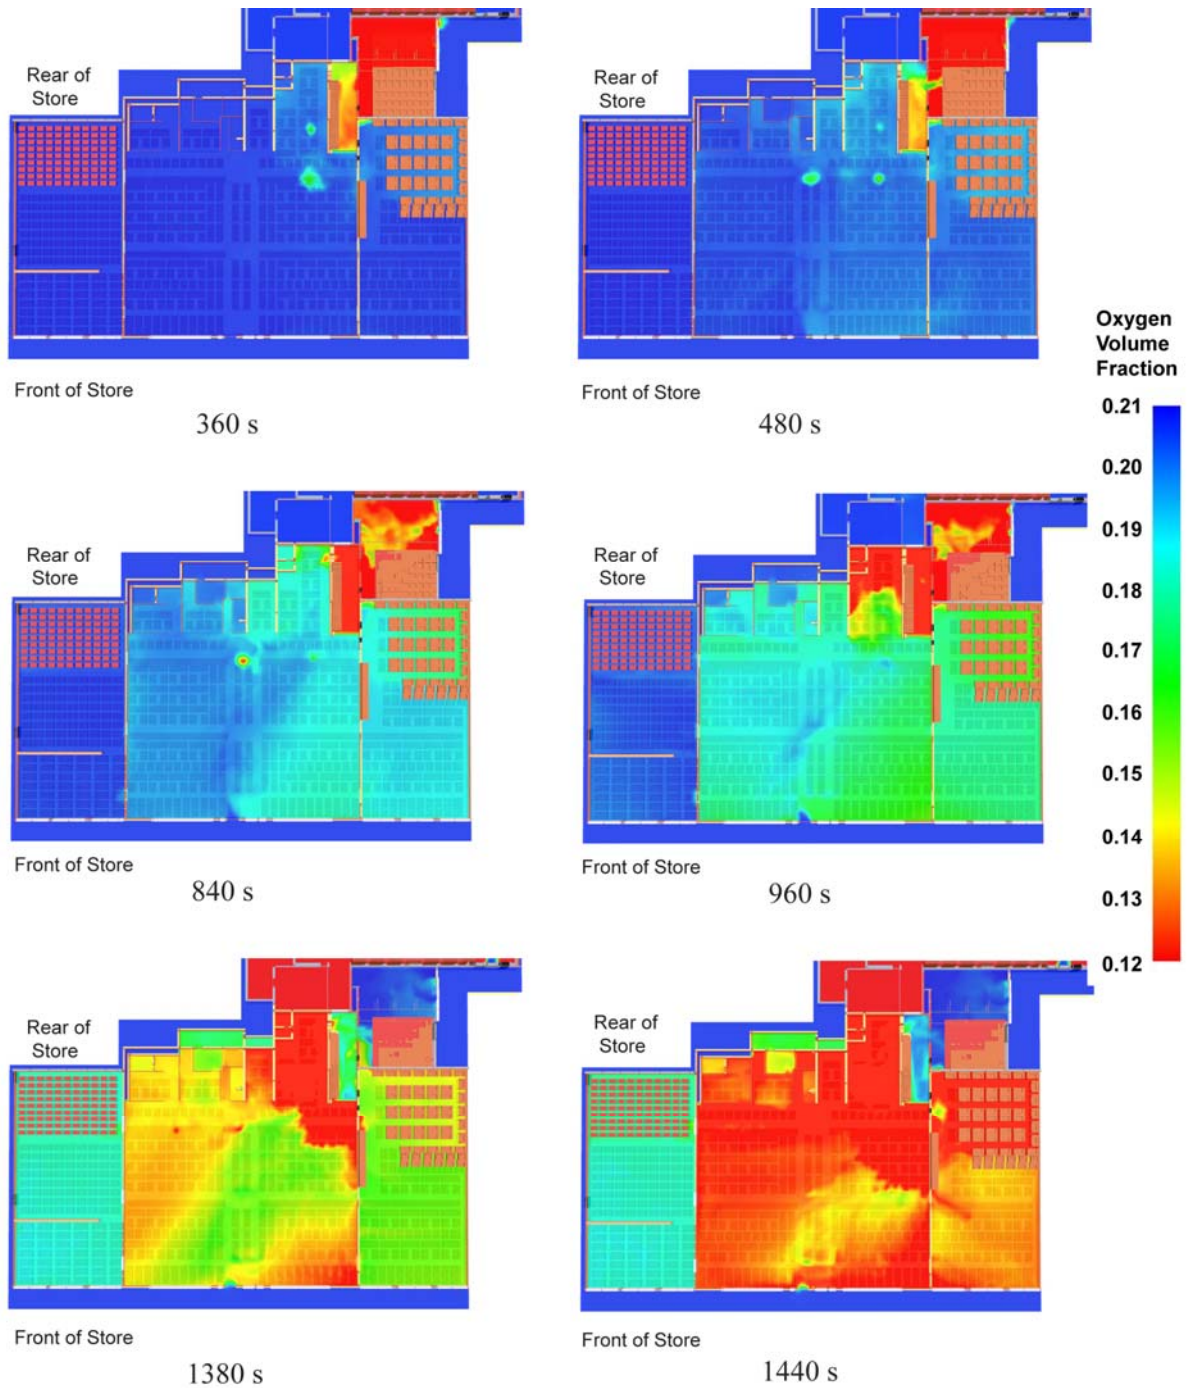
Figure K-36. Oxygen volume fractions (slice images) for 1.5 m (5 ft) above the floor.

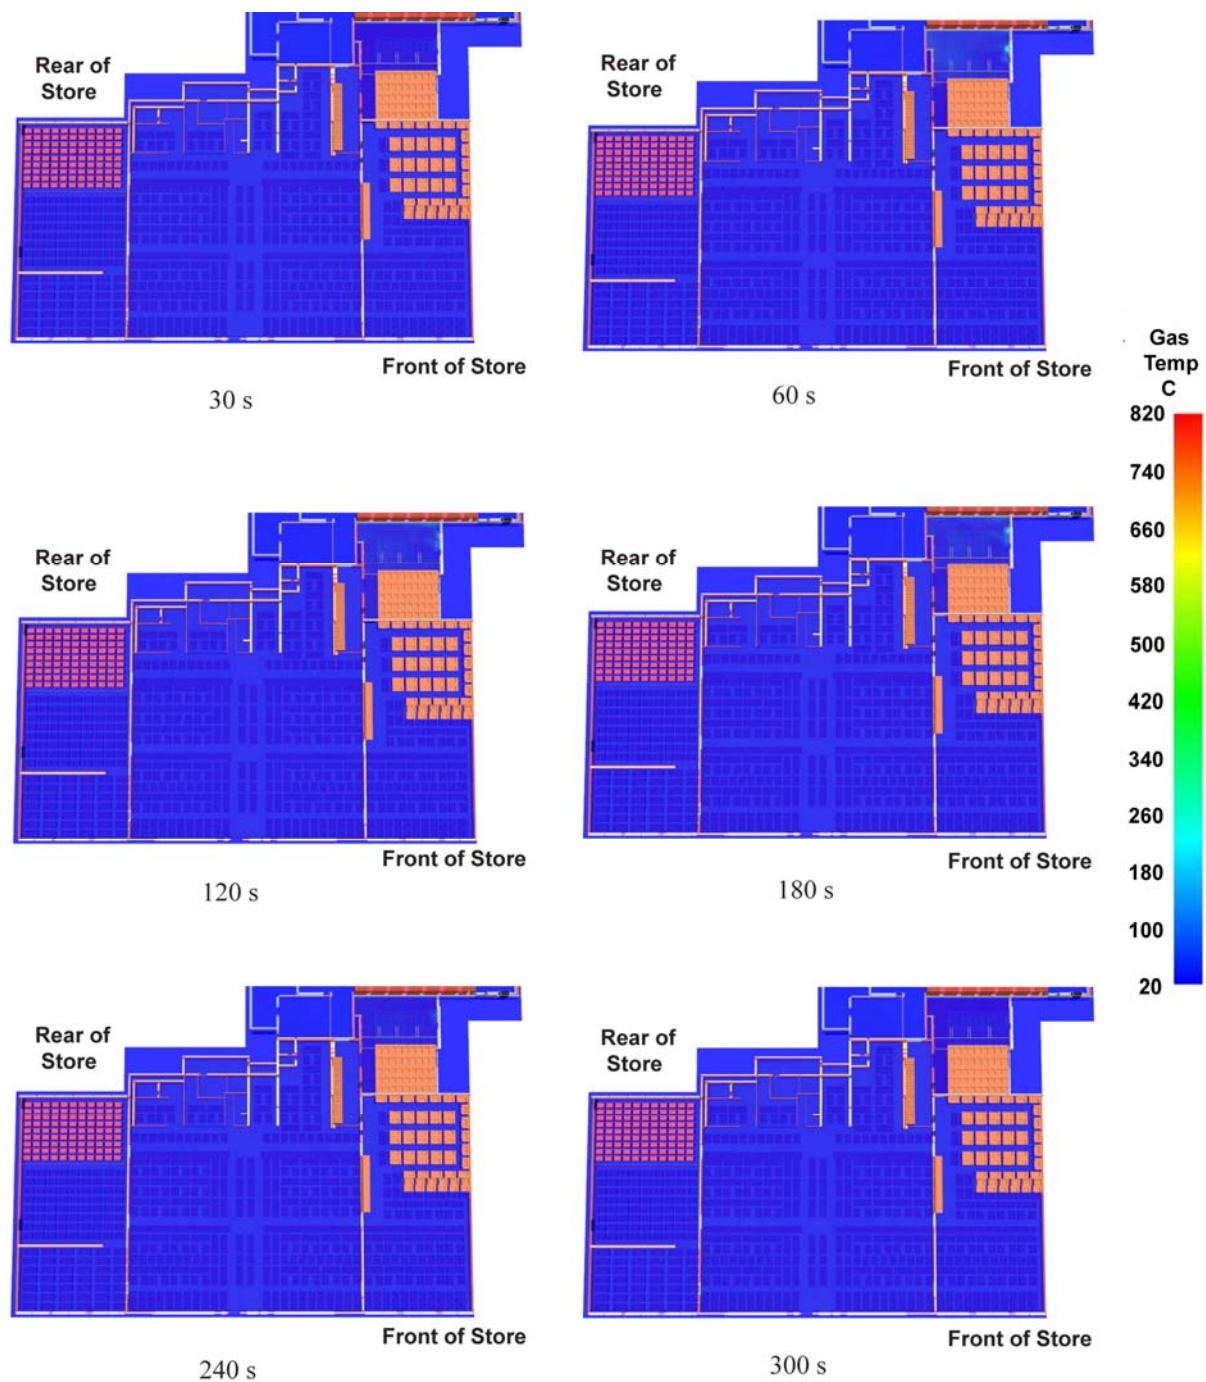
Figure K-44. Temperatures 1.5 m (5 ft) above the floor in the sprinklered simulation.

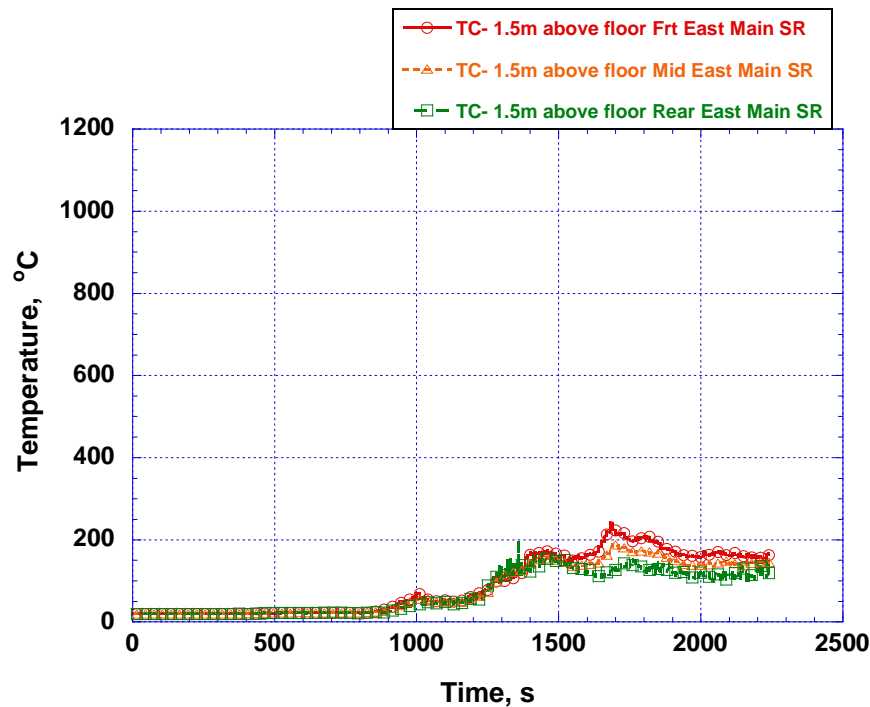
Figure K-53. Main showroom (east) temperatures for 1.5 m (5 ft) above the floor.

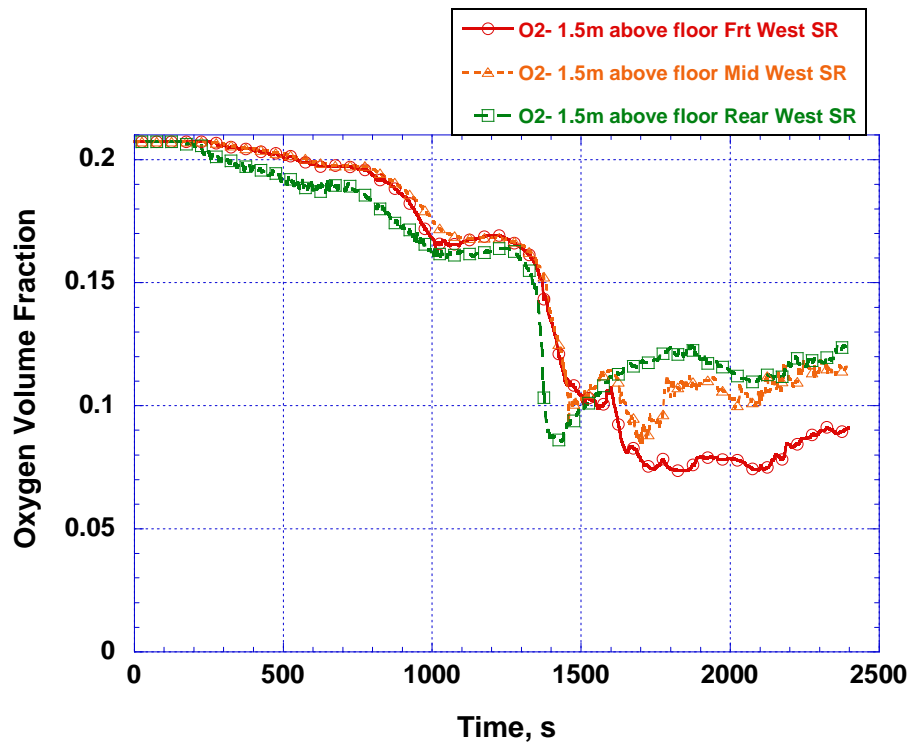
Figure K-54. West showroom oxygen volume fractions for 1.5 m (5 ft) above the floor.

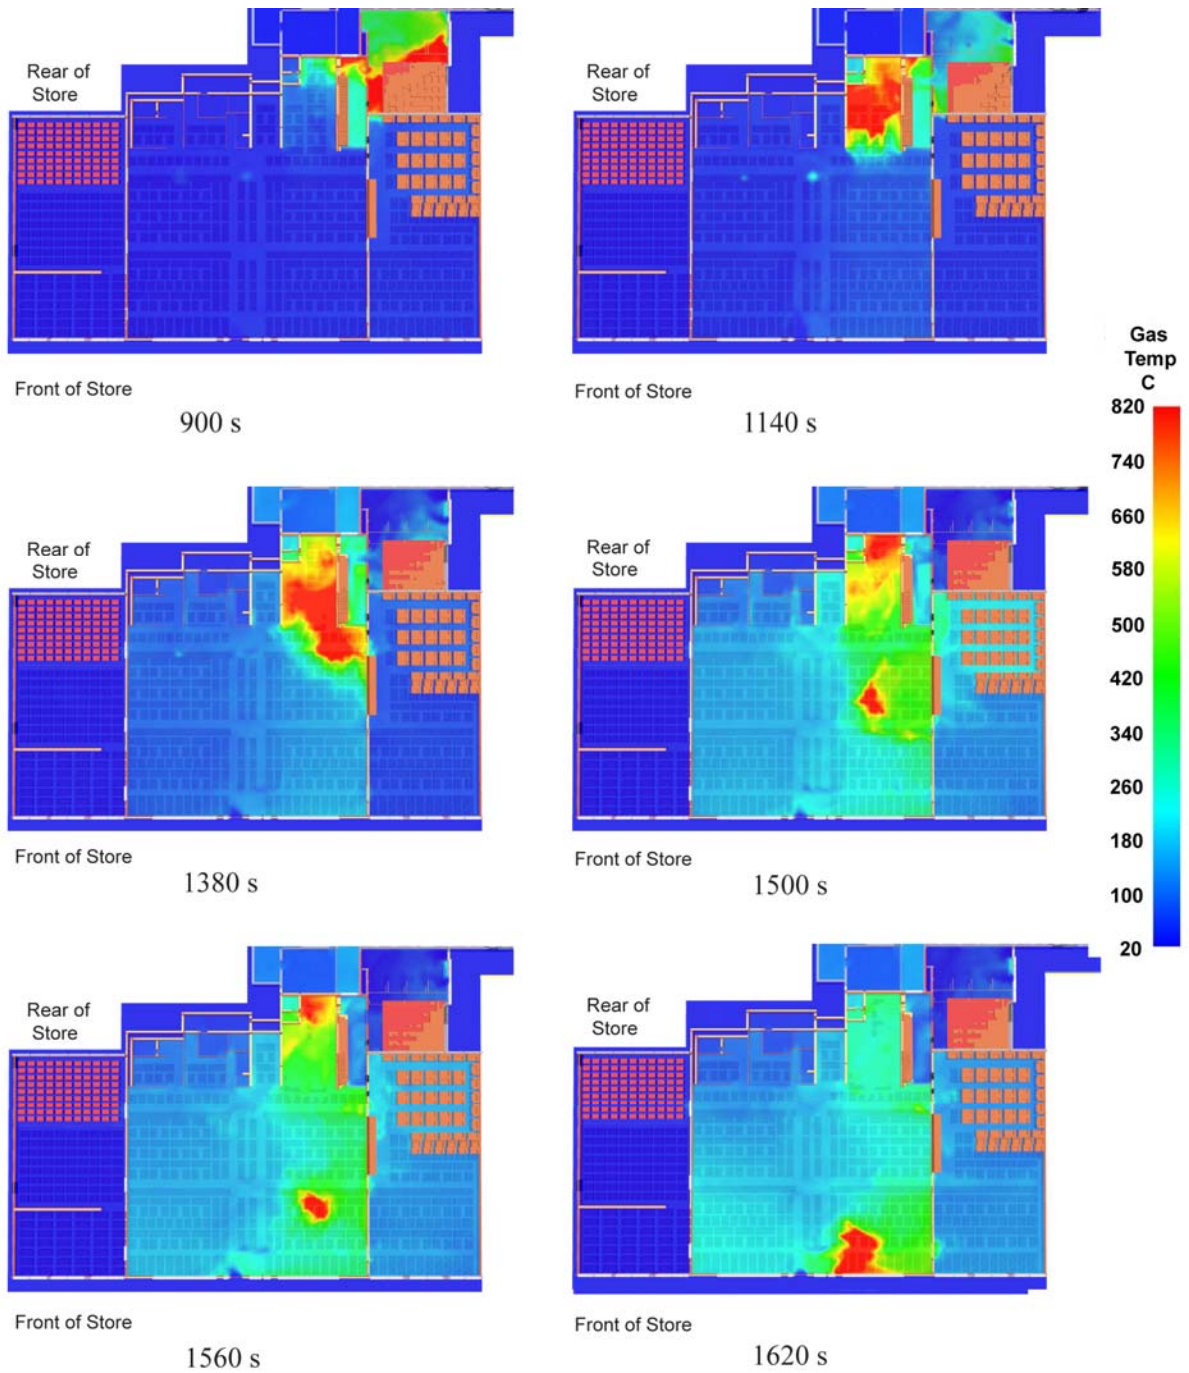
Figure K-62. Temperature slices located 1.5 m (5 ft) above the floor in simulation with front windows intact and small roof vent.

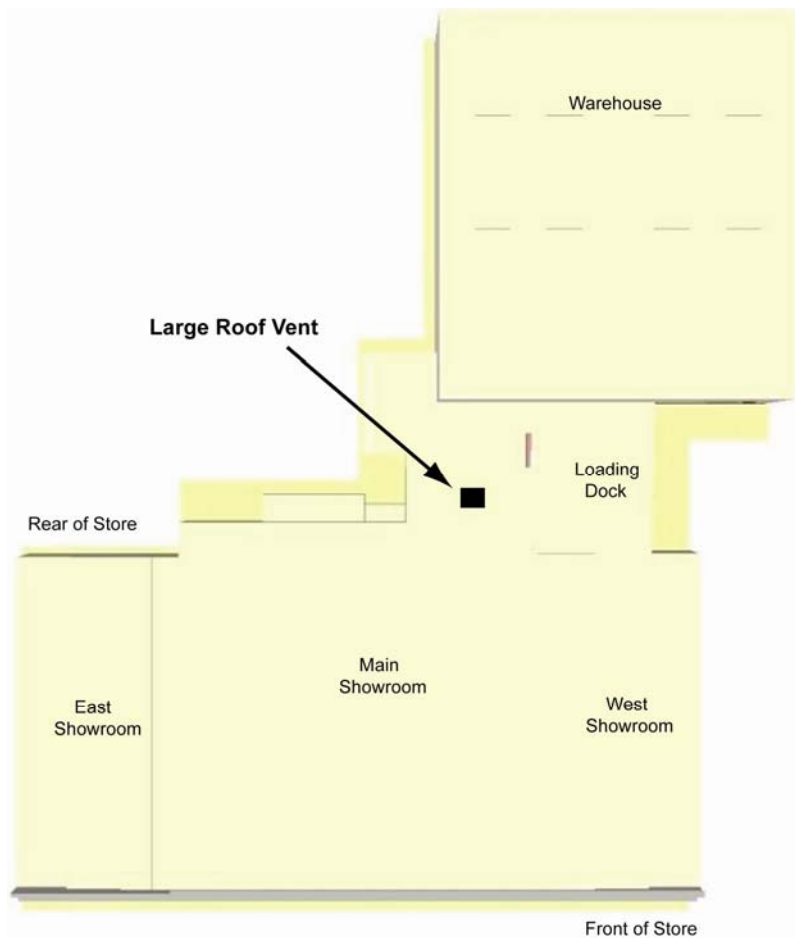
Figure K-72. Overhead view of the domain with the large roof vent identified.

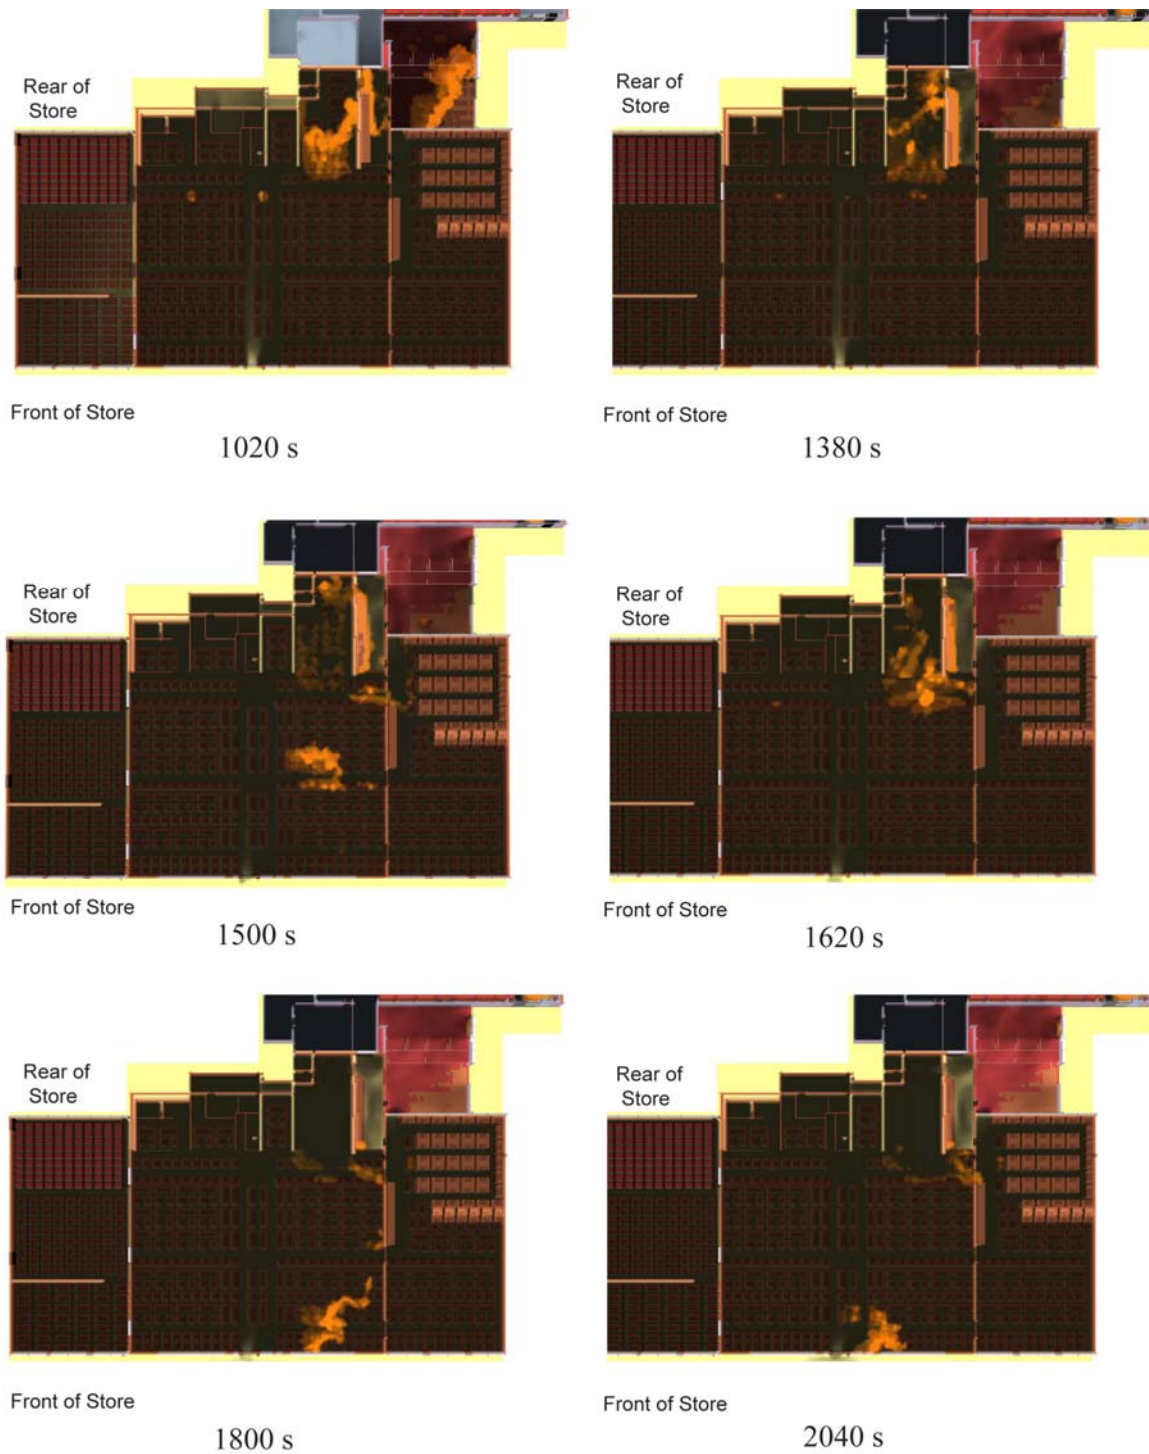
Figure K-73. Fire and smoke progression in scenario with front windows intact and large (5.9 m²) roof vent in showroom as rendered by computer simulation.
