NIST Special Publication 1126

**Summary of Full-scale Experiments to
Determine Vulnerabilities of Building
Components to Ignition by Firebrand
Showers**

Samuel L. Manzello
Sayaka Suzuki
*Fire Research Division
Engineering Laboratory*

December 2011

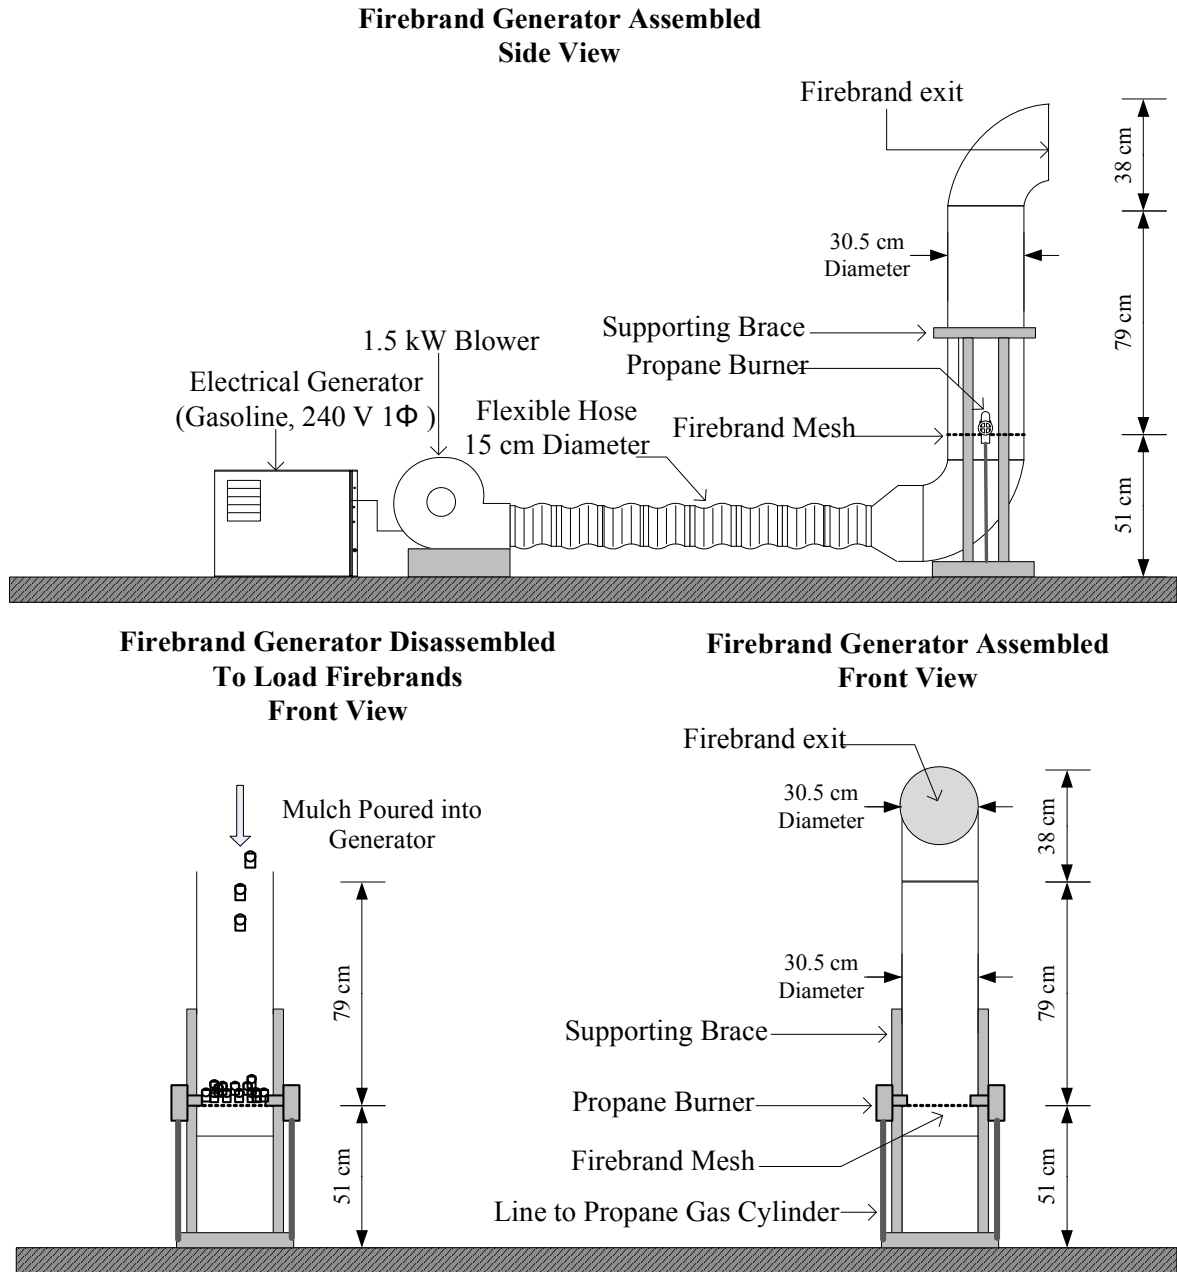
Figure 1 Schematic of NIST Firebrand Generator (NIST Dragon).

Figure 1 is a drawing of the NIST Firebrand Generator. A brief description of the device is provided here since a detailed description has been provided elsewhere [15- 18]. This version of the device was scaled up from a first-generation, proof-of-concept Firebrand Generator [19]. The bottom panel displays the procedure for loading tree mulch into the apparatus. Tree mulch is used as the fuel source to generate firebrands (details follow below).

The mulch pieces were deposited into the Firebrand Generator by removing the top portion. The mulch pieces were supported using a stainless steel mesh screen (0.35 cm spacing), which was carefully selected. Two different screens were used to filter the mulch pieces prior to loading into the firebrand generator. The first screen blocked all mulch pieces larger than 25 mm

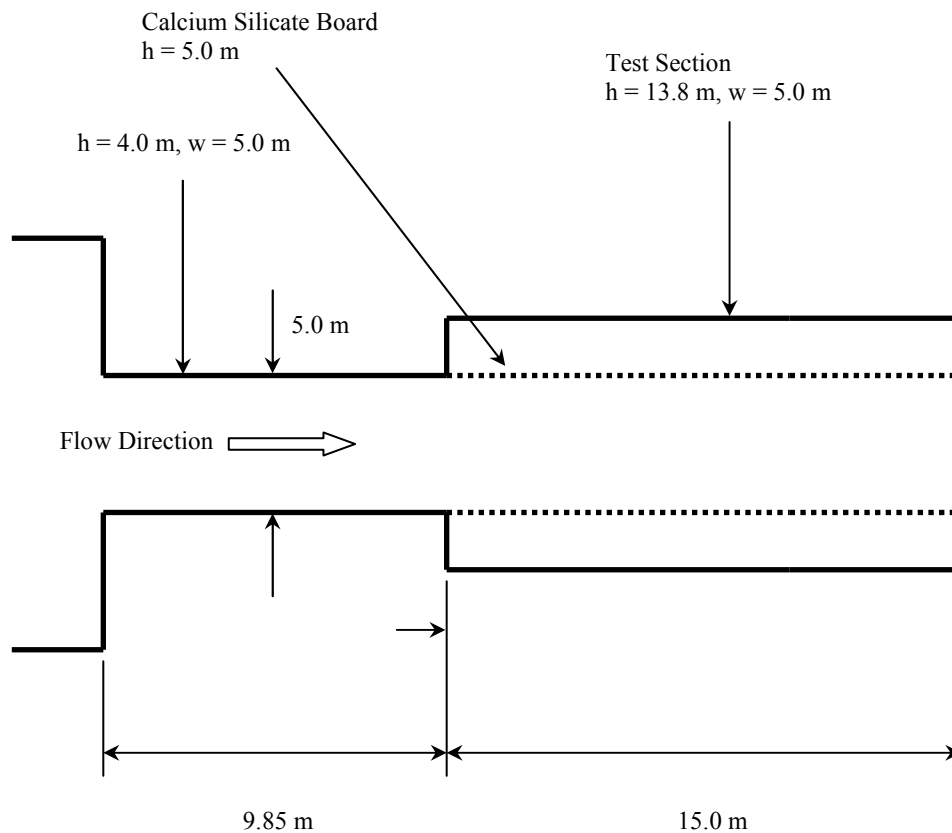
Figure 2a Schematic of test section of Fire Research Wind Tunnel Facility (FRWTF); h is height and w is width.

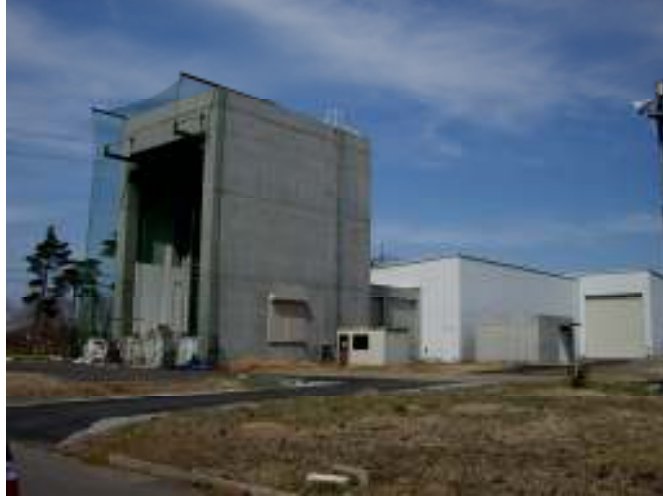
Figure 2b Photograph of FRWTF.

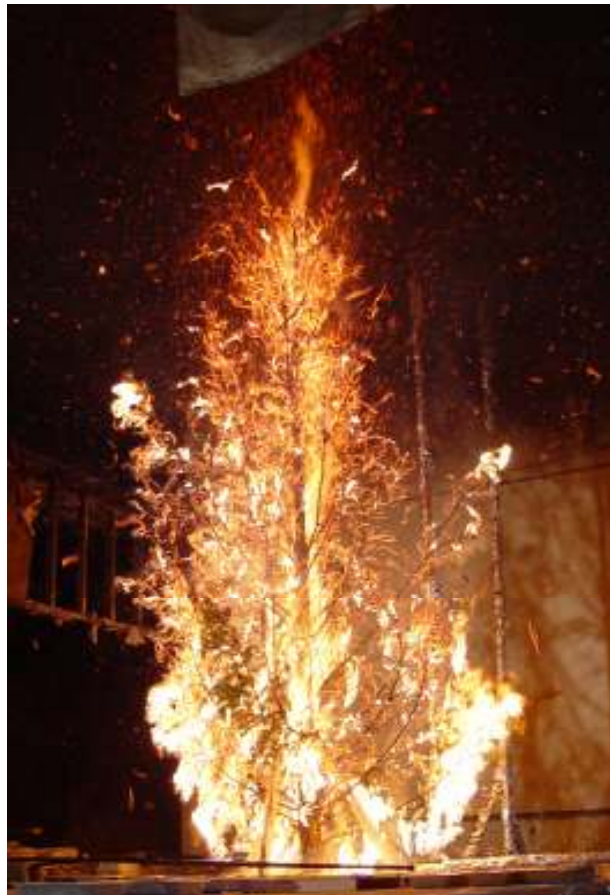
Figure 3 Photograph of a burning Douglas-Fir tree (5.2 m) used for firebrand collection.

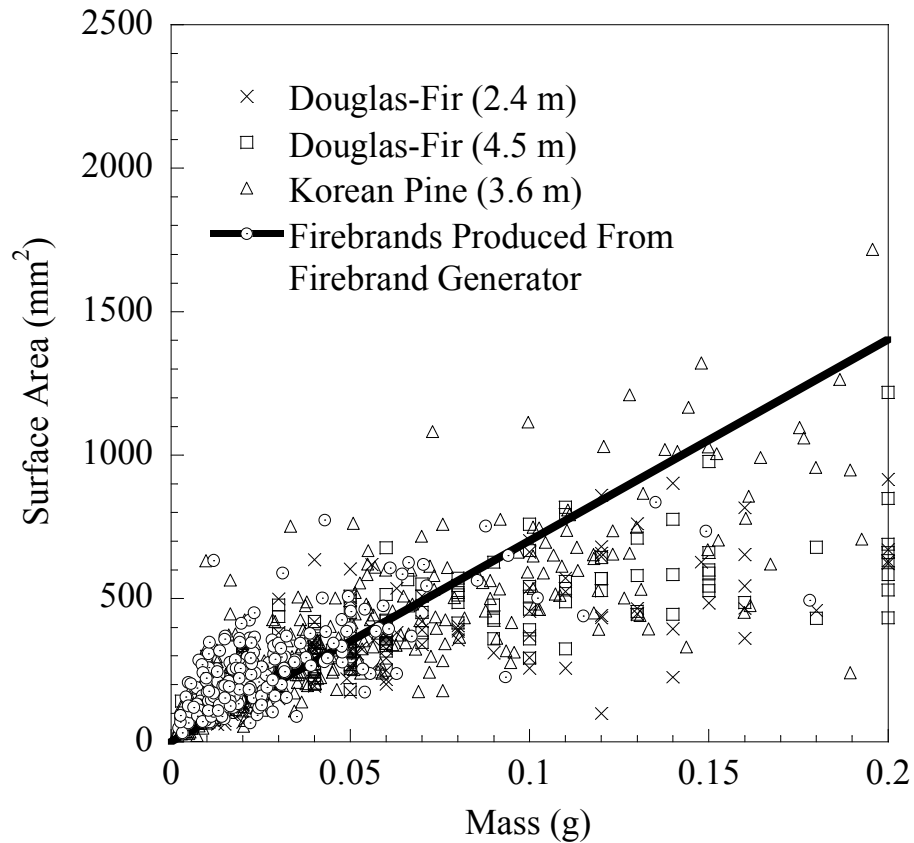
Figure 4 Firebrands produced from burning trees compared to those produced using the Firebrand Generator. The uncertainty in determining the surface area is $\pm 10\%$.

(Douglas-Fir Trees and Korean Pine Trees) burning singly under no wind, cylindrical firebrands were observed to be produced. Douglas-fir was selected as the tree species for the experiments in the USA since it is abundant in the Western United States of America and it is this part of the USA where WUI fires are most prevalent. Korean Pine, another conifer species, was used for comparison to Douglas-Fir. It was observed that more than 85 % of the firebrands produced from these tree experiments were less than 0.4 g [20-21]. Therefore, the filtering procedure for tree mulch used in the Firebrand Generator was selected to produce firebrands with size/mass distributions commensurate to those measured from burning trees (see **Figure 4**).

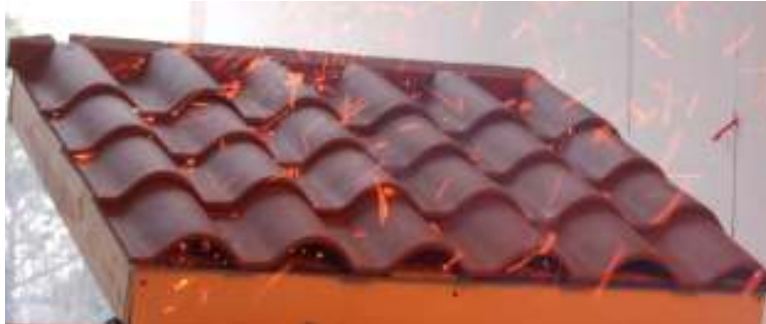
Figure 5 Images of experiments conducted using OSB/CT without bird stops installed. Intense SI was observed within the OSB base layer and eventually FI was observed. The wind tunnel speed was 7 m/s and the Firebrand Generator was located 2.0 m from the CT roofing assembly.

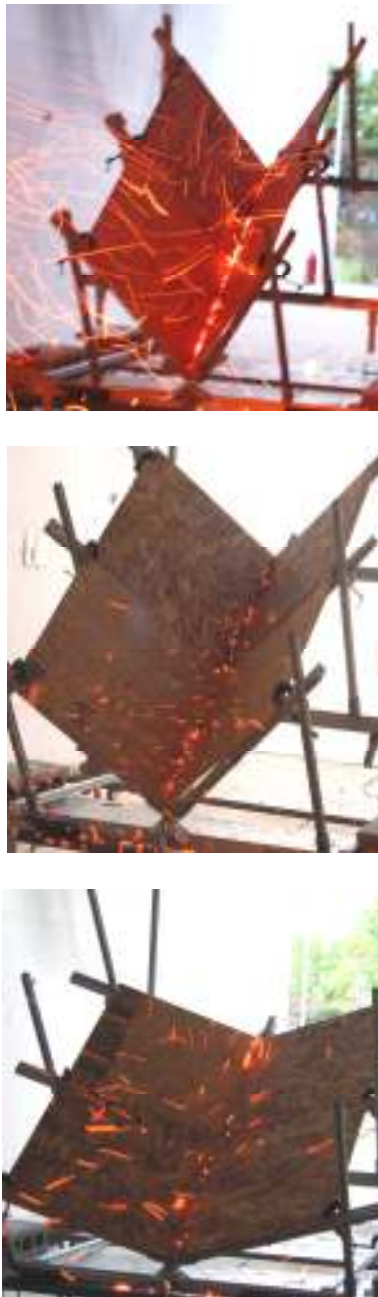
Figure 6 Bare OSB full-scale sections used for testing. (a) Angle of 60°; smoldering ignition observed (b) Angle of 90°; smoldering ignition observed (c) Angle of 135°; no ignition observed. The wind tunnel speed was 7 m/s in each case.

For ignition testing of roofing base layer materials (OSB), at an angle of 60°, the firebrands were observed to collect inside the channel of the OSB crevice (see **Figure 6a-c**). The firebrands that collected in the crevice produced SI where they landed, eventually resulting in several holes in the OSB. The OSB continued to smolder intensely near the locations where the firebrands landed. Eventually a transition to FI was observed on the back side of the OSB. As the angle was increased to 90°, similar behavior was observed where the firebrands that collected initiated intense smoldering. Eventually, holes were formed at these locations in an identical manner to the 60°. While SI was observed, it was not possible for a transition to flaming to occur. As the angle was increased to 135°, ignition was no longer possible.

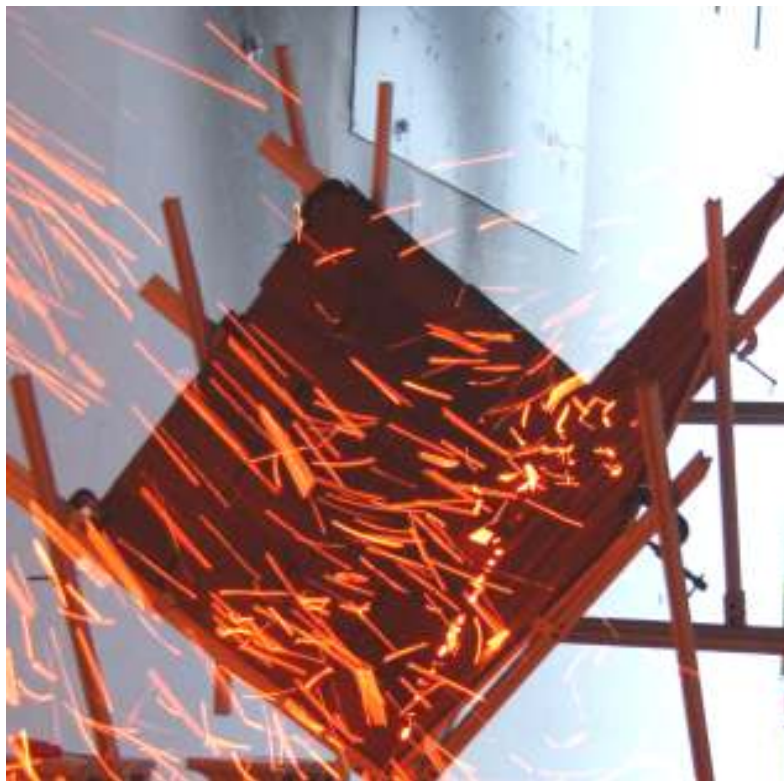
Figure 7 OSB base layer, tar paper, and asphalt shingles; Angle of 90°-no ignition observed.
The wind tunnel speed was 7 m/s.

With regard to ignition testing of roofing valleys (OSB, tar paper, and asphalt shingles), at 60° and 90°, several firebrands were observed to become trapped along the channel of two sections and along the seams of the shingles. However, no ignition events were observed. The firebrands were only capable of melting the asphalt shingles (see **Figure 7**). As the angle was spread further, fewer firebrands were observed to become trapped in the seam of the two sections, in a similar manner to the base layer OSB tests. While these tests did not consider the influence of aged or pre-heated shingles, the results clearly indicate that firebrands can melt asphalt shingles.

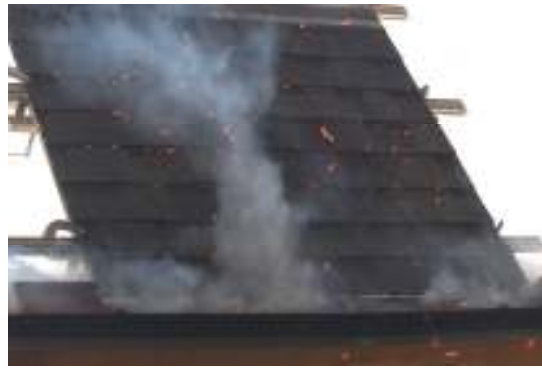
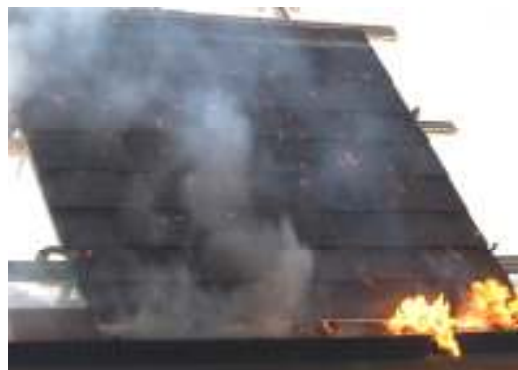
Figure 8 Section of full-scale roof assembly. (a) Smoldering ignition of needles/leaves inside gutter (b) Transition to flaming ignition. The wind tunnel speed was 7 m/s.

Figure 8a-b displays typical results obtained from the experiments. The firebrands that were deposited inside the gutter produced SI inside the gutter. The smoldering intensified and ultimately this transitioned to FI. The asphalt shingles were observed to melt once exposed to the intense flaming that occurred inside the gutter. The flames, however, did not spread up the roof section. While the flames did not spread upwards along the roof, these images are very important since they clearly show the dangers of not cleaning gutters. The influence of pre-heated shingles as well as aged shingles was not addressed.

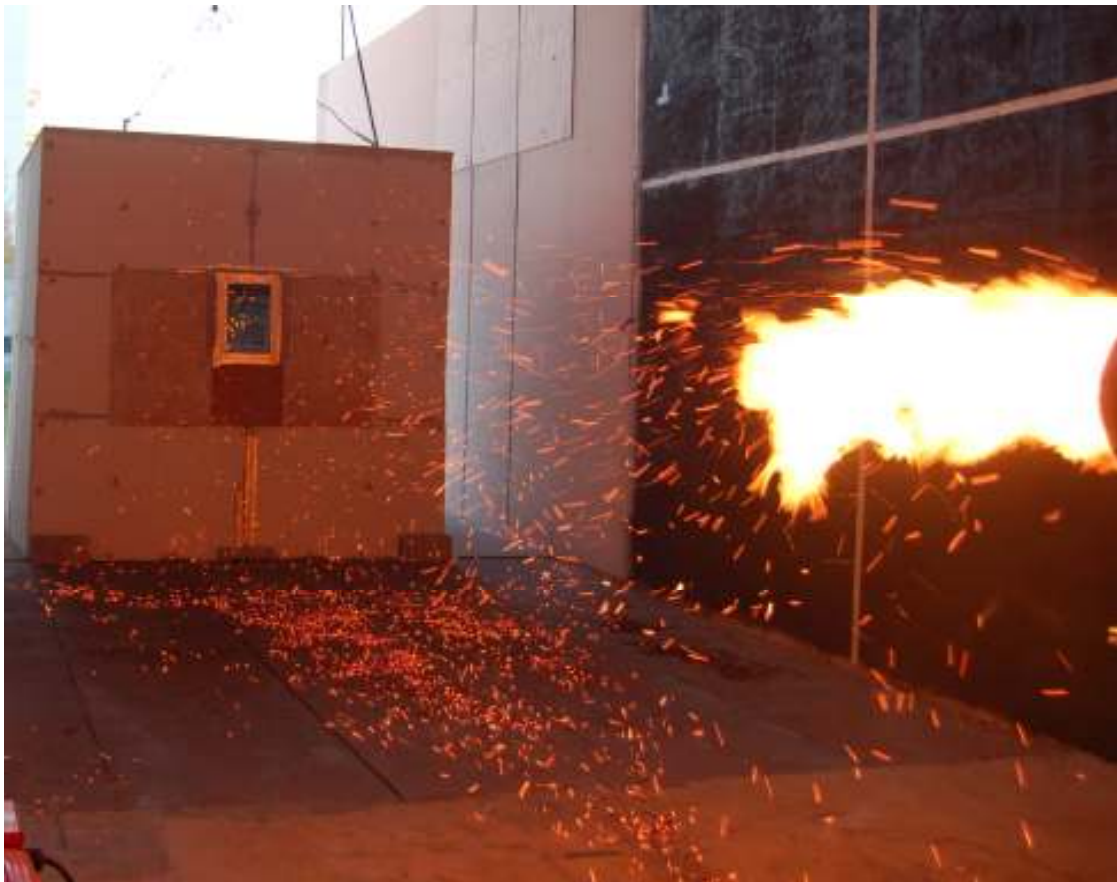
Figure 10 Typical experiment using NIST Firebrand Generator at BRI's FRWTF. The mesh installed in this experiment was 20 x 20 (1.04 mm), the wind tunnel speed was 7 m/s, and the Firebrand Generator was located 7.5 m from the structure.

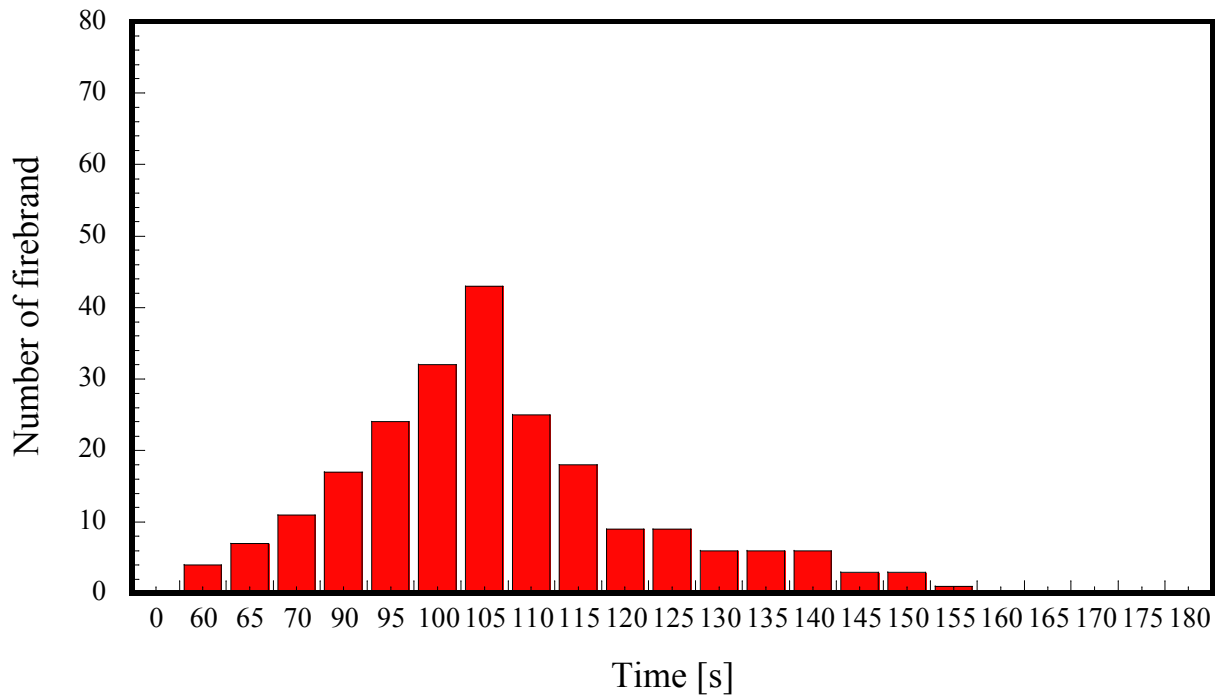
Figure 11 Number of firebrands arriving on the mesh as a function of time for the full scale experiments. The mesh area was 1600 cm². At each time, the number of firebrands plotted in the figure was based on the average of three repeat experiments. The relative variation in the average number of firebrands measured was similar for all times (less than 20 %).

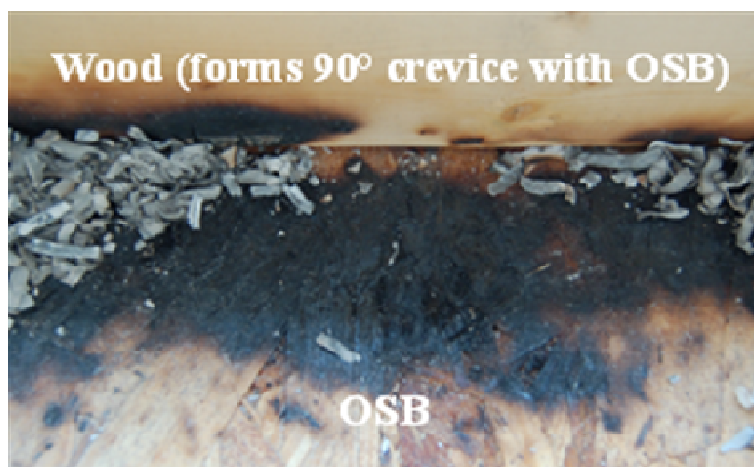
Figure 12 Images obtained (top view) for crevice filled with paper tests using 10 x 10 (2.0 mm) mesh.

The bare wood crevice experiments resulted in SI in the OSB layer for the 4 x 4 (5.72 mm) and 8 x 8 (2.74 mm) mesh sizes. As the mesh size was reduced to 10 x 10 (2.0 mm), the firebrands were not able to ignite the bare wood crevices. When the crevices were filled with shredded paper, SI followed by FI occurred in the paper for mesh sizes up 10 x 10 (2.0 mm). The OSB layer was then observed to ignite by SI and subsequently produced a self-sustaining SI that continued to burn holes into the OSB. For the smallest mesh sizes tested (16 x 16 and 20 x 20), NI was observed in the paper and consequently NI in the crevice. The results of an experiment conducted using 10 x 10 (2.0 mm) mesh are shown in **Figure 12**.

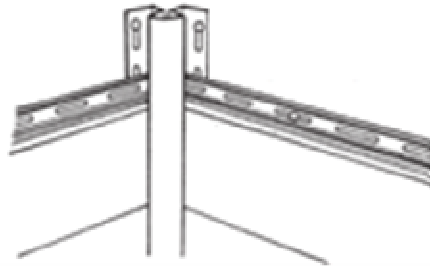
Figure 14 (a) Drawing of a corner post.

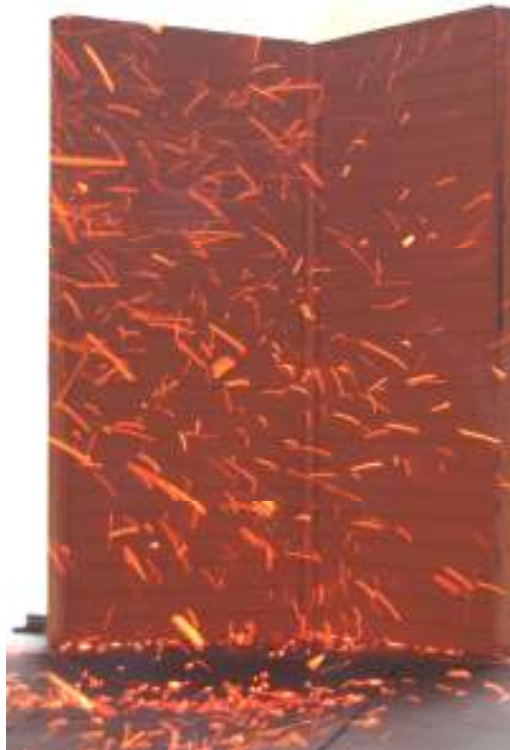
Figure 14 (b) Picture of vinyl siding corner assembly under firebrand bombardment.

For experiments with vinyl siding (see **Figure 14b** for typical experiment) conducted at 7 m/s and 9 m/s, the firebrands were observed to melt the siding to the point where holes developed through the material. A picture of this is shown in **Figure 15**. While burns were observed in the moisture barrier at both wind speeds (Tyvek), ignition of the OSB sheathing was only observed for vinyl siding tests at 9 m/s and when the sheathing was dried. It is important to

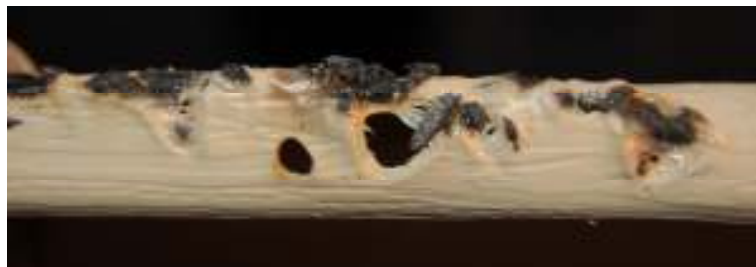
Figure 15 Image of vinyl siding (from bottom) after firebrand exposure at 7 m/s.

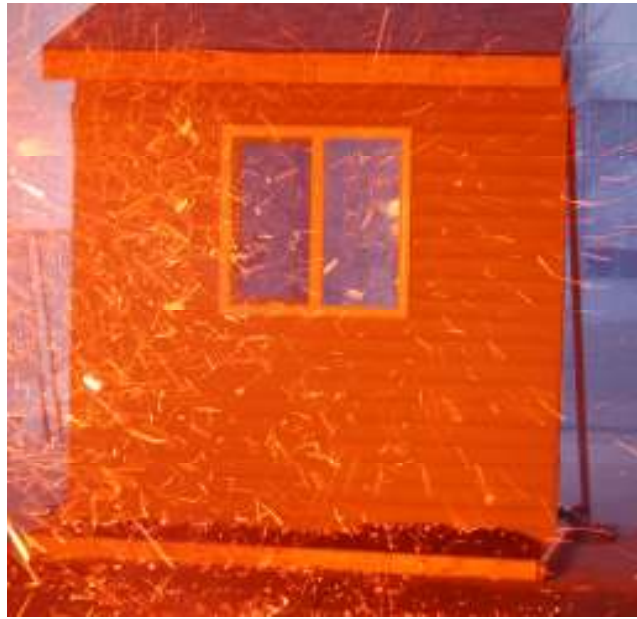
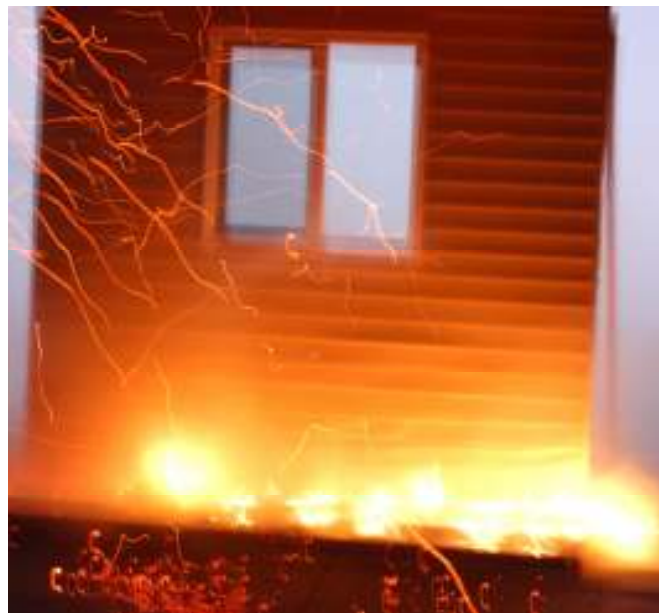
Figure 16 In the top image, firebrands have caused smoldering ignition in the mulch bed. In the bottom image, smoldering ignition has transitioned to flaming ignition and the wall assembly has ignited.

Firebrands were observed to ignite the needle bed via SI, the smoldering ignition become self-sustaining, and a transition to FI was observed (see **Figure 16**). The FI in the needles subsequently melted the vinyl siding and produced self-sustaining SI at the base of the wall assembly (within the OSB; this OSB was not even dried).

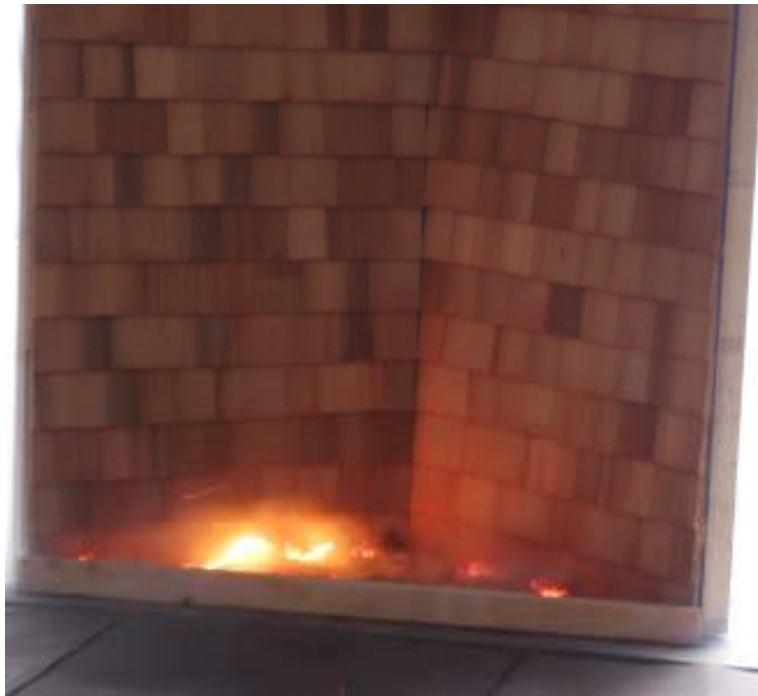
Figure 17 Images of untreated cedar shingle siding ignited under firebrand attack at a wind tunnel speed of 7 m/s.

When considering untreated cedar shingle siding, similar results were observed; namely ignition of the wall assembly itself (see **Figure 17**). The fire retarded cedar shingle siding performed very well. Even though the fine fuels exposed the wall assembly to flames, ignition of the cedar shingle siding was not observed, nor did any ignition occur in the OSB sheathing.

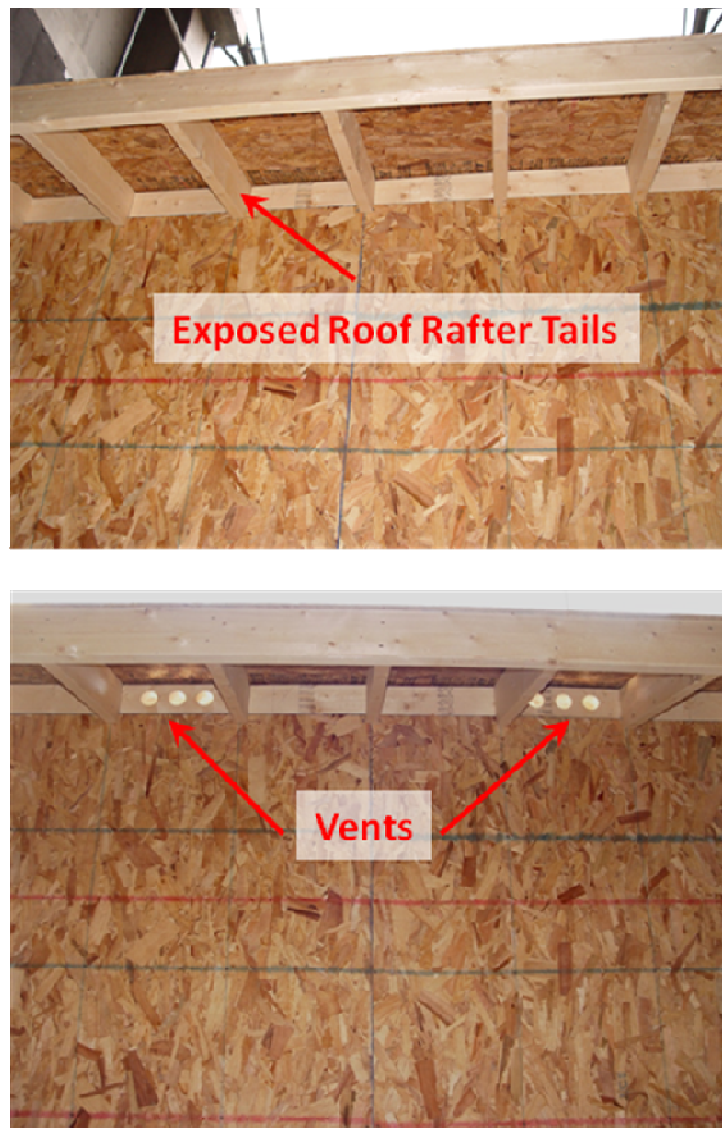
Figure 18 Images of open eave construction with no vents (top) and vents (bottom).

In half of the experiments, no vent opening was used to simply observe if firebrands actually accumulated within the exposed rafters and subsequent joints (see **Figure 18**). In the remaining experiments, vents were installed (see bottom panel) and a mesh was placed within the vent opening (see **Figure 18**). For the vent openings, 50 mm holes were drilled into the blocking material and an 8 x 8 mesh (2.75 mm opening) was secured, as recommended in the new, 2010 California WUI code [26]. Three replicate experiments were performed. For the experiments that used no vent opening, firebrands were not observed to accumulate under the eave over the range of wind speeds considered (see **Figure 19** for a typical experiment).

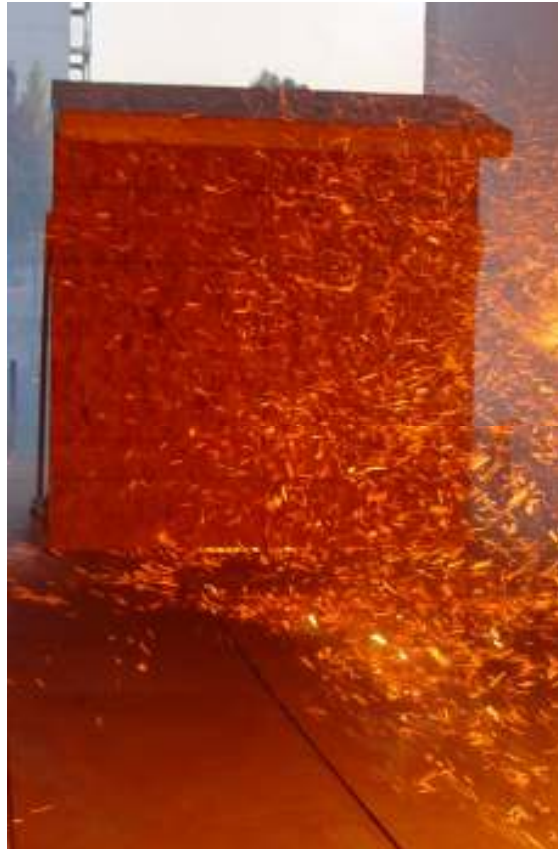
Figure 19 Image of wall fitted with eave under firebrand bombardment.

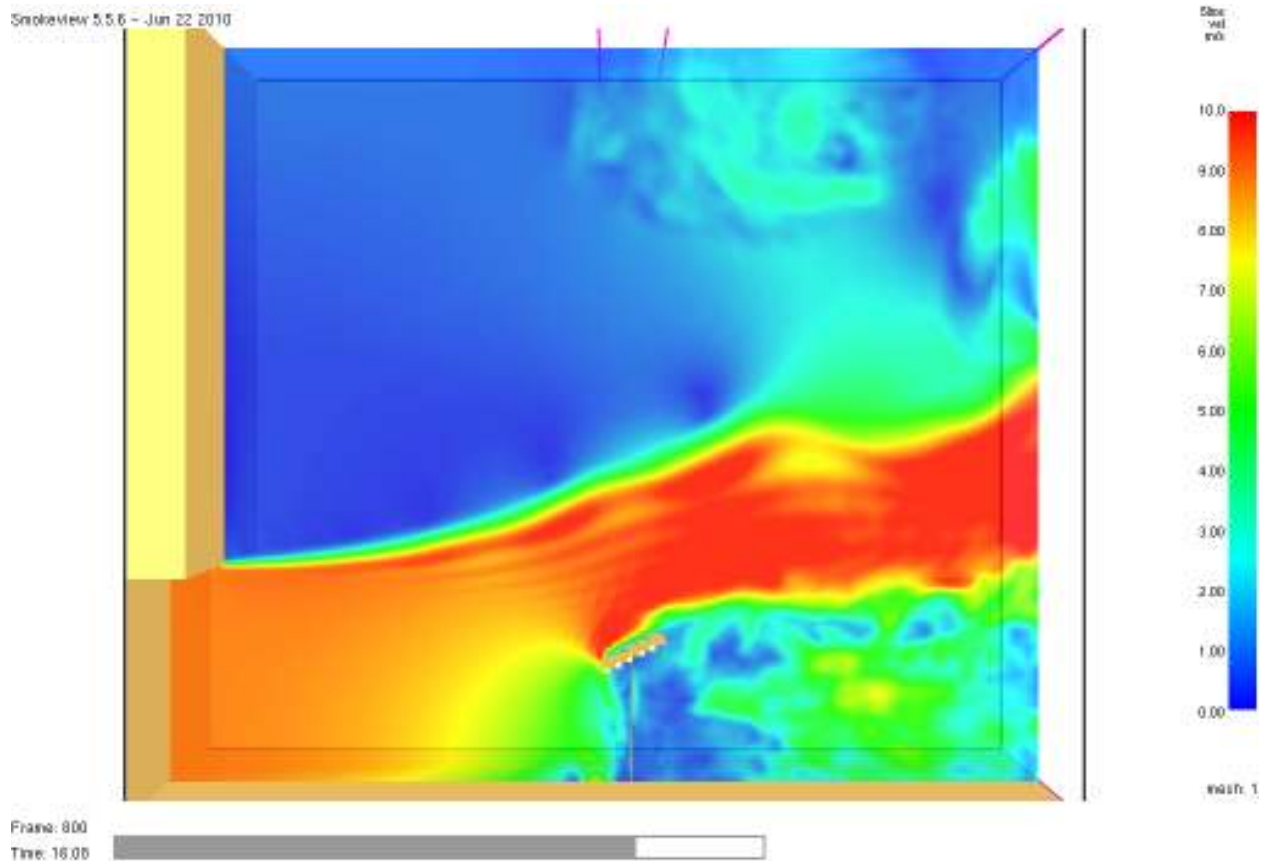
Figure 20 FDS simulations of air flow around eave assemblies for a wind speed of 9 m/s.

Although firebrands are not modeled, the resulting air flow profiles demonstrate why accumulation of firebrands was difficult under the eave (see **Figure 20**). Specifically, the presence of the wall results in a large stagnation zone in front of the wall that becomes more

pronounced as wind speed was increased. In addition, under the eave there is an area of little or no flow velocity that would be required to drive the firebrands into the joints between the eave and wall assembly. It is important to point out that these simulations considered only airflow and do not include the seeding of firebrands into the flow. Current work at NIST is aimed at incorporating a firebrand transport model into FDS.

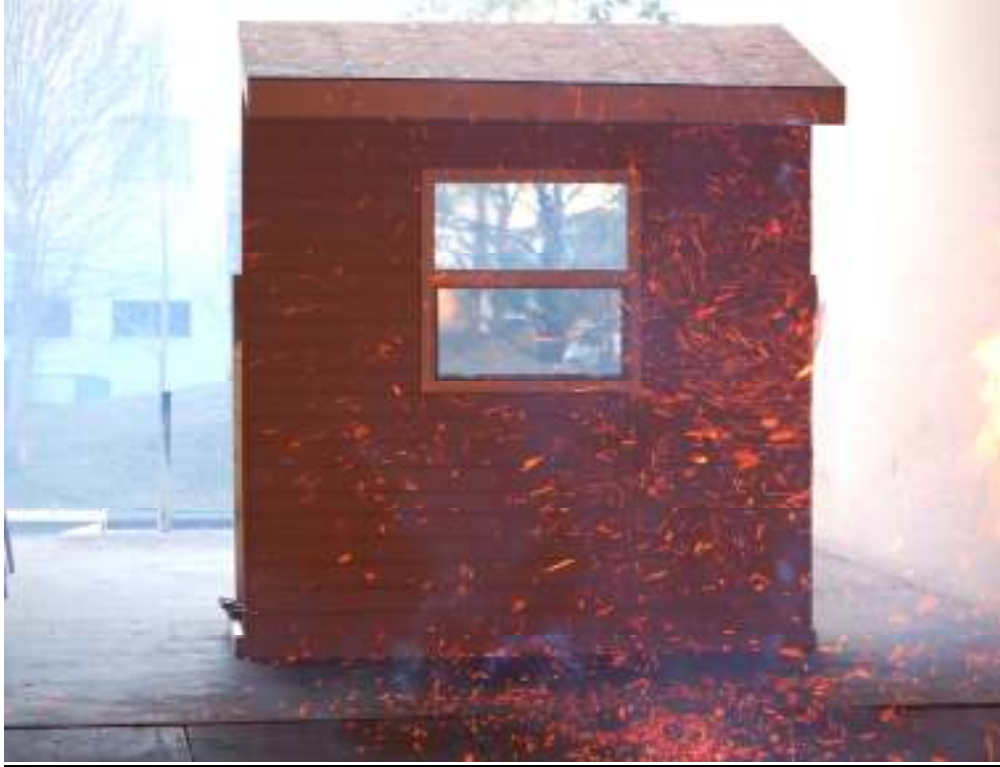
Figure 21 Picture of wall/eave assembly fitted with a vertically sliding, double hung window exposed to firebrand showers at a wind tunnel speed of 9 m/s.

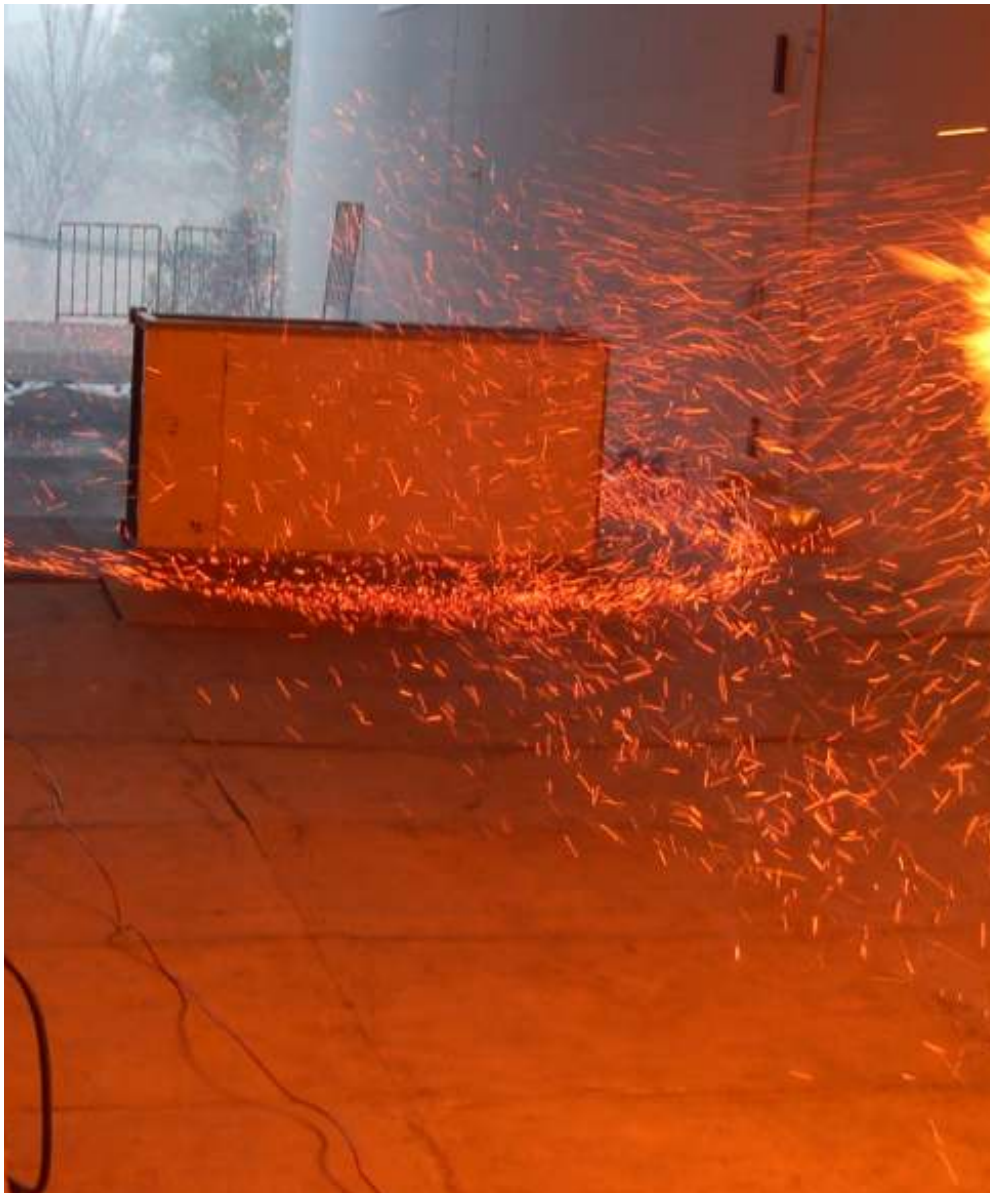
Figure 22 Image of firebrands flowing around one of the obstacles used.

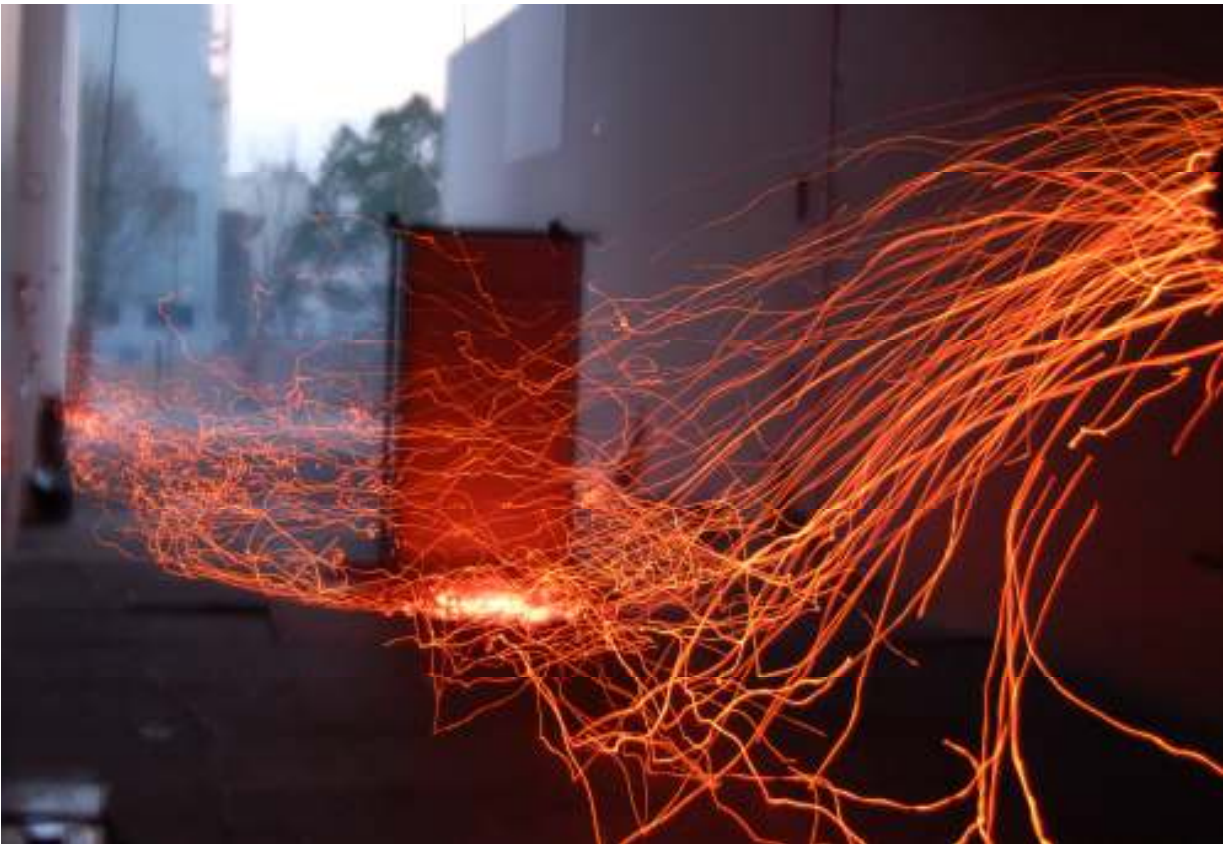
Figure 23 Photograph taken by increasing the exposure time on the camera to visualize the firebrand streaklines or flow over the obstacles.

samples. A series of photographs was also taken by increasing the exposure time on the camera to visualize the firebrand flow process over the obstacles. This image is shown in **Figure 23**.

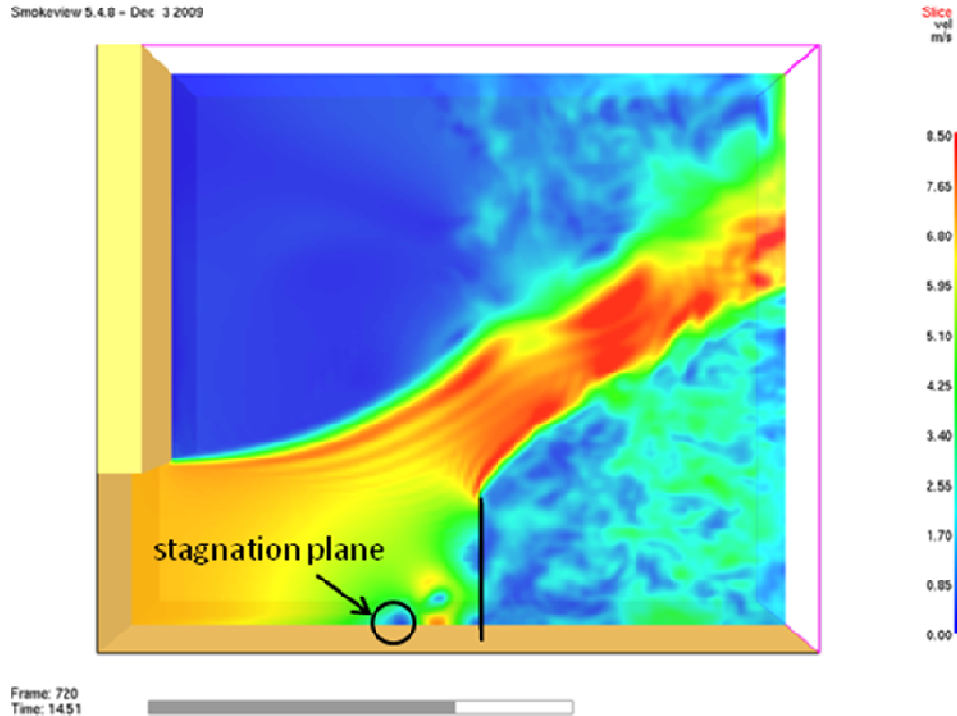
Figure 24 (c) Obstacle 3m by 3m.

5 cm, The obstacles used were modeled as well as a very large obstacle; the same profile of the structure used (3 m by 3 m). As can be seen, as the obstacle placed in the flow became larger, the recirculation and resulting stagnation plane became more intense. The experimental images qualitatively demonstrate this behavior.

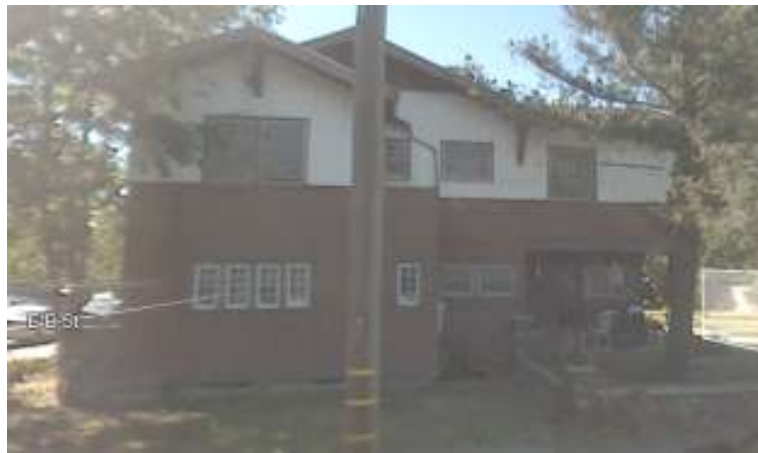
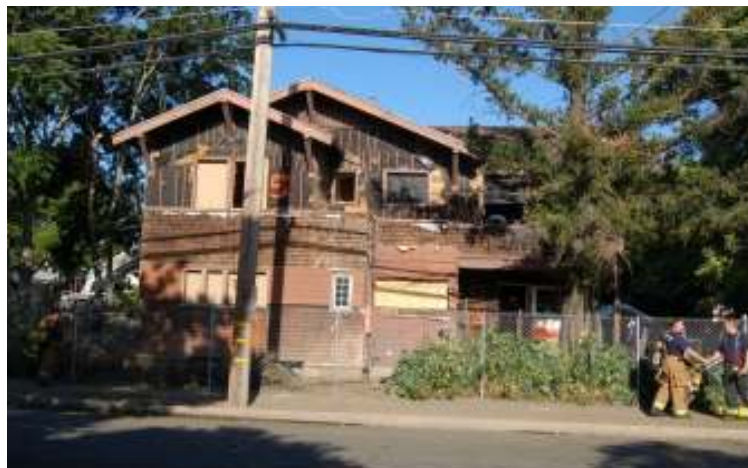
Figure 25 Pictures of burned structure from outside. Top: View from east side. Bottom: Prepared for burning

The structure used for the experiments was a two story house located in Dixon, CA. Debris piles were used to ignite the structure and it took approximately two hours after ignition for complete burn down (see **Figure 25** for pre-burn house pictures; see **Figure 26** for first floor layout of the house). The picture of the house burn is shown in **Figure 27**. A large amount of water was poured onto the structure several times to control the fire since the house was located in downtown Dixon. Firebrands were collected by using a series of water pans placed near (4 m) from the structure and on the road about 18 m downwind to the structure. After deposition into the water pans, the firebrands were filtered from the water using a series of fine mesh filters.

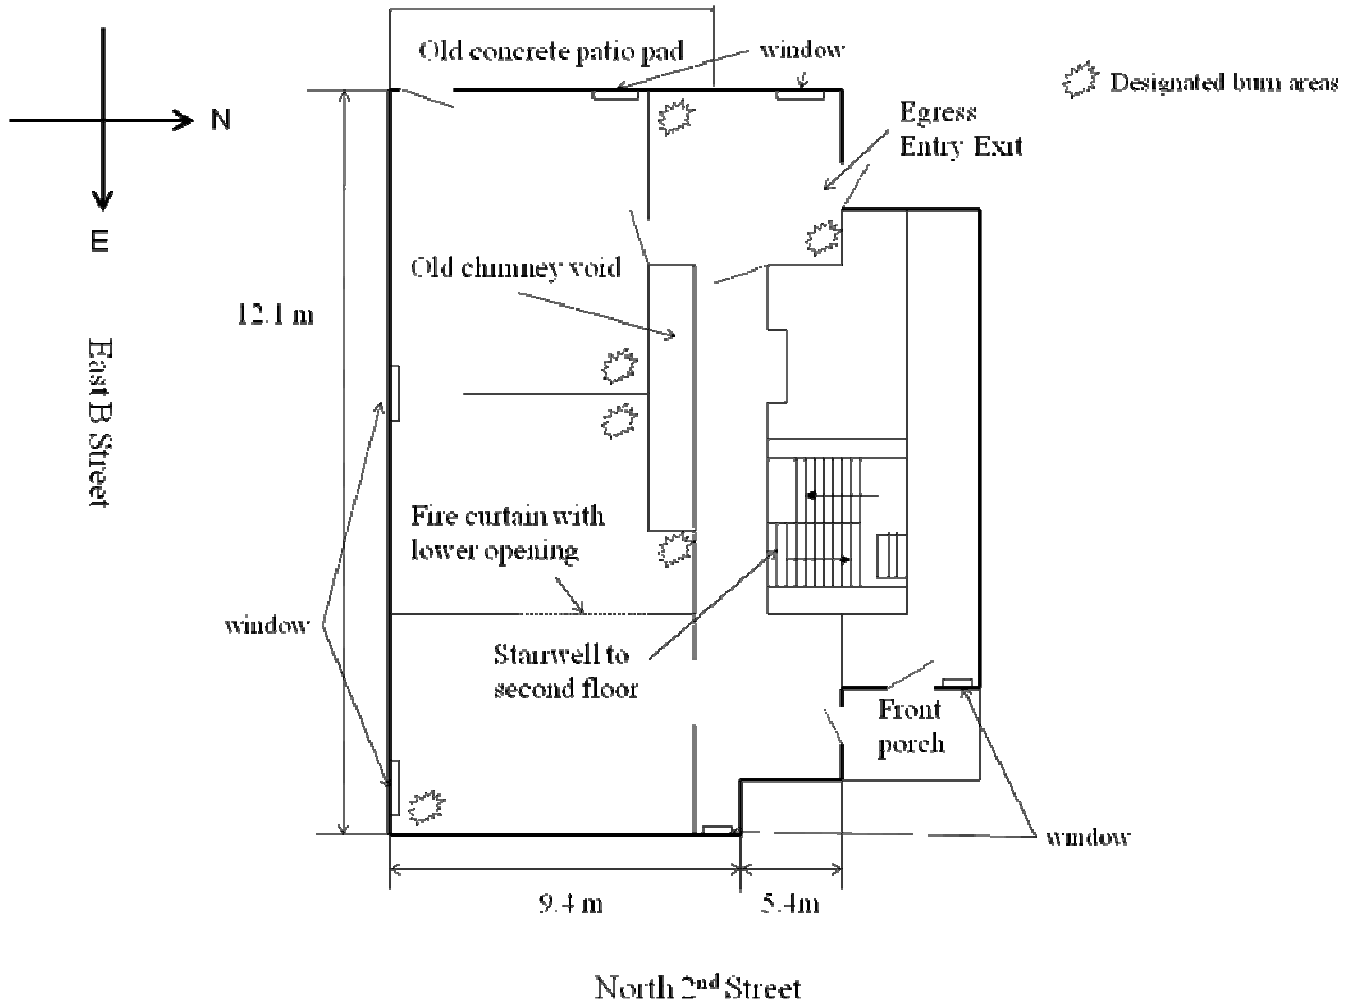
Figure 26 First floor plan of burned structure.

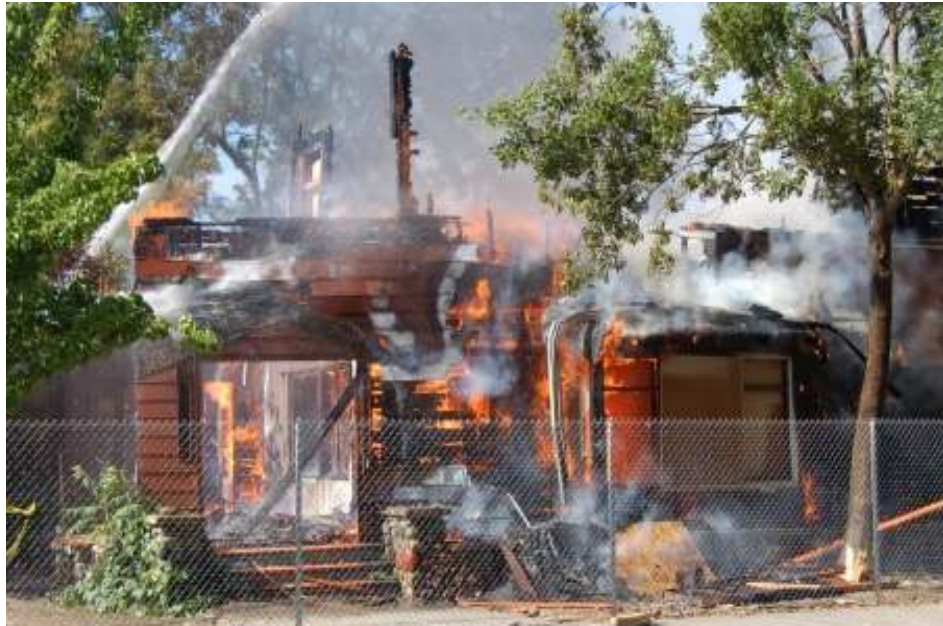
Figure 27 Picture of full-scale house burn used to collect firebrands.

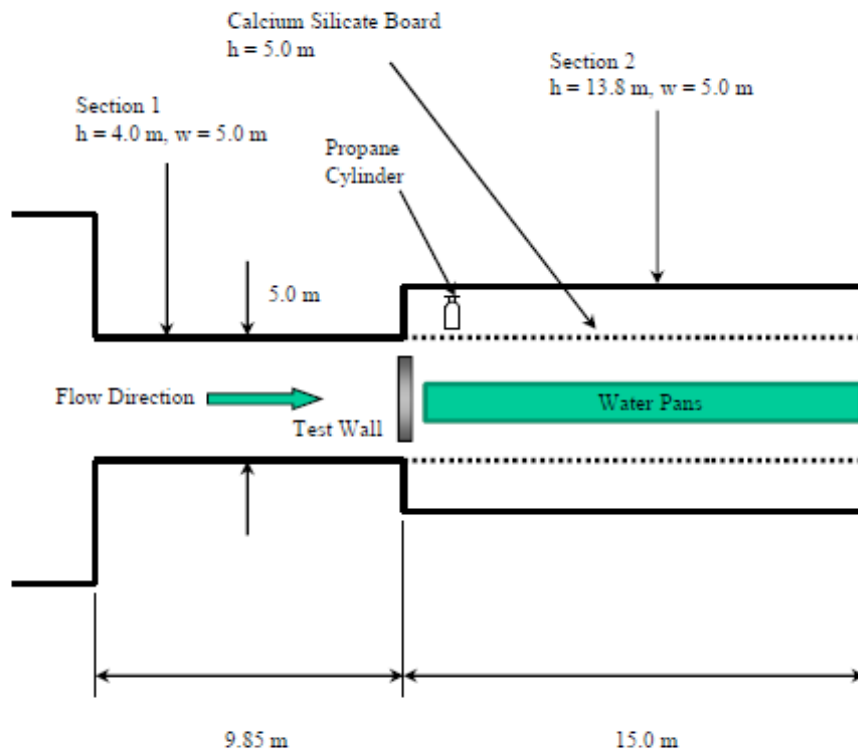
Figure 28 Schematic of FRWTF. The location of the wall assemblies used for firebrand generation experiments are shown.

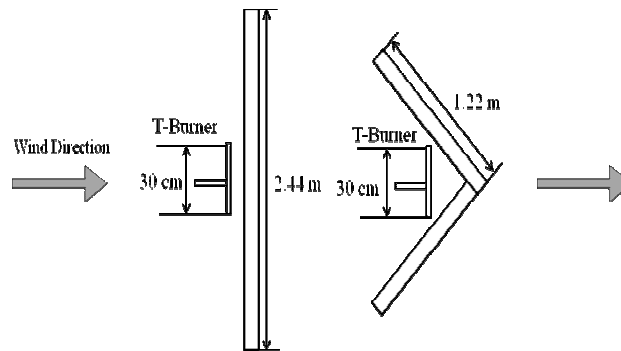
Figure 29 Schematic of Experimental Assemblies
Left: Wall Assembly, Right: Re-entrant Corner
