NIST Special Publication 1126

**Summary of Full-scale Experiments to
Determine Vulnerabilities of Building
Components to Ignition by Firebrand
Showers**

Samuel L. Manzello
Sayaka Suzuki
*Fire Research Division
Engineering Laboratory*

December 2011

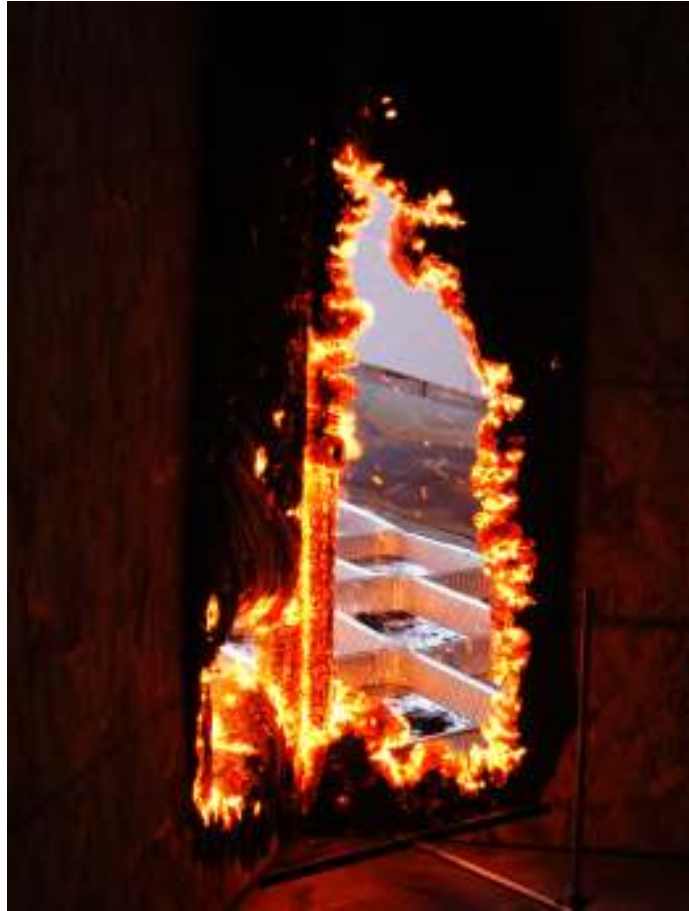
Figure 30 Firebrand generation from a burning re-entrant corner at 8 m/s applied wind. Firebrands are produced on the backside of the assembly and are collected using an array of water pans downstream.

tunnel on, experiments were conducted until the wall assembly could no longer support itself. Firebrands were collected by using a series of water pans placed behind the assemblies. After deposition into the water pans, the firebrands were filtered from the water using a series of fine mesh filters. Firebrands were dried in an oven and the mass and size of each firebrand was measured by a precision balance and using digital image analysis, respectively. A figure of a full-scale re-entrant corner, ignited using a propane burner, and burning under an applied wind speed of 8 m/s is shown in **Figure 30**.

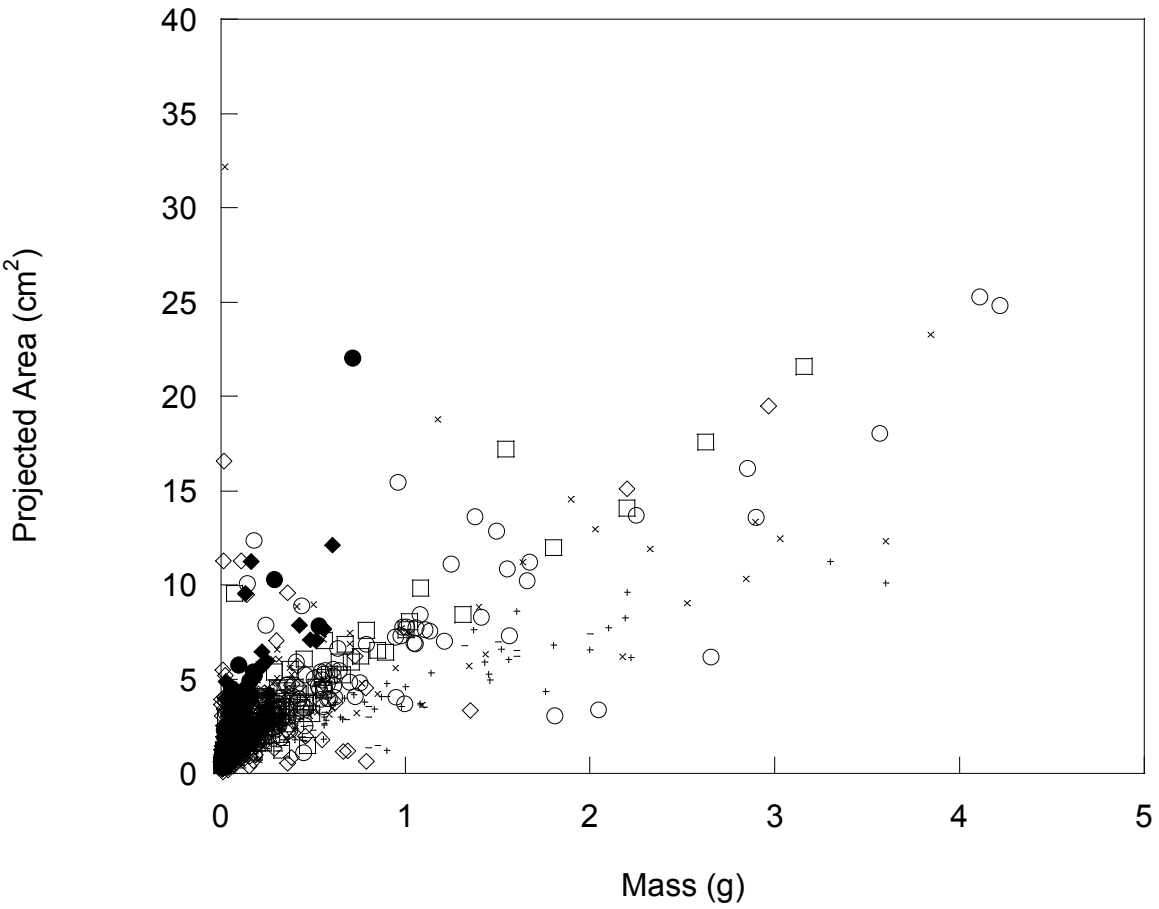
Figure 31 Size and Mass Distribution of Firebrands.

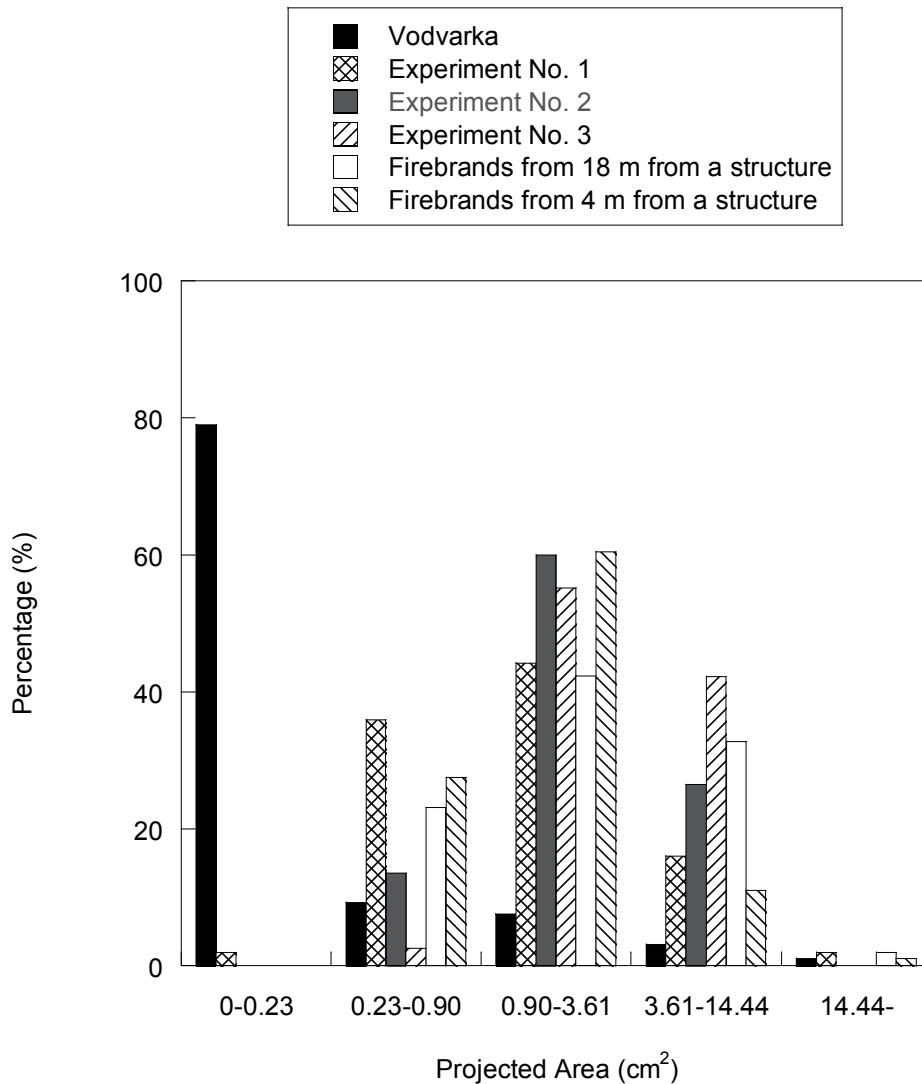
Figure 32 Size Distribution of Firebrands.
