Wind and Seismic Effects

NIST SP 796

PROCEEDINGS OF
THE 22ND JOINT
MEETING OF
THE U.S.-JAPAN
COOPERATIVE PROGRAM
IN NATURAL RESOURCES
PANEL ON WIND AND
SEISMIC EFFECTS

Issued September 1990

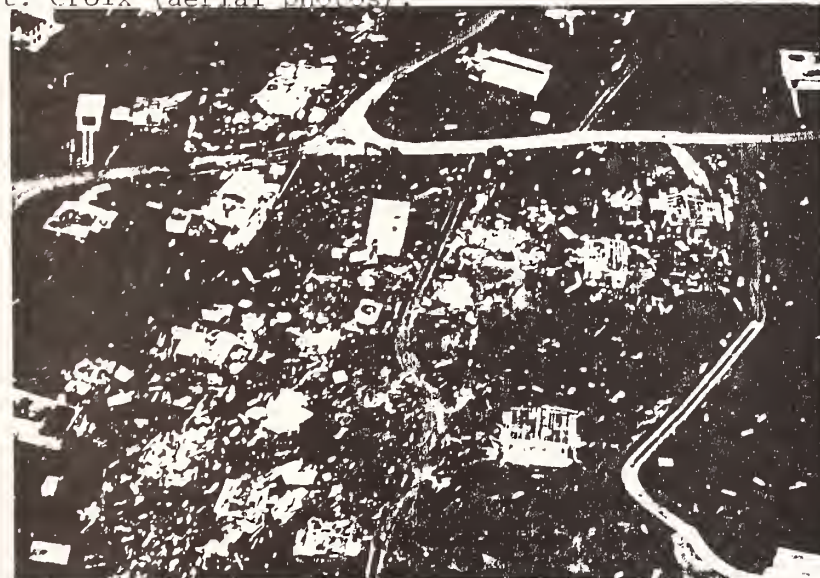
Figure 18b. Close-up aerial photo of microburst damage near north coast, Vieques.

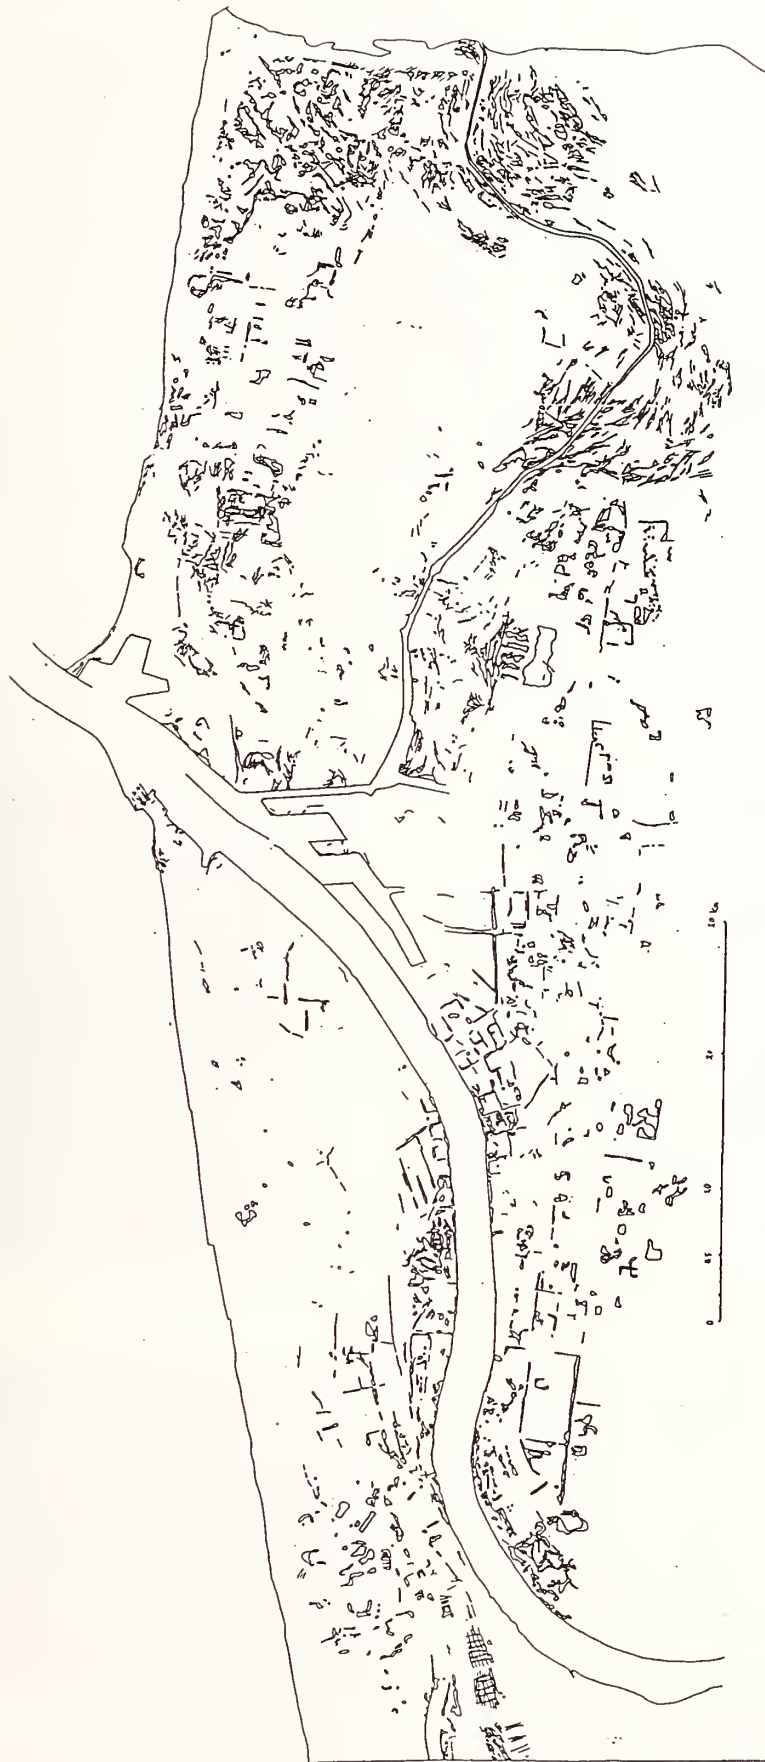
fig.-3 Distribution of cracks and sand boils
Compiled from "Actual condition map on
damages caused by Niigata earthquake at a scale
of 1:10,000"

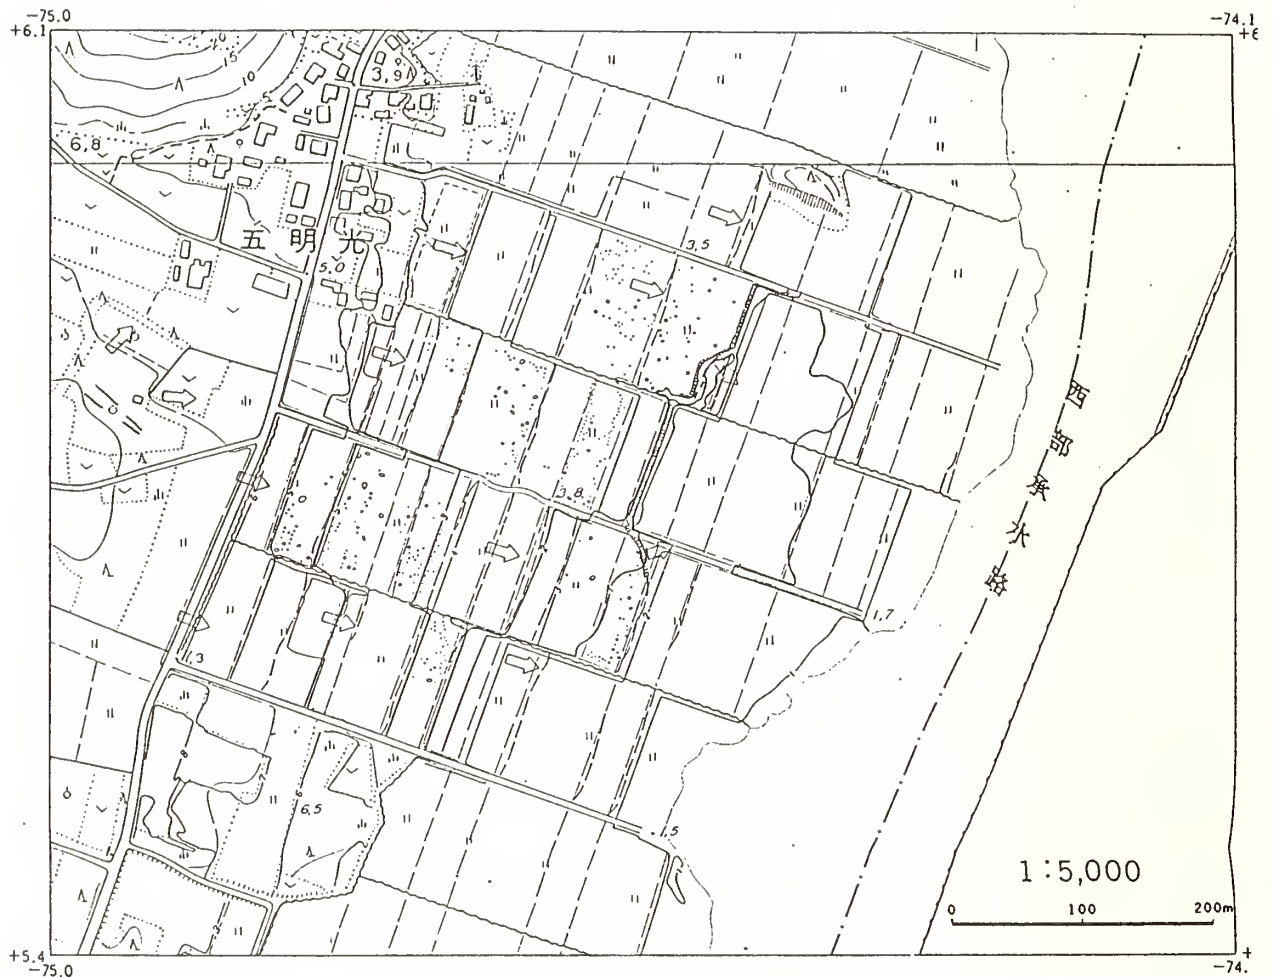
fig.4- Landform change (lateral displacement) at Gomyoukou near Lake Hachirougata in Akita pref. Caused by Nihonkai-Chubu Earthquake, 1983"

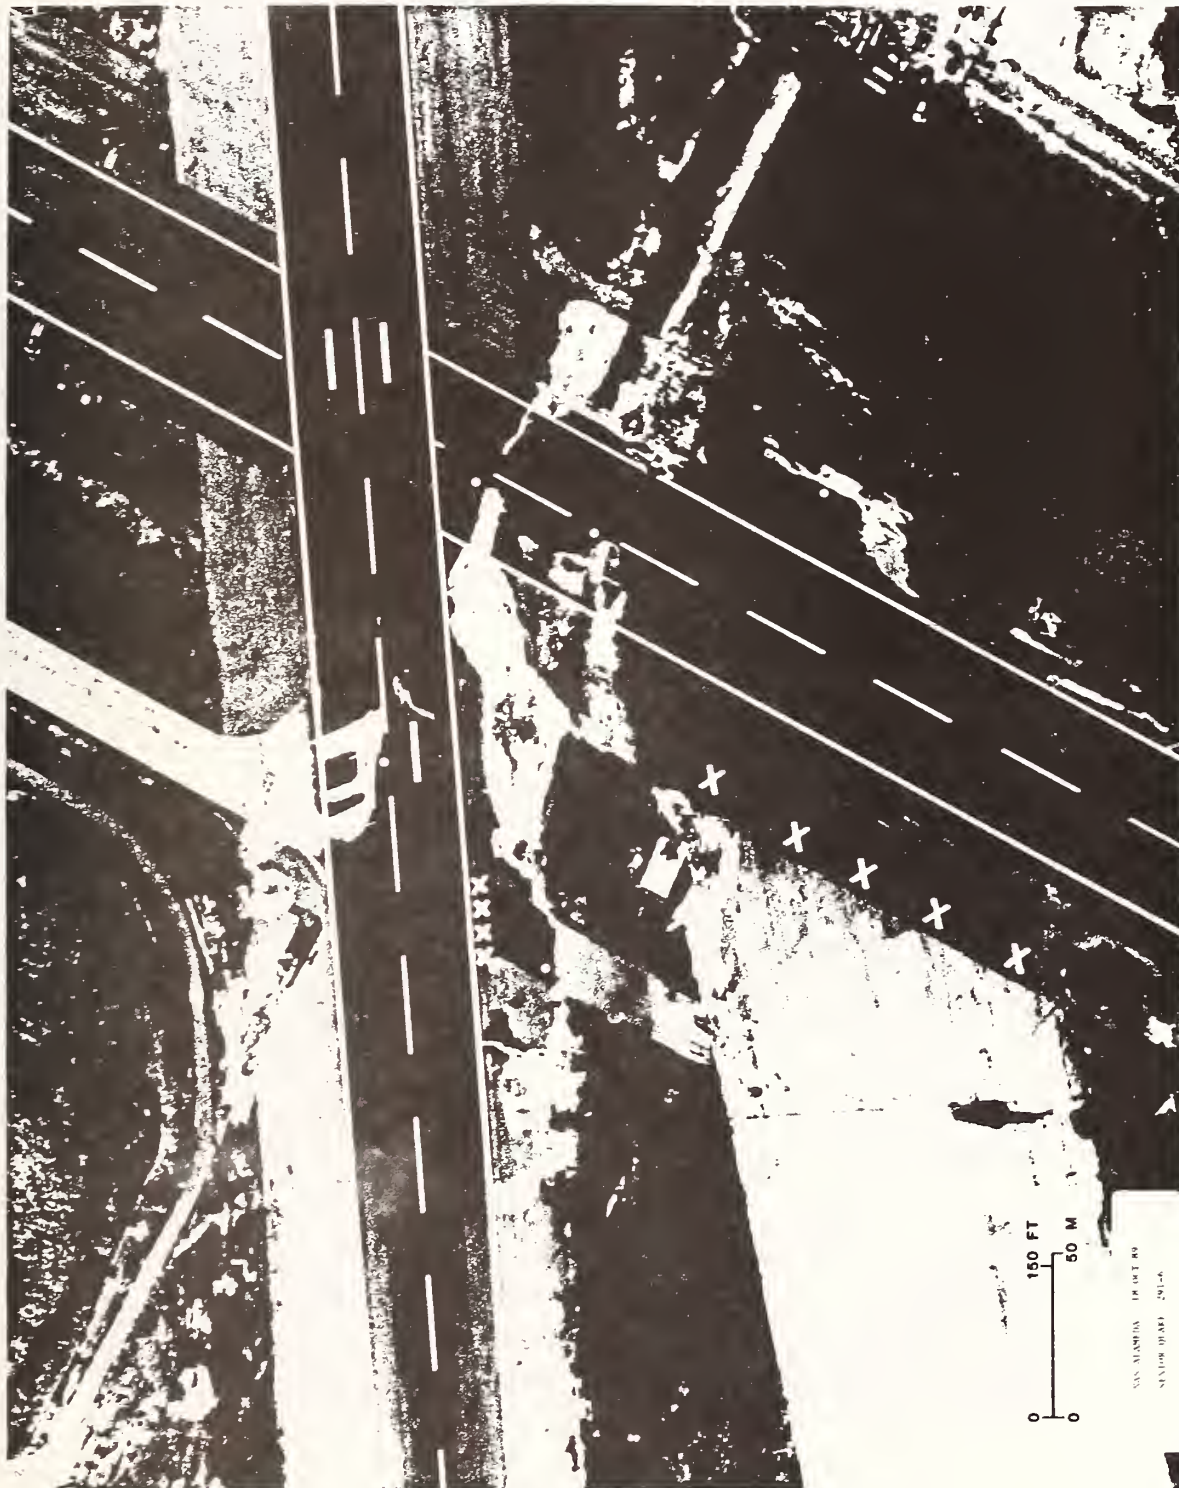
Figure 12. Large-scale soil liquefaction in fill materials at the Alameda Naval Air Station.

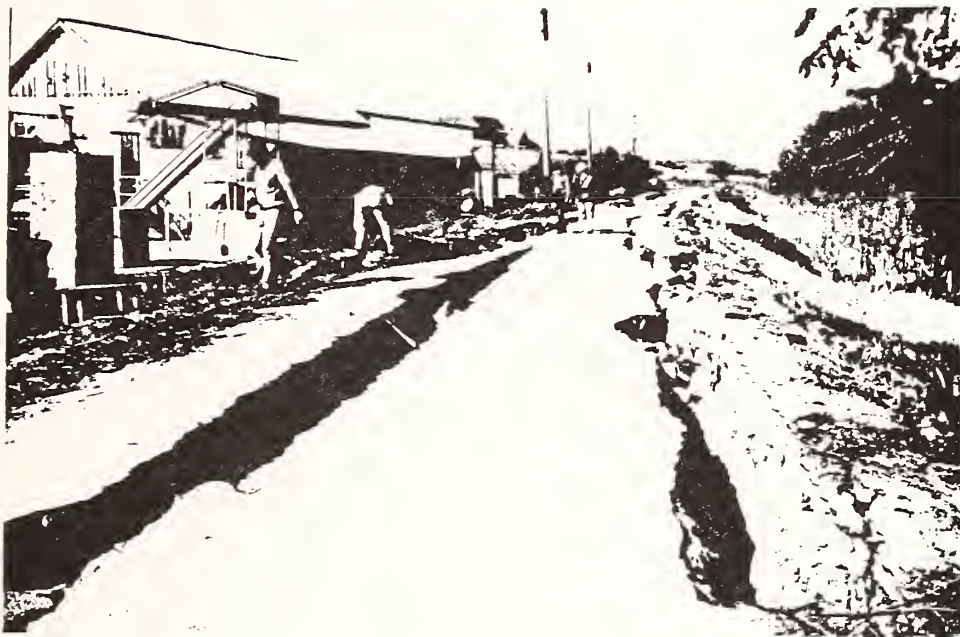
Figure 15. Liquefaction-induced fissures in levee of the Pajaro River, near Watsonville. The fissures were deeper than the height of the levee.

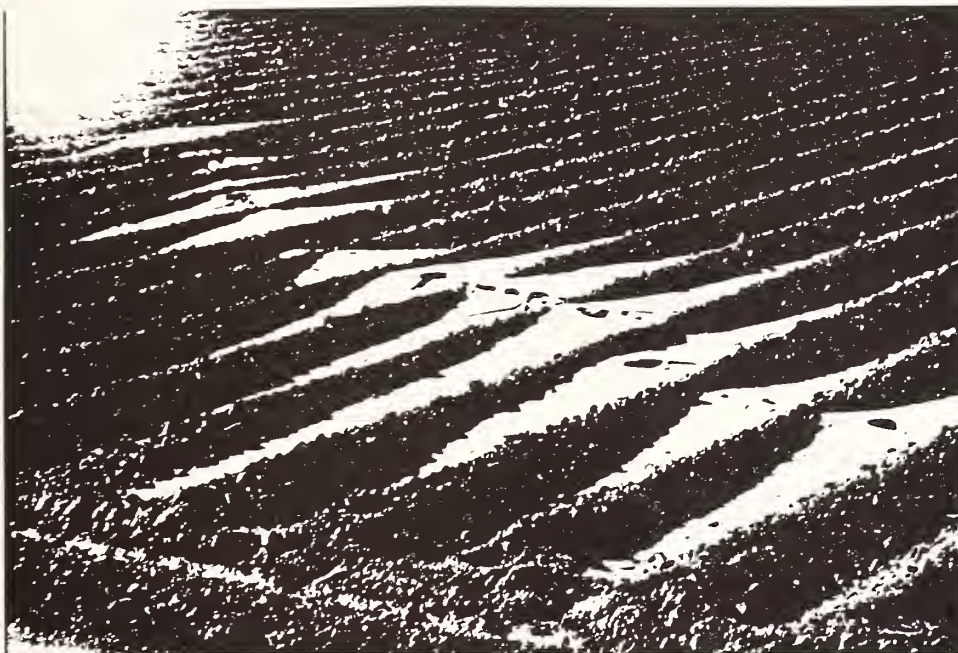
Figure 16. Liquefaction in a field adjacent to the Pajaro River levee near Watsonville. Sand extruded from a linear ground break, with multiple vent holes.

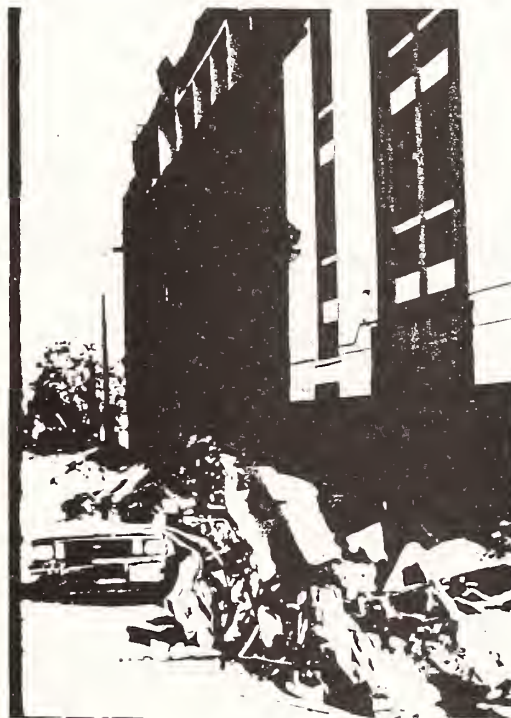
Fig. 4. Cars Crushed by Fallen Masonry,
Mission District, San Francisco

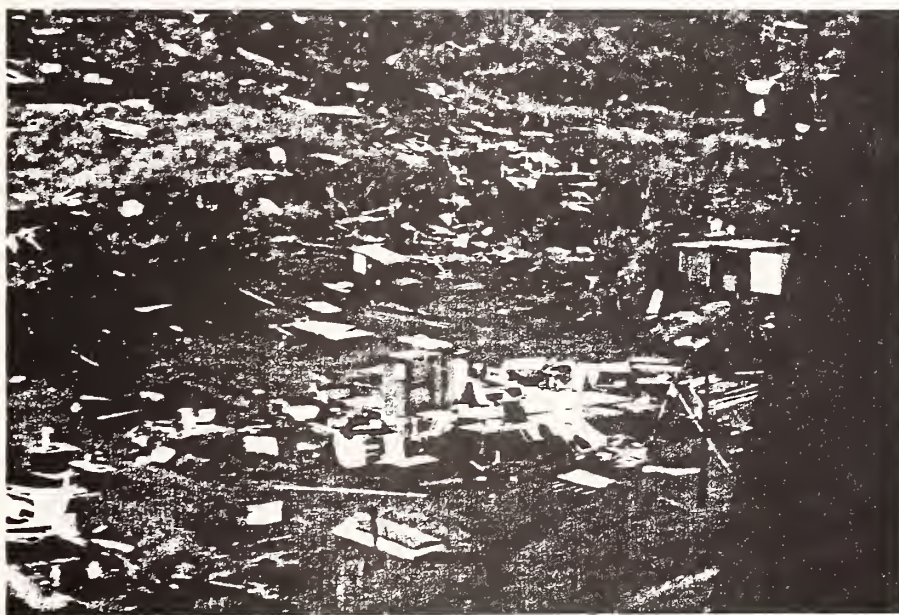
Figure 7. Housing damage near Culebra airport

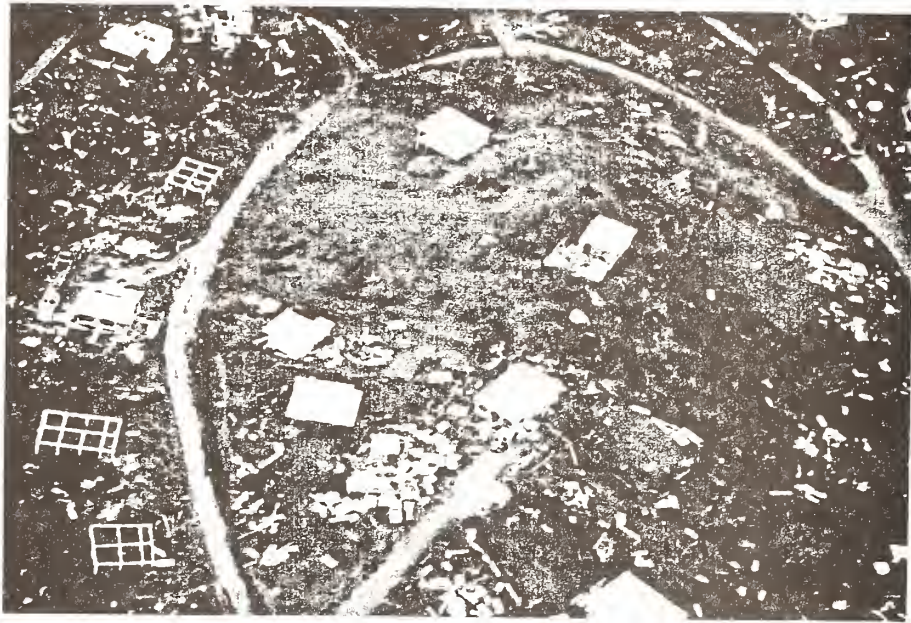
Figure 8. Housing damage on Vieques

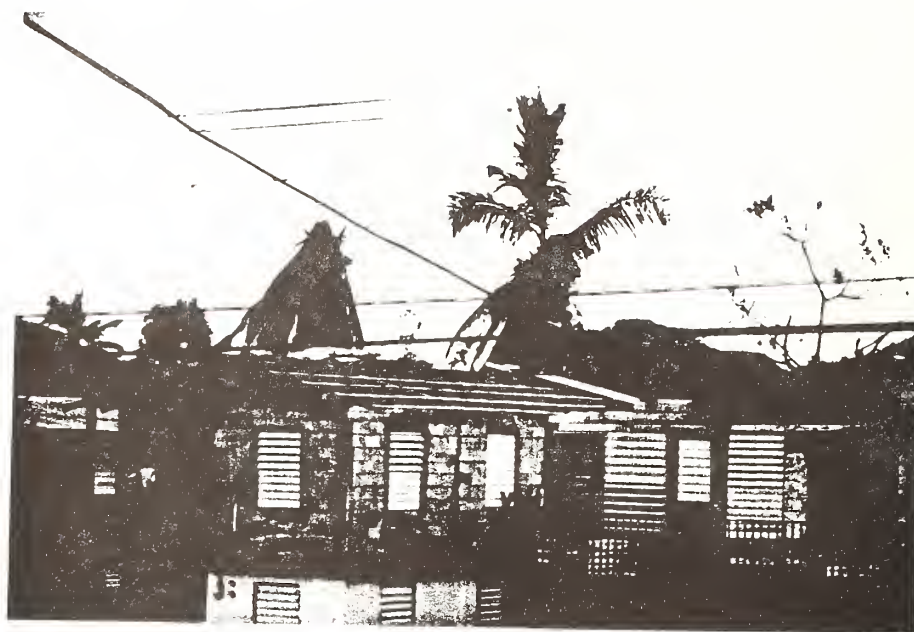
Figure 12. Failed corrugated steel sheet roofing, Puerto Rico

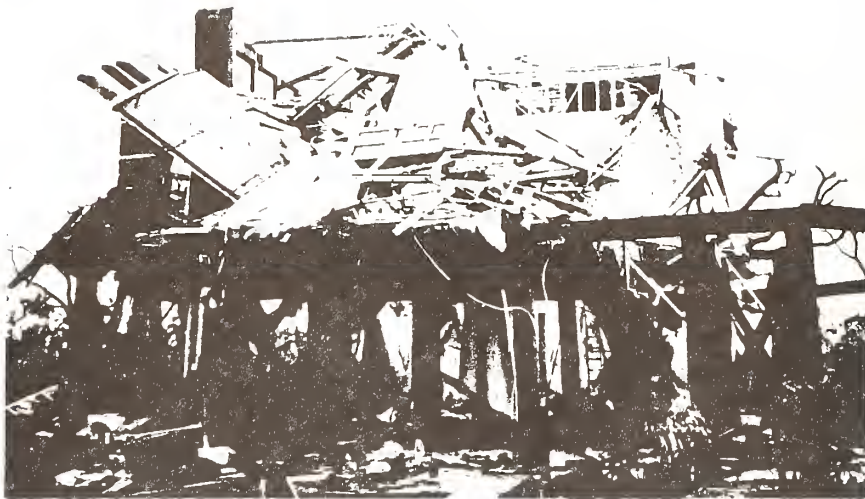
Figure 2. Heavily Damaged House, Bull Bay.

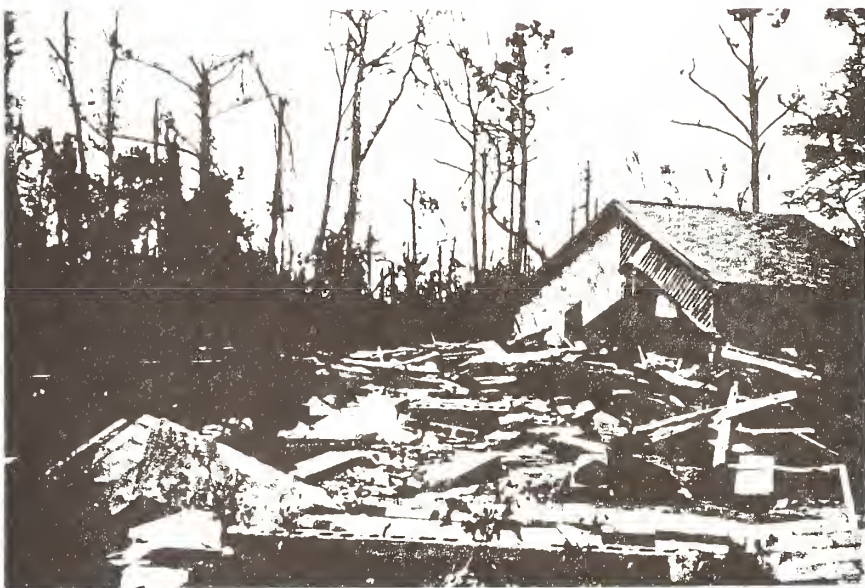
Figure 3. Shear Failure of House, Bull Bay.

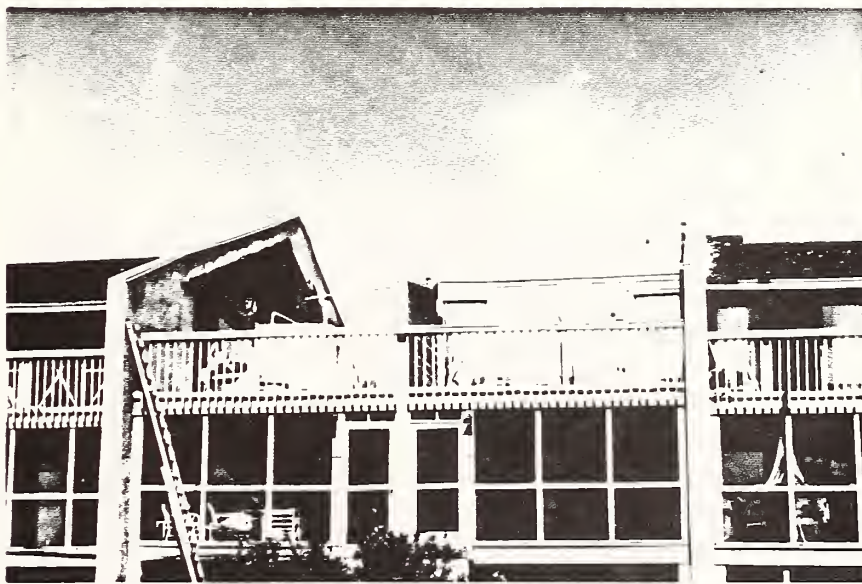
Figure 5. Condominium Roof Failure, Isle of Palms.

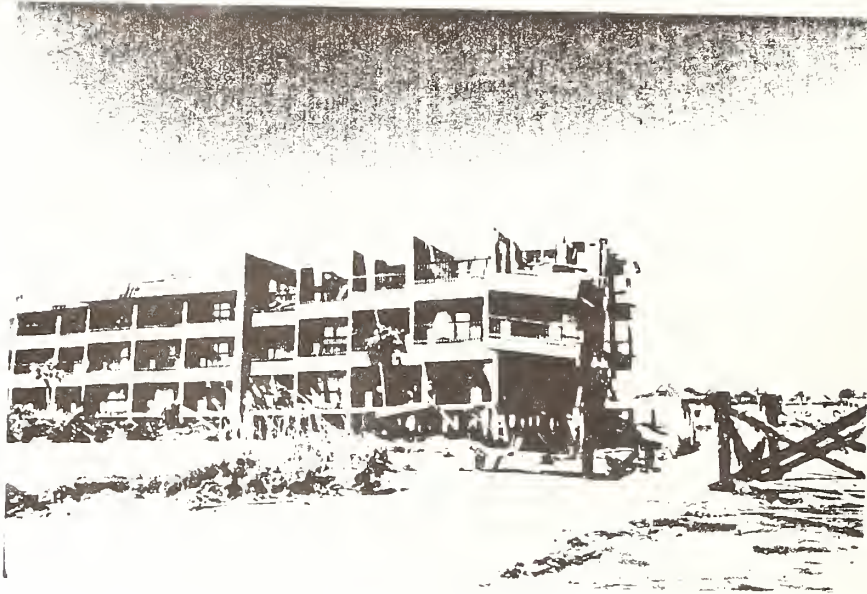
Figure 6. Wind and Surge Damage to Condominium, Isle of Palms.

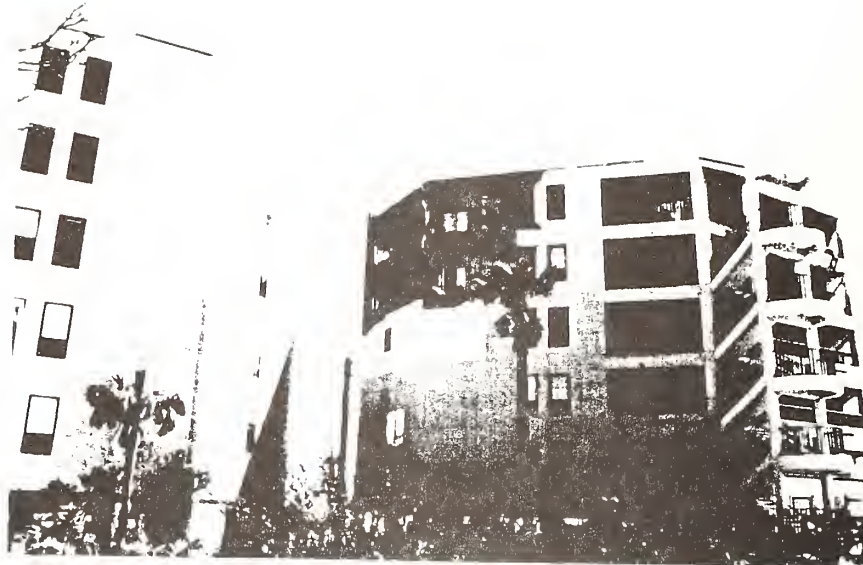
Figure 10. Typical Cladding Failure, Isle of Palms.
