NIST Special Publication 996

On the Fractographic Analysis of Machining Cracks in Ground Ceramics:

A Case Study on Silicon Nitride

George D. Quinn
Lewis K. Ives
Said Jahanmir

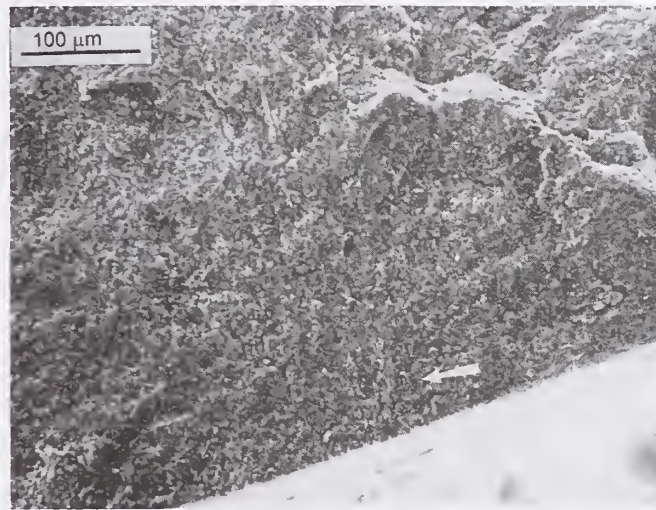
Figure 14 Material flaw fracture origin in a 320 grit longitudinally ground rod with a strength of 763 MPa. The origin is a porous region beneath the ground surface.

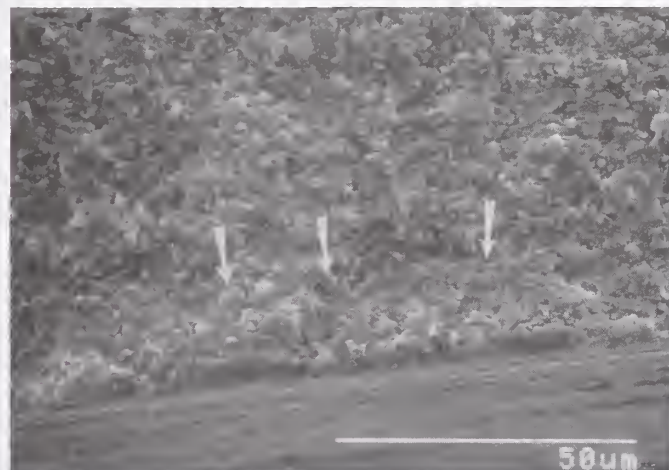
Figure 16 Coplanar parallel machining crack in a 320 grit transversely ground rod (641 MPa). (b) shows the fracture mirror region centered on a parallel machining crack. (c) shows a close-up of the origin which also shows evidence of stable extension. The critical crack size, which is more obvious in (b), is marked in (c) by arrows.

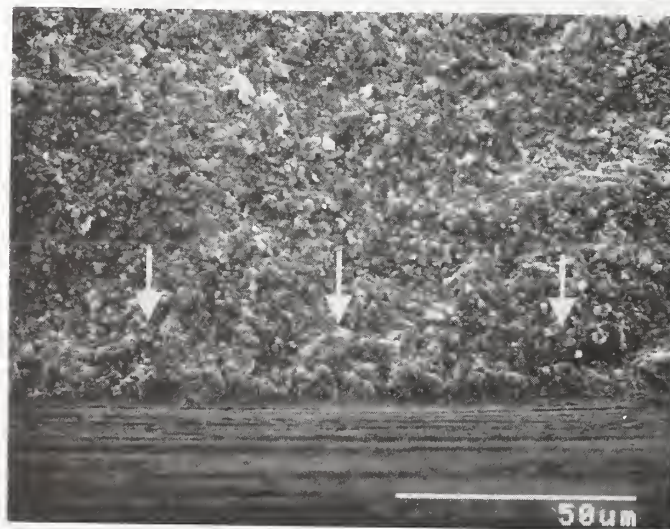
Figure 19 Parallel 25 μm deep machining crack in a 220 grit transversely ground rod (566 MPa nominal, 557 MPa at origin center). (c) is a composite of two SEM photos of the origin crack.

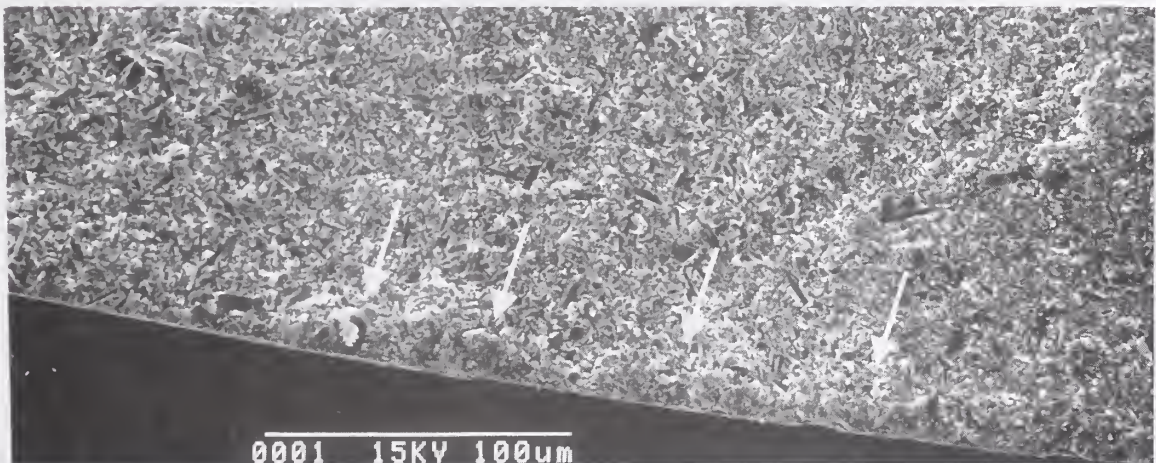
Figure 20 A parallel machining crack in a Shop F, coarse-grit (150/180), transversely ground rod with a strength of 409 MPa. The crack has a slight zigzag appearance and can be considered one form of a “zipper crack.”

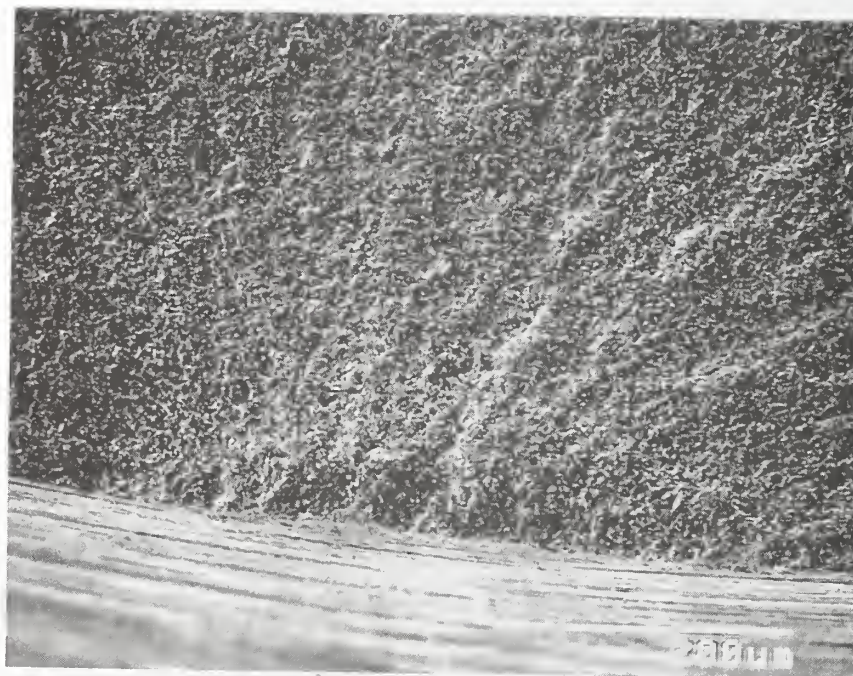
Figure 21 Classic “V” machining crack in a transversely ground rod (421 MPa). The arrows in (d) show the offset parallel machining cracks that are on several tiers as schematically shown in (b). (e) is an SEM image of the origin and the ground surface. (f) is an optical image that shows the ground outer surface at the origin site. The striations are not quite perpendicular to the specimen axis.

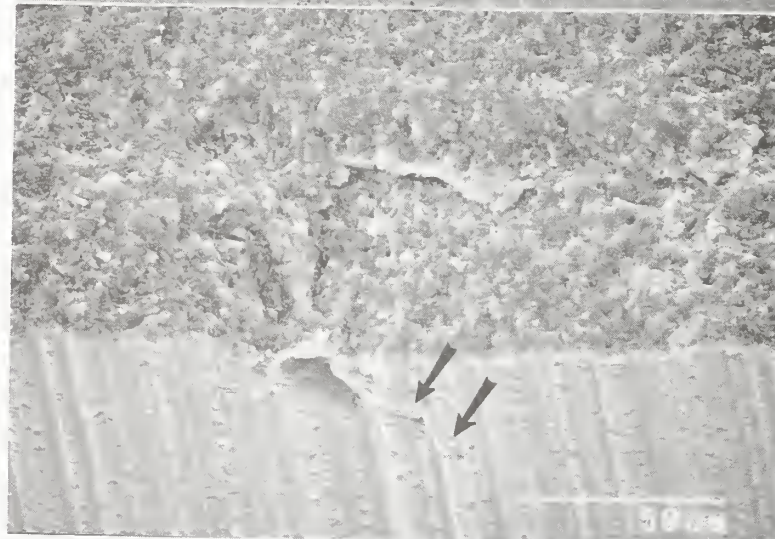
Figure 29 Agglomerate/pore type flaw detected in a 320 grit longitudinally ground Shop C bar. These flaws were almost always located at or near the surface of the bars and may have been altered or enlarged by orthogonal crack machining damage (535 MPa).

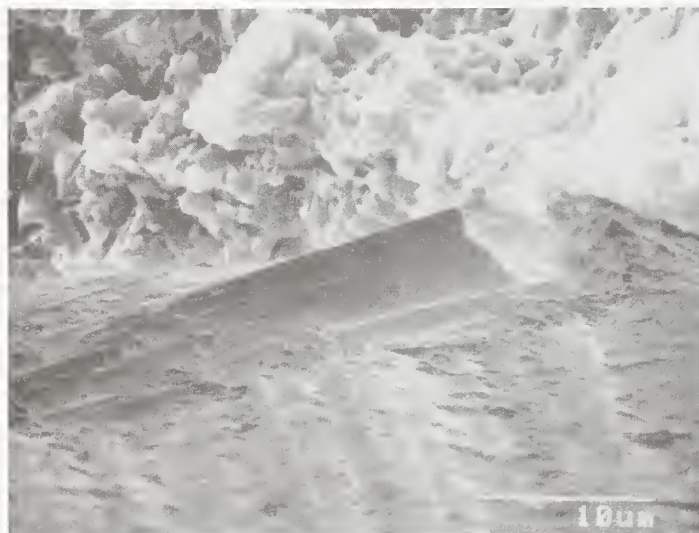
Figure 31 Optical photos of “Zipper machining cracks” in Shop C 320 grit transversely ground bars. The machining cracks are obvious even at these low magnifications. (a) shows both halves mounted back to back of the next to weakest bar in the set, 487 MPa. (b) is a schematic with close up, and (c) shows a 561 MPa strong specimen with 40 μm deep machining crack ($K_{Ic} = 5.64 \text{ MPa}\sqrt{\text{m}}$). Notice how the steps between the offset parallel cracks and the machining crack hackle that extend upward into the fracture surface are accentuated by the low angle incident lighting coming from the left side in (a) and the right side in (c). The machining crack hackle lines are tilted on either side of the origin. They form when fracture expands outward from middle of the row of machining cracks.

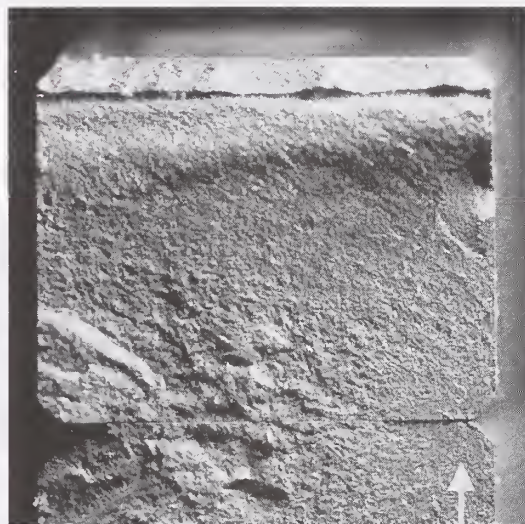
Figure 46 Fracture origin in an Eaton RBSN specimen transversely ground with 80 grit wheel. (a) and (b) show that the origin is a small damage cluster near the chamfer. (c) is the same region, but illuminated differently to highlight the 40 μm – 65 μm diameter agglomerates from the spray dry process that comprise this material. The machining damage zone is confined to one layer of these agglomerates.

The RBSN machining damage zones were relatively easy to detect, but their size and shape were controlled by the microstructure of the material as shown in **Figure 46**. This low strength (≈ 150 MPa) pressure-less sintered material is composed of densely packed spherical particles, $40\text{ }\mu\text{m} - 60\text{ }\mu\text{m}$ in diameter that are the vestiges of spray dry particles. The machining damage zone was only $35\text{ }\mu\text{m} - 50\text{ }\mu\text{m}$ deep and was confined to one layer deep of these agglomerates. Hence, this weak, low fracture toughness material is nonetheless effective in arresting machining cracks, much like a refractory firebrick is effective in arresting cracks.
