# NBS TECHNICAL NOTE 1134

## Guidelines for the Installation of Solar Components on Low-Sloped Roofs

Guidelines were prepared for the installation of solar collectors and related equipment on low-sloped roofs of commercial and industrial type buildings. The guidelines are concerned primarily with the waterproofing integrity of the roofing system, access to the collectors and roofing, attachment of different types of collector support frames, and safety. Technical information from the literature, building codes, roofing field surveys and acceptable roofing practice provided the basis for the guidelines. The guidelines include recommendations for the design of the solar installation with regard to roofing performance, workmanship during collector installation, and maintenance of roofs with solar components.

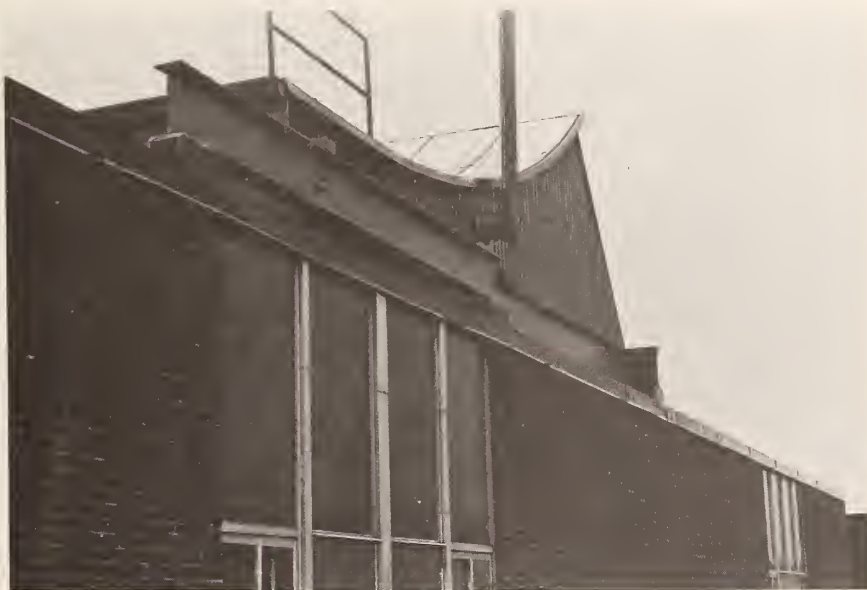
Figure C.6 Large Wooden Reflector Frame Supported by Exterior Walls and Columns of the Building

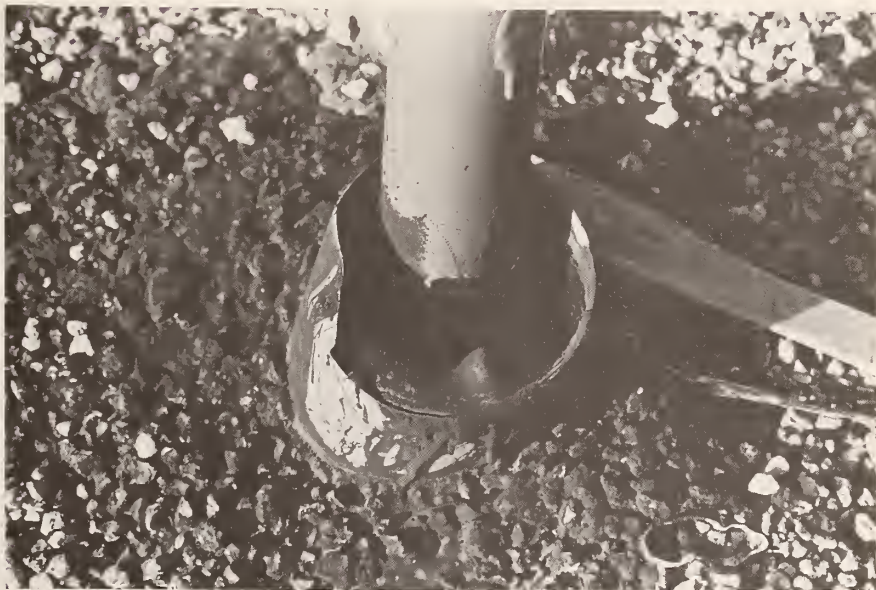
Figure C.10 Collector Support Column in a Tilted Pitch Pocket

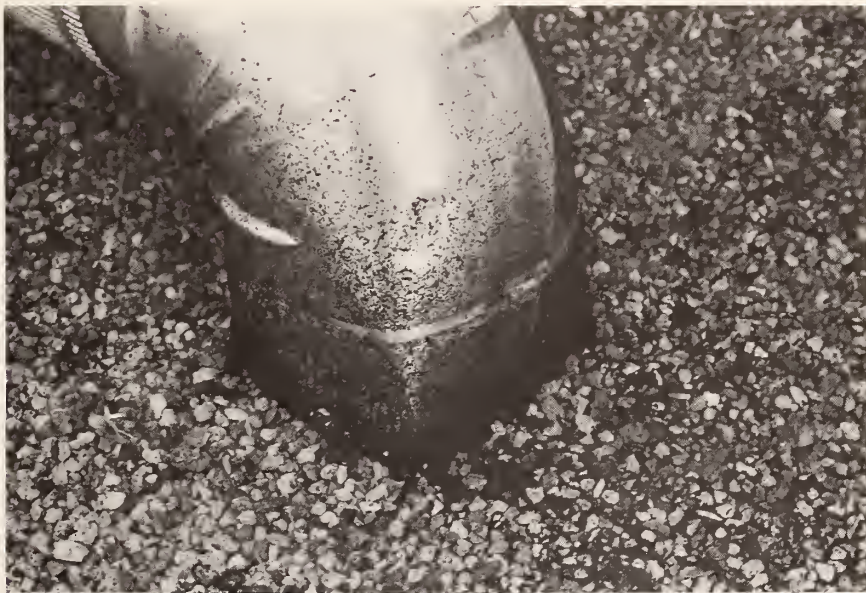
Figure C.14 Pipe Penetration for Which The Type of Flashing was Not Determined

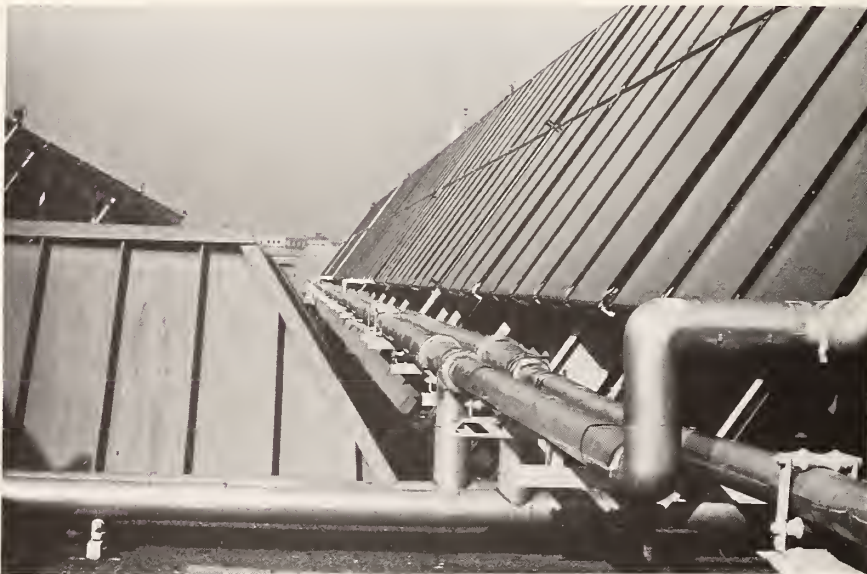
Figure C.20 Inadequate Clearance Between Front of Collector Array and a Mansard Style Roof Projection

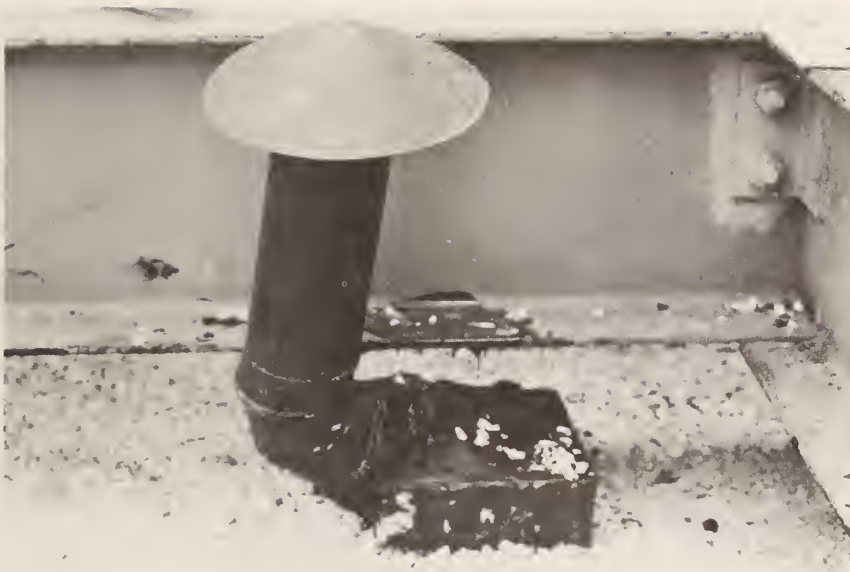
Figure C.21 Vent Pipe Modified to Allow for  
Solar Collector Installation

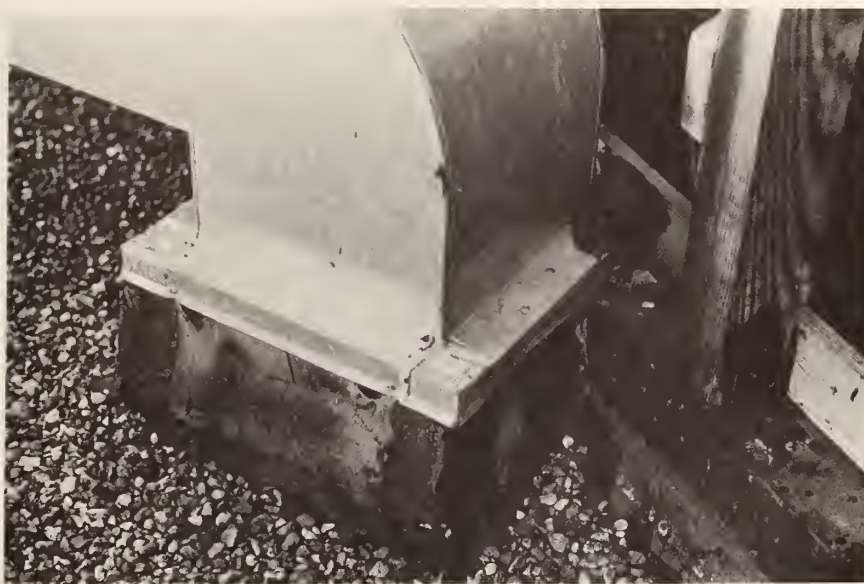
Figure 22. Modification of a Curb Supporting a Ventilator

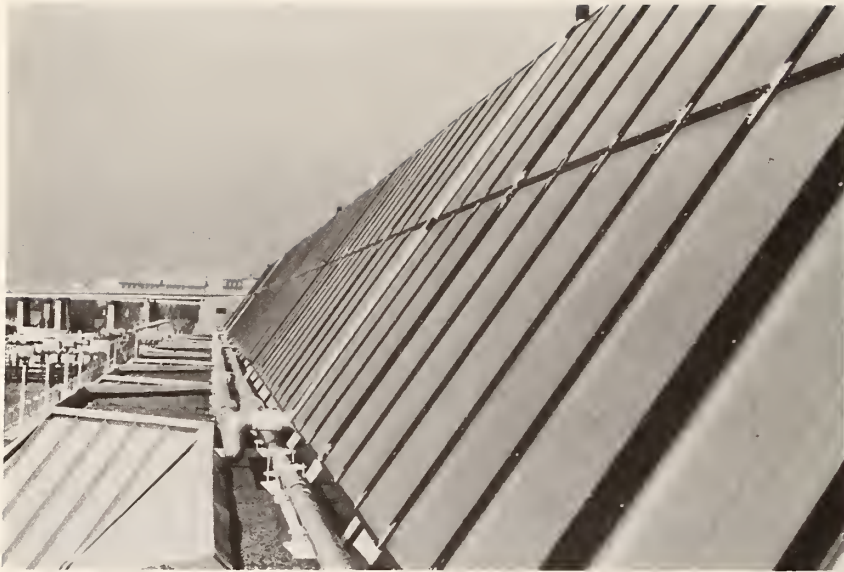
Figure C.27 Collector Array Installed Near Roof Edge
