NBS TECHNICAL NOTE **1196**

U.S. DEPARTMENT OF COMMERCE/National Bureau of Standards

NBS Solar Collector Durability/Reliability Test Program: Final Report

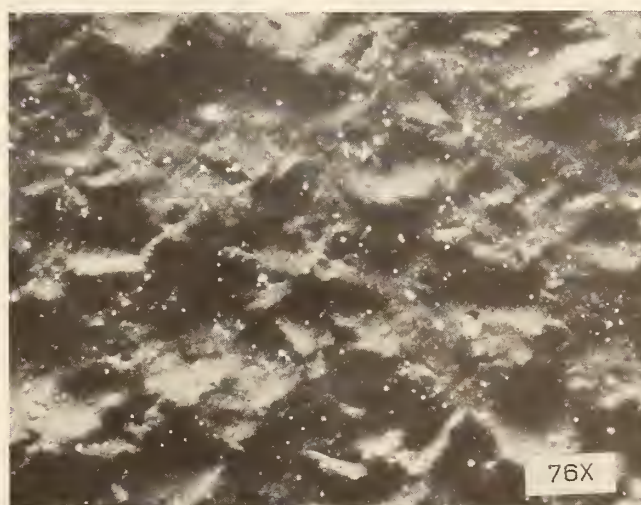
Figure 3.2.2 Corrosion of absorber material D sample from a full-size collector after 480 exposure days ($\geq 17,000$ kJ/sq-m-day)

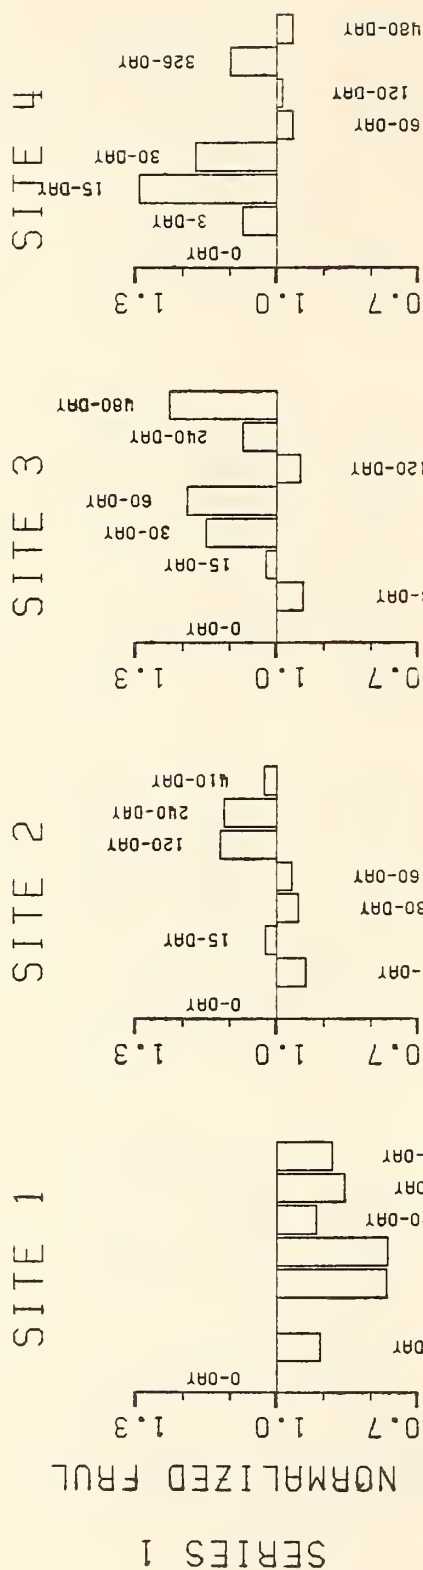
Figure 4.2.16. Collector D normalized F_{UL} vs retests, series 1 & 2, all test sites
