NIST Technical Note 1542

Propagation and Detection of Radio Signals Before, During, and After the Implosion of a Large Convention Center

Electromagnetics Division
National Institute of Standards and Technology
325 Broadway
Boulder, CO 80305

June 2006

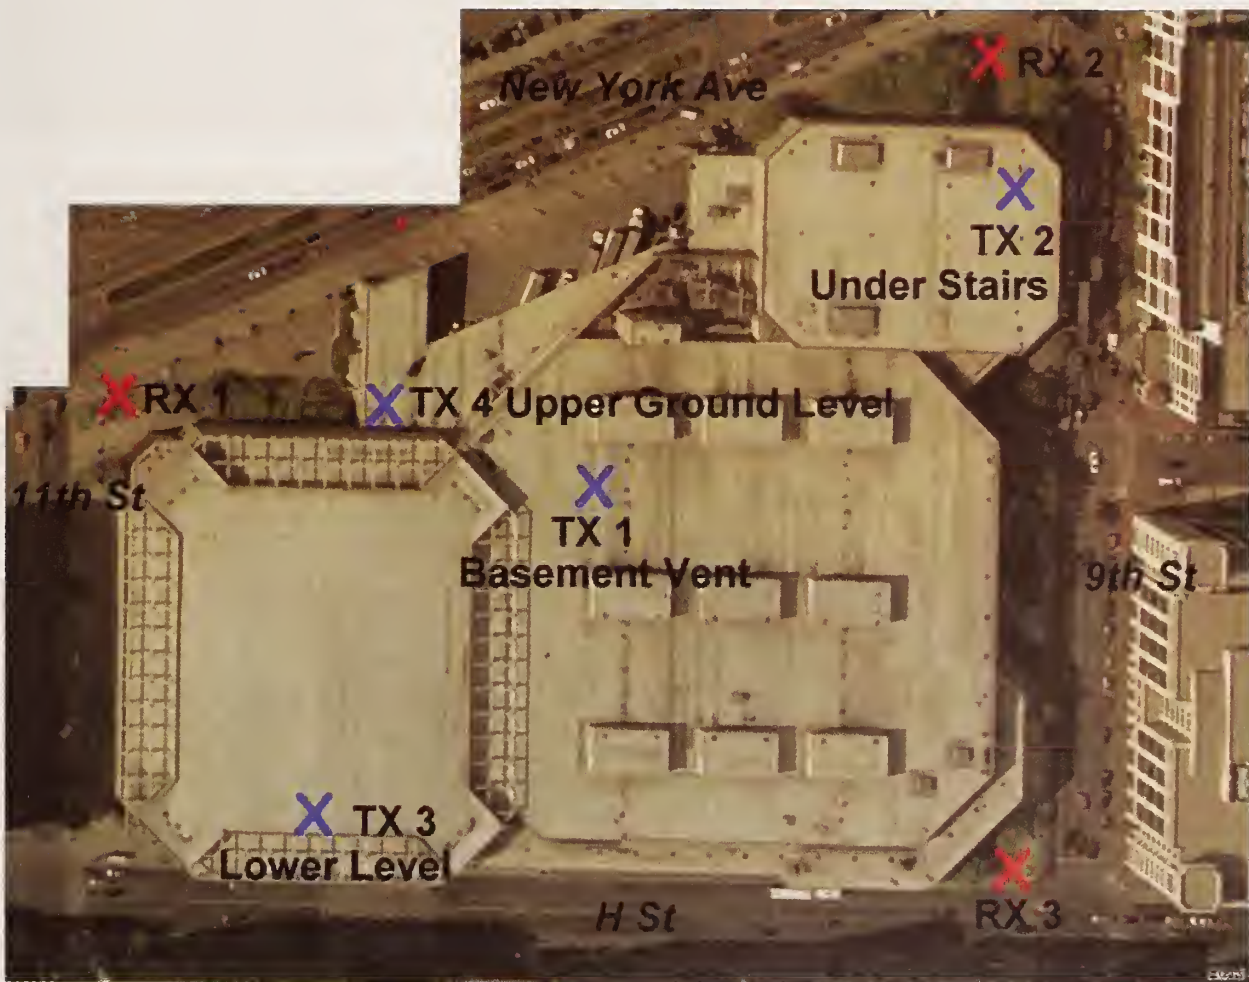
Figure 1. Overhead view of Washington DC Convention Center.
(Image courtesy of the United States Geological Survey)

For the radio mapping experiments, three fixed receiving sites (as described above in Section 5) were assembled on the perimeter of the convention center (see Figure 1 and Figures 13-15). Receiving site RX 1 was placed approximate 23 m (75 ft) from the northwest perimeter of the convention center (Figure 13). Receiving site RX 2 was placed approximate 23 m (75 ft) from the northeast perimeter of the convention center (Figure 14). Receiving site RX 3 was placed approximate 15 m (50 ft) from the southeast perimeter of the convention center (Figure 15). The measurement equipment at each of these sites was placed in custom-made plywood containers wrapped in plastic for protection from the weather and the implosion (see, Figures 13-15). During this experiment, the transmitters were carried throughout the convention center and the received signal levels were recorded. Measurements were performed with the receiving antennas polarized in the vertical direction (with respect to the ground). As the received signal was recorded, the locations of the transmitters in the convention center were also recorded.

For the second data set, radios were placed at four different fixed locations in the convention center where they would have a high likelihood of surviving the implosion. These four sites are labeled as “TX 1”, “TX 2”, “TX 3”, and “TX 4” in Figure 1. Received signals were collected before, during, and after the implosion. These receiving sites are the same locations as described above. After a careful analysis of the building, the following four sites were chosen: (1) in a circular vent pipe near the center of the lower level of the convention center (site TX 1: see Figure 16); (2) in a control room in the northeast corner on the lower level of the convention center (site TX 2, see Figure 17); (3) on the ground level near the west end of the south side in an office area of the convention center (site TX 3, see Figure 18); and (4) in another control room on an intermediate level in the north west corner of the convention center (site TX 4, see Figure 19).

using the receiving equipment mounted on the mobile cart. The cart was pulled around the perimeter of the convention center in a clockwise direction. In these measurements, we started the cart at the intersection of New York Ave. and 9th St (see Figure 1), headed south on 9th St, right onto H St, headed west on H St, right on 11th St, headed north on 11th St, right on New York Ave, then returning to 9th St. The received power for each frequency and the GPS location of the cart were recorded at the maximum sample rate as the cart was moved. These data essentially show the azimuth radiation pattern of the building for each of the interior transmitter locations. One objective of these measurements is to get an indication of how directive are the signals emanating from the structure and are there possible benefits to be gained from moving the receiving system around the perimeter in search of stronger signals. We will see in the data that follow that there can be dramatic variation in the signal strength at different receive locations on the perimeter. This could possibly make a difference in a search and recovery operation, especially if the signals are very weak.

As we did in the New Orleans [5] and Philadelphia [7] implosion experiments, we maximized our chances of a useful outcome by simulating the best-case scenario of a metallic object running continuously from a radio to a receive site. To do this, we laid stranded steel cables from two of the transmit sites to the edge of what would be the debris pile after implosion. Using pre-placed cables meant that even if post-blast safety considerations kept us from getting close to the collapsed building, we could still acquire useful data. Two cables were run, one from Transmit site TX 2 and one from Transmit site TX 4, see Figures 1, 21, 22 and 133.

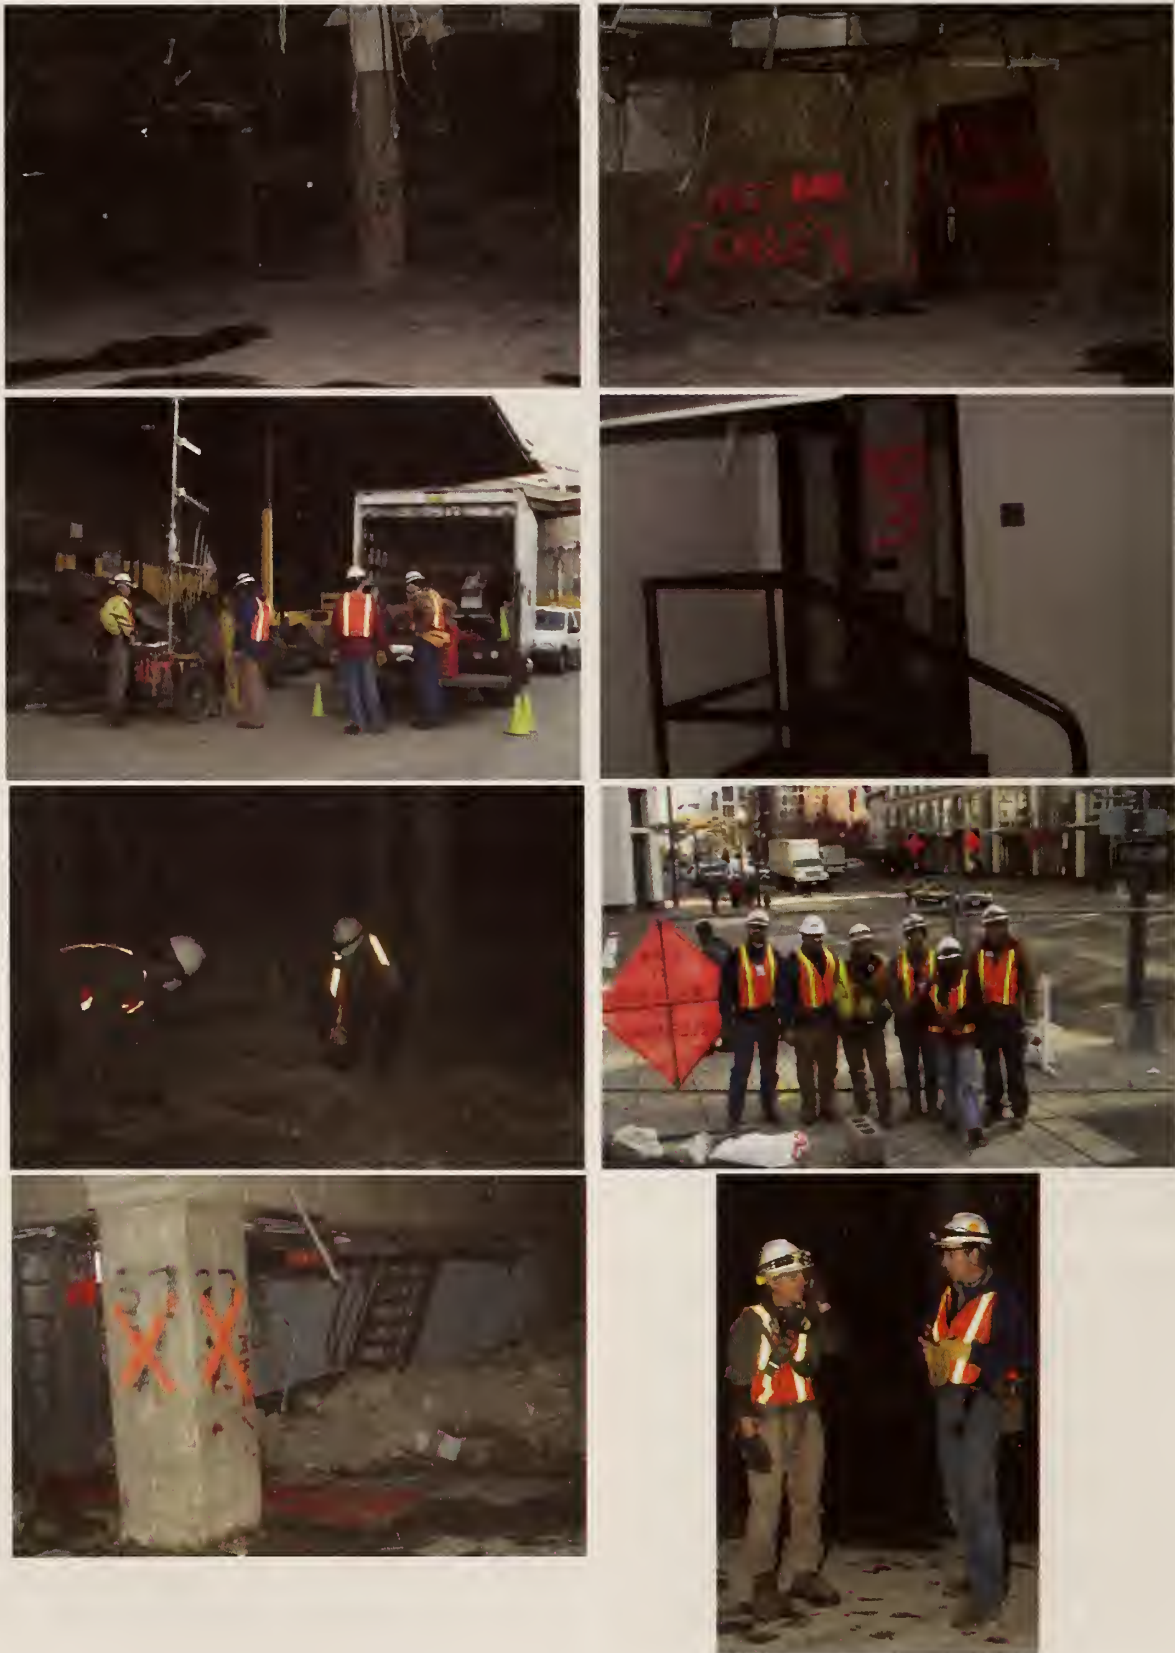
Figure 4. Pre-implosion preparation inside the convention center.

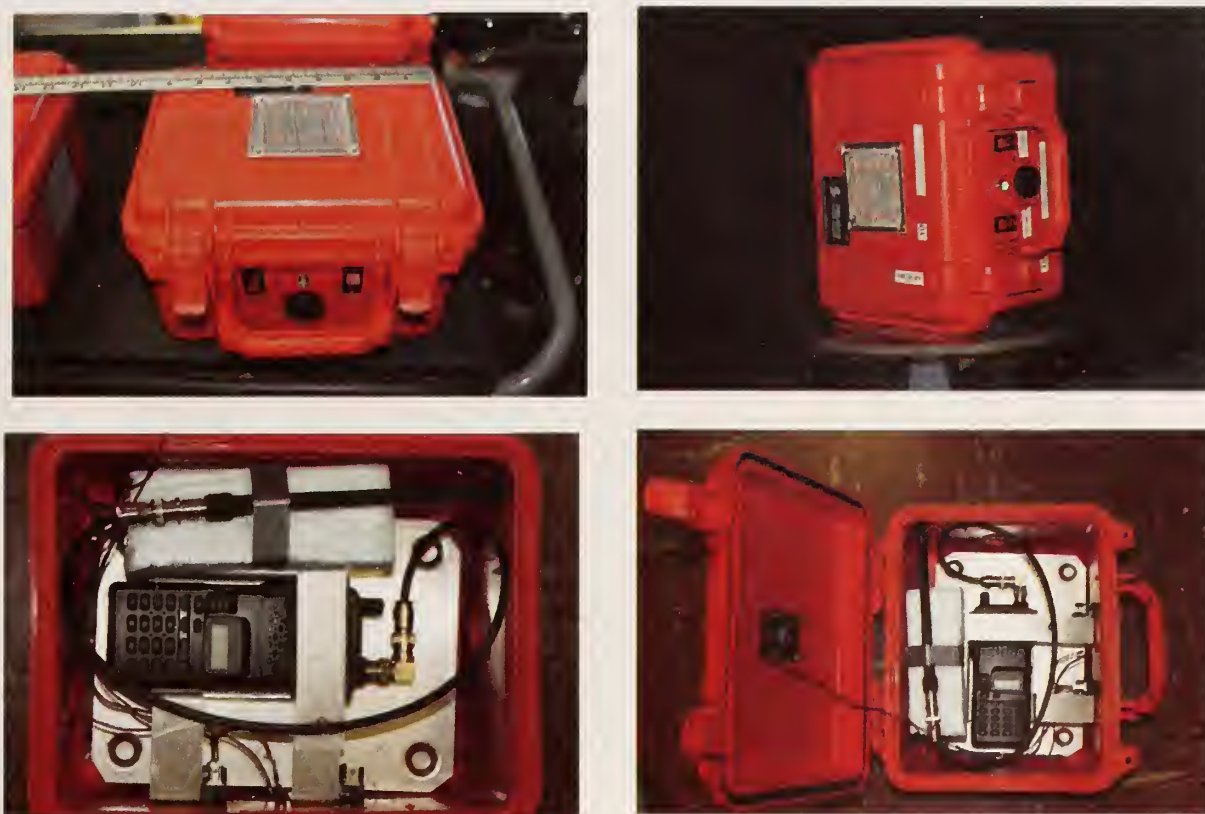
Figure 5. Typical transmitters used for the four lower frequency bands.

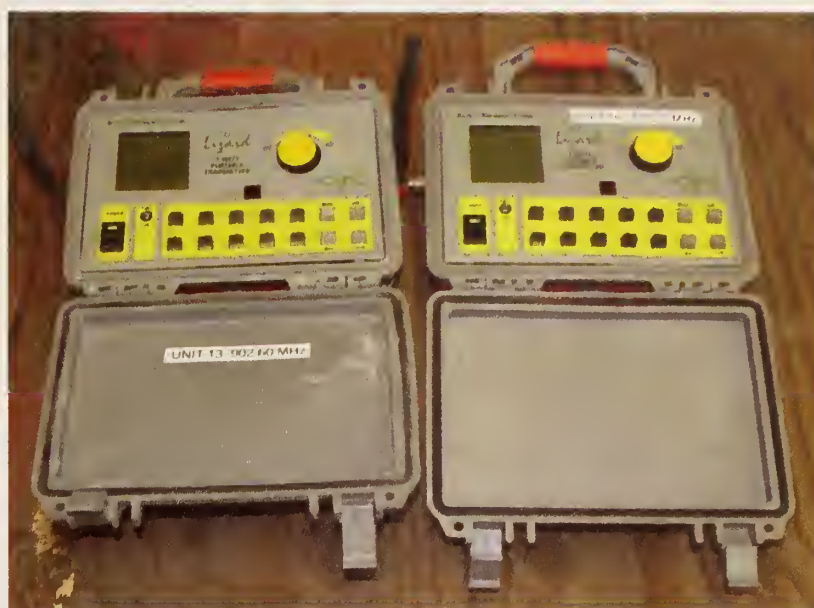
Figure 6. Transmitters used for the two higher frequency bands.

Commercial transmitters were available for the two higher frequency bands (900 and 1800 MHz). These off-the-shelf transmitters were already in plastic protective cases and could transmit continuously for 12 hours. Figure 6 shows these transmitters. Note that the cases for the higher-frequency transmitters were not orange, but grey.

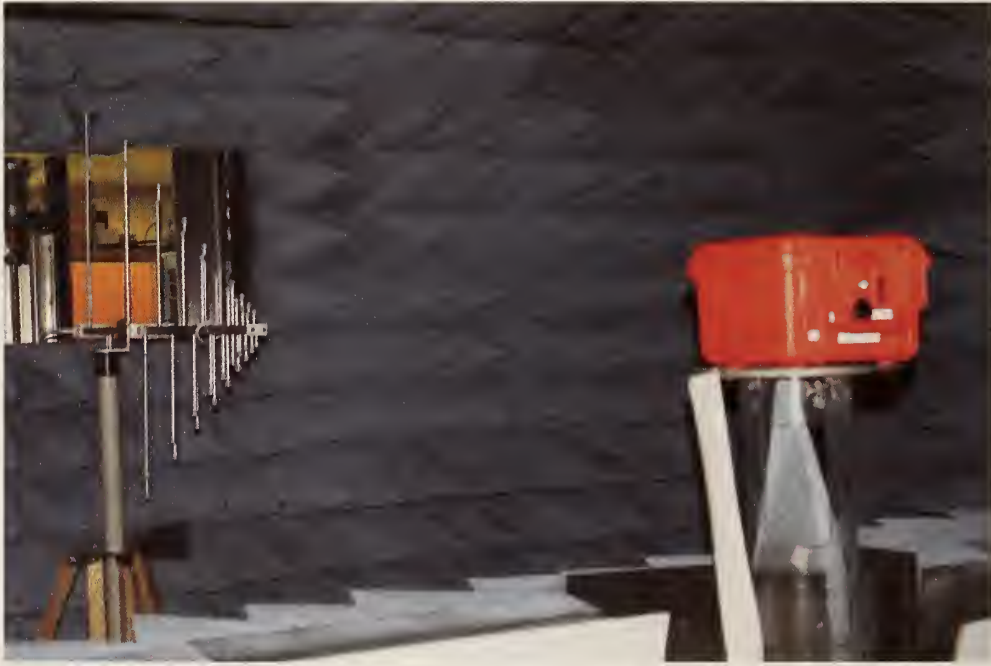
Figure 7. Transmitter in the NIST Boulder anechoic chamber.

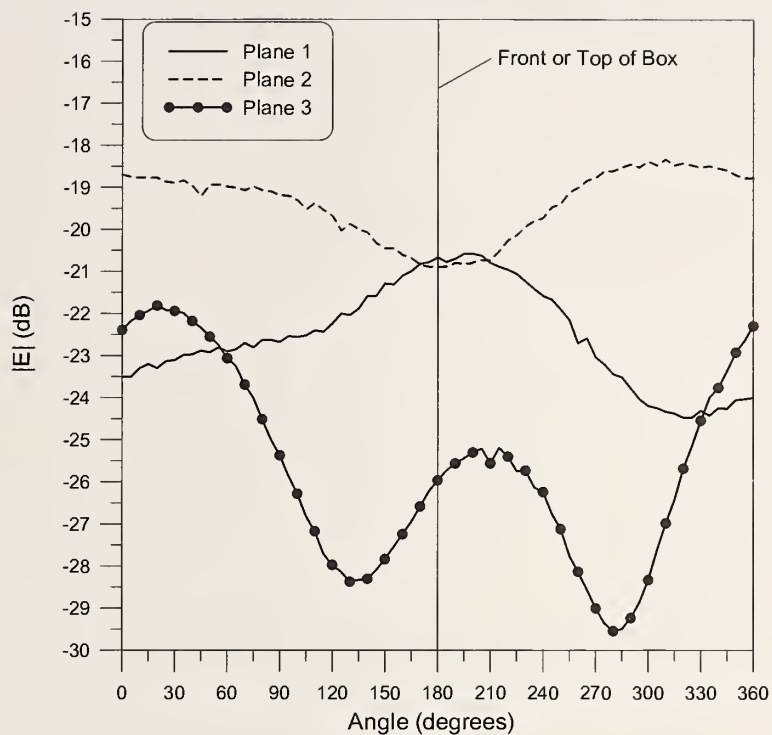
Figure 8. Radiation pattern of a 164 MHz transmitter in a protective case.

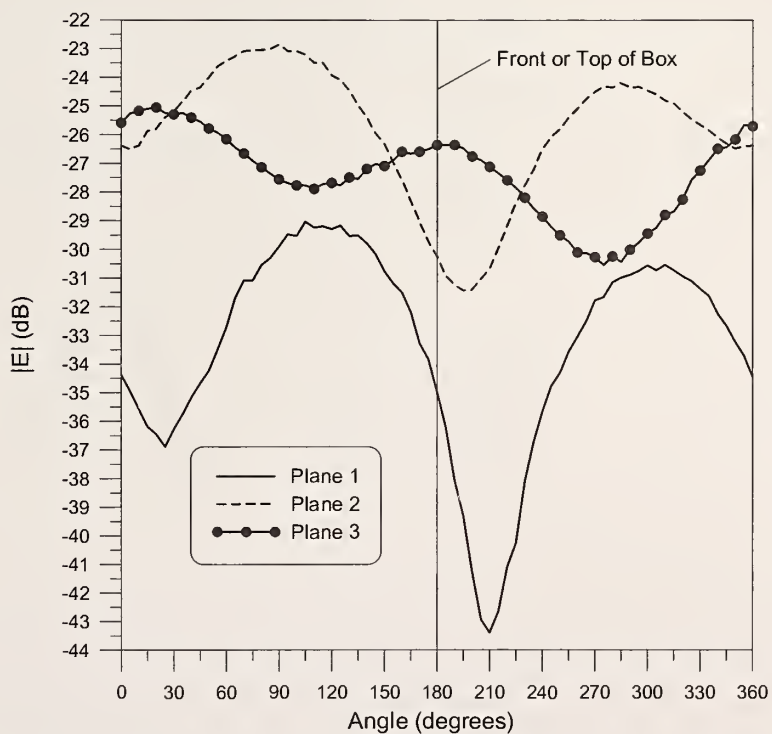
Figure 9. Radiation pattern of a 225 MHz transmitter in a protective case.

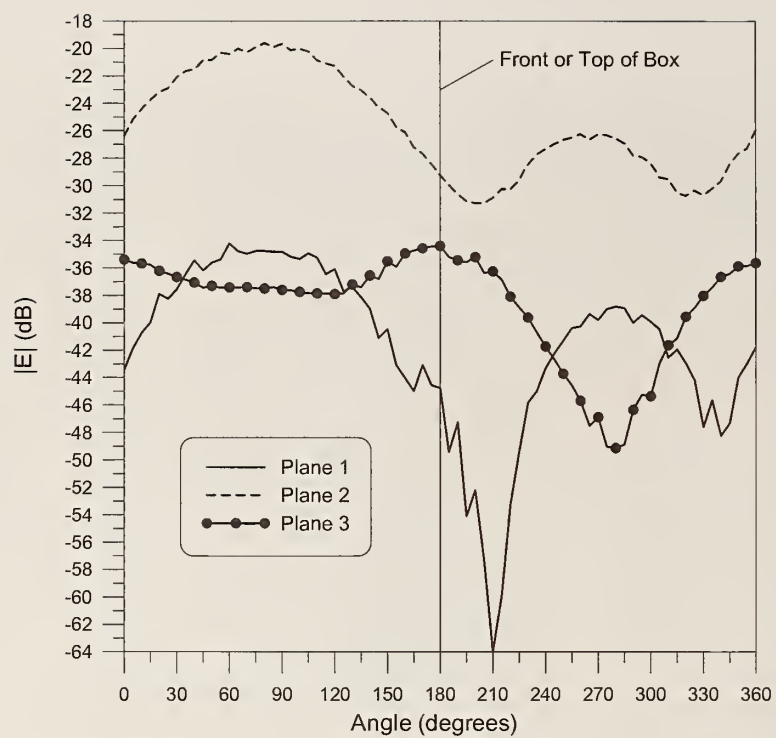
Figure 10. Radiation pattern of a 448 MHz transmitter in a protective case.

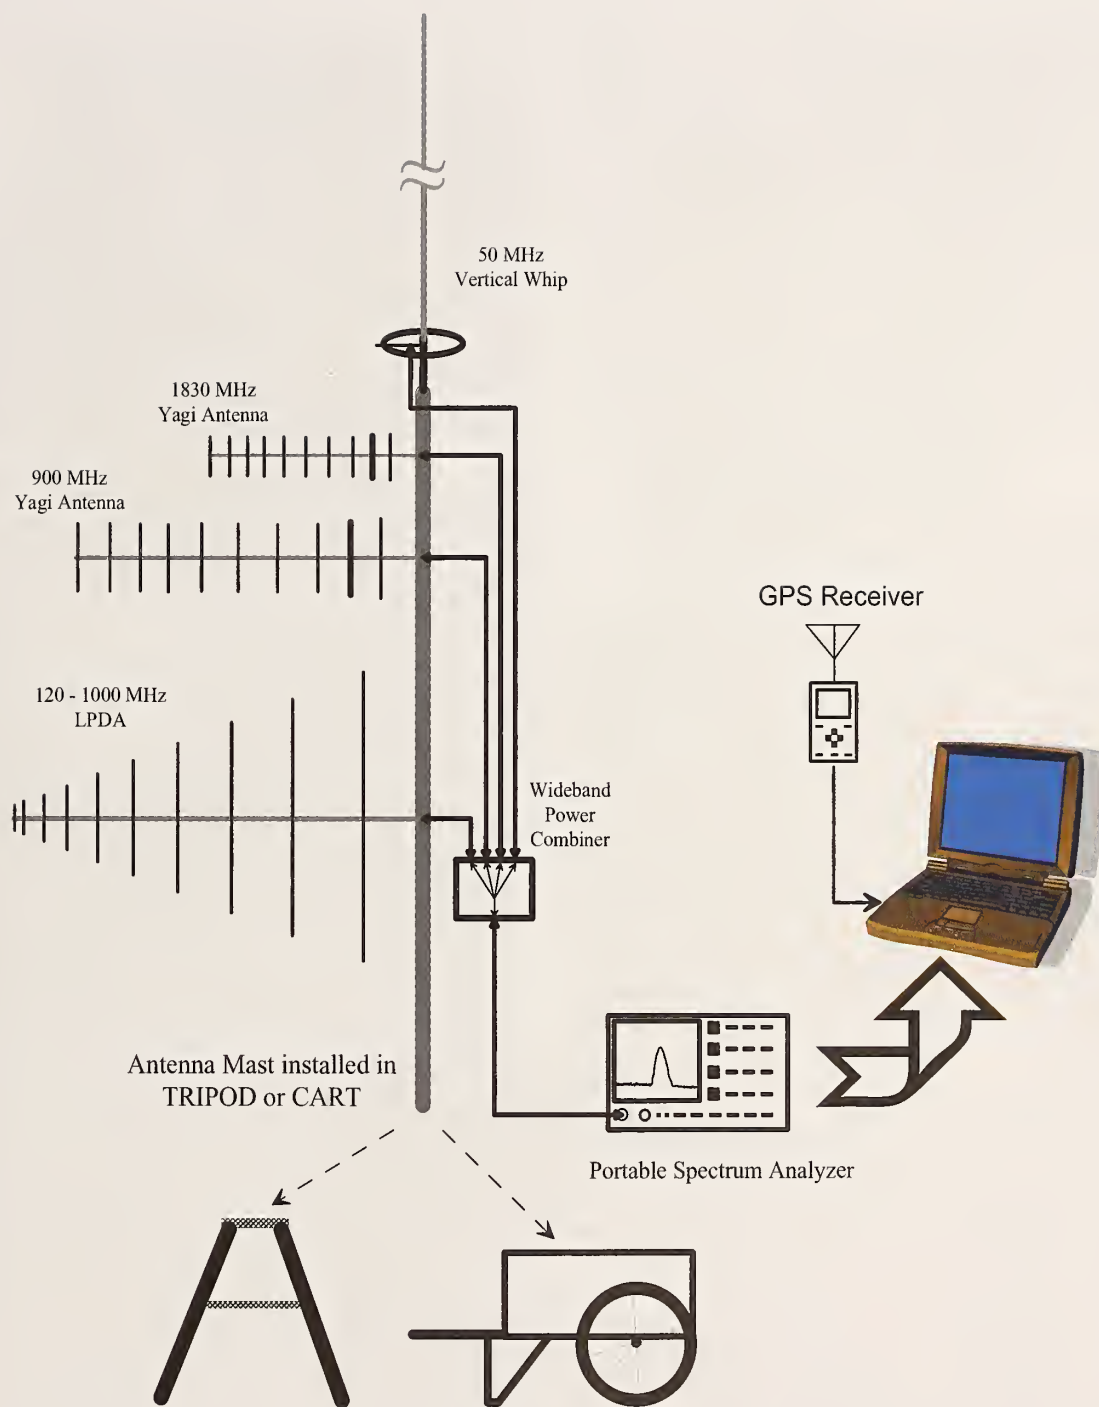
Figure 11. Schematic of the receiving system for the building penetration and field-mapping experiments.

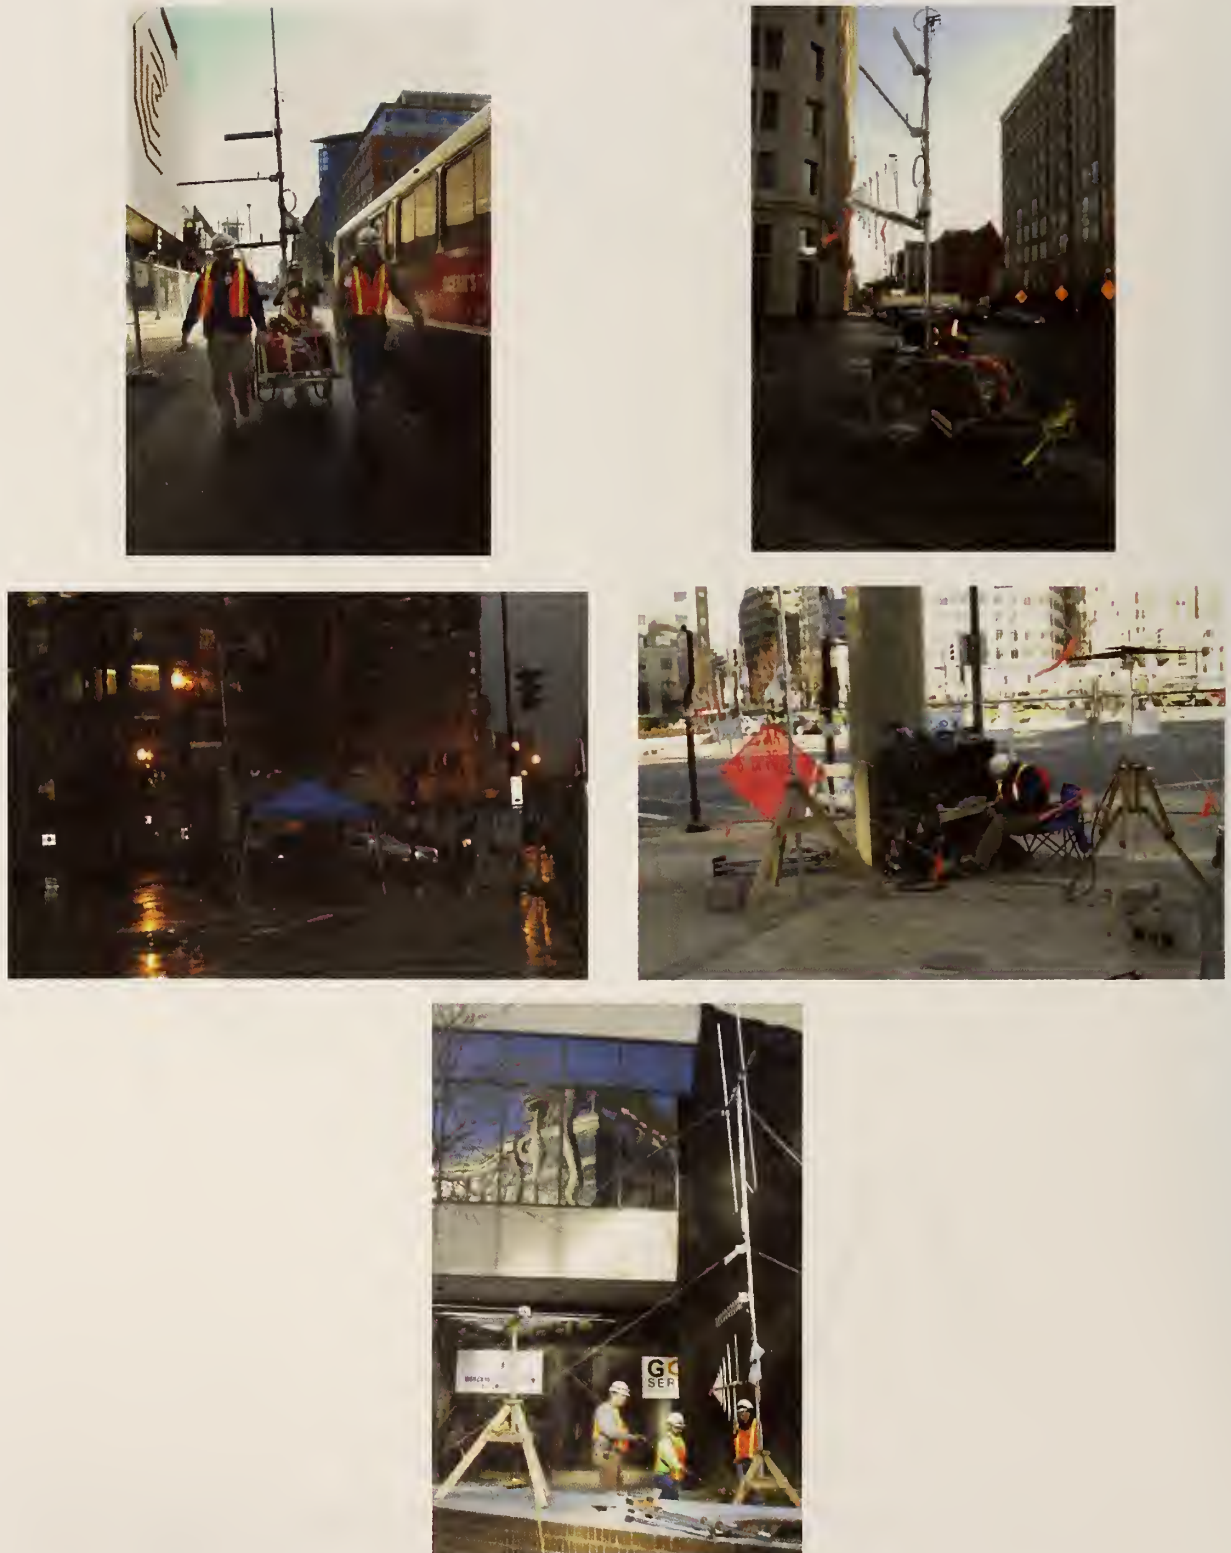
Figure 12. Photos of the antenna system mounted on a tripod and mounted to the mobile cart. The receiving instruments are protected inside the container near the tripod and inside the cart assembly when portable.

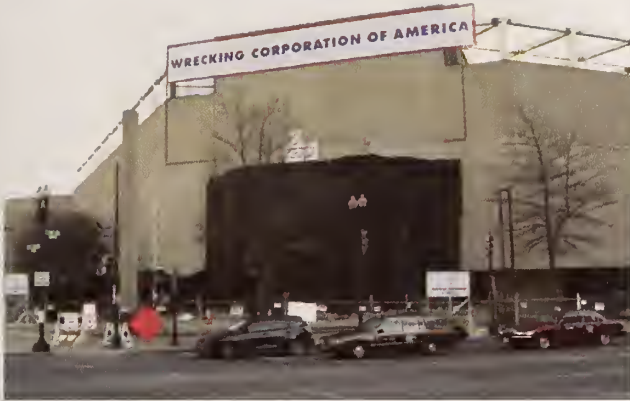
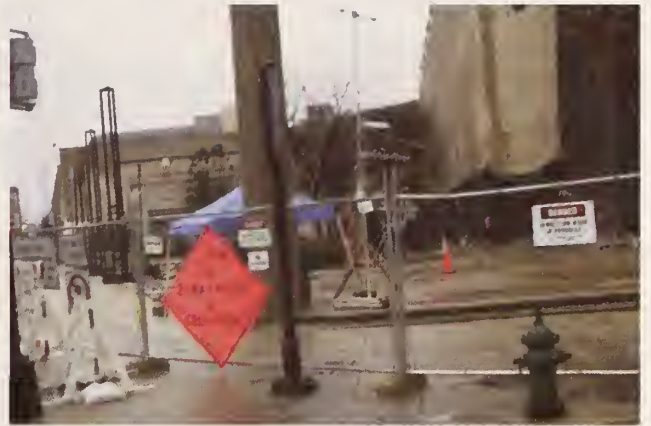
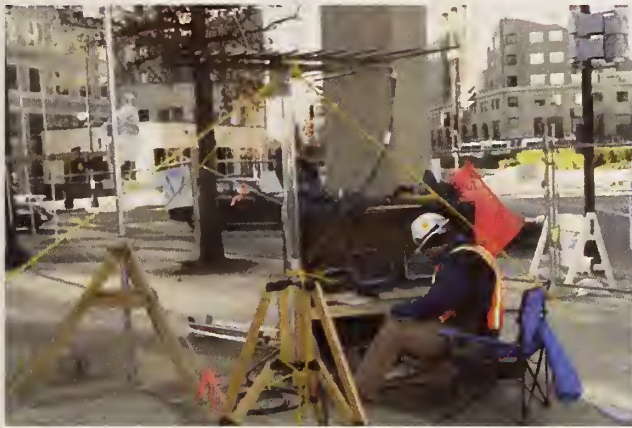
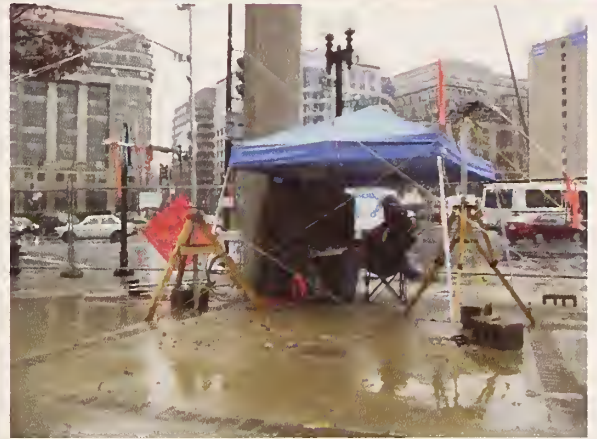
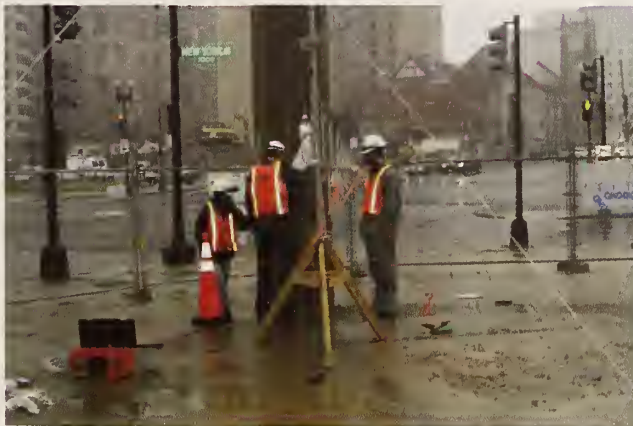
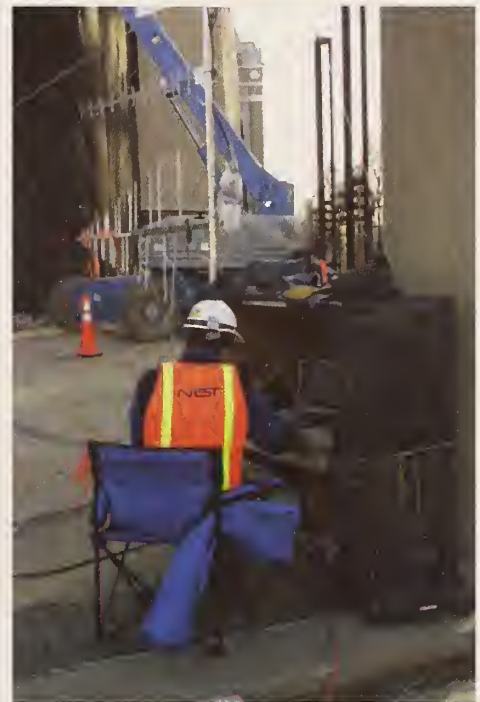
Figure 13. Fixed receiving site RX 1: northwest site. This site was used for both the radio mapping experiments (staffed) and for the implosion experiments (unstaffed).

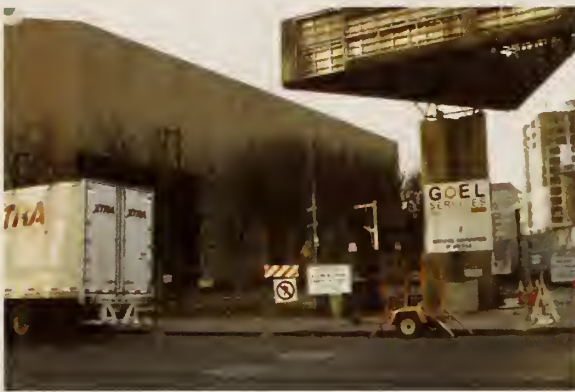
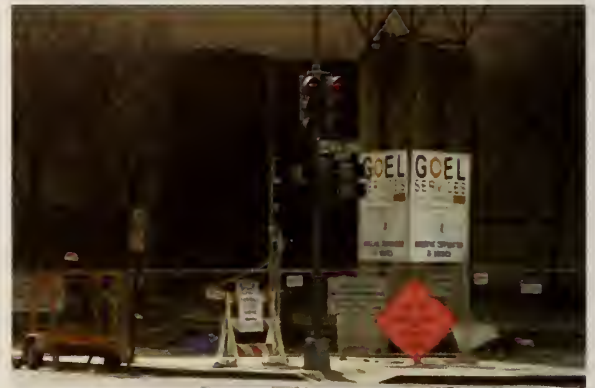
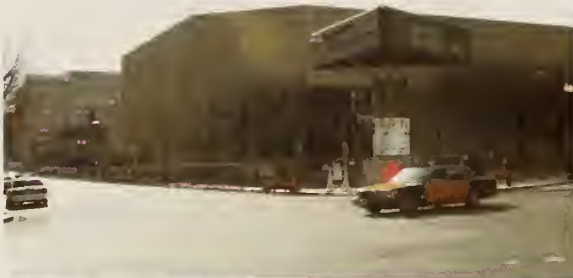
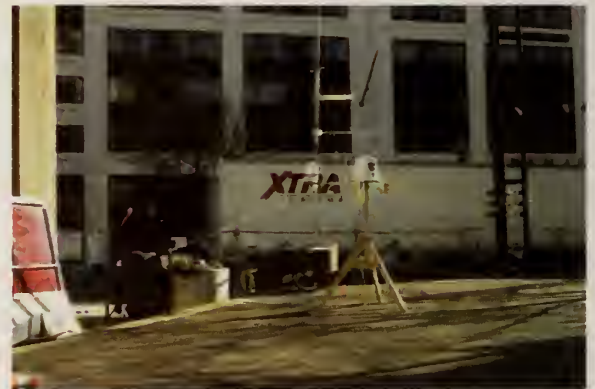
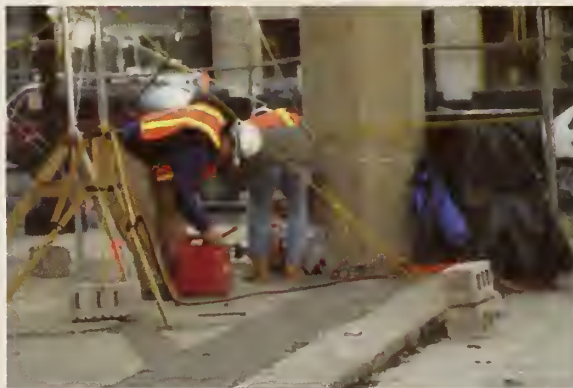
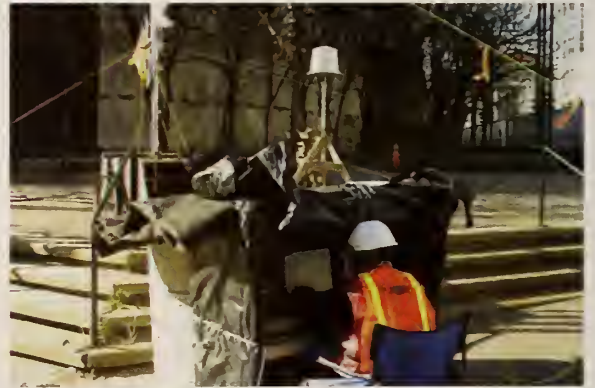
Figure 14. Fixed receiving site RX 2: northeast site. This site was used for both the radio mapping experiments (staffed) and for the implosion experiments (unstaffed).

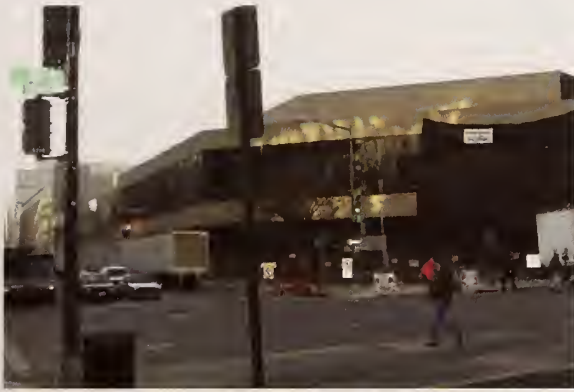
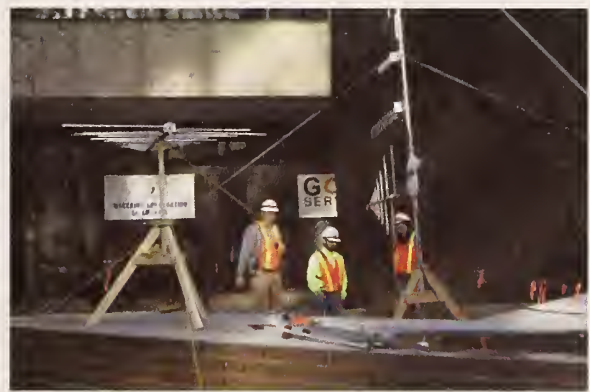
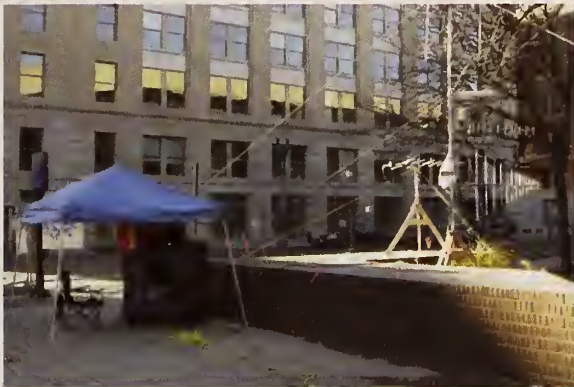
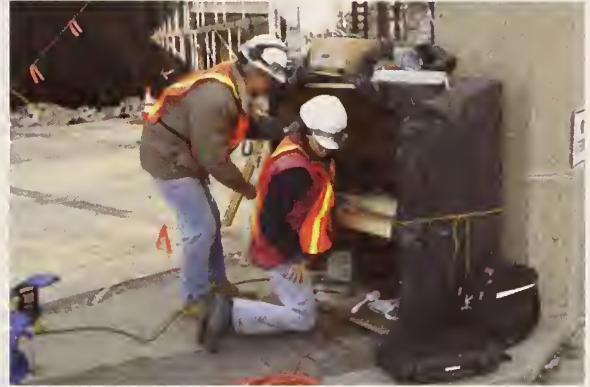
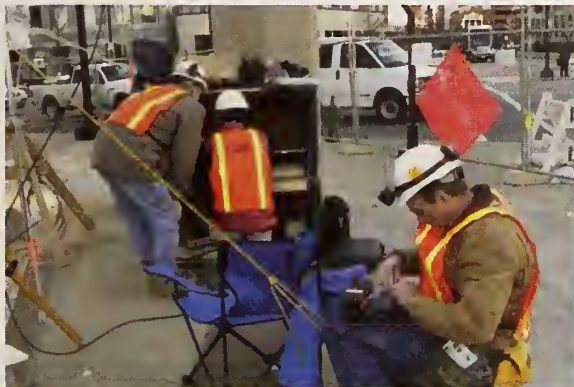
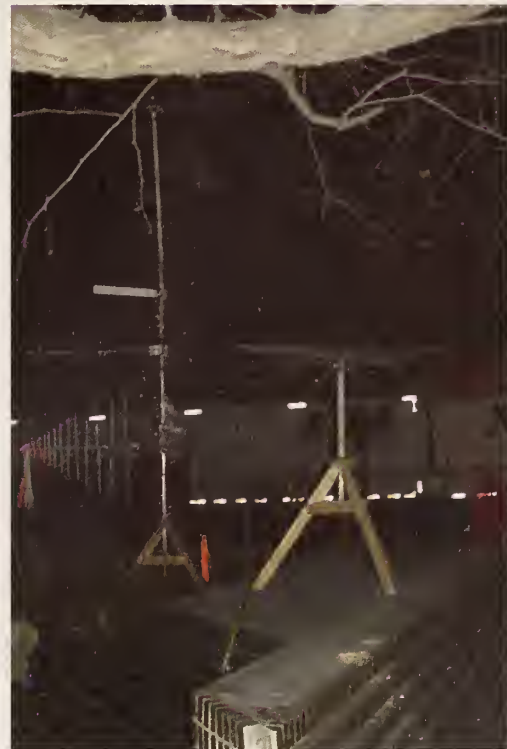
Figure 15. Fixed receiving site RX 3: southeast site. This site was used for both the radio mapping experiments (staffed) and for the implosion experiments (unstaffed).

The receiving instruments, which monitored these transmitters planted in the building, were both at fixed locations and mobile. Three fixed receiving sites were used to collect data before, during, and after the implosion. These three sites were placed around the perimeter of the convention center and are the same receiving sites used for the field-mapping experiments. Since these locations were close to the structure and well within the danger zone during the implosion, the instruments were unmanned and had to be fully automated and protected from flying debris. The three receiving stations are shown in Figures 1, 13, 14, and 15. The mobile receiving system consisted of measurement instruments placed on a cart (see Figure 20) as described in section 5. The cart was pulled around the perimeter of the building structure both before and after the implosion, enabling direct comparison of signal strength through the standing building and later through the rubble as a function of azimuth angle (which is discussed later).

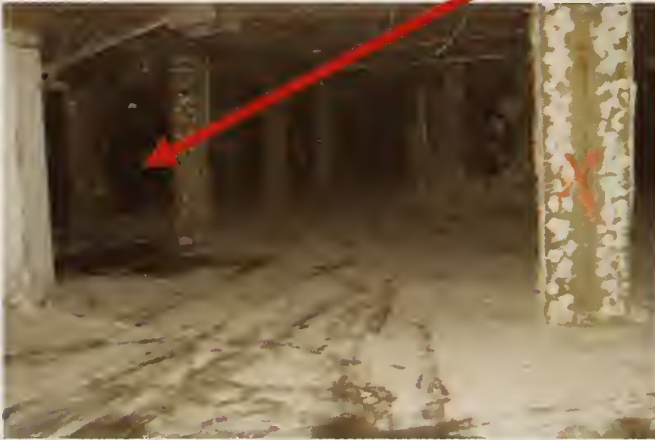
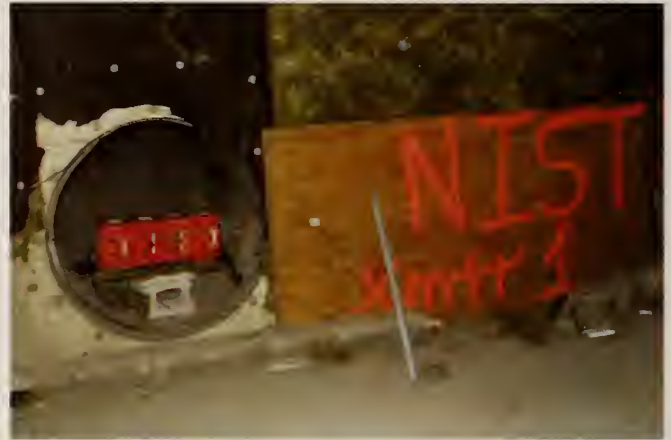
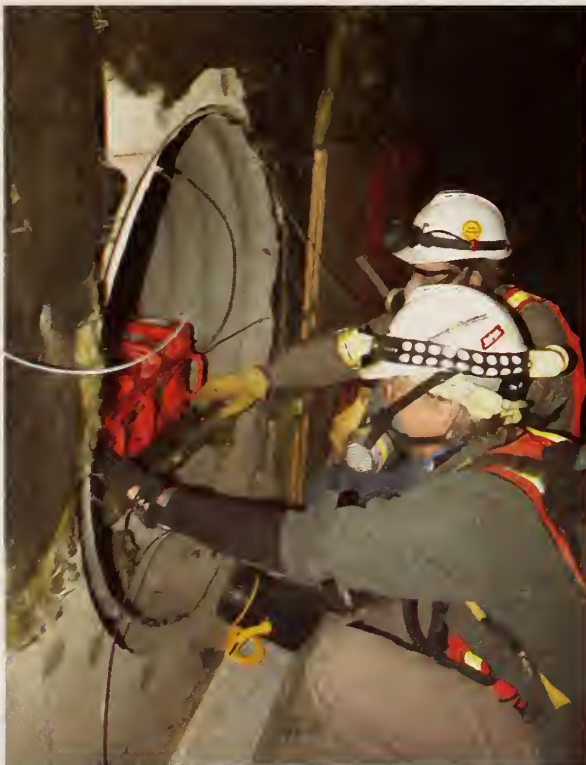
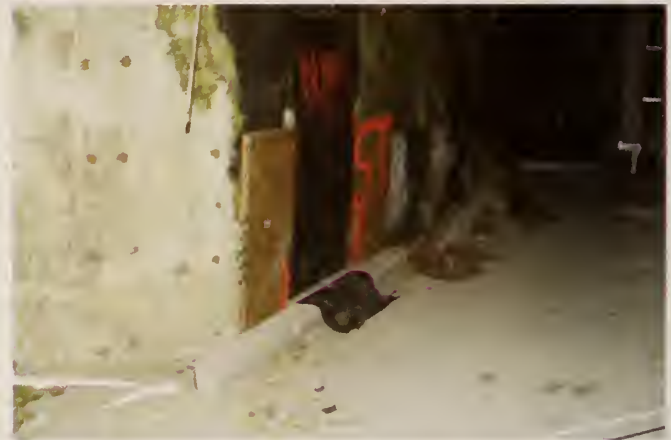
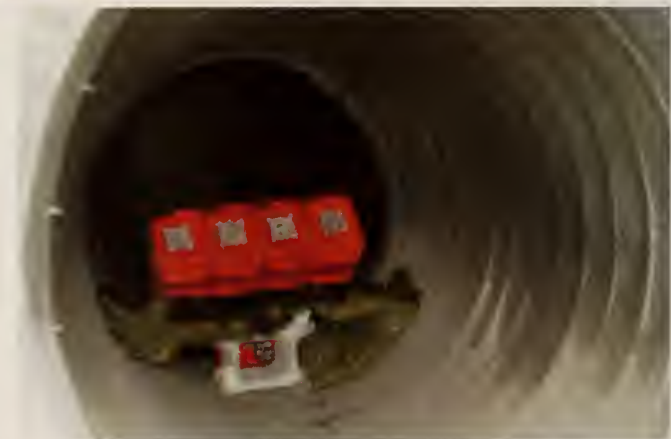
TX 1 Location

Figure 16. Fixed transmitter location TX 1; lower lever of the convention center.

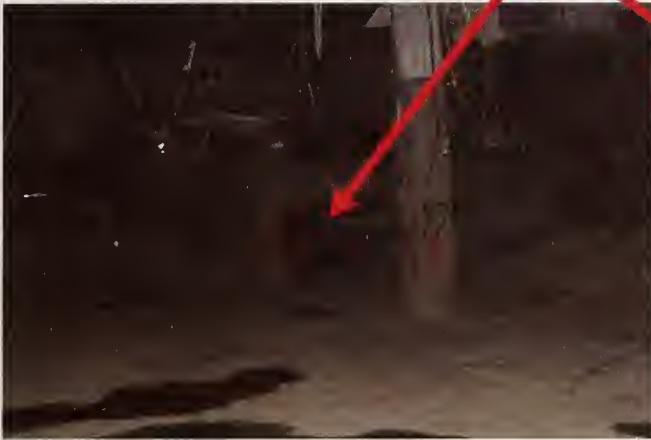
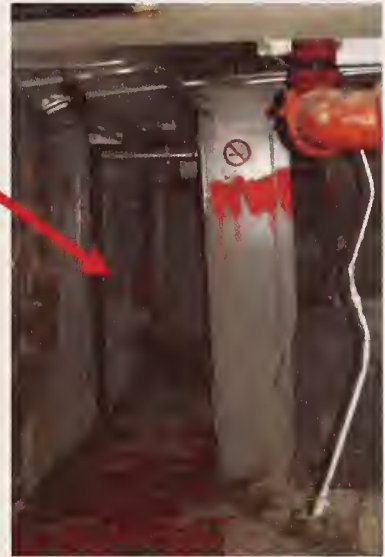
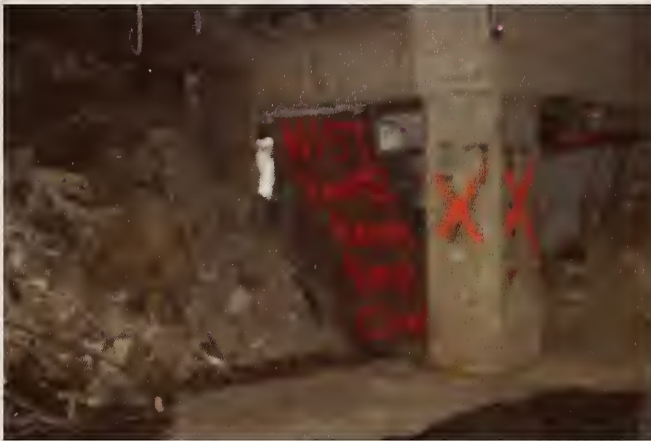
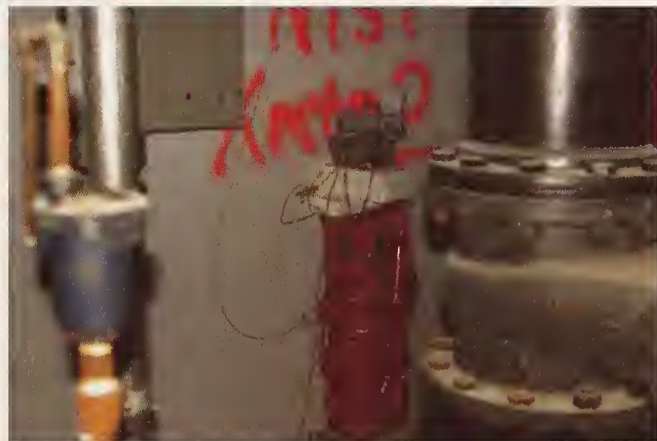
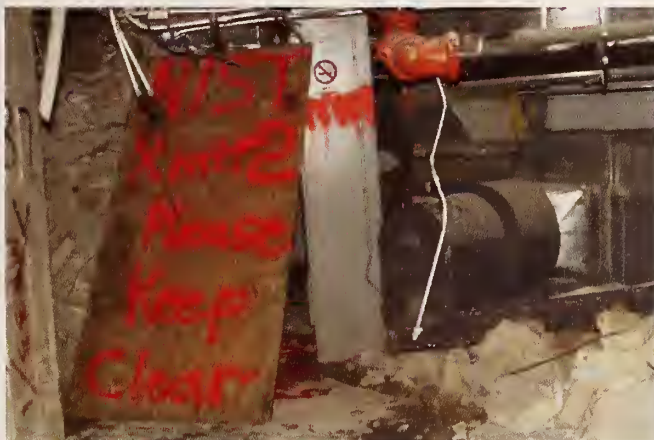
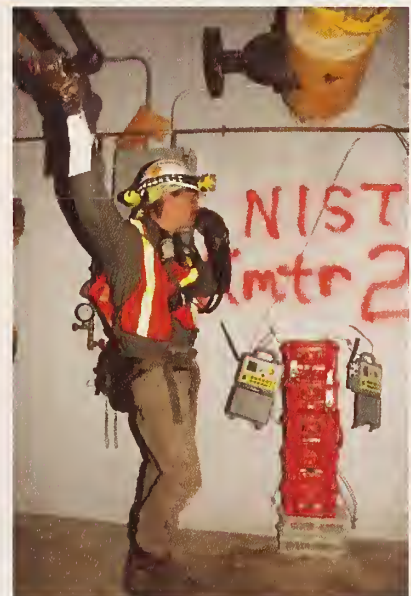
TX 2 Location

Figure 17. Fixed transmitter location TX 2; northeast corner in lower level.

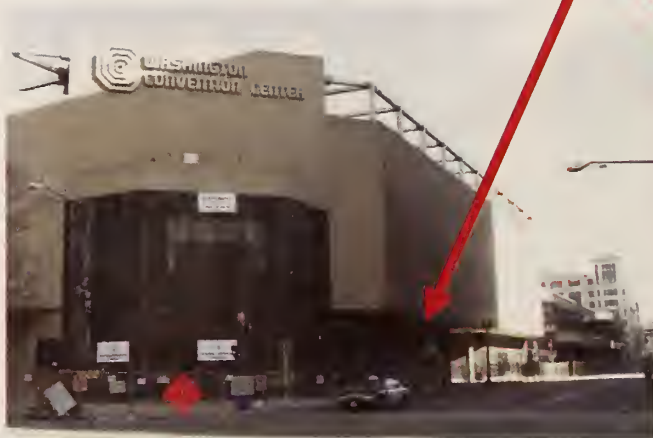
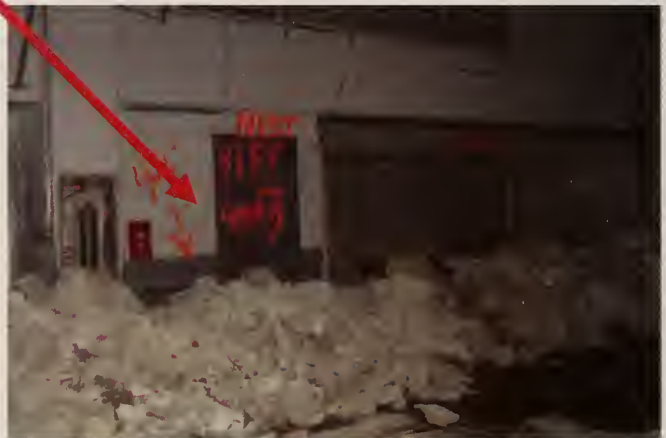
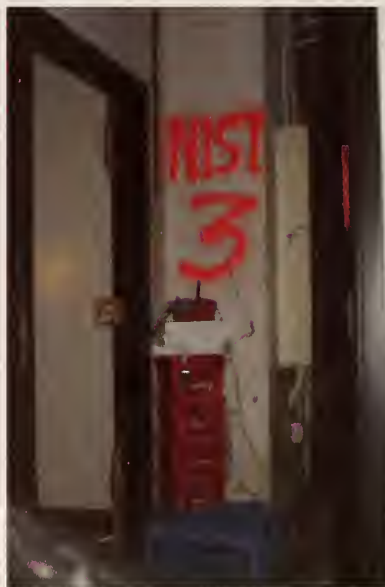
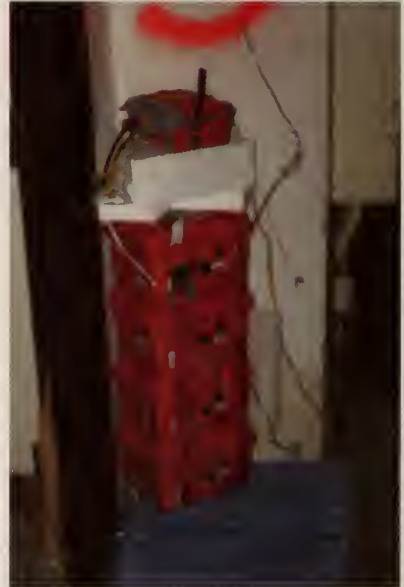
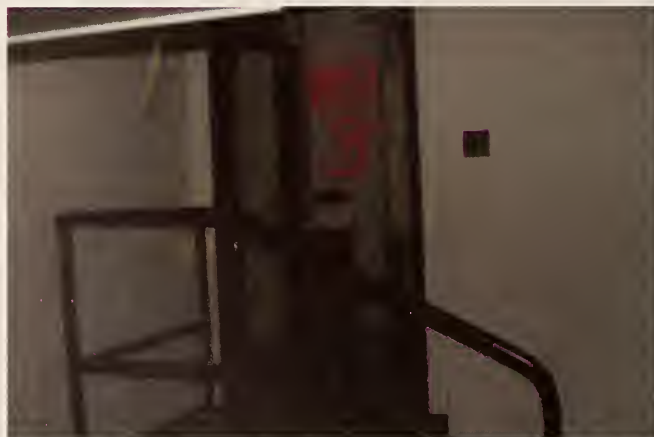
TX 3 Location

Figure 18. Fixed transmitter location TX 3; an intermediate level (office area) of the convention center.
