NIST Technical Note 1542

Propagation and Detection of Radio Signals Before, During, and After the Implosion of a Large Convention Center

Electromagnetics Division
National Institute of Standards and Technology
325 Broadway
Boulder, CO 80305

June 2006

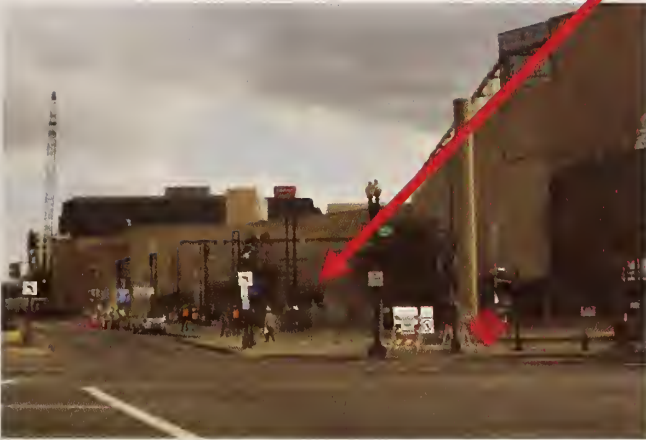
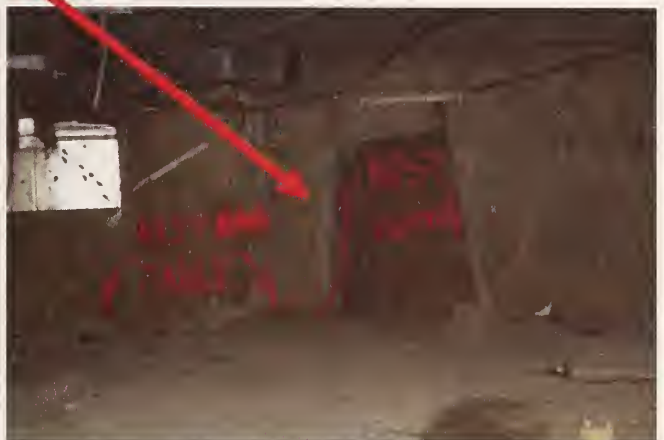
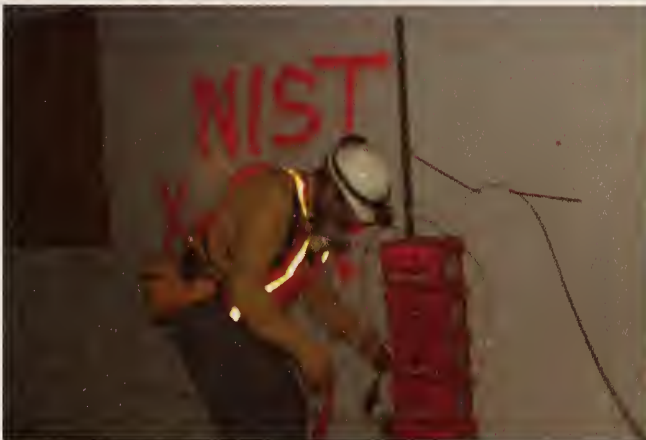
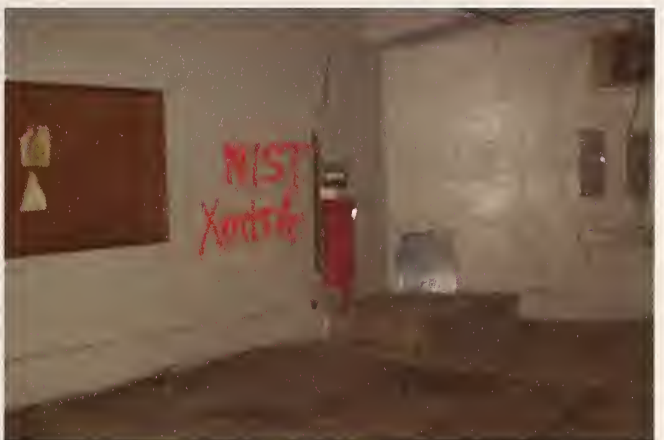
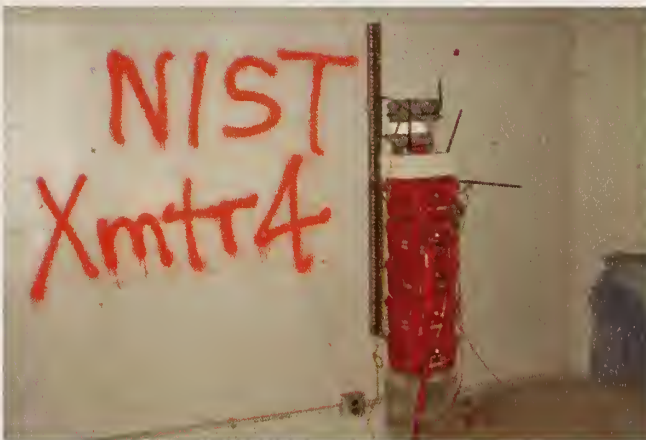
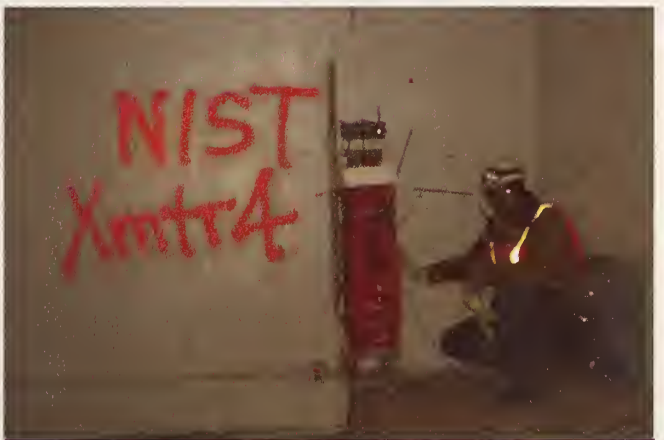
TX 4 Location

Figure 19. Fixed transmitter location TX 4; northwest corner on ground level.

For the second data set, radios were placed at four different fixed locations in the convention center where they would have a high likelihood of surviving the implosion. These four sites are labeled as “TX 1”, “TX 2”, “TX 3”, and “TX 4” in Figure 1. Received signals were collected before, during, and after the implosion. These receiving sites are the same locations as described above. After a careful analysis of the building, the following four sites were chosen: (1) in a circular vent pipe near the center of the lower level of the convention center (site TX 1: see Figure 16); (2) in a control room in the northeast corner on the lower level of the convention center (site TX 2, see Figure 17); (3) on the ground level near the west end of the south side in an office area of the convention center (site TX 3, see Figure 18); and (4) in another control room on an intermediate level in the north west corner of the convention center (site TX 4, see Figure 19).

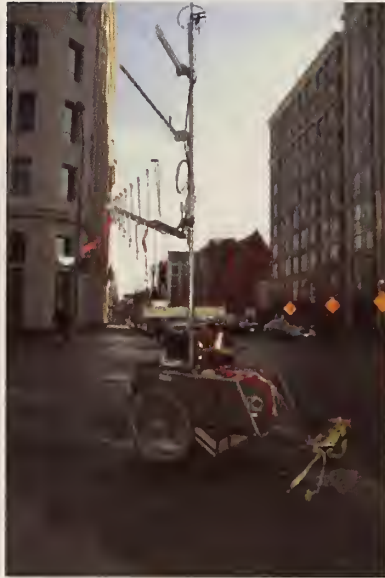
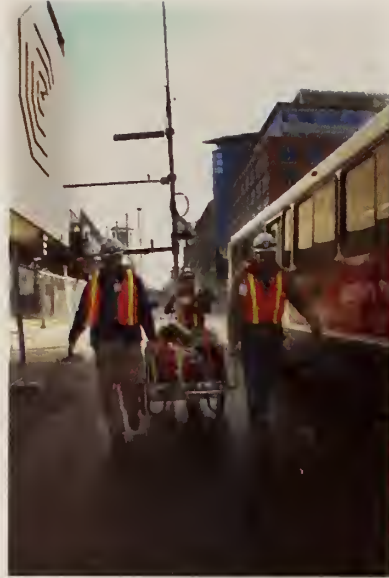
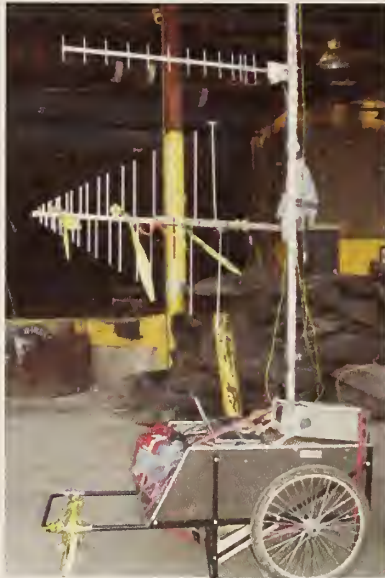
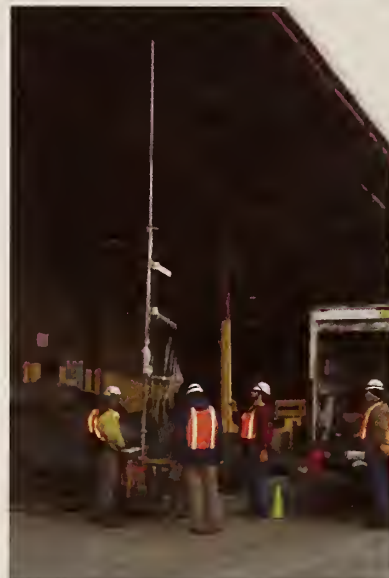
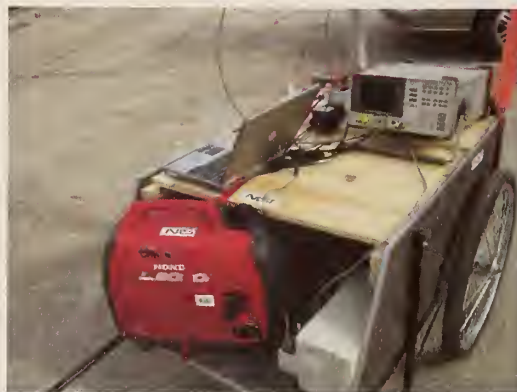
Figure 20. Mobile measurement cart.

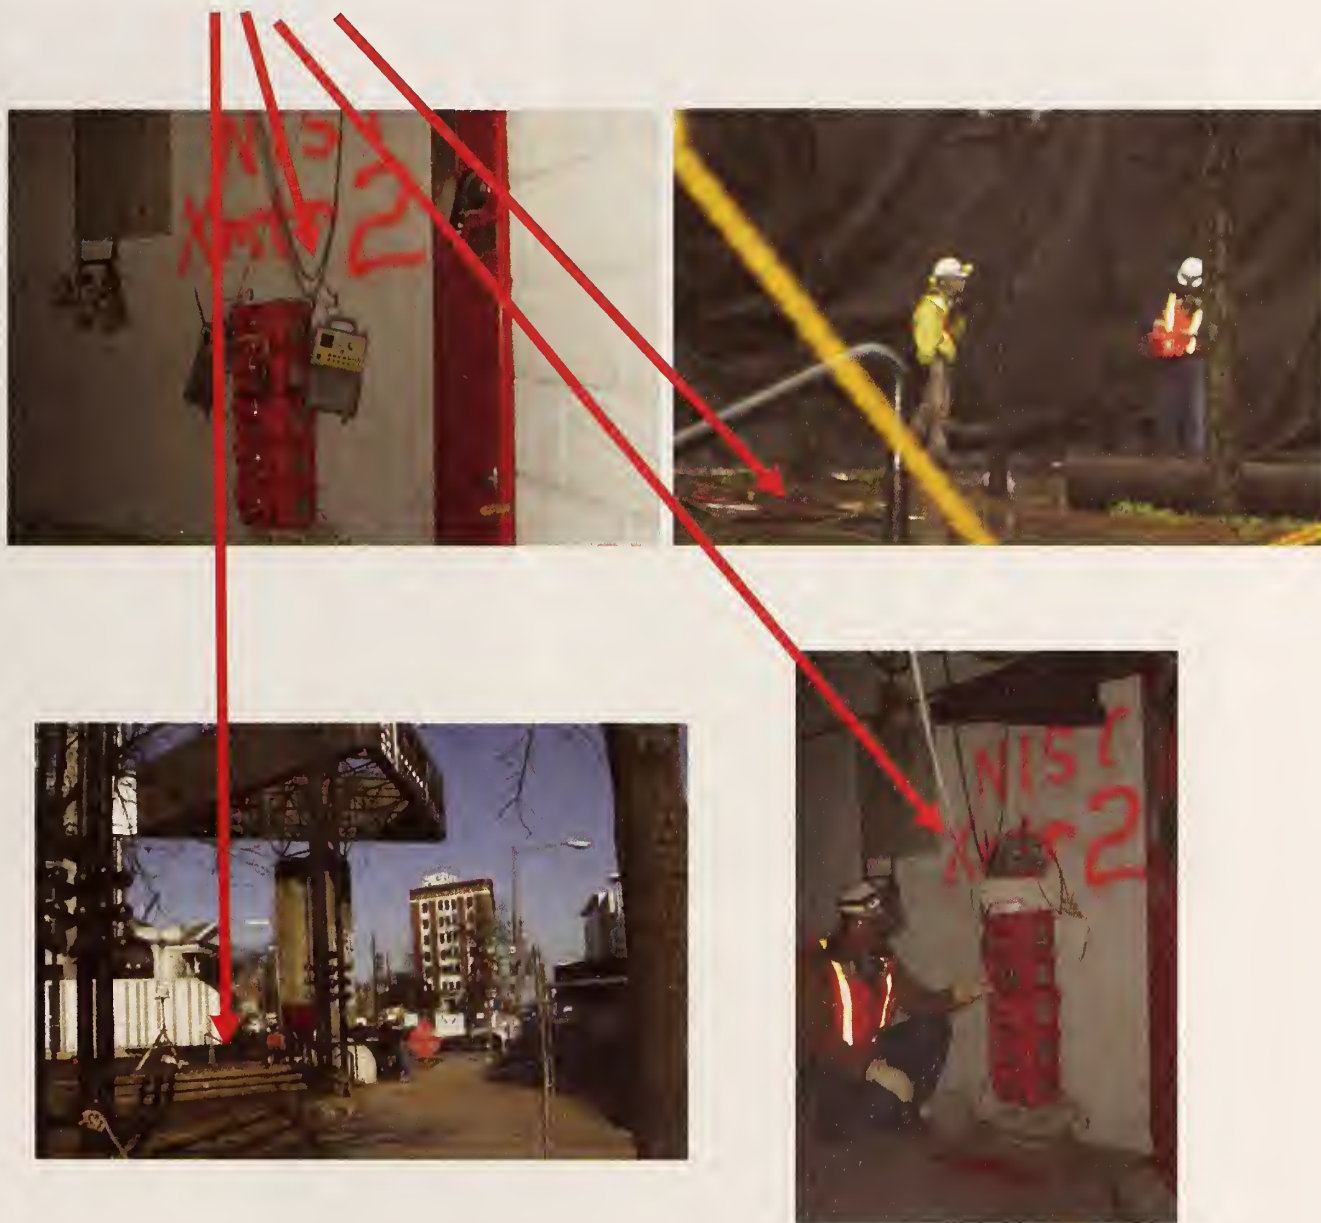
Figure 21. Cable on northeast side of the convention center. This cable was run from the transmitter site (TX 2) to the outside of the building structure.

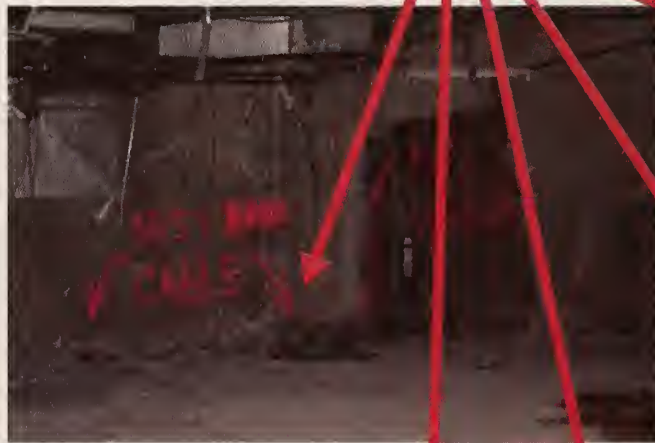
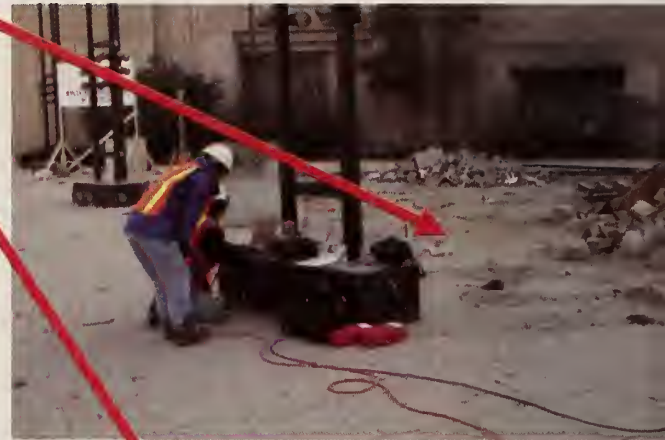
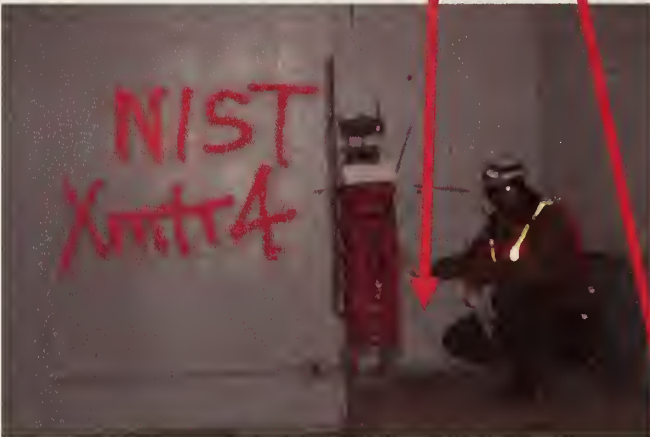
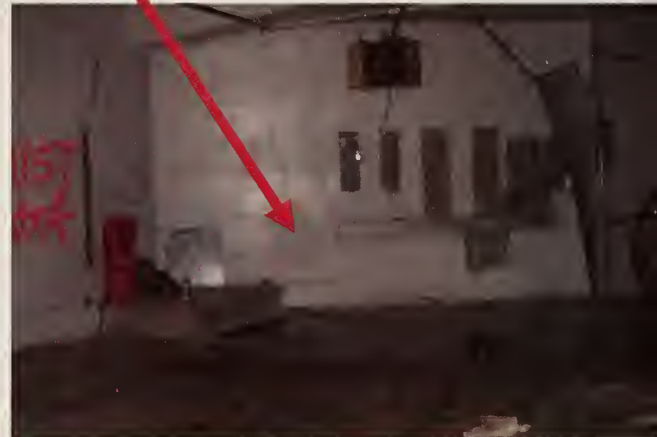
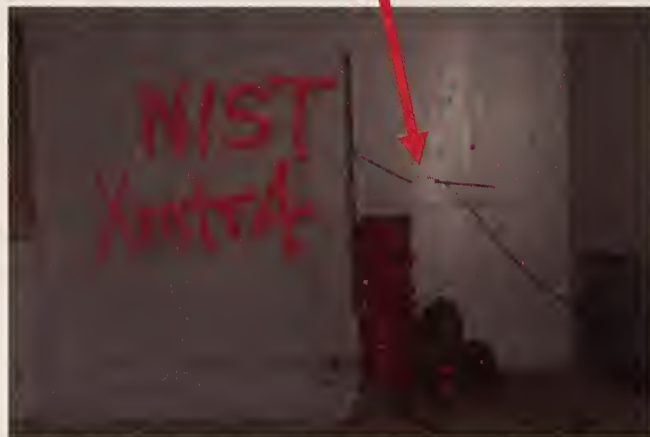
Cable connect to transmitter

Figure 22. Cable on northwest side of the convention center. This cable was run from the transmitter site (TX 4) to the outside of the building structure.

We designed this experiment differently from the corresponding experiments discussed in [5, 7]. To simulate the best-case scenario, the experiments in [5, 7] were designed to ensure that there was an unbroken metallic object (a metal cable) placed near transmitters that would lead to the outside of the buildings. The small antenna on the transmitter radiated the signal, which then coupled to the cable. In the experiments in the convention center, we attached the steel cables directly to the transmitter’s antenna port via an impedance-matching network. We intended for this to simulate the possibility of trapped first responders touching the antenna or somehow connecting a radio or cell phone to metal objects in their immediate area. The two transmitters at sites TX 2 and TX 4 (see Figure 1) were used for the cable experiment. At site TX 2 a transmitter operating at a frequency of 448.70 MHz was connected to the cable, and at site TX 4 a transmitter operating at a frequency of 448.80 MHz was connected to the cable. The cables were then run about 10 m beyond the convention center perimeter (see Figures 21 and 22). The 10 m distance was anticipated to be beyond the point where the building debris would lie after the implosion so that we would have safe access to the cable ends.

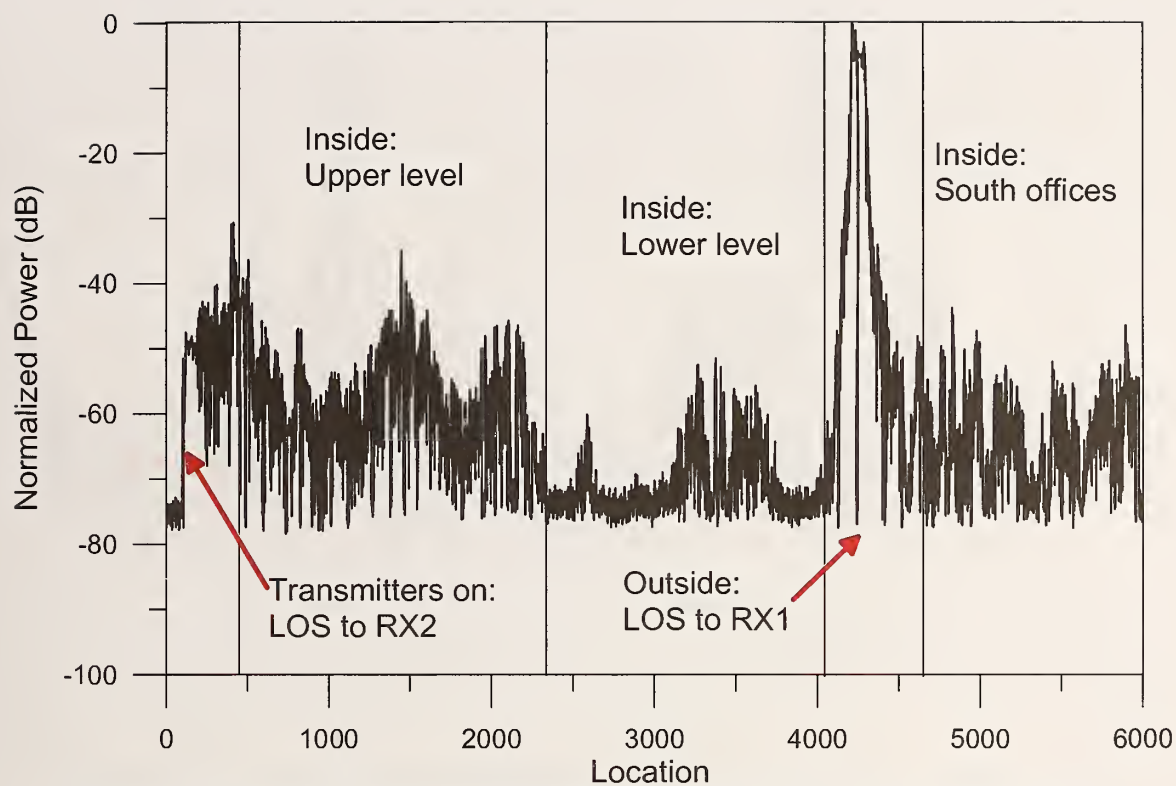
Figure 23. Convention Center walk-through for receiving site RX1 at 49.6 MHz.

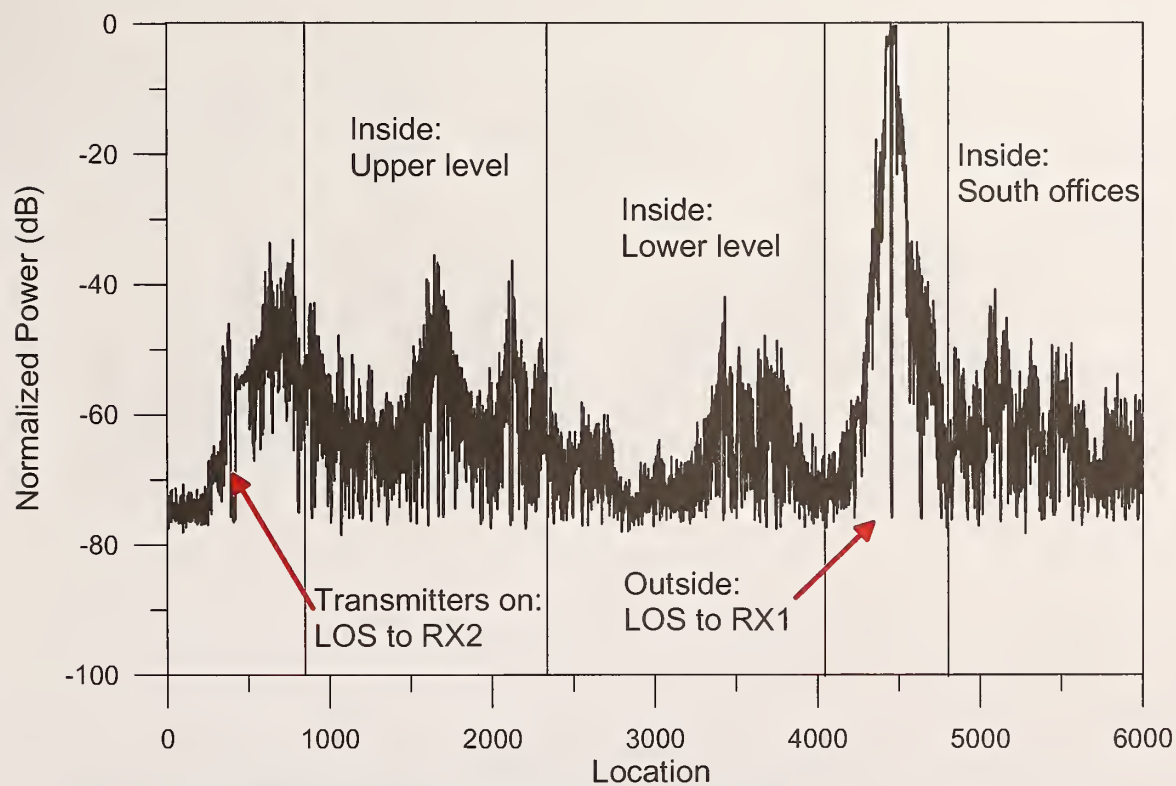
Figure 24. Convention Center walk-through for receiving site RX1 at 162.09 MHz.

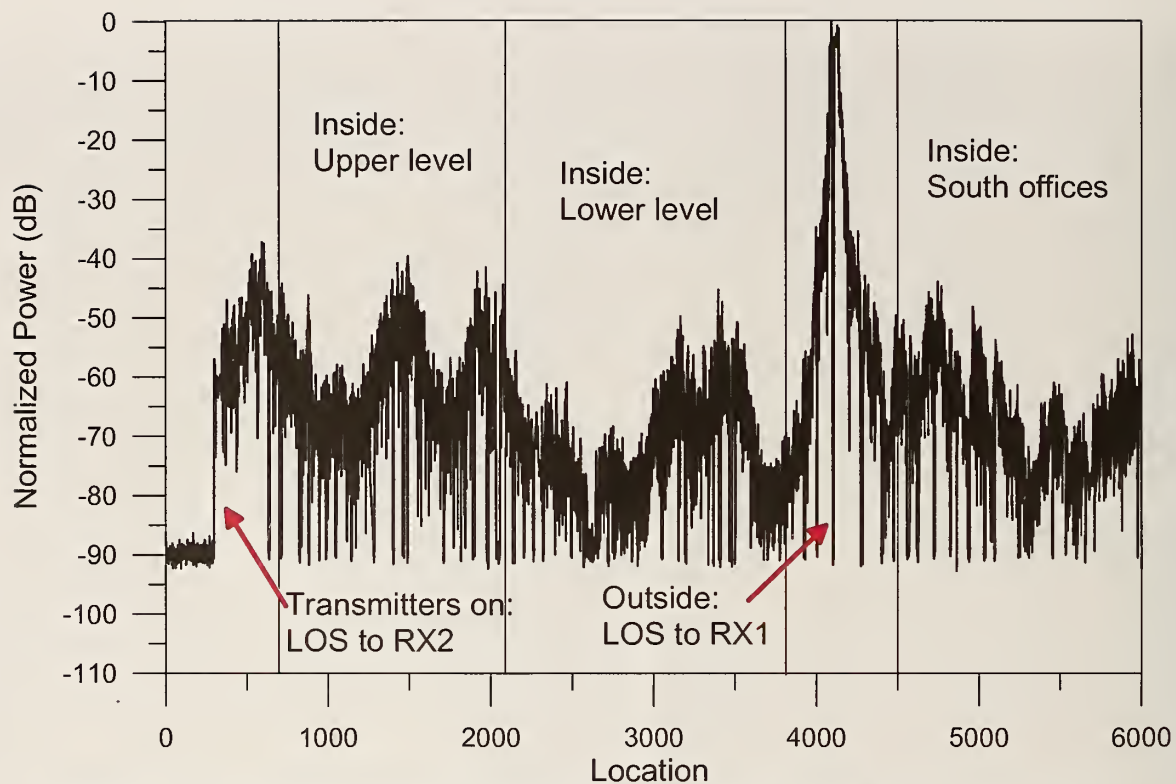
Figure 25. Convention Center walk-through for receiving site RX1 at 226.40 MHz.

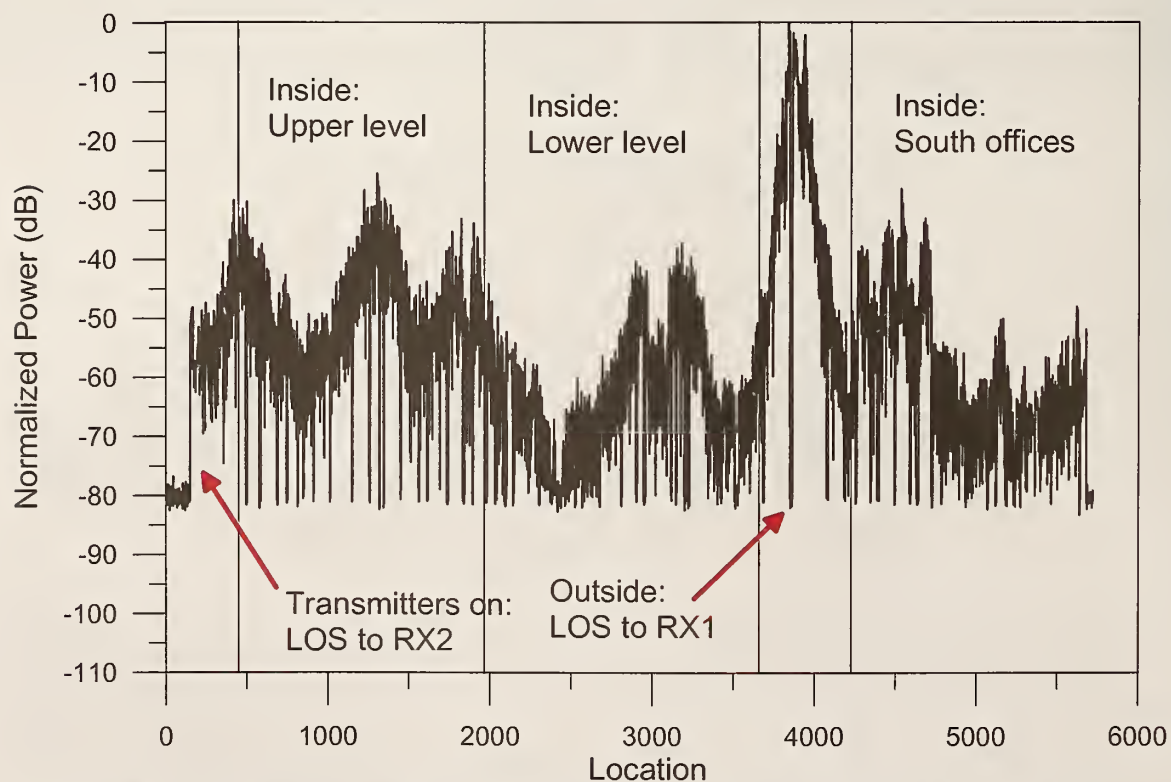
Figure 26. Convention Center walk-through for receiving site RX1 at 448.30 MHz.

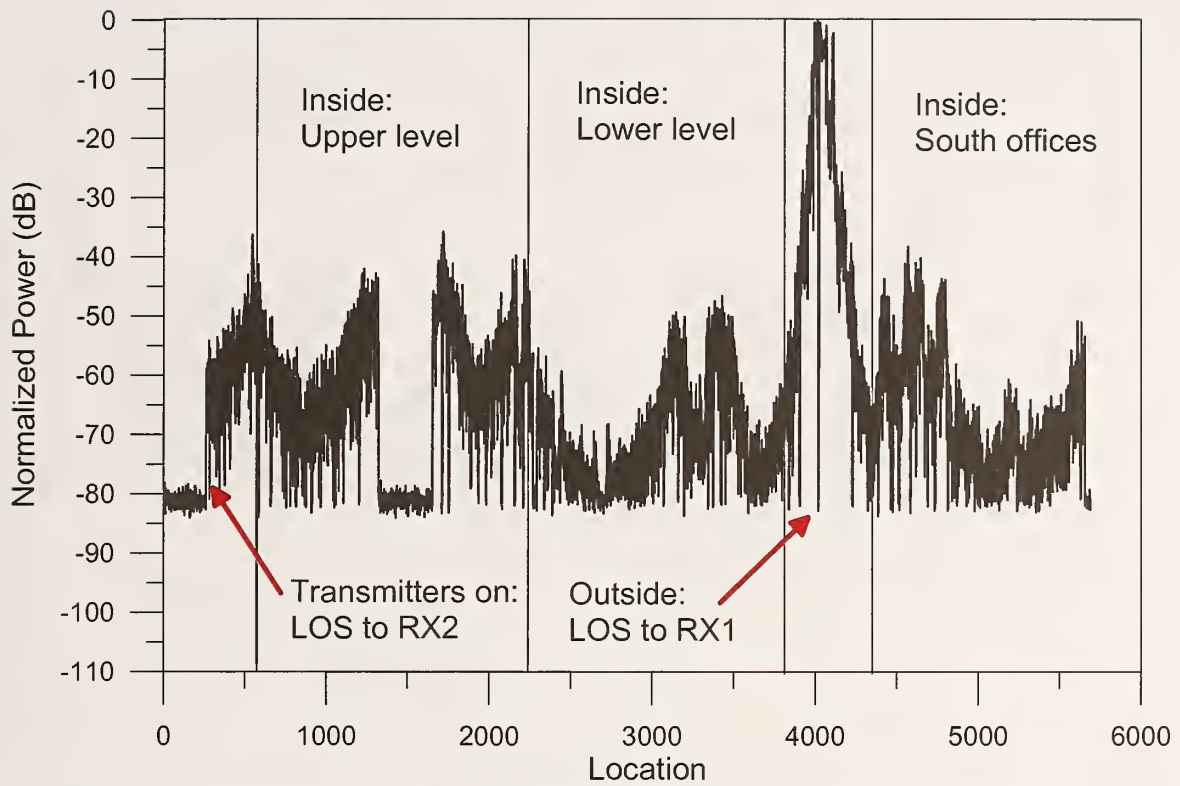
Figure 27. Convention Center walk-through for receiving site RX1 at 902.45 MHz.

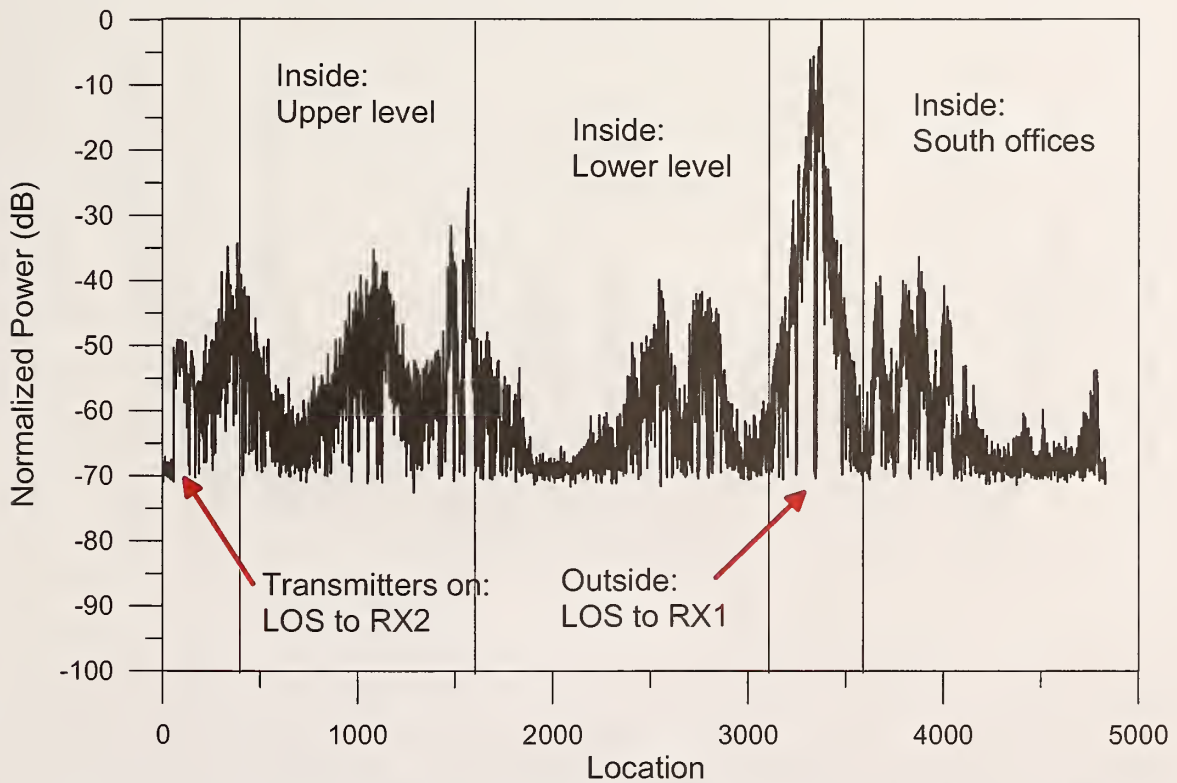
Figure 28. Convention Center walk-through for receiving site RX1 at 1830.00 MHz.

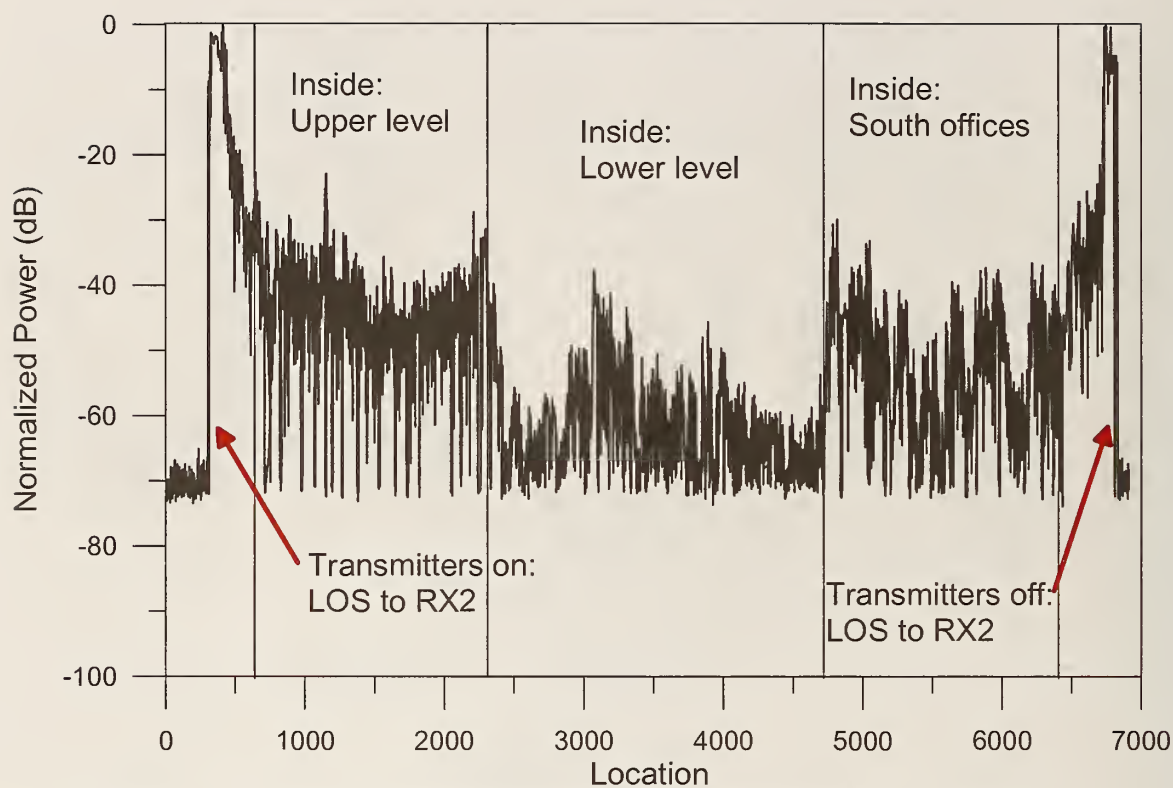
Figure 29. Convention Center walk-through for receiving site RX2 at 49.6 MHz.

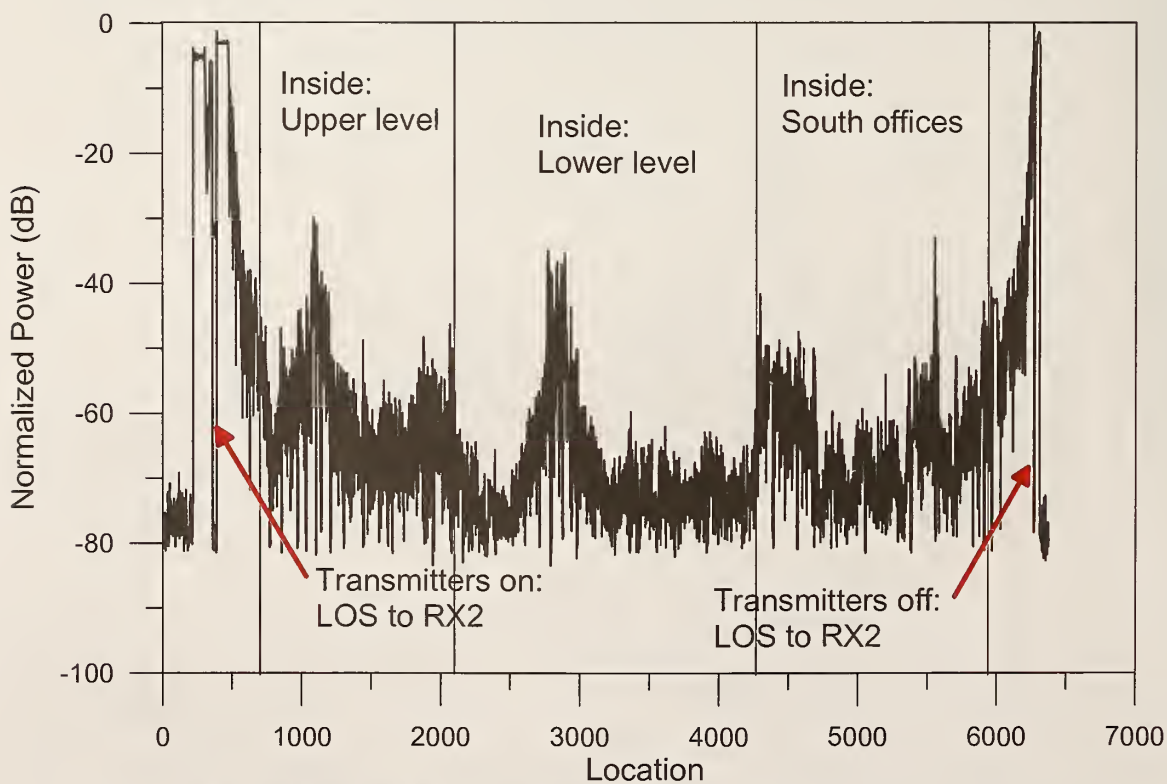
Figure 30. Convention Center walk-through for receiving site RX2 at 162.09 MHz.

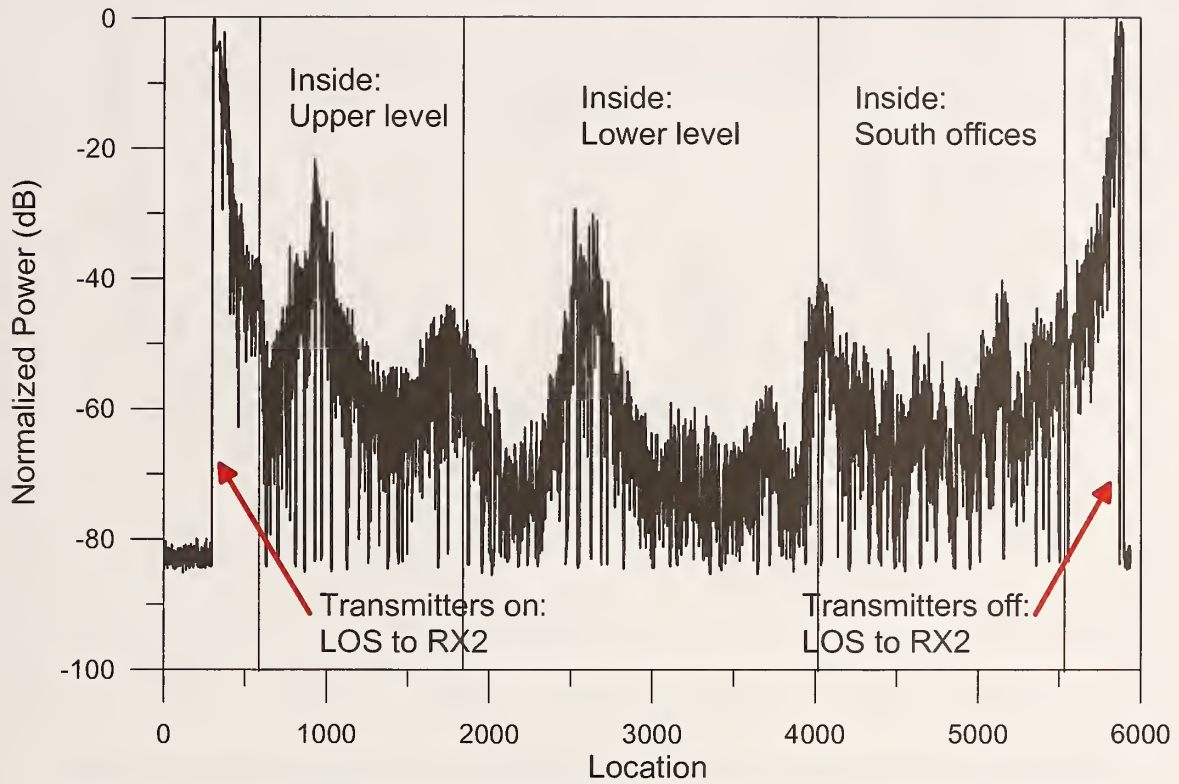
Figure 31. Convention Center walk-through for receiving site RX2 at 226.40 MHz.

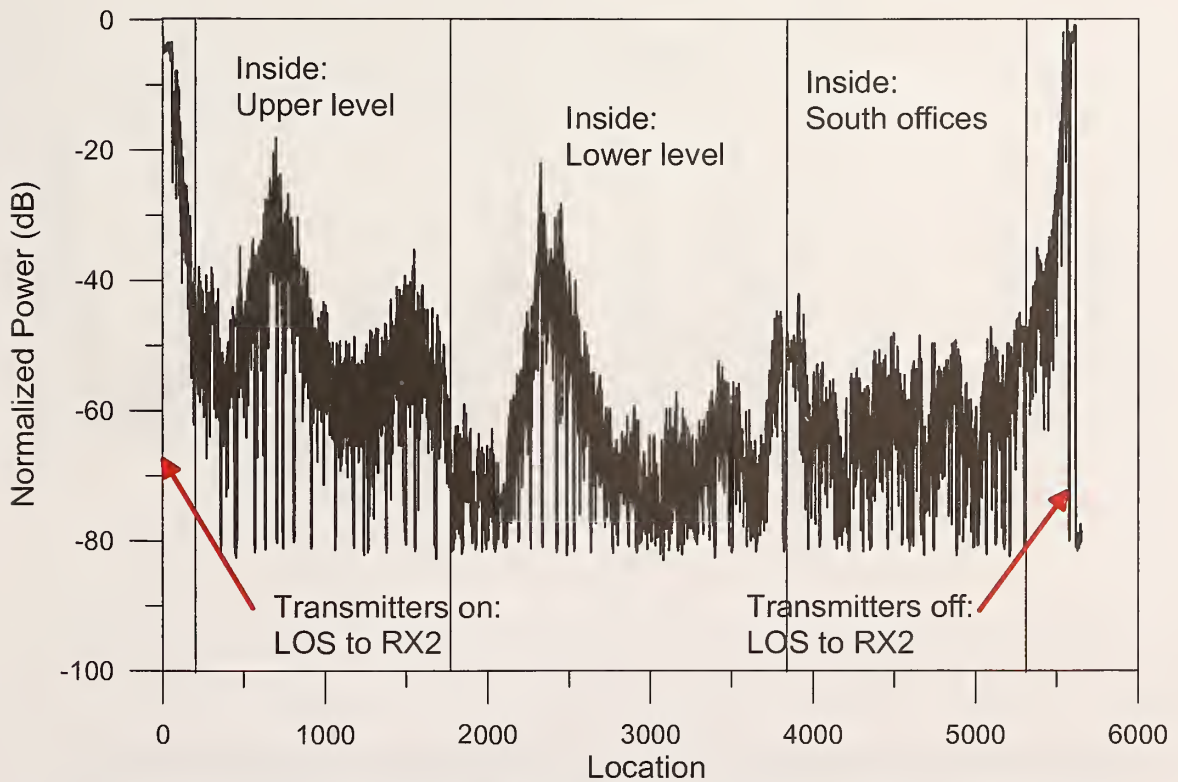
Figure 32. Convention Center walk-through for receiving site RX2 at 448.30 MHz.

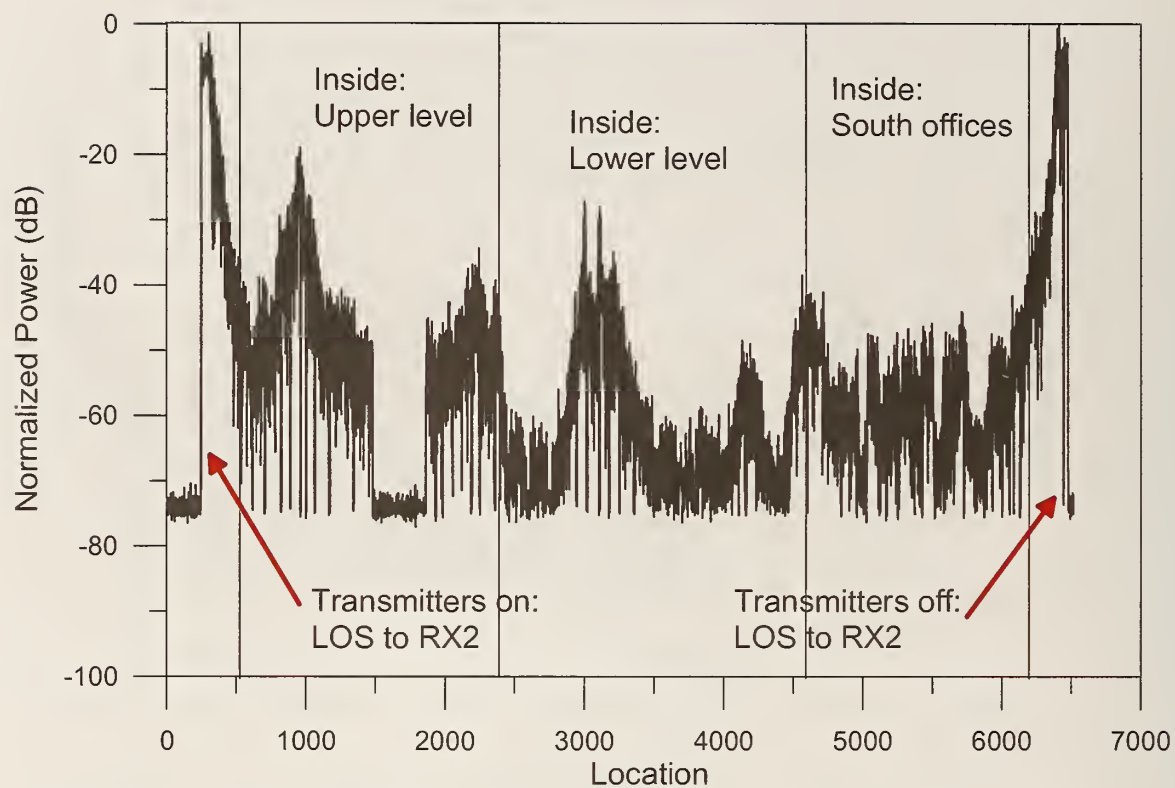
Figure 33. Convention Center walk-through for receiving site RX2 at 902.45 MHz.

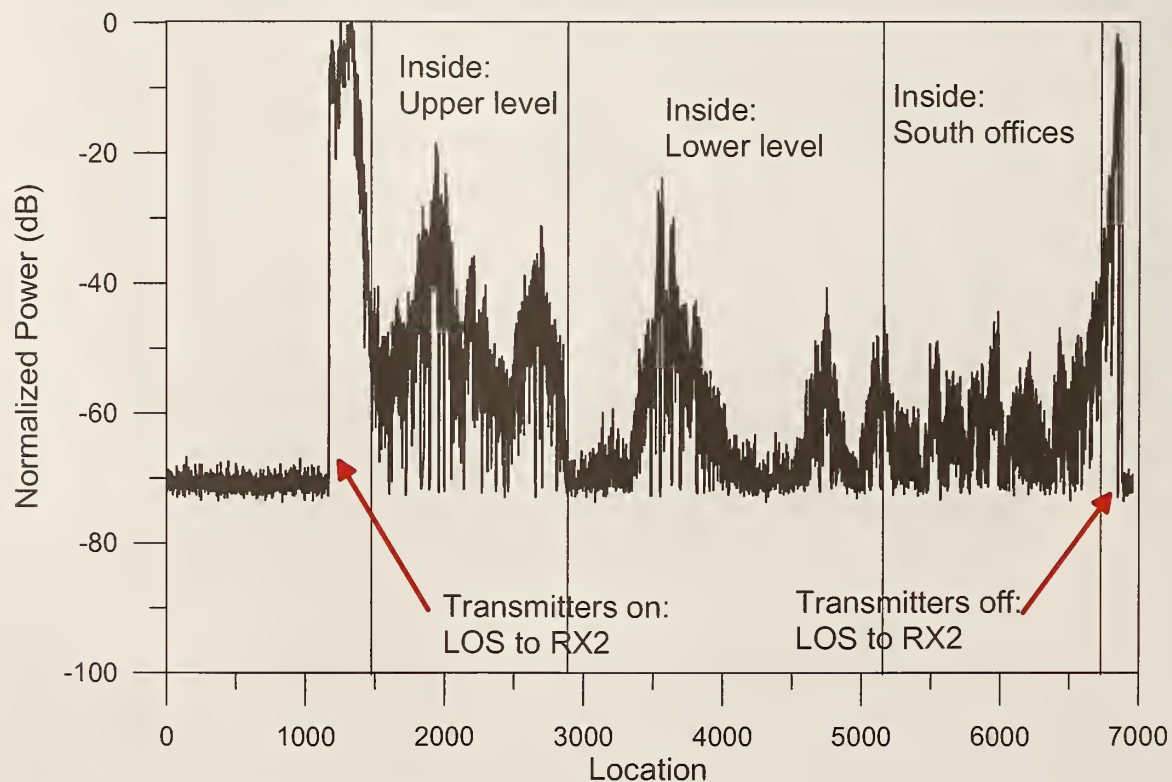
Figure 34. Convention Center walk-through for receiving site RX2 at 1830.00 MHz.

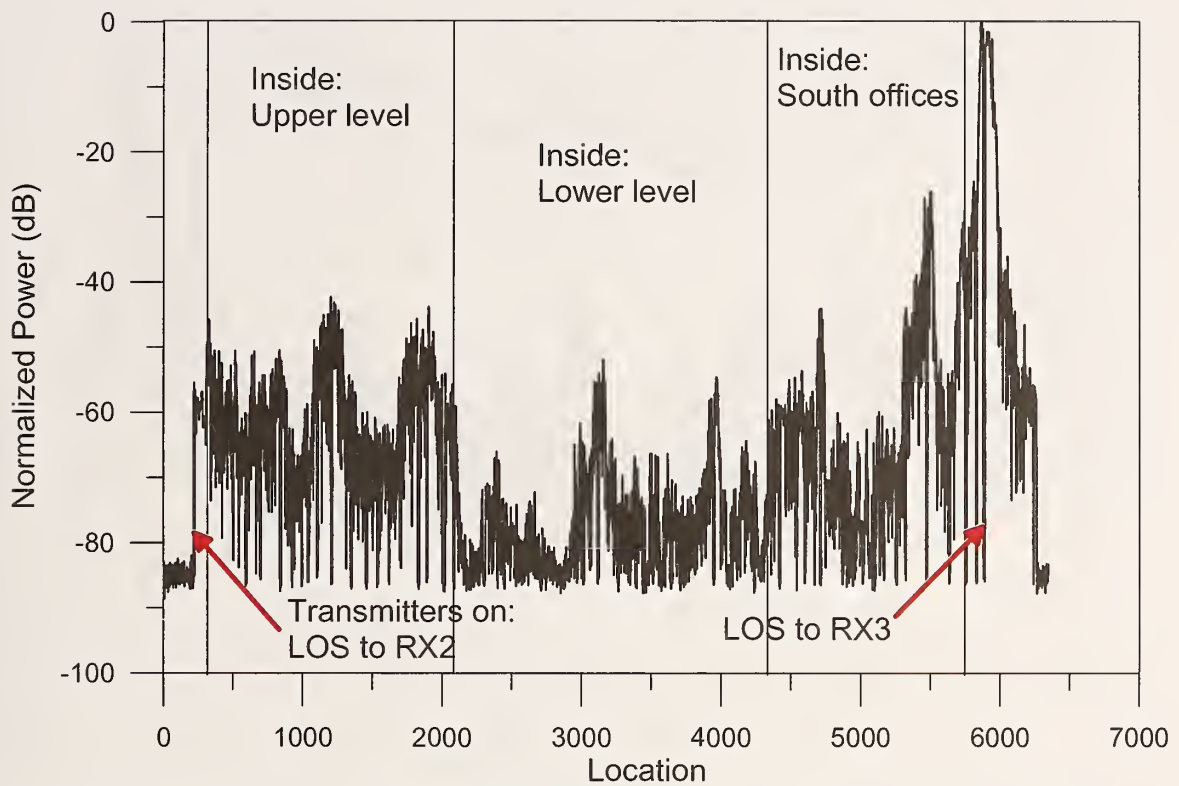
Figure 35. Convention Center walk-through for receiving site RX3 at 49.6 MHz.

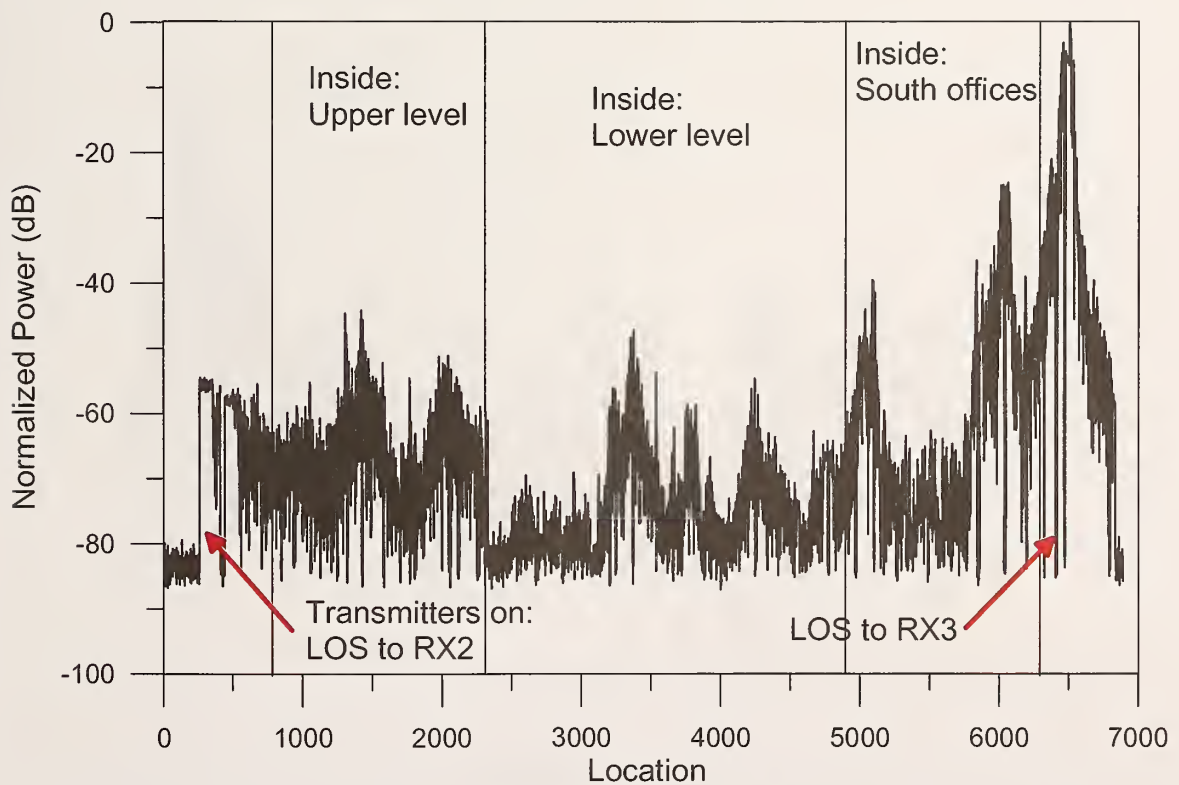
Figure 36. Convention Center walk-through for receiving site RX3 at 162.09 MHz.

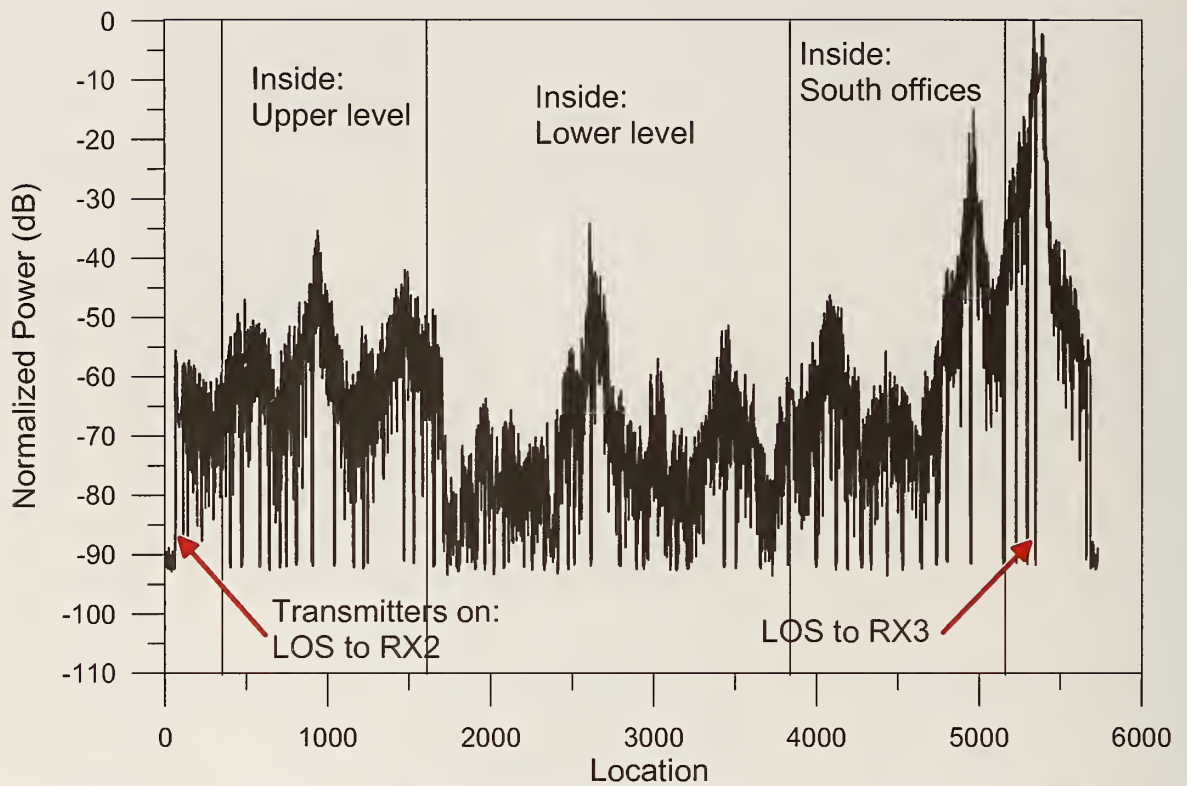
Figure 37. Convention Center walk-through for receiving site RX3 at 226.40 MHz.

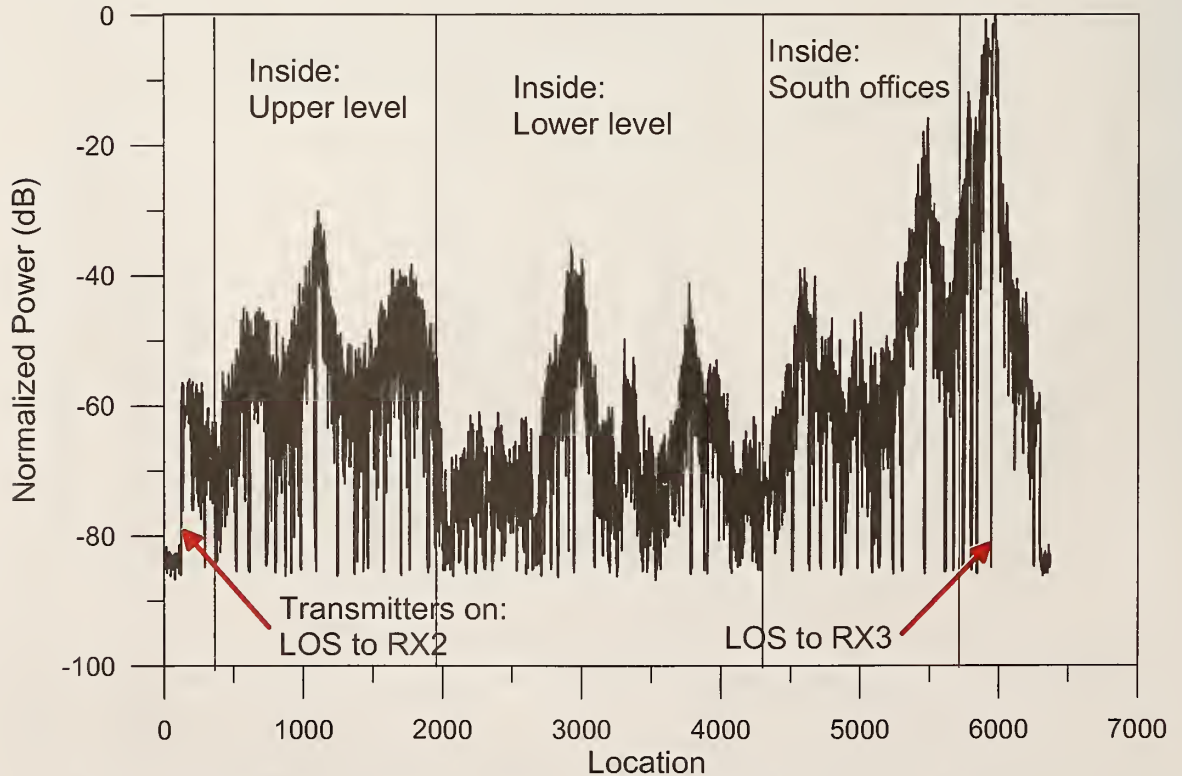
Figure 38. Convention Center walk-through for receiving site RX3 at 448.30 MHz.

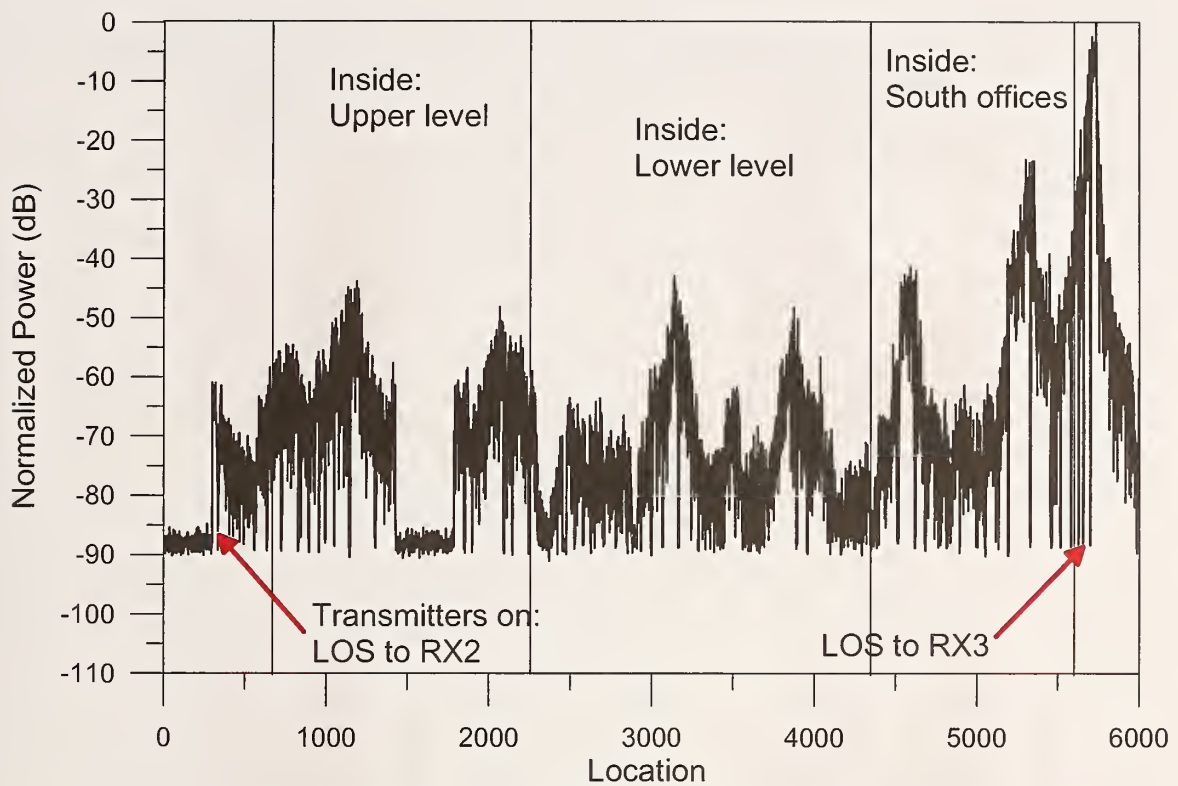
Figure 39. Convention Center walk-through for receiving site RX3 at 902.45 MHz.
