NIST Technical Note 1542

Propagation and Detection of Radio Signals Before, During, and After the Implosion of a Large Convention Center

Electromagnetics Division
National Institute of Standards and Technology
325 Broadway
Boulder, CO 80305

June 2006

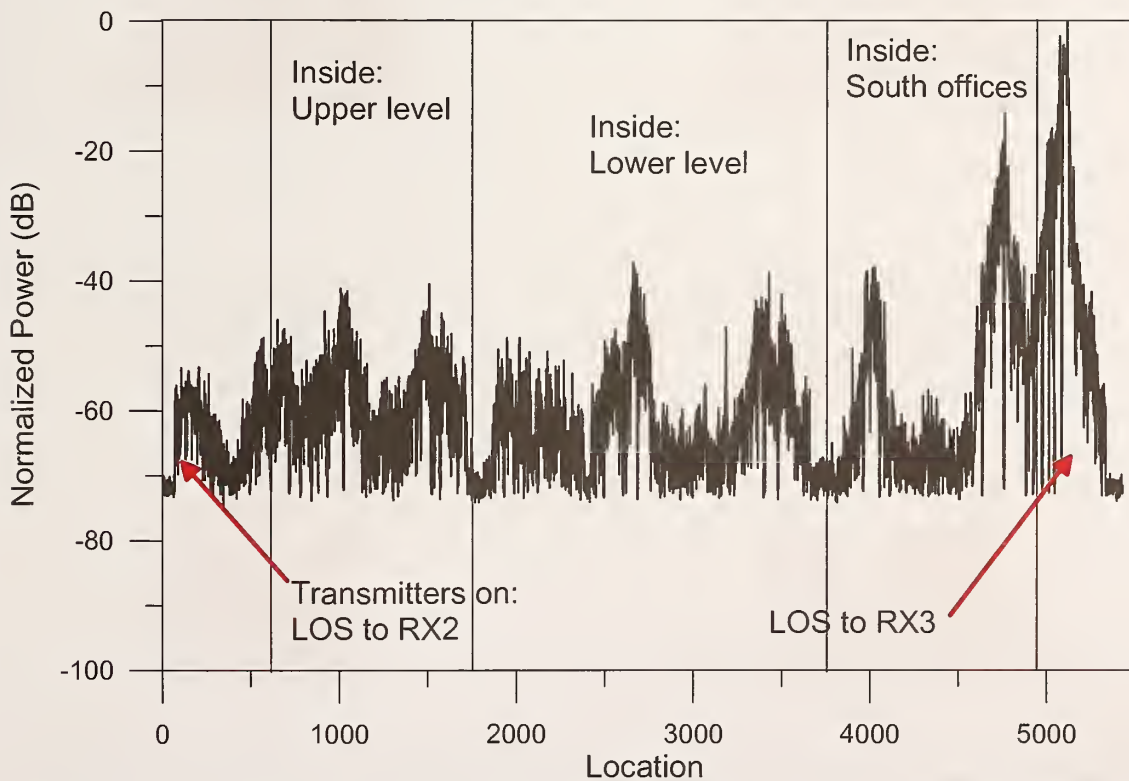
Figure 40. Convention Center walk-through for receiving site RX3 at 1830.00 MHz.

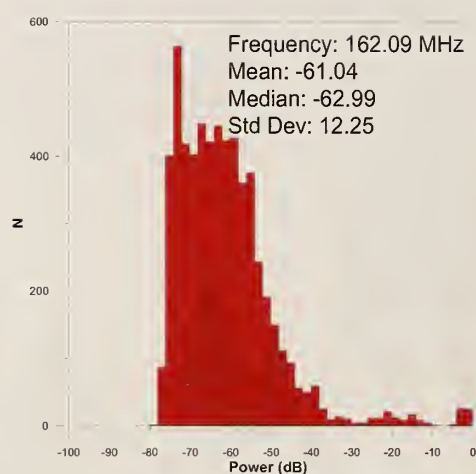
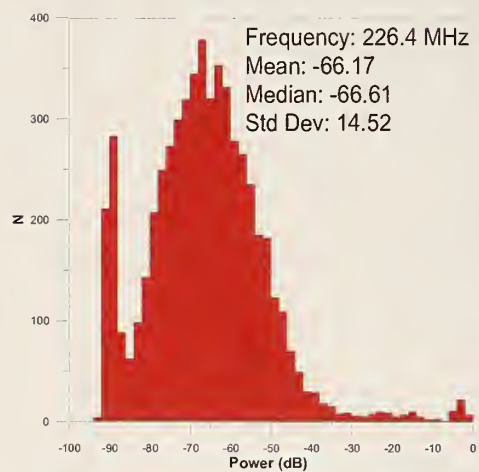
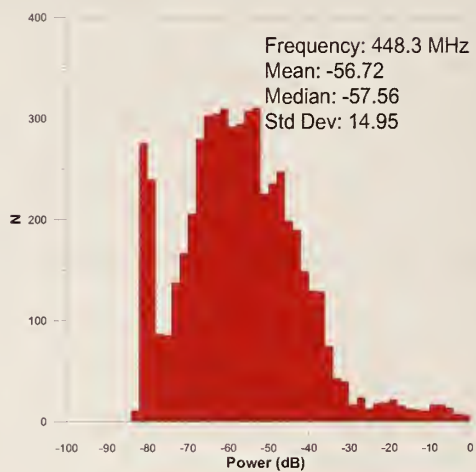
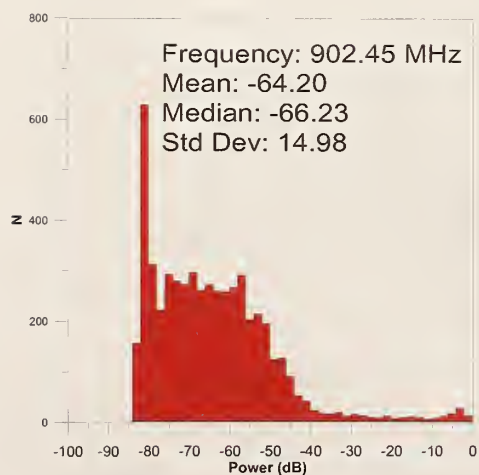
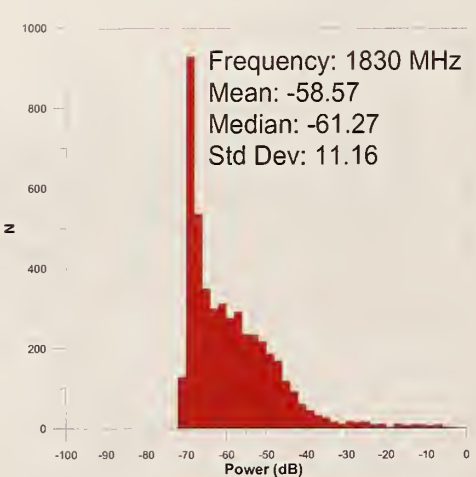
Figure 41. Histograms for the data collected during walk-throughs at receiving site RX 1.

The first set of data analyzed was collected for receiving site RX 1 when we carried the transmitters throughout the convention center (data in Figures 23-28). The histograms (2 dB bin size) for this dataset are shown in Figure 41. Table 6 summarizes the mean and median of received signal strength and the standard deviation for each frequency obtained from receiving site RX 1.

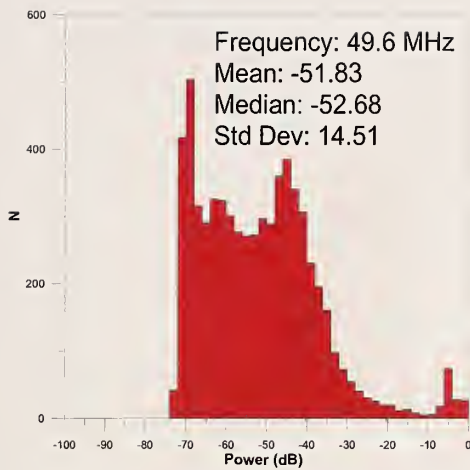
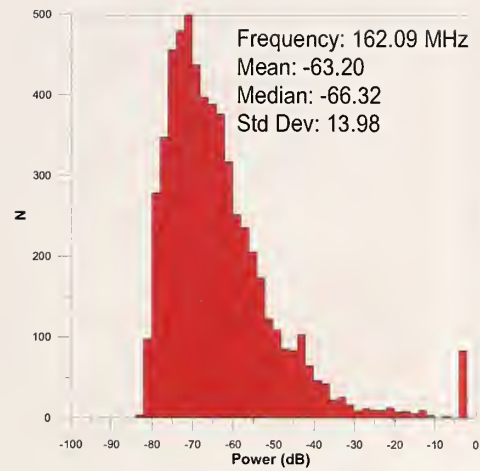
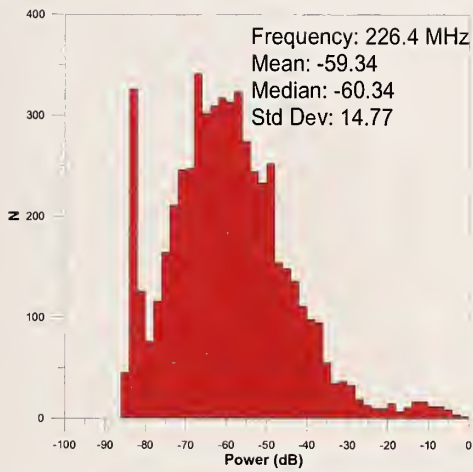
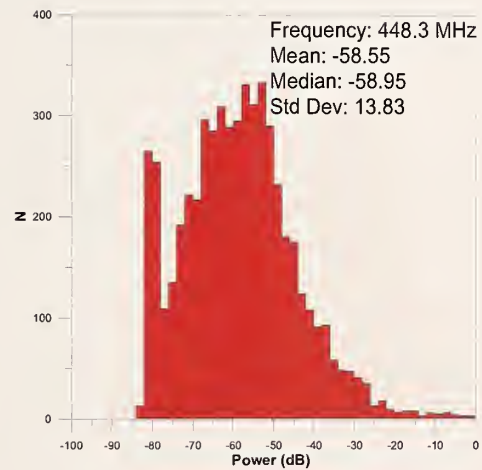
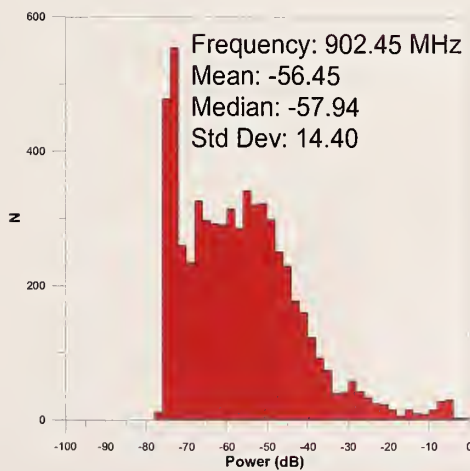
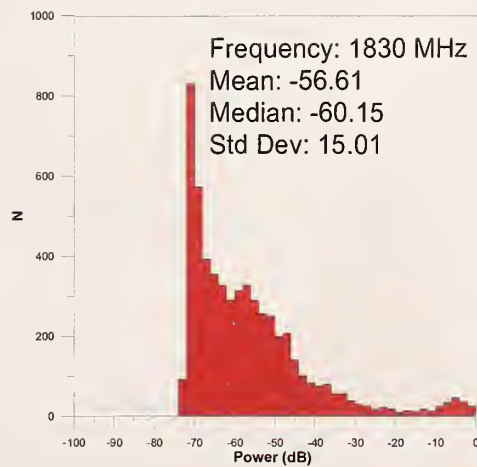
Figure 42. Histograms for the data collected during walk-throughs at receiving site RX 2.

The next set of data analyzed was collected for receiving site RX 2 when we carried the transmitters throughout the convention center (data in Figures 29-34). The histograms (2 dB bin size) for this dataset are shown in Figure 42. Table 7 summarizes the mean and median of received signal strength and the standard deviation for each frequency obtained from receiving site RX2.

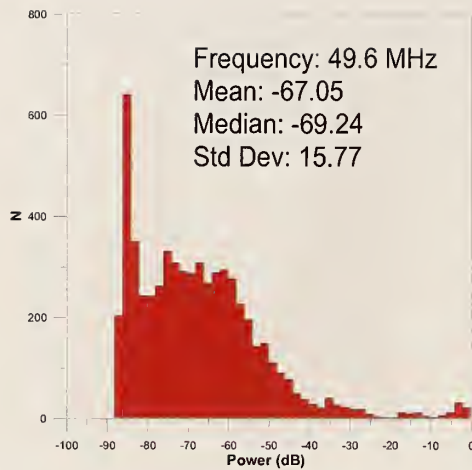
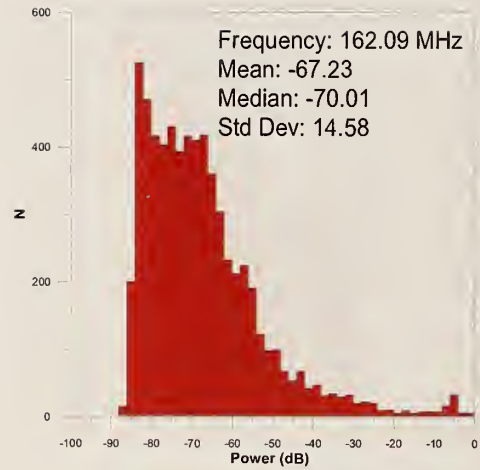
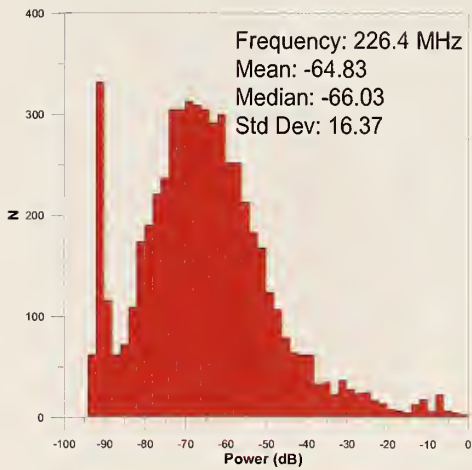
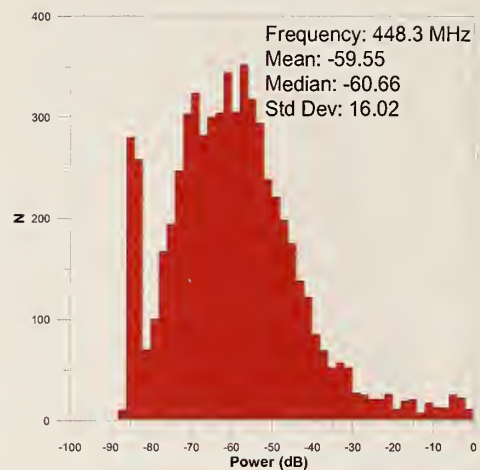
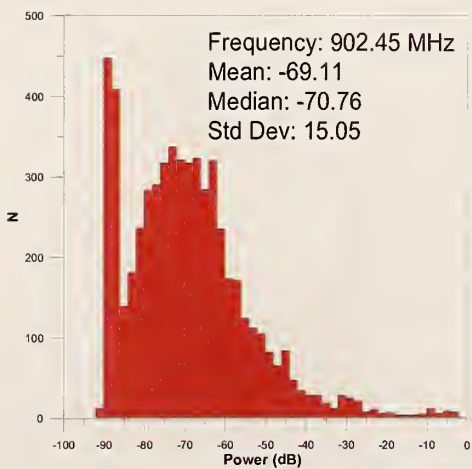
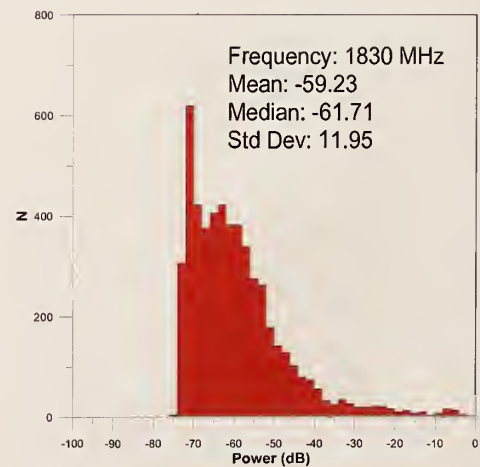
Figure 43. Histograms for the data collected during walk-throughs at receiving site RX 3.

The next set of data analyzed was collected for receiving site RX 3 when we carried the transmitters throughout the convention center (data in Figures 35-40). The histograms (2 dB bin size) for this dataset are shown in Figure 43. Table 8 summarizes the mean and median of received signal strength and the standard deviation for each frequency obtained from receiving site RX3.

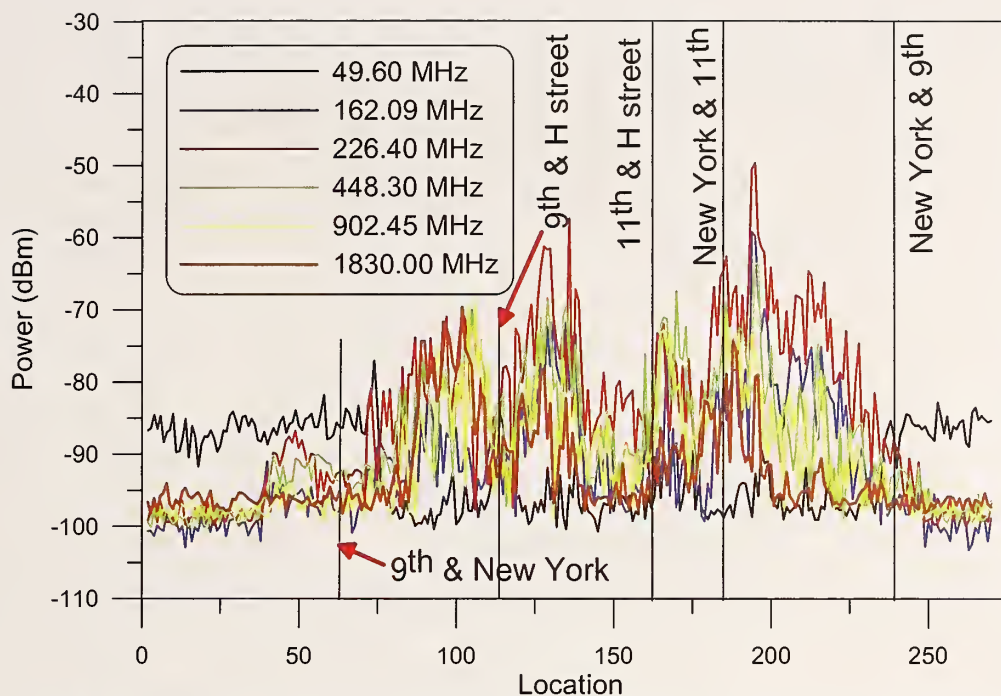
Figure 44. Signal strength measurements around the perimeter of the convention center for the transmitters located at fixed site TX 1 and horizontal polarized receiving antennas. The streets on the perimeter of the convention center are labeled.

Figures 44 and 45 show the variability in the received signal strength around the perimeter of the convention center for all six frequencies for transmitters located at fixed site TX 1. These two figures are for horizontally and vertically polarized receiving antennas, respectively. It should be noted that as the cart was pulled around the building, the antennas on the cart were always pointed toward the center of the convention center. Figures 46 and 47 show the data in Figure 44 and 45 normalized with respect to the overall (either horizontal or vertical polarization) maximum received signal. That is, each frequency is normalized to its maximum level for all data recorded during both perimeter travels of the receiving cart. We should note that this normalization reference includes a certain unknown amount of attenuation, caused by the structure between the transmit site and the location of best coupling on the exterior perimeter, which we cannot remove. These two plots show the relative variability in the signal strength as the cart is moved around the convention center. From these plots, we see that the presence of the convention center structural material causes the signal to vary by as much as 50 dB around the convention center perimeter.

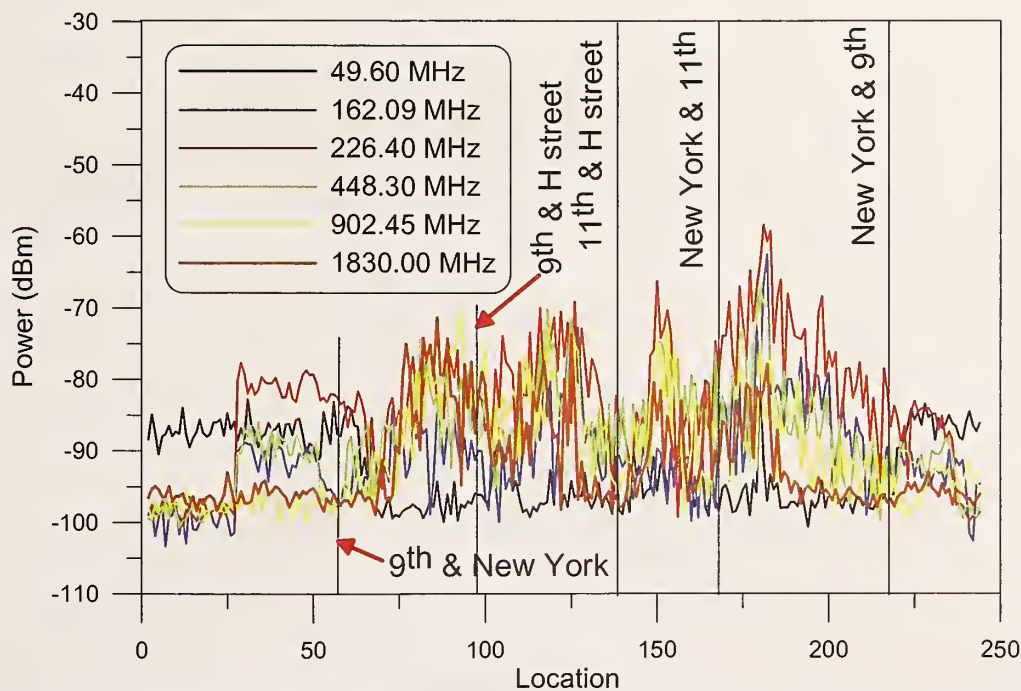
Figure 45. Signal strength measurements around the perimeter of the convention center for the transmitters located at fixed site TX 1 and vertical polarized receiving antennas. The streets on the perimeter of the convention center are labeled.

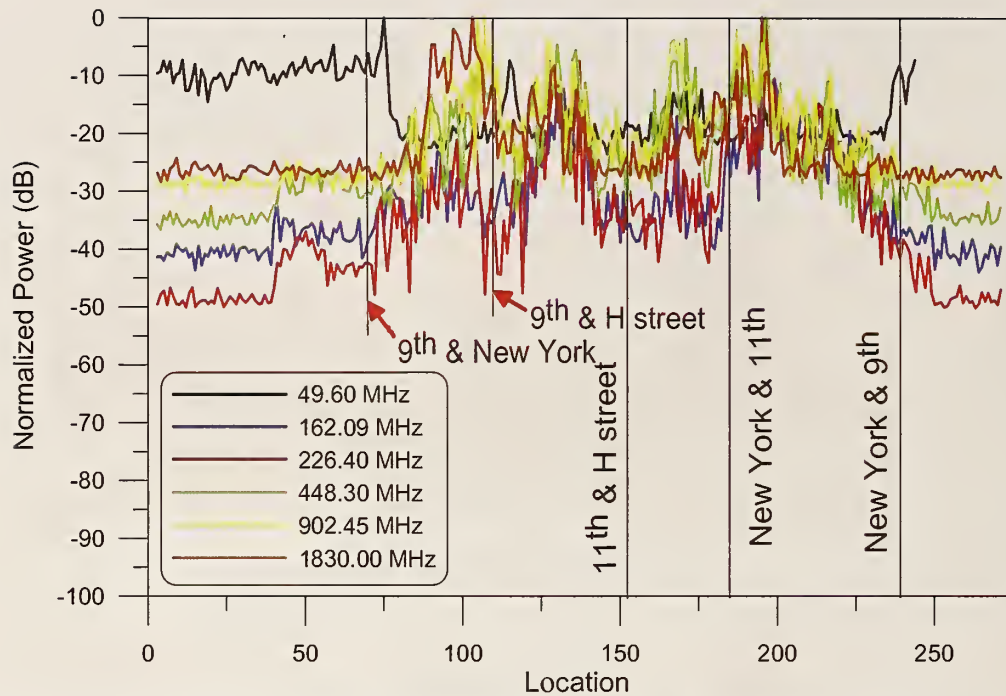
Figure 46. Normalized signal strength measurements around the perimeter of the convention center for the transmitters located at fixed site TX 1 and horizontal polarized receiving antennas. The streets on the perimeter of the convention center are labeled.

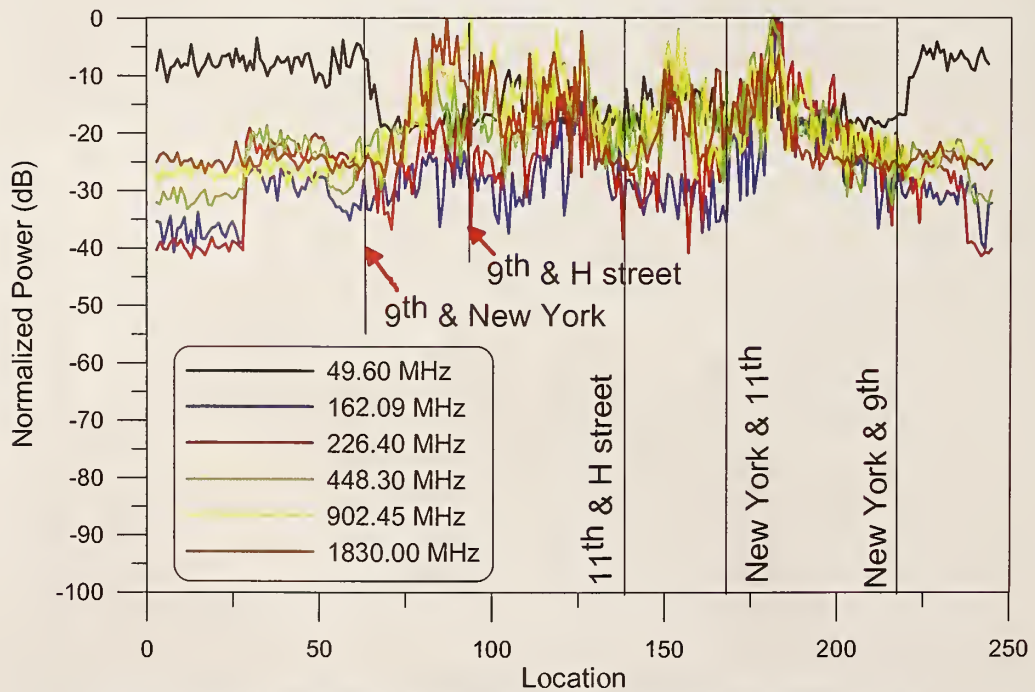
Figure 47. Normalized signal strength measurements around the perimeter of the convention center for the transmitters located at fixed site TX 1 and vertical polarized receiving antennas. The streets on the perimeter of the convention center are labeled.

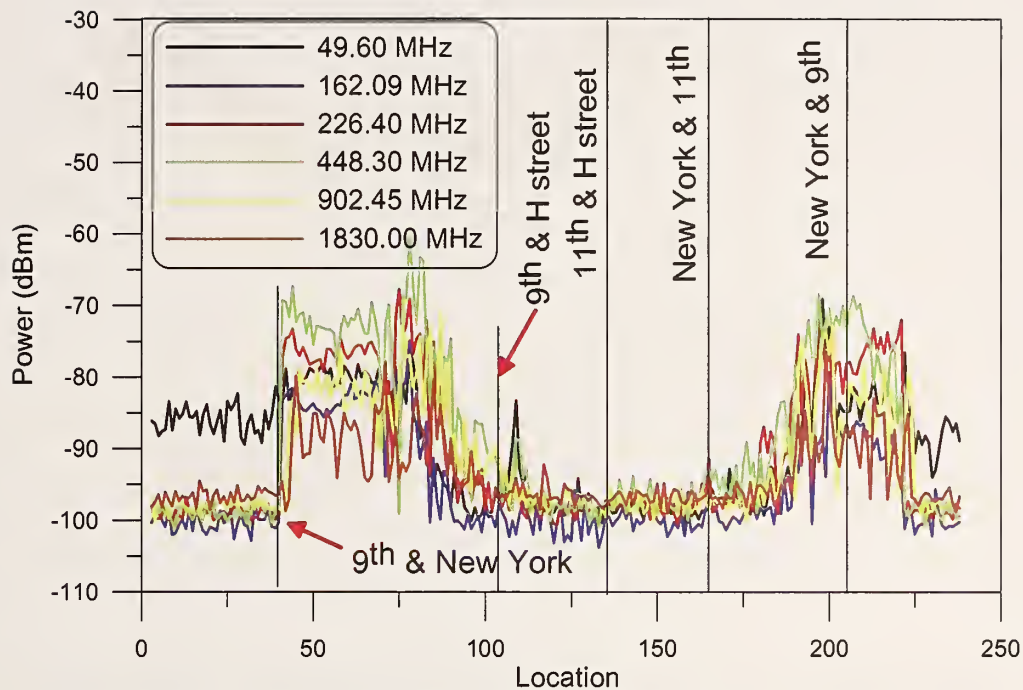
Figure 48. Signal strength measurements around the perimeter of the convention center for the transmitters located at fixed site TX 2 and horizontal polarized receiving antennas. The streets on the perimeter of the convention center are labeled.

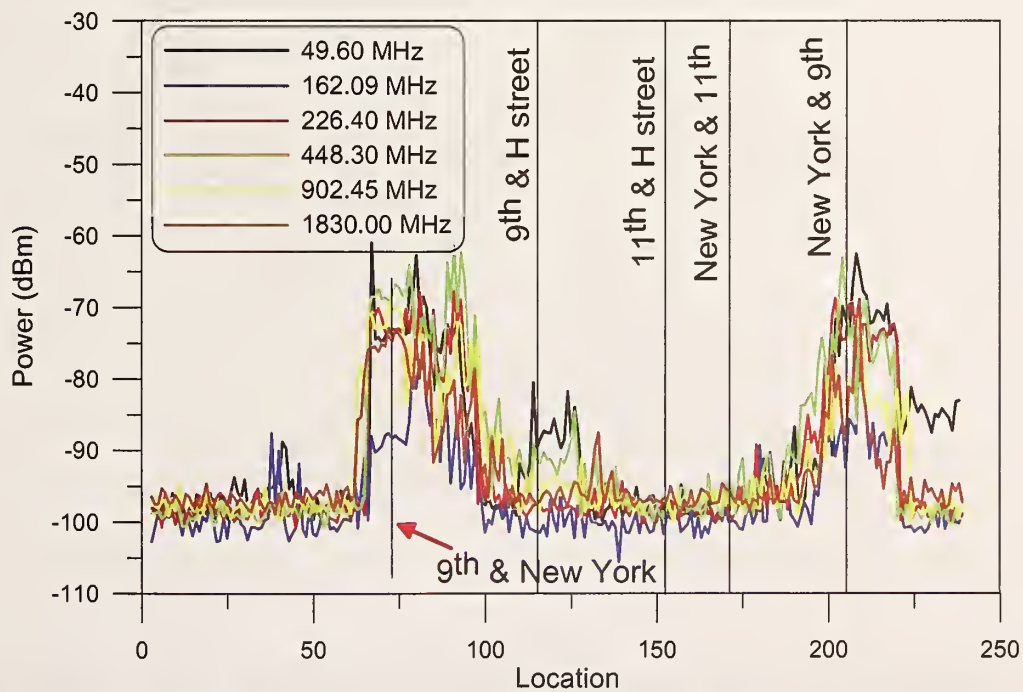
Figure 49. Signal strength measurements around the perimeter of the convention center for the transmitters located at fixed site TX 2 and vertical polarized receiving antennas. The streets on the perimeter of the convention center are labeled.

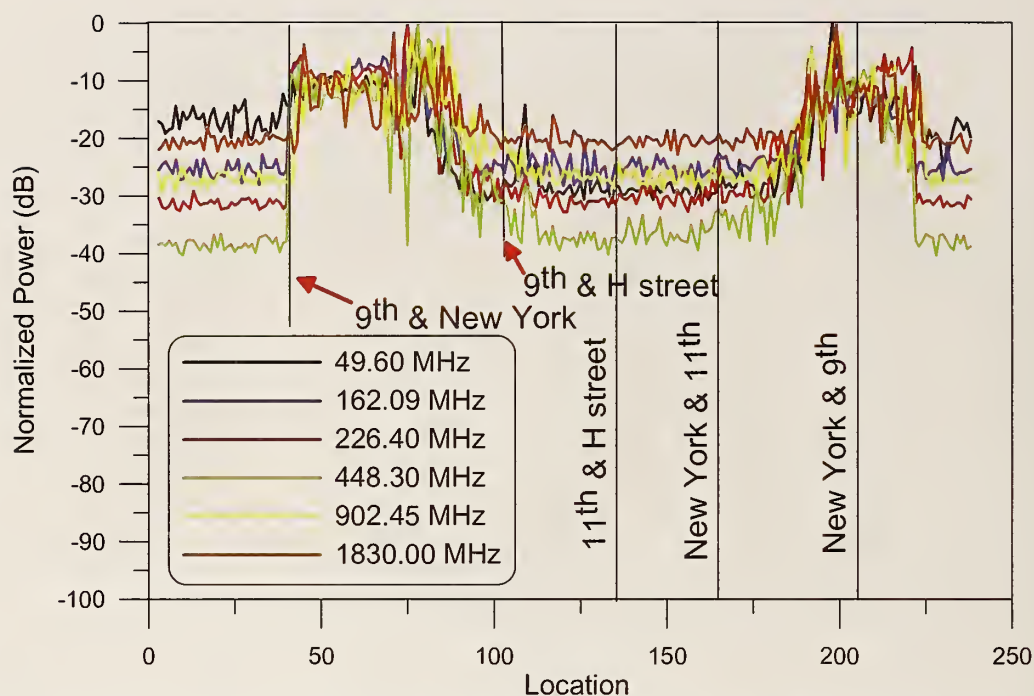
Figure 50. Normalized signal strength measurements around the perimeter of the convention center for the transmitters located at fixed site TX 2 and horizontal polarized receiving antennas. The streets on the perimeter of the convention center are labeled.

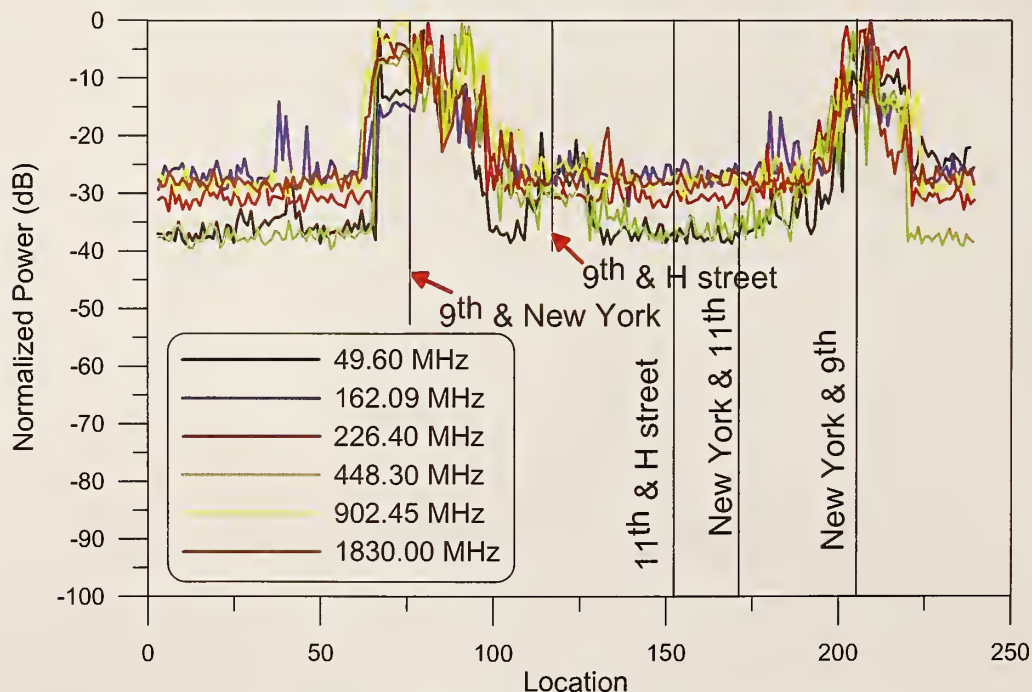
Figure 51. Normalized signal strength measurements around the perimeter of the convention center for the transmitters located at fixed site TX 2 and vertical polarized receiving antennas. The streets on the perimeter of the convention center are labeled.

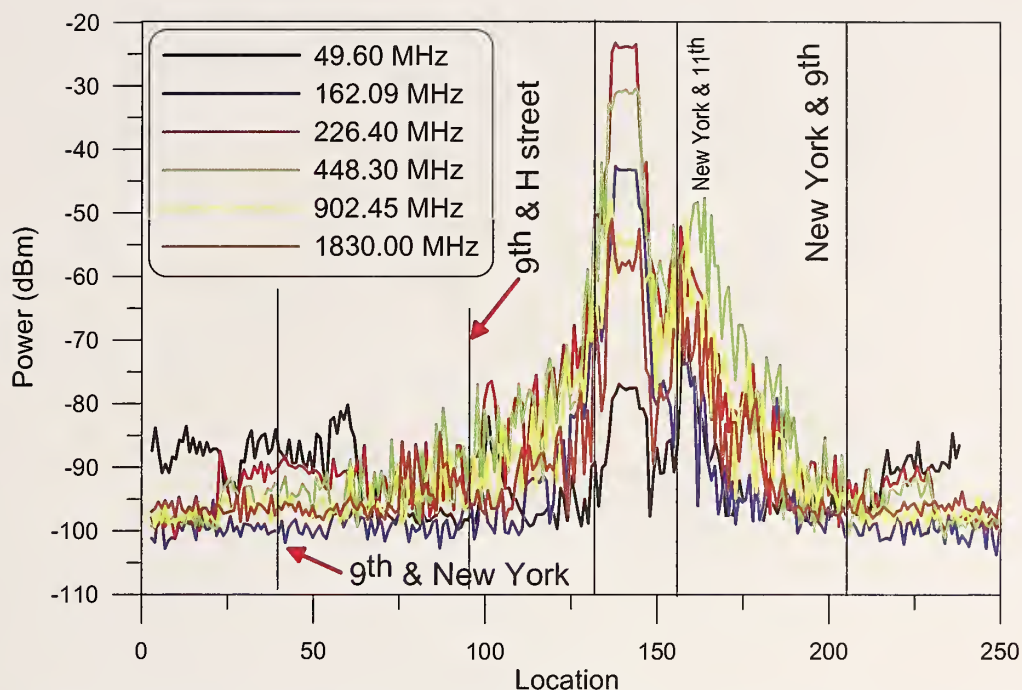
Figure 52. Signal strength measurements around the perimeter of the convention center for the transmitters located at fixed site TX 3 and horizontal polarized receiving antennas. The streets on the perimeter of the convention center are labeled.

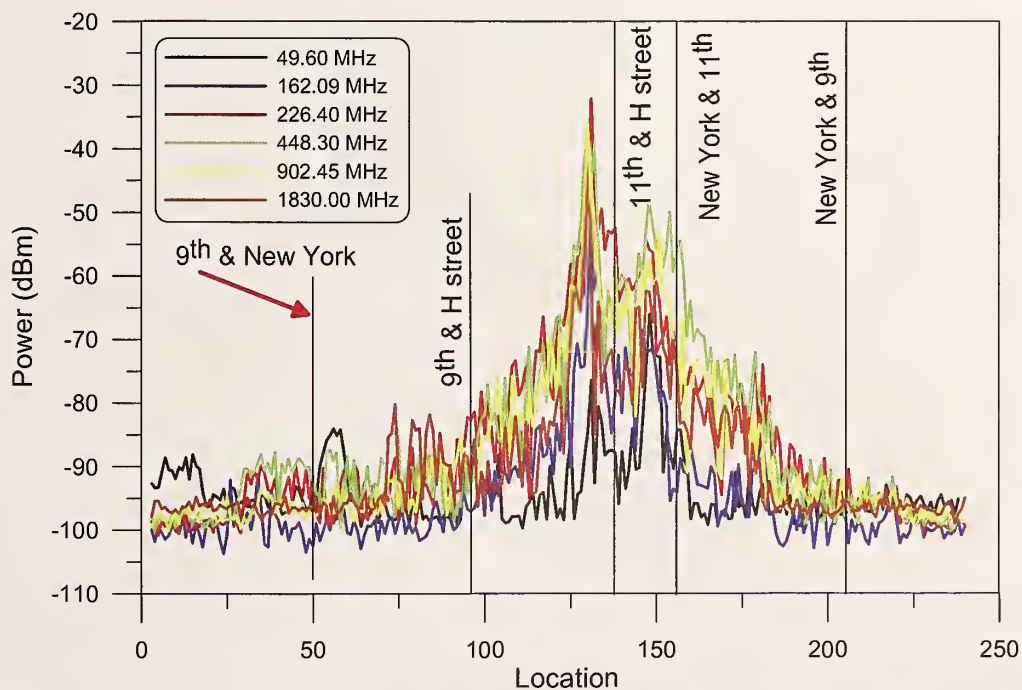
Figure 53. Signal strength measurements around the perimeter of the convention center for the transmitters located at fixed site TX 3 and vertical polarized receiving antennas. The streets on the perimeter of the convention center are labeled.

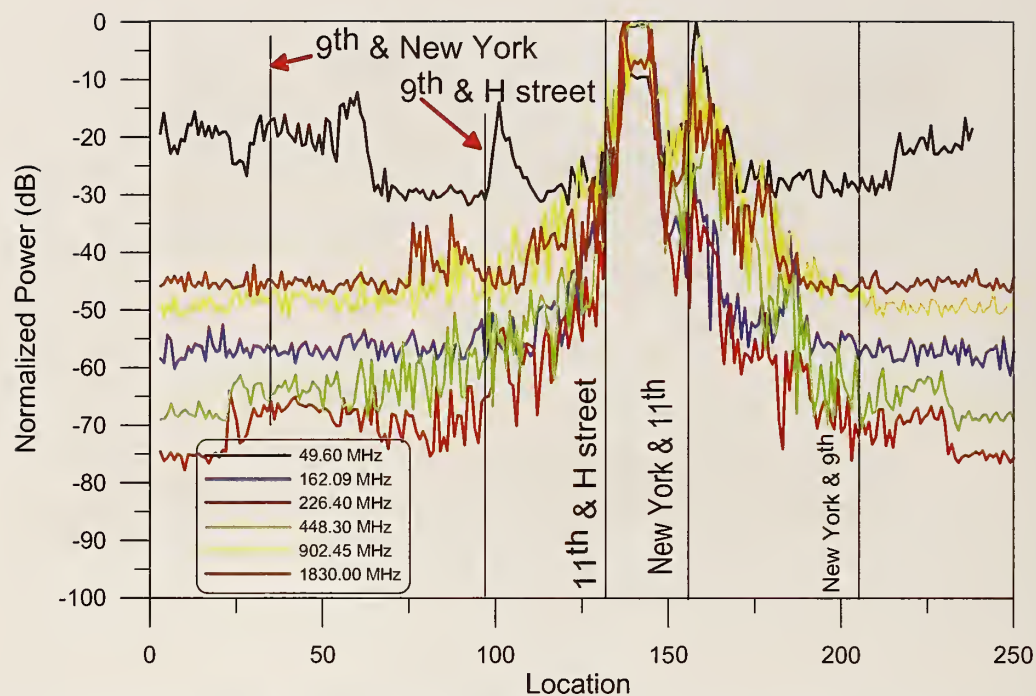
Figure 54. Normalized signal strength measurements around the perimeter of the convention center for the transmitters located at fixed site TX 3 and horizontal polarized receiving antennas. The streets on the perimeter of the convention center are labeled.

54 and 55 show the data in Figure 52 and 53 normalized with respect to the maximum received signal. From these plots, we see that the convention center structural material causes the signal to vary by as much as 70 dB around the convention center perimeter.

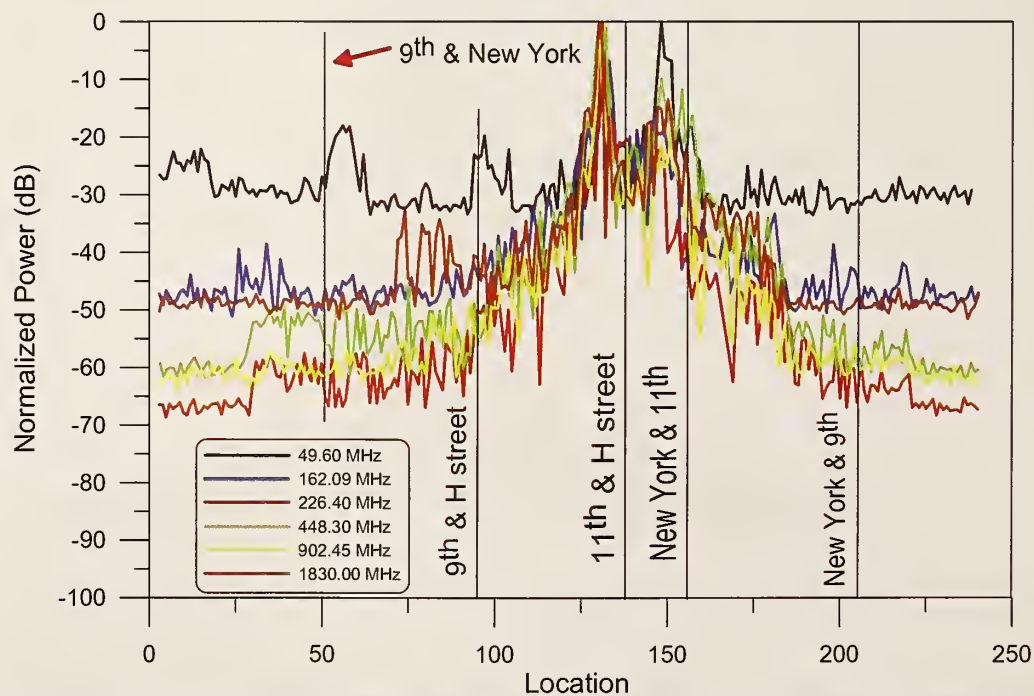
Figure 55. Normalized signal strength measurements around the perimeter of the convention center for the transmitters located at fixed site TX 3 and vertical polarized receiving antennas. The streets on the perimeter of the convention center are labeled.

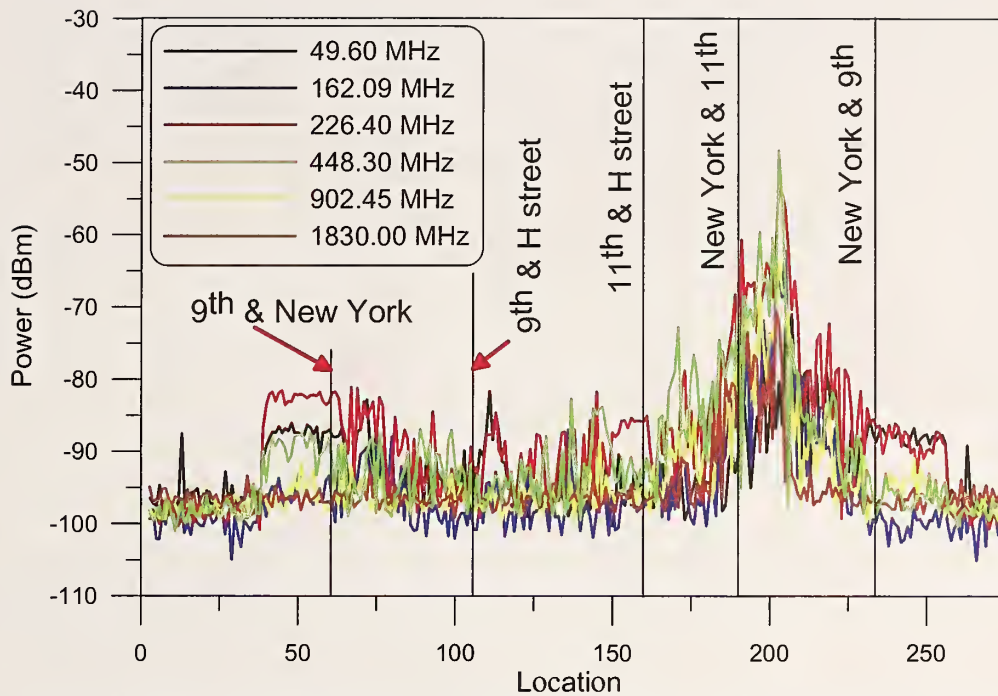
Figure 56. Signal strength measurements around the perimeter of the convention center for the transmitters located at fixed site TX 4 and horizontal polarized receiving antennas. The streets on the perimeter of the convention center are labeled.

Figures 56 and 57 show the variability in the received signal strength around the perimeter of the convention center for all six frequencies for transmitters located at fixed site TX 4. These two figures are for horizontally and vertically polarized receiving antennas, respectively. Figures 58 and 59 show the data in Figures 56 and 57 normalized with respect to the maximum received signal. These two plots show the relative variability in the signal strength as the cart is moved around the convention center. We see that the convention center structural material causes the signal to vary by as much as 50 dB around the convention center perimeter.

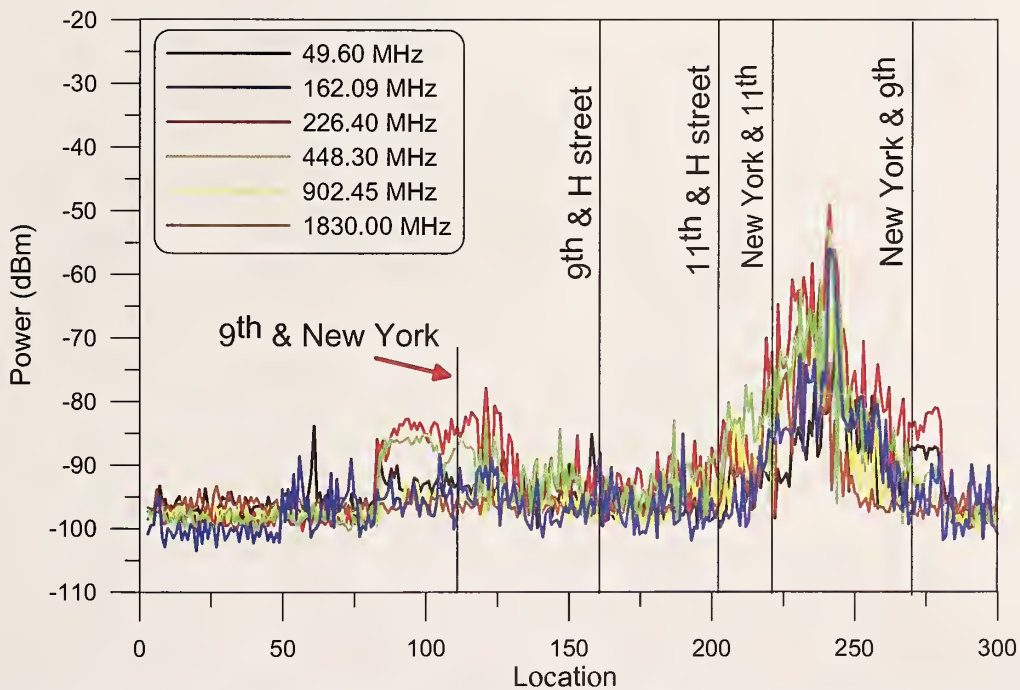
Figure 57. Signal strength measurements around the perimeter of the convention center for the transmitters located at fixed site TX 4 and vertical polarized receiving antennas. The streets on the perimeter of the convention center are labeled.

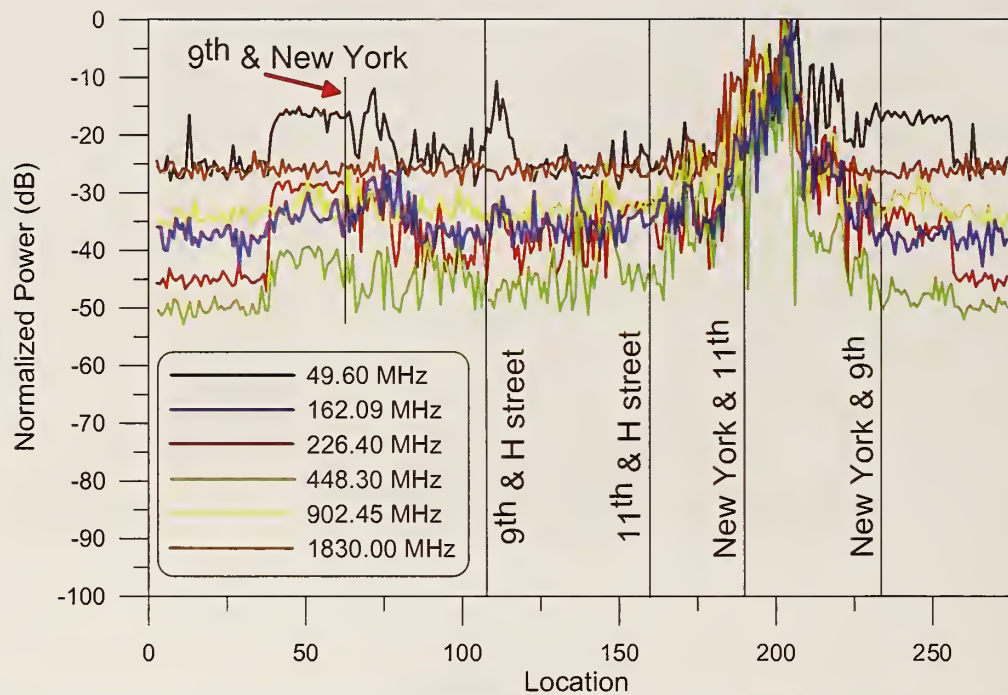
Figure 58. Normalized signal strength measurements around the perimeter of the convention center for the transmitters located at fixed site TX 4 and horizontal polarized receiving antennas. The streets on the perimeter of the convention center are labeled.

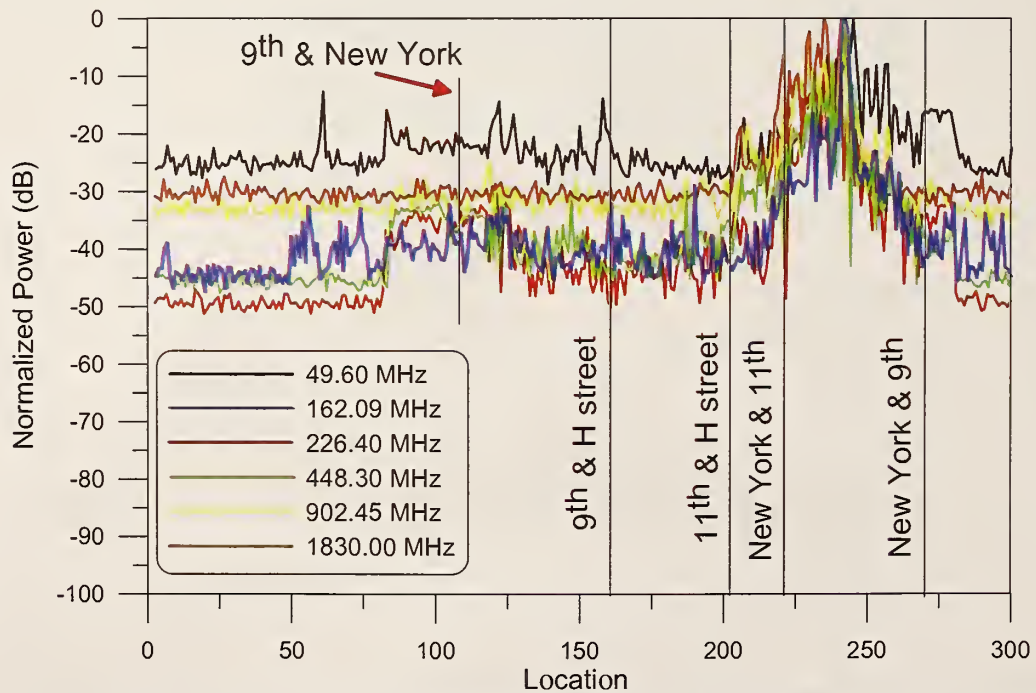
Figure 59. Normalized signal strength measurements around the perimeter of the convention center for the transmitters located at fixed site TX 4 and vertical polarized receiving antennas. The streets on the perimeter of the convention center are labeled.

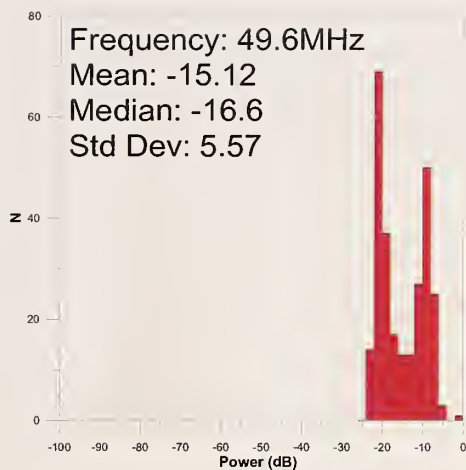
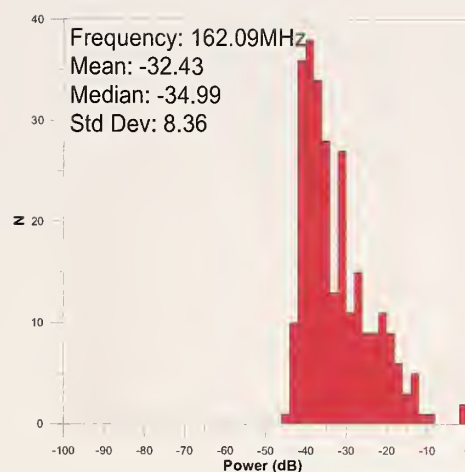
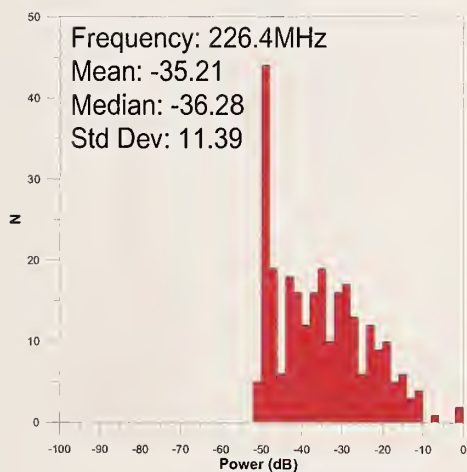
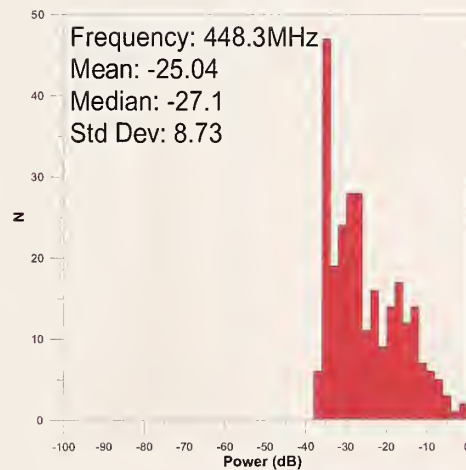
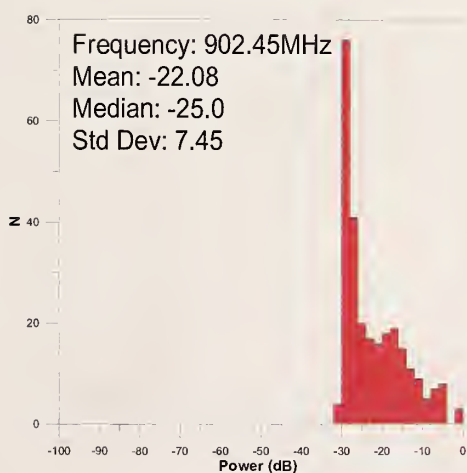
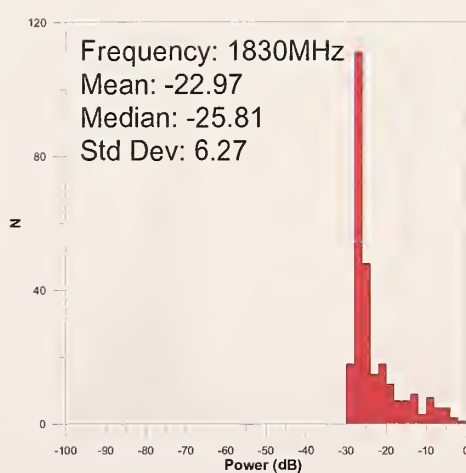
Figure 60. Histograms for the normalized perimeter measurements for site TX 1 fixed transmitters and horizontally polarized receiving antennas.

The results in the previous section illustrate that the pre-implosion received field strengths varied by as much as 50 to 70 dB around the perimeter of the convention center. In this section, some statistics of the field strength variability around the perimeter are investigated. The first set of data analyzed is for fixed transmitter site TX 1 (data in Figures 46 and 47). The histograms (2 dB bin size) for this dataset are shown in Figures 60 and 61, for horizontally and vertically polarized receiving antennas, respectively. Note that the histograms were generated from the normalized data. This presents the typical variability that would be seen for a communication system carried around the perimeter. Tables 9 and 10 summarize the mean and median received signal strength and the standard deviation for each frequency. Once again, this is not the total attenuation resulting from coupling into the convention center, but only the signal variability a communication system would experience.

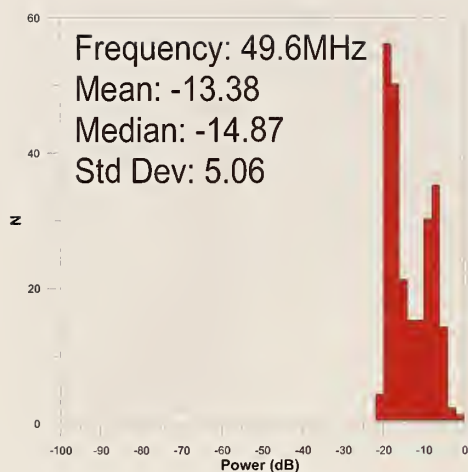
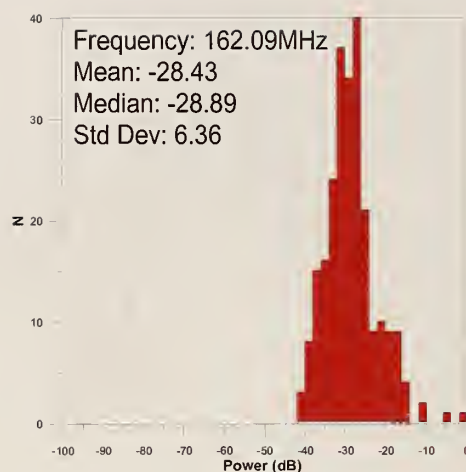
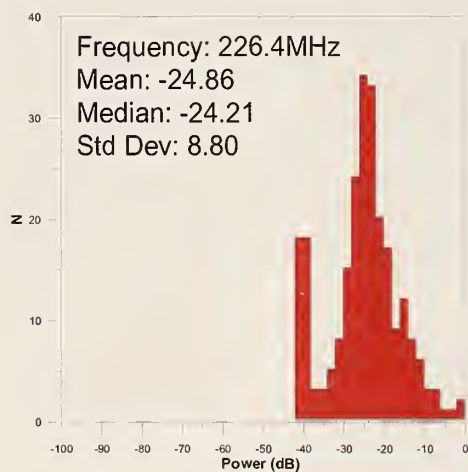
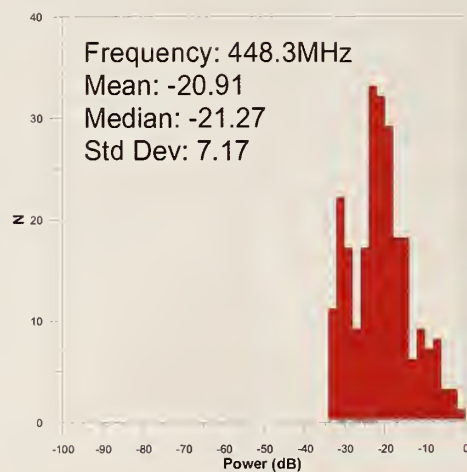
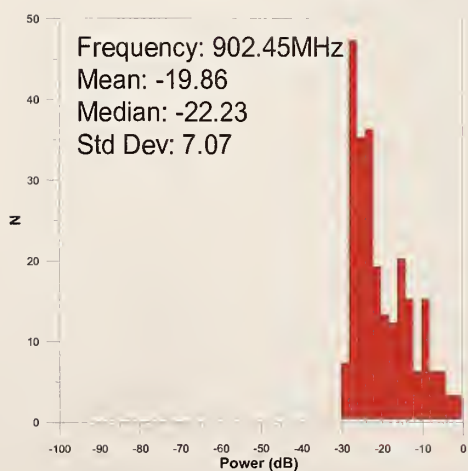
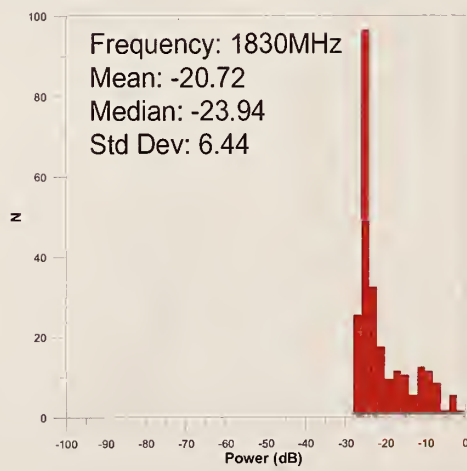
Figure 61. Histograms for the normalized perimeter measurements for site TX 1 fixed transmitters and vertically polarized receiving antennas.

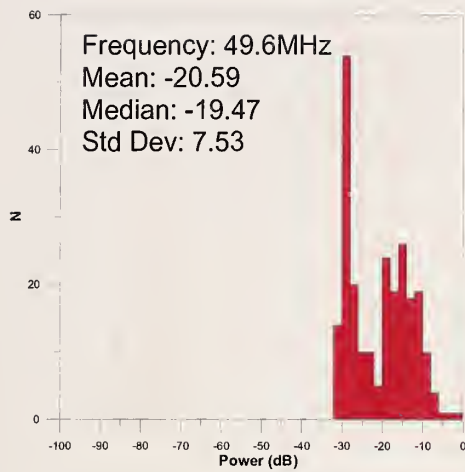
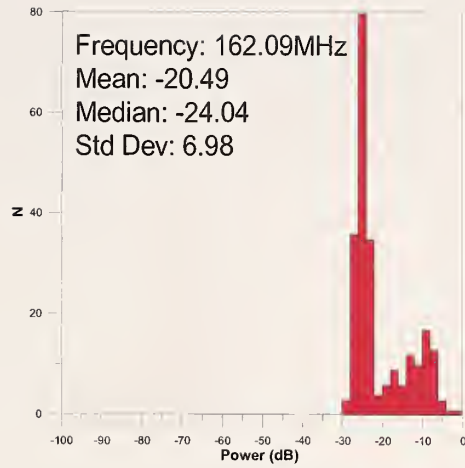
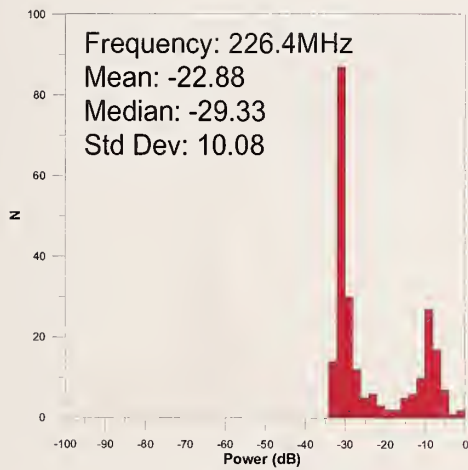
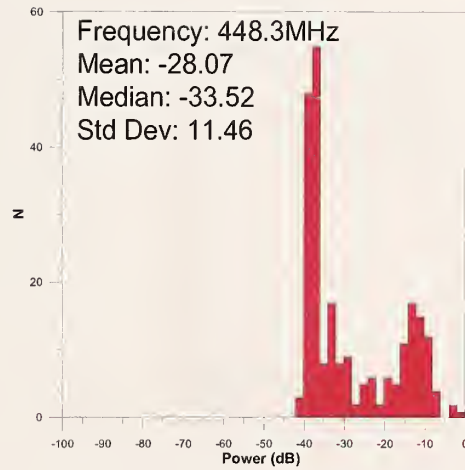
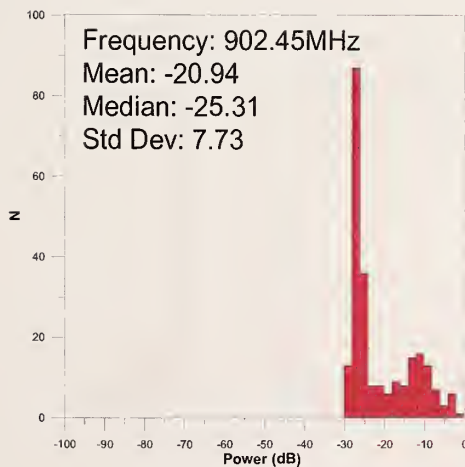
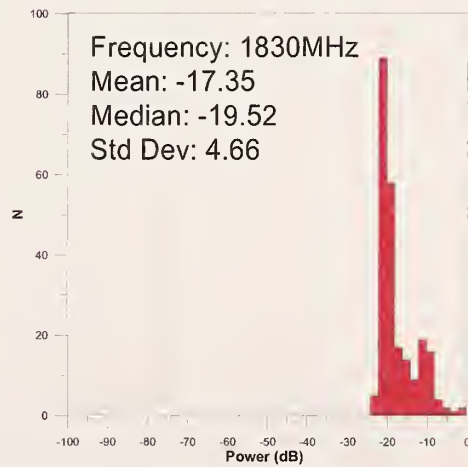
Figure 62. Histograms for the normalized perimeter measurements for site TX 2 fixed transmitters and horizontally polarized receiving antennas.

The next set of data analyzed is for fixed transmitter site TX 2 (normalized data in Figures 50 and 51). The histograms (2 dB bin size) for this dataset are shown in Figures 62 and 63, for horizontally and vertically polarized receiving antennas, respectively. Note the histograms were generated from the normalized data. This would be the actual variability that would be seen for a communication system carried around the perimeter. Tables 11 and 12 summarize the mean and median received signal strength and the standard deviation for each frequency.
