NIST Technical Note 1542

Propagation and Detection of Radio Signals Before, During, and After the Implosion of a Large Convention Center

Electromagnetics Division
National Institute of Standards and Technology
325 Broadway
Boulder, CO 80305

June 2006

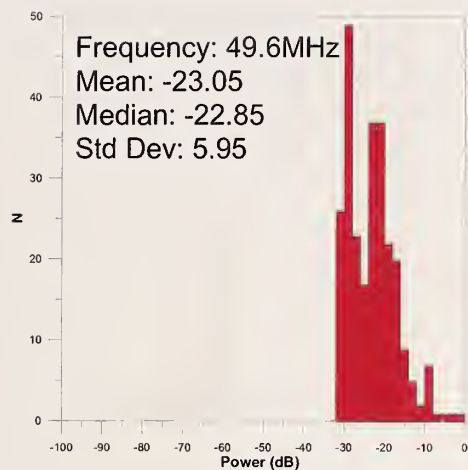
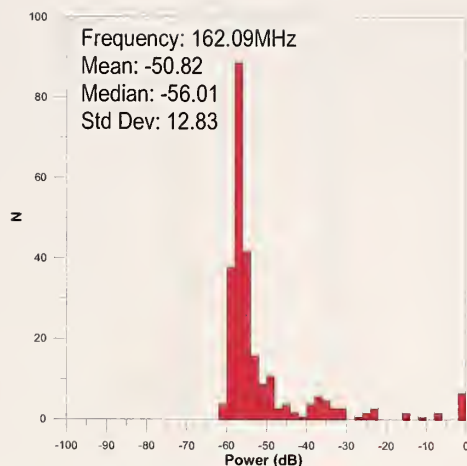
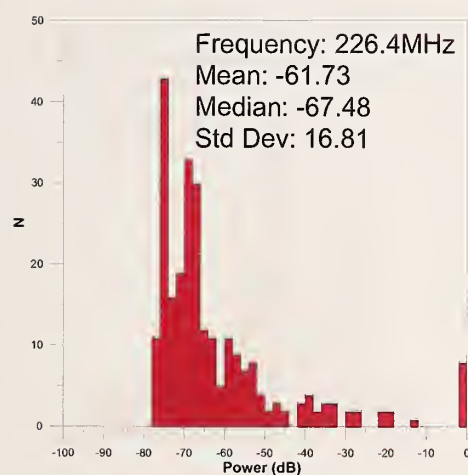
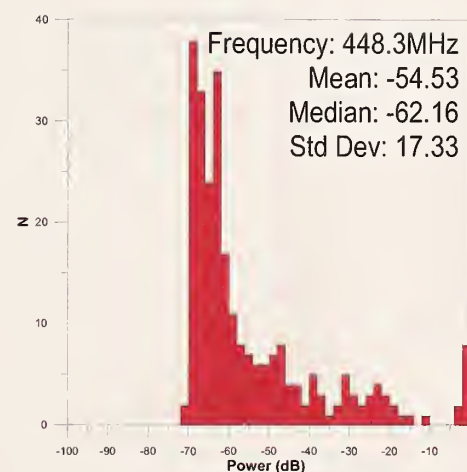
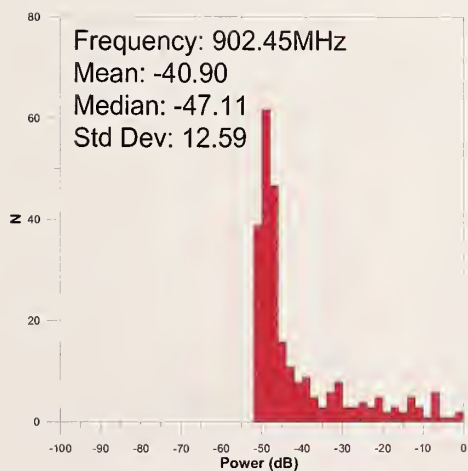
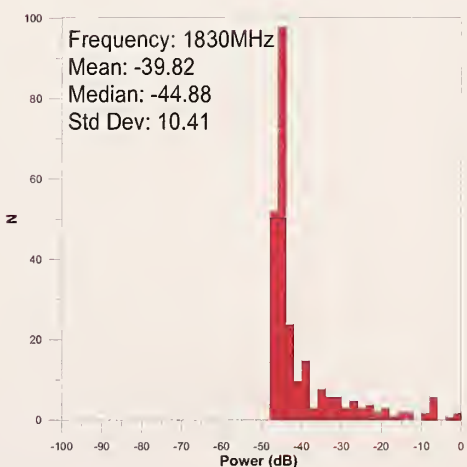
Figure 64. Histograms for the normalized perimeter measurements for site TX 3 fixed transmitters and horizontally polarized receiving antennas.

The next set of data analyzed is for fixed transmitter site TX 3 (normalized data in Figures 54 and 55). The histograms (2 dB bin size) for this dataset are shown in Figures 64 and 65, for horizontally and vertically receiving antennas, respectively. Note that the histograms were generated from the normalized data. Tables 12 and 13 summarize the mean and median received signal strength and the standard deviation for each frequency.

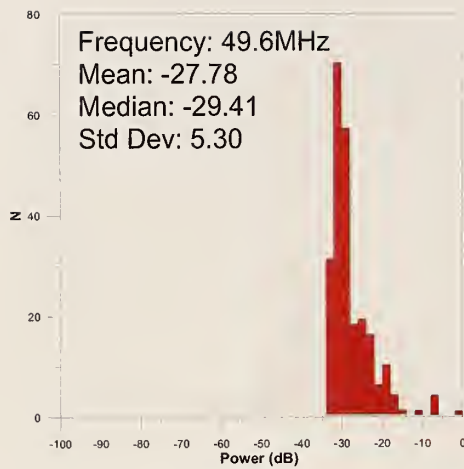
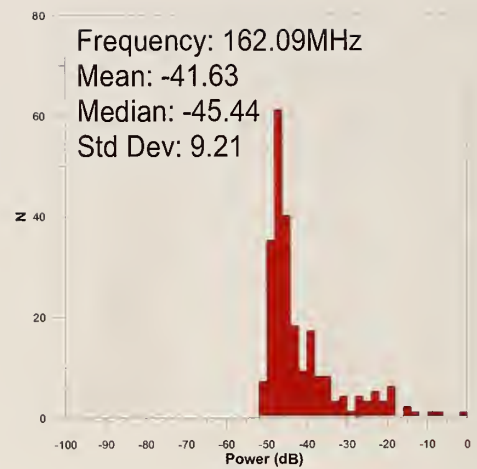
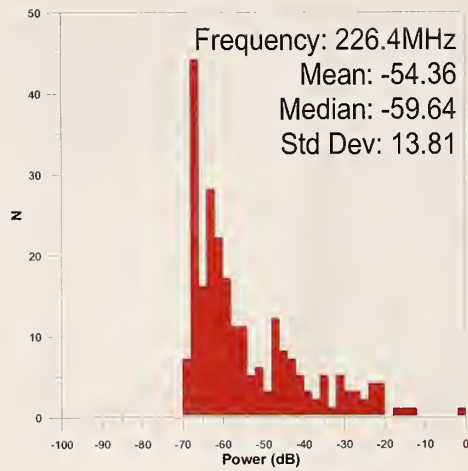
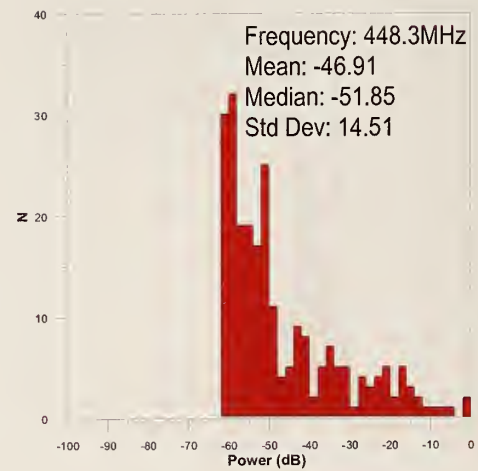
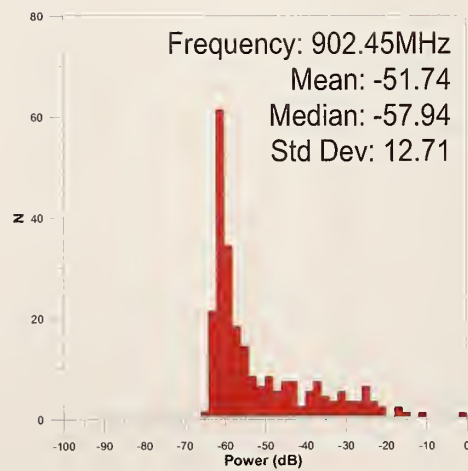
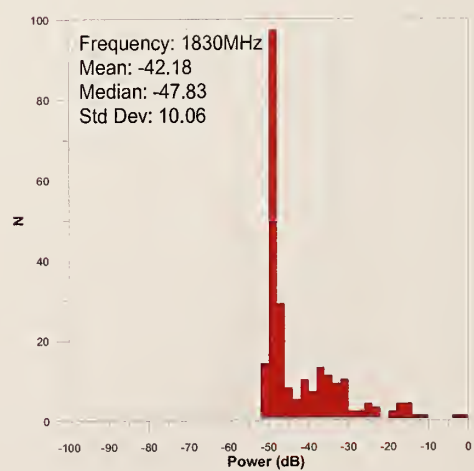
Figure 65. Histograms for the normalized perimeter measurements for site TX 3 fixed transmitters and vertically polarized receiving antennas.

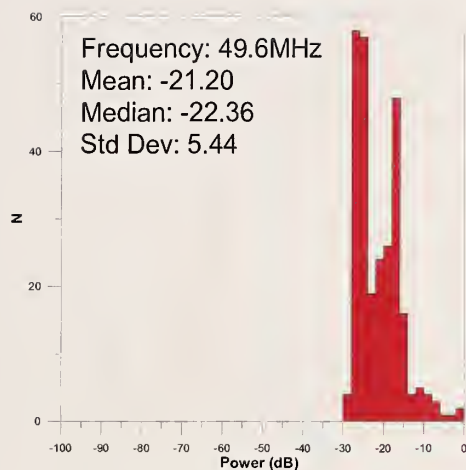
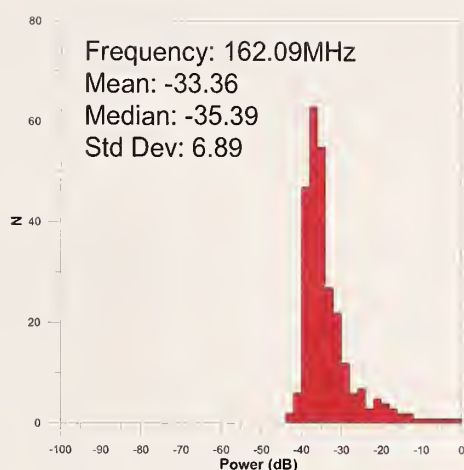
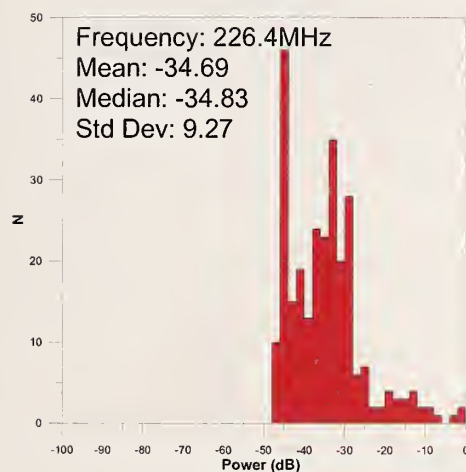
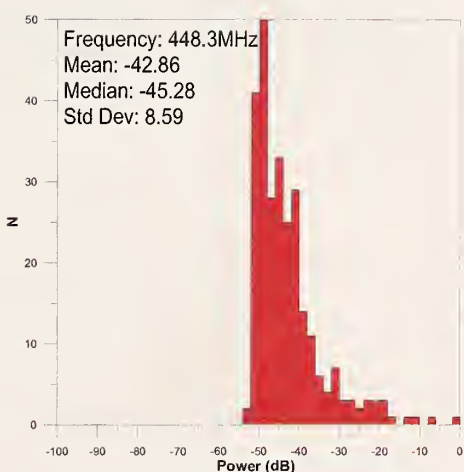
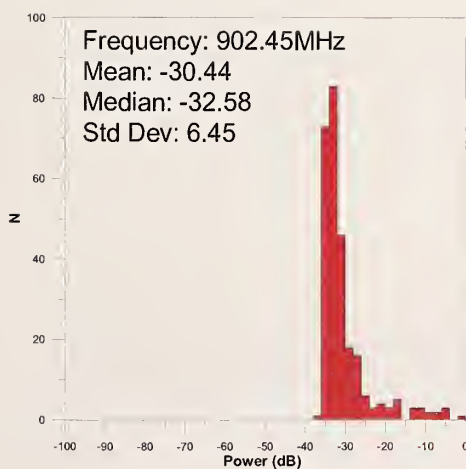
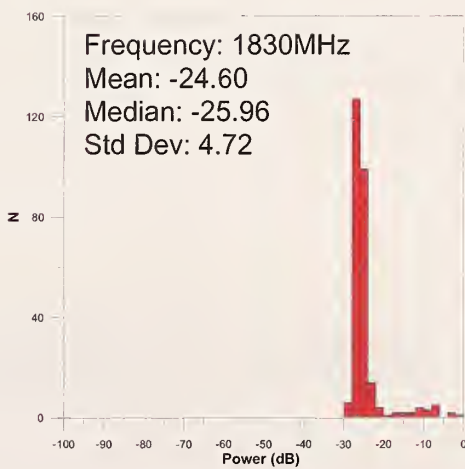
Figure 66. Histograms for the normalized perimeter measurements for site TX 4 fixed transmitters and horizontally polarized receiving antennas.

The next set of data analyzed is for fixed transmitter site TX 4 (normalized data in Figures 58 and 59). The histograms (2 dB bin size) for this dataset are shown in Figures 66 and 67, for horizontally and vertically polarized receiving antennas, respectively. Note the histograms were generated from the normalized data. Tables 14 and 15 summarize the mean and median received signal strength and the standard deviation for each frequency.

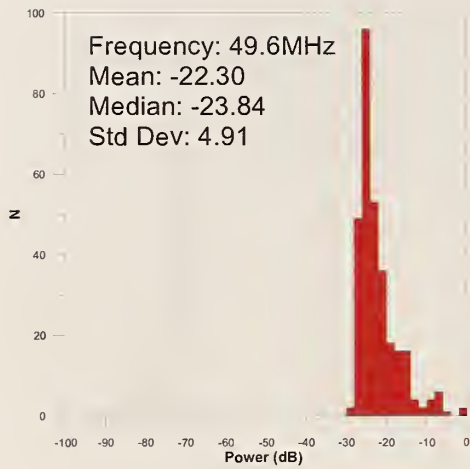
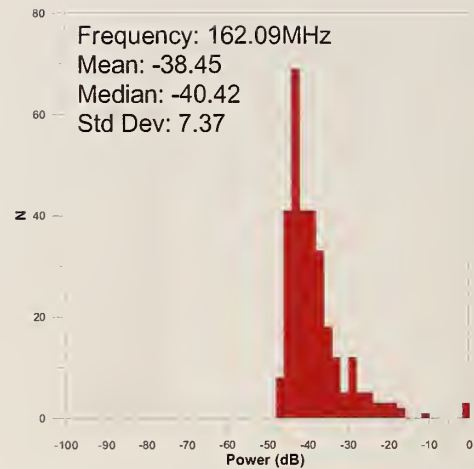
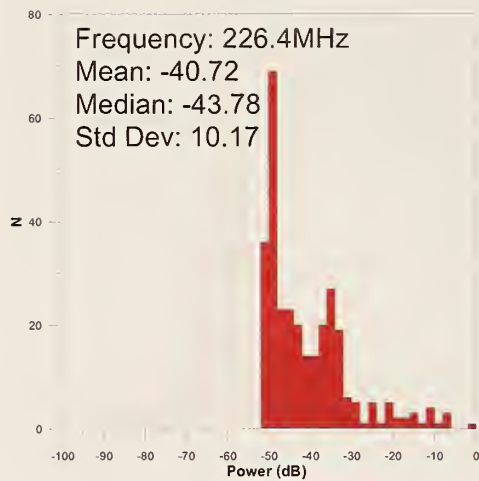
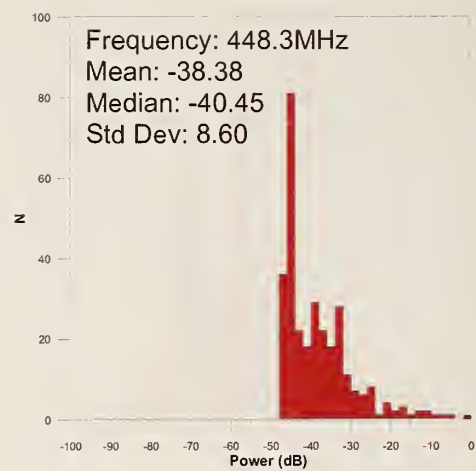
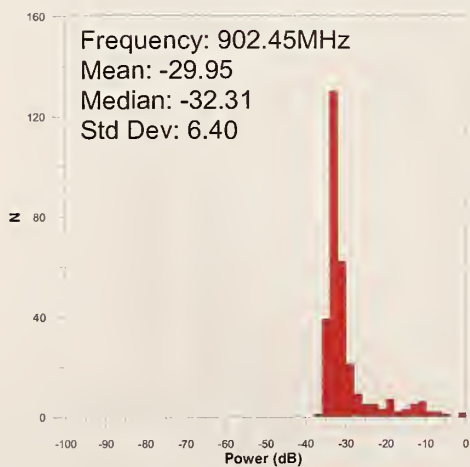
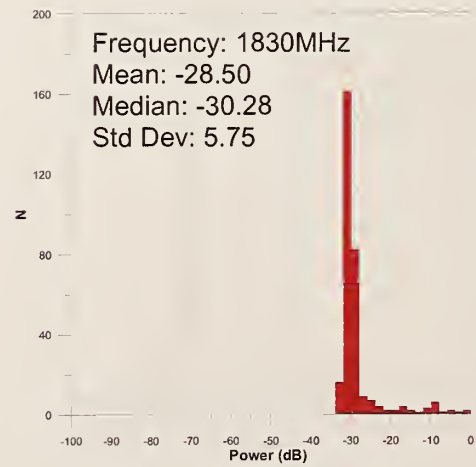
Figure 67. Histograms for the normalized perimeter measurements for site TX 4 fixed transmitters and vertically polarized receiving antennas.

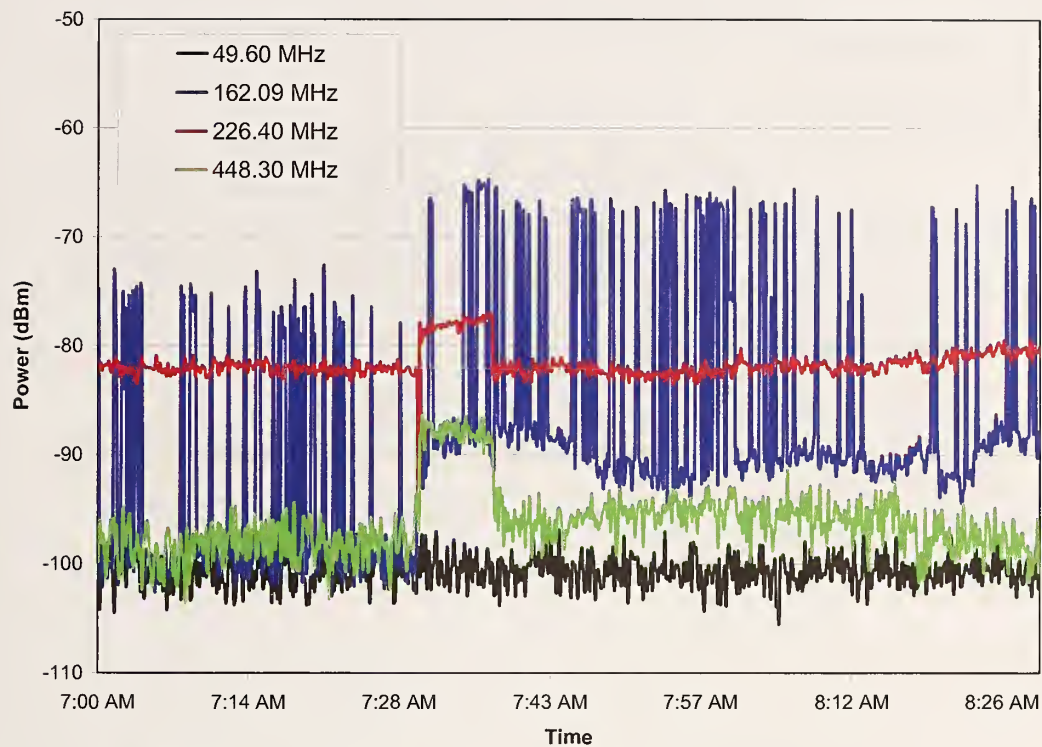
Figure 68. Pre- and post-implosion data collected from receiver site RX 1 for the transmitters located at site TX 1.

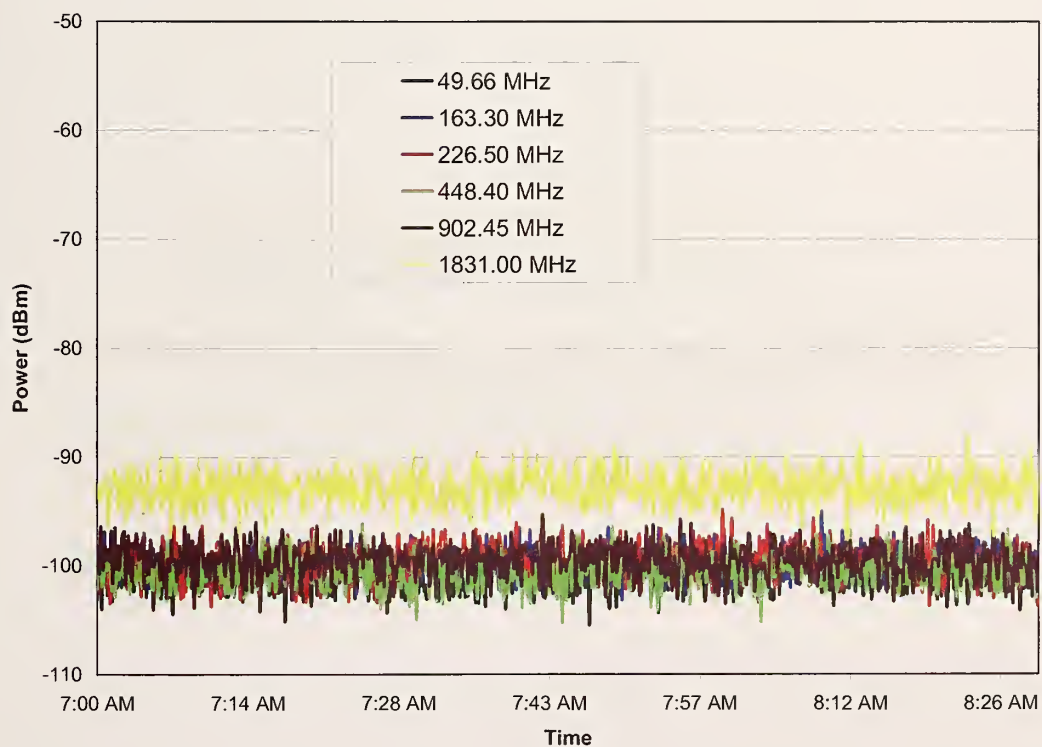
Figure 69. Pre- and post-implosion data collected from receiver site RX 1 for the transmitters located at site TX 2.

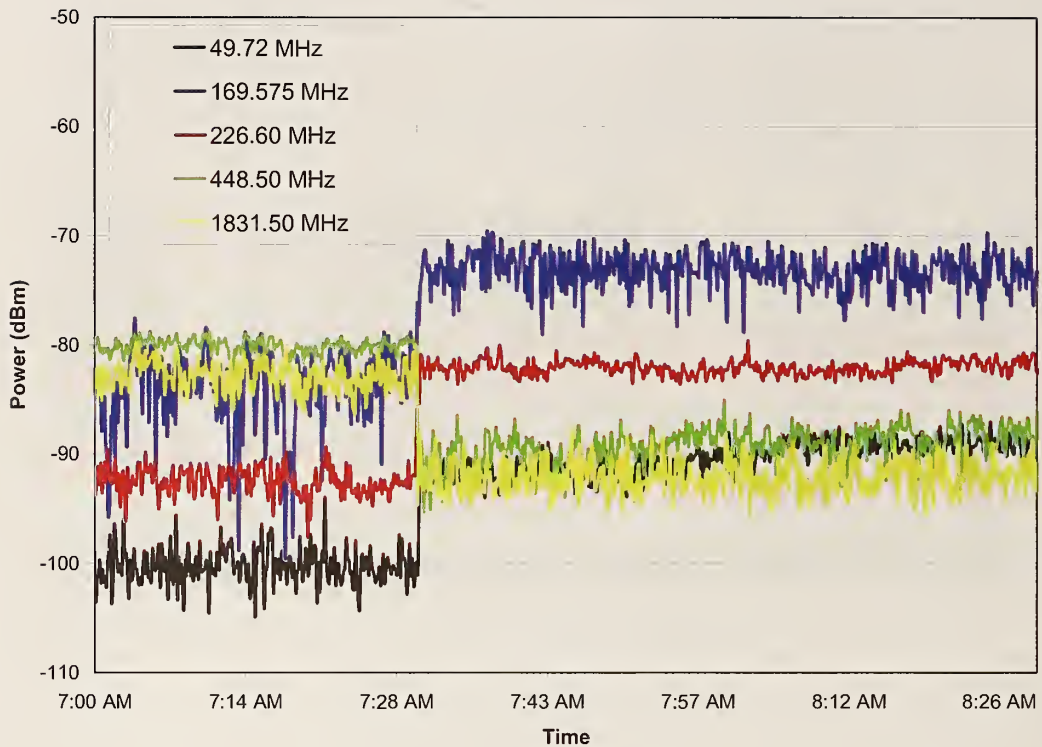
Figure 70. Pre- and post-implosion data collected from receiver site RX 1 for the transmitters located at site TX 3.

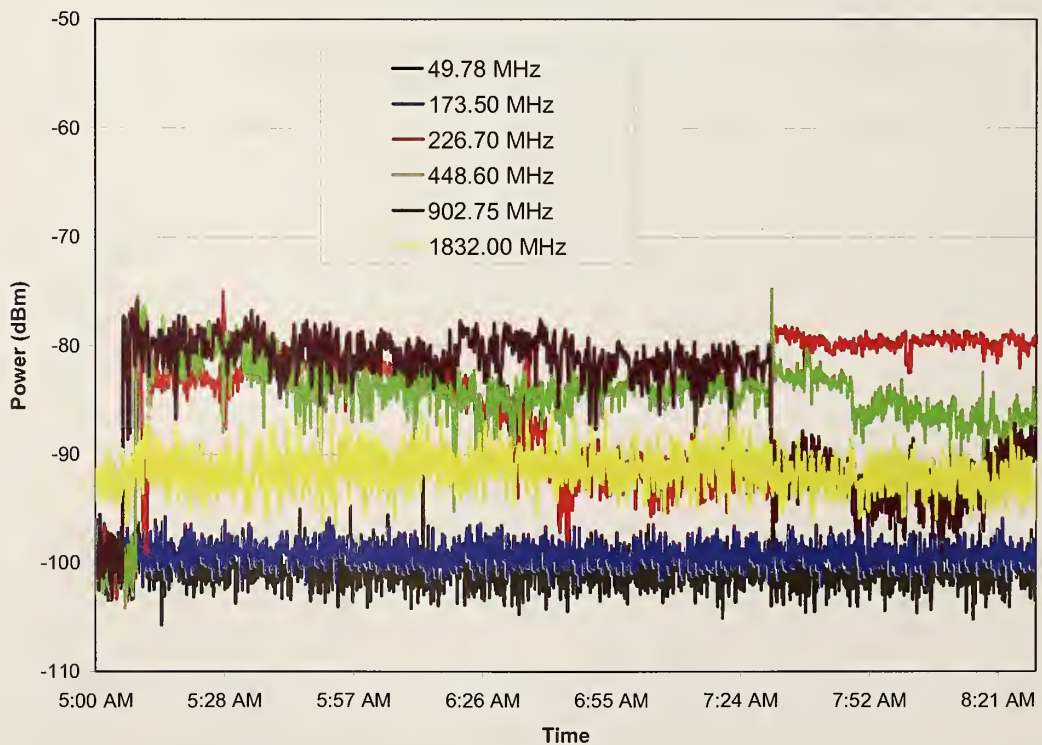
Figure 71. Pre- and post-implosion data collected from receiver site RX 1 for the transmitters located at site TX 4.

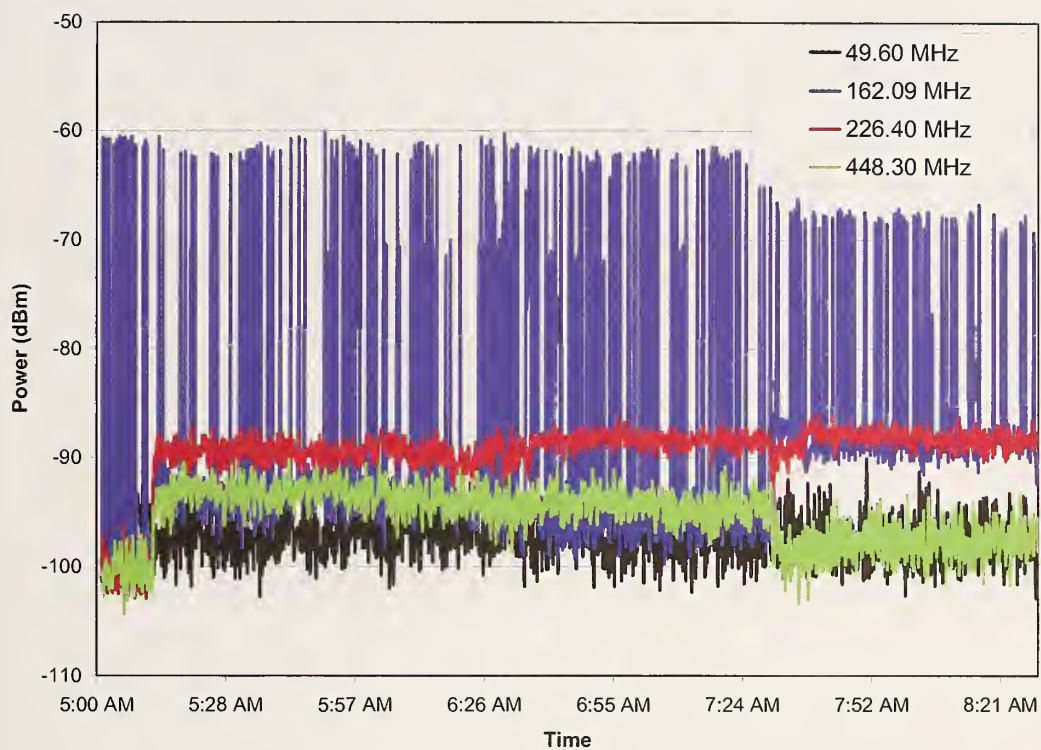
Figure 72. Pre- and post-implosion data collected from receiver site RX 2 for the transmitters located at site TX 1.

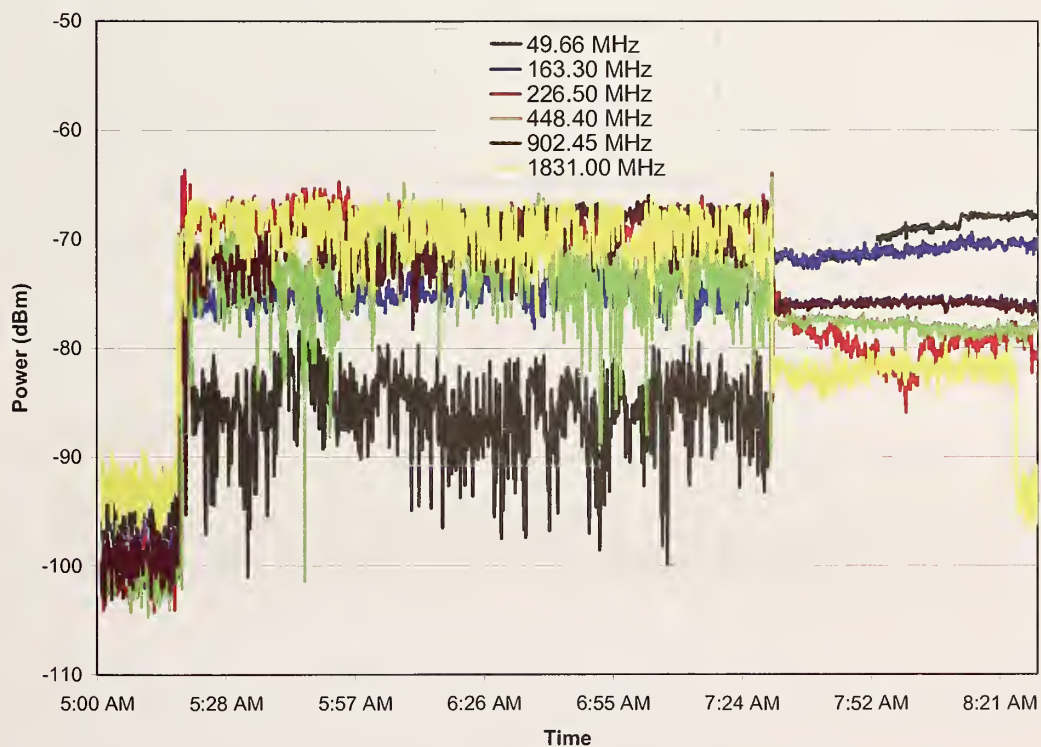
Figure 73. Pre- and post-implosion data collected from receiver site RX 2 for the transmitters located at site TX 2.

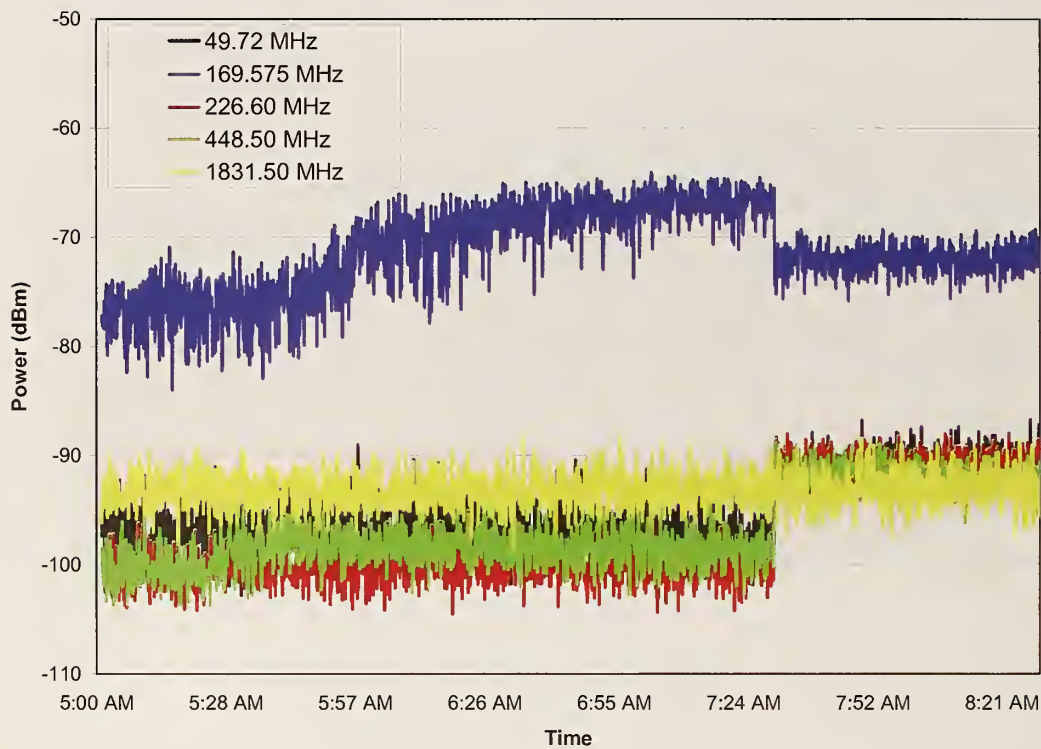
Figure 74. Pre- and post-implosion data collected from receiver site RX 2 for the transmitters located at site TX 3.

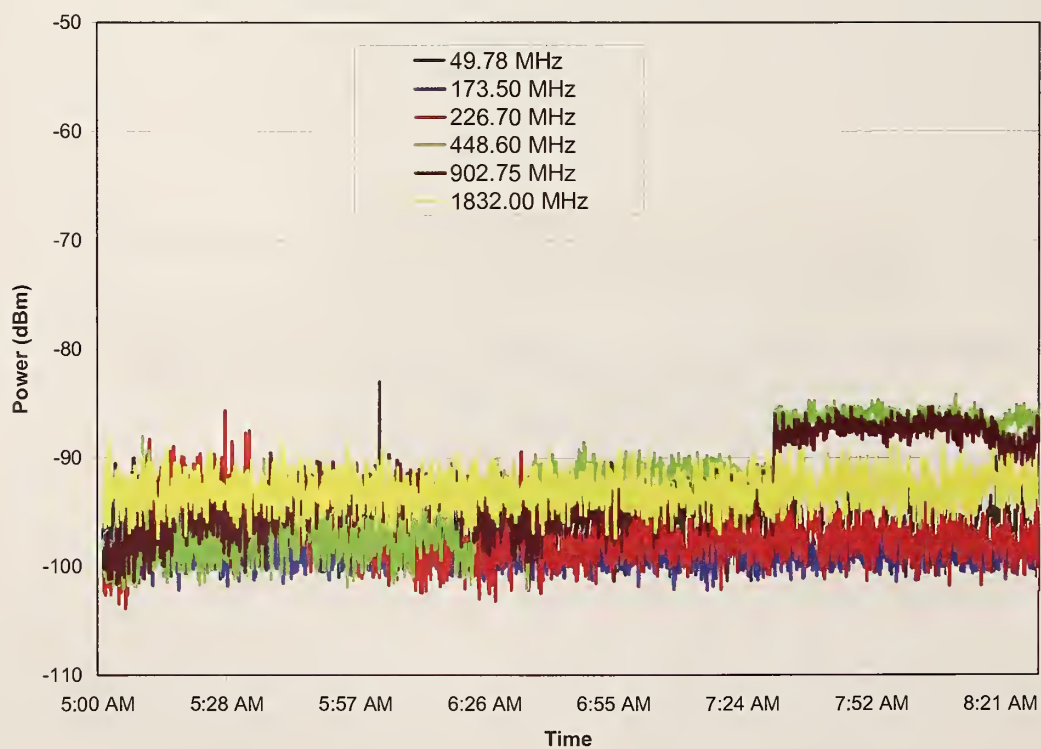
Figure 75. Pre- and post-implosion data collected from receiver site RX 2 for the transmitters located at site TX 4.

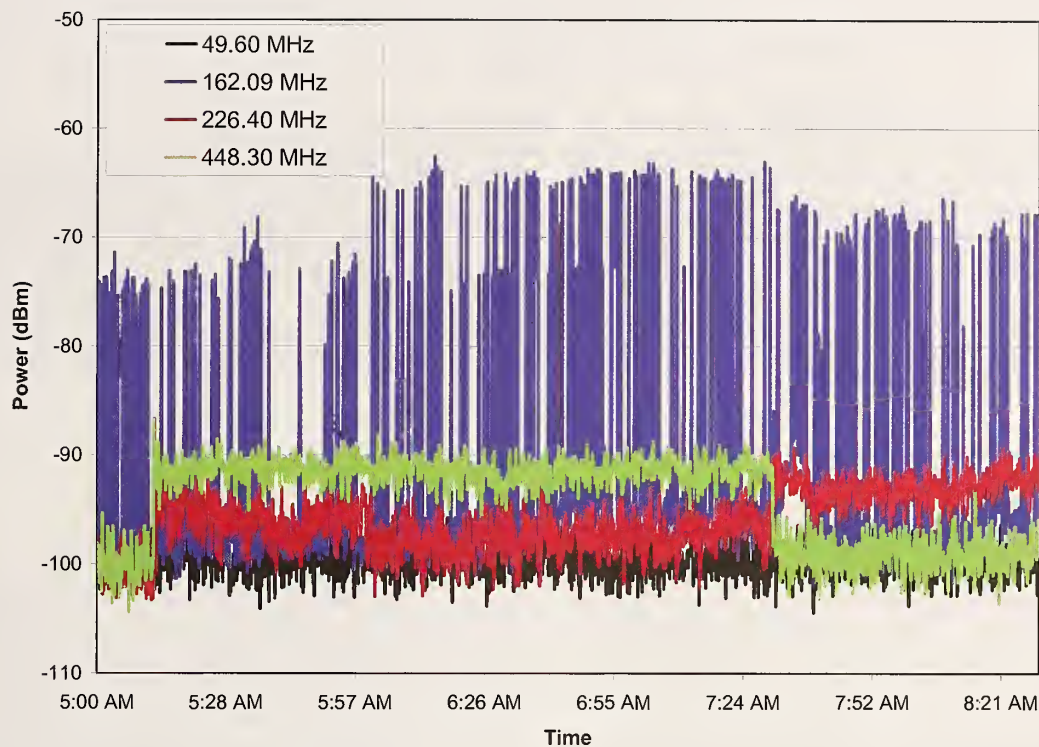
Figure 76. Pre- and post-implosion data collected from receiver site RX 3 for the transmitters located at site TX 1.

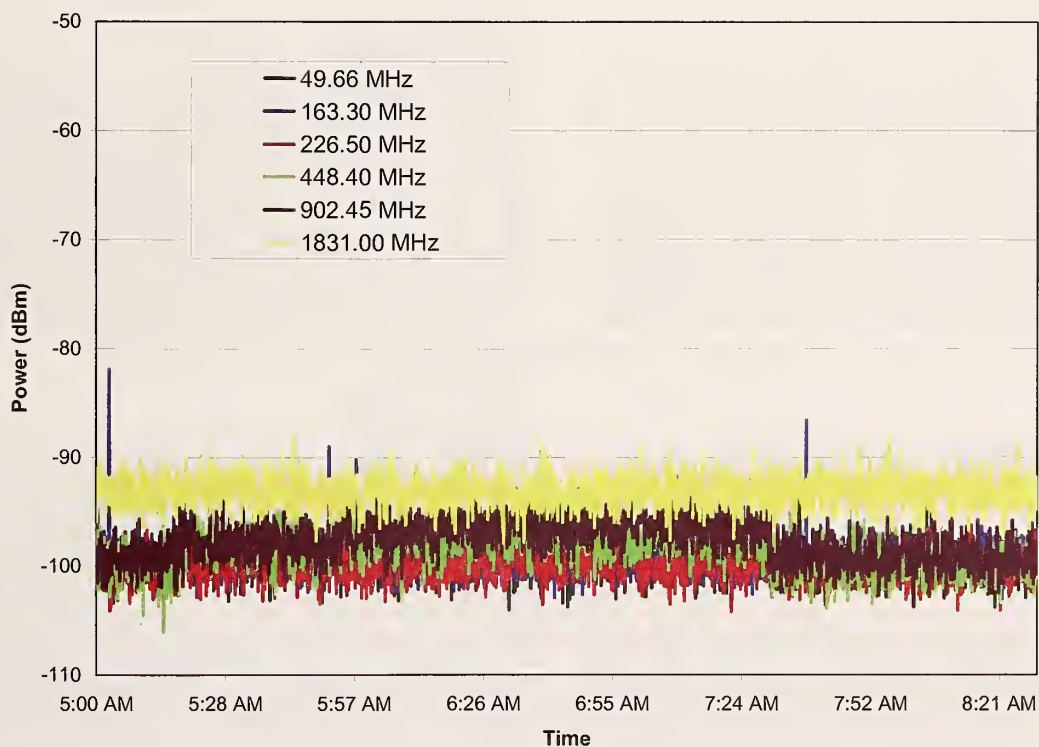
Figure 77. Pre- and post-implosion data collected from receiver site RX 3 for the transmitters located at site TX 2.

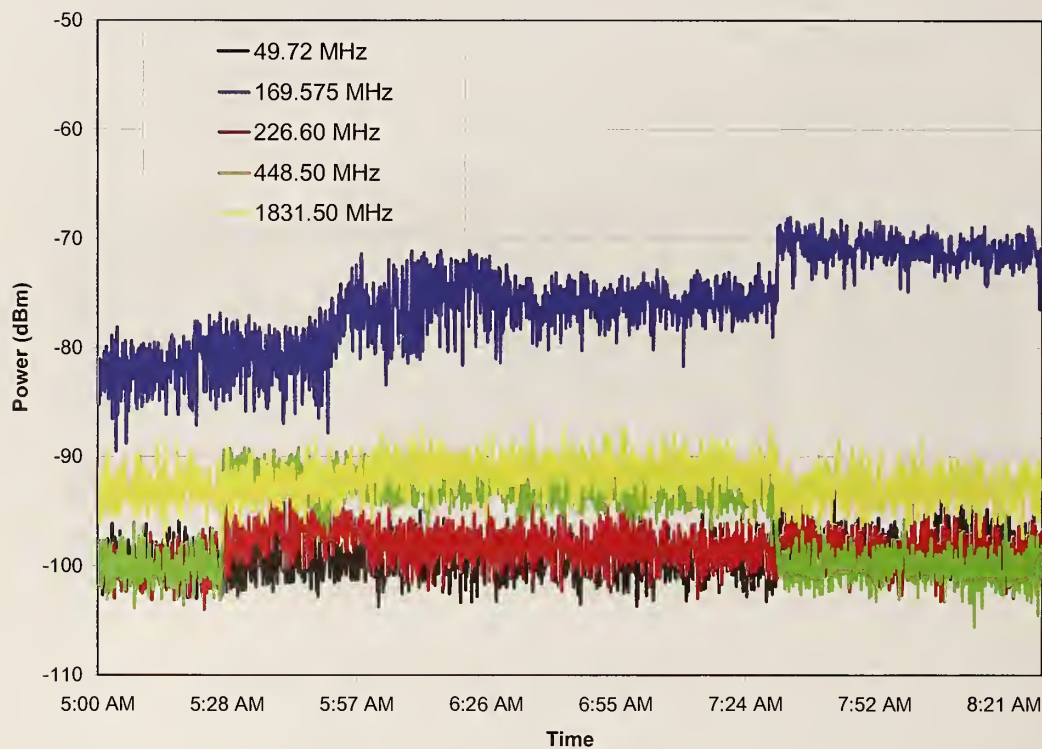
Figure 78. Pre- and post-implosion data collected from receiver site RX 3 for the transmitters located at site TX 3.

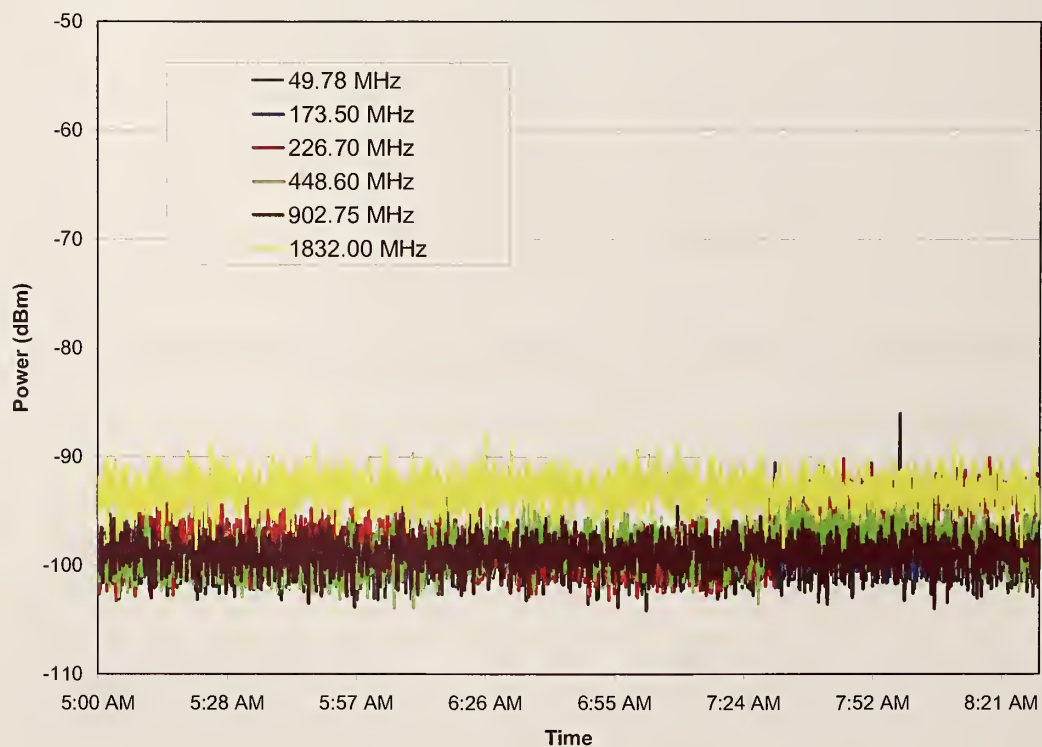
Figure 79. Pre- and post-implosion data collected from receiver site RX 3 for the transmitters located at site TX 4.

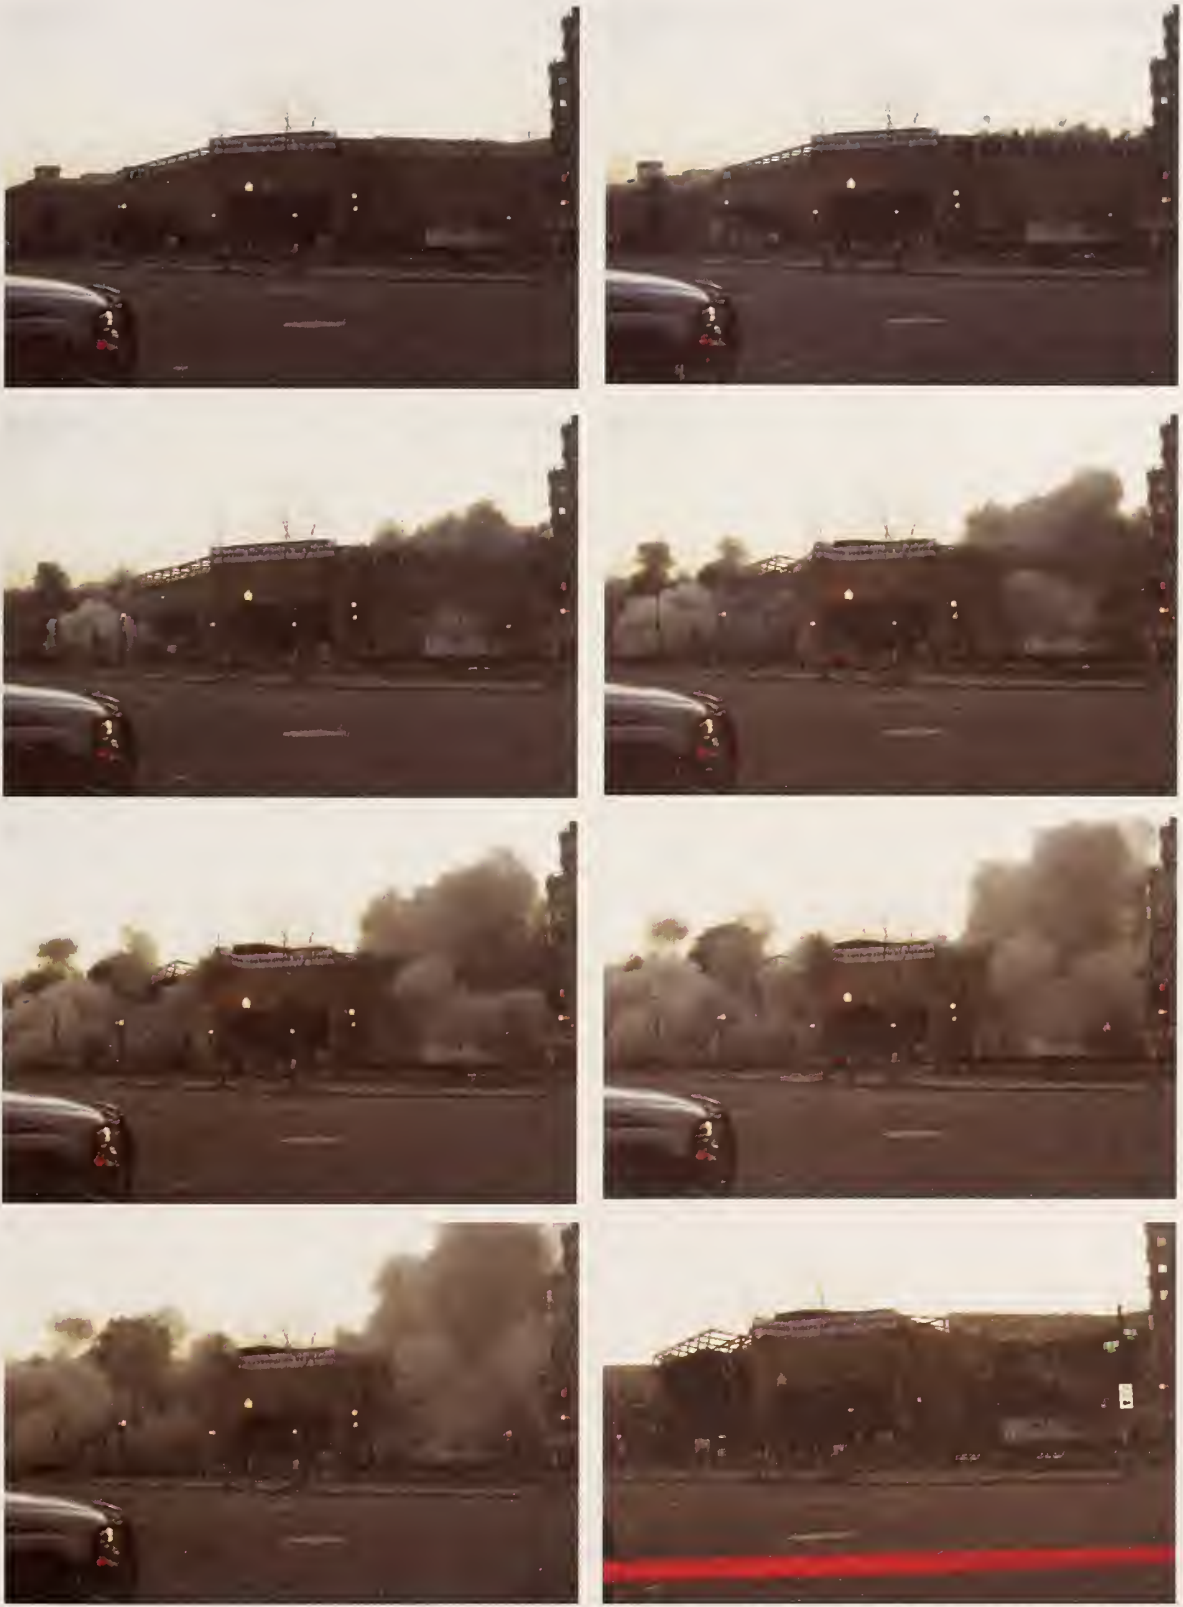
Figure 80. The convention center collapses during the implosion sequence.

This implosion was designed to create a partial collapse of the convention center, but leaving strategic parts of the building standing in order to protect adjacent buildings from the blast, as shown in the photographs in Figures 80-83. Fortunately for these experiments, a partial collapse represented a realistic scenario for simulating first-responder communications. Figure 80 shows the convention center collapsing, Figures 81 and 82 show the partially collapsed convention center after the implosion, and Figure 83 shows the change in the landscape as seen at each of the receiving sites before and after the implosion.

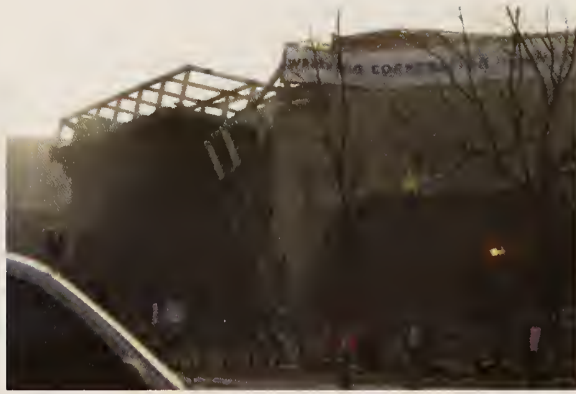
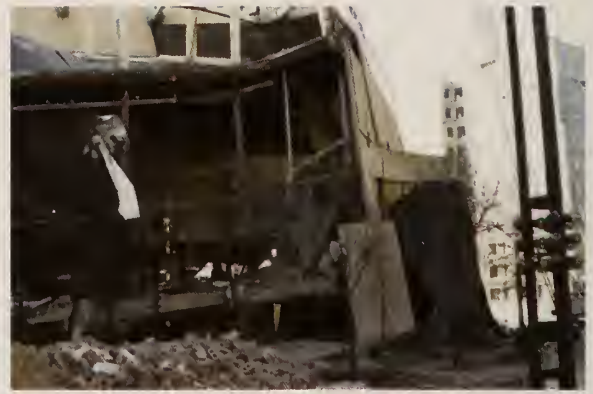
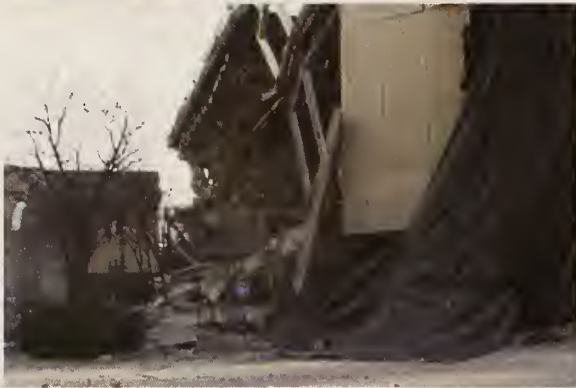
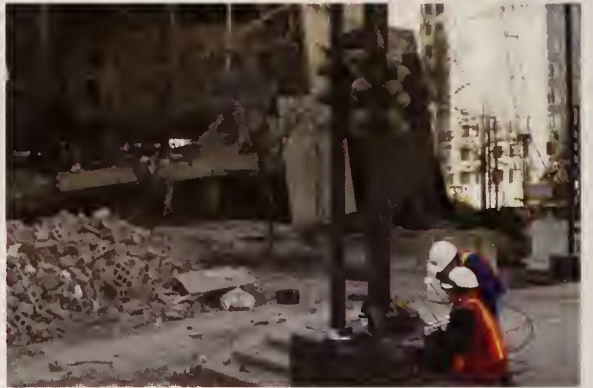
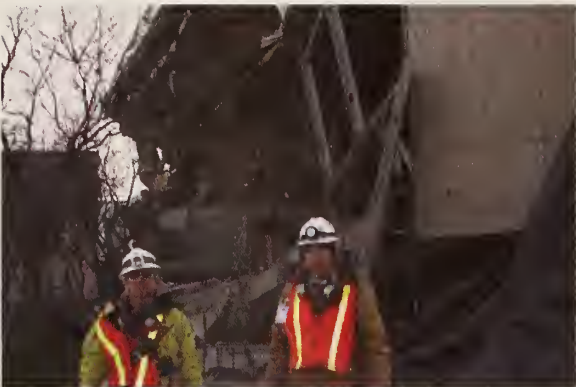
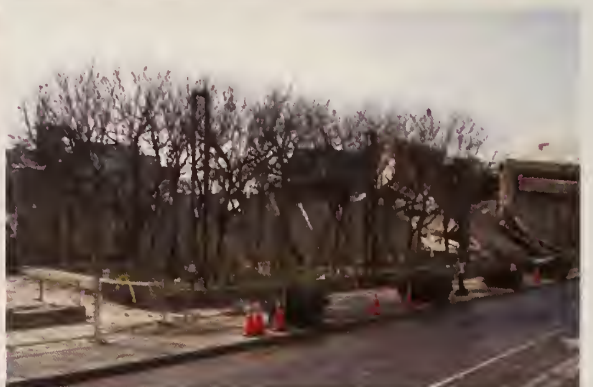
Figure 81. Photos of partially collapsed convention center after the implosion.

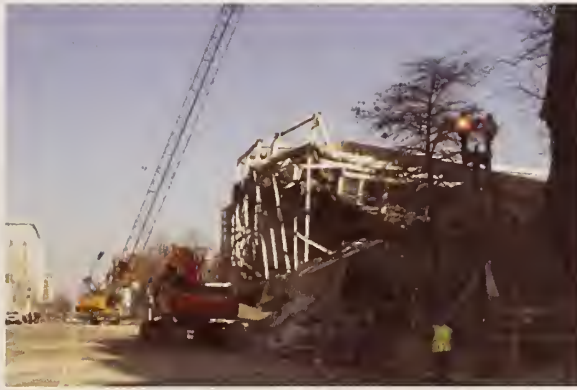
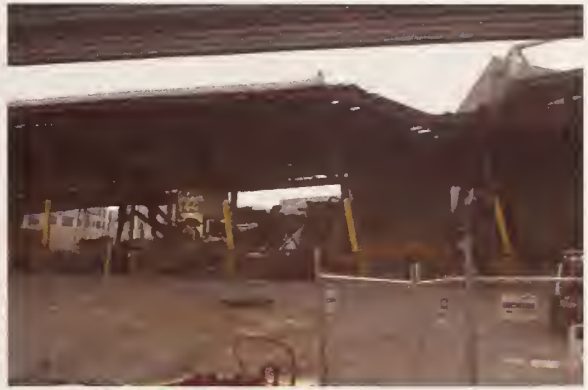
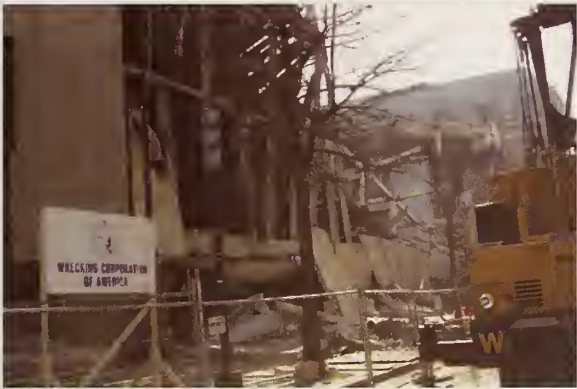
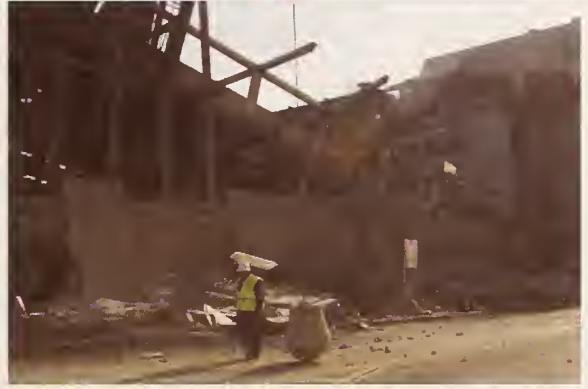
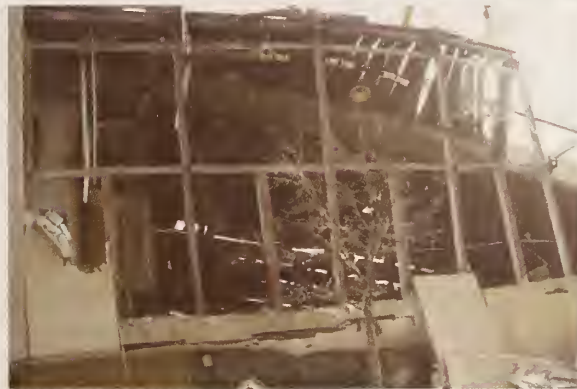
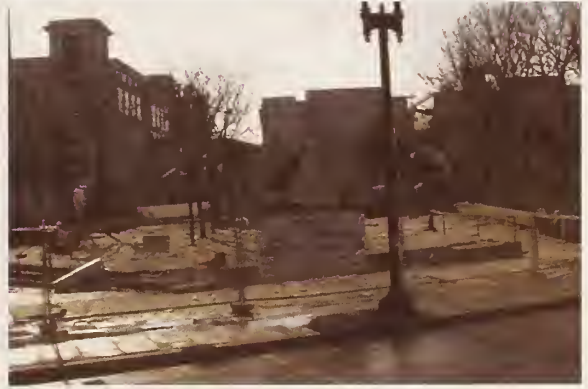
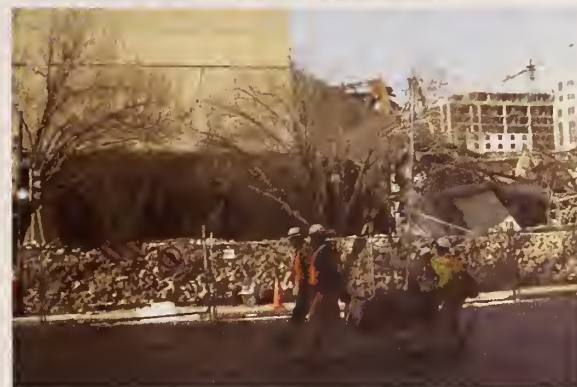
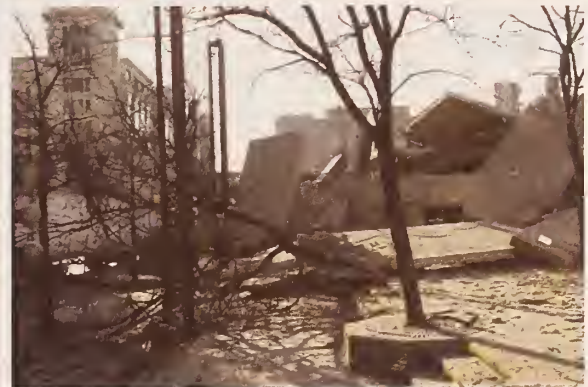
Figure 82. Photos of partially collapsed convention center after the implosion.

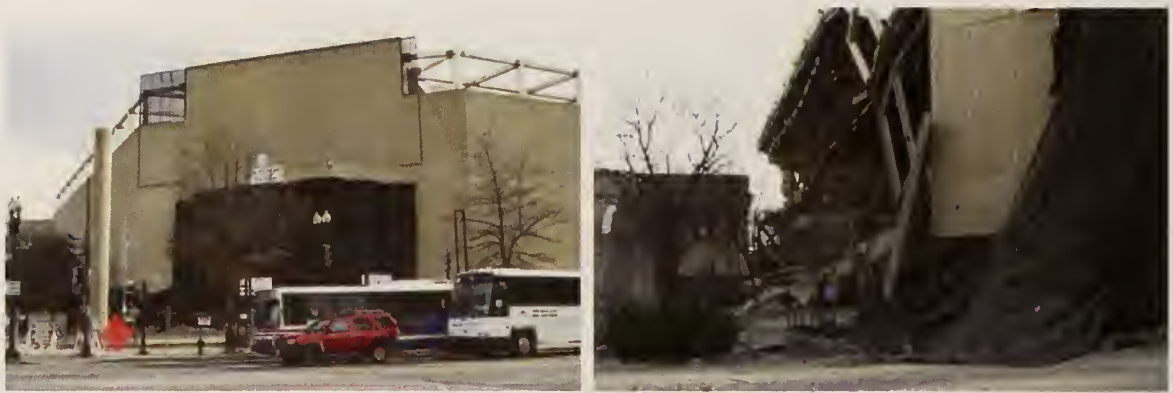
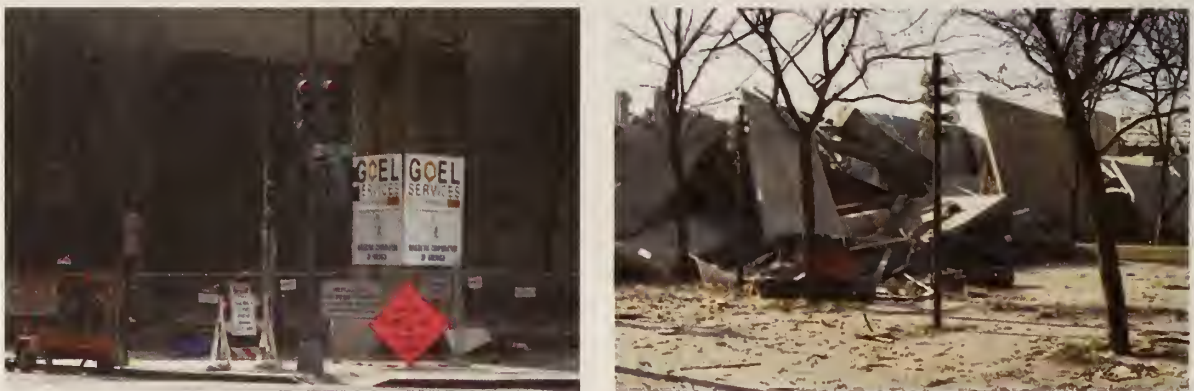
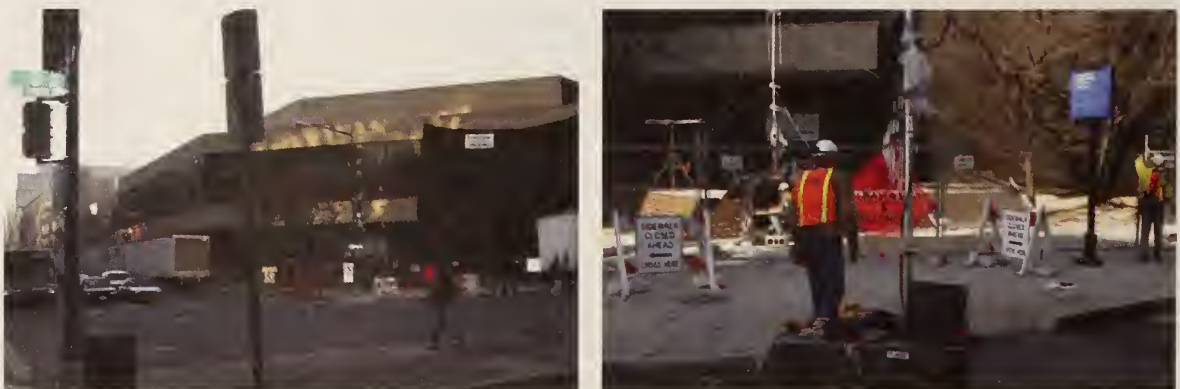
Figure 83. Receiving sites before and after implosion (a) site RX 1, (b) site RX 2, and (c) site RX 3.
