NIST Technical Note 1542

Propagation and Detection of Radio Signals Before, During, and After the Implosion of a Large Convention Center

Electromagnetics Division
National Institute of Standards and Technology
325 Broadway
Boulder, CO 80305

June 2006

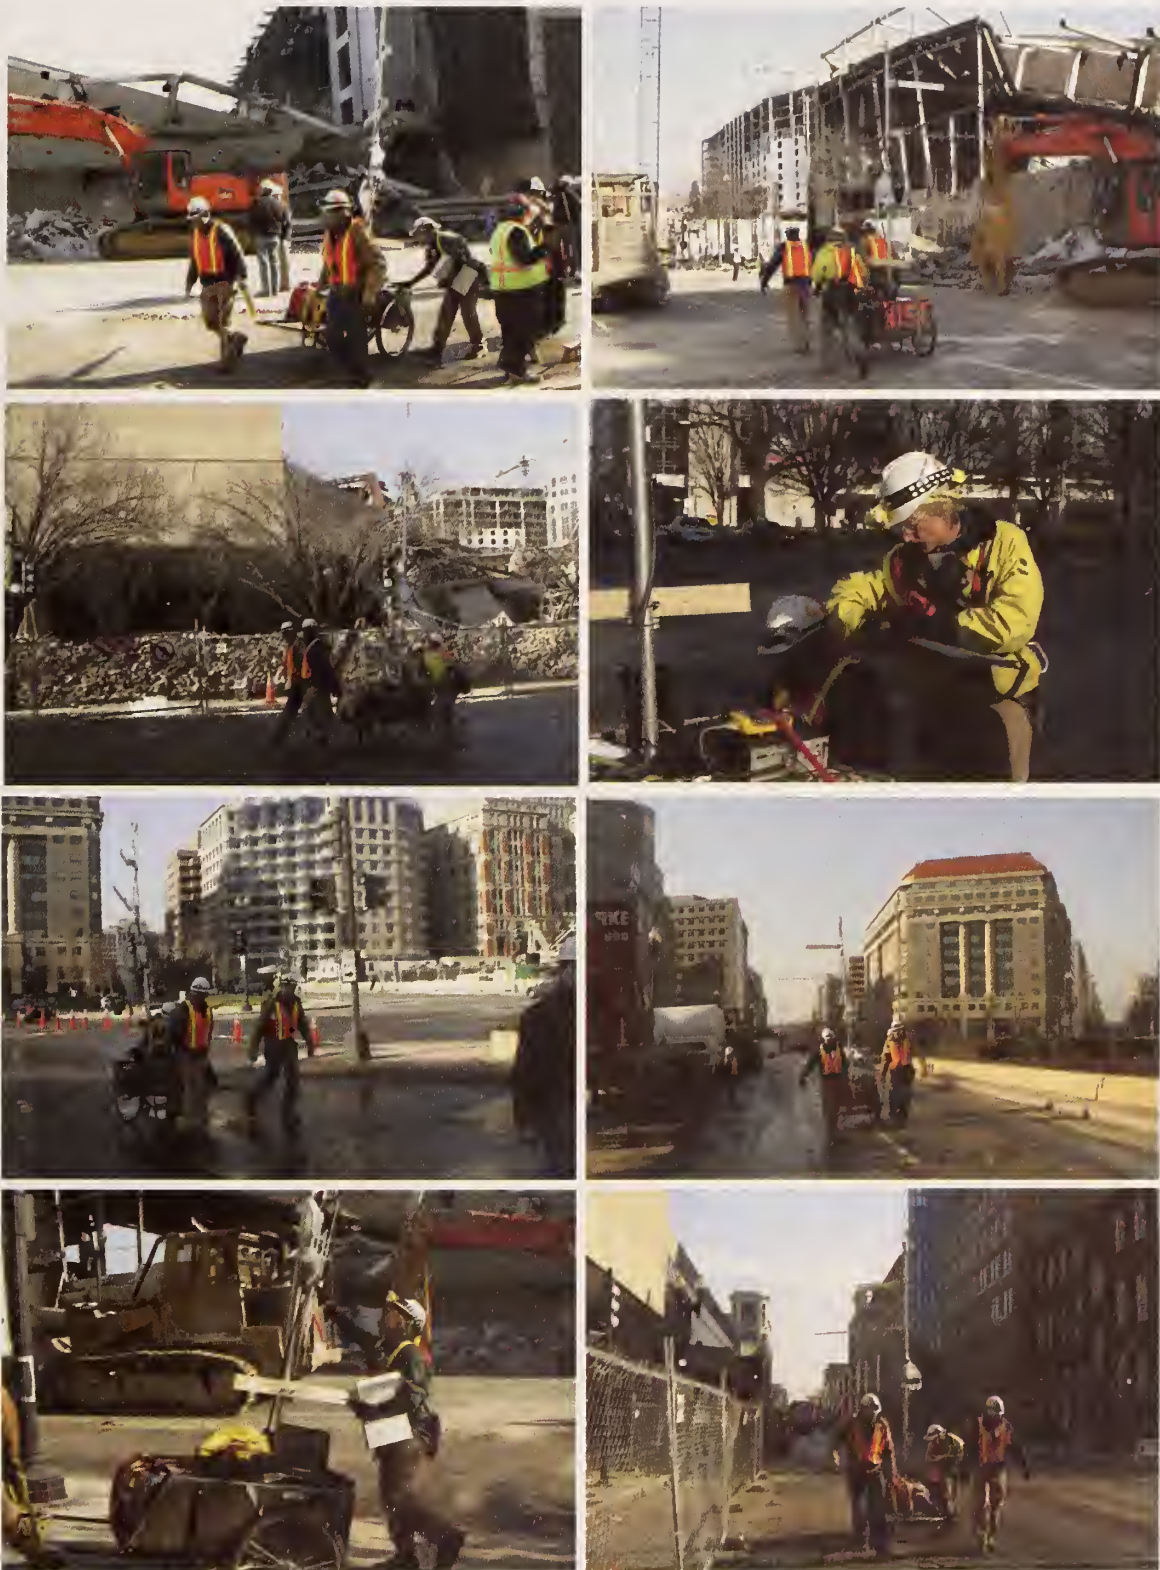
Figure 84. Illustration of measurements with mobile cart.

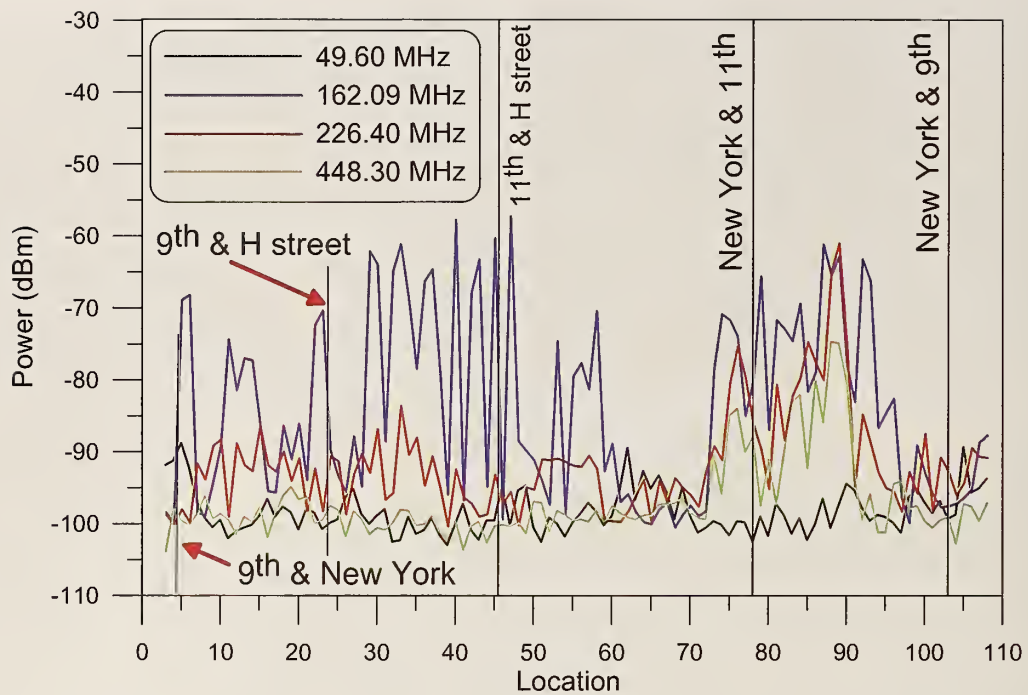
Figure 85. Post-implosion mobile cart perimeter measurements for the transmitters at transmitter site TX 1 for horizontally polarized receiving antennas.

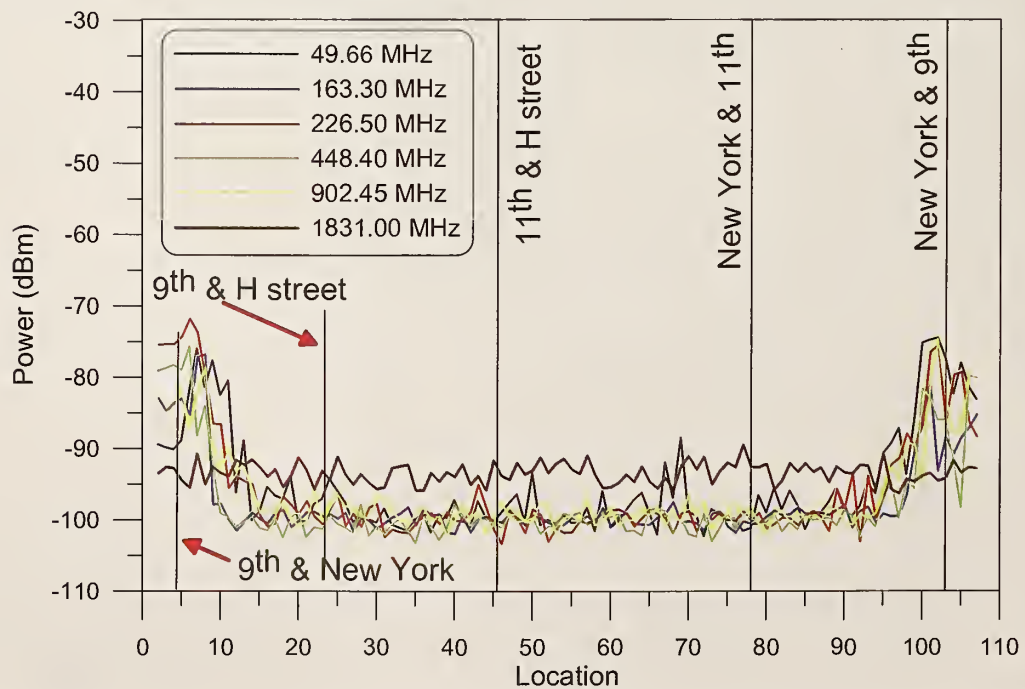
Figure 86. Post-implosion mobile cart perimeter measurements for the transmitters at transmitter site TX 2 for horizontally polarized receiving antennas.

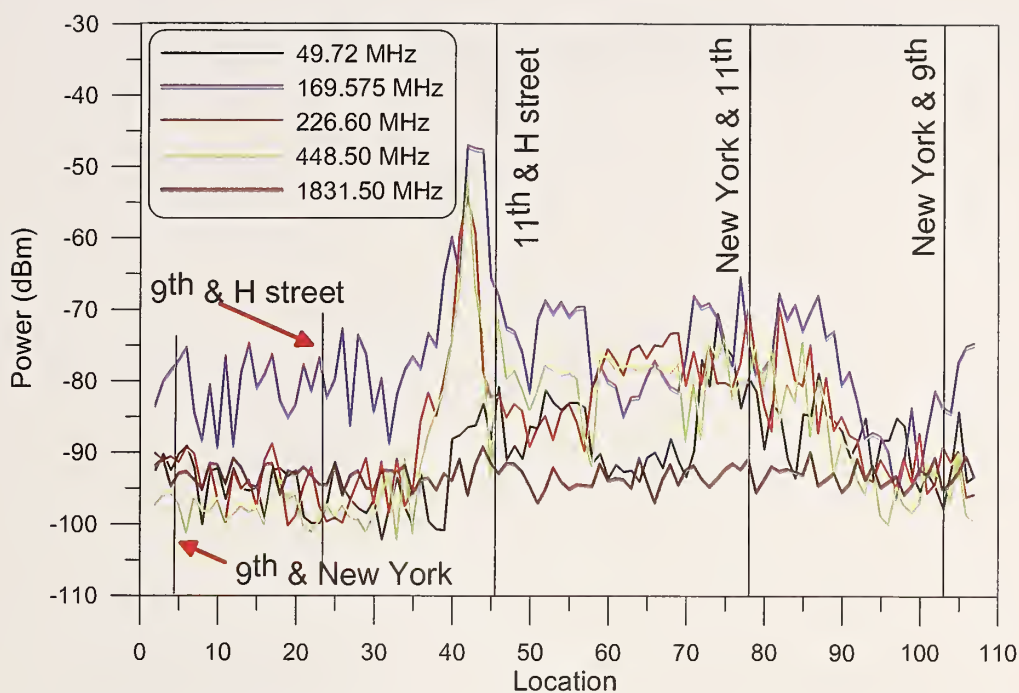
Figure 87. Post-implosion mobile cart perimeter measurements for the transmitters at transmitter site TX 3 for horizontally polarized receiving antennas.

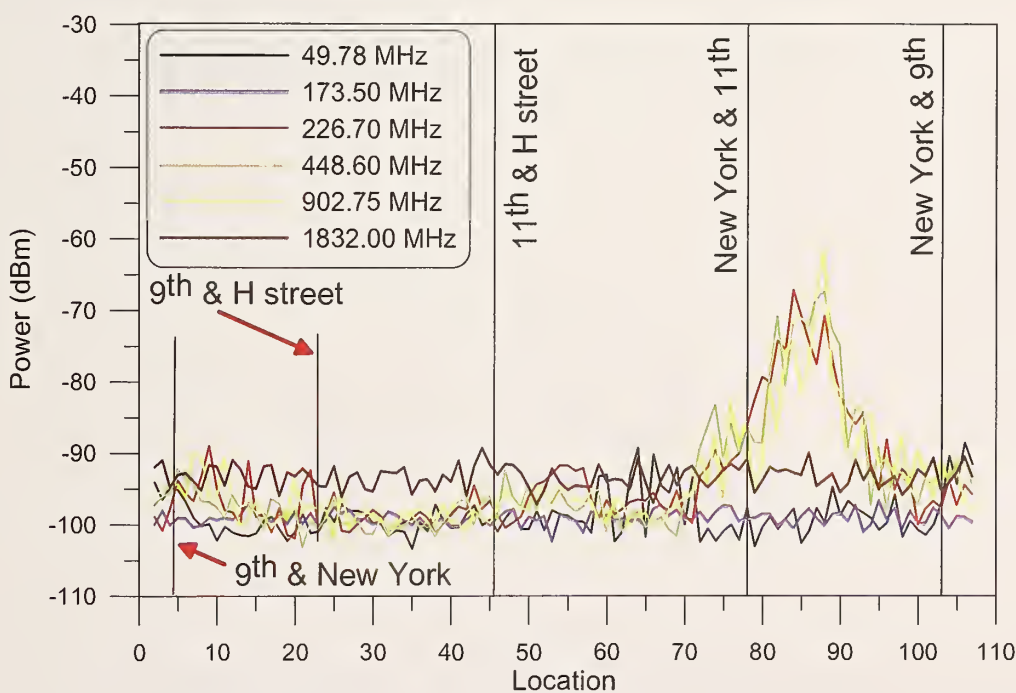
Figure 88. Post-implosion mobile cart perimeter measurements for the transmitters at transmitter site TX 4 for horizontally polarized receiving antennas.

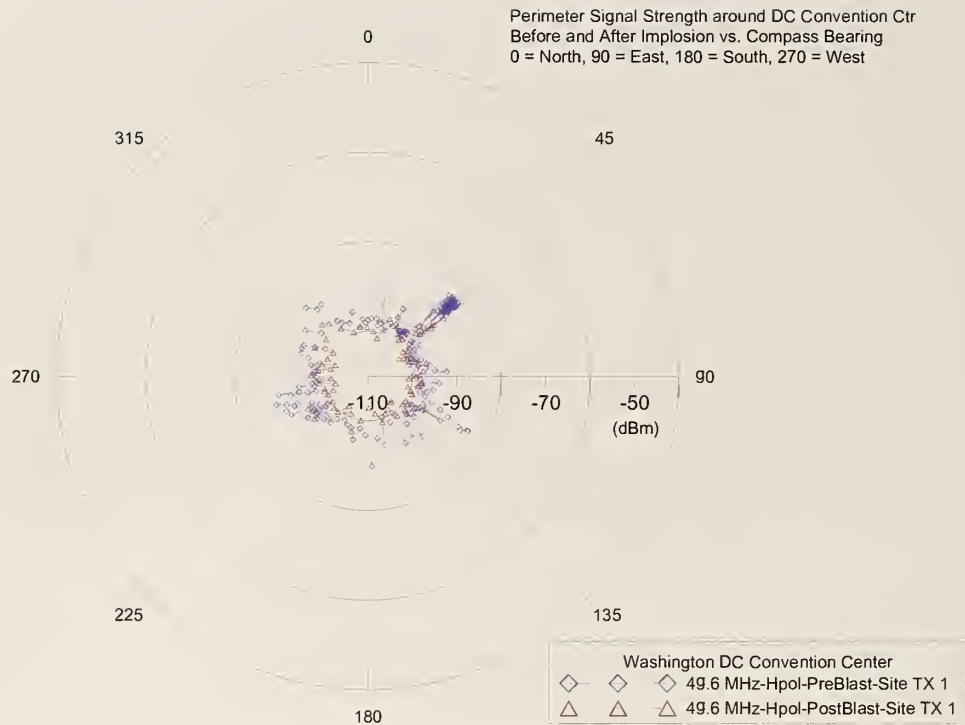
Figure 89. Comparison of pre- and post-implosion mobile cart perimeter measurements for the transmitters at site TX 1 for horizontally polarized receiving antennas: 49 MHz band.

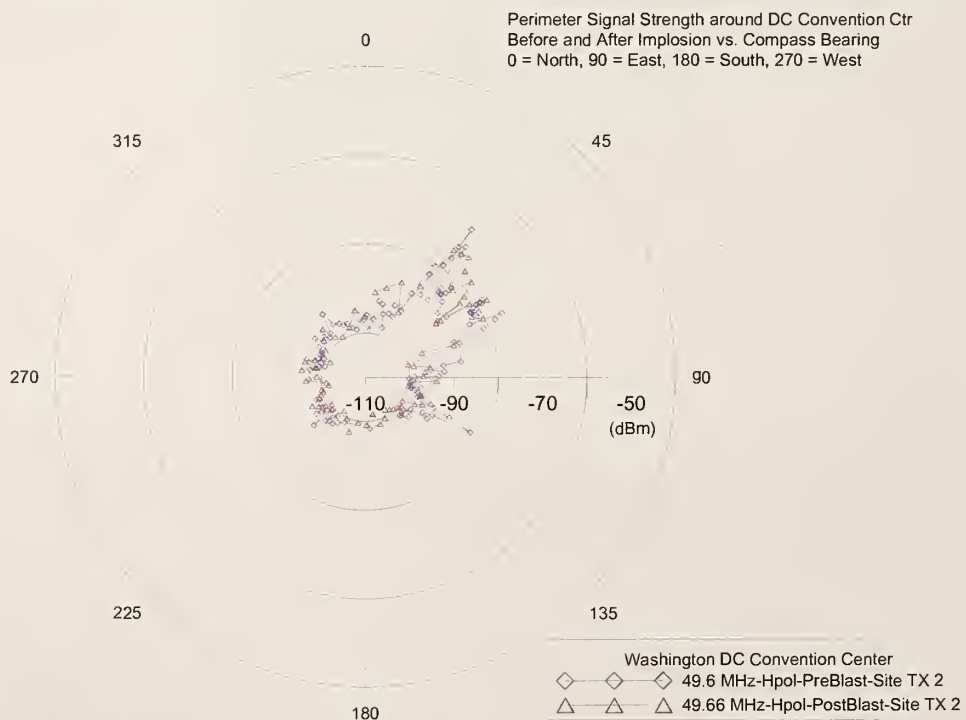
Figure 90. Comparison of pre- and post-implosion mobile cart perimeter measurements for the transmitters at site TX 2 for horizontally polarized receiving antennas: 49 MHz band.

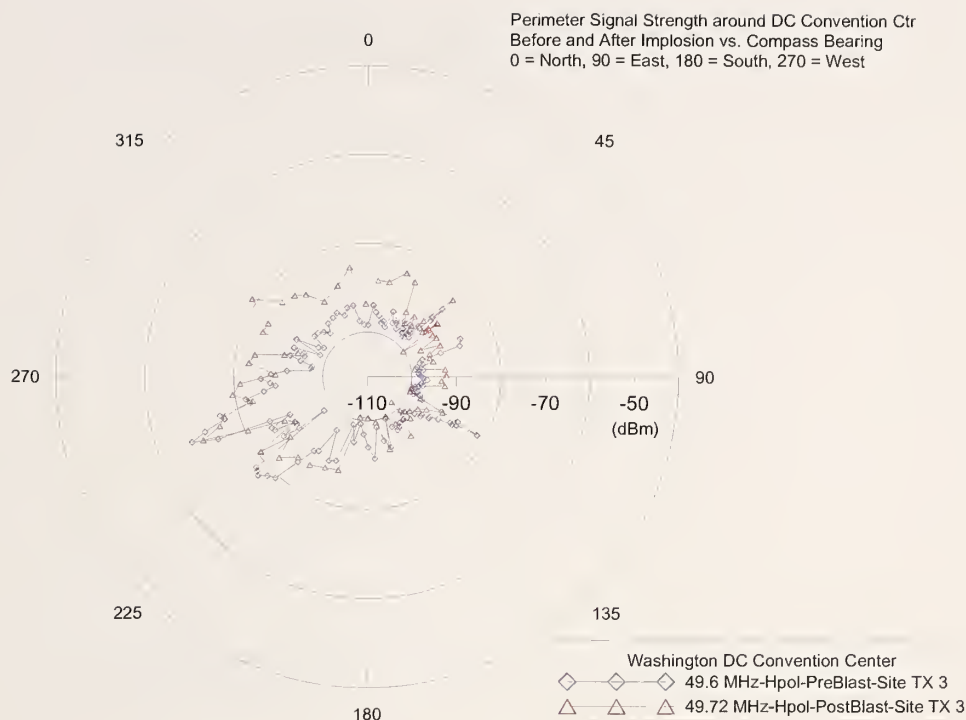
Figure 91. Comparison of pre- and post-implosion mobile cart perimeter measurements for the transmitters at site TX 3 for horizontally polarized receiving antennas: 49 MHz band.

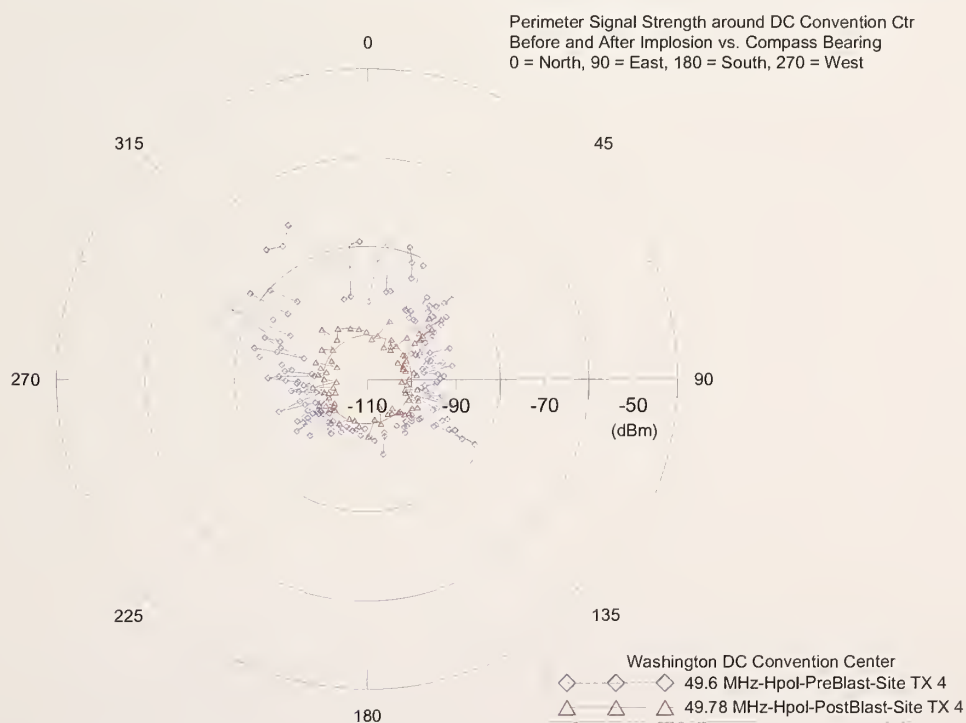
Figure 92. Comparison of pre- and post-implosion mobile cart perimeter measurements for the transmitters at site TX 4 for horizontally polarized receiving antennas: 49 MHz band.

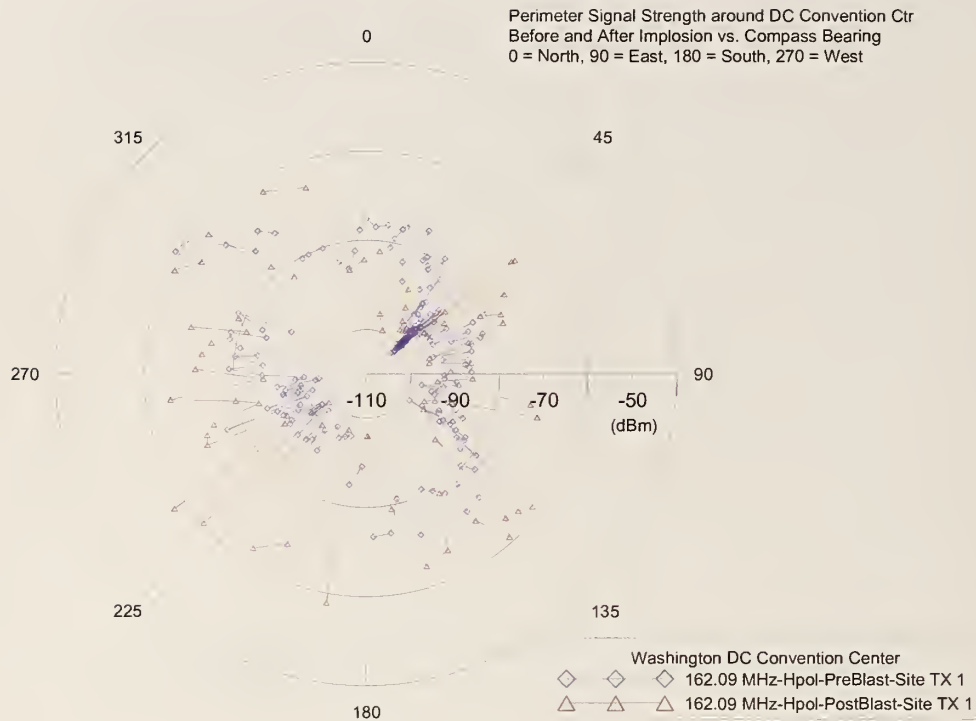
Figure 93. Comparison of pre- and post-implosion mobile cart perimeter measurements for the transmitters at site TX 1 for horizontally polarized receiving antennas: 160 MHz band.

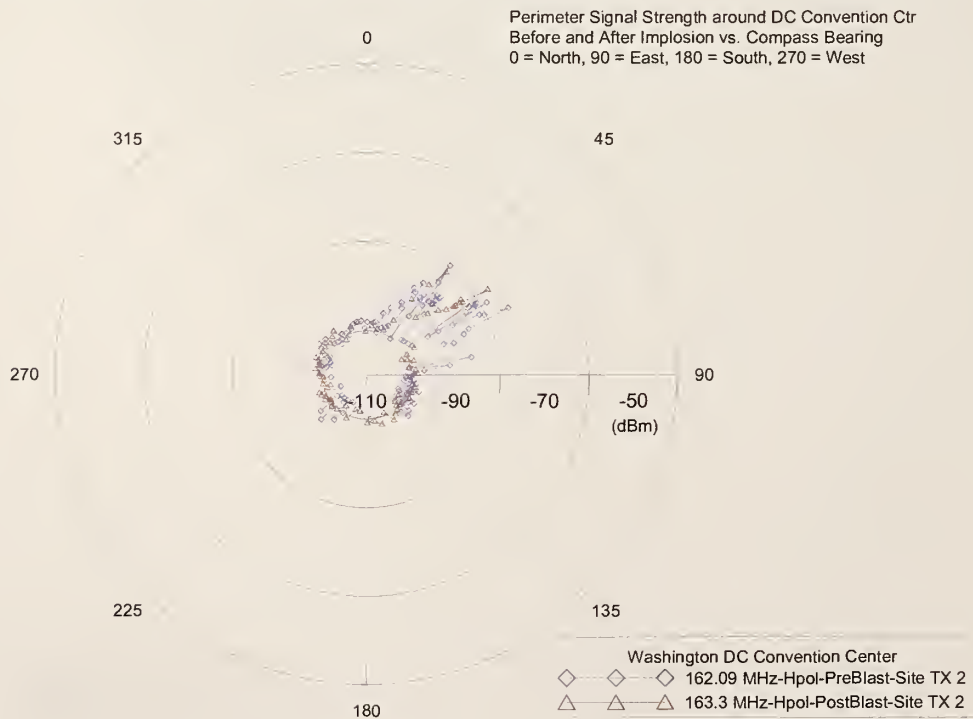
Figure 94. Comparison of pre- and post-implosion mobile cart perimeter measurements for the transmitters at site TX 2 for horizontally polarized receiving antennas: 160 MHz band.

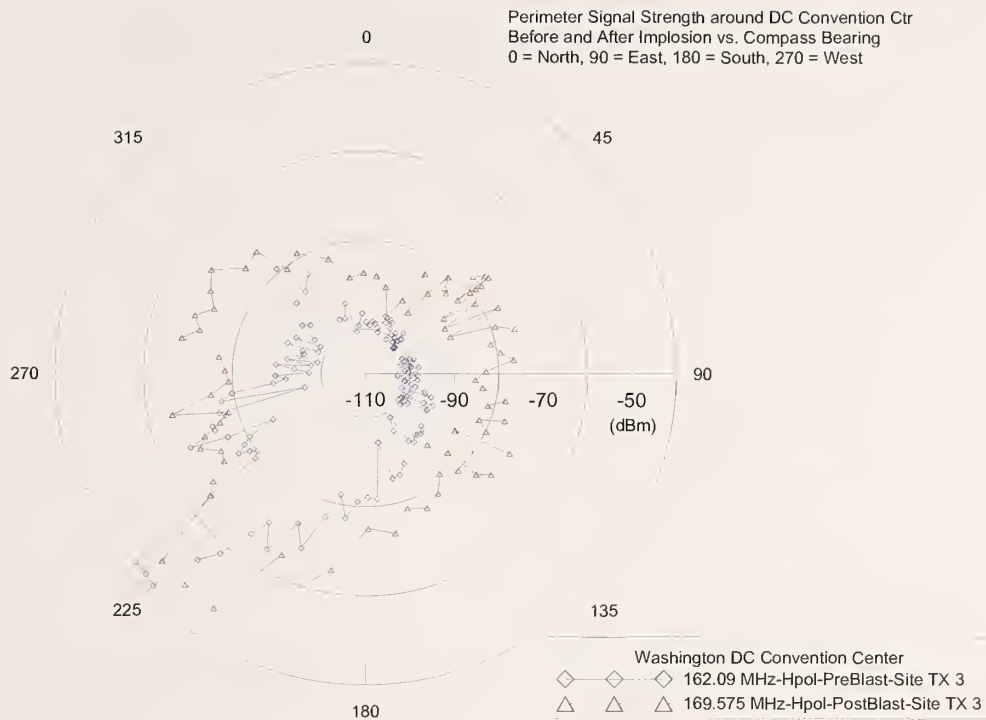
Figure 95. Comparison of pre- and post-implosion mobile cart perimeter measurements for the transmitters at site TX 3 for horizontally polarized receiving antennas: 160 MHz band.

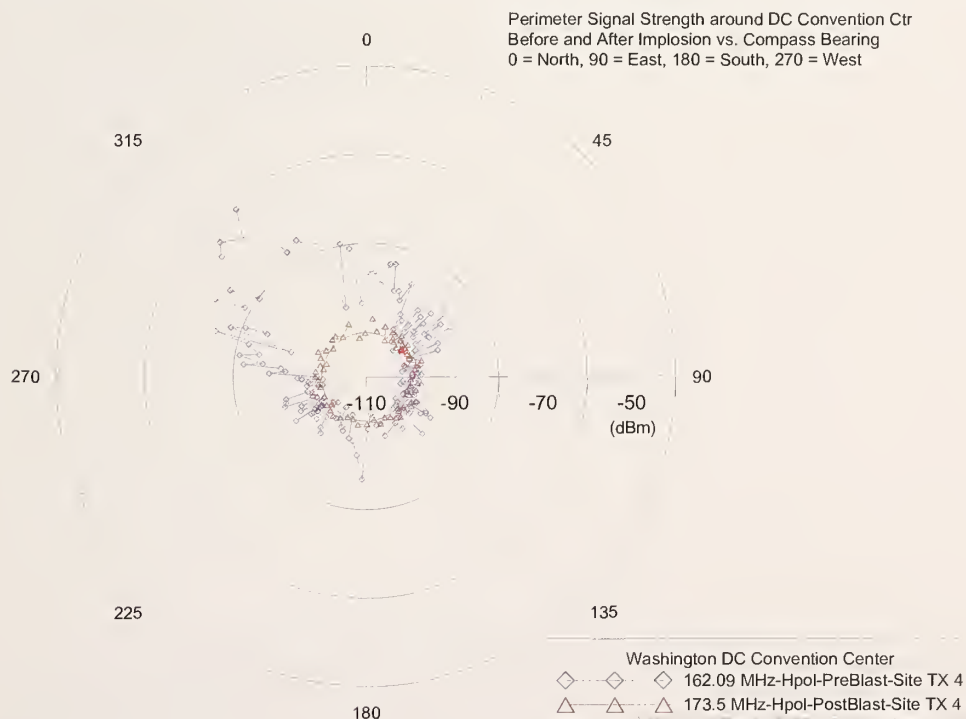
Figure 96. Comparison of pre- and post-implosion mobile cart perimeter measurements for the transmitters at site TX 4 for horizontally polarized receiving antennas: 160 MHz band.

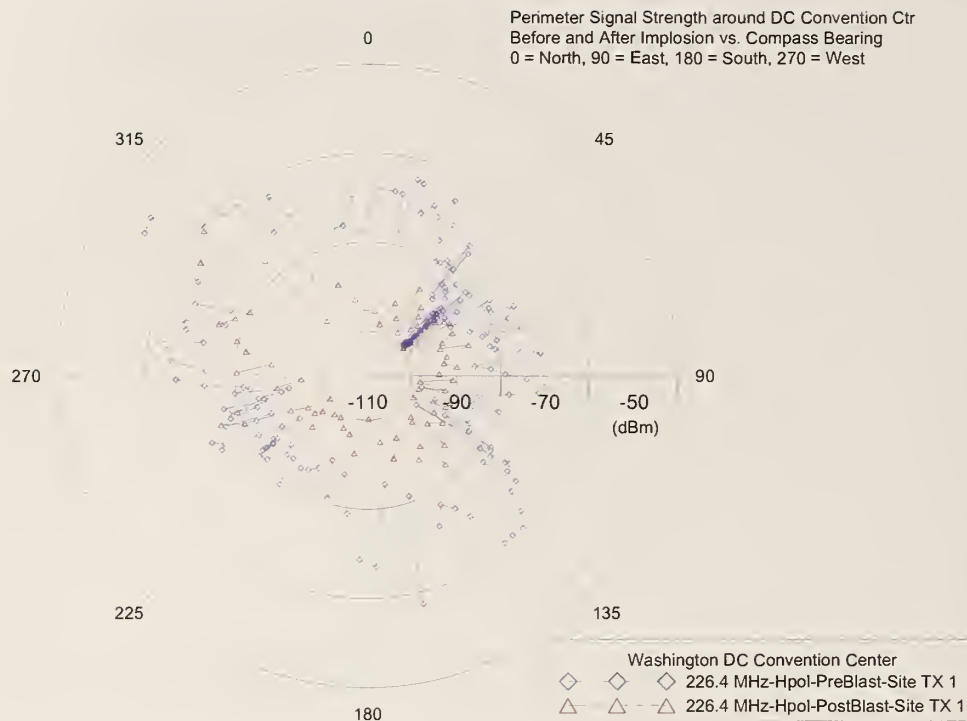
Figure 97. Comparison of pre- and post-implosion mobile cart perimeter measurements for the transmitters at site TX 1 for horizontally polarized receiving antennas: 225 MHz band.

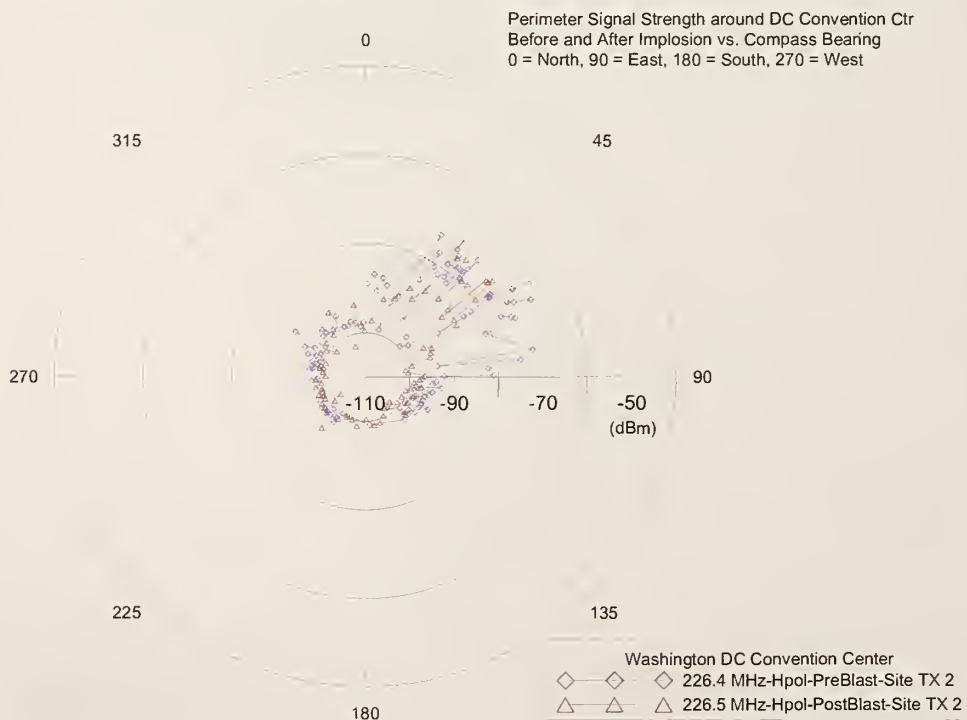
Figure 98. Comparison of pre- and post-implosion mobile cart perimeter measurements for the transmitters at site TX 2 for horizontally polarized receiving antennas: 225 MHz band.

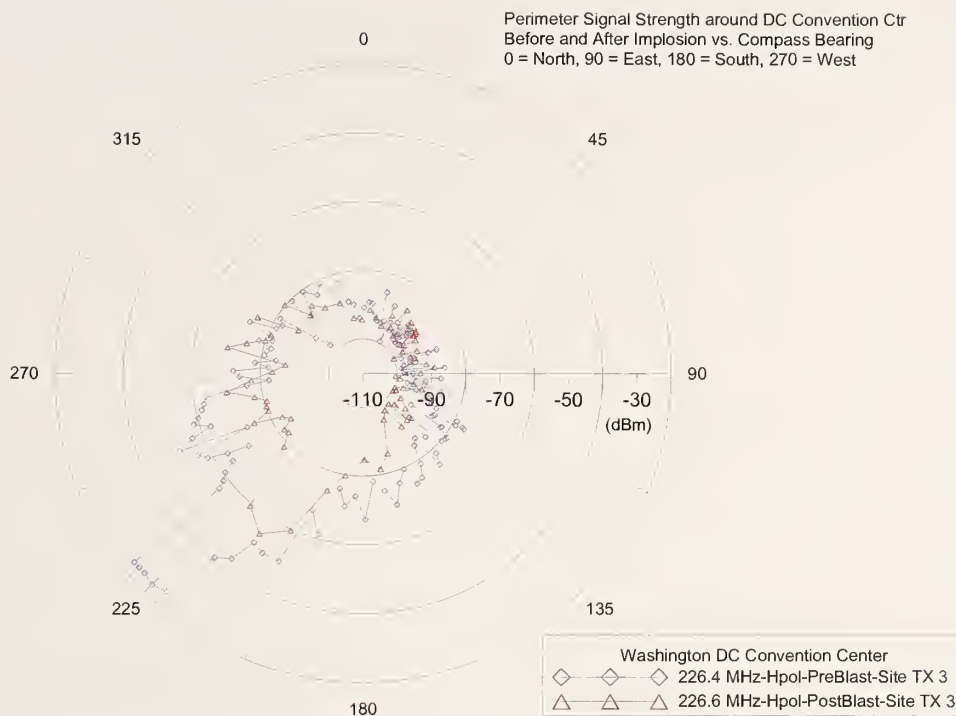
Figure 99. Comparison of pre- and post-implosion mobile cart perimeter measurements for the transmitters at site TX 3 for horizontally polarized receiving antennas: 225 MHz band.

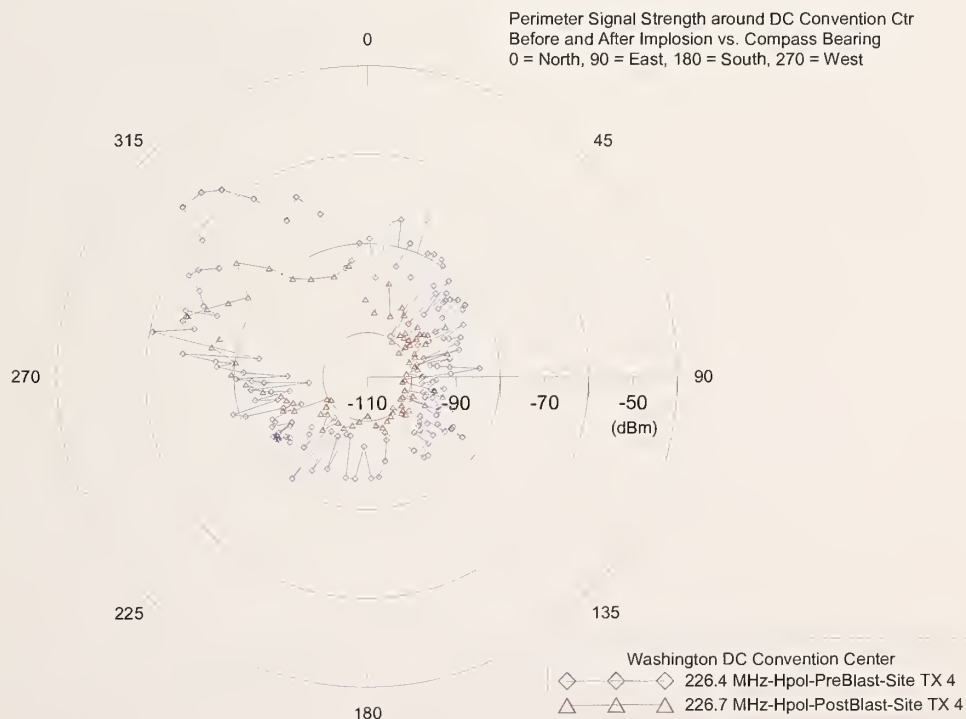
Figure 100. Comparison of pre- and post-implosion mobile cart perimeter measurements for the transmitters at site TX 4 for horizontally polarized receiving antennas: 225 MHz band.

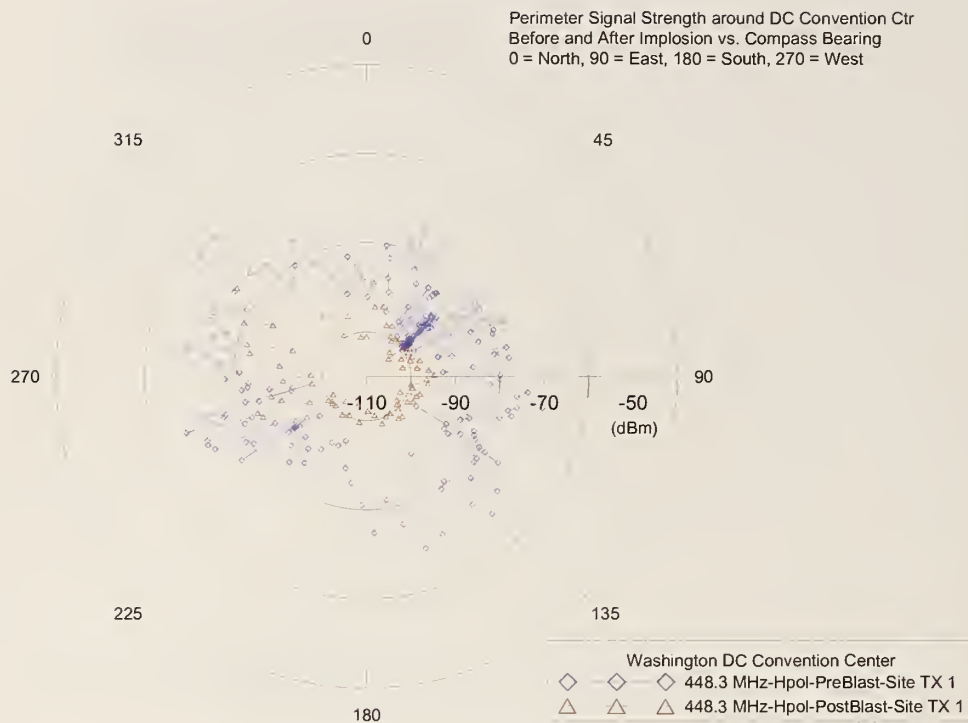
Figure 101. Comparison of pre- and post-implosion mobile cart perimeter measurements for the transmitters at site TX 1 for horizontally polarized receiving antennas: 450 MHz band.

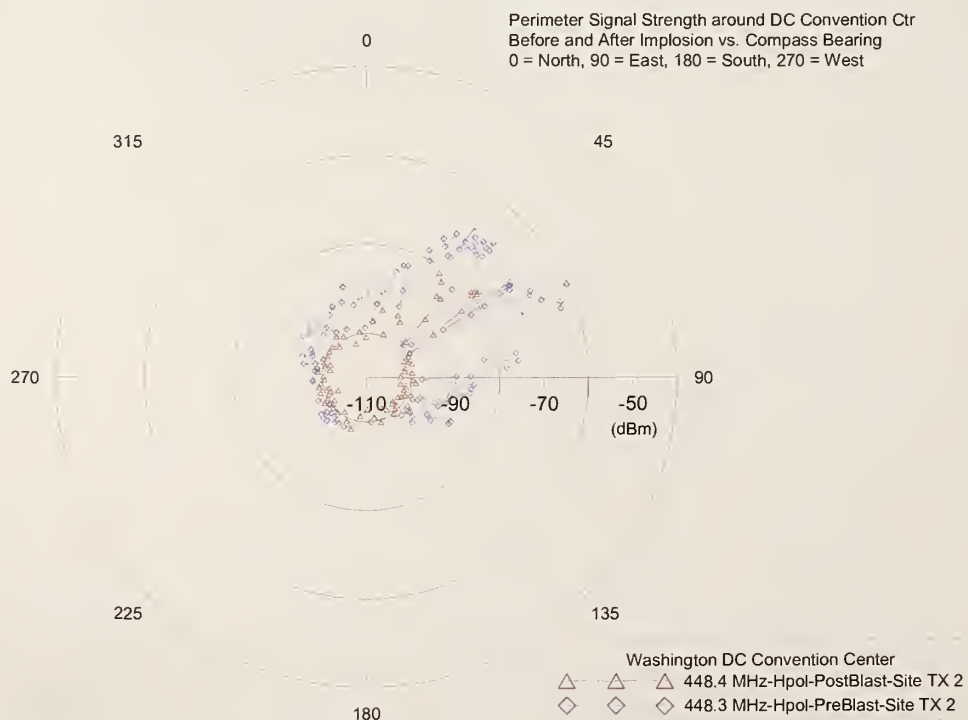
Figure 102. Comparison of pre- and post-implosion mobile cart perimeter measurements for the transmitters at site TX 2 for horizontally polarized receiving antennas: 450 MHz band.

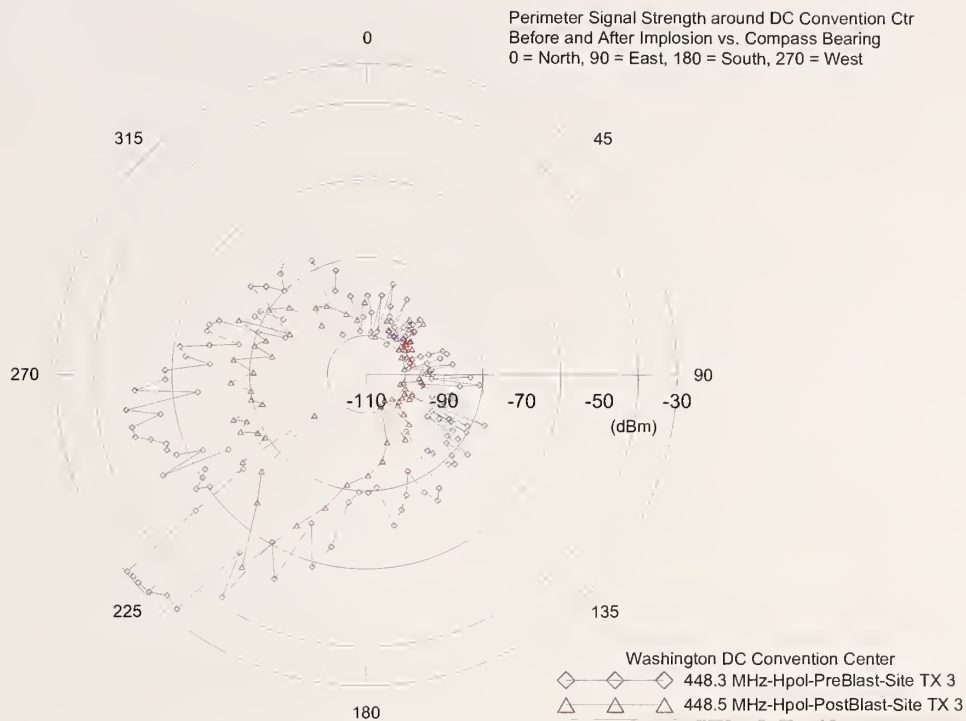
Figure 103. Comparison of pre- and post-implosion mobile cart perimeter measurements for the transmitters at site TX 3 for horizontally polarized receiving antennas: 450 MHz band.

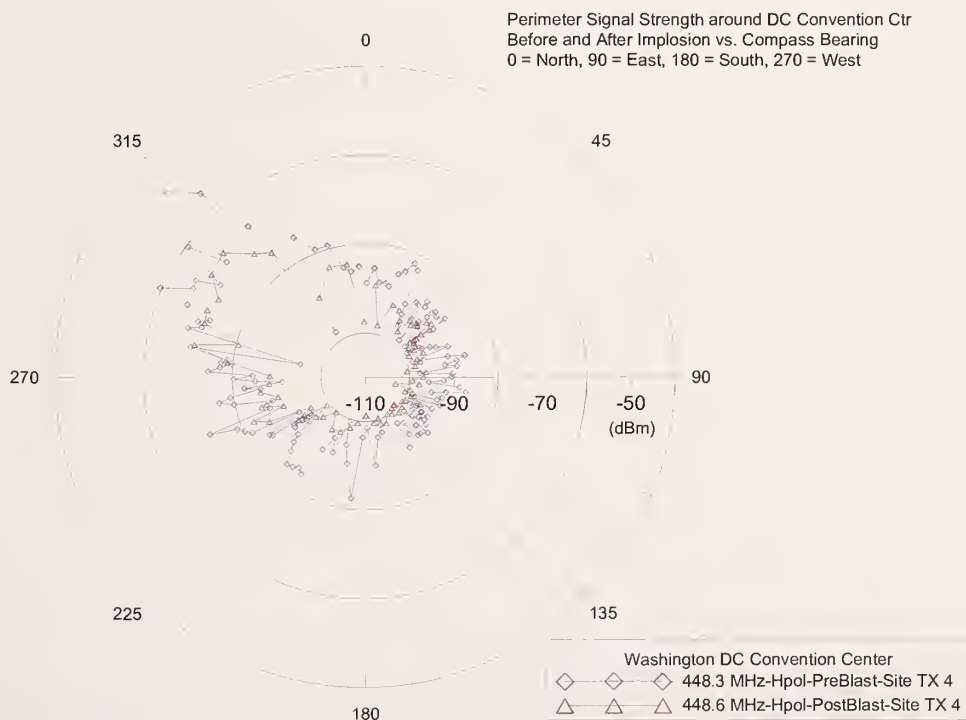
Figure 104. Comparison of pre- and post-implosion mobile cart perimeter measurements for the transmitters at site TX 4 for horizontally polarized receiving antennas: 450 MHz band.

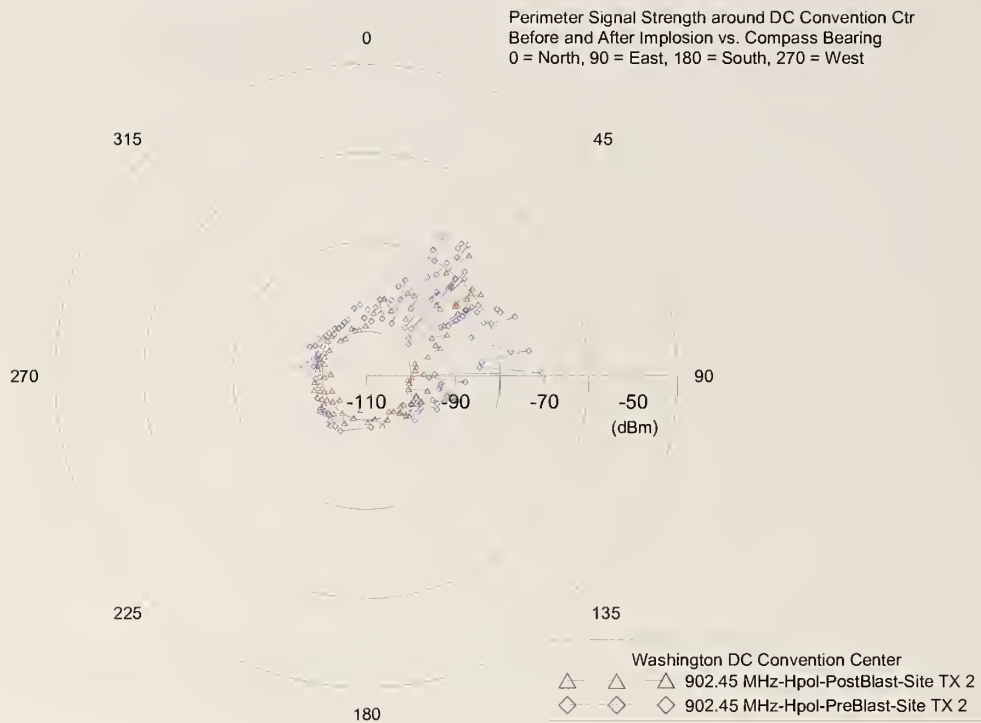
Figure 105. Comparison of pre- and post-implosion mobile cart perimeter measurements for the transmitters at site TX 2 for horizontally polarized receiving antennas: 900 MHz band.

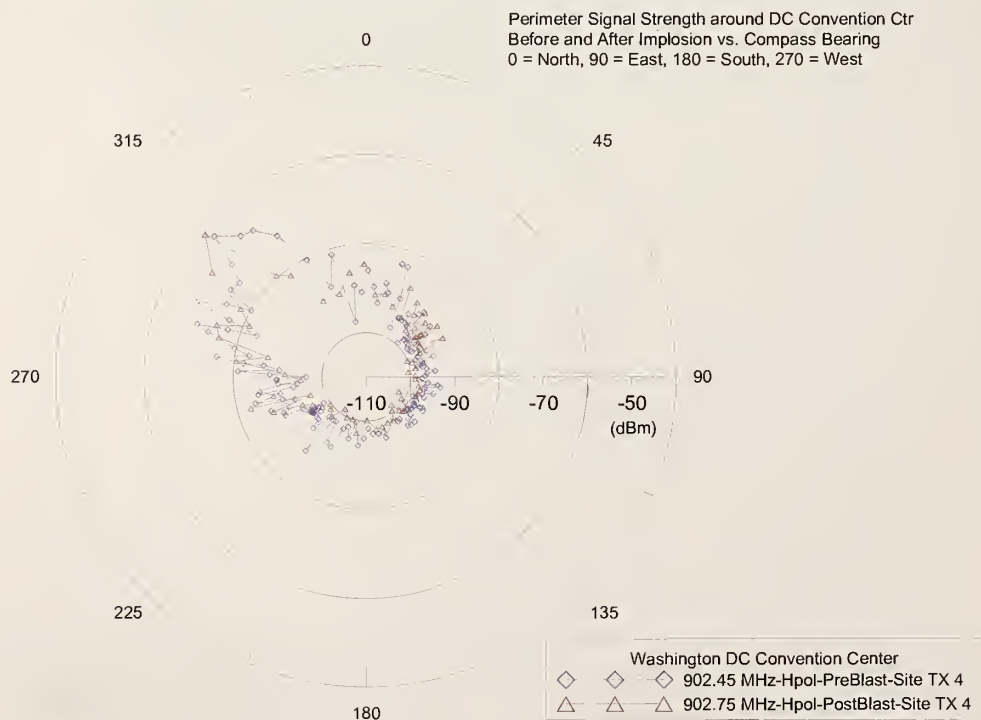
Figure 106. Comparison of pre- and post-implosion mobile cart perimeter measurements for the transmitters at site TX 4 for horizontally polarized receiving antennas: 900 MHz band.

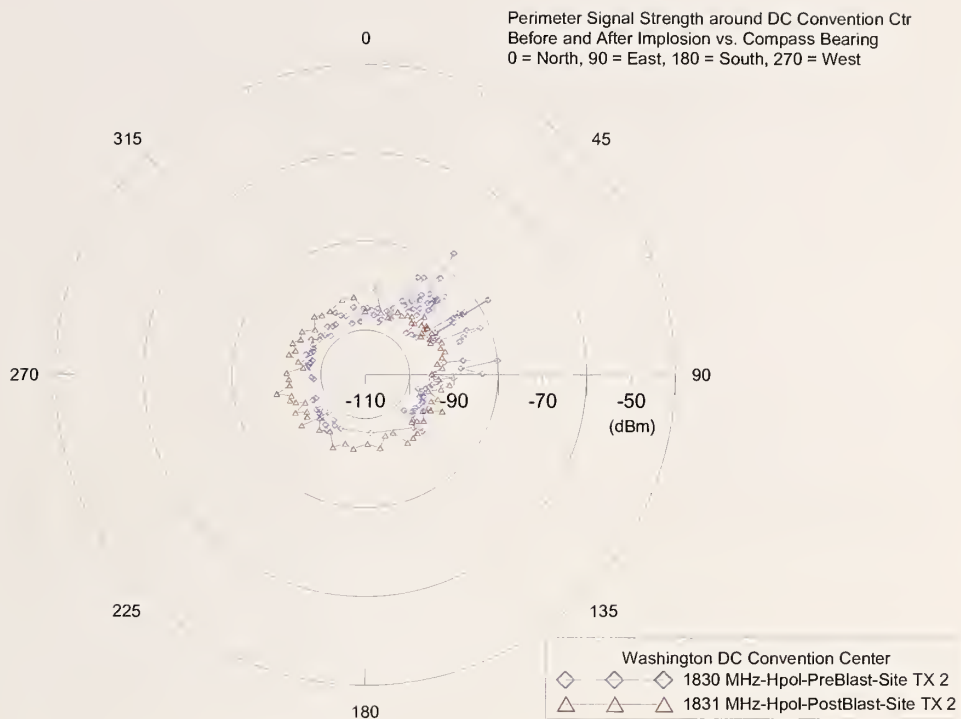
Figure 107. Comparison of pre- and post-implosion mobile cart perimeter measurements for the transmitters at site TX 2 for horizontally polarized receiving antennas: 1800 MHz band.

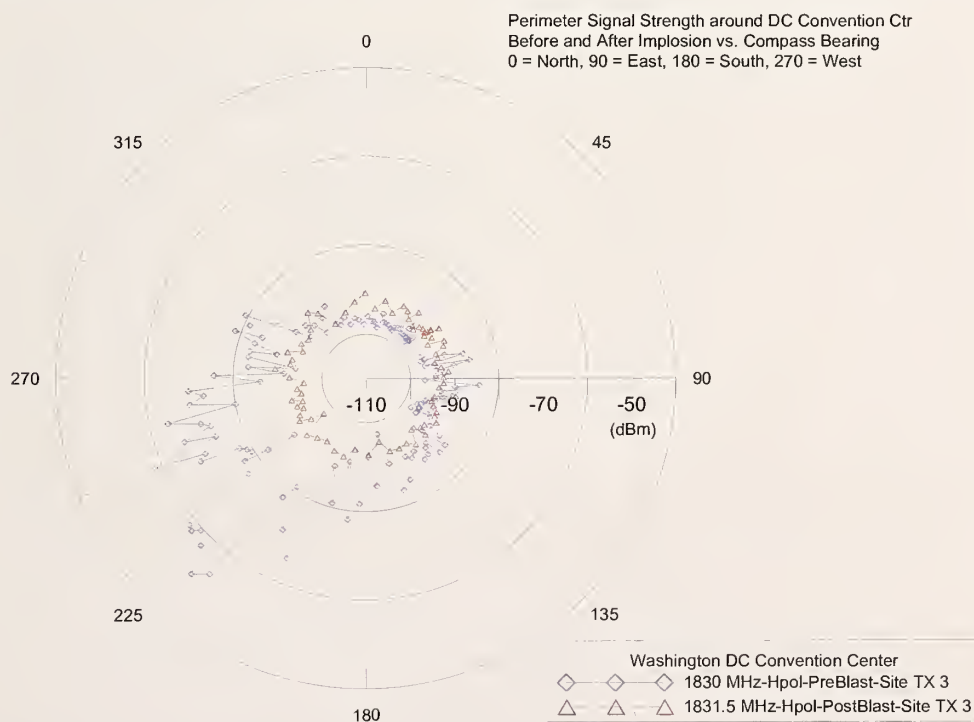
Figure 108. Comparison of pre- and post-implosion mobile cart perimeter measurements for the transmitters at site TX 3 for horizontally polarized receiving antennas: 1800 MHz band.

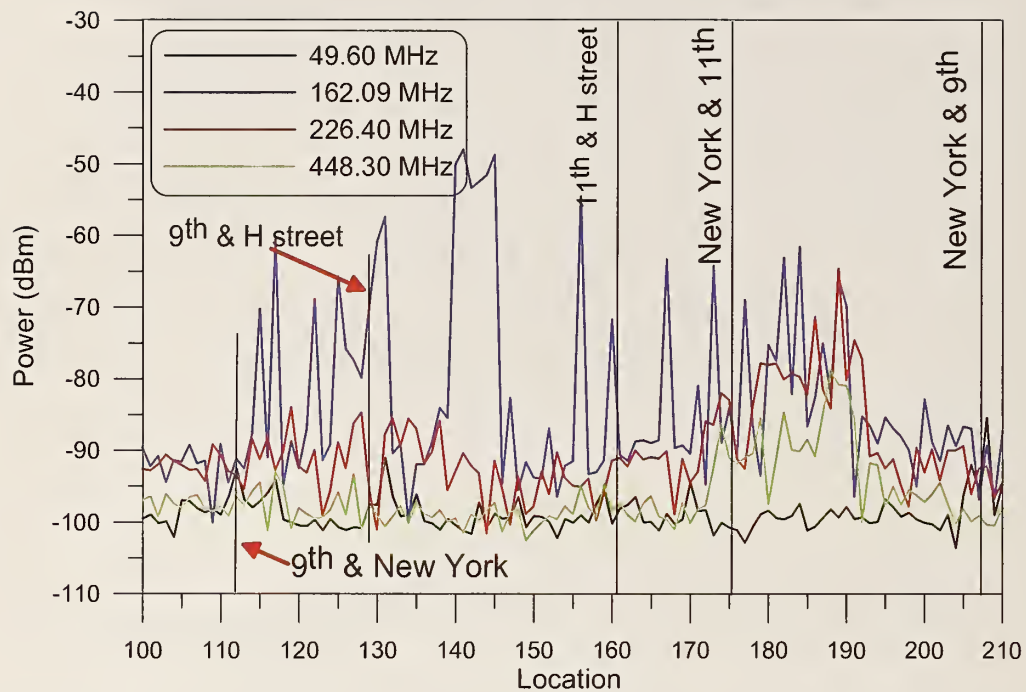
Figure 109. Post-implosion mobile cart perimeter measurements for the transmitters at transmitter site TX 1 for vertically polarized receiving antennas.

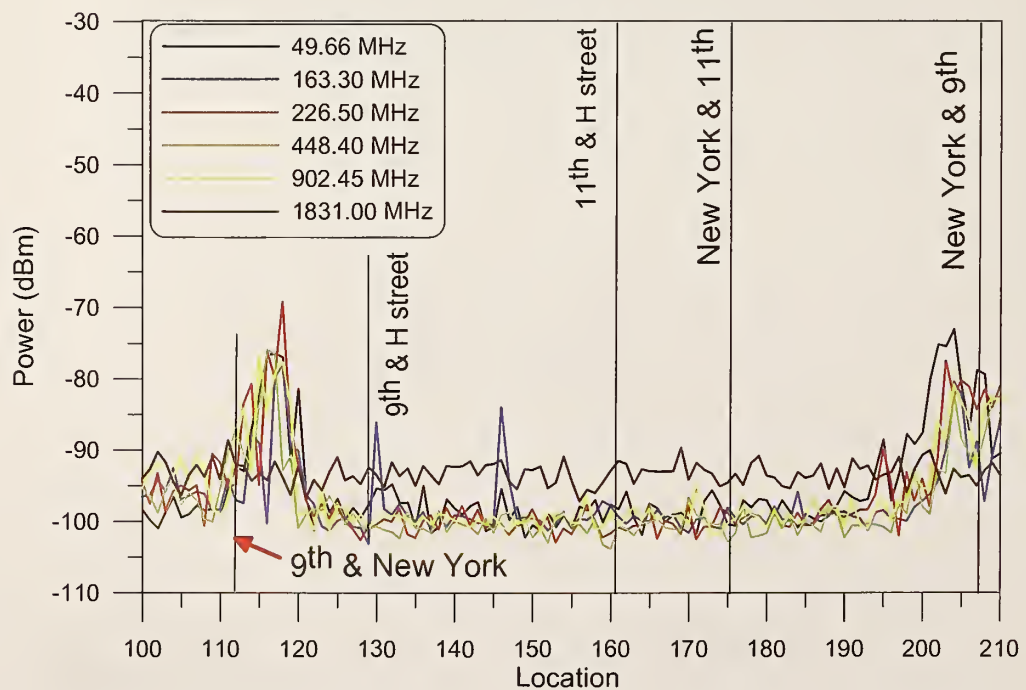
Figure 110. Post-implosion mobile cart perimeter measurements for the transmitters at transmitter site TX 2 for vertically polarized receiving antennas.

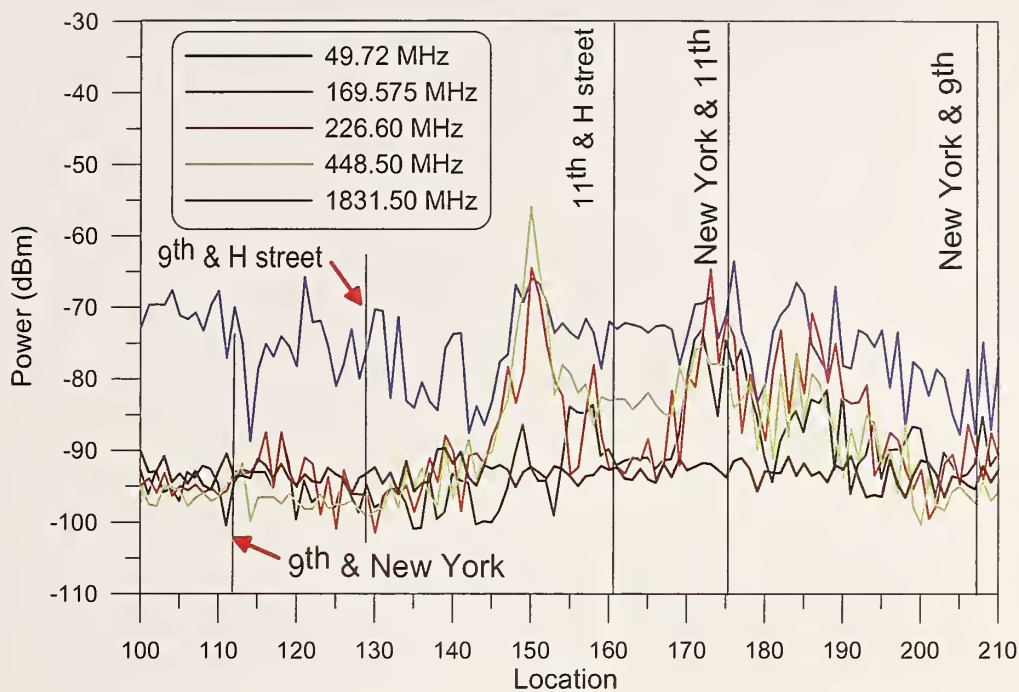
Figure 111. Post-implosion mobile cart perimeter measurements for the transmitters at transmitter site TX 3 for vertically polarized receiving antennas.

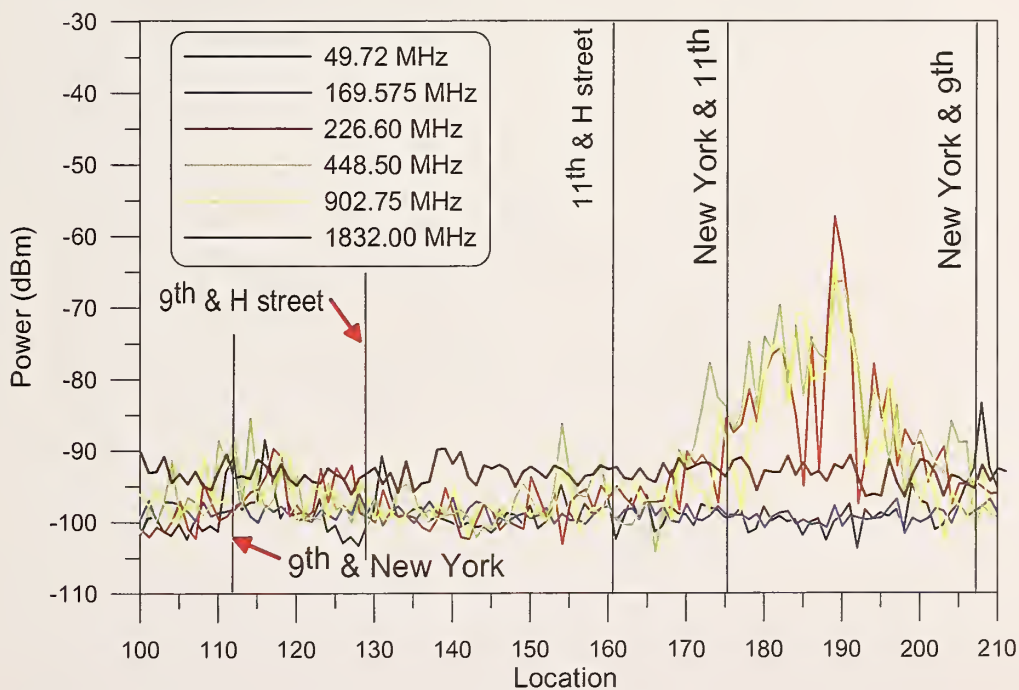
Figure 112. Post-implosion mobile cart perimeter measurements for the transmitters at transmitter site TX 4 for vertically polarized receiving antennas.
