NIST Technical Note 1542

Propagation and Detection of Radio Signals Before, During, and After the Implosion of a Large Convention Center

Electromagnetics Division
National Institute of Standards and Technology
325 Broadway
Boulder, CO 80305

June 2006

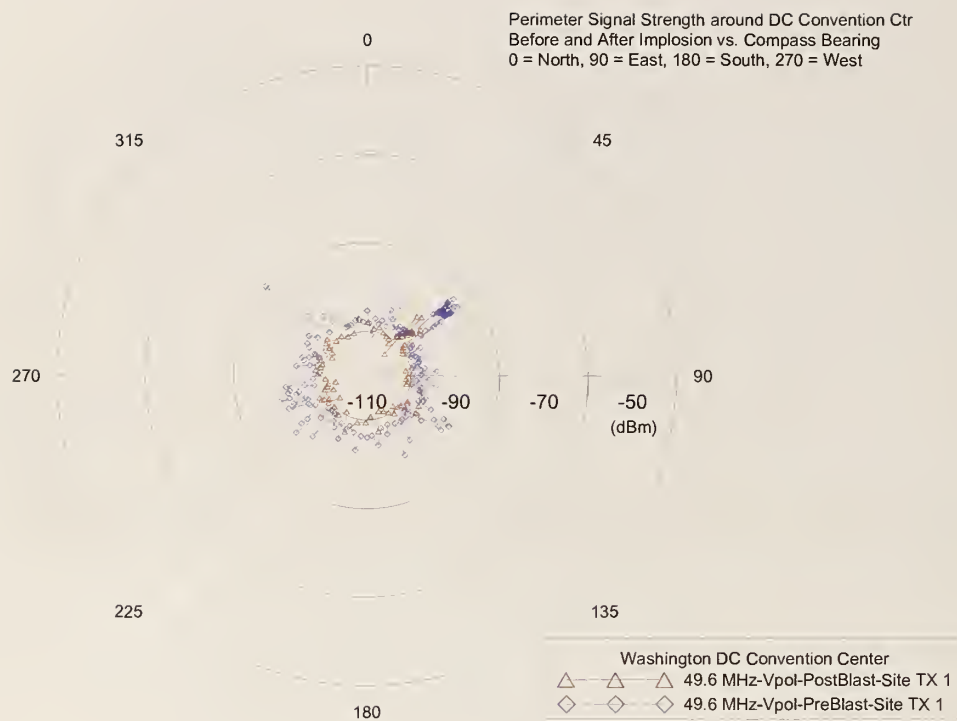
Figure 113. Comparison of pre- and post-implosion mobile cart perimeter measurements for the transmitters at site TX 1 for vertically polarized receiving antennas: 49 MHz band.

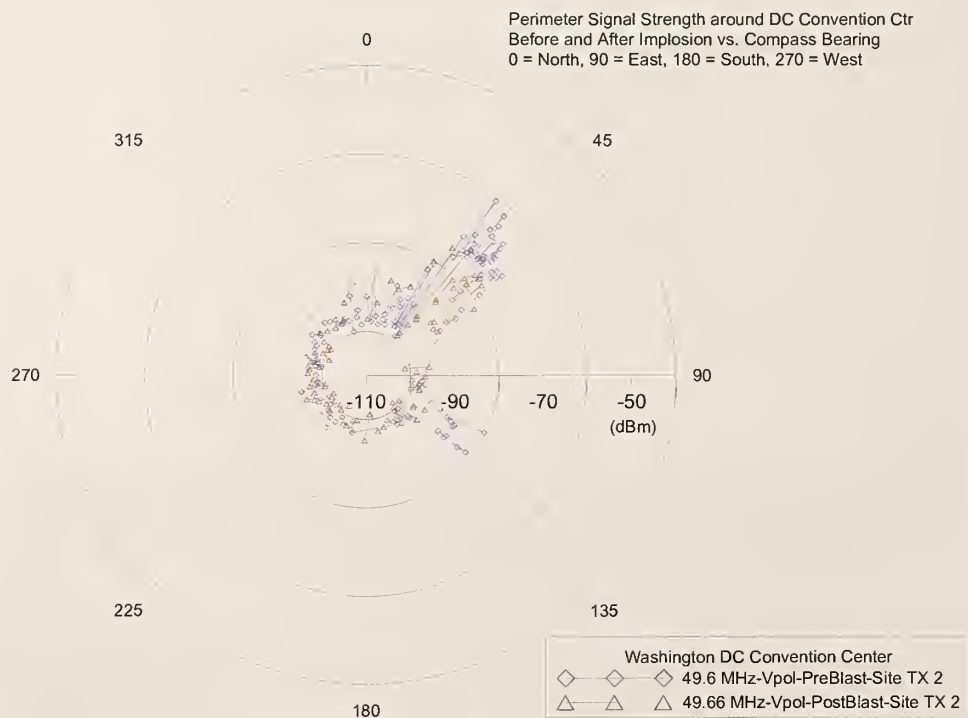
Figure 114. Comparison of pre- and post-implosion mobile cart perimeter measurements for the transmitters at site TX 2 for vertically polarized receiving antennas: 49 MHz band.

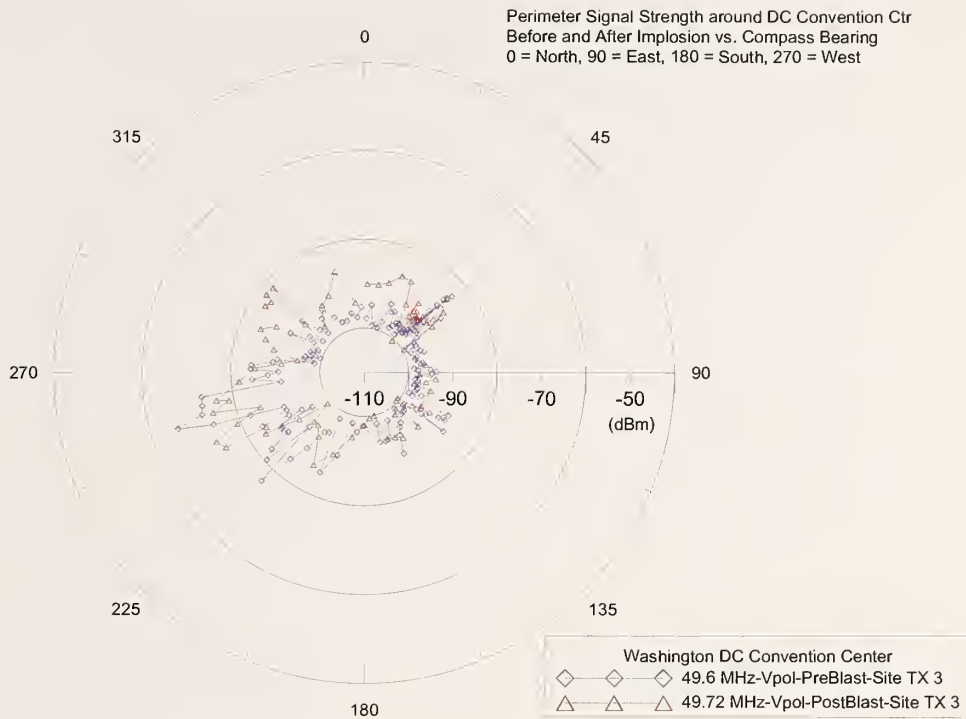
Figure 115. Comparison of pre- and post-implosion mobile cart perimeter measurements for the transmitters at site TX 3 for vertically polarized receiving antennas: 49 MHz band.

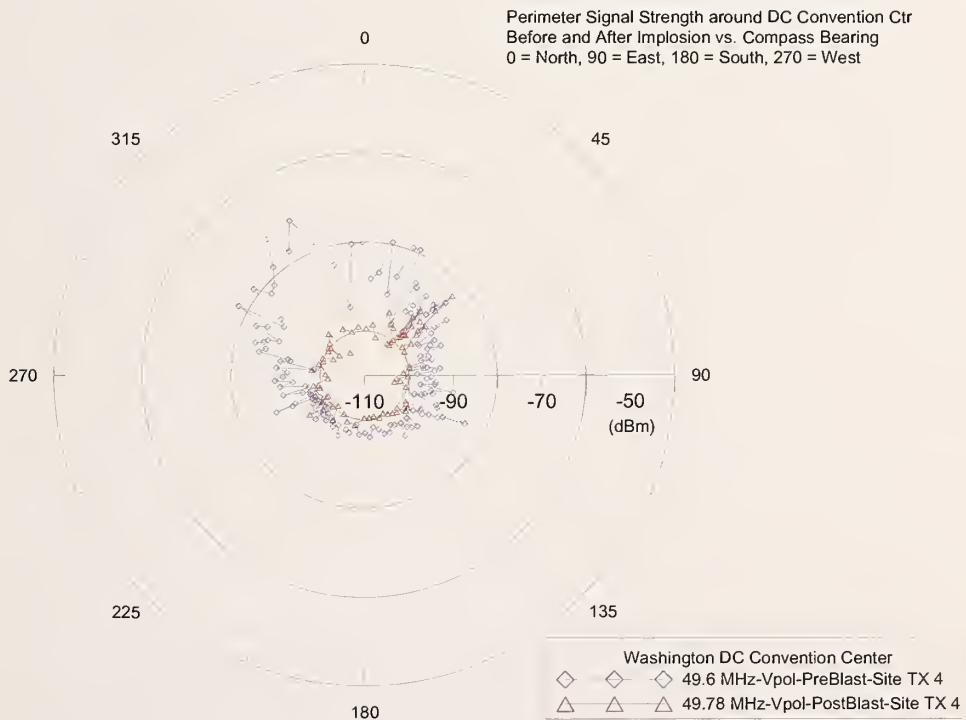
Figure 116. Comparison of pre- and post-implosion mobile cart perimeter measurements for the transmitters at site TX 4 for vertically polarized receiving antennas: 49 MHz band.

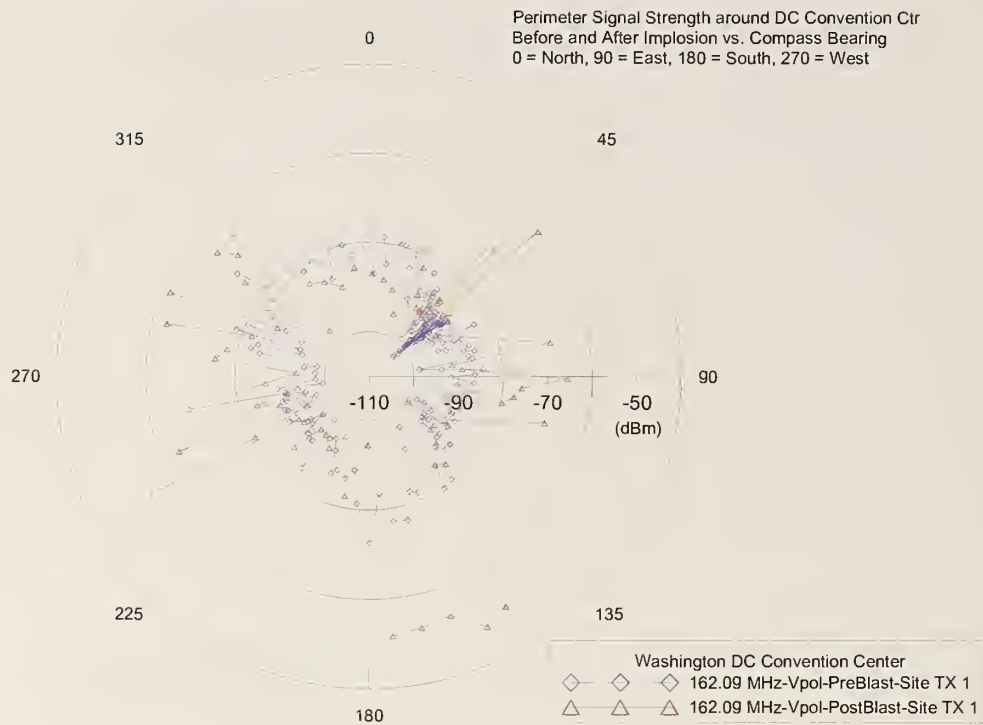
Figure 117. Comparison of pre- and post-implosion mobile cart perimeter measurements for the transmitters at site TX 1 for vertically polarized receiving antennas: 160 MHz band.

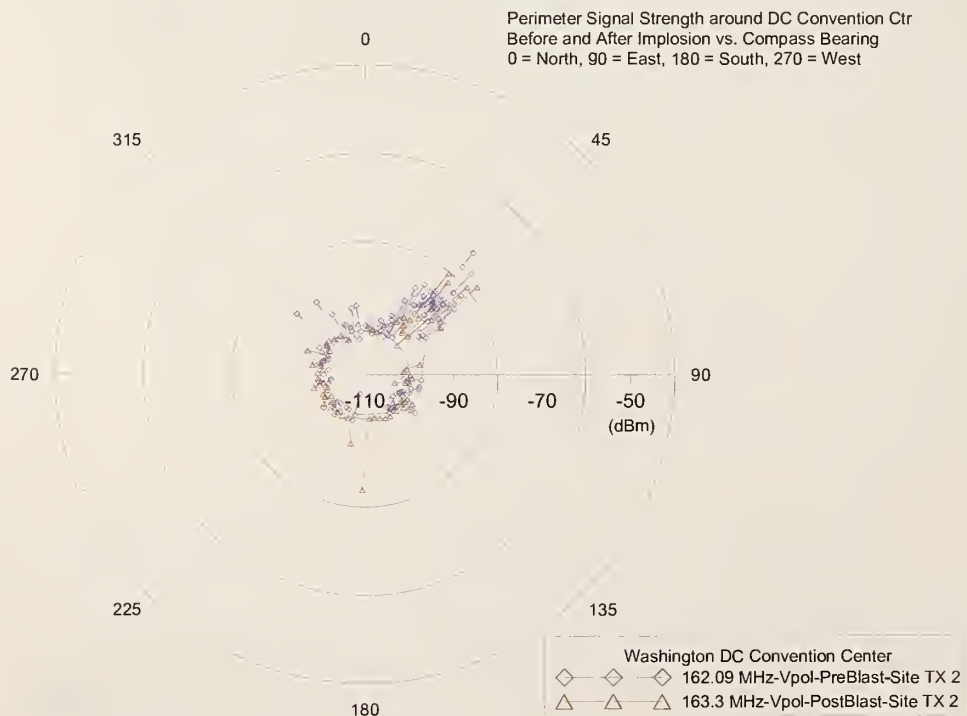
Figure 118. Comparison of pre- and post-implosion mobile cart perimeter measurements for the transmitters at site TX 2 for vertically polarized receiving antennas: 160 MHz band.

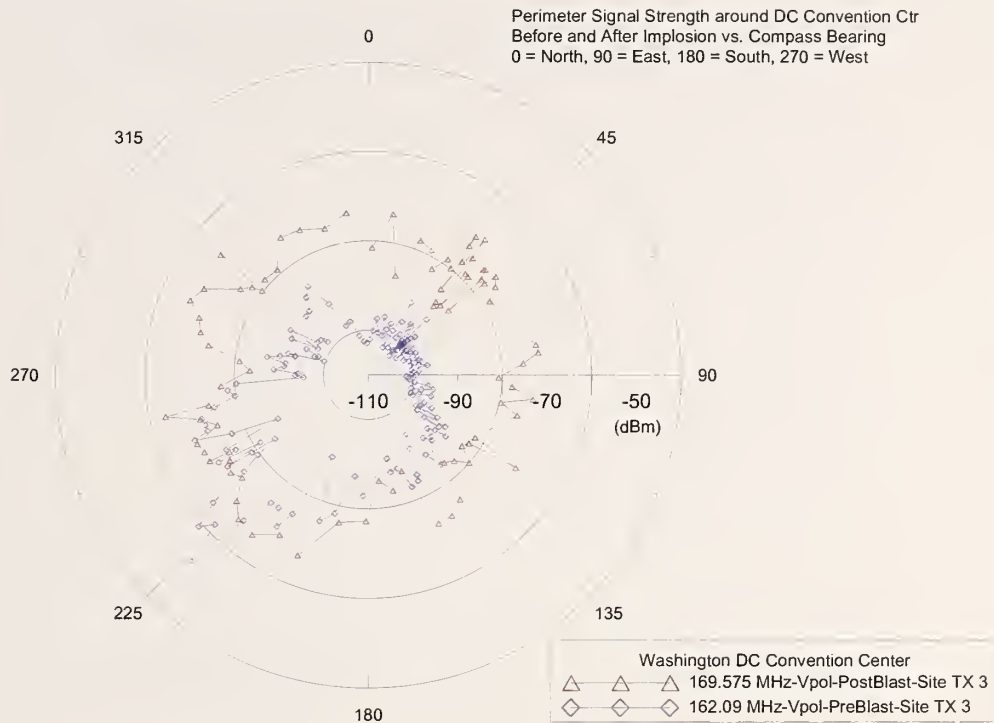
Figure 119. Comparison of pre- and post-implosion mobile cart perimeter measurements for the transmitters at site TX 3 for vertically polarized receiving antennas: 160 MHz band.

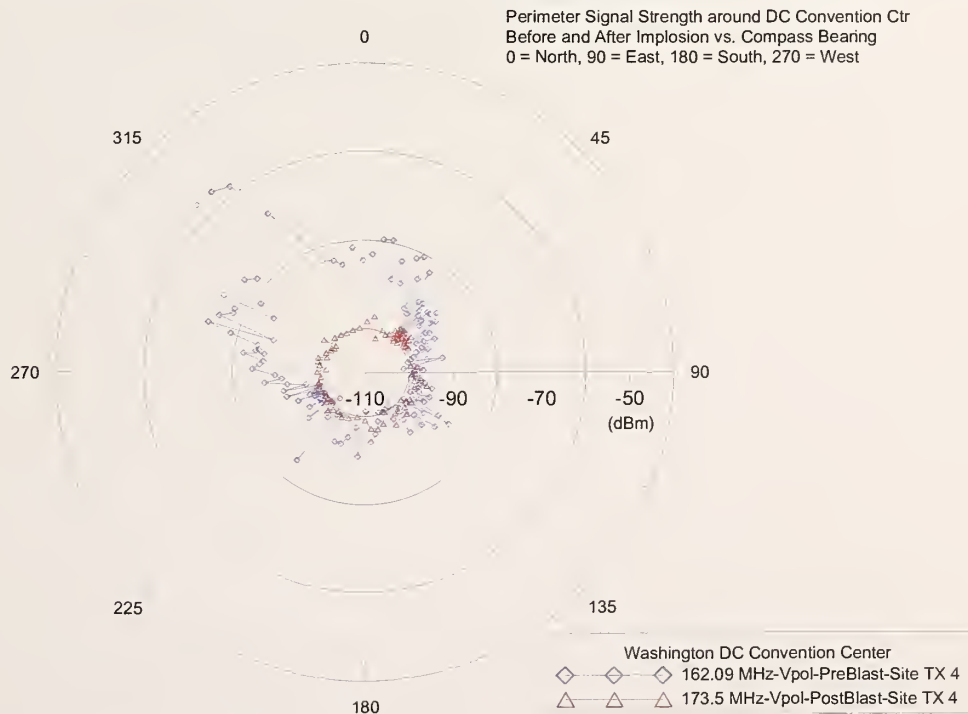
Figure 120. Comparison of pre- and post-implosion mobile cart perimeter measurements for the transmitters at site TX 4 for vertically polarized receiving antennas: 160 MHz band.

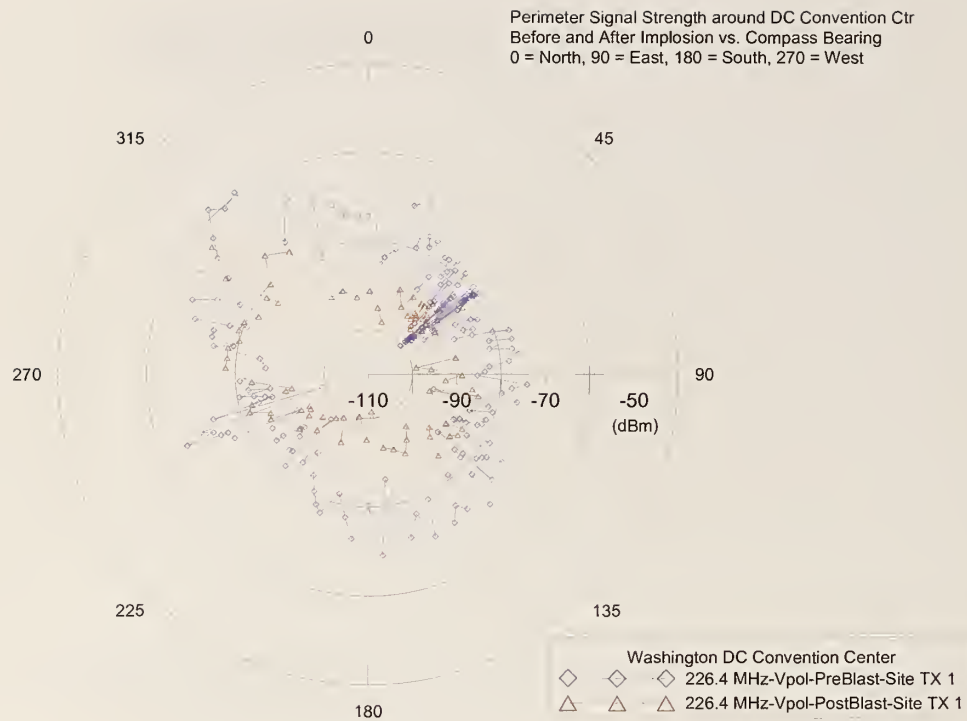
Figure 121. Comparison of pre- and post-implosion mobile cart perimeter measurements for the transmitters at site TX 1 for vertically polarized receiving antennas: 225 MHz band.

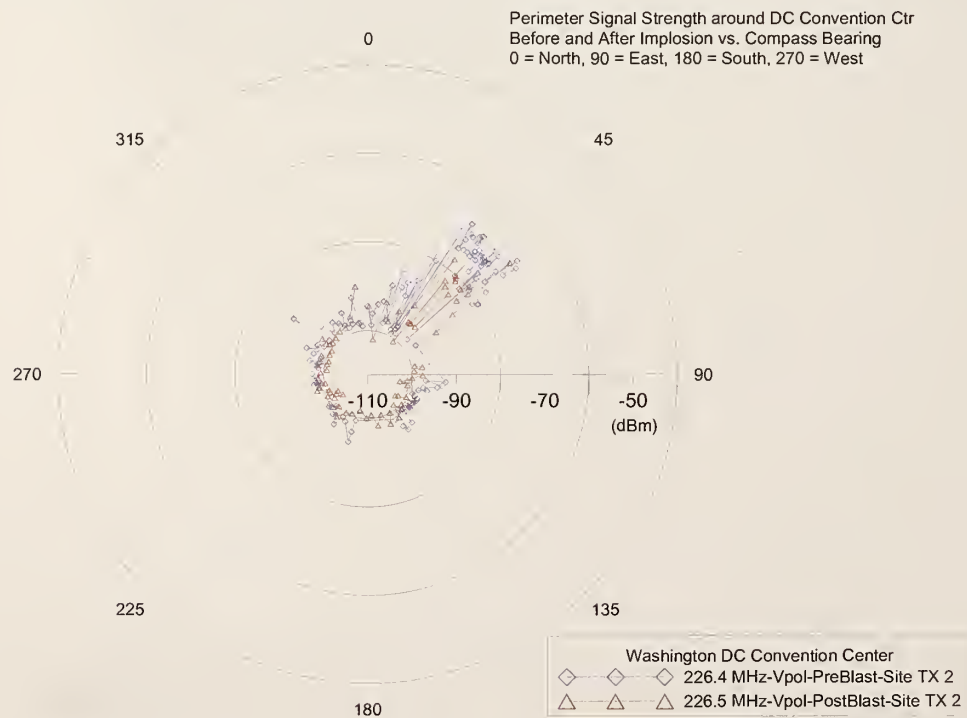
Figure 122. Comparison of pre- and post-implosion mobile cart perimeter measurements for the transmitters at site TX 2 for vertically polarized receiving antennas: 225 MHz band.

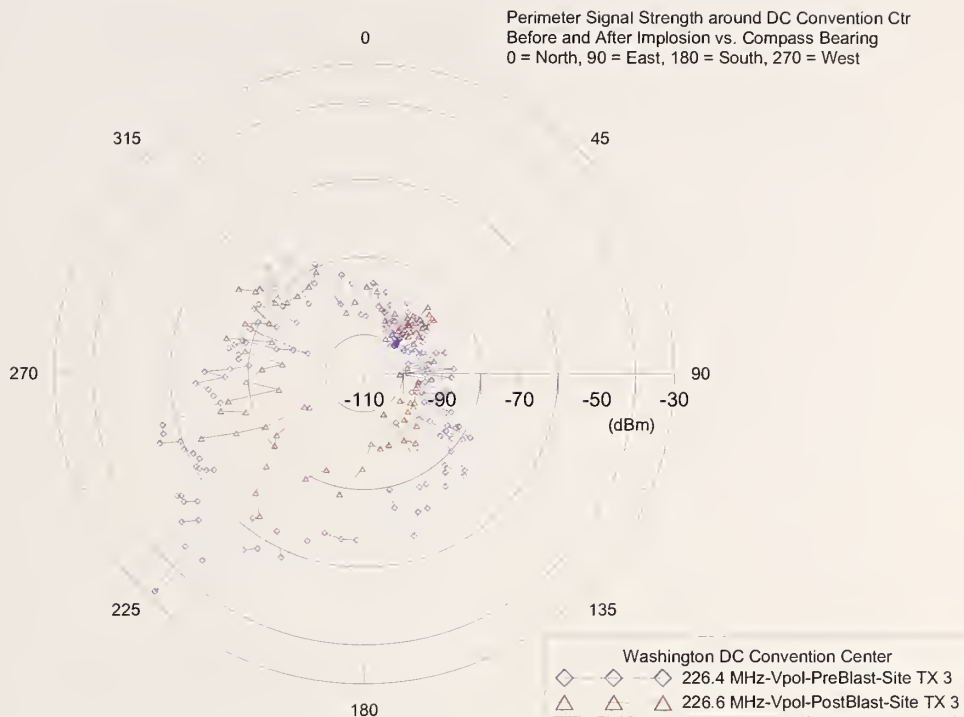
Figure 123. Comparison of pre- and post-implosion mobile cart perimeter measurements for the transmitters at site TX 3 for vertically polarized receiving antennas: 225 MHz band.

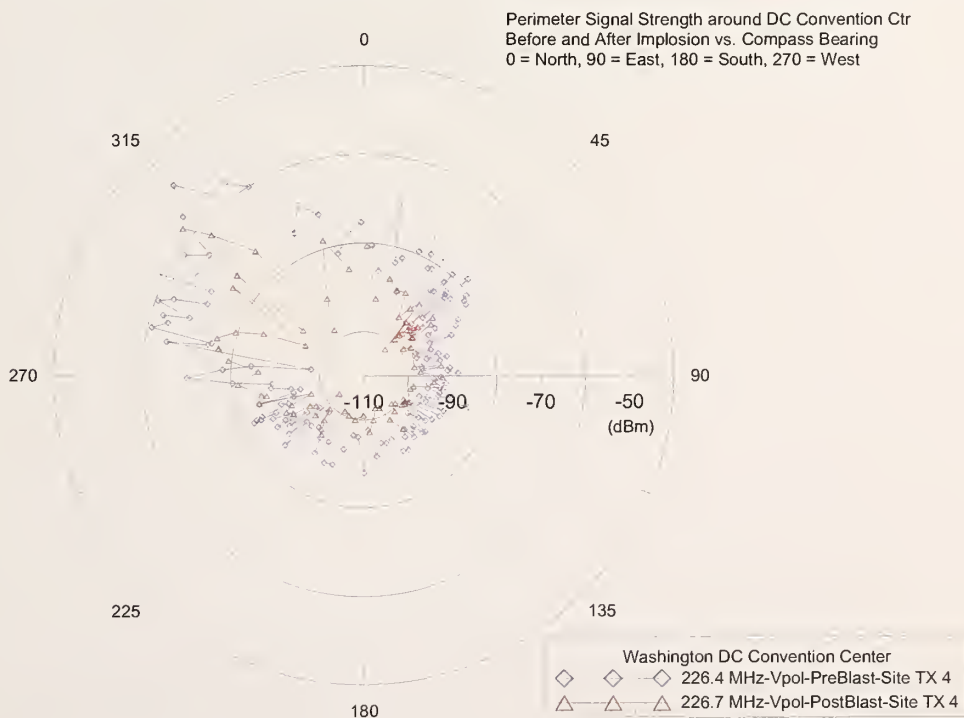
Figure 124. Comparison of pre- and post-implosion mobile cart perimeter measurements for the transmitters at site TX 4 for vertically polarized receiving antennas: 225 MHz band.

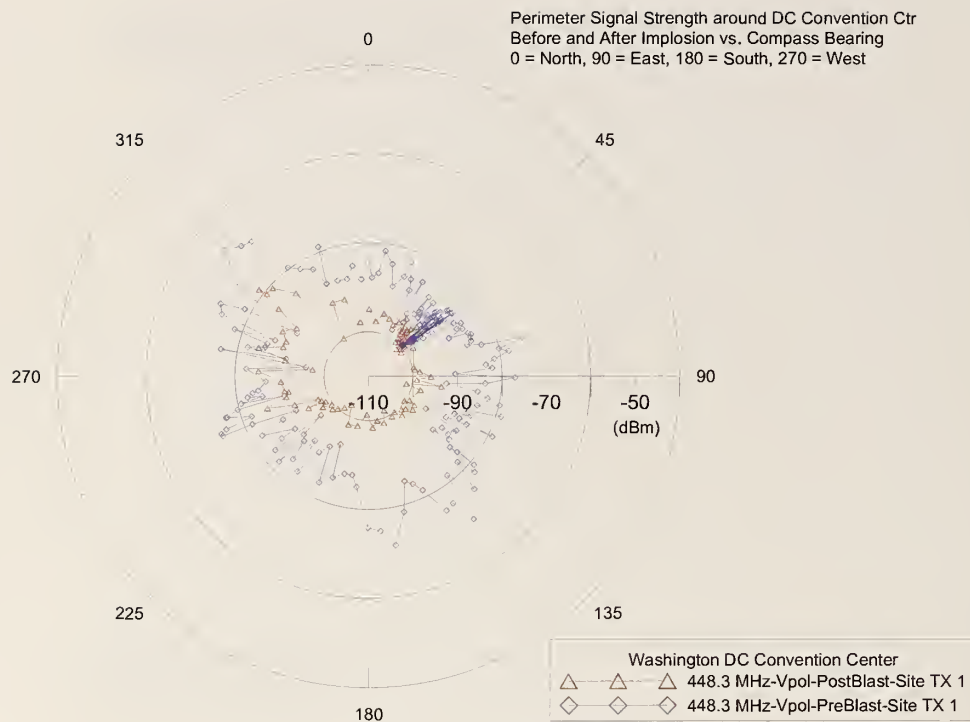
Figure 125. Comparison of pre- and post-implosion mobile cart perimeter measurements for the transmitters at site TX 1 for vertically polarized receiving antennas: 450 MHz band.

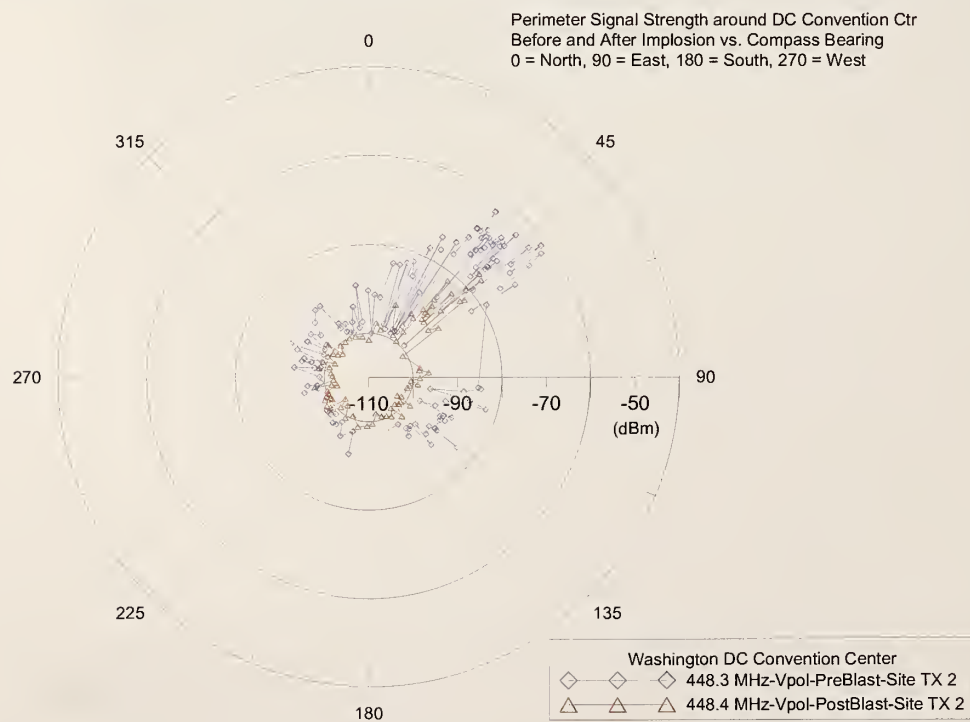
Figure 126. Comparison of pre- and post-implosion mobile cart perimeter measurements for the transmitters at site TX 2 for vertically polarized receiving antennas: 450 MHz band.

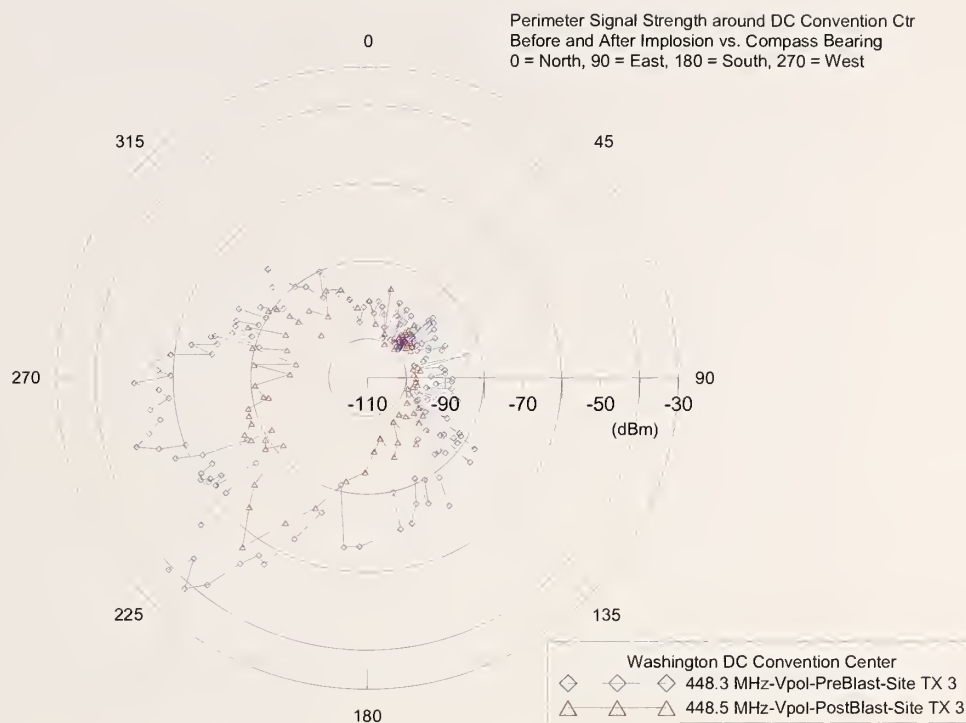
Figure 127. Comparison of pre- and post-implosion mobile cart perimeter measurements for the transmitters at site TX 3 for vertically polarized receiving antennas: 450 MHz band.

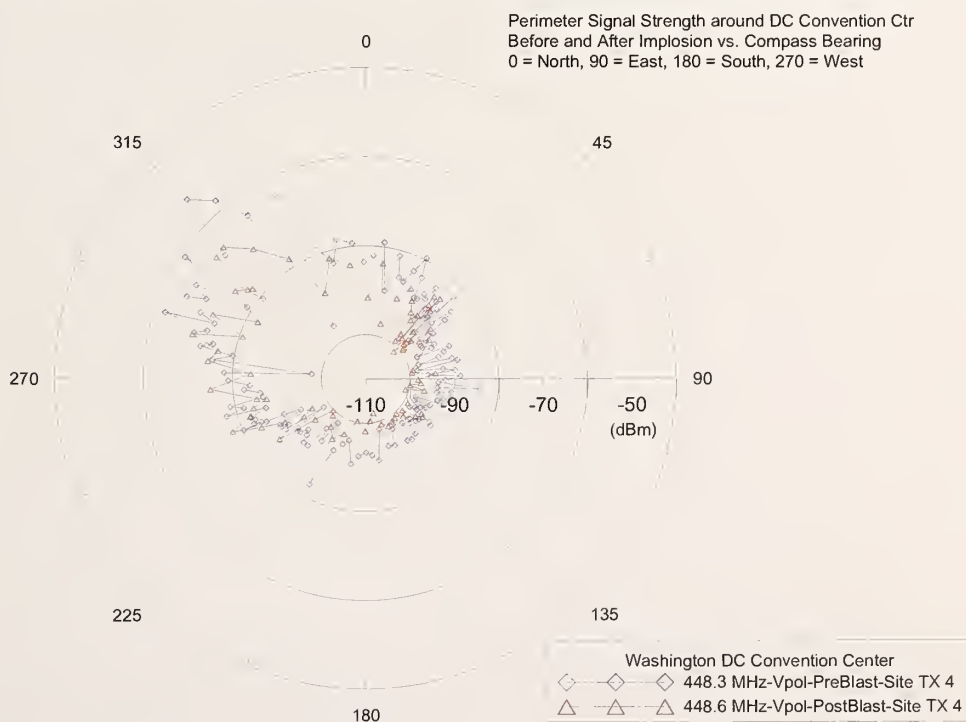
Figure 128. Comparison of pre- and post-implosion mobile cart perimeter measurements for the transmitters at site TX 4 for vertically polarized receiving antennas: 450 MHz band.

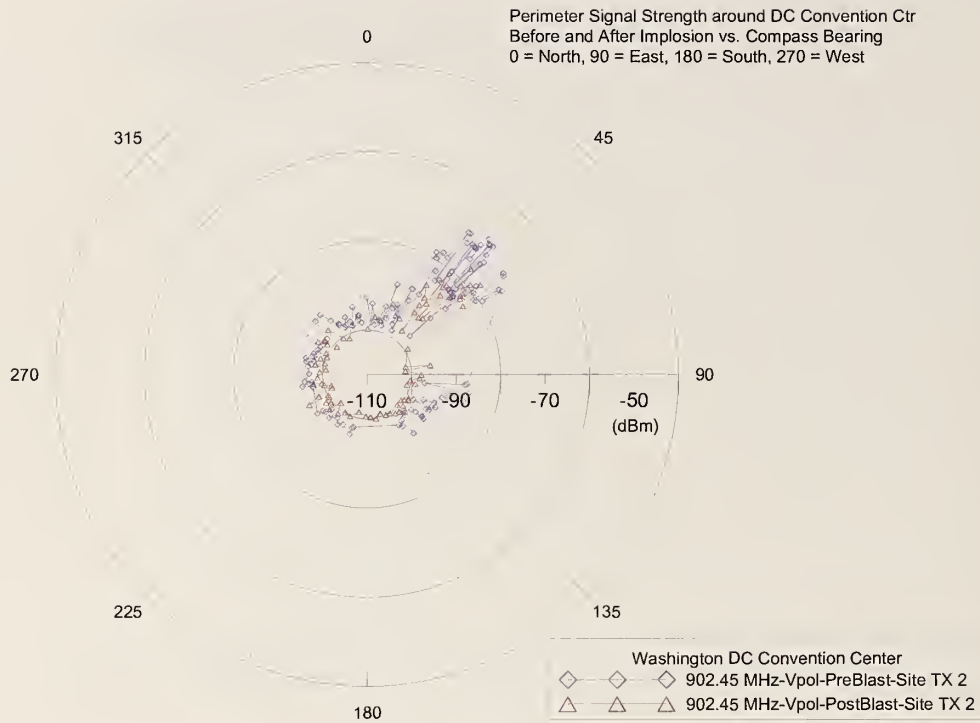
Figure 129. Comparison of pre- and post-implosion mobile cart perimeter measurements for the transmitters at site TX 2 for vertically polarized receiving antennas: 900 MHz band.

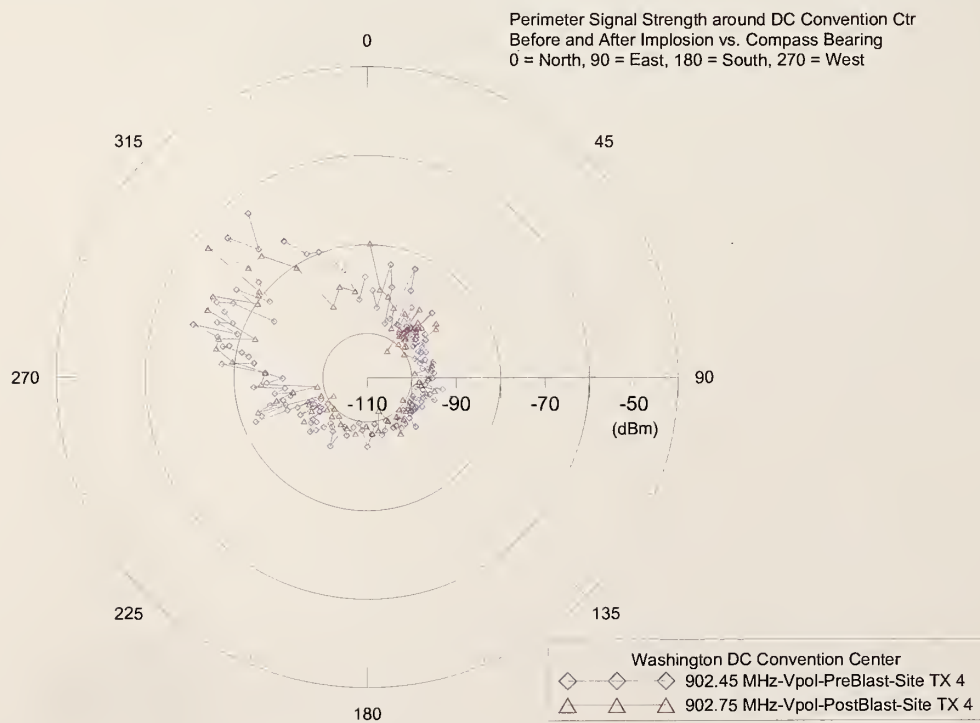
Figure 130. Comparison of pre- and post-implosion mobile cart perimeter measurements for the transmitters at site TX 4 for vertically polarized receiving antennas: 900 MHz band.

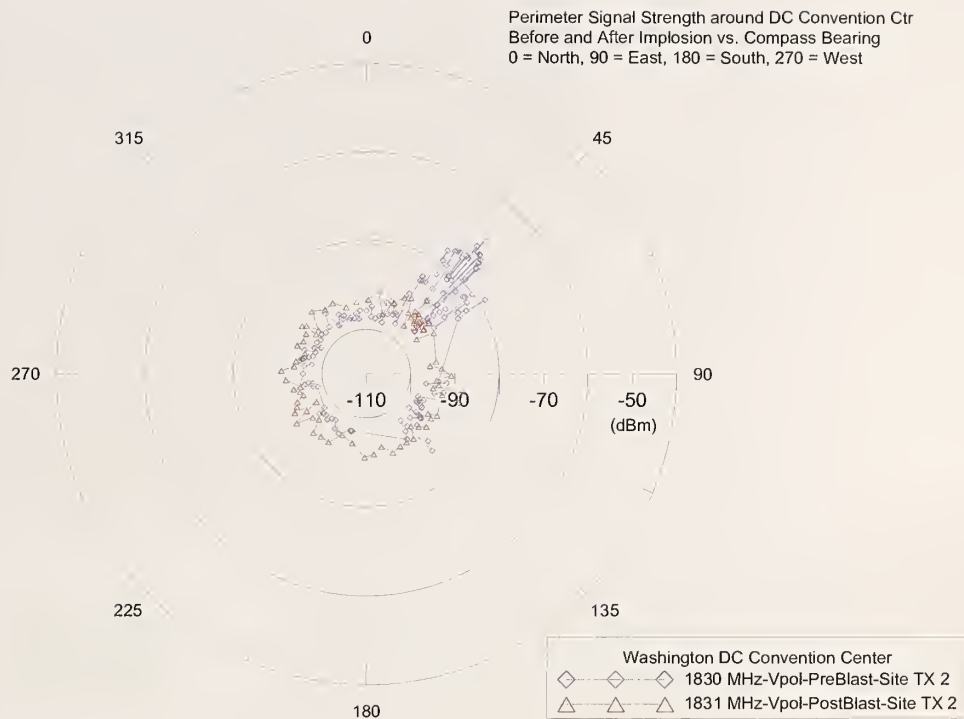
Figure 131. Comparison of pre- and post-implosion mobile cart perimeter measurements for the transmitters at site TX 2 for vertically polarized receiving antennas: 1800 MHz band.

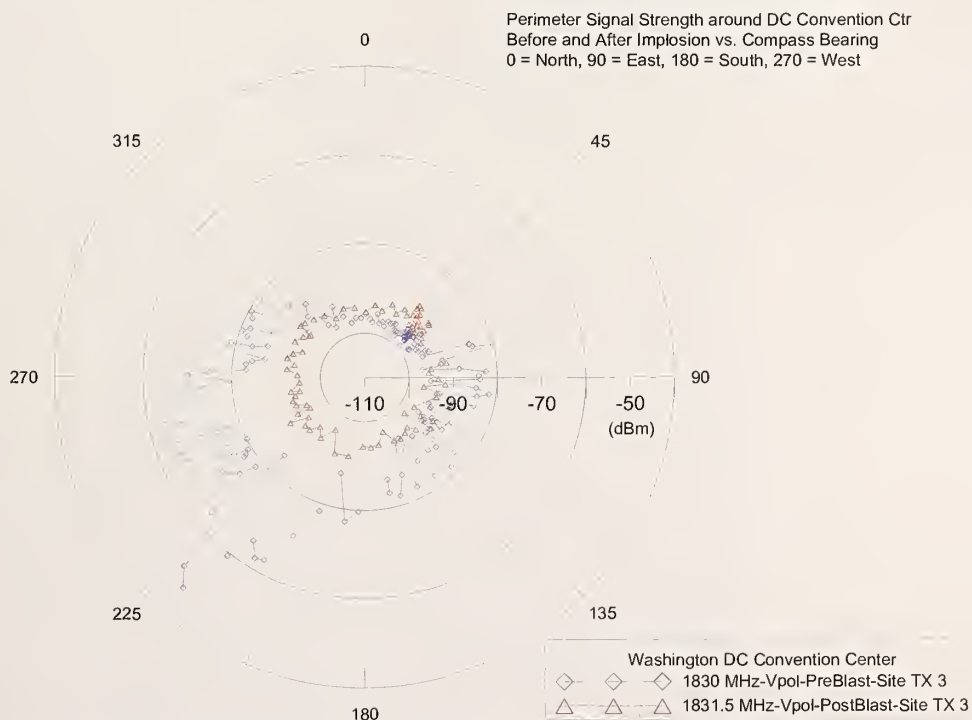
Figure 132. Comparison of pre- and post-implosion mobile cart perimeter measurements for the transmitters at site TX 3 for vertically polarized receiving antennas: 1800 MHz band.

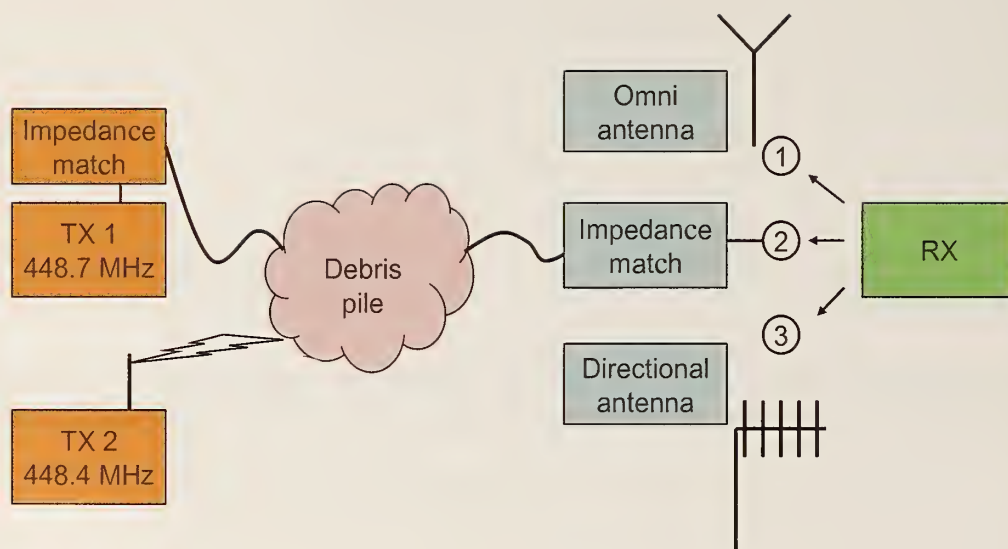
Figure 133. Debris radiator tests. Two transmitters tuned to slightly different frequencies were buried in the rubble. Transmitter 1 (TX 1) was connected through an impedance tuner to a long cable that ran to the edge of the debris pile. Transmitter 2 (TX 2) transmitted through a standard omnidirectional antenna. Three types of receive antenna were used: (1) a standard omnidirectional antenna; (2) direct connection through an impedance tuner; (3) a directional antenna. Measured results are given in Table 17.

As we did in the New Orleans [5] and Philadelphia [7] implosion experiments, we maximized our chances of a useful outcome by simulating the best-case scenario of a metallic object running continuously from a radio to a receive site. To do this, we laid stranded steel cables from two of the transmit sites to the edge of what would be the debris pile after implosion. Using pre-placed cables meant that even if post-blast safety considerations kept us from getting close to the collapsed building, we could still acquire useful data. Two cables were run, one from Transmit site TX 2 and one from Transmit site TX 4, see Figures 1, 21, 22 and 133.

In this experiment, unlike the previous two, we also tested whether using debris as a transmit antenna would improve chances of signal reception outside the debris pile. We replaced the omnidirectional "rubber duck" antenna on two of the transmitters with an impedance matching network, which was in turn attached to the stranded steel cable. Use of the impedance matching network improved the coupling efficiency of the radio wave signal to the metallic debris. Next to each transmitter that used the cable antenna, we placed transmitters that used standard "rubber duck" omnidirectional antennas. The four transmitters were tuned to similar frequencies. See Figure 133 for the experimental set-up. This experiment allowed us to compare received signal strength with and without use of the debris radiator antenna.

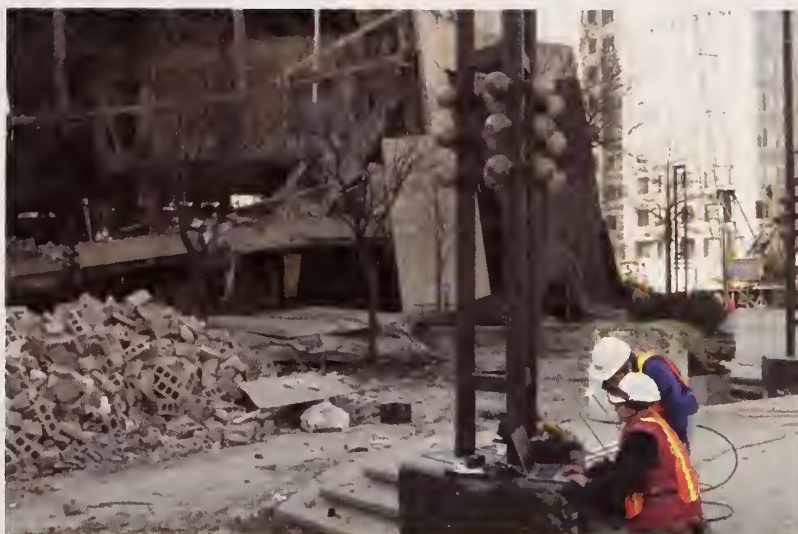
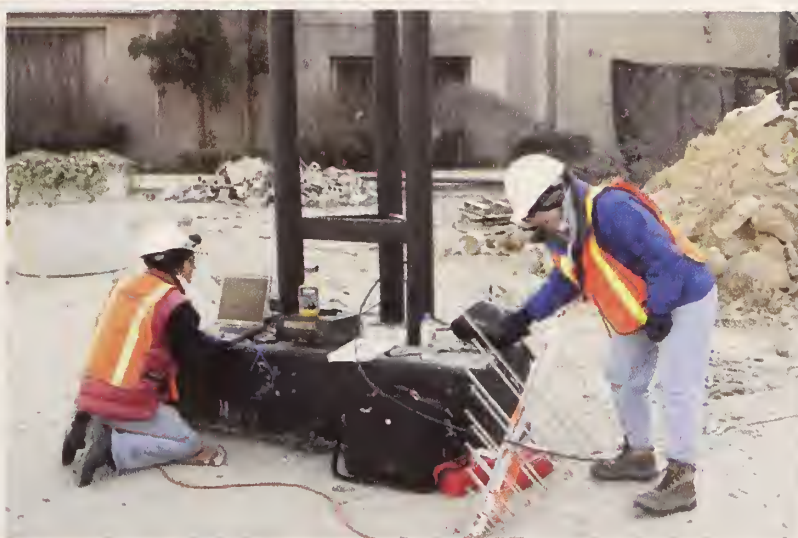
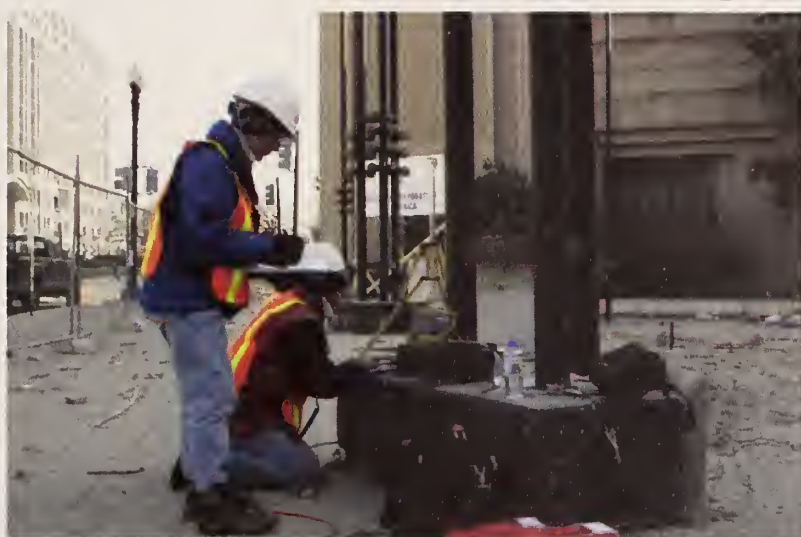
Figure 134. Near receiving site RX 1 and transmit site TX 4. Debris radiator tests are carried out using a spectrum analyzer, a communications receiver, and several types of receive antennas.

We measured signals in the 450 MHz frequency band from all four transmitters after the building implosion using a spectrum analyzer and three types of receiving antennas: (1) a standard omnidirectional "rubber duck" antenna; (2) a directional, log-periodic antenna with a gain of approximately ten (that is, the received signal in the direction of the array was ten times stronger than with an omni-directional antenna); and (3) direct connection to the steel cables through an impedance tuner. We repeated each measurement at least twice. Figures 134 and 135 show the post-implosion measurements being made at the two sites.

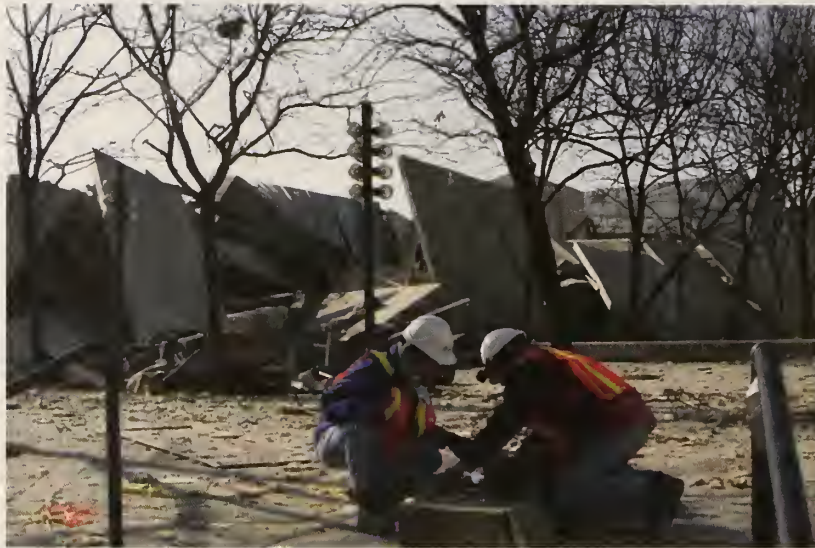
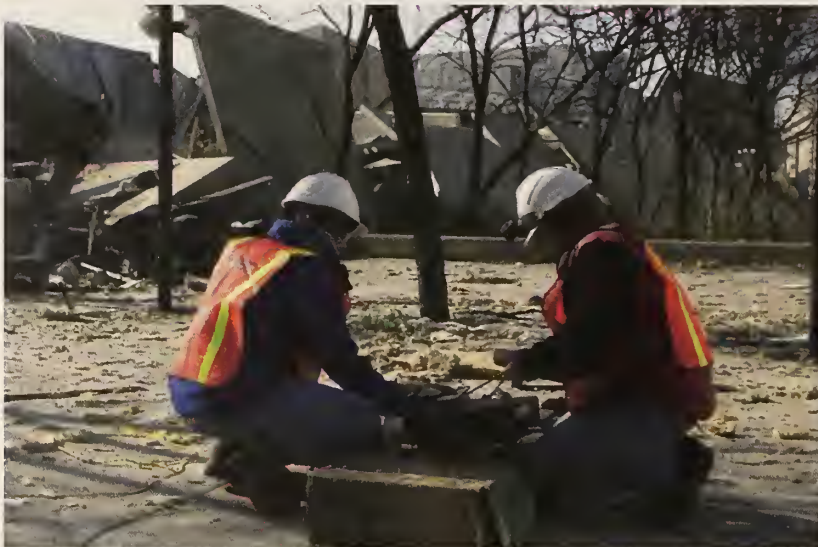
Figure 135. Near receiving site RX 2 and transmit site TX 2. Debris radiator tests similar to those in Figure 1 are carried out. Note the orange painted cable at the left side of the photo.
