## *NIST Technical Note 1545*

# Attenuation of Radio Wave Signals Coupled Into Twelve Large Building Structures

August 2008

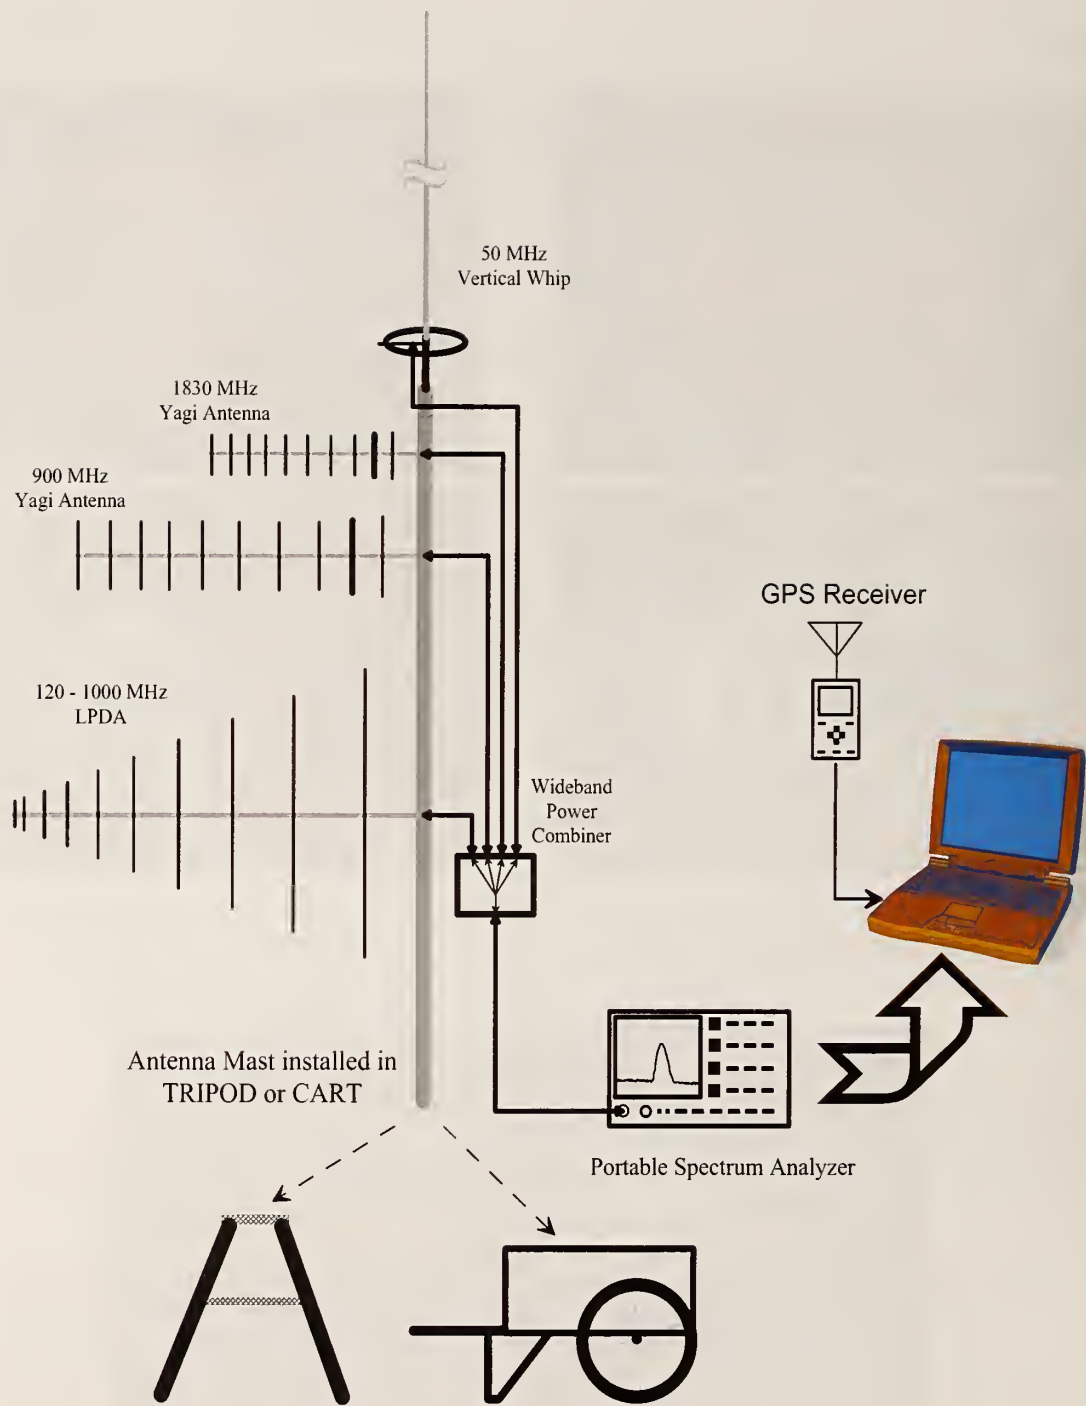
Figure 3. Schematic of the receiving system for the building penetration and field-mapping experiments.

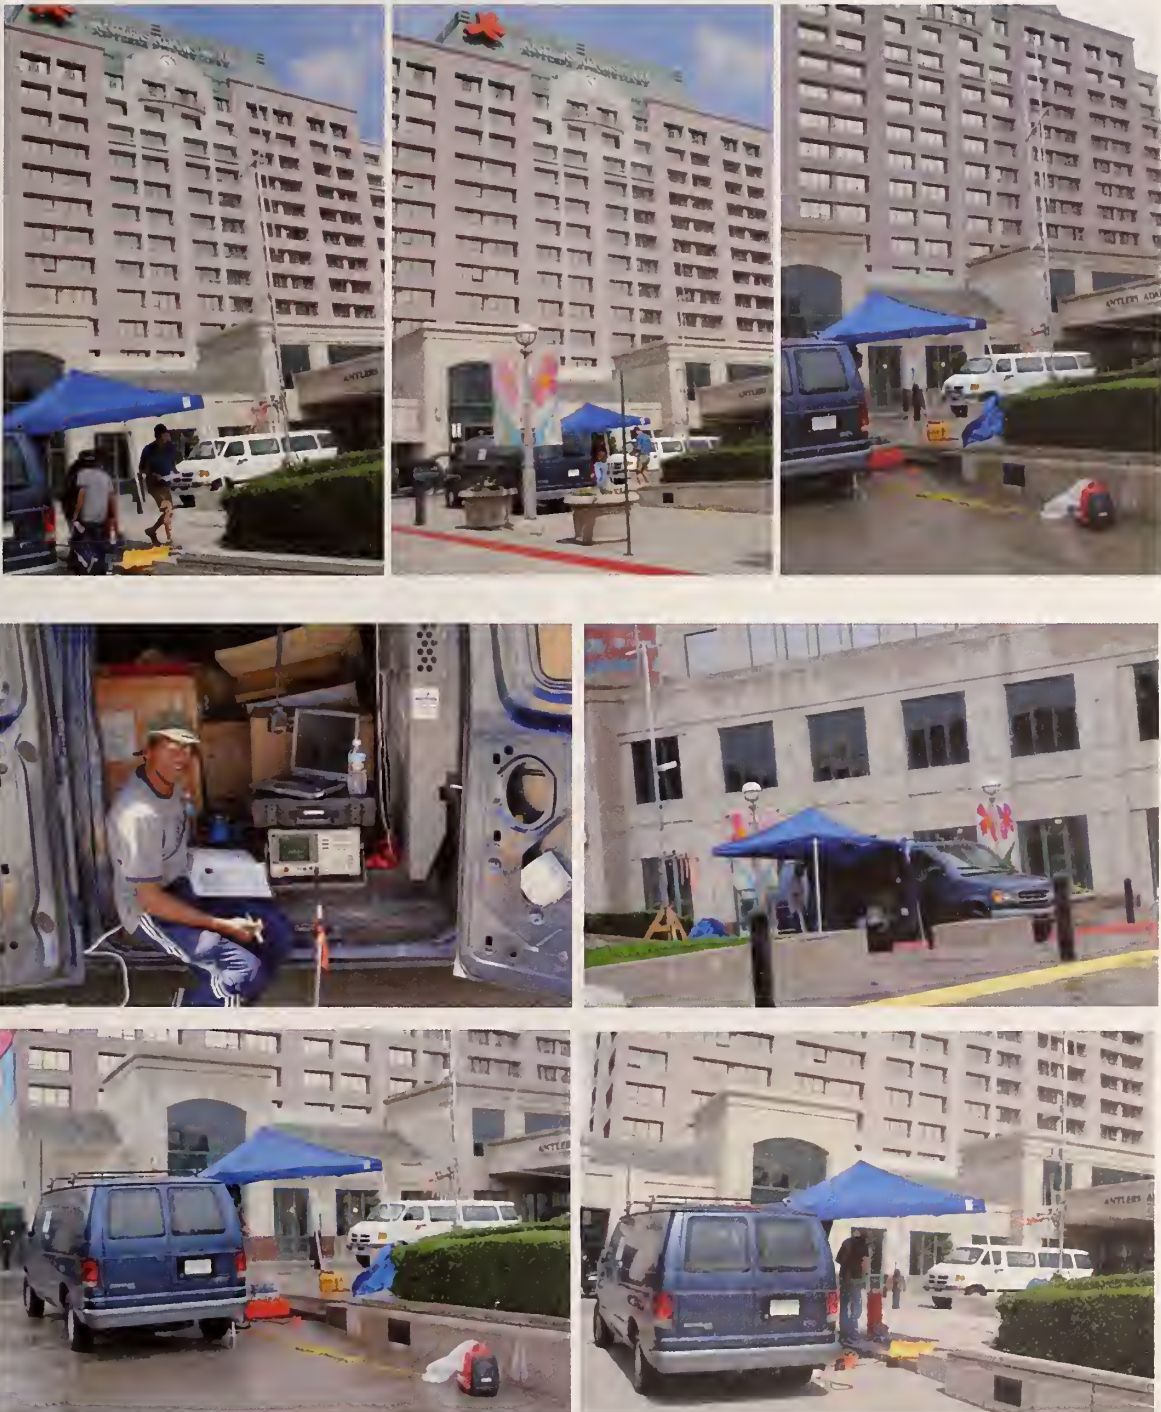
Figure 17. Receiver location and layout for the Colorado Springs, CO hotel complex.

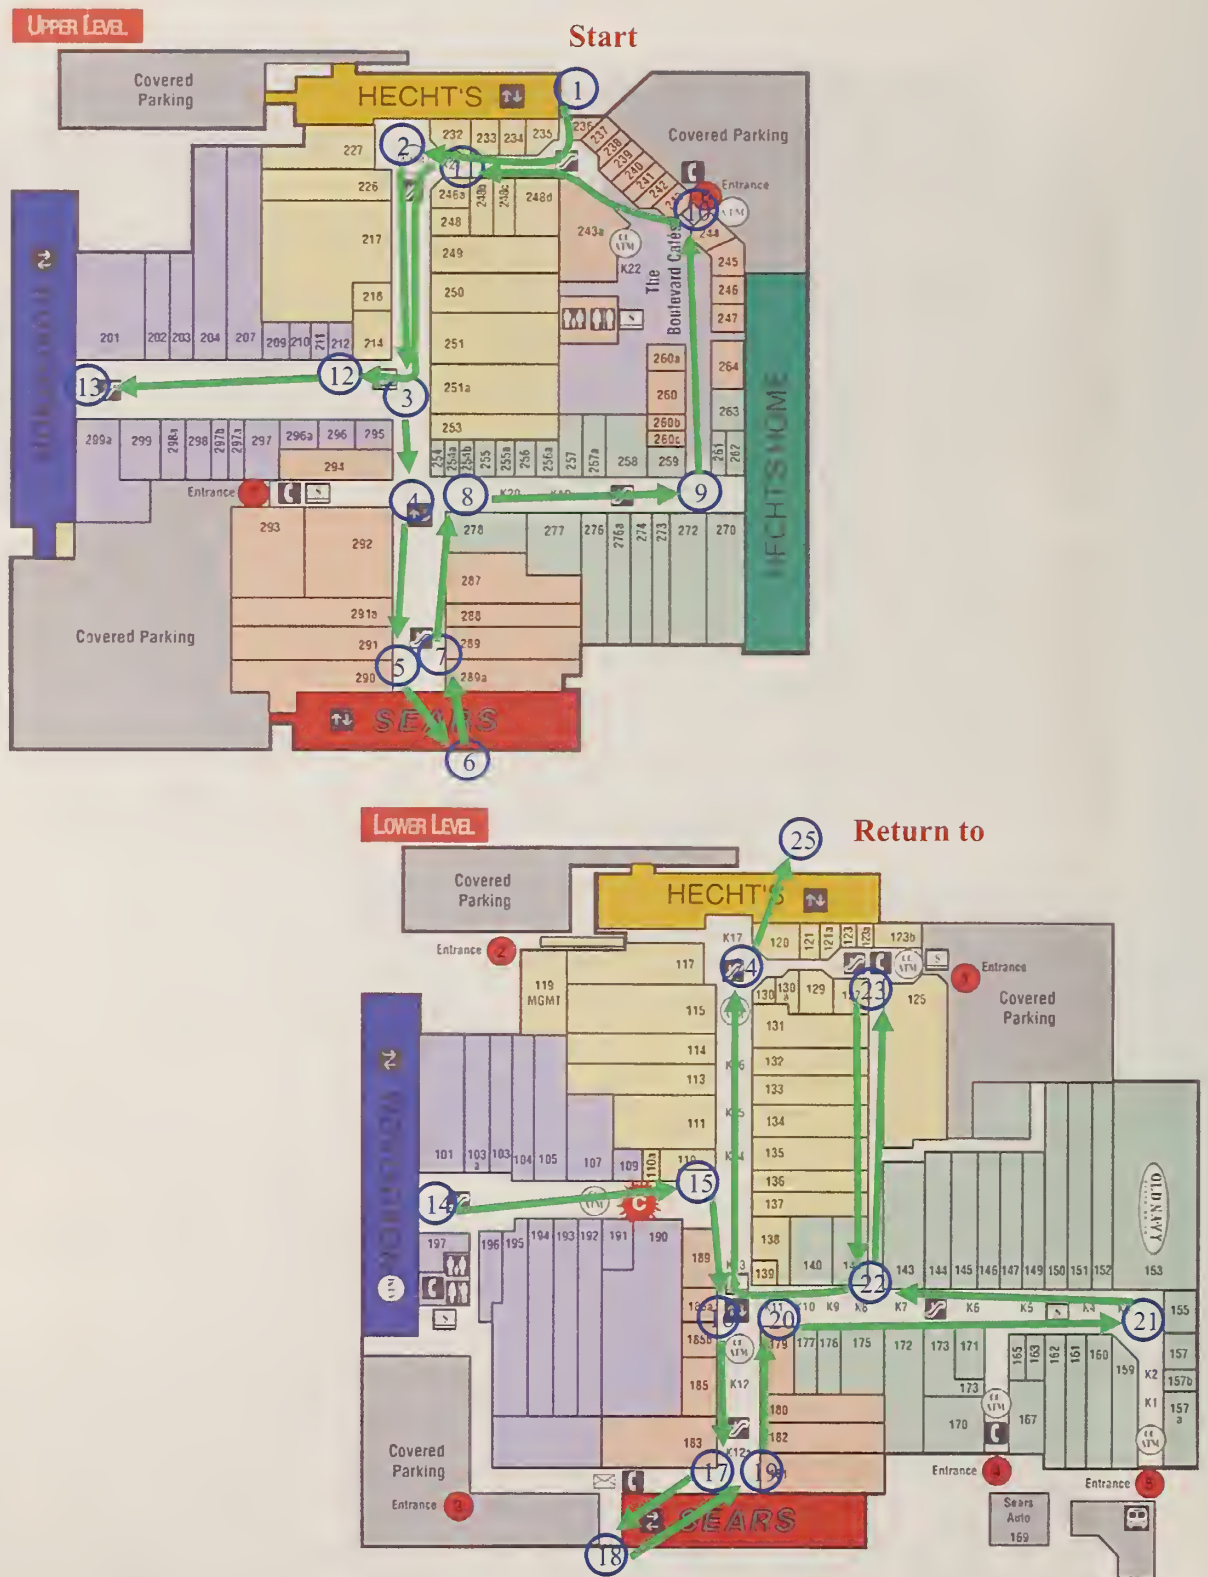
Figure 26. Upper and lower level floor plan with the predetermined locations on both levels of the shopping mall. The green arrows in the figure represent the actual paths that were walked.

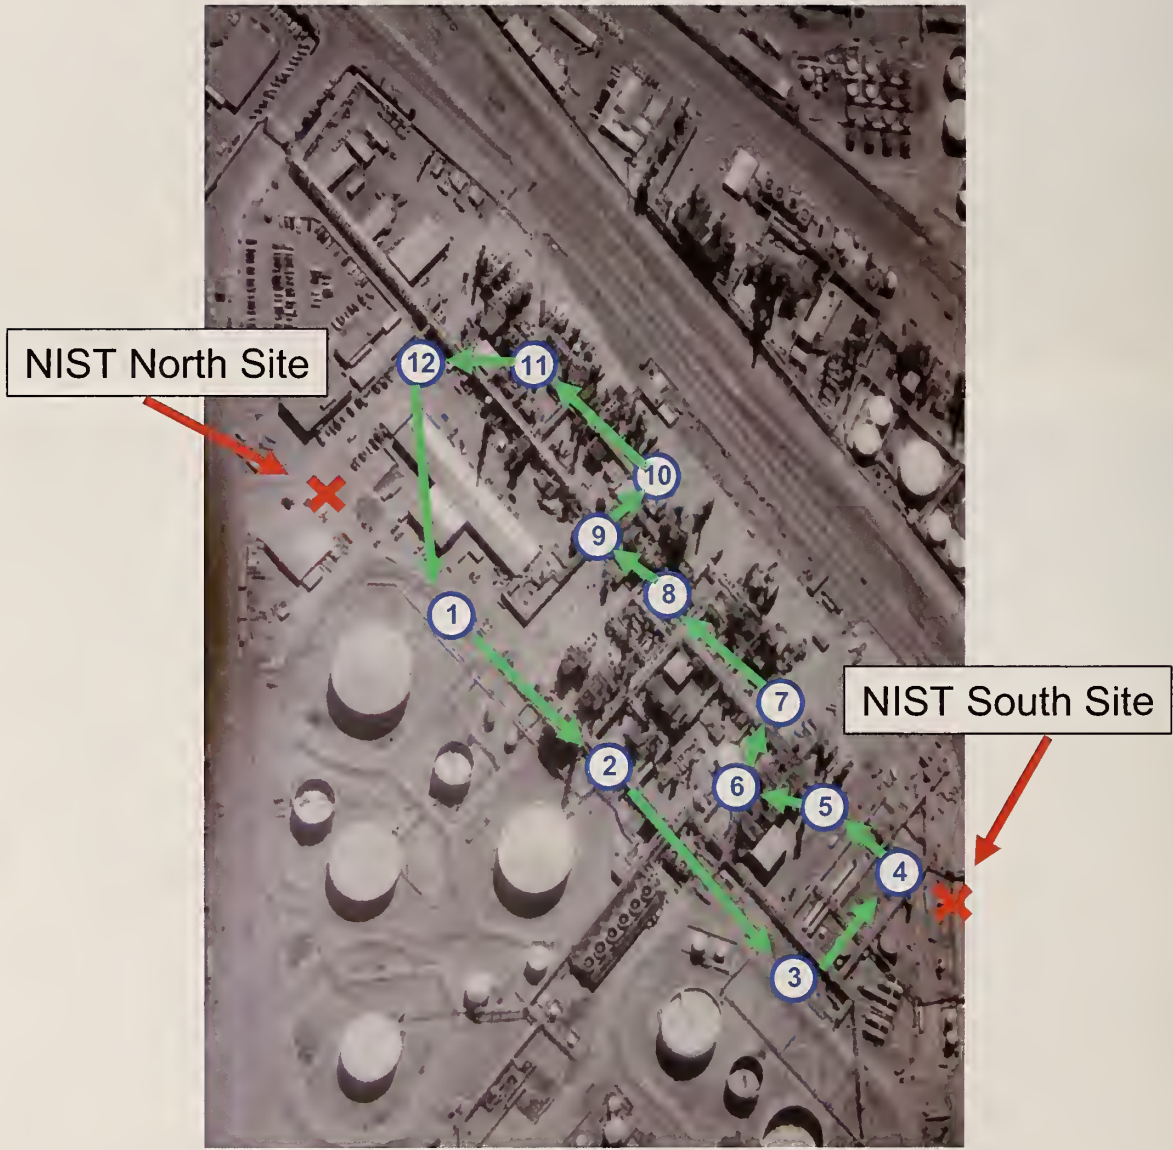
Figure 42. Receiver location and layout for the Commerce City, CO oil refinery.

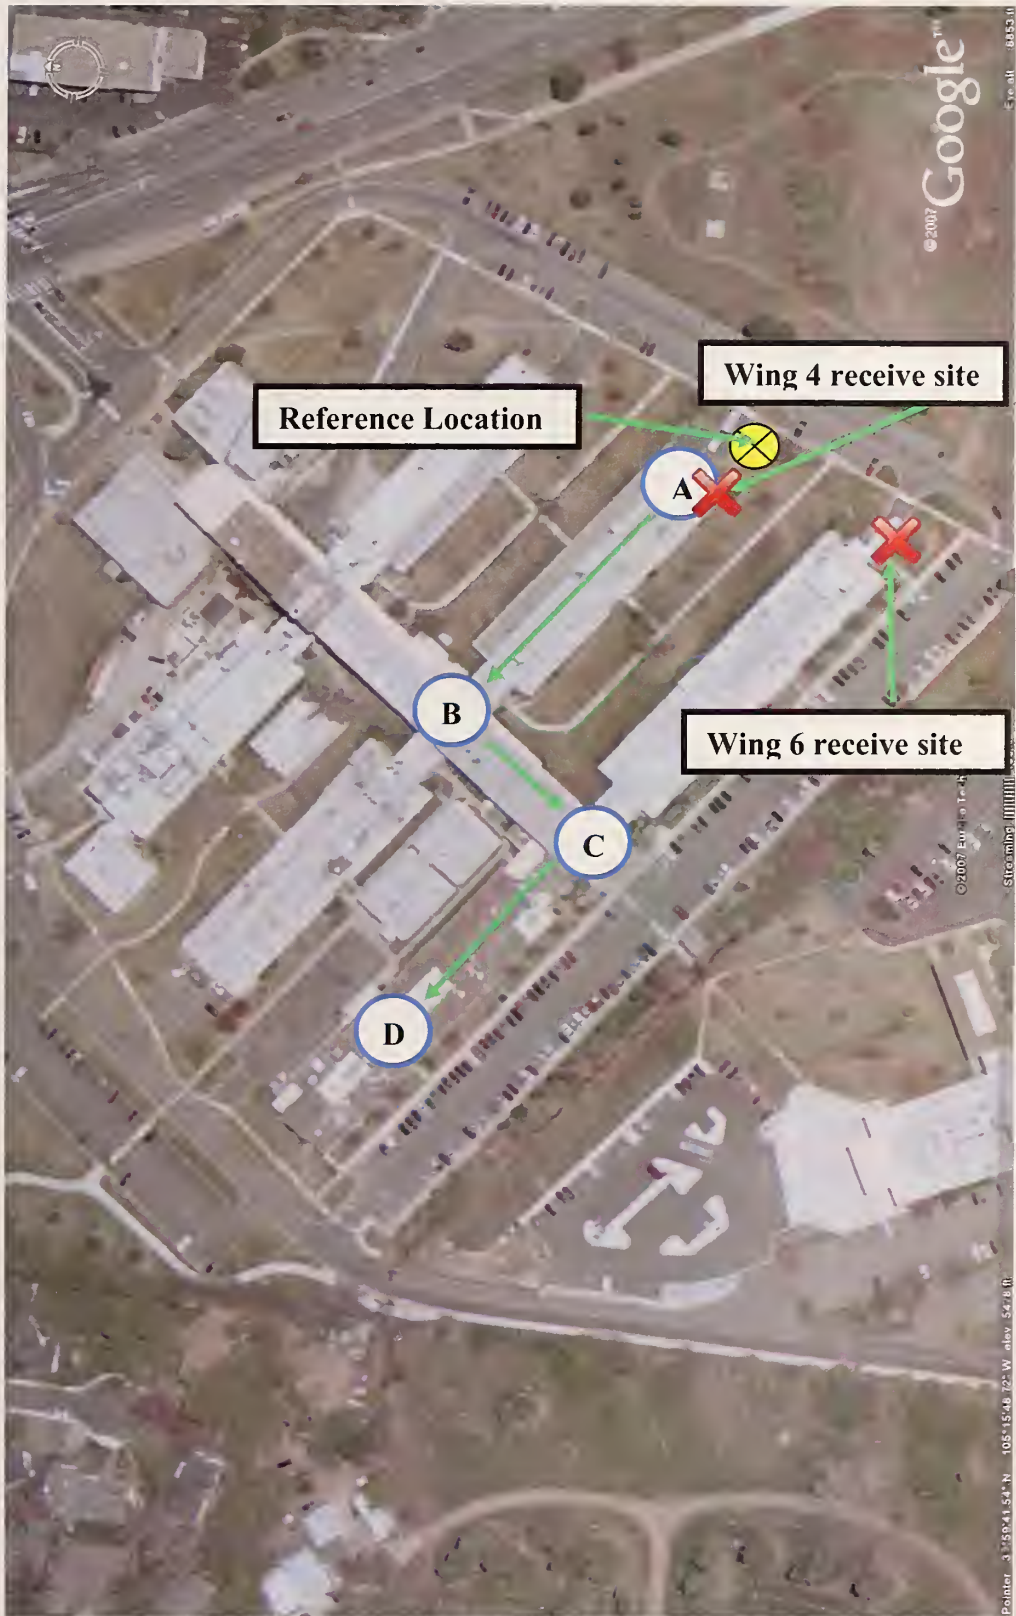
Figure 45. Receiver location and layout for the Boulder, CO laboratories.

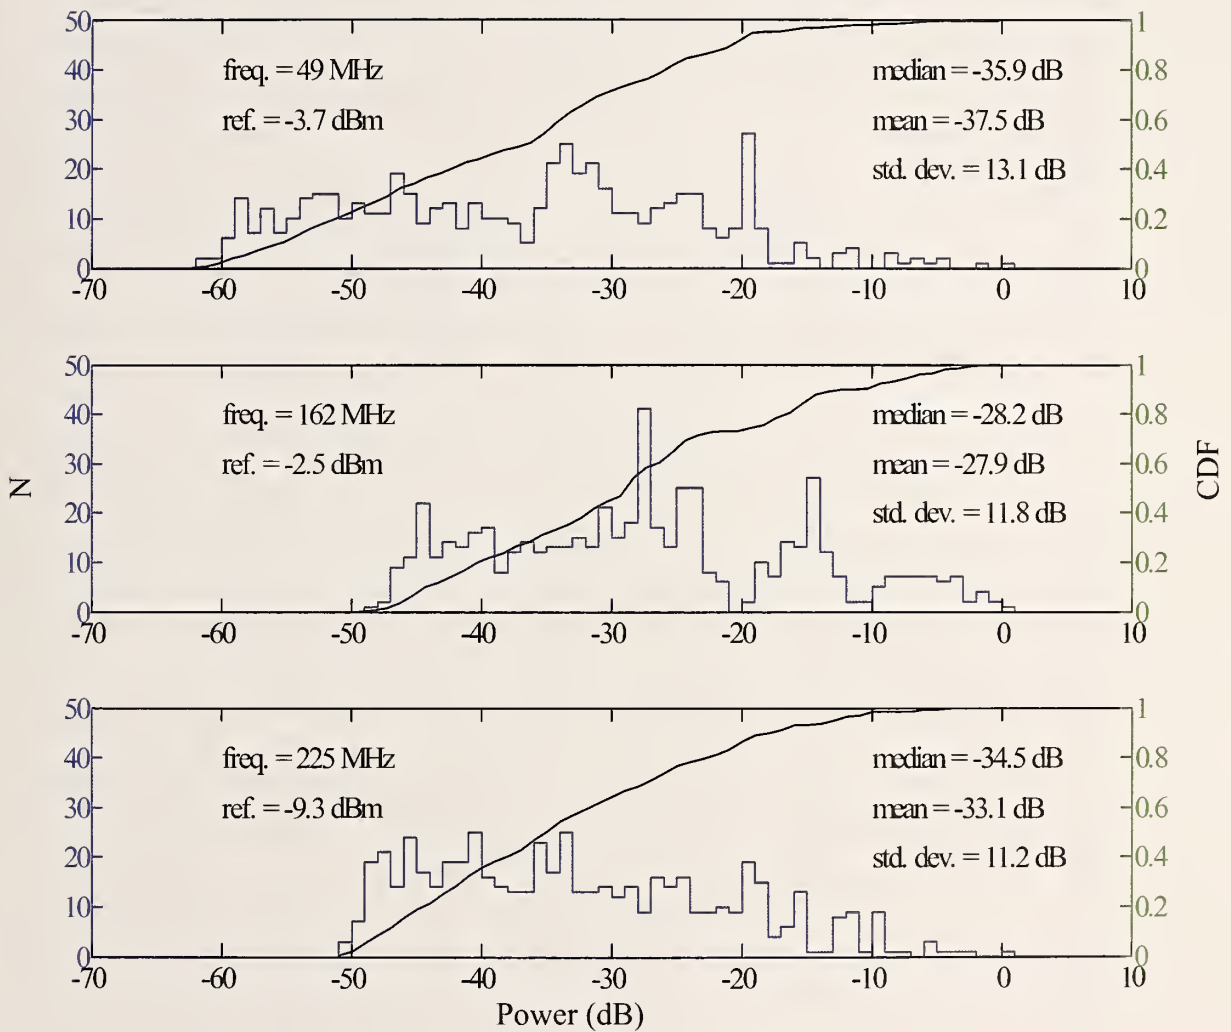
Figure 52. New Orleans, LA apartment building statistics, histograms, and empirical CDF for walk-through data at 49.60, 162.00, and 225.375 MHz.

The apartment building in New Orleans, LA provided the first set of data collected (in chronological order). Plots of the signal power versus sample number are provided for the six lower-frequency bands in Figure 46 to Figure 51. Corresponding histograms and empirical cumulative density functions (CDFs) are found in Figure 52 and Figure 53. In these experiments, approximately 500 samples were collected for each frequency over the complete building walk-through, and the time between samples was approximately 6 s. The reference level for the six frequencies is much higher than that used in most subsequent experiments, which suggests a starting location quite close to the receiver site. As we will see, the standard deviation results are quite similar to results from the other buildings. Also, this particular building had been prepared for demolition, and thus did not contain material such as window glass. This removal of substantial portions of building material, as well as internal content, may have impacted the data. We also performed measurements before, during, and after the implosion of this structure and details of these implosion measurements are reported in Reference [5].

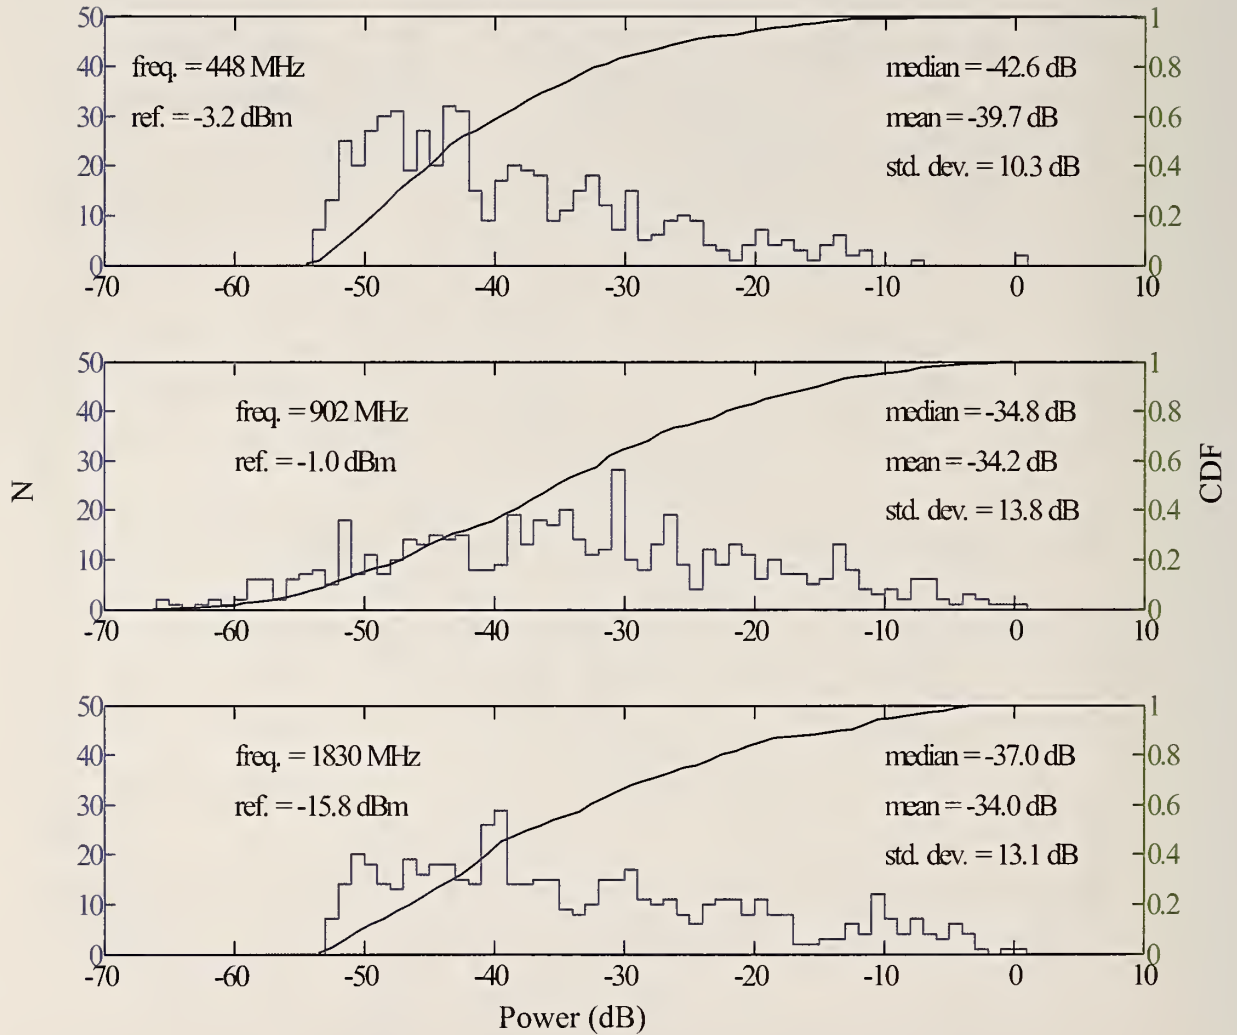
Figure 53. New Orleans, LA apartment building statistics, histograms, and empirical CDF for walk-through data at 448.60, 902.60, and 1832.50 MHz.

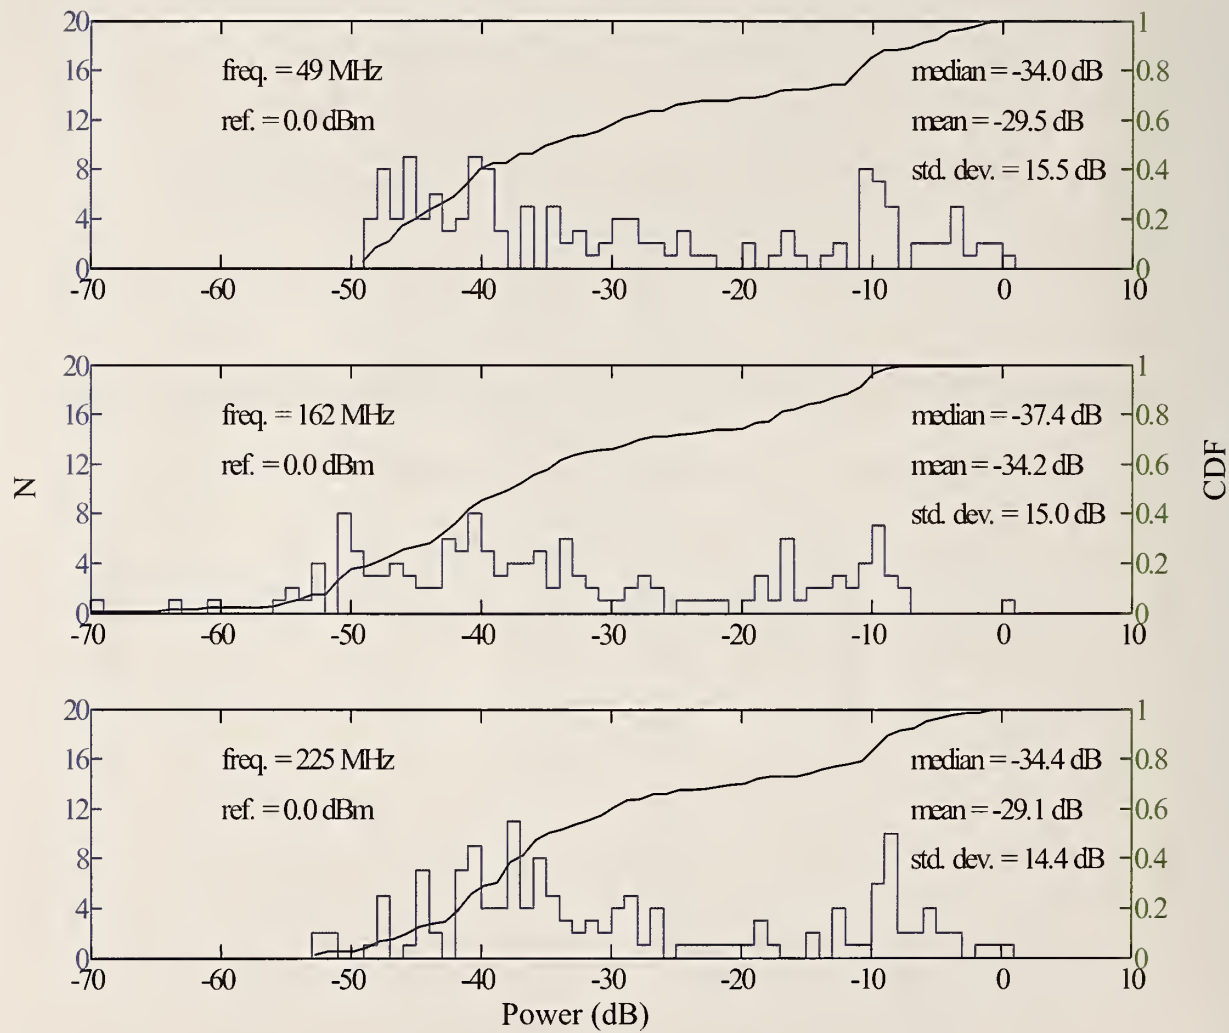
Figure 60. Philadelphia, PA sports stadium statistics, histograms, and empirical CDF for first inside walk data at 49.60, 162.09, and 225.30 MHz; horizontal polarization.

The walk-through plots for the interior of the stadium are found in Figure 54 to Figure 59 (horizontal polarization), Figure 62 to Figure 67 (horizontal polarization), and Figure 70 to Figure 75 (vertical polarization). Statistical plots corresponding to these three sets of figures are found in Figure 60 and Figure 61, Figure 68 and Figure 69, and Figure 76 and Figure 77. Note that the two inside walk-throughs with horizontal polarization do not directly concatenate, but in general, the combination of the two walk-throughs covers the same path as the single vertical polarization inside walk-through.

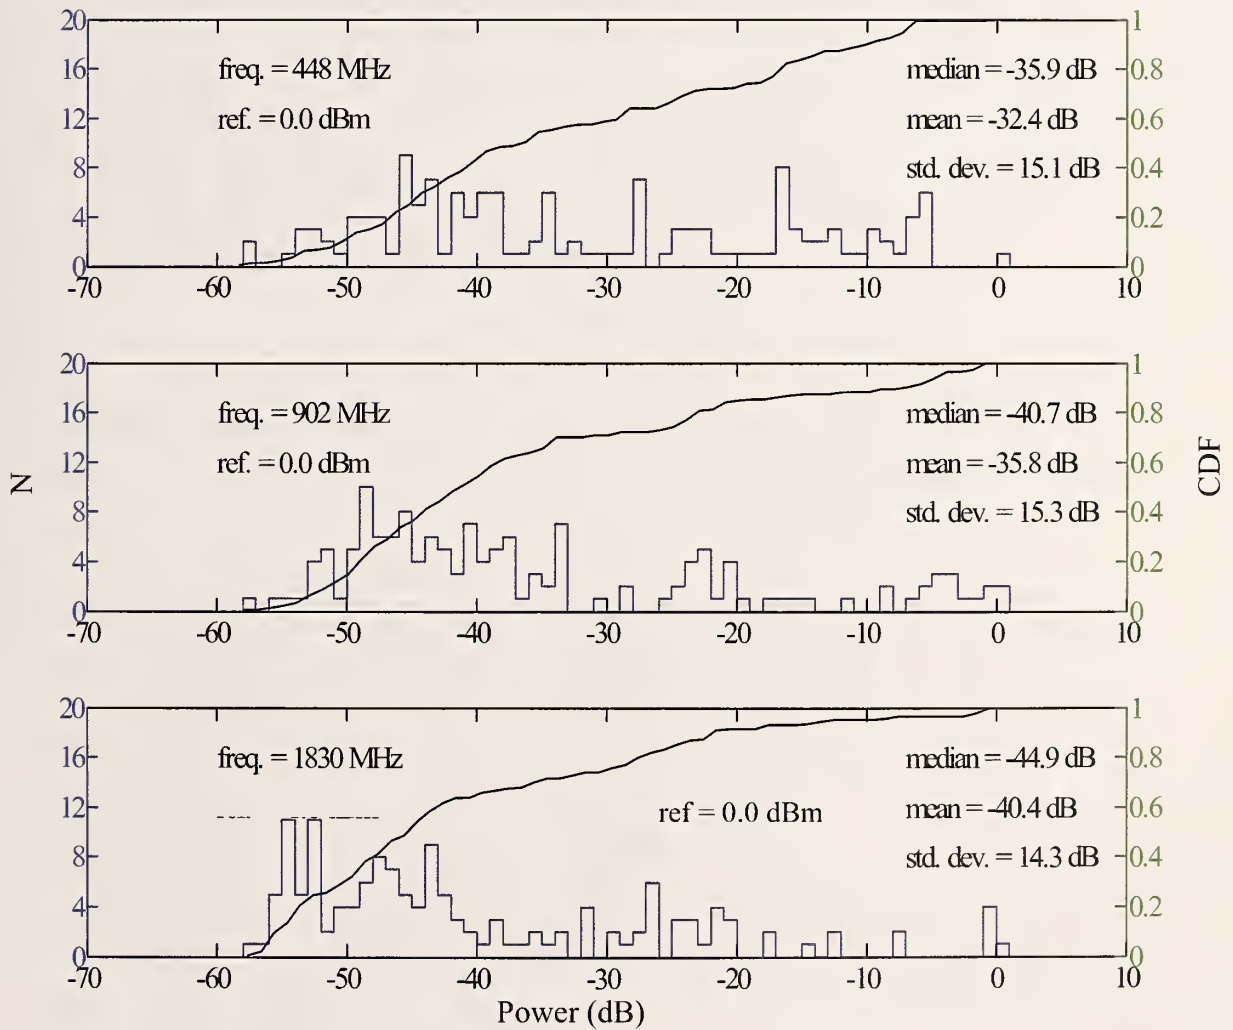
Figure 61. Philadelphia, PA sports stadium statistics, histograms, and empirical CDF for First inside walk data at 448.50, 902.45, and 1832.00 MHz; horizontal polarization.

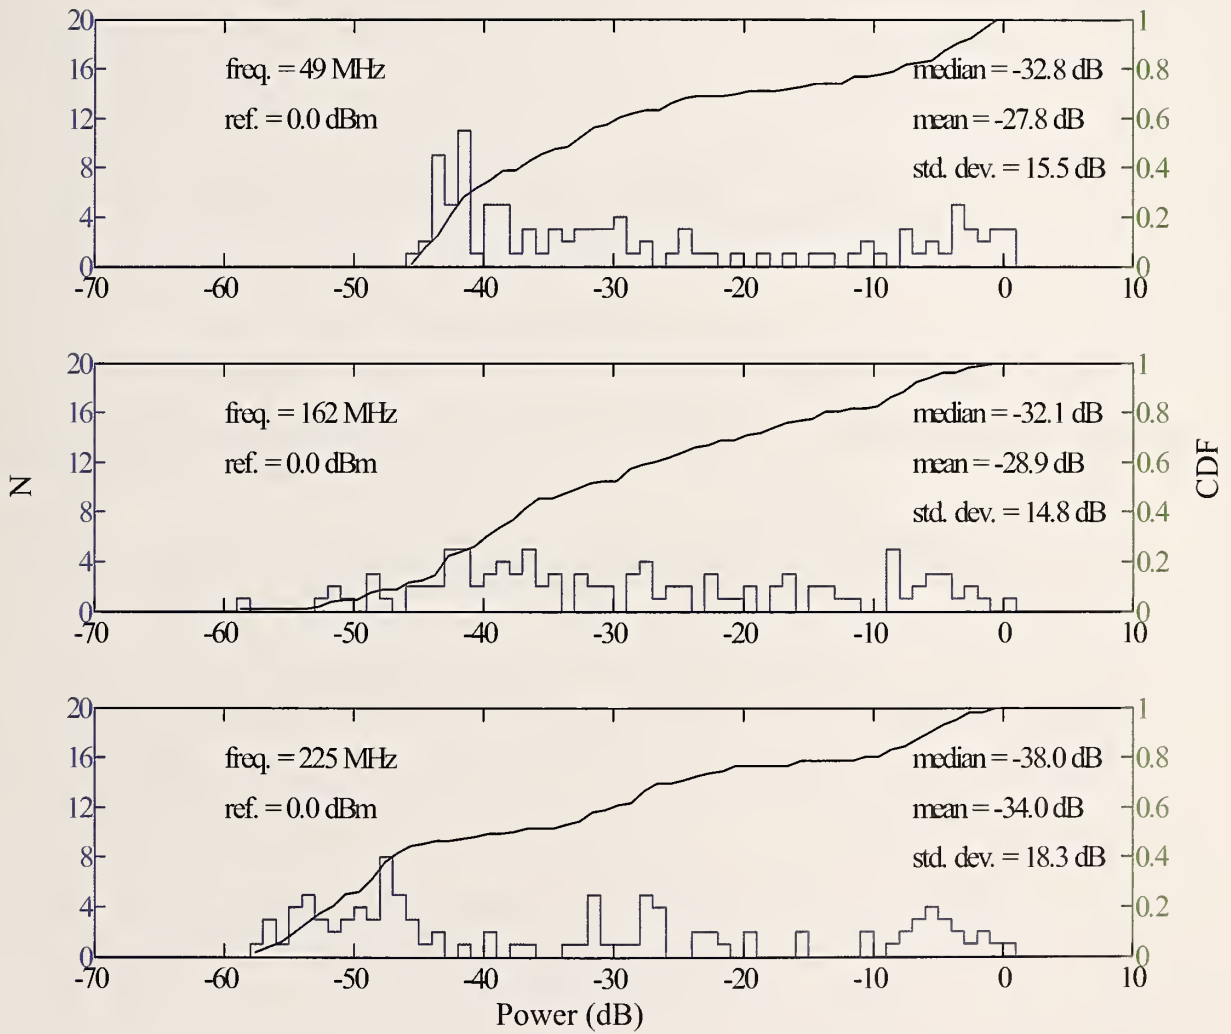
Figure 84. Philadelphia, PA sports stadium statistics, histograms, and empirical CDF for outside walk data at 49.60, 162.09, and 225.30 MHz; horizontal polarization.

Stadium exterior walk-through plots are found in Figure 78 to Figure 83 (horizontal polarization), and Figure 86 to Figure 91 (vertical polarization). The corresponding statistical plots are shown in Figure 84 and Figure 85 and Figure 92 and 93, respectively.

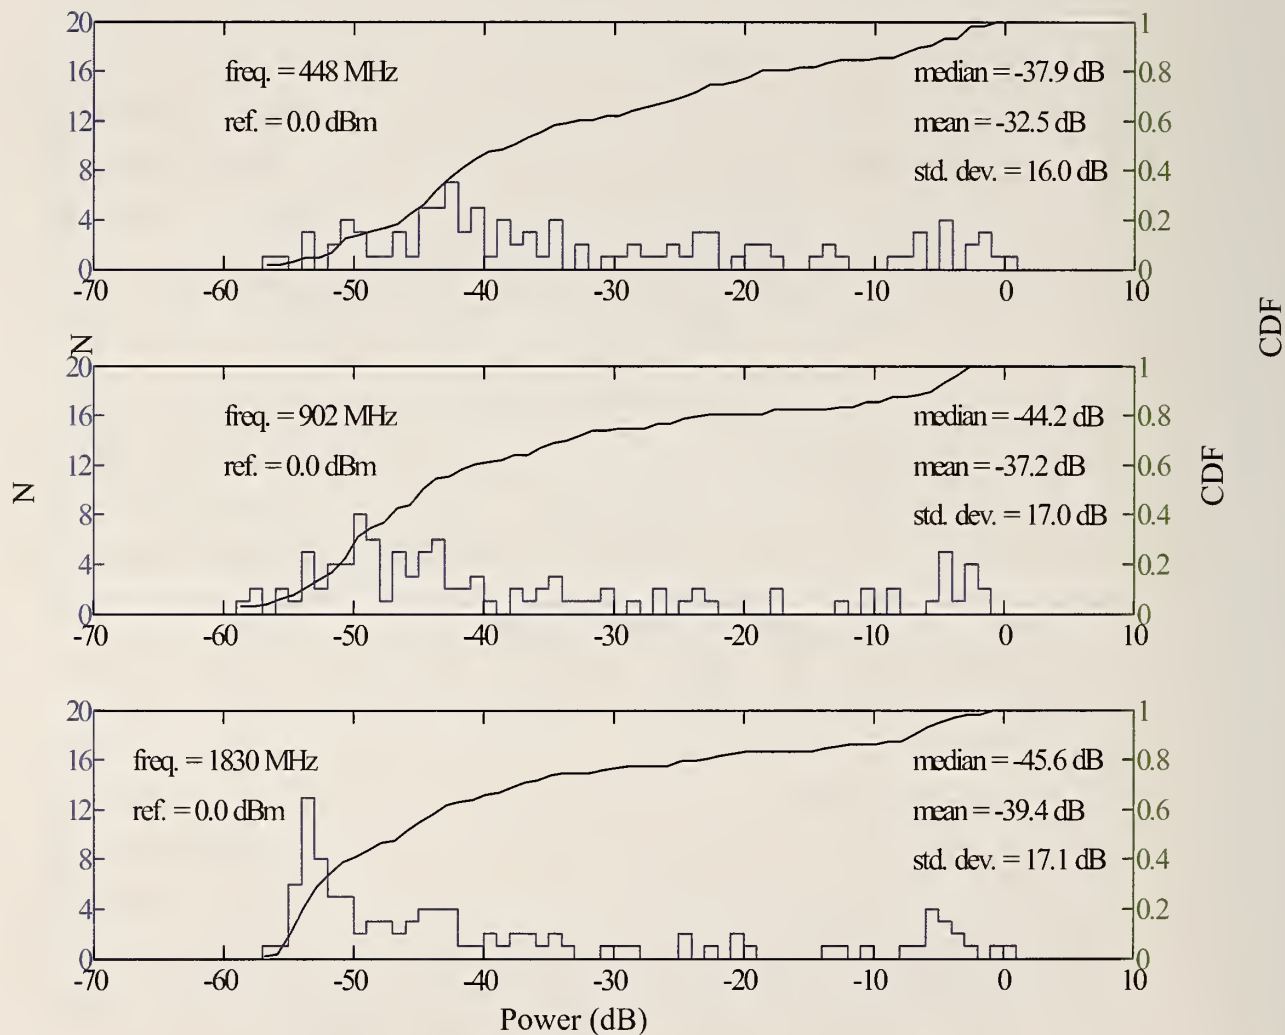
Figure 85. Philadelphia, PA sports stadium statistics, histograms, and empirical CDF for outside walk data at 448.50, 902.45, and 1832.00 MHz; horizontal polarization

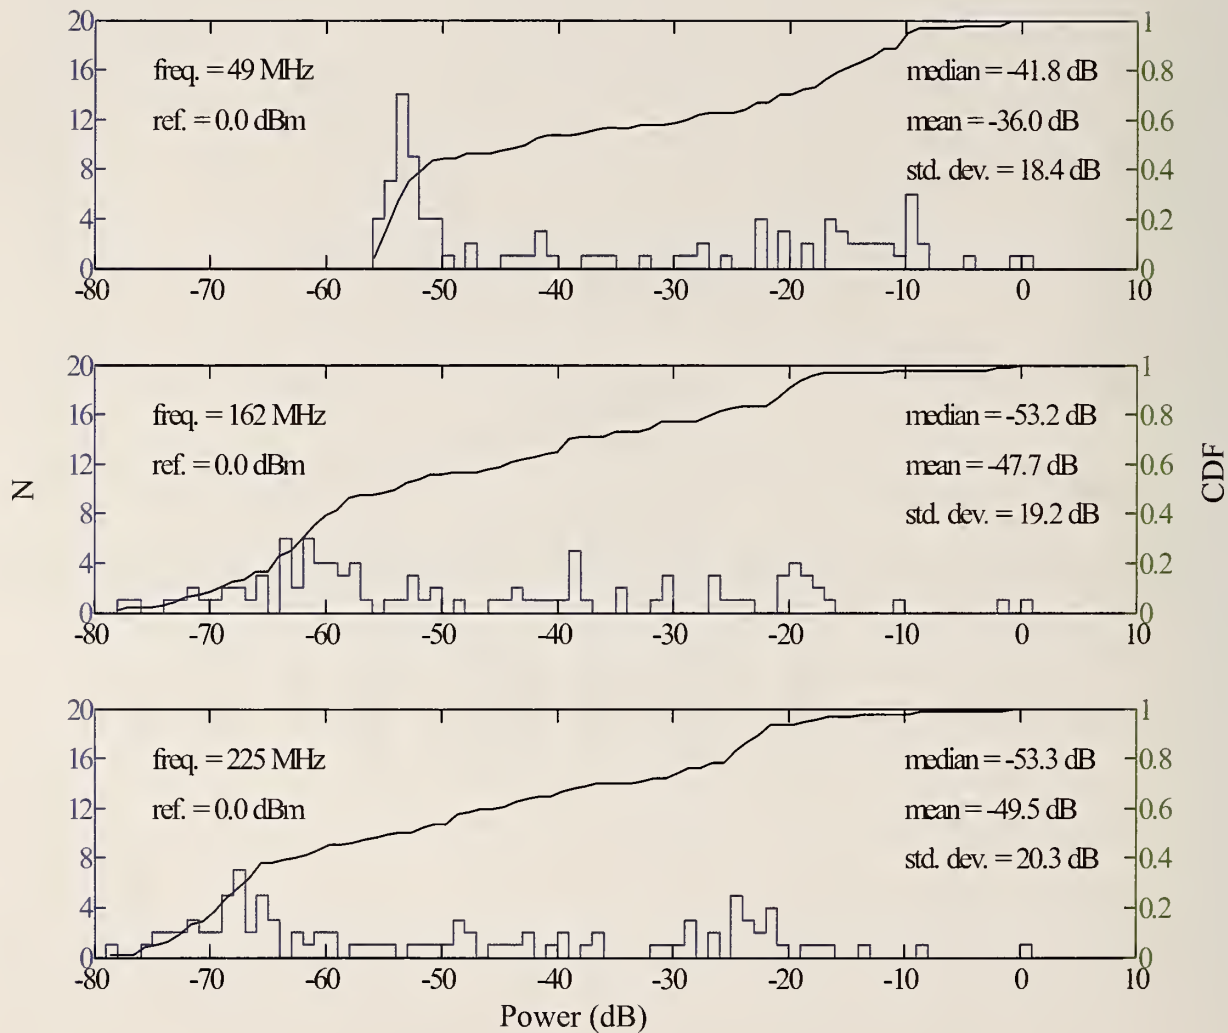
Figure 92. Philadelphia, PA sports stadium statistics, histograms, and empirical CDF for outside walk data at 49.60, 162.09, and 225.30 MHz; vertical polarization.

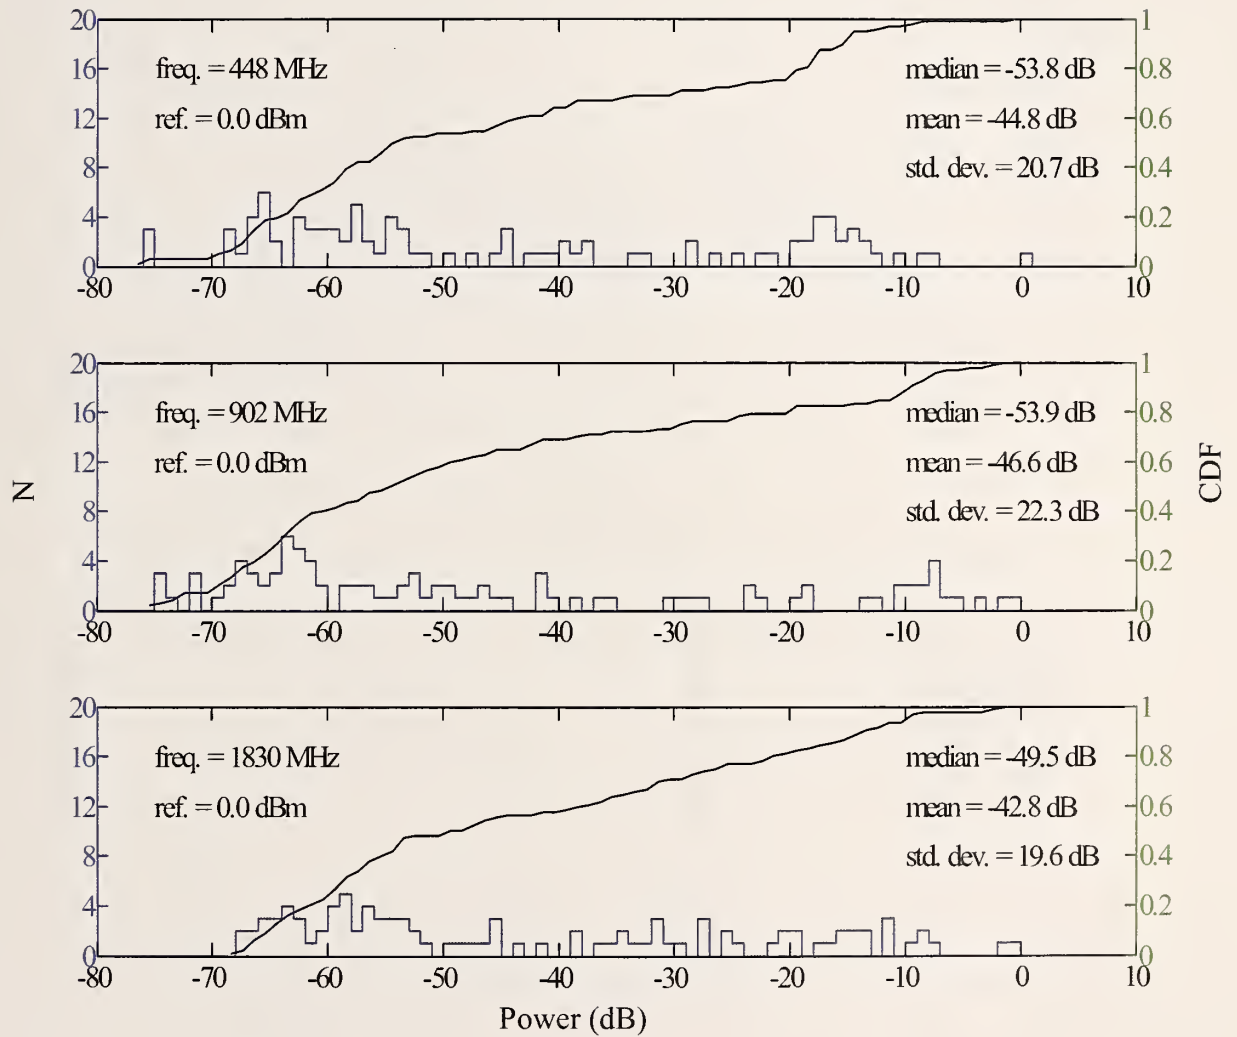
Figure 93. Philadelphia, PA sports stadium statistics, histograms, and empirical CDF for outside walk data at 448.50, 902.45, and 1832.00 MHz; vertical polarization

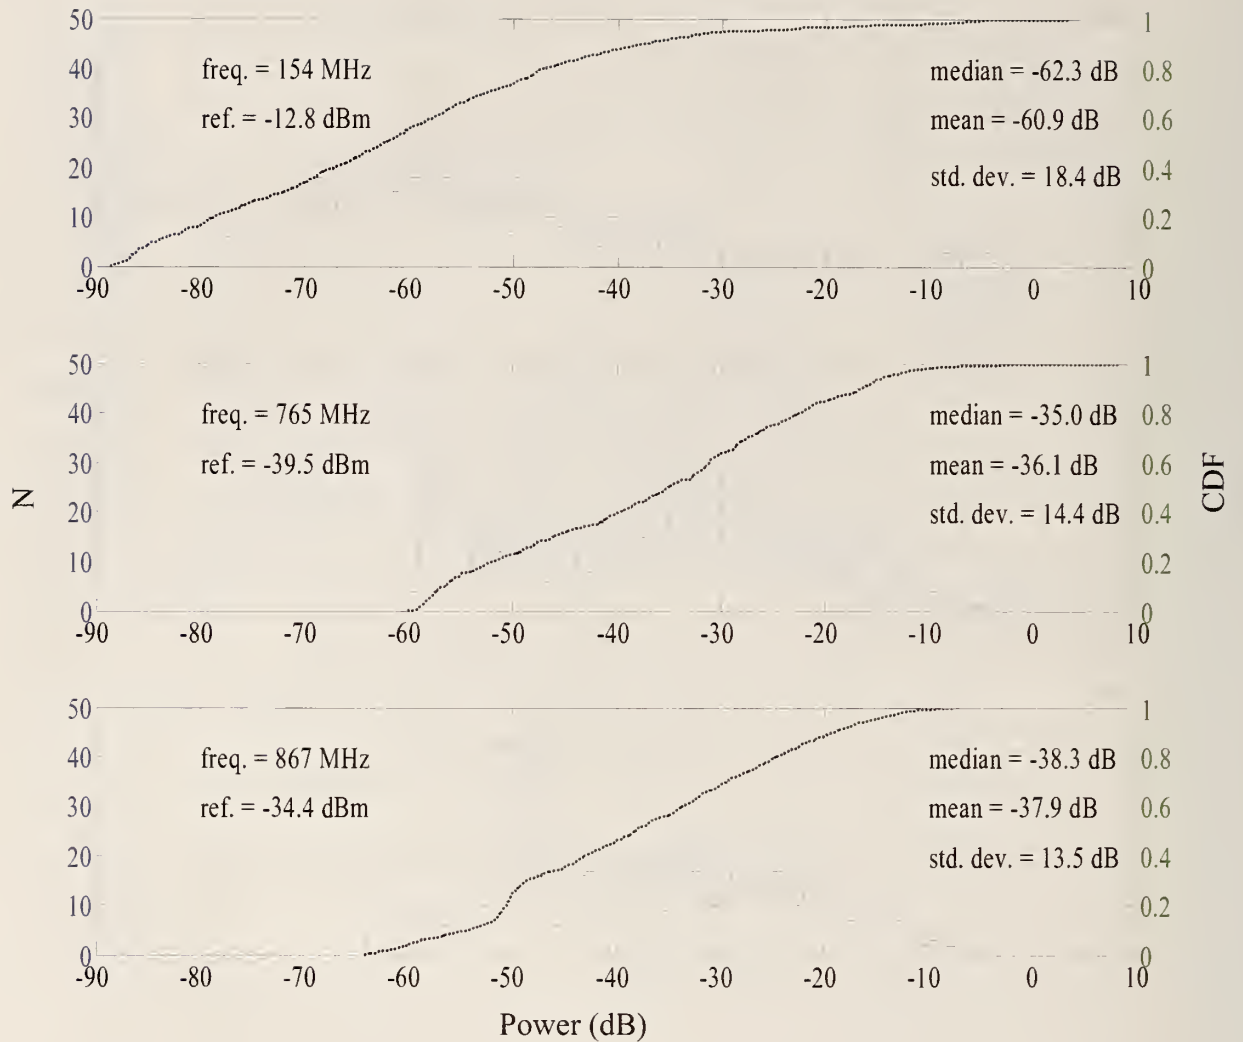
Figure 97. Phoenix, AZ office building statistics, histograms, and empirical CDF for walk-through data at 154, 765, and 867 MHz.

Three frequencies were measured at the Phoenix office building experiments described in Section 5.3. Walk-through plots are provided in Figure 94 through Figure 96, and the corresponding statistical plots are shown in Figure 97. As noted on the walk-through plots, a line-of-sight to the receiver location was possible only for the 154 MHz case. However, this did not appear to significantly alter the overall statistics in Figure 97, which depicts both a higher reference value and a larger standard deviation for the 154 MHz case, as compared to either the 765 or 867 MHz cases.

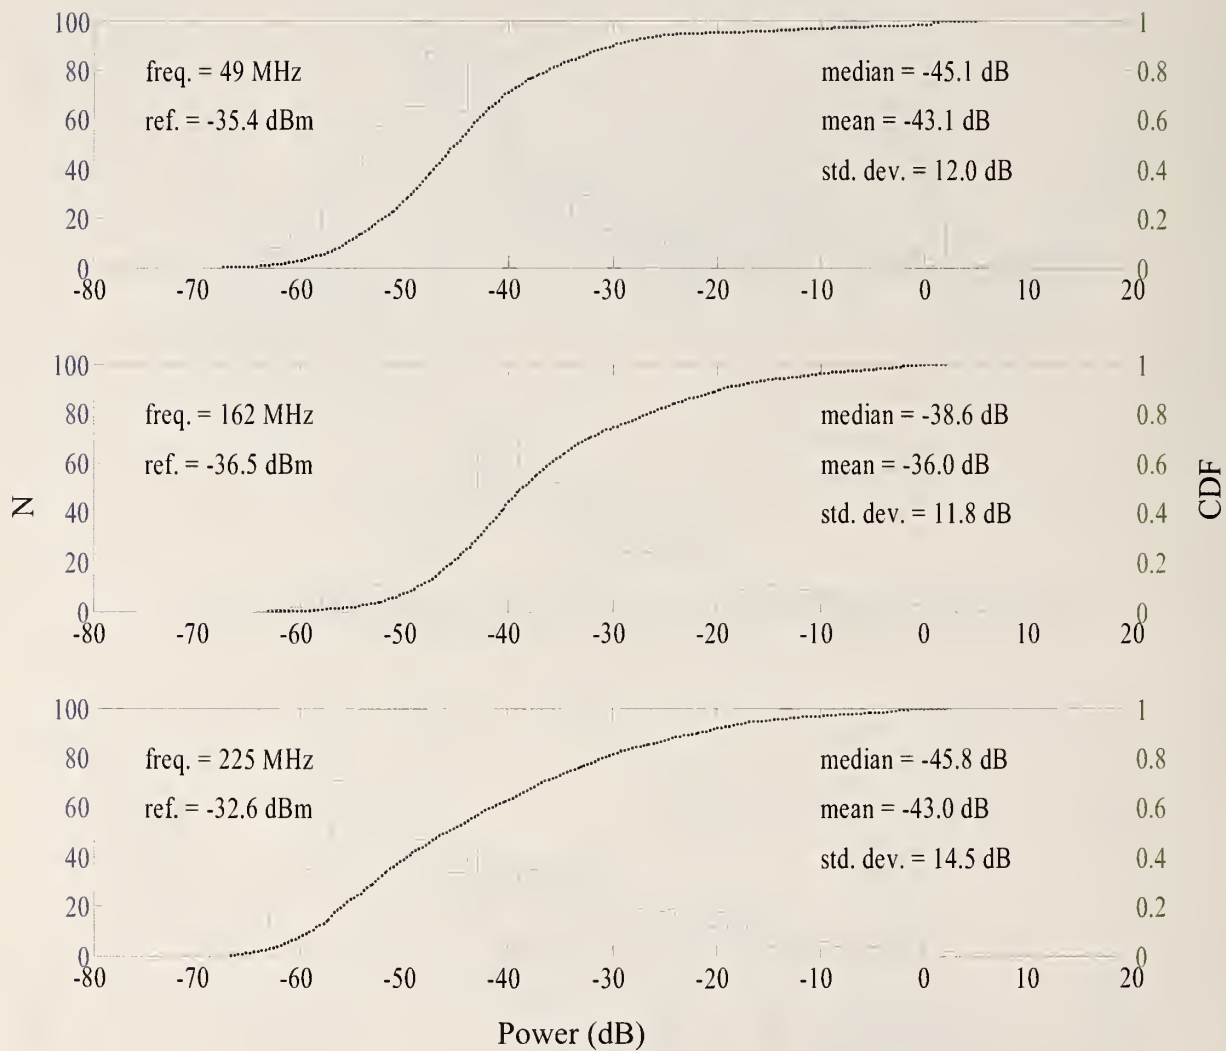
Figure 136. Boulder, CO grocery store statistics, histograms, and empirical CDF for walk-through data; 49.60, 162.09, and 225.30 MHz.
