## *NIST Technical Note 1545*

# Attenuation of Radio Wave Signals Coupled Into Twelve Large Building Structures

August 2008

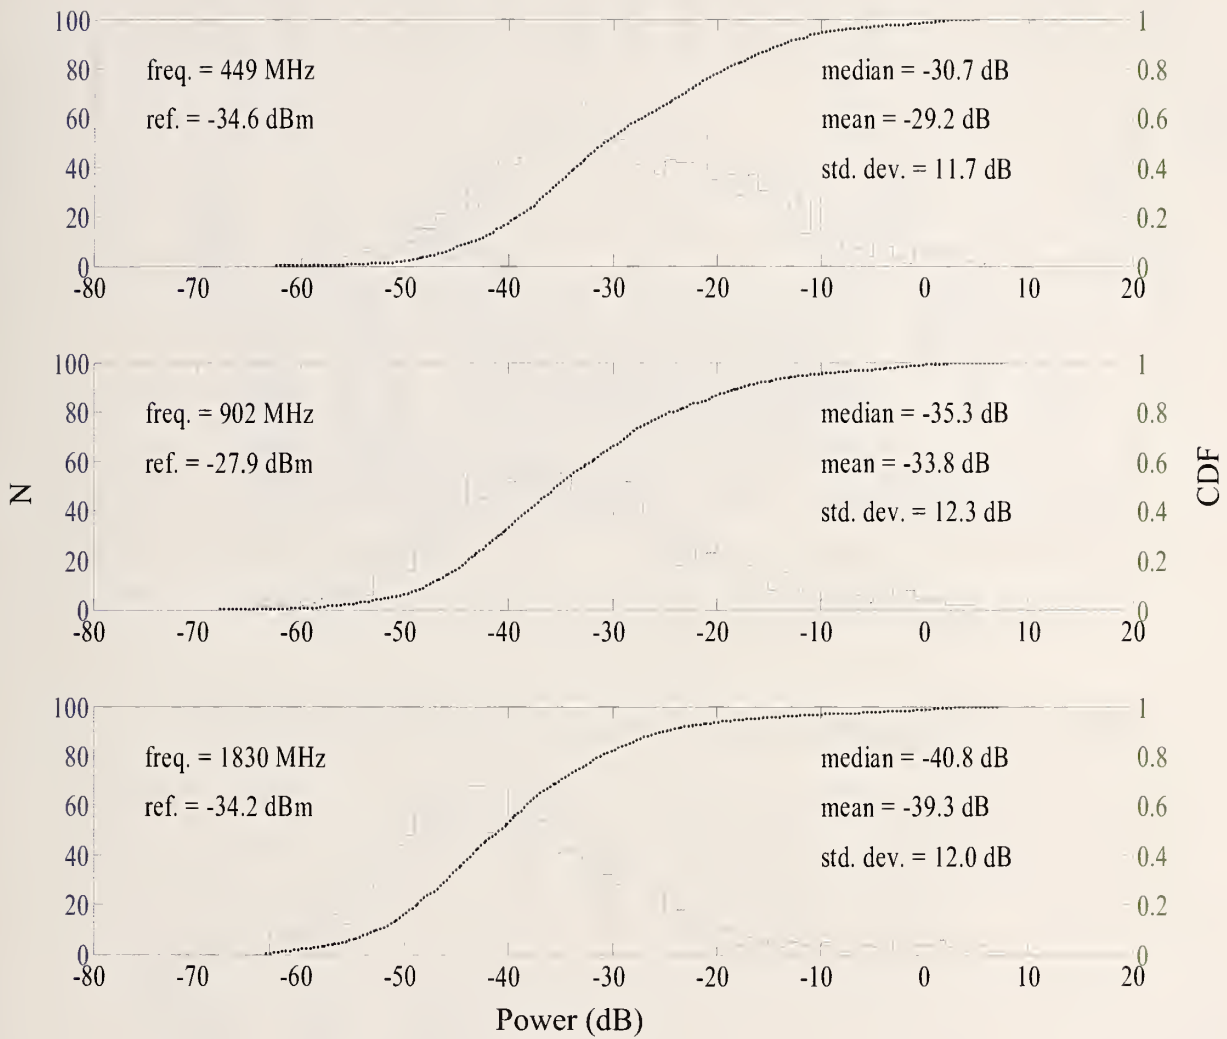
Figure 137. Boulder, CO grocery store statistics, histograms, and empirical CDF for walk-through data; 448.50, 902.75, and 1830.00 MHz.

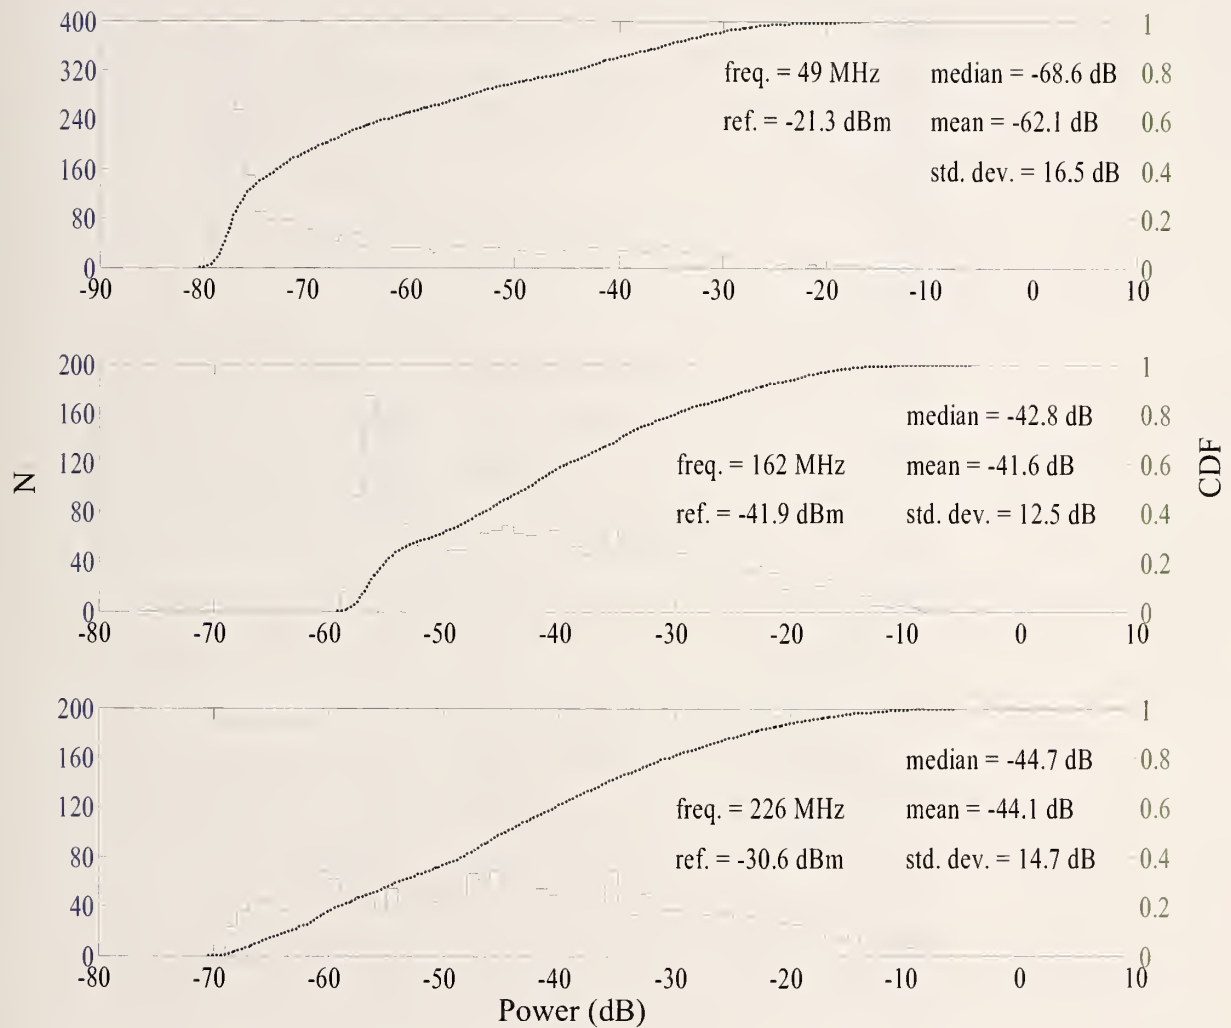
Figure 144. Gaithersburg, MD office building statistics, histograms, and empirical CDF for walk-through data; 49.60, 162.09, and 226.40 MHz.

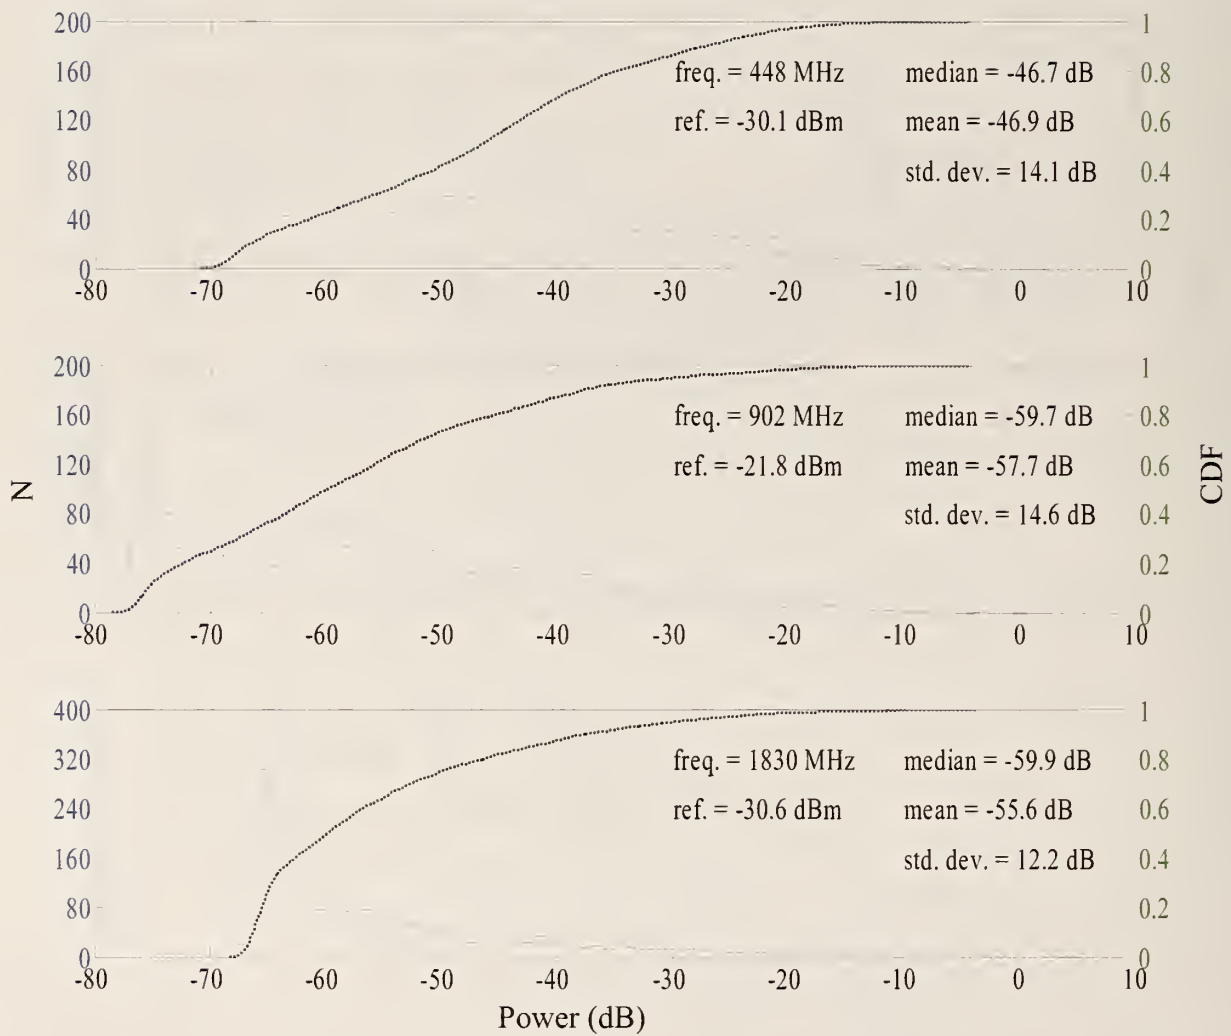
Figure 145. Gaithersburg, MD office building statistics, histograms, and empirical CDF for walk-through data; 448.30, 902.45, and 1830.00 MHz.

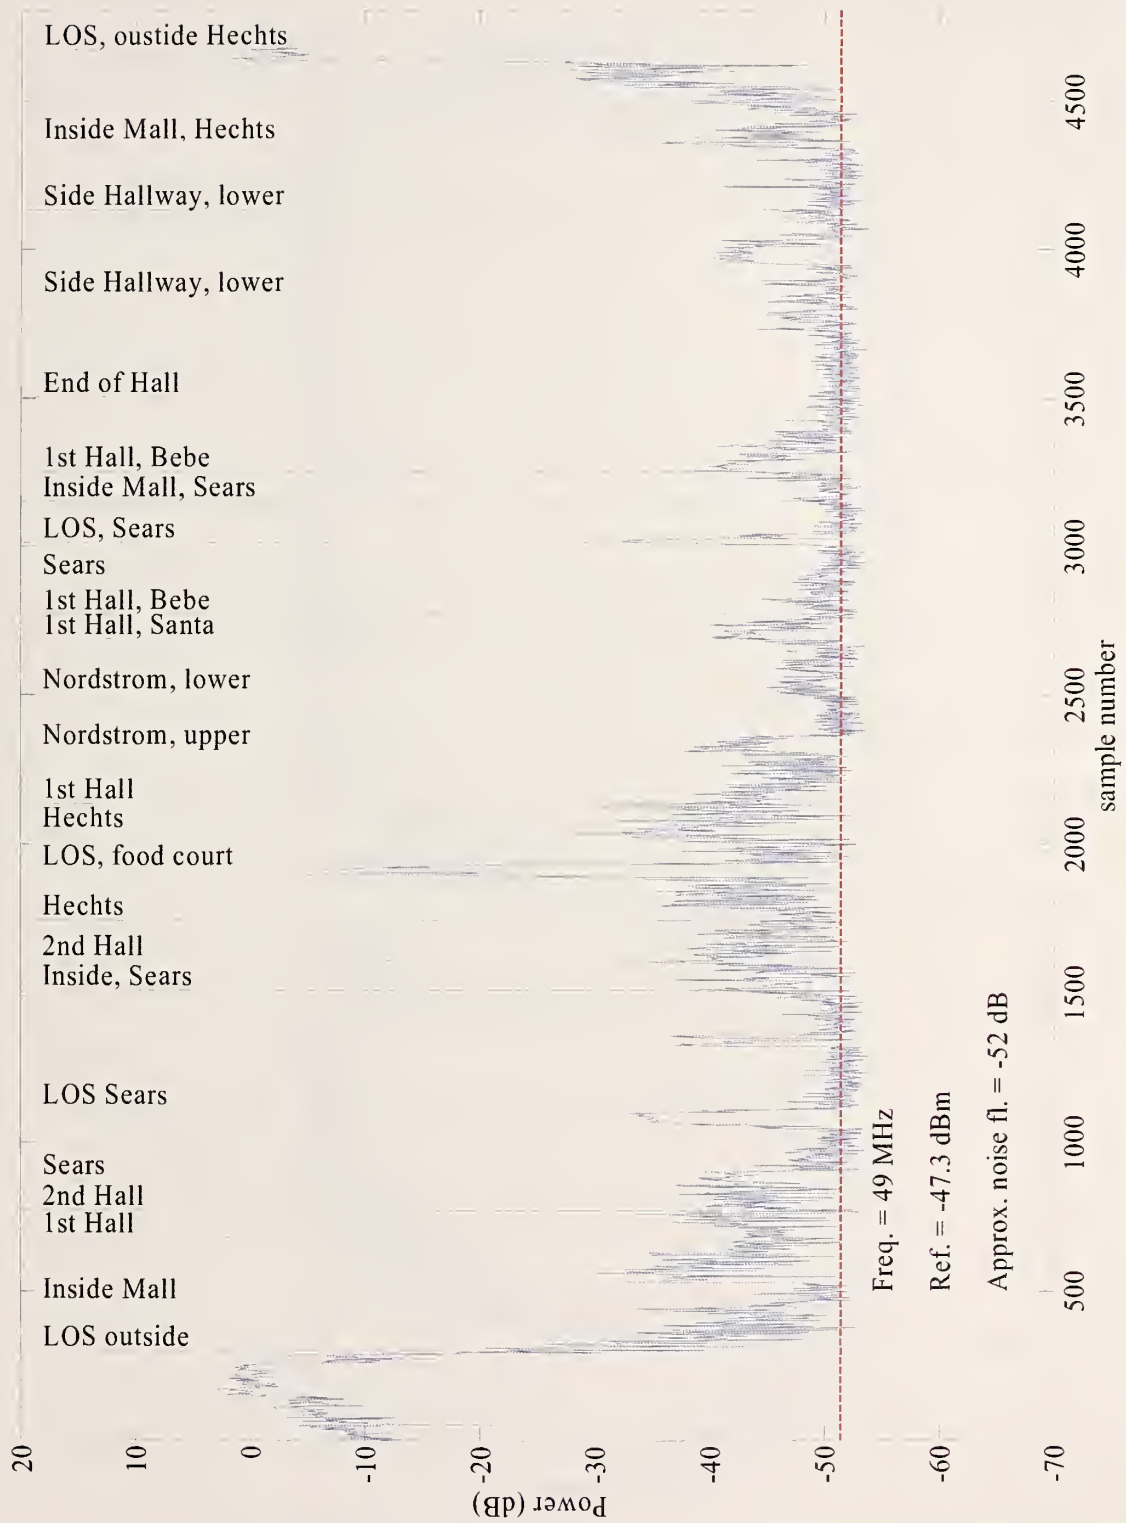
Figure 146. Bethesda, MD shopping mall walk-through at 49.60 MHz; receiver at site 1.

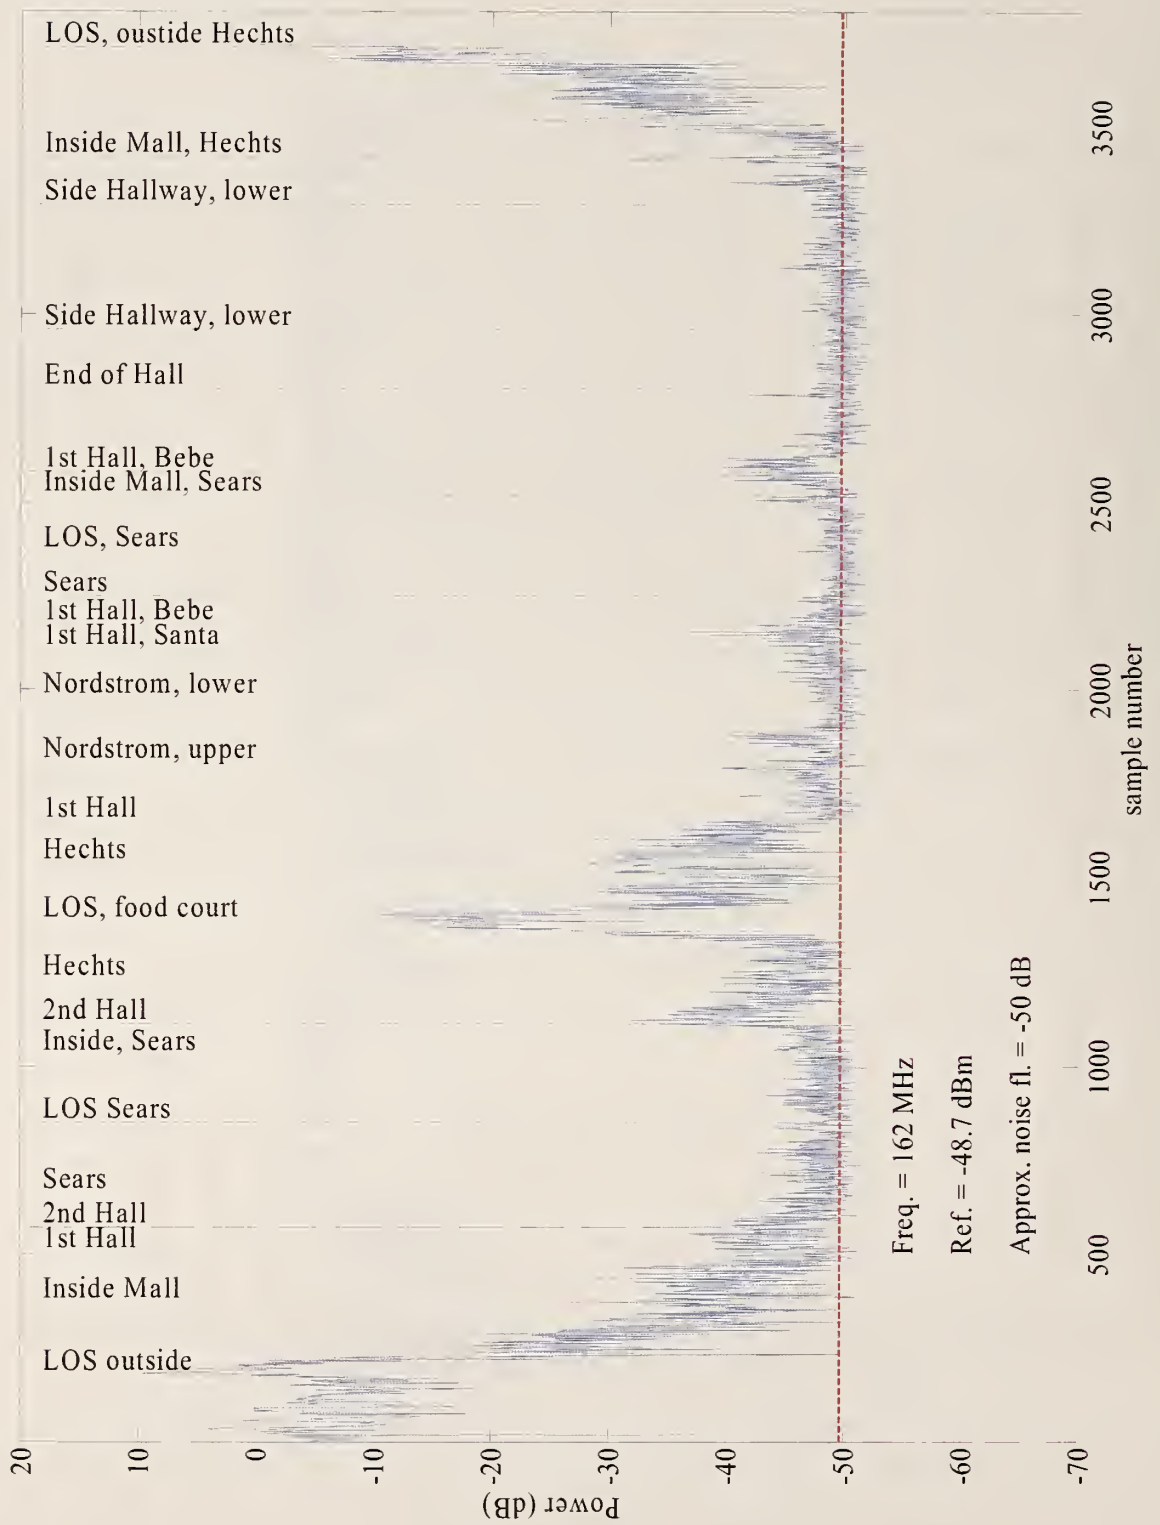
Figure 147. Bethesda, MD shopping mall walk-through at 162.09 MHz; receiver at site 1.

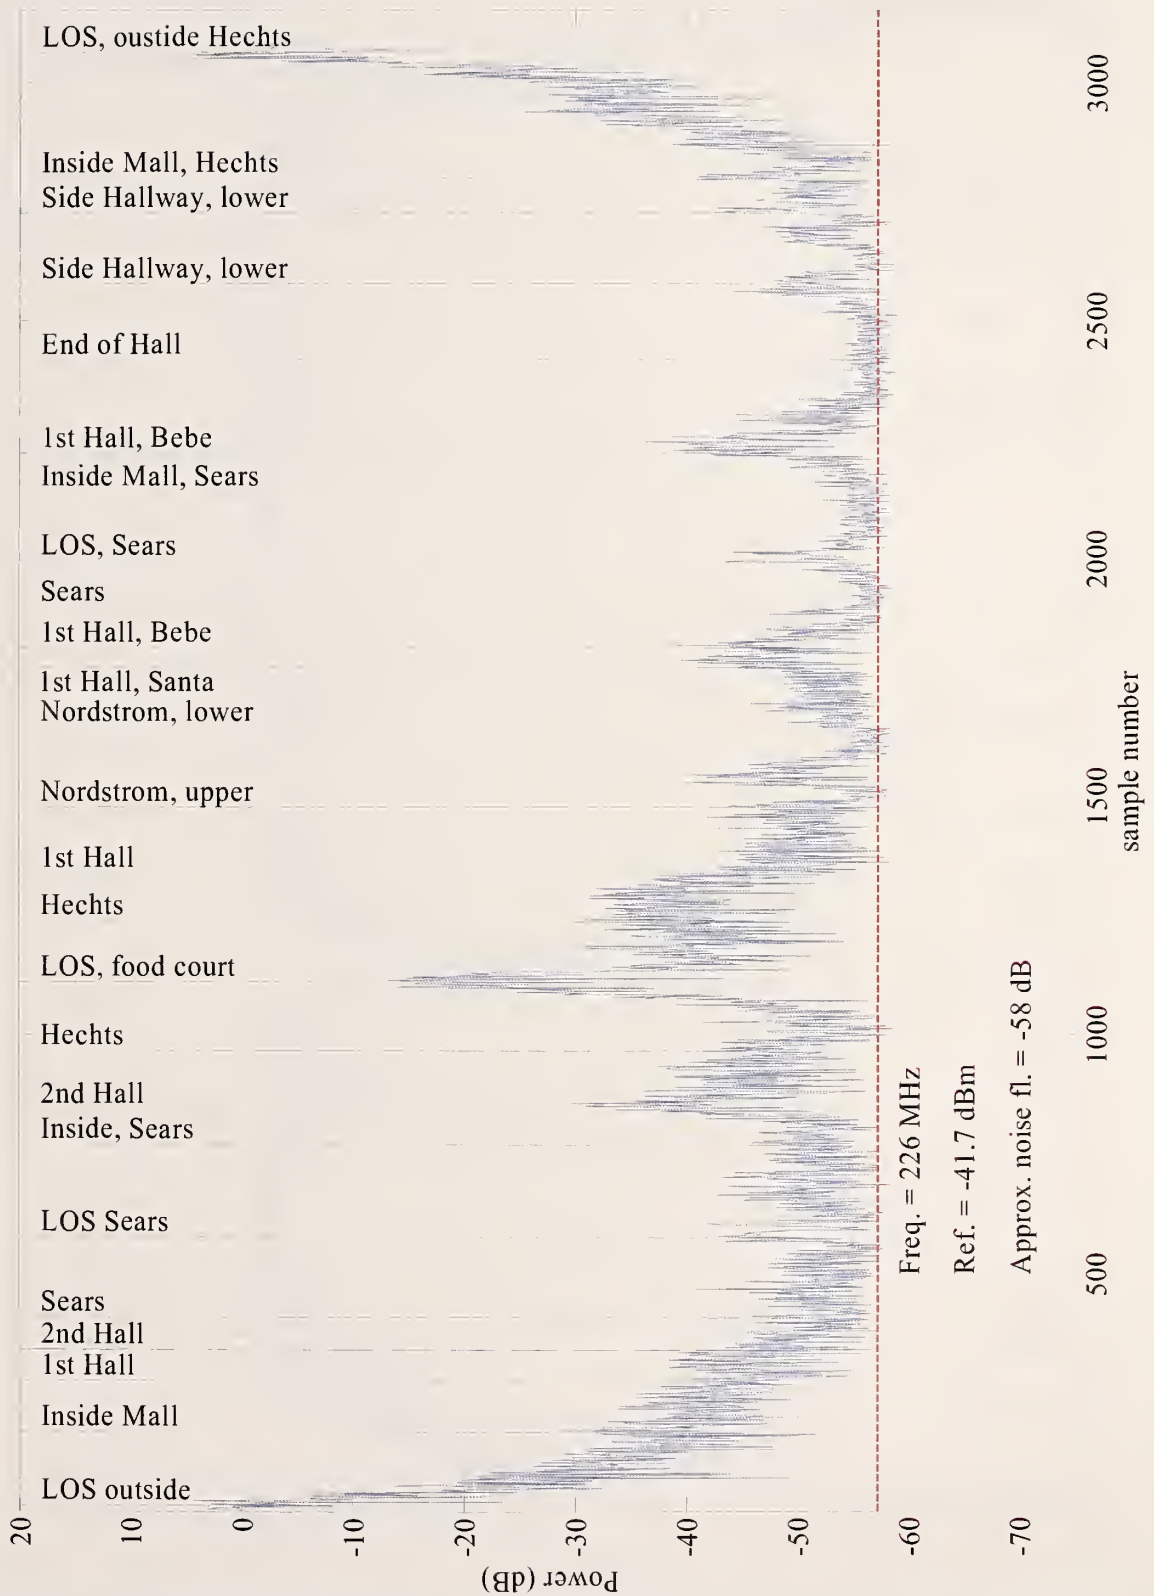
Figure 148. Bethesda, MD shopping mall walk-through at 226.40 MHz; receiver at site 1.

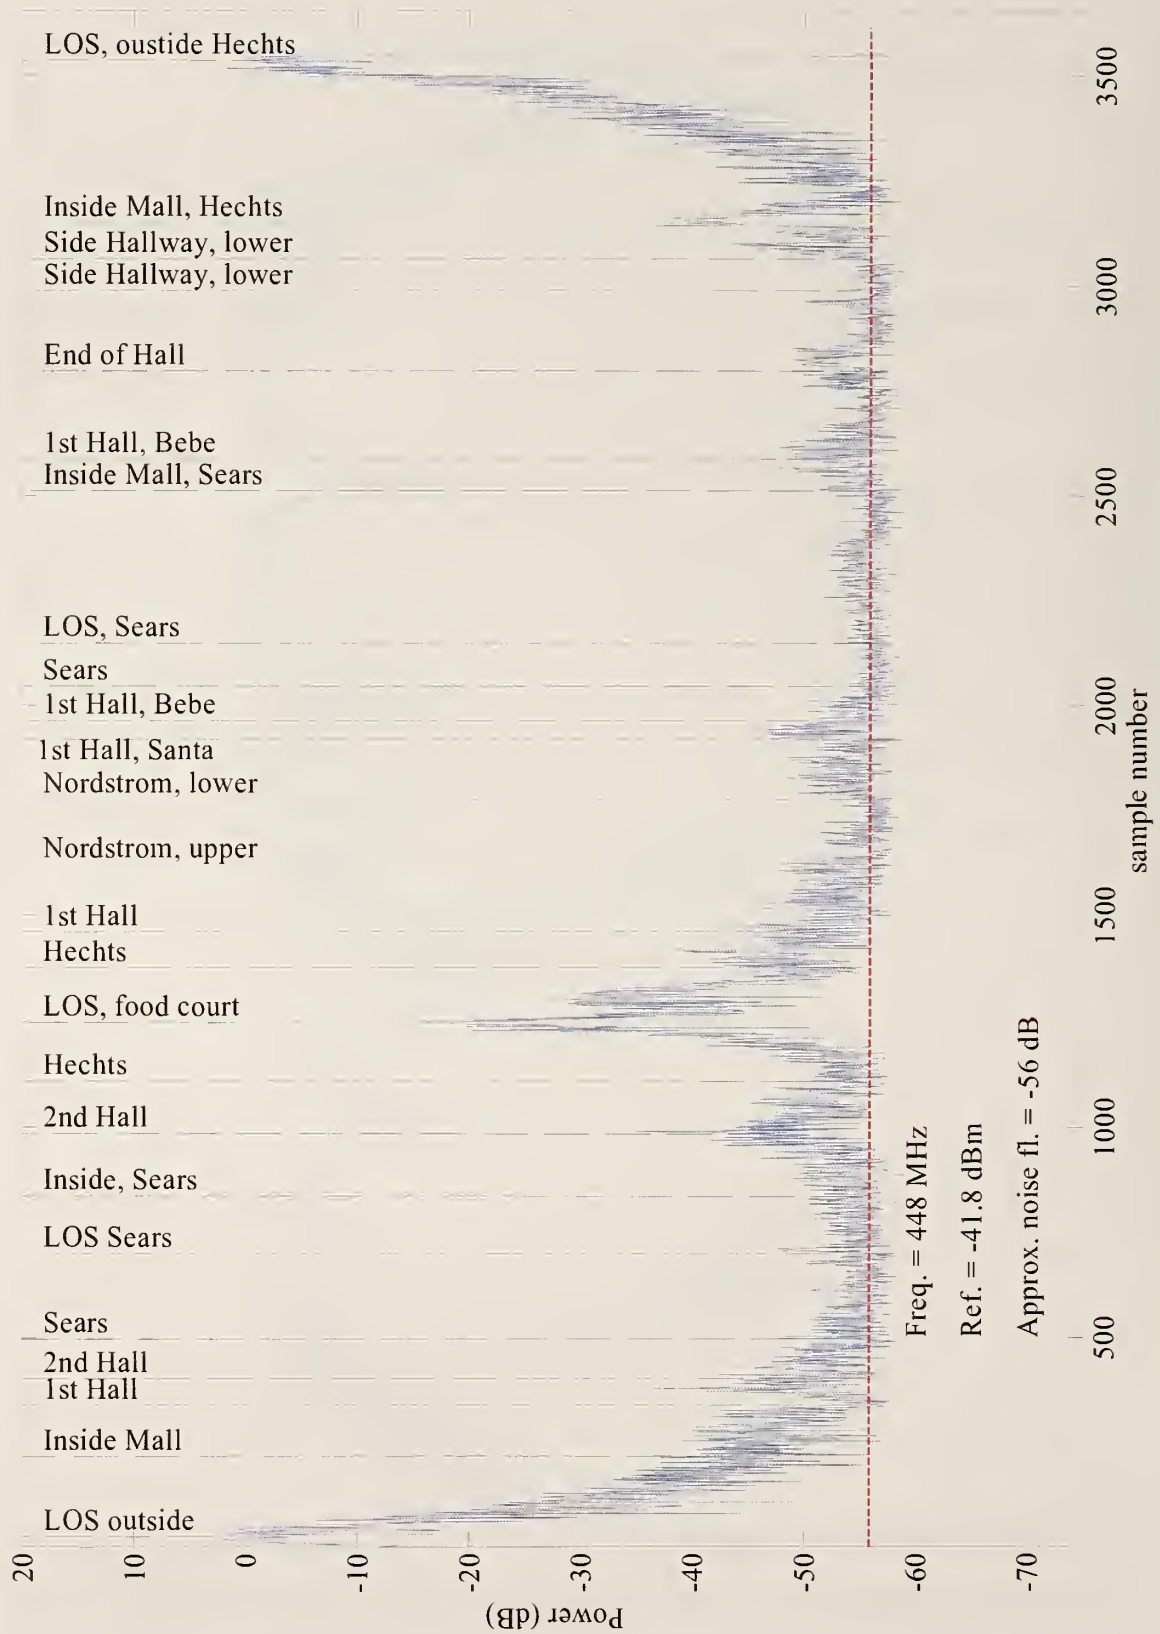
Figure 149. Bethesda, MD shopping mall walk-through at 448.30 MHz; receiver at site 1.

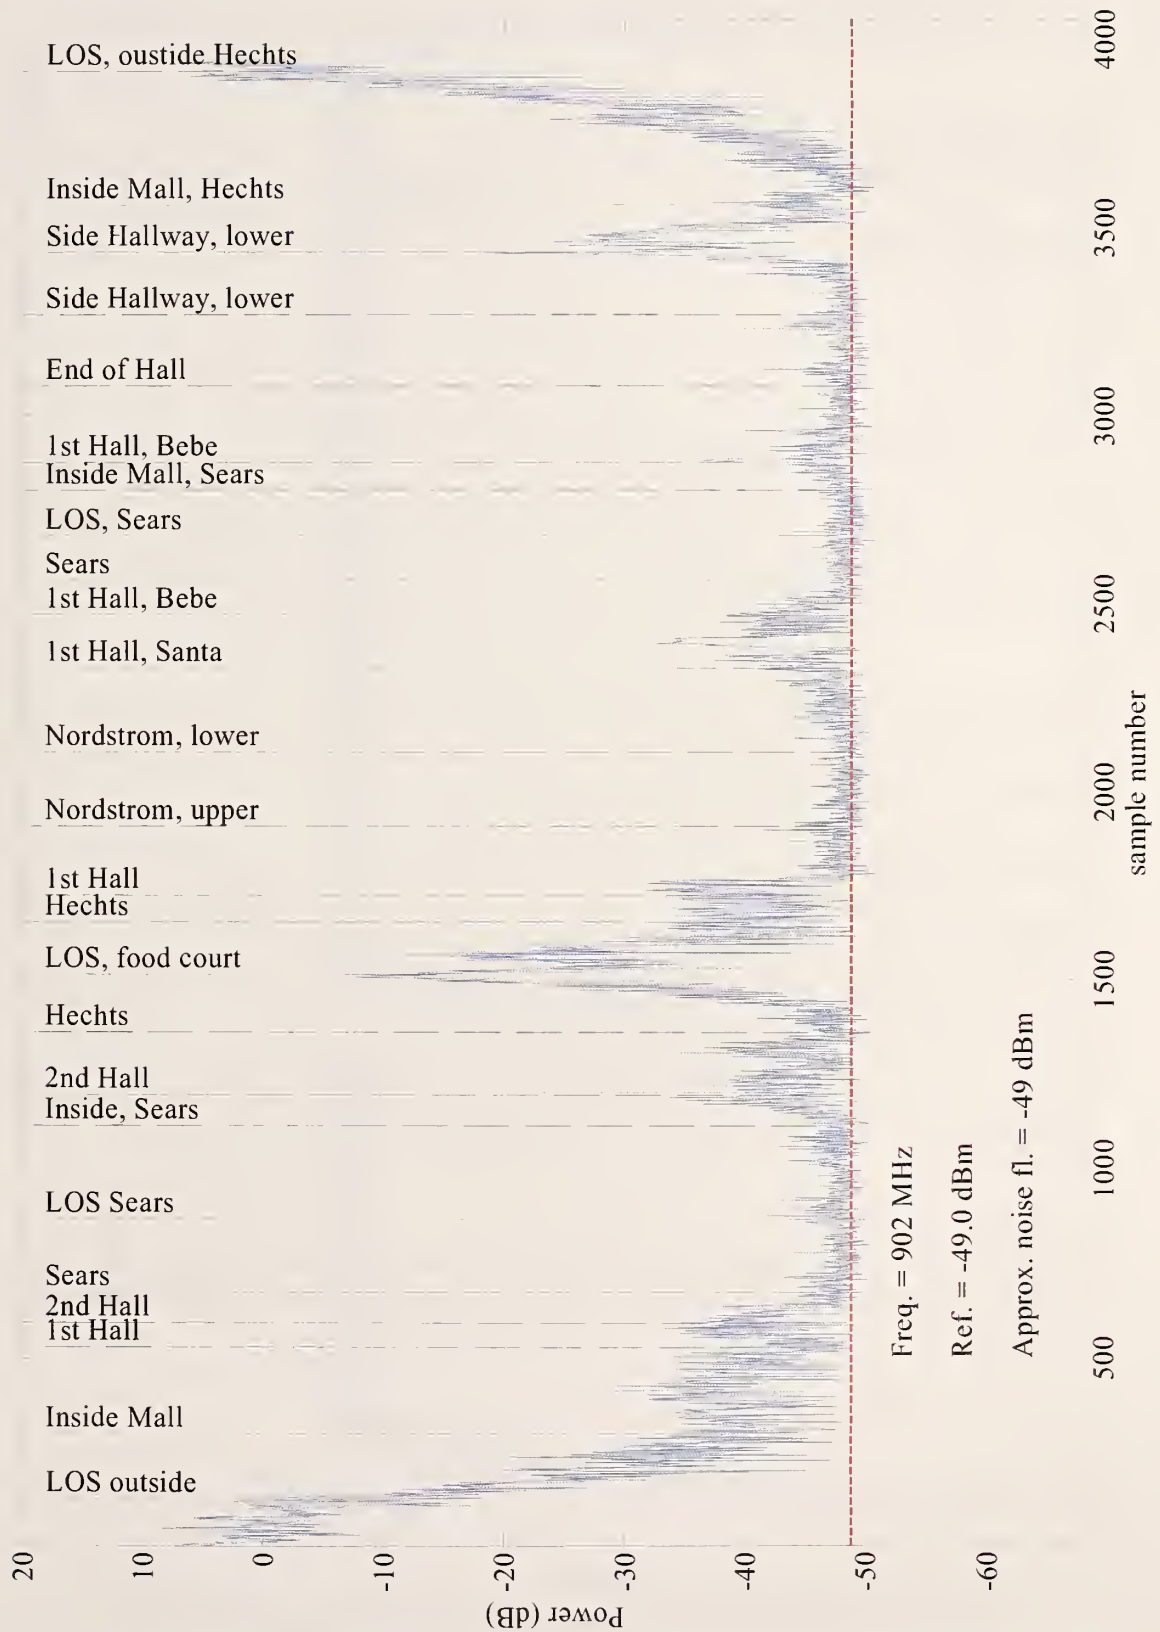
Figure 150. Bethesda, MD shopping mall walk-through at 902.45 MHz; receiver at site 1.

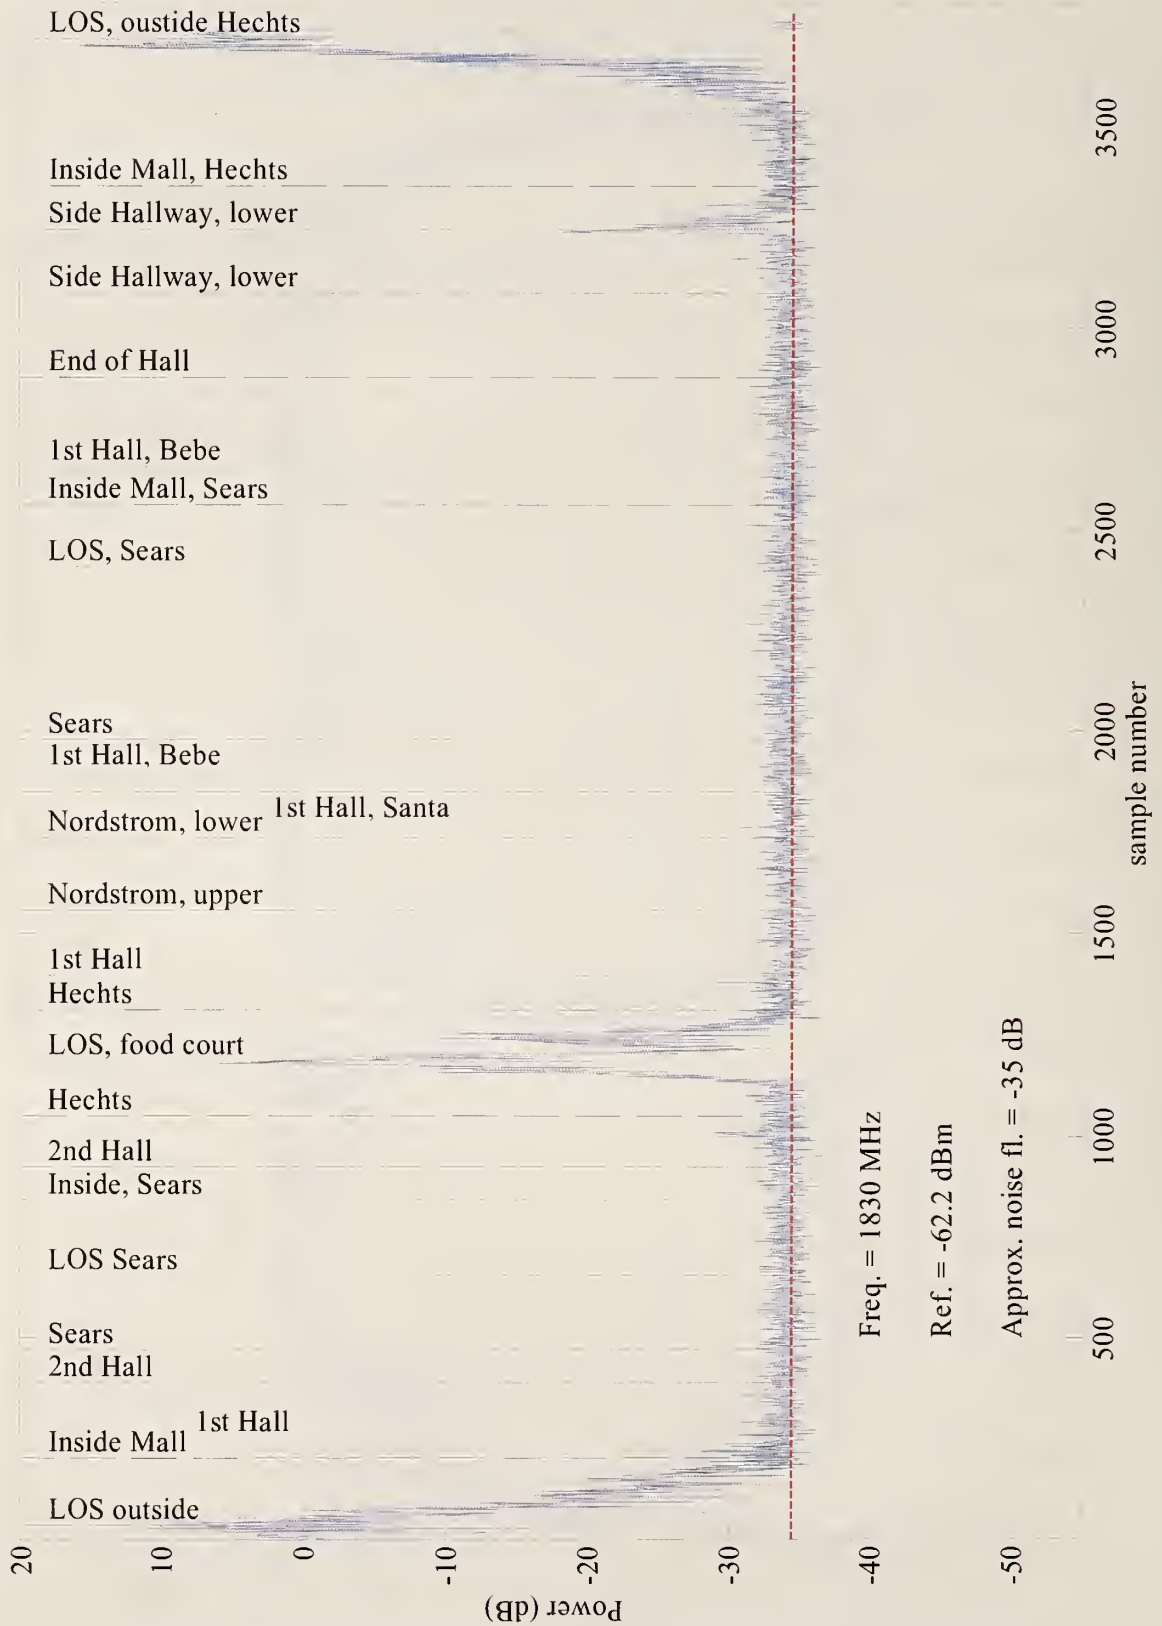
Figure 151. Bethesda, MD shopping mall walk-through at 1830.00 MHz; receiver at site 1.

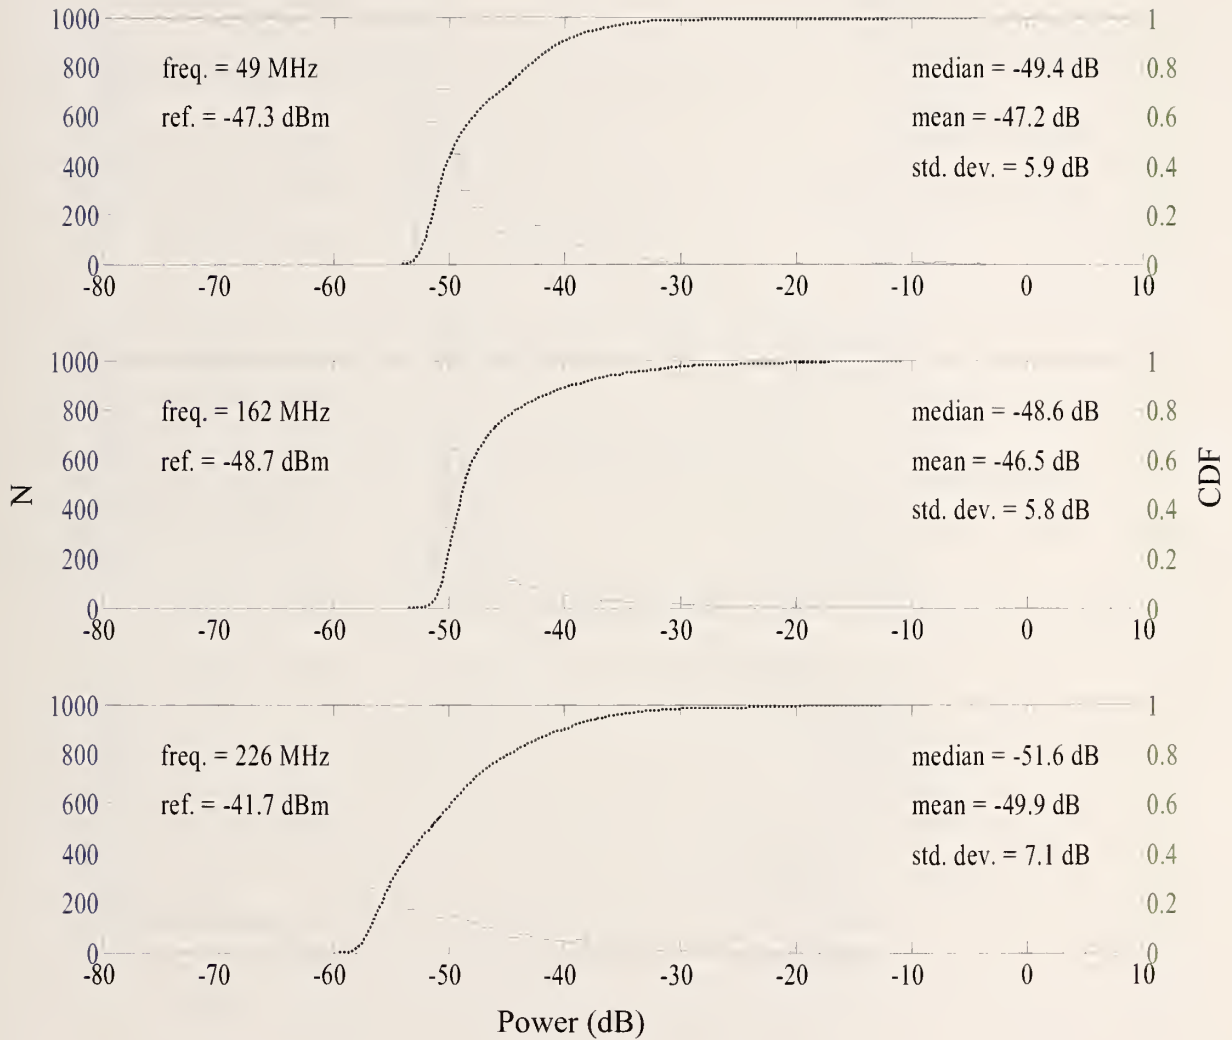
Figure 152. Bethesda, MD shopping mall statistics, histograms, and empirical CDF for walk-through data with the receiver at site 1; 49.60, 162.09, and 226.40 MHz.

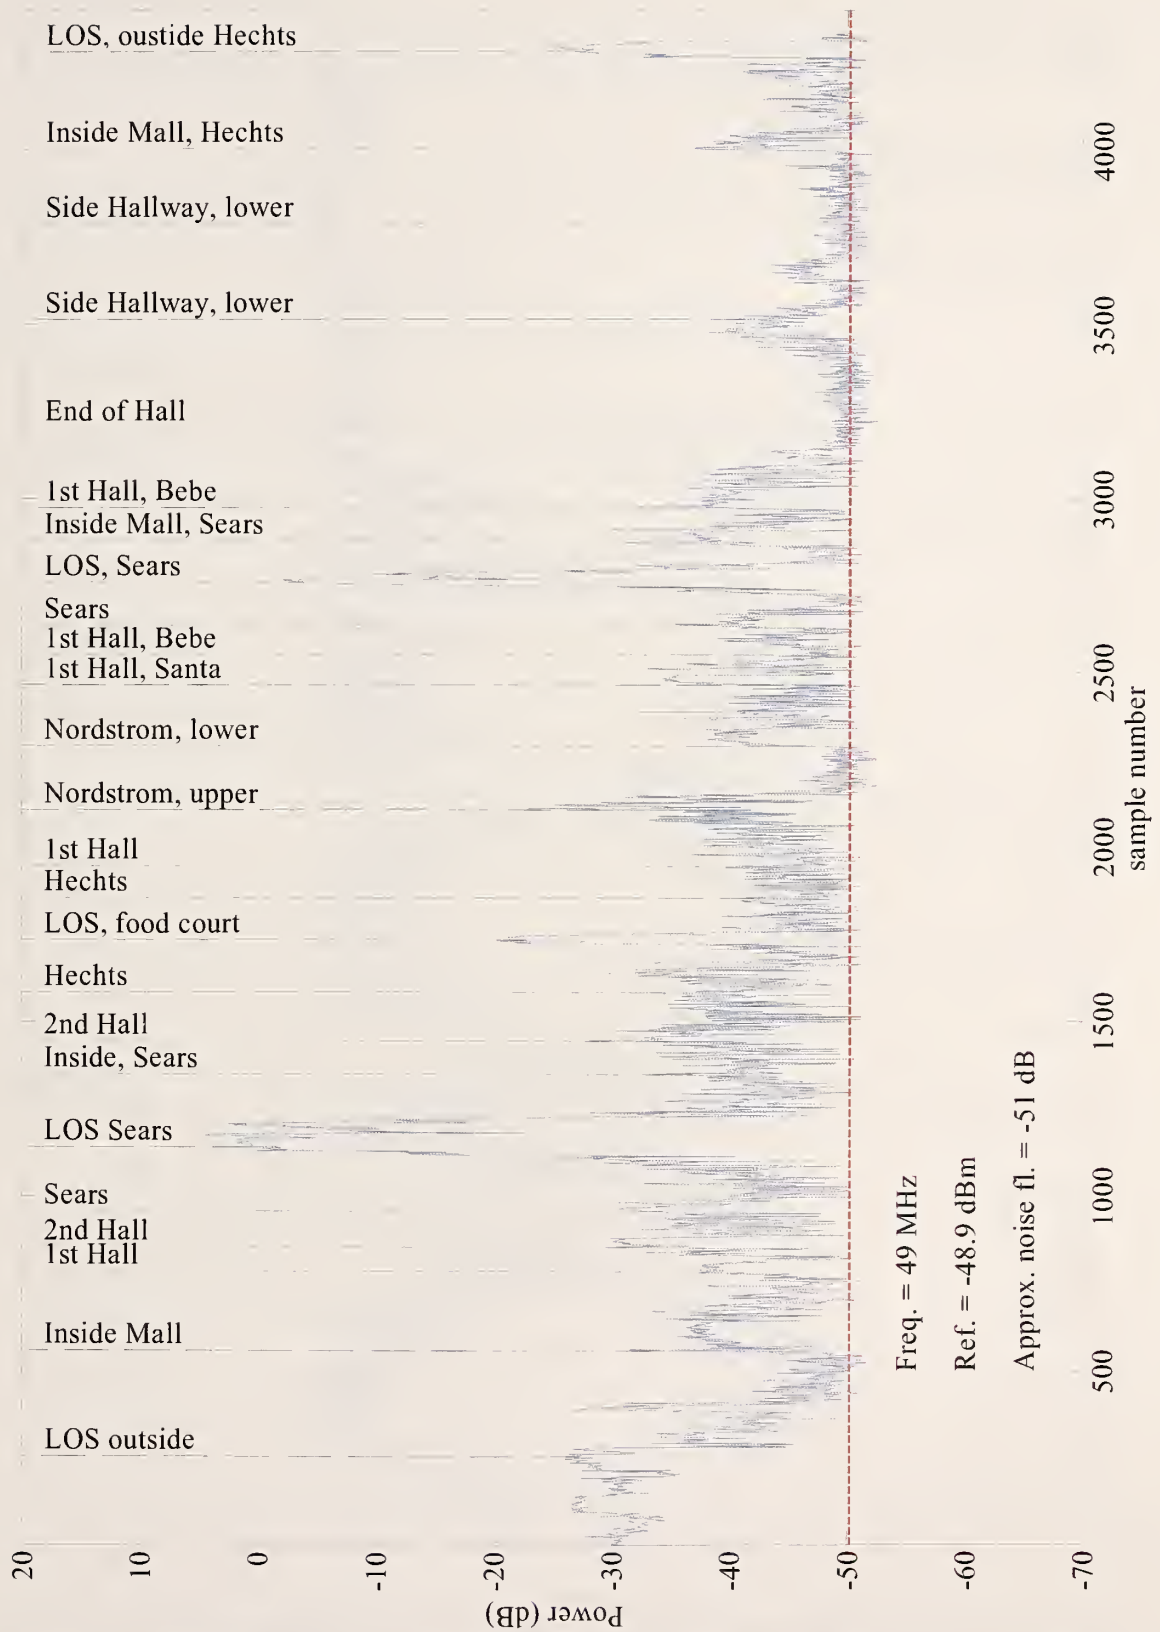
Figure 154. Bethesda, MD shopping mall walk-through at 49.60 MHz; receiver at site 2.

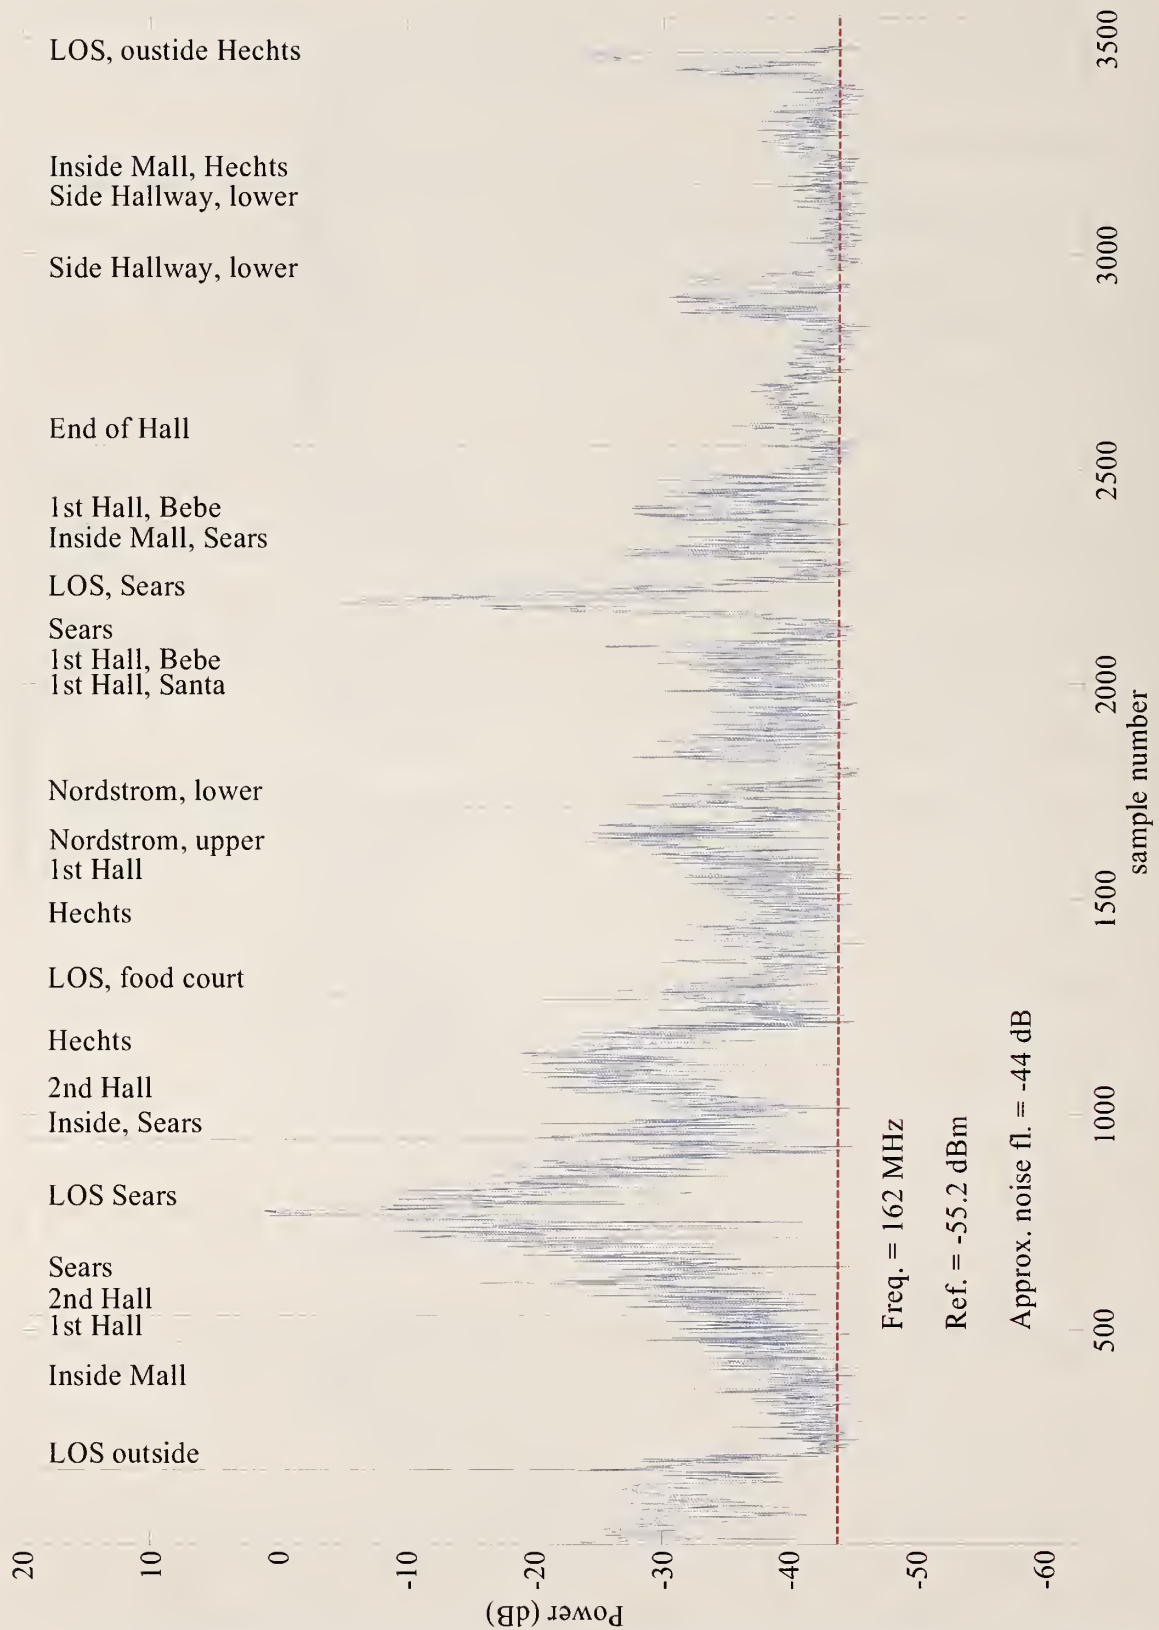
Figure 155. Bethesda, MD shopping mall walk-through at 162.09 MHz; receiver at site 2.

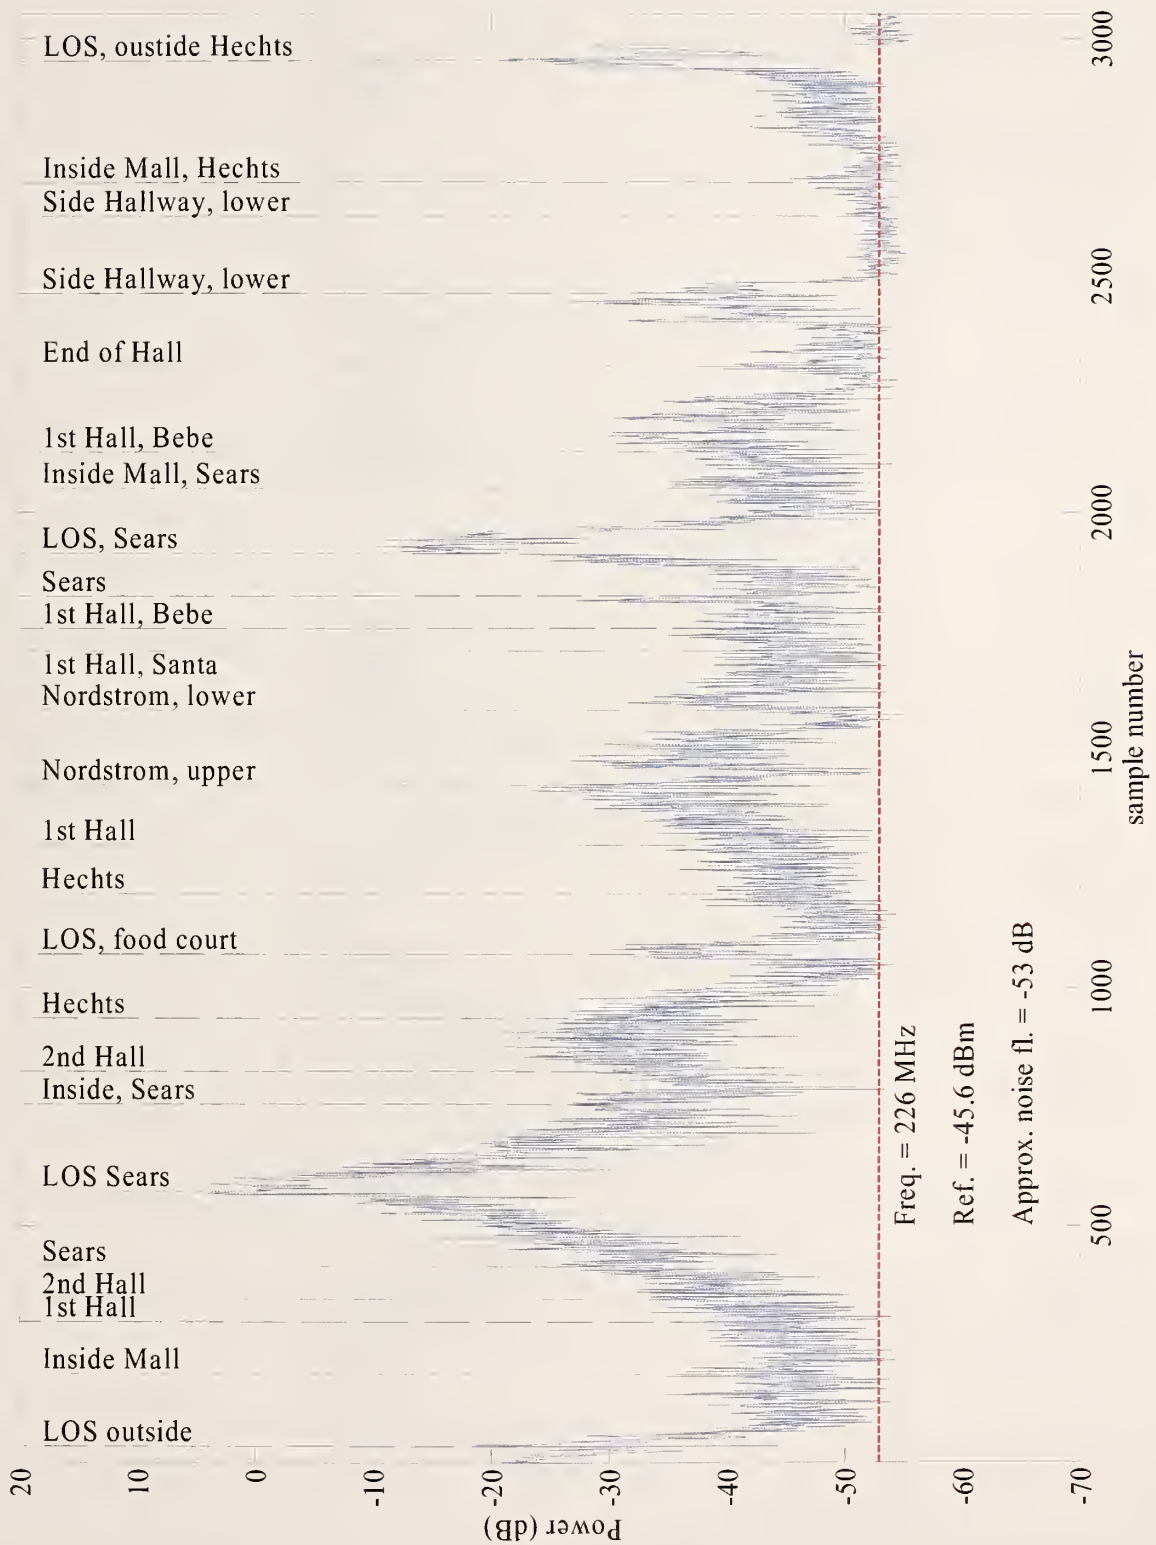
Figure 156. Bethesda, MD shopping mall walk-through at 226.40 MHz; receiver at site 2.
