## *NIST Technical Note 1545*

# Attenuation of Radio Wave Signals Coupled Into Twelve Large Building Structures

August 2008

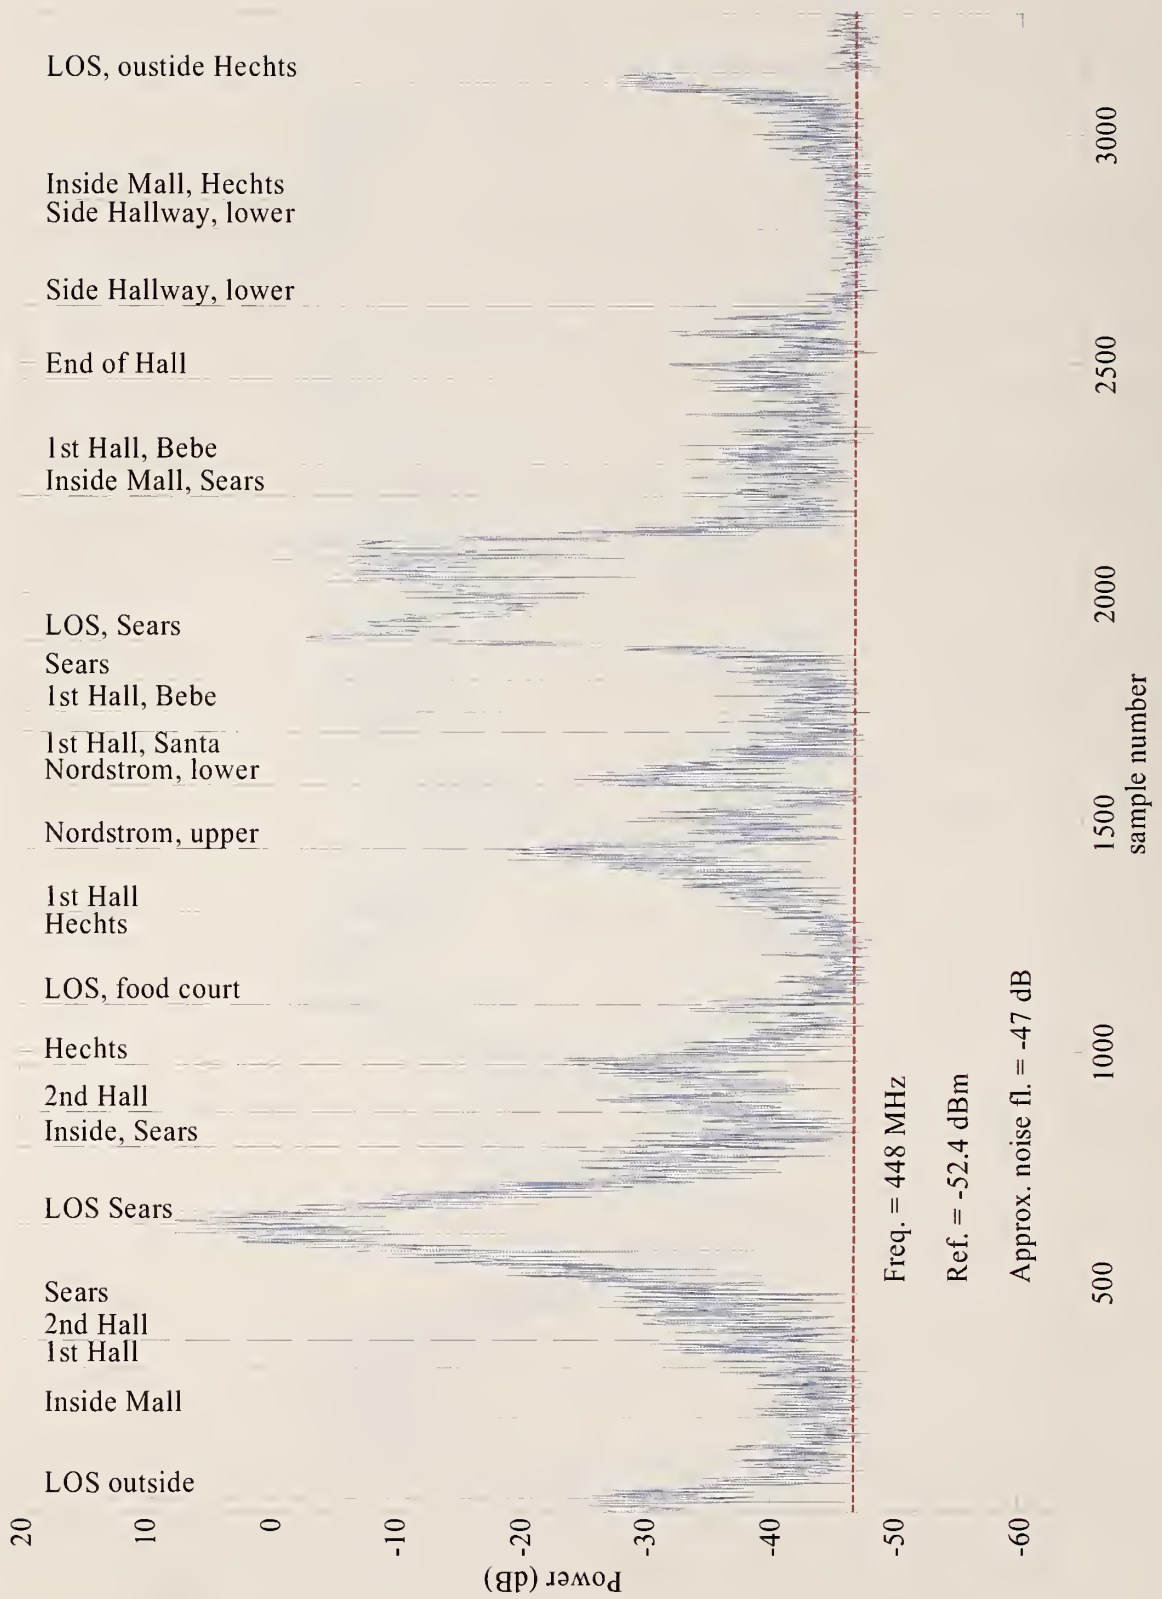
Figure 157. Bethesda, MD shopping mall walk-through at 448.30 MHz; receiver at site 2.

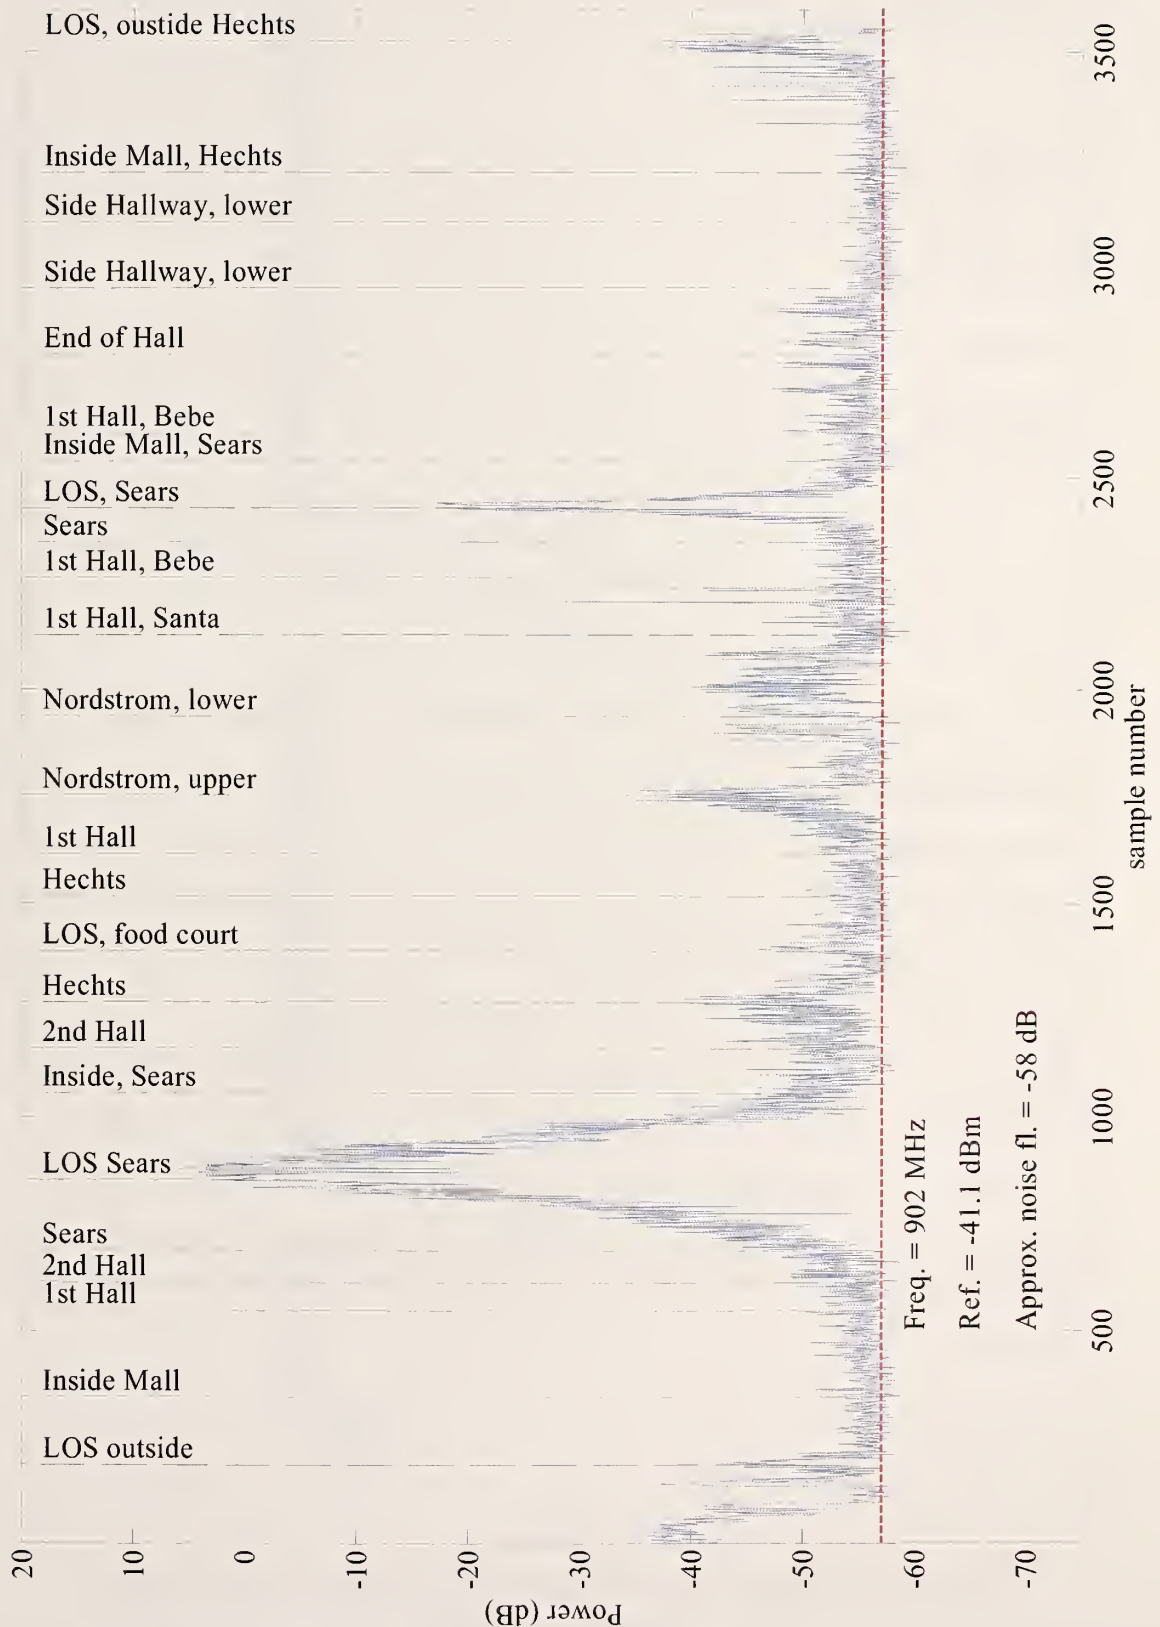
Figure 158. Bethesda, MD shopping mall walk-through at 902.45 MHz; receiver at site 2.

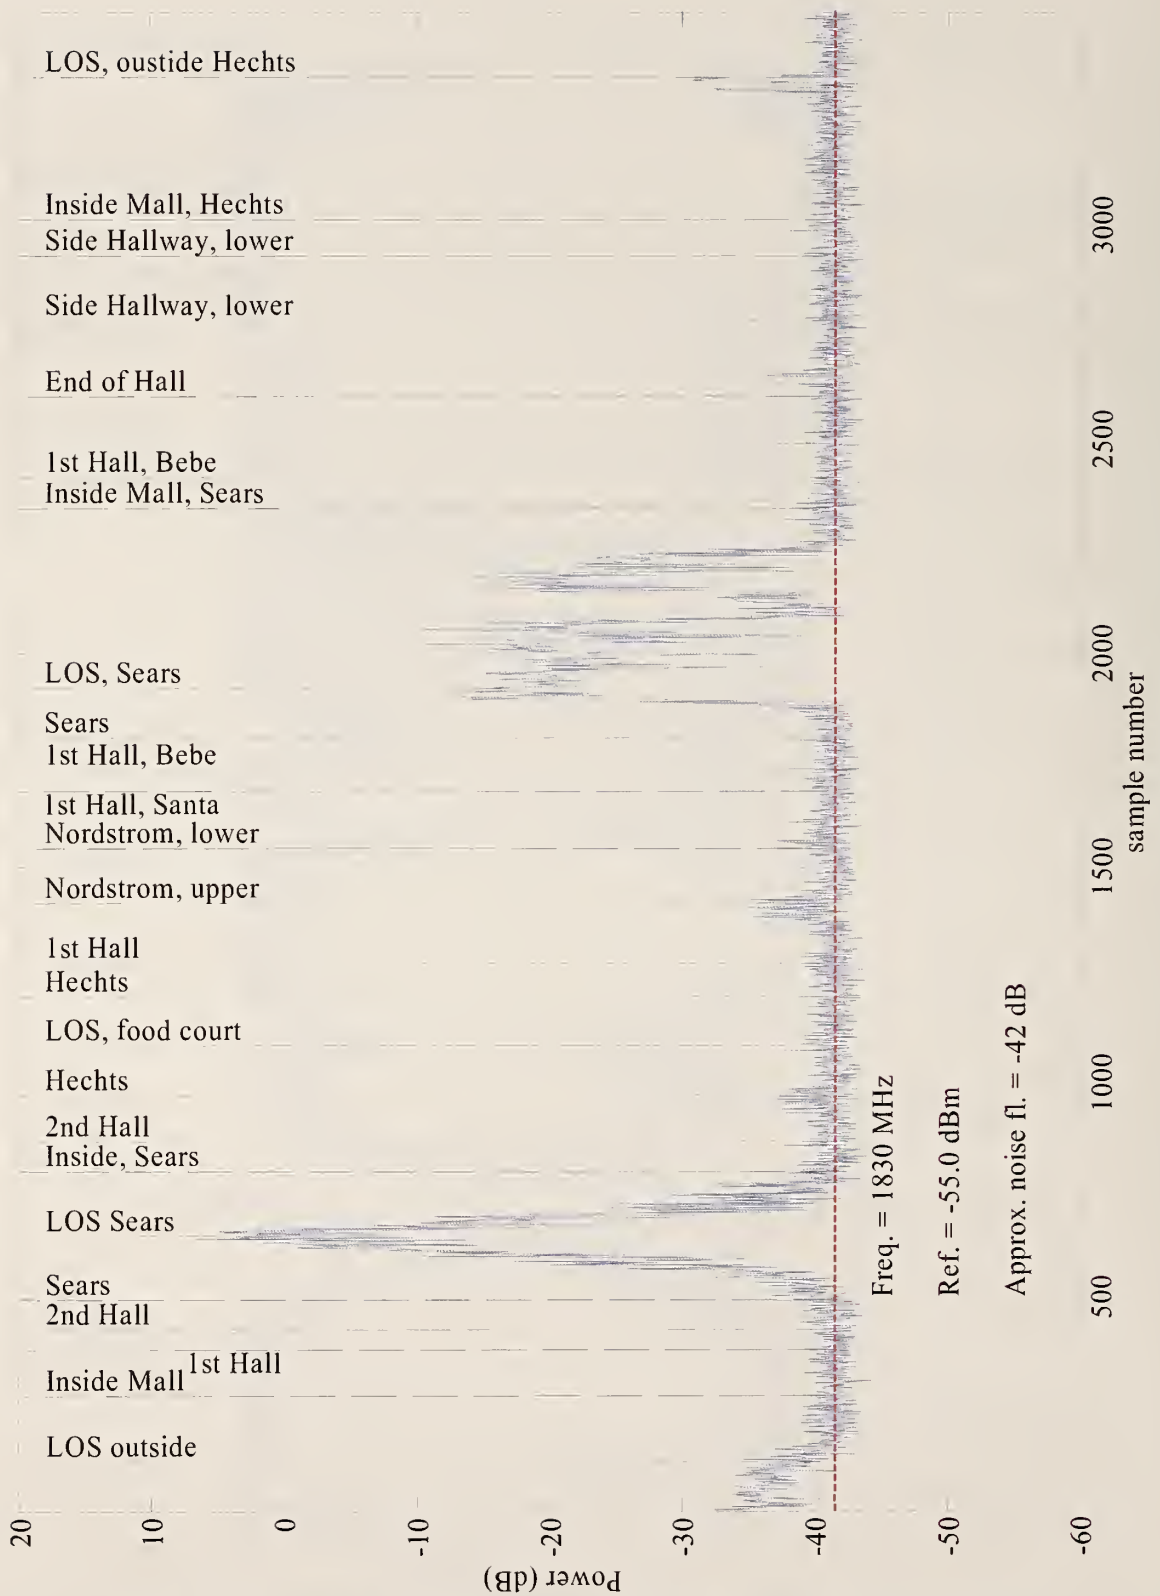
Figure 159. Bethesda, MD shopping mall walk-through at 1830.00 MHz; receiver at site 2.

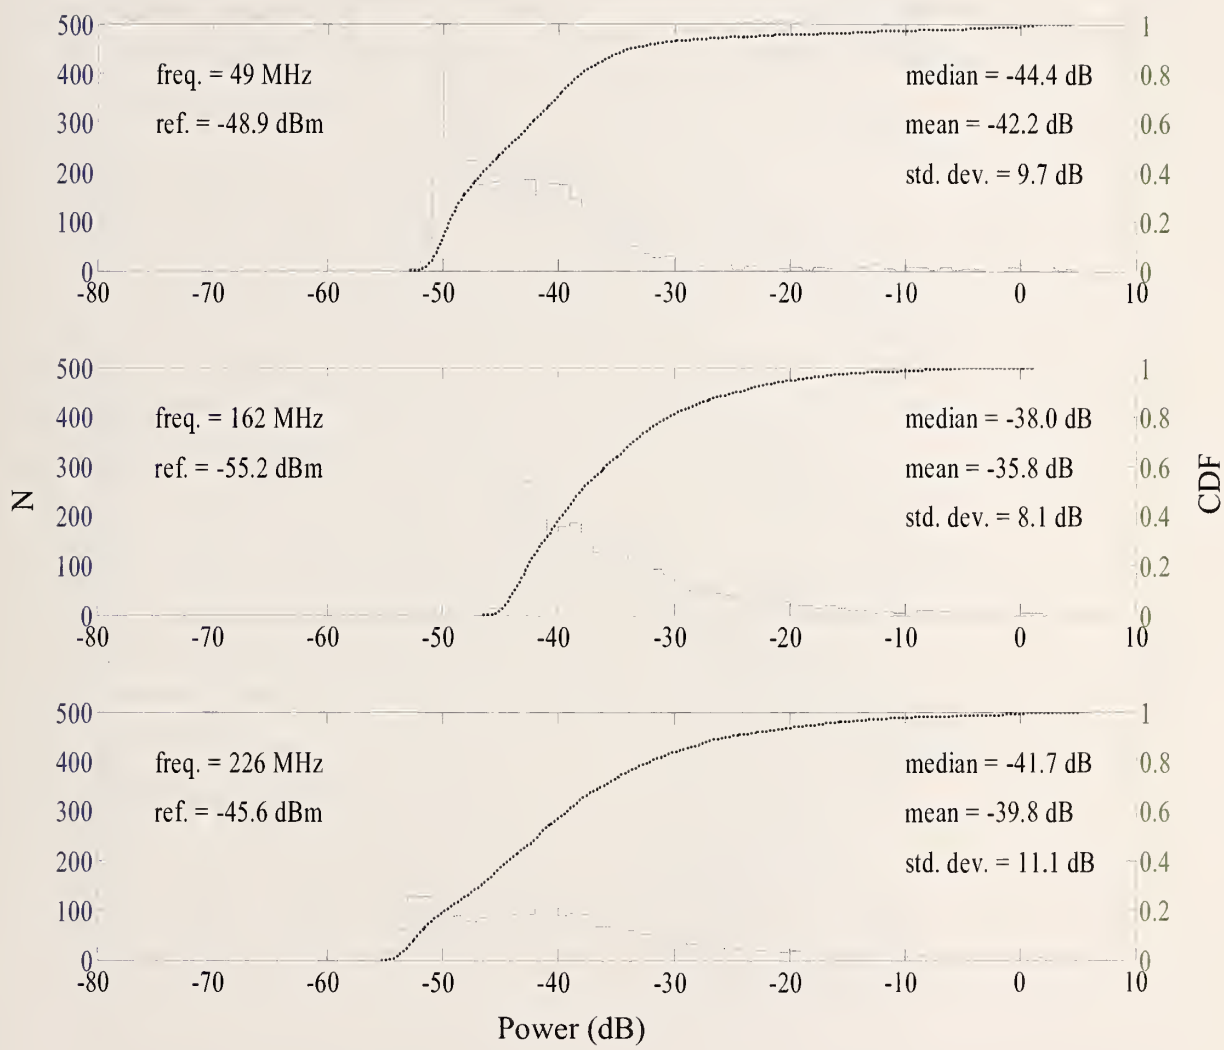
Figure 160. Bethesda, MD shopping mall statistics, histograms, and empirical CDF for walk-through data with the receiver at site 2; 49.60, 162.09, and 226.40 MHz.

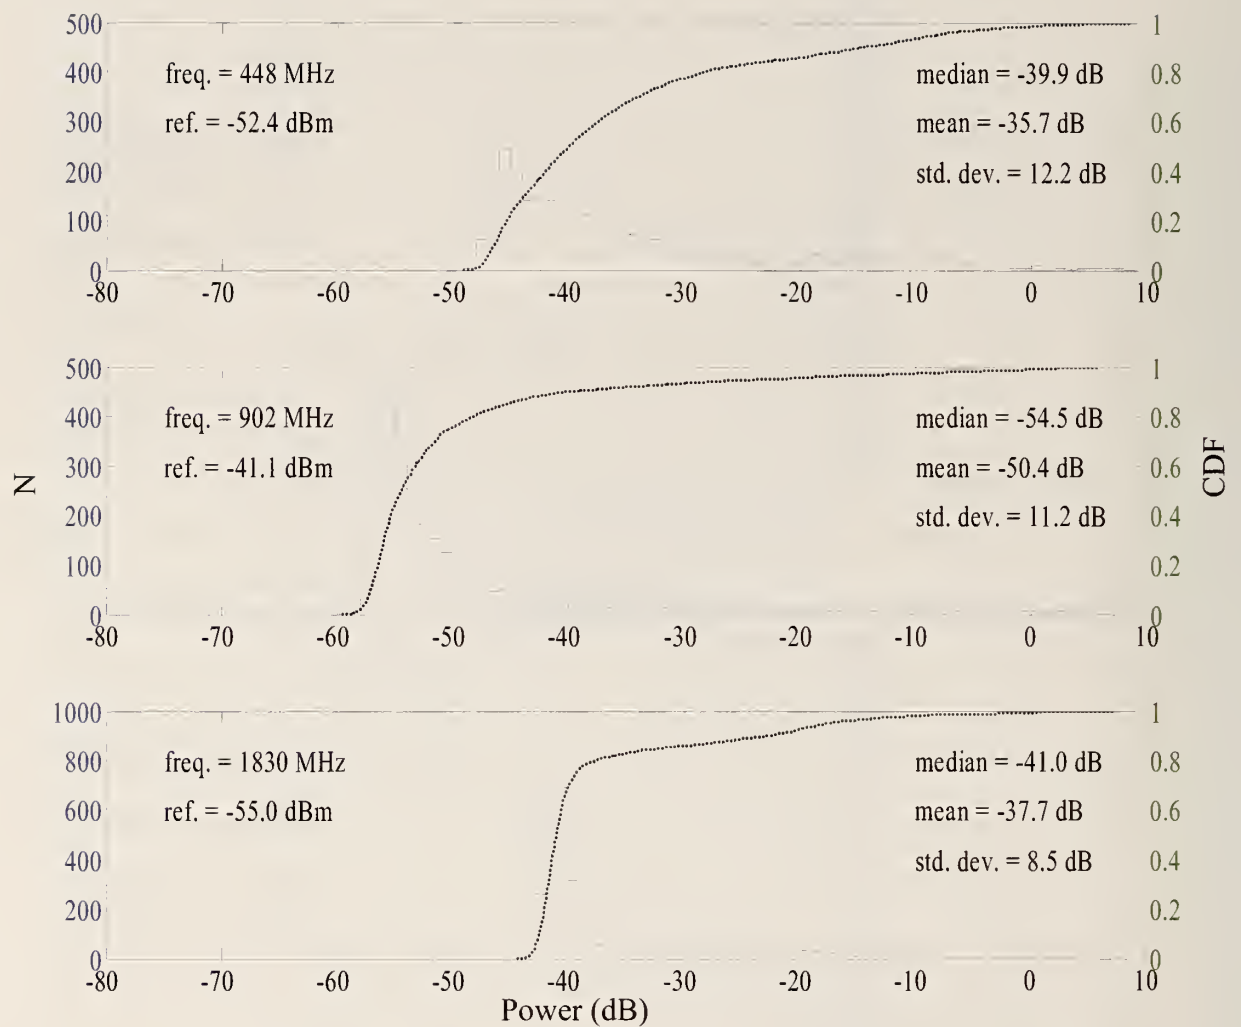
Figure 161. Bethesda, MD shopping mall statistics, histograms, and empirical CDF for walk-through data with the receiver at site 2; 448.30, 902.45, and 1830.00 MHz.

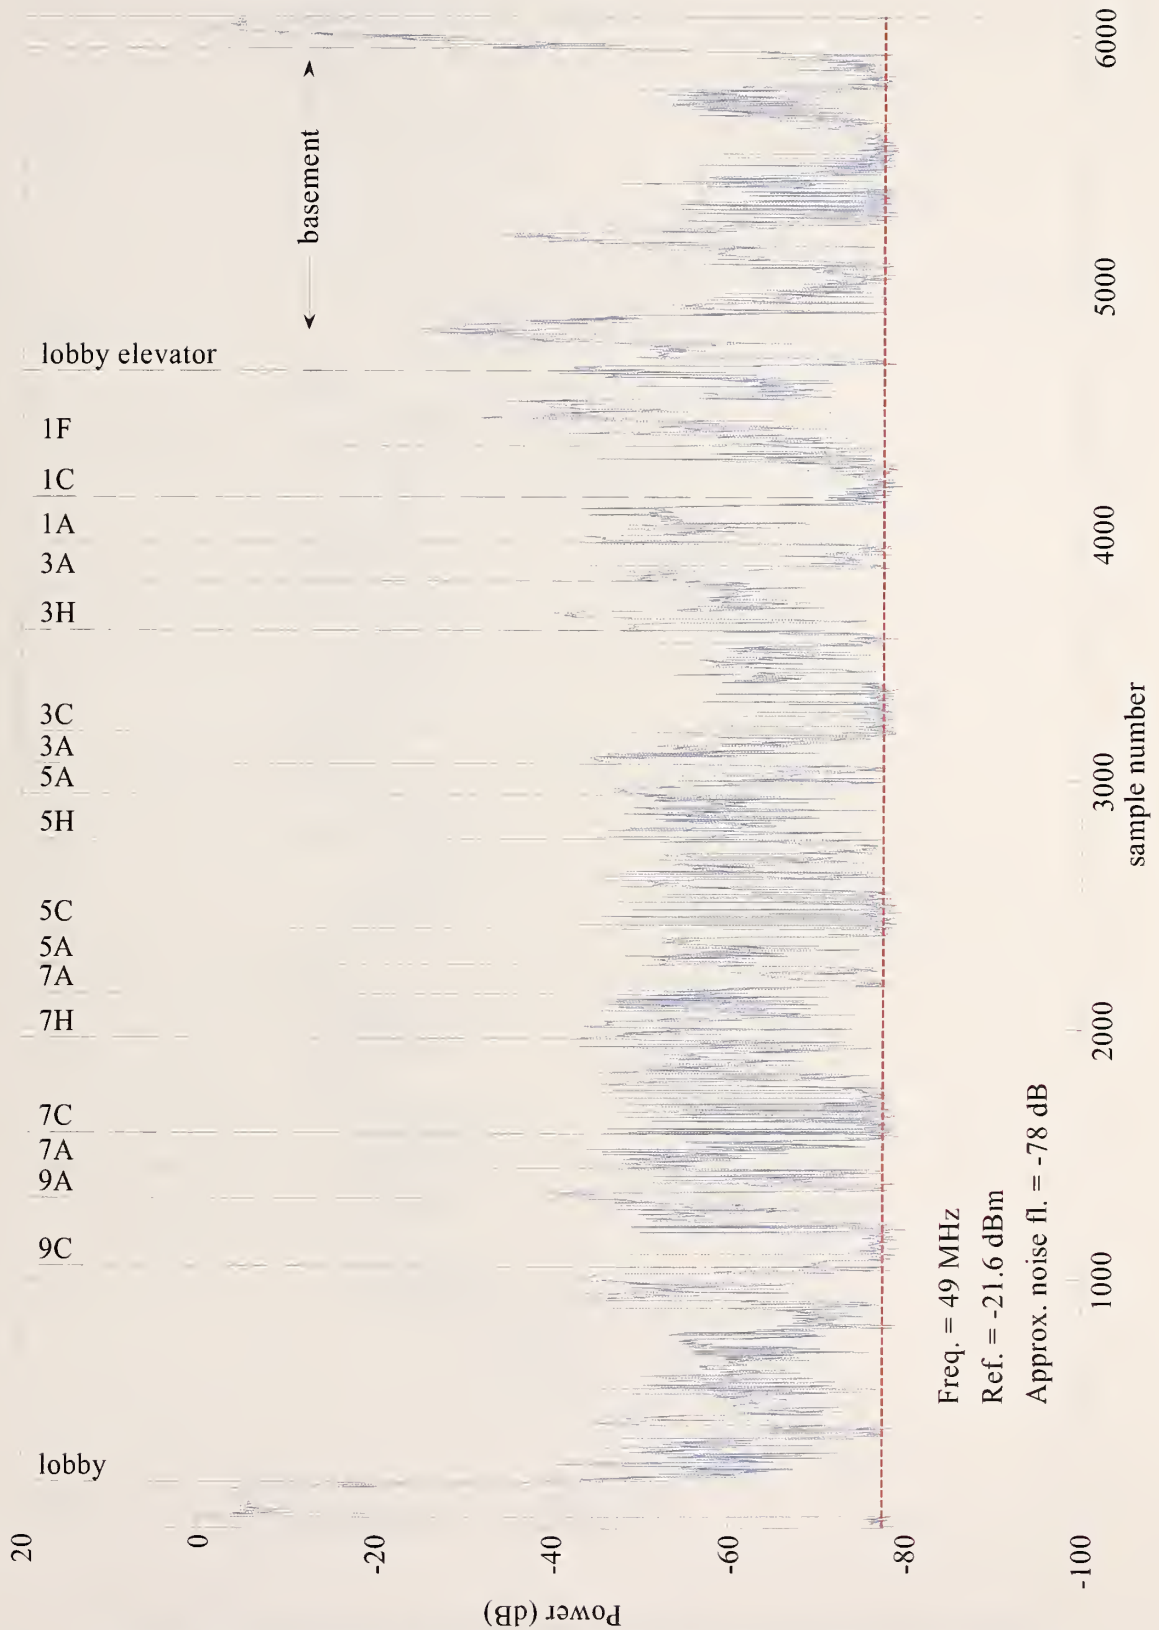
Figure 162. Silver Spring, MD office building walk-through at 49.60 MHz.

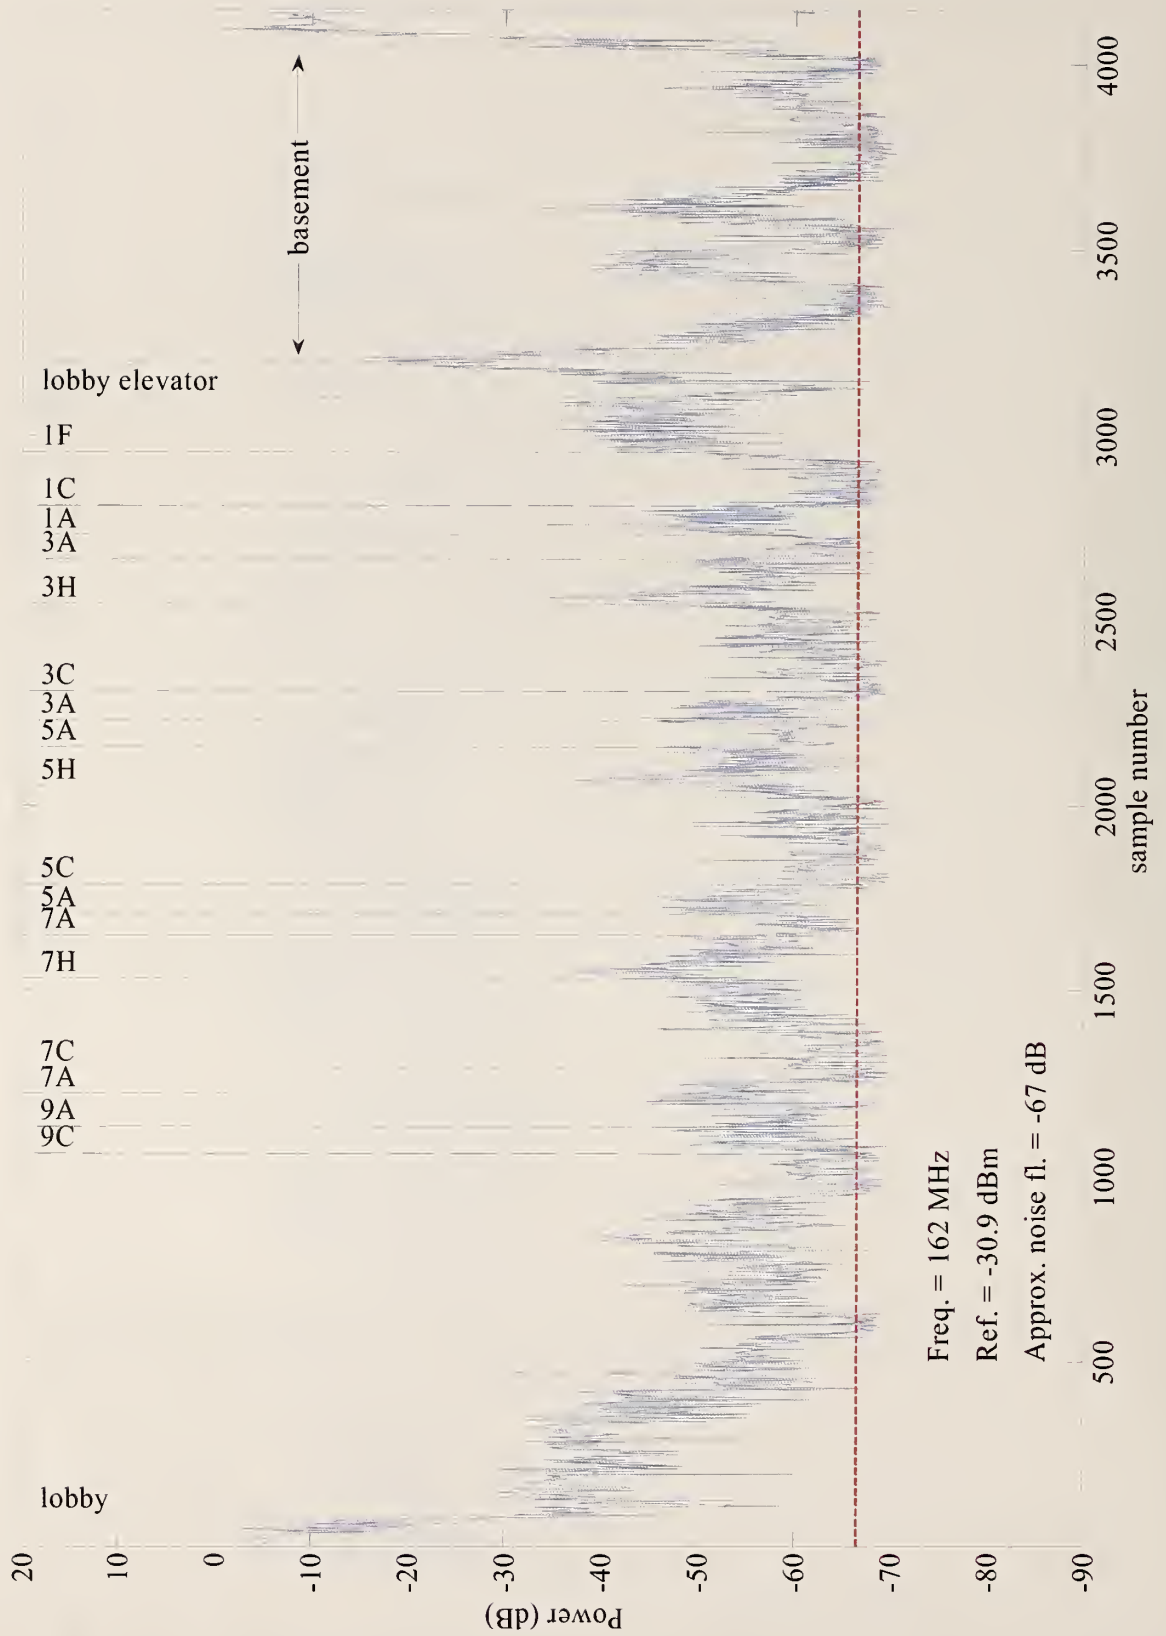
Figure 163. Silver Spring, MD office building walk-through at 162.09 MHz.

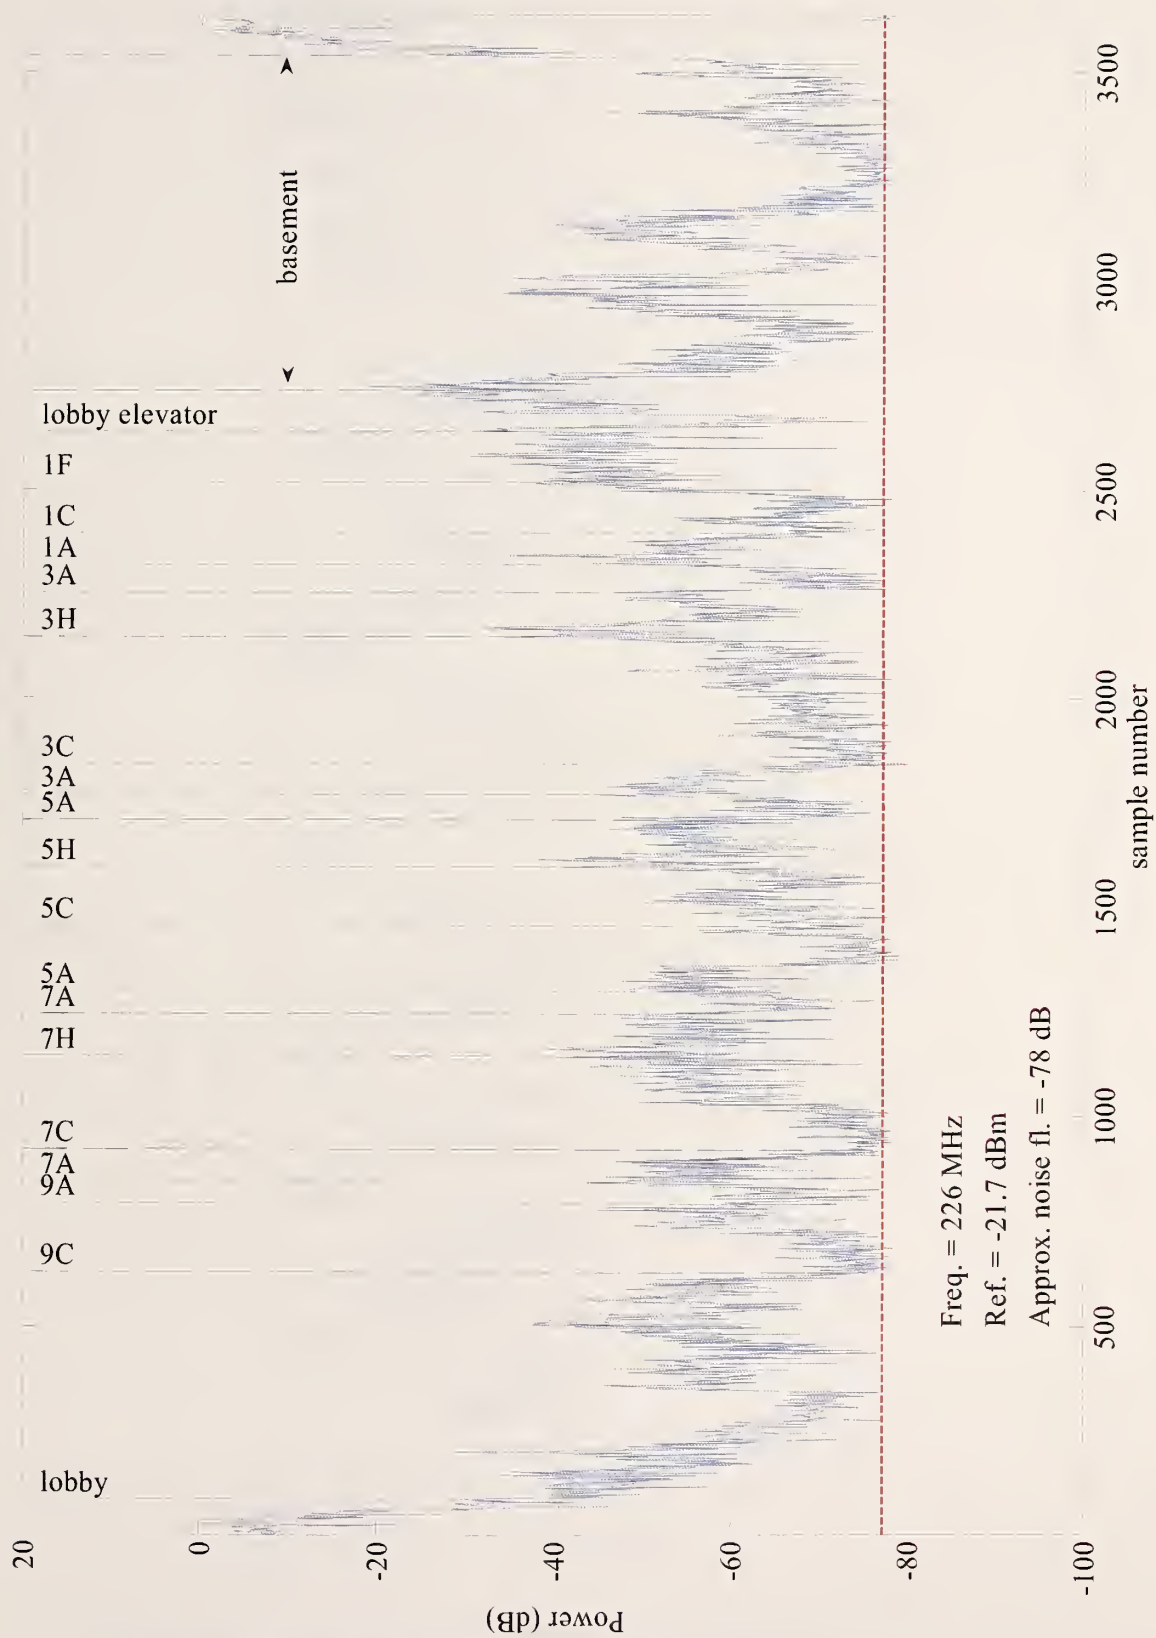
Figure 164. Silver Spring, MD office building walk-through at 226.40 MHz.

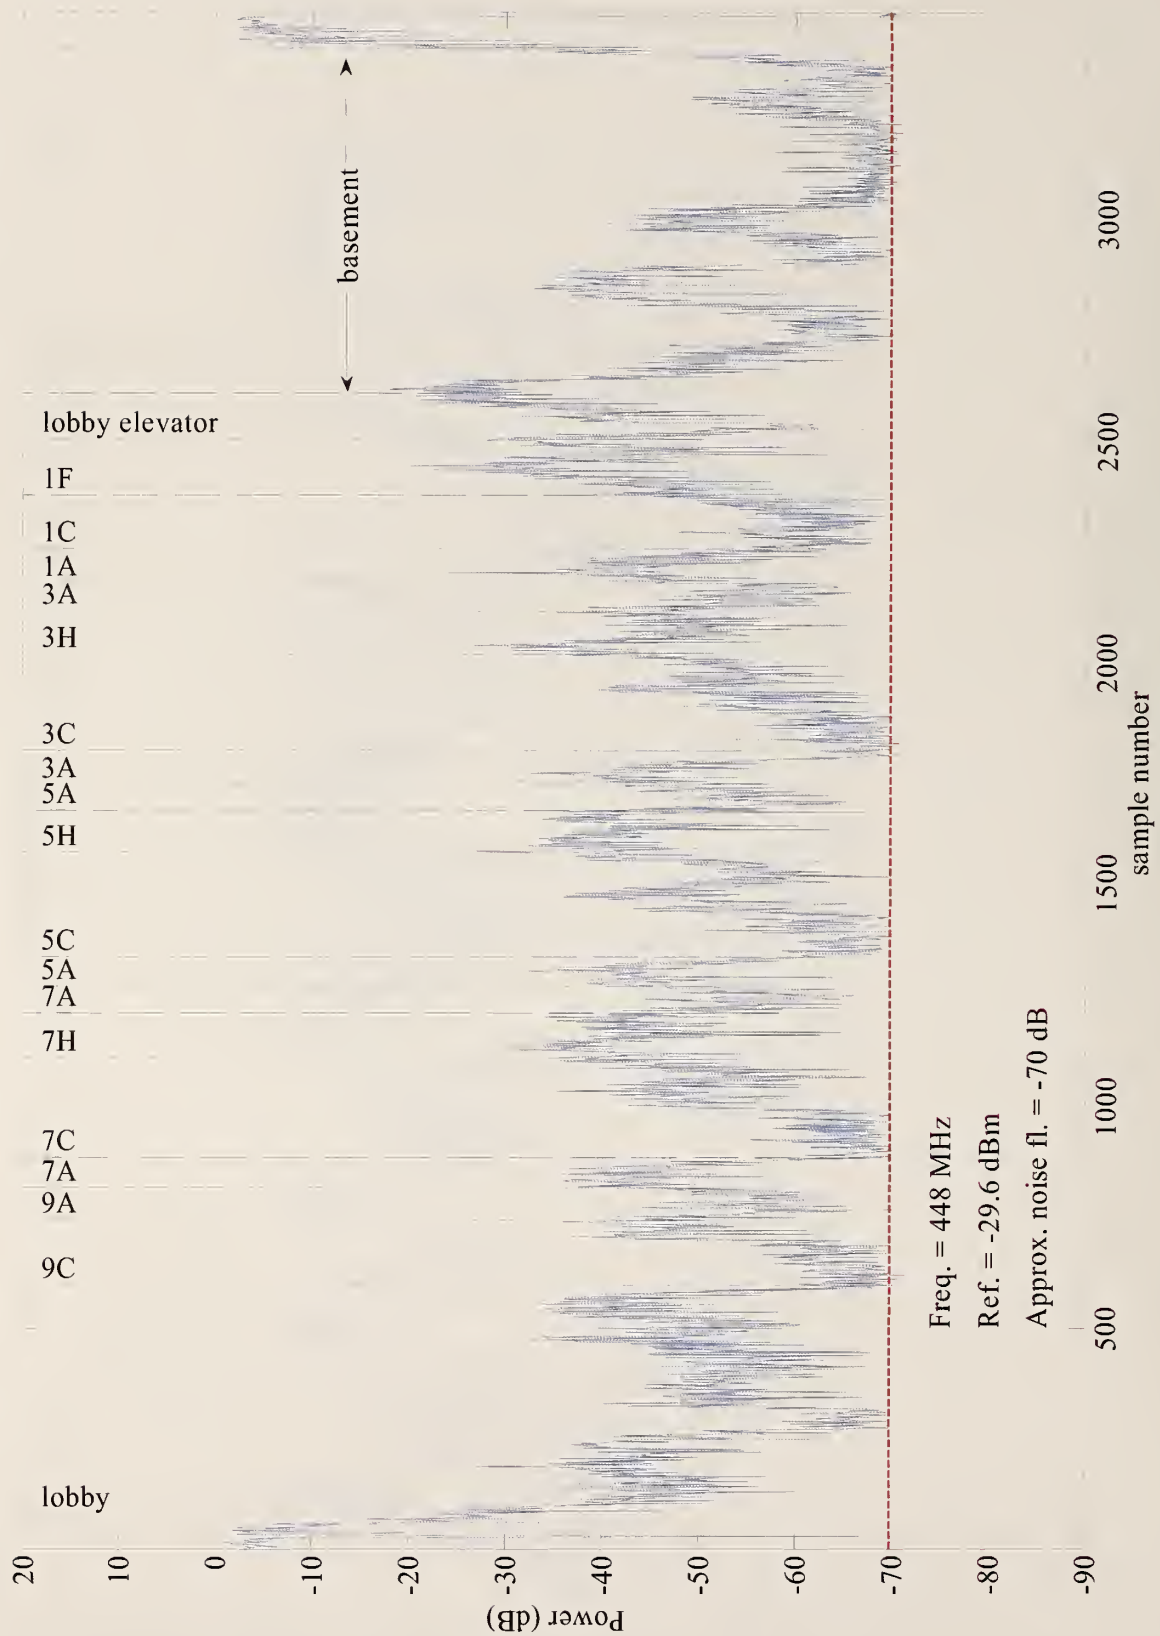
Figure 165. Silver Spring, MD office building walk-through at 448.30 MHz.

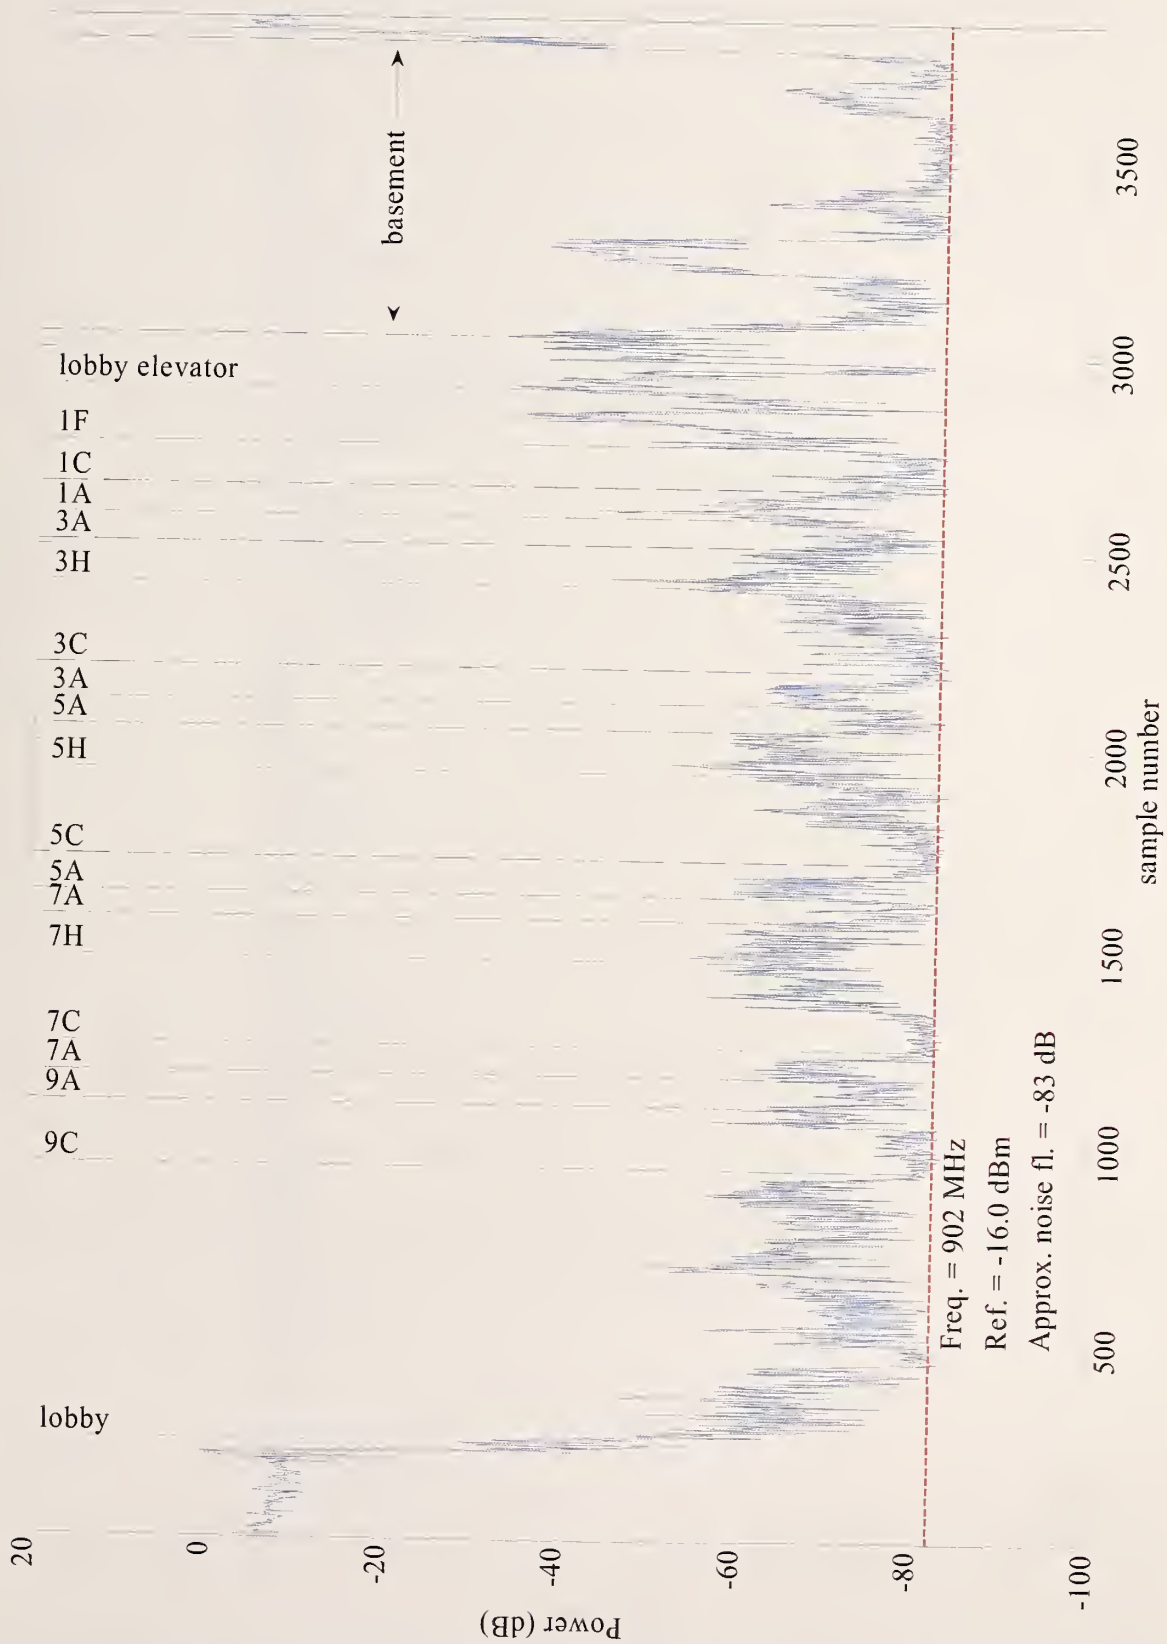
Figure 166. Silver Spring, MD office building walk-through at 902.45 MHz.

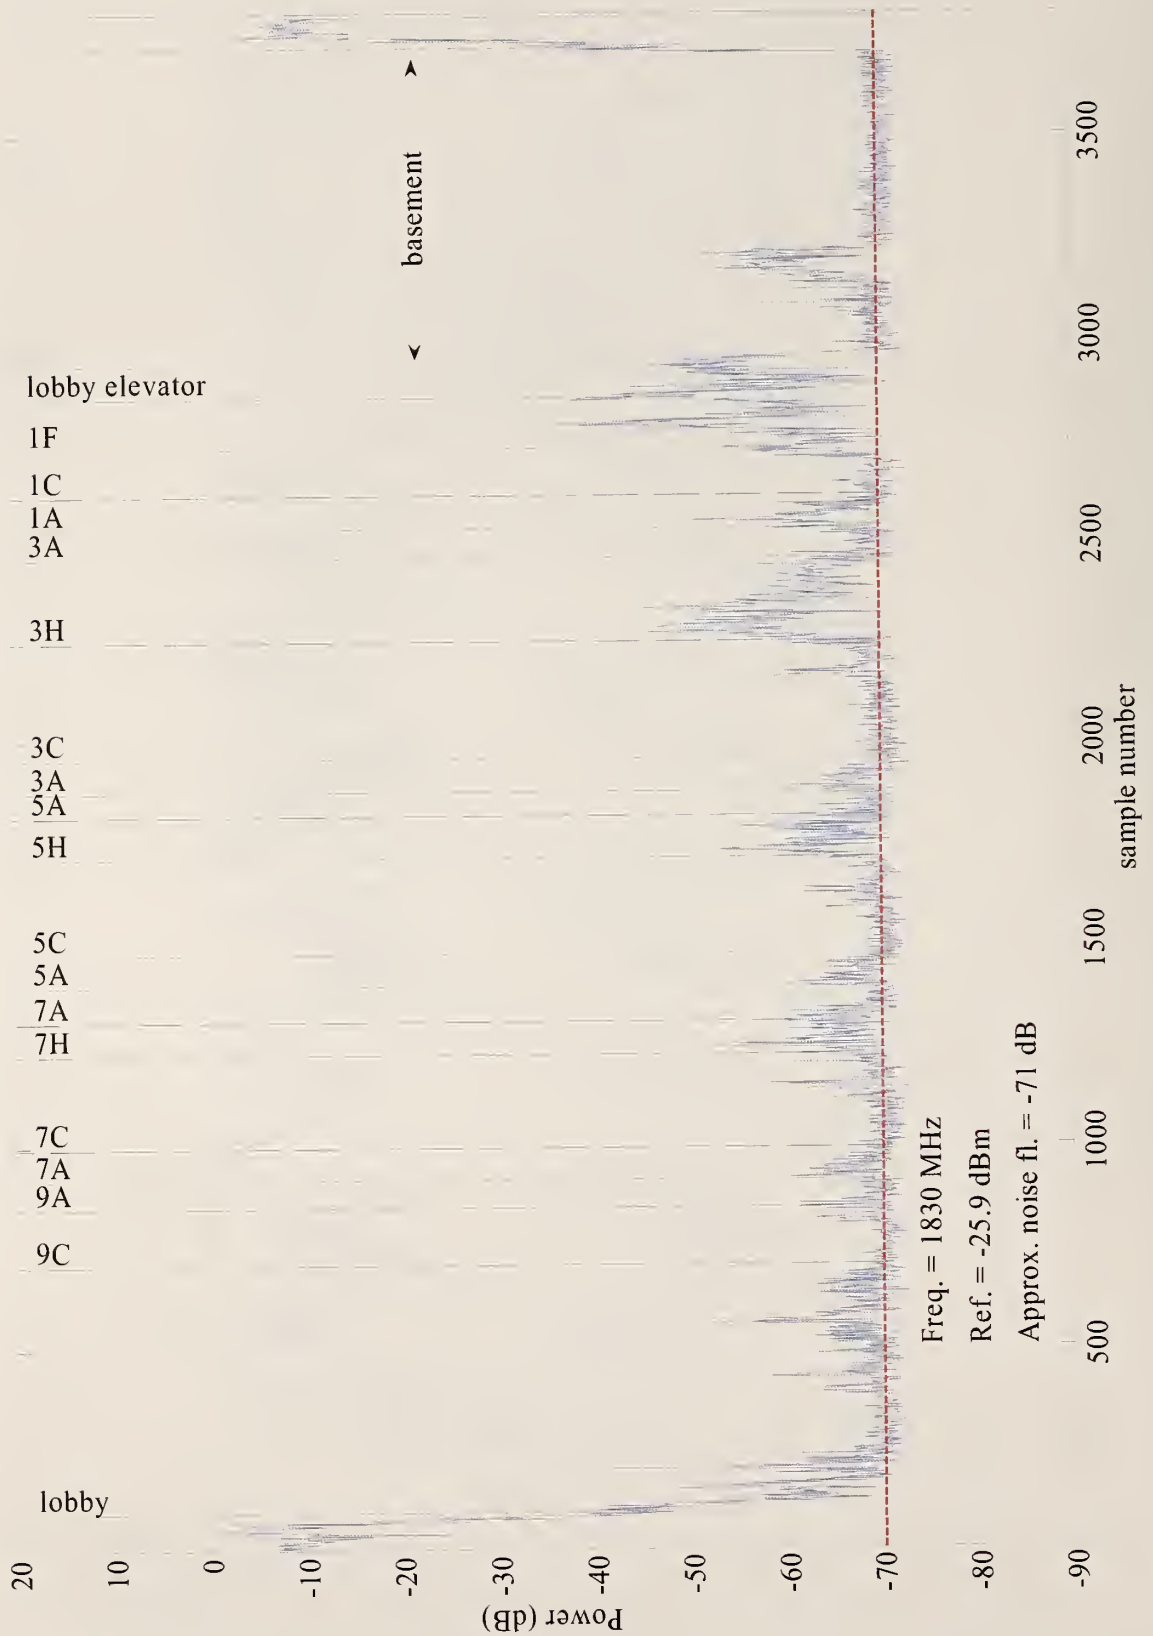
Figure 167. Silver Spring, MD office building walk-through at 1830.00 MHz.

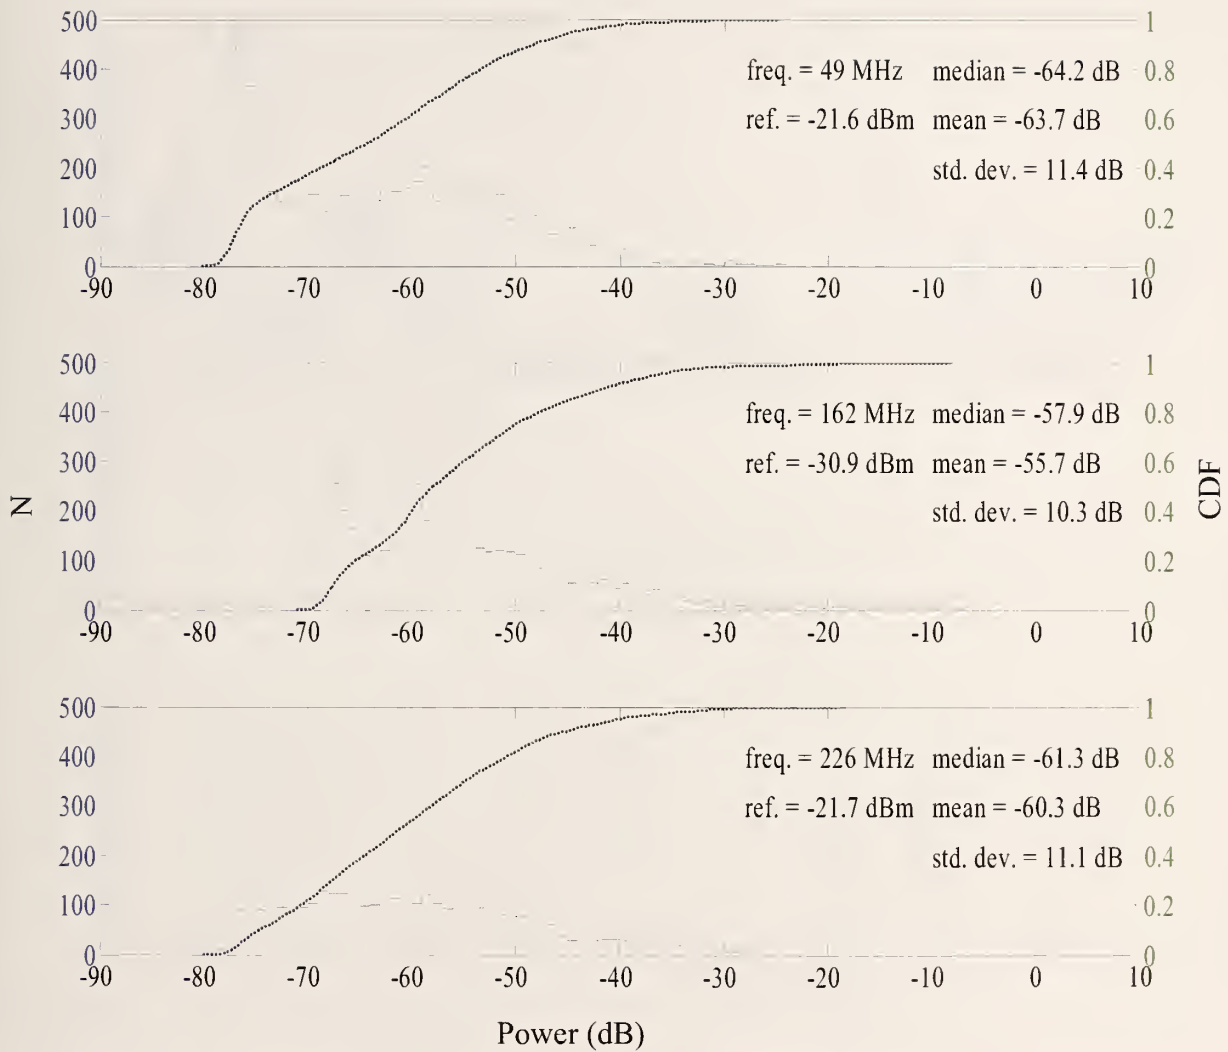
Figure 168. Silver Spring, MD office building statistics, histograms, and empirical CDF for walk-through data; 49.60, 162.09, and 226.40 MHz.

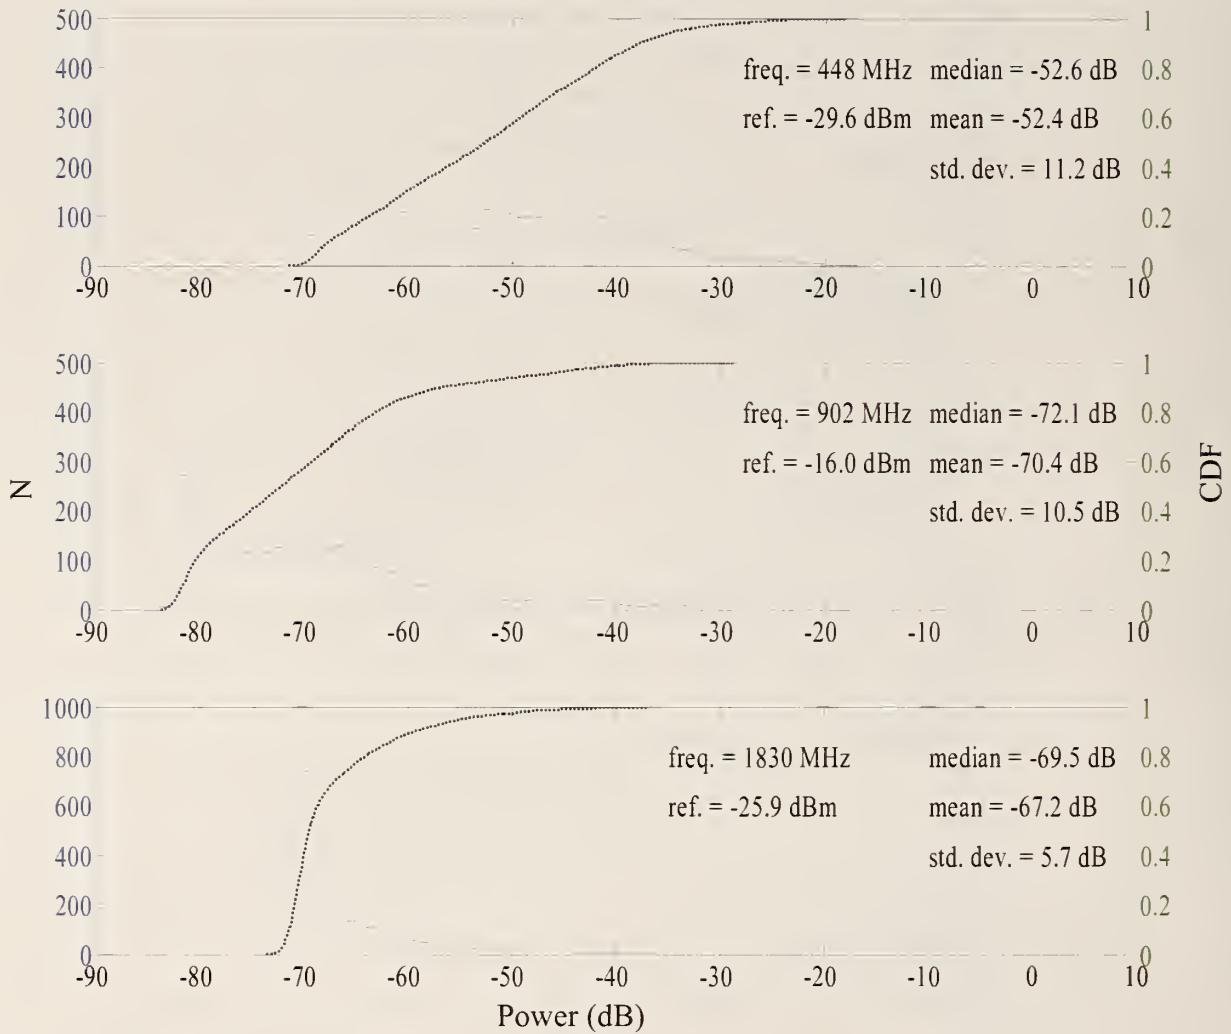
Figure 169. Silver Spring, MD office building statistics, histograms, and empirical CDF for walk-through data; 448.30, 902.45, and 1830.00 MHz.
