## *NIST Technical Note 1545*

# Attenuation of Radio Wave Signals Coupled Into Twelve Large Building Structures

August 2008

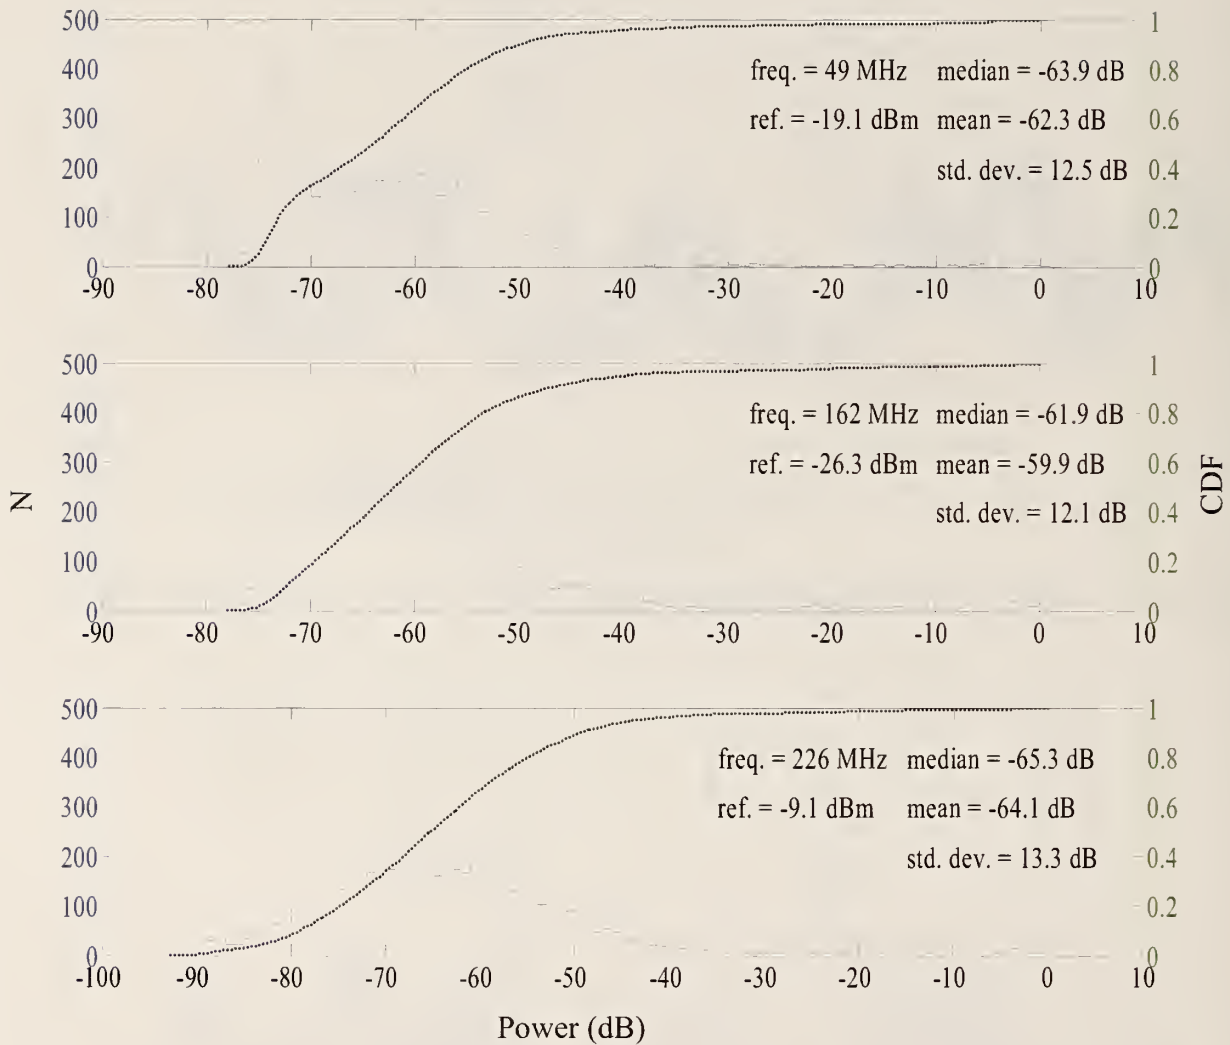
Figure 176. Washington, DC convention center statistics, histograms, and empirical CDF for walk-through data with the receiver at site 1; 49.60, 162.09, and 226.40 MHz.

Three receiver sites collected data at the Washington, DC convention center. The both the walk-through data and the statistics data for all three sites are presented in Figures 170 through 193. The corresponding walk-through data results for receiver sites labeled 1, 2, and 3 are provided in Figure 170 through Figure 175, Figure 178 through Figure 183, and Figure 186 through Figure 191, respectively. The statistics plots for receiver sites 1, 2, and 3 are found in Figure 176 and Figure 177, Figure 184 and Figure 185, and Figure 192 and Figure 193, respectively.

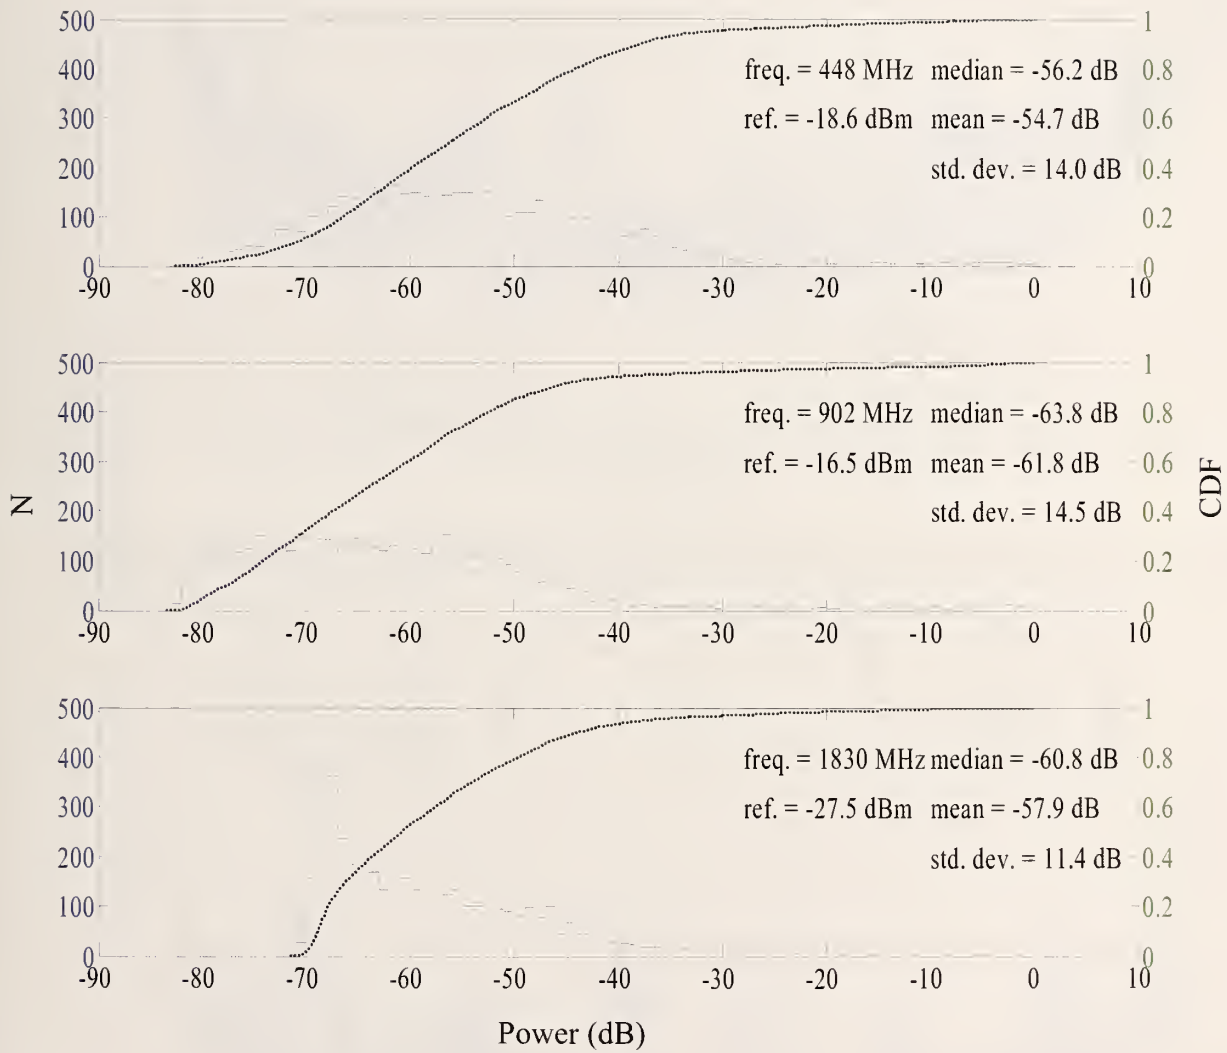
Figure 177. Washington, DC convention center statistics, histograms, and empirical CDF for walk-through data with the receiver at site 1; 448.30, 902.45, and 1830.00 MHz.

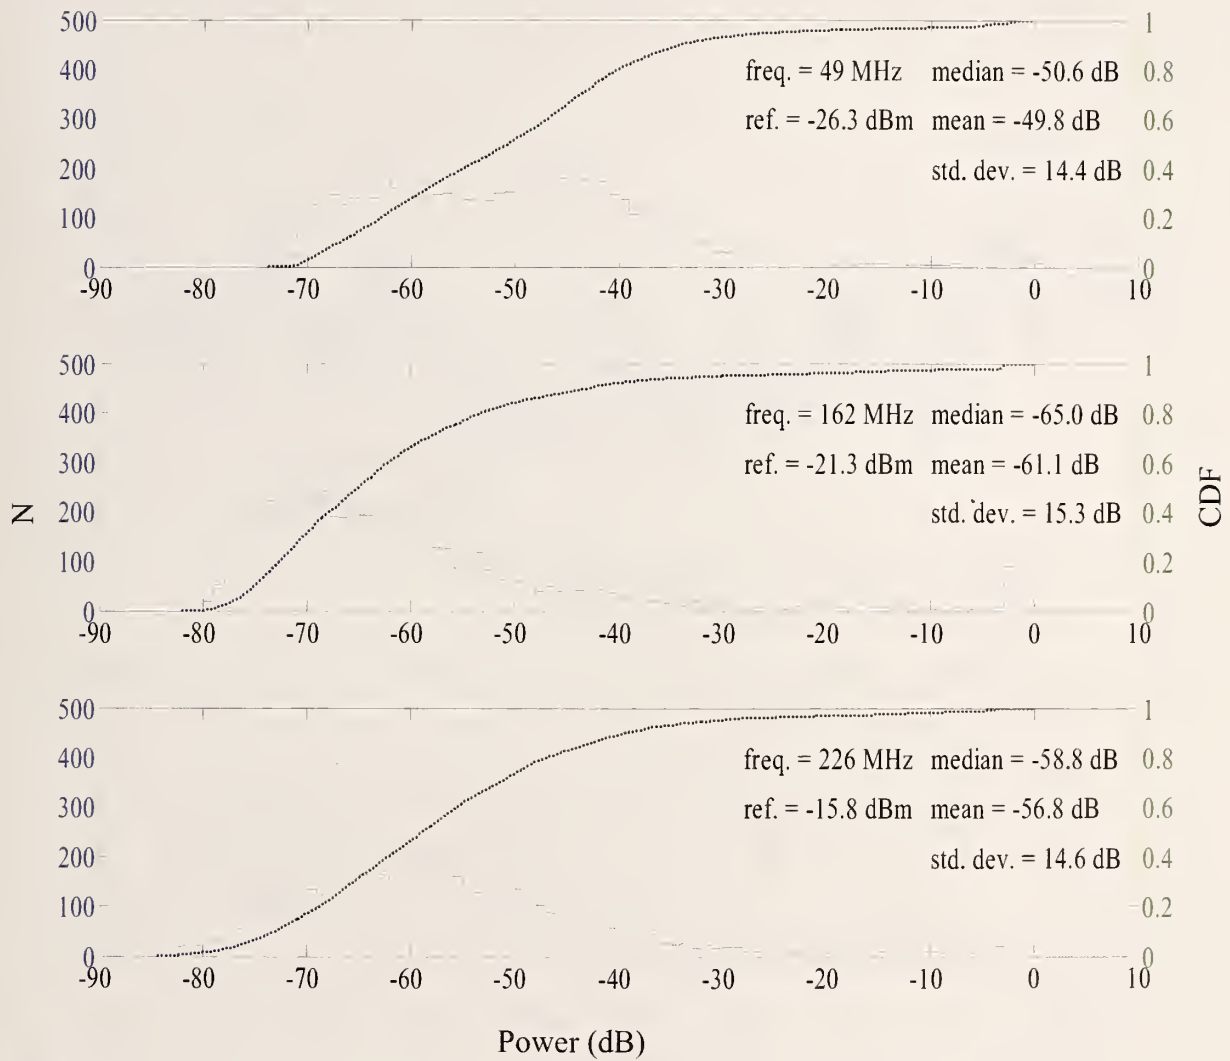
Figure 184. Washington, DC convention center statistics, histograms, and empirical CDF for walk-through data with the receiver at site 2; 49.60, 162.09, and 226.40 MHz.

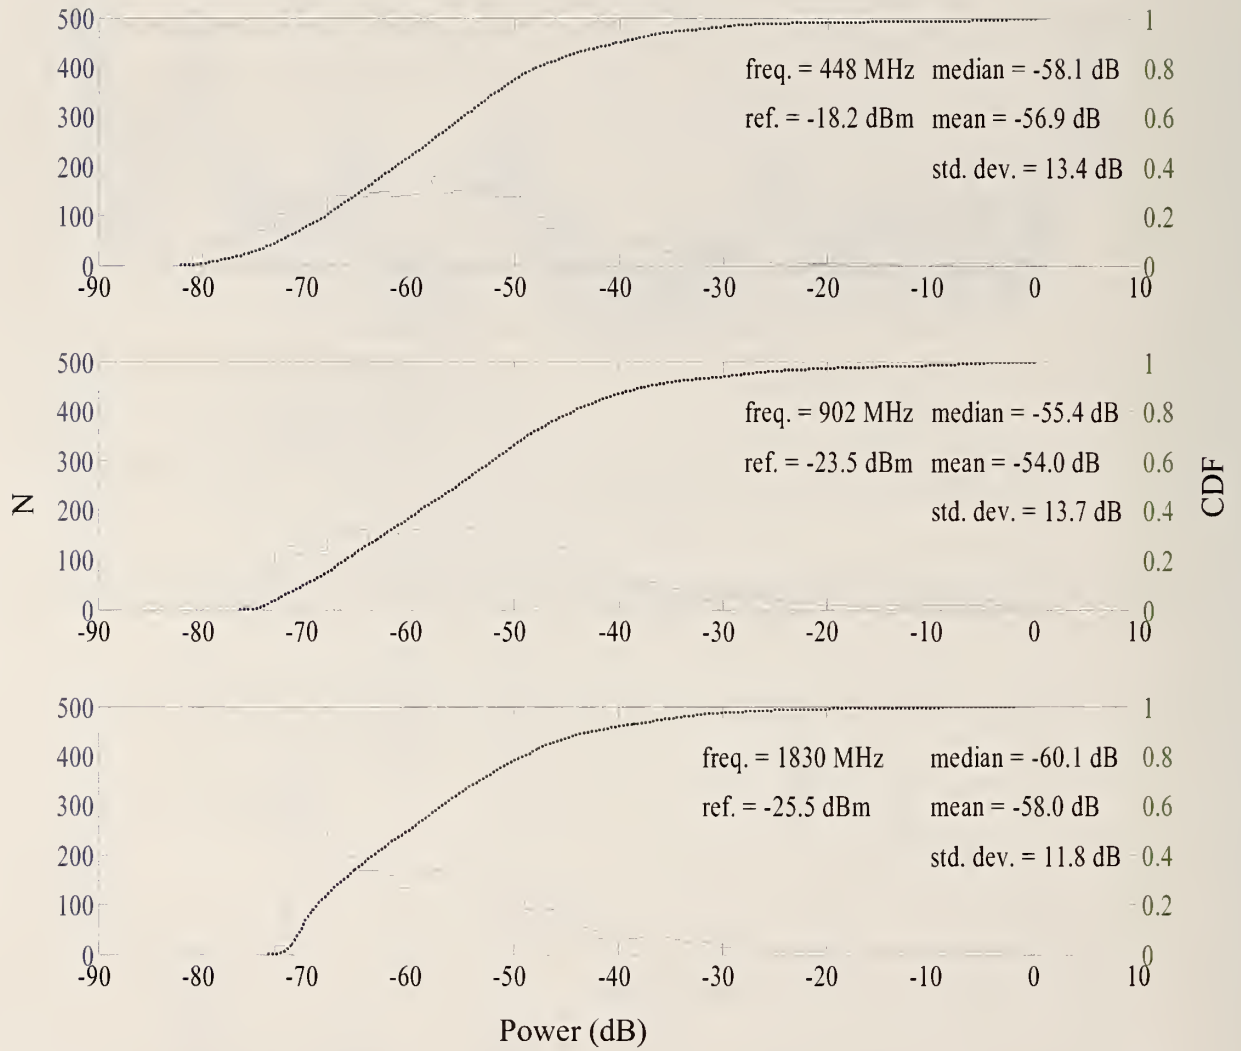
Figure 185. Washington, DC convention center statistics, histograms, and empirical CDF for walk-through data with the receiver at site 2; 448.30, 902.45, and 1830.00 MHz.

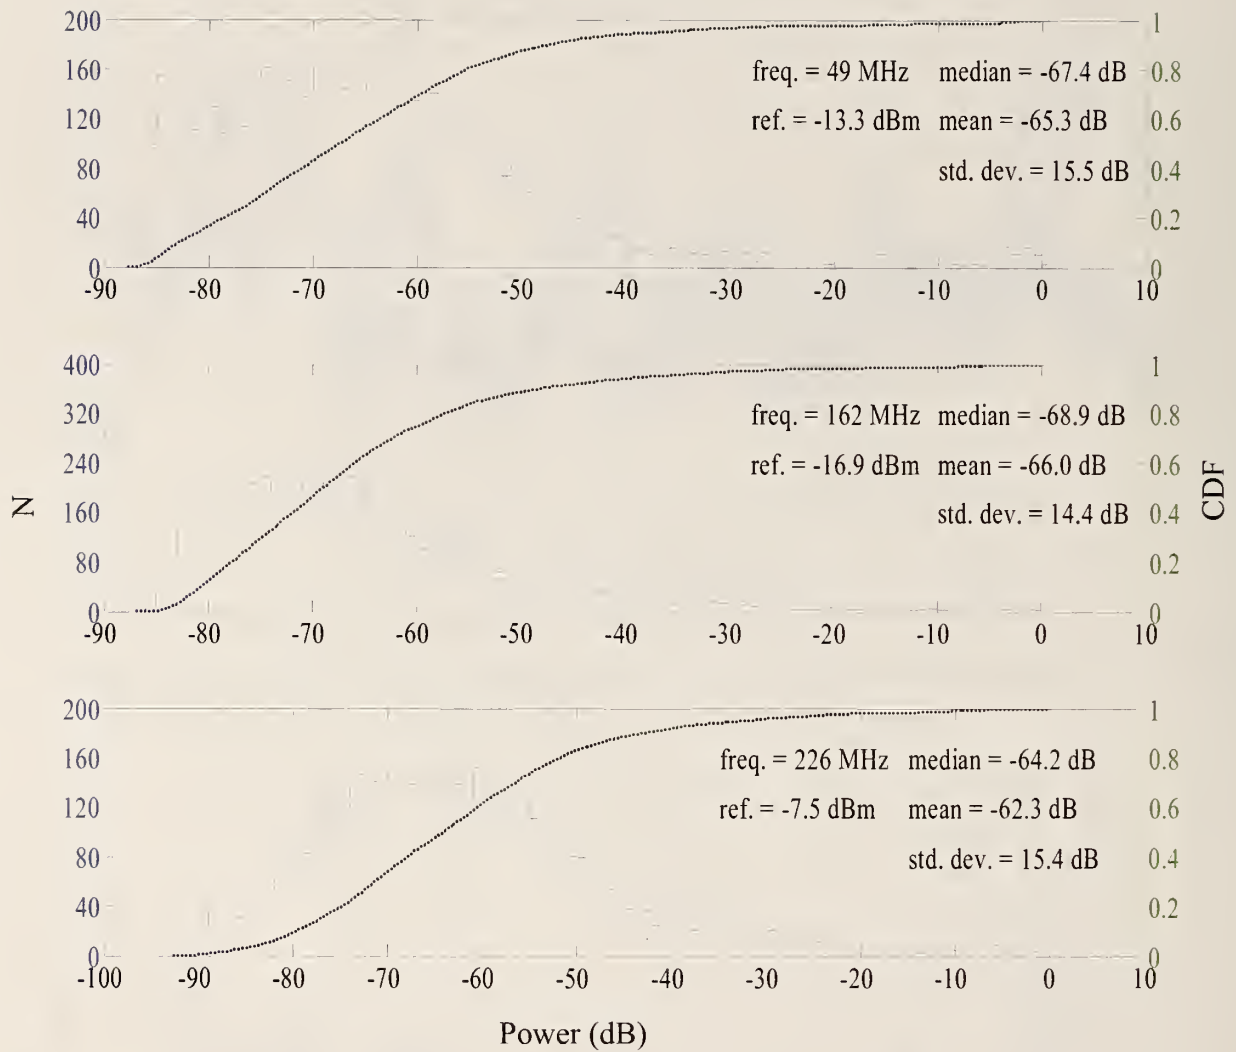
Figure 192. Washington, DC convention center statistics, histograms, and empirical CDF for walk-through data with the receiver at site 3; 49.60, 162.09, and 226.40 MHz.

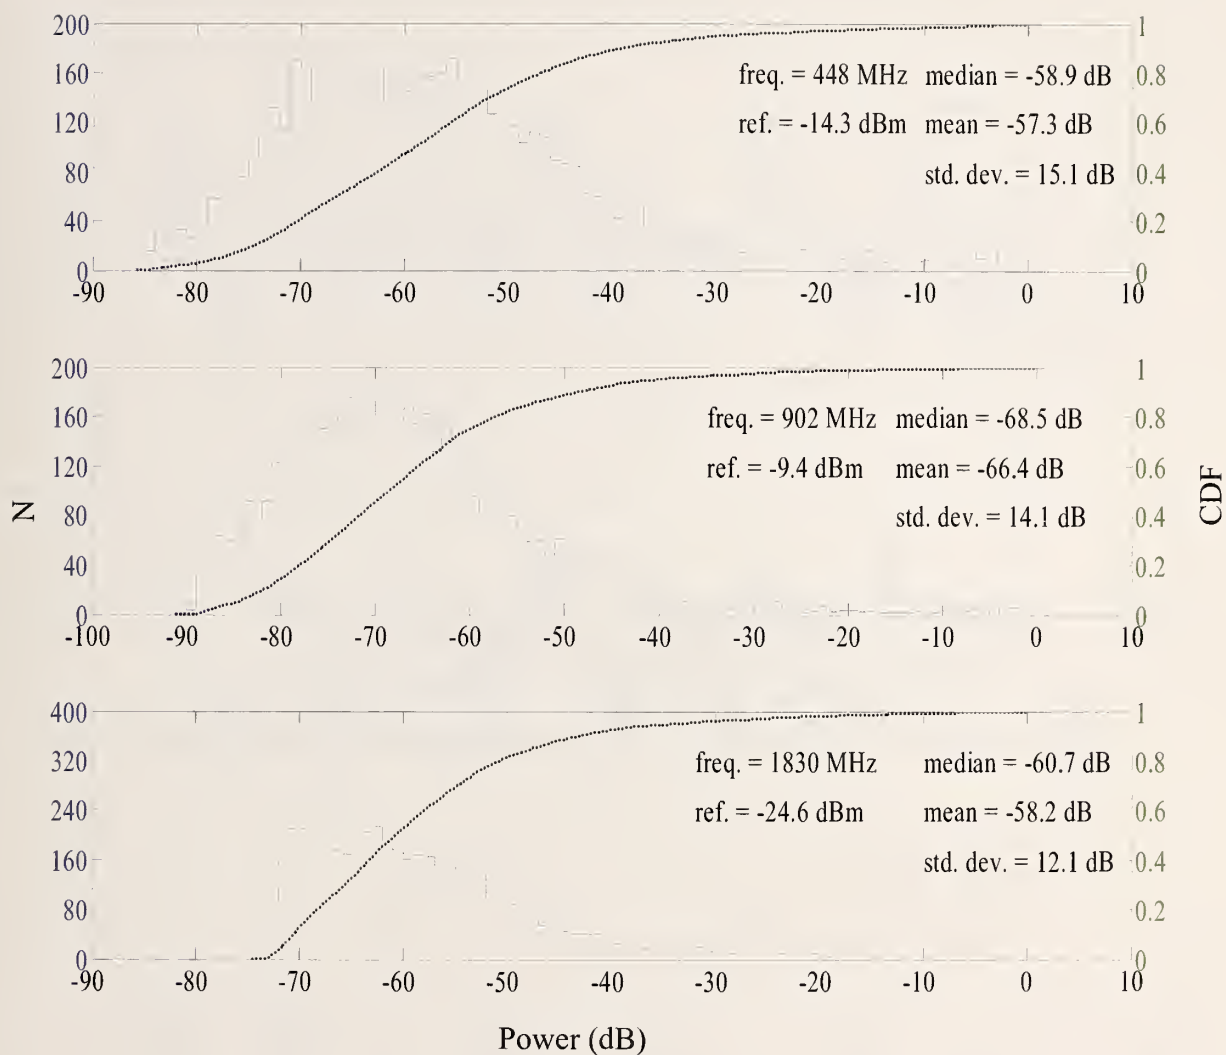
Figure 193. Washington, DC convention center statistics, histograms, and empirical CDF for walk-through data with the receiver at site 3; 448.30, 902.45, and 1830.00 MHz.
