Scanning Electron Microscope Examination of Wire Bonds from High-Reliability Devices

Kathryn O. Leedy

Technical Note 785

Issued August 1973

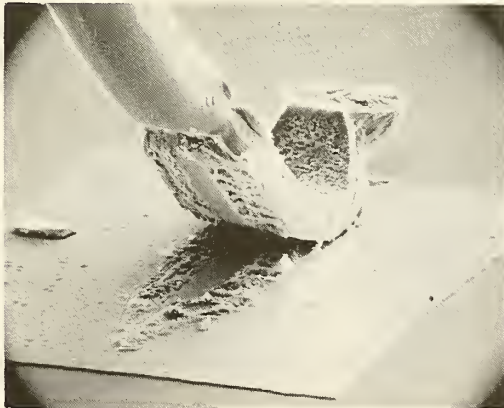
Figure 2. The lift-off pattern of a partially removed bond made under laboratory conditions. A similar pattern can be observed on both the wire and the pad. The center portion of the wire-metallization interface was not welded.

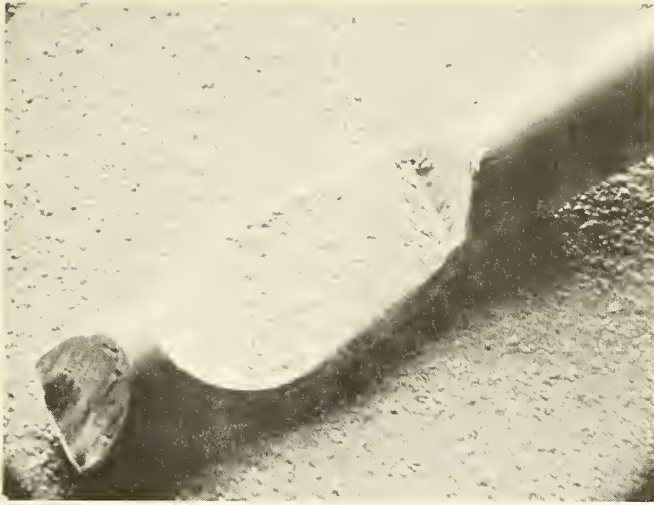
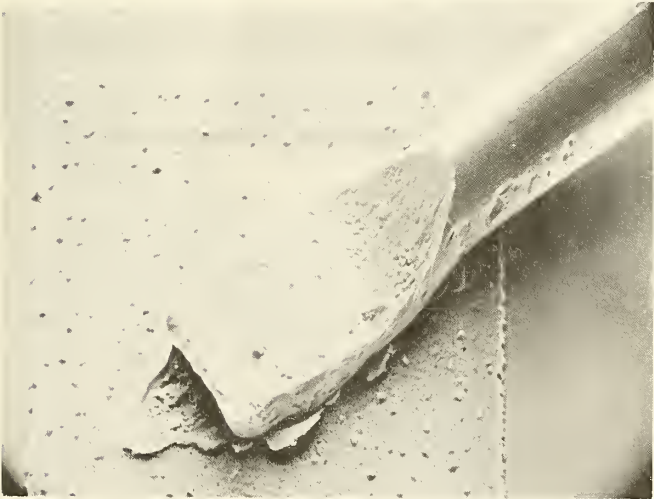
There are many differences in appearance and in structure between the first and second bonds. Some of these may be seen in Figure 4 where the first bond is shown in (a) and the second bond in (b). The most obvious difference between the two bonds in the figure is in the shape of the toe or free end of the bonding wire. The second bond exhibits evidence of the cut-off operation which occurred after it was made. The first bond shows the tail, the unflattened portion of the free end of the wire which extended beyond the foot during bonding. A more important difference is in the heel of the bond, the juncture between the undeformed wire and the bonded portion. The sharp heel of the tool, which provides for cut-off at the second bond, causes an indentation or crack in the heel of the first bond. This will be discussed in more detail below. In most of the devices examined, the first bond was made on the external lead (a post) and the second was on the pad. This accounts for the different appearances of the metallization in Figures 4a and 4b.

Figure 4. A comparison of a first (a) and second bond (b). They differ in appearance mainly in the nature of the toe of the bond (since the effect of the cut-off is evidenced there on the second bond) and in the condition of the heel of the bond.

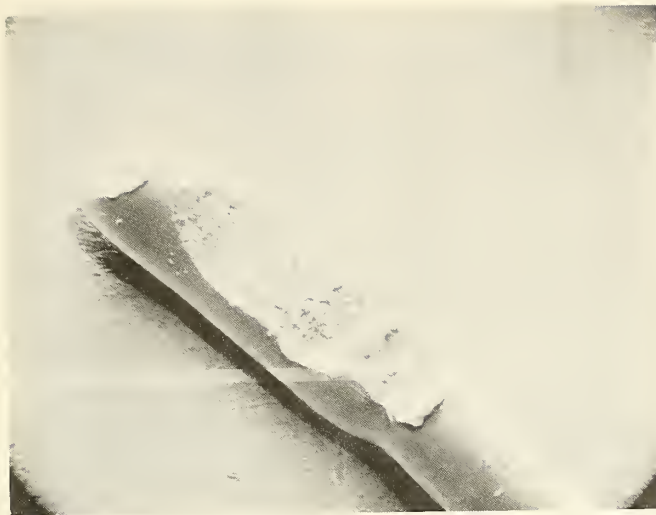
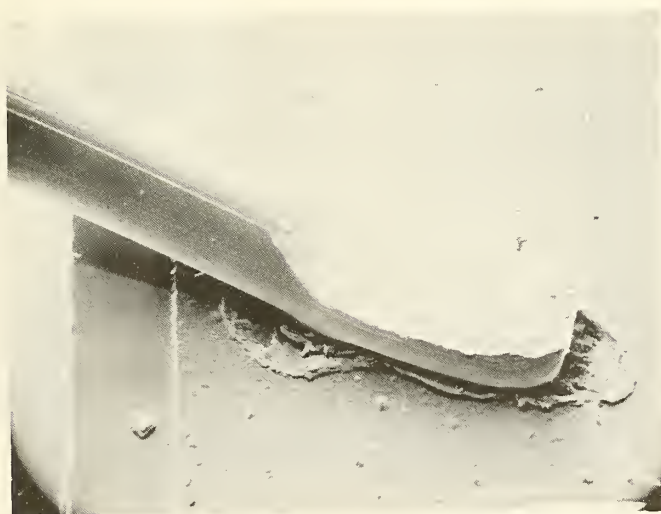
wire. The appearance of the heel of the bond depends on the amount of deformation. For example, Figure 4 shows bonds typical of those examined from one manufacturer compared with those of another manufacturer shown in Figures 5a and 5b. The fact that there is a great difference in bond deformation results from the different combinations of force, ultrasonic power and time that are used in bonding on these production lines. These adjustments of the bonding machine (the bonding schedule) involve a compromise. Setting combinations that yield a small deformation result in a small crack at the heel leaving the wire itself as strong as possible. However, if the deformation is very small, the bond is frequently weak due to lack of welding at the interface. This is called underbonding. In the extreme, the wire does not stick at all; it lifts off. More welding at the interface can be attained by increasing one of the settings in the bonding schedule. This will also result in increased deformation so that the heel will be thinner and weaker. In extreme cases the wire will be nearly severed at the heel. This is called overbonding. The optimum bonding schedule would be a compromise between underbonding and overbonding.

Figure 5. First and second bonds from another production line. These first and second bonds, shown in (a) and (b) respectively, differ from those of Figure 4 mainly in the amount of deformation of the bond and in the shape and size of the crack in the heel of the first bond.

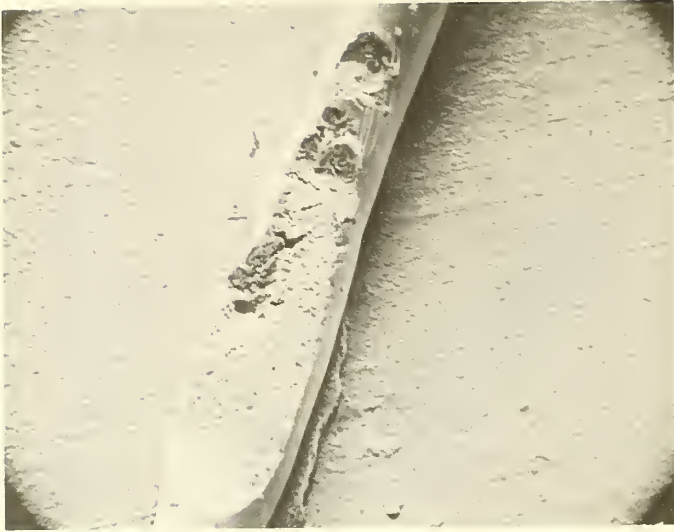
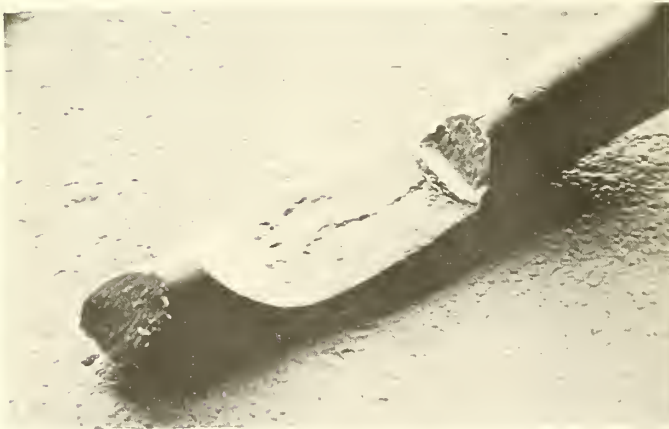
Typical examples of the variation in heel cracks with different deformations are shown in Figure 6 which shows two first bonds from devices from two different production lines. The bond in Figure 6a is less deformed than the one in Figure 6b so that it has a considerably smaller crack in the heel. It should be noted that the bonding machine which made the bond in Figure 6a had a malfunction in its cycle (the tool was allowed to bounce on initial impact) which caused the indentation in the wire above the heel. The indentation in the bond surface below the crack is probably due to build-up of aluminum in a small region of the bonding surface of the tool.

Figure 6. Examples of different types of first-bond heel cracks. The type of crack depends primarily on the amount of deformation of the wire during bonding. Small deformation yields a small crack as shown in (a), while a bond with greater deformation has a larger crack as shown in (b).

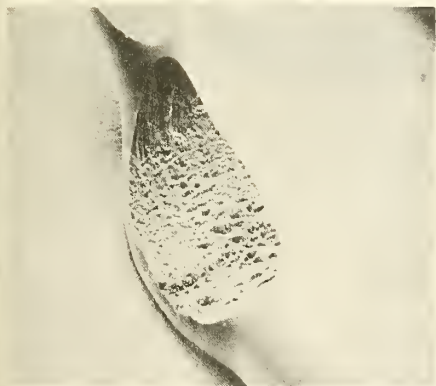
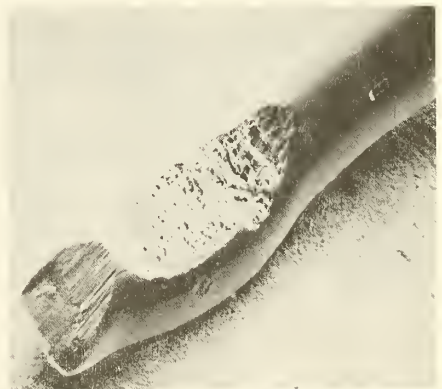
There can also exist a variation in the amount of deformation from bond to bond on a single device. The amount of this variation is usually (but not always) less than the variation described as existing from production line to production line. Two examples are shown in Figure 7. In Figure 7a, which shows eight of the bonds on a device, there is seen a large difference in deformation particularly visible in the two bonds marked A and B. These variations are easily observable with ordinary optical microscopes. Figures 7b and 7c show two consecutively made first bonds on another device. There is a significant difference in deformation between the two bonds. These bond-to-bond deformation differences are characteristic of unwanted motion between the tool and the work stage during bonding.¹ This motion can be caused by many different factors such as movement caused by the operator, building vibrations, or just the normal motion or vibration of the bonder itself as it goes through the bonding cycle. This kind of motion is significant because it can result in the type of occasional bond lift-off which has not otherwise been explained. Relative motions of 0.00025 in. (about 6 μm) or smaller between the tool and the work stage are large enough to be significant. In addition to deformation differences there are other aspects of the bond appearance which give indication of unwanted motion during bonding. Figure 8 shows a bond which suffered from gross motion of the tool as

Figure 7. Variation in bond deformation from bond to bond on a single device. In (a), there is a variation in the width of the bonds that is particularly noticeable between those marked "A" and "B". Two consecutively made bonds from a different device are shown in (b) and (c). While that in (c) is underbonded, the bond in (b) is not.

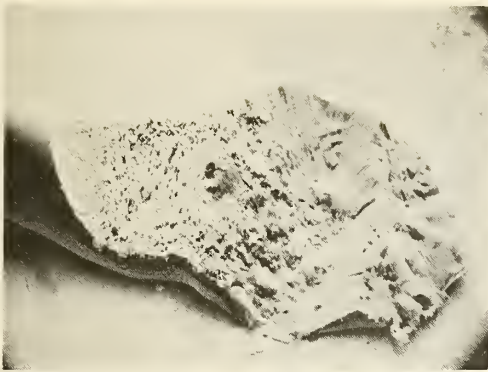
Figure 8. A bond which has suffered from gross unwanted tool-to-substrate motion during bonding as evidenced by the large side-to-side indentations.

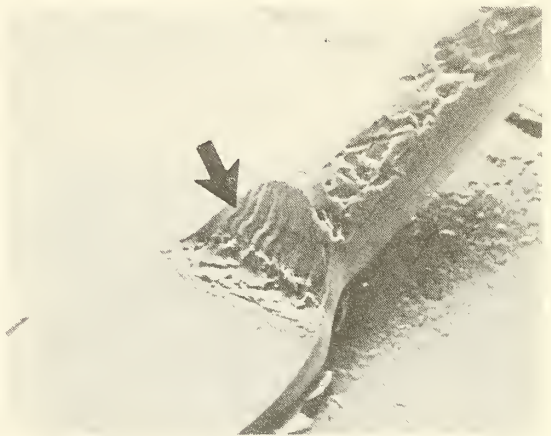
evidenced by the lateral deformation. An example of a much smaller motion is shown in Figure 9. The wiggle marks seen in the heel are due to motion between the bonding tool and the post as the tool lowers to form the bond.

Figure 9. A bond which exhibits small unwanted tool-to-substrate motion during bonding as indicated by the small "wiggle" marks (indicated by the arrow) seen on the crack in the heel. The marks on the wire above the bond are due to impressions of the wire-feed clamp.

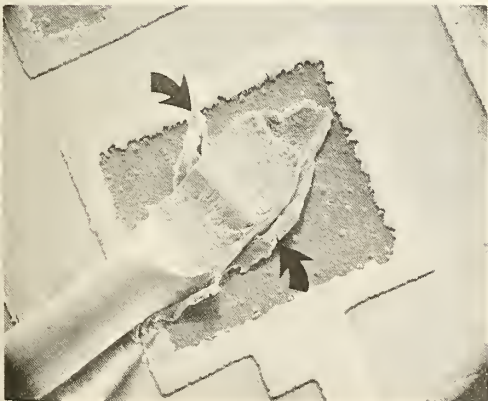
During the bonding process, aluminum is often extruded from under the wire to appear as little curls on either side of the bond. This is illustrated in Figure 10. The extruded material is part of the aluminum metallization that is pushed up as the bond is made. Extrusions usually occur when the metallization is too soft. Variation in the amount of this extrusion and in its relative position on either or both sides of the bond from bond-to-bond on a device is another indication of unwanted motion during bonding. The bonds in Figure 7a illustrate these variations. These variations can be seen with an optical microscope.

Figure 10. Aluminum extruded from under the wire during bonding. The extruded material appears as little curls (indicated by the arrows) on either side of the bond. Magnification: 300X

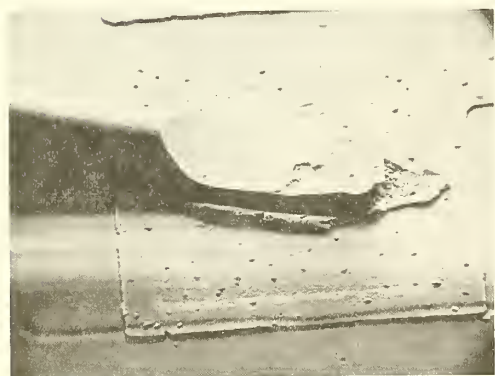
Differences in surface texture of the deformed wire were also observed. These differences are primarily due to the surface condition of the foot of the bonding tool. A clean tool will give a smooth bond appearance as can be seen in Figure 4a. A tool becomes rough as a result of aluminum build-up on its bonding surface. The bond in Figure 11a is one produced with a generally rough tool while those in Figures 11b and 11c were made by a tool that had only small areas of aluminum build-up similar to that which made the bond in Figure 6a. When these surface indentations were observed, the same pattern was generally repeated on all the bonds of a particular device. It is not known at this time if the presence of aluminum on the tool affects the quality of the bond produced.

Figure 11. Differences in surface texture of the deformed wire. In (a), the bond was made with a tool having significant aluminum build-up over its surface. Those in (b) and (c) had small areas of build-up which produced a pattern of indentations on the surface of the bond which was repeated for all the bonds on the device.

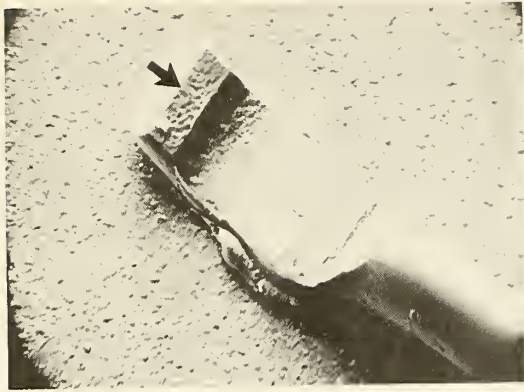
Figure 12 illustrates the unusual appearance found on the bonds of one device. The tail has been flattened. Since the surface appearance of the flattened area is similar to that of the wire-bond surface, it was probably subjected to a force by the tool. One would suspect malfunction in the bonding cycle of this particular bonder.

Figure 12. A bond presumably produced by a malfunctioning machine. The flattened toe of the bond is indicated by the arrow.

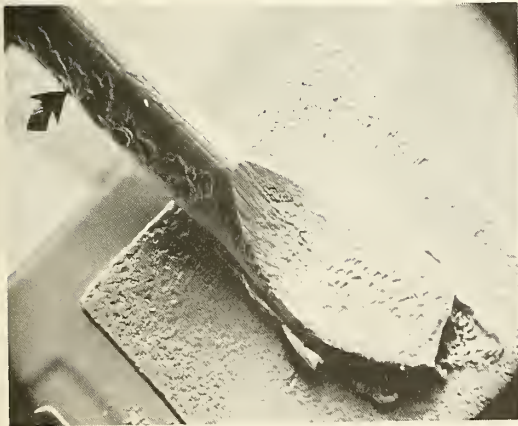
Large indentations have been observed on the sides of the wire in some bonds. The worst example is shown in Figure 13a with the area indicated shown at higher magnification in Figure 13b. It has been determined that these marks are produced by the jaws of the clamping system through which the wire is fed from the spool to the bonding tool. In addition to marring the surface finish, these imprints work-harden the wire and thus affect the bonding conditions. Occasionally the wire twists 90 degrees after passing through the clamping system, and the indented portion then becomes a part of the actual wire-metallization interface. Figure 14 shows a bond in which this twisting has taken place. Indentations are formed on opposing surfaces of the wire by the clamp so that marks similar to those seen on the top also appear on the underside of the wire. Of particular concern is the possibility of contaminants on the clamp becoming embedded in the wire and directly interfering with the bonding process. This combination of events may cause an occasional, weak bond which can not be detected by the usual inspection.

Figure 13. An extreme example of marks left on the wire by the wirefeed clamps. The bond and wire are shown in (a) with the part of the wire indicated by the arrow shown at greater magnification in (b).

Another defect that has been observed on the surface of the wire is a scrape or scratch mark. An example of this can be seen on the top part of the wire shown in Figure 13b. These scrapes or scratches can be due to rubbing of the soft aluminum wire against a hard surface somewhere along its path from the wire spool to the bond, such as guides on the wire feedhole of the tool itself. Since there is the possibility that damage of this type may induce stress or introduce contamination in the wire and thus affect the bonding process, these marks may be significant.

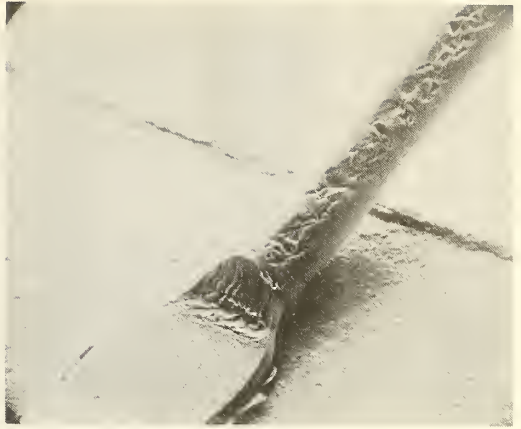
Figure 14. A bond showing the clamp marks on the top (and therefore also on the bottom instead of on the sides of the wire).

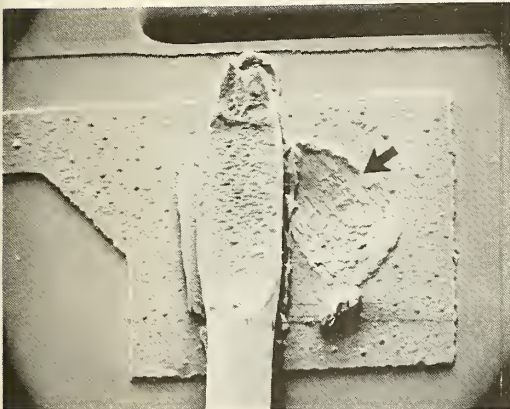
A mark often found on the bonding pad metallization is the indentation due to the probe used during the electrical testing of the circuit. A typical example of such a mark is shown in Figure 15. It is possible for the probe to completely scrape away the metallization as is shown in Figure 16. In any case the metallization may be scraped quite thin by the probe so that bonding should not be attempted over probe marks. Since probes are usually aimed at the center of bonding pads, it often becomes difficult, particularly on small pads, to find enough space for placing the bond on an unprobed area of the pad. As a result, there are many cases of bonding over probe marks as in Figure 17a or of bonding partially off the pad as shown in Figure 17b.

Figure 15. A probe mark on a bonding pad indicated by the arrow.

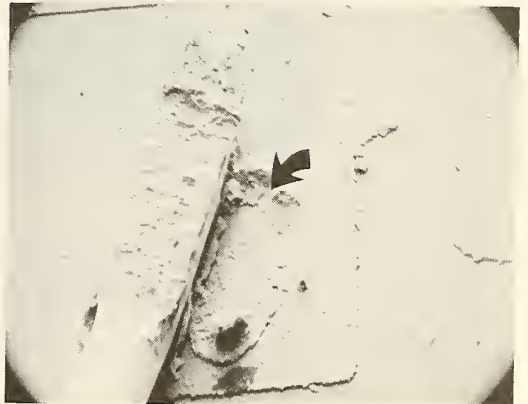
Figure 16. A probe mark on a bonding pad. Note where the probe has completely scraped through the metallization as indicated by the arrow. Magnification: 560X

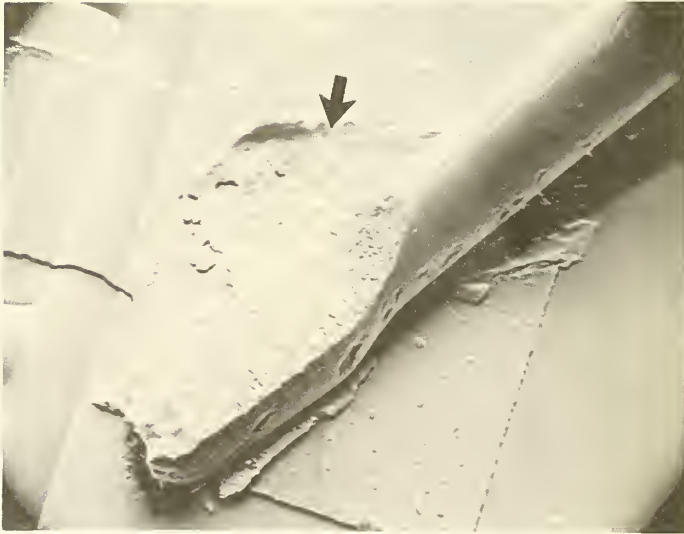
Figure 17. Examples of probe marks interfering with bonding. In (a), the bond is made over a probe mark and in (b), the bond was put partially off the pad to avoid bonding over the probe mark.

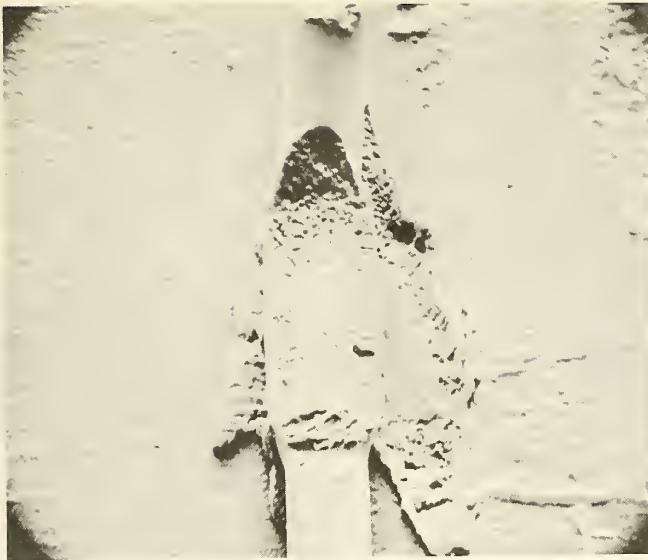
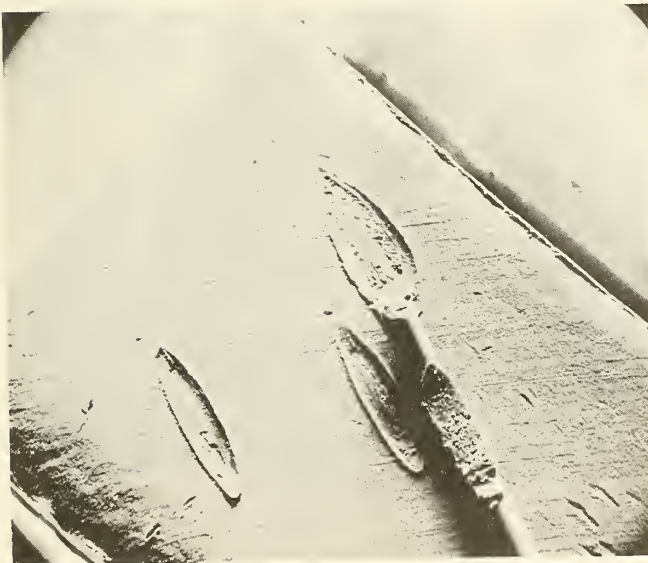
Another type of mark found on the metallization which may be similar to a probe mark is the lift-off mark (the mark left on the metallization when a bond does not stick, necessitating rebonding of the pad or post).² Examples of rebonded posts are shown in Figure 18 and examples of rebonded pads are shown in Figure 19. In Figures 19a and 19b, the marks to the left of the bonds are probe marks and those to the right are lift-off marks. In Figure 19a, lift-off was due to underbonding; the combination of power, time and pressure did not yield enough welding at the interface for the bond to stick. In fact, the successful bond which was subsequently made is also underbonded. In Figure 19b, lift-off could be due to unwanted motion during bonding. In Figure 19c, the initial bond attempt was over a probe mark as indicated by the arrow to the left of the lift-off mark. In this case lift-off might be due to overbonding or to poor metallization. Figure 19c illustrates the bond placement problems which result from rebonding. In the small area available for bonding, there is not enough room for two attempts without having one of them be partially off the pad, over a probe mark, or over a lift-off mark.

Figure 18. Rebonding on the package leads. The bond in (a) was the second attempt while that in (b) was the fourth.

The main reason for not rebonding on high reliability devices, particularly if more than two attempts are necessary, is the likelihood that if additional tries are needed it is indicative of a problem. It might

be bad metallization on that particular pad or post, bad wire, excessive unwanted motion during the bonding cycle, or even an incorrect bonding schedule. The result is that even if there is enough room left on the pad and a bond can be made to stick, there would be no assurance that it will be a good bond.

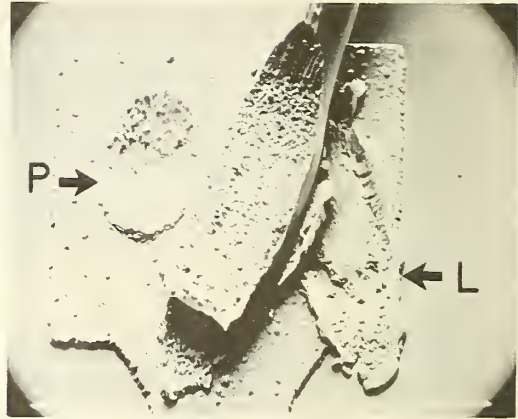
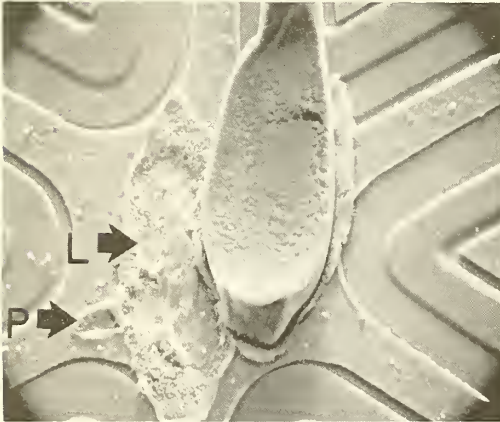
Figure 19. Rebonding on the bonding pads on the circuit chip. The probe marks are indicated as (P) and the lift-off marks as (L). In (a), lift-off was due to under-bonding while that in (b) seems to have been caused by unwanted motion during bonding. The bond which lifted-off in (c) was made over a probe mark.

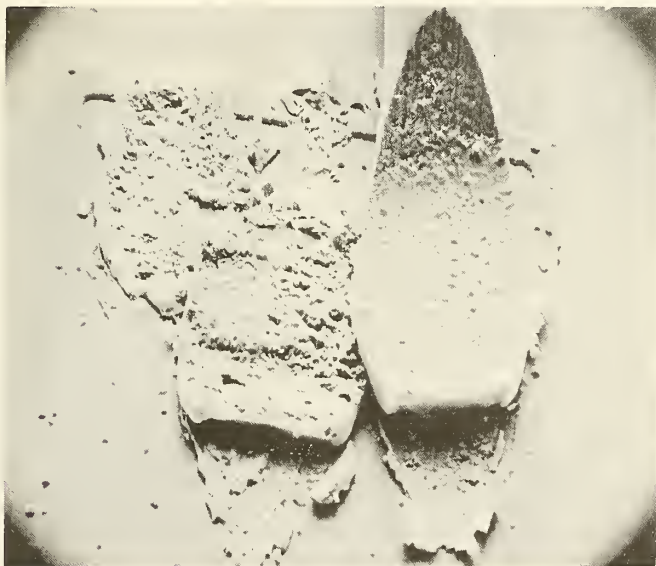
Another type of rebonding occurs where the wire breaks at the heel leaving the bond itself behind. It occurs for very highly deformed bonds which was usually not the case in the devices studied. In the example shown in Figure 20 there were at least two attempts before a successful connection was made.

Figure 20. Rebonding following wire break-off at the heel.

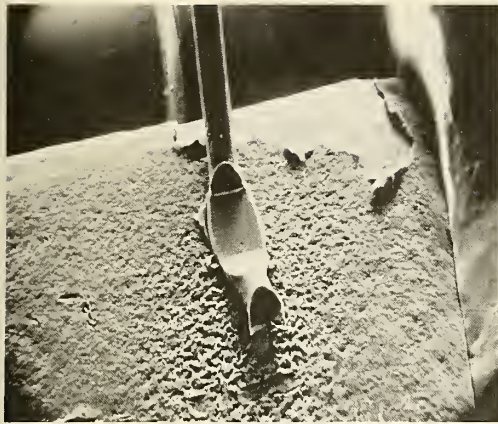
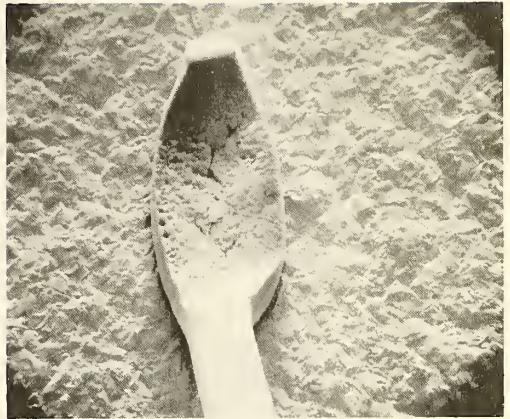
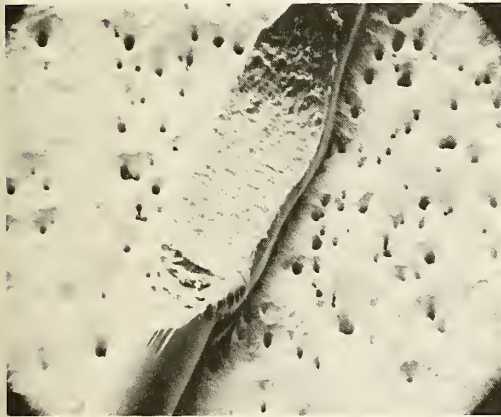
Poor metallization was frequently observed on the package leads of the devices examined. Figure 21a shows the metallization of a finger on a flat-pack. The area in which the bond is placed is extremely rough. There is a wide variation in texture across the finger and in a portion the metallization has actually peeled off. While roughness in the metallization surface is not necessarily difficult to deal with in bonding, variation in this roughness from bond to bond or package to package is a problem. Since the proper bonding parameters (power, time, and pressure) depend strongly on the surface texture, they cannot be at optimum settings for both extremes in surface texture. Therefore as this texture varies from package to package there will be a resultant variation in the character of the bond.

Figure 21. Defective package metallization. In (a) the metallization is actually peeling off of the finger of a flat-pack. In addition there is a great variation in the texture of the metallization across the lead. The examples in (b) and (c) are posts of transistor-type packages. The metallization in (b) is very hard and irregular as indicated by the impressions extending through the bond. The metallization in (c) is full of holes.

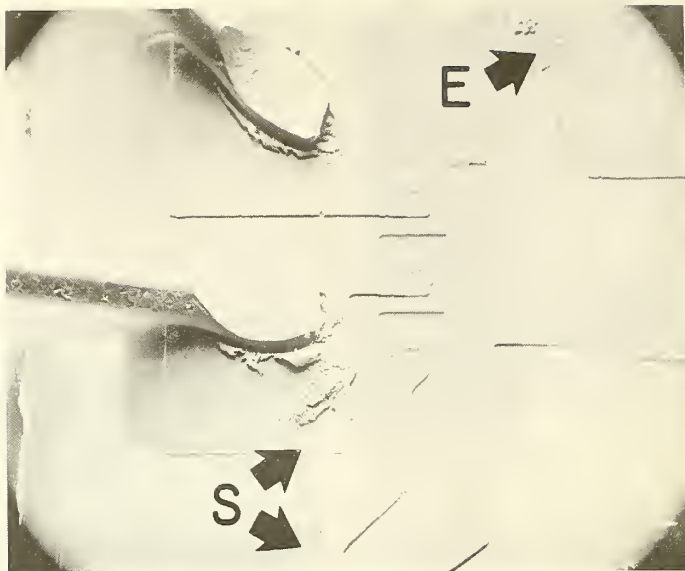
Figure 22. Examples of damaged metallization. In (a) some metallization seems to have been scraped away (S) while some other seems to have been etched away (E). In (b) the metallization over the humps in a dielectrically isolated device has been damaged.

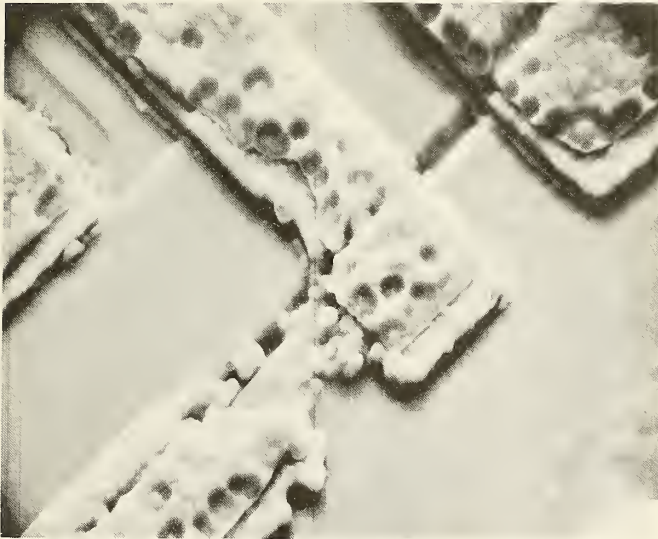
Figure 23. Over-etching of a metallization stripe. A portion of a circuit is shown in (a) with the region indicated by the arrow shown at greater magnification in (b).

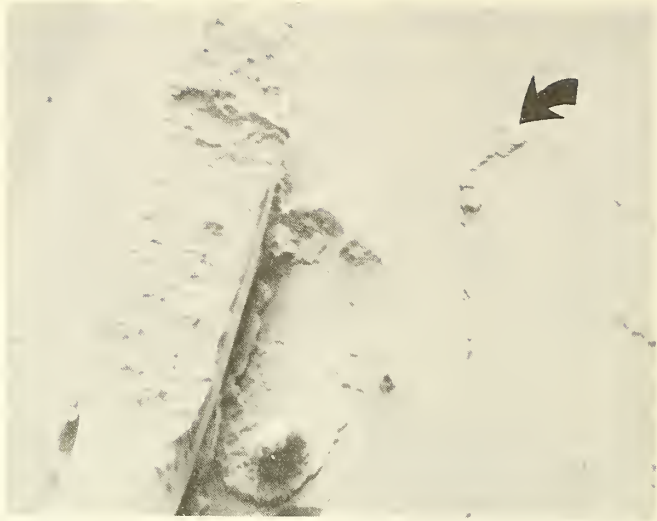
The primary purpose of this investigation was to study the wire bonds of the devices examined. However, occasional examples of other possible reliability problems were observed. Some of these have an indirect bearing on wire bonding. The metallization faults encountered were primarily scraping or scratching of metallization stripes. The area marked with an "S" in Figure 22a exhibits evidence of scraping and that which is marked "E" shows holes in the metallization where material was etched away. The dielectrically isolated circuit shown in Figure 22b illustrates the difficulty in running a metallization stripe over a raised area. The damage to the metallization may have occurred when the wafer was broken into individual circuit dice since it is then that the die surface often comes into contact with a hard surface. Figure 23a shows another example of a metallization stripe 0.001 in (25 μm) where some of the material has been etched away, but here the stripe is almost etched entirely away at one point. It is shown in a higher magnified view in Figure 23b. Also illustrated in Figure 23 is the thinning in the metallization placed over a step in the oxide. The obvious problem with any of such imperfections in metallization interconnections is the possibility of electrical open-circuits. Another metallization defect, shown in Figure 24, is the presence of small metal pieces which could become loose after packaging and could possibly cause an electrical short between two metallization stripes.

Figure 24. Small metal particles observed on the metallization.

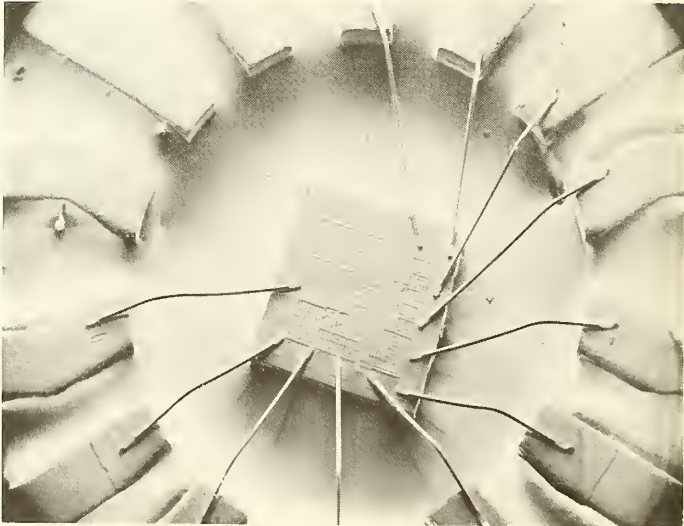
Improper placement of the die during die bonding can cause difficulties when the device is wire bonded. Figure 25 shows a case where the wires are unnecessarily long and where there exists the possibility of the wires touching one another. Bad placement of the wire bonds on a transistor could also cause an electrical short. Figure 26a shows a

Figure 25. Improper die placement resulting in wire bonding problems.

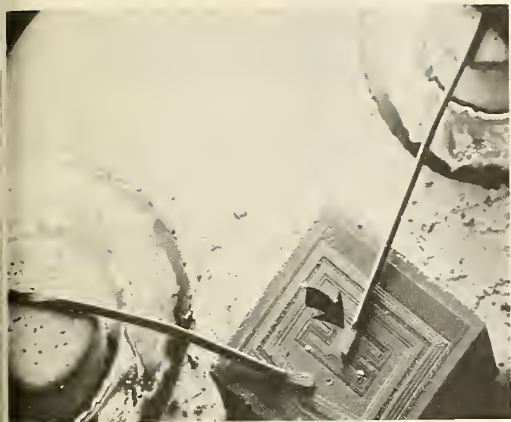
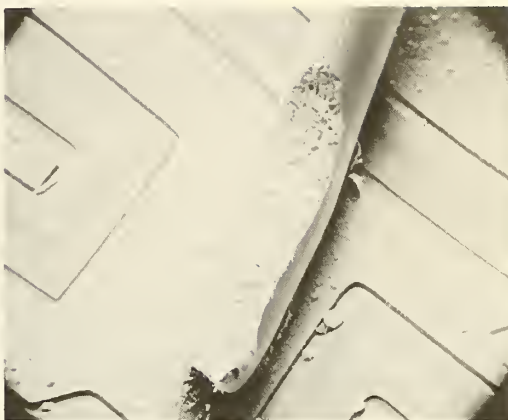
Figure 26. Improper placement of wire bonds on transistor chips. The bond indicated by the arrow in (a) is shown at greater magnification in (b). It is possible that the placement of this bond could cause an electrical short circuit. Another example of bad placement is shown in (c).

transistor; and in Figure 26b the emitter wire bond of the transistor is shown at greater magnification. Because of the way the bond is placed, the wire crosses very close to the base metallization. Another example of this is shown in Figure 26c.

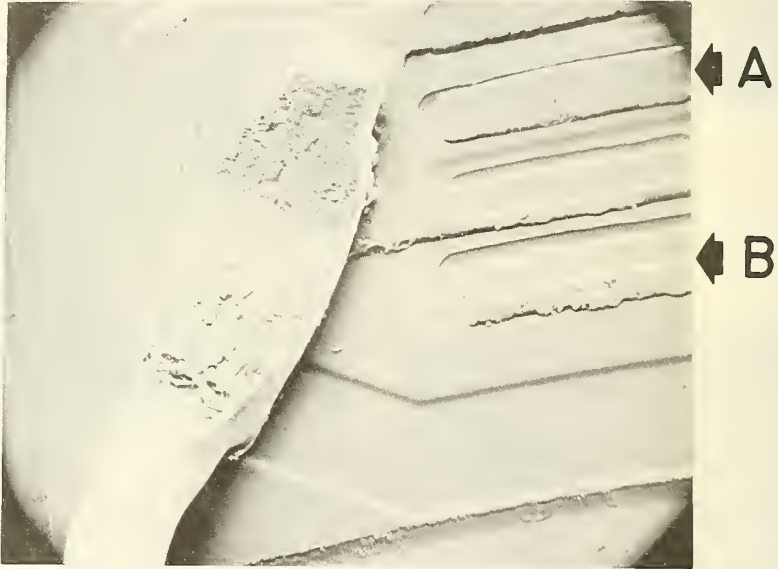
An unusual situation observed on one device, shown in Figure 27, was caused by poor masking. This is shown by the fact that while the alignment was correct in finger A of the transistor, quite near, at finger B, the alignment was off by nearly one-third of the width of the finger. The bonding pad in this example is very small, illustrating another type of difficult bond placement that is often encountered.

Figure 27. Misalignment caused by poor mask. Finger "A" is properly aligned but "B" is not. Note how the small bonding pad makes it difficult to find a suitable location for the bond.

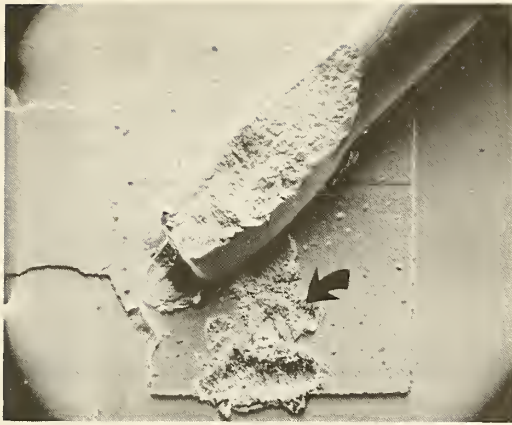
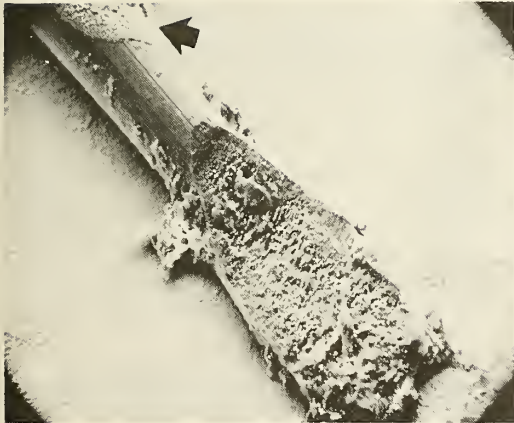
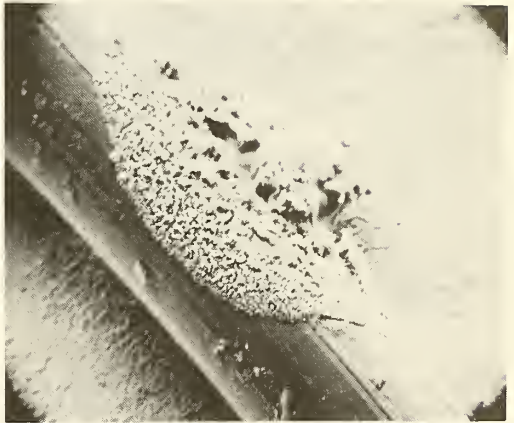
Extraneous material was observed at the surface of some of the metallization, on a few of the bonds, and on one piece of wire. Figure 28a shows such material on the metallization of one of the bonding pads. In Figure 28b, there is a bond with material on its surface that we have not identified. At the top of the picture, what appear to be corrosion products cover portions of the wire. This is shown at greater magnification in Figure 28c. No identification was made of this extraneous material.

Figure 28. Examples of extraneous material. The arrow in (a) indicates unidentified material seen on a bonding pad. In (b) the bonded area of a wire is covered with some foreign material. The material on the undeformed wire indicated by the arrow is shown in (c) at higher magnification.
