NBS TECHNICAL NOTE 811

Evaluation of the Column Connections Used in a Precast Concrete Modular Housing System

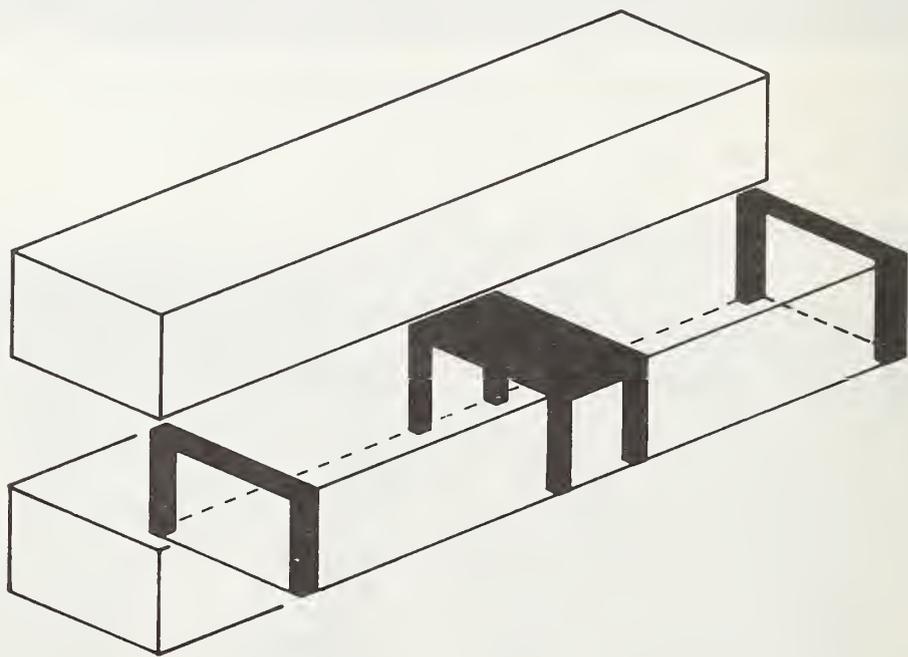
Figure 2.4. Structural Skeleton of Module

The structural skeleton of the modules is shown schematically in figure 2.4. A module contains four bents (ribs) which are rigid frames consisting of 12 x 15 1/4-in^{1/} columns and 12 x 12-in^{1/} beams near the module ends, and 12 x 12-in^{1/} columns, with a 8-in thick slab section providing a common beam to both ribs at the center of the module. The bents are connected by a 4-in thick top slab, 3-in thick sidewalls, and a 4 in thick bottom slab. The bents, top slab, and sidewalls are cast monolithically in a single operation using a steel form creating a "hull". The bottom slab, which is cast in a second casting operation is attached to the hull by bent dowels protruding from the bottom of the sidewalls and by special steel inserts welded to the four center columns. The modules are erected in a checkerboard pattern as shown in figure 2,5. Part of the living space is contained within the modules and part is space created between adjacent modules. The space within modules provides a clear height of 8 ft-3 in and a clear width between concrete wall surfaces of 12 ft-6 1/2 in. The created space has the same clear height and a clear width of 12 ft-11 1/2 in between the concrete surfaces of the sidewalls. The structure is completed as shown in figure 2.6 by inserting special end wall, roof, and floor panels to complete enclosure of the created spaces.

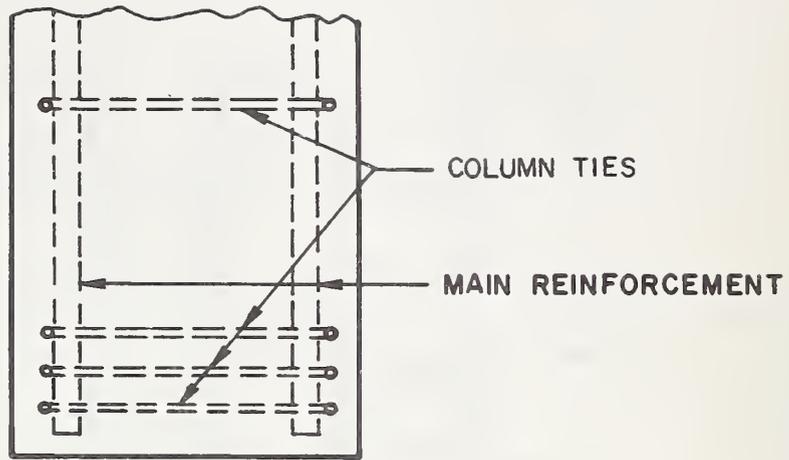
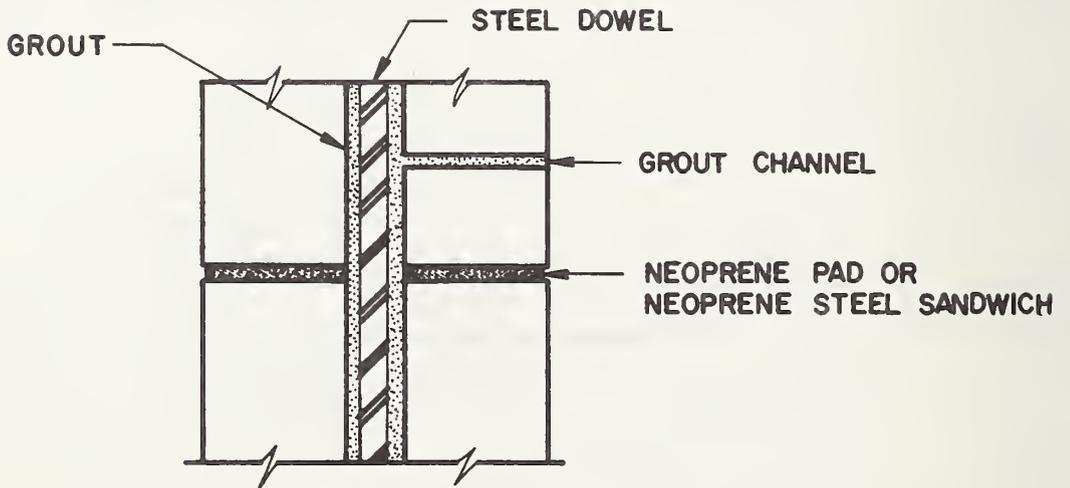
Figure 2.9. Proposed Connection Detail

(a) COLUMN REINFORCEMENT AT CONNECTION

(b) CONNECTION DETAIL

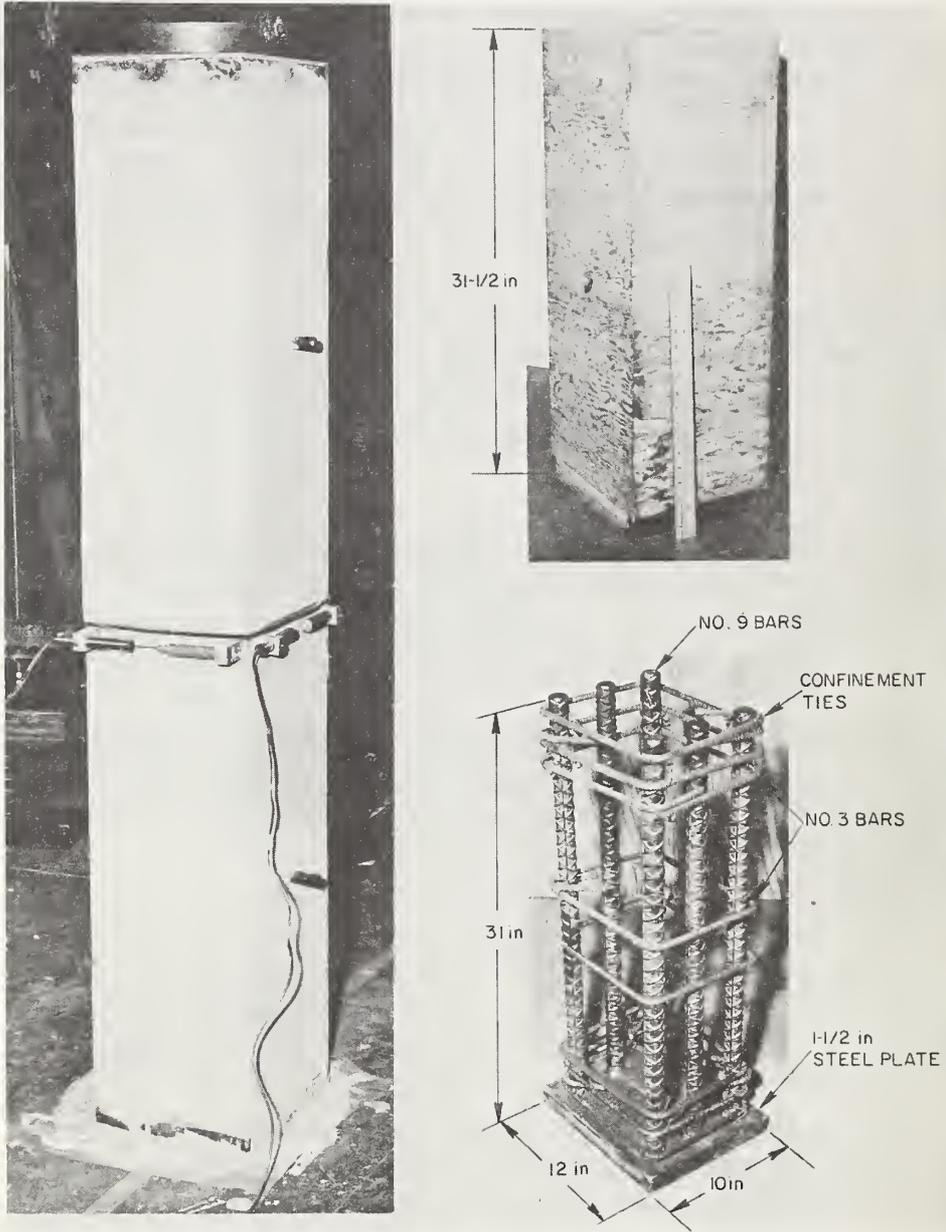
Figure 4.1. Specimen Used in Phase I Column Connection Tests

The welded wire mesh cage shown in the figure corresponds to the detail in the system used to prevent concrete breakage caused by form stripping. The welded wire mesh had an average yield strength of 63 ksi according to information obtained from the manufacturer.

In the Phase II tests the vertical deformation of the joint material was monitored by means of a 0.001-in dial gage. Lateral deformations were measured over a 9-in gage length using linear variable differential transducers. These deformations were monitored by X - Y recorders with a resolution of 0.001 in to aid in the determination of the onset of spalling (see figure 4.1).

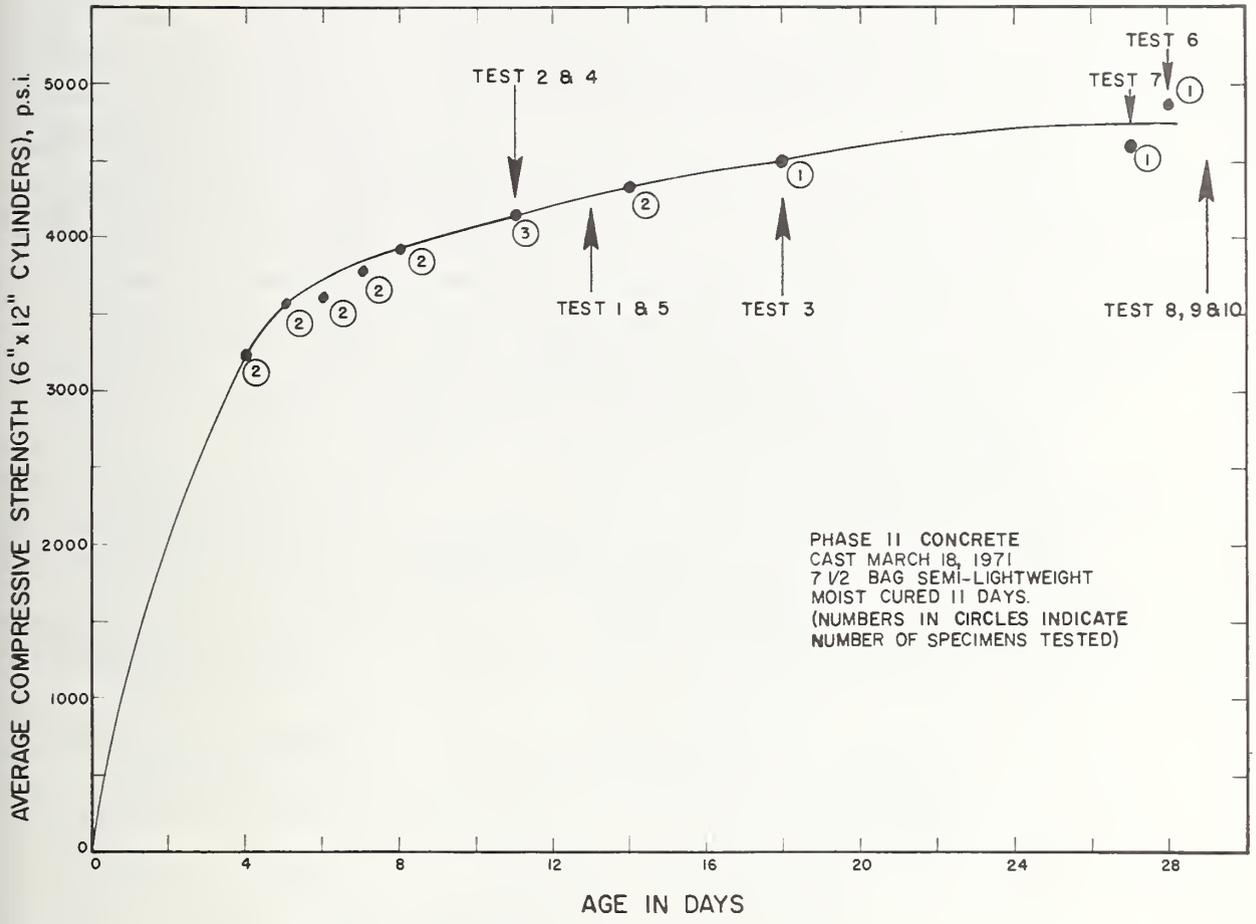
Figure 4.4. Strength of Age Relationship of Concrete Used for Column Stubs

The concrete in all specimens was a 4000 psi mix using sanded lightweight aggregate of 3/4 in maximum size. Figure 4.4 shows the age-strength relationship for these concretes.

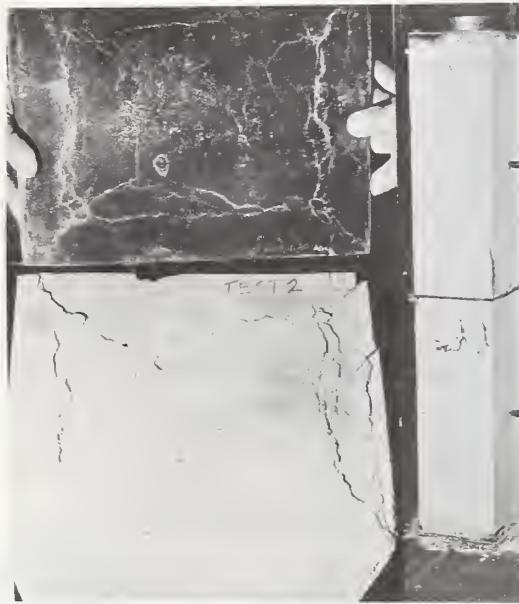
Figure 4.5. Typical Failure of Connection Using 1/4-in Neoprene Pad

Figure 4.5 shows a typical failure of a connection using a neoprene pad. The spalling between the core inside the ties and the shell outside the ties is an indication that at ultimate load the core supported most of the load. The same observation can be made in figure 4.6 which shows the typical failure of a grouted connection.

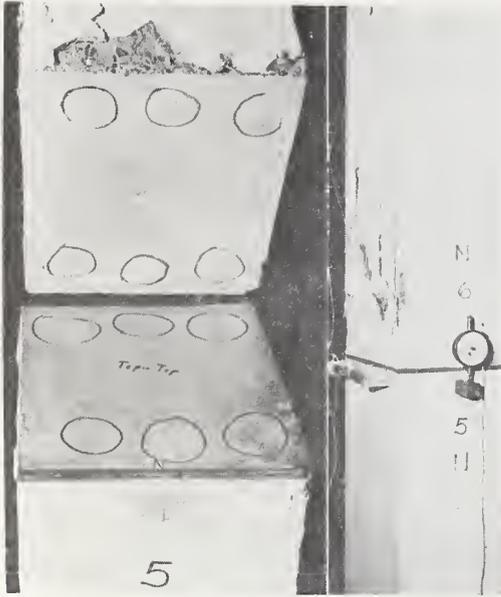
Figure 4.7 Typical Failure of Connection Using a Steel-Neoprene-Steel Sandwich

On the other hand, it can be seen from figure 4.7 that in the specimens using the steel-neoprene-steel sandwich there was no spalling of the shell, and thus, the entire cross-sectional area contributed to the load resistance. It can also be seen in this figure that the concrete bearing surface is

smooth and locally deformed with protruding imprints of the main reinforcing bars. The deformation is probably attributable to plastic flow of the concrete before failure which is taken as an indication of triaxial confinement. The imprint of the bars was caused by bond breakage near the end of the bars where the strain in the concrete could not be transmitted to the steel bars.

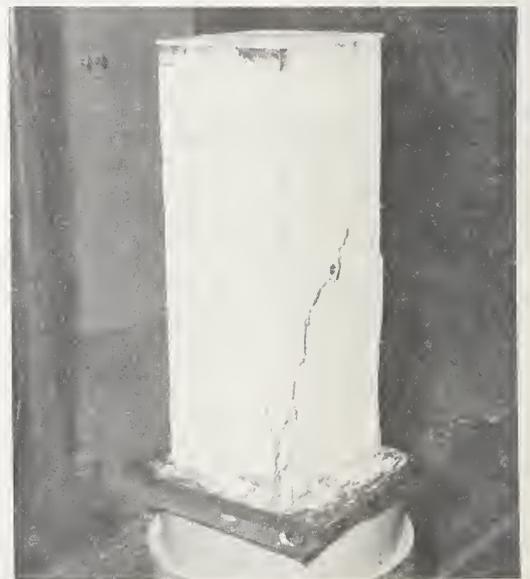
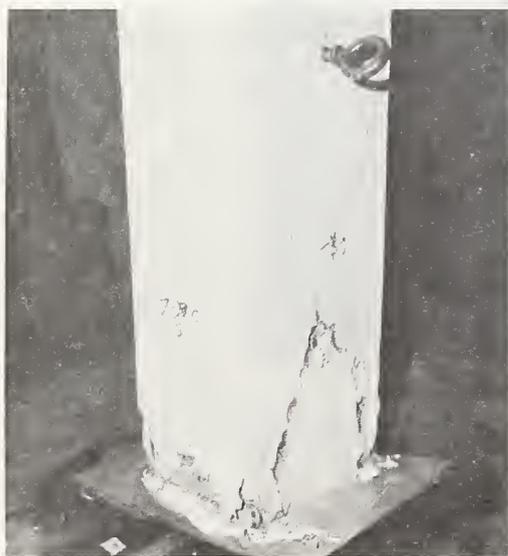
Figure 4.9. Failure of Column Stub Bearing on a Steel Plate Covered by a Low Friction Membrane

The failure of the column stub that was bedded in high-strength gypsum plaster, which is shown in figure 4.8, occurred in the middle of the column above the region of the additional confining ties. This is taken as an indication that in this case the effect of the confinement was even greater than that provided by the steel-neoprene-steel sandwich. On the other hand, the failure mode of the column stub which was tested with a low-friction membrane at the column face and is shown in figure 4.9, gives clear evidence of spalling of the shell.

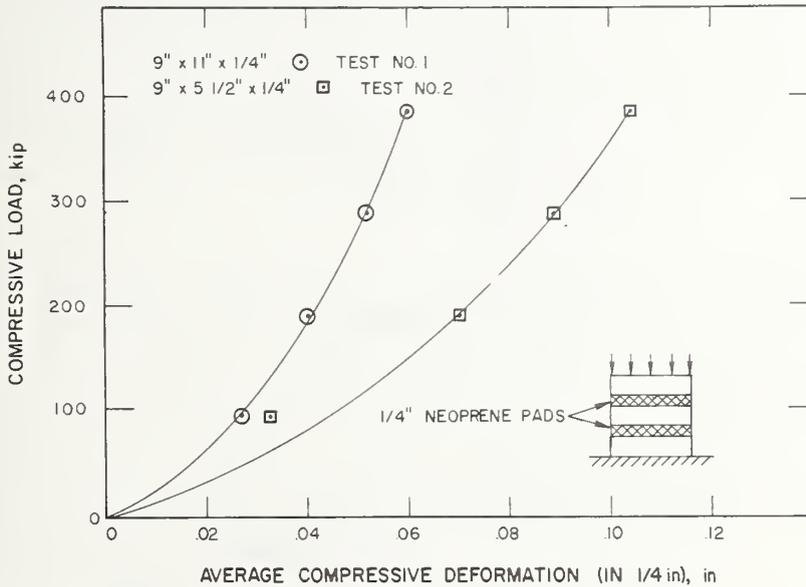
Figure 4.11. Relationship Between Compressive Load and Average Compressive Deformation of Neoprene Pads

(4) The load-deformation characteristics observed in the tests on the neoprene pads presented in figure 4.11 are reasonably consistent with joint compression measured in the bearing tests on column connections and presented in Table 4.1.4.

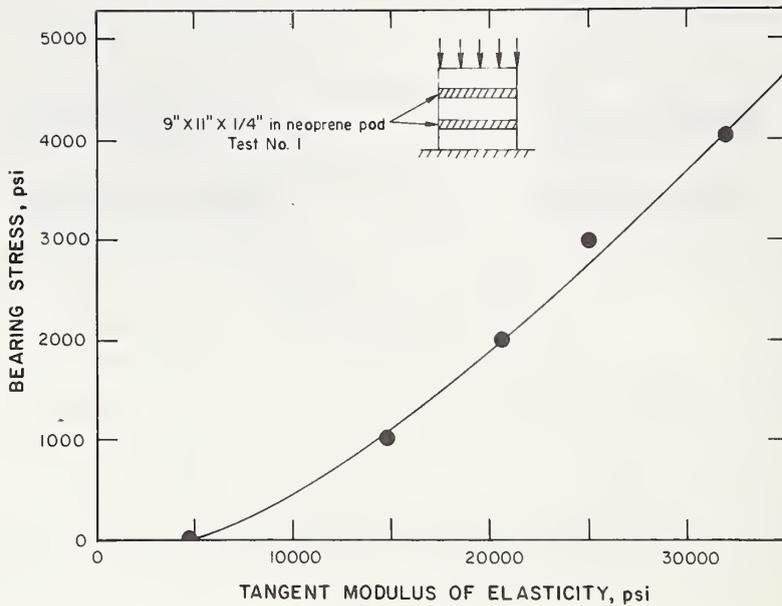
Figure 4.12. Relationship Between Compressive Stress and Tangent Modulus of Elasticity for the Full-Sized Neoprene Pads

Figure 4.12 is a plot of compressive stress (based on the 9 x 11-in area) versus tangent modulus of elasticity for the full-sized pad. This plot shows that the tangent modulus at 4,000 psi is over 6 times the initial tangent modulus.

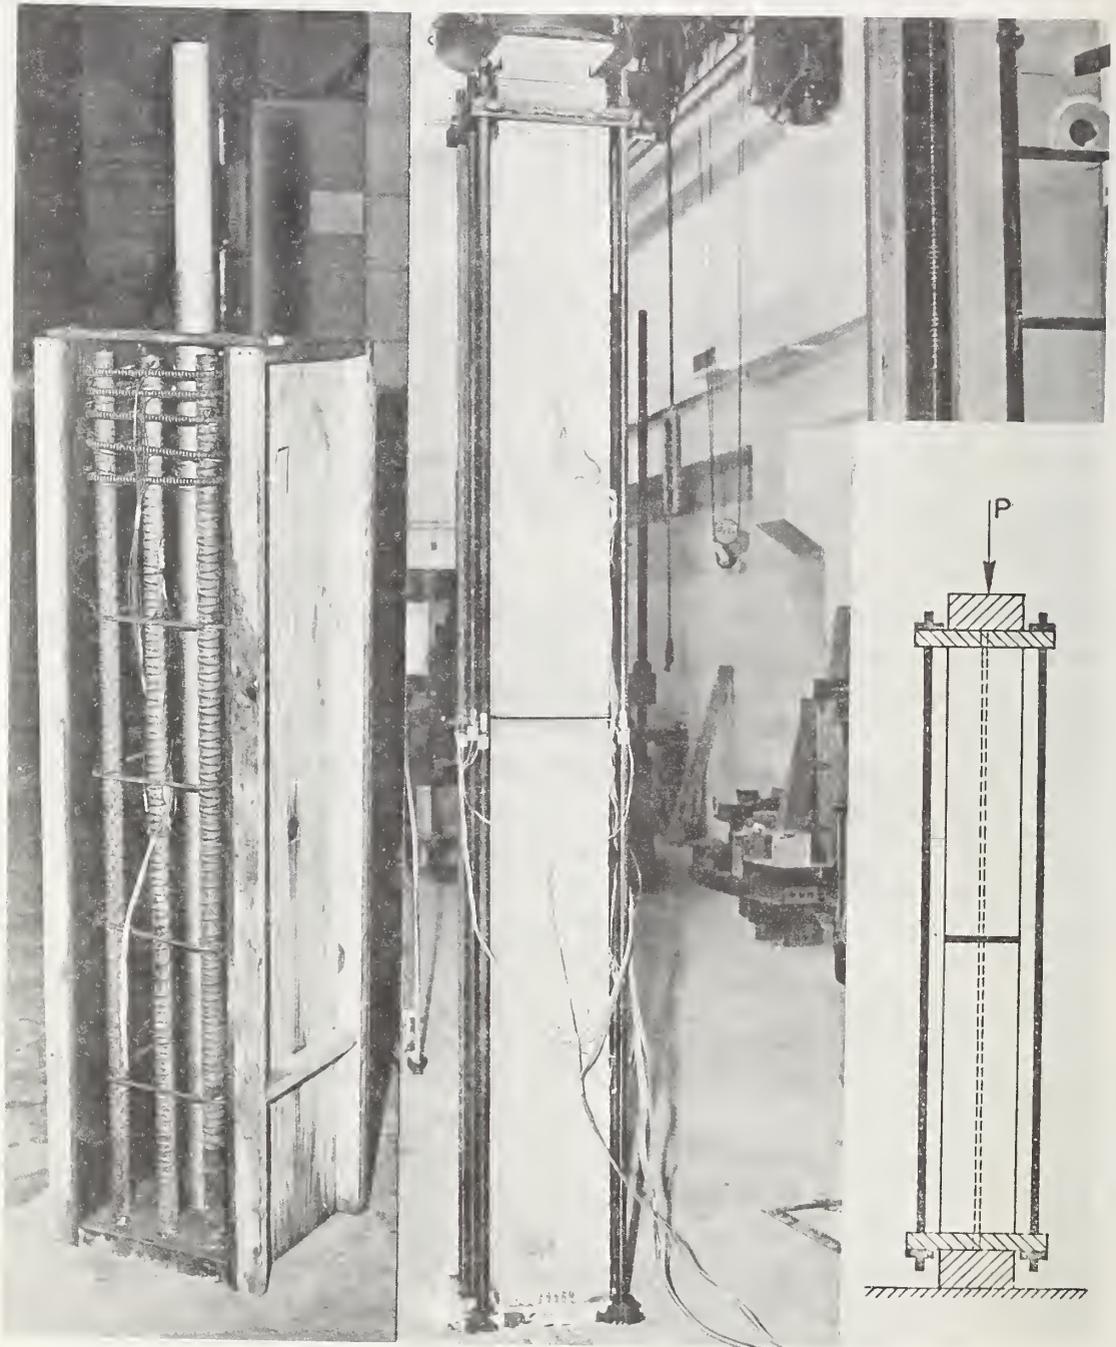
Figure 4.14. Test on Specimen With Grouted Dowel

The test specimen shown in figure 4.14, consisted of two 51 1/2-in high stub columns similar to those described in section 4.1.1. However, these stub columns, as shown in the figure, had five confinement ties instead of the three used previously. This change was made because of a design change in the proposed system. In addition, a 2-in round flexible conduit was cast in the center of each stub. The hole formed in the column by the conduit was for the #8 deformed reinforcing bar (ASTM A615-68, Grade 60 Steel) used as the dowel.

The two stubs were placed end to end with the steel-neoprene-steel sandwich joint separating the two concrete bearing surfaces. The length of the dowel inserted through the holes in the two stubs was slightly longer than the overall length of the two stubs (103 in). The six externally threaded 1-in diameter steel bars, which can be seen in figure 4.14, were used to apply a 10 kip axial preload to the specimen before grouting and to sustain the preload until testing.

Maxium Load:	600 kip
Loading Condition:	Concentric (figure 4.14)
Concrete Compressive Strength:	(6 x 12 in cylinders) 3930 psi
Grout Compressive Strength:	(2 x 2 in cubes) 11,000 psi
Condition After Testing:	Minor cracking

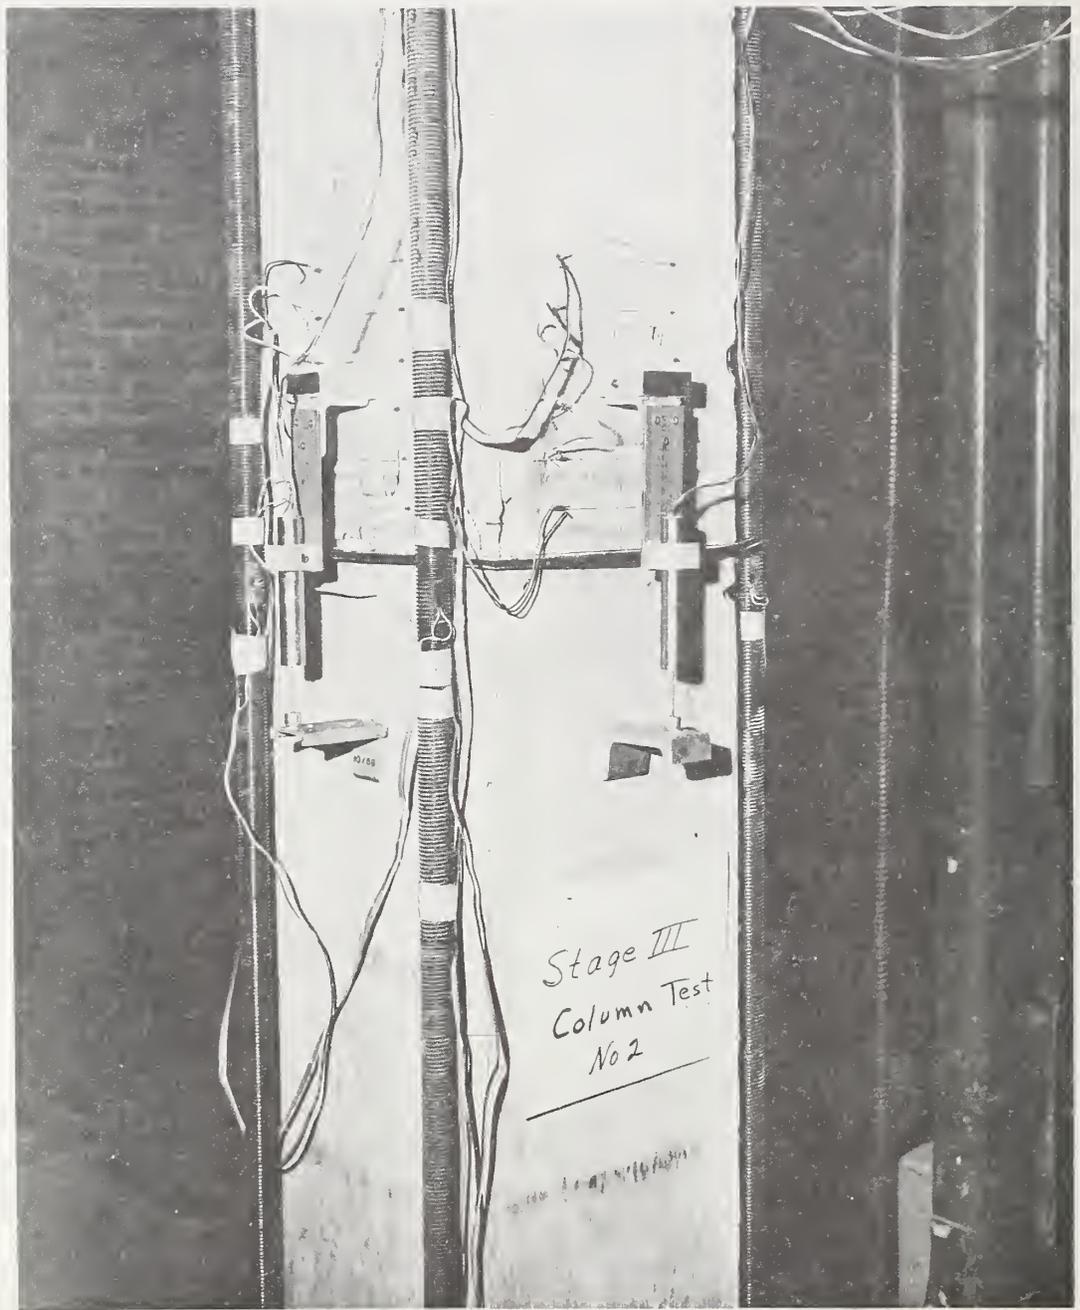
Figure 4.15. Instrumentation of Test Specimen With Grouted Dowel

in figure 4.15, but did not lose its ability to support the 600-kip load. On the basis of this evidence it may be assumed that the ultimate load would have exceeded 600 kip.

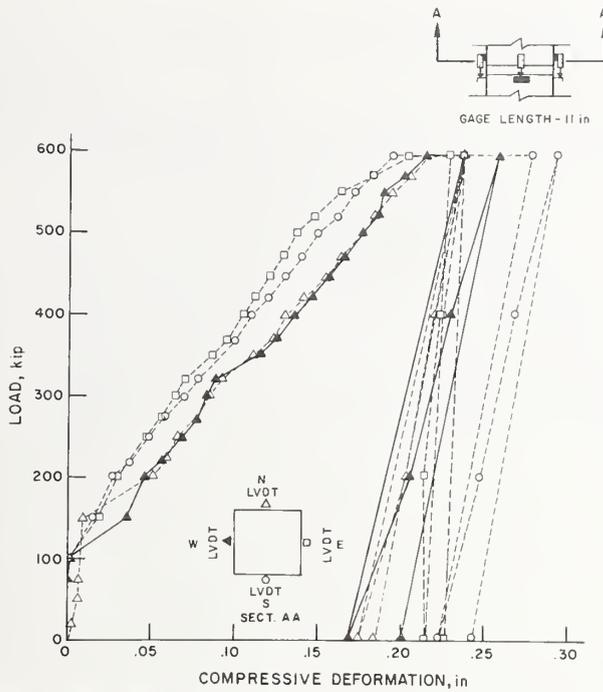
Figure 4.16. Specimen with Grouted Dowel Vertical Deformations of an 11-in Segment Including the Joint

Figure 4.16 shows the length change in a 11-in vertical column segment which includes the joint at its center. It can be seen in this figure that substantial "creep" occurred while the 600-kip load was maintained. As noted in the subsequent discussion, much of this length change was attributable to concrete deformation rather than joint deformation.

At the 600-kip load level there was substantial additional deformation during the period when the 600-kip load was sustained. Some of this deformation may be attributable to creep of the neoprene pad; however, in view of the large increase in transverse concrete strain shown in figures 4.18 and 4.19, it is reasonable to assume that most of this deformation was attributable to cracking of the concrete. This contention is supported by the large residual deformation after removal of the load. This residual deformation was approximately 0.21 in. The total deformation of the neoprene pad, when subjected to a 550-kip load, (50 kip would be carried by the dowel) is not expected to exceed 0.1 in (extrapolation from Table 4.19 and figure 4.11); and even though recovery of some of this deformation may have been prevented by a permanent set in the dowel and by visco-elastic time lag, most of the 0.21-in residual deflection should be attributable to the concrete compressive deformation.

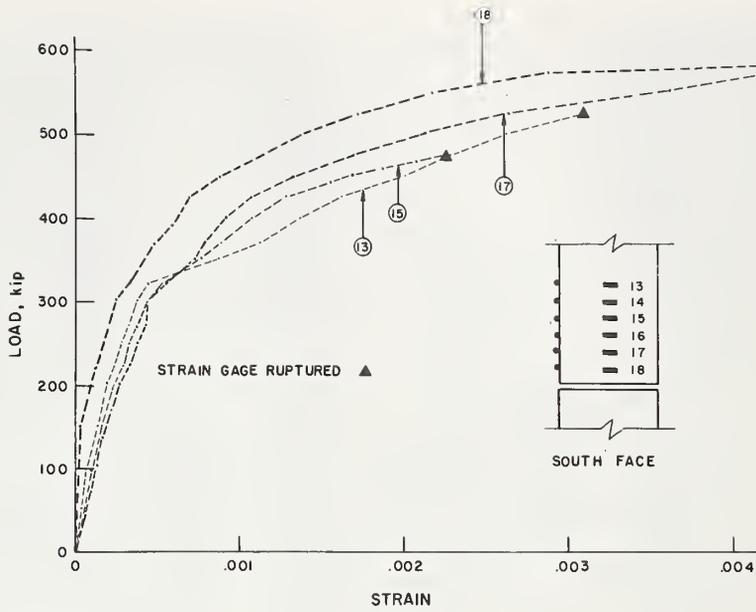
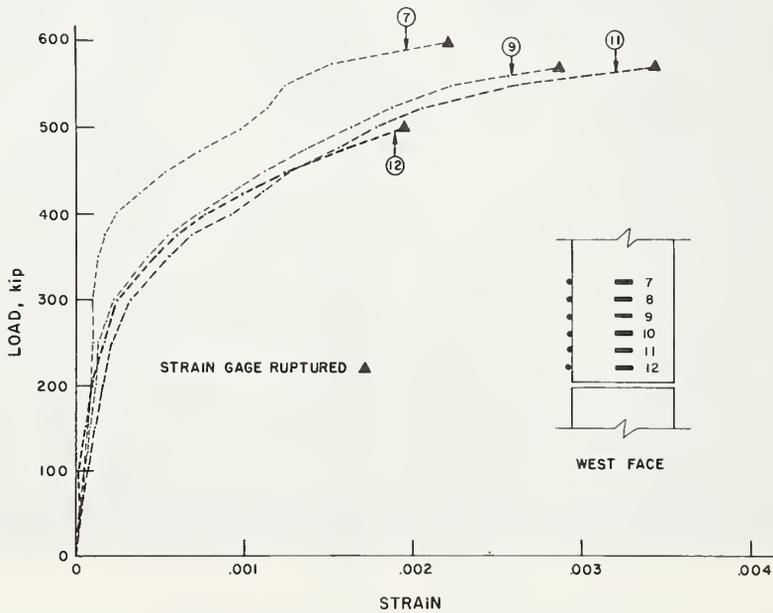
Figure 4.18. Specimen with Grouted Dowel, Horizontal Strain of Concrete on South Column Face

Figure 4.19. Specimen with Grouted Dowel, Horizontal Strain of Concrete on West Column Face

Strain data from the gages on the column faces are plotted in figures 4.18 and 4.19. On the basis of the characteristics of the load-strain relationship and the magnitude of strain it appears that significant cracking in the concrete occurred above the 350-kip load level. Very large apparent^{3/} strain developed at load levels above 500 kip. Three of the gages failed at 475, 525 and 600 kip respectively, probably as a result of severe cracking; gage 18, the closest to the joint, survived the entire load cycle. While the 600-kip load was sustained this gage showed a substantial increase in apparent strain (from 0.0059 to 0.0107). After removal of the load the gage returned to a residual strain of 0.0082. A similar trend is shown by the strain gage data on the other instrumented column face which are shown in figure 4.19. In this case all the gages failed between the 500 and 600 kip load levels: Thus, it can be concluded from the strain gage readings that substantial cracking occurred above the 500-kip load level and during the time the 600-kip load was maintained.

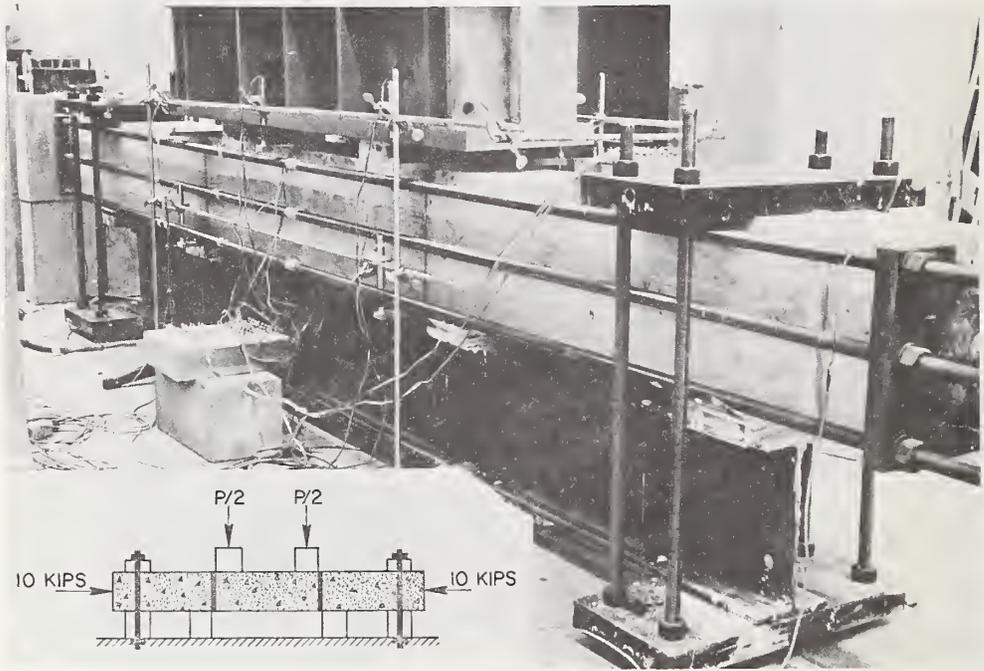
Figure 4.22. Arrangement for Shear Test 1

The test setup is shown in figures 4.22 and 4.23 for Test 1, and Tests 2 and 3, respectively. Shear load was applied simultaneously to both connections by applying lateral load to the center stub while the two end stubs were restrained from translation and rotation. Load was applied in the direction of the narrow dimensions of the columns. The tests were performed in a 600-kip hydraulic testing machine.

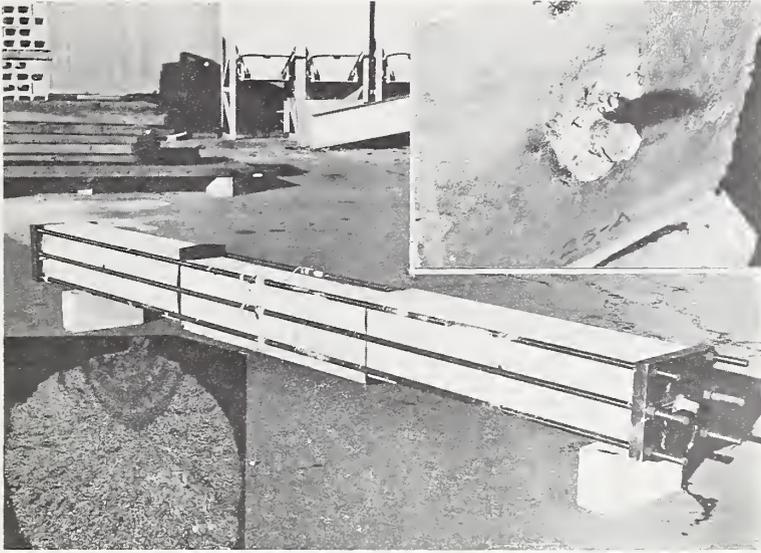
Figure 4.24. Shear Test 3 Specimen After Test

Figure 4.24 shows the Test 3 specimen after failure. Note the large slip at the joints, the extrusion of the neoprene and the cracked concrete near the upper left corner of the center segment. The two inset photographs show the appearance of the fractured dowel. The low-cycle fatigue fracture of the dowel originated at a defect (see inset in lower left corner) and was similar in appearance in both Test 2 and Test 3.

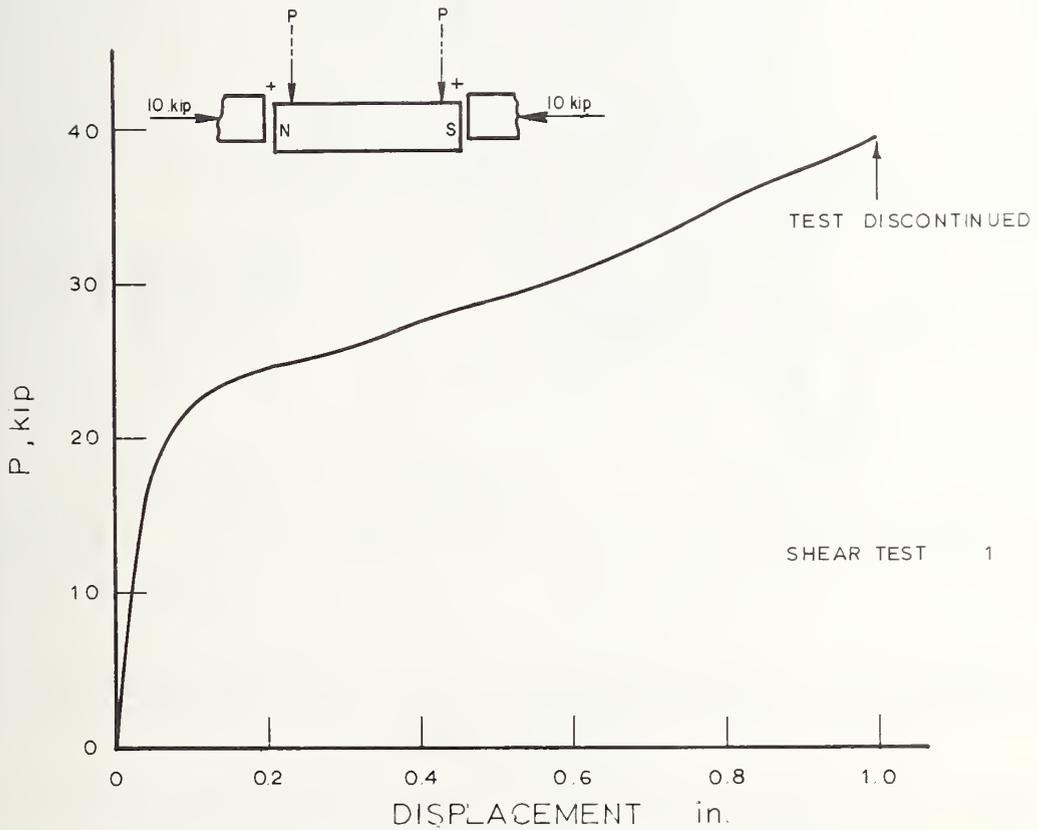
Figure 4.25. Vertical Displacements of South End of Center Segment in Shear Test 1

Test results for the connections subjected to low axial load are shown in figures 4.25 and 4.26. In figure 4.25 (Test 1) a change in stiffness similar to yield occurred at approximately 19 kip at a joint displacement of approximately 0.05 in. The test was discontinued at a 40-kip load when the joint displacement reached approximately 1 in. In Test 2 the load was applied in reverse cycles. In the first reverse load cycle the load was carried to 17.5 kip in either direction and there was substantial deflection recovery (over 80 percent). In the subsequent cycle yield occurred at approximately 25 kip. The envelope of the reverse load cycles in the direction of initial displacement (downward) is similar to the load-displacement curve in figure 4.25. At the failure load of + 37 kip the displacement was approximately 1.2 in. Thus the joint was able to resist 10 reversed load cycles with excursions equal to 5 times

Test results in the form of load versus displacement at one side of the center segment relative to the laboratory floor are shown in figures 4.25, 4.26 and 4.27. "Load" is the load on each connection which is 1/2 of the total applied load. Dowel strain caused by the axial loading of the Test 3 specimen is shown in figure 4.28. Strain gage 8 did not function. Figure 4.29 shows the dowel strain during Test 3 (including that caused by the preloading to 90 kip). Figures 4.30, 4.31, and 4.32 show the net joint displacement (slip) in Test 1 and the first half of the second cycle in Tests 2 and 3, corrected for the measured displacements of the end segments near the joints.

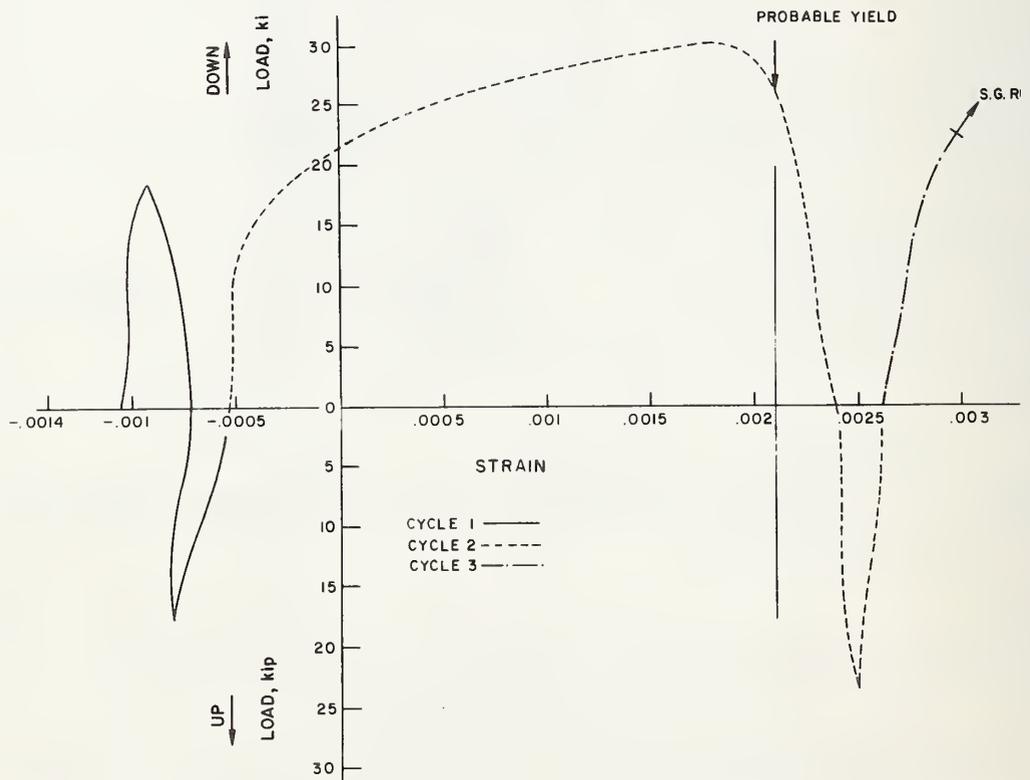
Figure 4.29. Dowel Strain in Shear Test 3 Recorded by Strain Gage #7

Figure 4.29 shows the average axial dowel strain measured in Test 3. Only strain gage 7 is shown, since the data from the other strain gages were erratic. The erratic readings were probably caused by dowel bending and other disturbances in the connection. It appears that average axial yield strain was reached during the unloading cycle of cycle 2, which is after the completion of an excursion equal to twice the yield displacement. Thus, "yielding" in the load-displacement curve may be attributable to crushing of the grout column in the joint, and not necessarily dowel-yielding. This observation, however, should be qualified since the strain gage was located in the neutral axis of the dowel with respect to bending and, therefore, approximately measures net axial tensile strain rather than maximum strain, while initial dowel yielding may have been caused by bending rather than tension.
