NIST SP 1230-3
Community Resilience-Focused Technical Investigation of the
2016 LUMBERTON, NORTH CAROLINA FLOOD

COMMUNITY IMPACT AND RECOVERY
FOLLOWING SUCCESSIVE FLOOD EVENTS

The Lumberton, North Carolina Flood of 2016, Wave 3: A Community Impact and Recovery-Focused Technical Investigation Following Successive Flood Events

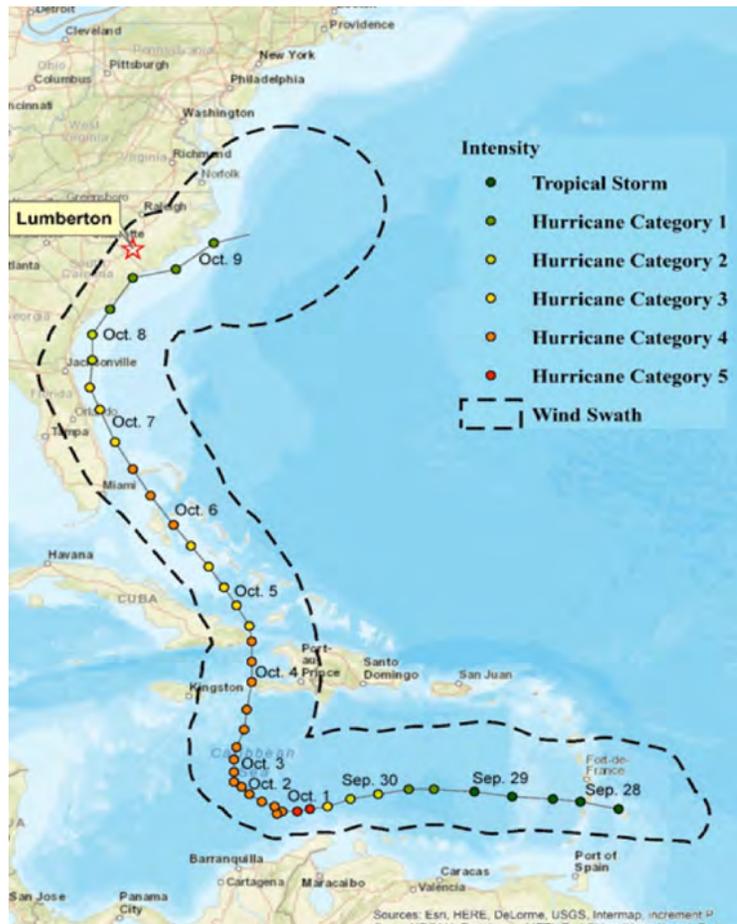
Figure 1-1. Path and intensity timeline of Hurricane Matthew.

North Carolina and Virginia (see Figure 1-1). More than 170 counties in Florida, Georgia, South Carolina, and North Carolina were included in Presidential Emergency Declarations and/or Presidential Disaster Declarations between October 6th and 11th, 2016. Economic loss estimates due to Hurricane Matthew exceed \$10 billion (NOAA, 2018).

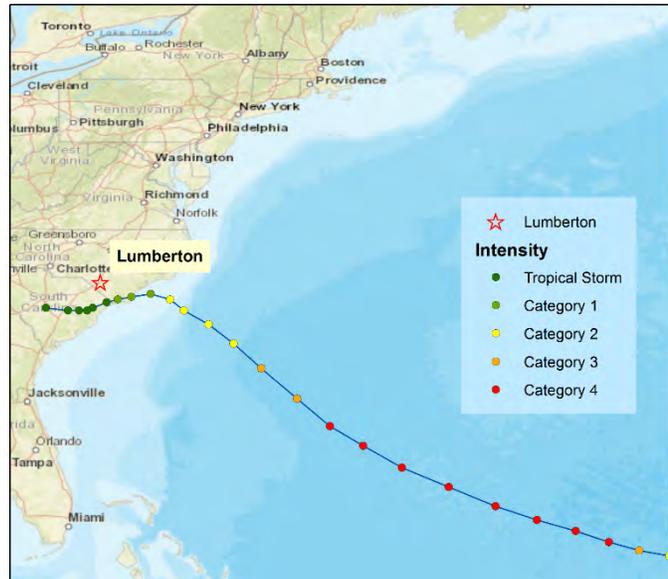
Figure 1-2. Path and intensity timeline of Hurricane Florence.

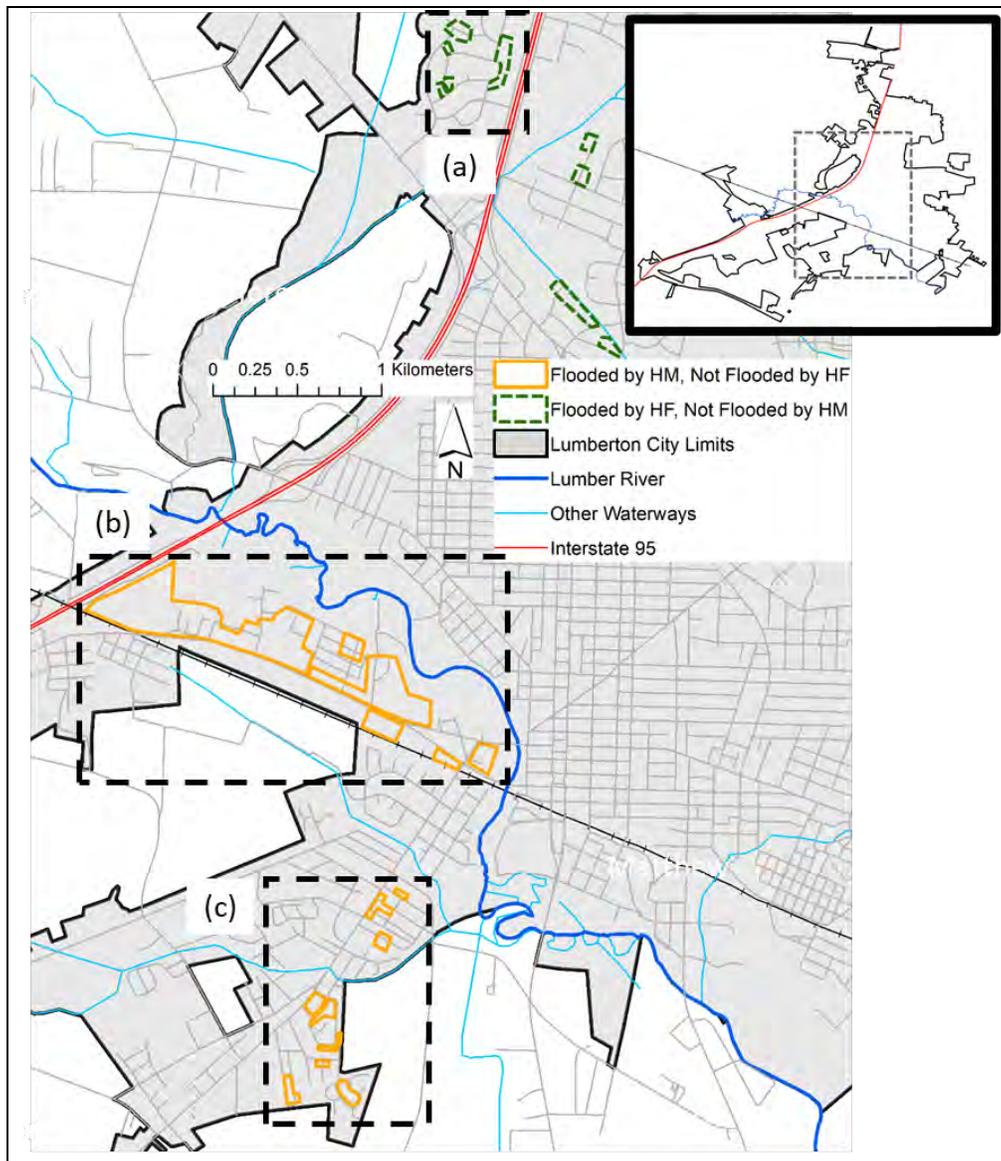
Figure 2-1. Map of Lumberton showing digitized differences in flood extents using NOAA aerial imagery, where solid orange polygons indicate areas flooded by Hurricane Matthew (HM) but not Hurricane Florence (HF), and dashed green polygons indicate areas flooded by Hurricane Florence (HF) but not Hurricane Matthew (HM). Dashed black rectangles indicate regions in the study area where the most difference in flooding occurred.

Lumberton in preparation for the flooding from Hurricane Florence likely contributed to the changes in the flood extents. These mitigation actions included building a temporary berm at the gap in the levee system where flood water entered the region south of the river during Hurricane Matthew (for more information on the levee system and gap, refer to van de Lindt et al., 2018; 2020), and using hydraulic pumps to quickly move water from the leveed area into the downstream river channel. The measurement science approaches taken by our team in Wave 3a (discussed in the next sections) accounted for individual- and community-level mitigation efforts, as they likely reduced damages from the flooding experienced in 2018.

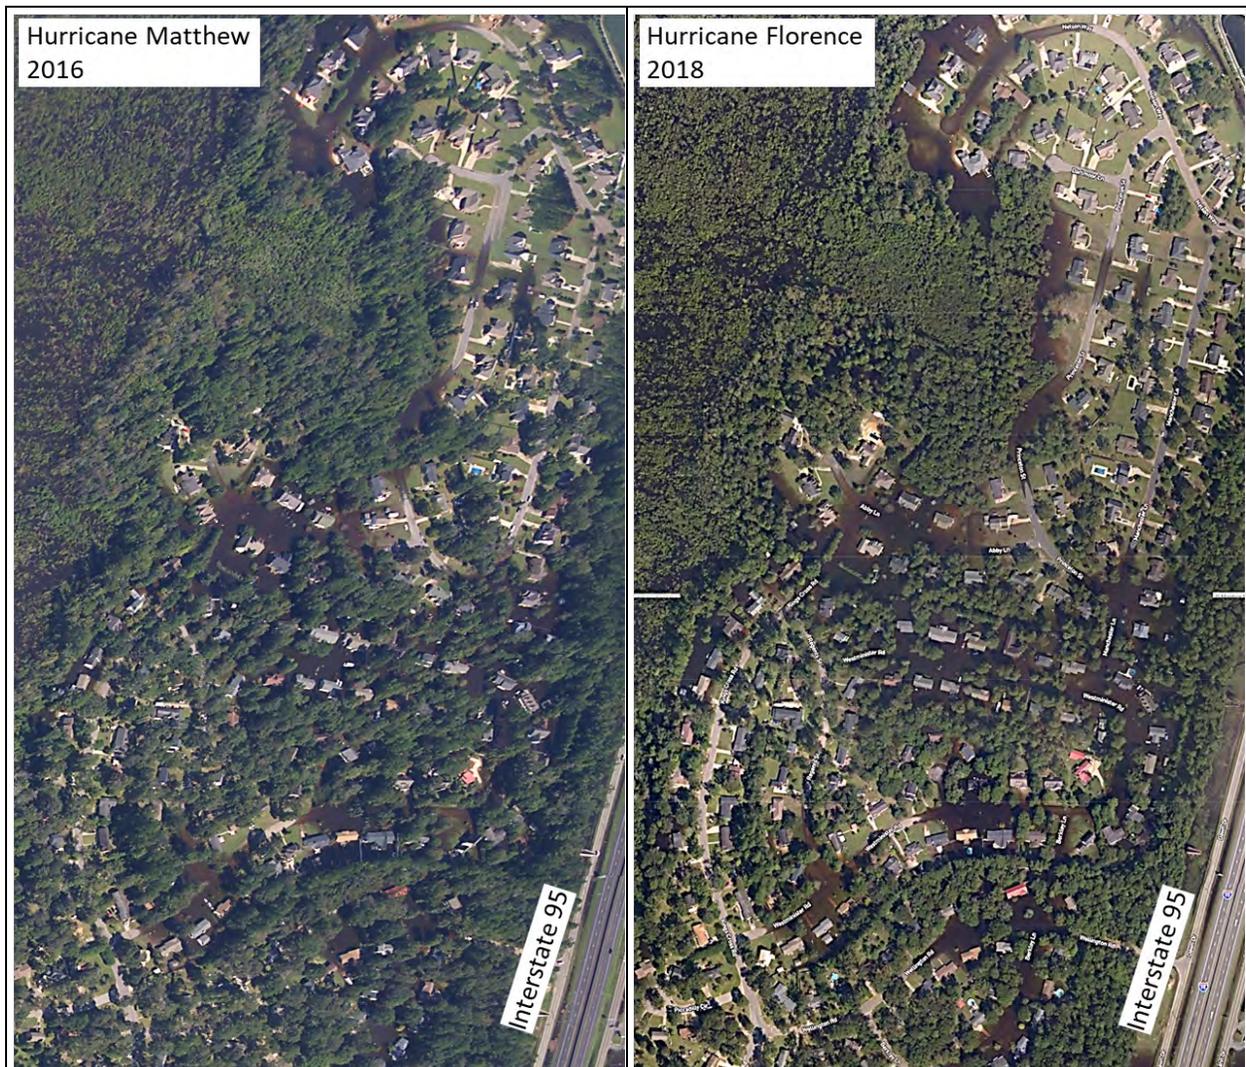
Figure 2-1a. Residential neighborhood located North of the Lumber River and west of Interstate 95 indicated by (a) in Figure 2-1. Imagery collected following Hurricane Matthew (NOAA 2016) and Hurricane Florence (NOAA 2018) has been edited to show flooded areas more clearly.

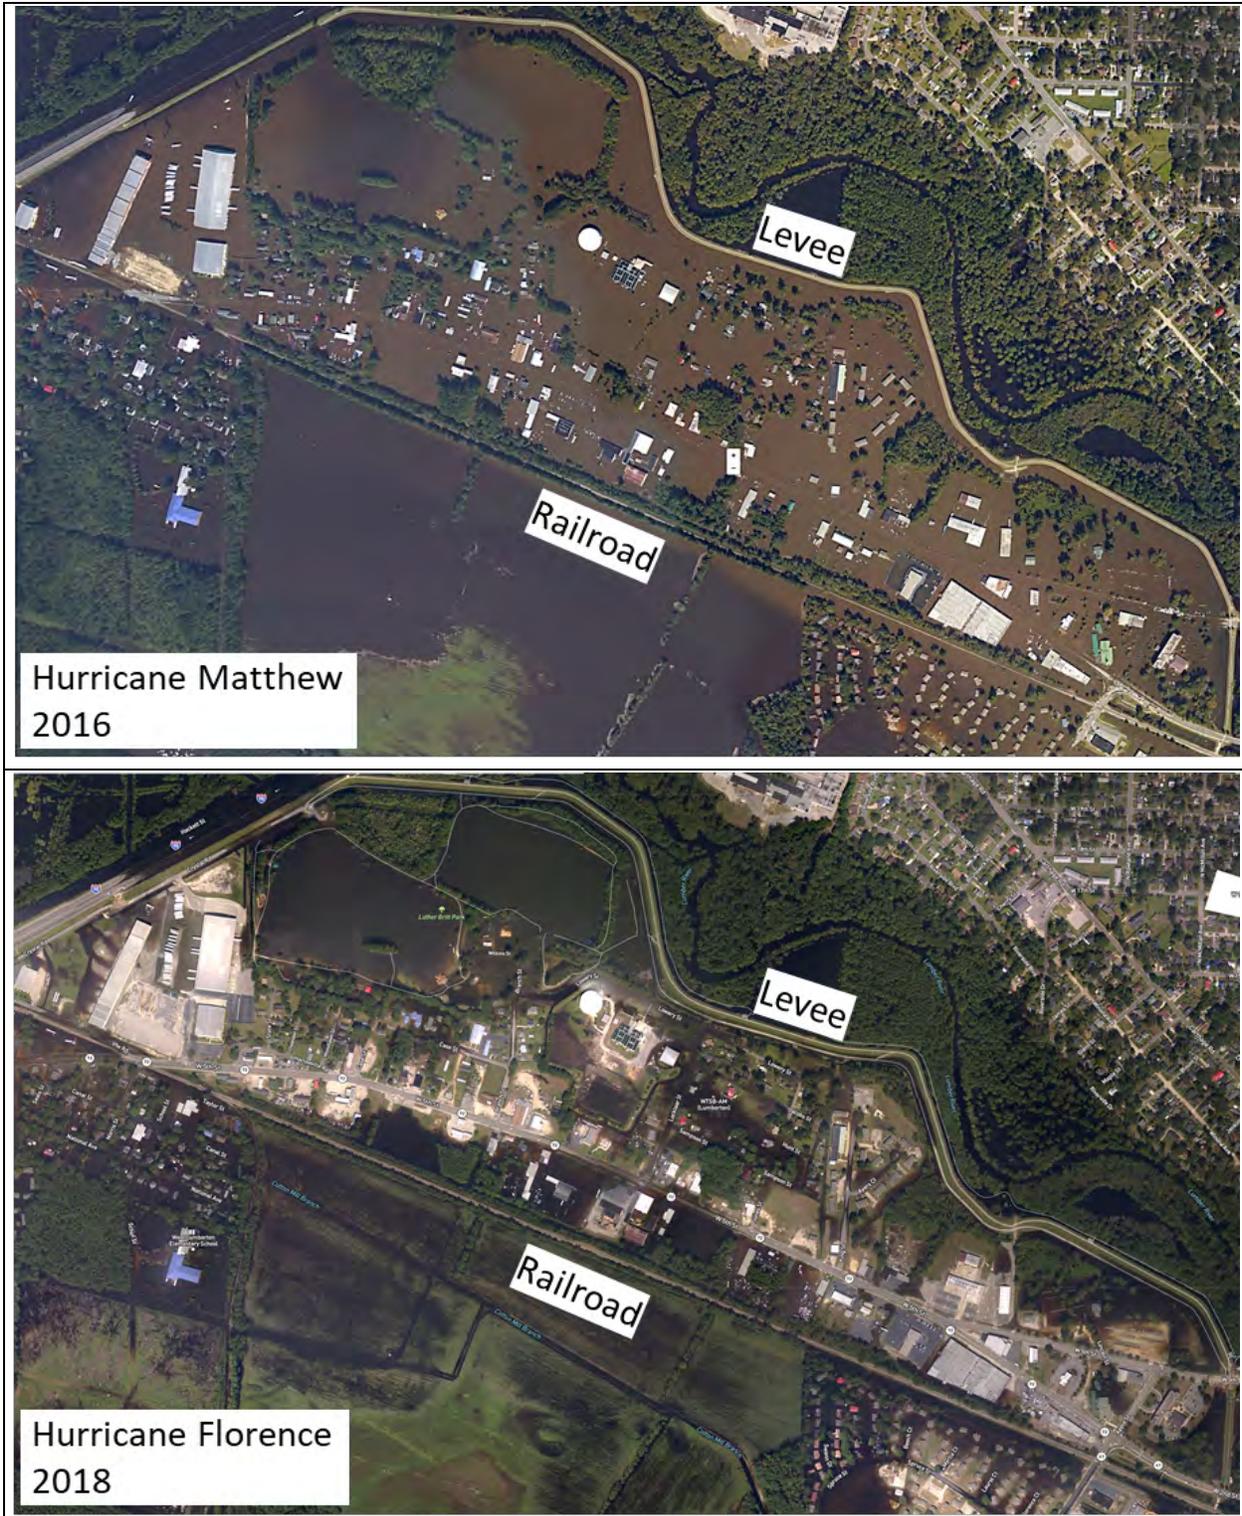
Figure 2-1b. Mixed commercial and residential area South of the Lumber River bound by the levee and railroad indicated by (b) in Figure 2-1. Imagery collected following Hurricane Matthew (NOAA 2016) and Hurricane Florence (NOAA 2018) has been edited to show flooded areas more clearly.

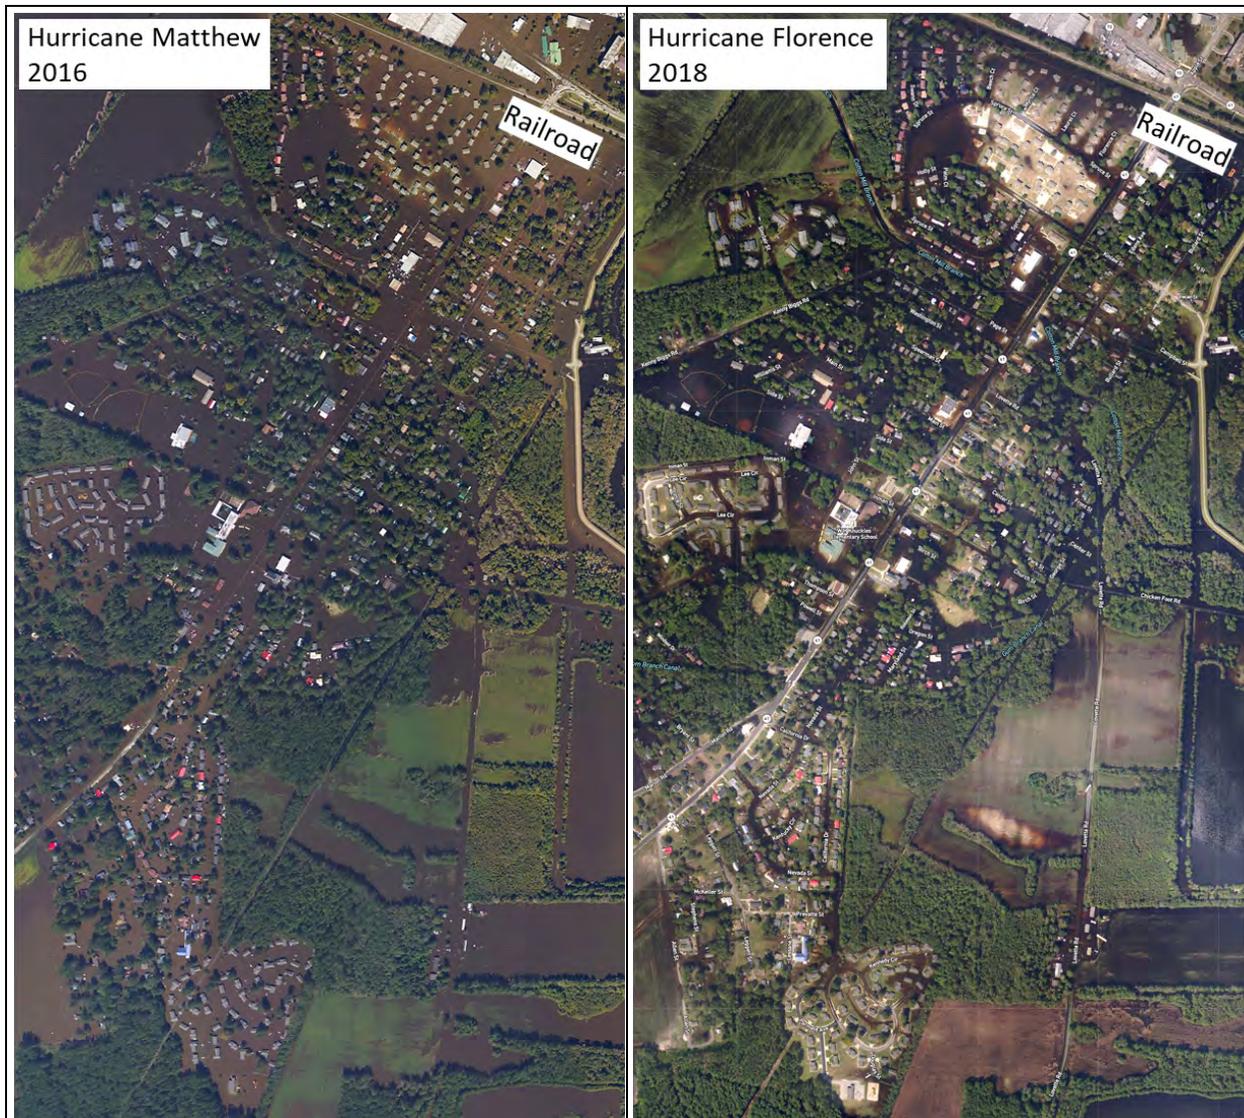
Figure 2-1c. Residential area South of the Lumber River and railroad indicated by (c) in Figure 2-1. Imagery collected following Hurricane Matthew (NOAA 2016) and Hurricane Florence (NOAA 2018) has been edited to show flooded areas more clearly.

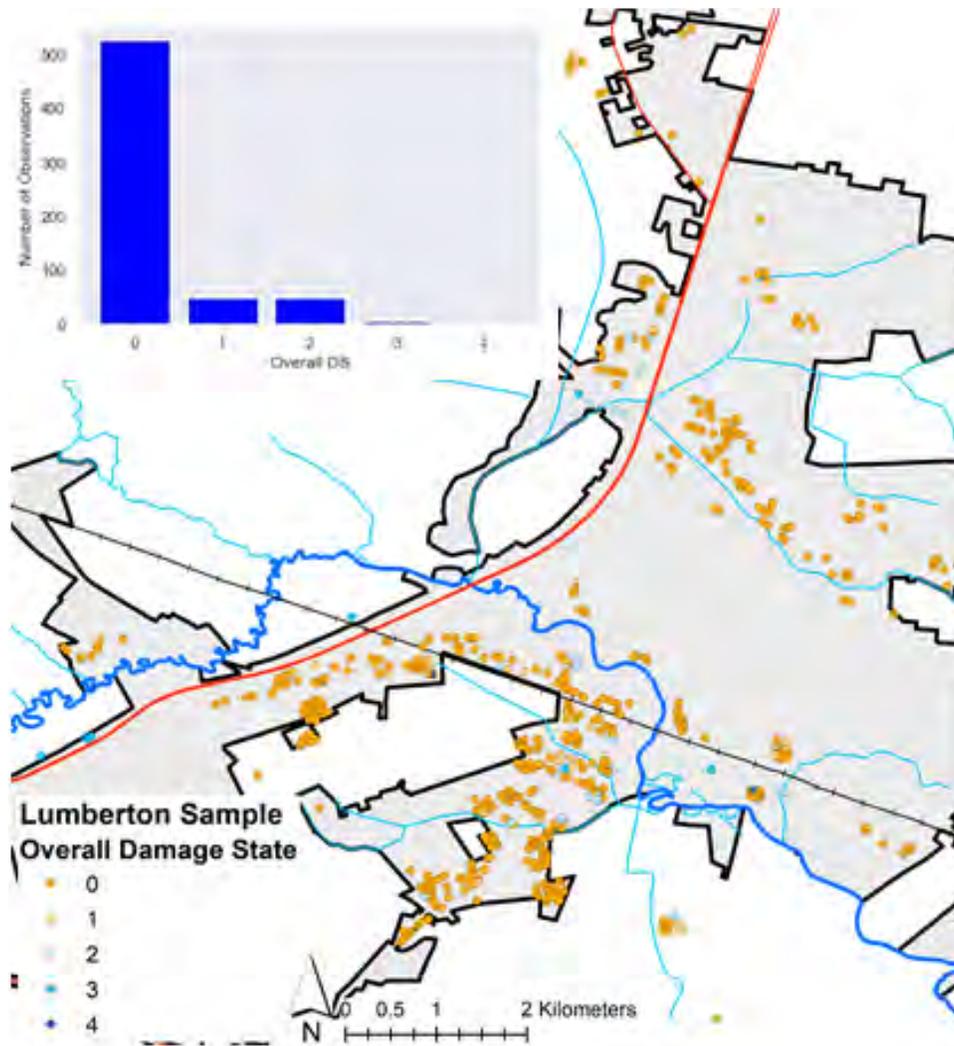
As previously discussed, at the time of Wave 3a, there remained buildings that had not been fully repaired from damage incurred by flooding following Hurricane Matthew. This was often evidenced by a gutted interior or determined by speaking with a neighbor, and when suspected, a flag was created in the data collection. While the detailed extent of damage or repair that existed immediately before Hurricane Florence is unknown, using a combination of information including Wave 2 repair state, visible high-water marks, sparse input from neighbors or occupants, and indicators of recently removed interior items, damage states were assessed for Hurricane Florence flood damage alone. Figure 2-3 shows the spatial distribution of damage caused by Hurricane Florence to our sample of residential and commercial buildings. A histogram of the damage distribution is included in the top-left corner of the figure. Of the housing units inspected, 409 were assessed as DS 0, 44 were assessed as DS 1, 41 were assessed as DS 2, 1 was assessed as DS 3, and 2 were assessed as DS 4. Of the businesses inspected, 117 were assessed as DS 0, 6 were assessed as DS 1, 9 were assessed as DS 2, 6 were assessed as DS 3, and 0 were assessed as DS 4.

Figure 2-3. Distribution of overall damage to residential and commercial buildings due to Hurricane Florence.

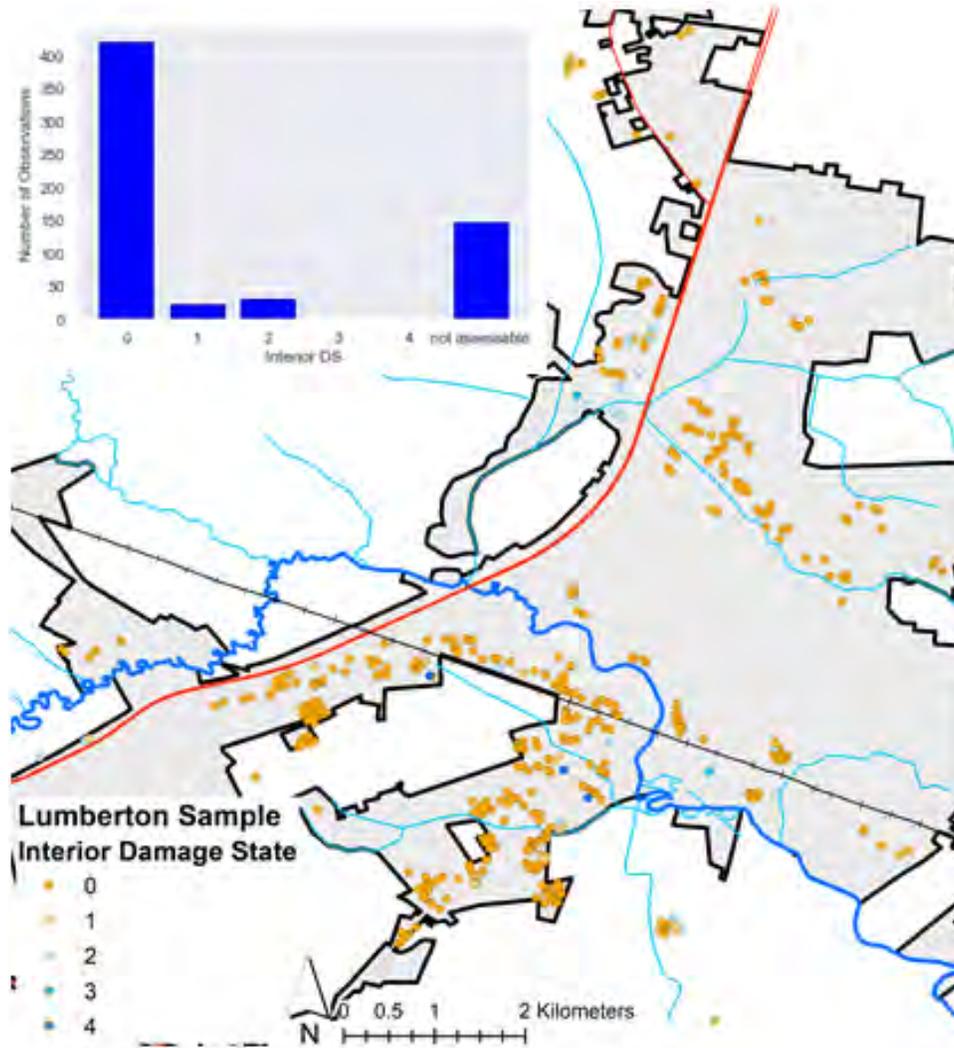
Figure 2-4 provides the overall interior damage states for commercial and residential buildings with a histogram provided in the top left corner. Interior damages were assessed for 124 commercial buildings and 362 housing units and interiors were not assessable for 149 buildings. Of the residential buildings in which interiors were assessed, 22 were assessed as DS 1, 23 were assessed as DS 3, and 3 were assessed as DS 4. Of the commercial buildings in which interiors were assessed, 3 were assessed DS 1, 10 were assessed DS 2, and 2 were assessed DS 3.

Figure 2-4. Distribution of damage to interior contents of residential and commercial buildings due to Hurricane Florence.

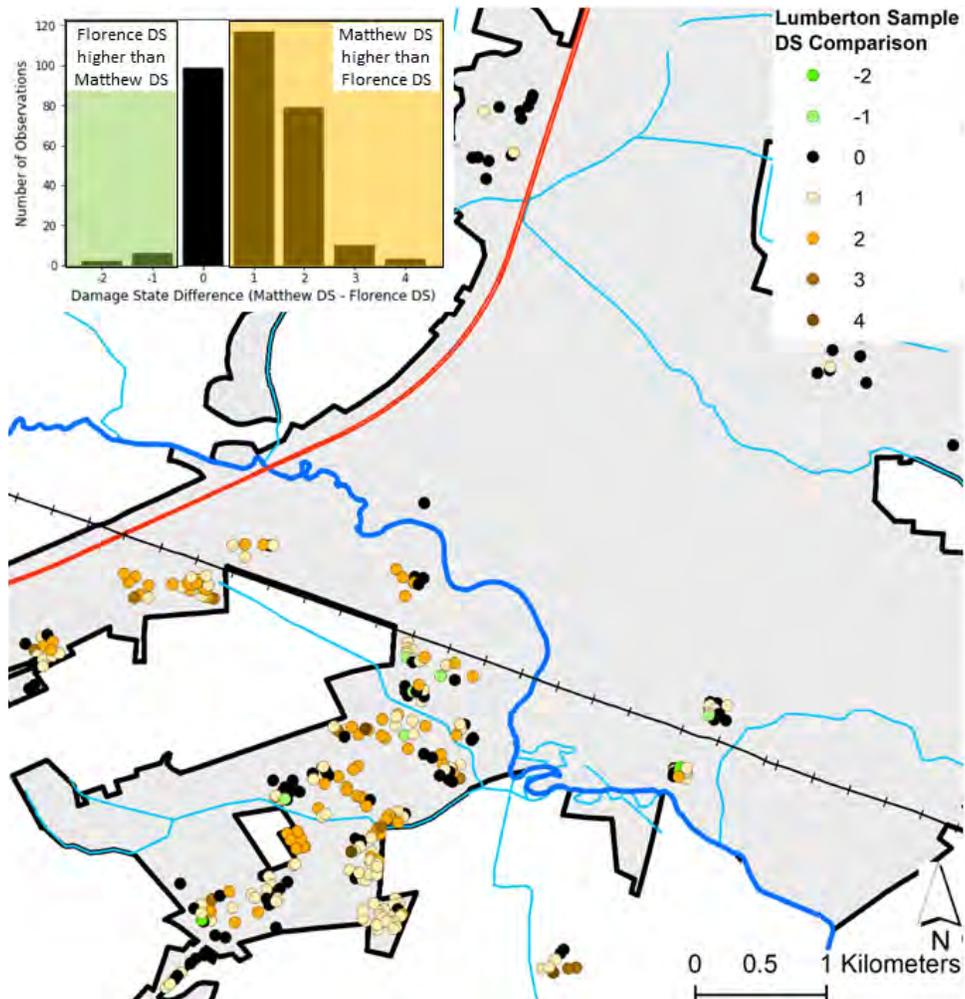
Finally, the difference in damage states recorded between Hurricanes Matthew and Florence is shown in Figure 2-5. Figure 2-5 includes only those 316 residential buildings that were assessed in both Wave 1 and Wave 3a and does not include commercial buildings because businesses were not part of the scope in Wave 1. In calculating the differences in Figure 2-5, Hurricane Florence damage states were subtracted from Hurricane Matthew damage states; therefore, a positive number in the histogram indicates a higher damage state in Hurricane Matthew than Hurricane Florence. Approximately two-thirds (66 %) of residential buildings (n=209) sustained more damage after Hurricane Matthew than after Hurricane Florence, while only 3 % of residential buildings (n=8) sustained more damage after Hurricane Florence compared to after Hurricane Matthew. Almost one-third (31 %) of the residential buildings (n=99) had the same degree of damage after both events; however, of those 99 buildings, 72 % were not flooded by either Hurricane. The high proportion of undamaged buildings is due in part to the nature of the sample created for the Wave 1 damage assessment, which deliberately included non-flooded buildings to better understand the socio-economic factors leading to flood vulnerability and the dependencies within a community. The spatial distribution of positive and negative values in Figure 2-5 can be

used to interpret factors influencing the observed differences in damage for individual residential buildings more closely.

Figure 2-5. Spatial distribution of difference in damage states assessed for residential buildings after Hurricanes Matthew and Florence.

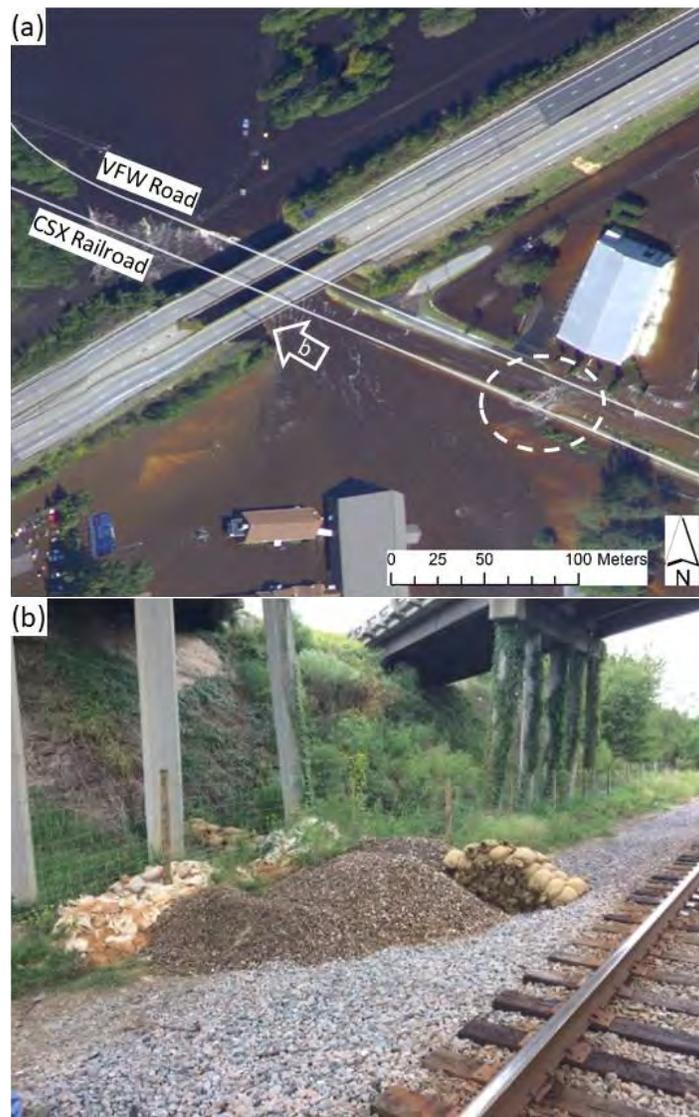
To provide context for the flood mitigation taken at the I-95/CSX underpass leading up to the flood generated by Hurricane Florence, Figure 2-6 shows the actions taken by the city at the underpass leading up to the 2016 flood in an effort to mitigate its impacts. Figure 2-6(a) shows an aerial view of the underpass taken at the time of highest inundation during Hurricane Matthew, with the locations of the CSX Railroad and VFW Road labeled. Figure 2-6(b) shows the use of backfill and sandbags in the ditches between the overpass abutments, railroad and road to create a constant elevation across the gap in the levee. The flood water exceeded the elevation of the underpass and surged into the city, causing damage to VFW road and undercutting the CSX railroad at the location of the dotted circle in Figure 2-6(a). For more information on the mitigation, damage, and repairs to the underpass made in 2016, refer to van de Lindt et al. (2018; 2020).

Figure 2-6. I-95/CSX Underpass seen in 2016: (a) from above; (b) from underneath, with flood prevention set in place. (NOAA, 2016). Photograph shown in (b) reproduced with permissions from van de Lindt et al., 2018.

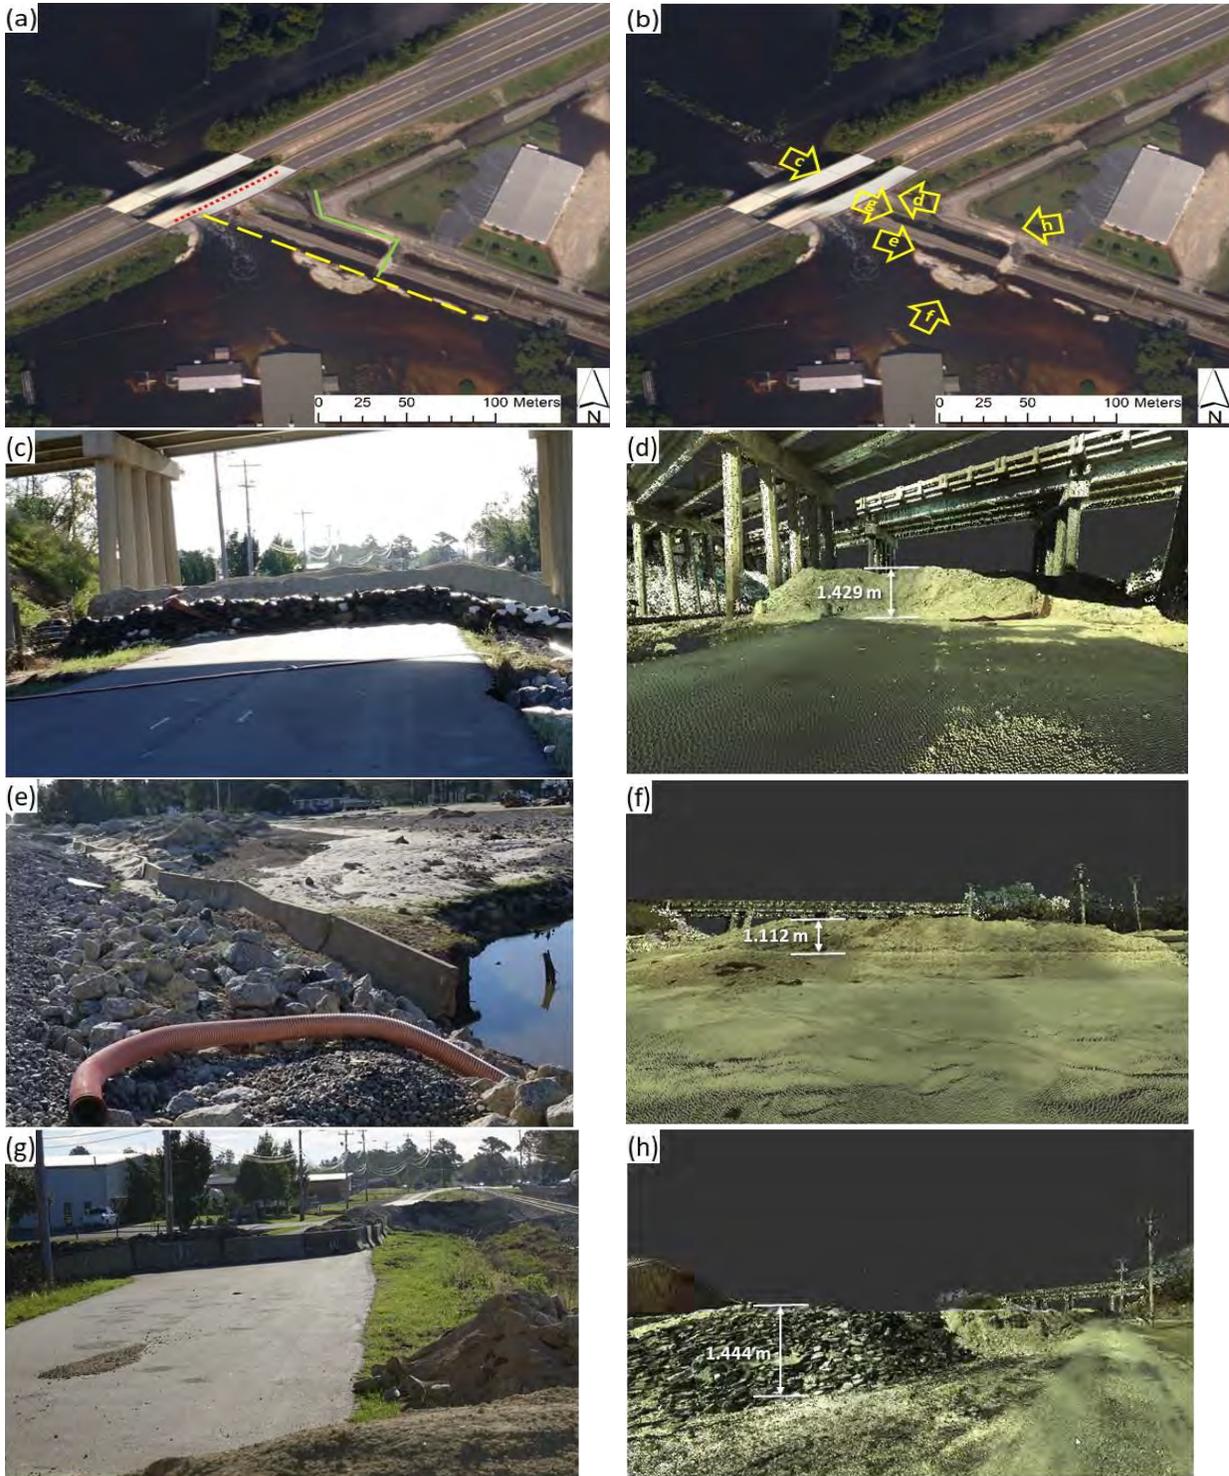
A system of three temporary berms was built at the I-95/CSX underpass in the days leading up to Hurricane Florence, which represented a more concerted effort to mitigate flooding than that taken in the days leading up to Hurricane Matthew in 2016. The increased mitigation activity leading up to Hurricane Florence was likely due to the recent experience with flooding from Hurricane Matthew. The last flood event before Hurricane Matthew had occurred over ten years previously and did not include flood water entering the leveed area of the city through the I-95/CSX underpass. Figure 2-7 provides the locations of the berms, designated in Figure 2-7(a) by a dotted red, a dashed yellow, and a solid green line. Figure 2-7(b) shows the locations and orientations of the images shown in Figure 2-7(c)-(h). A berm section, considered here to be the primary line of defense protecting water from entering the city, was built between the underpass abutments and is denoted by a red dotted line in Figure 2-7(a). This berm was built by placing highway dividers, backfilling sand on the east side of the dividers, and adding sandbags on the west (river) side of the dividers, as shown in Figure 2-7(c). This berm breached on the southwest side, allowing flood waters to enter the city, similar to what occurred in 2016. Following the flood, the material from the temporary berm structure overlaying the railway was removed to allow train access; therefore, measurement of the berm height in that region and assessment of the extent of the breach were not possible. It is assumed that the height of the berm in the region, that was gone at the time of measurement, was level with the remaining portion of the berm.

Figure 2-7(c) depicts the northeast section of the berm built atop VFW Road, which was remained during the Wave 3a deployment. Another berm was built along the southwest side of the railroad and is denoted by a yellow dashed line in Figure 2-7(a). This berm, considered here to be the secondary line of defense due to its protection of the railroad, was constructed by placing highway dividers along the railroad and adding sand, asphalt riprap, and sandbags on the southwest side of the dividers, as shown in Figure 2-7(e). Parts of the berm were destroyed and the constituent material was carried away by the flood. A third berm is denoted by a solid green line in Figure 2-7(a). This berm was built out from the east side of the bridge abutment toe slope, crossing VFW Road, running east along the south side of VFW road, crossing the railroad and connecting to the berm section running along the railroad. This third berm, considered a tertiary line of defense as it protected the area north of the railroad, was constructed by placing highway dividers and backfilling the eastern side of the dividers with sand and asphalt riprap, as shown in Figure 2-7(g). This berm was still intact while the Wave 3a team was in the field, and aerial imagery shows that the flood water was directed south of the railroad by the location of the breach of the primary berm and by the secondary berm.

Figure 2-7. Berm system deployed before Hurricane Florence: (a) Aerial overview with three berm sections marked (NOAA 2018); (b) Aerial overview with image locations and orientations (NOAA 2018); (c) Primary berm section; (d) LiDAR scan of primary berm section; (e) Secondary berm section; (f) LiDAR scan of secondary berm section; (g) Tertiary berm section; (h) LiDAR scan of tertiary berm section.

A series of six Light Detection and Ranging (LiDAR) scans were administered on 17 October 2018 at various locations around the underpass to collect survey-grade measurements of the remnants of the berms. LiDAR scans produce a dense, three-dimensional point cloud with an accuracy of ± 1 cm. The scans were used to measure heights of the berms with respect to VFW Road and CSX Railroad elevations. Figure 2-7(d) shows the point cloud representing the primary berm built between I-95 overpass abutments, where the CSX railroad is visible in the left side of the figure. The height of the berm was measured to be 1.43 m (4.69 ft) above the crest of VFW Road. Figure 2-7(f) shows the point cloud representing the secondary berm built along the railroad. The height of the berm measured 1.11 m (3.64 ft) above the elevation of the railroad. The crest of VFW Road measured 0.16 m (0.52 ft) above the railroad. Figure 2-7(h) shows the point cloud representing the tertiary berm built from the east abutment toe slope (i.e., baseline section) and connecting to the secondary berm running along the railroad. The height of the berm measured 1.44 m (4.72 ft) above the crest of VFW Road.

While the primary berm (dotted red line) was breached by the Lumber River, flooding many residential areas of the city for a second time, the secondary berm (dashed yellow line) may have prevented the reach of the flood by keeping the railroad and VFW Road intact. As pointed out by the dashed white oval in Figure 2-6(a), a section of the railroad and VFW Road was washed out in the 2016 flood, allowing water to spill into the northeastern areas of the city, between the levee and railroad. Figure 2-8 shows a digital elevation model of Lumberton (USGS, 2017), with brown to blue shades representing lower elevations and blue shades representing higher elevations, and color intensity representing increasingly extreme elevation in the direction of the shade. The railroad, levee, and underpass locations are shown in Figure 2-8; the data indicates that the railway structure is a local high point running completely across the southern area of the city. The secondary berm built along VFW Road directed water south and west, providing protection to the railway infrastructure, and further preventing the region of the city north of the railroad and south of the levee from being flooded by the Lumber River.

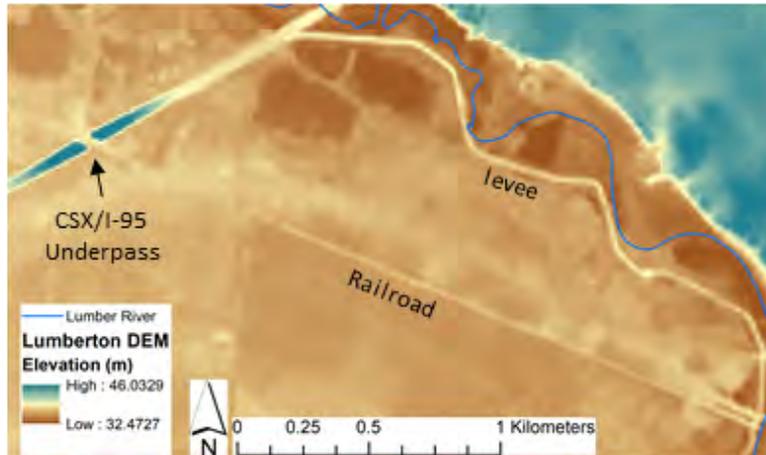
Figure 2-8. Digital elevation model (USGS 2017) showing elevations in area of Lumberton South of the levee, with CSX railroad and levee locations noted.

While some flooding did occur in this area in 2018, it was attributed to pluvial flooding alone as opposed to the flooding that occurred in 2016 which was mostly attributed to riverine flooding that entered through the I-95/CSX underpass and then through the undercutting of the railroad. Many of the homes and businesses in this region were completely protected from flooding in 2018. Of the homes from our sample that were flooded in this region, our team measured lower inundation levels in Wave 3a compared to those assessed in Wave 1.

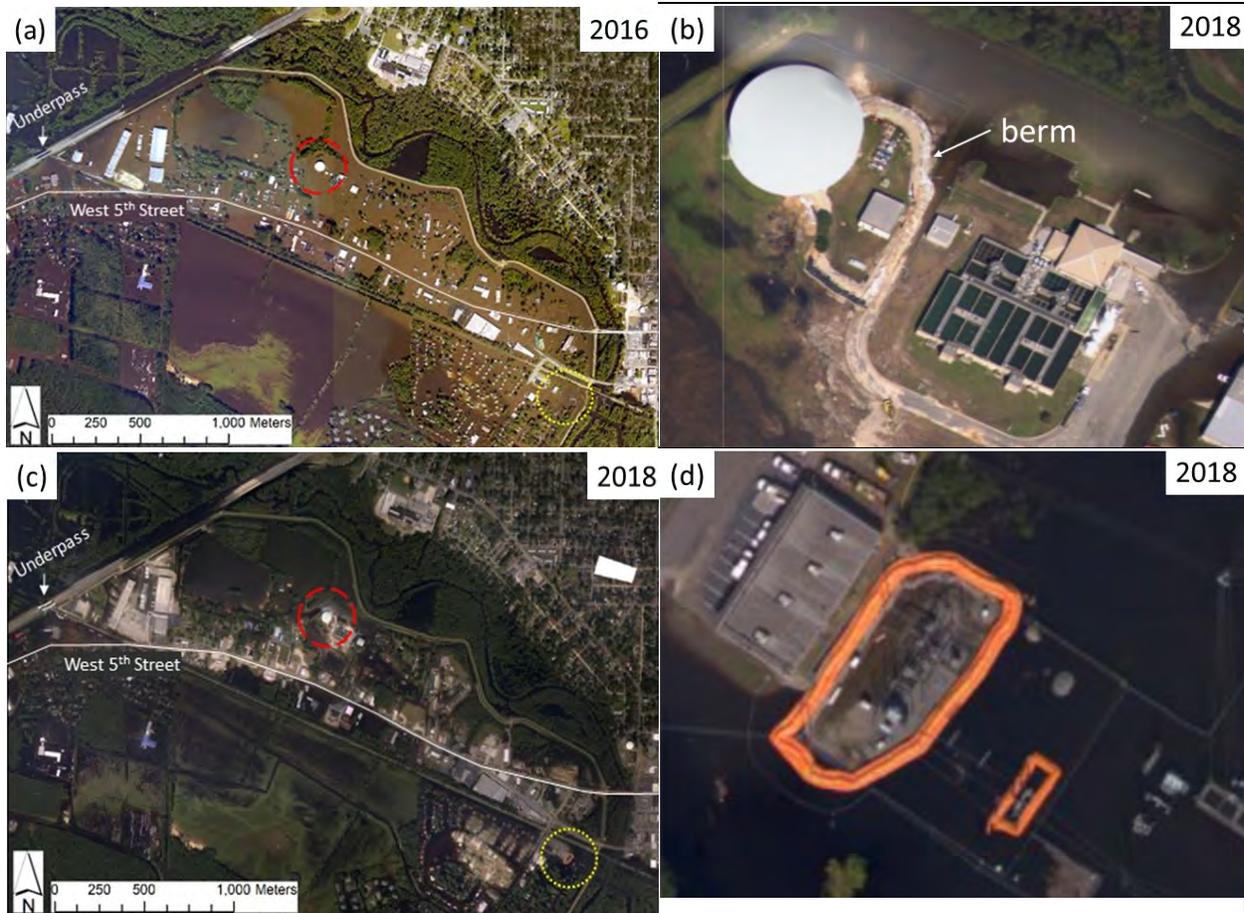
In addition to the berm system built at the I-95/CSX underpass, the City of Lumberton took mitigating actions to protect its infrastructure systems. Figure 2-9 shows the Lumberton Water Plant and an electrical power network substation in the leveed area of Lumberton. Both were severely flooded in 2016, which caused disruption to the water and power systems in Lumberton. The loss of these utility systems was a major stressor on many of the residents in the areas served by these systems and affected their recovery timelines (van de Lindt et al., 2018; 2020; Sutley et al., 2019). The Lumberton Water Plant, located south of the levee and north of West 5th Street, is marked with dashed red circles in Figures 2-9(a) and (c). Water service was disrupted following the 2016 flood (Armstrong, 2016) due to inundation of the water treatment plant as well as damage to an intake pump and failure of the treatment plant's primary generator. As shown in Figure 2-9(b), which provides the image from Figure 2-9(a) zoomed in for details of the plant, a protective berm was built around the plant controls leading up to Hurricane Florence. This berm may not have been needed to protect against the flood water in 2018 due to the protection of the I-95/CSX underpass berm system, described earlier, which kept flood water out of the Lumber River from entering that portion of the city. While the plant itself was not inundated in 2018, a well located outside of the levee was inundated to a higher level in 2018 than in 2016, according to city officials, resulting in a boil water advisory for those households in the water treatment plant's distribution network.

Figure 2-9. Lumberton water plant and an electrical power network substation in the leveed area of Lumberton that flooded in: (a) 2016 from Hurricane Matthew (NOAA, 2016) with (b) Close-up of Lumberton Water Plant, and (c) 2018 from Hurricane Florence (NOAA, 2018) with (d) Close-up of the electrical substation.

An electrical substation, denoted with yellow dotted circles in Figure 2-9(a) and (c), is located south of West 5th Street, on the eastern edge of the levee-protected area. The substation supplied electricity to much of the population south of the levee and was inundated by the 2016 flood. The City of Lumberton placed temporary flood barriers around the levee leading up to Hurricane Florence, as shown in Figure 2-9(d), which provides a close-up of the image from Figure 2-9(c). Flood waters reached the substation in 2018; the aerial imagery shows that the flood barriers prevented water from inundating the substation in 2018.

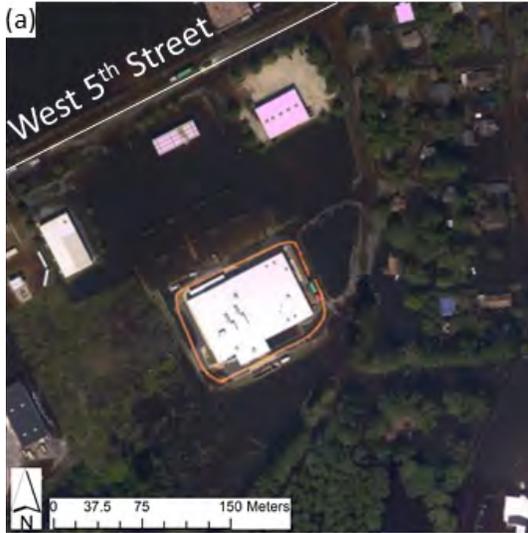
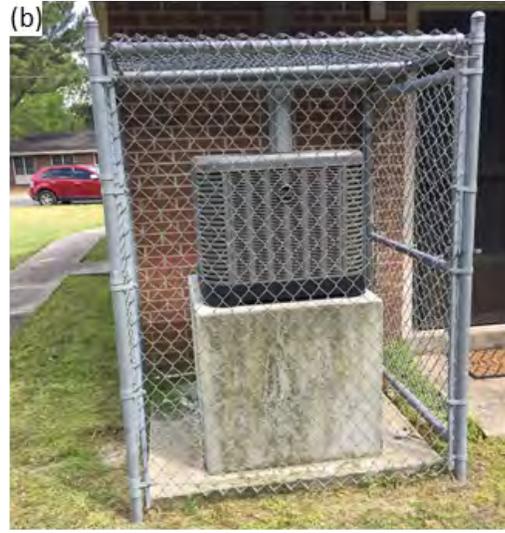
Figure 2-10. Examples of visible individual-level mitigation efforts in Lumberton implemented before the 2018 Flood; (a) Temporary perimeter flood protection around international retailer building (NOAA 2018); (b) Elevated air conditioning condensers in a public housing complex.
