NIST SP 1230

Community Resilience-Focused Technical Investigation of the **2016 LUMBERTON, NORTH CAROLINA FLOOD** MULTI-DISCIPLINARY APPROACH

Community Resilience-Focused Technical Investigation of the 2016 Lumberton, North Carolina Flood Multi-Disciplinary Approach

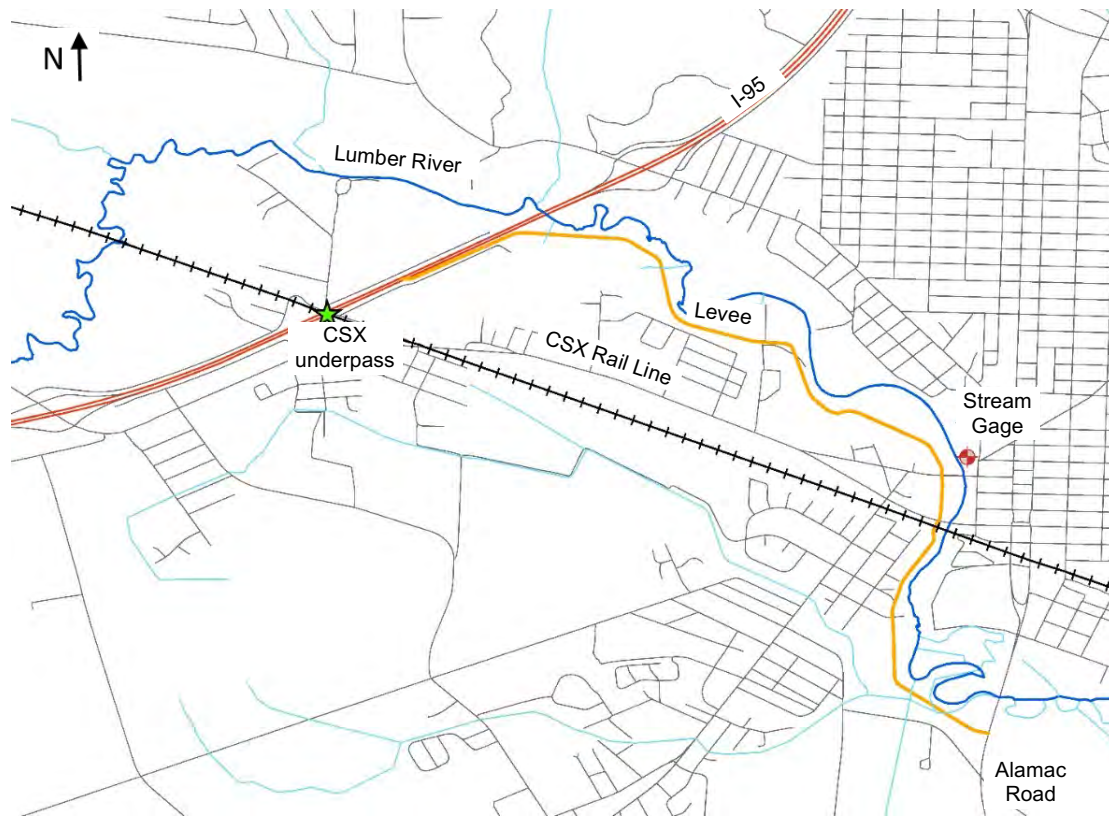
Figure 2-9. Southern Lumberton with the levee system denoted with an orange line.

Construction of the levee system in Lumberton was completed in September 1974 to protect the low-lying areas south of the Lumber River (Federal Emergency Management Agency, 2014). The levee system consists of a raised section along the river, connecting to I-95, which acts as part of the levee on the west side of the city and Alamac Road acting as levee to the east. Figure 2-9 displays a more detailed map of the southern sections of Lumberton showing the location of the levee system with an orange line. The levee was built by the U.S. Department of Agriculture, and the City of Lumberton manages and maintains the levee. However, the Jacob-Swamp District manages water movement in channels around the City of Lumberton. Just prior to Hurricane Matthew the city was going to work with the Army Corps of Engineers to certify the levee at the Corps' request.

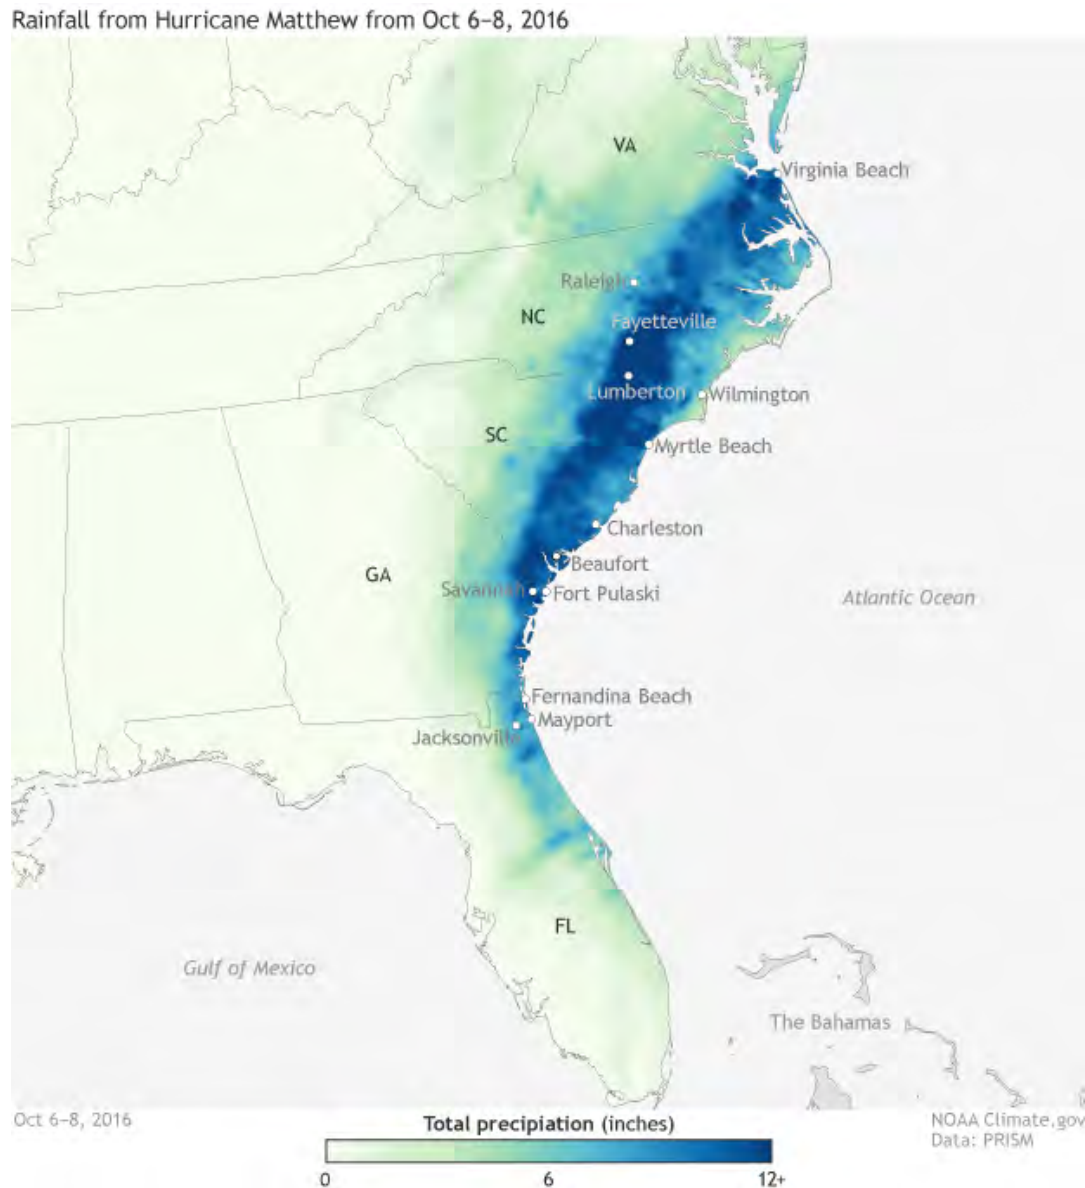
Figure 2-11. Rainfall for Hurricane Matthew with Lumberton evident in the highest rainfall area (Climate, 2017). [1 in = 25.5 mm].

Some areas in North Carolina received more than 380 mm (15 in) of rainfall, with total precipitation shown in Figure 2-11, causing flooding that was exacerbated by already saturated ground due to heavy rains in September. Hurricane Matthew was downgraded to a Post-Tropical

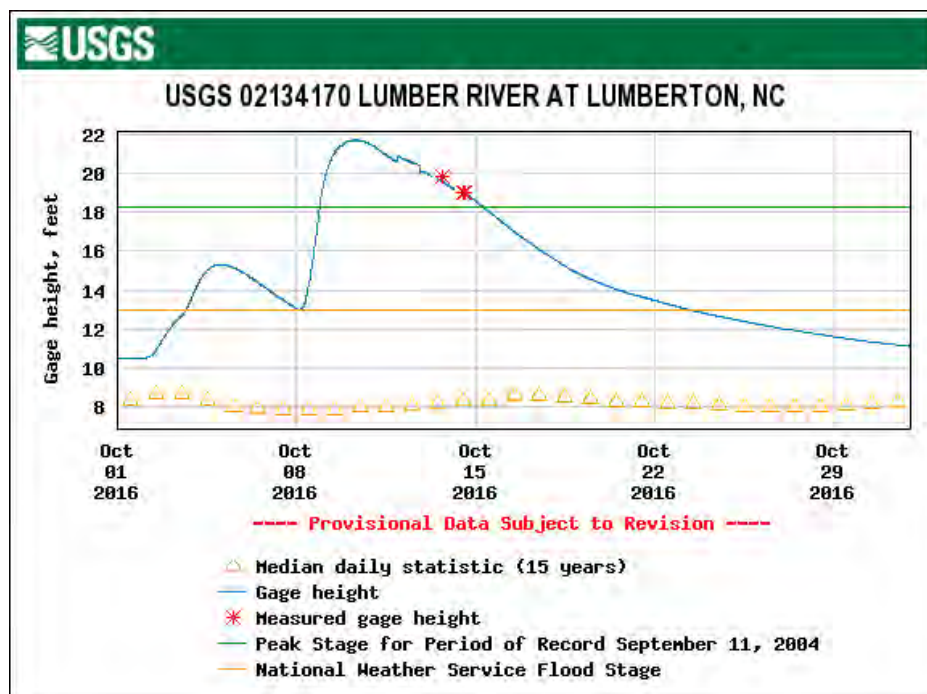
Figure 2-12. A hydrograph reporting river levels at the Lumberton gage location during October 2016 (USGS National Water Information System's Web Interface, 2017). [1 ft = 328 mm]

The river reached flood stage in Lumberton on October 3rd due to local heavy rains. It reached a local maximum on October 5th and began to decrease for three days (USGS National Water Information System's Web Interface, 2017). On October 8th, rain from Hurricane Matthew began to fall and once again the stream gage height rose drastically for two days until it peaked at a gage height of 6.7 m (22 ft) (36.12 m [118.5 feet] above the NAVD88) on October 11th. The water level began to fall slowly, eventually dropping below flood level on October 23rd.

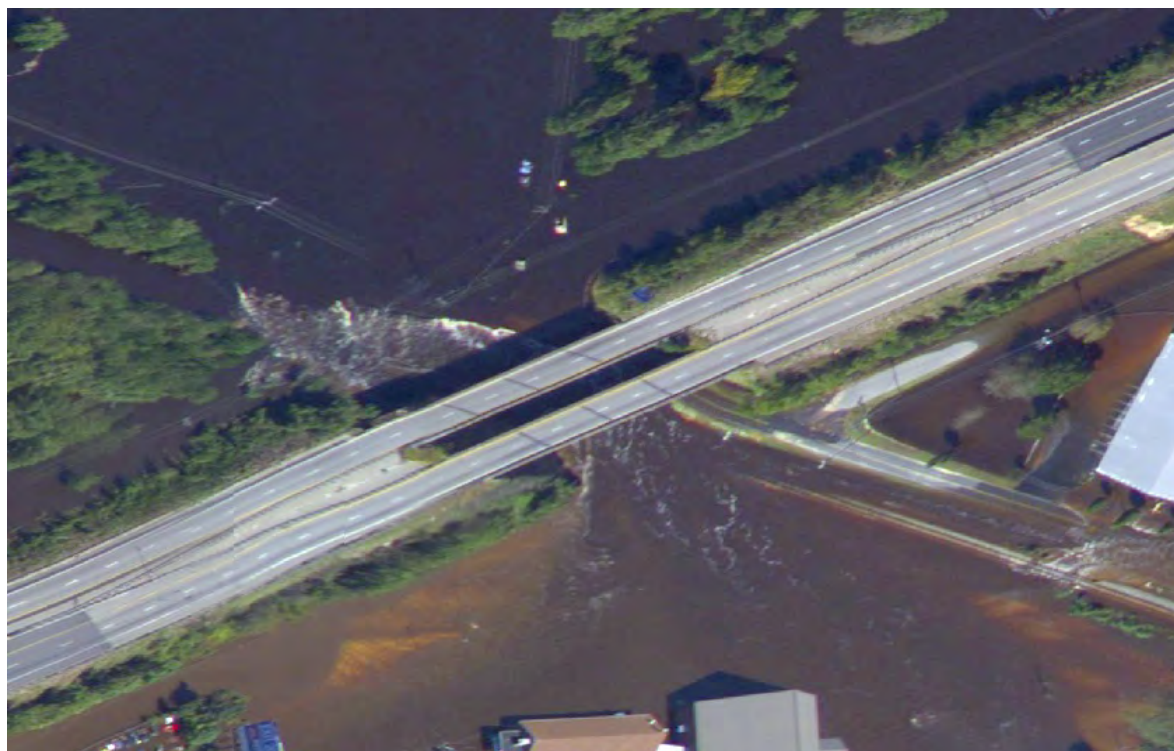
Figure 2-14. Lumberton levee system at the location of the CSX underpass showing flood waters moving through the underpass (NOAA Hurricane Matthew Imagery, 2016).

Imagery, 2016). The image shows water flowing through the underpass covering both the railroad tracks and the road. It should be noted that no water typically flows under I-95 at this location. A Digital Elevation Model (DEM) was obtained from the USGS National Elevation Dataset to determine elevation values along the levee system. The elevation of the levee on the north side is typically 37.2 m to 37.5 m (122 ft to 123 ft). To the west, where the levee merges with I-95, the elevation ranges from 37.5 m (123 ft) on the low end and crests at around 44.2 m (145 ft), on either side of the CSX overpass. On the eastern edge of the levee where the river turns south and curves around the city, the elevation is consistent with the northern elevations and gradually drops to around 35.1 m (115 ft) as the distance between the levee and river increases.

An underpass exists at the intersection of I-95 and the CSX railroad as indicated by the green star in Figure 2-8. At this location, the CSX railroad and VFW Rd go under I-95, which is acting as the northwest arm of the levee system. An aerial view of the CSX and VFW Rd underpass of I-95 taken on October 11th during the flood is shown in Figure 2-14 (NOAA Hurricane Matthew

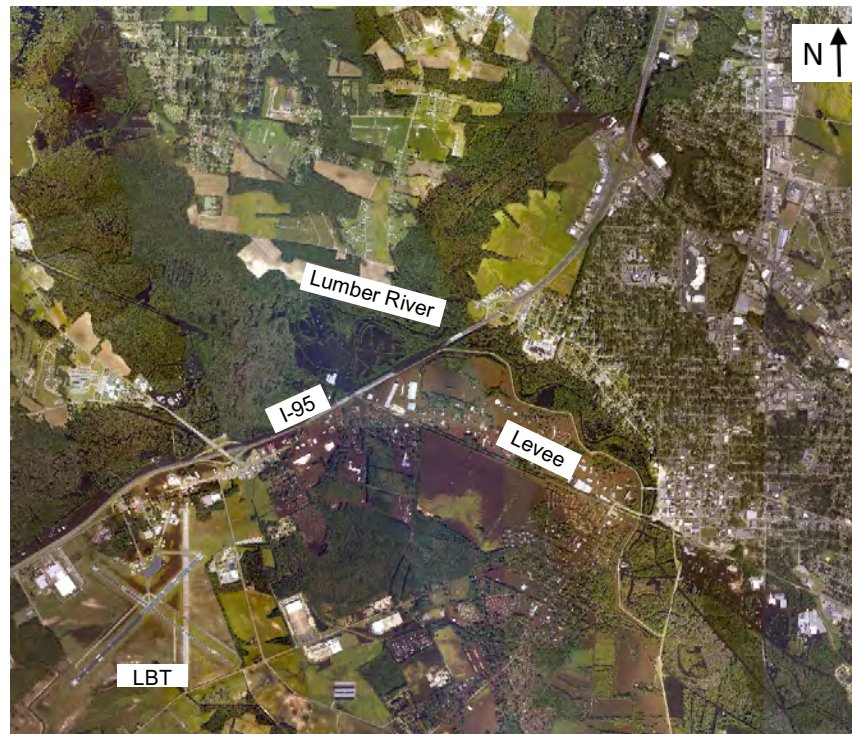
An aerial image mosaic captured by NOAA on October 11th is shown in Figure 2-16. The flooding to neighborhoods south of the river is visible along with some flooding to the north due to stream overflow. The water reached the Lumberton Municipal airport (LBT) but no damage was recorded there.

Figure 2-16. Aerial imagery of inundation of Lumberton on October 11, 2016. Photo: NOAA Hurricane Matthew Imagery, 2016.

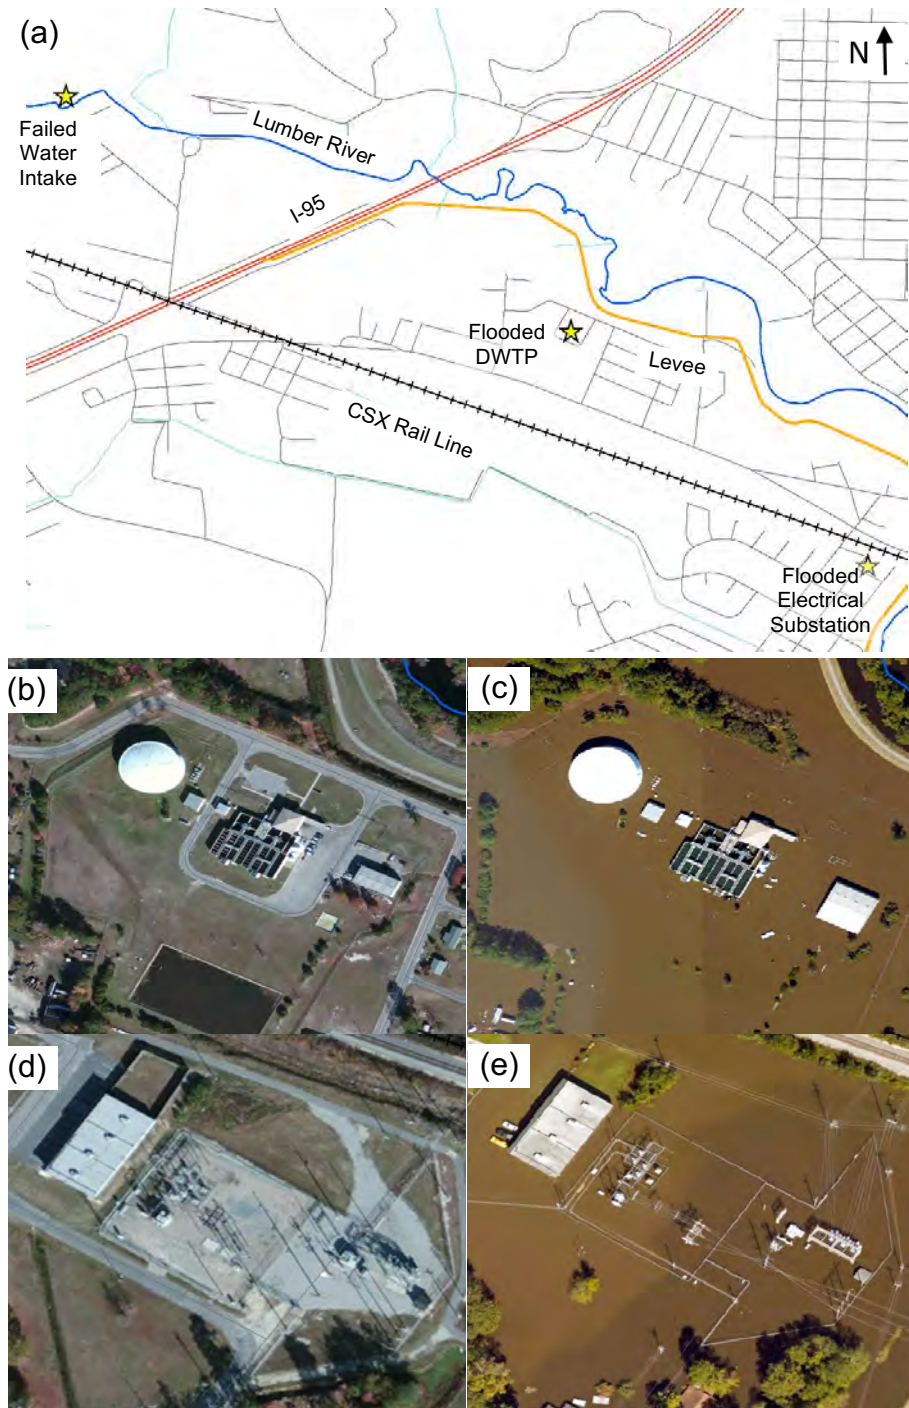
Hurricane Matthew disrupted water service in Lumberton (Armstrong, 2016) on October 10th, when the river intake pump suffered damage, a treatment plant generator failed, and the sole water treatment plant was inundated. Limited service was able to be resumed by October 15th, when 4 trailers carrying portable membranes were brought in to treat up to 6 MGD of water pumped directly from the groundwater wells, bypassing the treatment plant. Still, the wells began losing capacity after days of flushing an empty distribution system. A water conservation notice was issued to build up enough capacity to flush pipes and backwash the treatment filters. The conservation notice was lifted October 20th, but a boil water advisory for the city was active until the 25th. The treatment plant was operational by the end of the month, though the generator was still broken. Subsequent detection and repair of leaks in the distribution system revealed less subgrade damage than anticipated, with only one under-river main repair needed. The wastewater treatment plant was not damaged, although sanitary sewer overflows compromised the Lumber River water quality from upstream sources. Figure 2-17(a) indicates locations of failed networked systems for the city of Lumberton. Figure 2-17(b) and (c) show the drinking water plant serving the city before and during flooding, and Figure 2-17(c) and (e) show an electrical substation before and during flooding. The failed water intake was not visible in aerial imagery.

Figure 2-17. (a) A map of the flooded network infrastructure nodes, (b and d) aerial imagery of drinking water treatment plant (DWTP) and electrical substation before, and (c and e, respectively) during flooding. Photos: Esri, DigitalGlobe, GeoEye, i-cubed, USDA FSA, USGS, AEX, Getmapping, Aerogrid, IGN, IGP, swisstopo, and the GIS User Community.

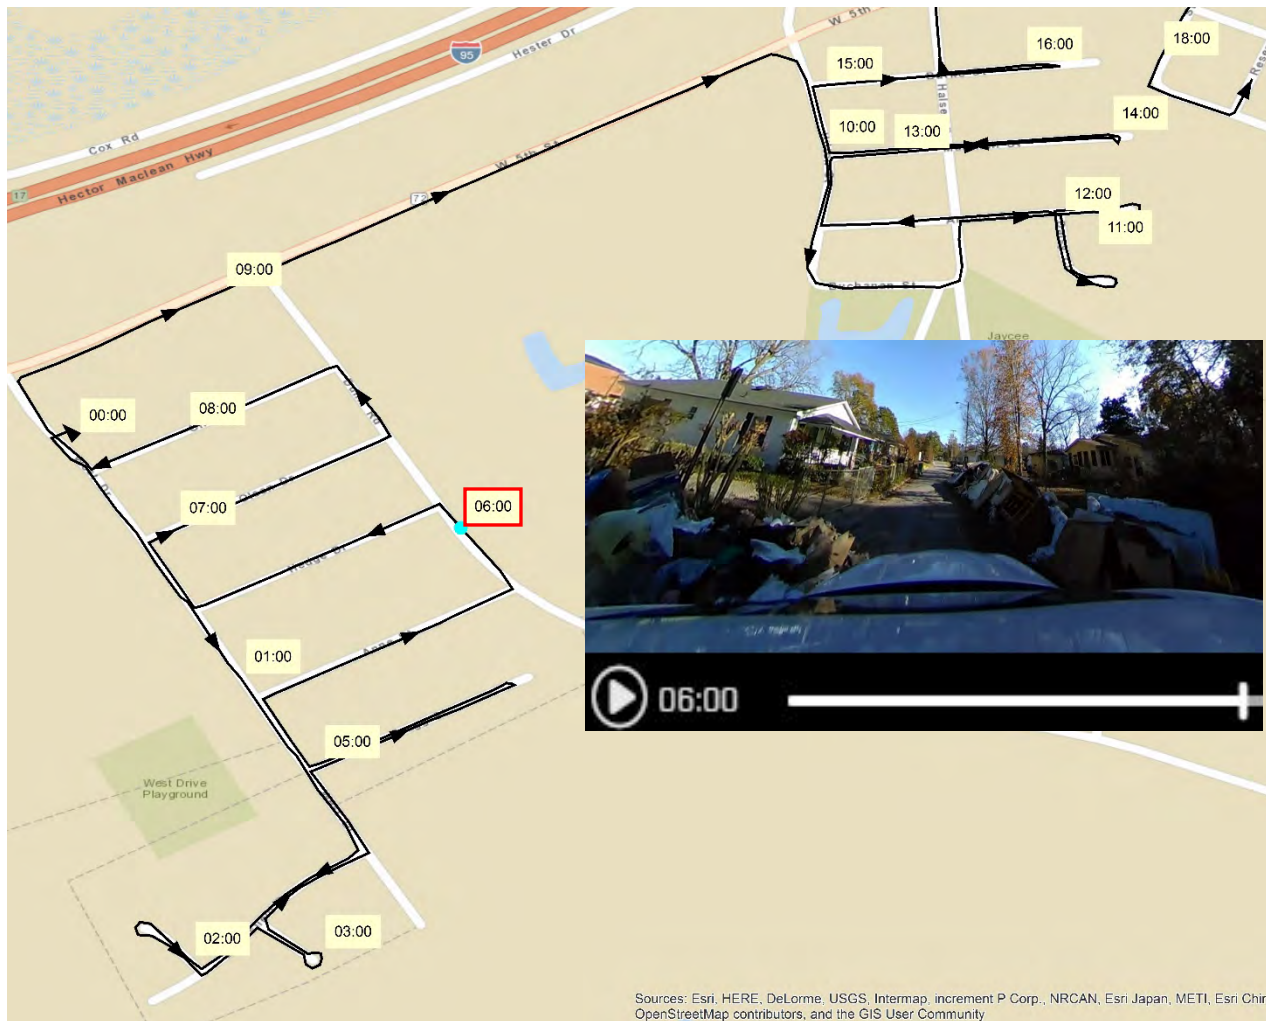
Figure 3-6. Map of 360° video path with arrows indicating direction and time labels.

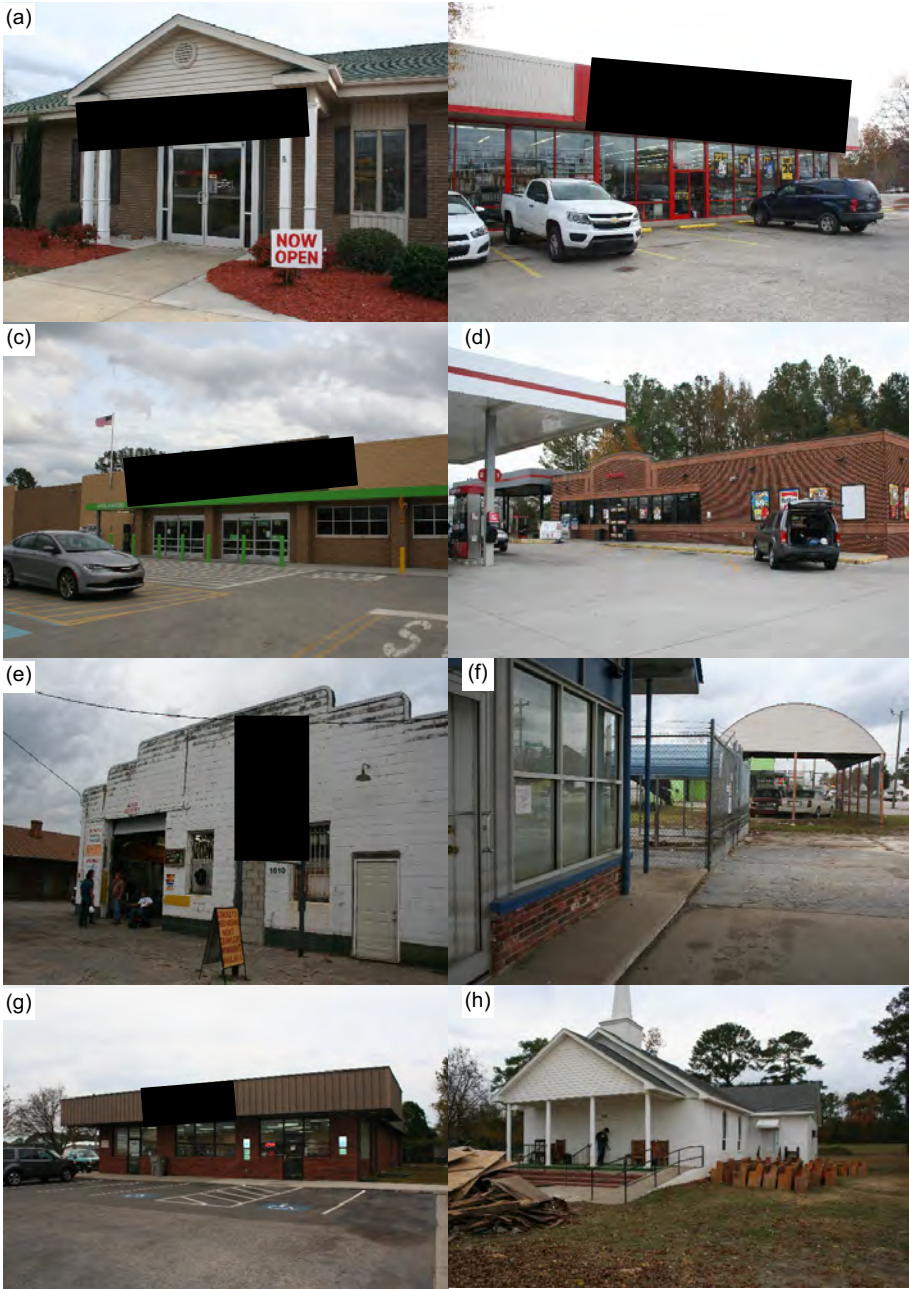
Figure 4-2. Front view of selected businesses.

The business sizes and types varied significantly. The non-residential inspections included two banks, three small retail stores, one big box retail store, two gasoline and convenience (small retail) stores, a propane distribution station, a produce center, a liquor store, a church, and a furniture store. Because all of these businesses were closed during the flood and for several weeks post-flood, most employees were not able to work. Many of the businesses adapted their locations and/or that of their employees to best continue operations: the big box store moved employees to other stores in the area; two of the small retail stores allowed employees to work in other locations; one of the banks shifted employees to another location; and the propane distribution center moved the entire operation to another rented location and will permanently close the location on 5th Street. The buildings inspected are shown by location in Figure 4-1 and a front view of each of the sites listed is presented in Figure 4-2.

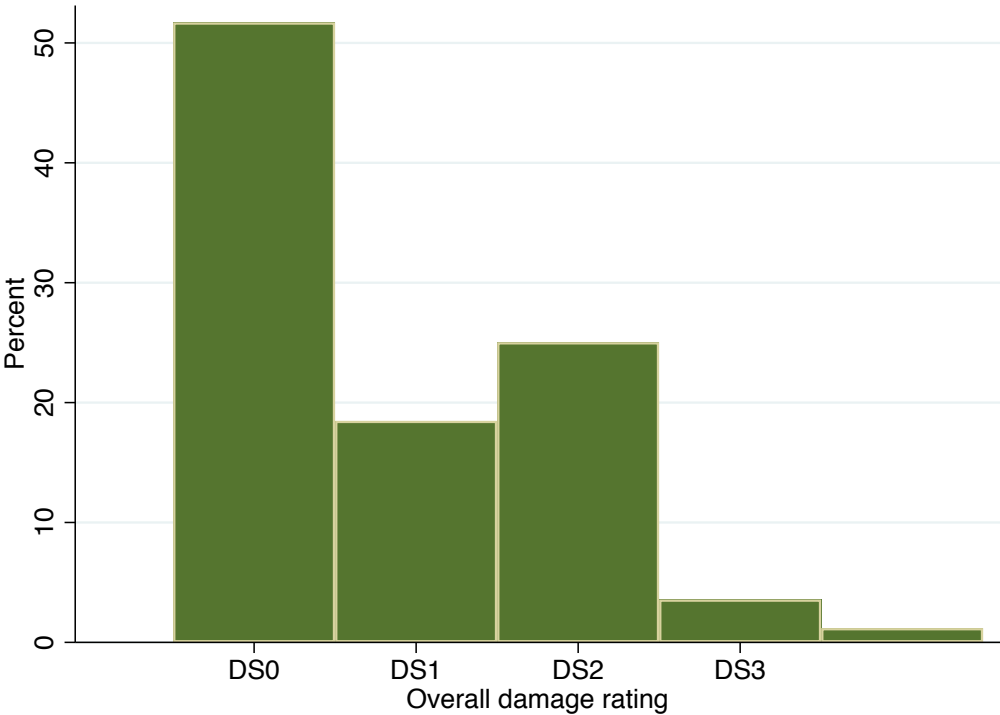
Figure 4-7. Overall damage state ratings of residential housing units.

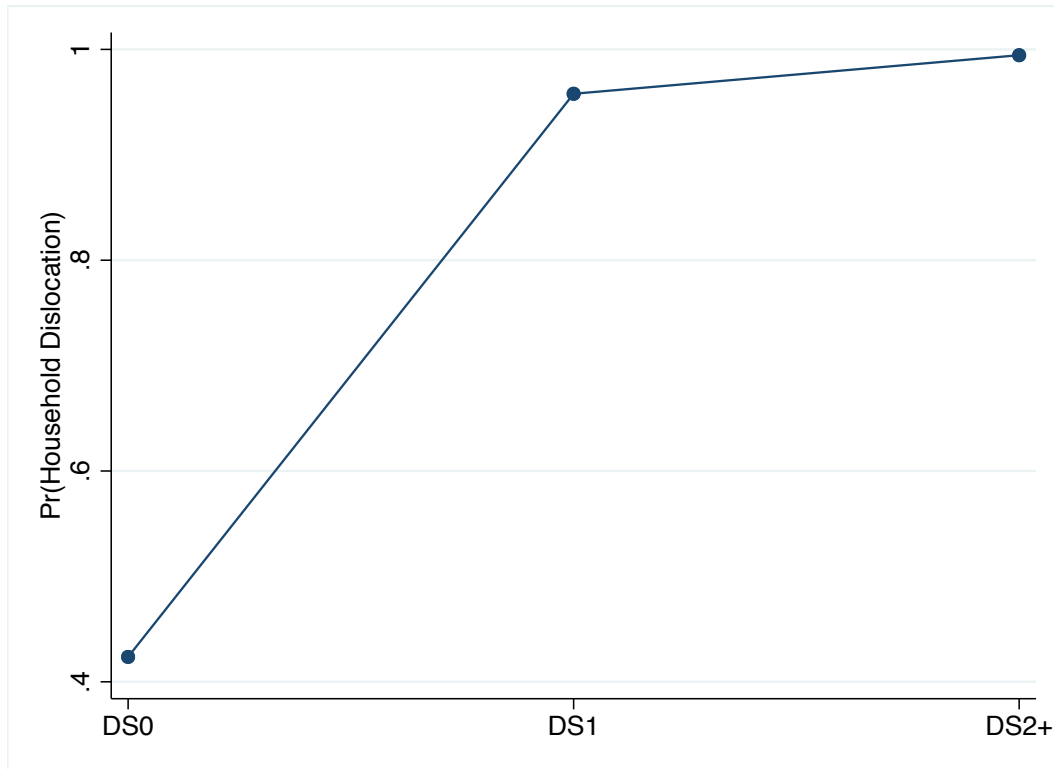
Figure 4-12. Probability of household dislocation by different damage states.
