**NIST Technical Note 1708**

# **Initial Reconnaissance of the 2011 Wildland-Urban Interface Fires in Amarillo, Texas**

July 2011

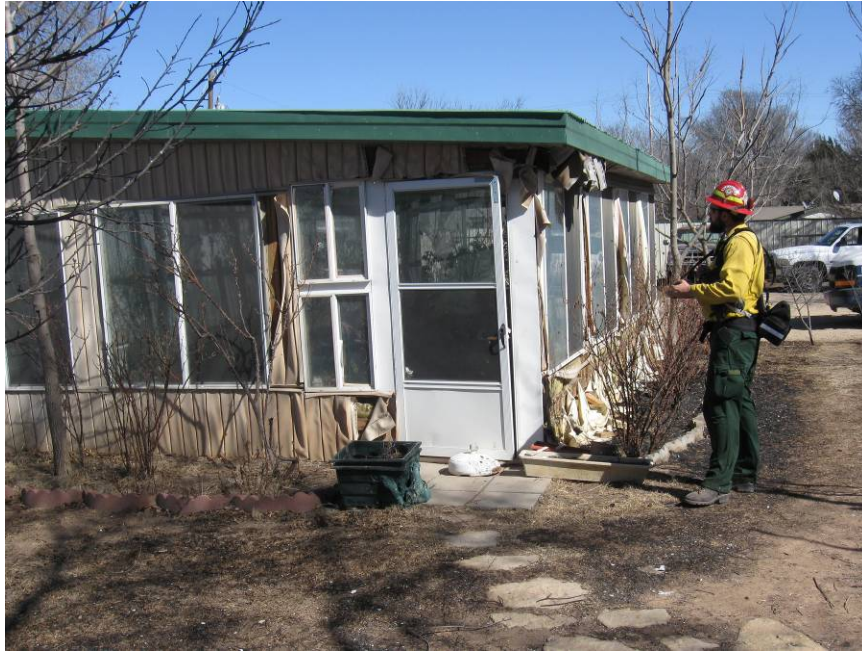
collections. Figure 9 is a photograph of a data taker using a tablet PC while inspecting a fire damaged structure.

**Figure 9 Tanglewood Complex Fire WUI 2 data collection using the tablet PC (NIST photo).**
