NIST Technical Note 1752

**Digital image correlation measurements during gusset
plate connection testing to structural failure.**

This report describes the use of three-dimensional (3D) digital image correlation to measure the shape, displacement, and in-plane strain fields, during testing of gusset plate structural connections. Twelve full-scale bridge gusset plate connections of various geometries and boundary conditions were tested at the the Federal Highway Administration (FHWA) Turner-Fairbank Highway Research Center (Ocel et al., 2012). These experiments are part of the verification of numerical models as part of the National Cooperative Highway Research Program (NCHRP) Project 12-84 “Guidelines for the Load and Resistance Factor Design and Rating of Riveted and Bolted Gusset Plate Connections for Steel Bridges”. The measurements described here are in regards to the tests performed to failure (i.e., maximum load carrying capacity of the connection). During each of the twelve tests to failure, a series (typically about 150) of image pairs were taken for subsequent digital image correlation analysis. Although all of the image pairs were processed, only a very small portion of

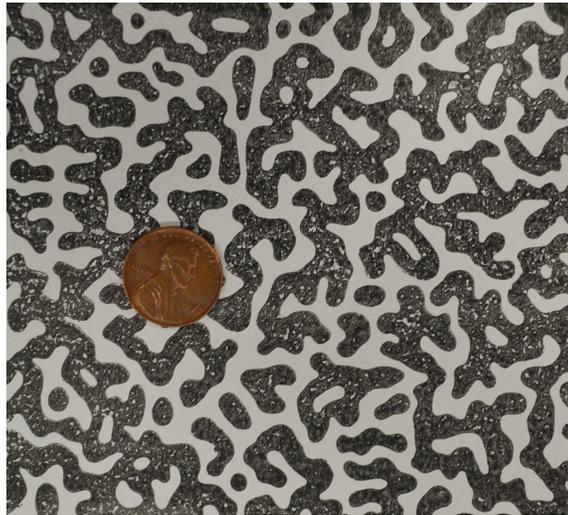
Figure 4: Pattern used for digital image correlation measurements as painted on a gusset plate specimen. A 19.0 mm diameter coin is shown for reference.

The North gusset plate was first painted matte white, then patterned with matte black ink stamped on the surface. Minor scratches and other damage to the pattern due to assembly were touched-up using paints of both black and white before testing began. The stamp pattern is 130 mm by 180 mm, which results in a slight chance of aliasing during correlation, due to the pattern repetition. This is rarely an issue because of the natural variation in the quality of the stamped pattern. This aliasing did occasionally occur during post processing, but was corrected through a combination of adjusted correlation thresholds or in extreme cases trimming of problem areas from the correlation analysis. The stamp pattern is designed to be semi-random with a nearly equal amount of area that is black or white (Fig. 4). The size of the pattern is such that the black and white features are each about 5 mm wide. This results in two to three edges being visible in any 15 mm length on the plates.

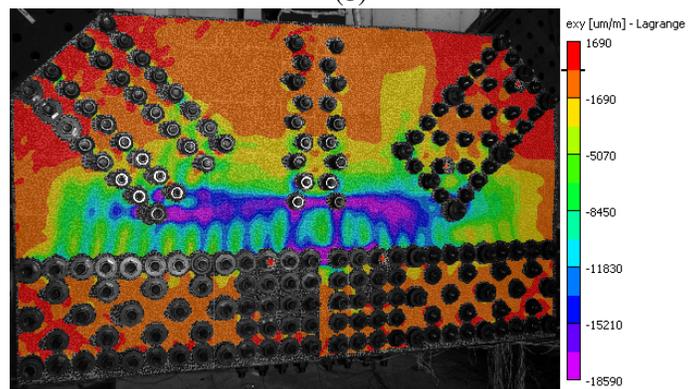
Figure 11: Strains (a) ϵ_{XX} , (b) ϵ_{YY} , and (c) ϵ_{XY} for GP307-SL3 measured at failure (maximum load, ALF = 0.95).

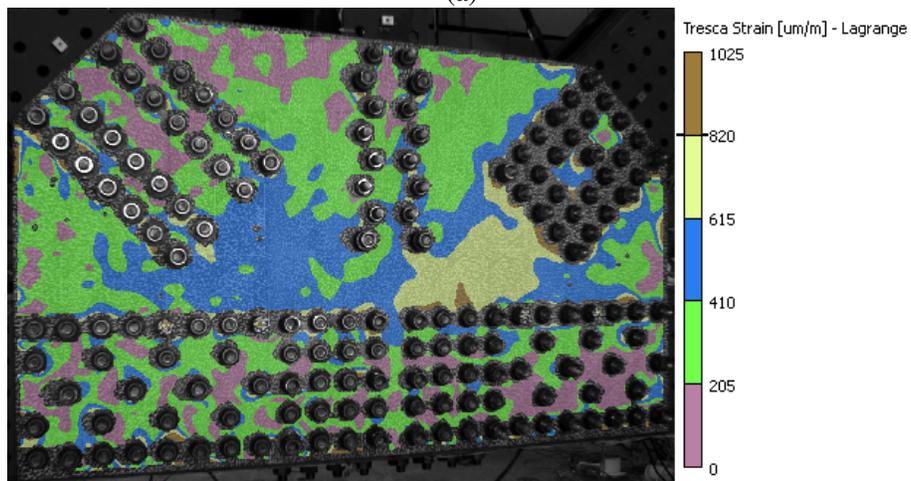
Figure 15: Maximum in-plane shear strain for GP307-SS3 at ALF of (a) 0.30, (b) 0.40, (c) 0.57, and (d) 0.71 (failure), with initial yield at $820 \mu\text{m}/\text{m}$.

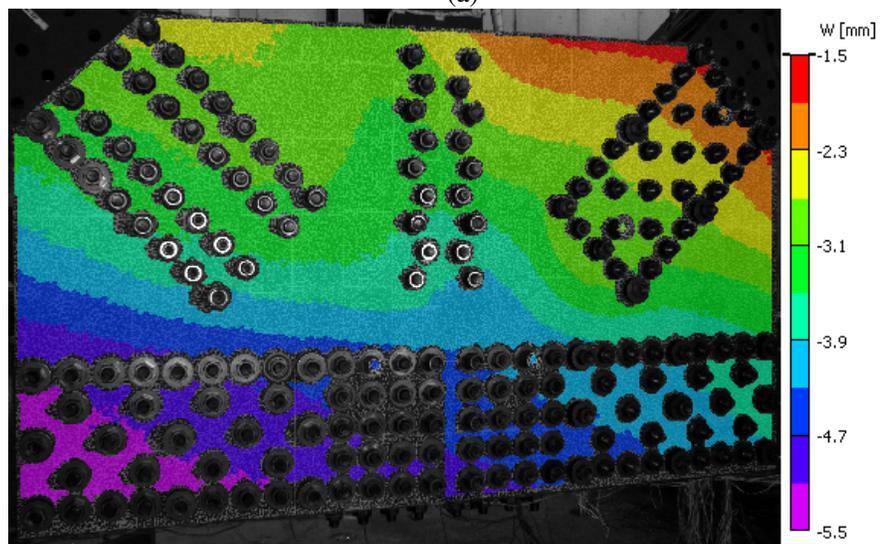
Figure 20: Out-of plane displacement (W) fields from the reference state to current plate shape for GP307-SL3 at ALF of (a) 0.33, (b) 0.52, (c) 0.68, and (d) 0.95 (failure).

Figure 19 shows the initial shape of GP307-SL3 at the start of the failure test under no load, after the plate was rotated to the selected coordinate system. After that rotation, the plate is relatively flat with a slight depression near the East Chord bolt line. Figure 20 shows the evolution of the Z-direction displacement from the initial shape in Fig. 19. The ALF values are in regards to the Compression Diagonal load (Table 4). During the test, the entire plate shifted toward the negative Z-direction from an early stage, until the final buckling of the Compression Diagonal in the positive Z-direction (Fig. 20d). Figure 21 plots the maximum in-plane shear strains at the same four ALF levels shown in Fig. 20. The yield strain in terms of Tresca strain is approximately

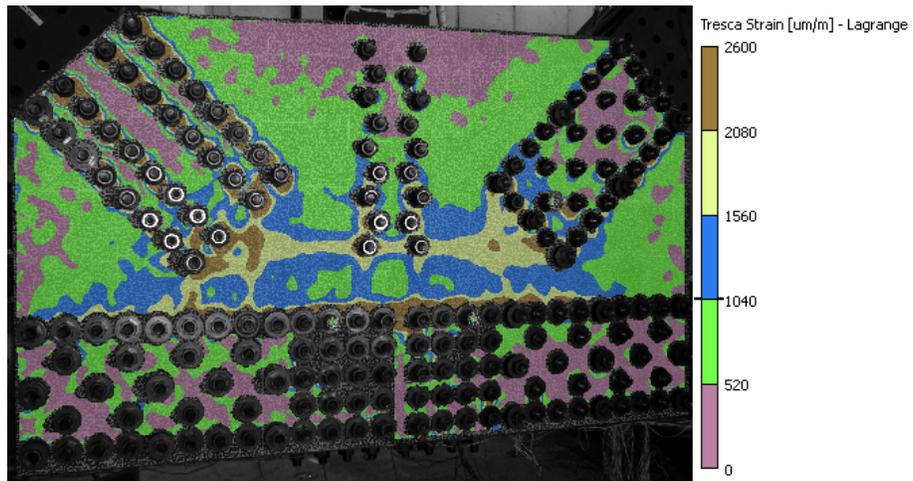
Figure 21: Maximum in-plane shear strain for GP307-SL3 at ALF of (a) 0.33, (b) 0.52, (c) 0.68, and (d) 0.95 (failure), with initial yield at $1040 \mu\text{m}/\text{m}$.

1040 $\mu\text{m}/\text{m}$, based on standard material testing of the same material. Figures 21a–c have strain ranges predominately in the elastic range and use a pseudorandom color map. Figure 21d has a strain range predominately in the plastic strain range (spectrum color map) with grey being used for areas of the plate that have not yet reached the yield strain. The results show that the Tresca strains were concentrated between the ends of the Compression and Tension Diagonals during the early stages of loading (Fig. 21a and b), with the largest strains occurring at the end of the Compression Diagonal and along the Chord bolt lines. The strain field is more uniform in the early stages of loading (Fig. 21a and b), but the later two stages (Fig. 21c and d) show more strain localizations, which extend across the plate between the diagonal bolt lines through the end of the Vertical bolts. Additional strain localizations of lower magnitude extend from this bands down to the Chord bolt lines.

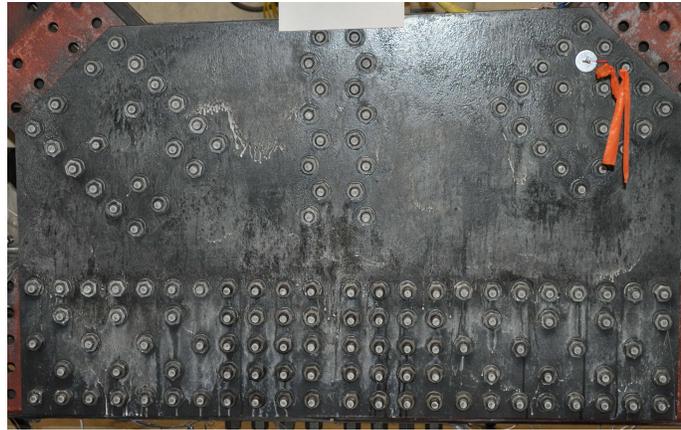
Figure 48: Comparison of brittle coating and maximum in-plane shear strain for GP490-LS3-1 connection. Mirror images of brittle coating on South gusset plate (a) unloaded initial condition and (b) at $ALF = 0.75$, and (c) maximum in-plane shear strain for North gusset plate at $ALF = 0.75$.

Attempts were made to apply a brittle coating to the outside face of the South gusset plate with limited success. In many cases, the coating did not flake off as intended even at the maximum strains achieved during the tests to failure. One of the tests where the coating was successful was for GP490-LS3-1. Figures 48 and 49 show the brittle coating results on the South face of the connection compared to the Tresca strains on the North face. In both figures, the brittle coating results for the South face are mirror images of the South plate, thus the Tension Diagonal is on the upper left and the Compression Diagonal is on the upper right. Also in both figures, the first image is of the brittle coating before testing began at zero load ($\text{ALF} = 0$). The second image in each figure is the brittle coating after the specified amount of loading in terms of ALF. The brittle coating was not calibrated so the strain level to cause flaking is not known quantitatively, but in the images the results of straining is a change from an initial grey or black color to a white in specific areas. For example, the distinct thin bands of white under the Tension Diagonal in Fig. 48a that do not appear in Fig. 48b. The third plot in each figure is a plot of the Tresca strain where the plastic strain range is shown in color and the strains below the expected yield for the material ($1030 \mu\text{m/m}$) is shown in grey. When comparing the results for the brittle coating and the DIC measurements two details should be kept in mind: (1) the brittle coating and DIC measurements are made on two different sides of the connection, and although the connection is designed as symmetric the out of plane motion (Fig. 46) could suggest some bending thus creating a difference in strain from the South to the North plate; (2) the spatial resolution of the strain system is on the order of the DIC

In Fig. 48b and c, the bands of high Tresca strain are located in similar position to some of the white lines on the brittle coating at the same load level. These areas along the East Chord bolt line, between the Chord and Vertical bolts, and between the lower Tension Diagonal bolts and the Vertical and East Chord. There also exists additional white lines in the brittle coating (Fig. 48b) extending from the Tension diagonal bolt closest to the Vertical and extending from the second bolt from the plate edge on the East Chord. These two lines do not have a clear corresponding band in Fig. 48c, which shows these areas are only being elastically deformed. There also exists an area of plastic strain in Fig. 48c above the West Chord that is somewhat diffuse, that does not correspond to any visible change in the brittle coating (Fig. 48b). The lower spatial resolution of the DIC versus the brittle coating may explain the white bands where the DIC measures only elastic strain, but does not explain the area that has DIC measured plastic strains where there is no change in the brittle coating. This latter result could be a result of the out of plane shape near the Compression Diagonal (Fig. 45) which starts concave to the North and continues developing in that direction (Fig. 46), which suggests the South plate may be concave in the same location. This could result in some bending and increased tensile strains in the North plate and decreased tensile strains in the South plate below the Compression Diagonal.
