NIST Technical Note 1838

Simulation of an Attic Fire in a Wood Frame Residential Structure - Chicago, IL

Craig G. Weinschenk
Kristopher J. Overholt
Daniel Madrzykowski

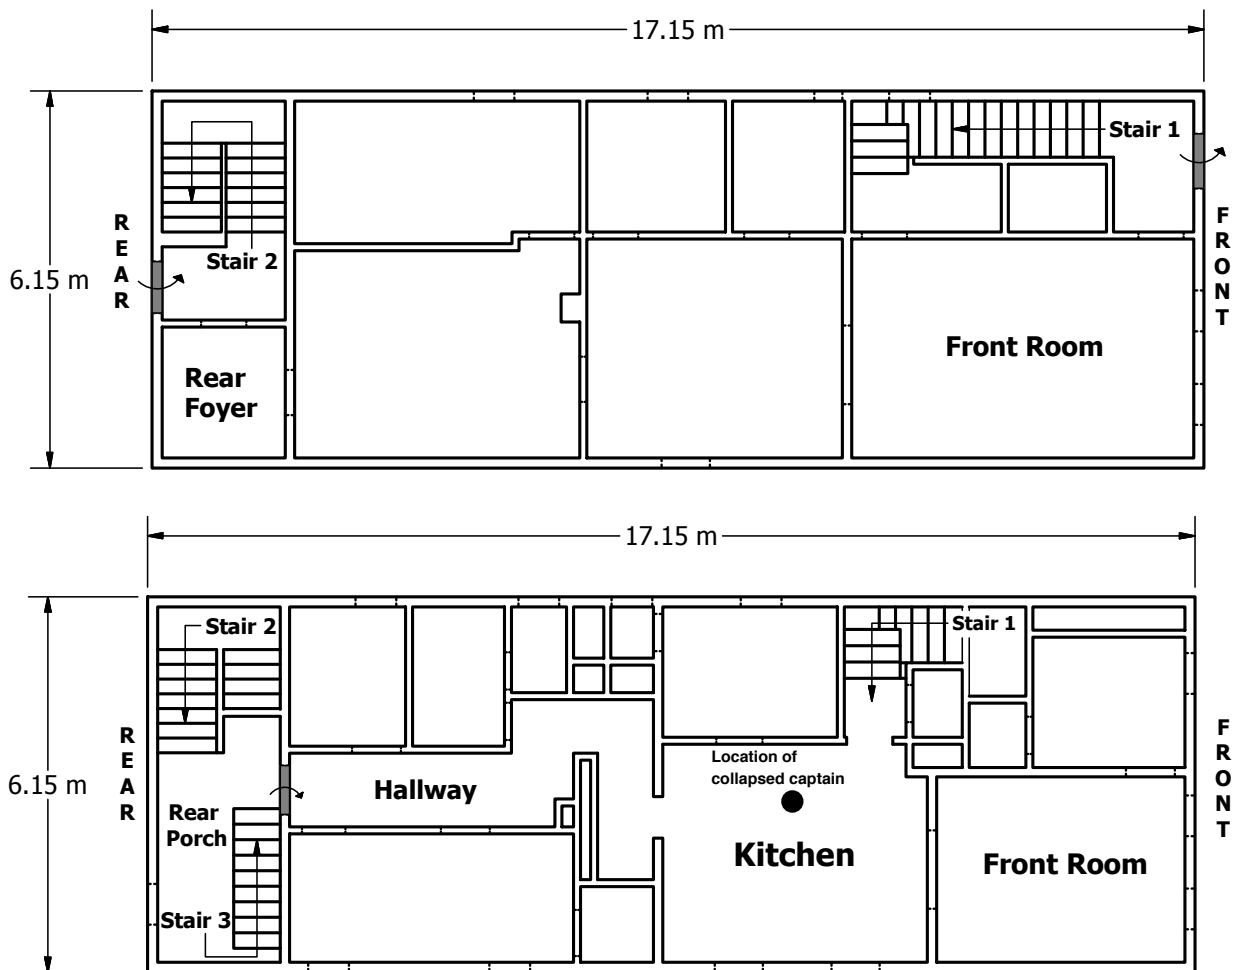
Figure 3.1: Plan view of first (top) and second (bottom) floor of structure. Stairs and key rooms are identified using measurements collected by NIST.

Table 2.1 shows an overview of the timeline of events. A plan view of the structure and the location where the captain collapsed are shown in Fig. 3.1, and more details of the fire development are provided in the following sections.

The structure involved in this fire incident was a 2 ½ story residential building with balloon frame construction and a gable roof.¹ The structure had a 17.15 m (56 ft) by 6.15 m (20 ft) footprint, as shown in Fig. 3.1. This results in a floor area of approximately 105 m² (1100 ft²) per floor and a main living area of approximately 110 m² (2200 ft²). The interior walls were constructed from nominal lumber covered by 12.7 mm (0.5 in) gypsum board [8]. Additionally, there was a half-story attic that contained the structure's hot water heater. Three sets of stairs were present in the structure: one front stairwell that connected the first and second levels (Stair 1 in Fig. 3.1), one rear stairwell that connected the first and second levels (Stair 2 in Fig. 3.1) and a second rear set of stairs which provided access to the attic (Stair 3 in Fig. 3.1). Entry to the first floor of the structure can be made either in the front or rear, as shown in Fig. 3.1.

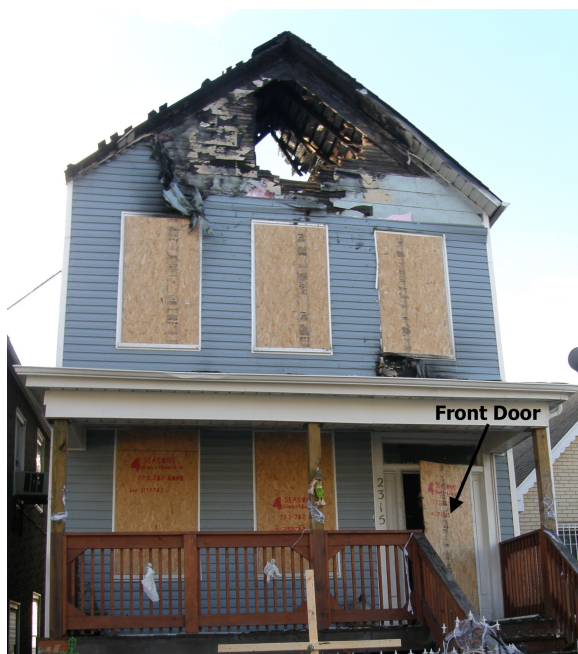
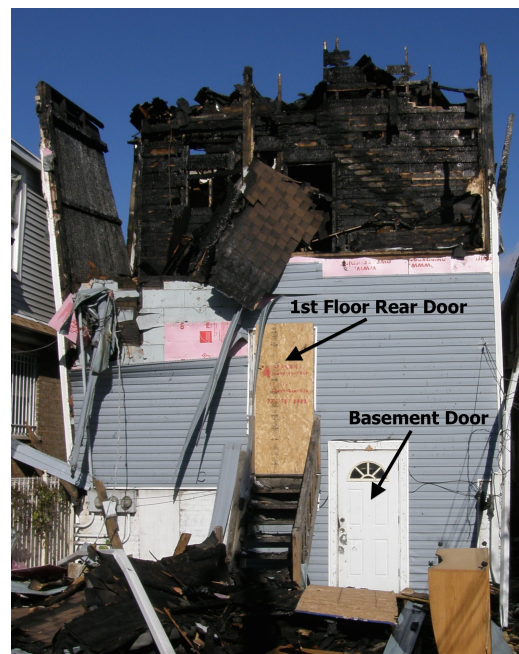
Figure 3.2: Photographs showing the front (left) and rear (right) exterior of the structure after the incident.

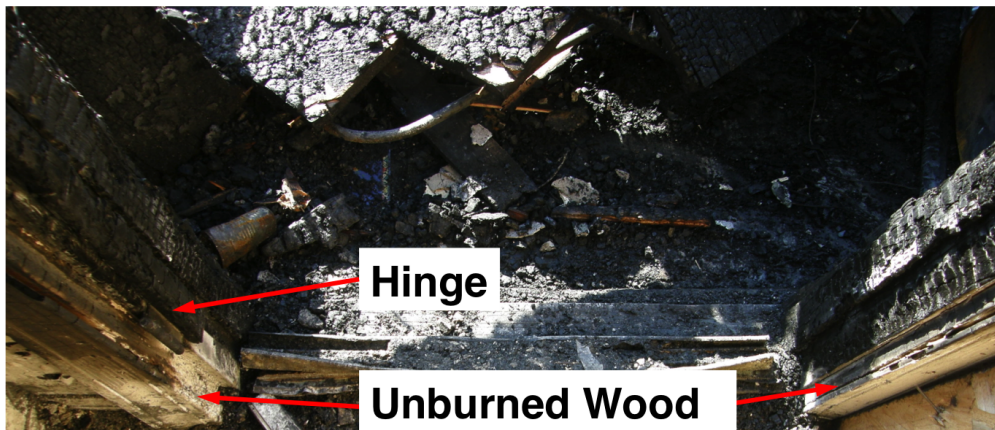
Figure 3.3: Post-incident image of the second floor porch door frame that failed taken from inside the structure looking toward the porch. Note that the hinge is still intact and there is unburned, “clean” wood along the bottom portion of the frame.

An unknown parameter in Table 3.1 that needed to be estimated was the time when the second floor interior/porch door failed (160 s into the simulation). The area of failure was also estimated based on the following observations. The bottom hinge from the door appeared to be closed throughout the fire due to the lack of fire damage and the lack of soot deposited on the interior faces of the hinge and remaining wood, as shown in Fig. 3.3. It appears that the door collapsed and failed partially open. In the simulations, only the upper portion of the door was assumed to fail. While this time and area may not be exact, the takeaway from the analysis in the following sections should be impact of the door's failure on the interior conditions of the structure.

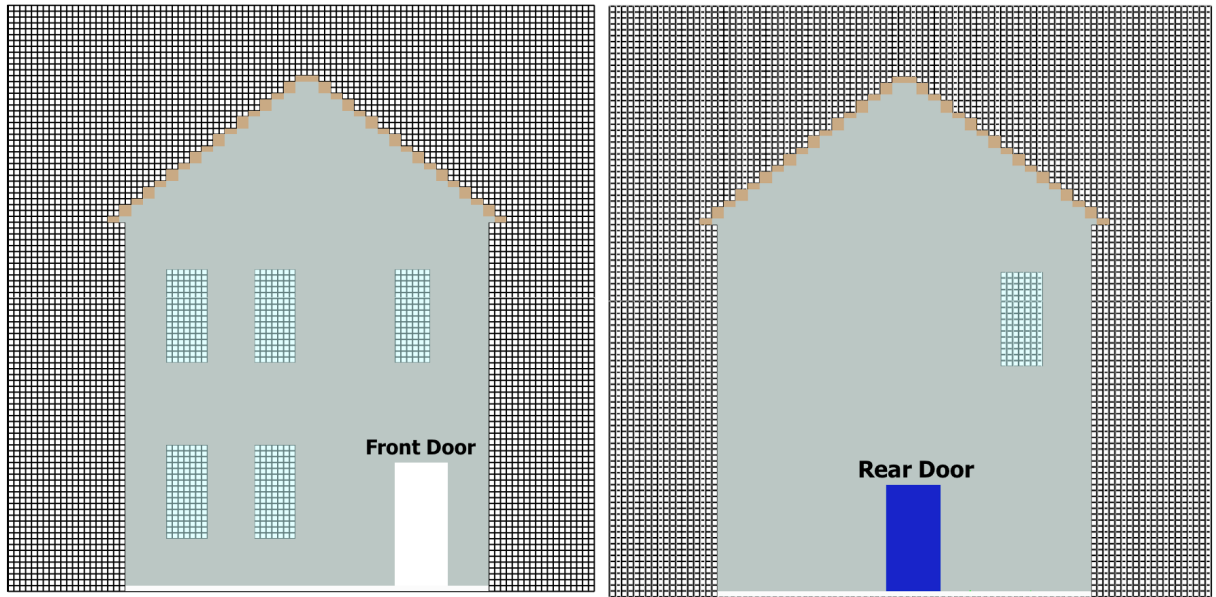
Figure 3.4: Front (left) and rear (right) of the structure with 10 cm computational mesh.

As discussed in Section 3.1, the structure has dimensions of 17.15 m (56 ft) by 6.15 m (20 ft) and a total height of 8.56 m (28 ft). To ensure adequately resolved fluid flow in and out of the structure, the computational domain was extended beyond the volume of the structure. The total volume of the computational domain was 24 m (79 ft) by 10 m (33 ft) by 10 m (33 ft). A grid resolution of 10 cm (3.9 in) was used, which required 2.4 million computational cells. As a result, all of the input model geometry lengths, ventilation openings (holes, doors, and windows), and fire areas will snap to the nearest 10 cm. Figure 3.4 shows the front of the structure rendered in Smokeview with the 10 cm mesh. The domain was divided into 16 equally sized meshes (each containing 150,000 grid cells) that could be processed in parallel, which reduced the amount of required calculation time to approximately 1.5 days. Figure 3.5 shows the entire structure within the computational domain that has been divided into multiple meshes. Table 3.2 shows a summary of the model input parameters for the simulations that were conducted as part of this study.

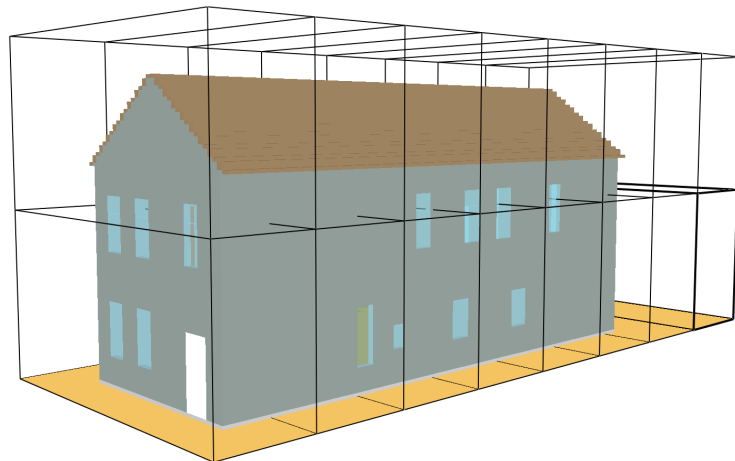
Figure 3.5: Front-right side of the structure within the computational domain (with multiple meshes). Each of the 16 meshes is 3 m (9.8 ft) by 10 m (33 ft) by 5 m (16.4 ft).

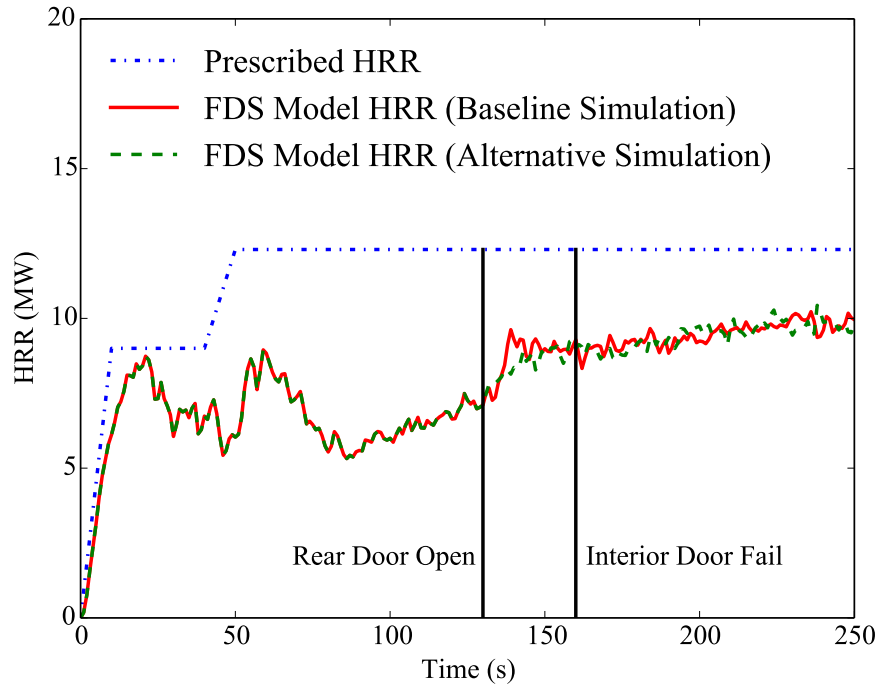
Figure 4.1: HRR versus time from the FDS simulations. The first vertical line indicates the time at which the back door failed (130 s), and the second vertical line indicates the time at which the interior hallway door failed (160 s).

The heat release rate output data from FDS quantifies the simulated rate of energy release in the simulation. Figure 4.1 shows the prescribed HRR versus time values based on the prescribed fires along with the FDS results for the two ventilation scenarios that were described in Section 3.4. The two vertical lines represent the time at which a firefighter opened the back door of the structure ($t = 130$ s) and the time at which the second floor interior door was estimated to fail ($t = 160$ s). Due to a lack of information about the time of fire ignition or how fast the fire grew, these parameters needed to be estimated. The growth rate shown in Fig. 4.1 (10 MW in approximately 20 s) is fast because the incipient stage of the fire growth was not considered in this study. The maximum size of the fire used in this study was selected such that the conditions would become ventilation limited quickly to minimize computational time while aligning with the timeline observations of video and picture evidence from the fire. Using this approach, the accuracy of heat transfer to the walls of the structure may be sacrificed; however, all of the window, door, and wall failures were driven by the event timeline rather than failure temperature criteria.

In Fig. 4.1, the solid line represents the baseline FDS simulation (this follows the noted door openings from the incident). The dashed line represents an alternative series of events in which the rear door does not get opened and the subsequent breach of the rear porch wall on the left side of the structure does not occur. The dash-dotted line represents the prescribed (or nominal) HRR that was input into FDS. As shown in Fig. 4.1, the HRR output from FDS is less than the prescribed HRR because the fire in the structure becomes ventilation limited. The maximum HRR value is slightly less than 9 MW before the fire becomes ventilation limited and begins to decay. The HRR is reduced to 5 MW as the oxygen inside the structure is consumed. There is an insufficient amount of oxygen in the structure to burn all of the fuel, therefore combustion occurs locally at the vents where fresh air is available. Figure 4.2 shows flaming combustion through the failed window on the rear side of the structure and attic breach just after the second fire ignites at 40 s. After additional

wall breaches occur at 45 s and 55 s (see Table 3.1), the abrupt change in ventilation causes the HRR to increase to 9 MW before it decreases to approximately 6 MW. The HRR then increases towards a sustainable steady-state value.

Figure 4.1 indicates that the HRRs for both of the ventilation scenarios in FDS are identical until 130 s ($\text{HRR} \approx 7 \text{ MW}$). At 130 s, the rear door is opened in the baseline simulation. At 135 s, there is an additional breach on the left side of the structure (Table 3.1). The open door and breach act as additional pressure releases for the structure. Again, the abrupt change in ventilation causes the HRR to increase from approximately 7 MW to 9.7 MW at 139 s. At the time of the door failure (160 s), the HRR in both cases was approximately 9 MW because of the increased amount of ventilation. While there might be some locally different burning characteristics between the baseline simulation and the alternative simulation, the interior conditions in both cases presented a significant hazard to firefighters inside of the structure. Therefore, the analysis will focus on the results of the baseline simulation.

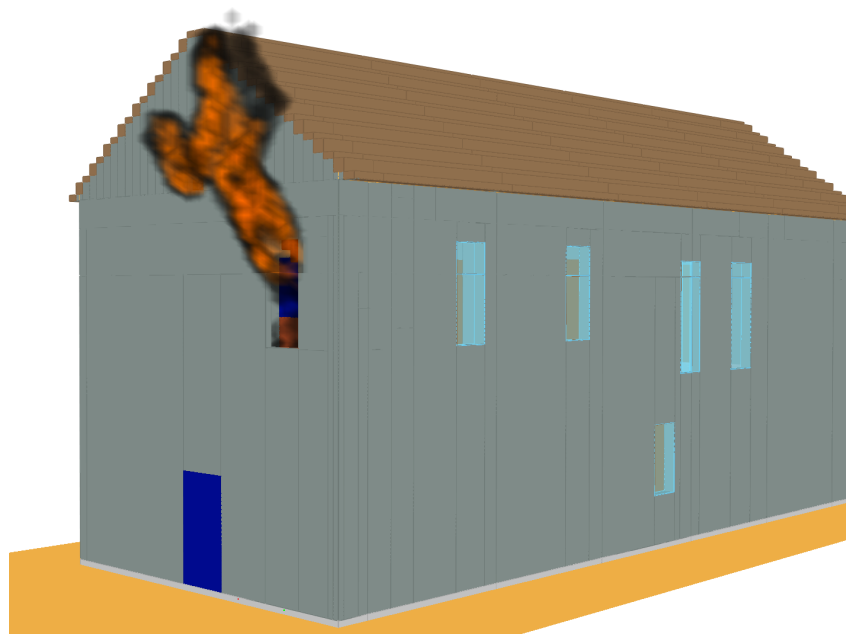
Figure 4.2: Smokeview rendering of exterior combustion occurring on the rear side of the structure.

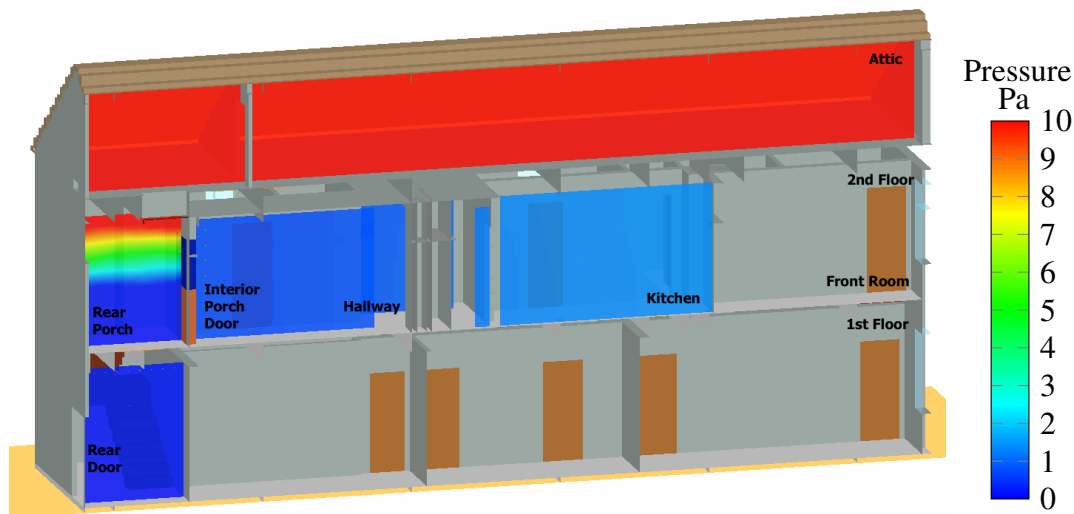
Figure 4.3: FDS simulated pressure contours, 1 s prior to interior door failure.

As the simulated fire grows in the attic and rear porch, the pressure rises. Figure 4.3 shows the calculated pressure conditions in the structure just before the interior door failed in the simulation. On the rear porch, the pressure rise ranges from a 4 Pa (5.8×10^{-4} psi) over-pressure at a height of 1 m to greater than 10 Pa (1.5×10^{-3} psi) at the ceiling. Gases at an elevated pressure will always move towards a region of lower pressure. The door serves as a boundary between the high and low pressure regions. Once the door fails open, the high pressure gases flow towards the low pressure regions in the house, hallway, kitchen, and front stairwell. The velocity vectors shown in Fig. 4.4 (15 s after the interior door fails) indicate the direction of flow within the structure.

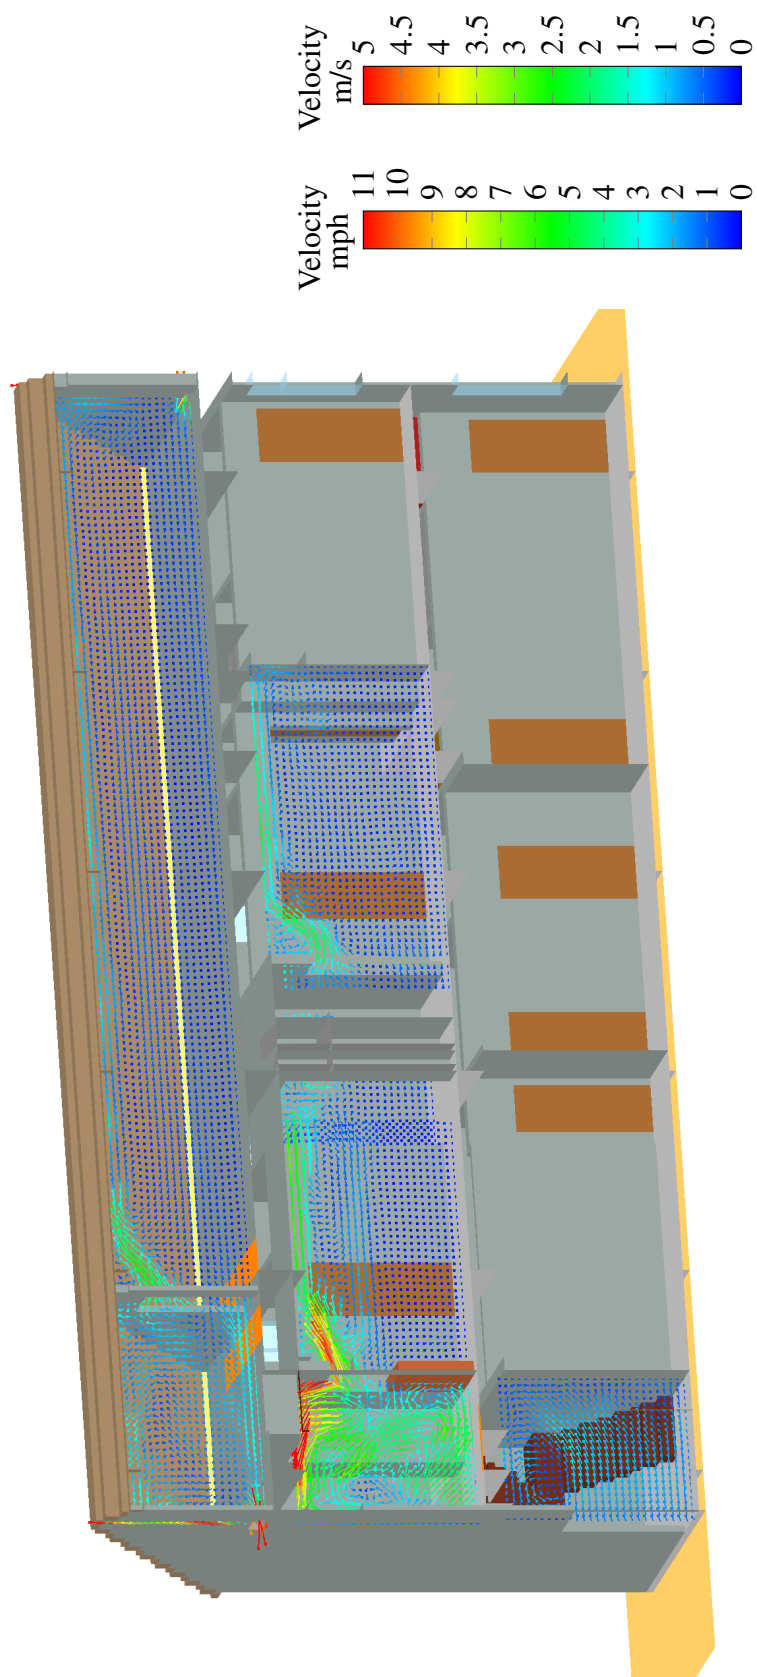
Figure 4.4: FDS simulated velocity vectors, 15 s after interior door failure.

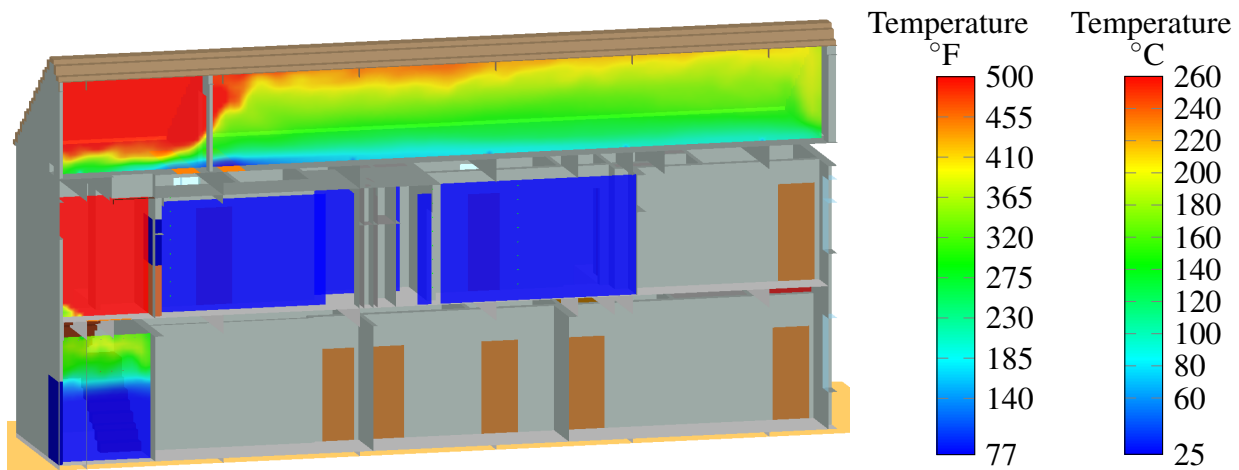
Figure 4.5: FDS simulated temperature contours, 1 s prior to rear door opening.

Figure 4.5 shows temperatures of at least 260 °C (500 °F) in the second floor rear porch and rear portion of the attic. In this figure, the lower temperature bound is set to 25 °C (77 °F), and the upper temperature bound is set to 260 °C (500 °F); however, these are only limits on the visualized output, and the actual simulated temperatures may exceed the lower or upper bounds.

High temperatures, between 80 °C (185 °F) and 200 °C (390 °F), also extend down to the rear entrance on the first floor. Before the interior door fails (Fig. 4.6), the inflow of ambient air from the open rear door reduces the temperatures near the interior doorway, but at the same time, the HRR increases because of the additional ventilation, as shown in Fig. 4.1. As shown in Fig. 4.7, after the second floor interior door fails, the high temperature gas that filled the rear porch flows in the direction of lower pressure (i.e., towards the front door). Note that the conditions in the attic do not appear to change.

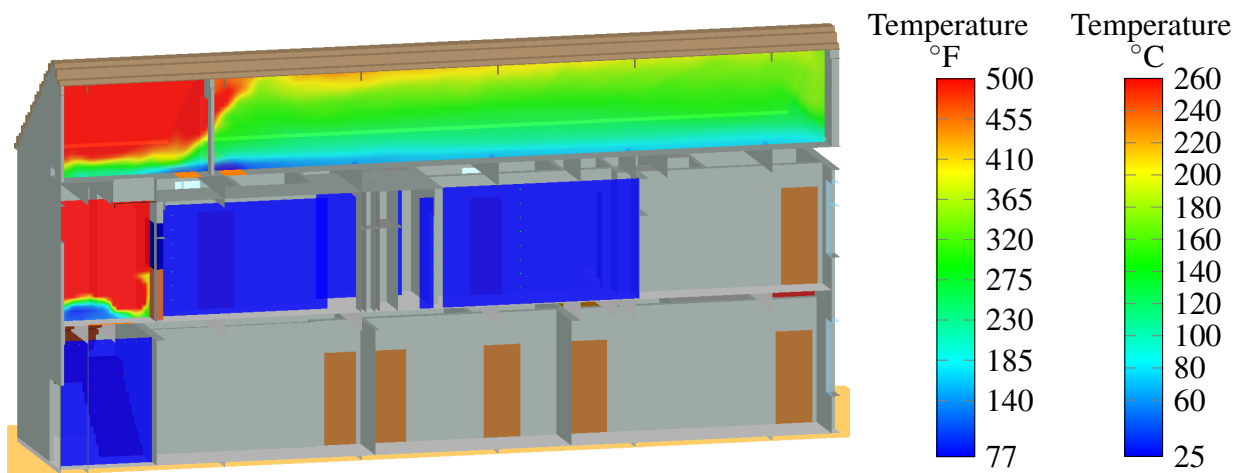
Figure 4.6: FDS simulated temperature contours, 1 s prior to interior door failure.

Analysis of the temperatures from the FDS simulation focuses on the high hazard areas of the structure: the attic, the rear porch and stairwell, and the interior hallway which connects the rear porch to the front stairwell. The temperature profile at these high hazard areas is shown via several snapshots in time to illustrate the change in the interior conditions. The first snapshots are shown at a time of 129 s into the simulation, just before a firefighter opened the rear porch door (as shown in Fig. 4.5), and 159 s into the simulation, just before the interior door fails (as shown in Fig. 4.6).

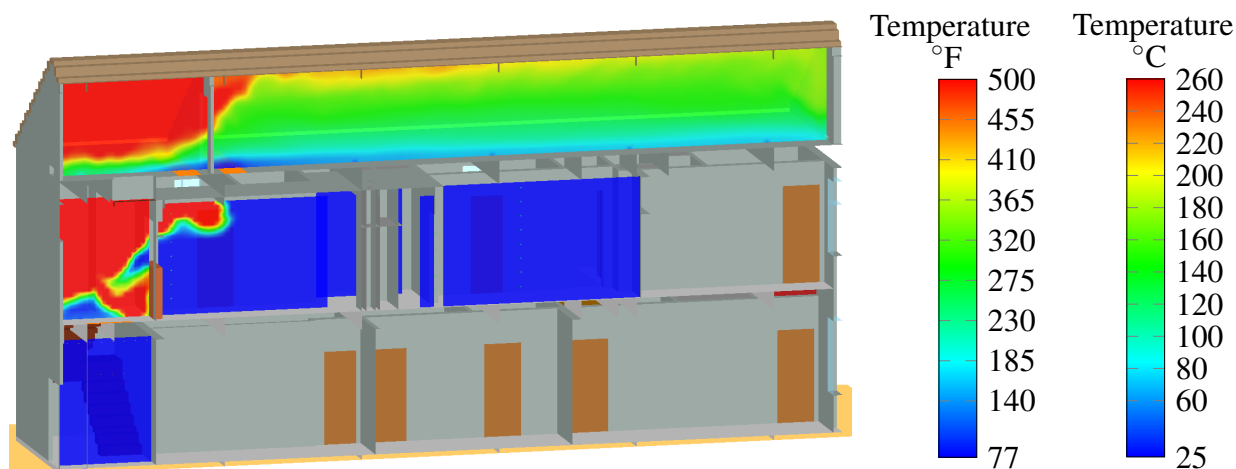
Figure 4.7: FDS simulated temperature contours, 1 s after interior door failure.

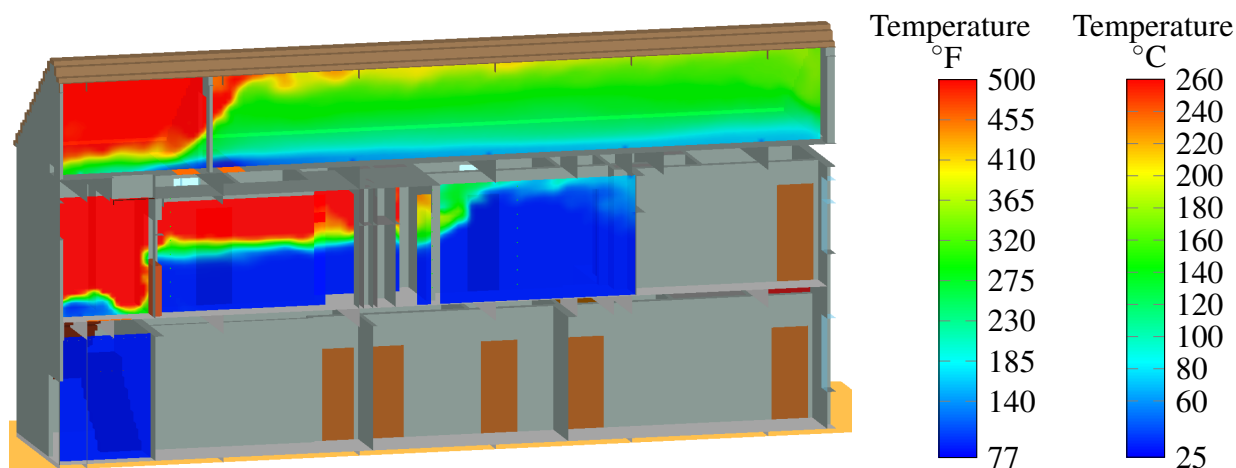
Figure 4.8: FDS simulated temperature contours, 15 s after the interior door failure.

As shown in Fig. 4.8, 15 s after the door failed, high temperature gases descended to approximately 1 m (3.28 ft) above the floor through the interior hallway and are flowing into the kitchen.

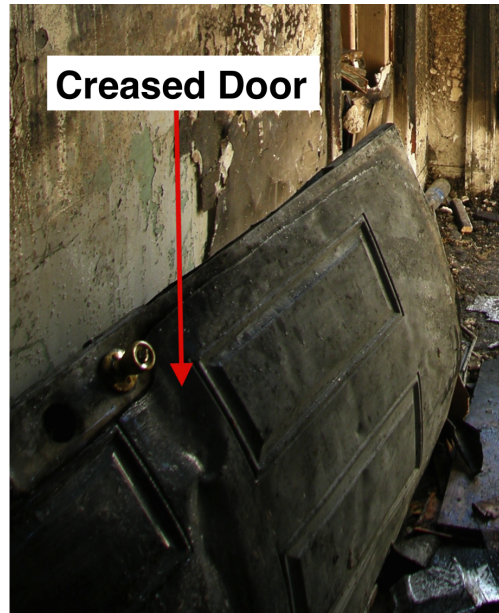
Figure 5.1: Post-fire image of interior door.

From on-scene reports (Section 2) and the FDS simulation results (Section 4.3), the interior conditions on the second floor of the structure were initially tenable. From the NIOSH report [8], while the IC was inside the structure on the second floor, only light haze and a glow around the door between the hallway and enclosed porch was observed. This indicated the presence of fire in the area of the enclosed porch. The simulation results indicate a high hazard area (temperatures greater than 260 °C or 500 °F) in the attic and the enclosed porch at this time. By the time the E123 captain and firefighter arrived on the second floor (Table 4.1) and approached the rear of the structure, the rear porch was fully involved. Temperature conditions greater than 260 °C (500 °F) were present on the porch side of the steel-faced, wood-framed door at the rear of the structure. Exposure to these conditions likely weakened the structural integrity of the door, which may have led to a partial failure (Table 4.1). Figure 5.1 shows the state of the rear door after the fire. Note the large crease in the steel face of the door just above the knob.

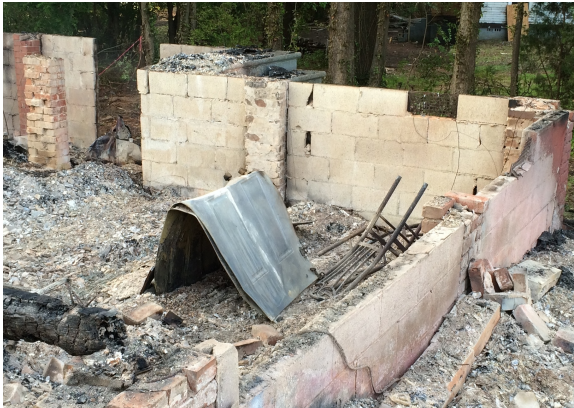
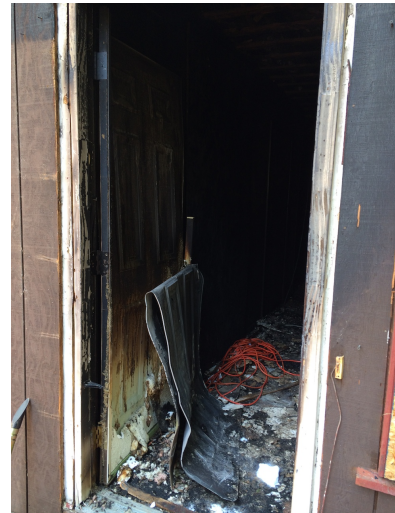
Figure 5.2: Post-experiment images of door failures.

Recent experiments conducted by NIST revealed similar post-fire states after doors of similar construction were exposed to fires. Figure 5.2 shows doors from two different residential fire experiments in different stages of degradation. In both cases, note that the door knob assembly served as a pivot point for the upper portion of the door to collapse around. This is similar to the location of the creases in the remains of the steel door that was located between the hallway and the enclosed porch in this fire incident.

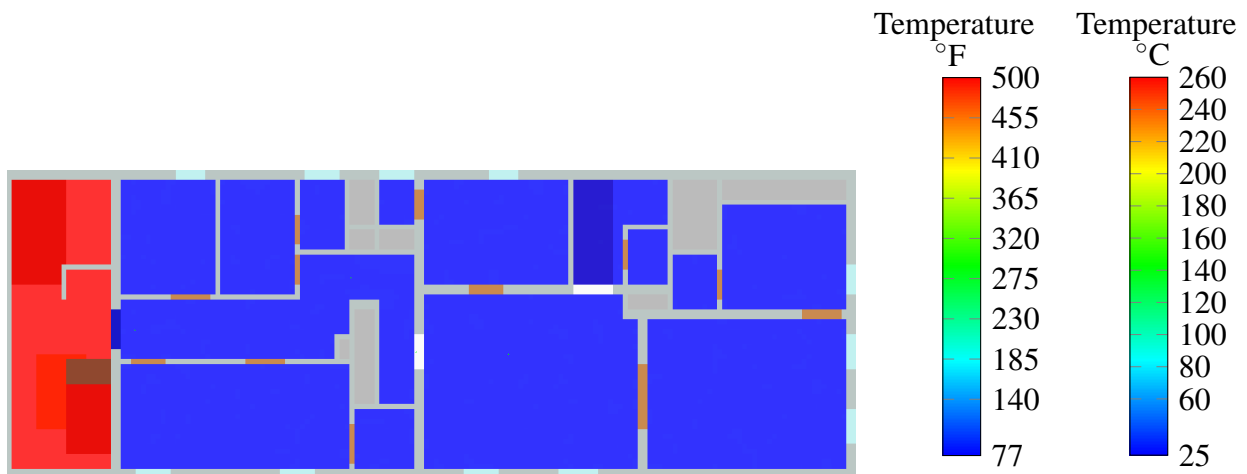
Figure 5.4: Temperature contours on the second floor, 1 s prior to interior door failure, 1.83 m (6 ft) above the floor.

Prior to the interior door failure, the elevated temperatures on the second floor were limited to the rear porch, as shown in Fig. 5.4. The temperatures were greatest at the back-left corner where there is sufficient oxygen due to the section of porch wall that had burned away and allowed additional oxygen to mix with the fuel-rich fire gases. Five seconds after the interior door failed, hot gases traveled the length of the interior hallway and approached the doorway into the kitchen, which was approximately 4.5 m (14.8 ft) away from the source fire, as shown in Fig. 5.5. Within 60 s of the interior door failure, the hallway temperatures were approximately at or above 260 °C (500 °F) throughout the hallway, as shown in Fig. 5.6. These results indicate that the high temperature gases seen 5 s after failure were not just a burst but rather the front of a sustained exhaust gas flow from the fire burning in the enclosed rear porch. The conditions in this hallway changed from tenable to high-hazard very rapidly following the door failure. Figure 5.6 also shows that the temperatures in the kitchen were at or below 90 °C (194 °F), and the temperatures at the top of the stairs were at or below 70 °C (158 °F). At these locations within the structure, the exhaust gases in the flow path were cooled and diluted by the inflowing ambient gas. These simulated temperatures are consistent with the post-incident conditions that were documented in the kitchen and second floor stairwell.

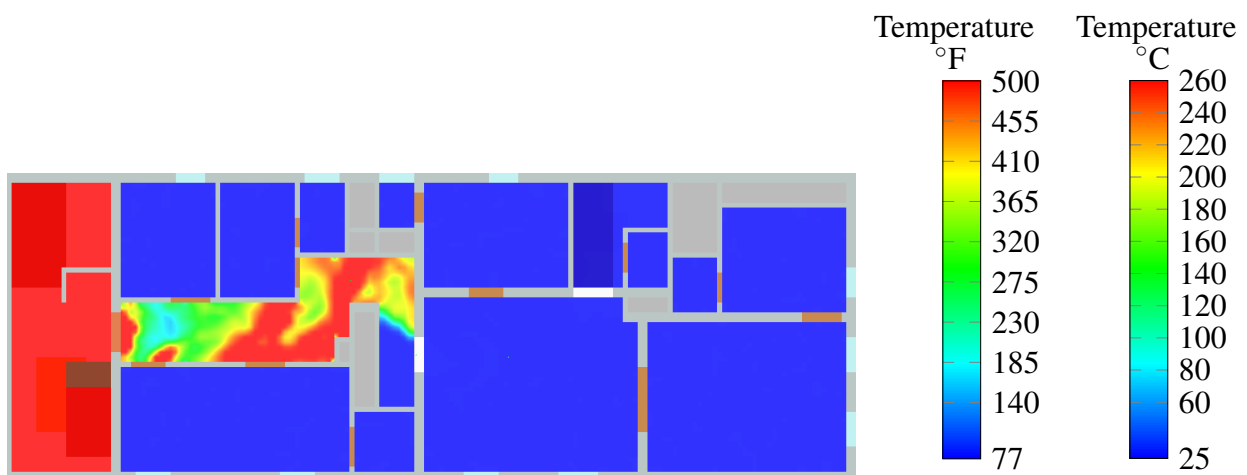
Figure 5.5: Temperature contours on the second floor, 5 s after interior door failure, 1.83 m (6 ft) above the floor.

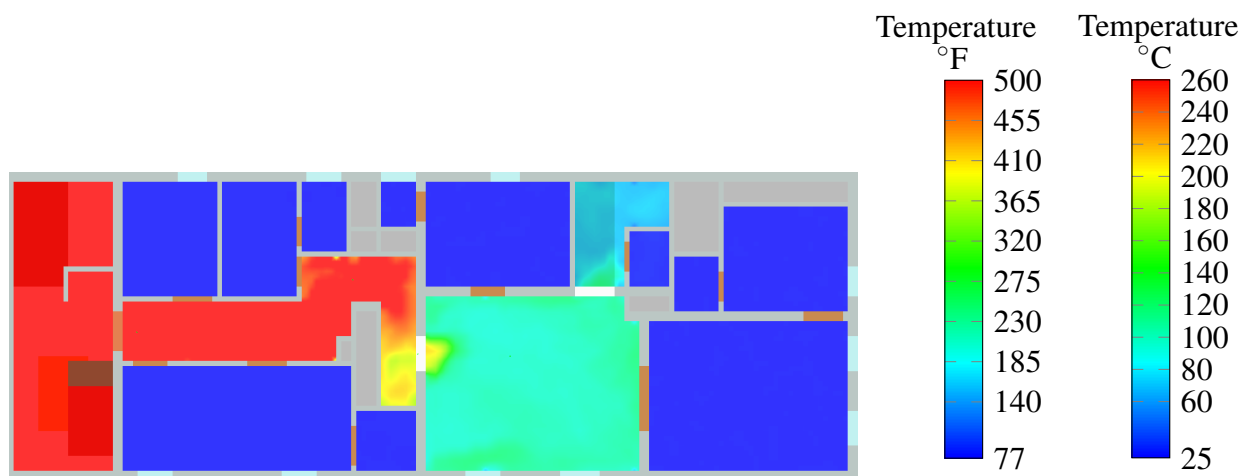
Figure 5.6: Temperature contours on the second floor, 60 s after interior door failure, 1.83 m (6 ft) above the floor.

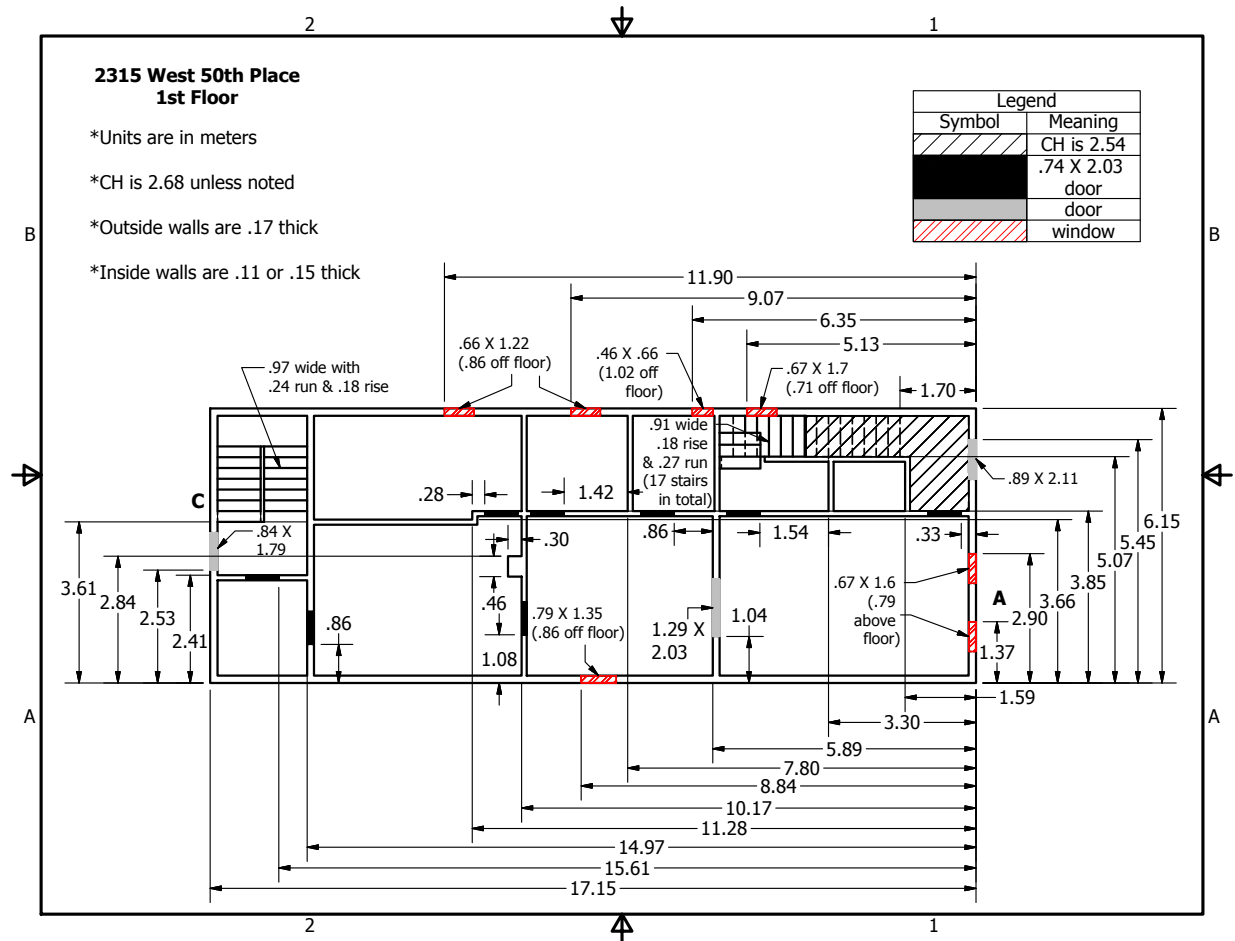
Figure A.1: Dimensioned drawing of first floor. The measurements are accurate to within 15 cm (6 in).

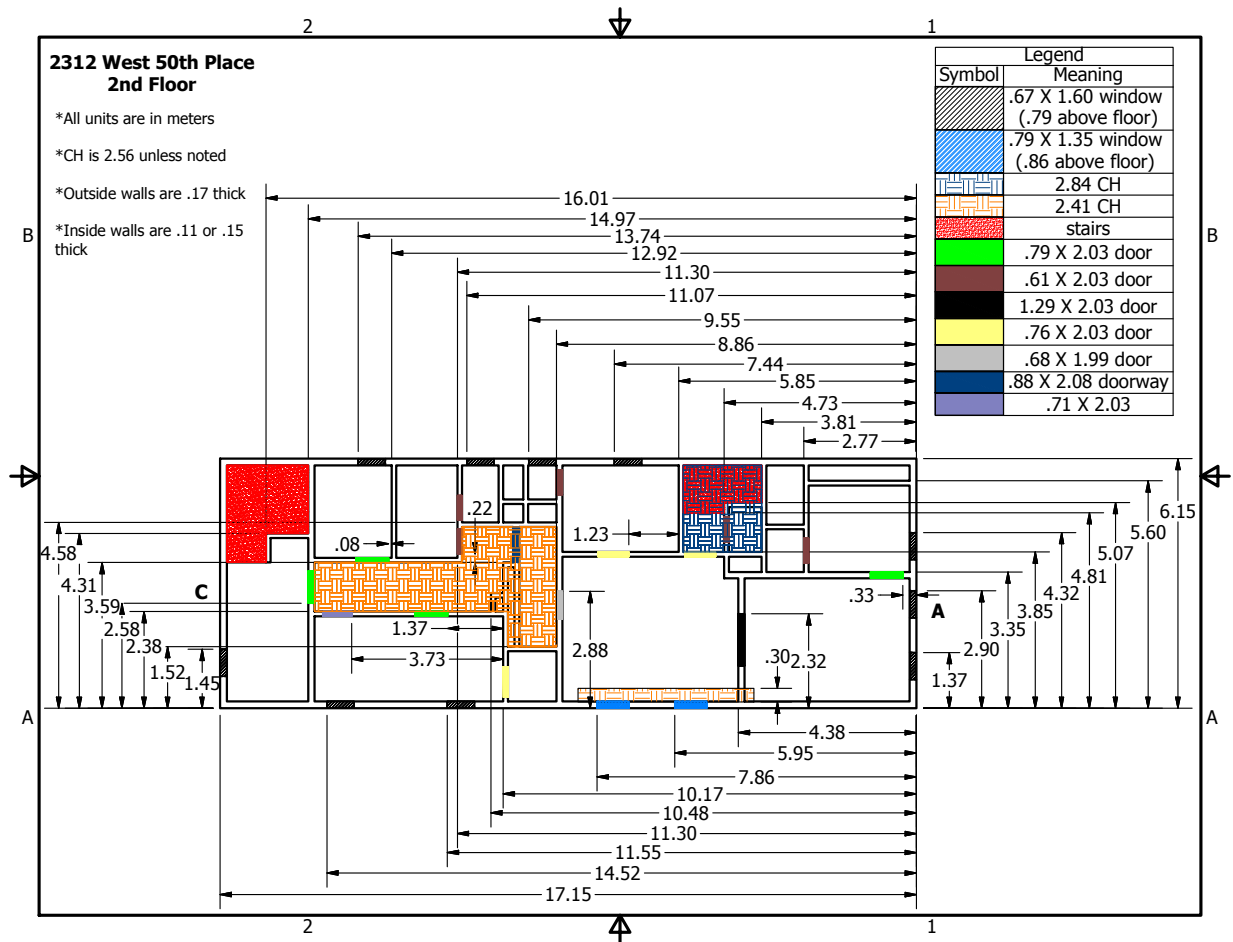
Figure A.2: Dimensioned drawing of second floor. The measurements are accurate to within 15 cm (6 in).
