National Fire Research Laboratory Commissioning Project: Testing Steel Beams under Localized Fire Exposure

NIST Technical Note 1983

This report presents the experimental design and results of a series of localized fire tests on structural steel I-shaped beams. A total of nine tests were conducted in the National Fire Research Laboratory, including thermal tests (Tests 1 through 5) and four-point bending tests at ambient (Test 6) and elevated temperatures (Tests 7 through 9). The specimens were nominally 6.2-m long W16×26 beams made of ASTM A992 steel. Each specimen was vertically supported with either a (i) simple support condition, or (ii) double-angles bolted to laterally braced support columns. The thermally-loaded specimens were exposed to fire generated using a natural gas burner. The burner had an area of 1 m² and was located 1.1 m below the bottom flange of the beam at midspan. A four-point flexural loading scheme was used to apply concentrated forces at two locations 2.44 m apart around midspan. The recorded data included temperatures, heat release rates from the burner, and structural measurements including forces, displacements and strains. The repeatability of several

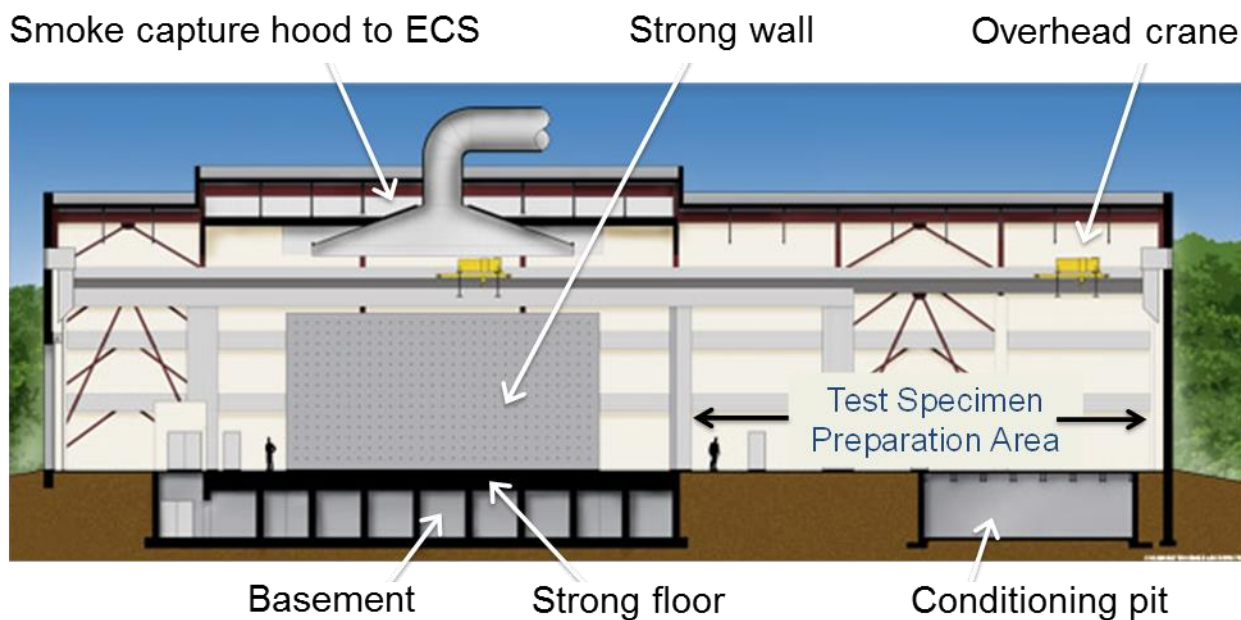
Figure 1-1 Cross-sectional view of expanded NFRL.

Fig. 1-1 presents a cross-sectional view of the laboratory, and Fig 1-2 shows a photograph of the newly constructed structural-fire testing area. The strong-floor is 1.2 m (4 ft) thick, 18.3 m (60 ft) wide, and 27.4 m (90 ft) long. It is post-tensioned and supported on nine reinforced concrete box girders spaced at 3.0 m (10 ft) on-center. The basement ceiling height is 2.7 m (9 ft). The strong floor has a total of 1218 anchor points spaced on a 0.61 m \times 0.61 m (2 ft \times 2 ft) grid. The sleeves that form the anchor points have an inside diameter of 76 mm (2.9 in). Each anchor point has an allowable tension capacity of 445 kN (100 kips), an allowable shear capacity of 222 kN (50 kips) at the top of the slab, and an allowable moment capacity of 136 kN-m (100 ft kips) at the center of gravity of the strong floor.

Two bridge cranes, each with a capacity of 18.1 metric tons (20 ton) are located 11.2 m (36 ft-8 in) above the strong-floor, providing a 9.8 m (32 ft) clearance from the bottom of the bridge to the floor. The lab also has a 12.2 m (40 ft) long, 11.0 m (35 ft) wide, and 3 m (10 ft) deep specimen conditioning pit, where concrete specimens can be dried under controlled temperature and humidity conditions. The removable panels forming the ceiling of the pit are an integrated part of the lab's floor, thus specimens can be stored in the pit for curing without impacting operating floor space (see Fig. 1-1).

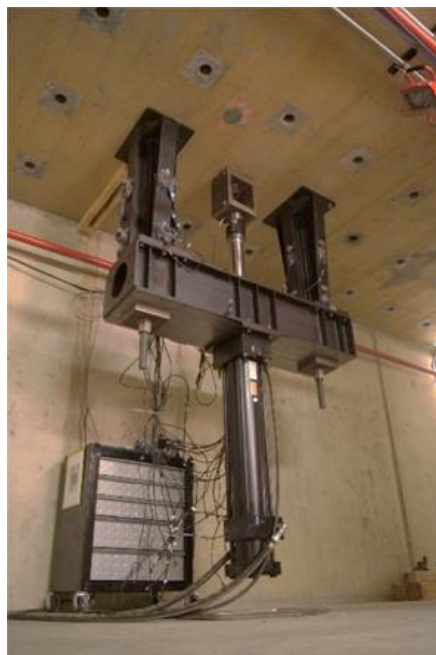
Figure 1-3 Actuator mounted on yoke located in basement underneath strong floor.

The laboratory is equipped with a hydraulic loading system which consists of a 340 L/min (90 GPM) hydraulic power unit, manifolds and controller, and double-acting actuators with 762 mm (30 in) total stroke. The actuators include: eight hydraulic actuators with a capacity of 240 kN (55 kip) in tension and 365 kN (80 kip) in compression, two actuators with a capacity of 445 kN (100 kip) tension and 650 kN (145 kip) compression; and two actuators with a capacity of 956 kN (215 kip) in tension and 1470 kN (330 kip) in compression. To protect the hydraulic actuators from fire, stiff steel frames (yokes) are used to mount the actuators to the ceiling of the basement, as shown in Fig. 1-3. The yokes attach to the anchor points of the basement's ceiling (the bottom of the strong floor), where the actuators can be used to pull down, through the anchor points, on the structural specimens placed on the strong-floor.

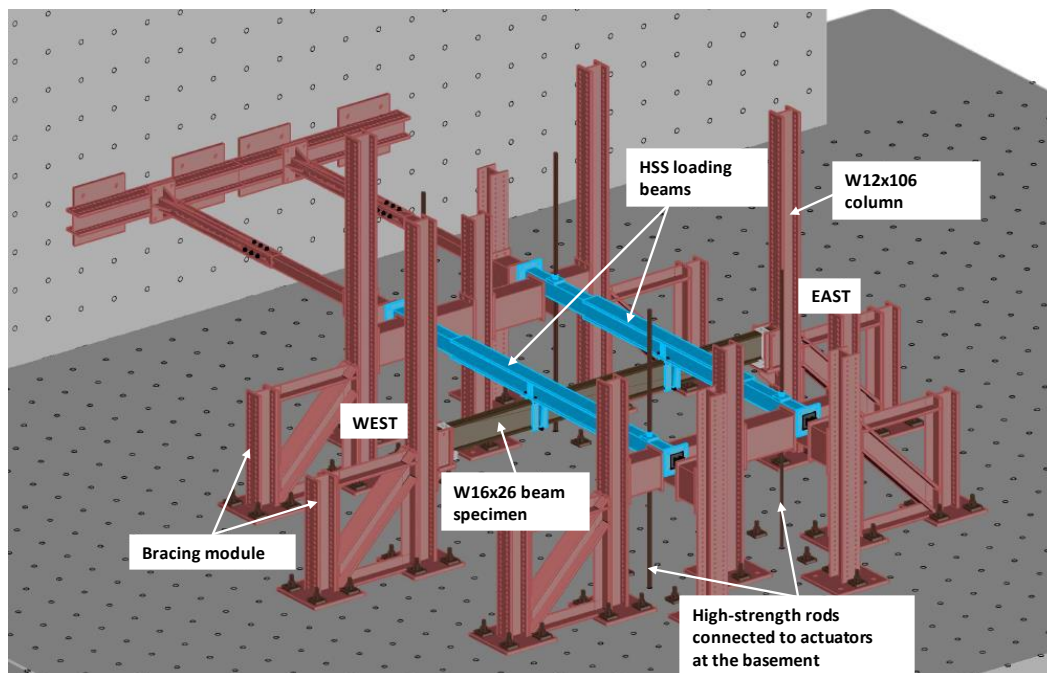
Figure 2-1 Rendering of test setup.

Fig. 2-1 shows a rendering of the test setup which was erected under the 20 MW exhaust hood in the high bay of the NIST National Fire Research Laboratory. The setup consisted of a W16×26 beam specimen, two loading beams made of hollow structural section (HSS), and a system of columns, connections, and braces that served to support and restrain the specimen. The components of structural steel frames were designed and fabricated in accordance with the American National Standards Institute (ANSI) – American Institute of Steel Construction (AISC) standard ANSI/AISC-360 (2010). The beam specimen was supported by the W12×106 columns. The column displacements in the direction of the strong axis were restrained by bracing modules 1.83 m high by 1.83 m wide. The bases of supporting columns and brace modules were fixed to the laboratory strong-floor by tensioning high-strength steel anchor rods to approximately 445 kN each. Fig. 2-2 shows a photograph of the test setup.

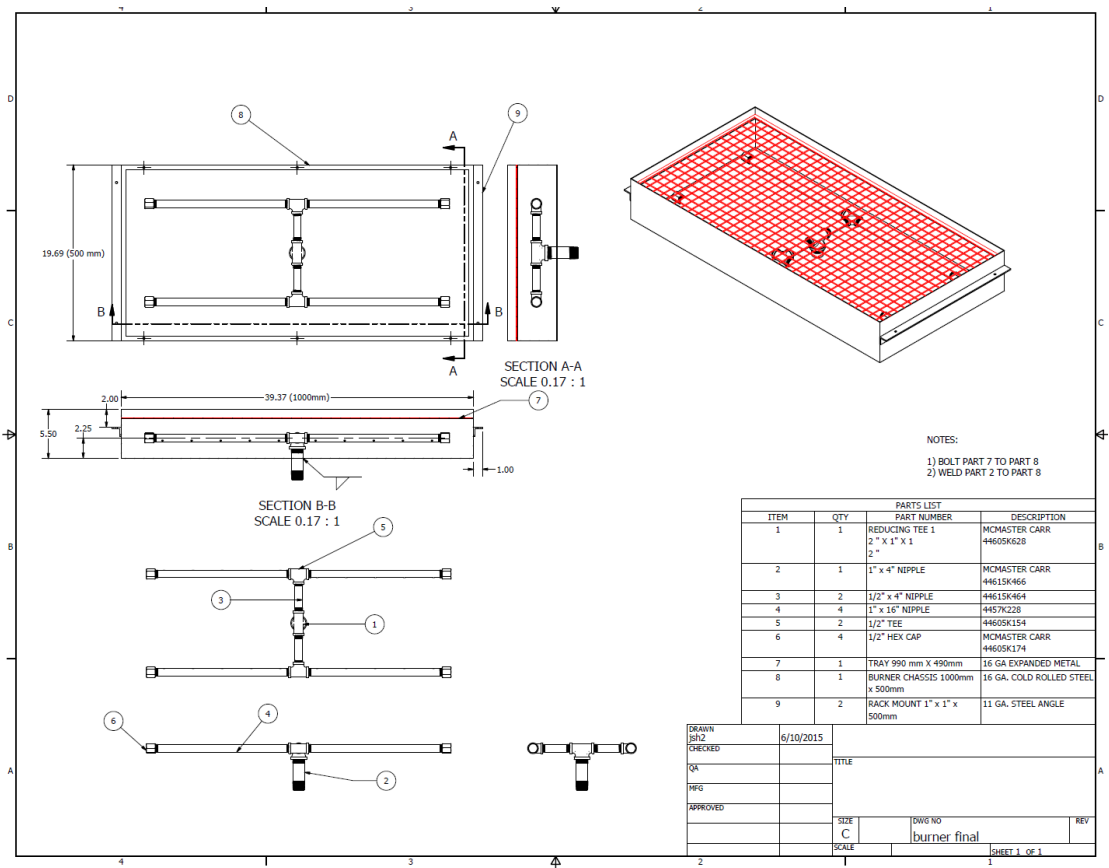
Figure 2-5 Detailed drawing of gas burner assembly.

The burner was made from two stainless steel sheet metal boxes measuring 0.5 m by 1 m in plan each. The fuel inlet tube was located at the bottom of the burner box. Steel mesh screens were used to keep the blanket in place. A detailed drawing of the burner design is shown in Fig. 2-5. The burner boxes were assembled so that there was a 25 mm gap between the two boxes to allow room for displacement measurements as presented in Section 2.3.

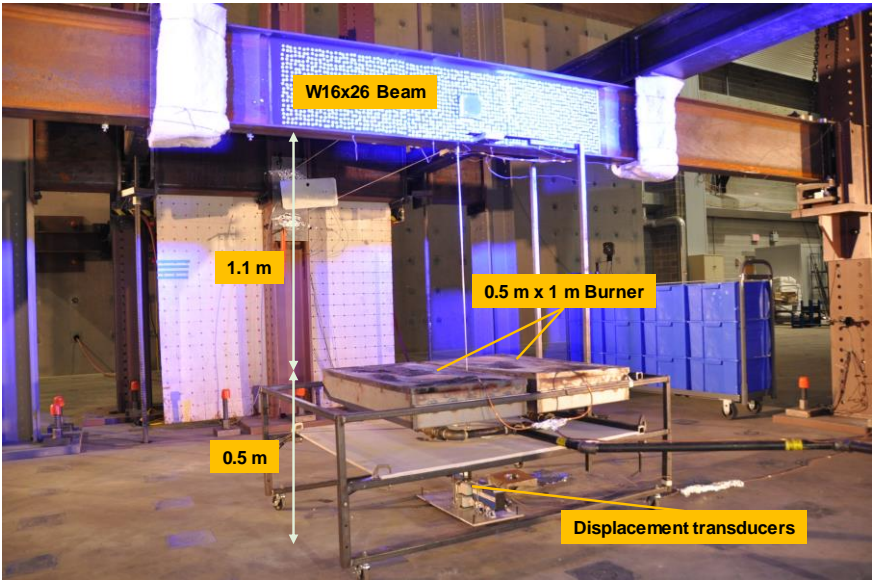
Figure 2-6 Photograph of burner in the test setup.

As shown in Fig. 2-6, the burner with the nominal area of 1 m^2 was located at the midspan of the specimen on the floor. The burner is placed at 1.1 m below the lower flange of the specimen. The distance from the centroid of the beam cross section to the strong floor was 1.8 m.

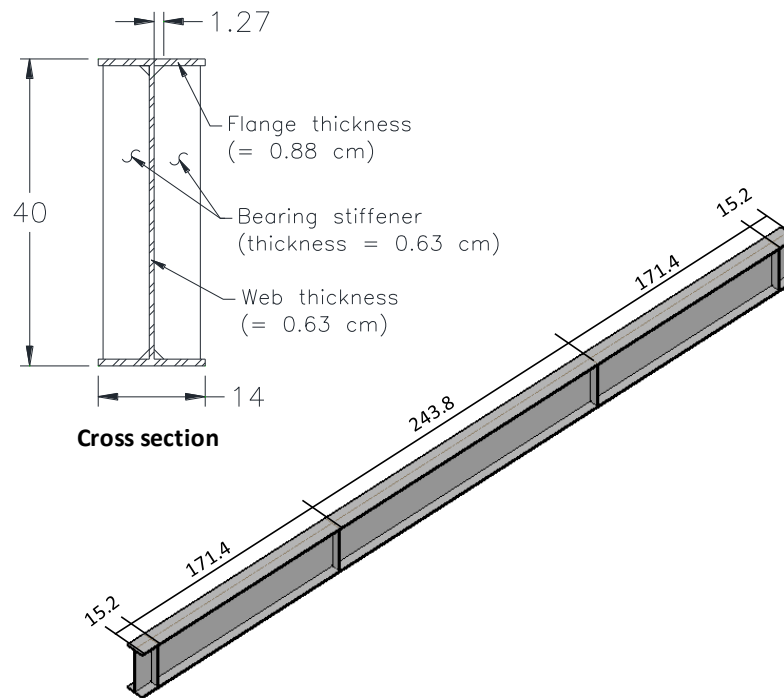
Figure 2-7 Dimensions of W16×26 beam specimen (unit: cm).

Fig. 2-7 shows the dimensions of the W16×26 beam specimens. The beam specimens were cut to a length of 6.17 m. No fire protection was applied. No stiffeners were welded to the Specimen 1. To prevent the local failure of the beam cross sections where the forces were applied, Specimens 2 through 4 had 0.63-cm thick steel bearing stiffeners welded to the beam cross sections at four different locations along the length. The HSS loading beam was placed at the location of intermediate stiffeners which were 243.8 cm apart. The Specimens 2 through 4 had the bearing-to-bearing length of 5.87 m, i.e. the distance between end stiffeners. Specimen 5 had intermediate stiffeners only, with bolted double-angle connections at beam ends. Drawing of the specimens are shown in Appendix A.

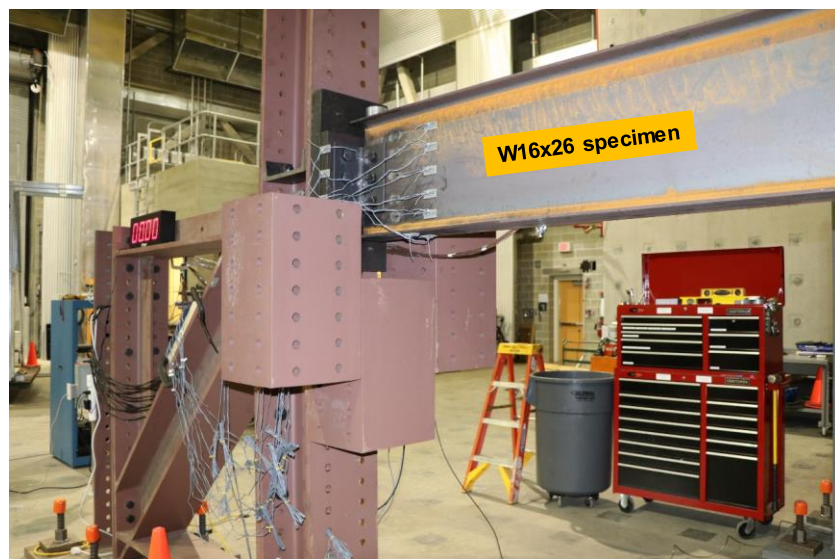
Figure 2-9 (a) Photograph of Specimen 5 and (b) details of all-bolted double-angle connection.

The connection type used in Test 9 was an all-bolted double-angle connection, one of the common shear connection types used in steel frame buildings, to provide the axial restraint to thermal elongation of the beam specimen. There was no additional side bearing installed to provide the lateral constraints at the beam ends in the north-south direction. Refer to Fig. 2-9(a) for a photograph of the double-angle connection provided at the end of the beam. The bolted double-angle shear connection was designed in accordance with ANSI/AISC 360 (2010) for a 6.2-m long W16×26 girder to resist the factored gravity loads using the load combination prescribed in the American Society of Civil Engineers (ASCE) standard *Minimum design loads for buildings and*

other structures (ASCE, 2016). The service loads assumed for the design included the self-weight of the steel beam, a superimposed dead load of 480 Pa (10 psf), and a live load of 3350 Pa (70 psf) for a typical office building. The dimensions of the connection are shown in Fig. 2-9(b). A 229-mm long double-angle with L5×5×5/16 section and three 19-mm diameter ASTM A325 bolts (ASTM, 2010) spaced at 76 mm was designed for the test specimen.

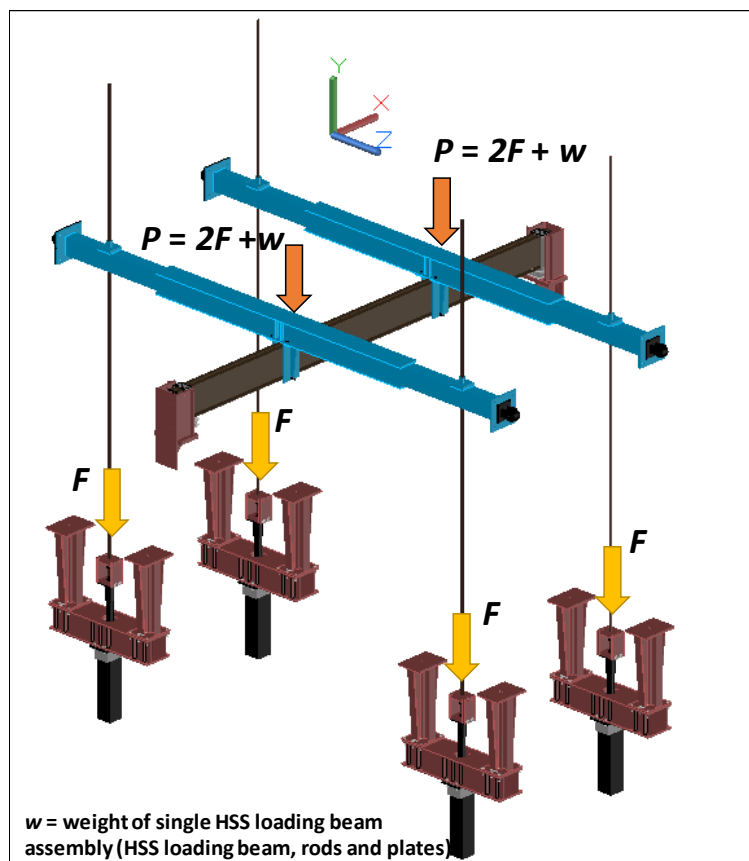
Figure 2-10 Structural loading arrangement. Strong floor, supporting columns, braces, and guide frames are not shown here.

The four-point flexural loading scheme was designed such that two point loads were simultaneously applied at 2.44 m apart around the midspan of the beam. As described in Section 2.1.1 and Fig. 2-10, the vertical point loads were provided by actuators via the HSS loading beams. The magnitude of each point load (P) was the summation tensile forces (F) provided by two connected actuators and the weight of single HSS loading beam assembly (w). Table 2-2 summarizes the measured weight of each component used in the tests. Note that weight listed in Tests 7 and 8 included the weight of water (w_{water}) flowing through HSS loading beams. The magnitude of w_{water} included in Tests 7 and 8 was 3.9 kN and 3.2 kN, respectively. A resulting moment over the middle portion of the beam specimen between two-point loads is theoretically uniform if the effects of moment due to the self-weight of the specimen, 2.43 kN, are ignored.

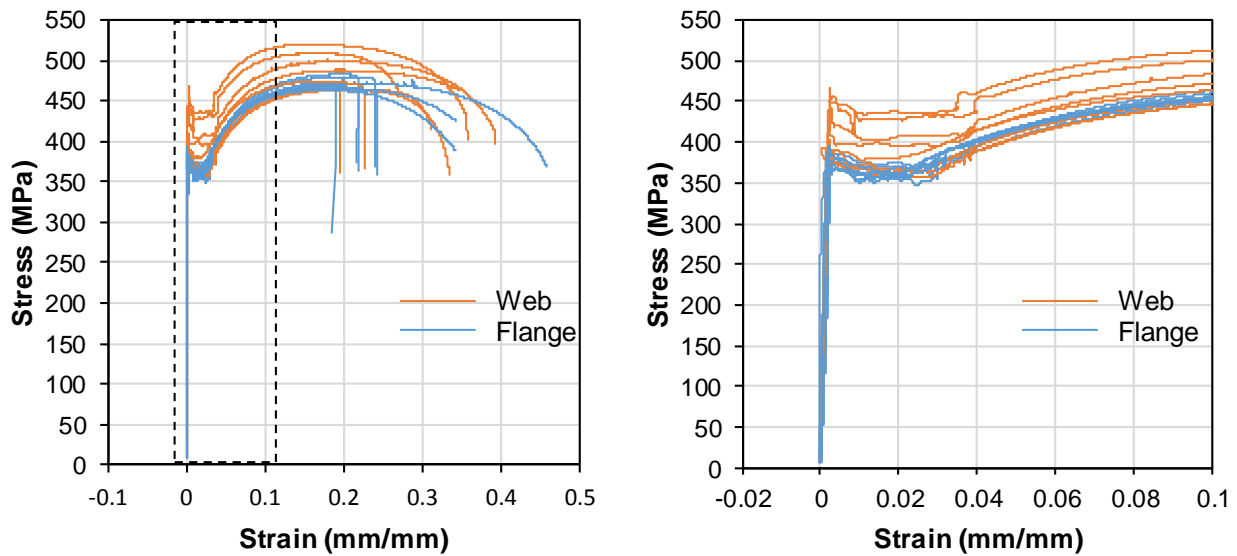
Figure 2-11 Stress-strain curves (a) showing the curves until fracture and (b) showing the initial portion of the curves until a strain of 0.1.

Fig. 2-11 shows the complete room-temperature stress-strain curves of individual specimens. Fig. 2-12 shows photographs of the specimens after tests, which failed by ductile fracture with (26.4 ± 1.2) % of elongation on average. The values after \pm symbol indicates the standard deviation.

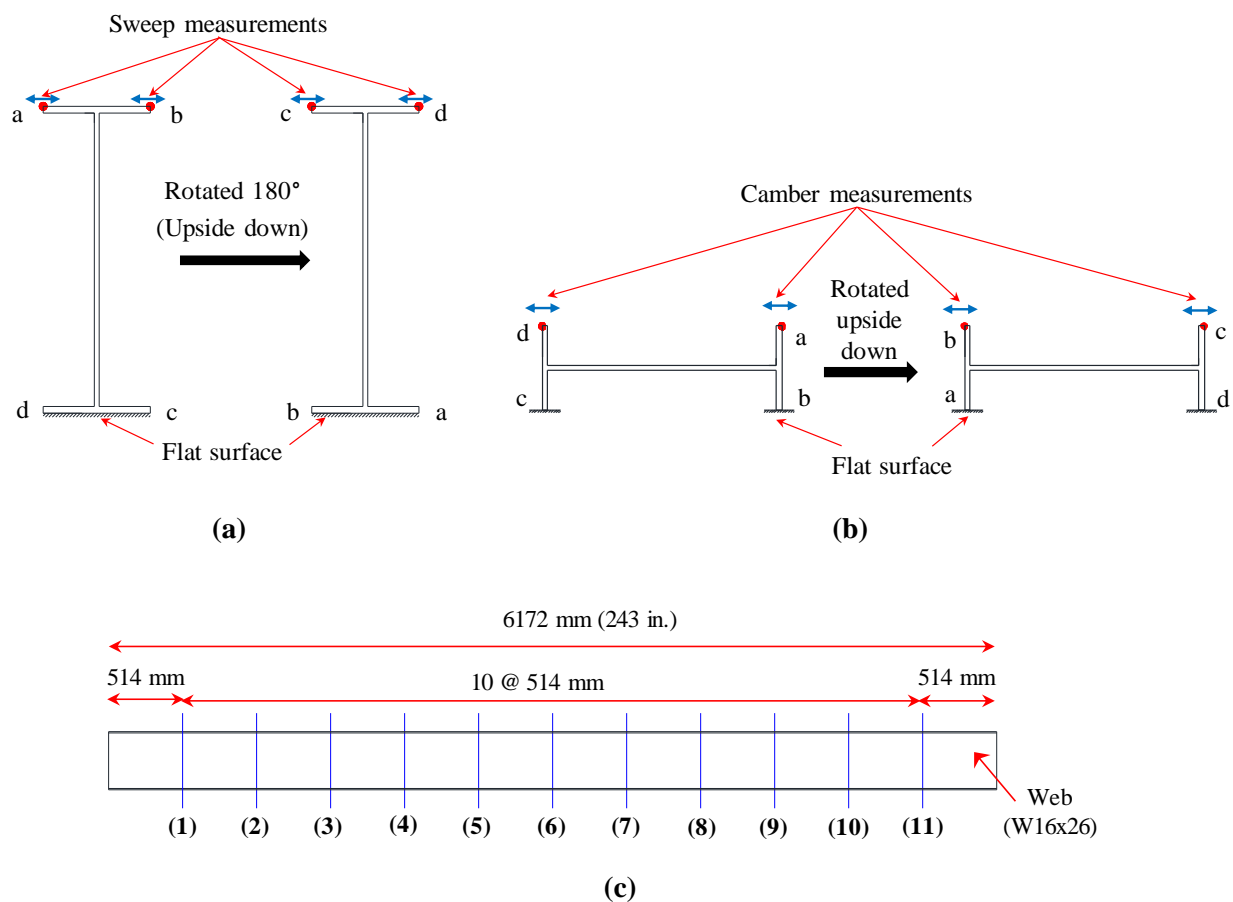
Figure 2-13 Arrangement of the W16 \times 26 beams for sweep and camber measurements.

Prior to the tests, a ISAT API Laser Tracker having a manufacture's specified accuracy of ± 10 microns/meter (with two standard deviations) was used to measure the global geometric imperfections of the W16 \times 26 beam specimen. Fig. 2-13 shows the arrangement of the beams for the camber and sweep measurements. For measuring sweep (i.e., the maximum deformation of the beam in the direction of the weak-axis of the cross section), one of the flanges rested on the floor to minimize the effect of the deflection due to the beam self-weight as shown in in Fig. 2-13(a). Coordinate measurements were taken at eleven sections along the beam on each side of flanges as shown in Fig. 2-13(c). Similar procedure was followed for measuring the camber (i.e., the maximum deformation of the beam in the direction of the strong-axis of the cross section) as shown in Fig. 2-13(b). The measured value of the camber and sweep of the W16 \times 26 beam specimen was (1.7 ± 0.1) mm and (4.4 ± 1.2) mm, respectively. The values after \pm symbol indicates the total expanded uncertainty with two standard deviation.

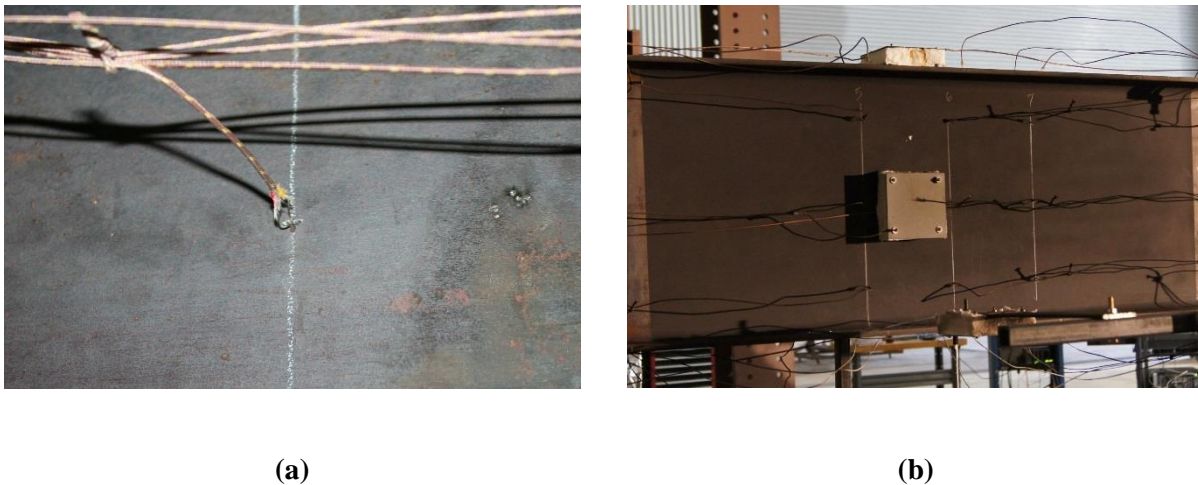
Figure 2-14 Typical temperature sensors: (a) thermocouple peened into drill hole in web of beam, (b) Plate thermometers mounted on and near beam.

The thermocouples used in all the beam specimen tests were glass-sheathed, K-type, 24-gauge, bare-bead thermocouples. Prior to testing, a study was conducted to investigate the influence of the method of attachment of the thermocouples to the specimen. The results of this study are provided in Section 2.3.7. No correction for radiation on the bead temperature was performed. In most cases, it was not relevant since the bead was embedded in the specimen and shielded from radiation, as shown in Fig. 2-14(a).

Plate thermometers constructed at NIST were used to measure adiabatic surface temperature. They consisted of a glass-sheathed, K-type, 24-gauge, thermocouple welded to an Inconel (nickel-chromium alloy) plate with dimensions of 100 mm \times 100 mm \times 0.7 mm and insulating material on the back, as shown in Fig. 2-14(b).

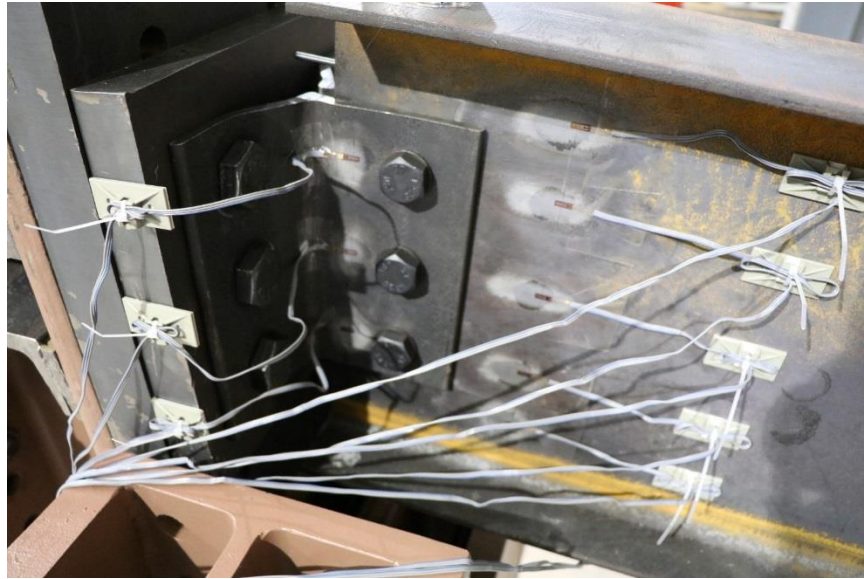
Figure 2-15 Strain gauges installed near end of beam specimen.

Strains developed in the specimens and loading fixtures due to the applied forces were measured using the surface attached strain gages. FLA-6-11 linear strain gages with a nominal resistance of 120 ohm manufactured by Texas Measurements were attached to the steel surfaces. A photograph of strain gages installed near the end of the specimen is shown in Fig. 2.15. The manufacture-specified operating temperature range of the strain gage is -196 °C to 150 °C. The strain gages were at (25 ± 10) °C during testing.

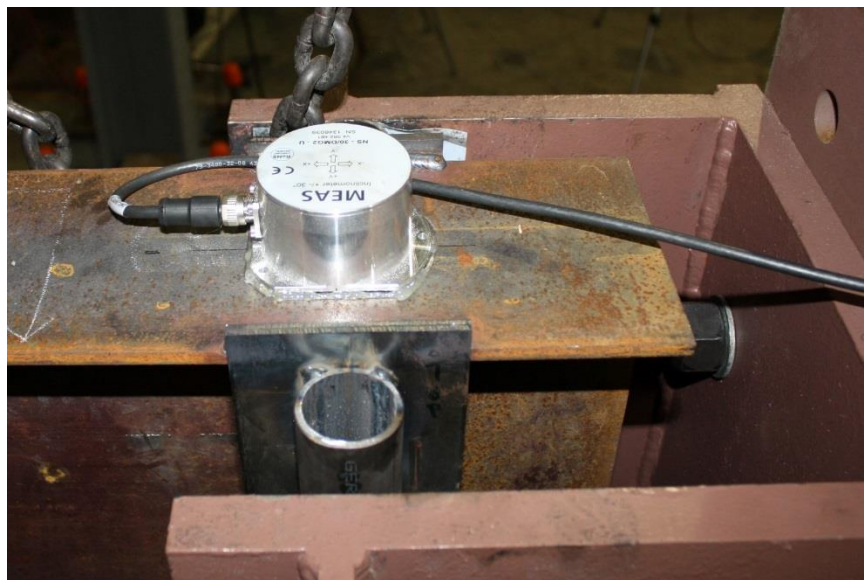
Figure 2-16 Inclinometer attached to the top flange of a beam specimen.

Inclinometers attached to the top flange of the beam specimens along the centerline at each end were used to measure the rotation of the beam as it deformed (Fig. 2-16). The inclinometers from Measurement Specialties, Inc. (model G-NSDMG-023) were used to measure the rotation during the tests.

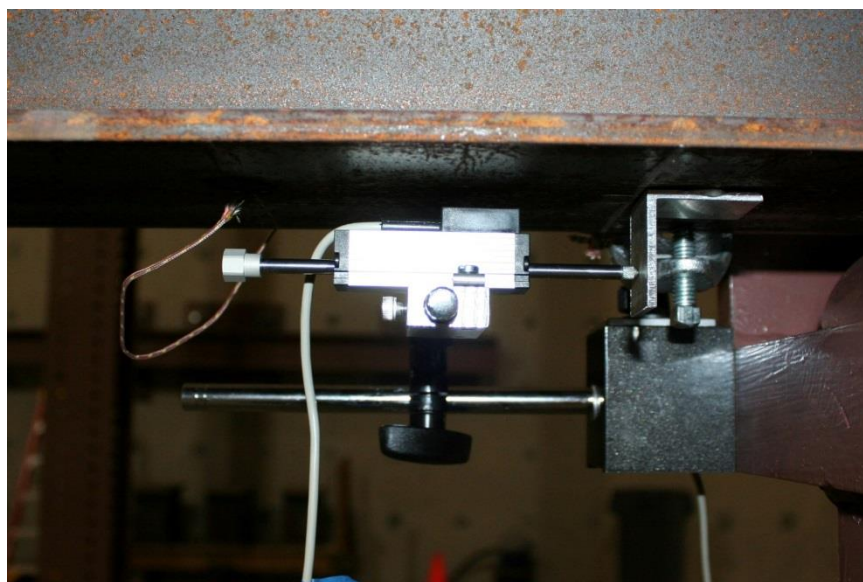
Figure 2-17 Linear potentiometer attached to the bottom flange of a beam specimen.

Axial elongation of the beam was measured using linear potentiometers attached to the flanges of the beam specimens along the centerline as shown in Fig 2-17. The sensors were Novotechnik model TR 25 (refer to Table 2-5 for specifications).

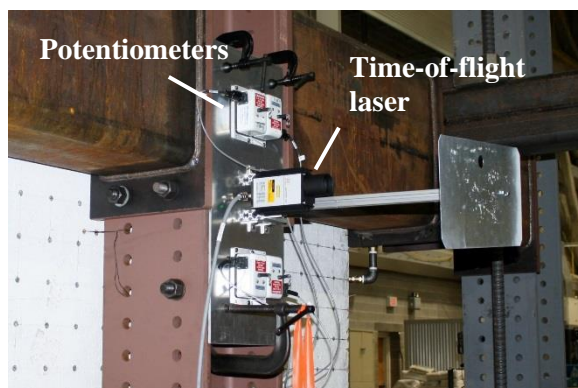
(b)

Downward displacement of the beam specimen as well as movement of the top and bottom beam flanges transverse to the beam's strong axis were measured at midspan of the beam (three locations total) using potentiometers with special temperature-compensated probes. For each measured displacement in the heated zones, two potentiometers were mechanically connected to the point of interest with probes made of silicon carbide or aluminum oxide fibers. The fibers spanned from the potentiometers and the specimen (Fig. 2-18 and Fig. 2-19). The fibers exhibited different and approximately linear thermal expansion at the gas temperatures present in the fire. Because each pair of fibers was co-located and thus subjected to nearly identical temporal and spatial thermal variations in the fire, the two measurements could be used to correct for the influence of thermal

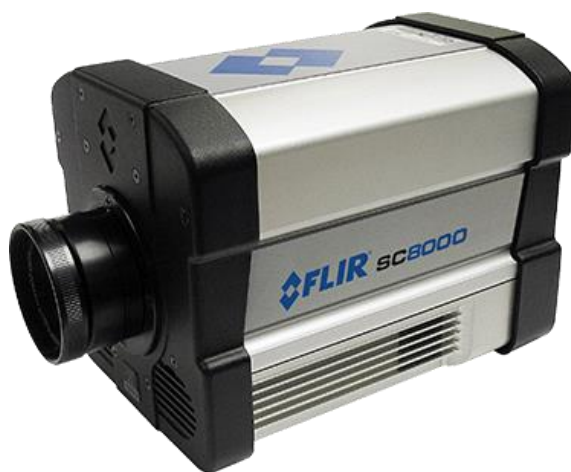
Figure 2-20 FLIR SC8000 series thermal imaging camera (source: <http://www.flir.com>).

Thermal imaging of the beam specimens was performed using a high-speed infrared camera (FLIR SC8300HD; Fig. 2-20). For detailed information about the specifications of this camera, the reader can visit the manufacturer's website.

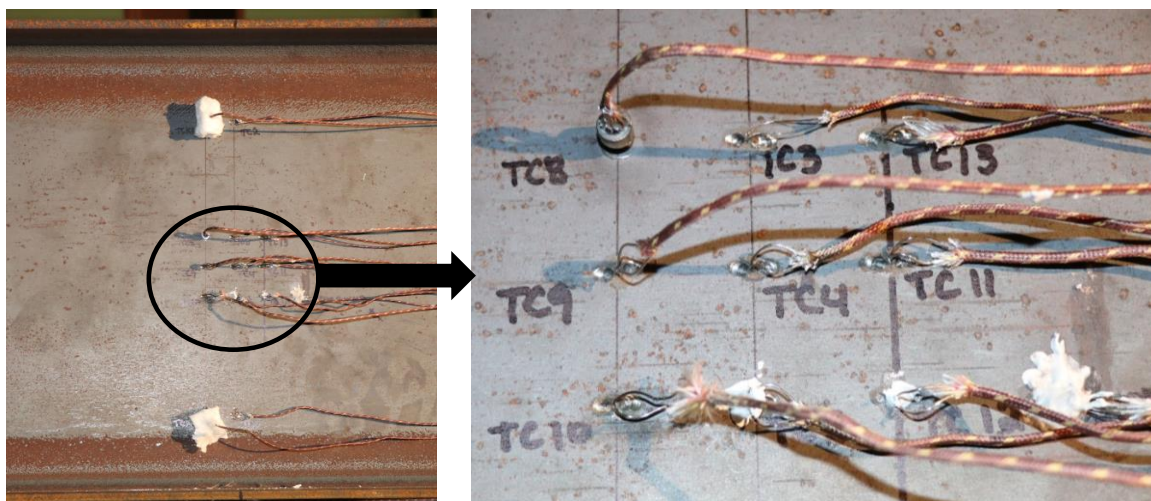
Figure 2-23 Thermocouples installed on the web of the beam

Various insulation methods were used for protecting thermocouple junctions, which included (i) applying a high temperature cement on the peened holes, (ii) coating the thermocouple bead with a ceramic epoxy before peening, and (iii) covering the peened holes with a piece of Kaowool blanket. Other variables were also investigated, such as thermocouples wire gauges (24 or 32 gauges), thermal gradient along the extended thermocouple wire (thermocouple wire running normal to or parallel with the fire-exposed steel surface), and presence of an additional junction within the fire-exposed region.

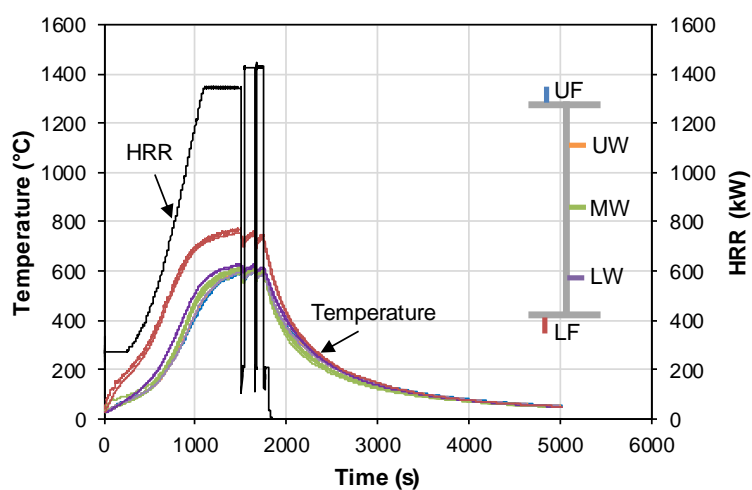
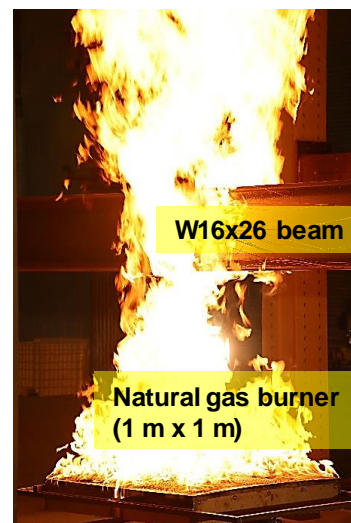
Figure 2-24 The measured burner HRR versus steel temperatures and photograph of the specimen exposed to a fire.

As shown in Fig.2-24, the burner was turned off twice with each at 1505 s and at 1647 s. The fire was out after 1754 s after ignition of the burner. Fig. 2-26 shows the graphs of temperature changes within four discrete locations (LF, LW, MW, and UW) of the cross section during two short cycles of the burner HRR control. In each graph, the green lines indicate the data from individual thermocouples and the black line is the averaged values. The temperature in the location of LF dropped by (54 ± 12) °C in about 30 s when the fire was suppressed. The temperature in other locations dropped by 35 °C on average.

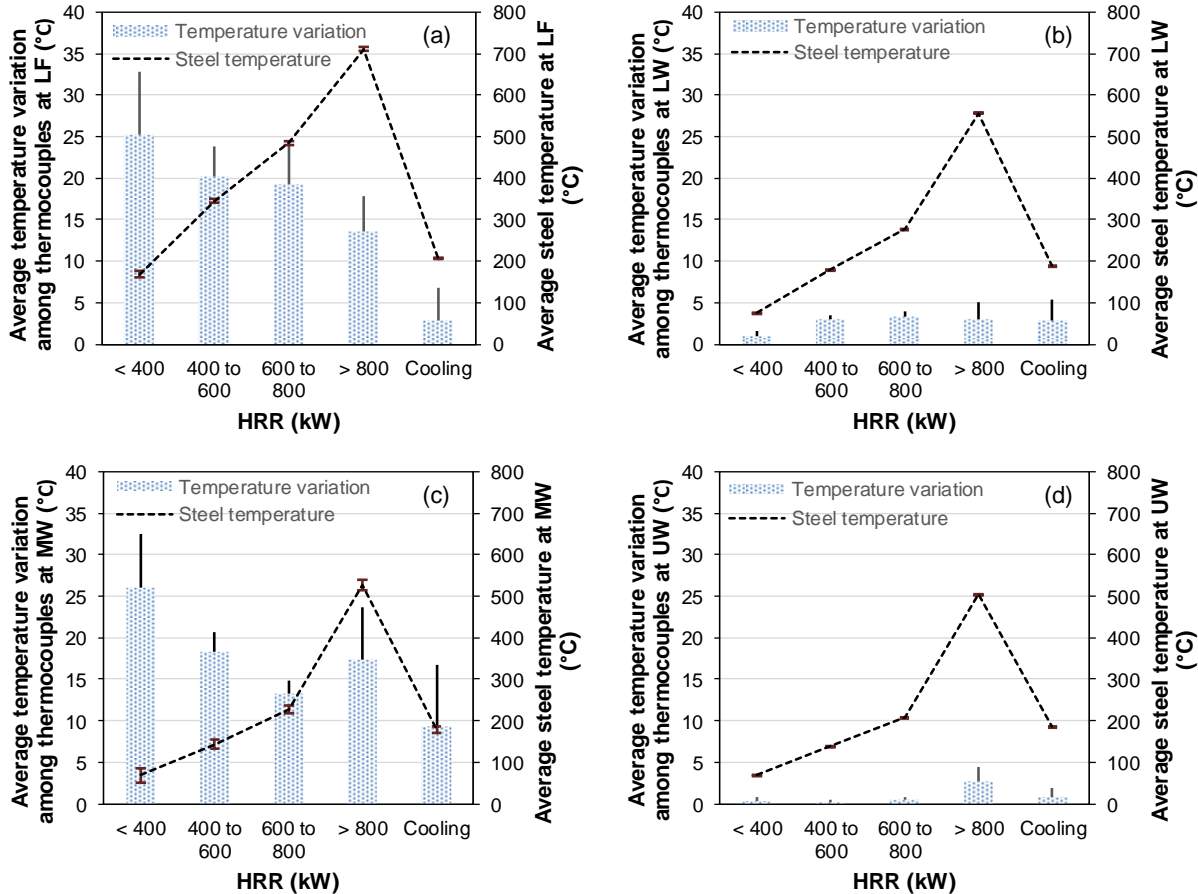
Figure 2-25 Temperature variation between thermocouples at different ranges of HRR and average temperature as a function of the burner HRR at the (a) lower flange (LF), (b) lower web (LW), (c) middle web (MW), and (d) upper web (UW). Error bars indicates the standard deviation.

Around the centerline of the web (MW) where ten thermocouples were mounted with various methods, the maximum temperature difference between the ten thermocouples was 9 °C on average throughout the duration of the test.

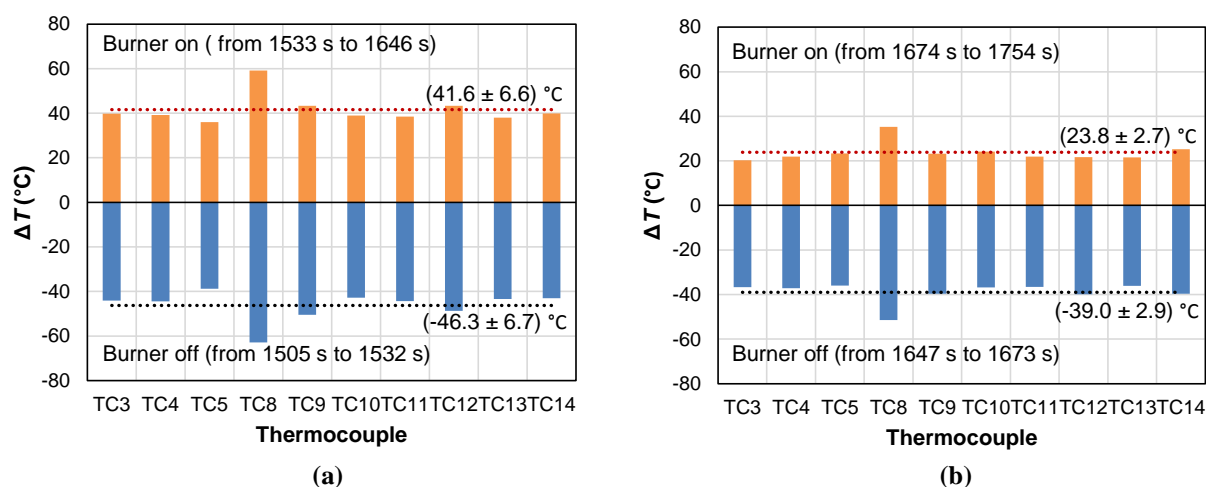
Figure 2-27 Temperature change (ΔT) measured by thermocouples mounted in the location of MW from (a) 1505 sec to 1646 sec and from (b) 1650 sec to 1750 sec. Values after \pm symbol indicate standard deviation.

The mounting and insulation techniques of thermocouples also influenced the temperature measurement in the middle web (MW) of the beam specimen. Fig. 2-27 illustrates the measured temperature change (ΔT) measured by individual thermocouples mounted at the location of middle web during two cycles of the burner controls. The first cycle took place from 1500 s to 1650 s and the second cycle took place from 1650 s to 1750 s in test time. The average values of ΔT measured by all thermocouples are indicated as dashed lines. The results showed that TC8 mounted using a threaded bolt was highly sensitive to change in gas temperature which would require additional insulation to minimize an error in the measurements of steel temperatures. Other thermocouples revealed similar magnitude of temperature changes resulted from either cooling or heating.

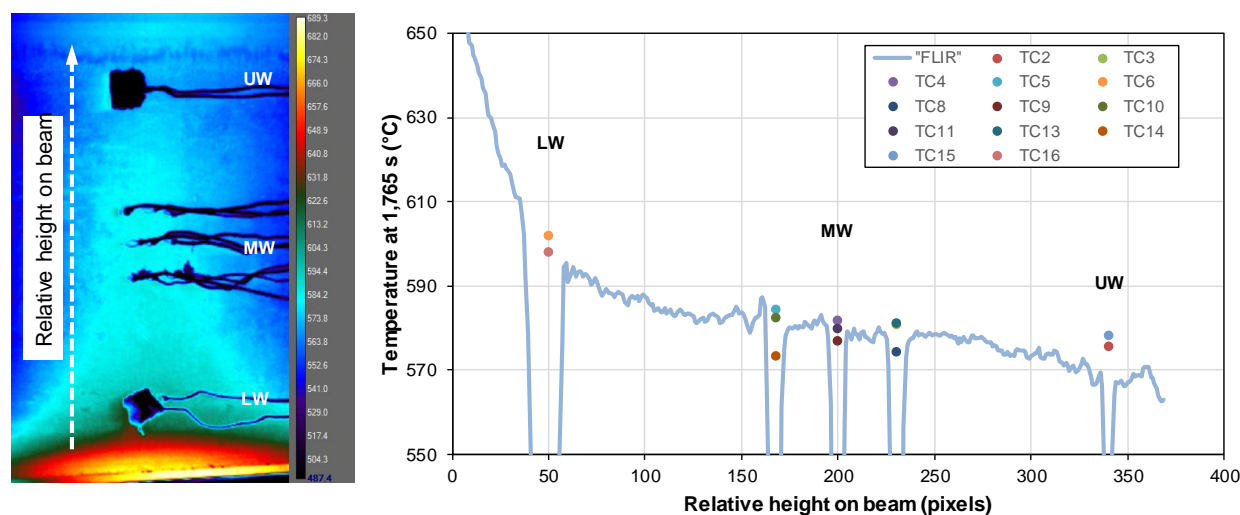
Figure 2-28 Web temperature measured using the FLIR camera and thermocouple readings at 1765 sec

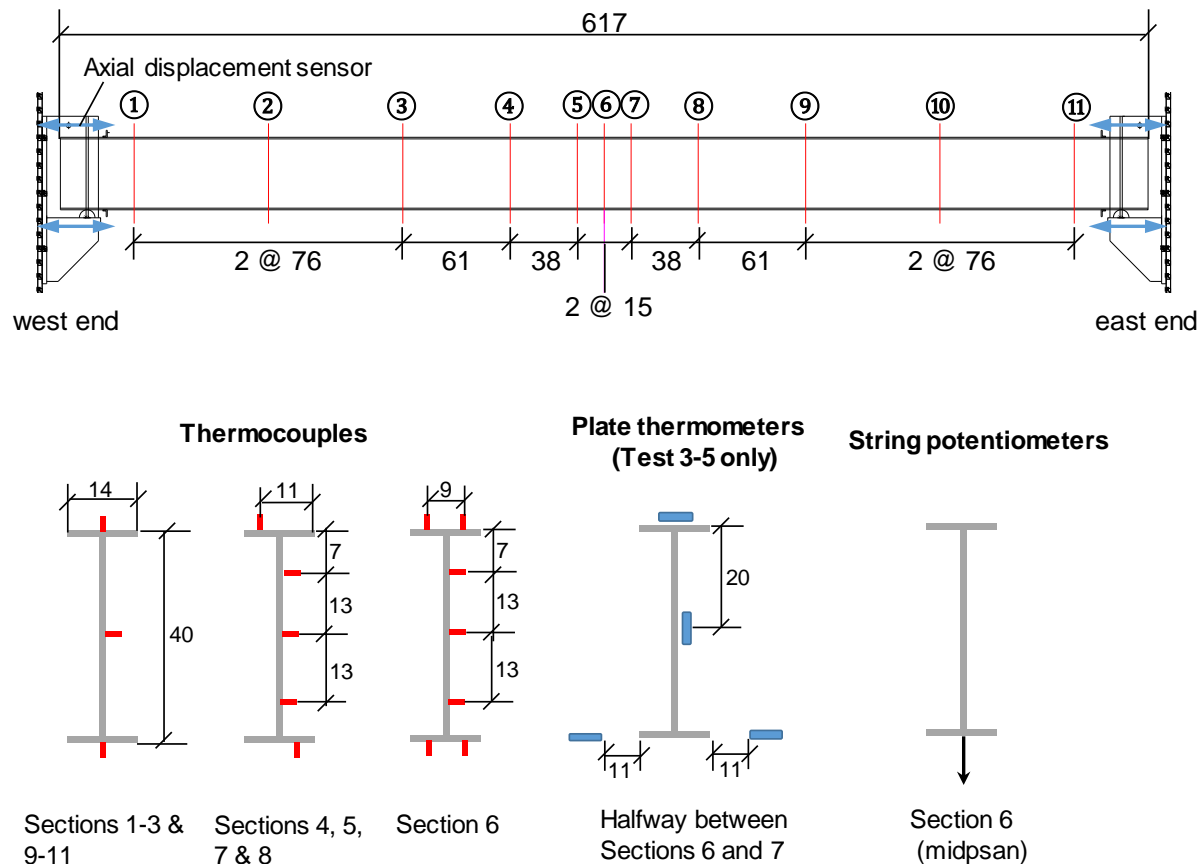
Figure 3-1 Instrumentation layout (unit: cm).

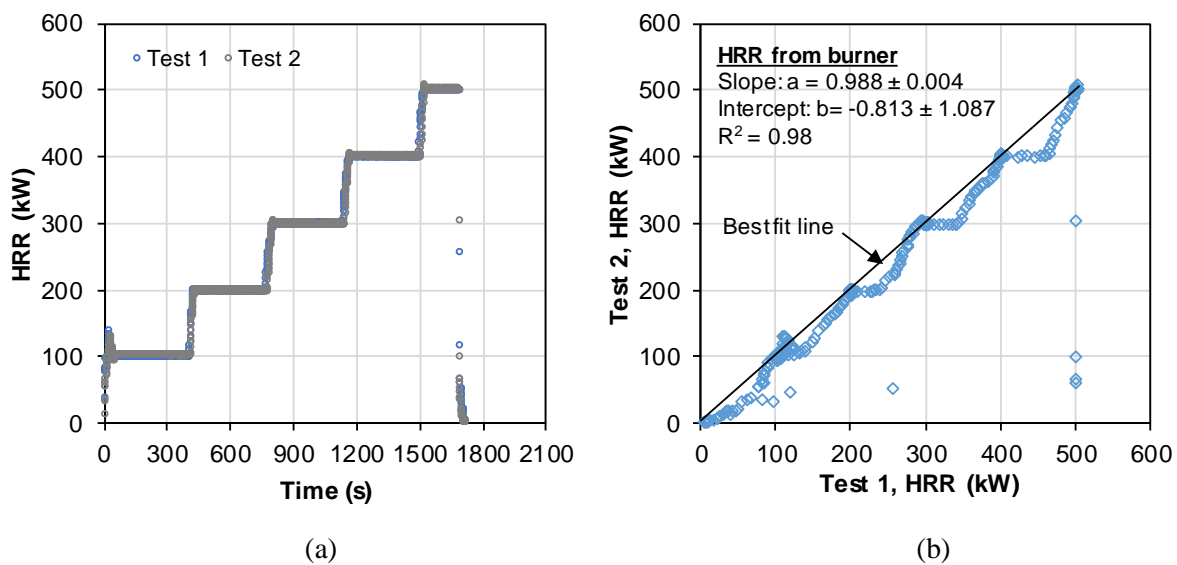
Figure 3-3(a) Recorded burner HRR versus time relation and (b) comparison of Tests 1 and 2.

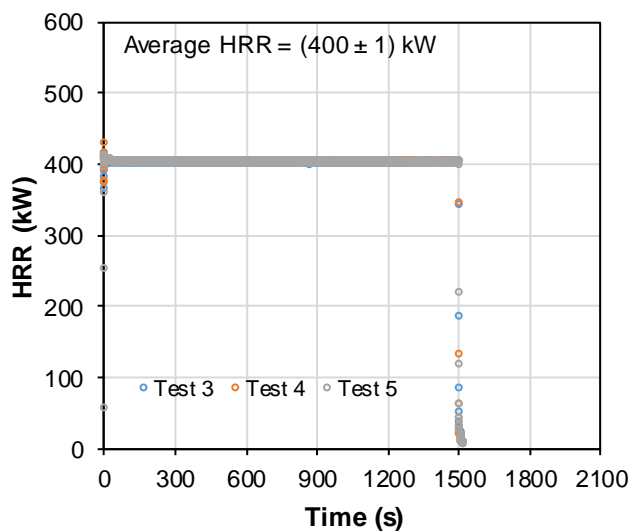
Figure 3-4 Recorded burner HRR versus time relation of Tests 3 through 5.

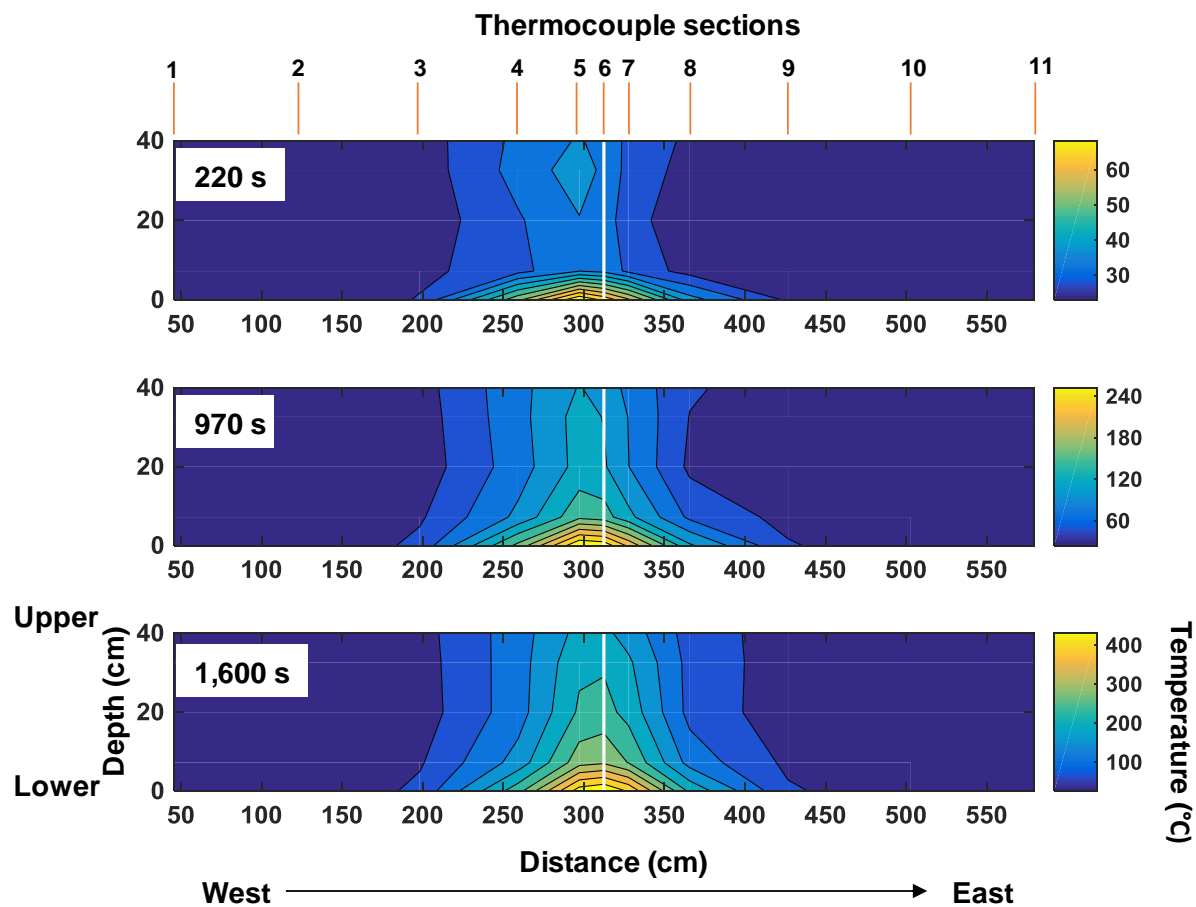
Figure 3-6 Temperature contours of the beam specimen exposed to a localized fire with increasing heat release rates of the burner.

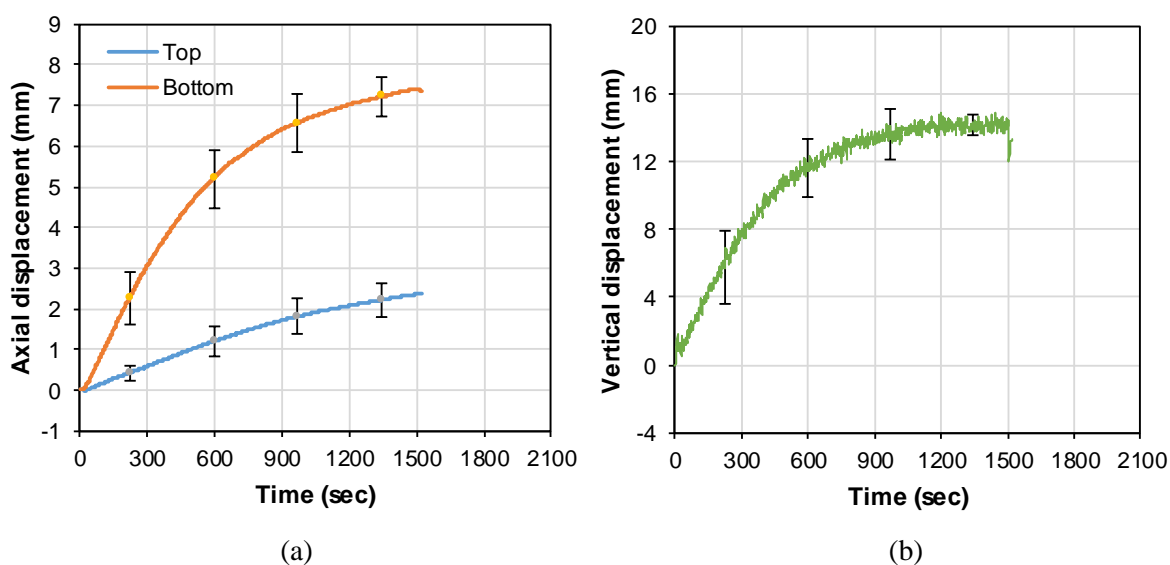
Figure 3-12(a) Axial and (b) vertical displacements of the beam specimen. Error bars indicate the standard deviation among Tests 3 through 5.

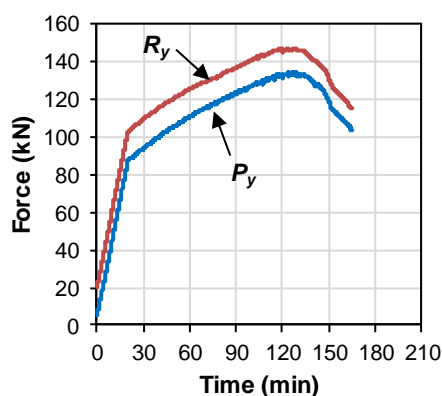
Figure 4-3 Time history of point load (P_y) and reaction force (R_y) in Test 6.

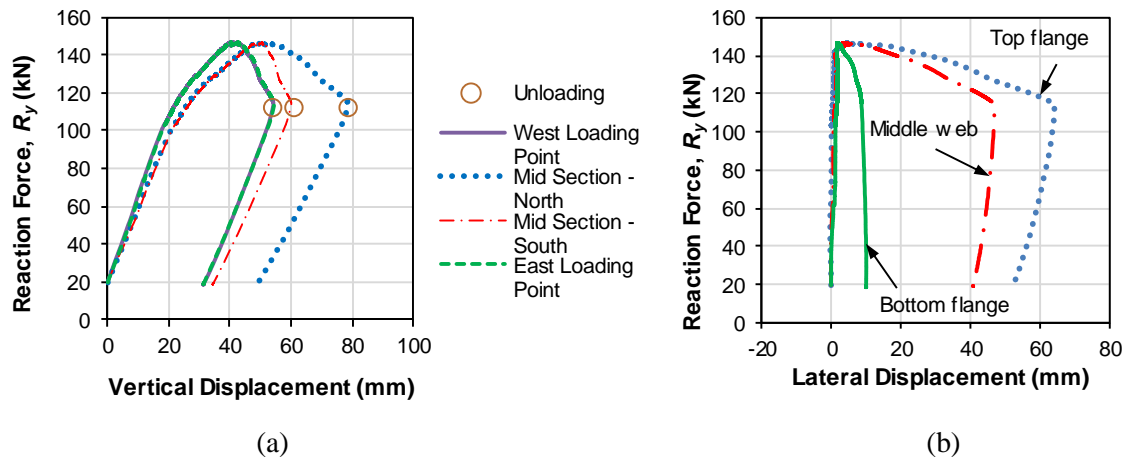
Figure 4-5(a) Reaction force versus vertical displacement and (b) reaction force versus lateral displacement of the specimen.

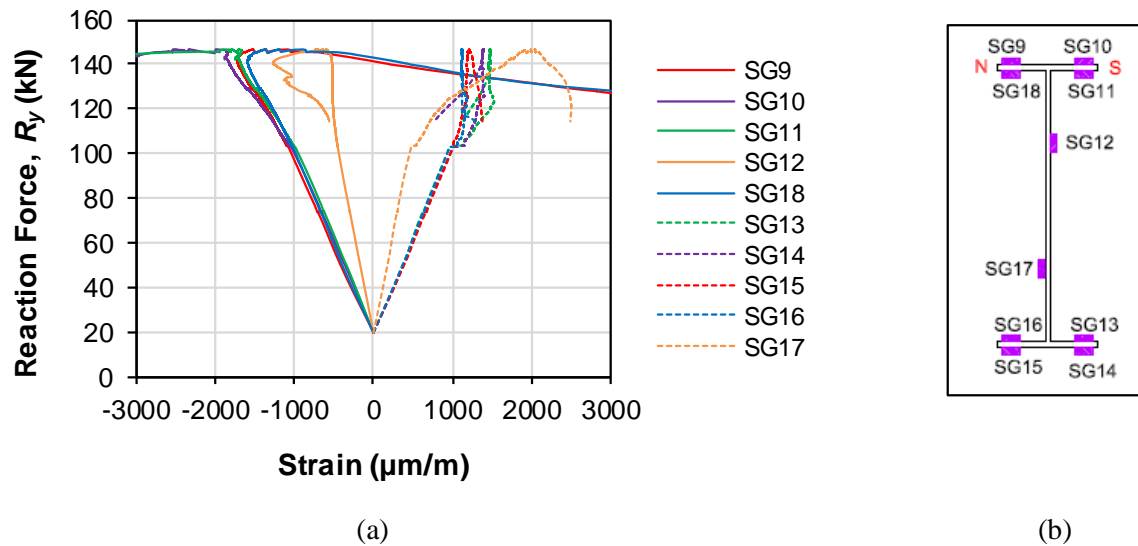
Figure 4-6(a) Reaction forces at the beam ends versus strains in the mid-section and (b) location of strain gauges used in Test 6.
