National Fire Research Laboratory Commissioning Project: Testing Steel Beams under Localized Fire Exposure

NIST Technical Note 1983

This report presents the experimental design and results of a series of localized fire tests on structural steel I-shaped beams. A total of nine tests were conducted in the National Fire Research Laboratory, including thermal tests (Tests 1 through 5) and four-point bending tests at ambient (Test 6) and elevated temperatures (Tests 7 through 9). The specimens were nominally 6.2-m long W16×26 beams made of ASTM A992 steel. Each specimen was vertically supported with either a (i) simple support condition, or (ii) double-angles bolted to laterally braced support columns. The thermally-loaded specimens were exposed to fire generated using a natural gas burner. The burner had an area of 1 m² and was located 1.1 m below the bottom flange of the beam at midspan. A four-point flexural loading scheme was used to apply concentrated forces at two locations 2.44 m apart around midspan. The recorded data included temperatures, heat release rates from the burner, and structural measurements including forces, displacements and strains. The repeatability of several

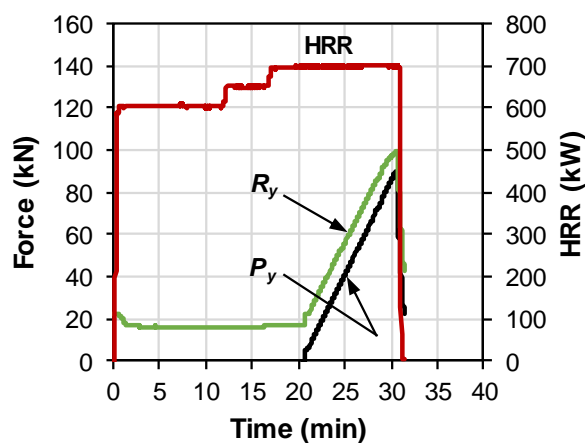
Figure 4-8 Measured burner HRR, average point load (P_y), and average reaction force (R_y) as a function of test time. The standard deviation of P_y and R_y data was 0.28 kN, and 0.81 kN, respectively.

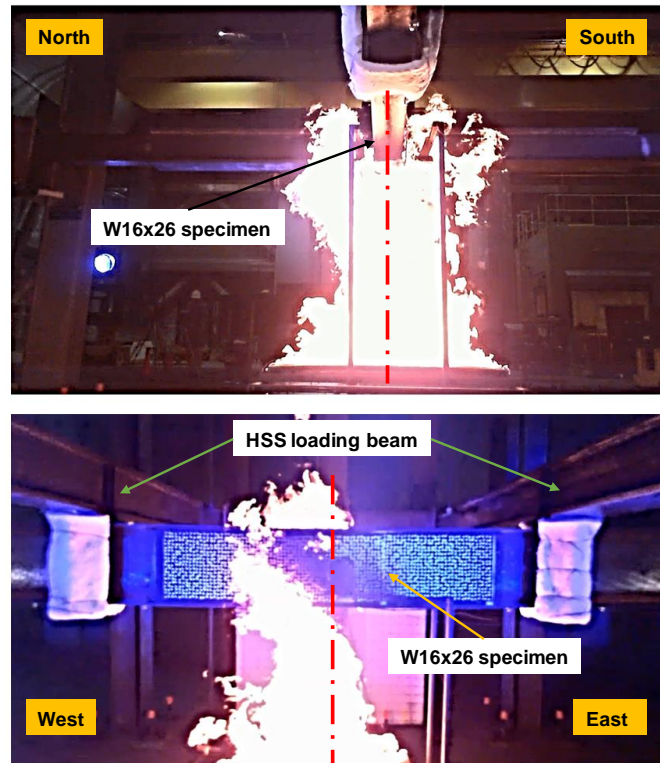
Figure 4-10 The beam specimen exposed to an open flame natural gas fire with the views looking toward the east direction (top) and the north direction (bottom).

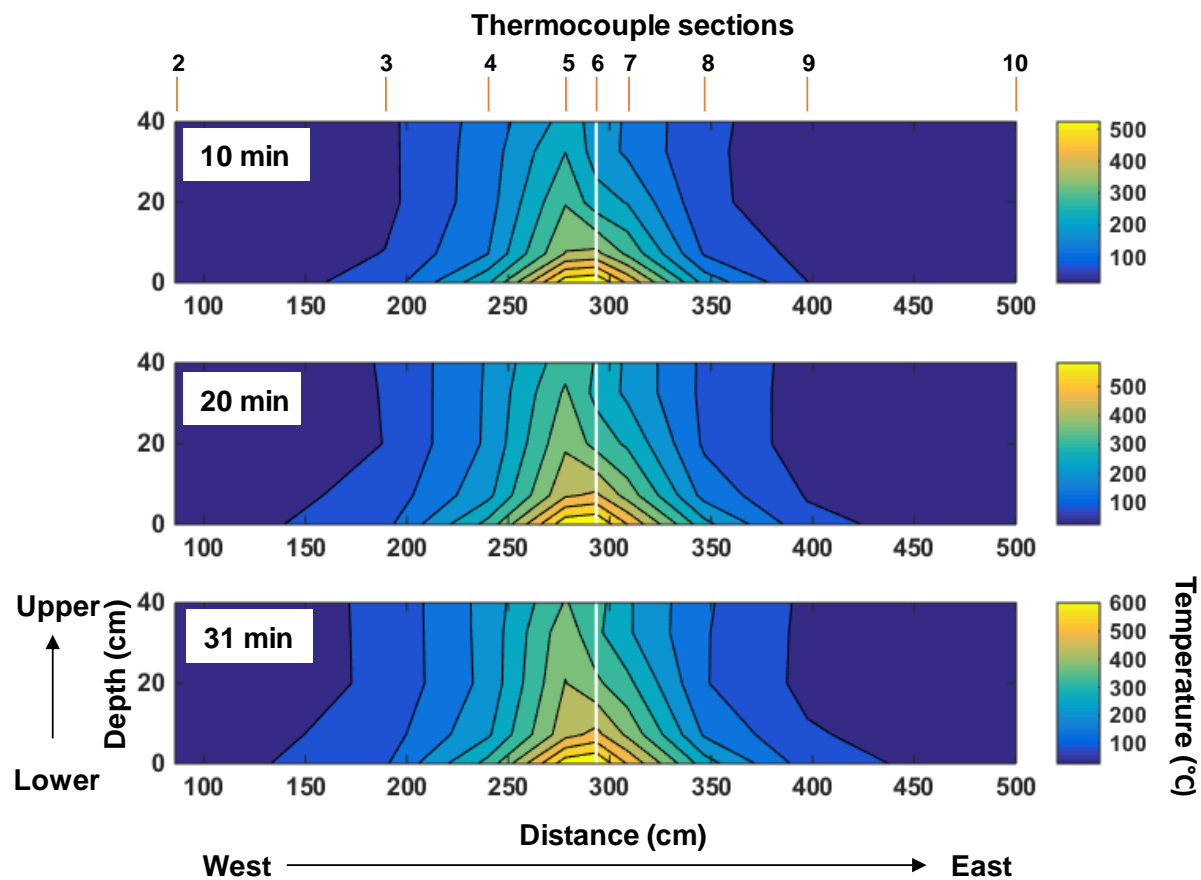
Figure 4-11 Temperature contours of the beam specimen in Test 7.

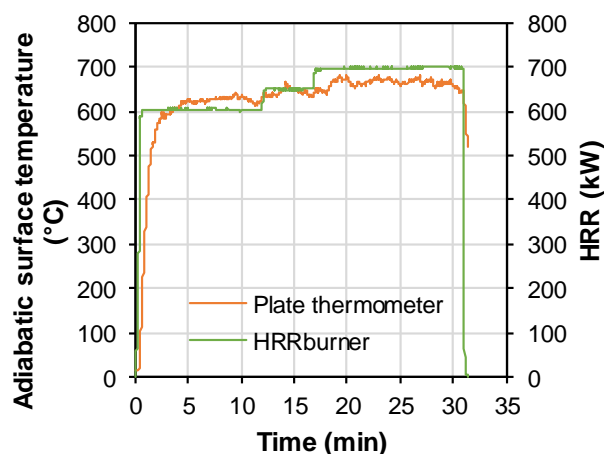
Figure 4-13 Time history of average adiabatic surface temperature measured using plate thermometers near the lower flange of the specimen at midspan.

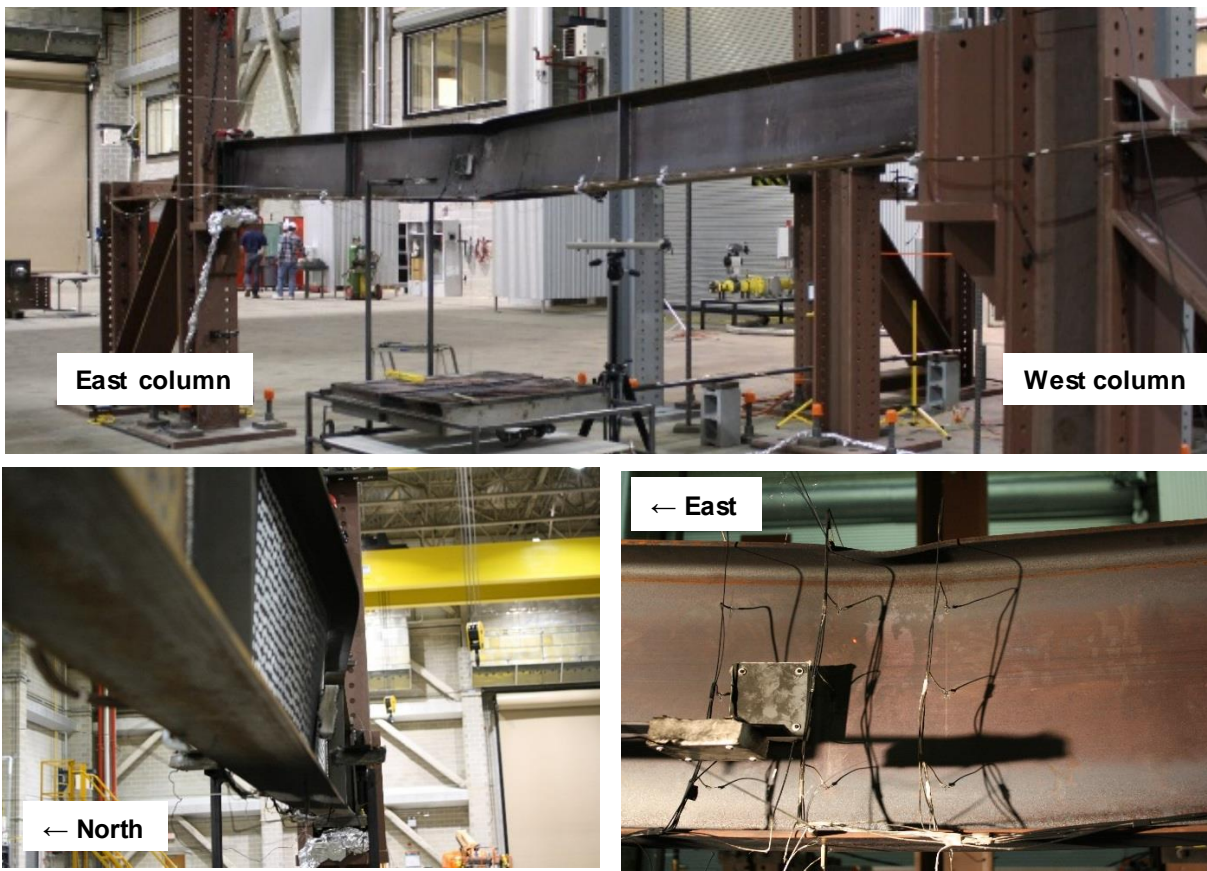
Figure 4-15 Photographs of overall deflected shape of the specimen after cooling (above) and local flange deformations in the fire-exposed midspan (below)

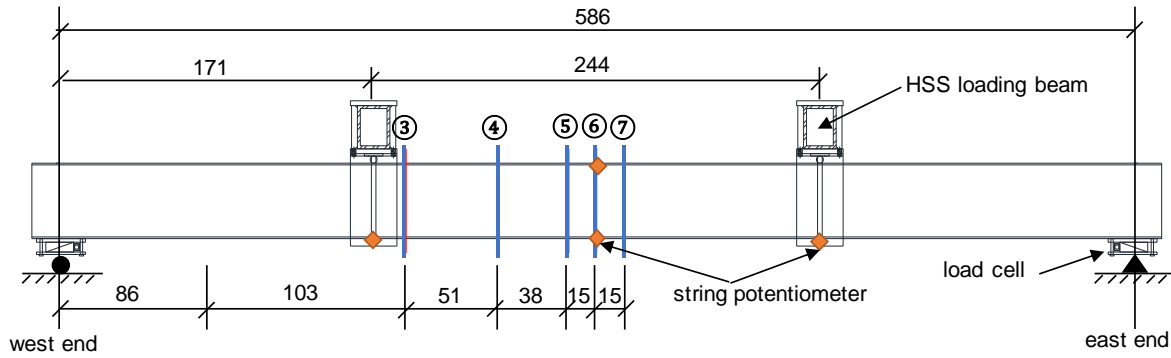
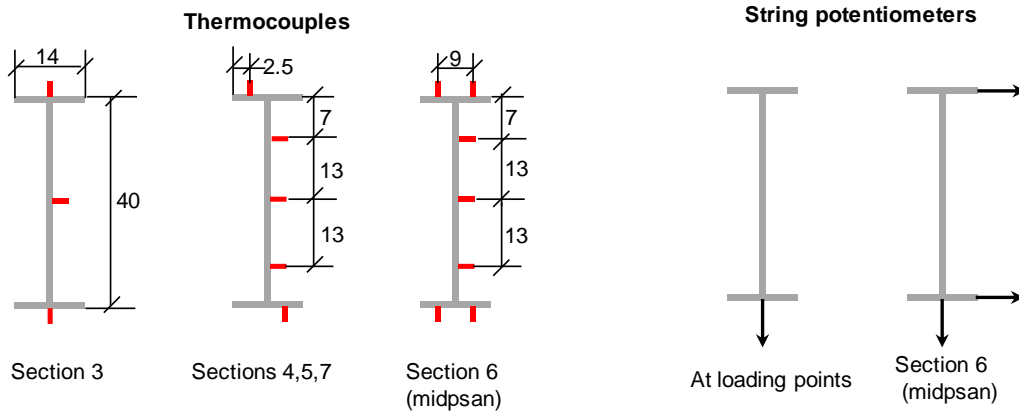
Figure 4-16 Instrumentation layout for Test 8. (unit: cm).

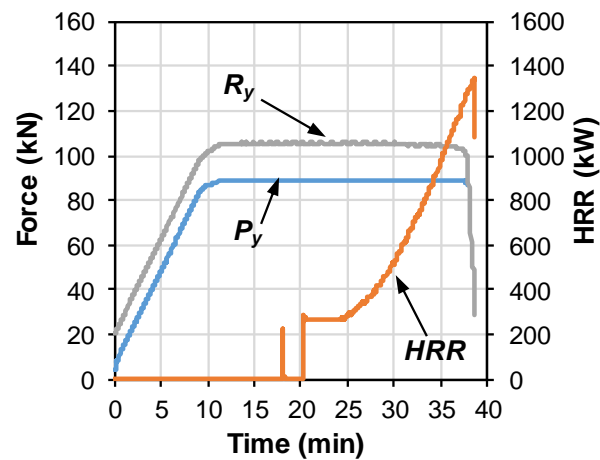
Figure 4-17 Measured HRR of the burner, average point load (P_y), and average reaction force (R_y) as a function of test time. The standard deviation of P_y and R_y values were 0.35 kN and 1.2 kN, respectively.

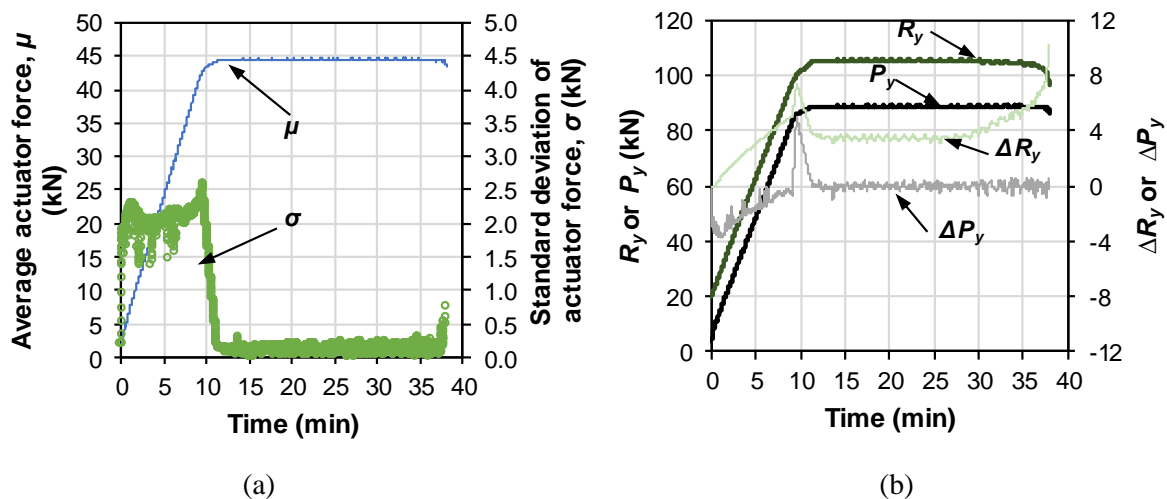
Figure 4-18 (a) Average actuator force and standard deviation as a function of test time and (b) average reaction force (R_y) and point load (P_y) over the test period along with the difference (ΔP_y) in two points loads and the difference (ΔR_y) in reaction forces at the beam ends.

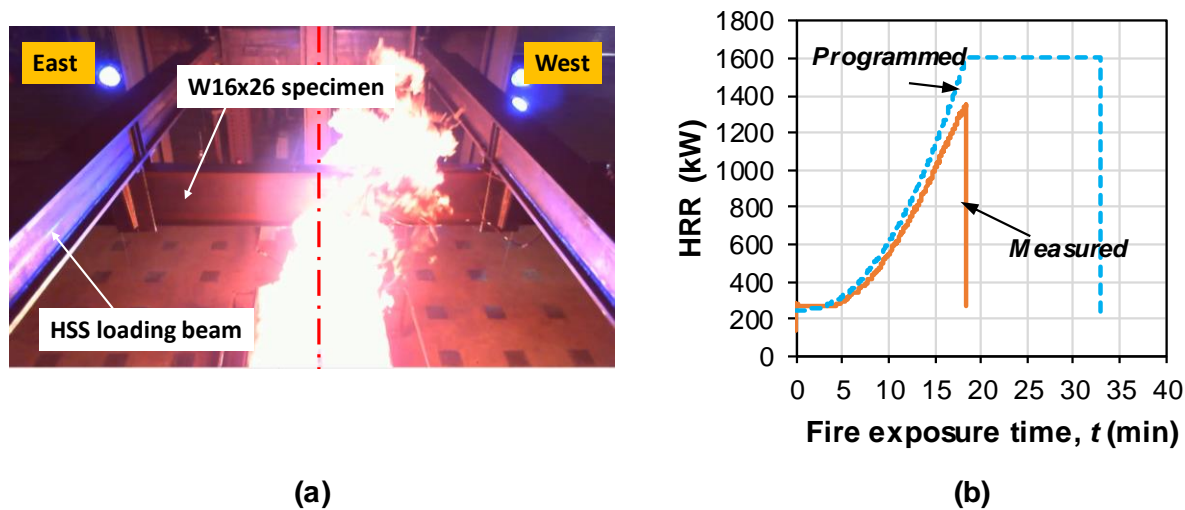
Figure 4-19 (a) a snapshot of Test 8 with view looking down to the beam specimen and (b) comparison of the programmed and measured HRR of the burner.

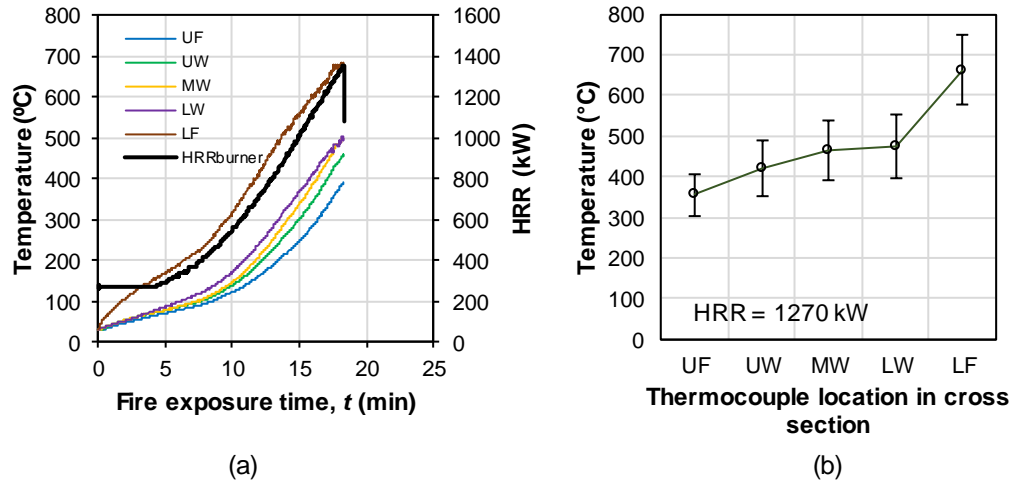
Figure 4-21(a) Measured steel temperatures in Test 8 and (b) 1 minute-average temperatures in fire exposed cross sections at the specimen failure.

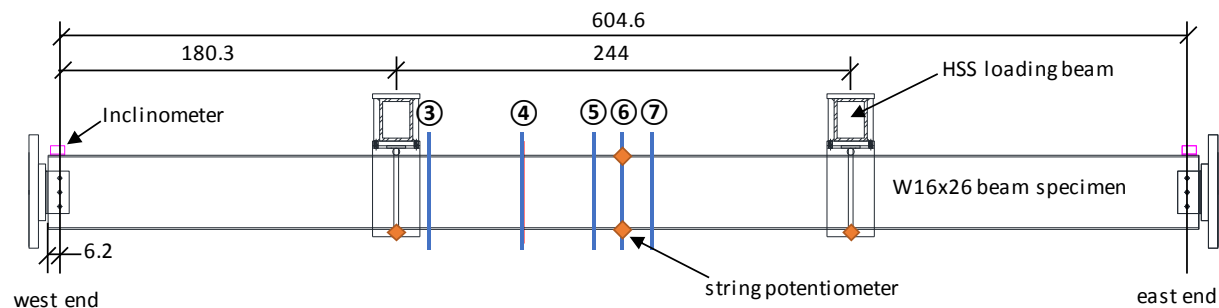
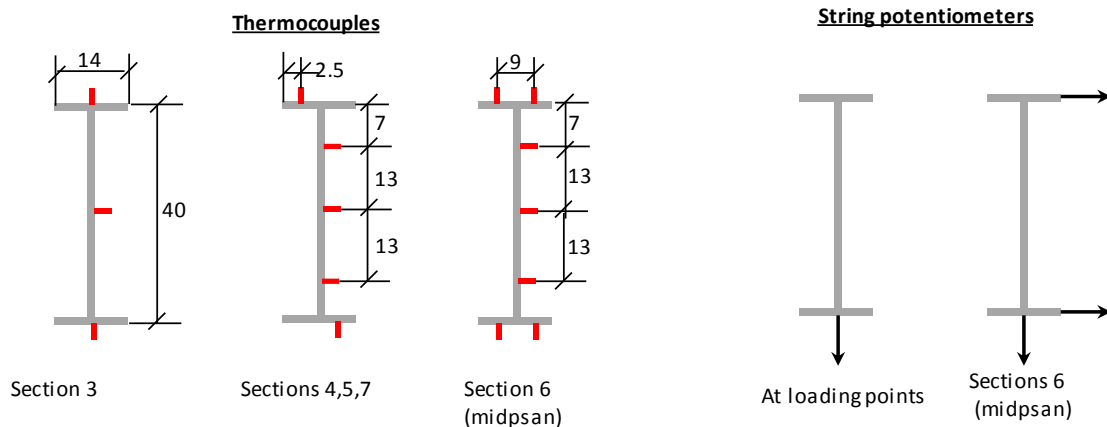
Figure 4-24 Instrumentation layout used in Test 9. (unit: cm).

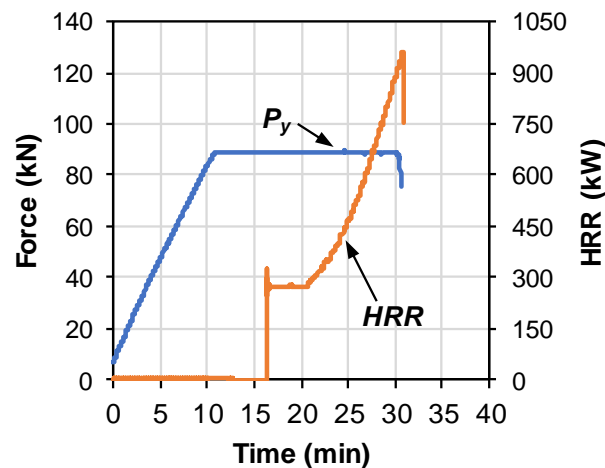
Figure 4-25 Measured HRR of the burner and the average point load (P_y) as a function of test time. The standard deviation of P_y values was 1.2 kN, respectively.

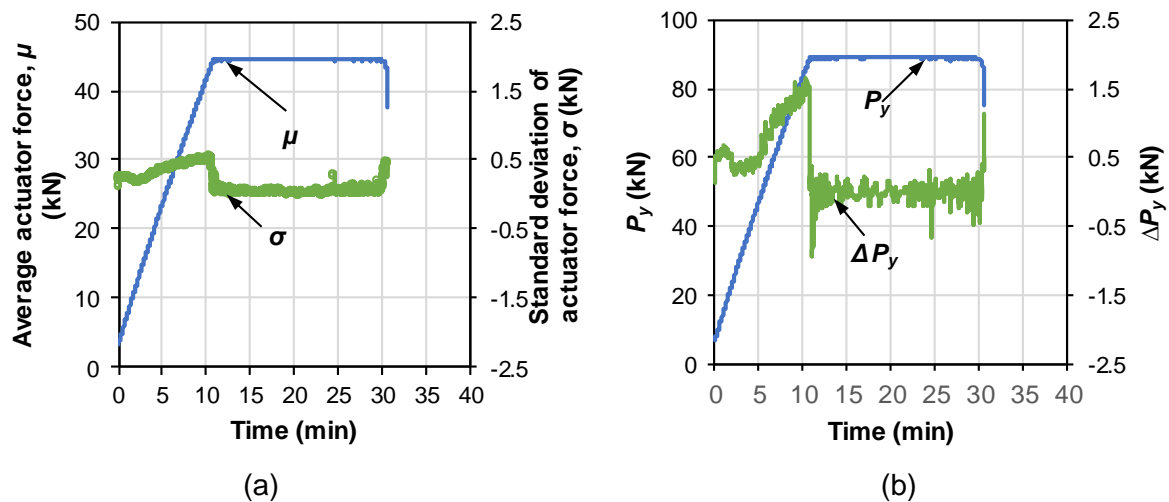
Figure 4-26 (a) The time series of average actuator force and standard deviation and (b) average point load (P_y) over test period along with the differences (ΔP_y) of two points loads at the location of loading beams.

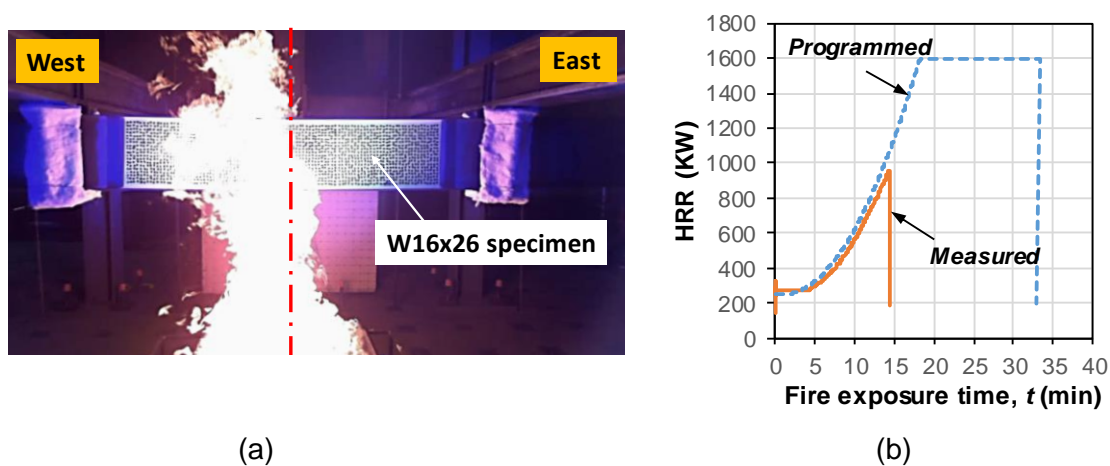
Figure 4-27(a) Snapshot of Test 9 with view looking down to the beam specimen and (b) comparison of the programmed and measured HRR of the burner.

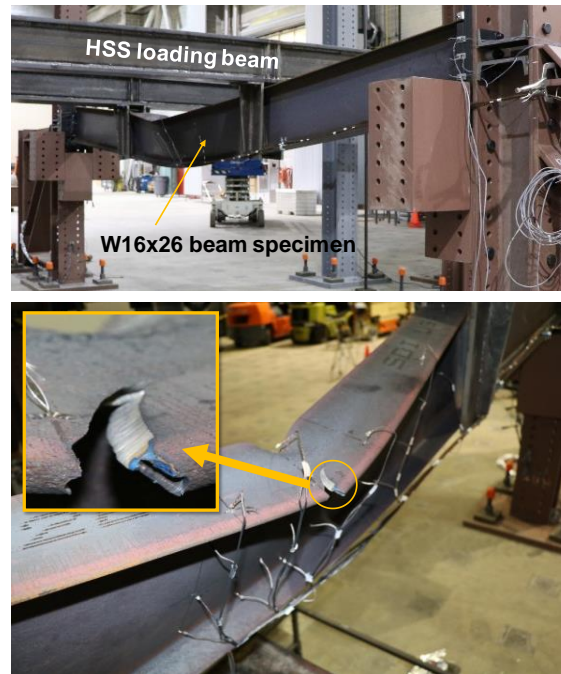
Figure 4-31 Deflected shape of the specimen after cool-down (top) and ductile fracture failure at midspan (bottom)

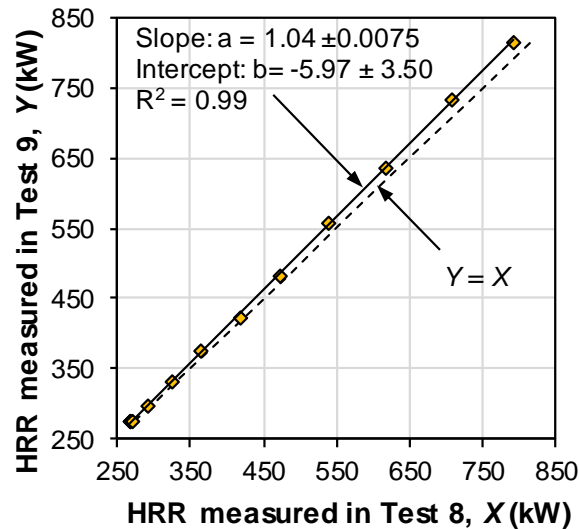
Figure 4-34 Comparison of the burner HRR measured in Tests 8 and 9

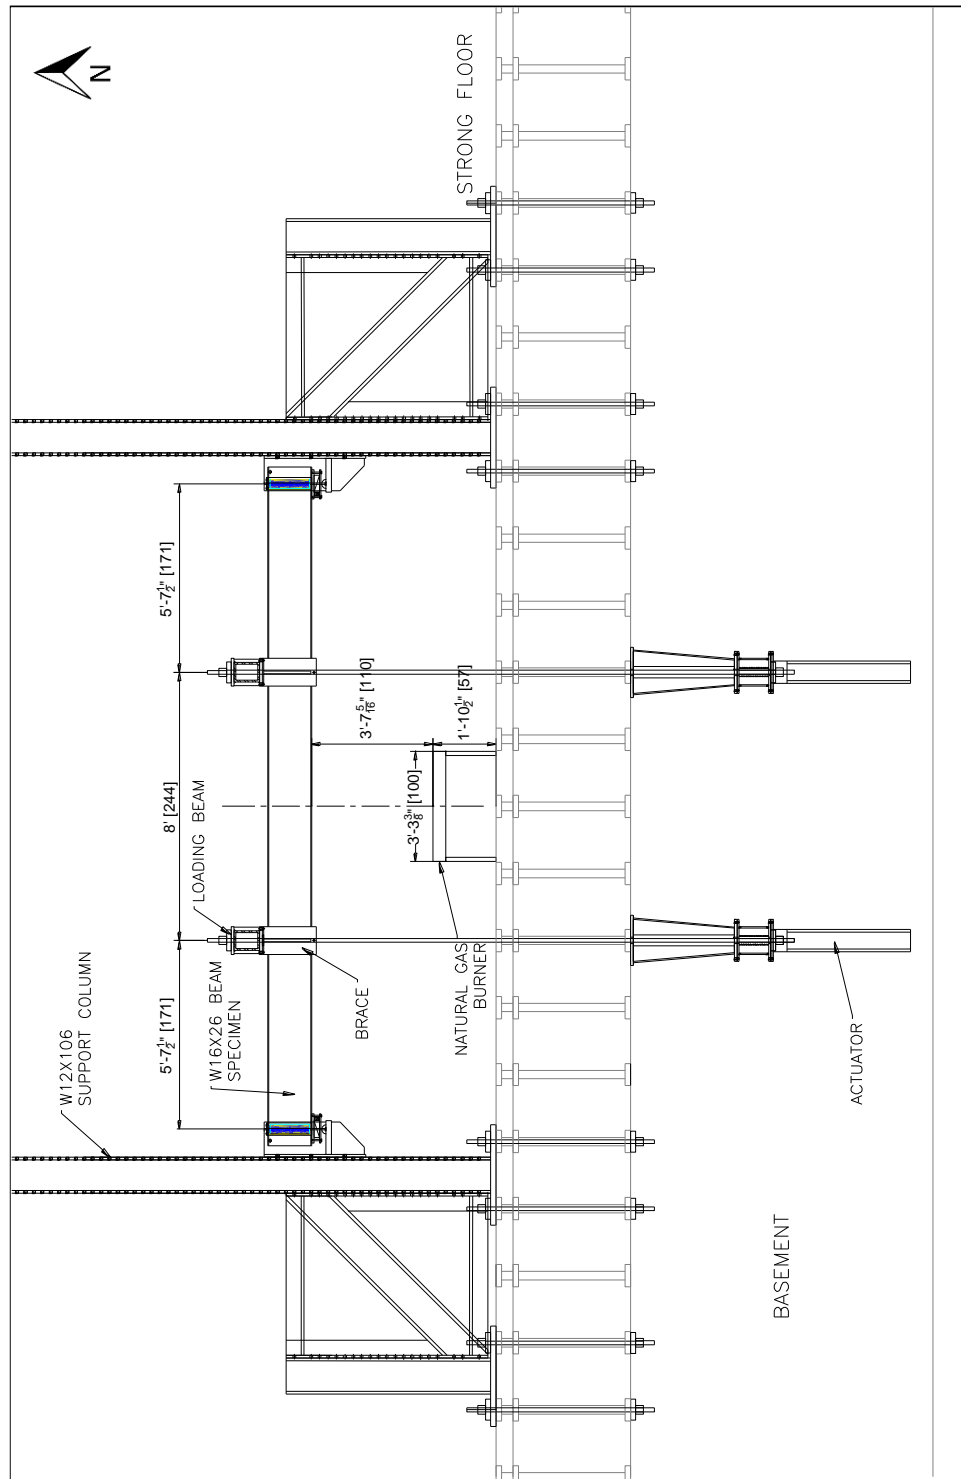
Figure A-2 Elevation view of test setup for simply-supported beam (units in [] = cm).

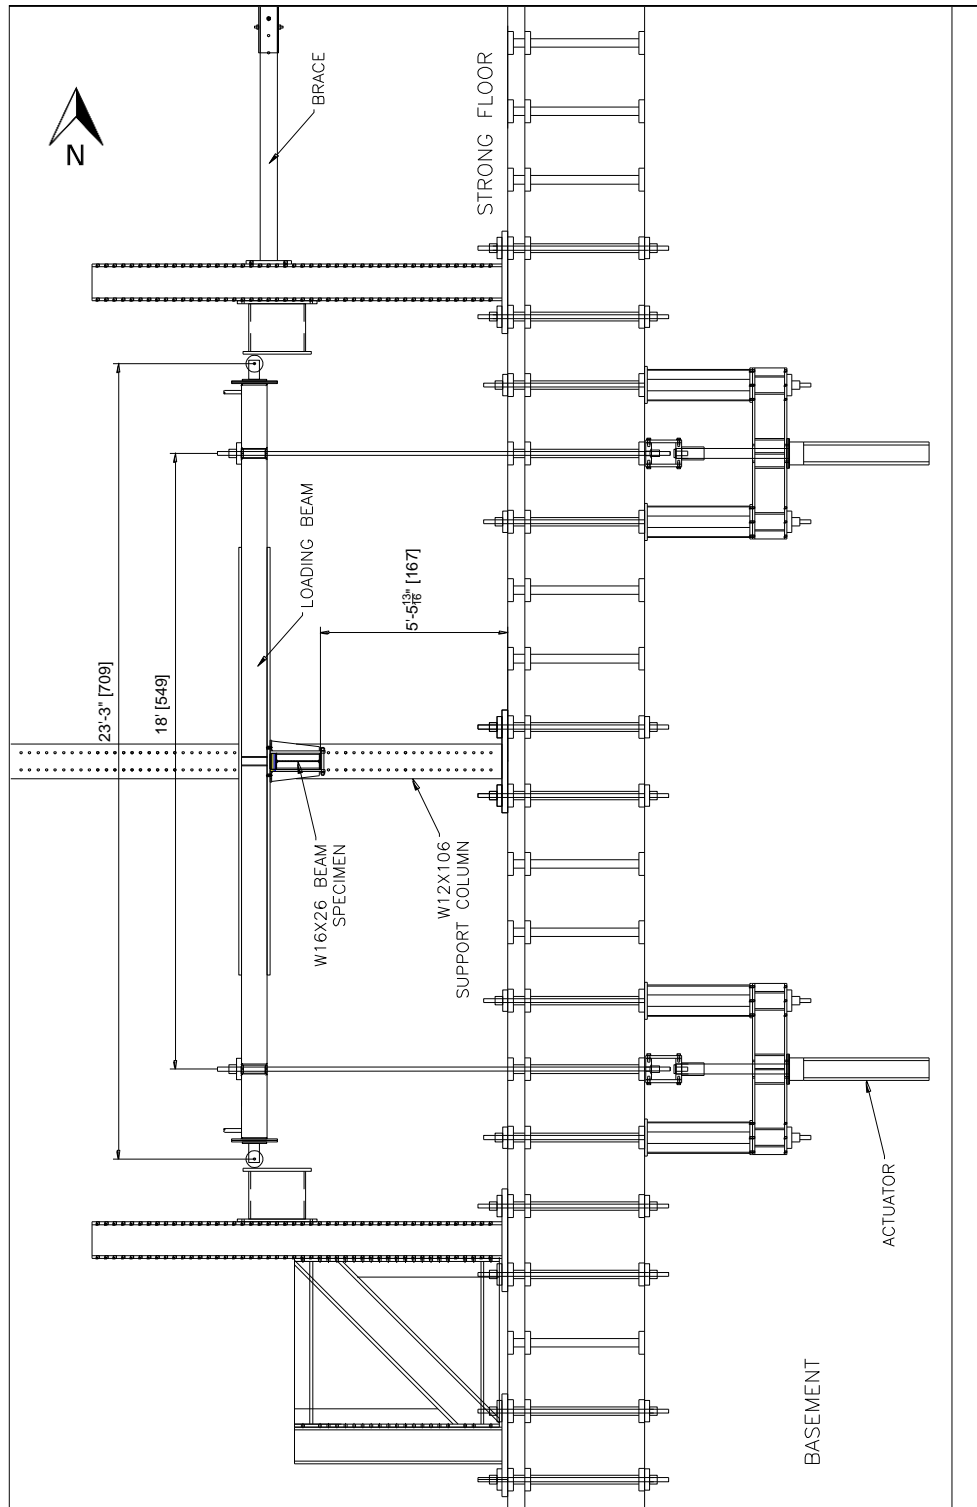
Figure A-4 Elevation view of buide frames for loading beam (units in [] = cm).
