REPORT ON HIGH ENERGY ARCING FAULT EXPERIMENTS

Experimental Results from Medium-Voltage Bus Duct and Switchgear Enclosures

Date Published: September 2023

NIST Technical Note NIST TN 2263

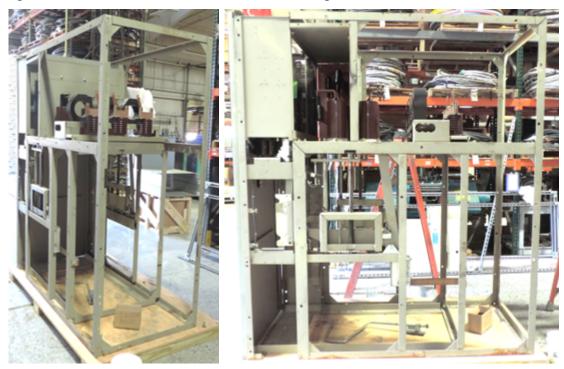
Fig. 4. Type M-36 Metal Clad Enclosure (note: bus bar and breaker not shown)

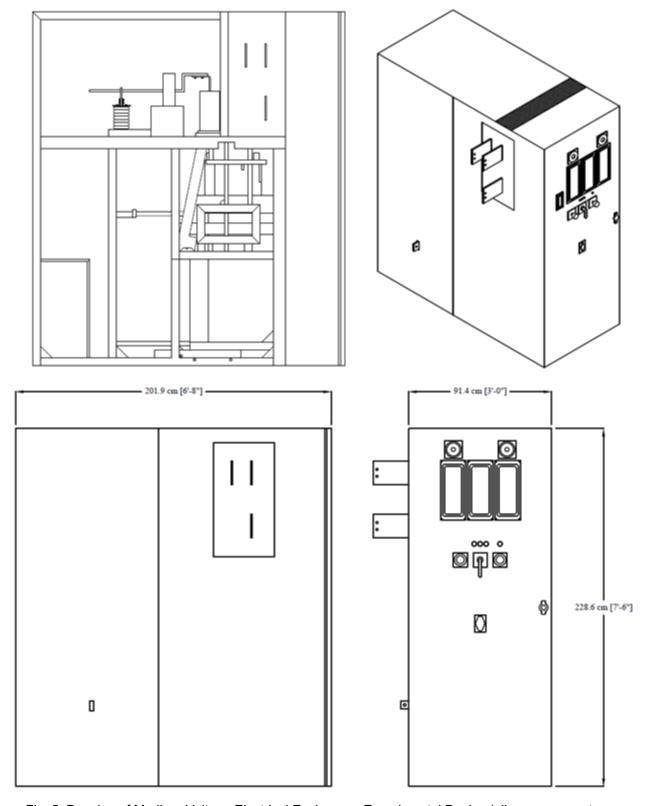
Fig. 5. Drawing of Medium-Voltage Electrical Enclosure - Experimental Device (all measurements are approximate)

Copper bus bars were used for the main bus conductors and primary cable compartment buses. The breaker socket/tube conductors were copper. The original equipment contained insulation on the primary cable compartment buses, but the insulation was removed to be consistent with the 2018 experimental series for comparative purposes [16]. In the U.S., equipment can be found with and without insulation on the bus bars. Unlike the 2018 experimental series, the current transformers (CTs) were included in the experiments. This inclusion added realism in the experimental configuration as switchgear found in the field typically have CTs as part of the protection circuit. The CT's secondary sides were shorted to minimize the concern of high voltage conditions due to open circuit CTs. Field-installed cable potheads or cable clamp terminations were not included. The absence of bus cabling reduced the amount of combustible load but is consistent with previous experiments.

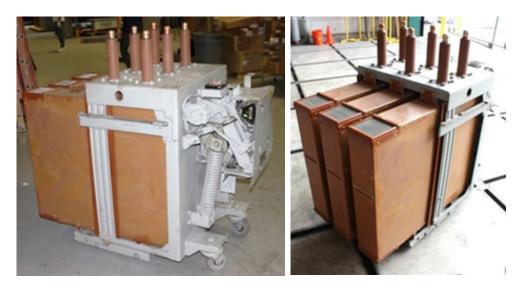
Fig. 6. Photo of AM-7.2-500 GE Magne-blast breaker

Each unit contained one medium-voltage circuit breaker. All breakers were GE Magne-blast Type AM-7.2-500 circuit breakers. The breaker ratings are shown in Table 1 and a photo of a breaker removed from the enclosure is shown in Fig. 6. After receipt of the equipment, the breakers were tested by the electrical contractor to ensure functionality. The breaker in the experiment enclosure was closed prior to, and remained closed during, the arc experiment. Prior to the experiments, Megger testing was performed with and without the breaker closed. A Megger test consists of applying a DC voltage across an insulator and measuring the resulting current. Ohms law allows for the measurement of the insulation resistance, typically in the megaohm range for a good insulator. This ensured the equipment and breaker were functional prior to each experiment.

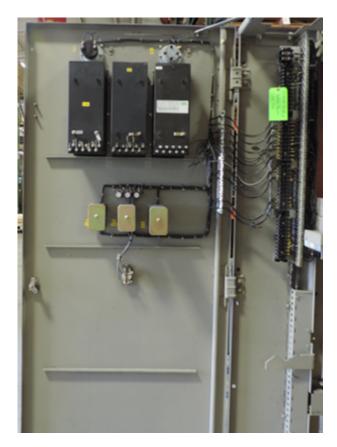
Fig. 8. Photo of combustible component loading in the secondary enclosure

material was not on the primary cable compartment buses as discussed previously. The secondary enclosure contained protective relays, fuse holders, control switches, meters, resistors, and associated insulated conductors. The insulation on the SIS-insulated conductors represented most of the combustible loading in the secondary enclosure. Some of the wiring had been cut and removed prior to receipt of the equipment. It was unclear if the equipment supplier removed it, or if it was removed by the previous owner. The amount of combustible material varied between enclosures, but was minimal and separated from the arc location by metal cladding. Fig. 8 shows this loading.

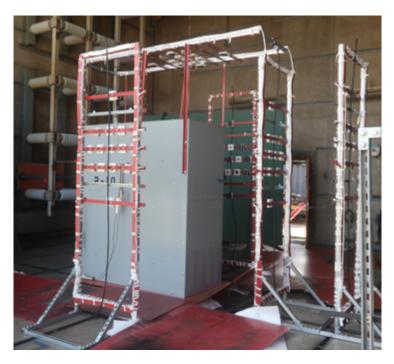
Fig. 11. Photo of instrumentation racks during experimental setup

The majority of the thermal instrumentation devices were located on instrument racks with the face of the instrument located approximately 91 cm (36 in) from the exterior of the metal-clad enclosure. One additional instrument rack (Rack 3) was located approximately 183 cm (72 in) from the expected arc breach side of the electrical enclosure. Rack 3 had its sensors shifted up approximately 102 mm (4 in) to reduce shadowing effects from the Rack 2 located between Rack 3 and the enclosure. An instrumentation rack was also located above the enclosure. This instrumentation rack (Rack 5) was secured to the electrical enclosure with 90-degree angle red GPO-3 board (glass reinforced thermoset polyester) and nominal $\frac{1}{4}$ in-20 fasteners. The sensors on Rack 5 are located approximately 91 cm (36 in) from the top of the enclosure's metal cladding. This instrumentation rack configuration is shown in Fig. 9 and Fig. 10. Details of the instrument locations are presented in Appendix A, with a photograph showing the instrumentation racks around the experimental device during setup in Fig. 11. The expanded uncertainty in the measurement of the distances from the instrumentation racks to the electrical enclosure is \pm 13 mm (0.5 in) with a coverage factor of 2 and an estimated confidence interval of 95 percent.

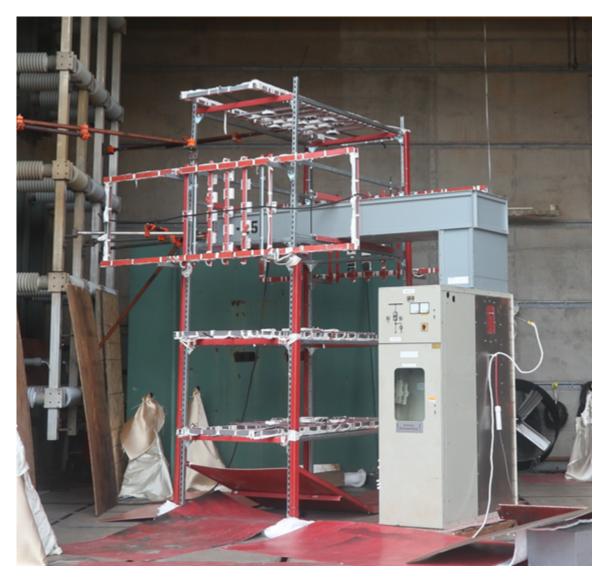
Fig. 14. Photo of bus duct instrumentation configuration prior to experiment

Following the same scheme as the switchgear experiments, the majority of the thermal instrumentation devices were located on instrument racks with the face of the instrument located approximately 91 cm (36 in) from the exterior of the bus duct enclosure. One additional instrument rack (Rack 5) was located approximately 183 cm (72 in) from the expected arc breach side of the bus duct enclosure (below the duct). An instrumentation rack (Rack 3) was also located above the bus duct enclosure. The sensors on Rack 3 are located approximately 91 cm (36 in) from the top of the enclosure metal cladding. This instrumentation rack configuration is shown in Fig. 12 and Fig. 13. Fig. 14 is a photograph showing the instrumentation racks around the experiment device and the sheathed thermocouple in the side of the switchgear. The sheathed thermocouple penetrates the side panel of the switchgear 20 cm (8.0 in) form the top, and 46 cm (18.0 in) from the rear. The tip of the sheathed thermocouple is located 21.6 cm (8.5 in) inside the switchgear so that it intersects the centerline of the bus duct above. The expanded uncertainty in the measurement of the distances from the instrumentation racks to the bus duct enclosure is \pm 13 mm (0.5 in) with a coverage factor of 2 and an estimated confidence interval of 95 percent. The expanded uncertainty in the measurement of the location of the sheathed thermocouples is \pm 6 mm (0.25 in) with a coverage factor of 2 and an estimated confidence interval of 95 percent.

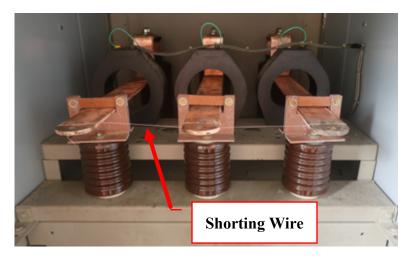
Fig. 15. Shorting wire location Experiment 2-10.

The arc was located near the ends of bus bar in the cable connection compartment of the switchgear. Power flow resulted in a load experiment configuration. The arcing wire installed on the bus and marked up illustrations of the arc wire location is presented in Fig. 15.

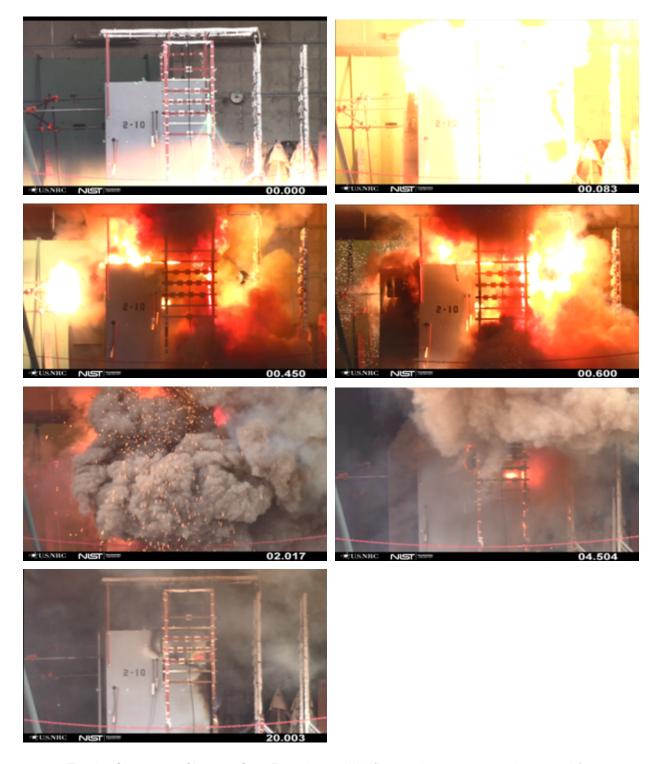
Fig. 16. Sequence of Images from Experiment 2-10 (image time stamps are in seconds).

Time (ms)	Observation
0	Initial light observed in bottom rear louver
83	Door opens
445	Door hits Phase A power supply and arcs for 143 ms
600	End of door arcing
2 017	End of arc
4 504	First visual of cabinet after smoke rises above cabinet
20 000	Image at 20 s following arc initiation

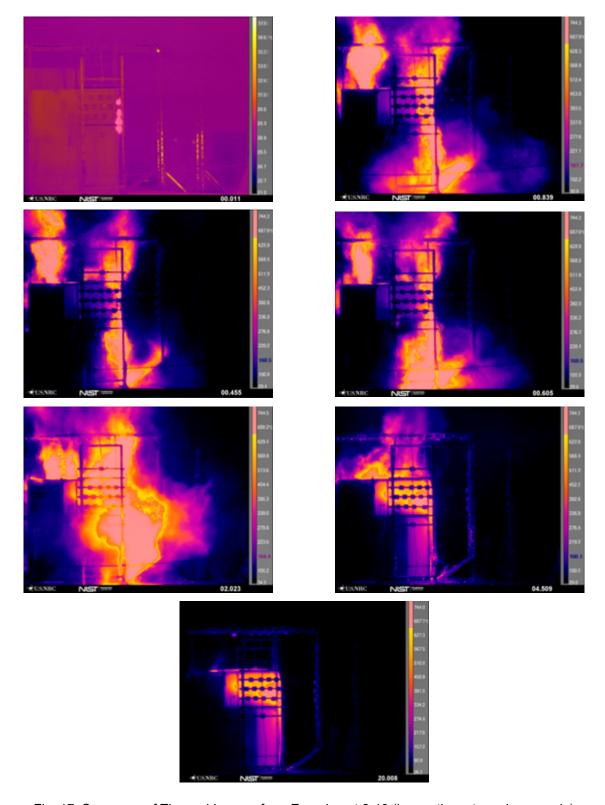
Fig. 17. Sequence of Thermal Images from Experiment 2-10 (image time stamp in seconds)

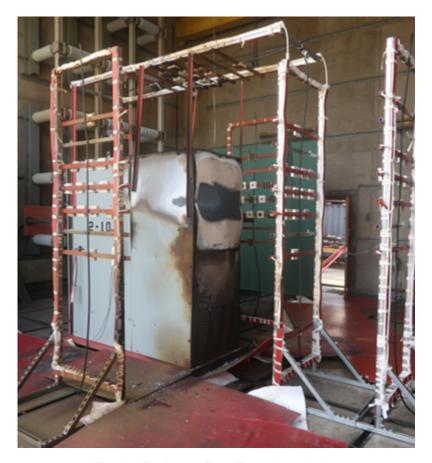
Photographs of the enclosure following the experiment are presented in Fig. 18. The enclosure did not experience a breach due to thermal burn through.

Fig. 18. Enclosure Post-Experiment 2-10.

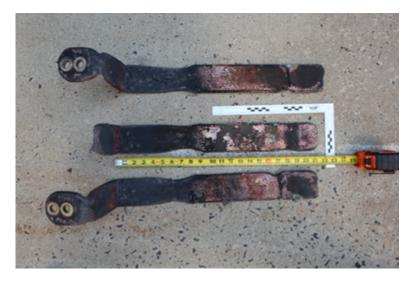
Fig. 19. Photo of Experiment 2-10 bus bars post-experiment (arc location shown right).

An image of the bus bars removed from the enclosure after the experiment are shown in Fig. 19. The total mass loss of the bus bars was $2\,035g \pm 1g$. Additional details are presented in Appendix C.

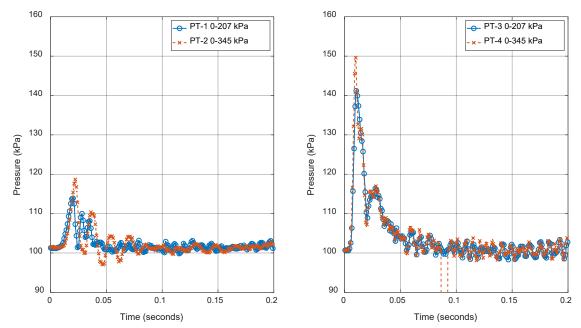
Fig. 20. Pressure measurements from Experiment 2-10 (breaker compartment (left); Main bus [arcing compartment] – (right)). Measurement uncertainty ± 3 percent.

above ambient at its peak. The maximum change in pressure in the breaker compartment is approximately 17.0 kPa (2.5 psi) above ambient.

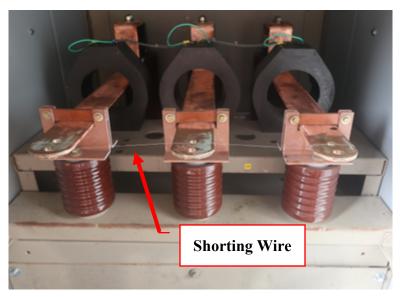
Fig. 21. Shorting wire location Experiment 2-12

The arc was located near the top of the main bus bar in the load section of the switchgear. The arcing wire installed on the bus and marked up illustrations of the arc wire location is presented in Fig. 21.

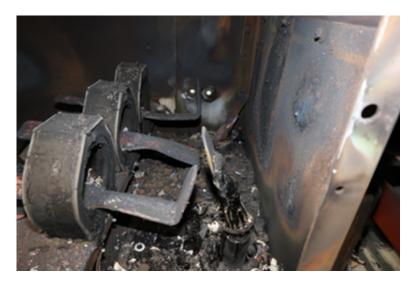
The arc did not last for expected duration and self-extinguished at 2.88 s. It appeared that the arc migrated towards the front of the cabinet and severed the bus bar at the connections to the breaker bottles as shown in Fig. 22. Excessive panel buckling was observed on the rear panel. The enclosure breached on the top near the vent above the main bus. No enclosure breach was observed on any sides or the back panel. No visible cable damage was observed. The switchgear door was opened due to HEAF generated enclosure pressure. The arc energy was 129 MJ.

Fig. 22. Photo of severed bus bars at insulating bushing (breaker stab bottles).

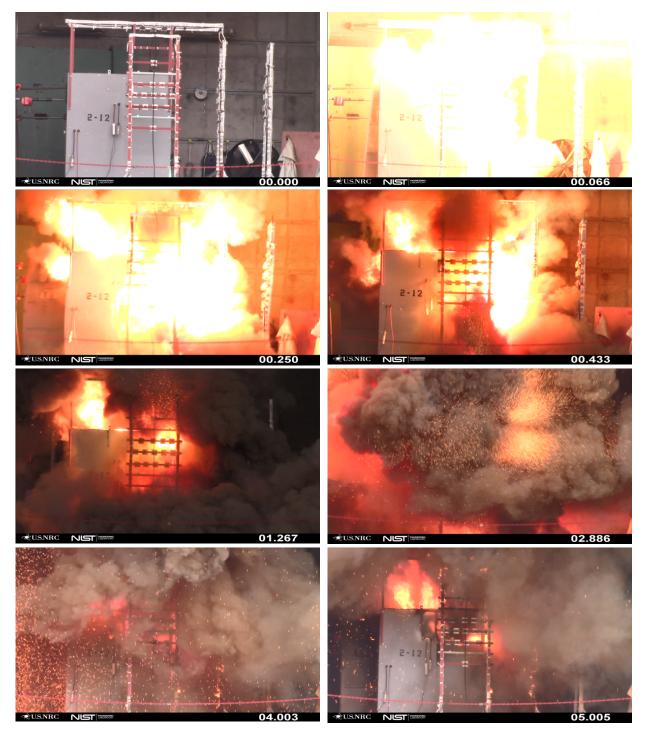
Fig. 23. Sequence of Images from Experiment 2-12 (image time stamps are in seconds).

Time (ms)	Observation	
0	Initial light observed in top rear louver	
66	Door opens	
250	Luminescent flash zone reaches top rack 5 and half-way between rack 2	
250	and 3	
433	Particle ejecta observed near rack 1 and 5	
1 267	Smoke beginning to obscure visual	
2886	End of arc	
4 003	Smoke begins to clear	
5 005	Flames emit from vent on top of enclosure

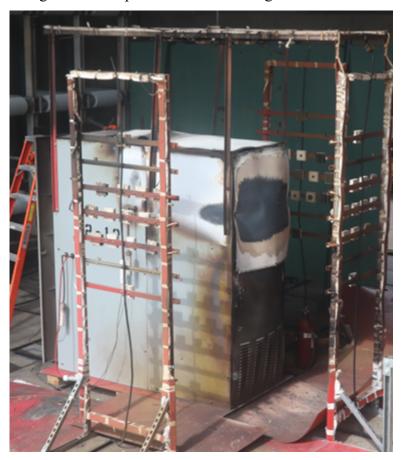
A photograph of the enclosure following the experiment is presented in Fig. 25. The enclosure experienced a breach on the top panel with two openings near the vent. A majority of the vent grating area was missing from the exposure as shown in Fig. 26.

Fig. 25. Enclosure Post-Experiment 2-12.

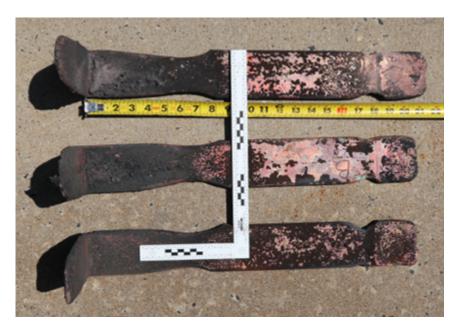
Fig. 27. Photo of Experiment 2-12 bus bars post-experiment (arc location shown right).

An image of the bus bars removed from the enclosure after the experiment are shown in Fig. 27. The total mass loss of the bus bars was $3\,349$ g \pm 1g. Additional details are presented in Appendix C.

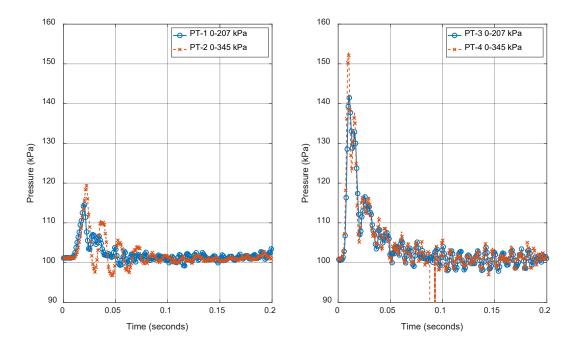
The pressure profiles for the first two tenths of a second are shown in Fig. 28. Pressure is measured at two locations (primary cable connection compartment and the breaker compartment). At each measurement location there are two pressure transducers. The 0 kPa to 207 kPa (0 psia to 30 psia) and 0 kPa to 345 kPa (0 psia to 50 psia) transducer recordings at a specific location were consistent. After the initial pressure spike, the pressure rapidly decays to a relative steady state. The peak pressure is higher in the primary cable connection compartment as would be expected since this is the compartment where the arc is initiated. The maximum change in pressure in the primary cable connection compartment is approximately 51.9 kPa (7.5 psi) above ambient at its peak. The maximum change in pressure in the breaker compartment is approximately 18.5 kPa (2.7 psi) above ambient.

Fig. 28. Pressure measurements from Experiment 2-12 (breaker compartment (left); Main bus [arcing compartment] – (right)). Measurement uncertainty ± 3 percent.

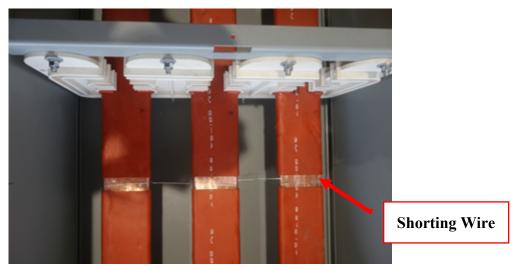
The arc wire was located at center of the duct section. A strip of insulation, approximately 2.5cm (1 in) long, was removed from each of the three bus conductors, and the arcing wire was wrapped around each conductor. The arcing wire installed on the bus is presented in Fig. 29.

Fig. 29. Shorting wire location Experiment 2-25

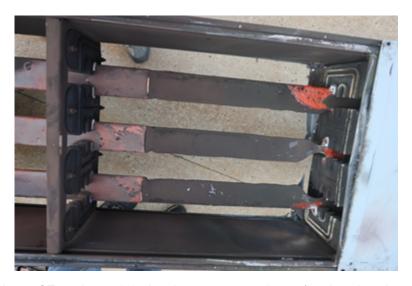
Fig. 33. Photo of Experiment 2-25 bus bars post-experiment (arc location shown center).

An image of the bus bars in the enclosure after the experiment are shown in Fig. 33. The total mass loss of the bus bars was $3\,848.5$ g \pm 1 g. Additional details are presented in Appendix C.

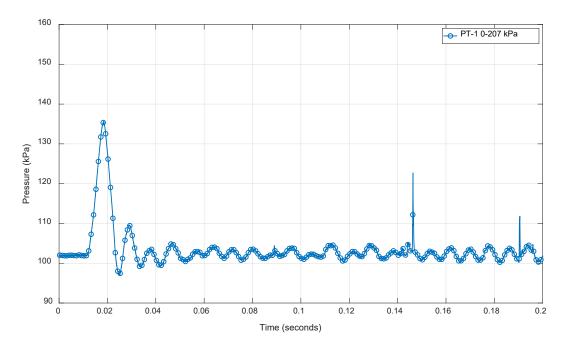
The pressure profiles for the first two tenths of a second are shown in Fig. 34. Only one pressure probe, 0 kPa to 207 kPa (0 psia to 30 psia), was used due to a problem installing the second probe. After the initial pressure spike, the pressure rapidly decays to a relative steady state. The maximum change in pressure is approximately 33.7 kPa (4.9 psi) above ambient at its peak.

Fig. 34. Pressure measurements from Experiment 2-25 located in connected switchgear. Measurement uncertainty ± 3 percent.

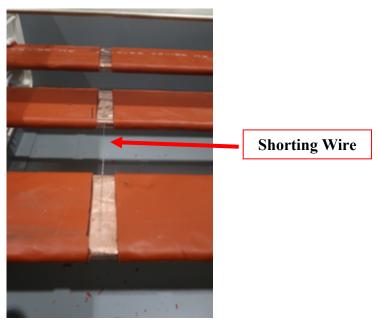
The arc wire was located at center of the started duct section. A strip of insulation, approximately 2.5cm (1 in) long, was removed from each of the three bus conductors and the arcing wire was wrapped around each conductor. The arcing wire installed on the bus is presented in Fig. 35.

Fig. 35. Shorting wire location Experiment 2-26

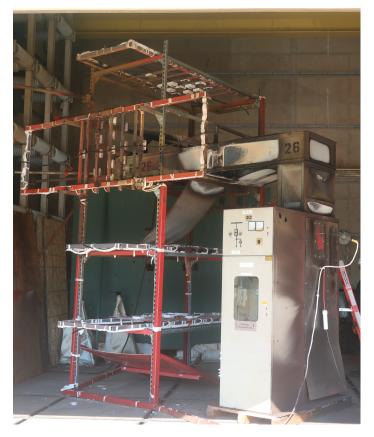
Fig. 38. Enclosure Post-Experiment 2-26.

Photograph of the enclosure following the experiment is presented in Fig. 38. The enclosure did not experience a breach due to thermal effects.

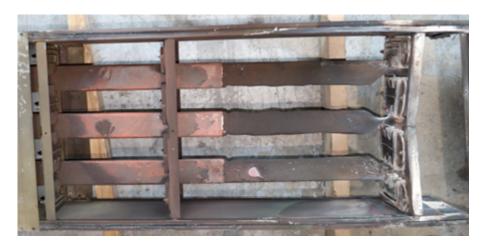
Fig. 39. Photo of Experiment 2-26 bus bars post-experiment (arc location shown center).

The bus bars in the duct enclosure after the experiment are shown in Fig. 39. The total mass lost from the bus bars was $5991.0 \text{ g} \pm 1 \text{ g}$. Additional details are presented in Appendix C.

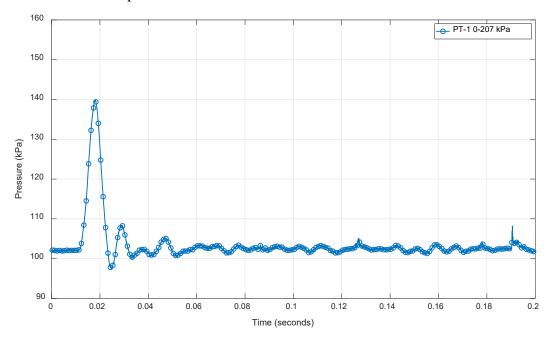
The pressure profiles for the first two tenths of a second are shown in Fig. 40. After the initial pressure spike, the pressure rapidly decays to a relative steady state. Only one pressure probe, 0 kPa to 207 kPa (0 psia to 30 psia) was used due to a problem installing the second probe. The maximum change in pressure in the connected switchgear unit is approximately 37.8 kPa (5.5 psi) above ambient at its peak.

Fig. 40. Pressure measurements from Experiment 2-26 (breaker compartment (left); Main bus [arcing compartment] – (right)). Measurement uncertainty ± 3 percent.

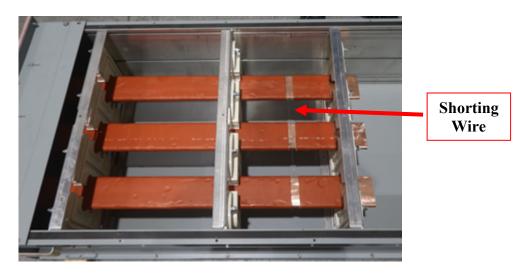
The arc wire was located at center of the straight duct section. A strip of insulation, approximately 2.5cm (1 in) long, was removed from each of the three bus conductors and the arcing wire was wrapped around each conductor. The arcing wire installed on the bus and marked up illustrations of the arc wire location is presented in Fig. 41.

Fig. 41. Shorting wire location Experiment 2-27

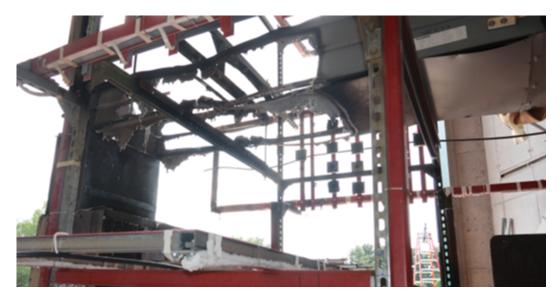
A photograph of the enclosure following the experiment is presented in Fig. 44. The enclosure did experience a breach. Most of the bus duct beyond the end of the bus bars was missing on the horizontal straight section. In addition, the end of the 90-degree duct elbow experienced a breach with most of the material missing post-experiment.

Fig. 44. Enclosure Post-Experiment 2-27.

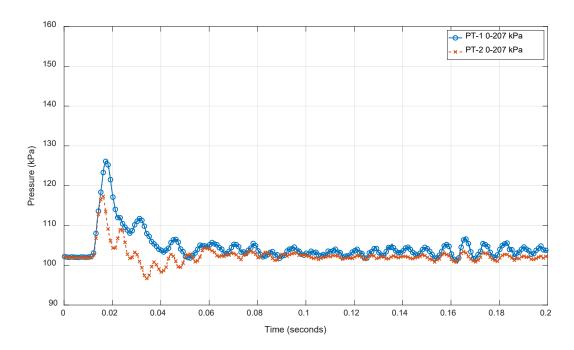
The pressure profiles for the first two tenths of a second are shown in Fig. 46. After the initial pressure spike, the pressure rapidly decays to a relative steady state. The maximum change in pressure in the switchgear enclosure is approximately 24 kPa (3.5 psi) above ambient at its peak.

Fig. 46. Pressure measurements from Experiment 2-27. Measurement uncertainty ± 3 percent.

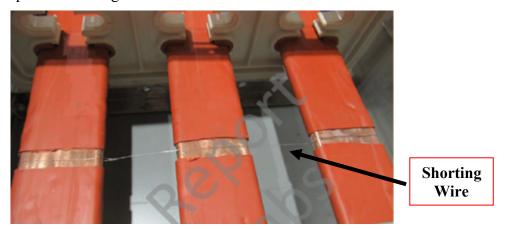
The arc wire was located at center of the duct section. A strip of insulation, approximately 2.5cm (1 in) long, was removed from each of the three bus conductors and the arcing wire was wrapped around each conductor. The arcing wire installed on the bus and marked up illustrations of the arc wire location is presented in Fig. 47.

Fig. 47. Shorting wire location Experiment 2-28 [photo from KEMA report]

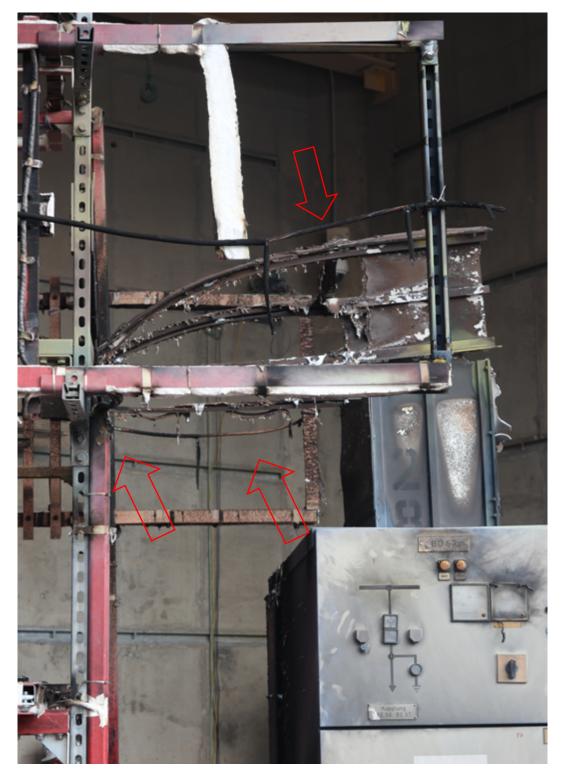
Fig. 48. Location of cable jacket damage relative to equipment. (Red arrows identify locations missing cable jacket and in some cases conductor jacket)

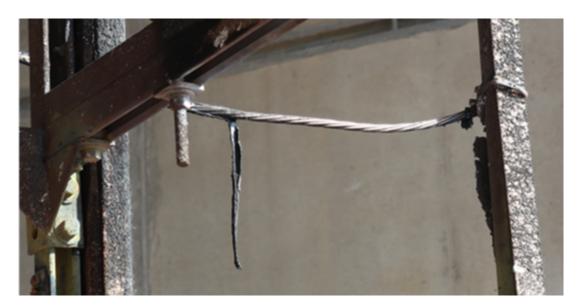
Fig. 49. Close-up of cable on Rack 2 from Experiment 2-28.

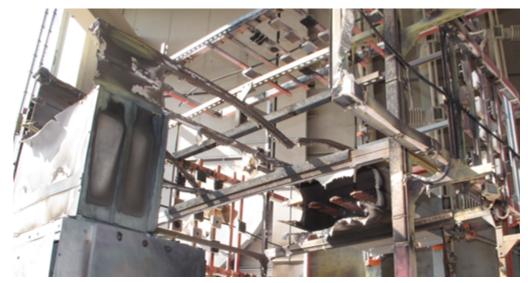
Fig. 52. Enclosure Post-Experiment 2-28.

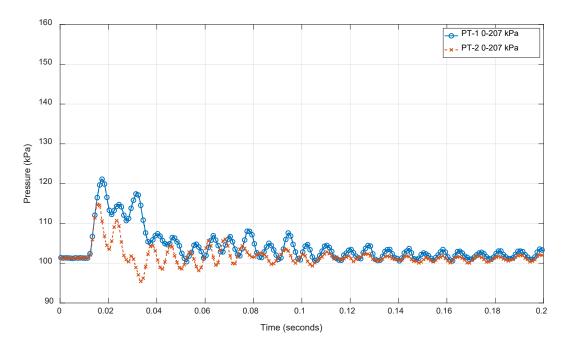
Fig. 54. Pressure measurements from Experiment 2-28. Measurement uncertainty ± 3 percent.

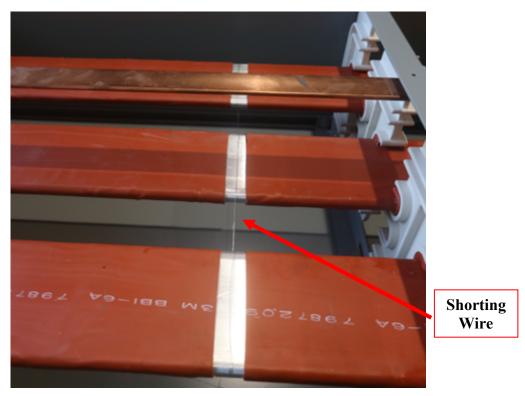
Fig. 55. Shorting wire location Experiment 2-30. Note that the bus duct is inverted in this photo.

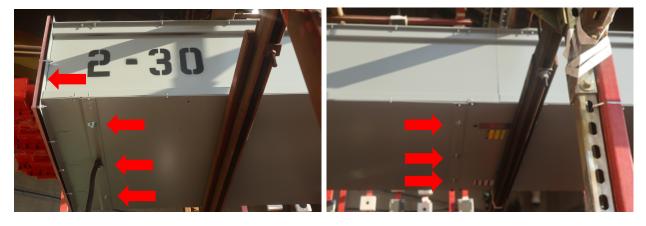
Fig. 56. Photo showing changes to duct enclosure to increase ability of panel to remain intact.

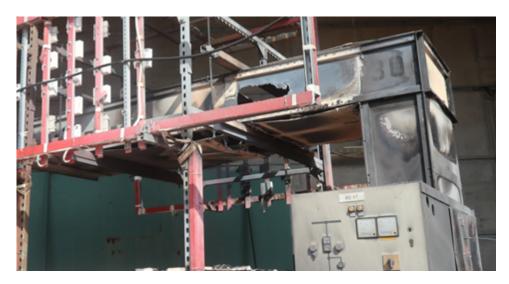
Fig. 59. Enclosure Post-Experiment 2-30.

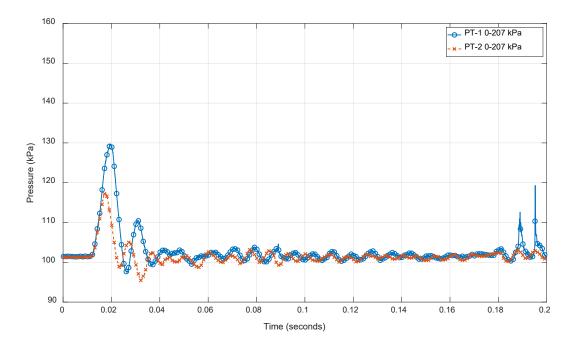
Fig. 61. Pressure measurements from Experiment 2-30 (breaker compartment (red dashes with "x" markers); Main bus [arcing compartment] – (blue line with "o" markers)).

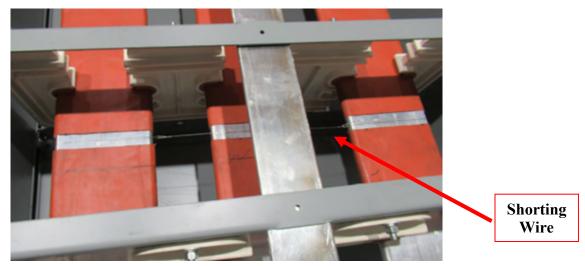
Fig. 62. Shorting wire location Experiment 2-30B. Note, image is from bottom of bus duct with uninsulated ground bus showing in center of image.

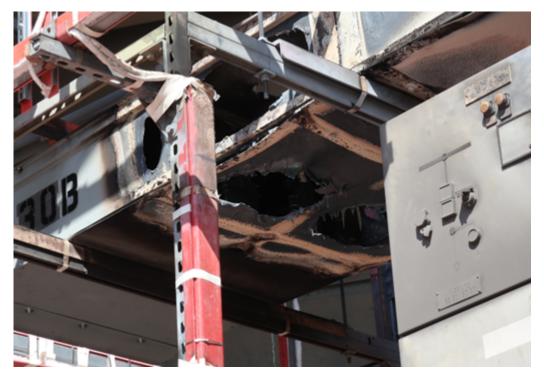
Fig. 65. Enclosure Post-Experiment 2-30B.

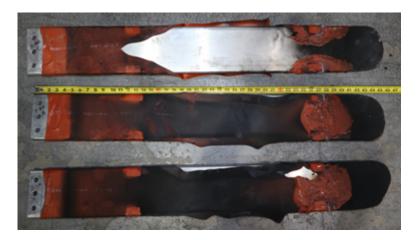
Fig. 66. Photo of Experiment 2-30B bus bars post-experiment (arc location shown center).

An image of the bus bars removed from the enclosure after the experiment is shown in Fig. 66. The total mass loss of the bus bars was $3\,605.0~g~\pm 1~g$. Additional details are presented in Appendix C.

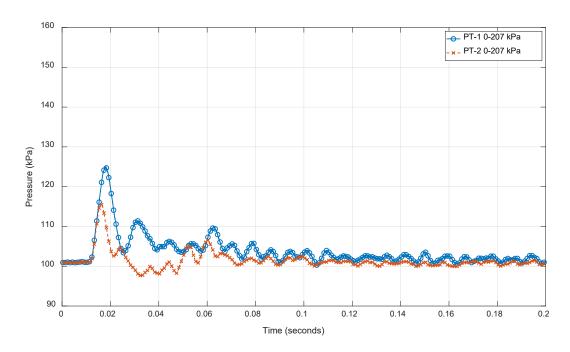
Fig. 67. Pressure measurements from Experiment 2-30B (breaker compartment (red dashed line with "x" marker); Main bus [arcing compartment] – (Blue solid line with "o" marker)).

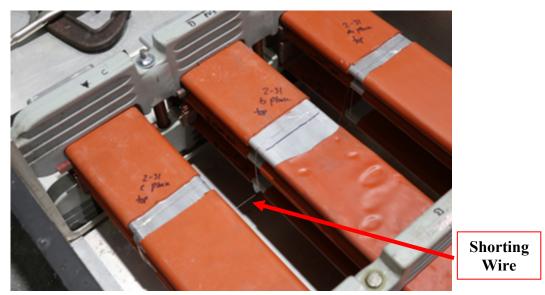
Fig. 68. Shorting wire location Experiment 2-31

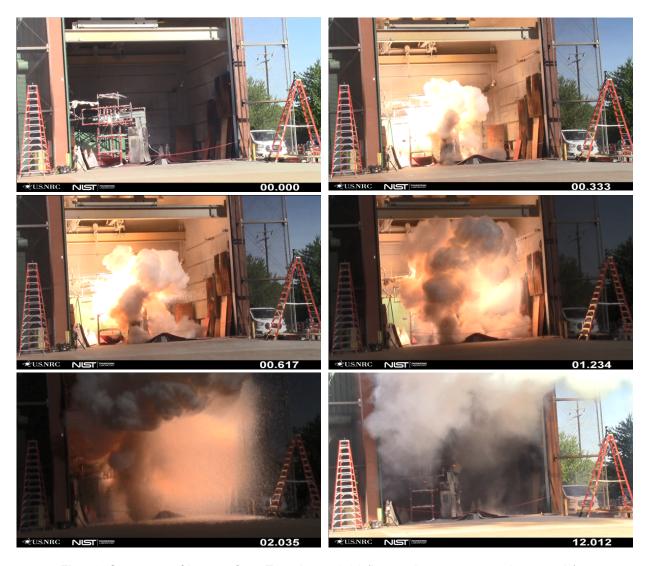
Fig. 69. Sequence of Images from Experiment 2-31 (image time stamps are in seconds).

Observations documented below are based on review of video and thermal imaging that was taken during the experiment. The observations are provided in Table 47 and include an approximate time reference. Corresponding images are provided in Fig. 69, with thermography images presented in Fig. 70.

Time (ms)	Observation
0	Initial light observed
333	Particle ejecta observed
617	Particle ejecta reaches right wall of test cell
1 234	Smoke reaches overhead crane
2 035	End of arc
12 012	Smoke beginning to clear test cell 10 s after end of arc

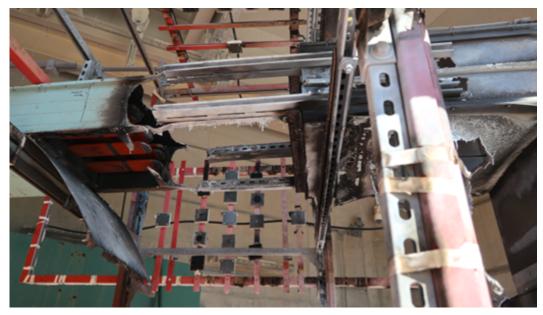
Fig. 71. Enclosure Post-Experiment 2-31.

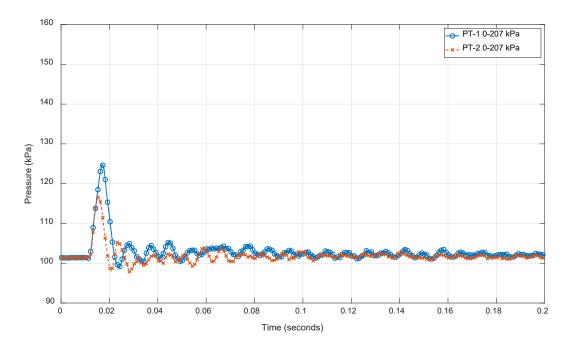
Fig. 73. Pressure measurements from Experiment 2-31. Measurement uncertainty ± 3 percent.

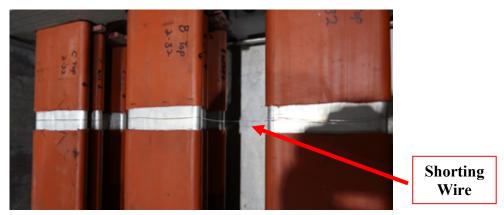
Fig. 74. Shorting wire location Experiment 2-32.

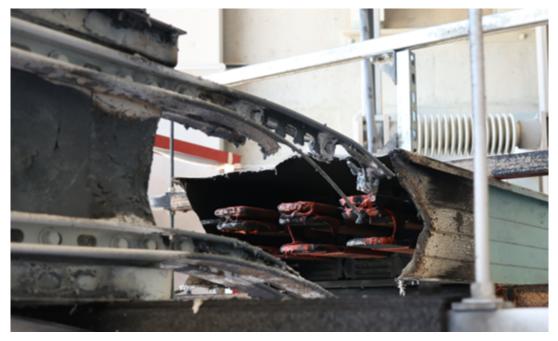
Fig. 77. Enclosure Post-Experiment 2-32.

A photograph of the enclosure following the experiment is shown in Fig. 77. The enclosure did experience a breach. The aluminum bus duct straight section beyond the bus bars was destroyed. The 90-degree elbow was made of steel and remained intact. The Unistrut supports used to connect the 90-degree elbow to the straight section were deformed with some material loss.

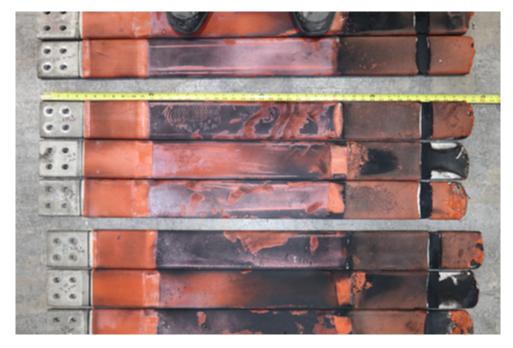
Fig. 79. Photo of Experiment 2-32 bus bars post experiment (arc location shown right)

An image of the bus bars removed from the enclosure after the experiment are shown in Fig. 79. The total mass loss of the bus bars was $4793 \text{ g} \pm 1 \text{ g}$. Additional details are presented in Appendix E.

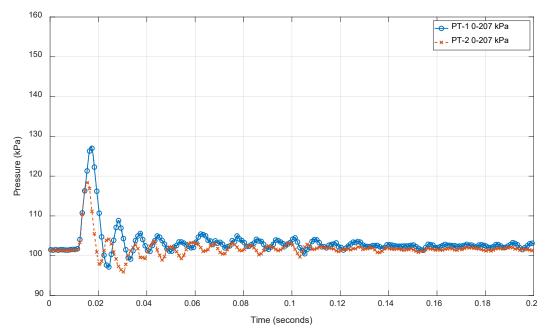
Fig. 80. Pressure measurements from Experiment 2-32. Measurement uncertainty ± 3 percent.

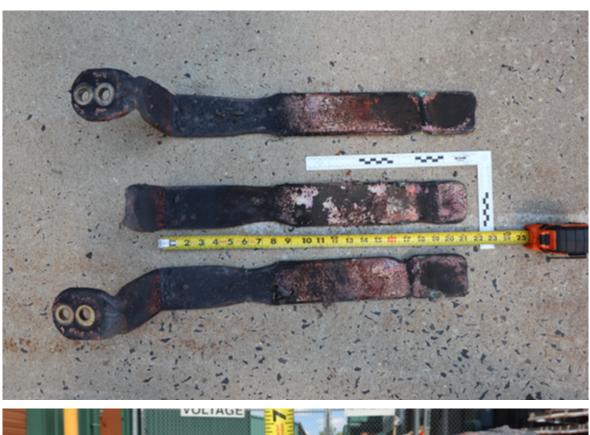
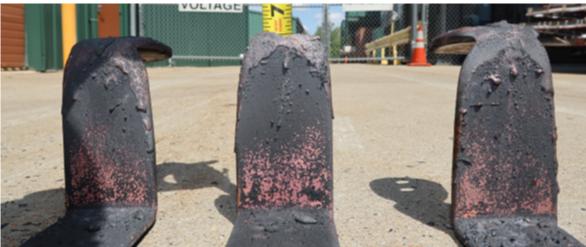
Fig. 149. Post-Experiment Conductors. Top (Plan view of primary cable connection bus bars; top – Phase C, middle – Phase B, bottom – Phase C), Bottom (elevation view of primary cable connection bus bars; left – Phase A, center – Phase B, right – Phase C)

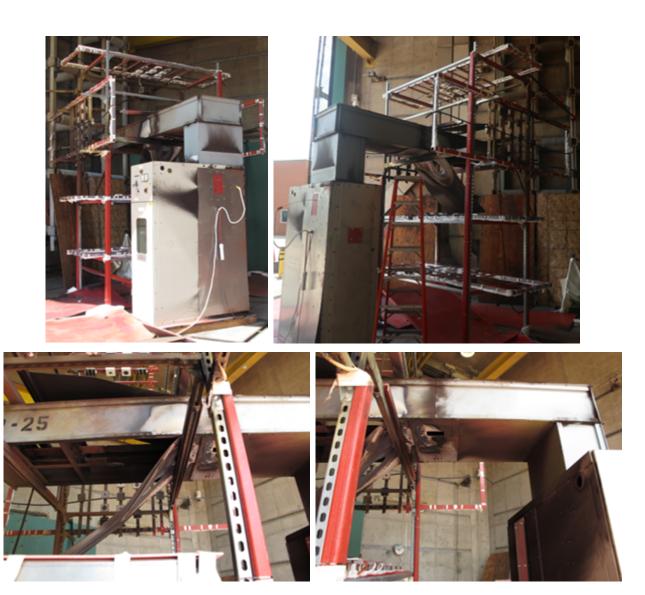
Fig. 156. Post-Experiment Experiment 2-25 (clockwise from top-left, Front angle; rear angle; front showing panel damage; front showing splice joint with breather)

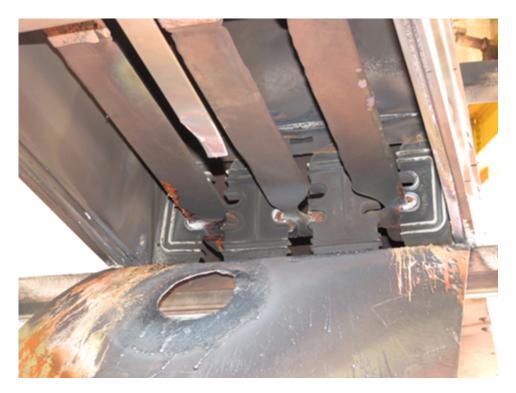
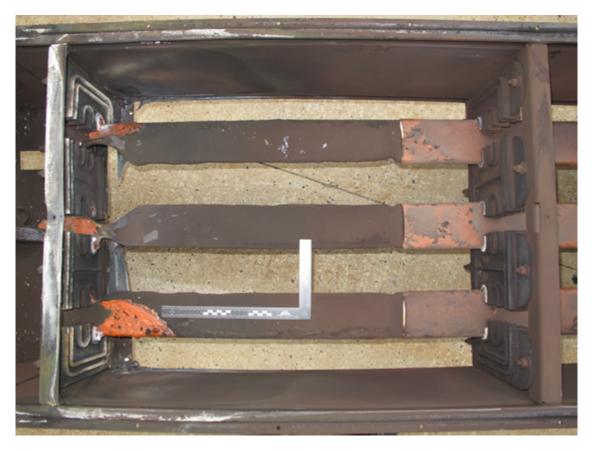
Fig. 157. Post-Experiment 2-25 Conductors

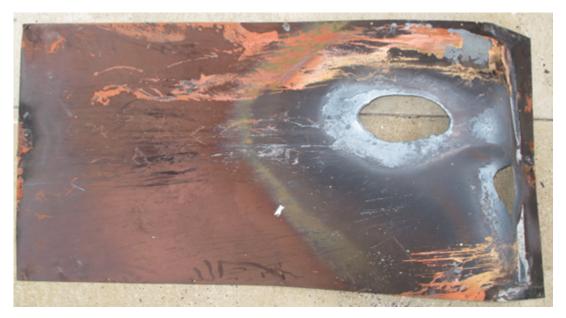
Fig. 159. Post-Experiment Experiment 2-25 Enclosure Breach (note panel is not lying flat on ground near right side, there is a bend downward near the right breach).

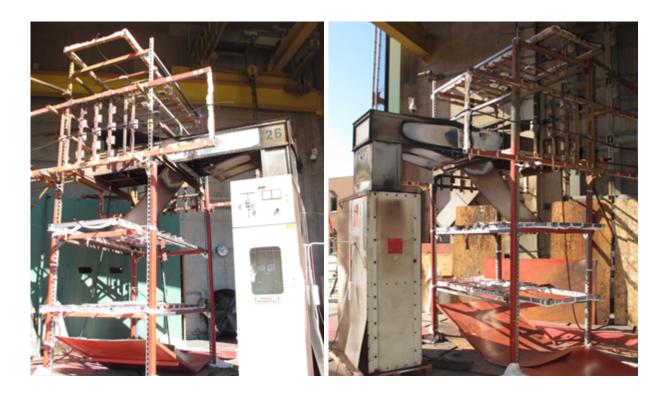
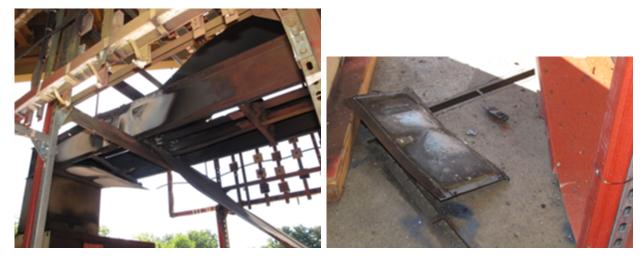
Fig. 161. Post-Experiment 2-26 (top-left – front; top-right – rear; bottom-left – rear looking up at bus duct; bottom-right – lower splice panel found lying on ground, breather screen missing)

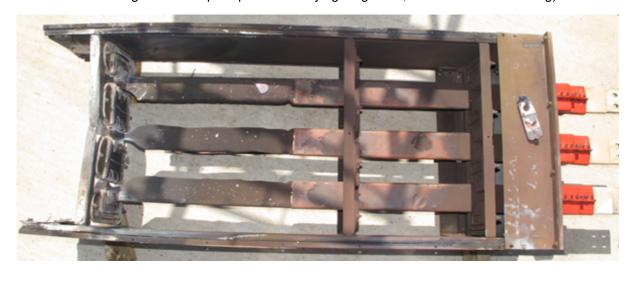
Fig. 162. Post-Experiment 2-26 Conductors (top – with conductors in duct; Bottom conductor ends A-B-C left to right)

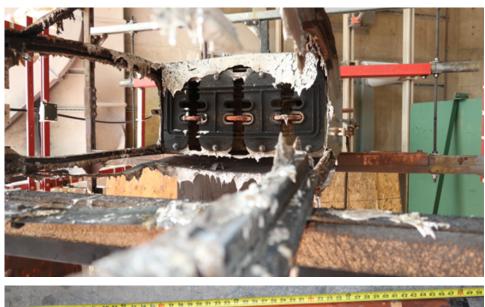
Fig. 165. Post-Experiment 2-27 Conductors (top – conductors in duct at end of experiment; bottom – conductors removed A-B-C: top to bottom)

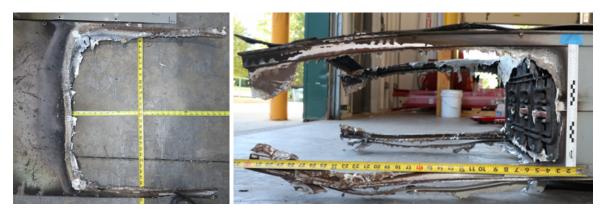
Fig. 166. Post-Experiment 2-27 Enclosure Breach (Top-left – top cover; Top-right – front side; Bottom-left – bottom cover; Bottom-right – rear side)

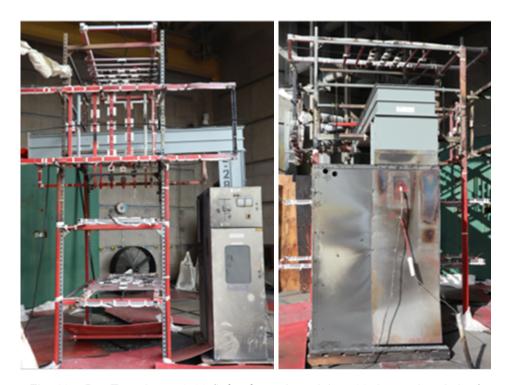
Fig. 167. Pre-Experiment 2-28 (left – front view; right – 90 degree bend view)

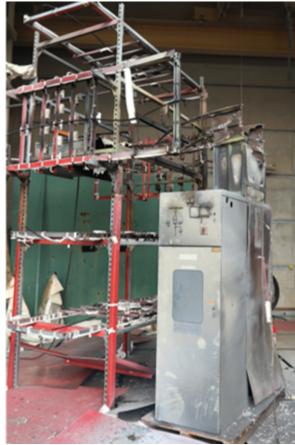
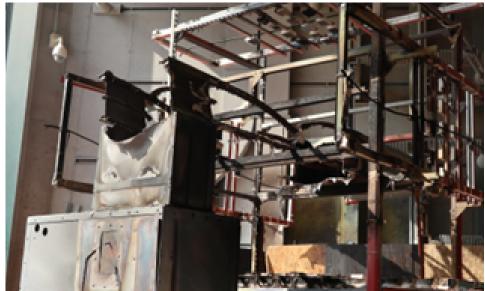
Fig. 168. Post-Experiment 2-28 (Top – front angle view; Bottom – rear angle view)

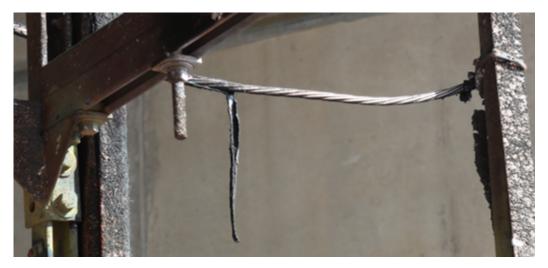
Fig. 170. Post-Experiment 2-28 insulated conductor Rack 2 at 90 degree bend end

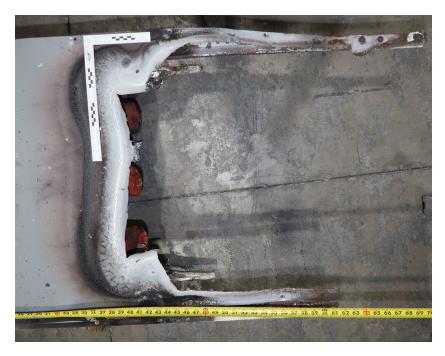
Fig. 171. Post-Experiment 2-28 Enclosure Breach

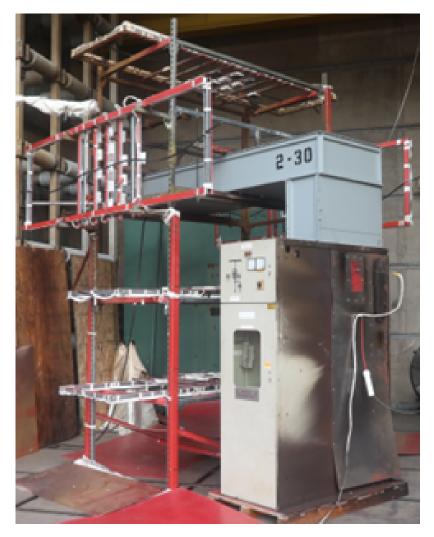
Fig. 172. Pre-Experiment

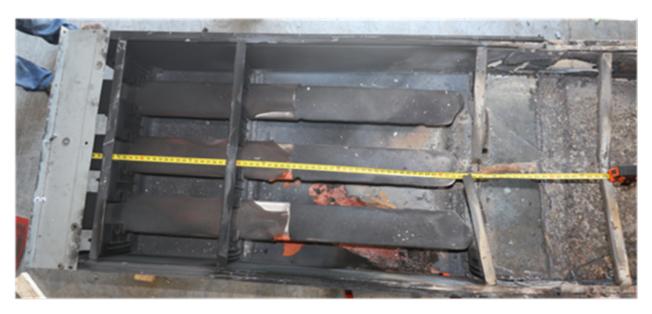
Fig. 174. Post-Experiment 2-30 Conductors

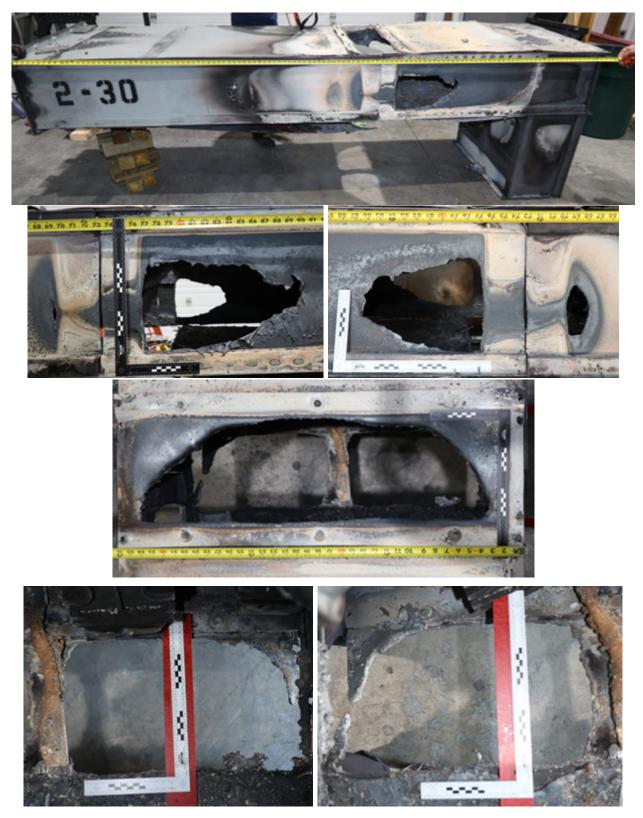
Fig. 175. Post-Experiment 2-30 Enclosure Breach (Top – front; Upper-Mid-left – front breach; Upper-Mid-right – rear breach; Lower-Mid – top breach; Bottom-left – lower cover front; Bottom-right – lower cover rear)

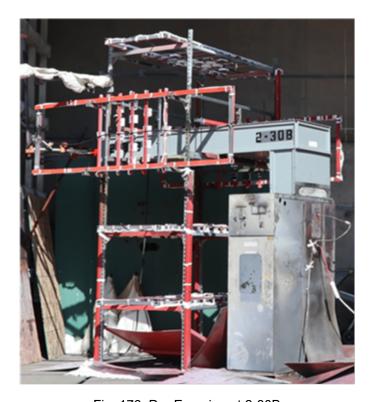
Fig. 176. Pre-Experiment 2-30B

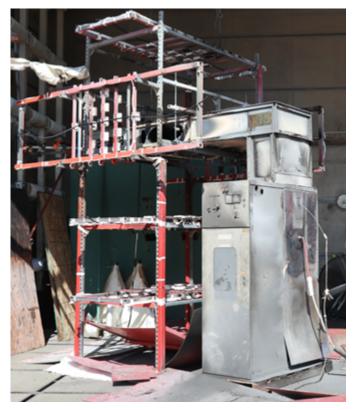
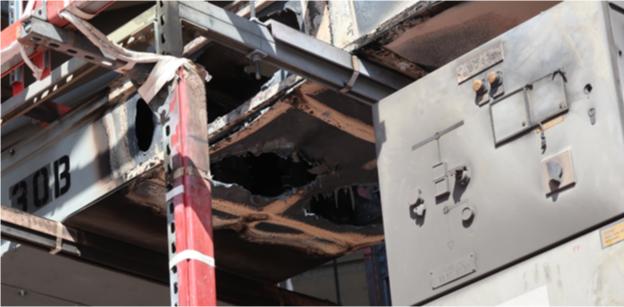
Fig. 177. Post-Experiment 2-30B (Top – front view; Bottom – front view zoomed to breach)

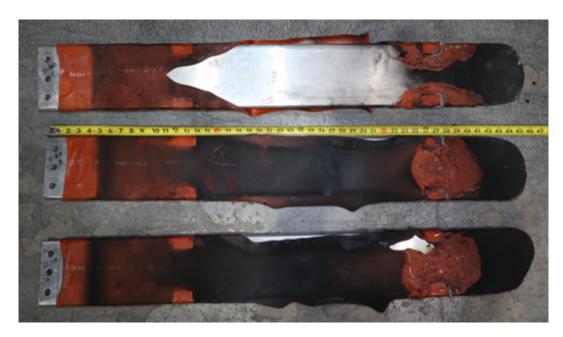
Fig. 178. Post-Experiment 2-30B Conductors (C-B-A, top to bottom)

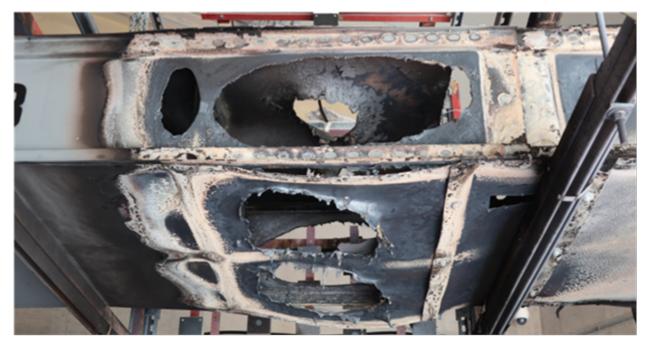
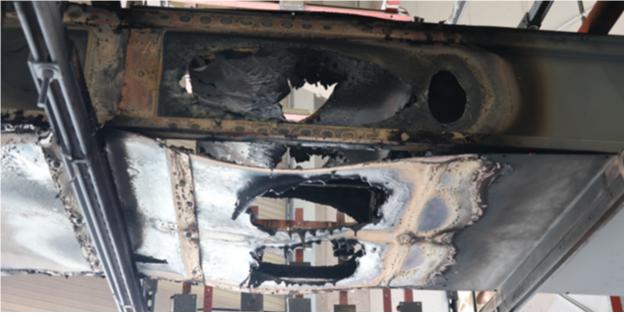
Fig. 179. Post-Experiment 2-30B Enclosure Breach (Top – view from below duct front; Bottom – view from below duct rear)

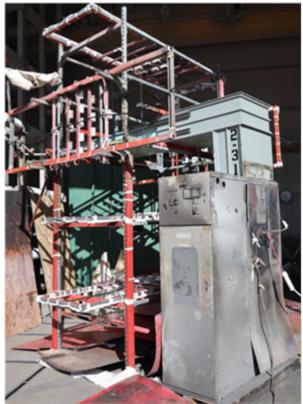
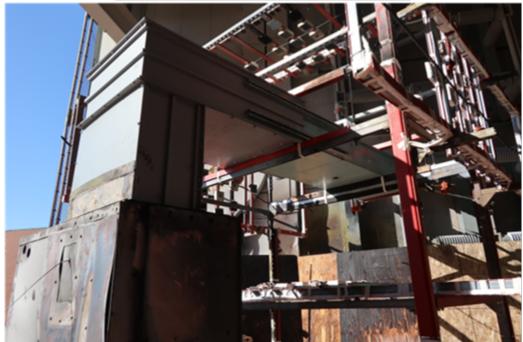
Fig. 180. Pre-Experiment 2-31

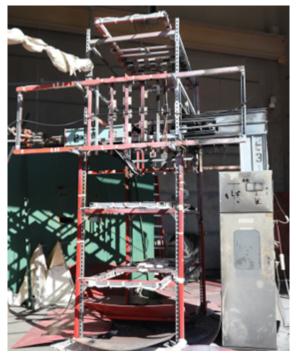
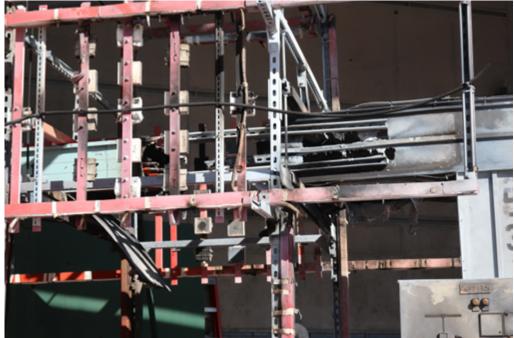
Fig. 181. Post-Experiment 2-31 (Top - front; Bottom - front zoomed)

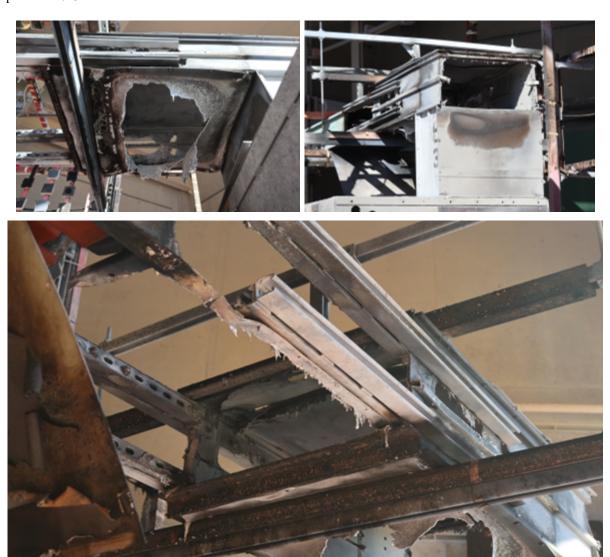
Fig. 182. Post-Experiment 2-31 (Top-left – bottom horizontal duct cover on 90 degree; top-right – end view of 90 degree; bottom – view from below duct in front)

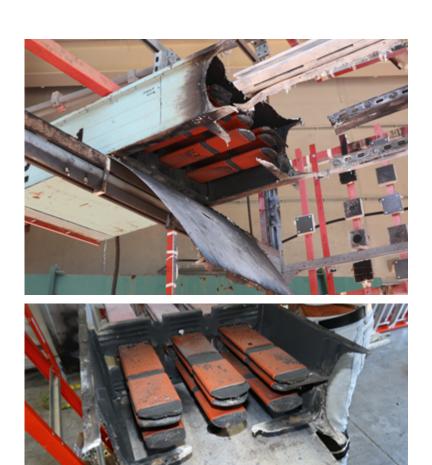
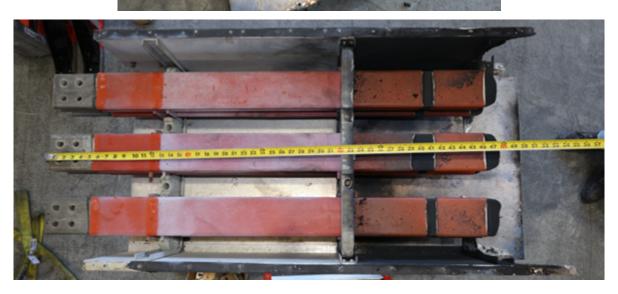
Fig. 183. Post-Experiment 2-31 Conductors

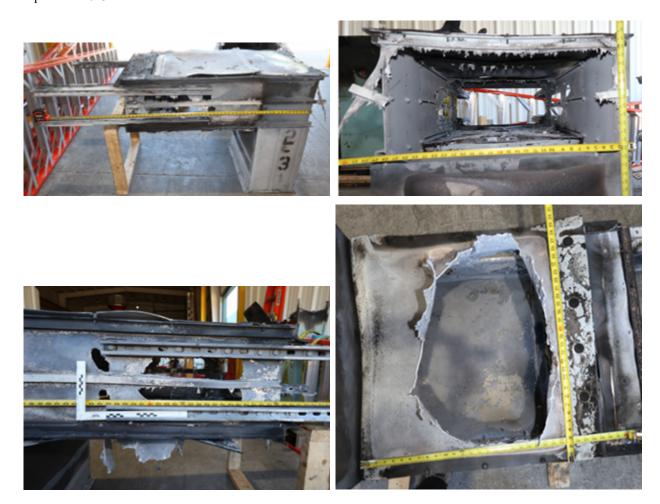
Fig. 184. Post-Experiment 2-31 Enclosure Breach (Top-left – 90 degree front; Top-right – 90 degree end; Bottom-left – 90 degree rear; Bottom-right – 90 degree lower cover)

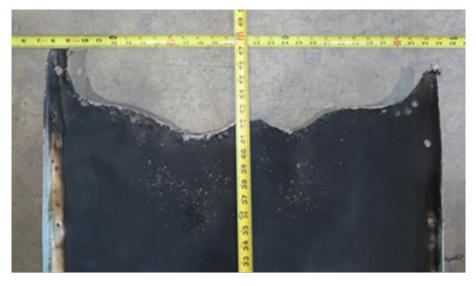
Fig. 185. Post-Experiment 2-31 (Straight section top cover), note bottom cover did not experience damage.
