REPORT ON HIGH ENERGY ARCING FAULT EXPERIMENTS

Experimental Results from Medium-Voltage Bus Duct and Switchgear Enclosures

Date Published: September 2023

NIST Technical Note NIST TN 2263

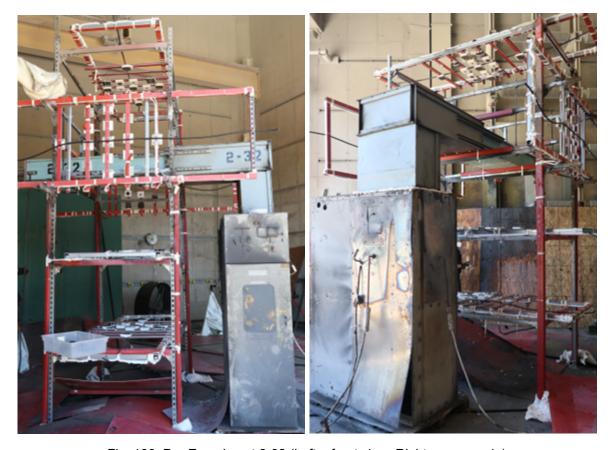
Fig. 186. Pre-Experiment 2-32 (Left – front view; Right – rear angle)

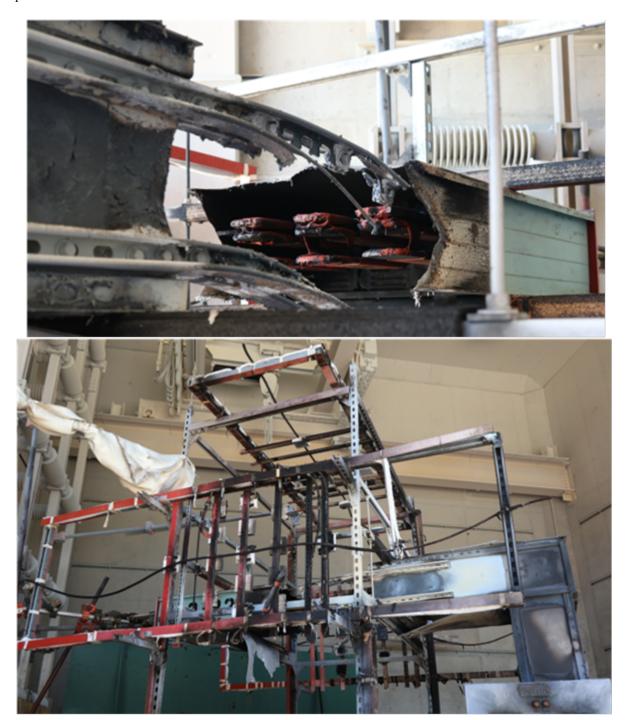
Fig. 187. Post-Experiment 2-32 (Top – rear view of enclosure breach and conductors; Bottom – Front view)

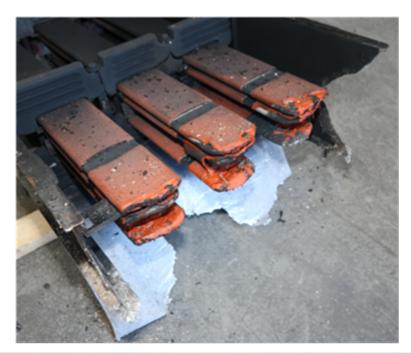
Fig. 188. Post-Experiment 2-32 Conductors (Top – Conductor ends; Bottom – overhead view of top conductors with enclosure top removed)

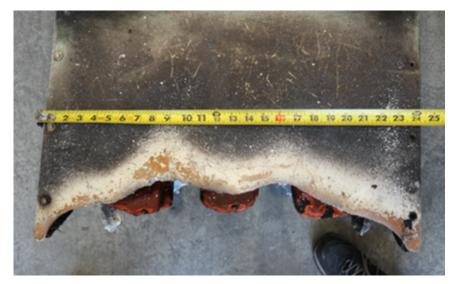
Fig. 189. Post-Experiment 2-32 Enclosure Breach Straight Aluminum duct (Top – Overhead view; Bottom-left – Rear; Bottom-right – front)

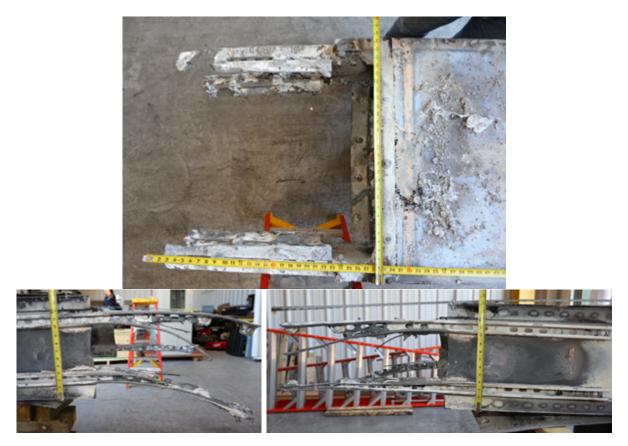
Fig. 190. Post-Experiment 2-32 Enclosure Breach 90 degree steel duct (Top – overhead view; Bottom-left – rear; Bottom-right – front)

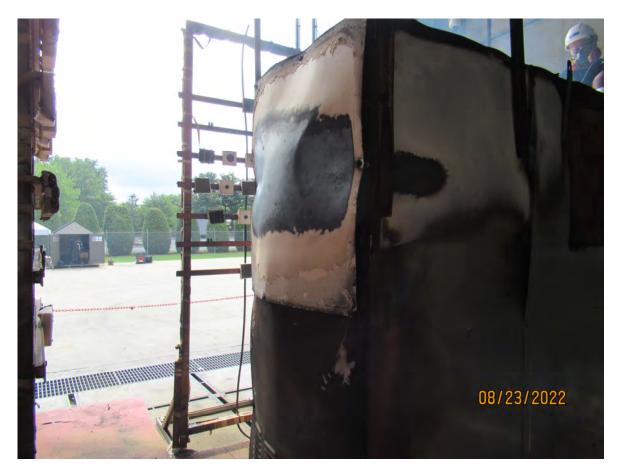
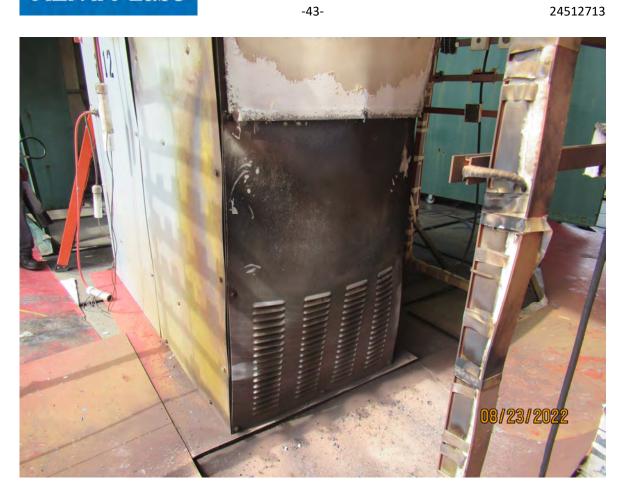
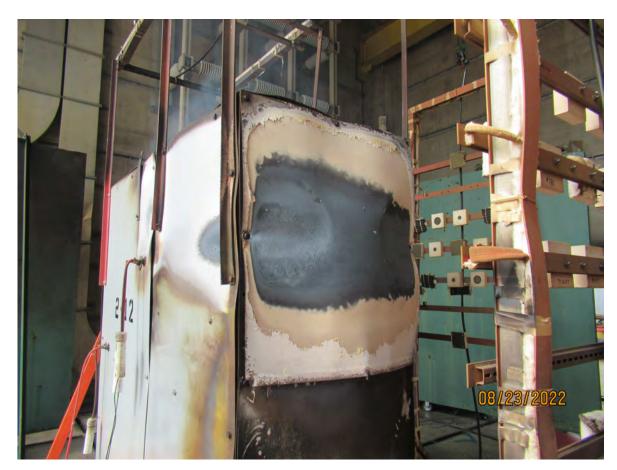
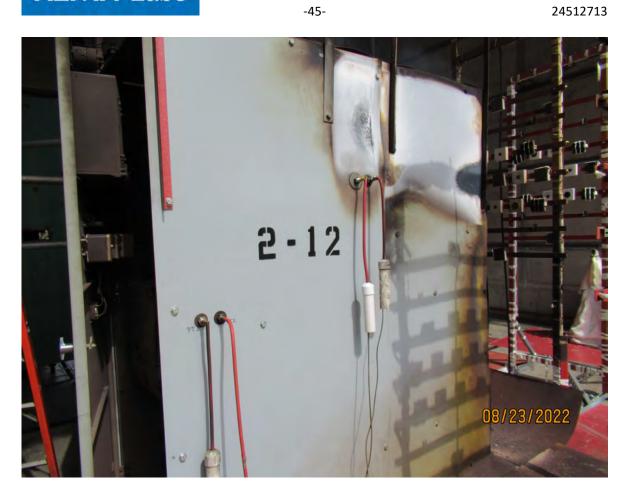
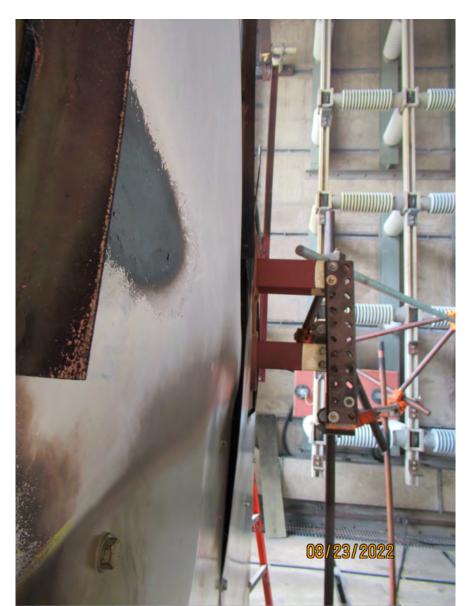
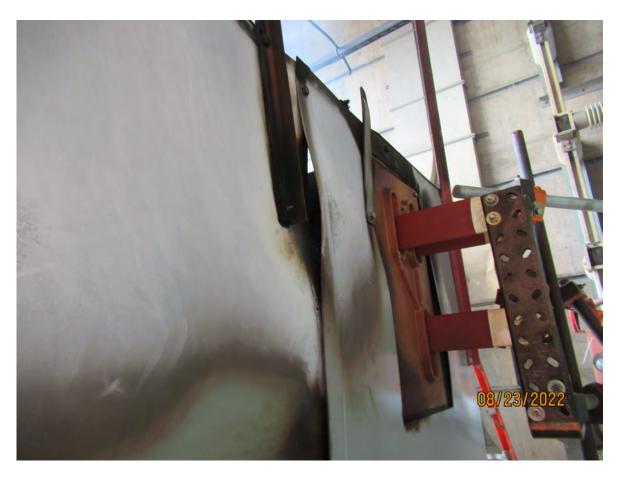
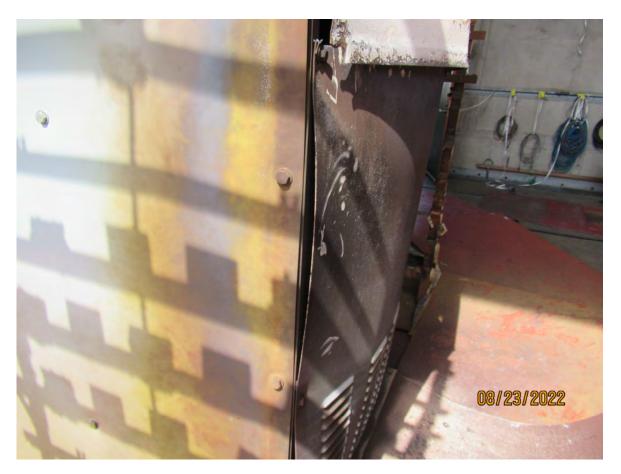
6.6 Photograph after test

Heavy damage to the test device. Signs of arcing and burn through on each side of the switchgear. Fire inside of the switchgear was put out.

Emission of flames and gas observed. Arc self-extinguished after 2.87 seconds. Fire inside the unit was put out with fire extinguisher.

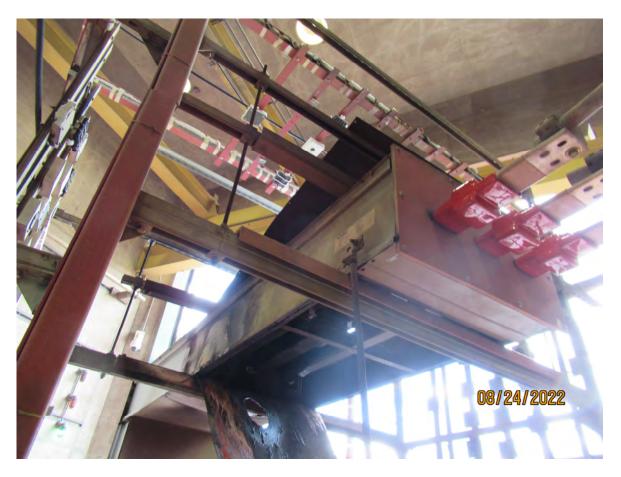
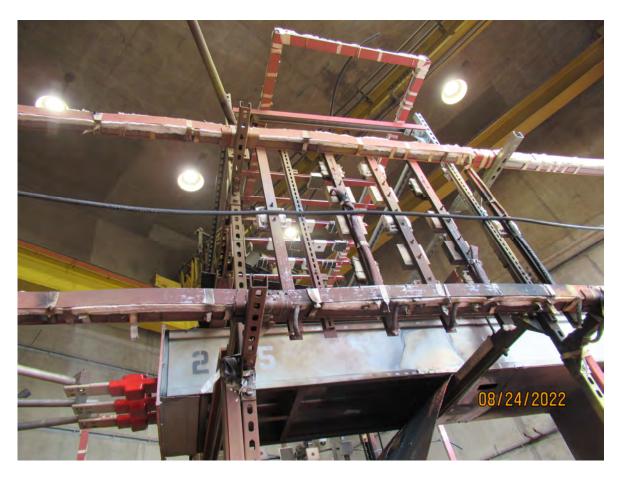
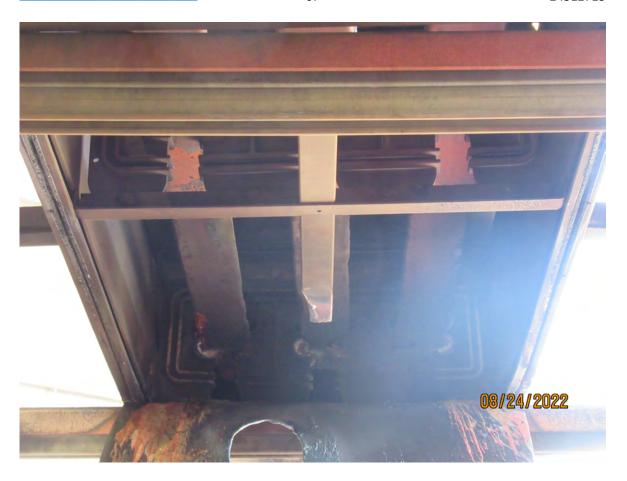
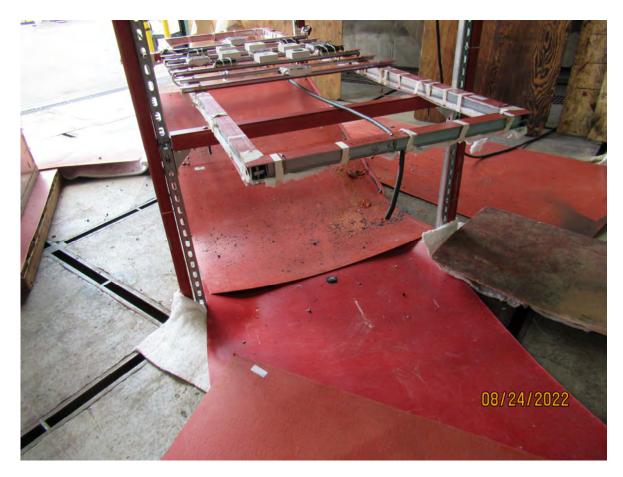
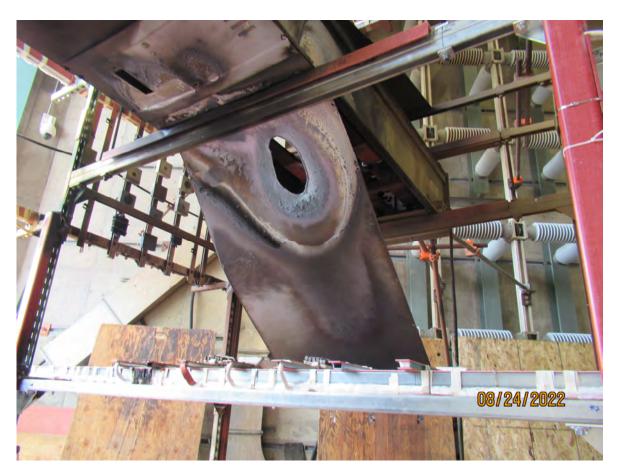
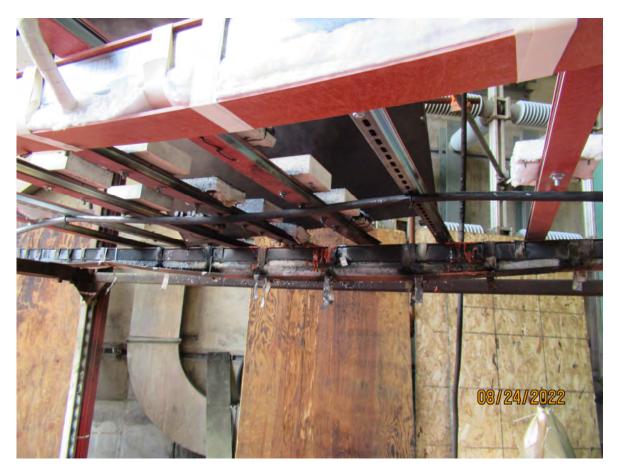
8.6 Photograph after test

Heavy damage to the test device. Signs of arcing and burn through on each side of the bus duct. After test, fire on the instrumentation racks were put out.

Observations: Emission of flames and gas observed.

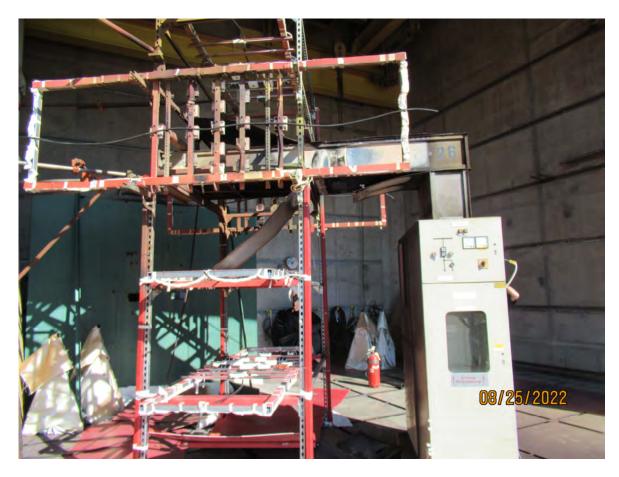
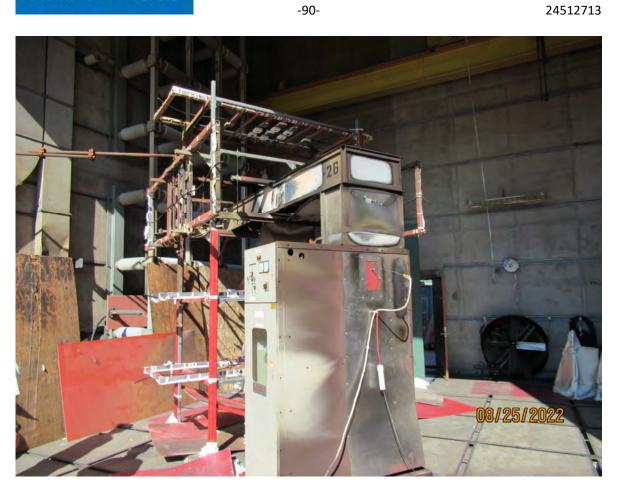
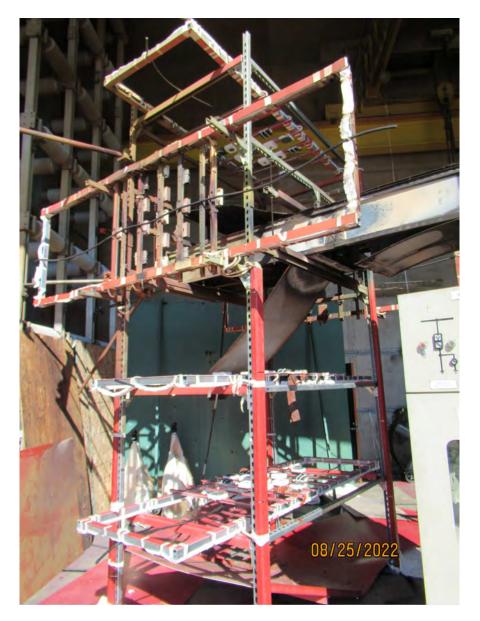
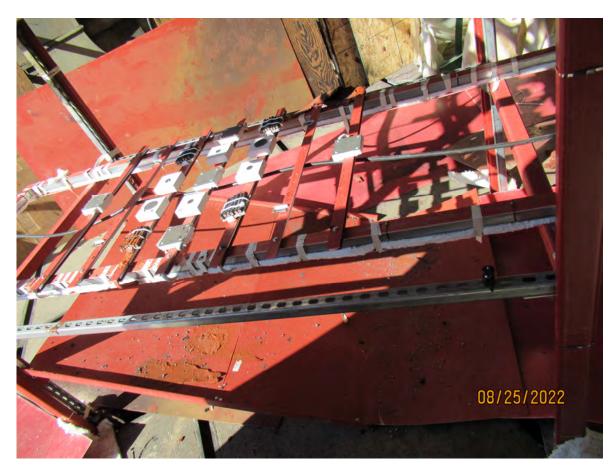
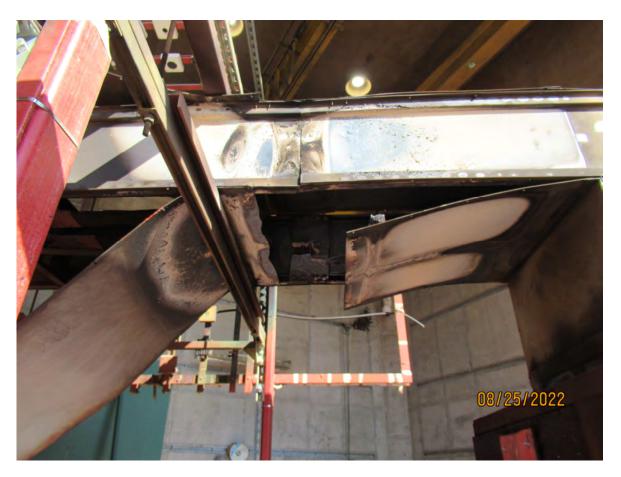
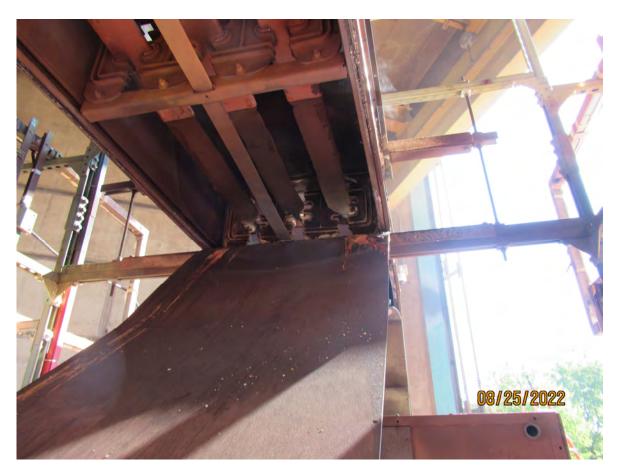
9.6 Photograph after test

Heavy damage to the test device. Signs of arcing and burn through on each side of the bus duct. After test, fire on the instrumentation racks were put out.

Observations: Emission of flames and gas observed.

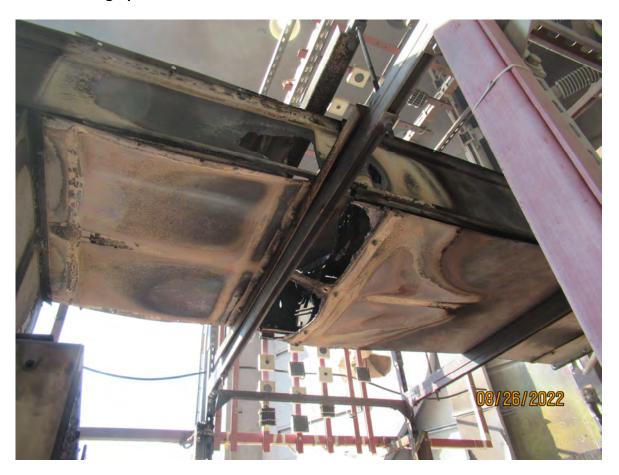
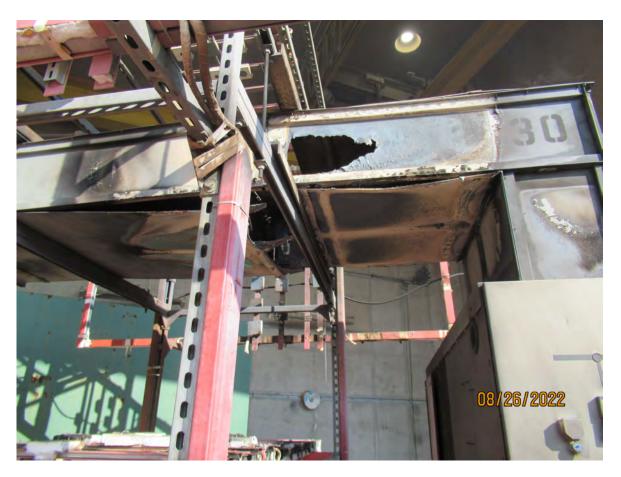
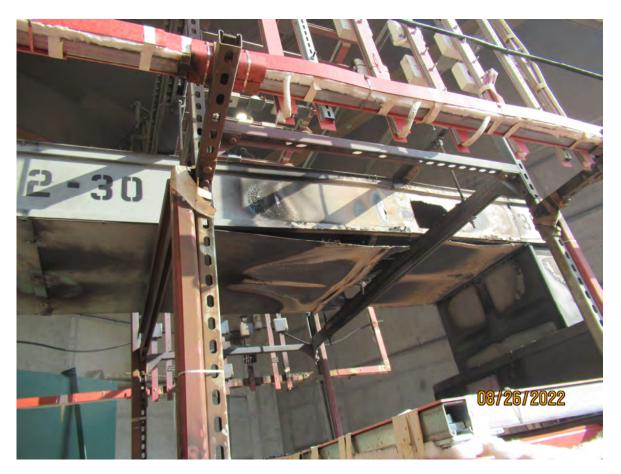
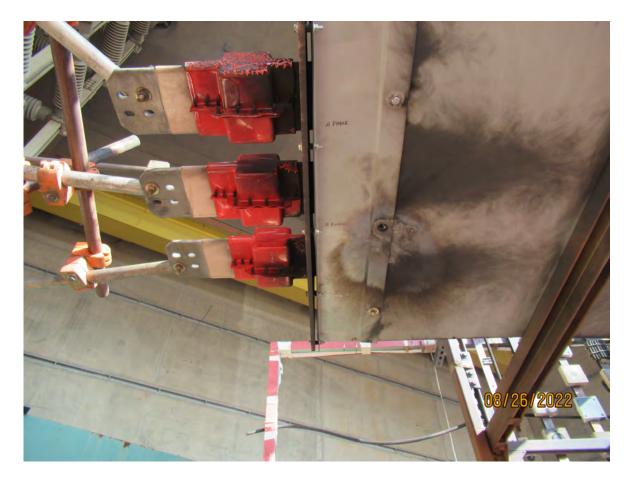
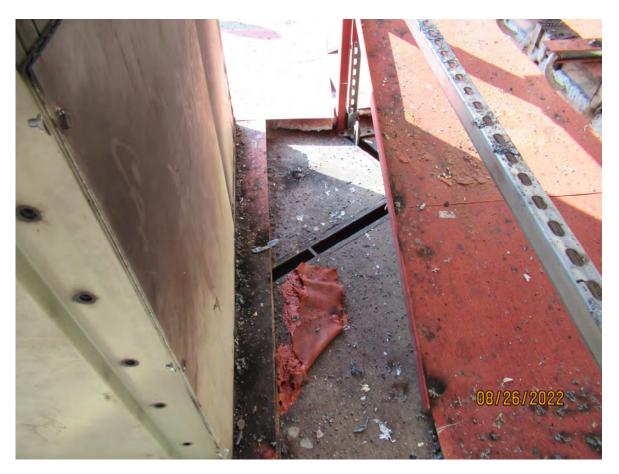
10.6 Photograph after test

Heavy damage to the test device. Signs of arcing and burn through on each side of the bus duct. After test, fire on the instrumentation racks and bus duct were put out.

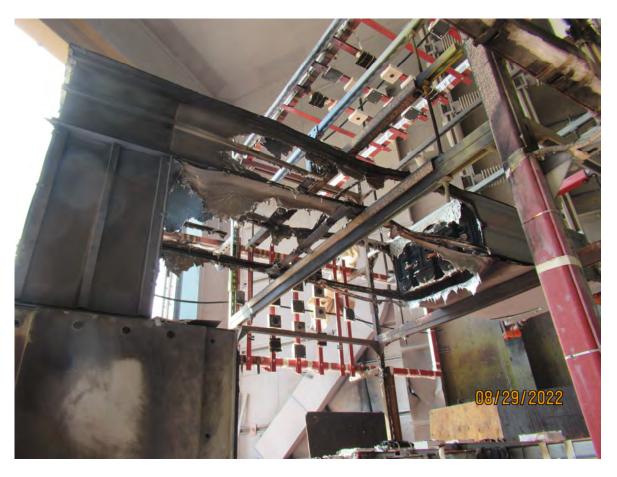
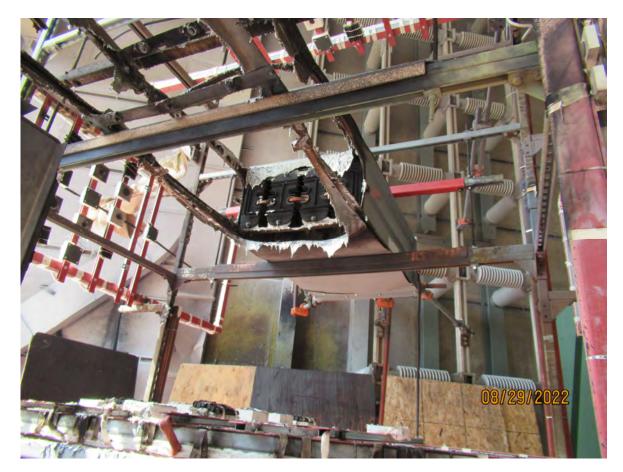
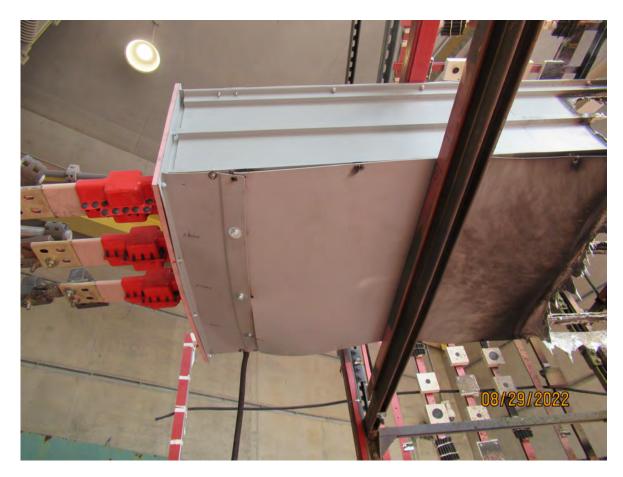
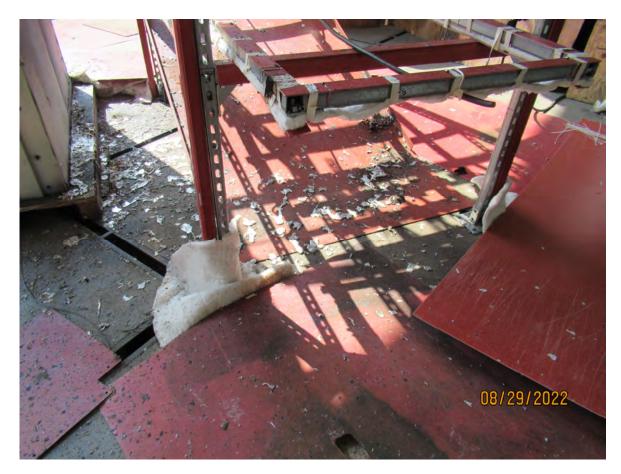
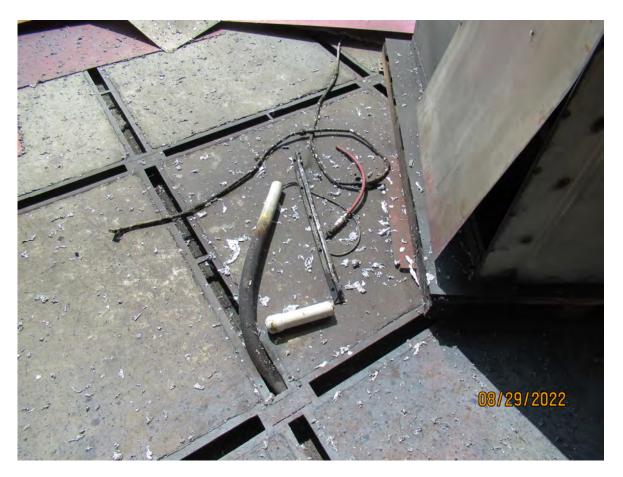
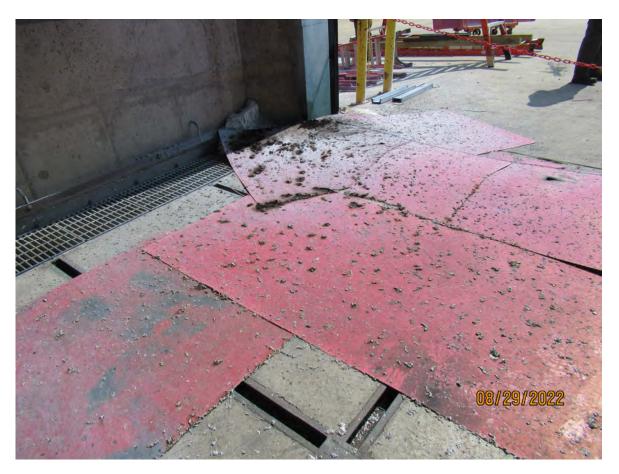
11.6 Photograph after test

Heavy damage to the test device. Majority of bus duct enclosure has vaporized. Pressure transducer #1 found on the ground after the test.

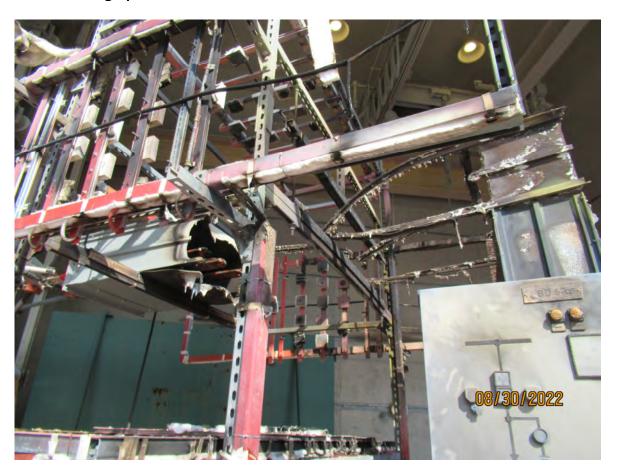
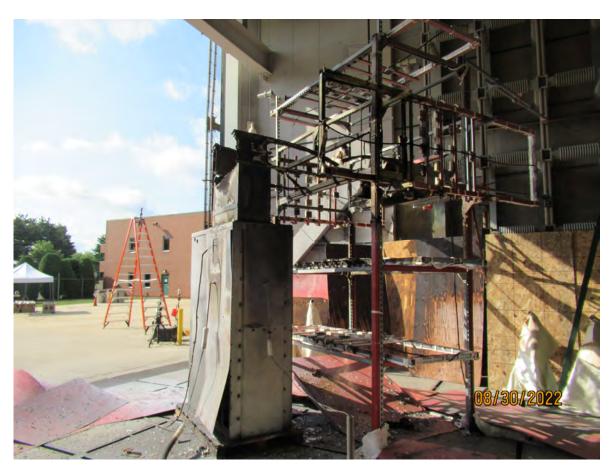
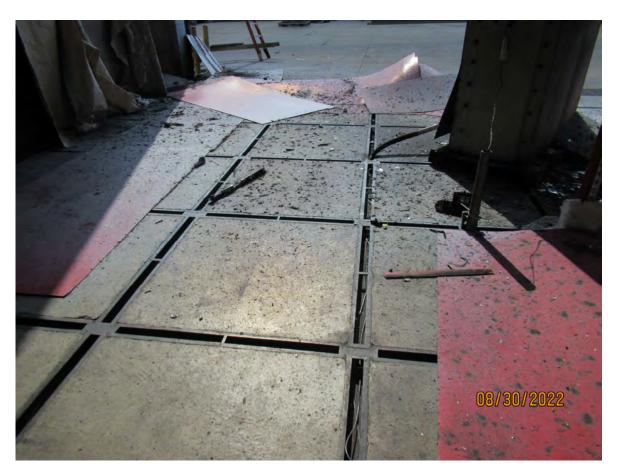
12.6 Photograph after test

Heavy damage to the test device. Majority of bus duct enclosure has vaporized.

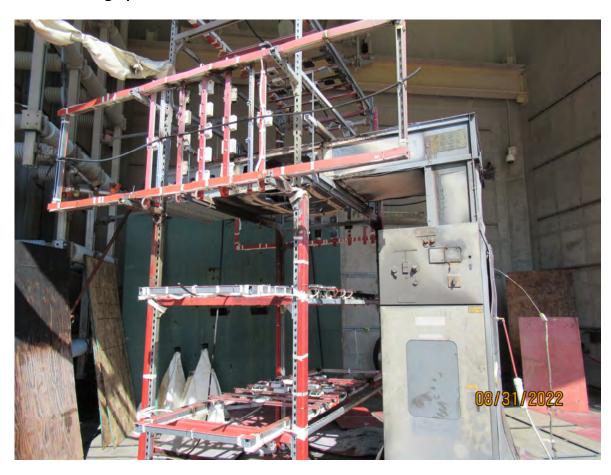
13.6 Photograph after test

Heavy damage to the test device. Signs of arcing and burn through on each side of the bus duct. After test, fire on the instrumentation racks and bus duct were put out.

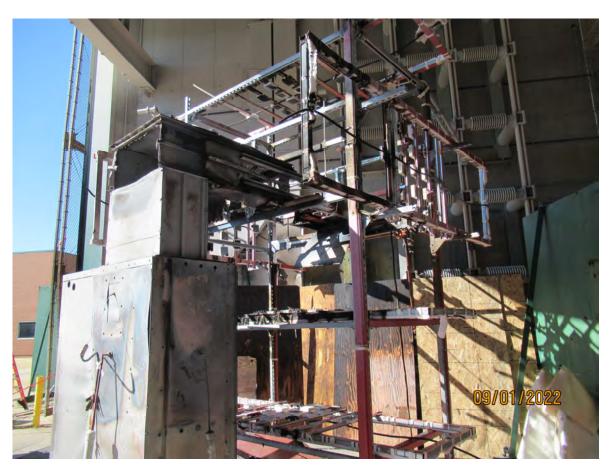
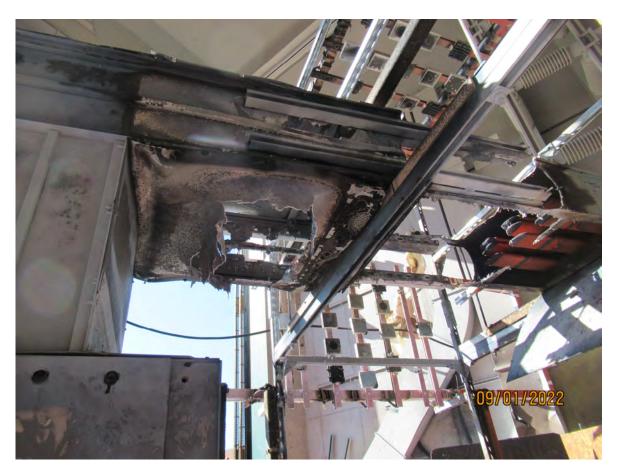
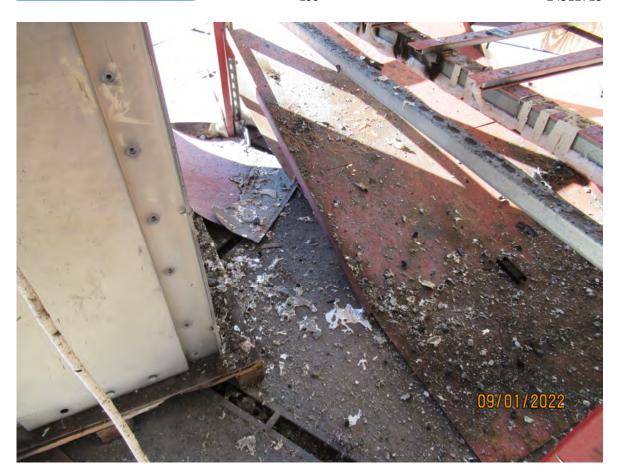
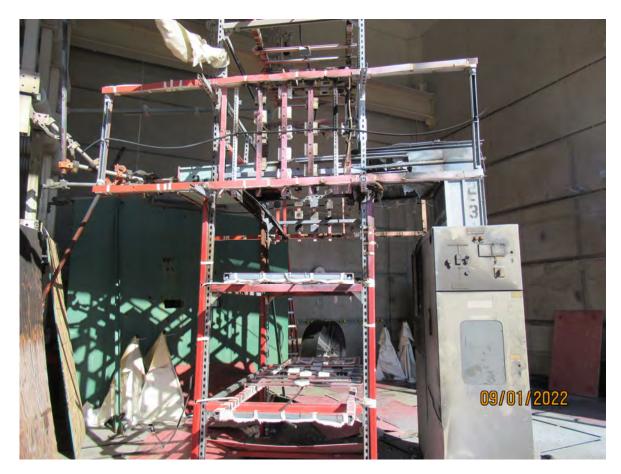
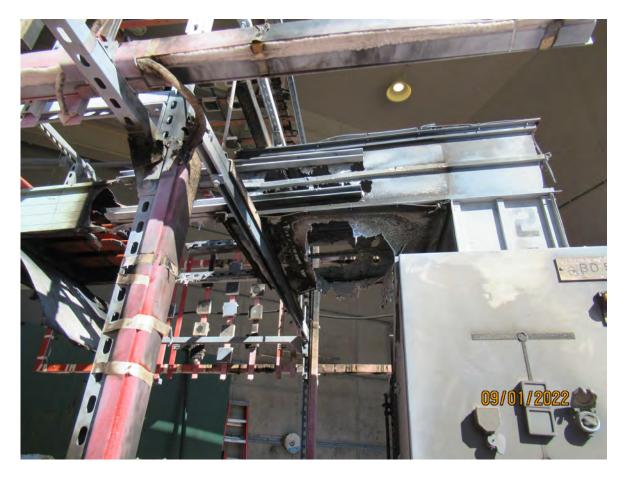
14.6 Photograph after test

Heavy damage to the test device. Majority of bus duct enclosure has vaporized.

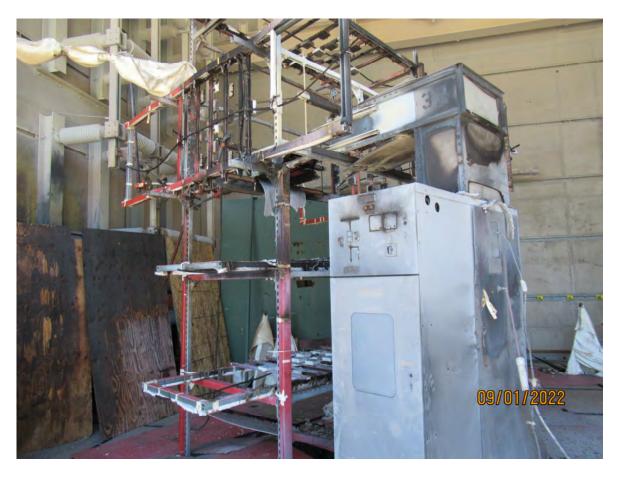
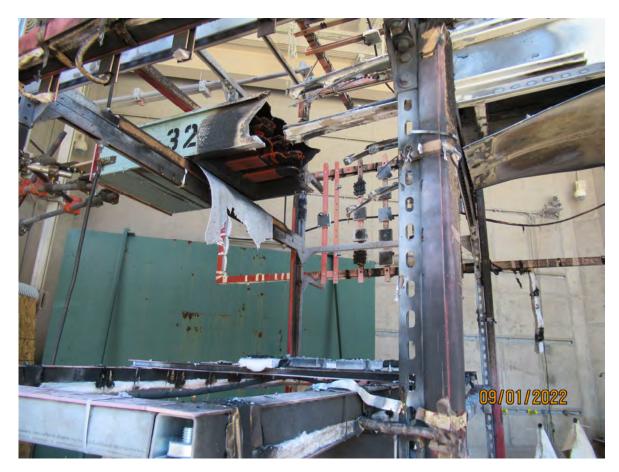
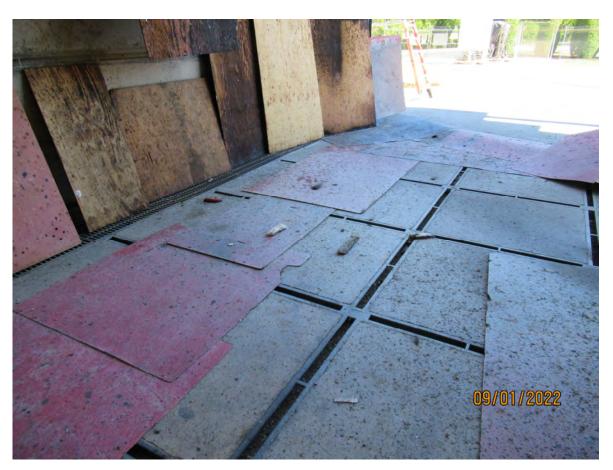
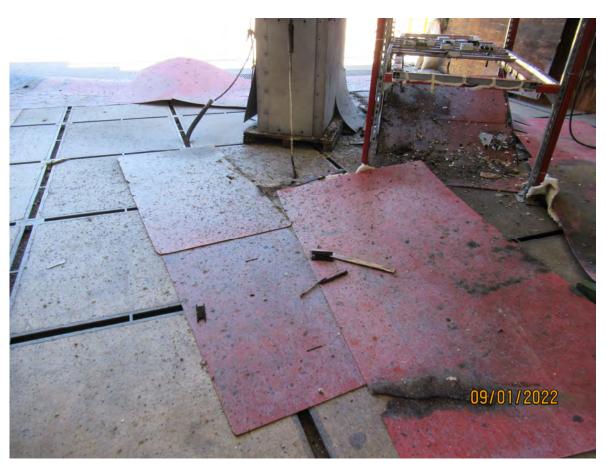
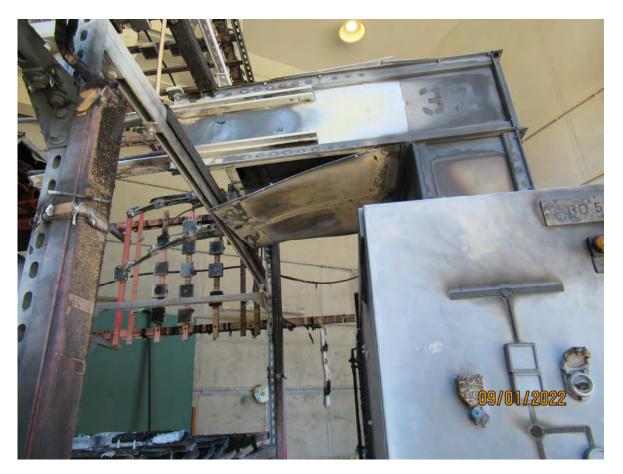
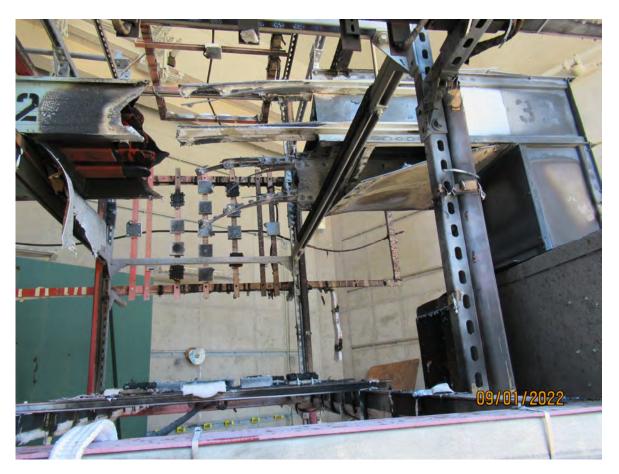
15.6 Photograph after test

Heavy damage to the test device. Majority of bus duct enclosure has vaporized.

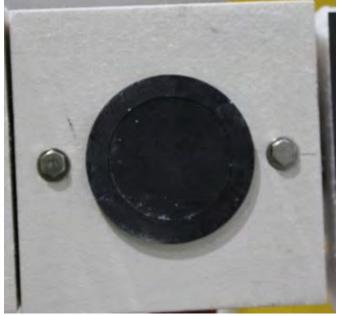
Figure 10 Cross-section of ASTM Slug (top) nominal dimensions in millimeters, photo of device being prepared in the field (bottom). Note that the two bolts on each side of the device are used for mounting to the DIN rail of the instrumentation rack.

where m is the mass of the copper disc, $\overline{C_P}$ is the average heat capacity of the copper disc, T_f is the temperature of the disc at the end of the arc, T_i is the temperature of the disc before the arc, and A is the front surface area of the disc. The total energy per unit area resulting from the arc is reported in a summary table for each sensor location in each experiment. The ASTM F1959 standard also refers to the total energy per unit area as incident energy (cal/cm² or kJ/m²).

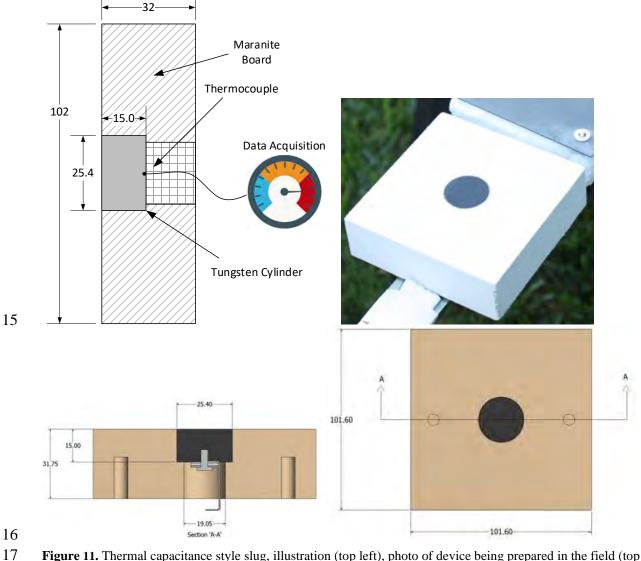
Figure 11. Thermal capacitance style slug, illustration (top left), photo of device being prepared in the field (top right), dimensional drawings showing internal construction (bottom left and right). All nominal dimensions in mm.
