NIST GCR 17-917-44

Seismic Analysis, Design, and Installation of Nonstructural Components and Systems – Background and Recommendations for Future Work

Applied Technology Council

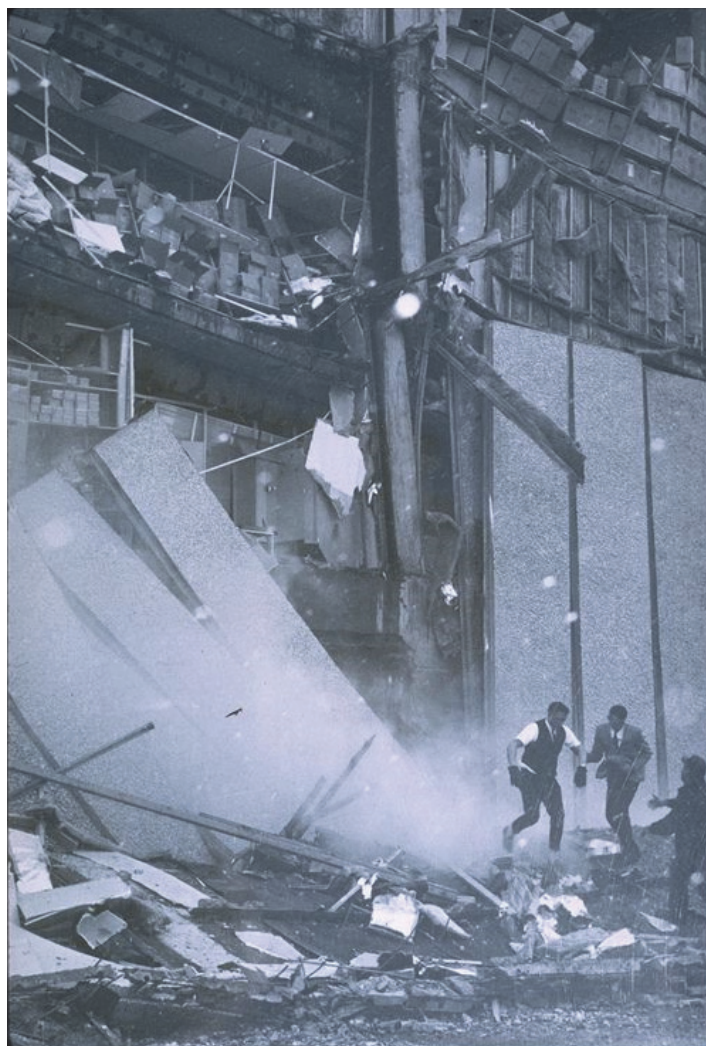
Figure 2-1 People escaping the J.C. Penney store during the 1964 Great Alaska earthquake (NISEE, 2016a).

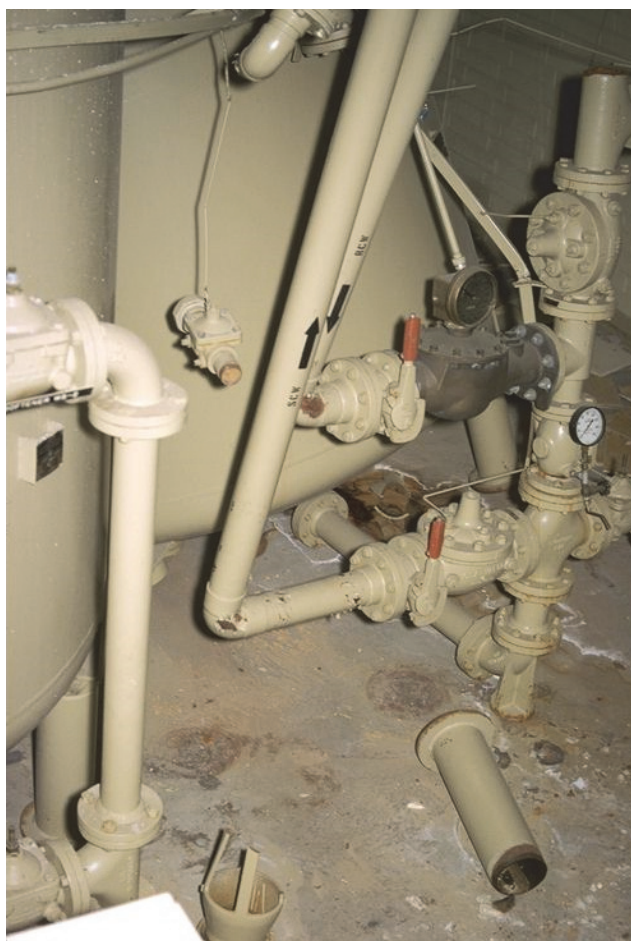
Figure 2-2 Broken piping in the new power house for the Olive View Hospital, 1971 San Fernando earthquake (NISEE, 2016b).

Medical facilities in the San Fernando Valley were hit particularly hard in the earthquake. The new 850-bed Los Angeles Olive View Medical Center had been dedicated in November 1970, just months prior to the earthquake. The reinforced concrete building was constructed under the 1965 County of Los Angeles Building Code (1965). Most of the buildings on the site suffered severe structural damage, which dominated the attention of the engineering community. Horizontal ground accelerations might have exceeded 0.5g. The report contains little information on the performance of nonstructural components at the site, although it is implied that damage was substantial. Severe story drift in the first story of the main building destroyed the curtain walls, partitions, and elevator doors at that level. Photographs of other areas on the ground floor show extensive damage to food service equipment. Severe damage to the equipment in the power plant building was reported with boilers shifting up to four feet. An example of this damage is shown in Figure 2-2.

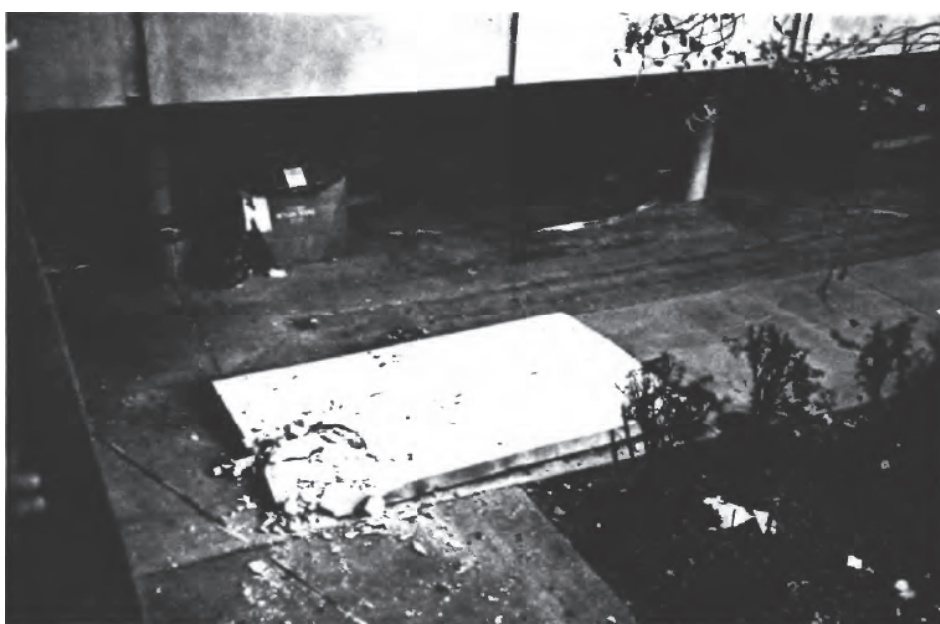
Figure 2-3 Fallen precast concrete panel at the California State University Los Angeles parking structure, 1987 Whittier Narrows earthquake (Çelebi et al., 1987).

The parking structure was a two-level reinforced concrete and prestressed concrete structure. Precast spandrel panels of lightweight concrete, six inches thick, measuring seven to 20 feet in length, and over seven feet in height, were installed along the perimeter of the parking deck. The units were attached to prestressed concrete L-beams with four to eight connections depending on the length of the panel. The connections on a twelve-foot long panel failed, causing the panel to fall to the ground (Figure 2-3). This failure resulted in the death of one student. In an aftershock, concrete inserts supporting a twelve-inch diameter chilled water line in the parking structure failed, and a 125-foot long section of the pipe fell.

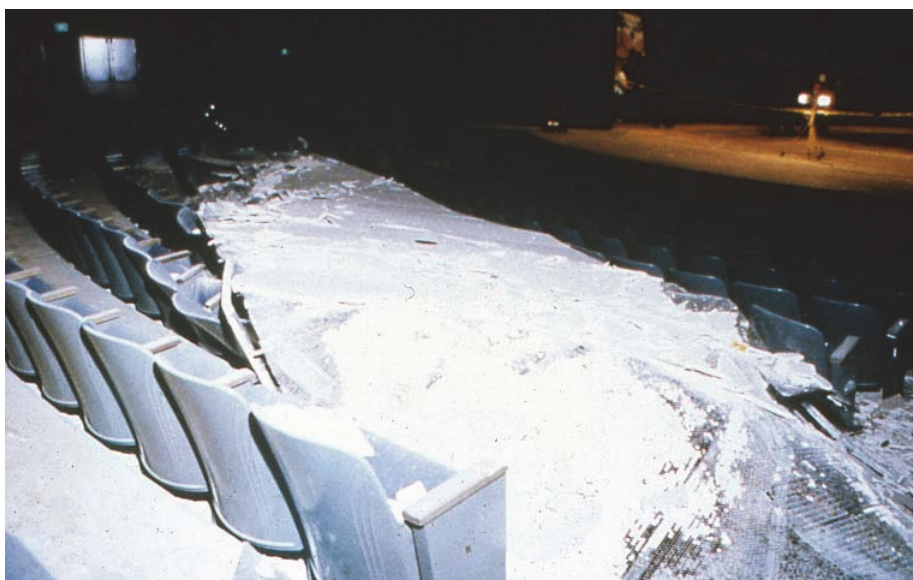
Figure 2-4 Collapsed heavy ceiling in the Geary Theater, San Francisco, California, 1989 Loma Prieta earthquake (NISEE, 2016c).

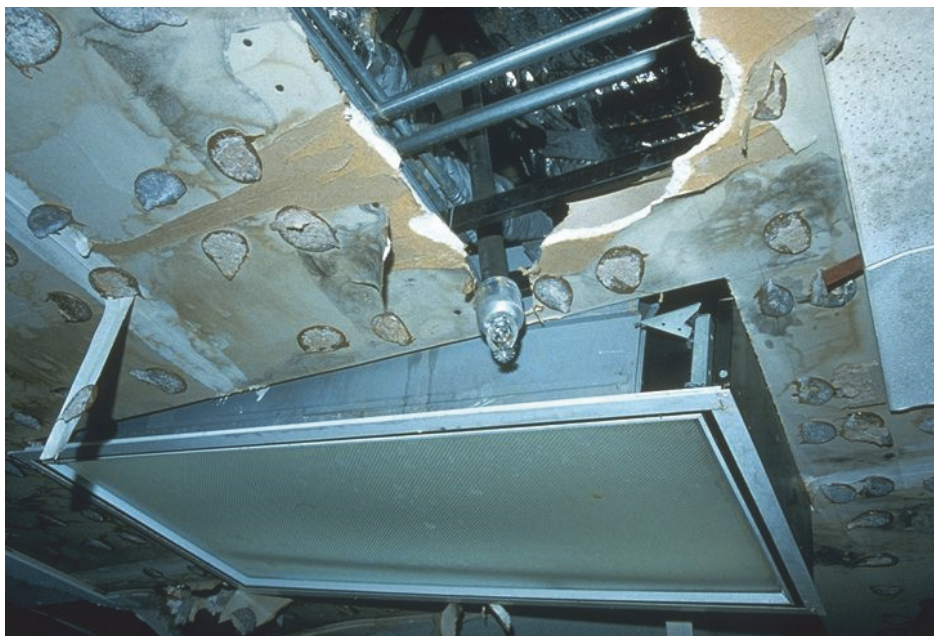
Figure 2-5 Fractured sprinkler line and dislodged light fixture in the Olive View Medical Center, 1994 Northridge earthquake (NISEE, 2016d).

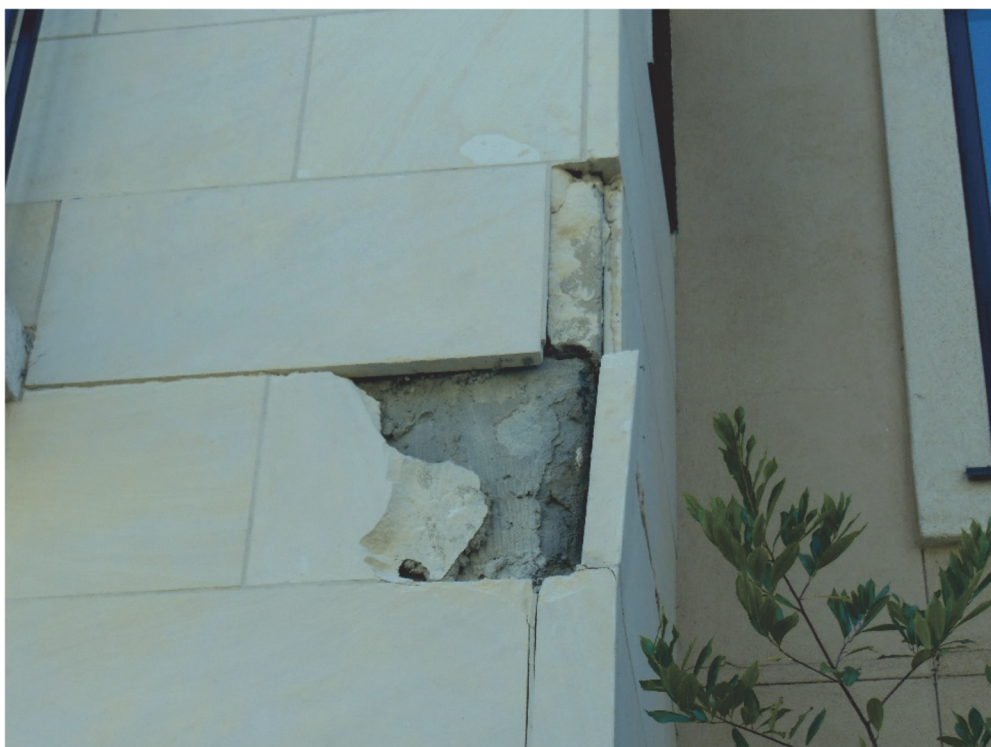
Figure 2-6 Adhered veneer damaged during the 2014 South Napa earthquake (FEMA, 2015a).

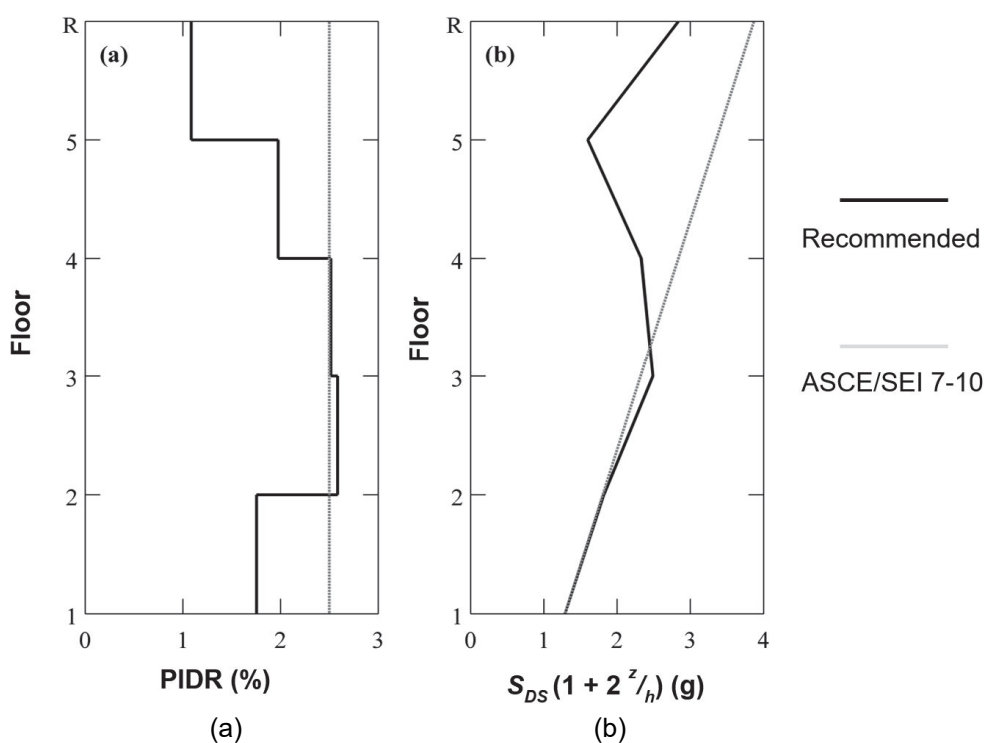
Figure 6-2 Comparison between the recommended design criteria and those conforming to ASCE/SEI 7-10: (a) interstory drift ratio; and (b) $S_{DS}(1 + 2^{z/h})$ (Wang et al., 2013).

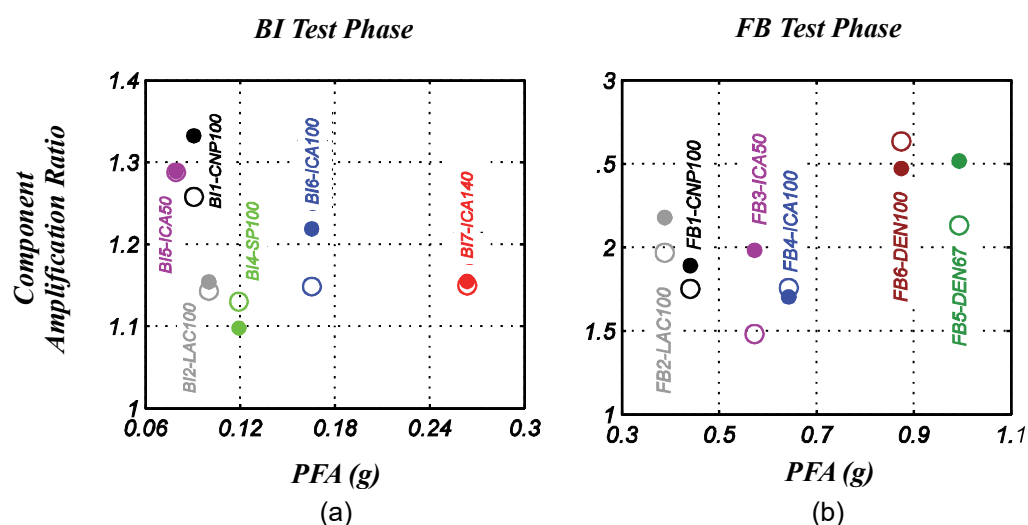
Figure 6-5 Component amplification ratios of the cooling tower system in: (a) base-isolated test phase; and (b) fixed-base test phase (Astroza et al., 2015).

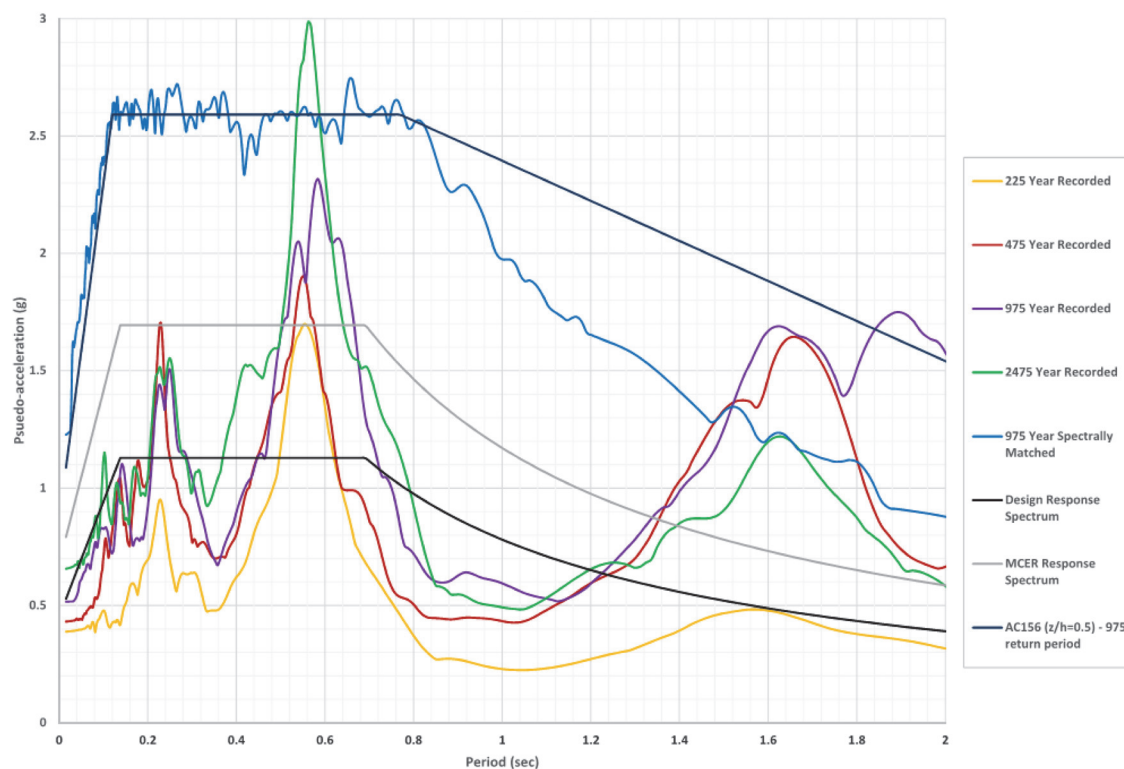
Figure 6-14 Floor response spectra of the input floor accelerations.

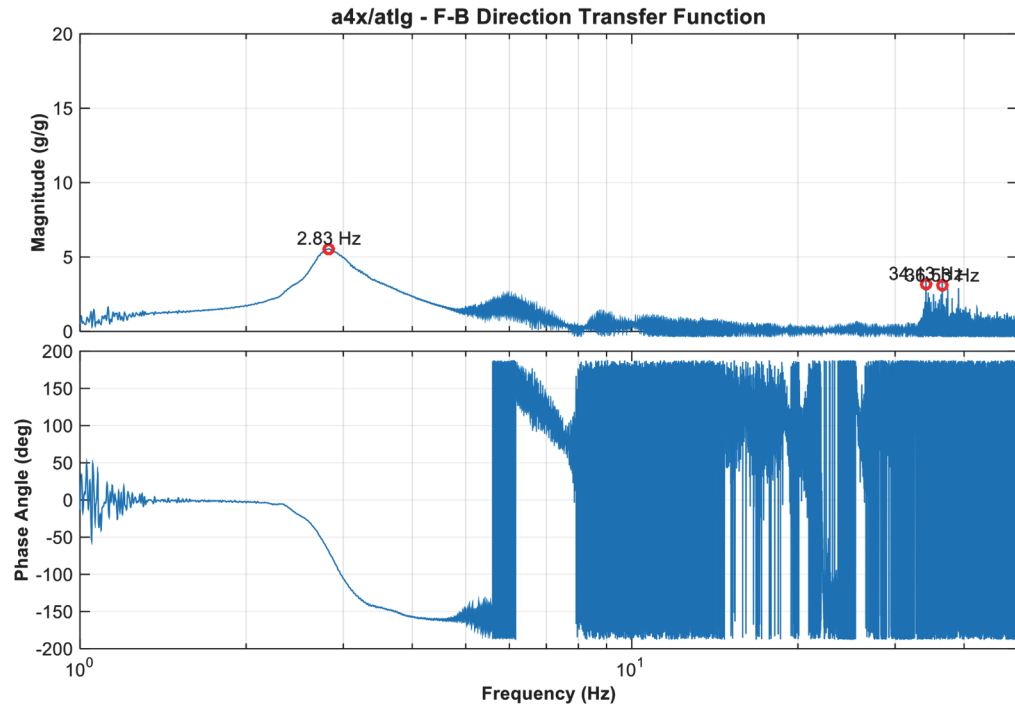
Figure 6-16 Transmissibility plot of natural frequency of a unit under test (UUT).

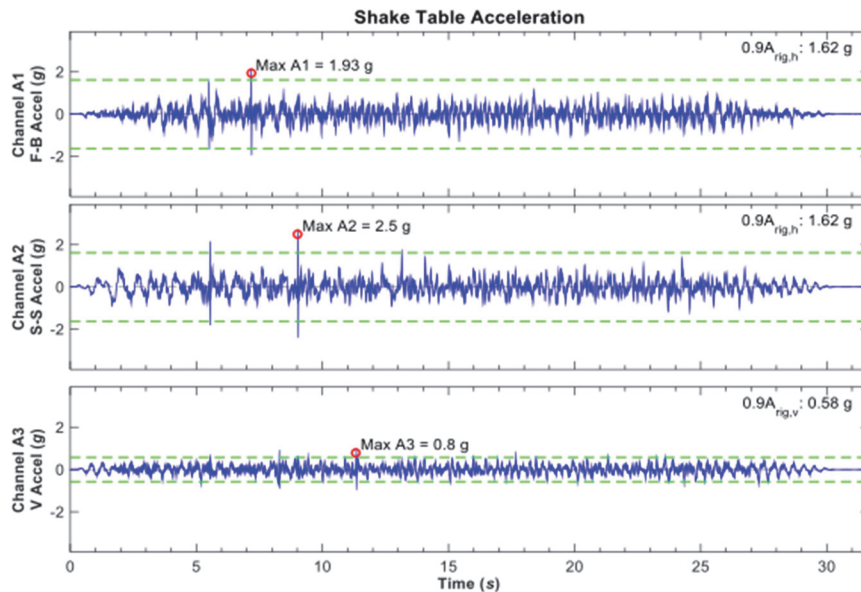
Figure 6-17 Acceleration time histories from an AC156 test.

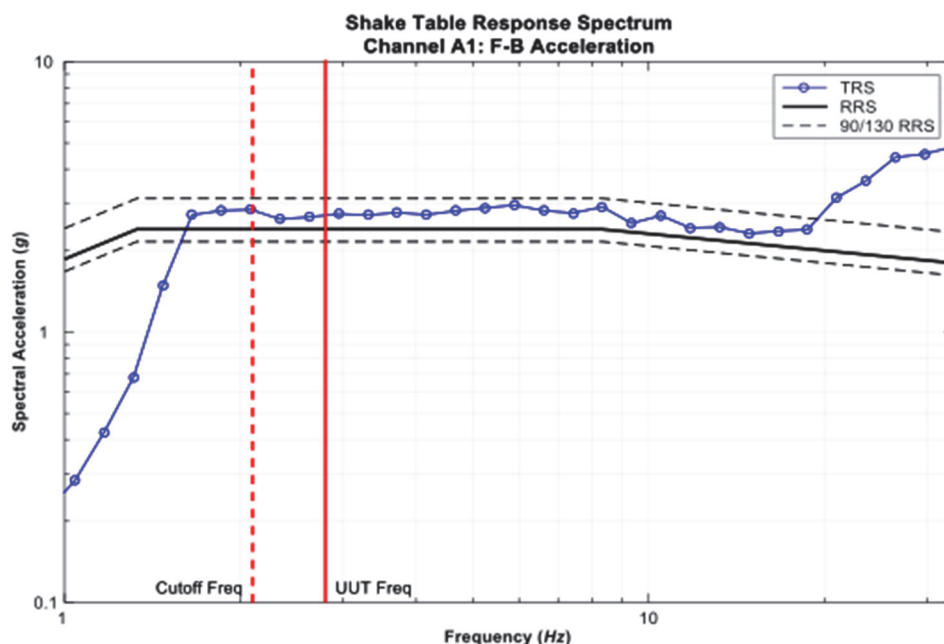
Figure 6-18 Required response spectrum (RRS) versus test response spectrum (TRS).

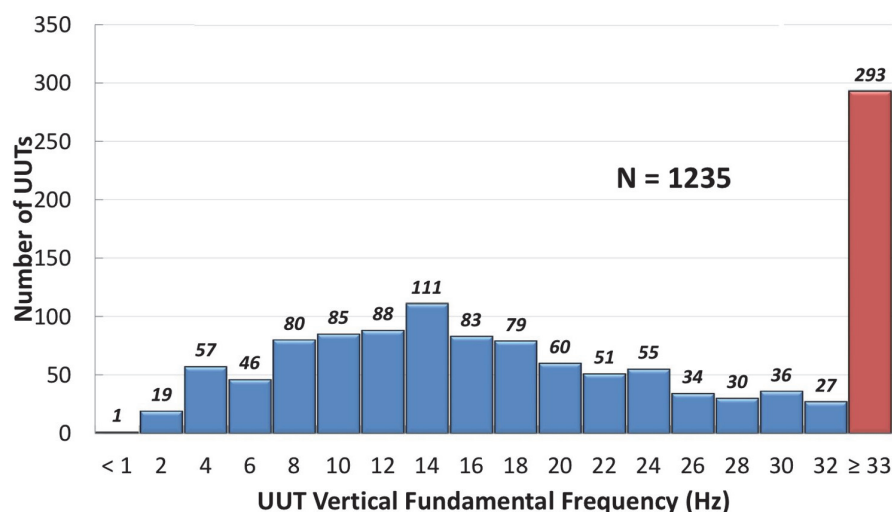
Figure 6-20 Vertical natural frequency distribution of a unit under test (UUT) rigidly mounted to the floor.

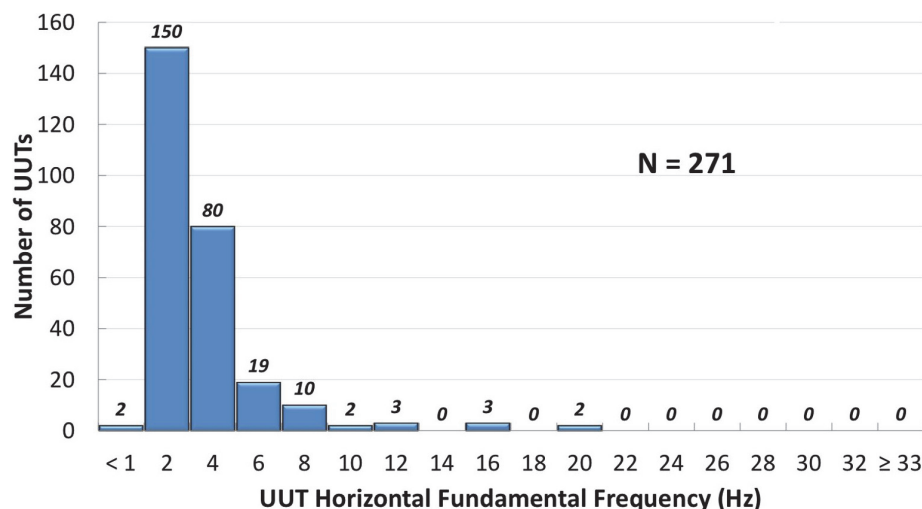
Figure 6-21 Horizontal natural frequency distribution of a unit under test (UUT) with spring isolators mounted to the floor.

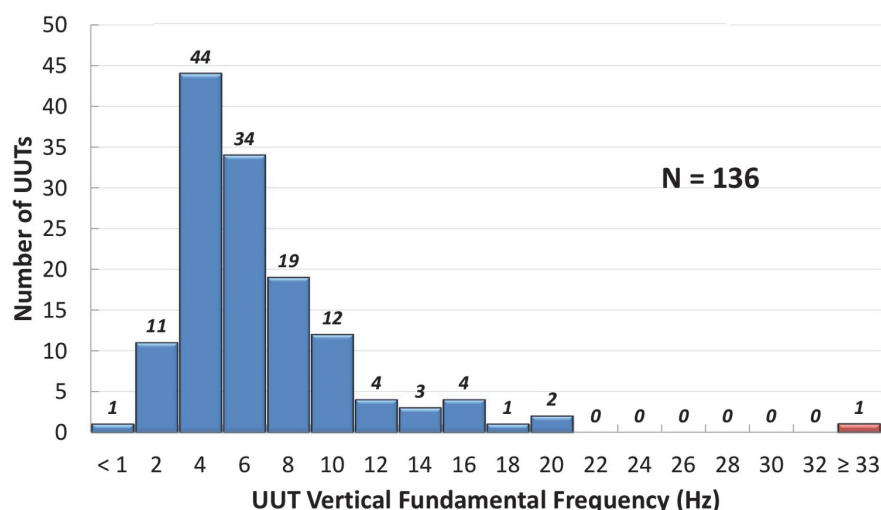
Figure 6-22 Vertical natural frequency distribution of a unit under test (UUT) with spring isolators mounted to the floor.

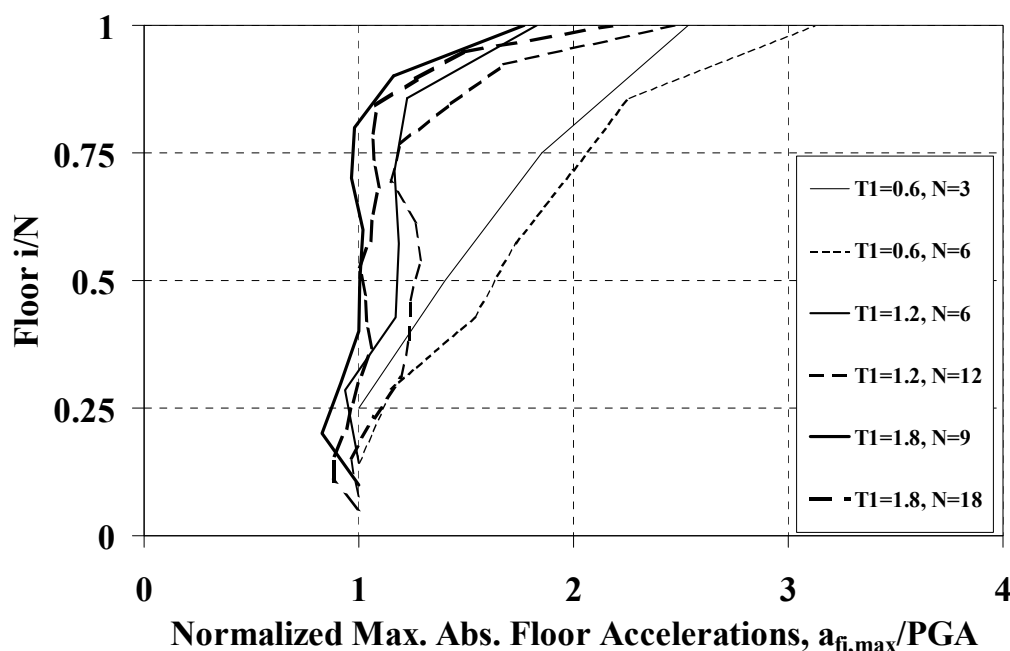
Figure 7-1 Normalized median peak floor acceleration (PFA/PGA) for elastic frame structures with different numbers of stories and fundamental periods (Medina and Krawinkler, 2004).

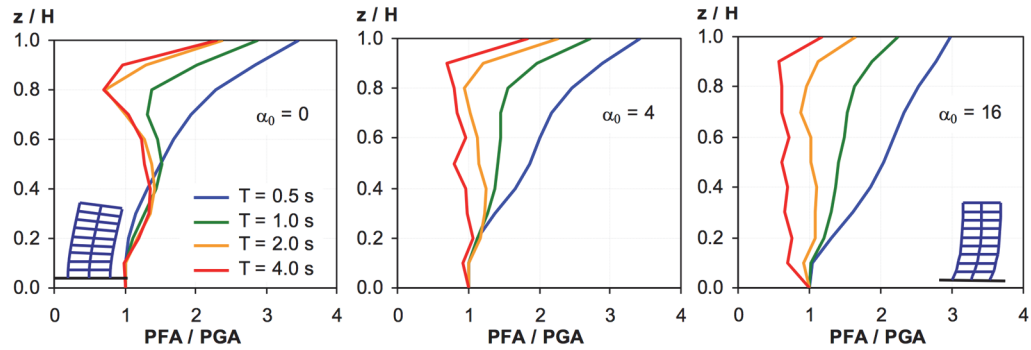
Figure 7-2 Variation of peak floor accelerations (PFA) along the height of buildings with different fundamental periods of vibration and different lateral stiffness ratios α_0 (Taghavi and Miranda, 2006).

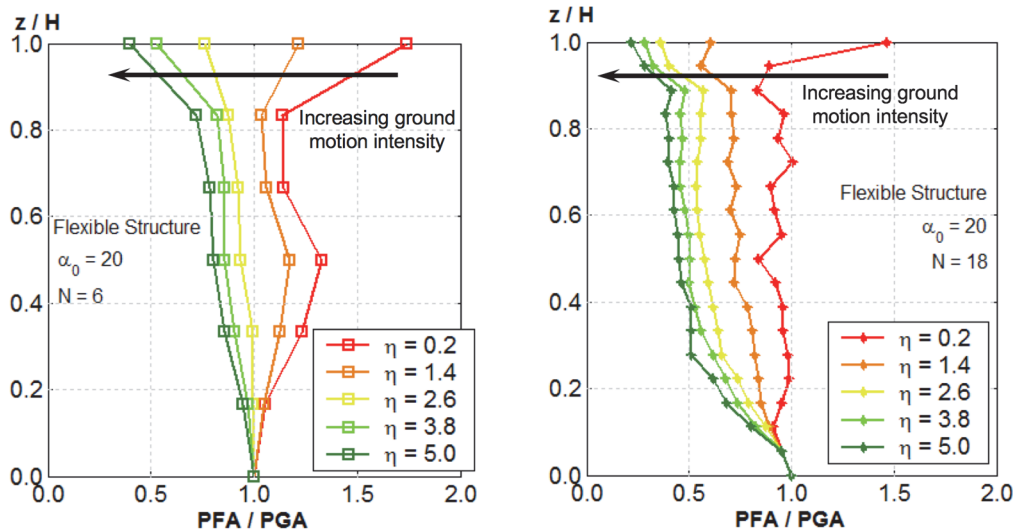
Figure 7-3 Normalized peak floor acceleration (PFA/PGA) versus height for mean responses from different intensity levels, η , for a 6-story (left) and an 18-story (right) flexible moment frame buildings (Miranda and Taghavi, 2009).

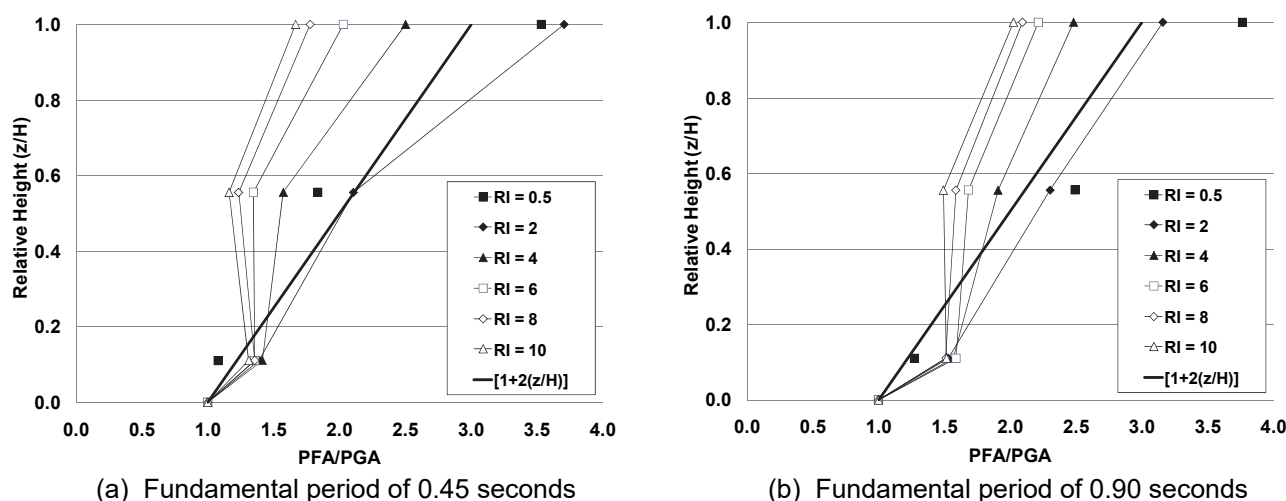
Figure 7-6 Normalized median peak floor acceleration (PFA/PGA) ratios for 9-story shear-wall structures exposed to increased ground motion relative intensities (Medina and Clayton, 2010).

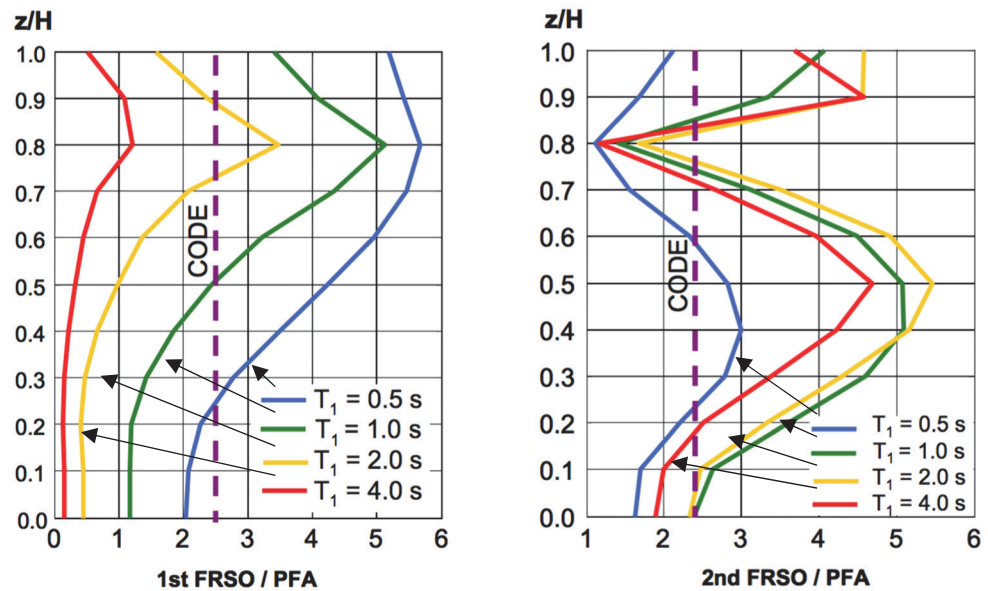
Figure 7-7 Influence of fundamental period on floor spectral ordinates of systems tuned to the fundamental and second periods of vibration of the building (Miranda and Taghavi, 2009).

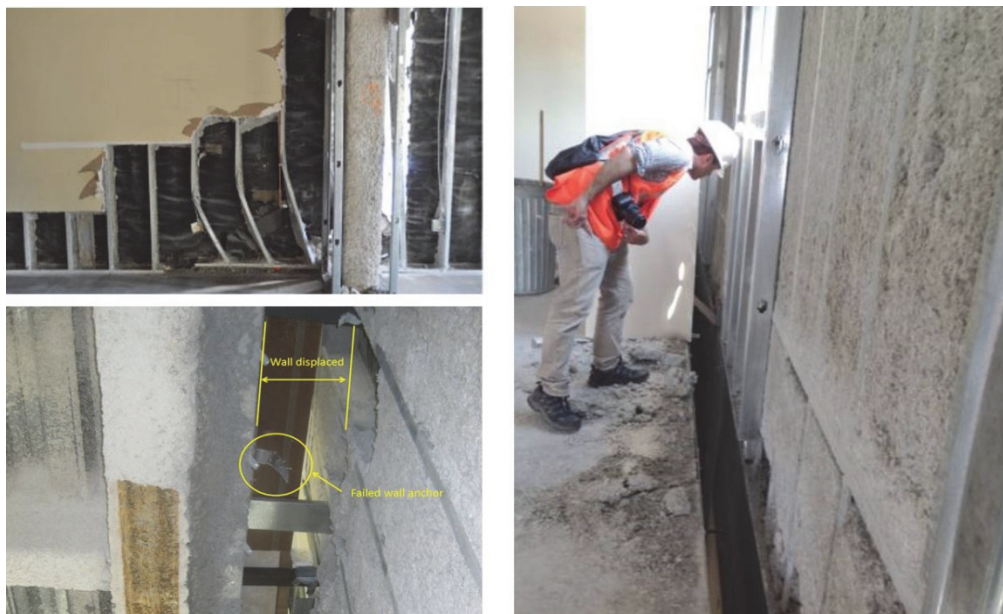
Figure A-1 Lightweight exterior cladding is damaged and requires replacement, but there is no safety concern due to falling panels.

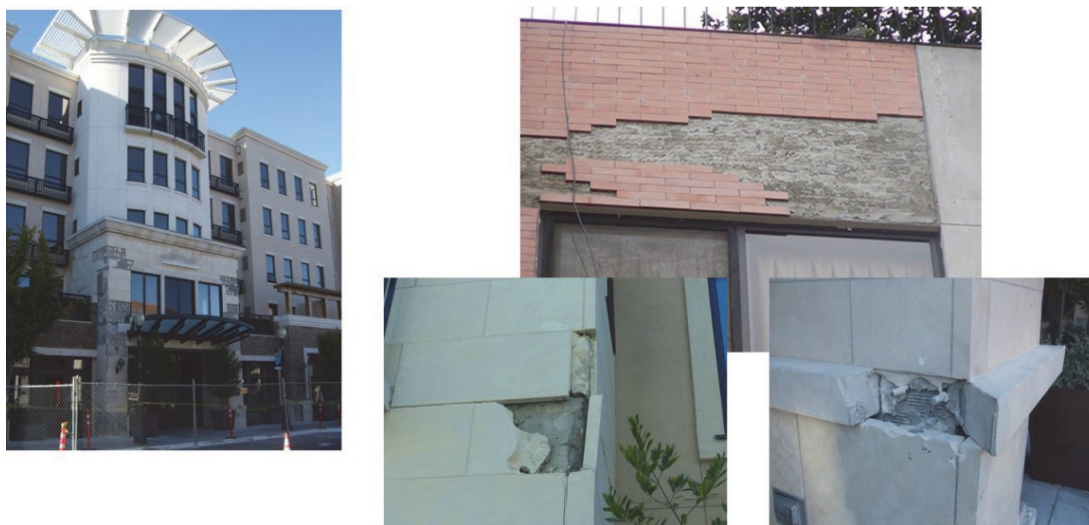
A.2 Situation No. 2 – Exterior Veneer

Situation 2a: Each piece weighs 20 pounds or less, and not above a building egress.

Situation 2b: Each piece weighs 20 pounds or less, and above a building egress.

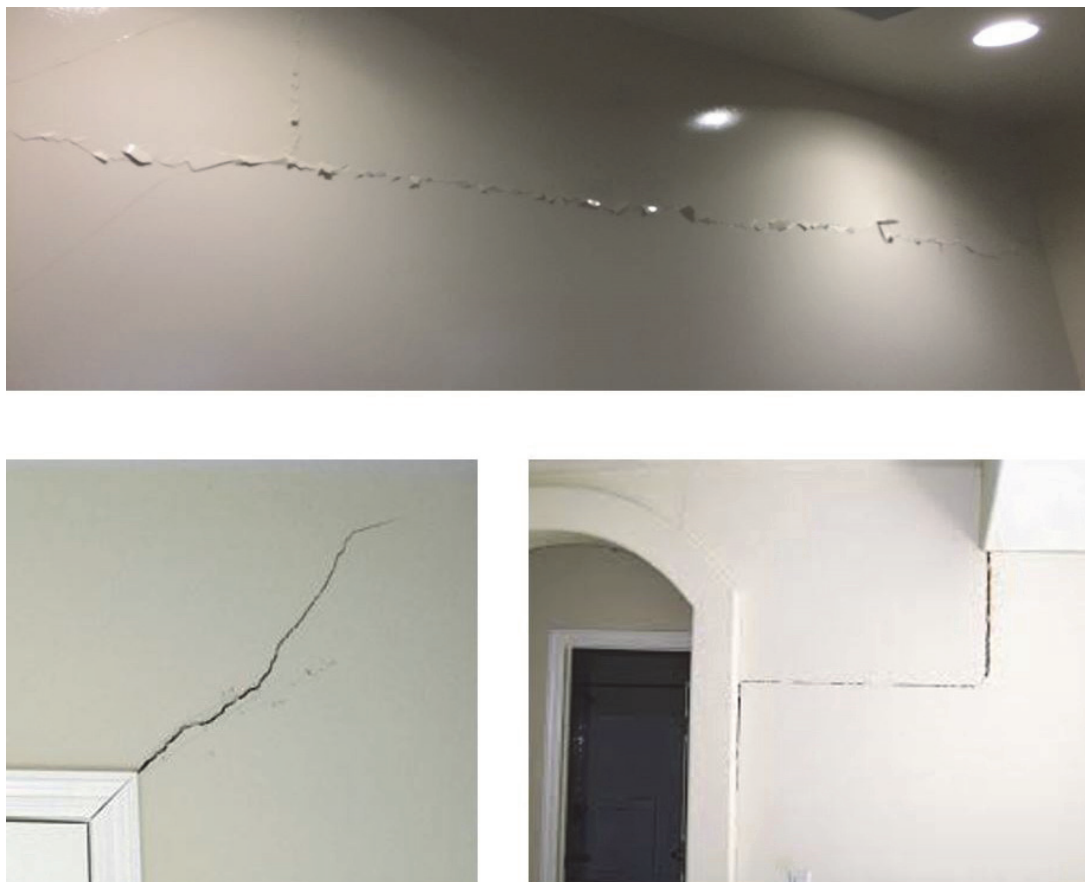
Figure A-3 Gypsum wallboard cracks.

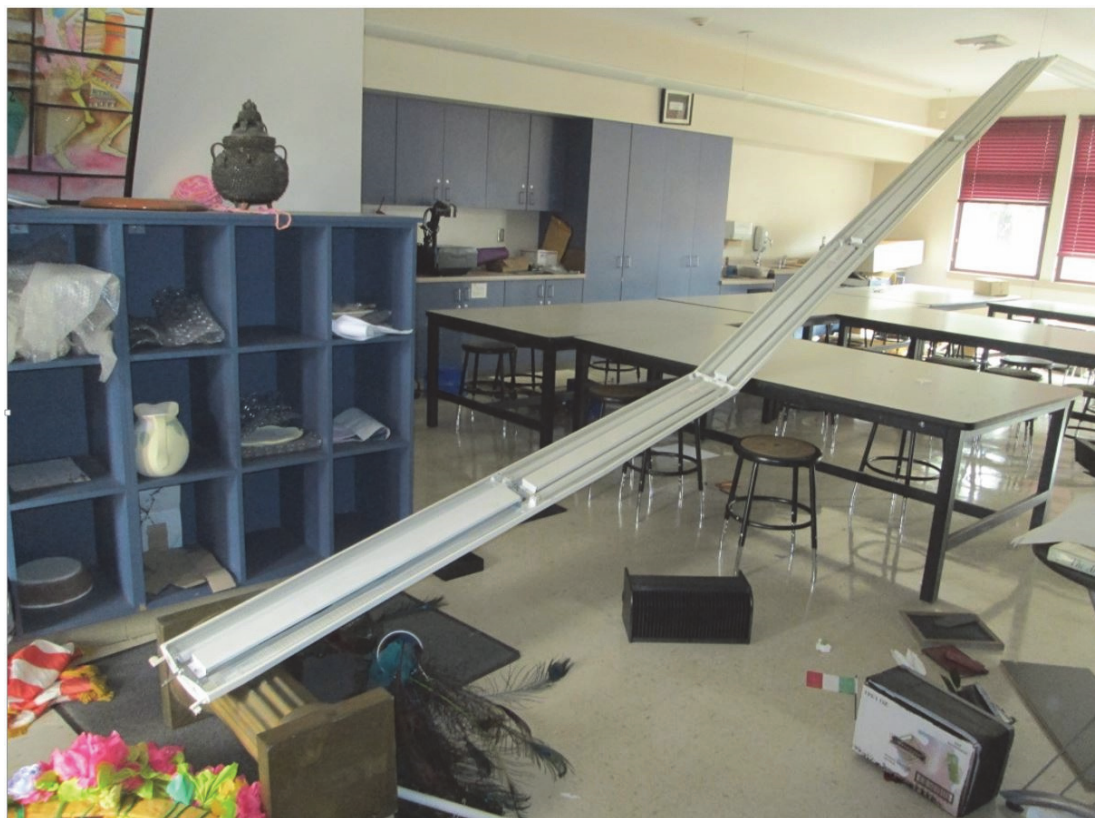
Figure A-4 Suspended light fixture is dislodged and falls.

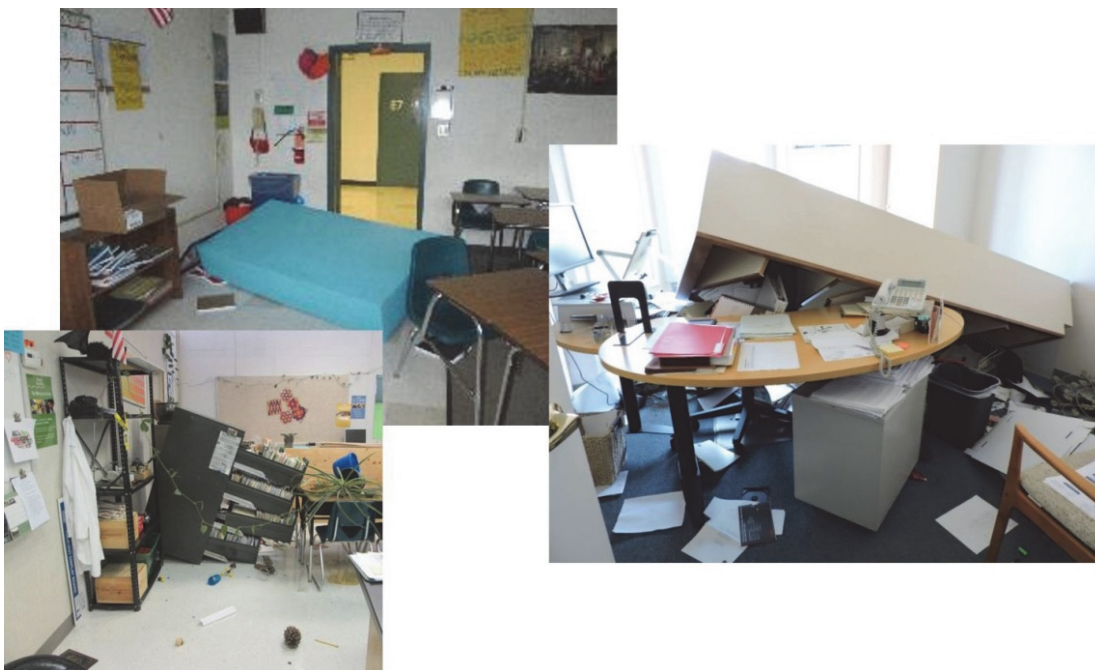
Figure A-5 Unsecured five-foot tall furniture topples over.

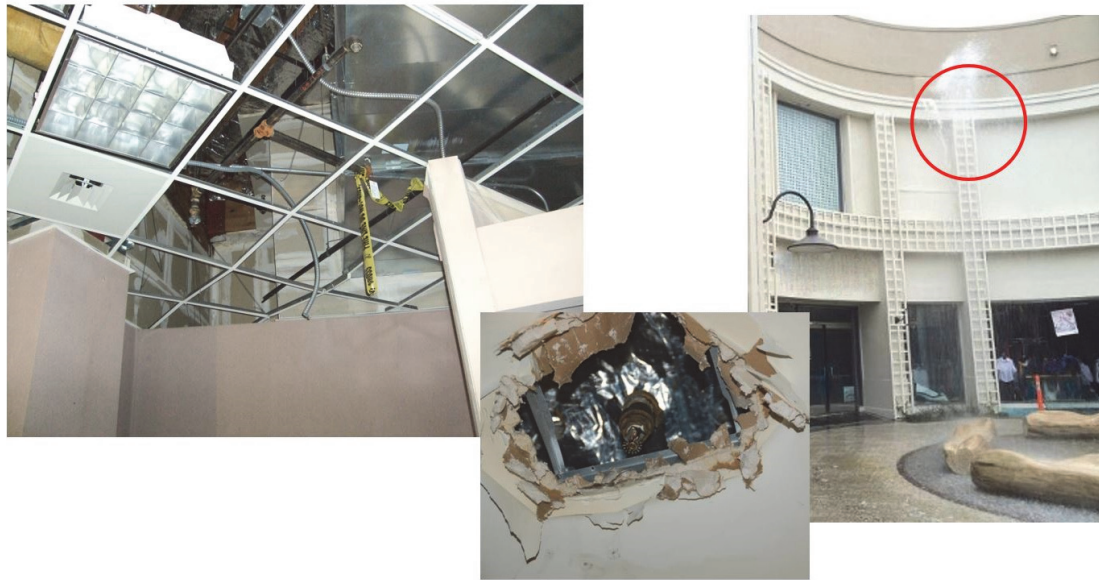
A.6 Situation No. 6 – Fire Sprinkler or Water Supply Systems

Situation 6a: One sprinkler head is damaged and water is released.

Situation 6b: Five percent of sprinkler heads are damaged and water is released.

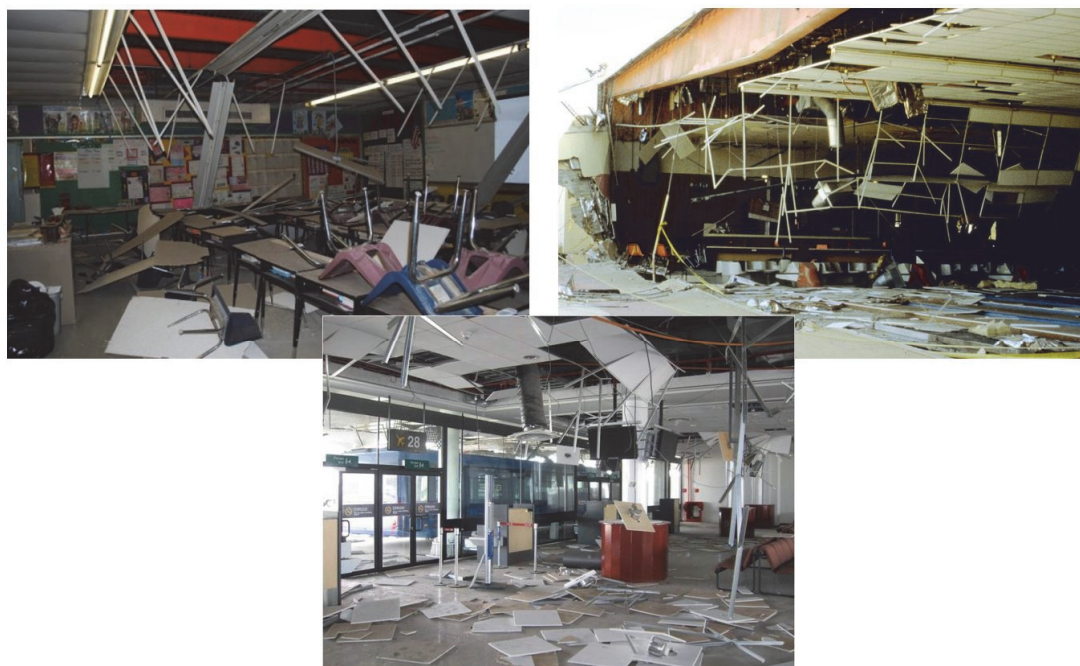
Figure A-8 Acoustic tile ceiling grid is damaged and requires replacement.
