NIST GCR 18-019

Mechanical properties and off-gassing characteristics of new and legacy SCBA facepieces

*Illinois Fire Service Institute Research
University of Illinois*

December 2018

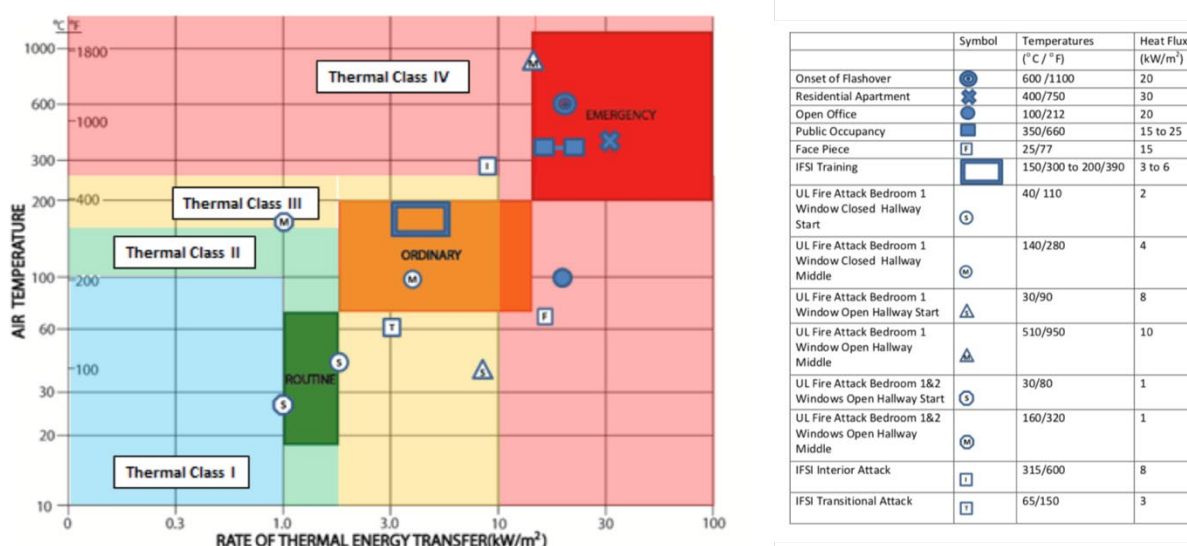
Figure 1. Visual representation of potential thermal conditions during fireground operations, from Madrzykowski [27].

typically exposed, but may be encountered in rapidly deteriorating situations. Madrzykowski [27] compiled the data from Donnelly [26] and Utech [28] with literature on thermal conditions and potential firefighter equipment exposures during test burns, providing an excellent overview of typical conditions in which firefighters operate (Figure 1).

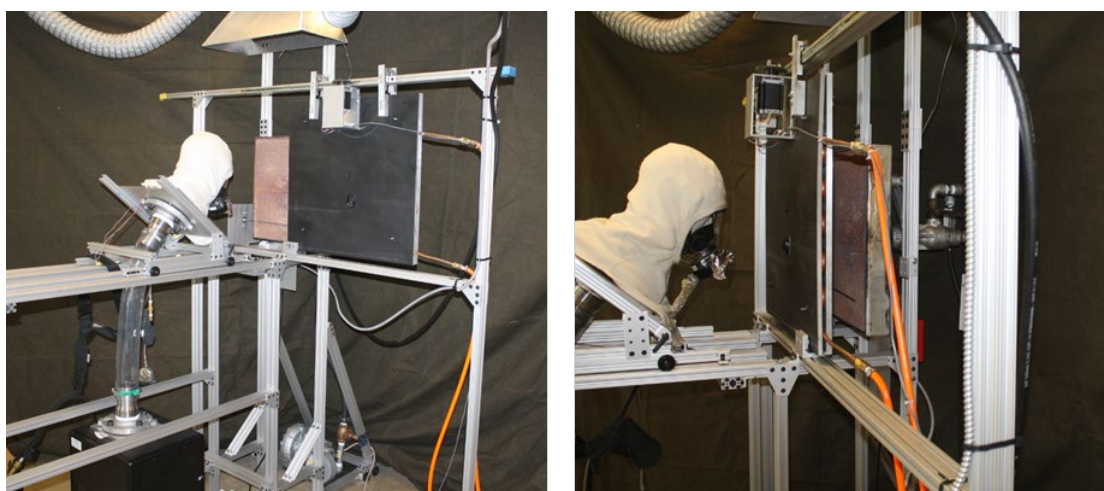
Figure 2. Radiant Panel Test Apparatus modified for repeated exposure testing [30].

Thermal exposures were achieved by altering the radiant panel apparatus developed by NIST [29] and utilized in the NFPA 1981 "Lens Radiant Heat Test" [32] for facepiece testing (Figure 2). The panel provides controlled and repeatable radiant heat flux to the SCBA facepiece while minimizing the convective heat transfer. Natural gas was utilized in accordance with ASTM E162-09 *Standard Test Method for Surface Flammability of Materials Using a Radiant Energy Source*. The air flow rate to the panel for the 5 kW/m² exposures was approximately 450 L/min (960 SCFH), and the natural gas flow rate was approximately 33 L/min (70 SCFH) and adjusted to ensure a uniform blue sheet flame at the surface of the panel. Panel exhaust was removed from the testing environment through the building's laboratory ventilation system. The radiant panel was allowed to heat up and stabilize thermal conditions for one hour prior to testing. Before each scenario, a Schmidt-Boelter heat flux gauge mounted on a translating cart was placed on the frame in front of the radiant heat flux panel to determine the location at which the facepiece placed on the headform would experience the appropriate heat flux. Heat flux was measured at the beginning of each test day and spot checked at the end of various testing days to ensure consistency of exposure.

A headform was then placed at the indicated location so the front of the SCBA lens received the prescribed incident heat flux and was parallel to the radiant panel surface (Figure 2). Simulated breathing was achieved using a Honeywell Posi 3 USB PosiChek system, with a breathing rate of 40 L/min as outlined in NFPA 1981 [32]. The PosiChek was connected to the headform assembly via a 51mm inner diameter tube such that the PosiChek system was not exposed to radiant heat. Air was provided to the headform via an SCBA connected to a high-pressure line supplied by a six-tank compressed air cascade to allow for extended test periods throughout a given day.

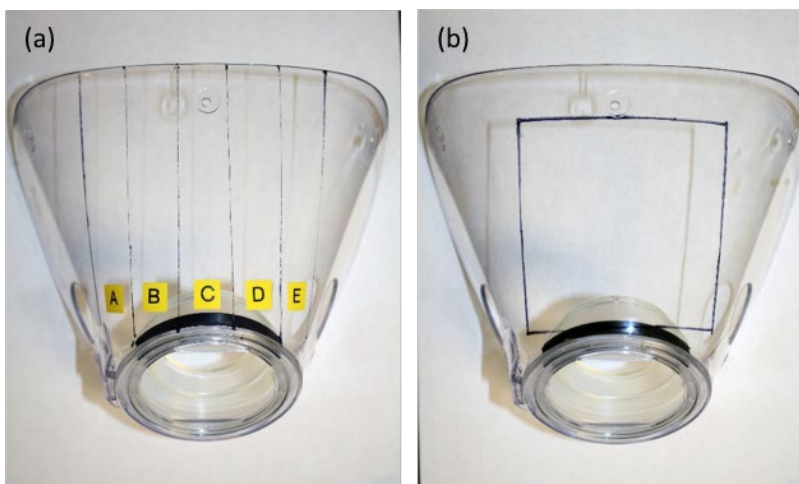
Figure 3. Mechanical test sample harvesting locations: (a) Tensile Test, and (b) Impact Test.

SCBA facepiece geometry limits the opportunity for preparing test specimens from the lenses to specific geometry. Due to the curvature of the lenses special care was required to avoid damaging the lenses during sample preparation that might alter mechanical properties beyond the thermal damage from the radiant exposures. To conduct ASTM standard mechanical property evaluations, two types of samples were prepared: tensile dogbone test strips and square impact testing coupons (Figure 3). Facepieces designated for tension testing were cut into 5 rectangular strips spanning the front of the facepiece using a band saw (Figure 3a). After the rectangular strips were rough cut from the facepiece the test strip was then milled to the final dogbone shape (Figure 4). A rotary mill and mill guide were used to produce ASTM D638-10 Type IV dogbone-type specimens [33]. A mill guide assembly drawing and supporting engineering drawings can be found in the appendix of NIST GCR 17-014 [30]. Final dimensions were measured from each sample using digital calipers. Facepiece curvature and design led to slightly varying thicknesses across the facepiece locations.

ASTM D7137 [34] square (89x89mm) impact testing samples were rough cut from the center of the facepiece (Figure 3b). Burrs on the specimen edges were filed smooth so that the specimen would lay flat when clamped during impact testing (Figure 4). Thickness measurements were collected from all edges of the impact test specimens and an average value was calculated to account for the curvature of the facepieces.

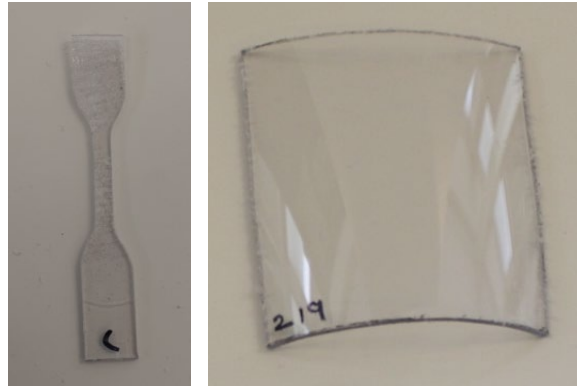
Figure 4. Prepared test samples

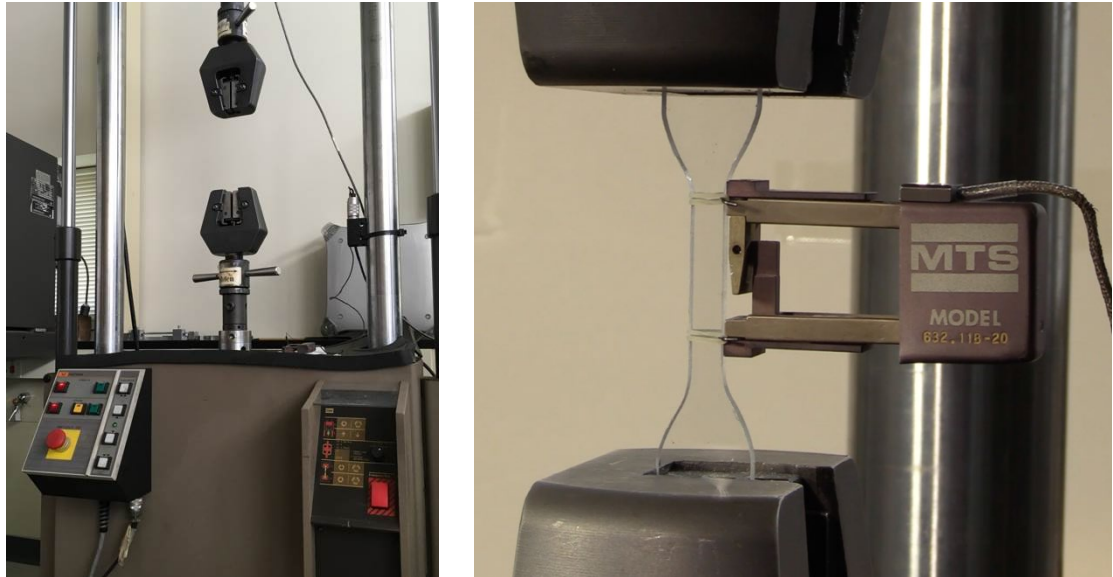
Figure 5: Servo-hydraulic quasistatic tensile test apparatus

Constant-displacement tension tests were performed on the dogbone samples taken from the facepieces in accordance with ASTM D638-10 [33] using an MTS Systems Corporation Model 880 servo-hydraulic load frame coupled with an Instron 8500 Plus digital controller, a National Instruments LabVIEW custom data collection program, and an Eaton Corporation Lebow 3173-500 2.2 kN load cell (Figure 5). Strain data were collected from select samples using MTS Systems Corporation Model 380041-01 extensometer with a 25.4 mm gage length and 10% maximum range. Data collected during tension testing was utilized to determine tensile strength, the modulus of elasticity, and an estimation of strain to failure for the test specimens.

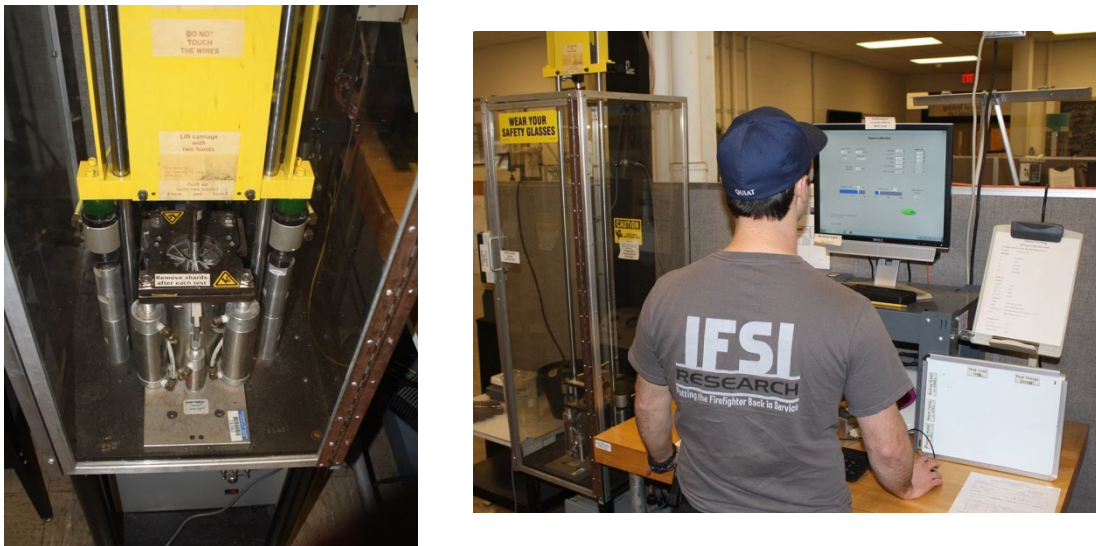
Figure 6: Dynamic mechanical testing apparatus

An Instron Corporation Dynatup Model 8210 drop tower with a 15.9 mm instrumented tup was used to conduct dynamic mechanical testing on the facepiece lens samples. Samples were held with a 76 mm diameter pneumatic clamp, centered around the instrumented tup. The total fracture energy of the lens samples is calculated by integrating the force recorded by the load cell with respect to displacement of the tup. Since the lens specimens are not instrumented to record the deflection of the material during impact, the displacement is computed mathematically by evaluating the motion of the tup as described in NIST GCR 17-014 [30].

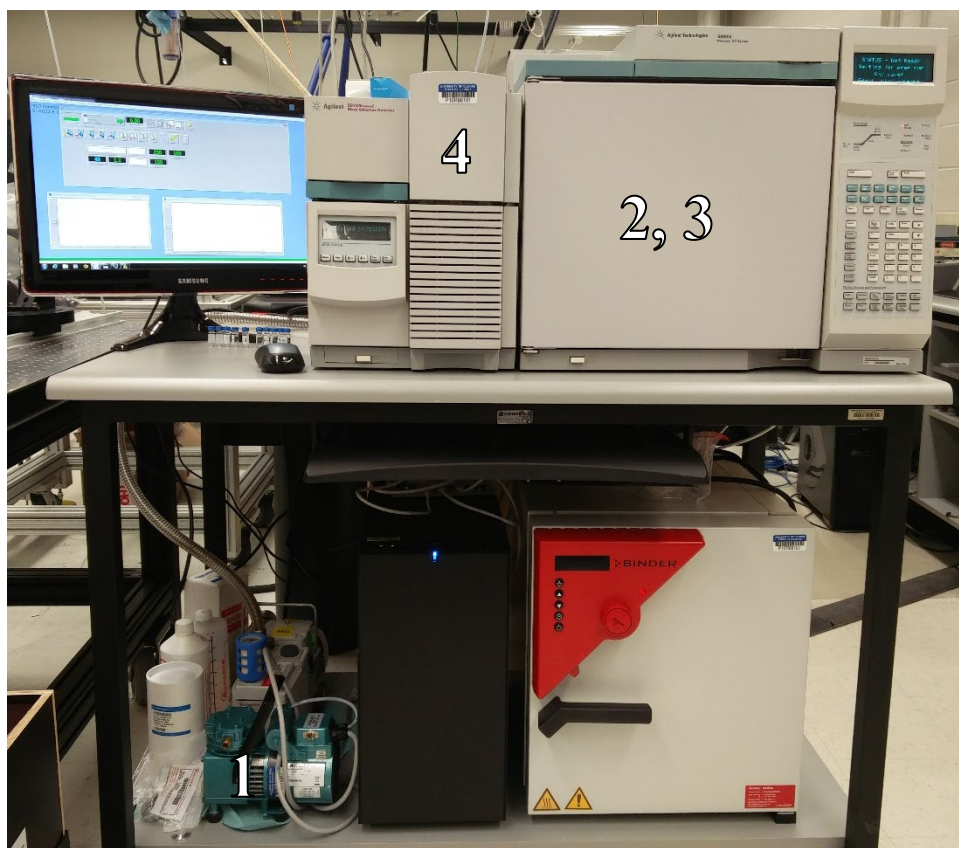
Figure 7. Gas Chromatograph–Mass Spectrometer (GC-MS) system employed in SCBA facepiece testing including vacuum pump (1), GC and column (2,3) and MS (4).

The GC-MS apparatus consists of four major components (Figure 7). The vacuum pump eliminates contaminants from the sampling train, and maintains a pressure of less than 10^{-6} Torr in the system. The gas chromatograph, separates the gas mixture into its components, before it enters the mass spectrometer through the use of a column. The column contains a stationary phase, which is a microscopic layer of liquid or polymer, on an inert solid support, inside a piece of glass. The gaseous compounds being analyzed are transported through the column by the mobile phase which is normally a carrier gas (in this case Helium). As the compounds move through the column, they interact with the walls of the column which is coated with the stationary phase, causing them to elute at different times. The elution time of each compound is called the retention time, and it remains constant if the same test procedure is used. The last part is the mass spectrometer, which is used to identify the various compounds within the injected substance. This is done by ionizing chemical species and sorting them by their mass to charge ratio (m/z).

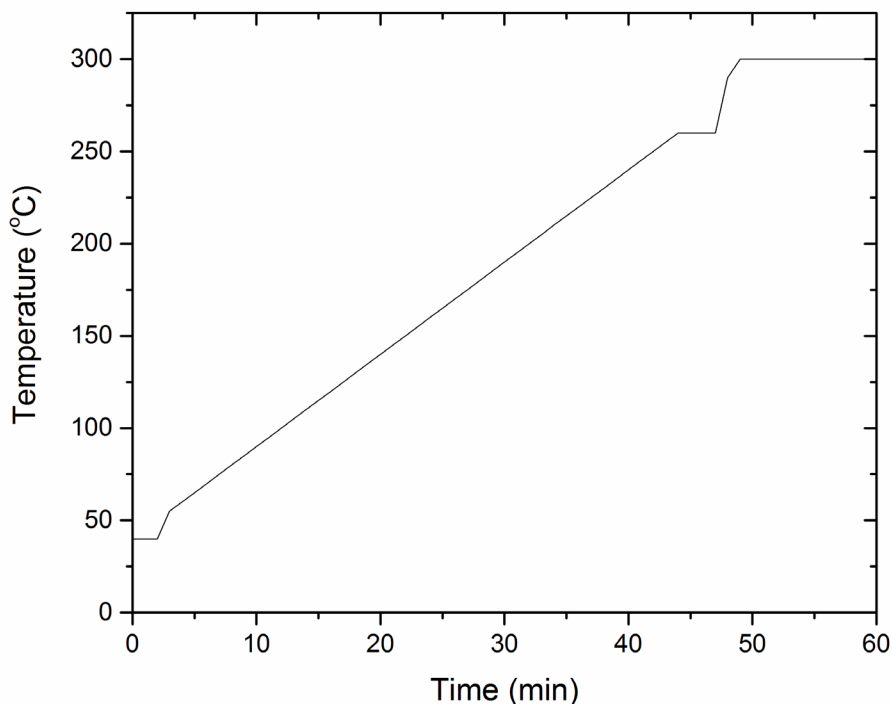
Figure 8. Temperature Ramp utilized for GC Oven

An Agilent DB-5 Ultra Inert column was employed with a 25 μm thick DB-5ms, (5%-Phenyl)-methylpolysiloxane stationary phase applied on the 320 μm diameter glass column with total length of 30 m. This column is a non-polar low bleed column and has a high temperature limit. The flow rate of the Helium mobile phase was a constant 1.2 ml/hr. The GC also contains an oven which allows for an additional degree of freedom in experimental design. Increasing the temperature of the column can reduce the elution time of compounds, reducing total test time. The oven temperature ramp used throughout all the experiments is shown in Figure 8. The oven is initially held at 40 $^{\circ}\text{C}$ for 2 minutes, before ramping to 260 $^{\circ}\text{C}$ at a rate of 5 $^{\circ}\text{C}/\text{min}$, followed by a hold for 3 minutes. A slow temperature ramp allows for better separation of the compounds by increasing the retention time between them. Finally, the oven temperature ramps up to 300 $^{\circ}\text{C}$ at 30 $^{\circ}\text{C}/\text{min}$, and is held for 10 minutes in order to clear the column of any remaining compounds and prepare it for the next test.

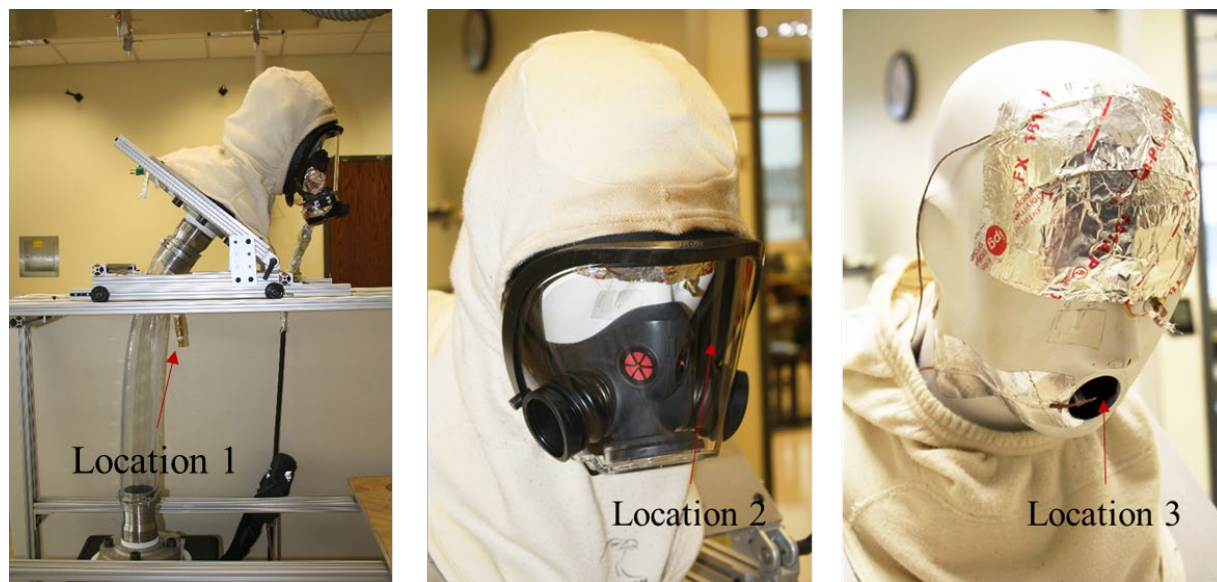
Figure 9. Sampling locations for gaseous injection in the GC-MS. Sampling in the airway (Location 1), between the SCBA lens and nose-cone (Location 2), and at the mouth (Location 3).

Three regions of interest were identified in the SCBA testing apparatus: 1) In the airway between the headform and bellows as a surrogate for the firefighter's lungs, 2) between the SCBA lens and nose-cone where the highest concentrations of off-gassing might be expected (prior to mixing with incoming SCBA air during a breath) and 3) at the mouth where breathing air would enter the firefighter's body (Figure 9). Gas was sampled from these three locations and injected into the

GC-MS through the use of the air pump at 138 kPa (20 psi). SCBA facepieces were tested under a wide variety of heat flux conditions, with injection occurring when the inside surface of the lens reached the target temperatures shown in Table 5. In some cases, the SCBA facepieces were exposed through their glass transition temperatures, started to craze, and began to form a hole.

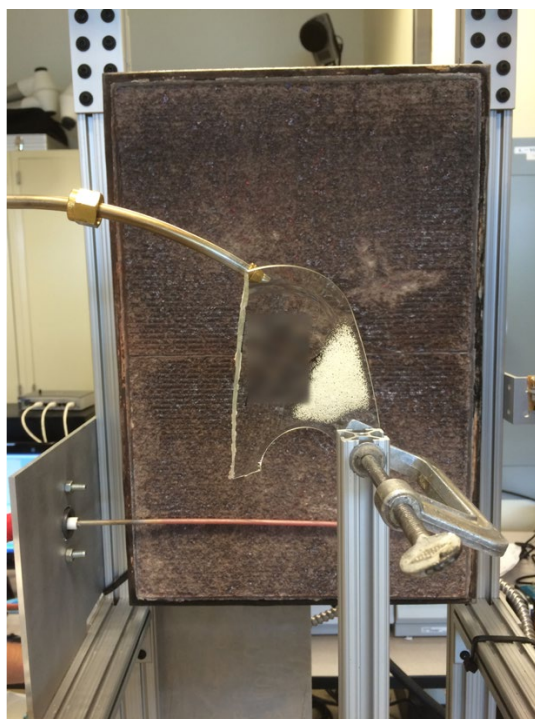
Figure 10. Experimental setup for GC-MS off-gas testing under extreme condition.

In addition to these tests with the breathing mannequin, sectioned samples of the SCBA facepieces were mounted directly in front of the radiant heat panel, without the headform and the breathing apparatus (Figure 10). Gas samples were collected both behind the facepiece (firefighter side) as well as in front of the facepieces (radiant panel side) where off-gassing was visible. Gas samples were collected prior to craze formation, during crazing, and during bubble formation (Figure 11). This test illustrated a scenario where the SCBA facepiece has no cooling from incoming breathing air while being exposed to a high heat flux.

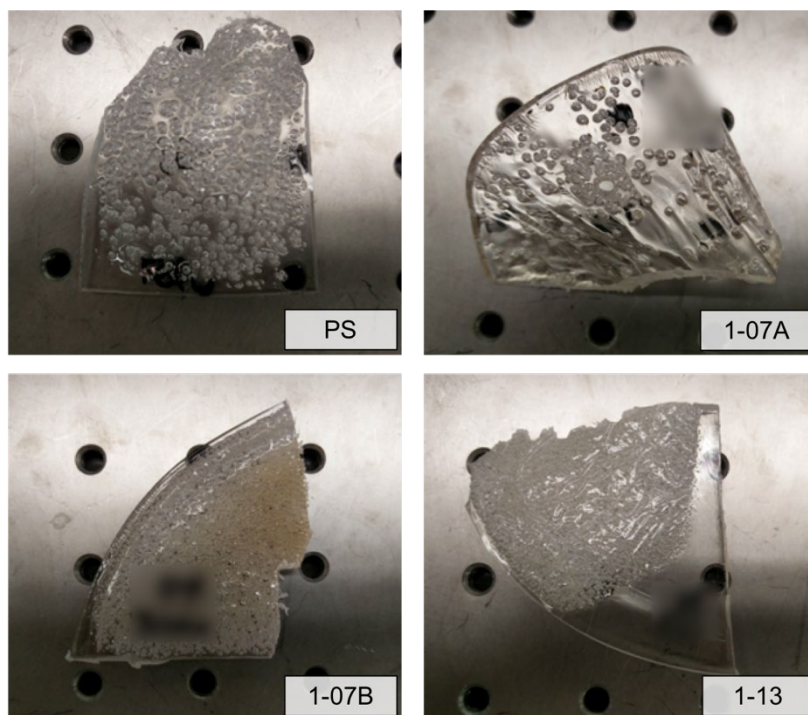
Figure 11. SCBA facepiece sections subjected to high heat flux until bubble occurrence.

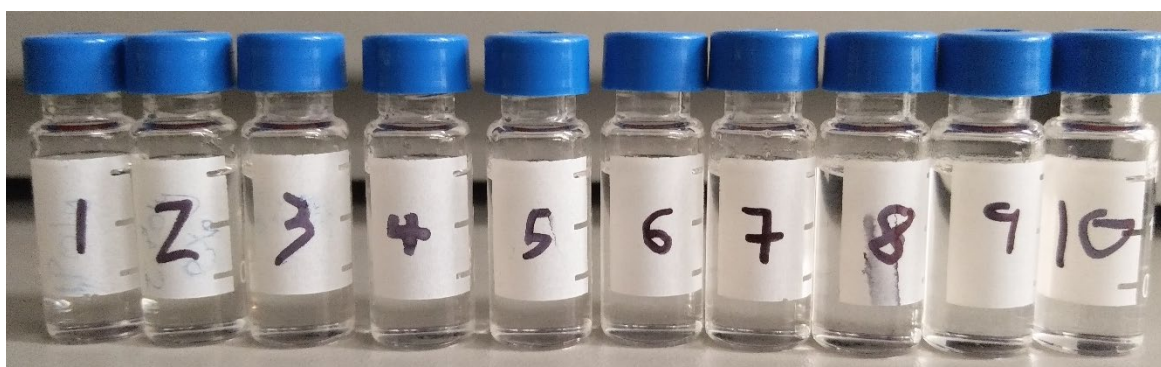
Figure 12. Prepared liquid samples in glass containers.

To determine the chemical compounds utilized in the SCBA facepiece materials (that might potentially be available for off-gassing at elevated temperatures), samples harvested from the SCBA facepieces were injected in a liquid form into the GC-MS. Two sets of samples were used, 1) new samples with no previous thermal exposure (unexposed), and 2) those from the 'Emergency Situation' (exposed) shown in Figure 11. Both sets of samples were dissolved in chloroform and injected in the GC-MS. This approach allows the direct comparison of the exposed samples to their unexposed counterparts, as well as a direct comparison between the SCBA facepieces themselves. Samples were prepared by cutting a small piece of the SCBA facepiece weighing in the range of ~30-60mg, which was then dissolved with ~1.4-1.5ml of chloroform for 6 days at 23°C (Figure 12). Table 6 summarizes their individual weights for each sample, as well as their concentrations within the solvent solution. The samples were measured using a high-fidelity laboratory scale with accuracy to within 1mg. The uncertainty on the mass measurements was calculated to be less than 0.1%.

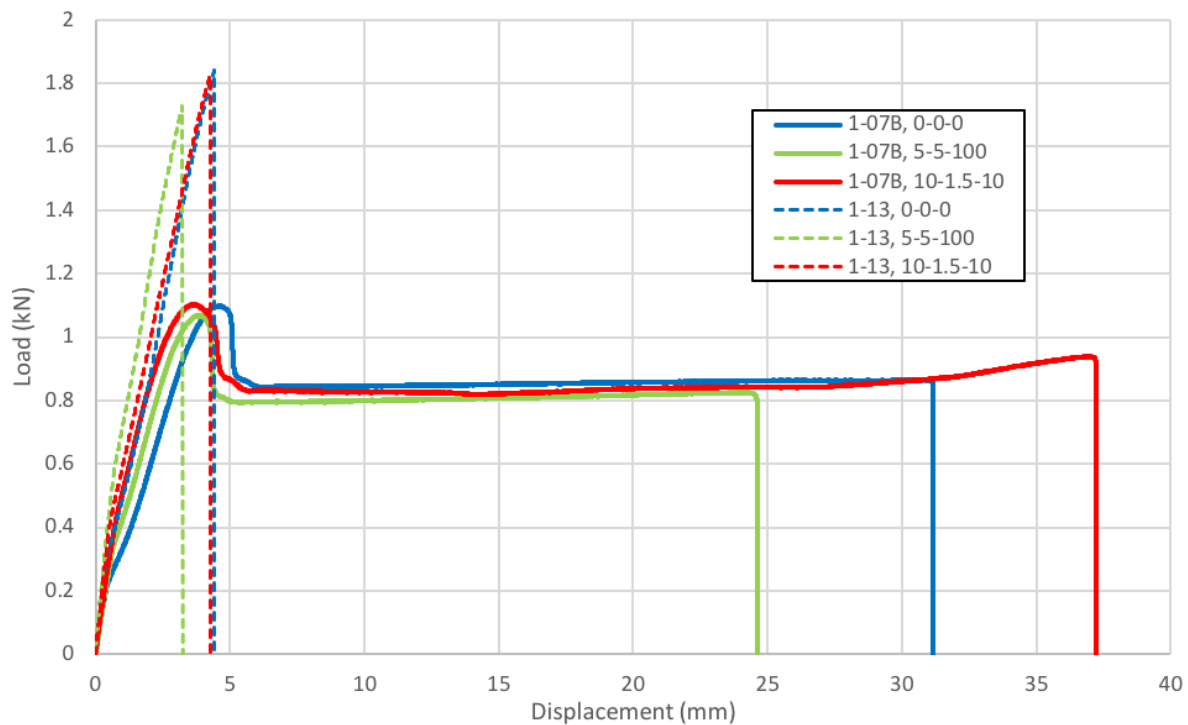
Figure 13. Quasistatic load-displacement plots for representative samples from each facepiece and exposure condition.

Representative quasistatic load-displacement curves for the two facepiece models and three thermal conditions are shown in Figure 13. Facepiece models are differentiated by line patterns (Solid **1-07B**; Dashed **1-13**), while the thermal exposures can be identified by line colors (Blue, 0-0-0; Green, 5-5-100; Red, 10-1.5-10) to allow comparison. Table 7 indicates the number of samples reported in each test condition, while Table 8 shows a summary of the quasistatic tensile test results from these samples. With the 2x3 ANOVA framework, it is possible to compare main effects of facepiece model and exposure type.

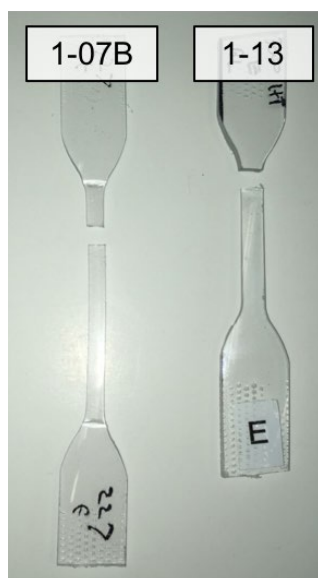
Figure 14. Representative samples of elongation following quasistatic tensile testing of unexposed facepiece sections.

Statistically significant differences were found between facepiece models for all three quasistatic tensile properties. Tensile strength, elastic modulus, and strain to failure were significantly different between facepieces ($p<0.001$, $p=0.011$, $p<0.001$; respectively). **1-13** facepieces had higher tensile strength and elastic modulus, but lower strain to failure. The **1-13** material can carry a much higher load prior to failure, but fails in a more brittle manner (limited ductility or ‘stretch’ prior to failure) than the **1-07B** material. During tension testing both the **1-07A** and **1-07B** facepieces displayed highly ductile behavior prior to failure – greater than 100% strain at failure for the unexposed samples while the **1-13** facepiece displayed brittle behavior with minimal necking and less than 20% strain to failure (Figure 14). Data from the **1-07A** facepieces from NIST GCR 17-014 [30] are provided for comparison.

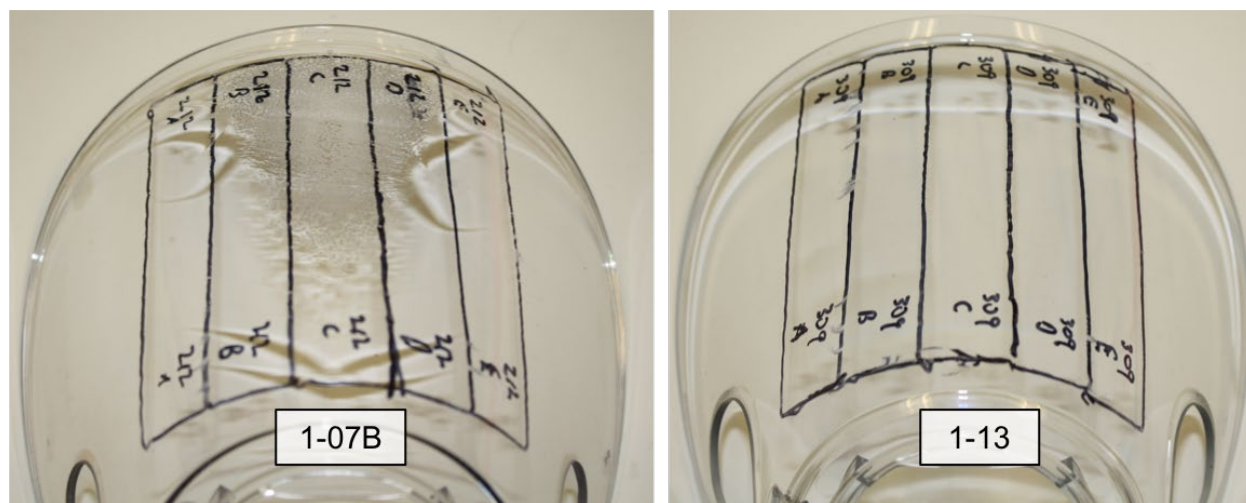
Figure 15. 1-07B and 1-13 facepiece showing damage from thermal exposure (10-1.5-10) prior to sample harvesting.

The **1-07B** and **1-13** facepieces exposed to the 10-1.5-10 condition resulted in minimal changes in mechanical properties when compared to the unexposed samples. In fact, for the both facepiece models, there were no significant differences between the unexposed facepieces and those exposed to the 10-1.5-10 condition. After exposure to the 10-1.5-10 condition, the **1-07B** facepieces had noticeable microcracking (Figure 15) which was not present after the 5-5-100 condition. Interestingly, these visible indications of damage did not translate to changes in quasistatic mechanical properties, while significant degradations in ductility were noted after 5-5-100 despite no visible thermal damage.

in the **1-13** sample. This trend is particularly notable considering the lack of visible indications of thermal damage in the **1-13** mask after this exposure (Figure 17). As shown in Figure 15, this higher intensity exposure resulted in microcracking and bubbling in the **1-07B** samples, which may have acted as a dynamic stress concentrator during the high strain rate loading here, but did not result in any changes for the slower tests where there may be more time for molecular reorientation.

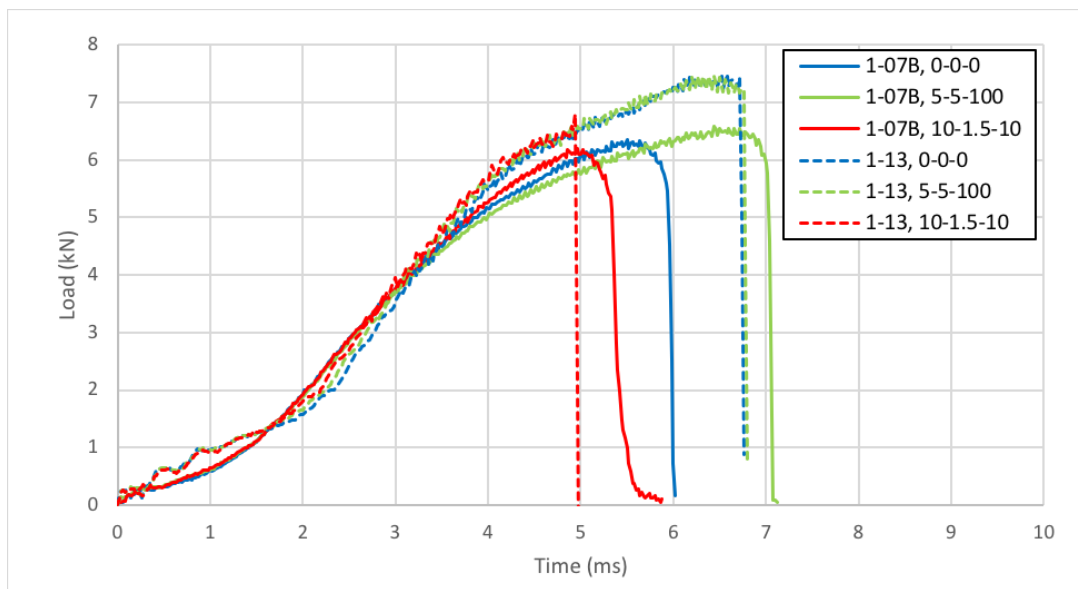
Figure 16: Dynamic load-time plots for impact tested samples from each facepiece and exposure condition.

Representative dynamic load-time plots from each of the facepiece samples and exposure conditions can be found in Figure 16 with results summarized in Table 9. While the sample size did not allow statistical analysis, a few interesting observations can be made. The **1-13** facepiece samples reached the highest load before failure for each of the three facepiece exposure conditions. However, energy absorption prior to failure was not as consistent; while the unexposed **1-13** sample absorbed more energy than the unexposed **1-07B** sample, energy absorption was similar after the 5-5-100 condition, and after then 10-1.5-10 condition, the **1-13** sample absorbed less energy than the **1-07B** sample. The 5-5-100 exposure resulted in relatively small changes in dynamic mechanical properties when compared to their unexposed samples. In contrast, after exposure to the 10-1.5-10 condition both facepiece samples failed at a notably lower maximum load and lower energy absorption relative to the unexposed condition. It should be noted, while these thermal exposures resulted in measureable change in dynamic mechanical properties, these exposed samples failed at higher loads and absorbed more energy than the unexposed **1-07A** samples tested in NIST GCR 17-014 [30].

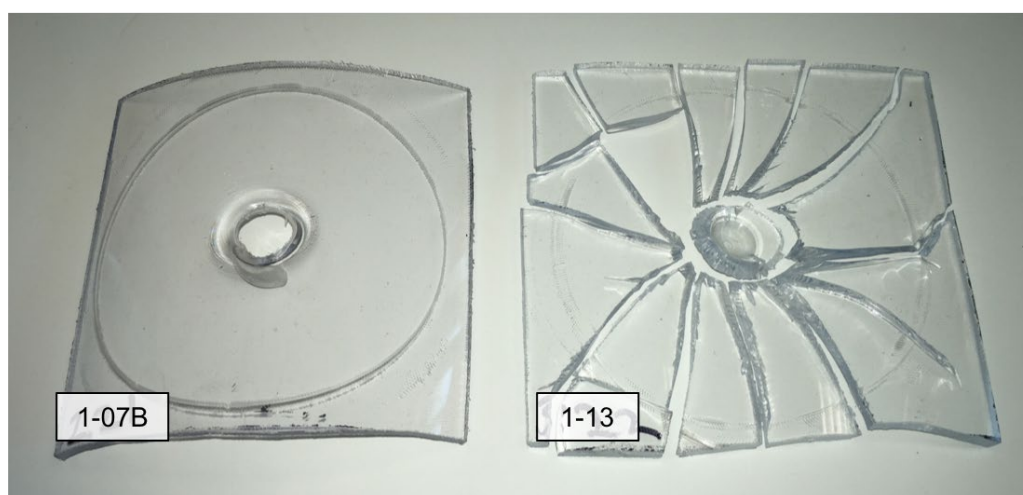
Figure 17. Unexposed facepiece lenses after dynamic impact testing (left to right: 1-07B, 1-13).

Even after repeated heat exposures, these materials are very tough, carrying high loads and absorbing significant amounts of energy prior to failure. Facepiece models conforming to the 2013 standard (**1-13**) achieved the highest load carrying capacity for all three exposure categories. However, the mechanism of failure was quite different between the models (Figure 17). During impact testing the **1-07A** and **1-07B** samples all experienced extensive deformation in the center of the sample prior to failure and failed with the tup punching through the thickness with the sample remaining intact. In contrast, the **1-13** facepiece shattered into multiple fragments on impact and the center piece of the facepiece only displayed minor deformation at the point of loading. When this material does eventually fail, the pattern is indicative of a brittle failure and the resulting pieces may be sharp and may travel a considerable distance from the point of impact.

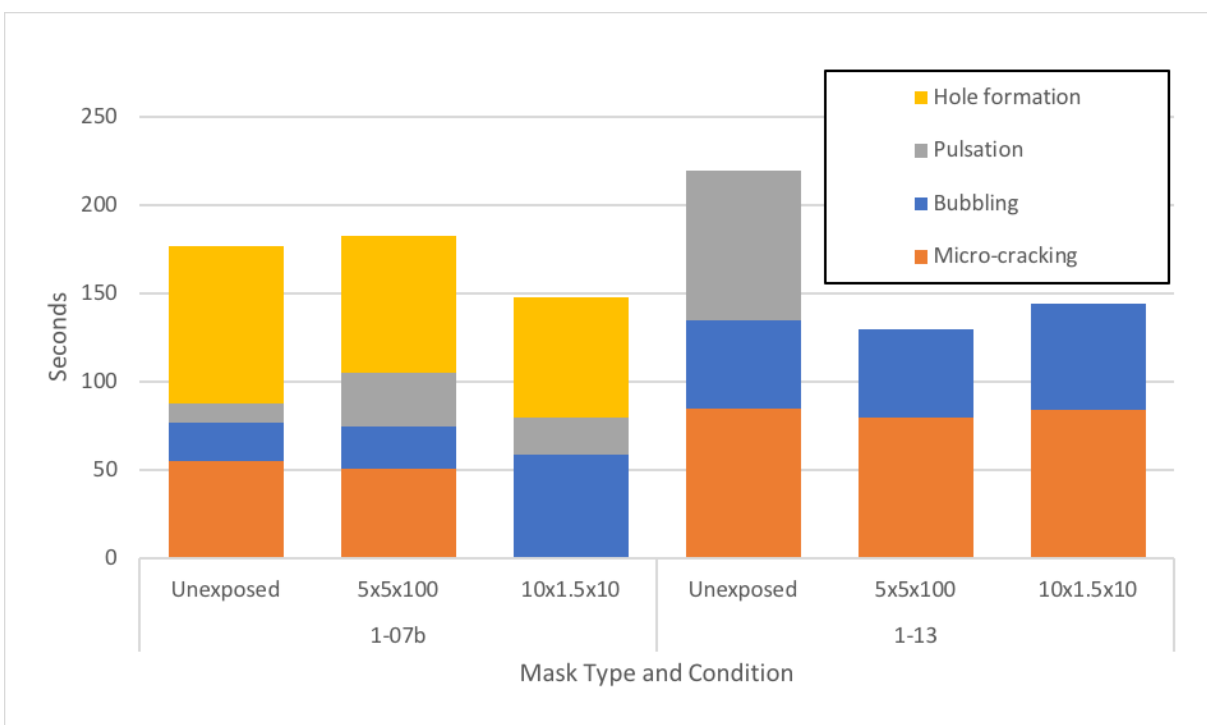
Figure 18. Time to event for NFPA 1981 Lens Radiant Heat Tests. Note that two of the 1-13 facepieces never accumulated damage beyond bubbling.

Facepieces of both models and exposure to all three conditions were subjected to the NFPA 1981 Lens Radiant Heat Test. Throughout the 5 minute, 15 kW/m² exposure and 24 minute post-exposure test, facepieces were monitored for four visually identifiable changes in the lens material: 1) microcracking (small hairline cracks in the lens which did not appreciably affect visibility through the lens), 2) bubbling (generation of small bubbles which noticeably reduced visibility through the lens), 3) pulsation (movement of a the lens in response to pressure changes from the breathing headform), 4) hole formation (creation of an opening between the interior and exterior of the facepiece). The time at which each event occurred (Table 10), graphical representation of time to each event (Figure 18), and visual representation of the progression of facepiece lens damage (Figure 19) are shown below.

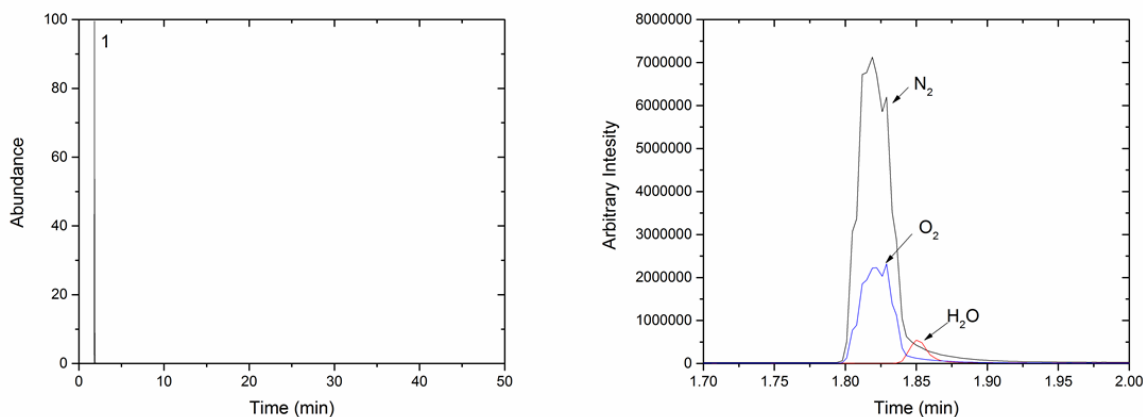
Figure 20. Total Ion Chromatogram from representative sample of gaseous injection of samples collected inside the SCBA facepiece tests (Note peak labelled 1, Left). Extracted Ions for Nitrogen (N₂), Oxygen (O₂) and Water (H₂O) (Right).

No visible off-gassing from the SCBA facepieces was noted during testing when the facepieces were secured to the breathing headform. In general, air was the only component that was distinguished from the Total Ion Chromatogram (TIC). A representative TIC is shown in Figure 20. The single peak in the TIC was determined to be air, by extracting the respective ions for Nitrogen and Oxygen, 28 m/Z and 32 m/Z respectively (where m/Z denotes the mass-to-charge ratio), and comparing their mass ratio to that of air (3.29).

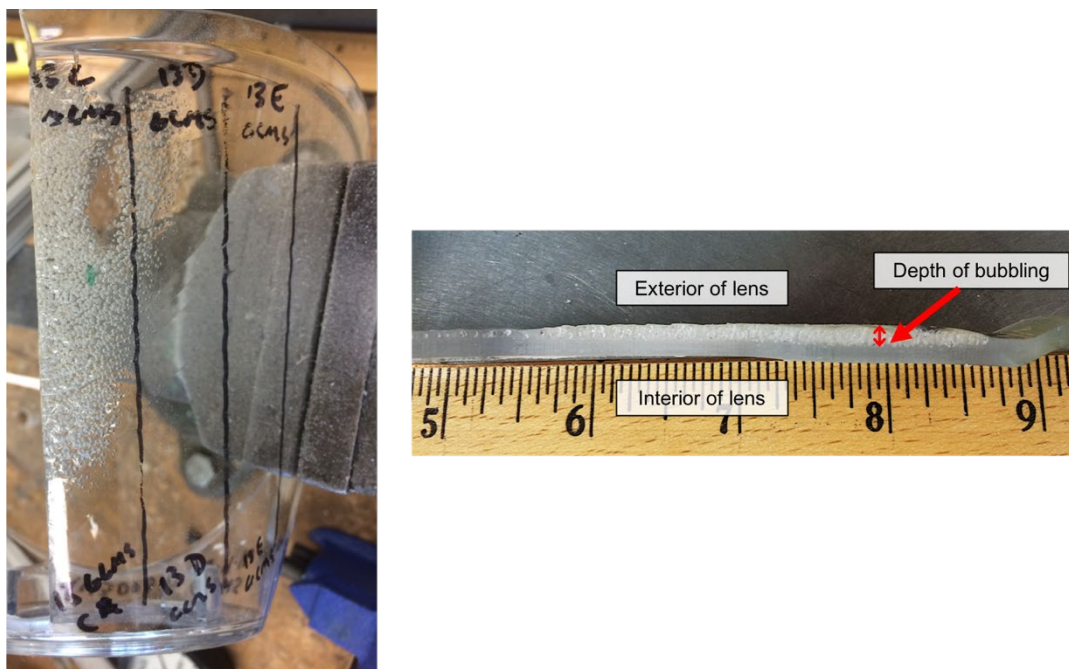
Figure 21. Damaged facepiece and cross-section showing damage only to exterior of facepiece.

Cross-sectional analysis of the facepieces provided evidence that thermal damage, at least up until hole formation, did not penetrate uniformly through the thickness of the lens (Figure 21). As bubbles formed and damage accumulated during the radiant exposure to the outside of the facepiece, the air entering the facepiece cooled the interior surface such that bubble accumulation and pathway for damage was concentrated on the outer surface of the facepiece lens (Figure 21). Discoloration of the lens that occurred due to polymer oxidation in some tests is also limited to the outer surface of the lens (Figure 22). Thus, products of degradation that may be released in other formulations are likely to initiate outside the breathing zone.

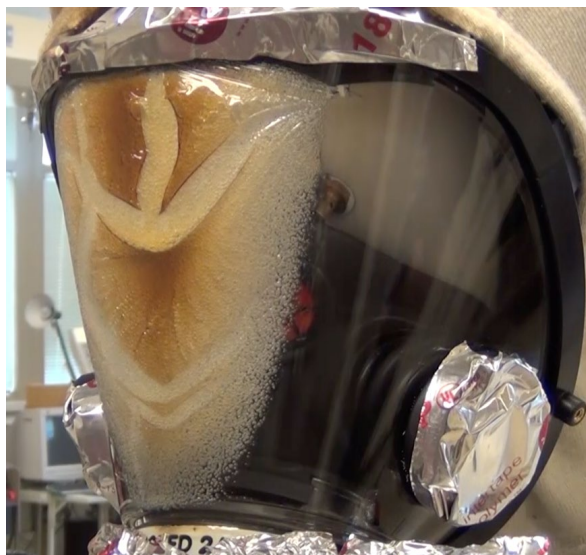
Figure 22. Facepiece lens showing discoloration as a result of polymer oxidation.

In general, yellow discoloration of the SCBA facepieces is likely attributed to the oxidation of the polycarbonate, and more specifically to the occurrence of ring oxidation of BPA [40]. It is important to note that polycarbonate tends to oxidize at an appreciable rate at temperatures of 250-300 °C, and may form alkylperoxide radicals, followed by their isomerization in the formation of a number of oxygen-containing carbonyl groups, which may undergo further conversions [41]. Several cyclic compounds were noted in Figure 25, but not identified at a high enough level of confidence between the elution times of 40 and 60 minutes. The ratio between the concentration and signal strength to background is small, making it hard to correctly match with the NIST database. Additionally, and more probable, is that several different compounds were eluting at the same time, resulting in overlap between peaks. There are more unidentified compounds in the exposed samples, possibly a result of the thermal exposure fundamentally affecting the facepiece composition which results in reactions and the breaking of polymer bonds. Determination of the compounds produced during the facepiece degradation was outside the scope of the original project, and thus further research would be needed to draw definitive conclusions.
