Bending Tests of Large Welded-Steel Box Girders at Different Temperatures

By Ambrose H. Stang and Bernard S. Jaffe

Tests were made to determine the effect of constraint caused by geometrical shape and by differences in temperature on the ductile behavior of welded structures. Four large box girders of identical design were fabricated from fully killed steel from the same heat. The box girders were tested as simply supported beams, one girder being tested at each of the following temperatures: -40° , 0° , 40° , and 80° F. The girders tested at -40° and 0° F broke with a square type of fracture. The other two girders could not be broken with the available equipment, although deflections at midspan of more than 16 inches were induced on a 22-foot span. The results of these tests are discussed and compared.

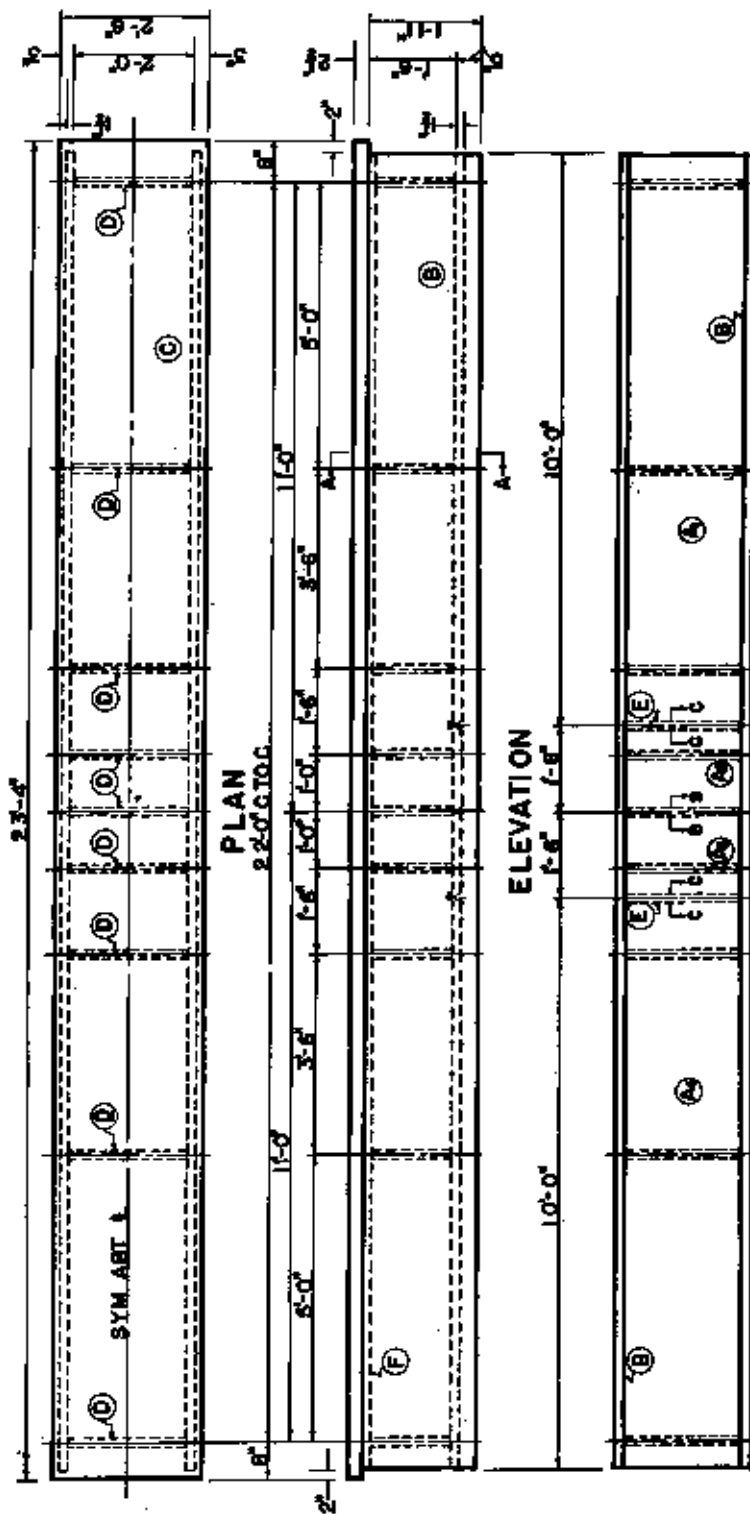
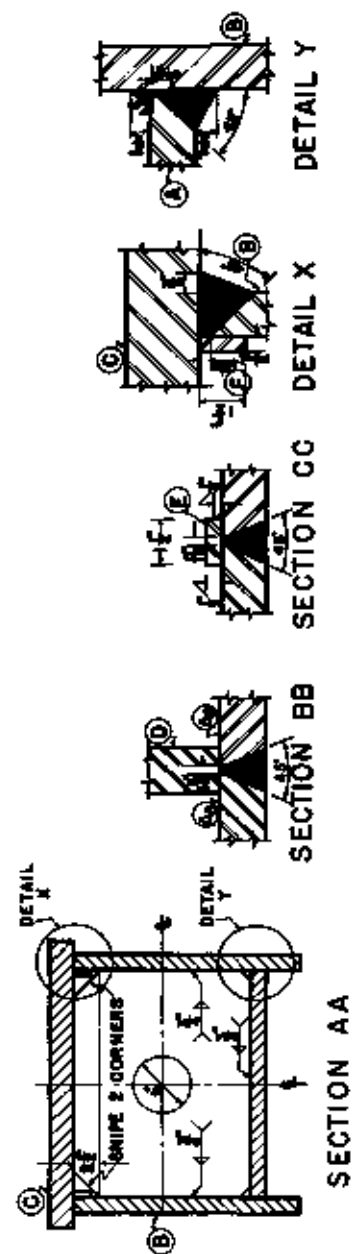
FIGURE 1. Details of the box girders.

The details of the box girders are shown in figure 1. Each girder consisted of a bottom plate, A, $1\frac{1}{2}$ in. thick; of two side plates, B1 and B2, each $1\frac{1}{2}$ in. thick; of a top plate, C, $2\frac{1}{2}$ in. thick; and of nine diaphragms, D, $1\frac{1}{2}$ in. thick. The bottom plate, A, was made up of four separate plates—A1, A2, A3, and A4—with three transverse welds. The diaphragms, D, had snipes, $2\frac{1}{2}$ in. on a side, at each of the top corners, and smaller ones at the two bottom corners, as well as a central hole 6 in. in diameter. Backing-up bars, E and F, were used as indicated in figure 1.

A fifth box girder, the material of which was a semi-killed steel instead of the fully killed steel used in the other four girders, was also tested at room temperature, about 80° F. This box girder was the same size as the others and differed from the design shown in figure 1 only as follows:

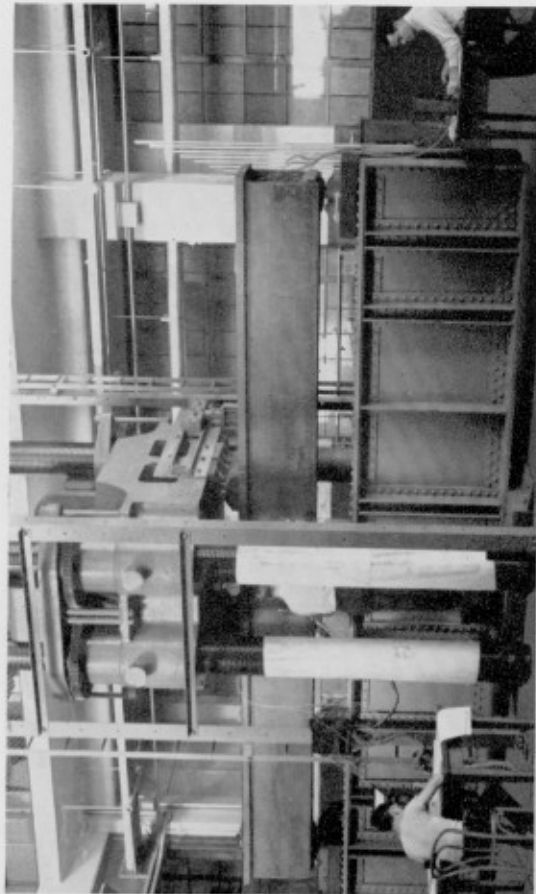
FIGURE 3. Box girder in the testing machine, at 80°F , before test.

Each box girder was tested as a simple beam, supported on cylindrical bearings on a horizontal span of 22 ft, and loaded by two equal loads, 5 ft apart and each 8 ft 6 in. (102 in.) from the nearer support. Figure 3 shows the box girder in the testing machine for the test at 80° F.

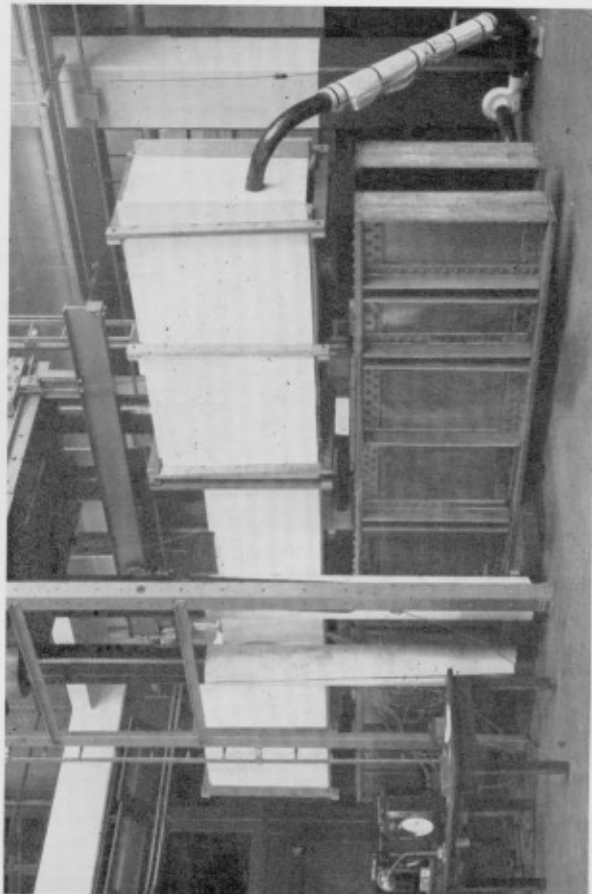
FIGURE 4. Enclosure of the box girder for tests at temperatures below 80°F .

Note the frost covered blower and pipes of the forced-circulation system.

For the girder tested at -40° F, the strains were measured with scanning switches and recorders shown in figure 4 to the left of the girder. Portable strain indicators were used during the other tests.

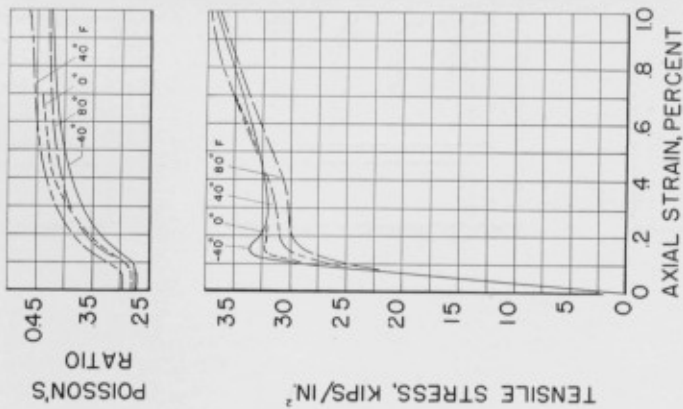
FIGURE 2. Average results of tensile tests of coupons.

Figure 2 shows the average values for the stress-strain and Poisson's ratio-axial-strain relations. The latter values did not appear to vary consistently with temperature. In the stress-strain diagram, the stresses at the knee of the curves decreased as the temperature increased, but on the later ascending portions of the curves, the temperature effects appear to be negligible.

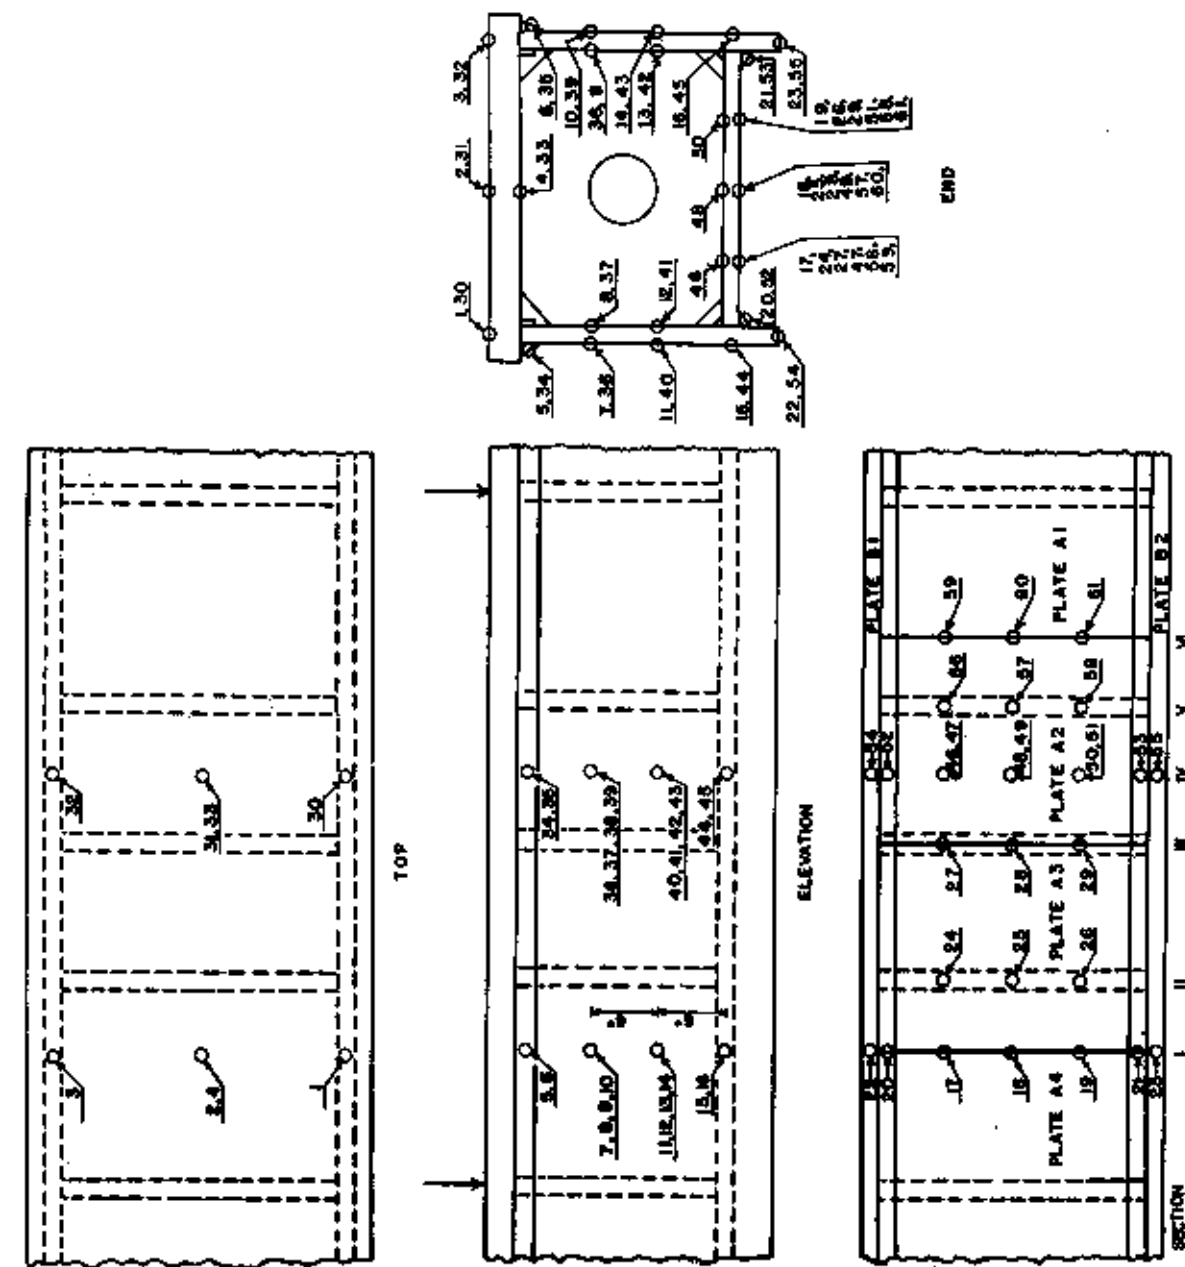
FIGURE 5. Location of wire-strain gages.

The strains at various locations between the lines of load application were measured with SR-4 bonded-resistance wire-strain gages. The locations of the strain gages are shown in figure 5. Gages 22, 23, 54, and 55 on the bottom edges of the plates B were single gages, A1 or A3. The gages at other locations were rosette gages, AR-1 or AR-2. The nominal gage length was 13/16 in. for all gages.

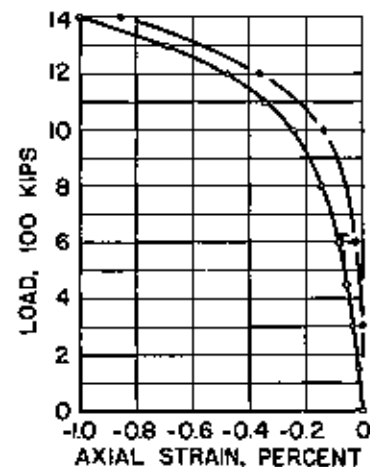
FIGURE 6. Average axial strains in the top of plate C of the girder tested at 40° F (8 gages).

The average strains at a given load for the gages at equal distances from the top of the girder were averaged and have been plotted—for the girder tested at 40° F—in figures 6 to 17. In these figures, the inclined dotted line terminated by a horizontal bar represents the load-strain relation as computed by the ordinary beam theory for the location of the gages under consideration and using the average value for Young's modulus for the coupons, as given in table 1 for this girder. The load at the end of this line corresponds to the average proportional limit stress from table 1.

Tensile strains are plotted to the right. Compressive strains are plotted to the left and indicated as negative. The observed average strains due to the load are shown as open circles. The sets, remaining after the load was removed, are shown as solid circles.

In general, it may be noted in these figures that the load-axial strain curves practically coincide with the theoretical lines for loads in the lower elastic range. The observed strains at the proportional limit values were generally larger than the computed values. The set values for the greater loads are generally a very large fraction of the corresponding strain-under-load values.

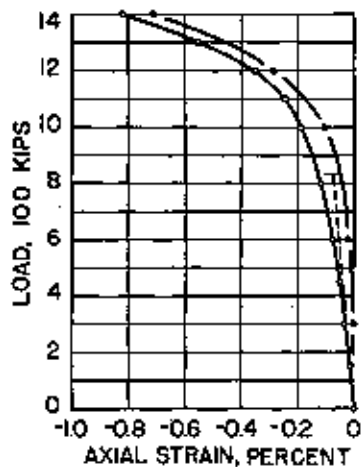
FIGURE 7. Average axial strains in the bottom of plate C of the girder tested at 40° F (8 gages).

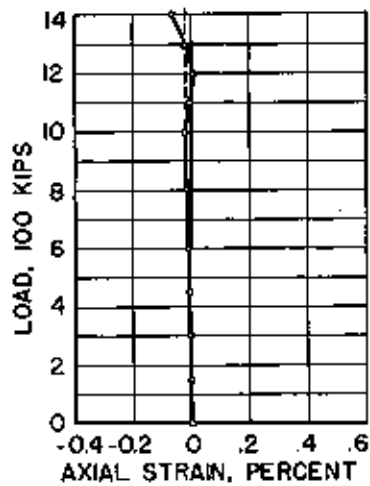
FIGURE 8. Average axial strains in plates B at 9.25 in. from the top of the girder tested at 40° F (8 gages).

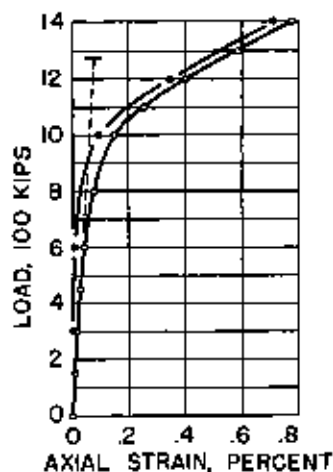
FIGURE 9. Average axial strains in plates B at 15.25 in. from the top of the girder tested at 40° F (8 gages).

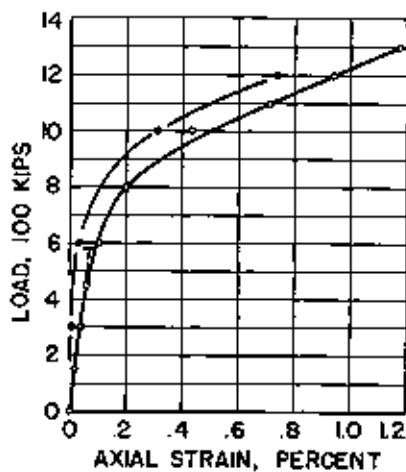
FIGURE 10. Average axial strains in the top of plate A of the girder tested at 40° F (8 gages).

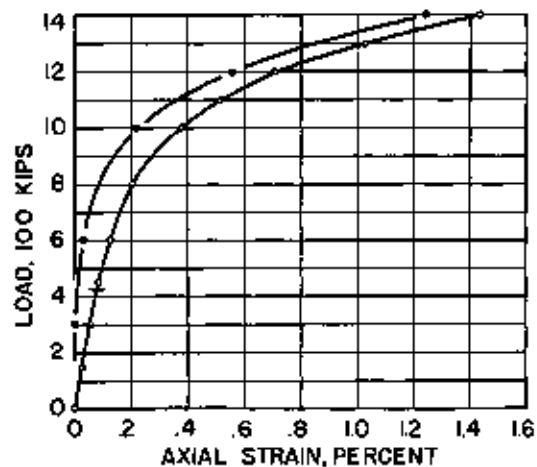
FIGURE 11. Average axial strains in plates B opposite the midheight of plate A of the girder tested at 40° F (4 gages).

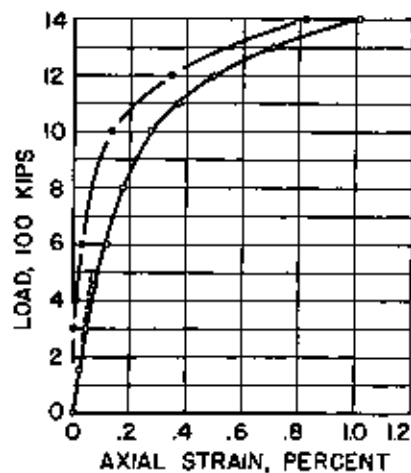
FIGURE 12. Average axial strains in the bottom of plate A, not on a weld, opposite a diaphragm of the girder tested at 40° F (6 gages).

The load-strain curves for gages on the bottom of plate A, figures 12 to 15, are of especial interest. For the gages not on a weld, figures 12 and 13, the strain was much less in the plastic range for the gages that were opposite a diaphragm, figure 12, than for those not opposite a diaphragm, figure 13. These strains in the bottom of plate A not on a weld were, in the plastic range, much larger than for the gages that were on a weld, figures 14 and 15. This same phenomenon may be observed during the tensile test of a steel coupon, which has a transverse weld at midlength. For some grades of steel and of weld metal, the weld metal reduces in section very little, after the yielding of the plates commences, whereas there is a visible reduction in section of the adjacent plate material. The permanent sets for the gages on a weld were negative for loads up to more than 1,200 kips. The difference between the load-strain and the load-set curves, at a given load, is, however, very nearly equal at each of these four locations.

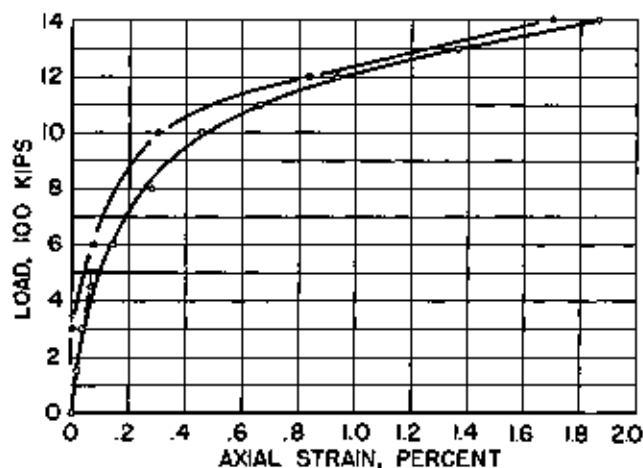
FIGURE 13. Average axial strains in the bottom of plate A, not on a weld, not opposite a diaphragm of the girder tested at 40° F (8 gages).

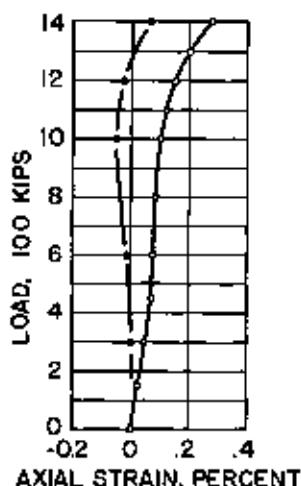
FIGURE 14. Average axial strains in the bottom of plate A, on a weld, opposite a diaphragm of the girder tested at 40° F (3 gages).

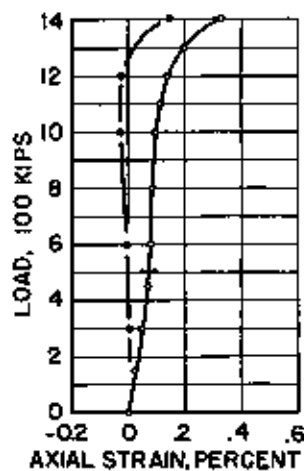
FIGURE 15. Average axial strains in the bottom of plate A,—on a weld, not opposite a diaphragm—of the girder tested at 40° F (6 gages).

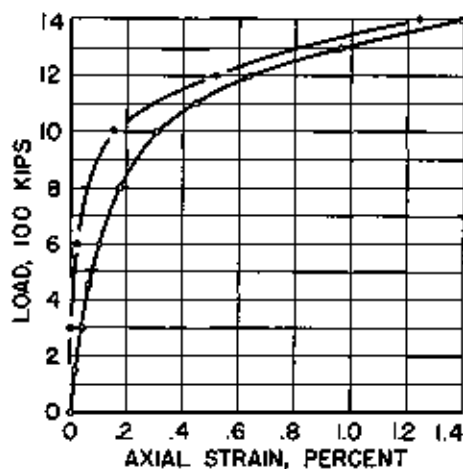
FIGURE 16. Average axial strains in the welds between plates A and B of the girder tested at 40° F (4 gages).

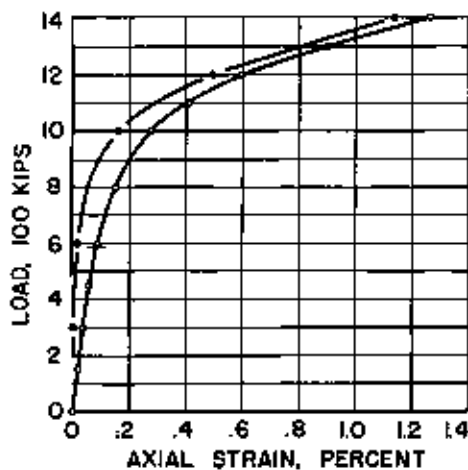
FIGURE 17. Average axial strains in the bottom edge of the plates B of the girder tested at 40° F (4 gages).

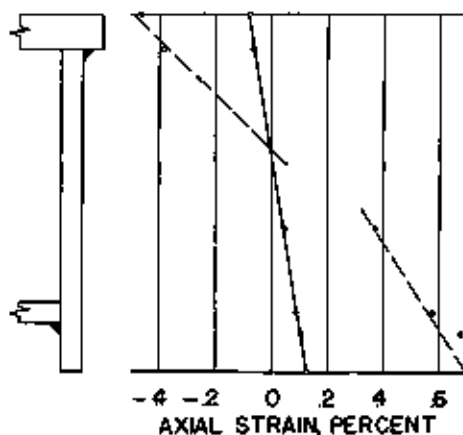
FIGURE 18. Average axial strains versus gage location, on plates B and C for loads of 600 kips (solid line) and of 1,200 kips (dash line).

The load-axial strain data, obtained during these tests, throws some light on the question as to whether sections plane before loading remain plane after a load is applied. To answer this query, the average axial strains on plates B and C for all the girders have been plotted in figure 18, against the location of the gages on the girder. The solid line is for the 600-kip load (average for four girders). This line cuts the zero-strain line at the computed location of the neutral surface, and all the values are close to this one line. The dash lines have been drawn through the average values for the 1,200-kip load (average for three girders, since the girder tested at -40° F did not attain this load), and certainly no one line can be drawn through these values so that the strain values at different distances from the top of the girder are close to it. It seems that for these box girders, with diaphragms at various locations along their length, plane sections did not remain plane under loads in the plastic range.

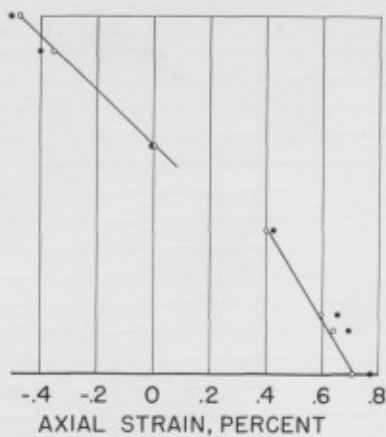
FIGURE 19. Average axial strains versus gage location for a load of 1,200 kips on the girder tested at 40° F.

Open circles are for readings started as soon as the load was reached; solid circles for readings started 2 hr 40 min after the load was reached.

an initially vertical plane section was due to the timing under which the gage readings were taken and that if the load—while in the plastic range—were applied for some time before the reading of the gages was started, the sections would be found still plane. The procedure had been to start taking the strain readings about as soon as the load was reached. To study this effect, during the testing of the girder at 40° F, several sets of readings at a load of 1,200 kips were taken, as has been stated. The average strain values from the readings, started as soon as the load was reached, are plotted in figure 19 against the location on the girder as open circles. As for figure 18, no one line would represent the data well. The strain values from the readings, started 2 hr and 40 min after the 1,200-kip load had been reached, are plotted as solid circles in figure 19. They show the commonly observed phenomenon of continued yielding in both tension and compression with a consequent still greater warping. It may be noted that the gages under consideration were not located in the plane of a diaphragm (see fig. 5).

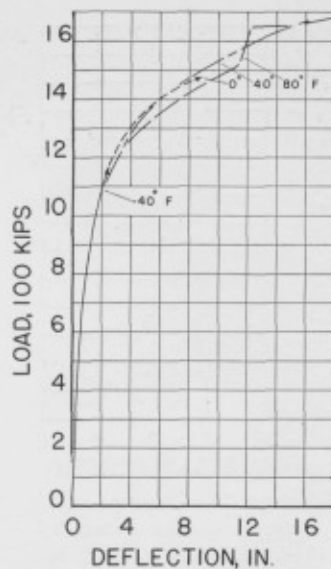
FIGURE 20. Deflection at mid-span for the girders.

The load-deflection curves for the girders are shown in figure 20. The temperature apparently had no significant influence on the deflection. The arrow heads indicate the load and deflection at the failure of the girders, which were tested at -40° and at 0° F. These failures were on the rising portion of the curve. The results indicate that the restraints induced by the welding of the ductile plates were of such magnitude as to result in rather brittle failure for temperatures as high as 0° F. The temperature of 40° F was evidently not low enough to induce failure.

The break in the load-deflection curve, figure 20, for the girder tested at 80° F, at a deflection of 11.56 in. and a load of 1,530 kips was due to the fact that during the test of this girder, the test was stopped at this deflection when the middle of the girder nearly came in contact with the supporting girder. During this first portion of the test, the supports for the girder were as shown in figure 3. Since fracture had not occurred, the box girder was taken out of the machine, the cylindrical supports were raised about 6 in. by the blocks shown in figure 21, and the

girder was again placed in the testing machine. The second portion of the test was made 7 days after the first portion of the test. On reloading, the load-deflection curve between loads of 1,530 and 1,650 kips was not a smooth continuation of the load-deflection curve obtained during the first portion of the test but was much steeper. After the load of 1,650 kips had been attained, the deflection increased with little increase in load until the curve became practically a continuation of that obtained during the first portion of the test. The moving of the girder and the time between the two portions of the test evidently contributed to bringing about some change in the load-deflection relation for this girder, which had already been subjected to plastic yielding.

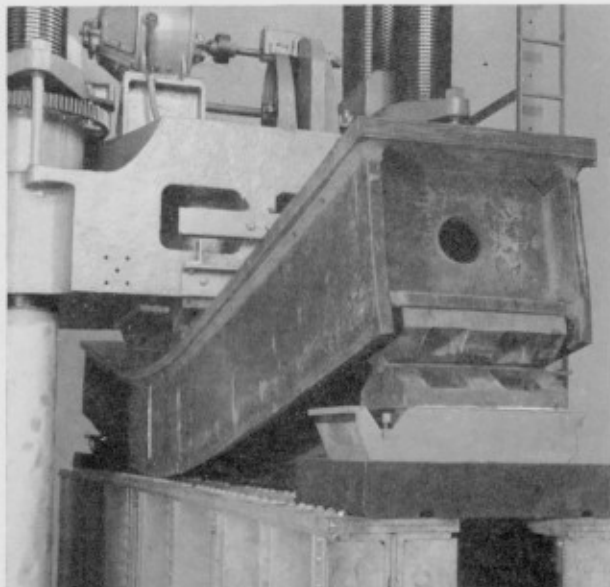
FIGURE 21. Girder tested at 80° F when the deflection was 18.06 in.

Figure 21 shows the girder tested at 80° F with a deflection of more than 18 in.

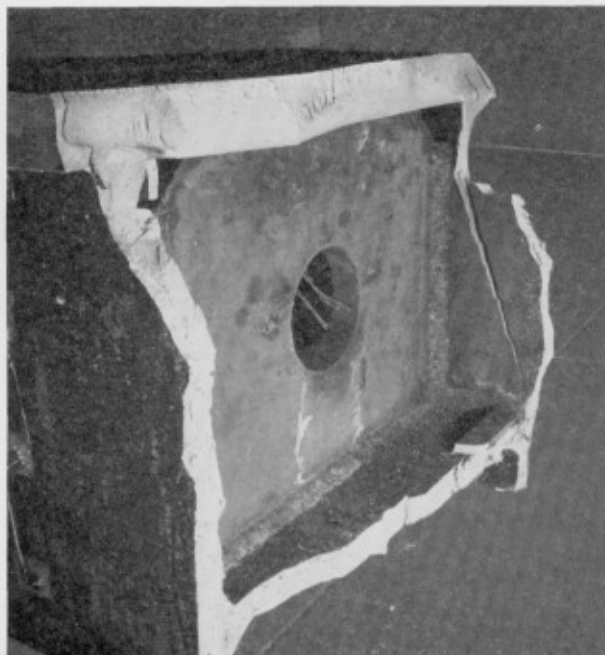
FIGURE 22. Fractured surface of the girder tested at -40° F.

The fractured surface of the girder tested at -40° F is shown in figure 22. The fracture was partly in the weld between the plates A1 and A2 and partly in plate A2. The fracture at midspan of the girder tested at 0° F is shown in figure 23. This fracture took place in plate A2 and not in any portion of a transverse weld.

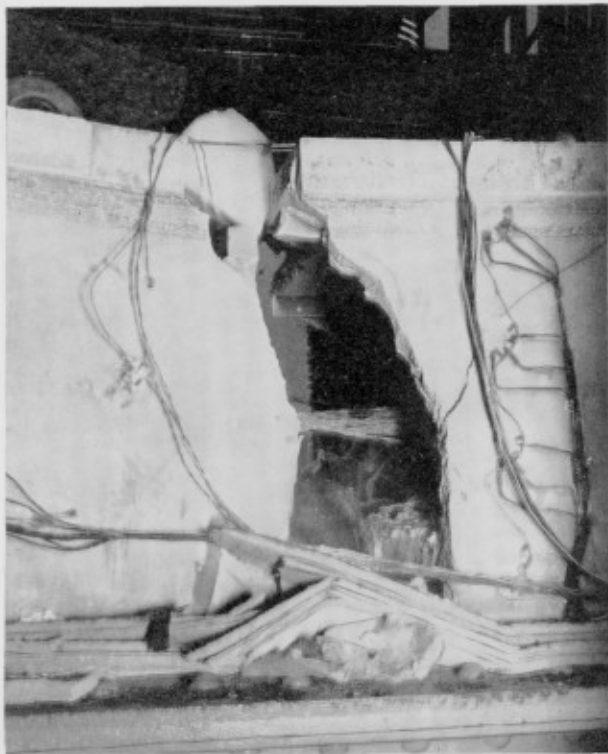
FIGURE 23. Fracture at midspan of the girder tested at 0° F.

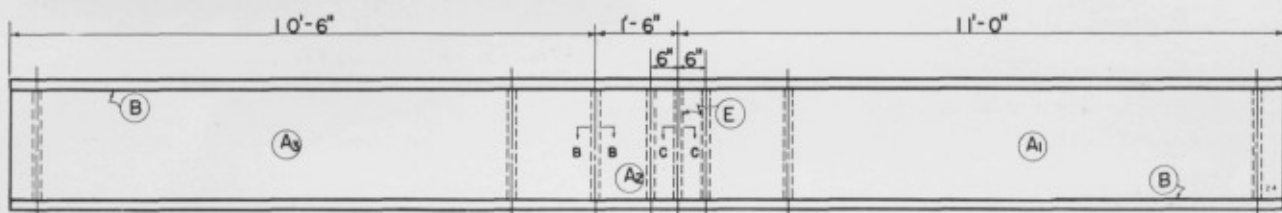
FIGURE 24. Bottom view of the girder of semiskilled steel.

Other details are shown in figure 1.

The two diaphragms D were omitted; the bottom A plate was made of three plates with two transverse welds. Figure 24 shows the details of the bottom view of this girder of semikilled steel. It failed with a square type of fracture after being tested in a manner similar to that for the other four girders.

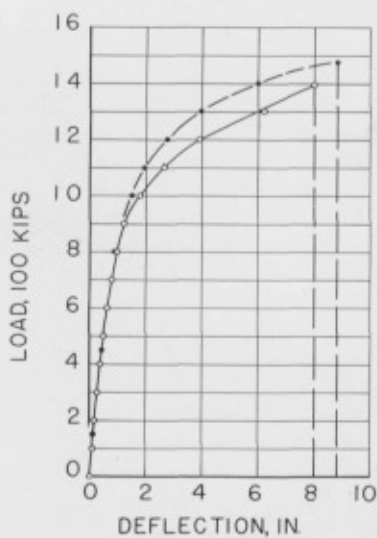
FIGURE 25. Load—deflection curves for two box girders.

Solid line, open circles, a girder of semiskilled steel tested at 80° F. Dash line, solid circles, a girder of fully killed steel tested at 0° F.

The load-deflection curve for the girder of semikilled steel is shown in figure 25 by open circles and solid line. The load-deflection curve for the girder of fully killed steel, which was tested at 0° F, is also shown in this figure, by solid circles and dash line. The results of the tests of these two girders are compared in table 3.
