Thermal Evaluation of Scorched Graphite-Epoxy Panels by Infrared Scanning

A. J. Slifka and T. Hall

National Institute of Standards
and Technology,
325 Broadway,
Boulder, CO 80305

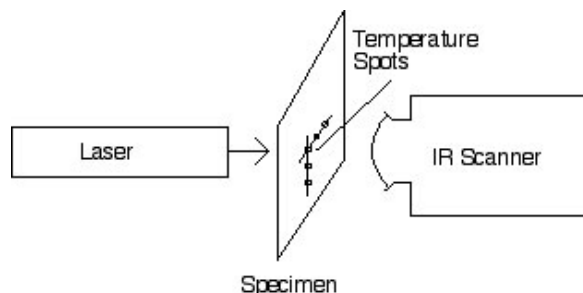
Fig. 1. Schematic drawing of the experimental setup showing the temperature spots, arranged orthogonally, which are viewed by the scanner.

The thick panels had been exposed to a jet-fuel burner for decreasing lengths of time, whereas the thin specimens were baked for decreasing times using quartz-filament heaters, ending with one undamaged specimen in each set. Our measurement consisted of heating the backside of each specimen with a carbon dioxide laser and observing the temperature response at the front side. We used an 8.5 W pulse of 3 s duration for the thin specimens and a 5 s, 12 W pulse for the thick specimens. This amount of heat over this short amount of time will not cause appreciable damage to the specimens. We recorded the temperature response of the center of the spot opposite the point where the laser illuminated the specimen, and in many cases, collected temperature data at points 13 mm and 26 mm from the center of illumination. Figure 1 shows a schematic drawing of the simple experimental setup used to make these measurements.

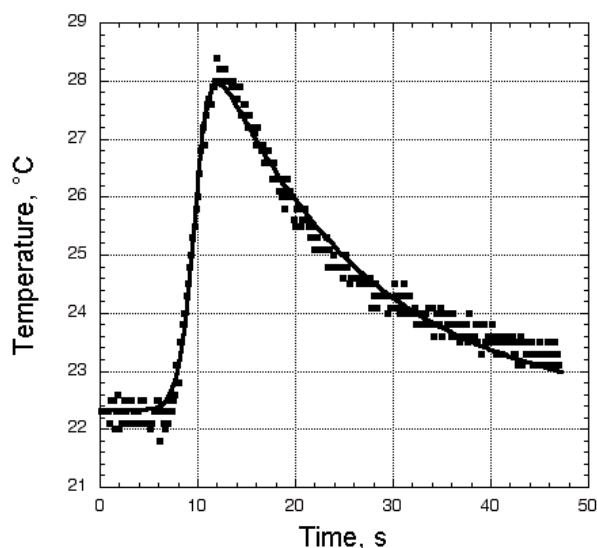
Figure 2. Raw temperature data from the IR scanner and the best curve-fit of the data for a thin, quasi-isotropic specimen.

The IR system records temperature data at a rate of six measurements per second. Each temperature transient represents between 250 and 280 data points. No data averaging was used because the method should be fast and easy to use. A few panels were measured eight separate times, which resulted in better than 1% repeatability for the measurements.

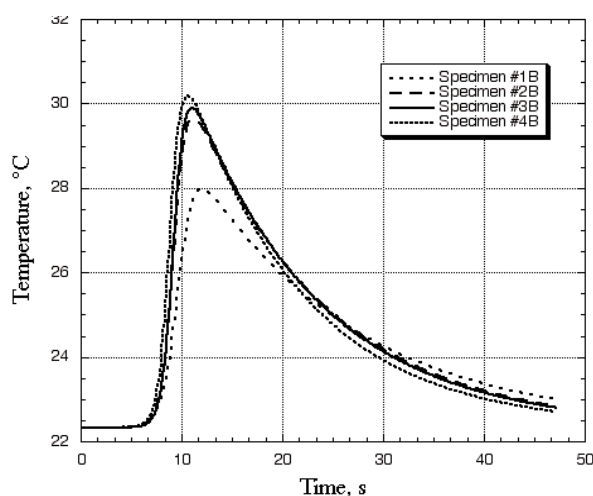
Fig. 3. Fitted curves showing temperature profiles for the set of thin, quasi-isotropic specimens.

Figure 3 showed that as the specimen number within the set of thin, quasi-isotropic specimens increases, there is probably a decreasing amount of scorching damage to the specimens. Specimen #1B had obvious damage to the naked eye, whereas the other three

specimens visually appeared to have decreasing amounts of damage when compared to one another. However, if specimens #2B-4B were in place on an aircraft, scorching damage might not be discernable by visual inspection. For further analysis, we normalized the peak temperature differences using specimen #4B, which had no damage and had the largest peak temperature difference. Specimen #1B, which showed obvious heat damage, had a 28 % drop in peak temperature difference. Specimen #2B had a 7 % drop. The 4 % drop observed for specimen #3B may not be significant since the relative standard uncertainty of the temperature measurement is 4 %, based on the standard uncertainty of the fits for the four runs. The numeric data for spots 13 mm and 26 mm away from the laser-heated spot showed a similar trend with less signal due to the distance between the laser and recording spots. Since this set of specimens was quasi-isotropic, it is not surprising that the data recorded away from the laser-heated spot yielded no new information.

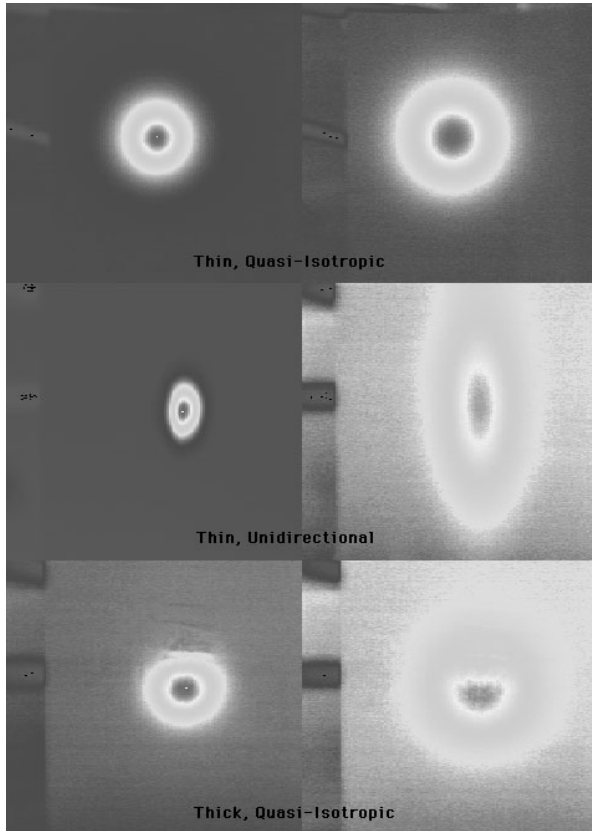
Fig. 4. Infrared images of representative panels from each of the three sets of specimens.

Figure 4 shows infrared images with a representative panel from each of the three specimen sets. The images on the left were made with the specimen at peak temperature and the images on the right were taken well after the peak, when much of the heat had conducted and radiated away. These infrared images show that the fiber layup of the second set of thin specimens is non-isotropic. The fibers are unidirectional according to the manufacturer. Figure 5 shows the temperature profile curves for the set of thin, unidirectionally laminated specimens. These temperature profiles were recorded from the spot corresponding to the laser heating spot. The specimen that shows the most damage to the naked eye (#1A) has a fitted temperature profile curve that indicates a large amount of damage, as the peak time is significantly delayed and the peak temperature difference is over 63 % less than for the undamaged specimen in the set. Specimen #2A in the set of thin, unidirectionally laminated specimens shows a 6.5 % drop, which is statistically significant, given the 4 % relative standard uncertainty in the peak temperature-difference measurement. Specimens #3A and #4A in this set are indistinguishably close in peak temperature difference.

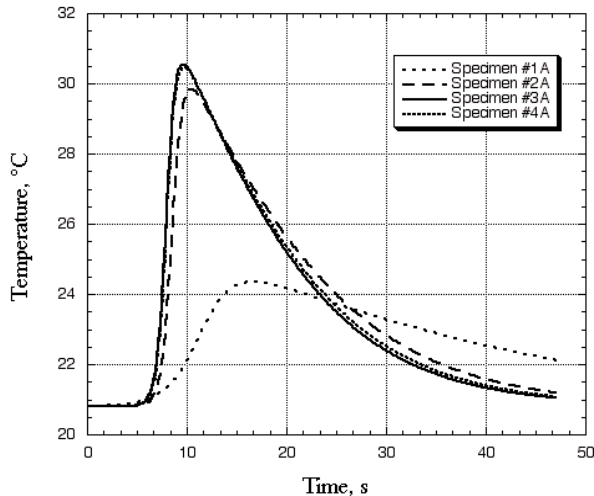
Fig. 5. Fitted curves showing temperature profiles for the set of thin specimens with a unidirectional lamination.

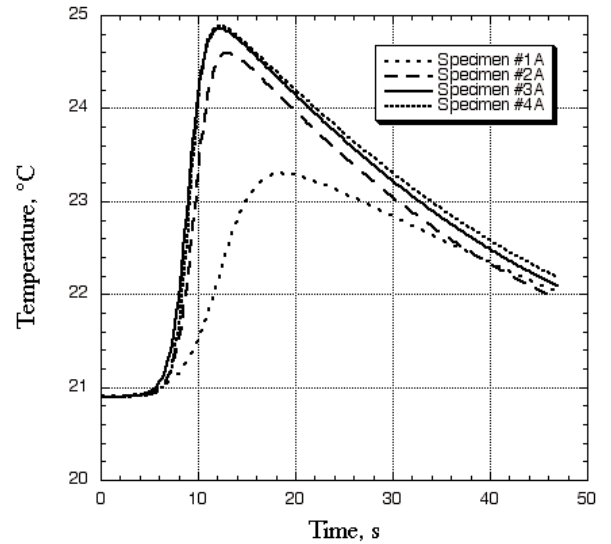
Fig. 6. Fitted curves showing temperature profiles 13 mm away from the laser heating spot on a path in the direction of the fibers for the set of thin, unidirectionally laminated specimens.

Figure 6 shows temperature profile curves for the thin, unidirectionally laminated specimens for a spot 13 mm away from the laser heating spot, along the direction of the fibers, which is in the direction of high thermal conductivity. Specimen #1A is obviously damaged to the naked eye, and shows a peak temperature drop of 40 %. Specimen #2A shows a 7.4 % drop, and specimens #3A and #4A are statistically indistin-

gishable. These data are similar to data recorded at the spot corresponding to the laser heating spot because the fibers run in a direction from one recording spot to the

other, and this is the preferred heat path. The functional form of the best-fit function is even the same for both temperature recording spots.

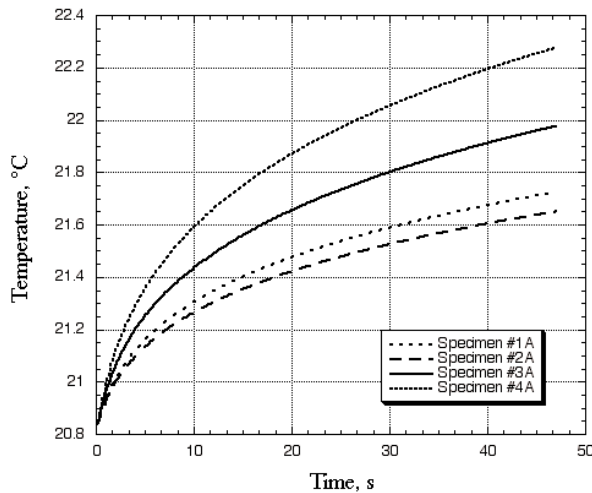
Fig. 7. Fitted curves showing temperature profiles for a thin, unidirectionally laminated set of specimens 13 mm away from the laser heating spot on a line perpendicular to the fibers.

A plot of the fitted temperature profiles for a spot 13 mm away from the laser heating spot in a direction perpendicular to the fibers is shown in Fig. 7. For this type of curve shape, a higher thermal conductivity specimen would show a more rapid temperature rise, indicating less damage from the thermal exposure. The thermal conductivity in this direction is so much lower than for the fiber direction, there are no peaks even after 30 s, as the heat is preferentially transferred away in a different path. Two things should be noted from the figure, however. The thermal performance in this direction is significantly better for specimen #4A than for specimen #3A, which indicates that there is probably some damage to the epoxy matrix but not to the fibers in specimen #3A. A possible anomaly is seen in the data for specimen #2A, which shows a significantly lower temperature curve than specimen #1A. Even though specimen #2A has had less thermal exposure than specimen #1A, there is probably a large thermal defect, such as a transverse crack in the matrix between the laser spot and the detector spot, that gives this result. Figure 7 shows that different but meaningful results can occur at detector spots away from the laser heating spot.

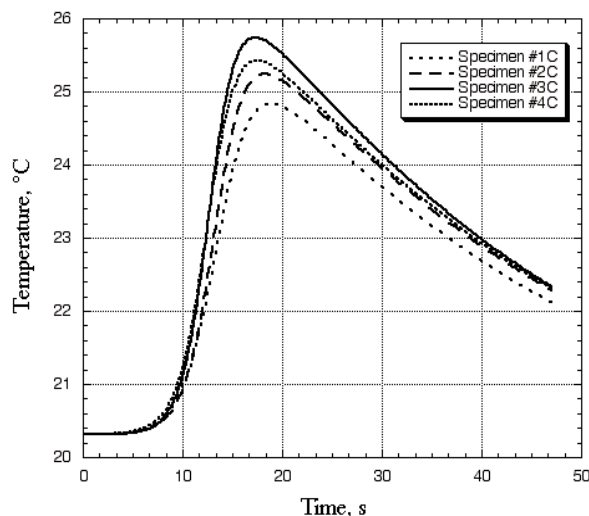
Fig. 8. Fitted curves showing temperature profiles for the set of thick, quasi-isotropic specimens.

that no additional damage would be caused by the measurement. A higher-power laser used for a shorter duration would probably produce better results for the thick specimens. Figure 8 shows the resulting temperature profile data. Specimen #1C showed a nearly 12 % drop, compared to specimen #4C, which was the undamaged sample of the set. Specimen #2C showed a 3.7 % drop, which was on the edge of being statistically significant. Specimen #3C showed a 6 % rise in temperature peak difference, which was not expected. We made three additional measurements on this set of

specimens, and the fitted temperature profiles agreed to within 0.5 %. It may have been that specimen #3C had a fairly short thermal exposure, so that high temperature did not result, or at least not for very long, so the effect was to cure the epoxy or increase the epoxy-fiber or fiber-fiber contact, raising the thermal conductivity slightly. Curing of epoxies to generate full cross-linking is a well-documented phenomenon [7]. In addition, subjecting the material to a thermal environment where the thermal performance of the composite increases would also increase the mechanical performance of the composite.
