TECHNOLOGIC PAPERS
OF THE
BUREAU OF STANDARDS

No. 97

SOME UNUSUAL FEATURES IN THE
MICROSTRUCTURE OF WROUGHT IRON

HENRY S. RAWDON, Associate Physicist
Bureau of Standards

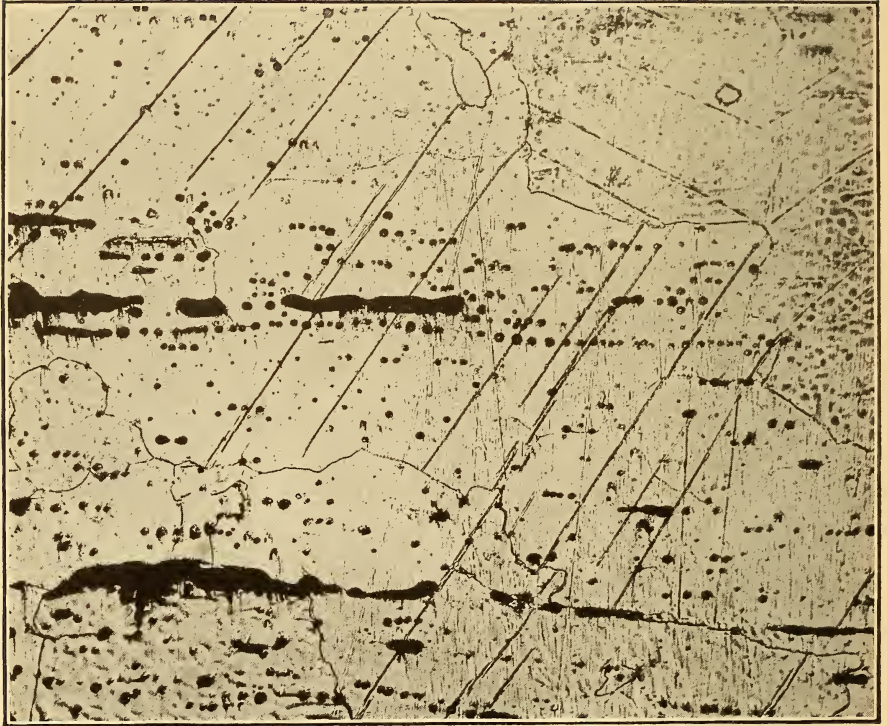
FIG. 1.—*Unusual features in the microstructure of wrought iron*

The dark lines, parallel within any single grain, are the Neumann lines. The mottled appearance of the corner grains indicates the nonhomogeneity of the ferrite due to the unequal distribution of the phosphorus. Specimen: W 1, longitudinal section. Magnification, 100; etching, 10 per cent alcoholic nitric acid.

The etch pattern referred to above is illustrated in Figs. 1, 2*b*, 3, and 4. By using the copper-chloride etching reagent referred to later (p. 14) these patterns may be developed in a very striking

The straight lines, resembling polishing scratches, shown by some of the crystals near the fracture (Fig. 1), are the well-known Neumann lines. Such markings are usually considered to be "mechanical" twin crystals, i. e., the twinned position of the metal within each of the narrow zones has been brought about by mechanical causes alone, particularly by shock¹⁵ (Fig. 10). They, in all probability, are the result of shock which finally caused the fracture of the bar. A comparison of these lines with the long narrow bands which often constitute the mottled etch pattern shows immediately that such etch bands can not be attributed to twinning or a similar cause.

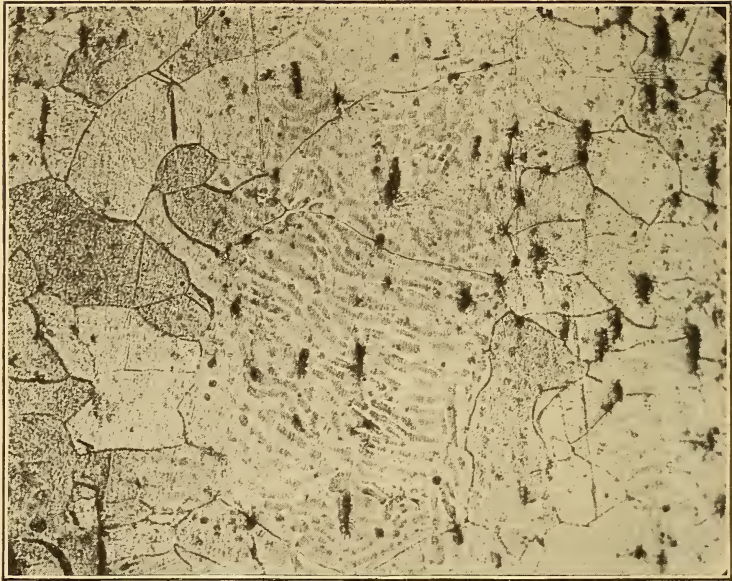
FIG. 4.—Unusual microstructural features of wrought iron

(*a*) Specimen W 1, longitudinal section. The streaks exhibiting the unusual etch-pattern are very often composed of grains which are much larger than the average for the piece. Magnification, 100; etching, 10 per cent nitric acid.

(*b*) Specimen W 22, longitudinal section. Low-carbon steel sometimes exhibits a structure similar to the unusual features in wrought iron. Magnification, 500; etching, Stead's reagent.

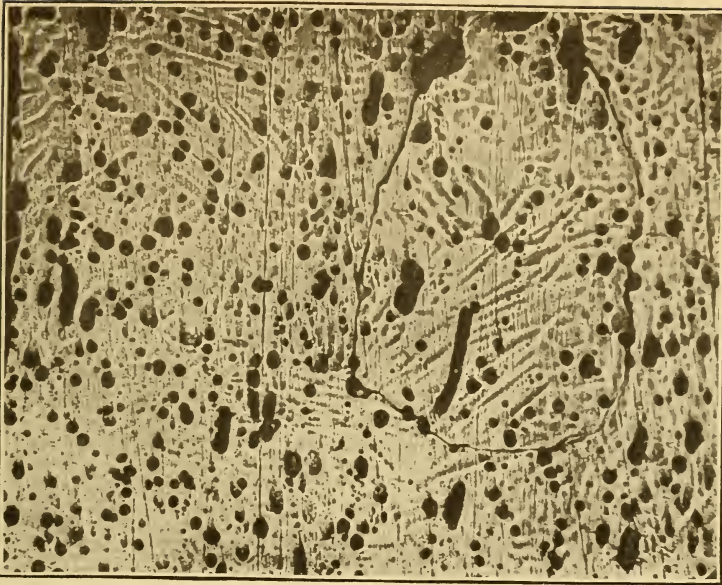
FIG. 9.—Effect of annealing upon unusual features in wrought iron

(a) W 1, heated for three hours at 600° C.

(b) W 1, heated for one and one-half hours at 725° C.

Magnification, 100; etching, 10 per cent nitric acid.

The persistence of the unusual intracrystalline structural features upon heating is remarkable. Fig. 9a shows the appearance of a specimen of the wrought-iron eyebar previously described after heating it for three hours at approximately 600° C (585°–625°) and then allowing it to cool in the furnace. No appreciable changes have resulted from this treatment. A second sample (Fig. 9b) heated for about one and one-half hours at approximately 725° C (718°–735°) and furnace cooled still shows faint traces remaining of the former condition.
