NBS BUILDING SCIENCE SERIES 102

The Thermal Performance of a Two-Bedroom Mobile Home

DEPARTMENT OF COMMERCE • NATIONAL BUREAU OF STANDARDS

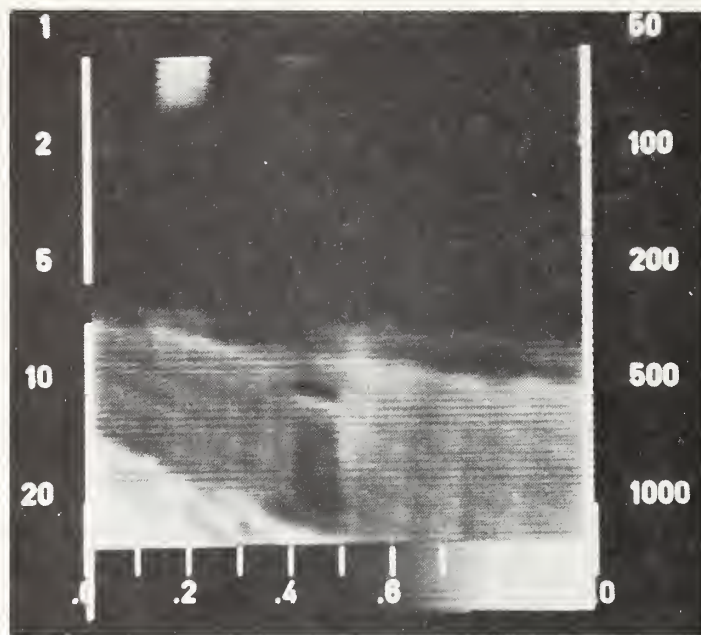
FIGURE 23. *Angular thermograph of exterior sidewall of mobile home.* Dark area (colder) is the aluminum wall surface. Lighter area (warmer) below is the skirting at base of mobile home, and white area in lower left is ground surface. Dark area found in skirting is an air vent (refer to figure 14).

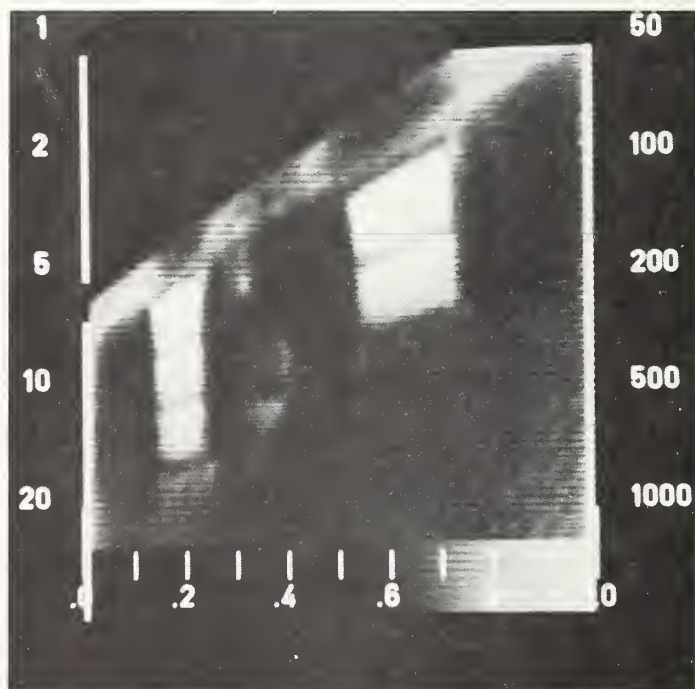
FIGURE 24. *Warmer horizontal aluminum trim at wall/roof juncture.*

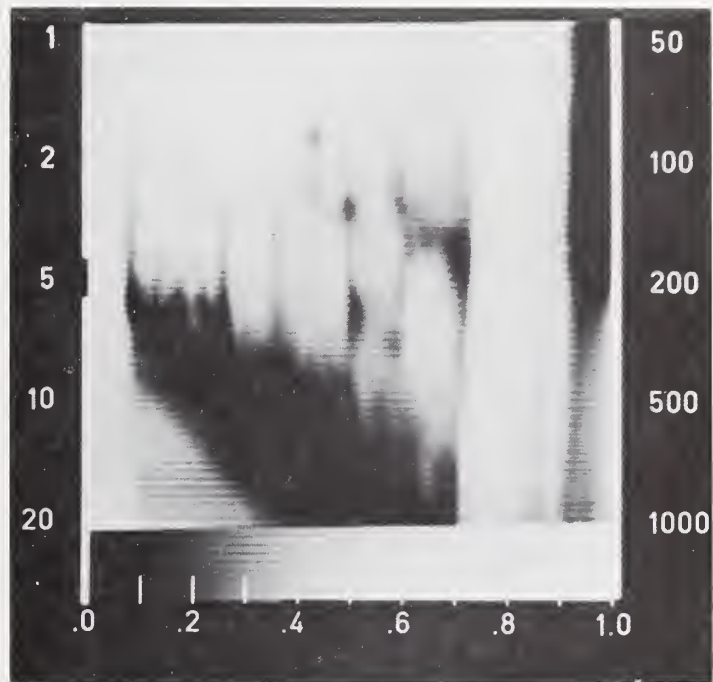
Most observations were made of the inside surfaces including several general observations. The location of wood studs was observable because the inside surface was slightly colder over the studded areas. Wall surfaces were observed to be colder toward the bottom as compared to the top of the wall (fig. 25). The warm heating ducts created an obvious pattern on the floor. Figure 26 shows an obviously warm floor

FIGURE 25. *Wall along hallway looking from kitchen area.* Walls are colder at the base of the wall. Cold streaks occur randomly along wall.

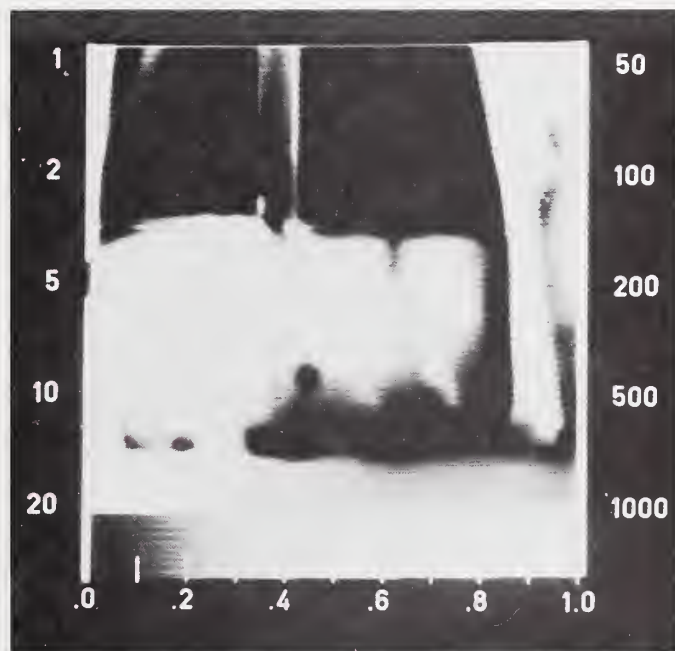
register with a resulting warm wall area caused by the heater air warming the wall surface. The general thermographic observations also revealed some air infiltration locations. Figure 27 shows a cold (dark) area under a window where outside air is leaking in around the window framing. The wall/floor corner shown in figure 28 is obviously very cold. Closer observations at this location revealed an air leak at the wall/floor junction resulting in an interior surface temperature of 29 °F in the corner (inside 72 °F, outside 0 °F).

FIGURE 26. *Wall at base of double living room window.* Warm air registers at lower left is warming the wall surface under left window.

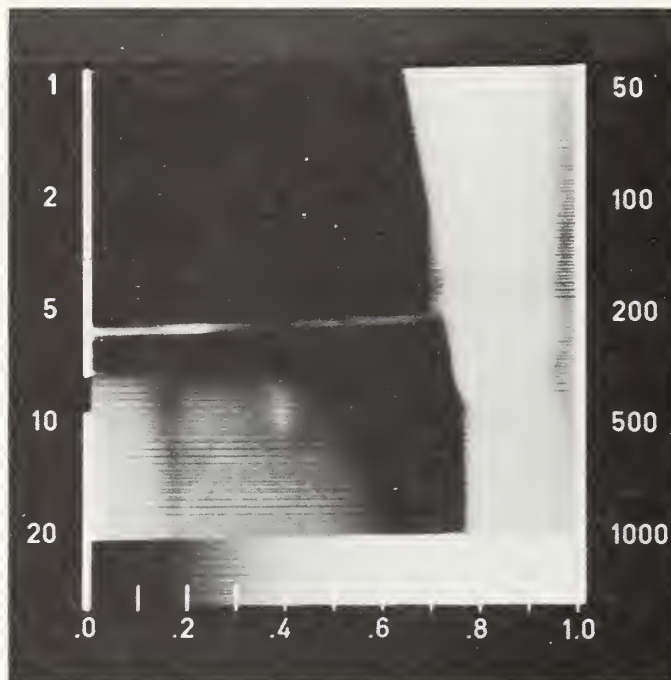
FIGURE 27. *Window with warm curtain (light area) on right side.* Dark (cold) area on wall under window is due to perceptible cold air leaking into mobile home.

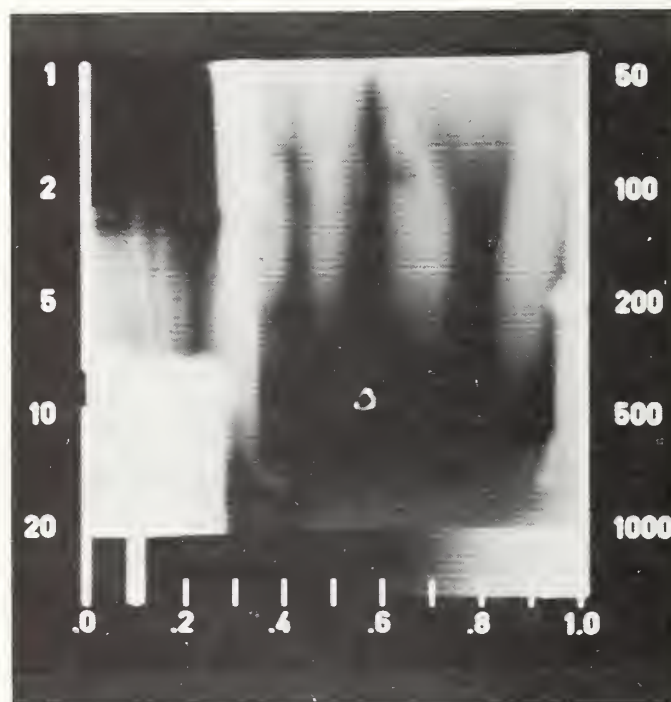
FIGURE 28. *Living room wall/wall/floor corner.* Perceptible air leak in corner created very cold spot, out of camera range. Light area in lower left is couch.

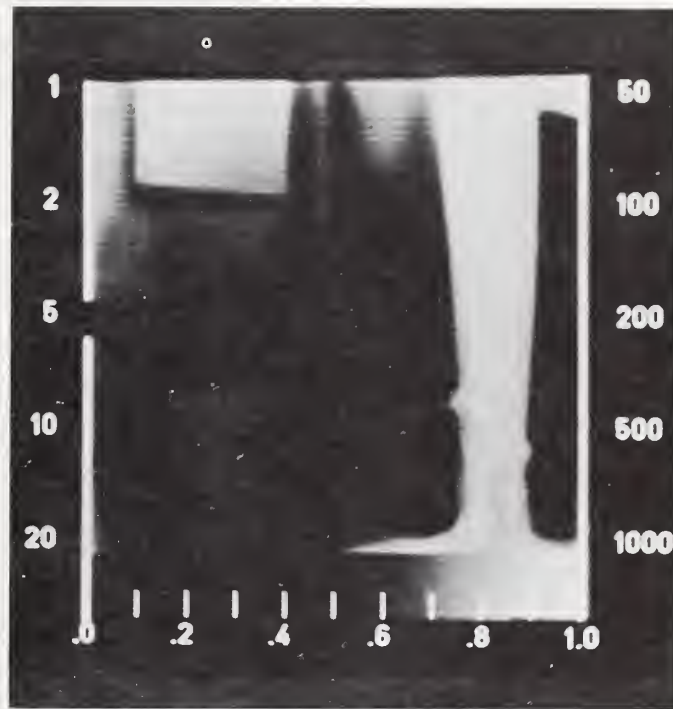
From these observations, it was hypothesized that cold air must be in contact with the interior wood paneling. This early hypothesis was later supported when it was observed that the cold patterns on the wall correspond directly with locations where the insulation was not in contact with the wood paneling, leaving an air channel between the insulation and the paneling.

FIGURE 29. *Wall area to left of living-room side-wall window.*
Picture on wall at upper left, draperies along window on
right side of picture. Dark areas are cold. Note wall studs
showing through in upper center. Location as shown on
figure 30.

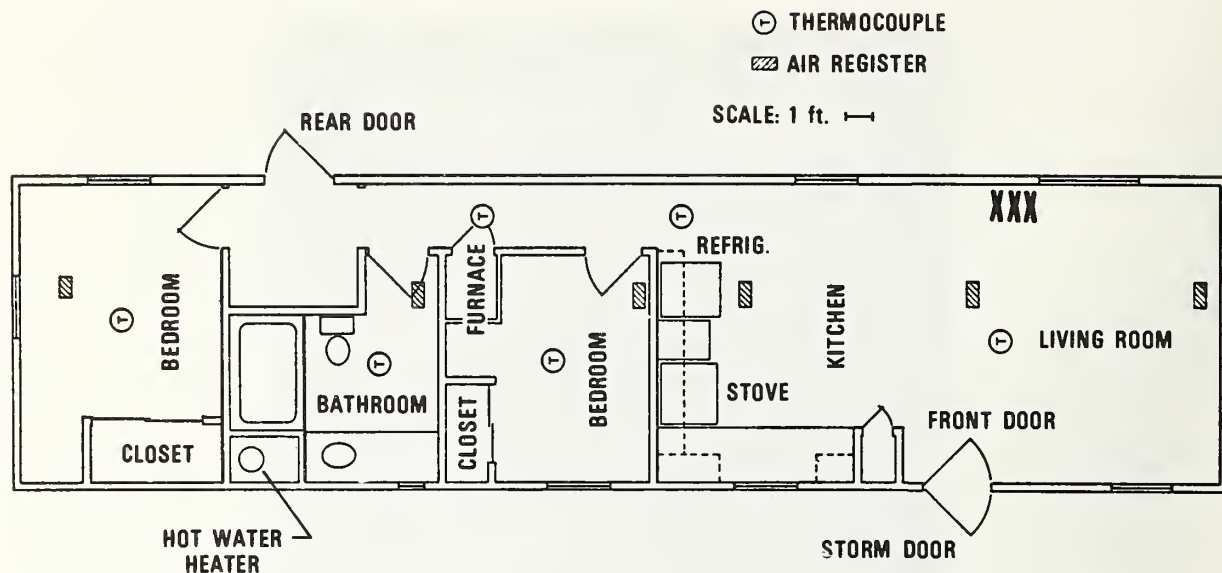
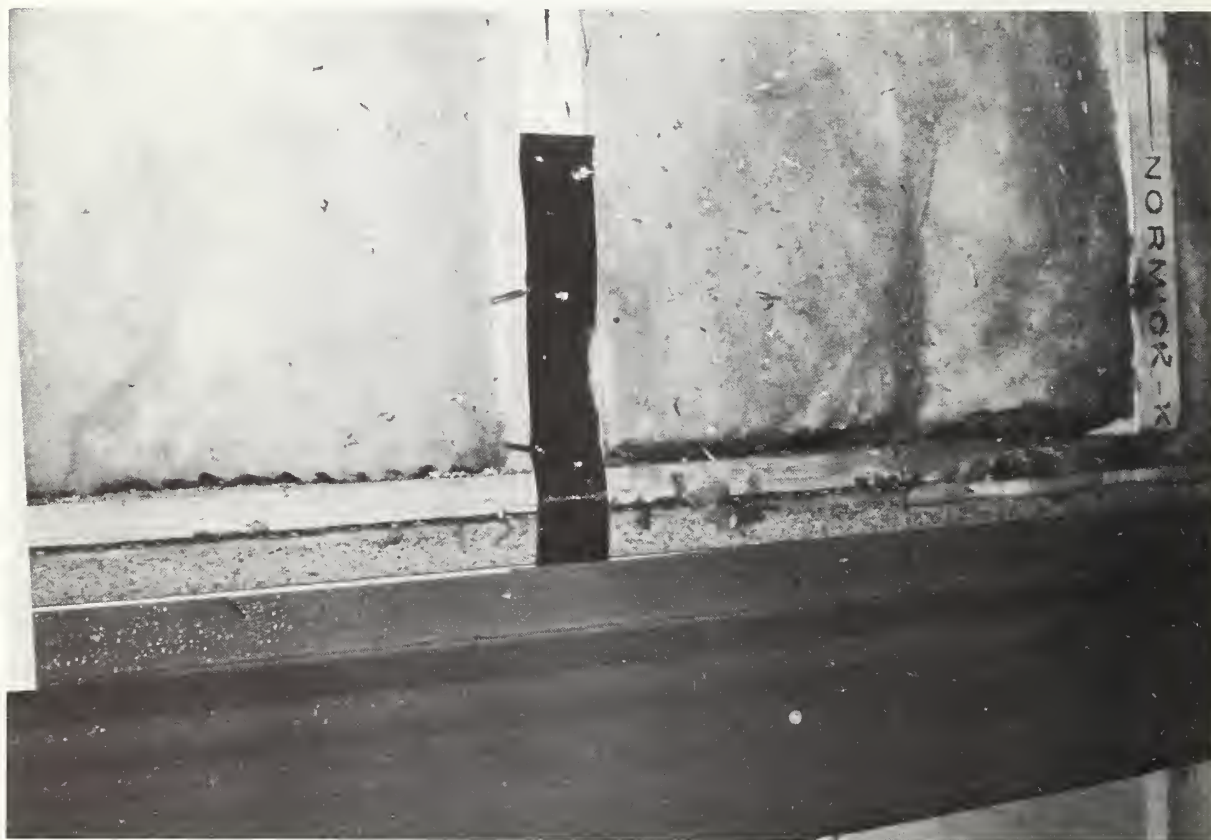
Since gaps were observed at the top and bottom of the
insulation (fig. 31), it was considered possible that
cold air could enter the cavity, pass under the
insulation, rise between the insulation and interior
paneling and then pass to the outside over the
insulation at the top. The exterior aluminum paneling
allows more or less free passage of outdoor air into and
out of the wall cavity outside of the insulation.

FIGURE 31. Gap between still plate and bottom of insulation which could allow outside air in contact with back of inside paneling.

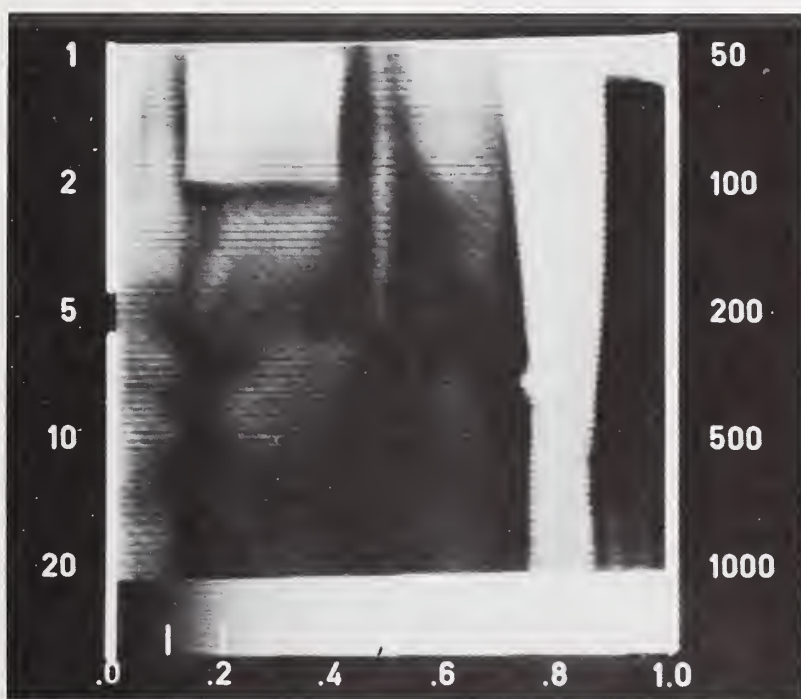
FIGURE 33.   Thermograph of wall test area after sealing outside of insulation
cavity with polyethylene film.

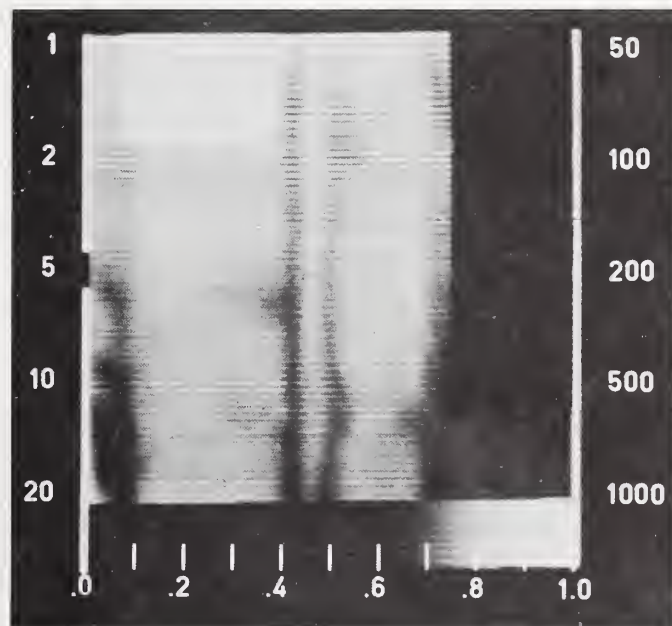
An alternative way to stop air movement within wall cavities and subsequent siphoning of heat to the outside would logically be to fill the cavity with insulation to remove locations where air could move. This theory was tested by removing the original insulation (R-7) and replacing with an R-11 full thick batt. This technique was evaluated with insulation installed by friction fit (fig. 35) and with the insulation stapled neatly to the faced of the wood studs (fig. 36).

In both cases, thermographic and thermocouple observations revealed that the cold streaks were substantially eliminated with full batts. Without neat, mechanically-attached placement, some streaks did occur along the studs where the insulation was wrinkled due to stuffing the stapling flanges of the vapor barrier into the stud space, allowing air passage (see fig. 37). With neat attachment, cold streaking was eliminated and surface temperatures were very even, as shown in figure 38. As changes were made in the insulating system, inside-surface temperatures were recorded with the thermocouples located at A and B as shown in figure 39. These temperatures are shown in table 4.

FIGURE 36. *Same as figure 35 but with R-11 batt stapled neatly in place.*

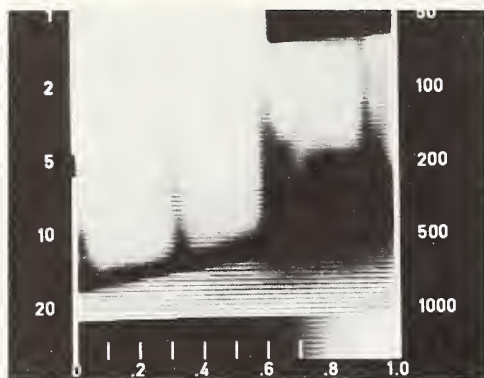
FIGURE 37. *Interior thermograph after installing R-11 batt with friction fit.* Note studs and cold streak caused by wrinkle in friction fit batt in narrow cavity.

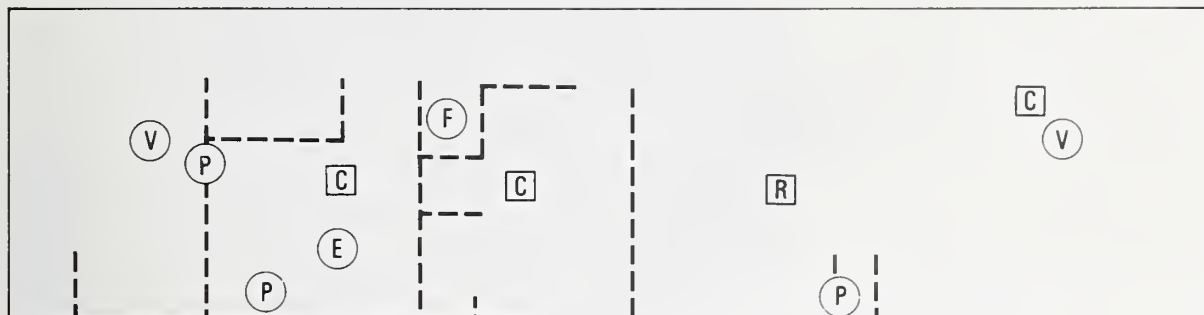
FIGURE 49. Plan view of roof.

b. Results from visual observations: Observations of interior structural condensation were made by cutting holes through the metal roof to observe attic condensation. Refer to figure 49 for location of roof cuts. These test cuts were made at the end of the second week of condensation testing while the chamber was still at 0 °F and the interior temperature and relative humidity were still maintained at 72 °F and 42 percent RH.

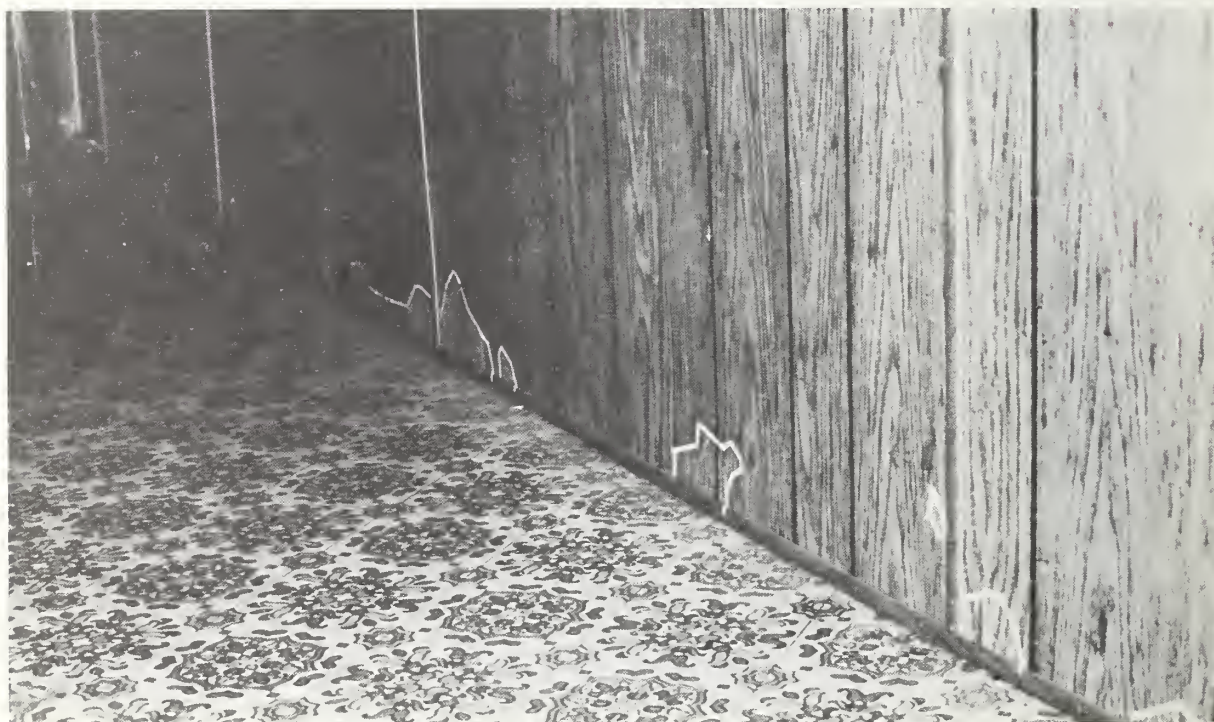
FIGURE 54. Pattern of surface condensation at base of wall.

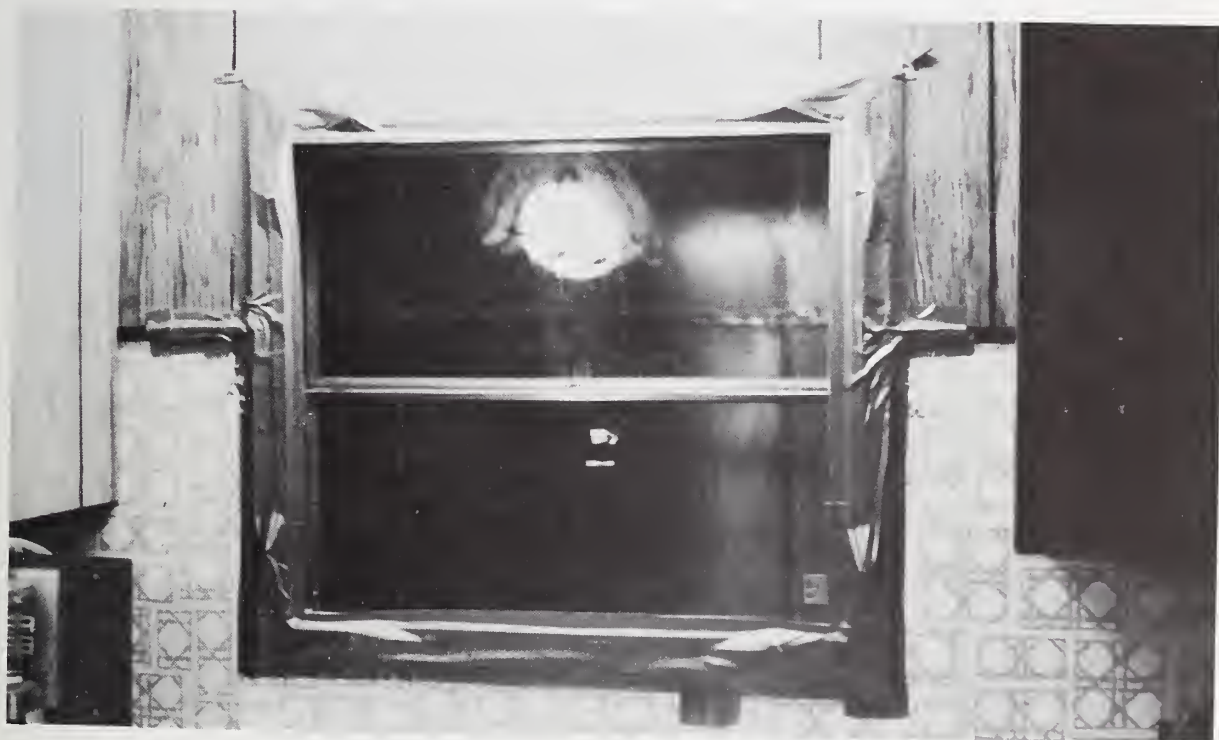
FIGURE 55. *Typical window condensation.*
