NBSIR 73-188

Structural Tests on Housing Components of Glass Fiber Reinforced Polyester Laminate

April 1973

Final Report

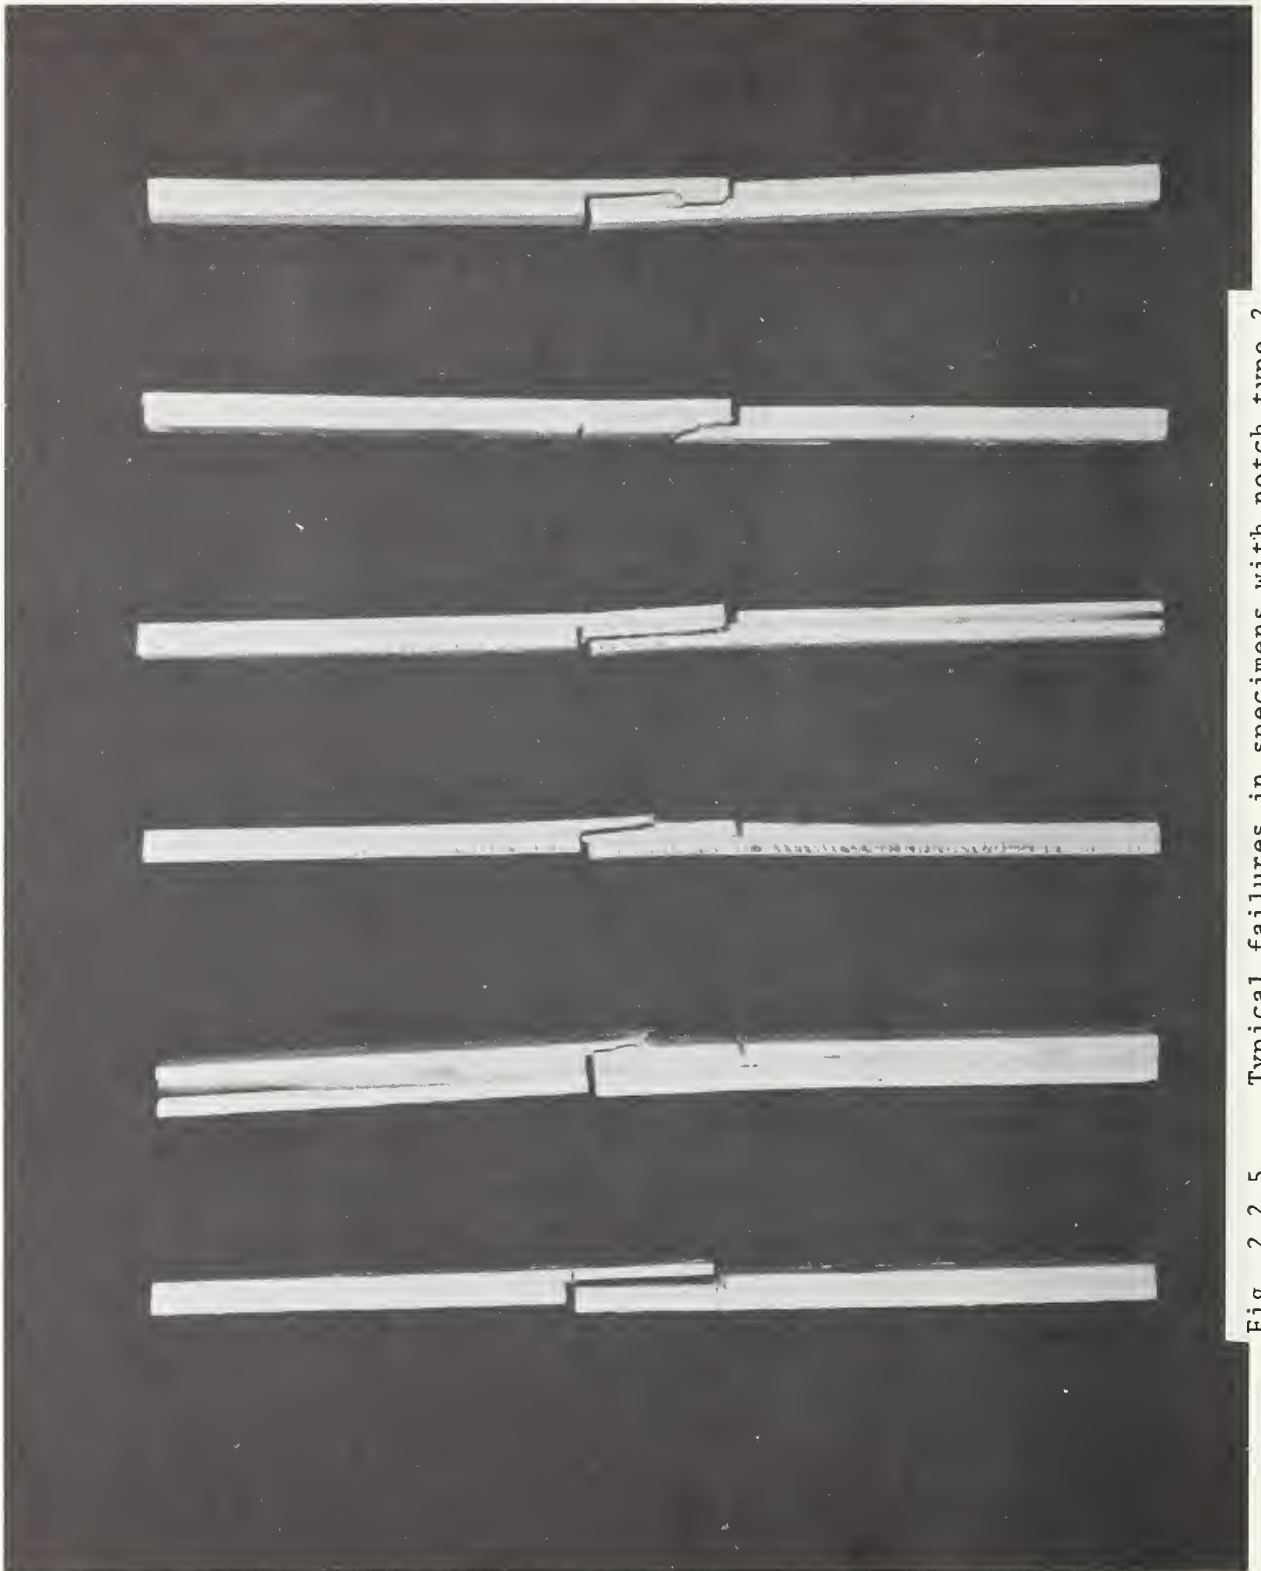
2.2.4.1 Bond Strength Versus Temperature. Approximately seventy specimens were tested in tensile shear at temperatures of 105, 120, 150, and 180°F. The failure for all specimens was in the polyester adhesive bond to the node of the corrugated core FRP laminate. The results of these tests are presented in table 2.2.3.

Fig. 2.2.5   Typical failures in specimens with notch type 2.

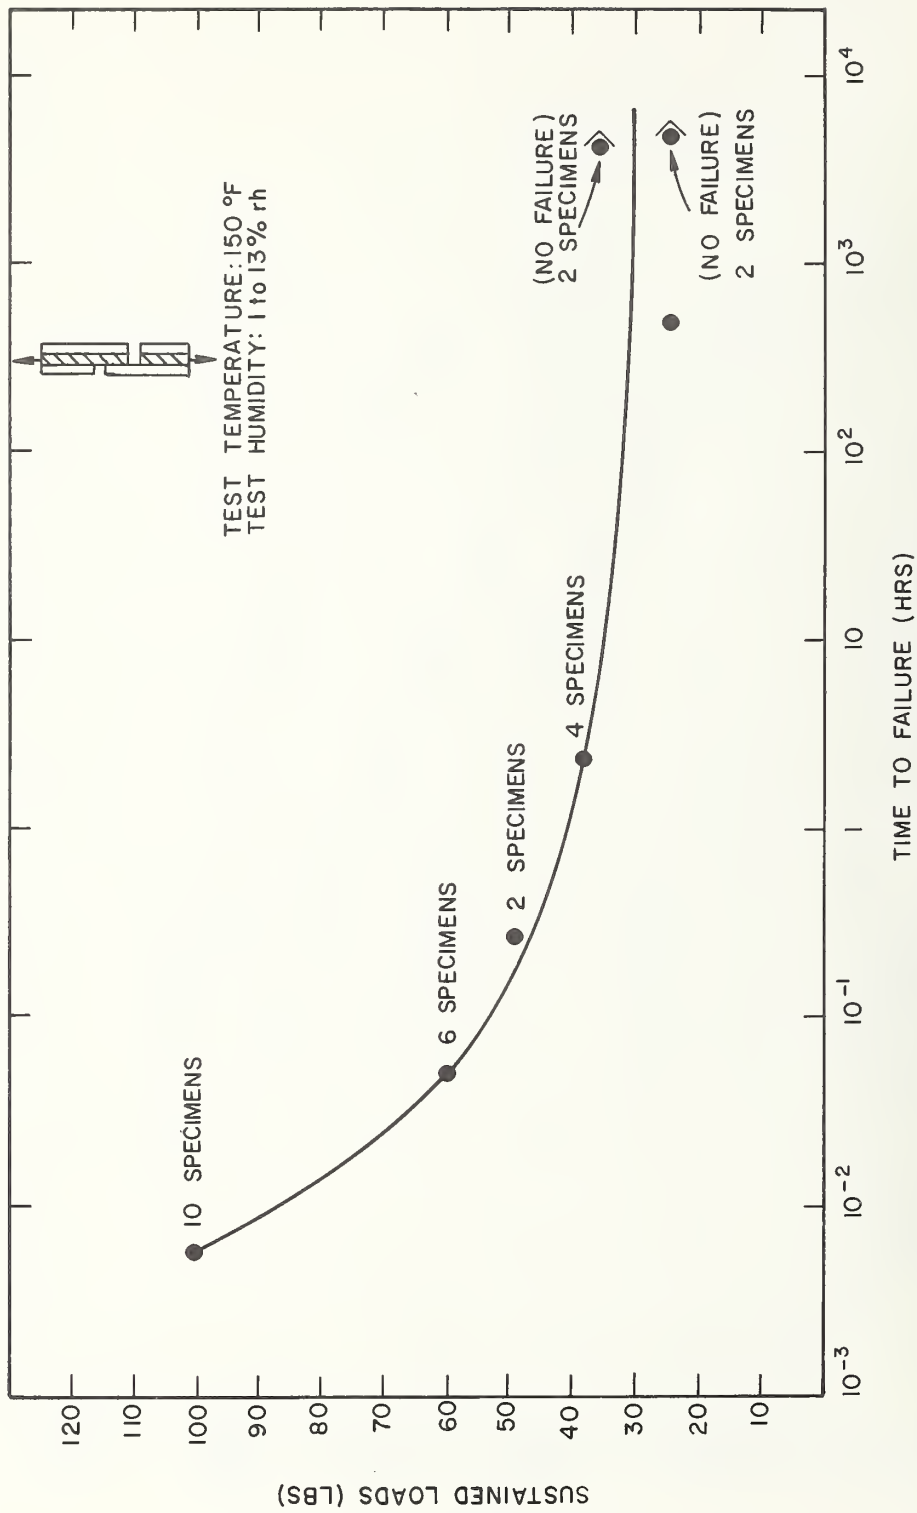
2.2.4.5 Bond Strength Under Sustained Loading.
Thirty-two Group B (1.0-2.0 mm adhesive thickness)
specimens were tested at 150°F with sustained loads
in tensile shear to determine the endurance limit.
Sustained loads of 100, 60, 50 and 40 lbs were
applied with the testing machine. Other sustained
loads of 40, 35, and 25 lbs were applied by
suspending the lead shot weights from the specimens.
All failures observed were in the polyester adhesive
bond to the core FRP laminate. The data obtained are
presented in table 2.2.7. Figure 2.2.9 is a graph
of the sustained load versus time to failure. Three
specimens were tested in the sustained load apparatus
at 35 lb and three at 25 lb. One specimen loaded
at 35 lb failed at 296 hours and one specimen loaded
at 25 lb failed at 728 hours. The other two specimens
ʌt each of these loads exhibited no failure at 3000
and 3500 hours, respectively. Extrapolation of the
curve of figure ?.2.9 to 10,000 hours yields an

In conclusion, these results indicate that the sustained
shear stress in the polyester adhesive bond of the roof
panels identical to those tested should not exceed 5 psi.
Because of the variability in the bond area the shear
stress in the bond of a typical roof panel can only be
approximated, and so, when computing design stresses this
variability should be considered. The long-term effect
of high humidities on the strength of these polyester
adhesive bonds is probably very significant, but was not
fully investigated. Additional testing is being performed
on this effect, but some development work is needed towards
improving the long-term reliability of the bond between
the FRP facing and core.

Fig. 2.2.9 Effect of sustained-load magnitude on time-to-failure.

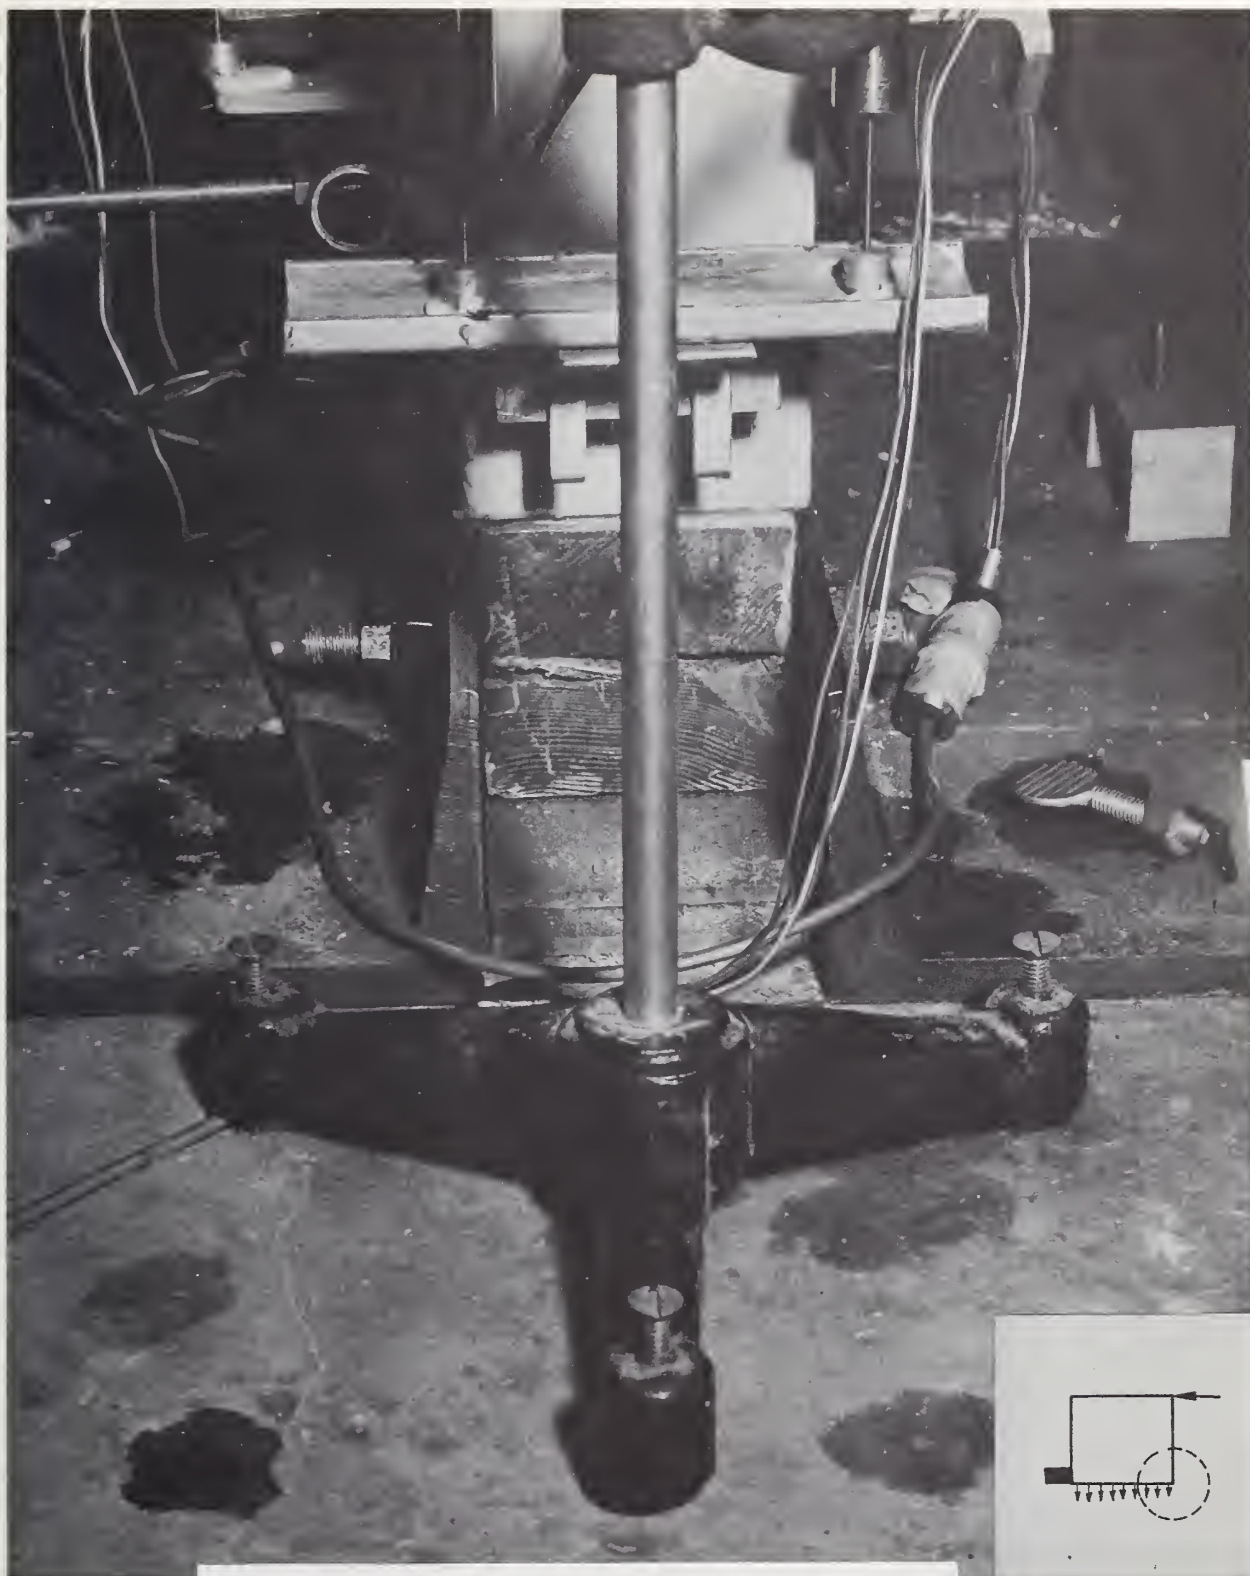
2.3.2.3 <u>Racking Test Results</u>. The first test
was conducted without the vertical hold-down recom-
mended in ASTM Method E-72 in an effort to evaluate
the performance of the bond between the FRP panel
facings and the wood sole plate. However, the test was
terminated at a maximum total racking load of
5700 lb (800 lb/ft) beyond which the load could not
be increased. The failure which prevented greater
load development occurred in the bond between the two

extra bottom 2 x 4's with no apparent damage to
the FRP facing bond. Figure 2.3.5 shows the failure
at the bottom trailing corner (heel) of the specimen
where uplift was being measured. The graph of figure
2.3.6 shows the relationship between racking load
and net horizontal drift (corrected for uplift and
sliding); and between racking load and rotational uplift
for test No. 1.

Fig. 2.3.5   Failure in racking test No. 1.

All evidences of failures in the wall tests point toward
the need for improvement in fabrication methods at the
top and bottom of wall panels. In addition to improving
the adhesive bond between FRP facing and the 2 x 4 wood
plates, the gaps between the corrugated cores and the wood
plates should be eliminated in order to improve the
transfer of loads throughout the panel.

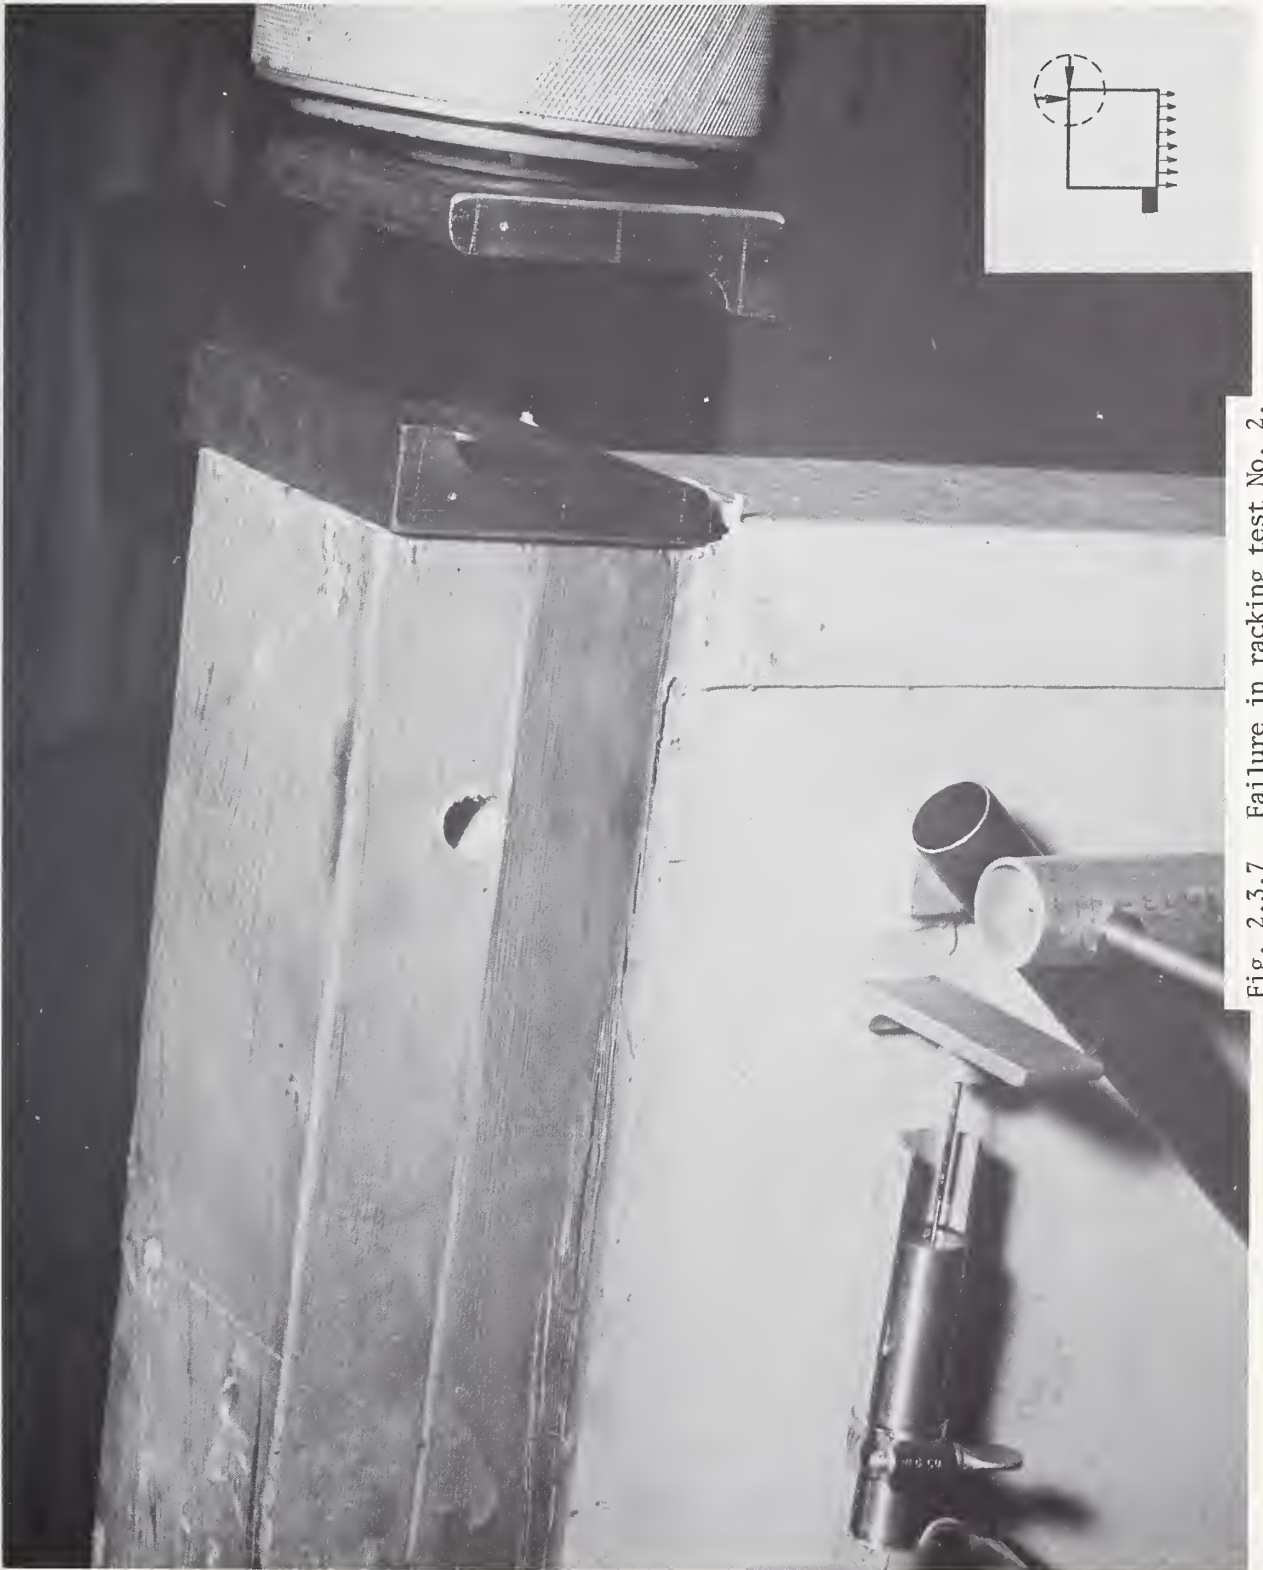
After re-setting and re-clamping the bottom edge of
the wall, the second test was performed in the manner of
ASTM Method E72; i.e., with vertical restraint
provided at the loading corner. The maximum total
racking load which could be developed was 7200
lb (1010 lb/ft). The observed failure was in the
epoxy adhesive bond between the FRP facings and the
top plate at the loading corner of the specimen
(Fig. 2.3.7).   Figure 2.3.8 shows racking load versus
net drift under load; and versus net residual drift
(set) measured at no-load upon removal of each
incremental load. Note that the dotted portions
of the curves represent the concluding part of this
test in which displacement readings are considered
unreliable. The apparent stiffening (reduction of
displacement with increase in load) is attributed
to the development of greater distortions at locations
on the specimen other than those instrumented.

Fig. 2.3.7 Failure in racking test No. 2.

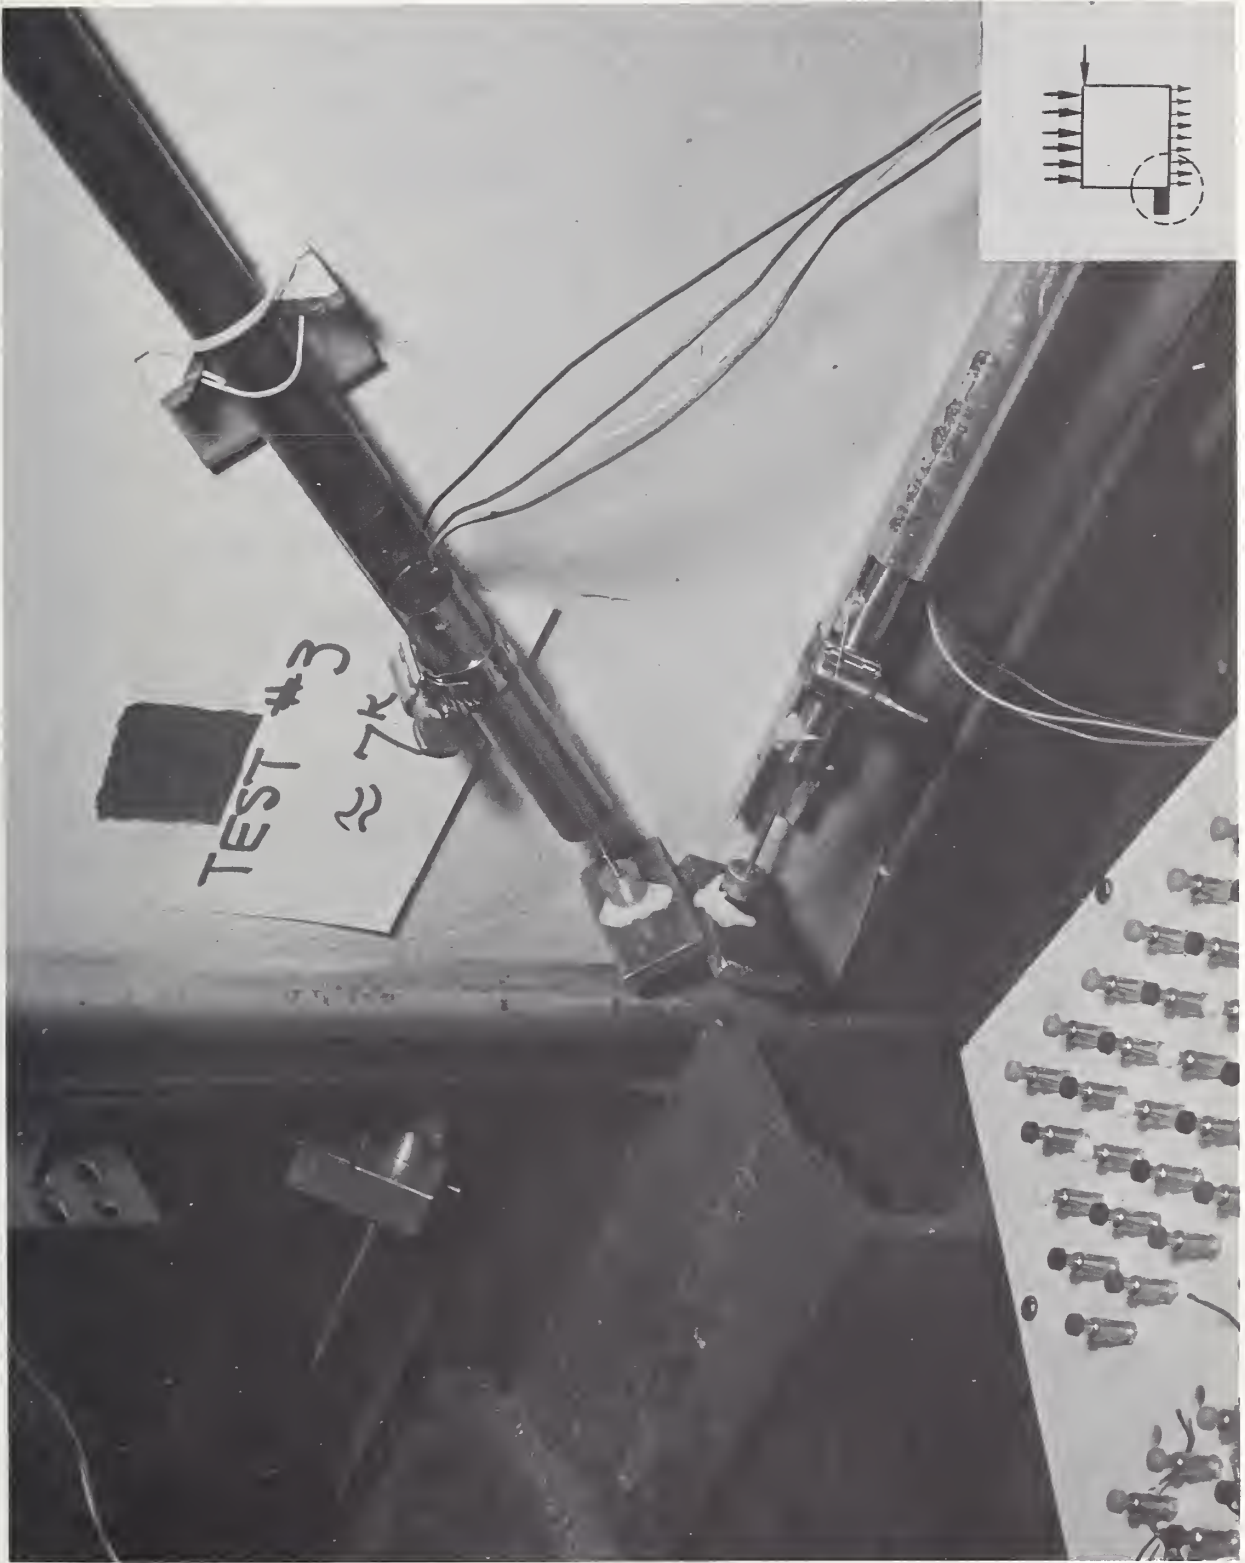
The third test which employed a vertical hold-down
distributed along the top of the wall (instead of
the ASTM E72 hold-down), developed a maximum total
racking load of 6800 lb (950 lb/ft). The failure
was in the epoxy adhesive bond between the FRP facings

Fig. 2.3.9   Failure in racking test No. 3.

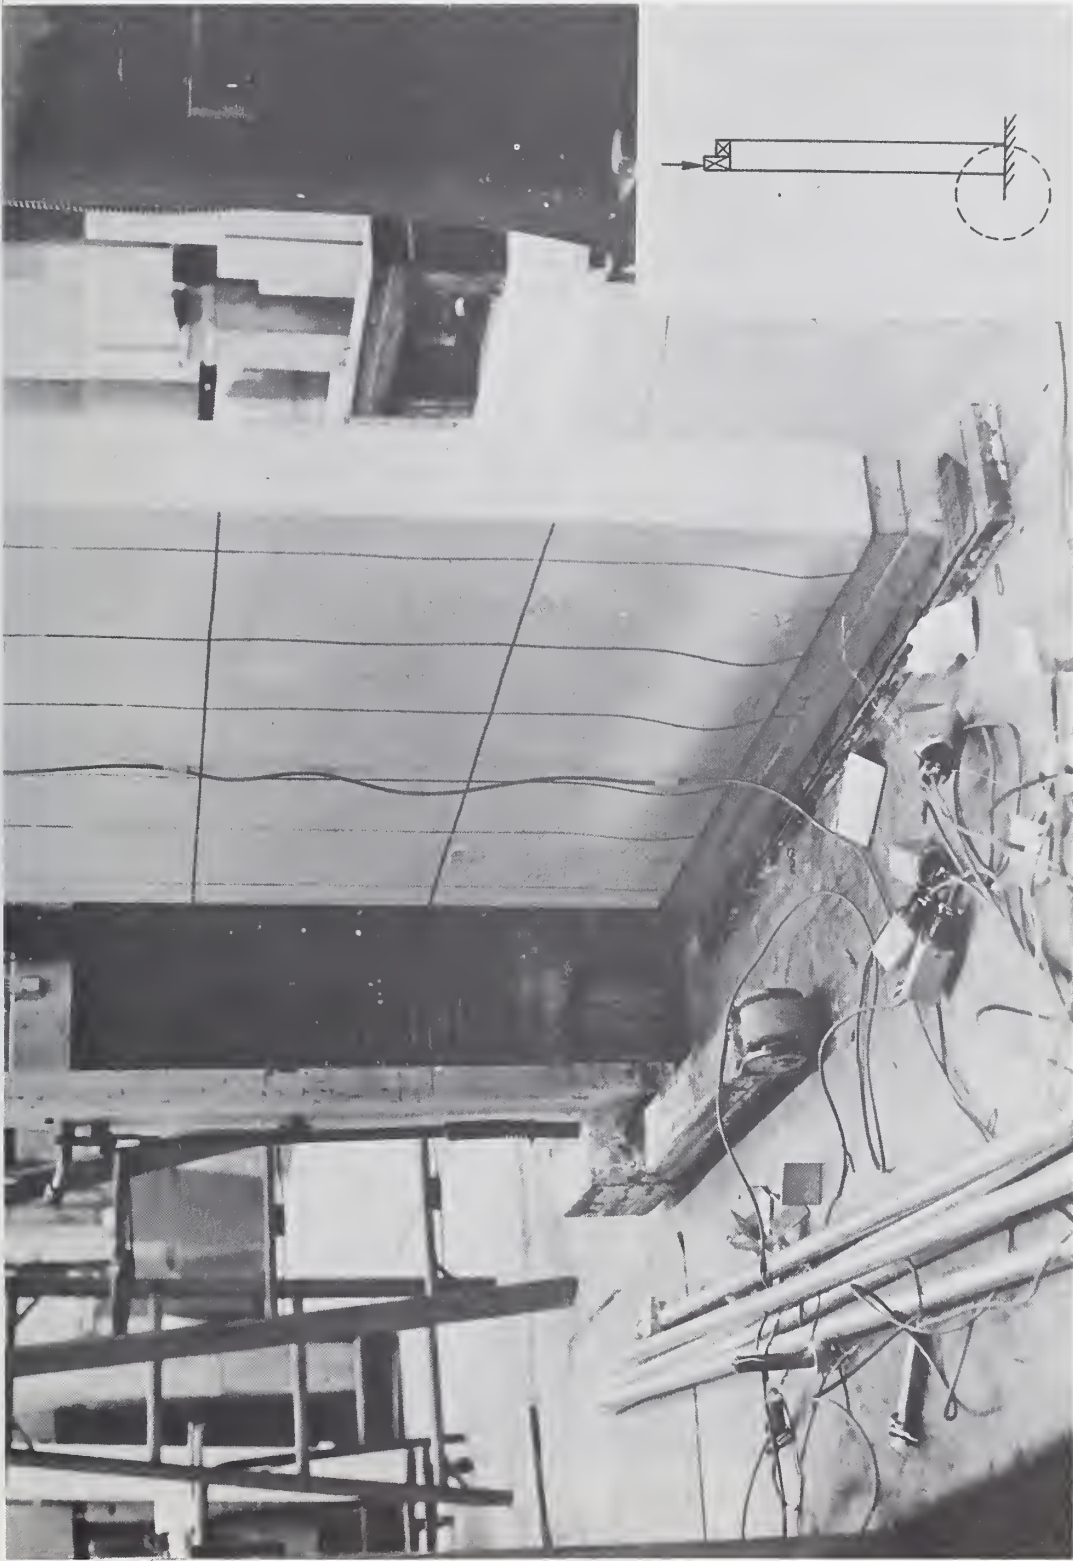
2.3.3.3 Test Results. The two short-term compressive
specimens were used for duplicate tests. The first
specimen sustained a maximum compressive load of
20,800 lb (6240 lb/ft) and the second specimen,
19,750 lb (5925 lb/ft). Failure in the first specimen
occurred in the epoxy adhesive bond between the FRP
facing and the wood sole plate on the side closer
to the eccentric load (Fig. 2.3.15). In the second
specimen a similar failure occurred in the epoxy
adhesive bond between the FRP facing and the top
plate on the side closer to the load (Fig. 2.3.16).
Subsequent to these bond failures, secondary failures
occurred in both specimens when the facings buckled
near the bond separations.

Fig. 2.3.15 Failure in short-term compressive test No. 1.

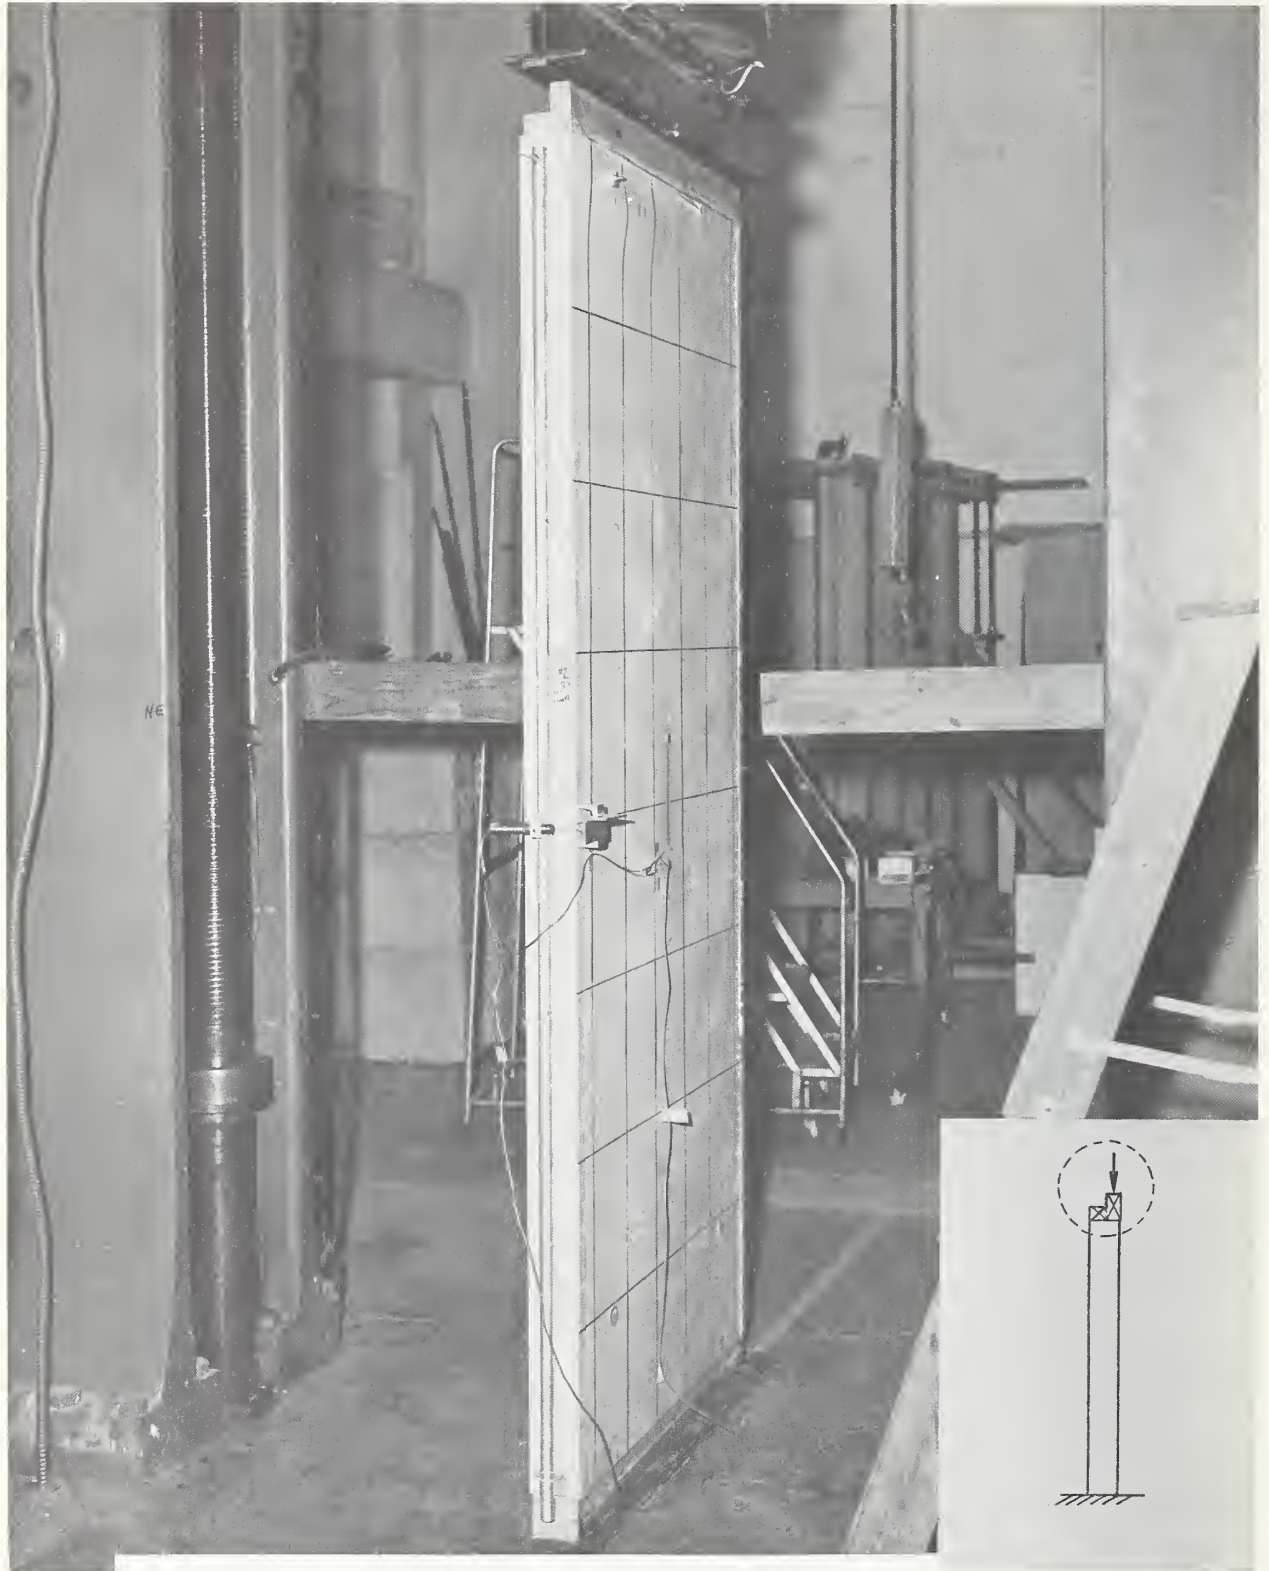
Fig. 2.3.16 Failure in short-term compressive test No. 2.

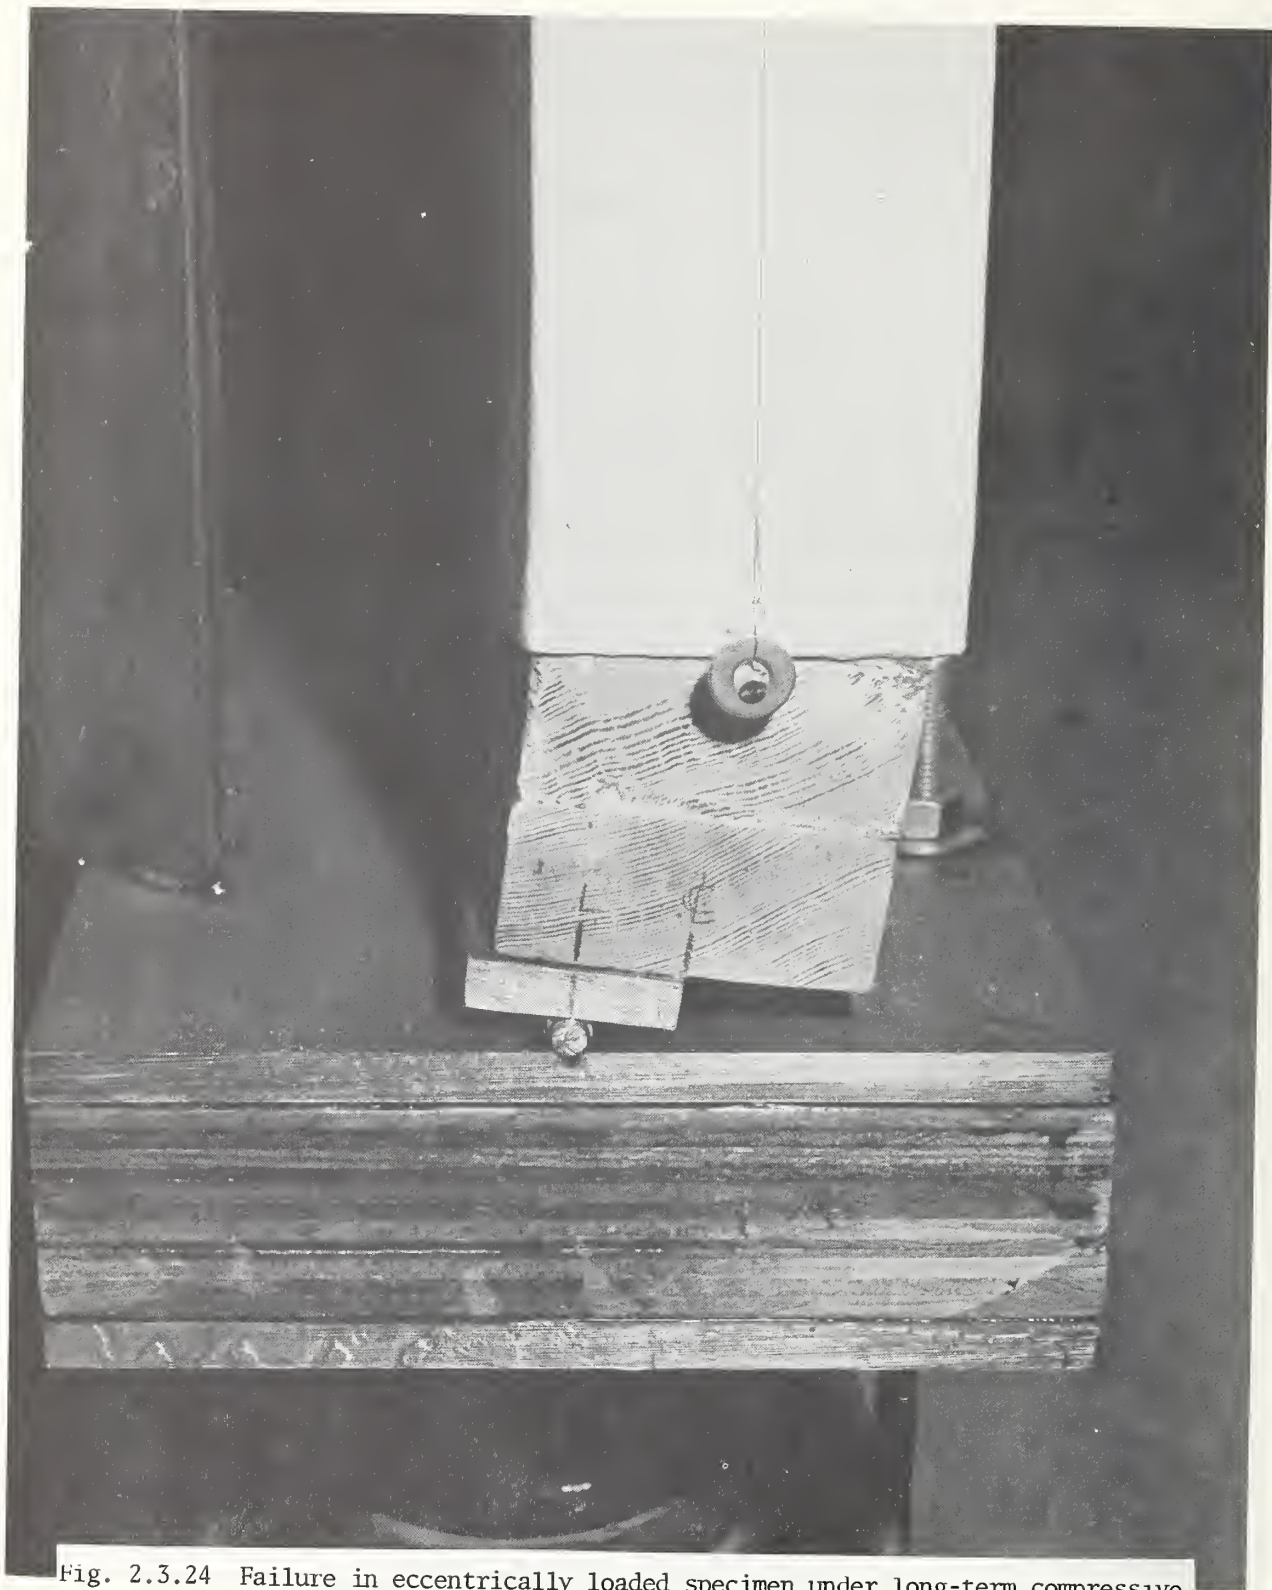
Specimen No. 2 had also been loaded with the flat
bottom support, however, after 24 days under 6000 lb of
sustained load it did not show any sign of failure.
Specimen No. 2 was then unloaded and reloaded to
6000 lb with the eccentric-bottom support. After
53 days under these conditions specimen No. 2 failed
in an identical manner as specimen No. 1. Figure
2.3.24 is a photograph of the bottom end of this
specimen after failure. Failures in both specimens
were gradual; i.e., there was a slight rotation
at the sole plate several days before the epoxy
adhesive bond broke loose for the full width of the
specimen.

Fig. 2.3.24 Failure in eccentrically loaded specimen under long-term compressive load test.
