NBSIR 83-2702

Corrosion Evaluation of Underground Telephone Cable Shielding Materials

May 1983

J.L. Fink
E. Escalante

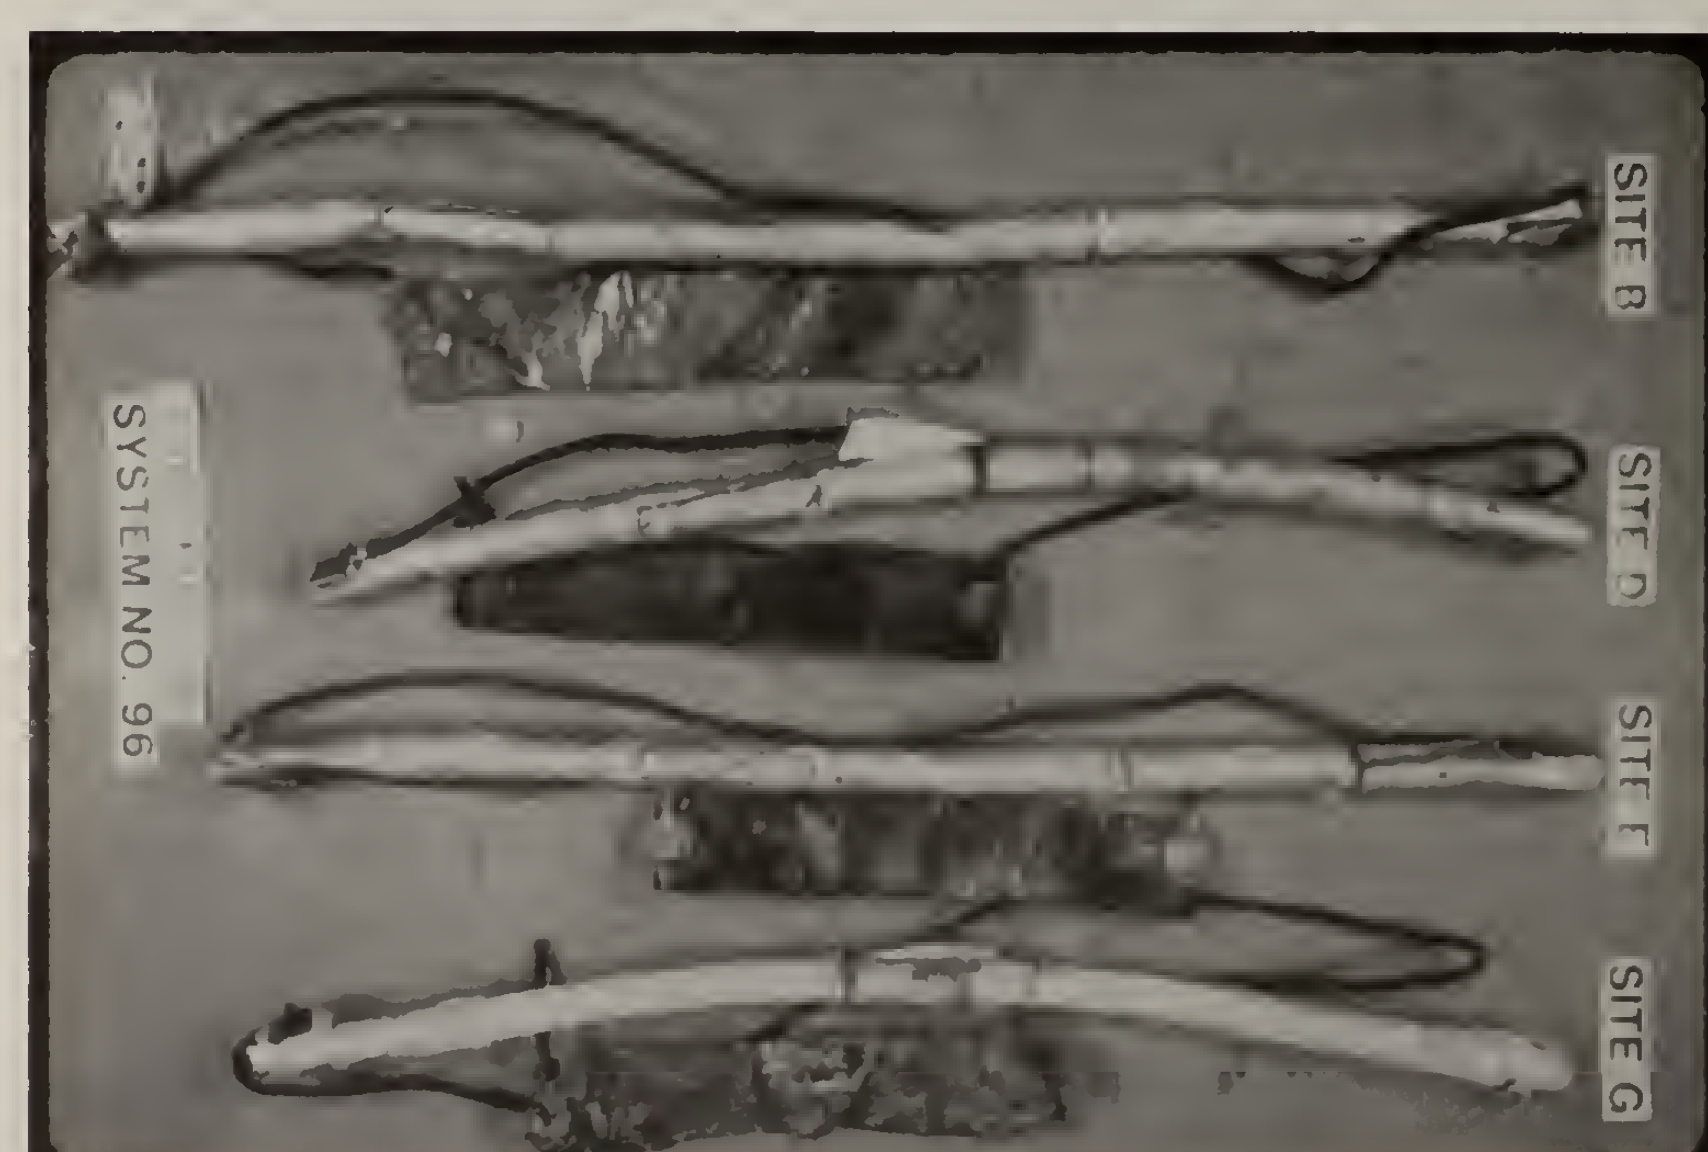
Figure 2. Outer Shield: Systems 95, 96, 97, 98, 101, and 102, left to right, exposed at Site C for one year. Severe corrosion on Systems 96, 98, and 102 at window and ring areas.

Figure 3. Outer Shield: Systems 95, 96, 97, and 98, Inner Shield: Systems 101 and 102, left to right, exposed at Site C for one year. Severe corrosion on Systems 96, 98, and 102 at window and/or ring areas.

Figure 4. Outer Shield: System 95, Sites B, D, E, and G, top to bottom, exposed for two years. Degradation at the window and ring areas on the specimen from Site G.

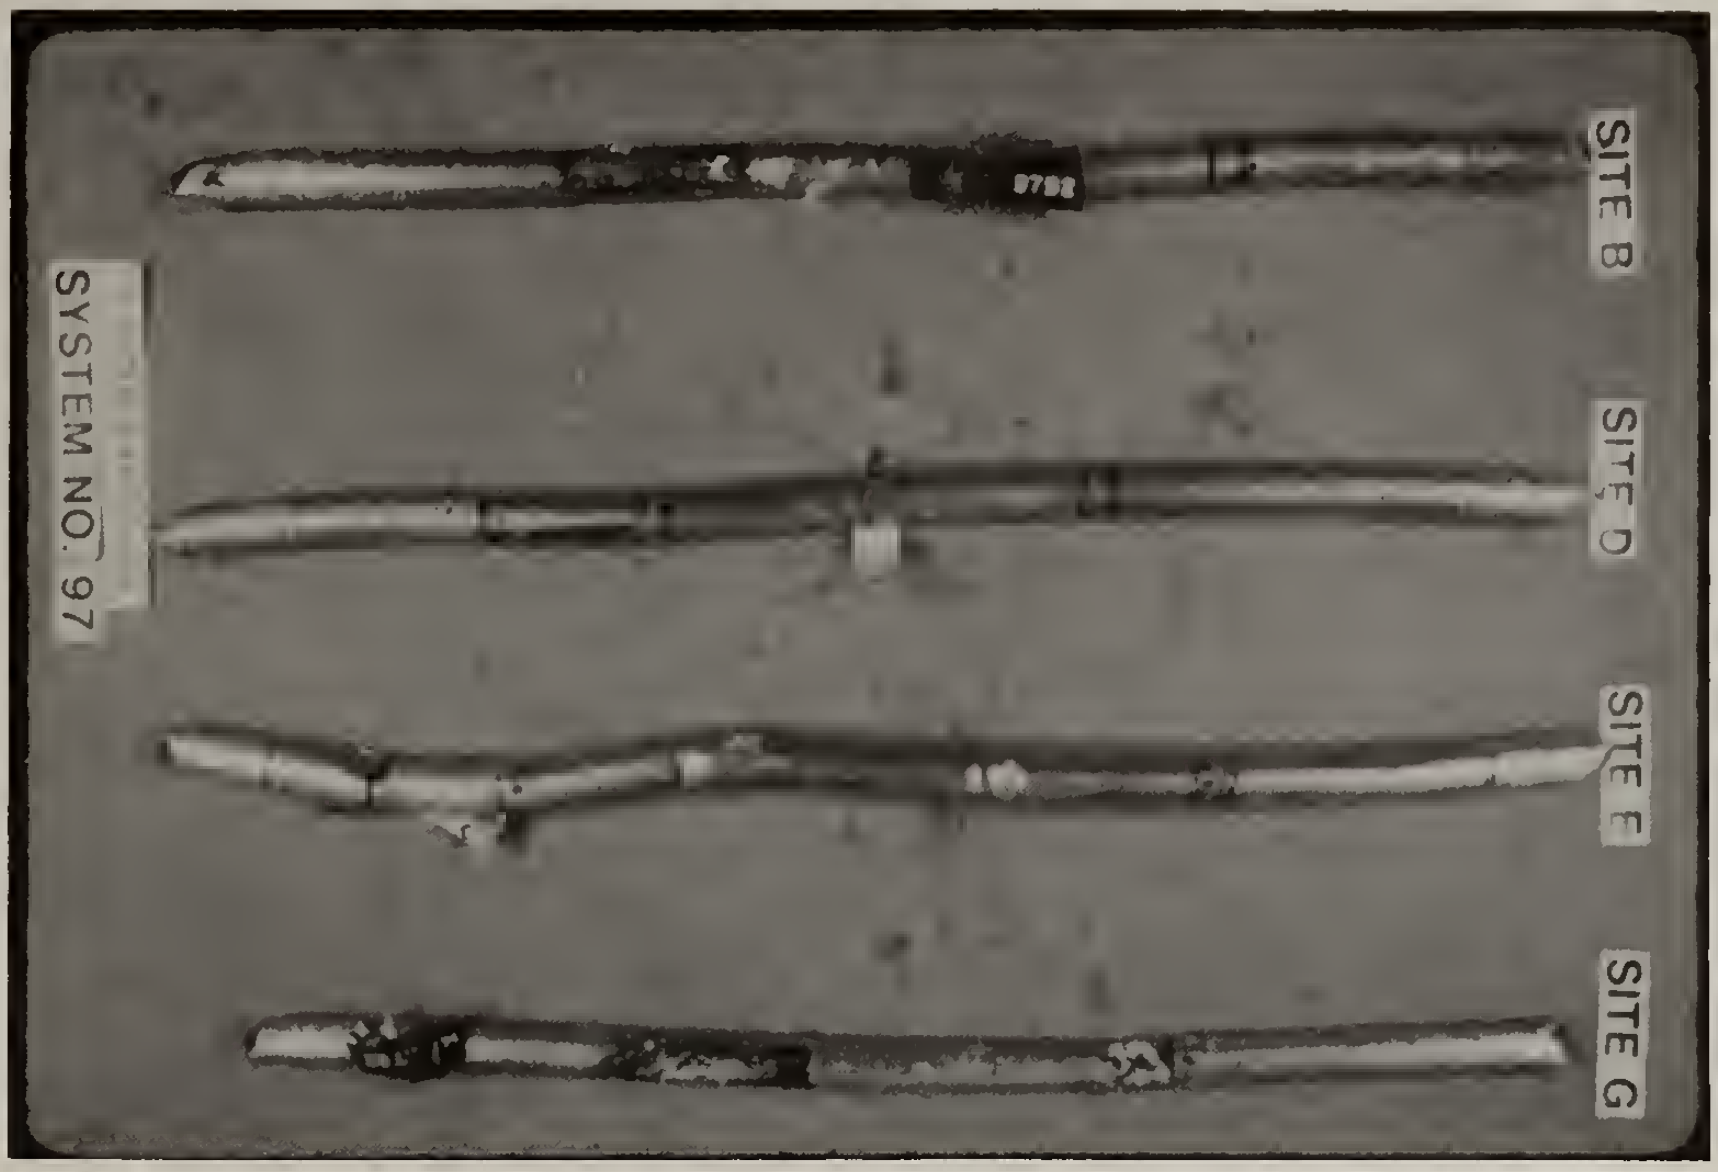
Figure 5. Outer Shield: System 96, Sites B, D, E, and G, top to bottom, exposed for two years. Coupling this system to copper accelerated corrosion on the specimens from Sites B, E, and G severely.

Figure 6. Outer Shield: System 97, Sites B, D, E, and G, top to bottom, exposed for two years. Degradation at the ring area on the specimen from Site G was severe.

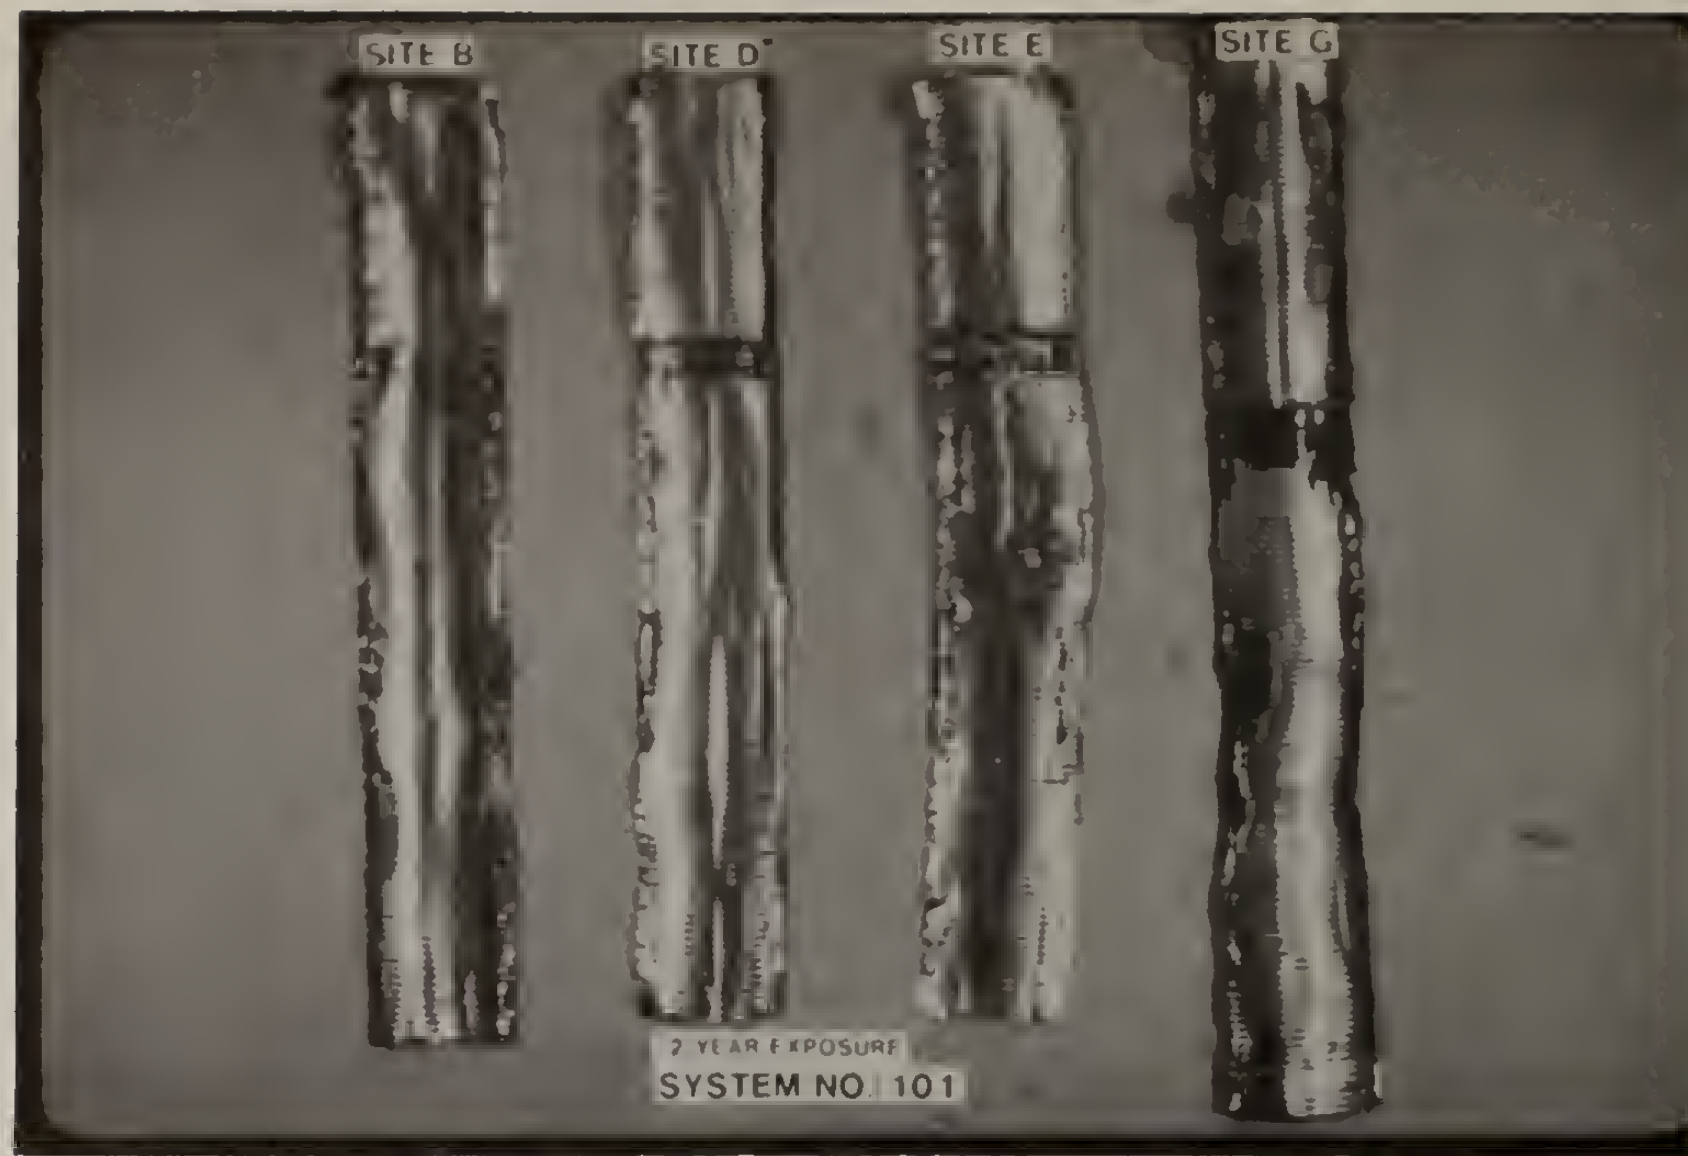
Figure 7. Outer Shield: System 98, Sites B, D, E, and G, top to bottom, exposed for two years. Coupling this system to copper accelerated degradation at the window and ring areas on all specimens.

Figure 8. Outer Shield: System 101, Sites B, D, E, and G, left to right, exposed for two years. Dark areas indicate corrosion at the window and ring areas.

Figure 9. Inner Shield: System 101, Sites B, D, E, and G, left to right, exposed for two years. Dark areas indicate corrosion at the window and ring areas on specimens with severe corrosion on the specimen from Site G.

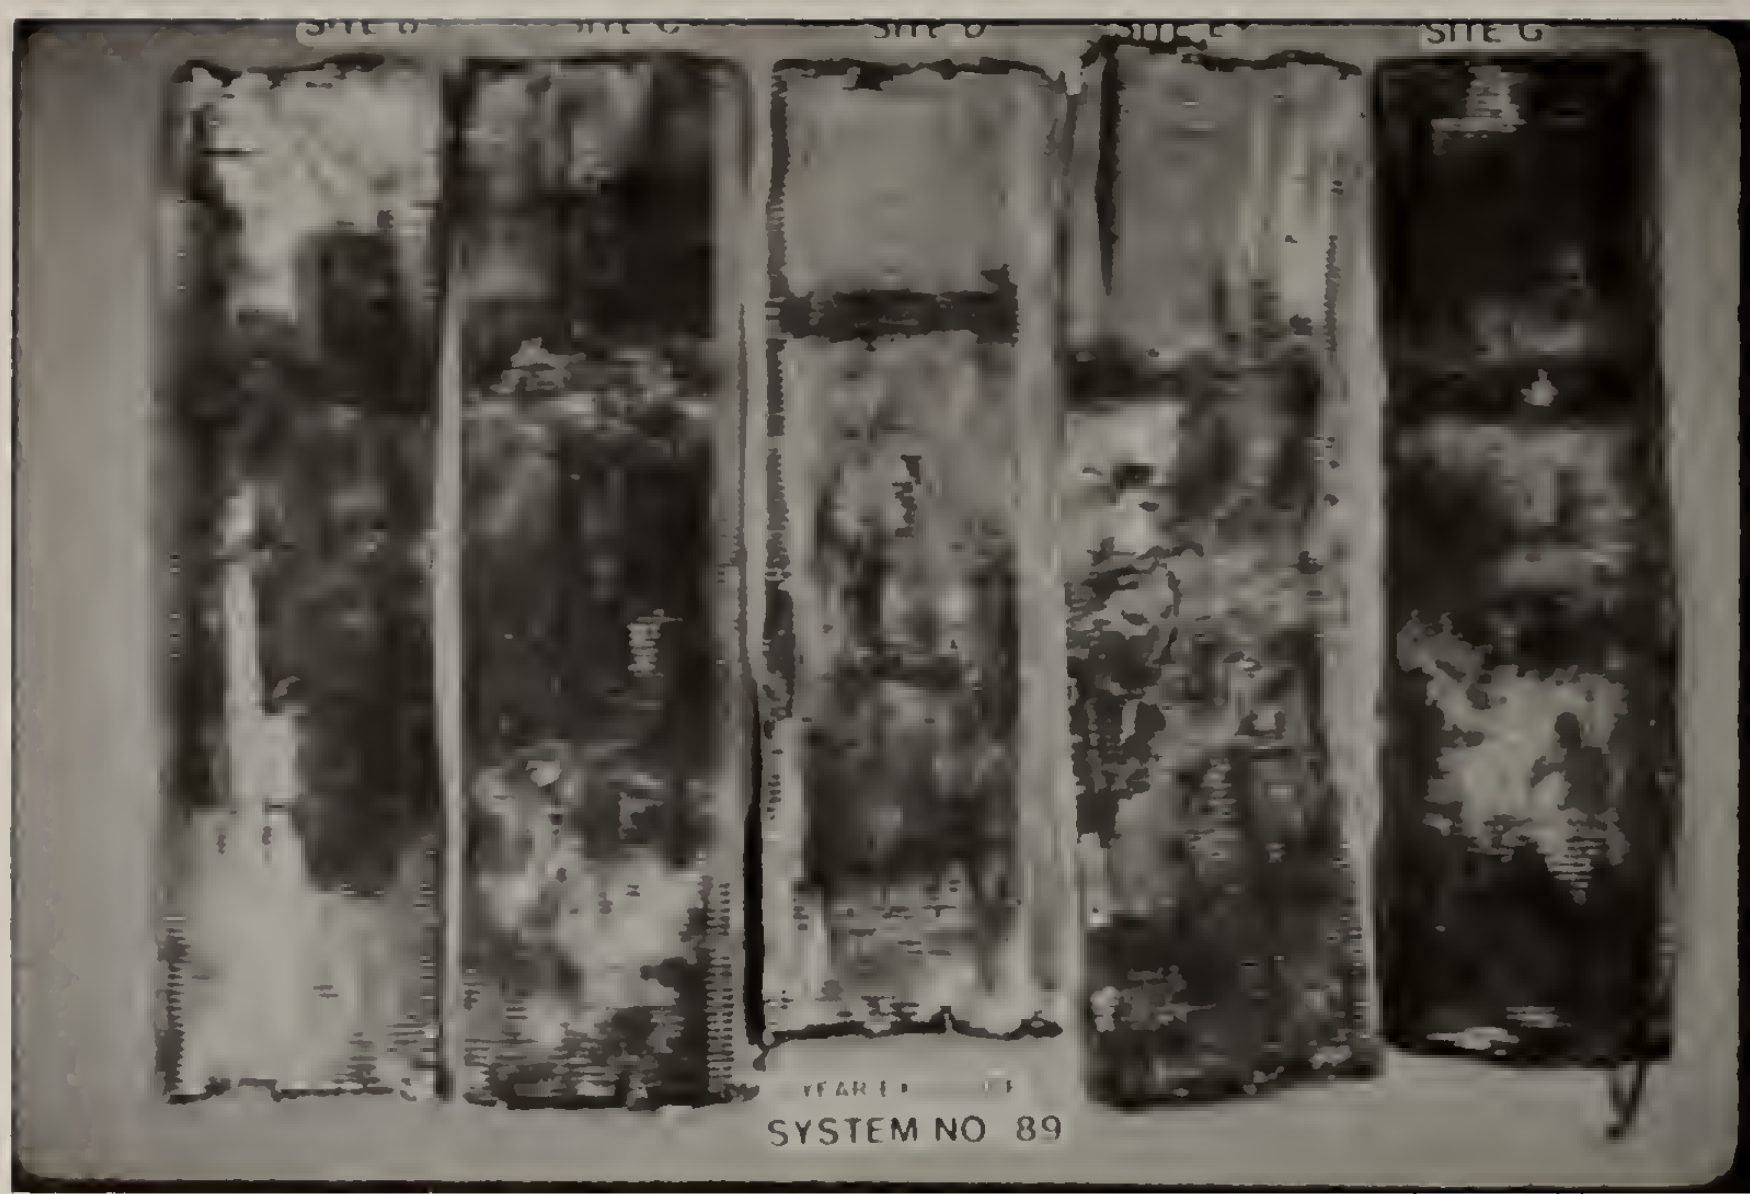
Figure 10. Outer Shield: System 102, Sites, B, E, and G, left to right, exposed for two years. Coupling this system to copper accelerated corrosion on specimens at window and ring areas with severe corrosion on the specimen from Site G.

Figure 11. Inner Shield: System 102, Sites B, E, and G, left to right, exposed for two years. Coupling this system to copper accelerated corrosion on specimens at window and ring areas, with severe corrosion on the specimen from Site G.

Figure 12. Outer Shield: System 89, Sites B, C, D, E, and G, left to right, exposed for three years. Light areas indicate perforation due to corrosion at the window and ring areas on the specimen from Site G.

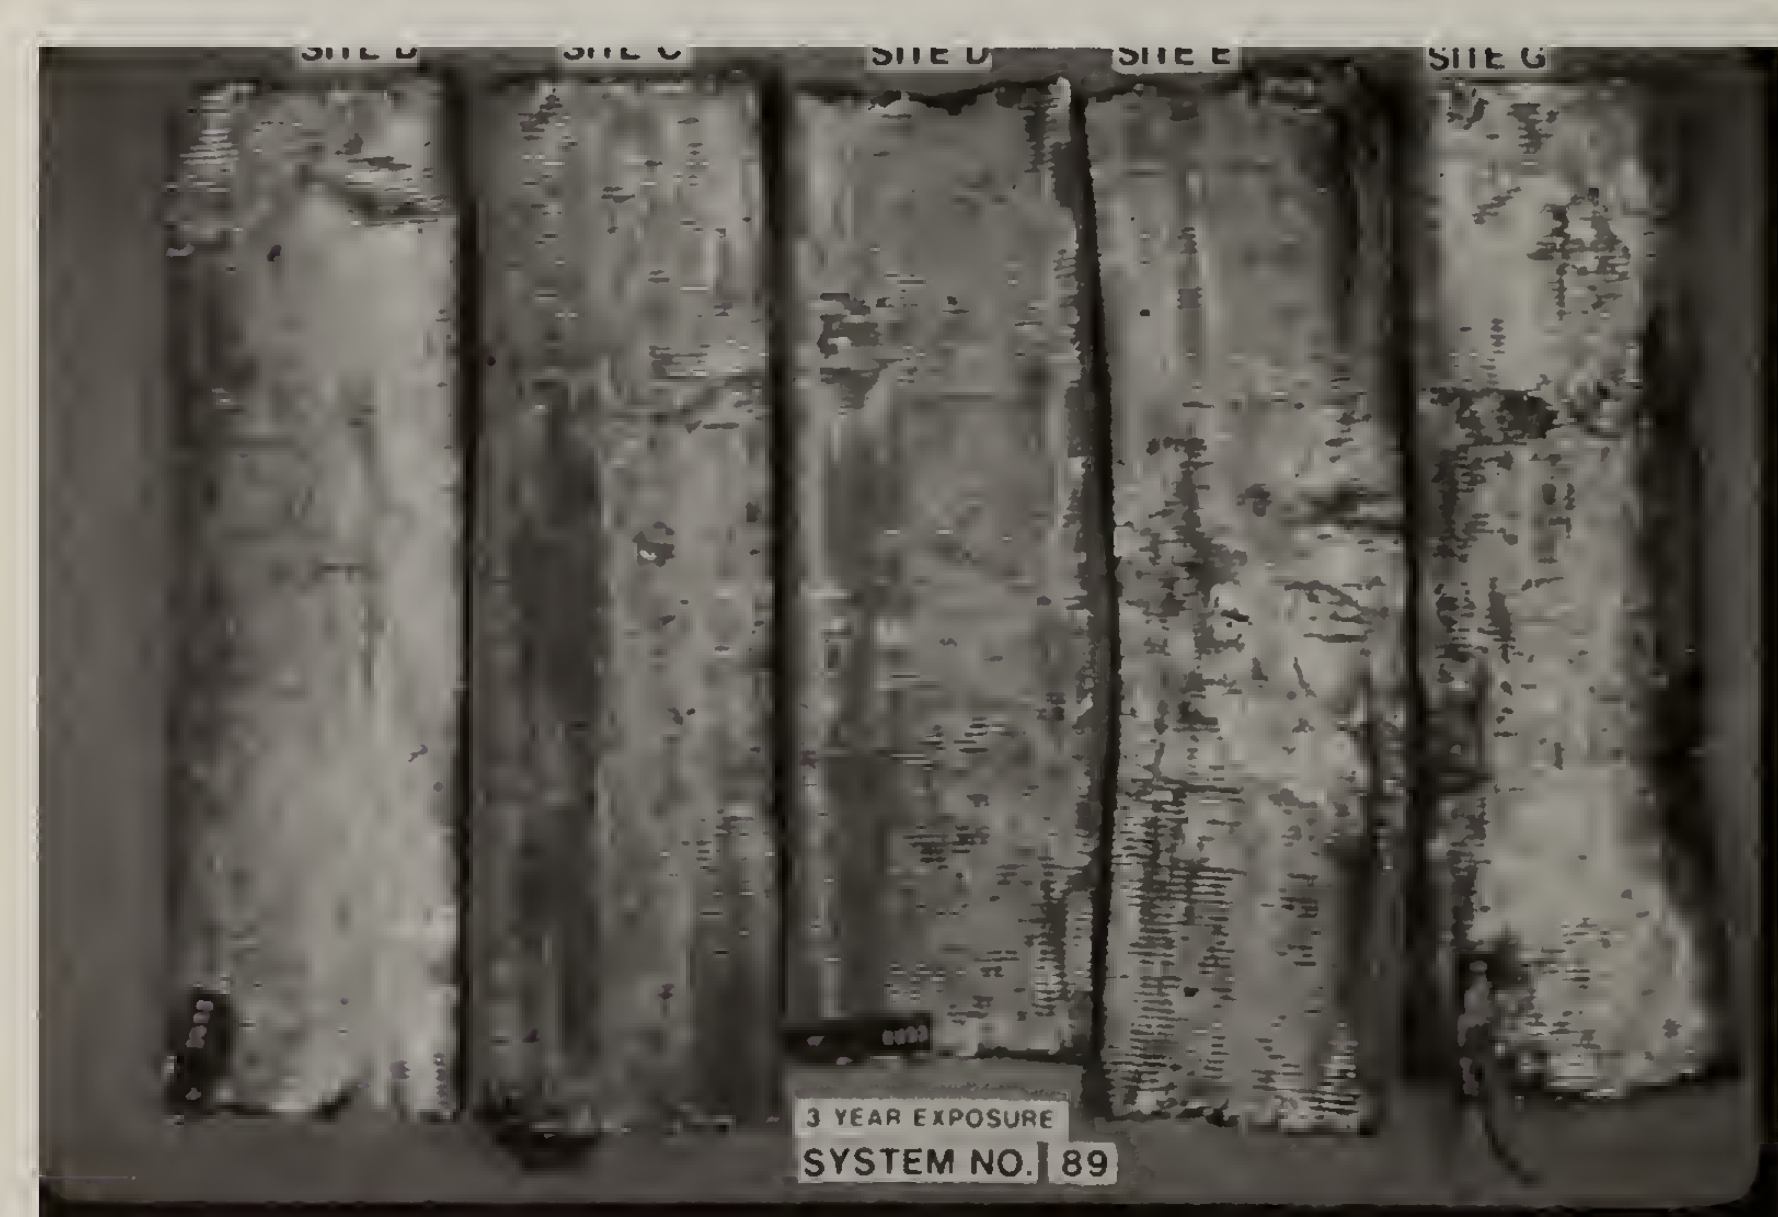
Figure 13. Inner Shield: System 89, Sites B, C, D, E, and G, left to right, exposed for three years. Dark areas indicate corrosion at the window and ring areas of specimen from Site G.

Figure 14. Outer Shield: System 73, Sites B, C, D, E, and G, left to right, exposed for four years. Dark areas indicate corrosion with severe corrosion at the window and rings on specimens from Sites B, C, E, and G.

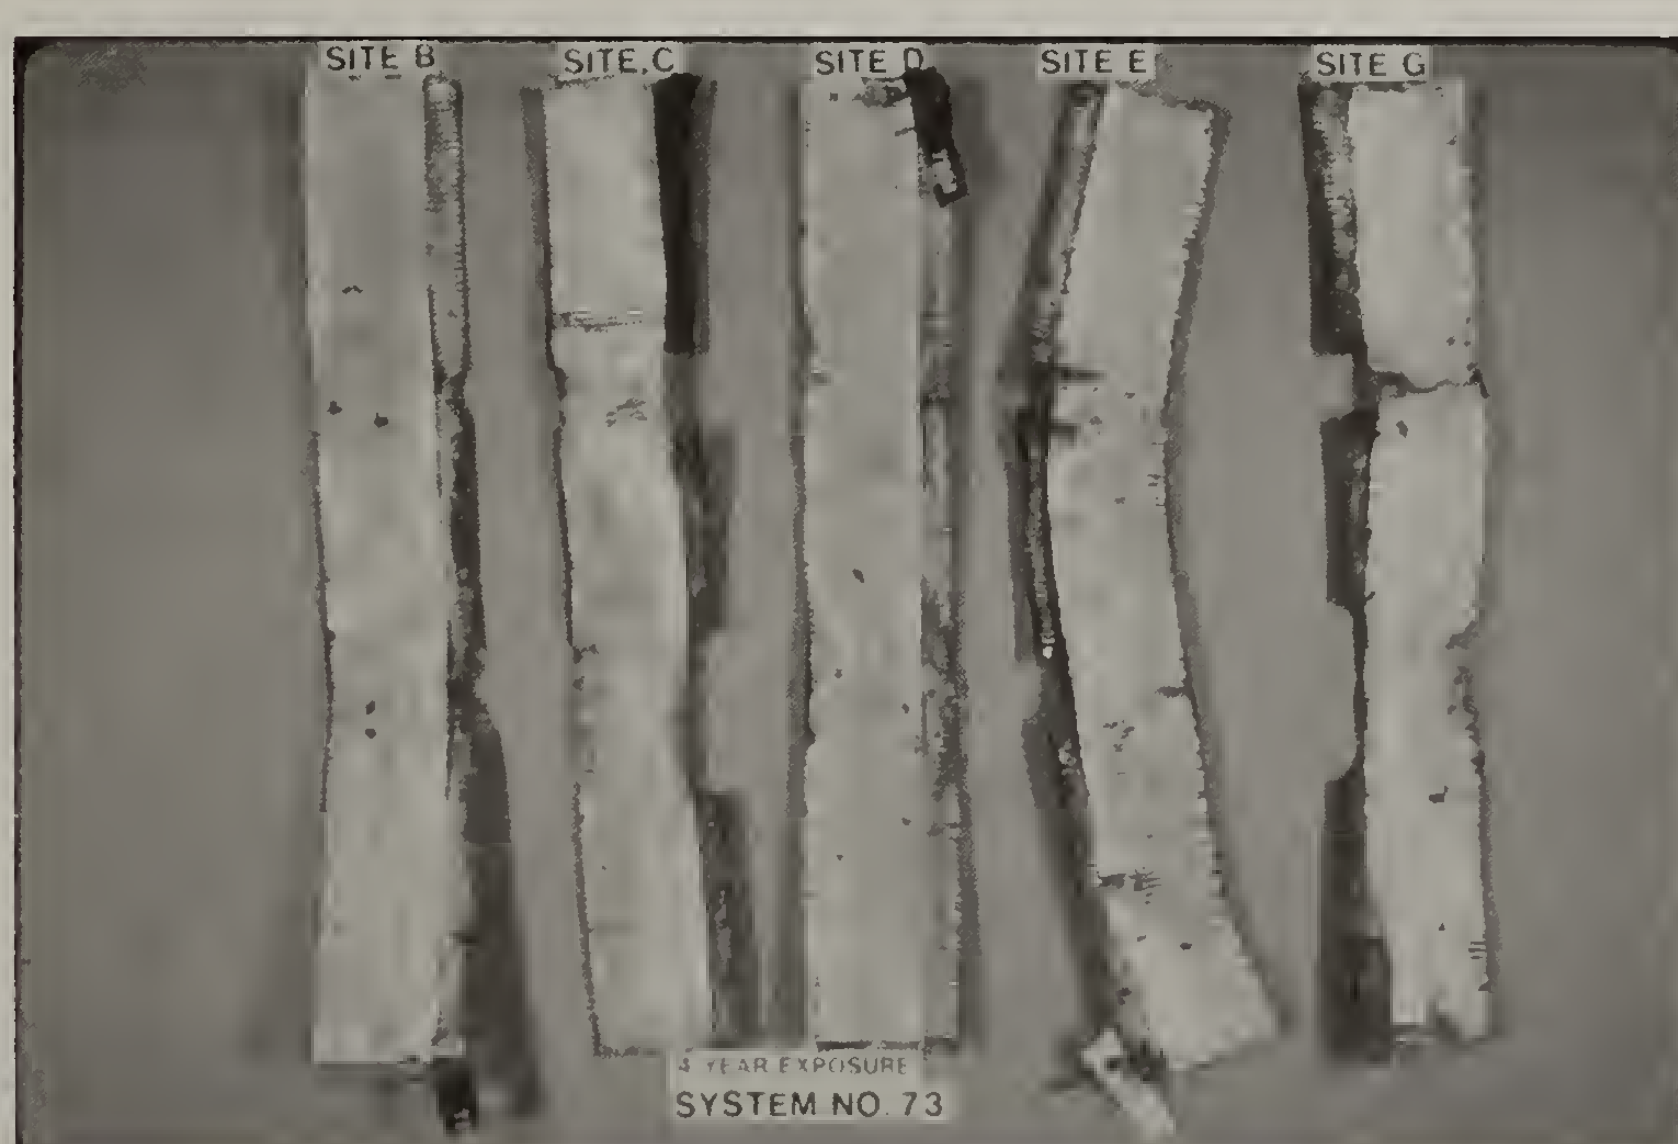
Figure 15. Inner Shield: System 73, Sites B, C, D, E, and G, left to right, exposed for four years. Severe degradation at the window and ring areas on the specimen from Site G.

Figure 16. Outer Shield: System 74, Sites B, C, D, E, and G, left to right, exposed for four years. Coupling this system to copper accelerated corrosion on the specimens from all sites.

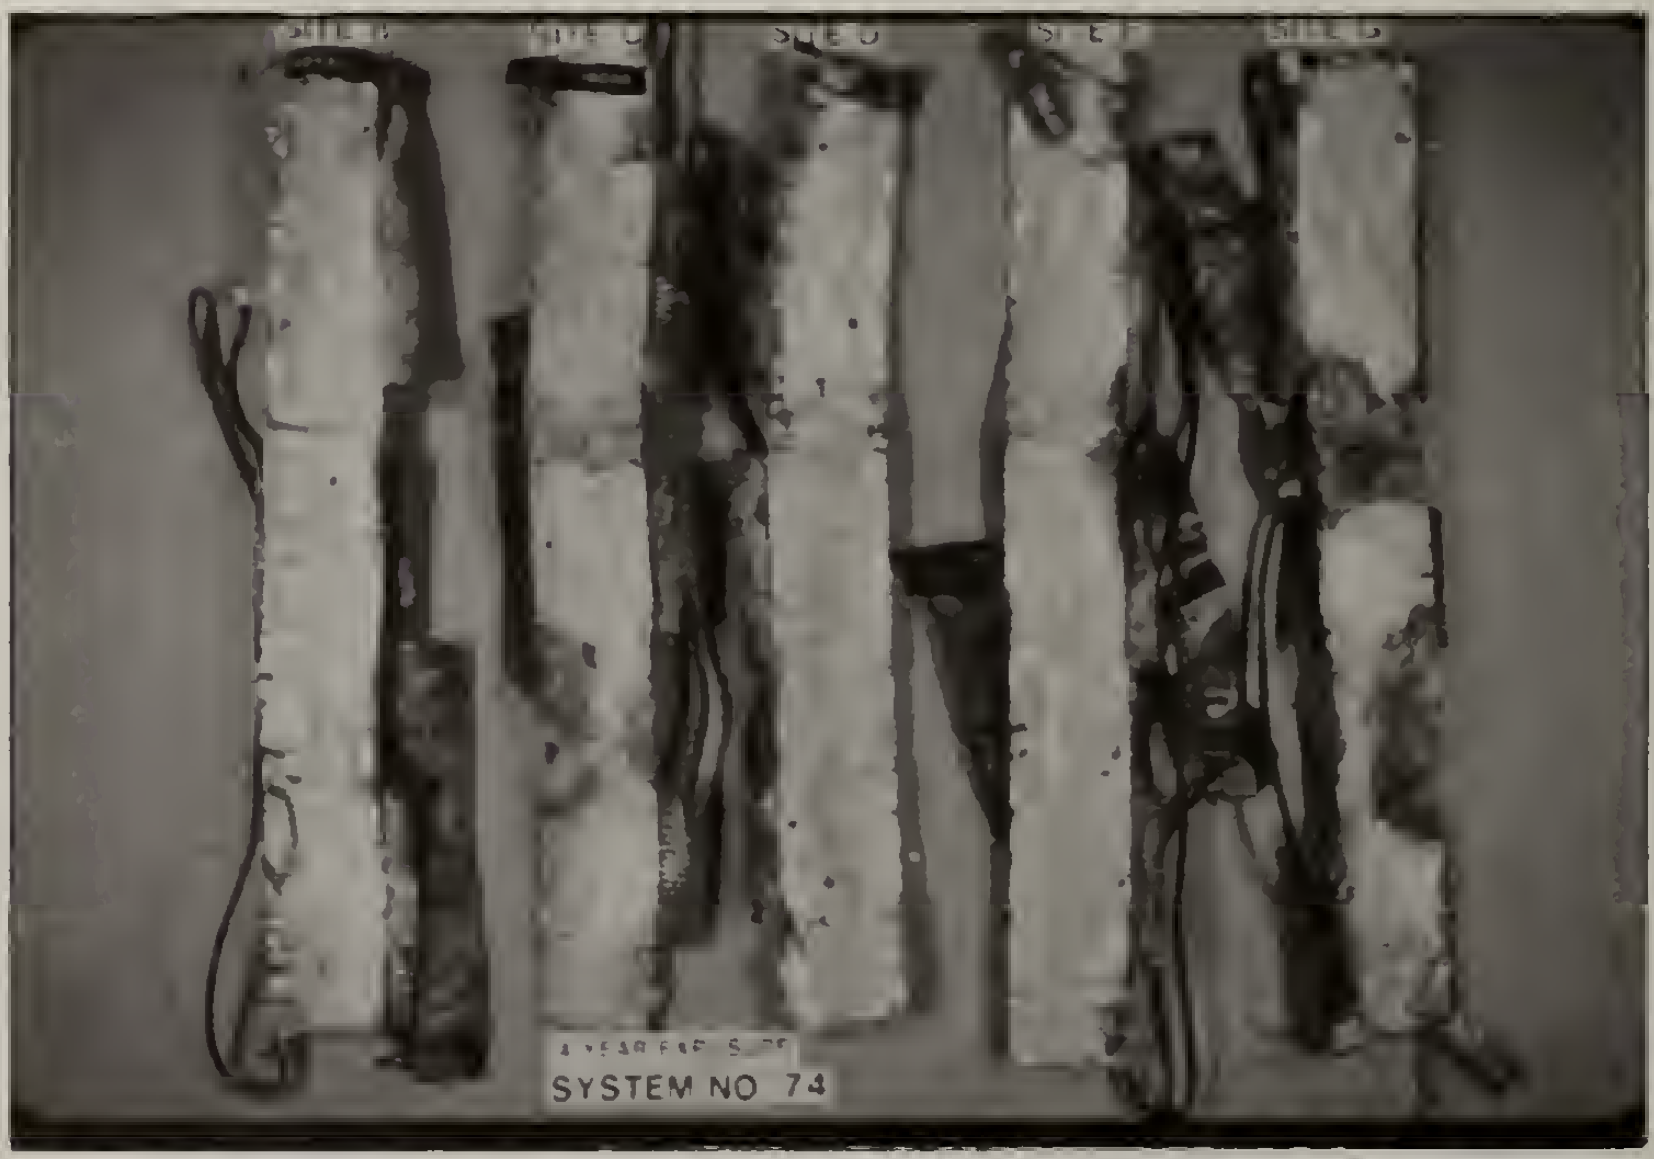
Figure 17. Inner Shield: System 74, Sites B, C, D, E, and G, left to right, exposed for four years. Coupling this system to copper accelerated degradation on the specimens from Sites C, E, and G.

Figure 18. Outer Shield: System 75, Sites B, C, D, E, and G, left to right, exposed for four years. Dark areas indicate corrosion at the window and ring areas on the specimen from Site G.

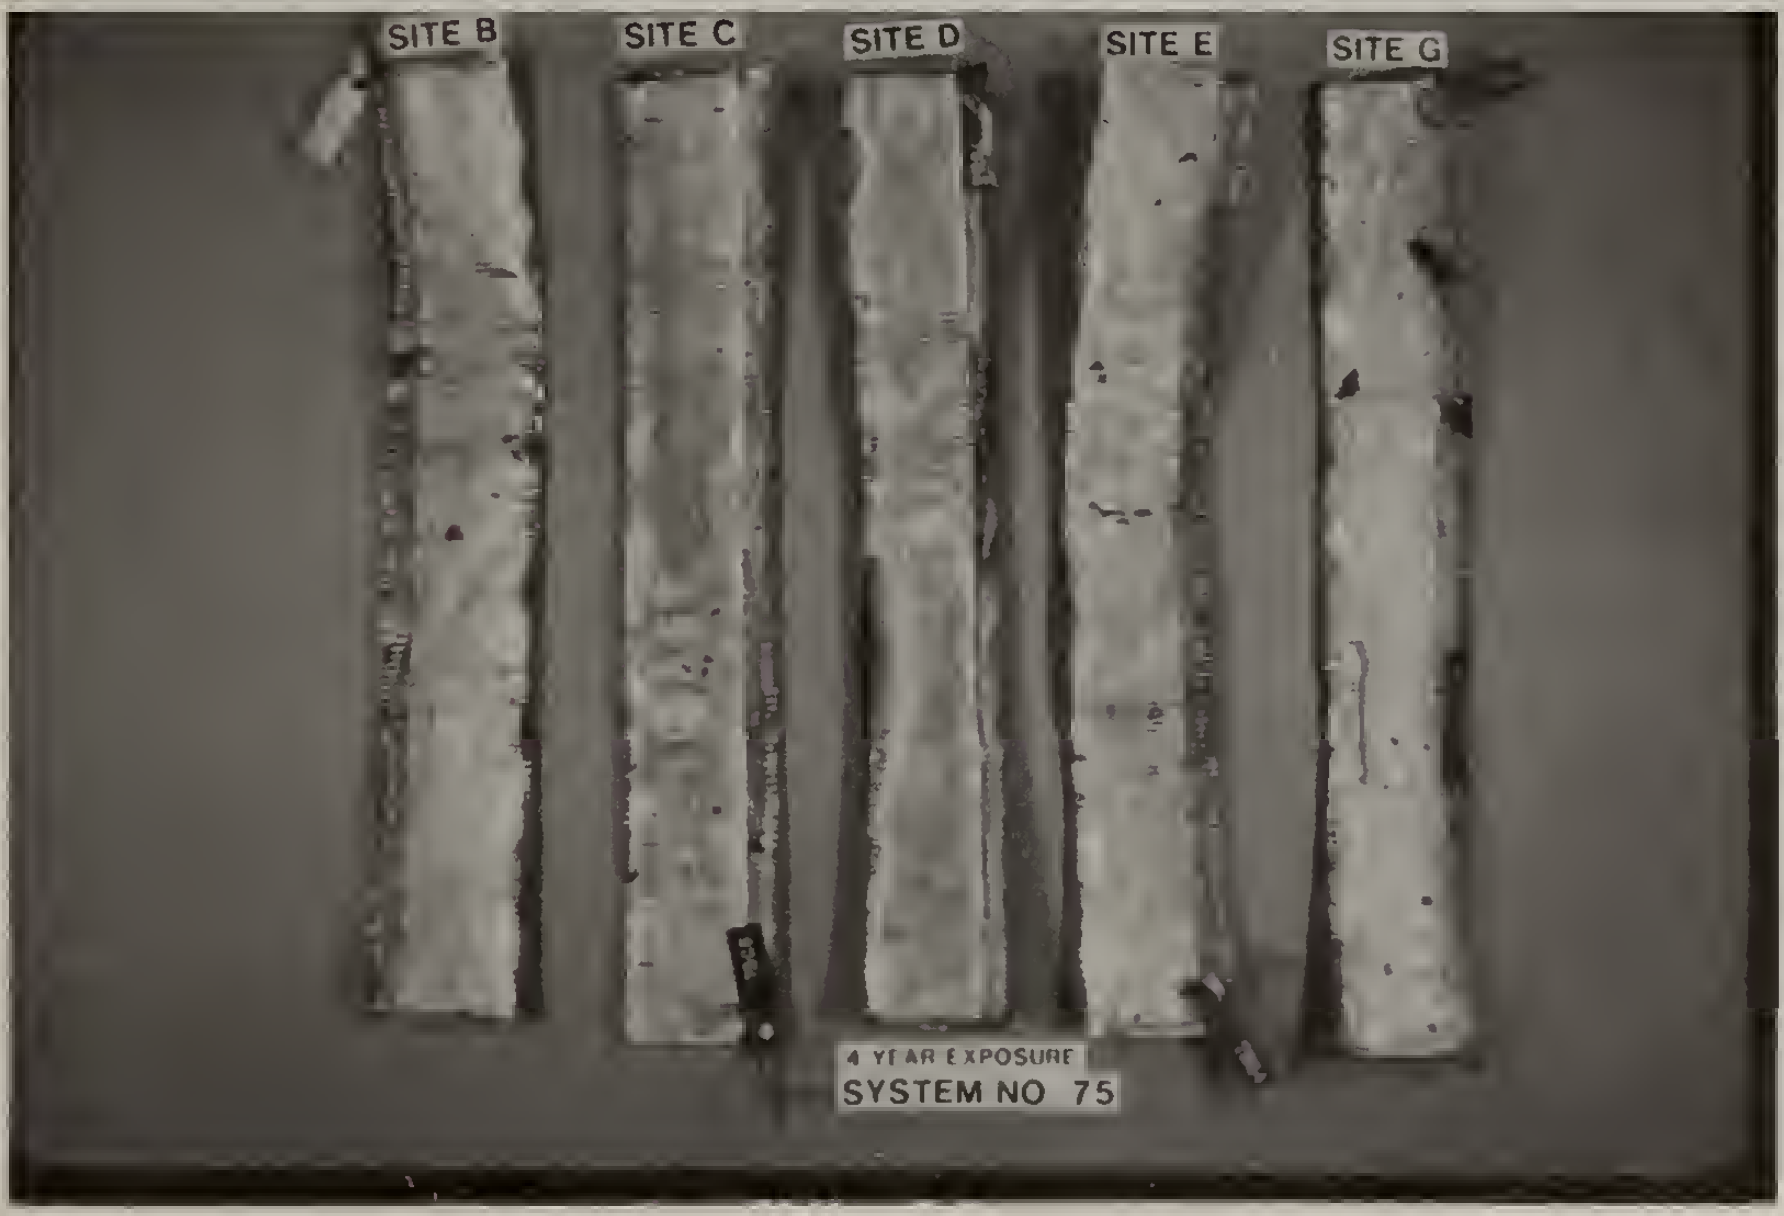
Figure 19. Inner Shield: System 75, Sites B, C, D, E, and G, left to right, exposed for four years. Specimens were unaffected by corrosion.

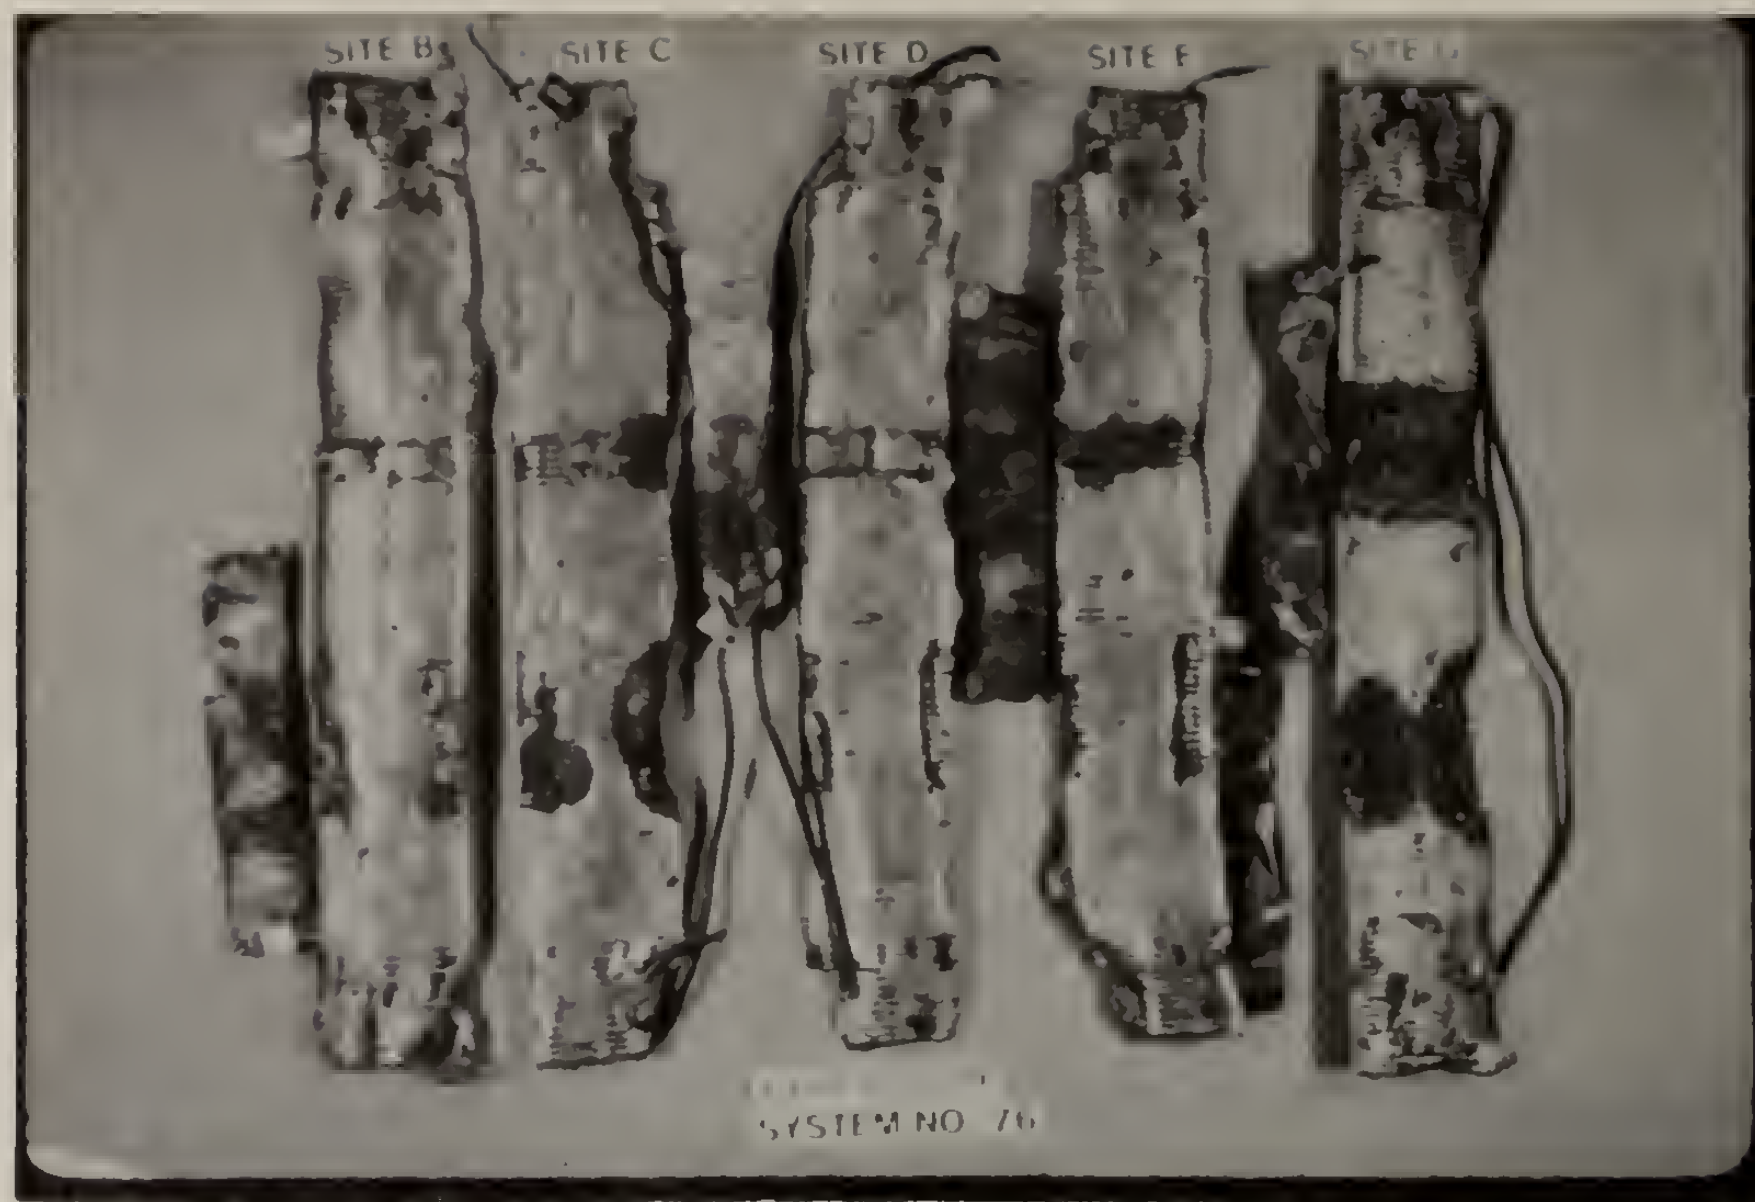
Figure 20. Outer Shield: System 76, Sites B, C, D, E, and G, left to right, exposed for four years. Coupling this system to copper accelerated corrosion at the window and ring areas as indicated by dark areas.

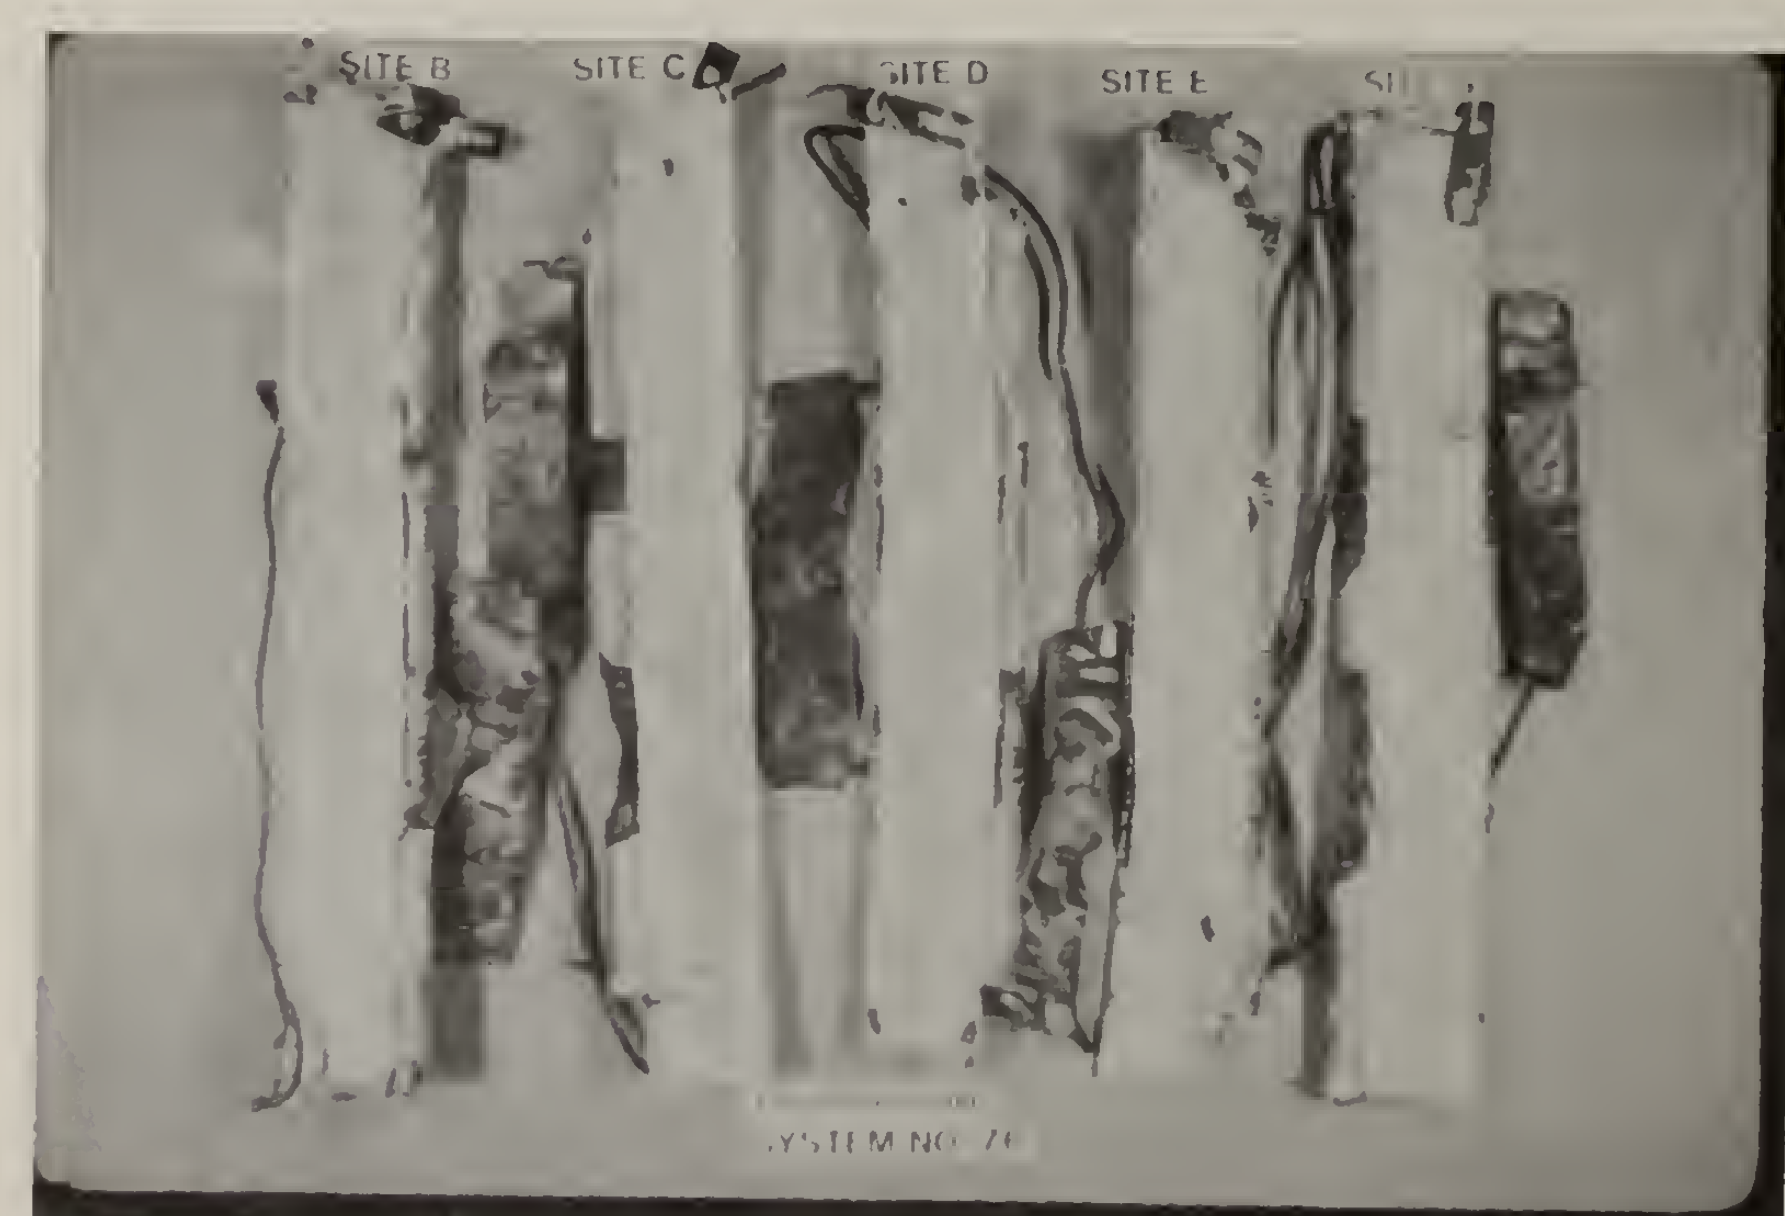
Figure 21. Inner Shield: System 76, Sites B, C, D, E, and G, left to right, exposed for four years. After coupling this system to copper the shield was unaffected by corrosion.

Figure 22. Outer Shield: System 77, Sites B, C, D, E, and G, left to right, exposed for four years. Dark areas indicate corrosion with severe corrosion at the window and/or ring areas on all the specimens.

Figure 23. Inner Shield: System 77, Sites B, C, D, E, and G, left to right, exposed for four years. Severe degradation of the window and ring area on the specimen from Site G.
