NBSIR 83-2702

Corrosion Evaluation of Underground Telephone Cable Shielding Materials

May 1983

J.L. Fink
E. Escalante

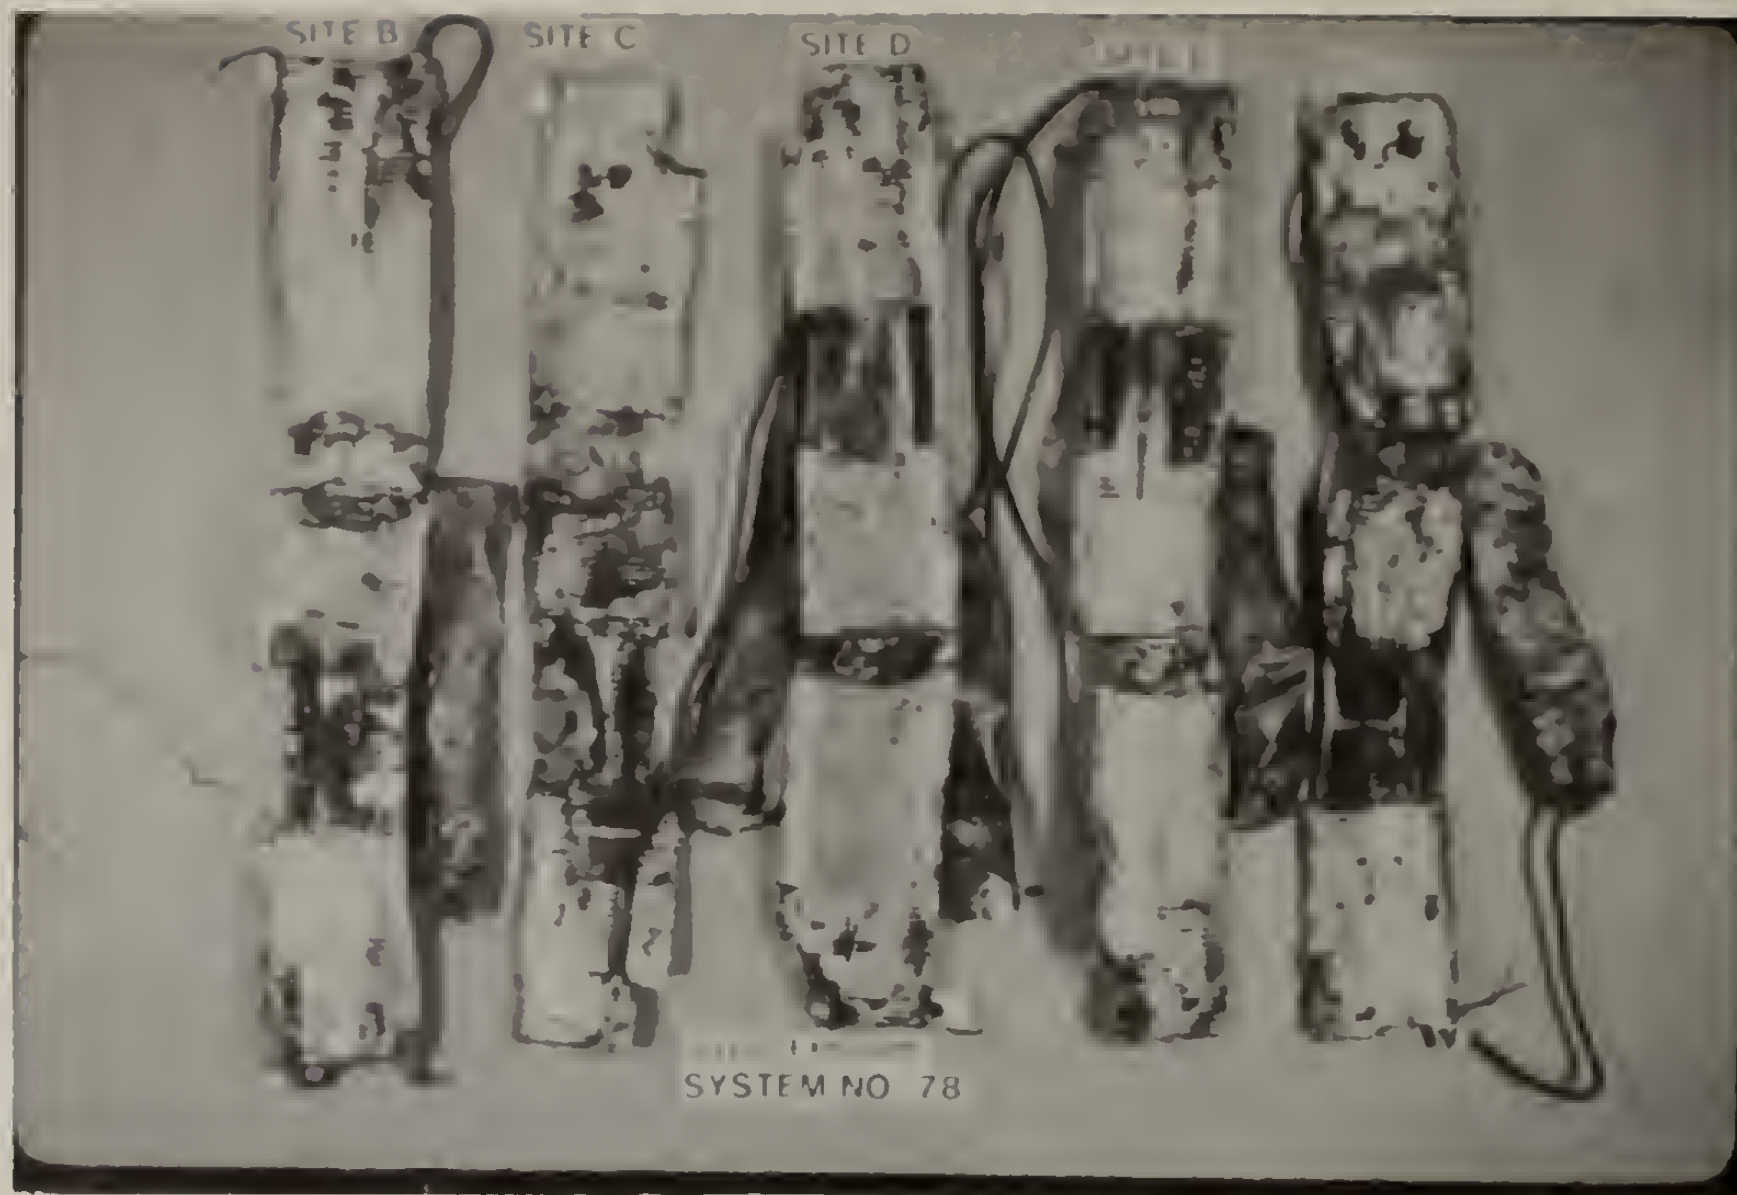
Figure 24. Outer Shield: System 78, Sites B, C, D, E, and G, left to right, exposed for four years. Coupling this system to copper accelerated corrosion at the window and ring areas.

Figure 25. Inner Shield: System 78, Sites B, C, D, E, and G, left to right, exposed for four years. Coupling this system to copper accelerated degradation on specimens from Sites C, E, and G.

Figure 26. Outer Shield: System 79, Sites B, C, D, and G, left to right, exposed for four years. Dark areas indicate corrosion with severe corrosion at the window and ring areas.

Figure 27. Inner Shield: System 79, Sites B, C, D, and G, left to right, exposed for four years. Severe degradation on the specimen from Site G and the ring area on the specimen from Site C.

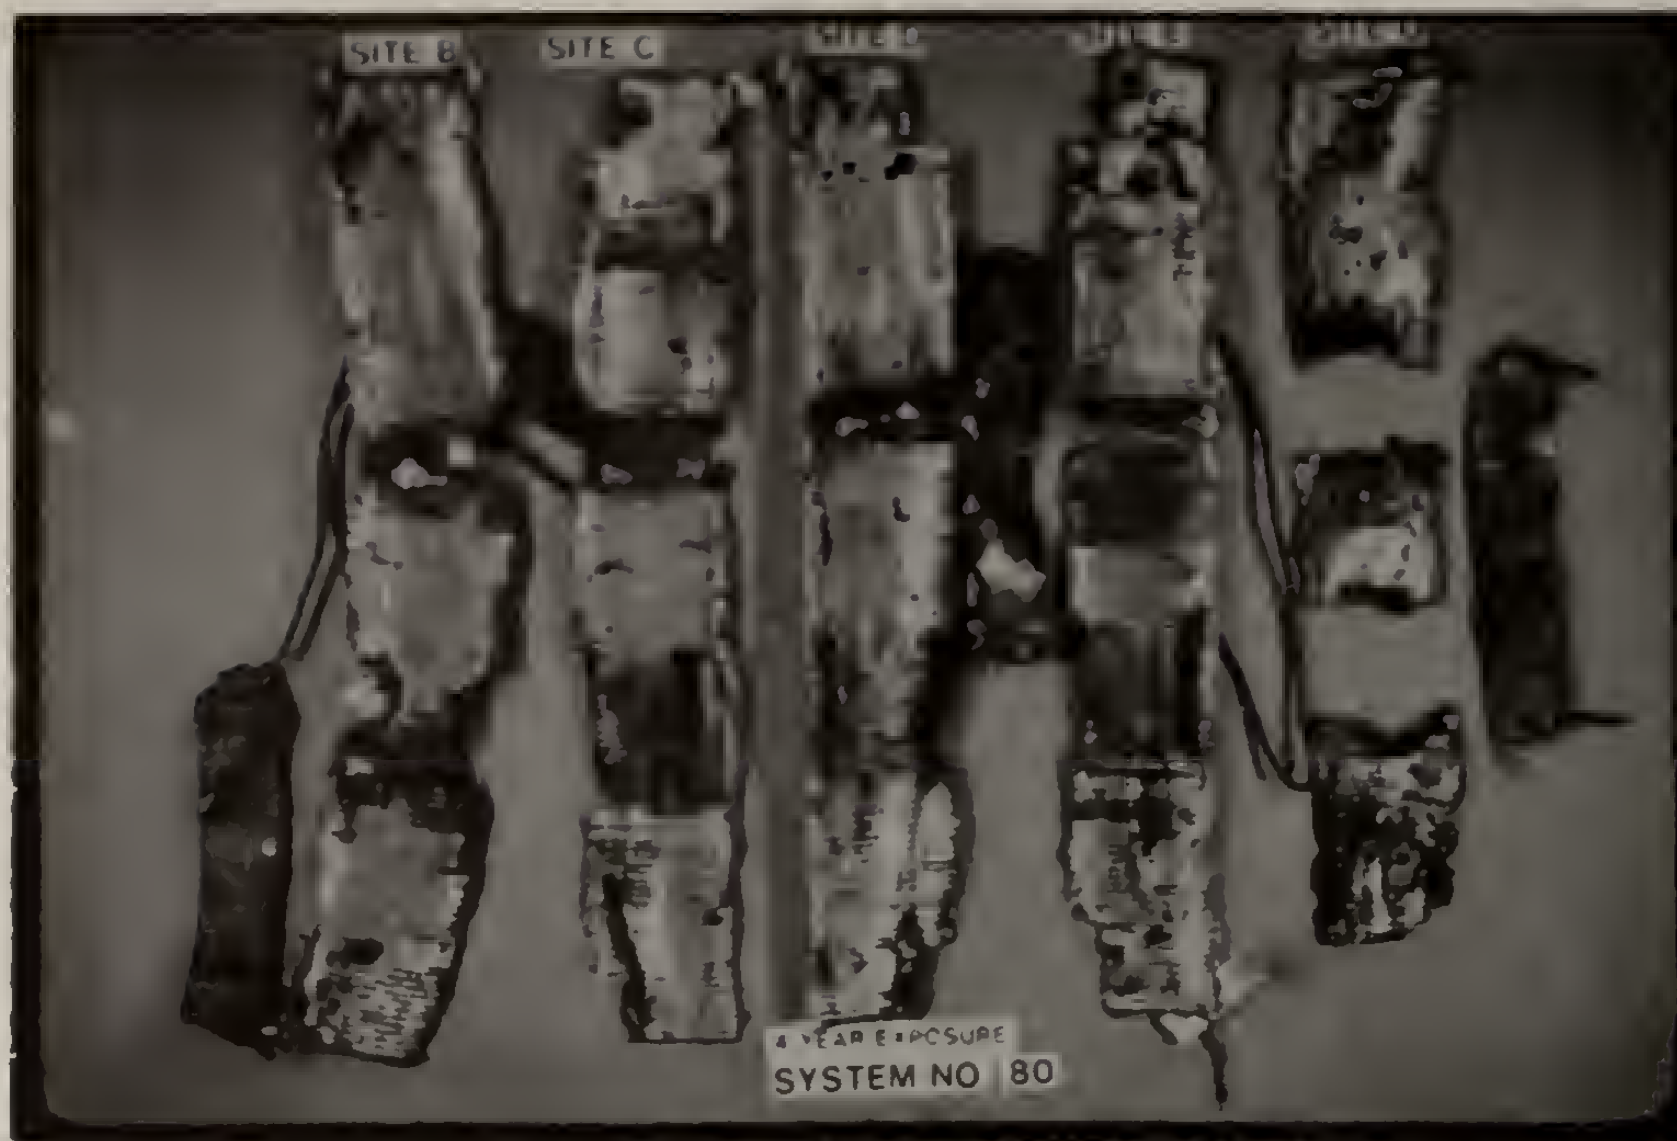
Figure 28. Outer Shield: System 80, Sites B, C, D, E, and G, left to right, exposed for four years. Coupling this system to copper accelerated corrosion on all specimens severely.

Figure 29. Inner Shield: System 80, Sites B, C, D, E, and G, left to right, exposed for four years. Coupling this system to copper accelerated the degradation on all specimens.

Figure 30 Outer Shield: System 81, Sites B, C, D, E, and G, left to right, exposed for four years. Dark areas indicate corrosion with severe corrosion on the specimens from Site G.

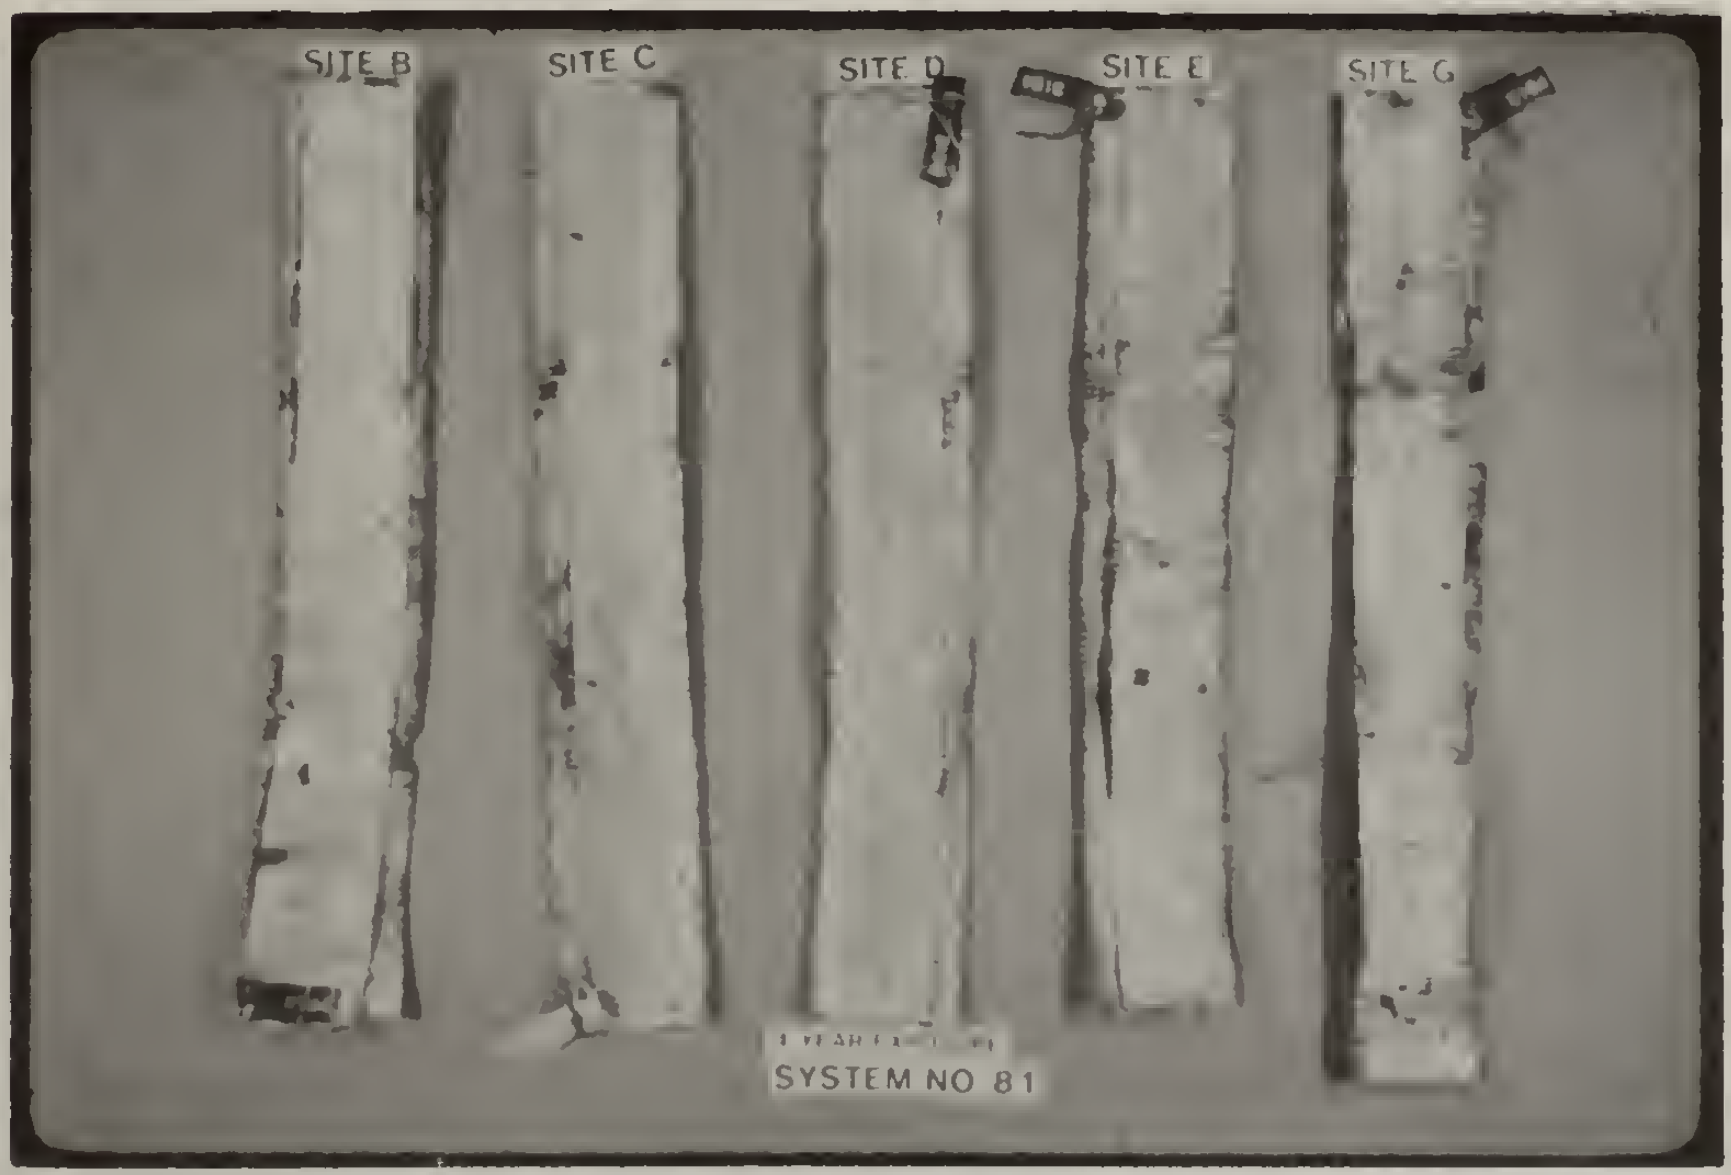
Figure 31. Inner Shield: System 81, Sites B, C, D, E, and G, Left to right, exposed for four years. Severe degradation at the window and ring areas on the specimen from Site G.

Figure 32. Outer Shield: System 82, Sties B, C, D, E, and G, left to right, exposed for four years. Coupling this system to copper accelerated corrosion at the window and ring areas.

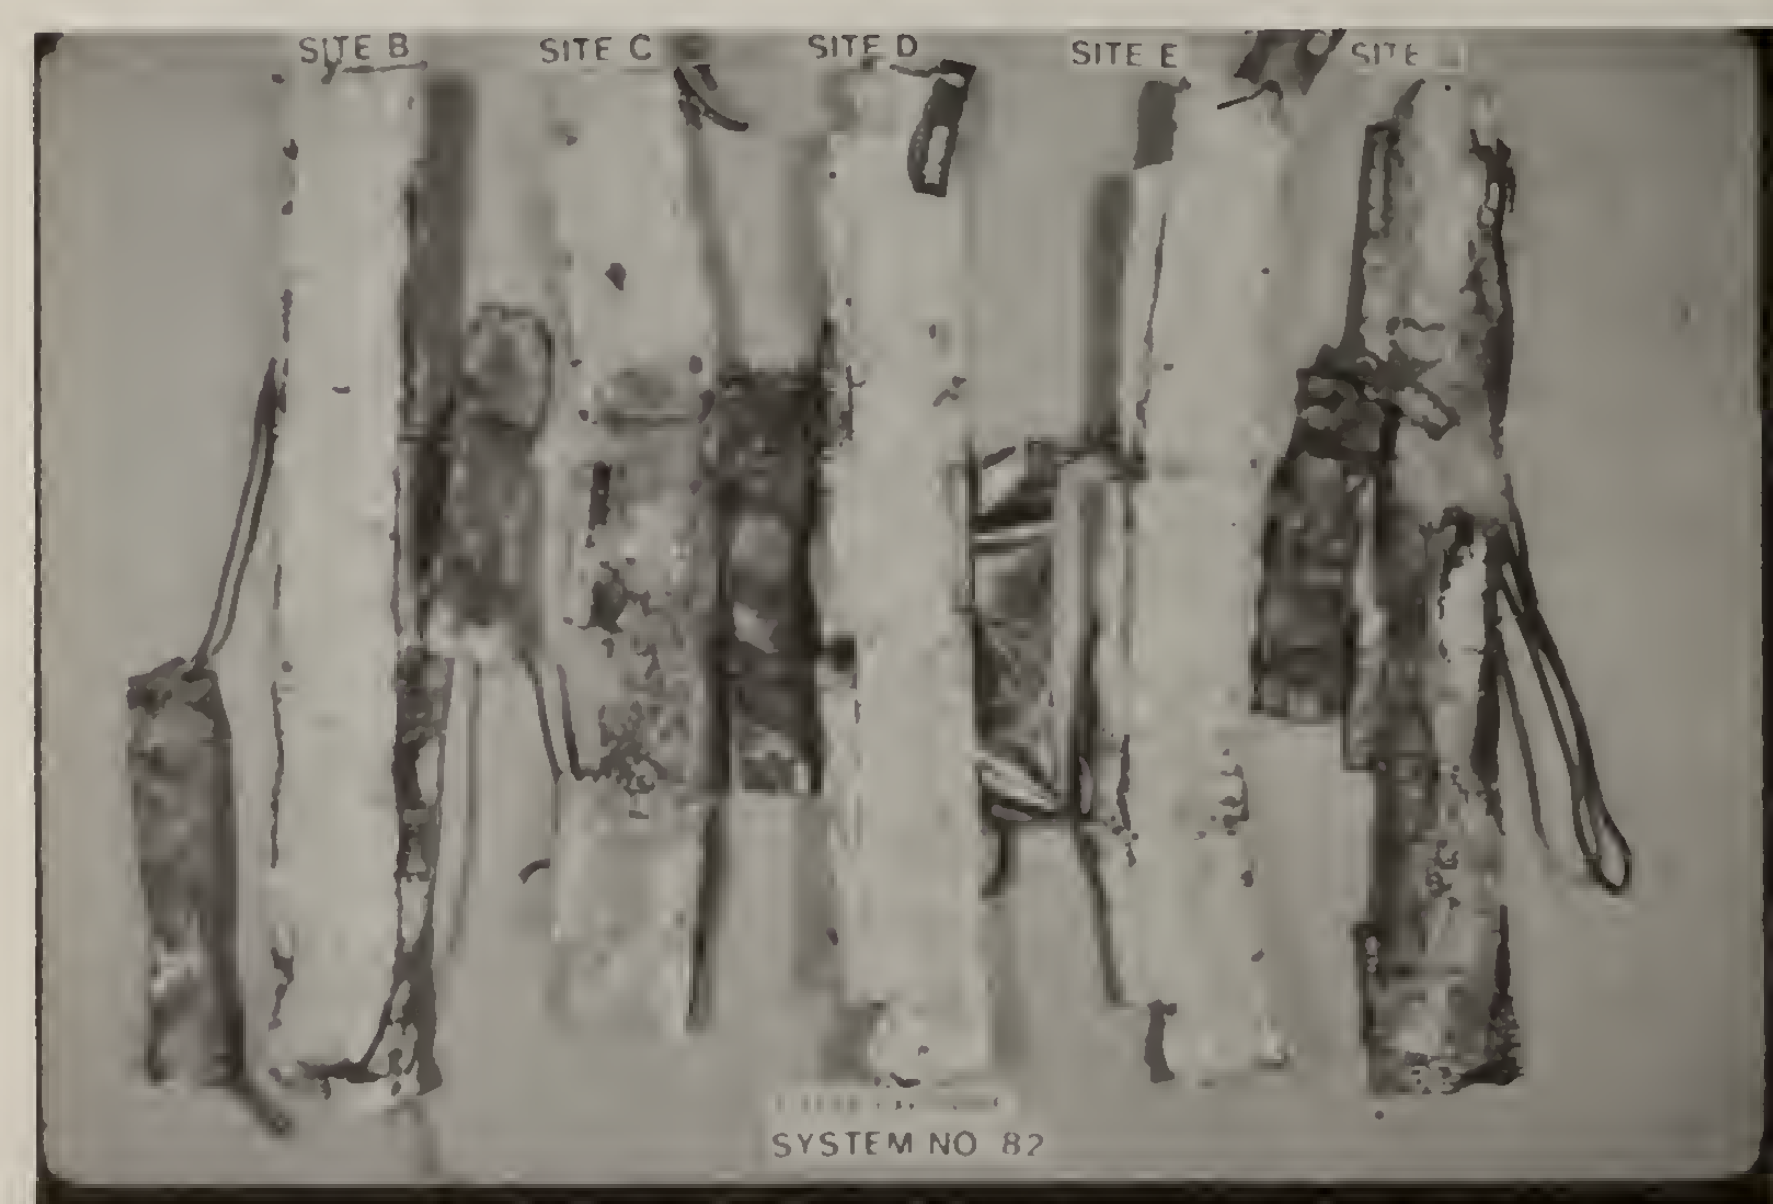
Figure 33. Inner Shield: System 82, Sites B, C, D, E, and G, left to right, exposed for four years. Coupling this system to copper accelerated degradation severely on the specimens from Sites C and G.

Figure 34. Outer Shield: System 83, Sites B, D, E, and G, left to right, exposed for four years. Severe corrosion at the window area on the specimen from Site G.

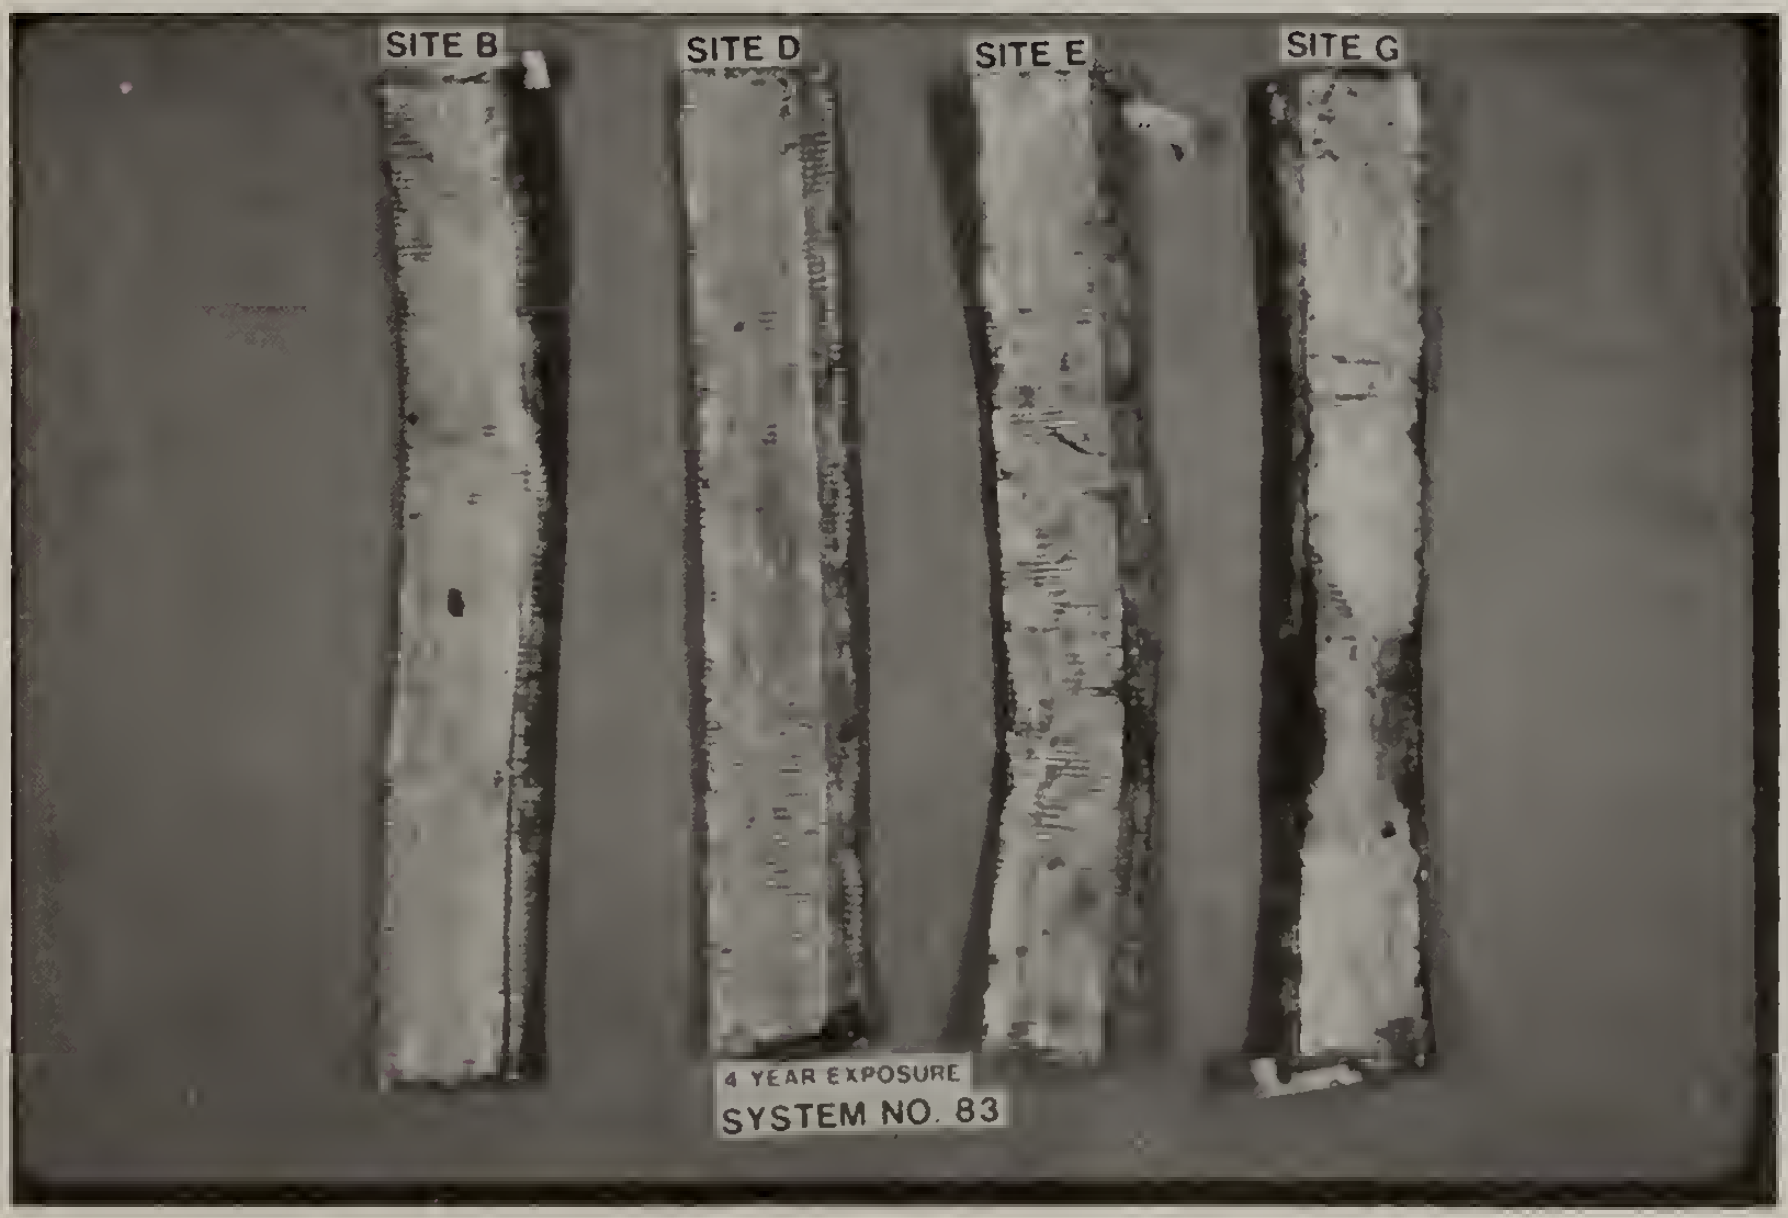
Figure 35. Inner Shield: System 83, Sites B, D, E, and G, left to right, exposed for four years. Dark areas indicate severe degradation at the window area on the specimen from Site G.

Figure 36. Outer Shield: System 84, Sites B, C, D, E, and G, left to right, exposed for four years. Coupling this system to copper accelerated corrosion at the window and ring areas.

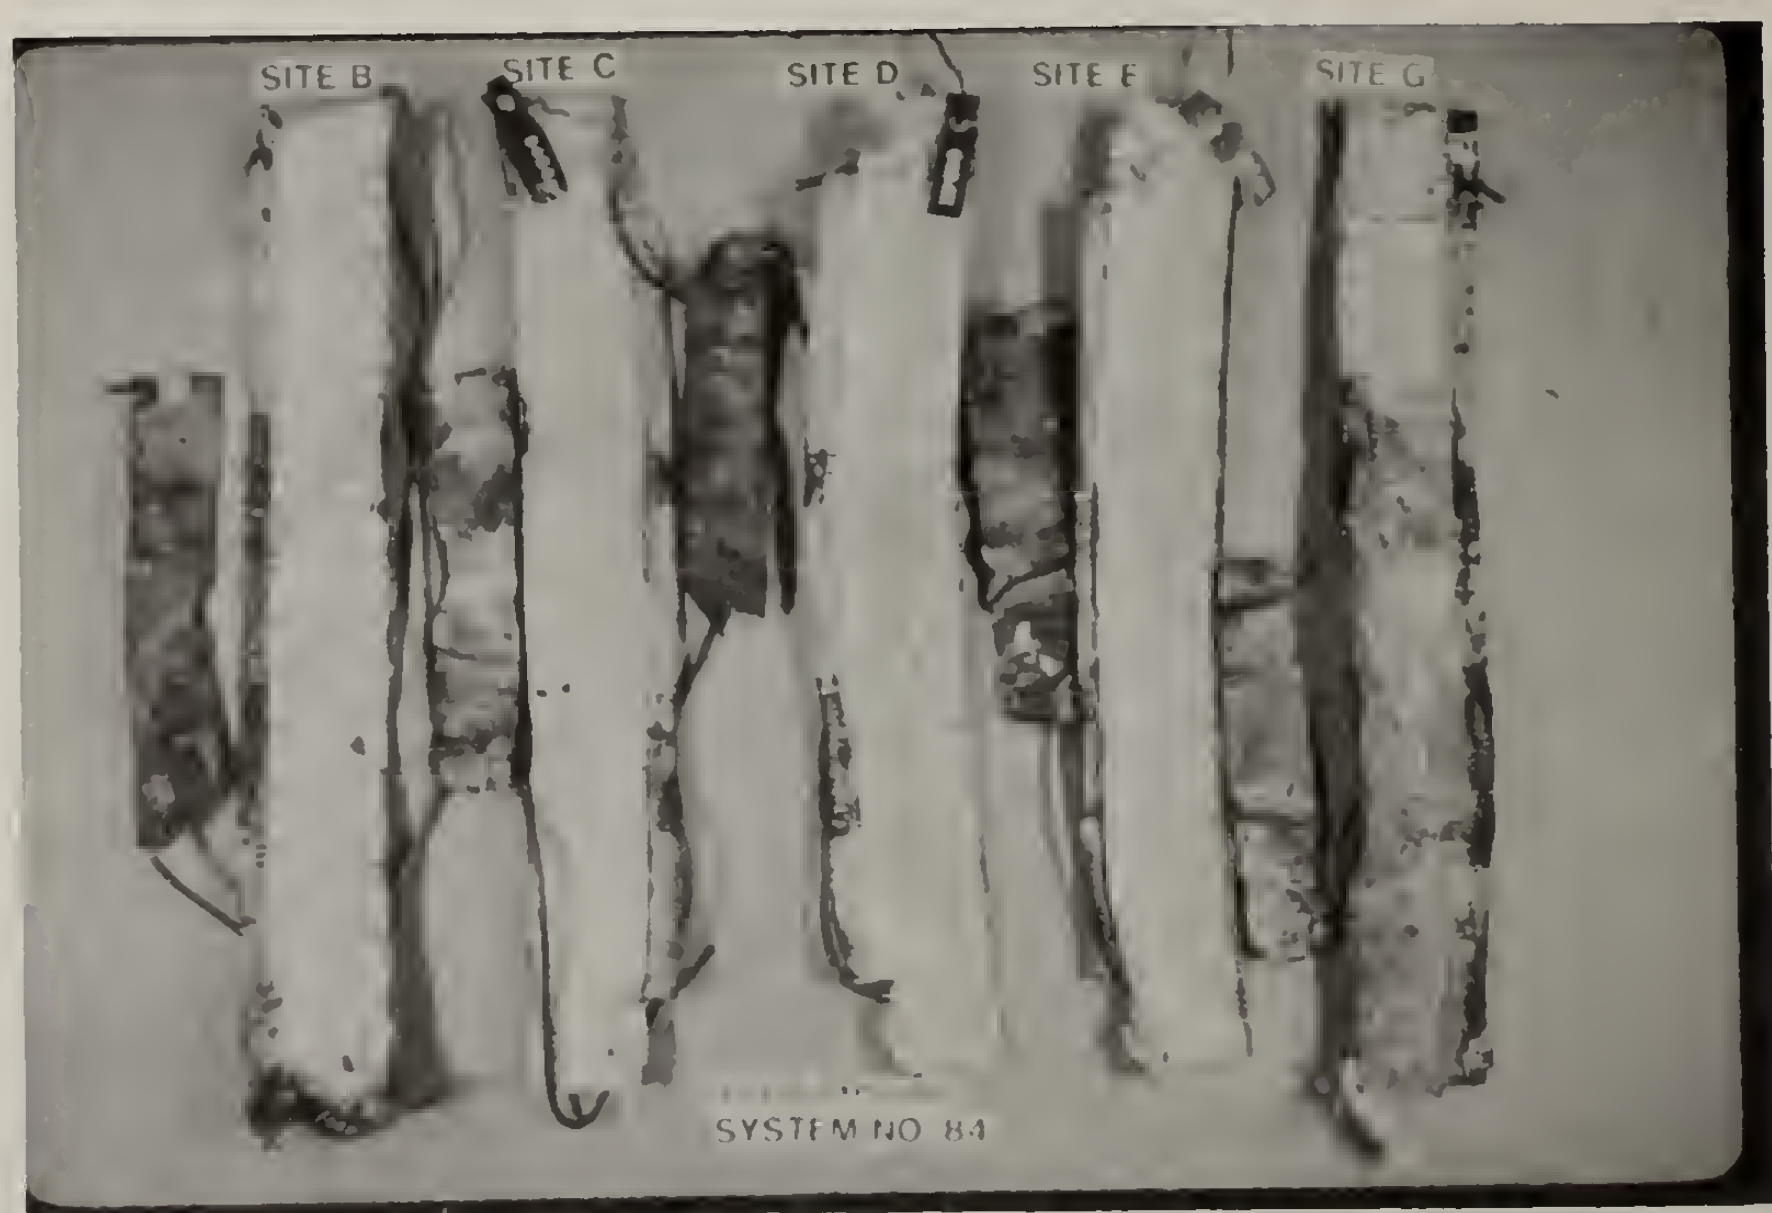
Figure 37: Inner Shield: System 84, Sites B, C, D, E, and G, left to right, exposed for four years. Coupling this system to copper accelerated degradation on the specimen from Site G severely.

Figure 38. Outer Shield: System 85, Sites B, C, D, E, and G, left to right, exposed for four years. Severe corrosion at the window and ring areas on the specimens from Sites B, C, D, and G.

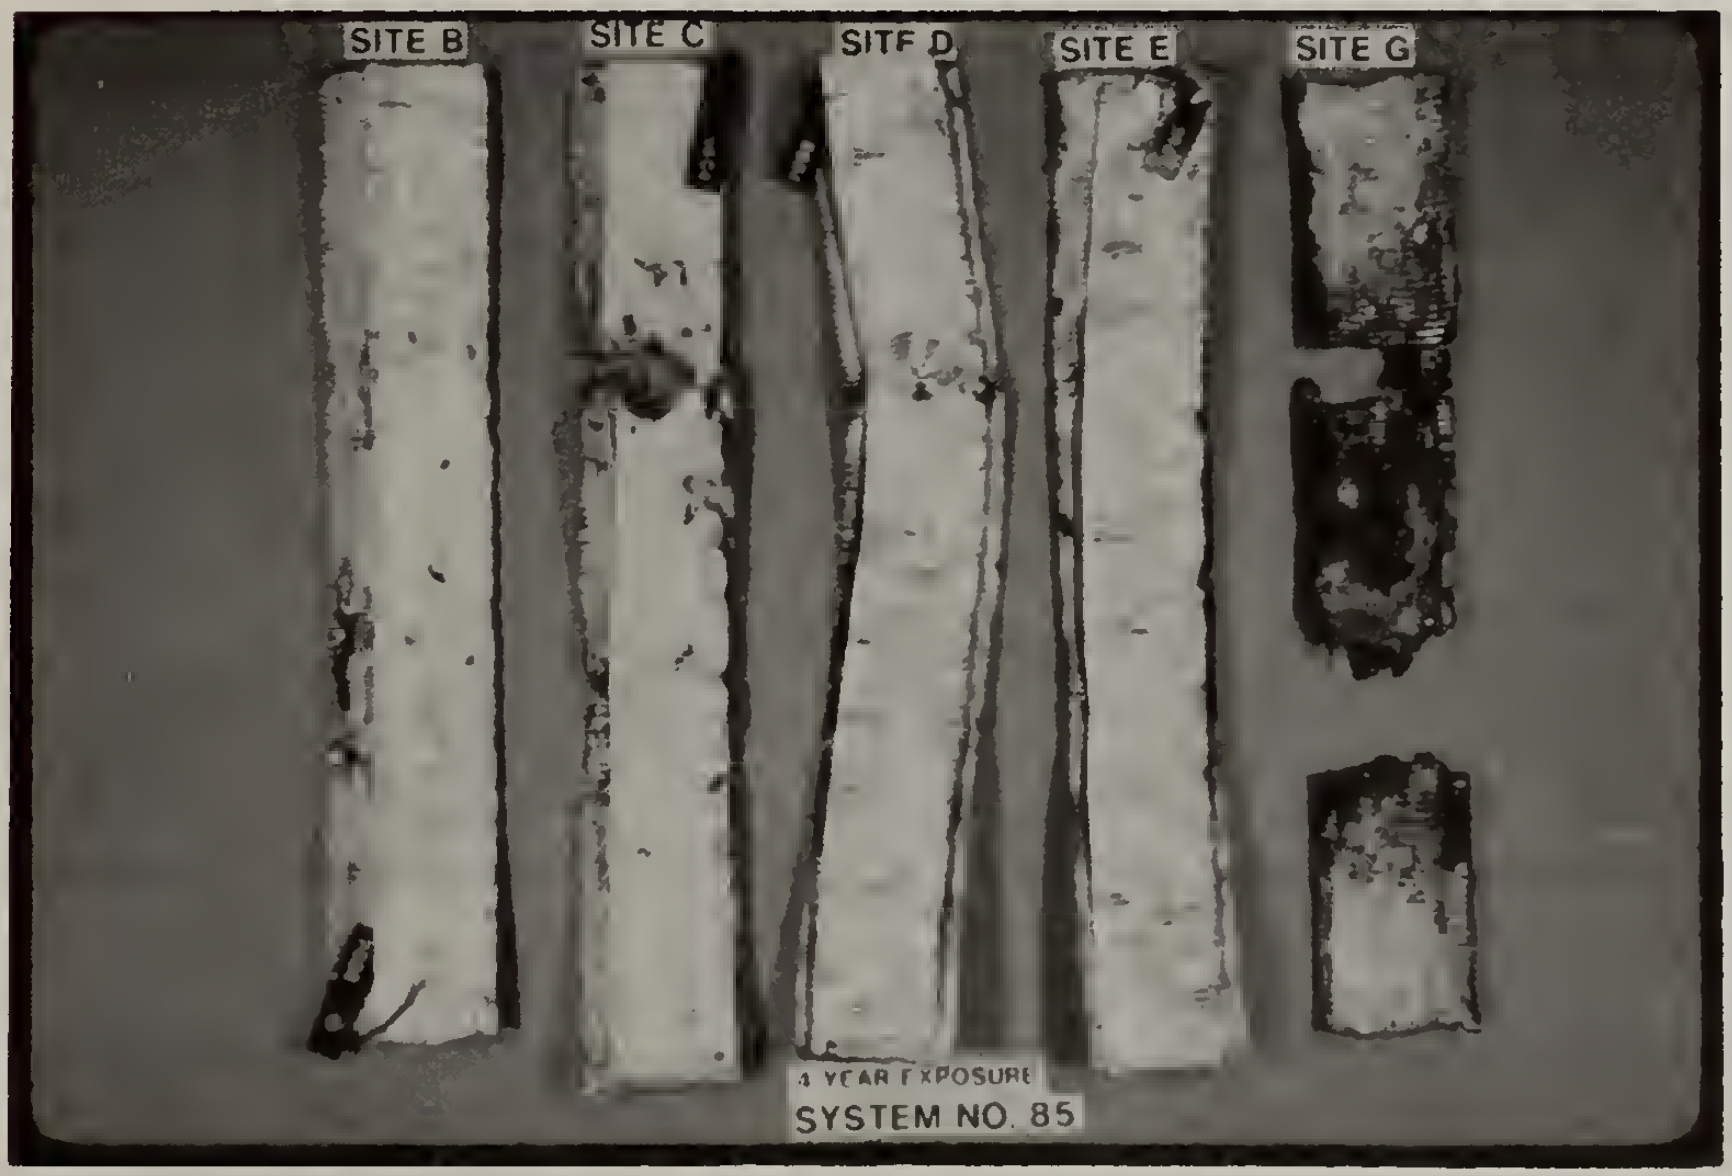
Figure 39. Inner Shield: System 85, Sites B, C, D, E, and G, left to right, exposed for four years. Severe degradation at all examined areas on the specimen from Site G.

Figure 40. Outer Shield: System 87, Sites B, C, D, E, and G, left to right, exposed for four years. Dark areas indicate corrosion with severe corrosion at window and ring areas on specimens from Sites B, C, D, and G.

Figure 41. Inner Shield: System 87, Sites B, C, D, E, and G, left to right, exposed for four years. The specimen from Site G was severely degraded.

Figure 42. Outer Shield: System 88, Sites B, C, D, E, and G, left to right, exposed for four years. Coupling this system to copper accelerated corrosion on all specimens severely.

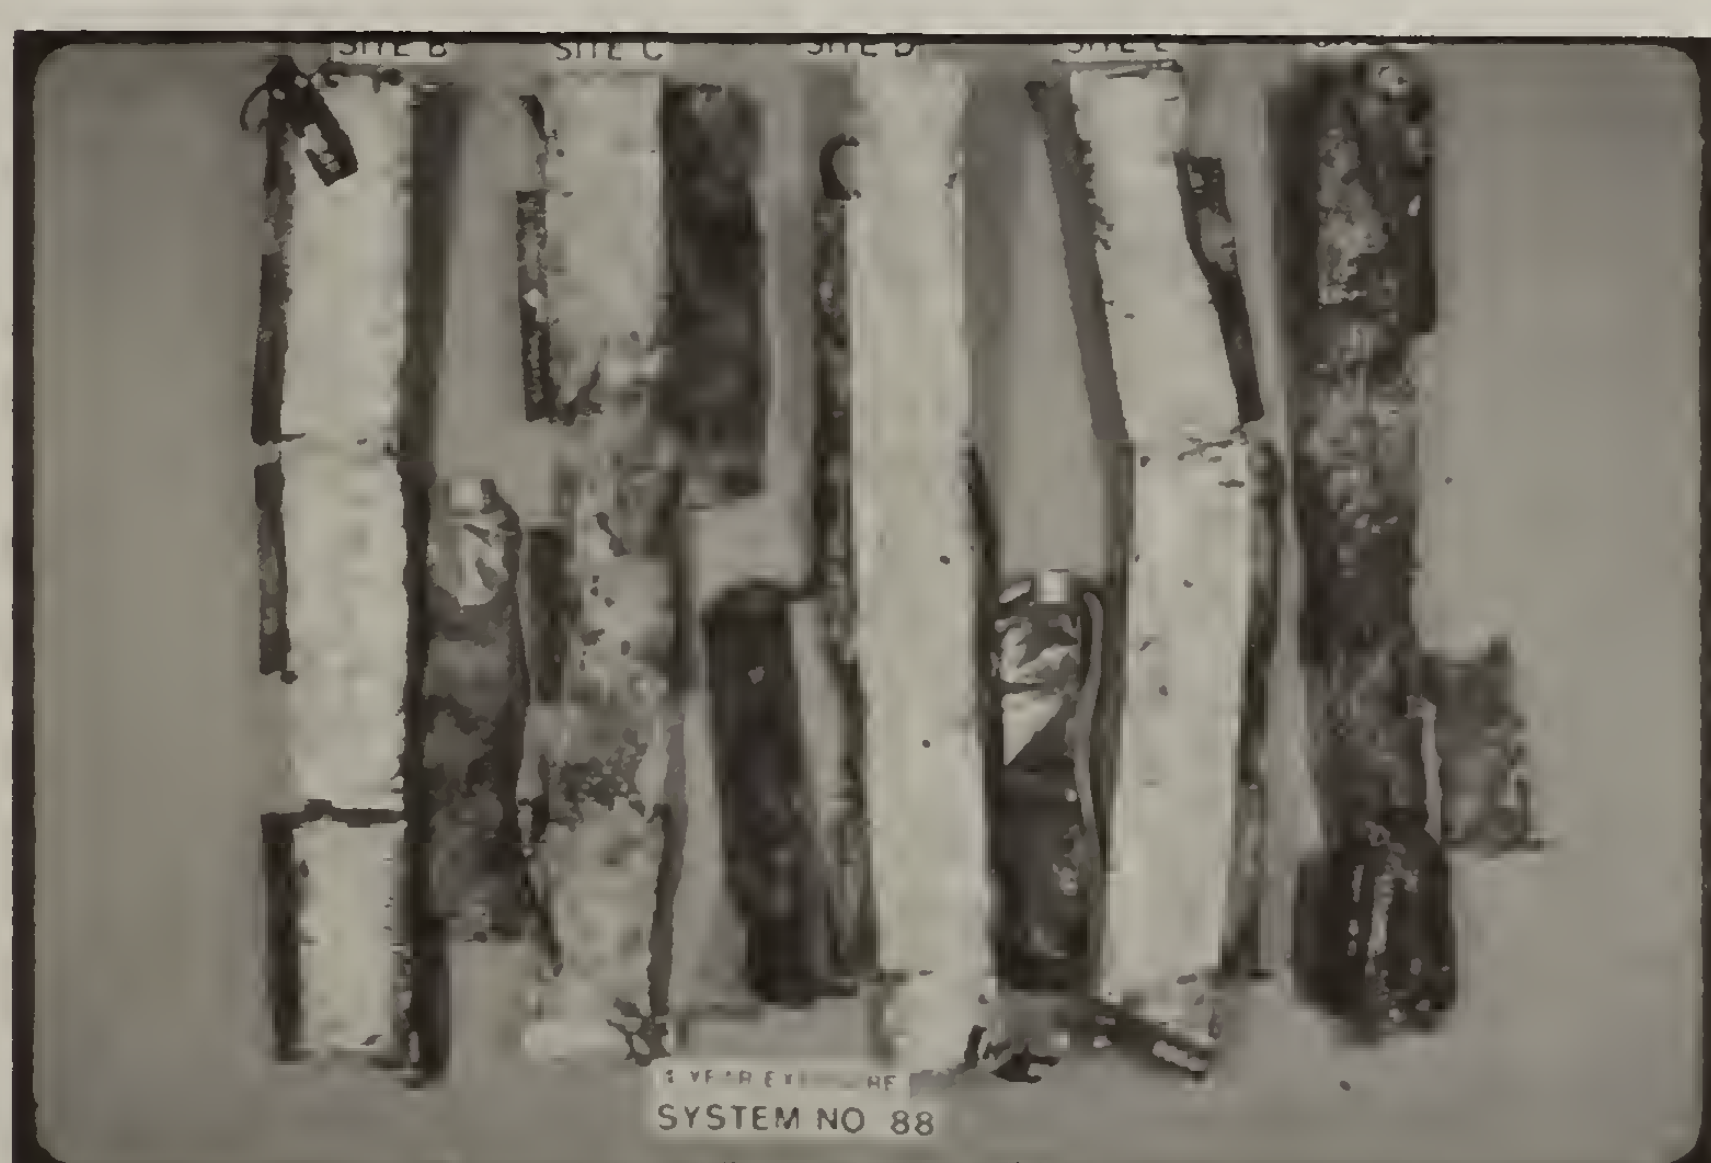
Figure 43. Inner Shield: System 88, Sites B, C, D, E, and G. left to right, exposed for four years. Coupling this system to copper accelerated degradation or the specimens from Sites C and G.
