NISTIR 3966

A CRYOGENIC 4.4 MN MECHANICAL TEST SYSTEM FOR LARGE SCALE TESTS OF COMPOSITE SUPPORT STRUTS

Materials Reliability Division
Materials Science and Engineering Laboratory
National Institute of Standards and Technology
Boulder, Colorado 80303

March 1992

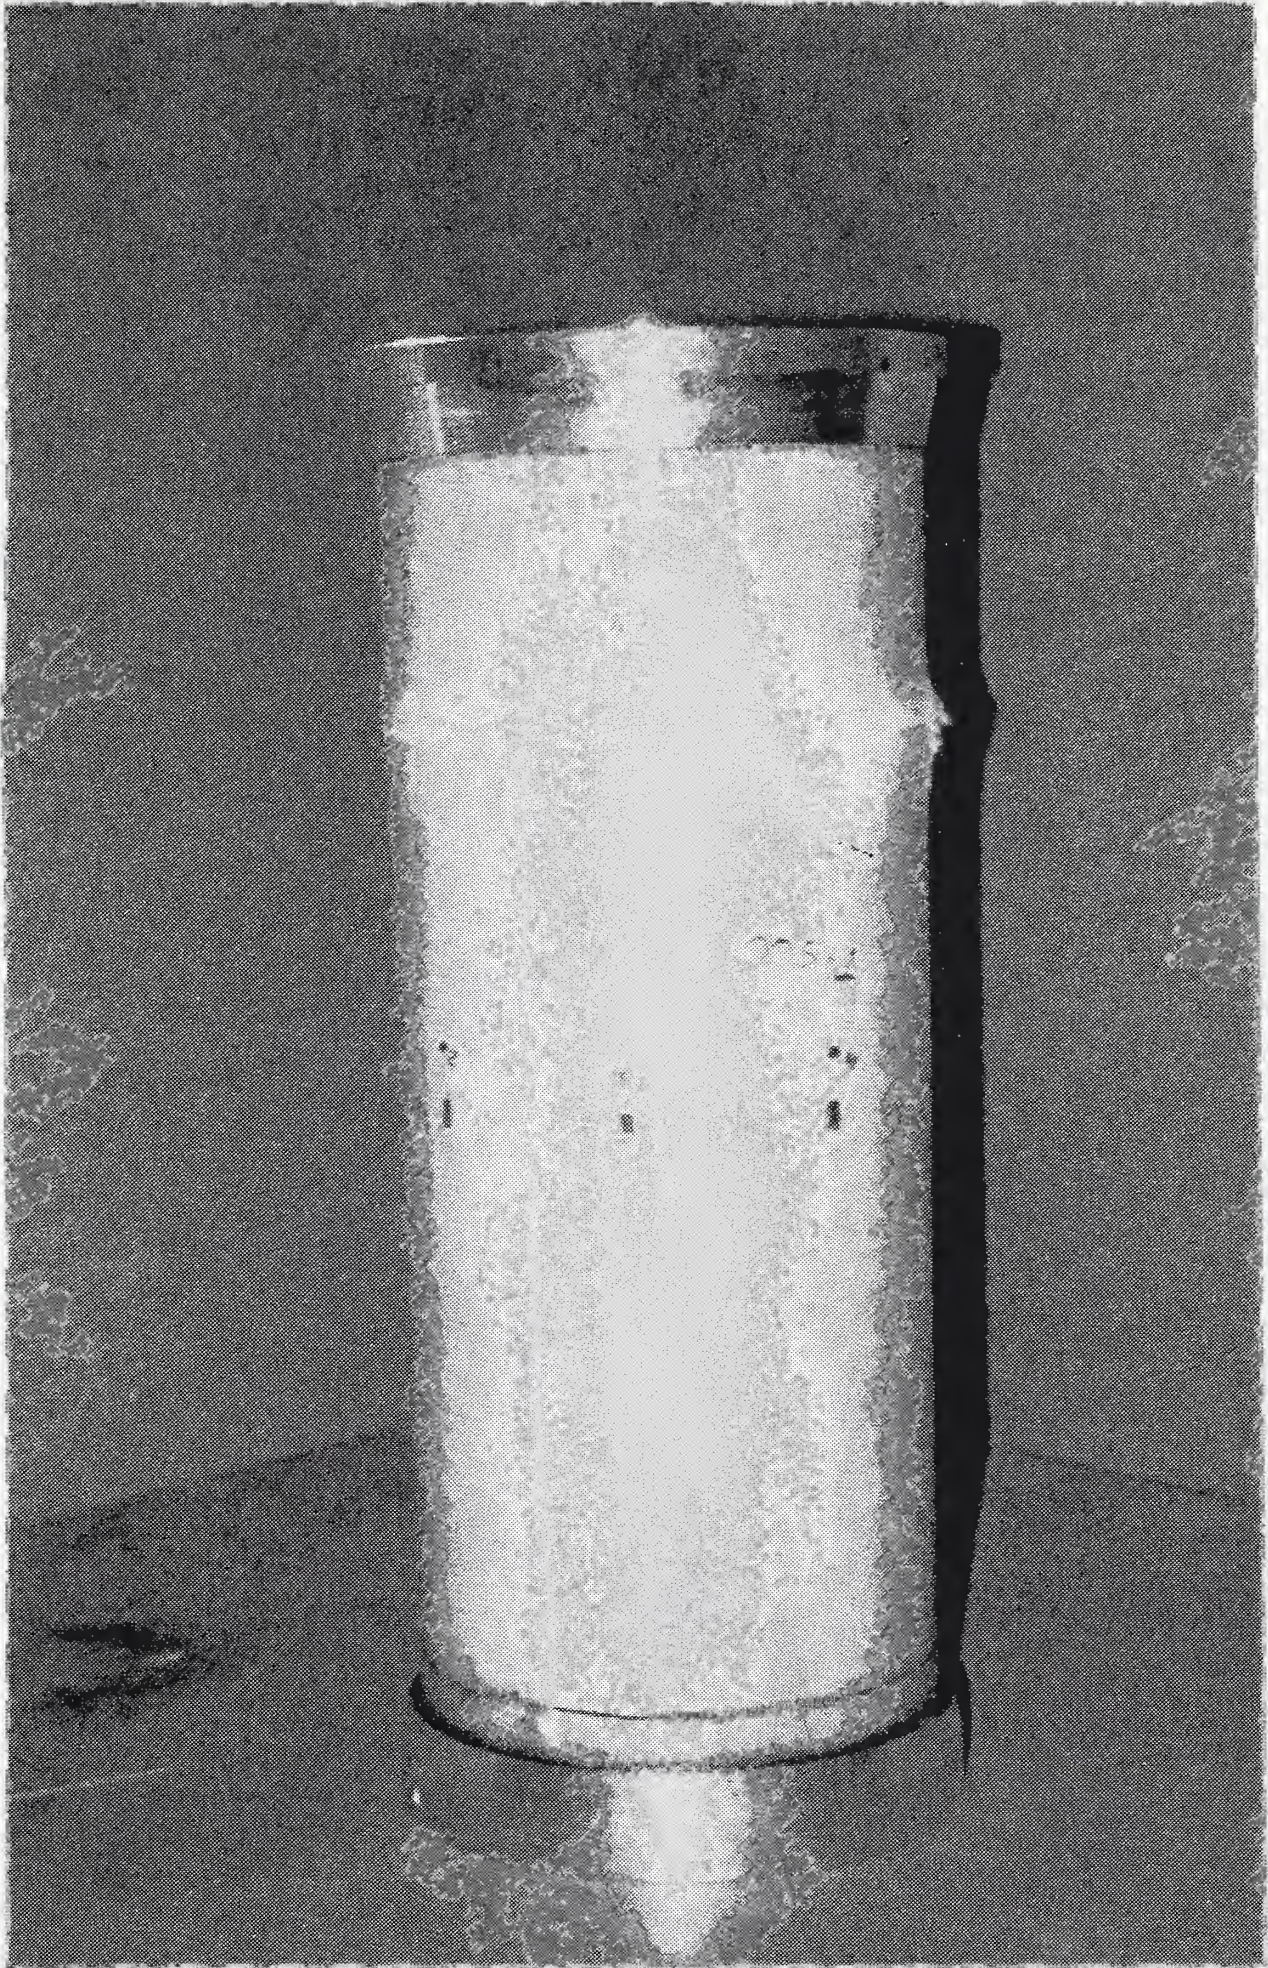
The specimen was tested at 295 K in a 4.4 MN (1000 kips) servohydraulic test machine. The specimen failed at a maximum compressive load of 1.6 MN (369 kips). The specimen failed in primarily a shell-buckling mode, but a longitudinal crack running the length of the specimen was found in post-mortem analysis. One end fitting had an exterior surface crack, radially oriented, about 150 mm (6 in) long.

The specimen failed at a maximum compressive load of 1.7 MN (384 kips) in the 4.4 MN (1000 kips) test machine. The primary failure mode was shell buckling which was also the failure mode of specimen 005-1. The shell buckling was preceded by a large longitudinal crack which initiated at the rigid aluminum end fitting and propagated the length of the specimen.

The aluminum end fitting exhibited premature failure at approximately half the maximum load. The end fitting failure was characterized by radial cracking on the exterior surface. The location of the cracking showed that the cracks initiated at the bottom of the internal groove. The cracks were 75 to 100 mm (3 to 4 in) long in about four places.

Figure 5.   A failed short specimen with end fittings.

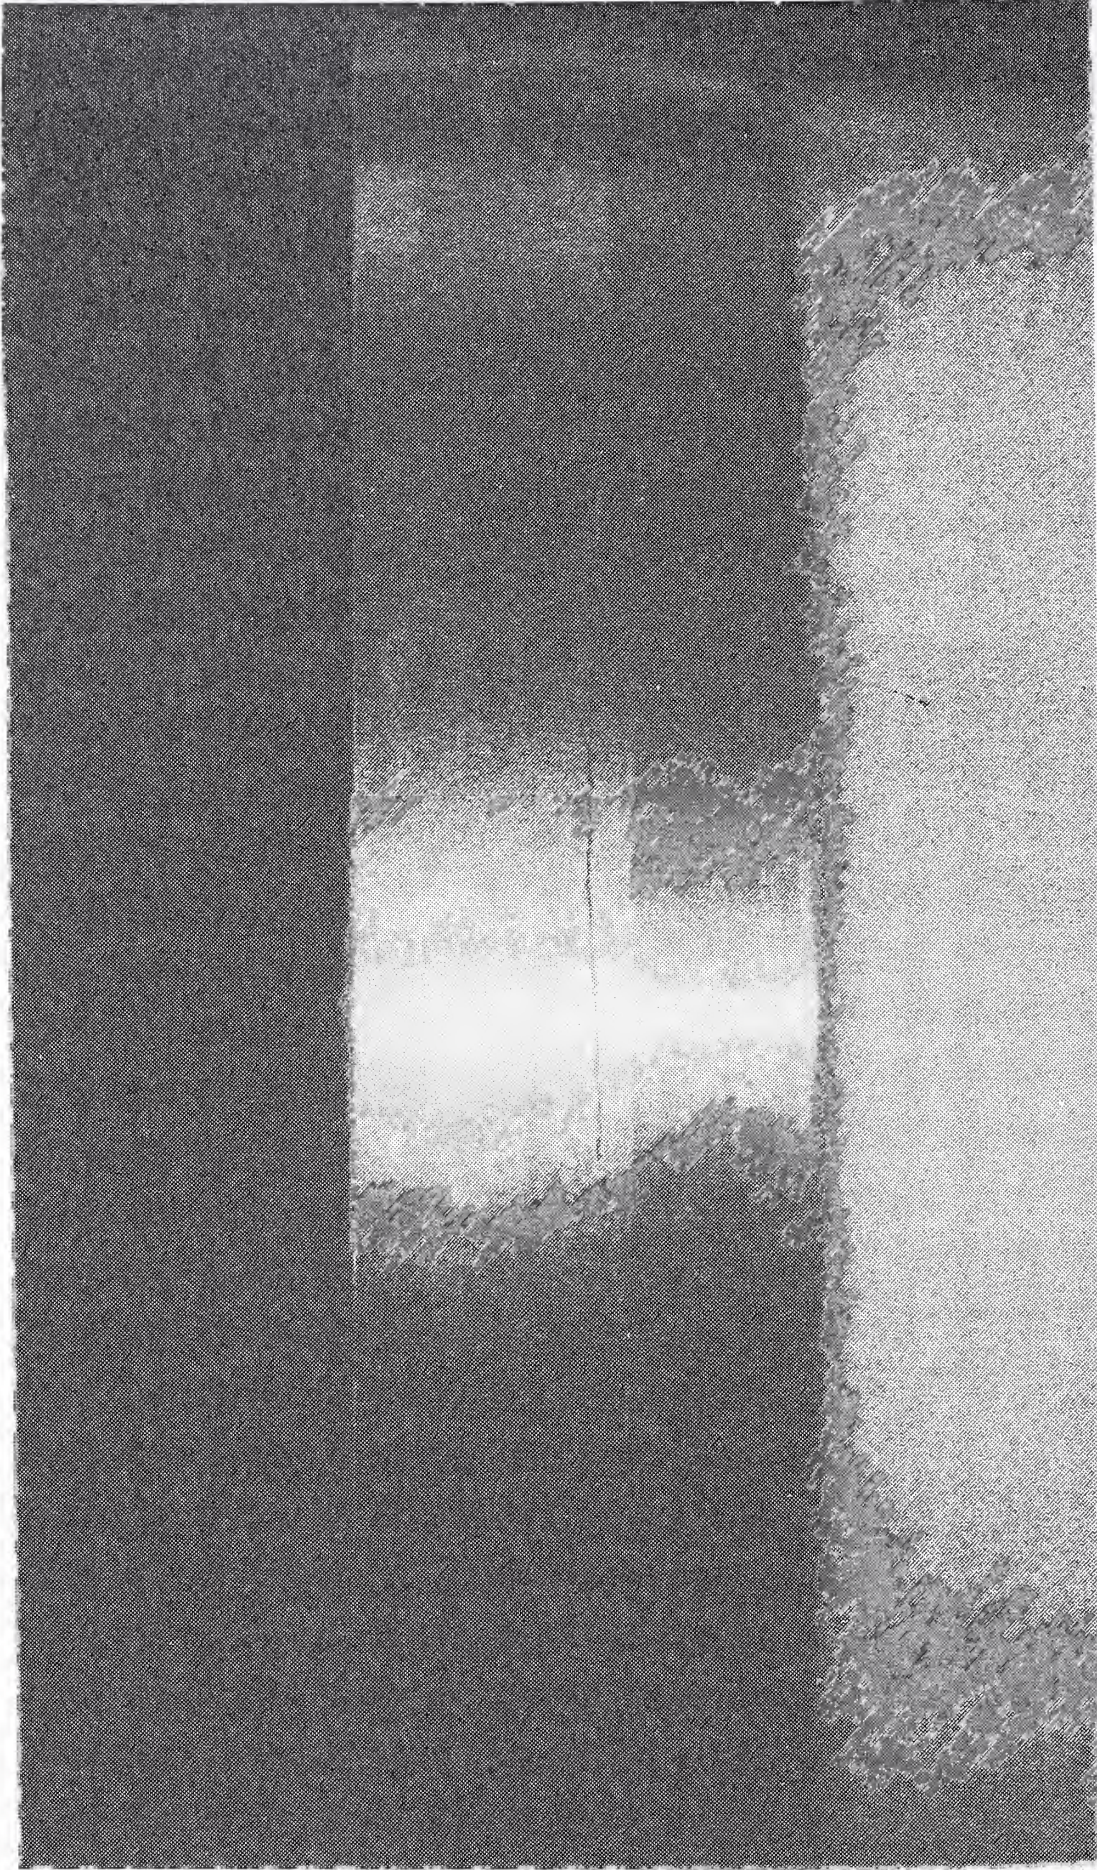
The other two tests (specimens 005-1 and 006-1) failed at loads of 1.6 MN (369 kips) and 1.7 MN (384 kips) giving an average ultimate strength of 262 MPa (38 ksi). The failure mode for these two tests was shell buckling, but both tubes had longitudinal cracks emanating from one end (see Figure 5). The end fittings also exhibited initial signs of failure on both tests. Circumferential cracks on the exterior surface of the end fitting (relative to the base of the internal machined groove) were observed (see Figure 6).

The specimen failed catastrophically by a combination of failure modes: shell buckling, column buckling, and longitudinal cracking. Column buckling is indicated by the midlength fracture and the angle at which the specimen came to rest after the failure event. Shell buckling is inferred from the appearance of the fracture area: both halves of the specimen are broomed, splayed, and pushed together (Figure 9). Both end fittings exhibited the initial signs of failure described for the previous short specimen tests: circumferential cracking on the exterior surface relative to the base of the internal machined groove (Figure 6).

Figure 6. A circumferential crack on surface of end fitting.

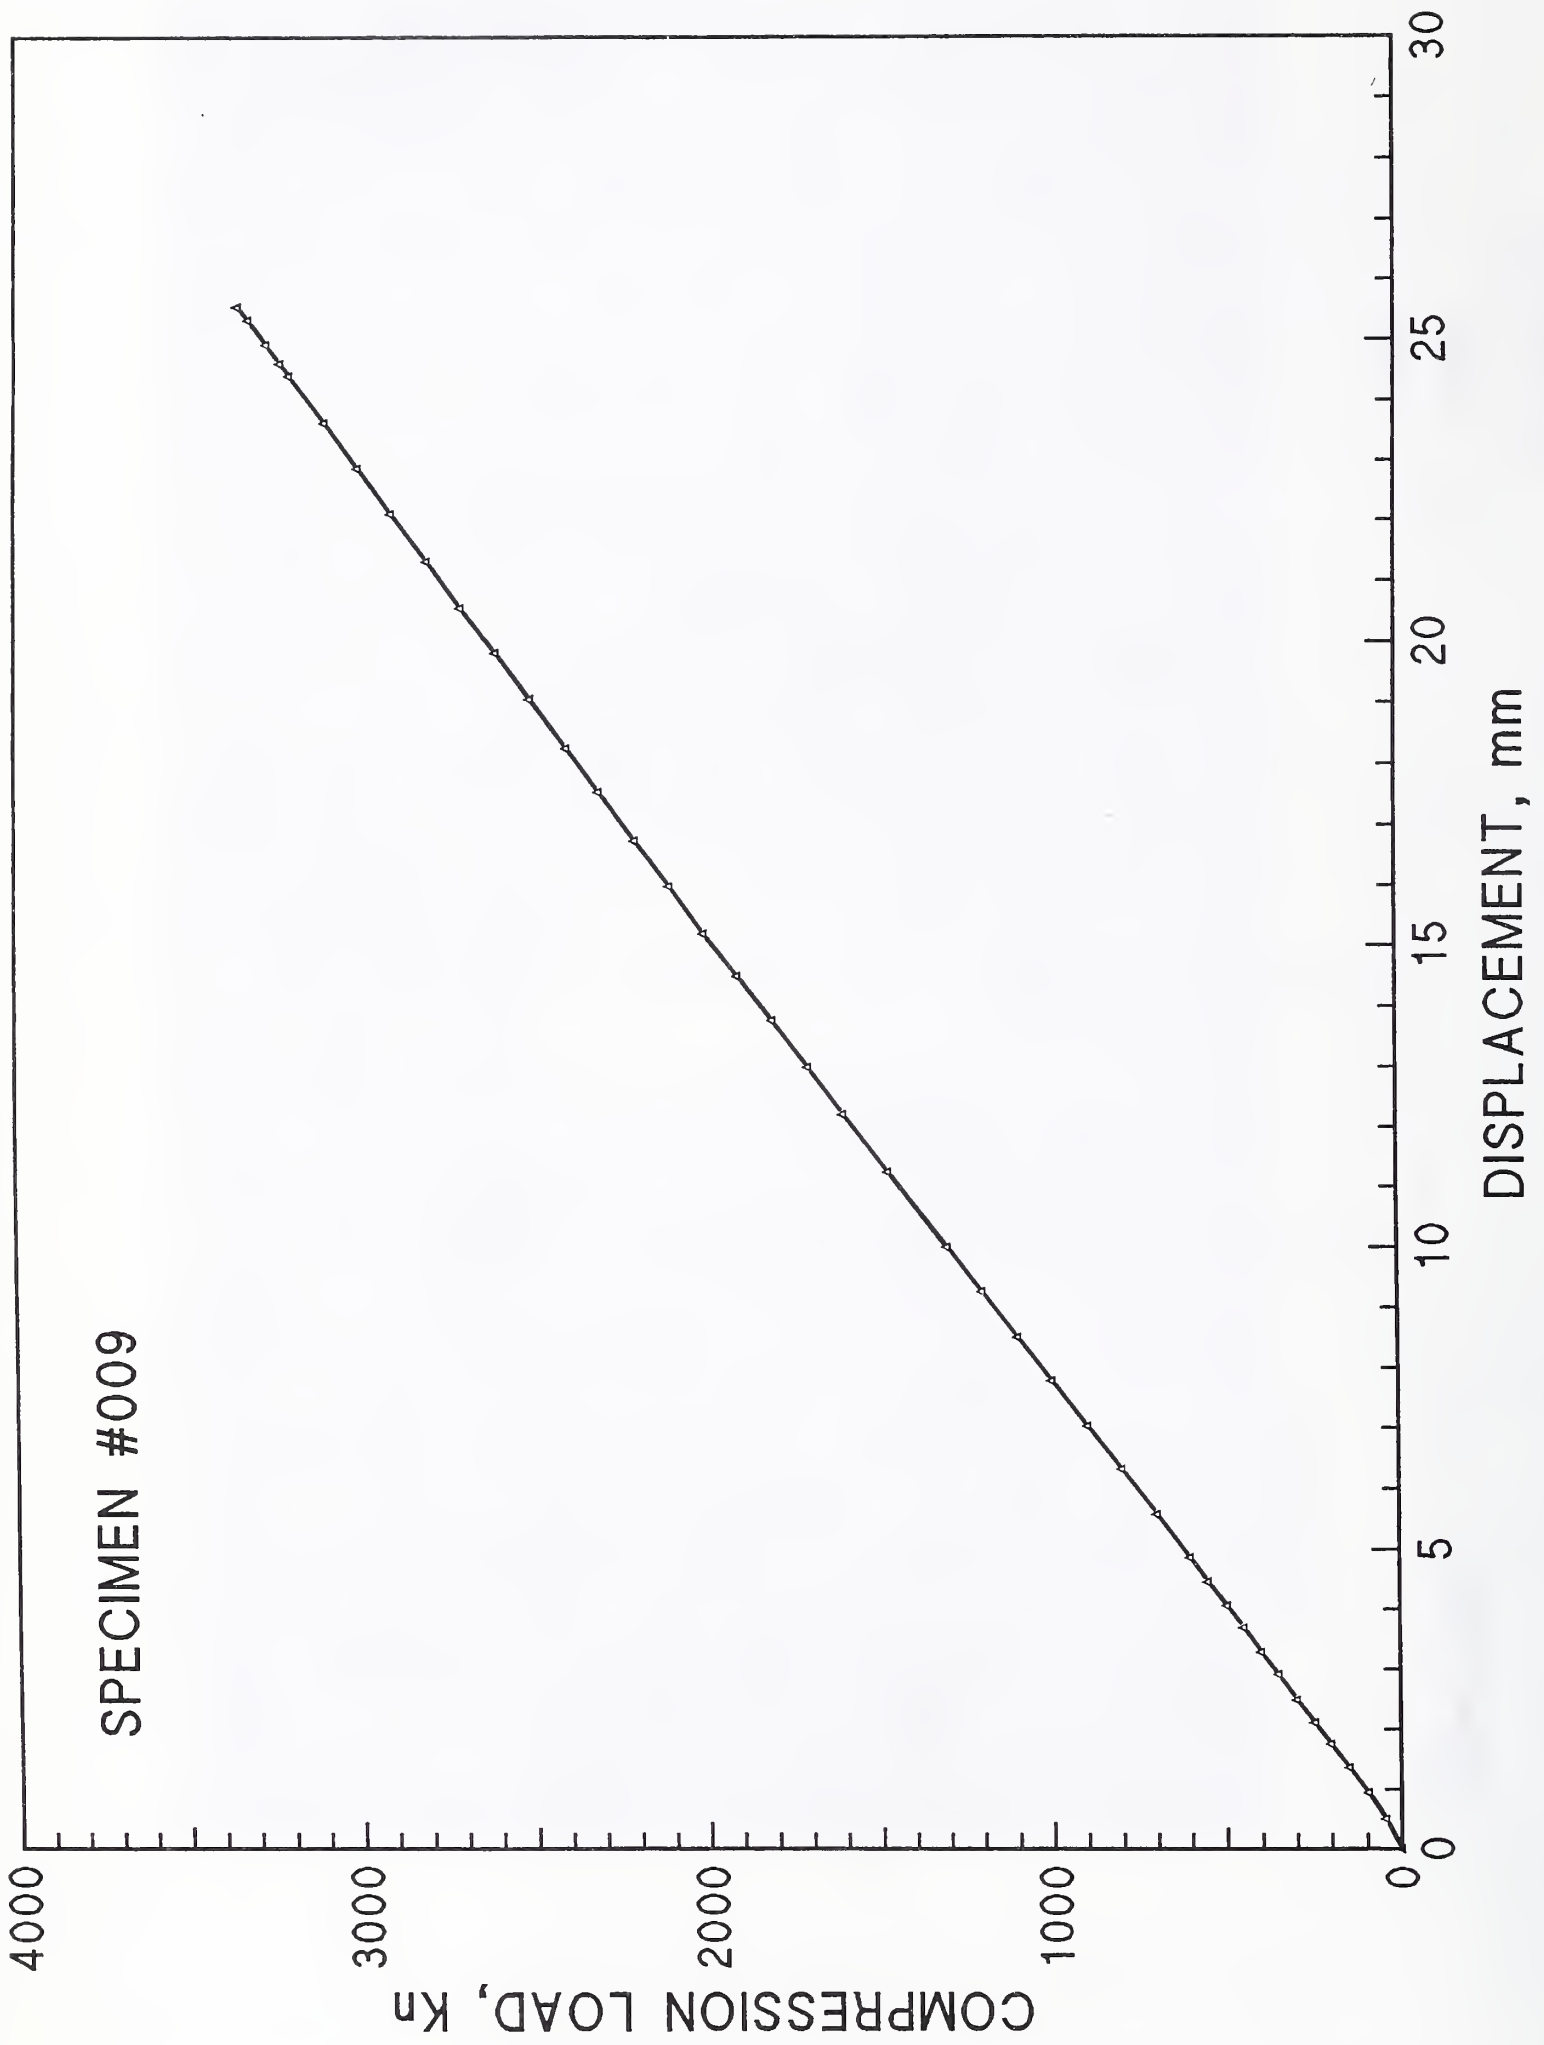
Figure 8. Load-versus-displacement curve for specimen 009.

The full scale, ultimate compressive strength test on specimen 009 was successful in characterizing the mechanical performance of the FRP tube subjected to a thermal gradient. The failure stress (518 MPa) was slightly lower than expected (620 MPa). The location of the failure is a potential problem that needs further design evaluation. It is also important that the specimen failed in a cold (140 K) region. Further down the specimen (Figure 7), the temperature was higher (190 K) and the stress was equivalent (518 MPa). The end fittings again exhibited cracking which possibly induced premature failure of the FRP tubes.

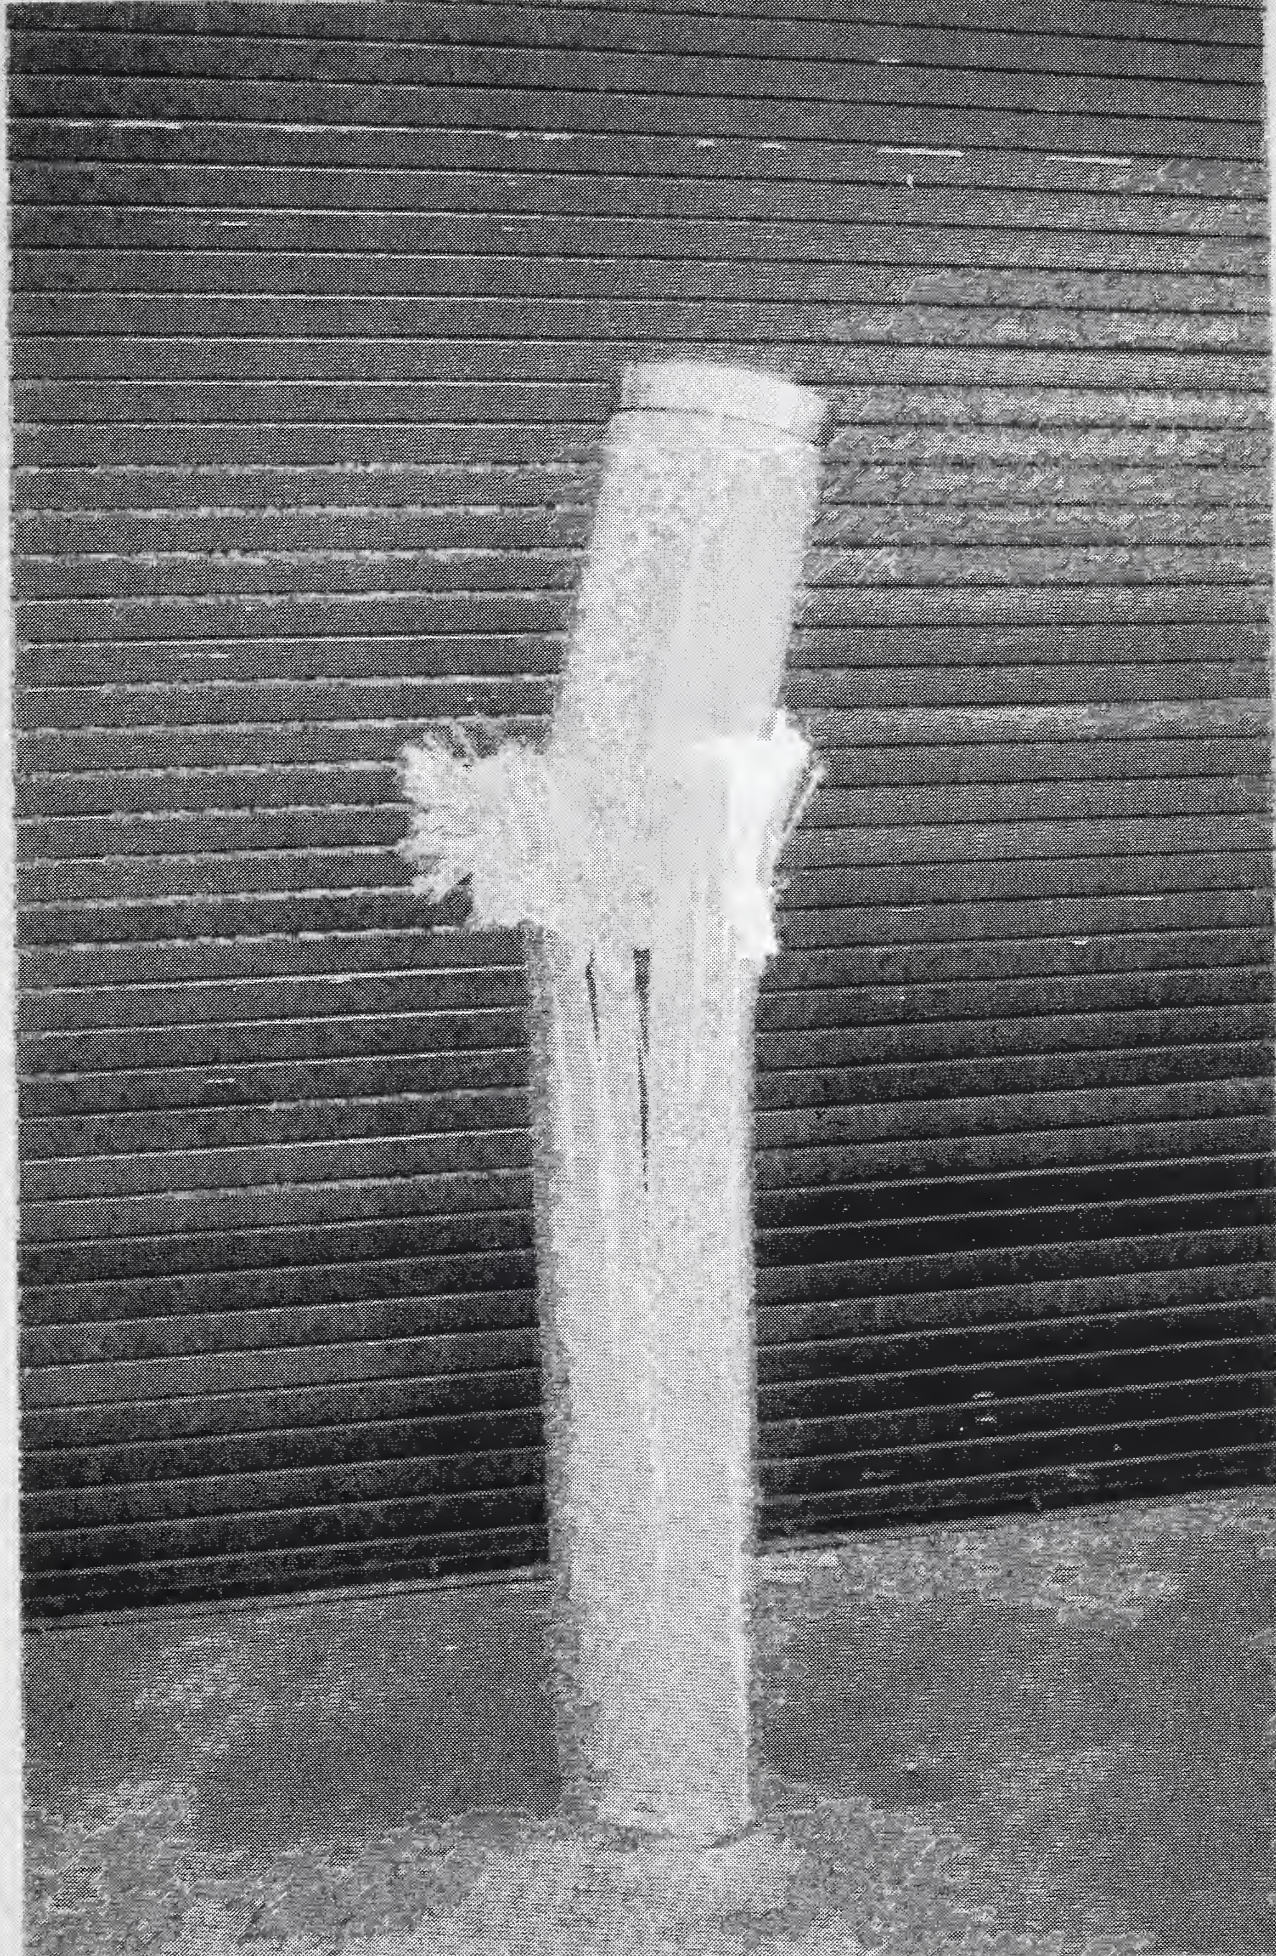
Specimen 009 failed in the mid-region, where the liquid nitrogen thermal intercept was attached (Figure 9). At this location, several factors could influence the stress field in the material. The mechanical attachment of the thermal intercept (Figure 10) could increase the localized stress on the specimen since it confines diametral strain when the tube is compressed. This is also the location along the length of the specimen where the specimen changes from a constant cross-sectional area (see Figure 1) to an increasing outside diameter and increasing cross-sectional area.

The ultimate compressive strength of specimen 009 was 518 MPa (75 ksi). The temperature in the region of fracture was 140 K. The elastic modulus calculated from the load-displacement curve was 45 GPa (6.5 Msi). Total strain to failure was 0.0135.

Figure 9.   Specimen 009 after ultimate strength test.

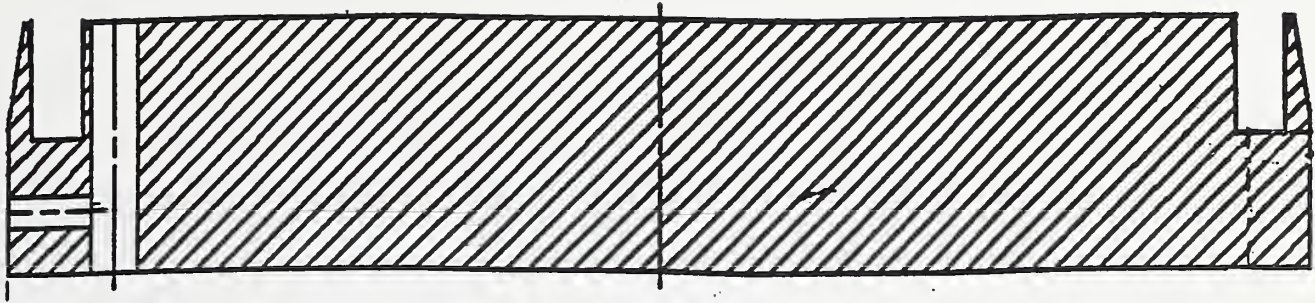
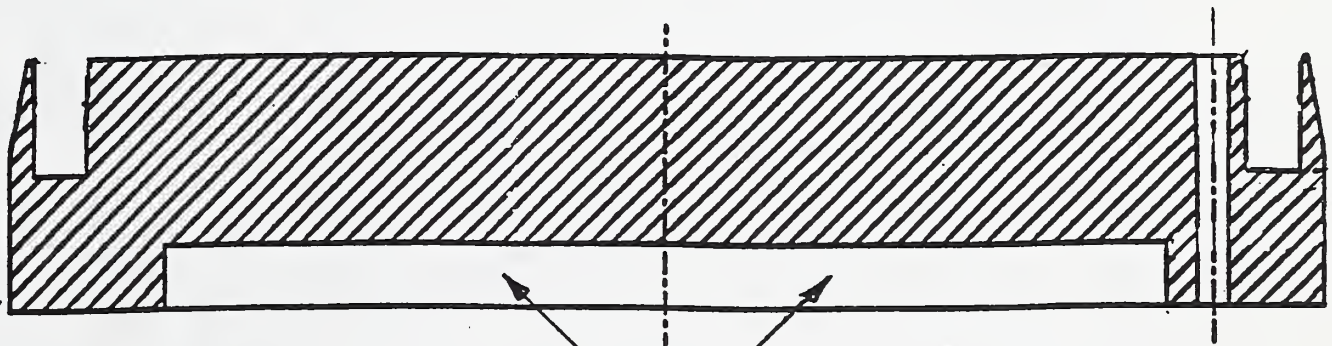
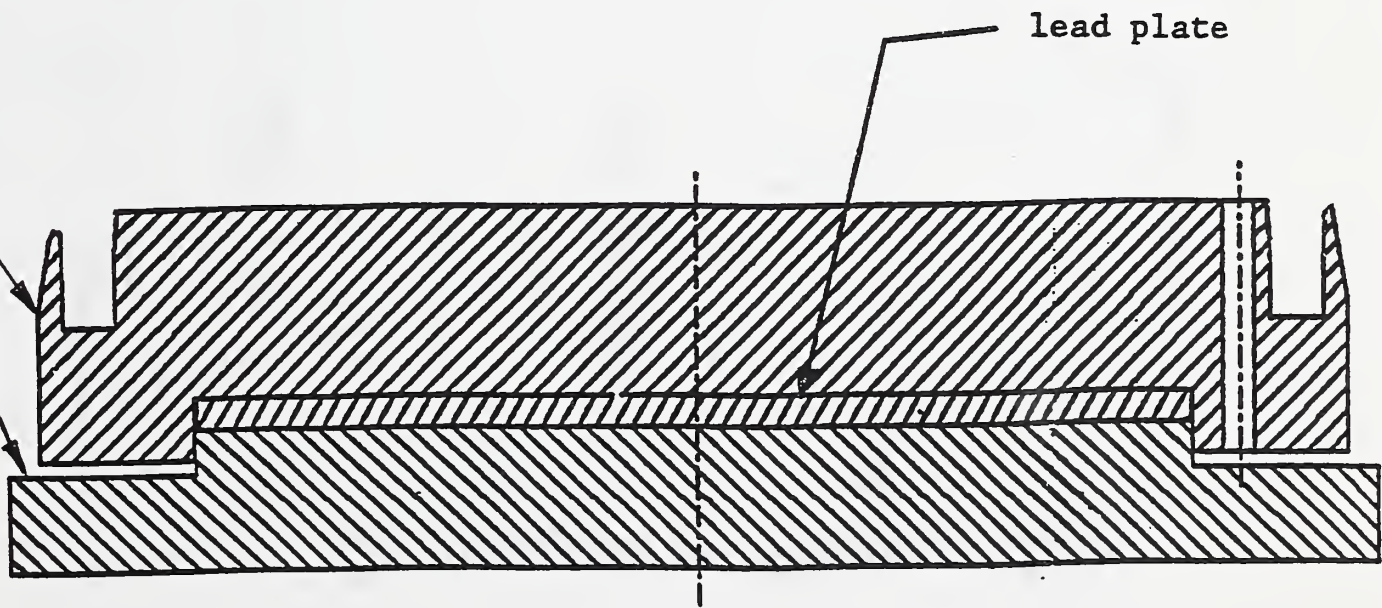
Two extreme thermal gradient tests, using liquid helium cooling, are discussed in this section. The first (specimen 007) was a cyclic fatigue test that had multiple failure events before total catastrophic failure at 385 cycles. The second (specimen 008) was a single load cycle test performed with approximately the same environmental and mechanical conditions to help analyze the results of the first test. The two fatigue specimens were fitted with self-aligning end fittings. The difference in design between the two types of end fittings is shown in Figure 11.

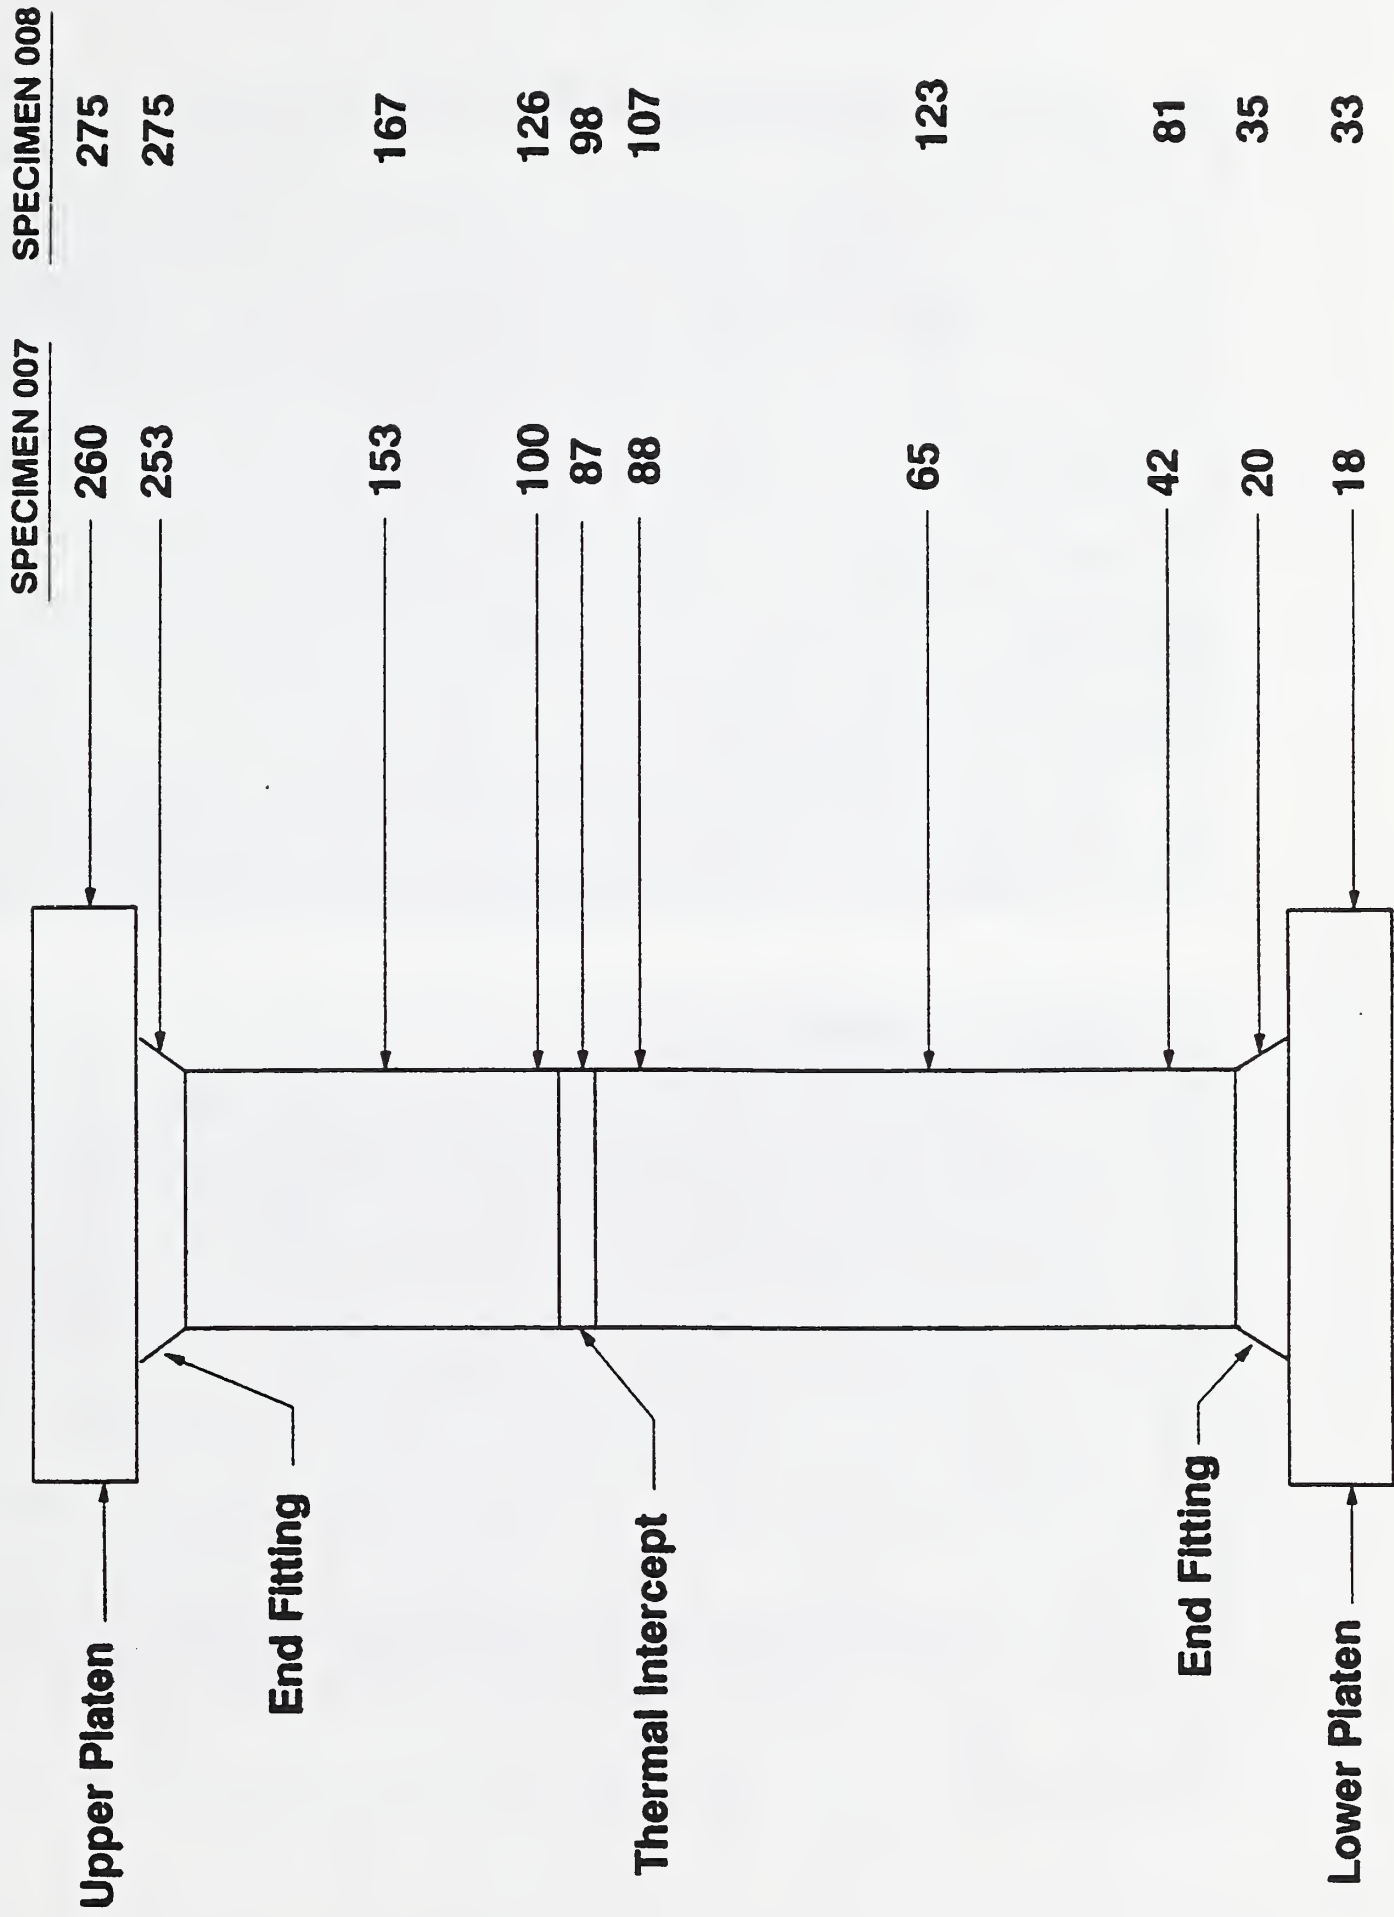
Figure 13.   Schematic for thermal gradient of specimens 007 and 008.

After 12 h in phase II cooling, the lower platen and the lower end fitting temperatures were both 35 K while 25 mm (1 in) above the end fitting, the specimen temperature was 83 K. At the intermediate liquid nitrogen thermal intercept the specimen temperature was 100 K. The thermal gradient measured just before testing is shown schematically in Figure 13.

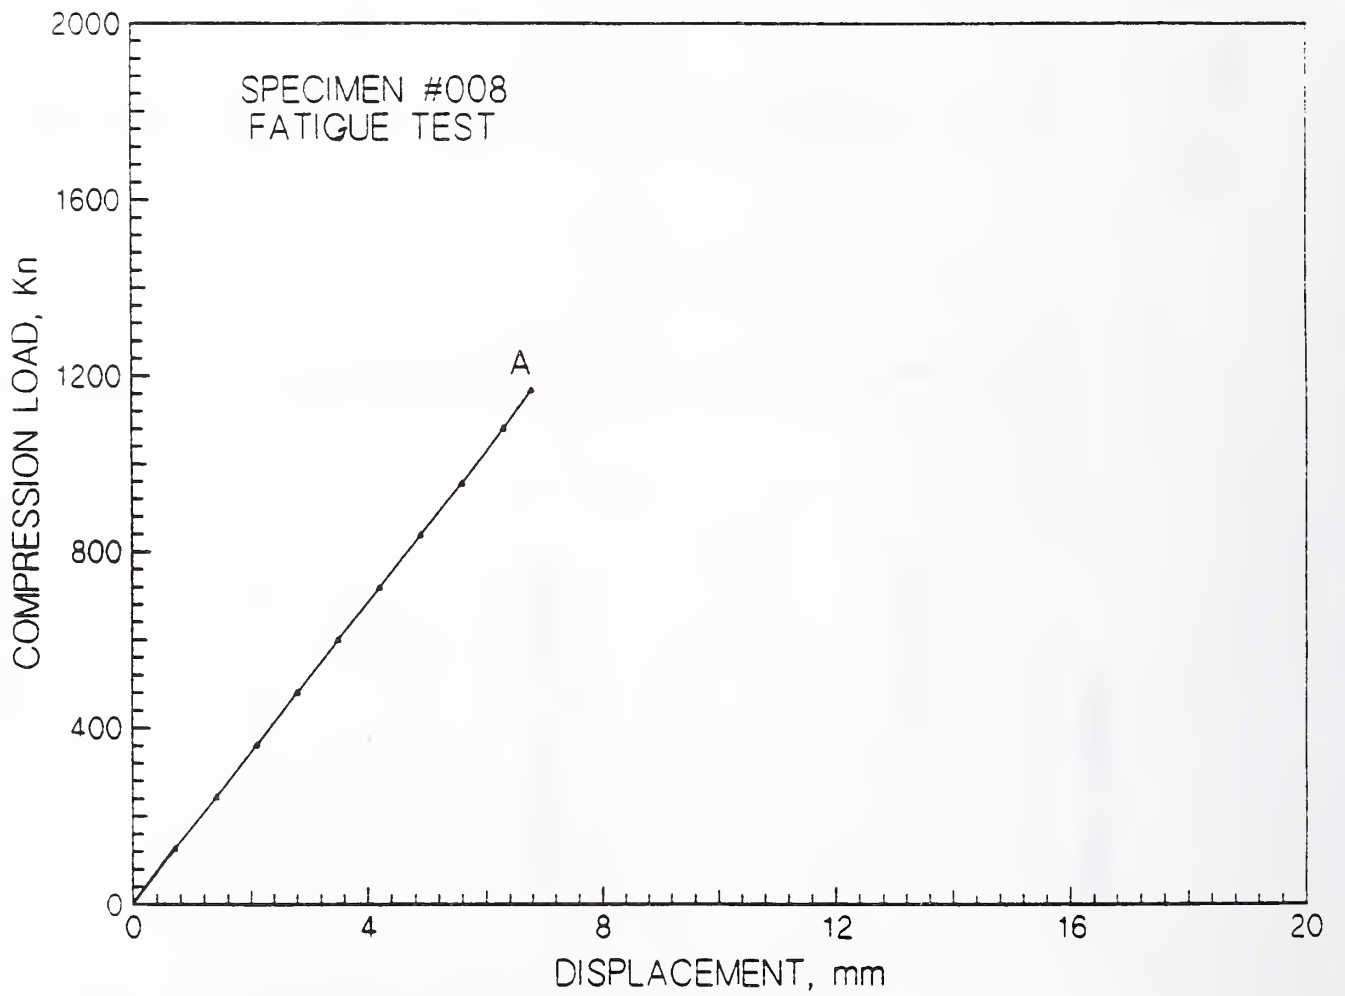
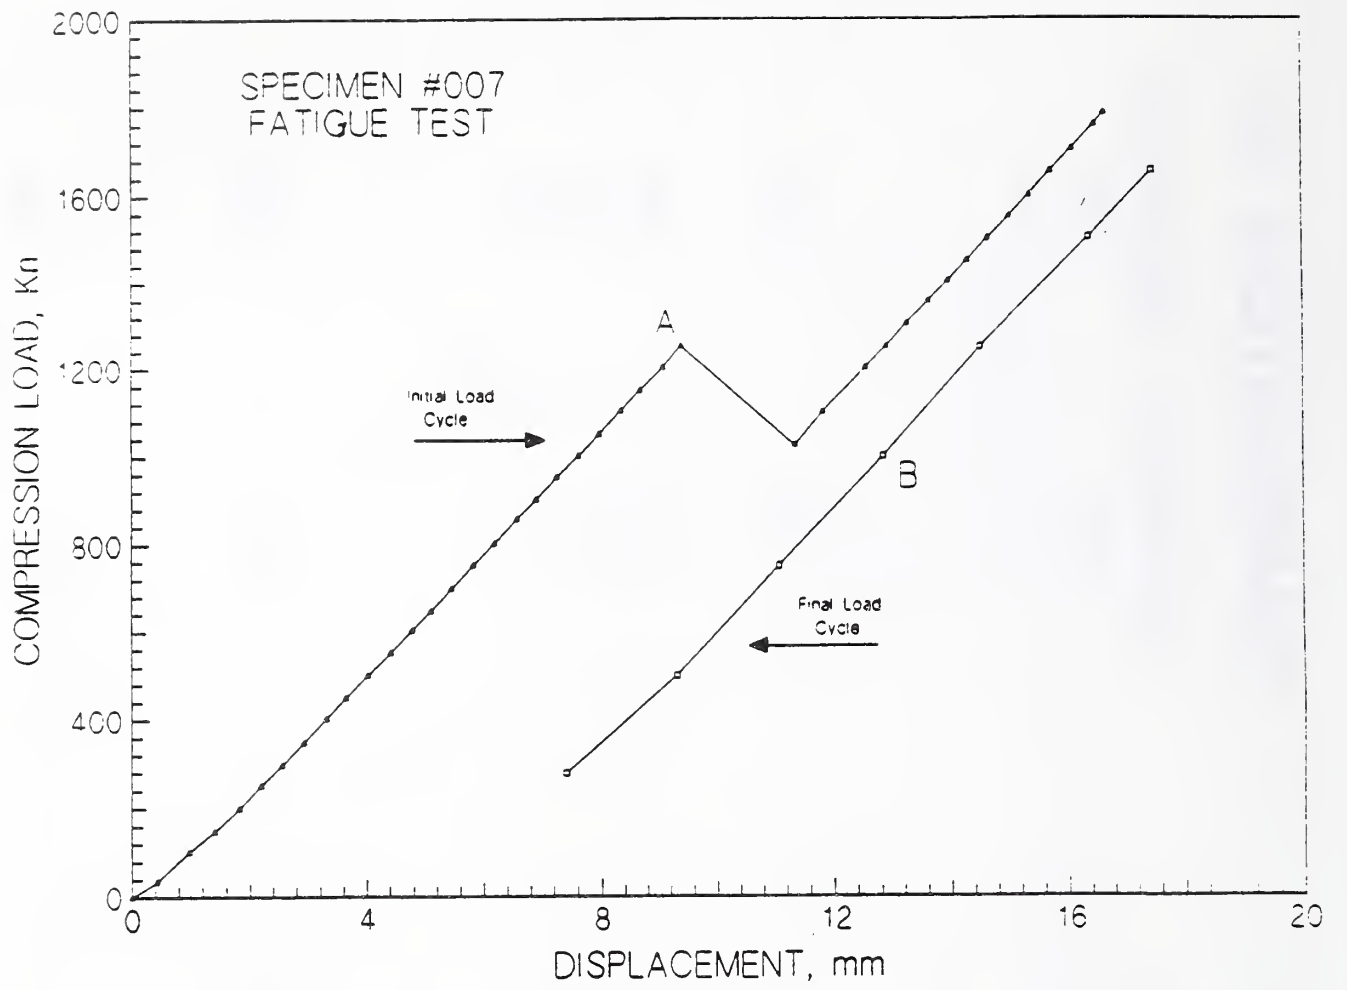
Figure 14. Load-versus-displacement curves for specimens 007 and 008.

Due to the complexity of this full scale test, the first load cycle was controlled manually. The load was applied with the machine in displacement control in approximately 4.4 kN (1000 lb) increments. The load-versus-displacement curve, shown in Figure 14, was linear to 1.2 MN (282 kips), when a loud noise occurred. The specimen load dropped to 1.0 MN (230 kips), and the load- versus-displacement curve shifted an amount that indicated 3.5 mm (0.14 in) of platen-to-platen closing. The specimen was then manually unloaded to 0.76 MN (170 kips) and had the same linear elastic slope as before the noise. The specimen was then reloaded to 1.0 MN (230 kips) where the manual incremental step loading was restarted. The desired maximum fatigue load of 1.8 MN (400 kips) was reached without incident. The specimen was unloaded to the minimum fatigue load of 0.18 MN (40 kips) and the test machine was switched to load control in preparation for the computer controlled fatigue waveform.

The specimen was loaded manually in displacement control. The loading was suspended every 8.9 kN (2 kips) and all transducers were scanned. The resulting load-versus-displacement curve, shown in Figure 14, was linear up to point A, where a loud acoustic emission was heard. The load at this point was 1.16 MN

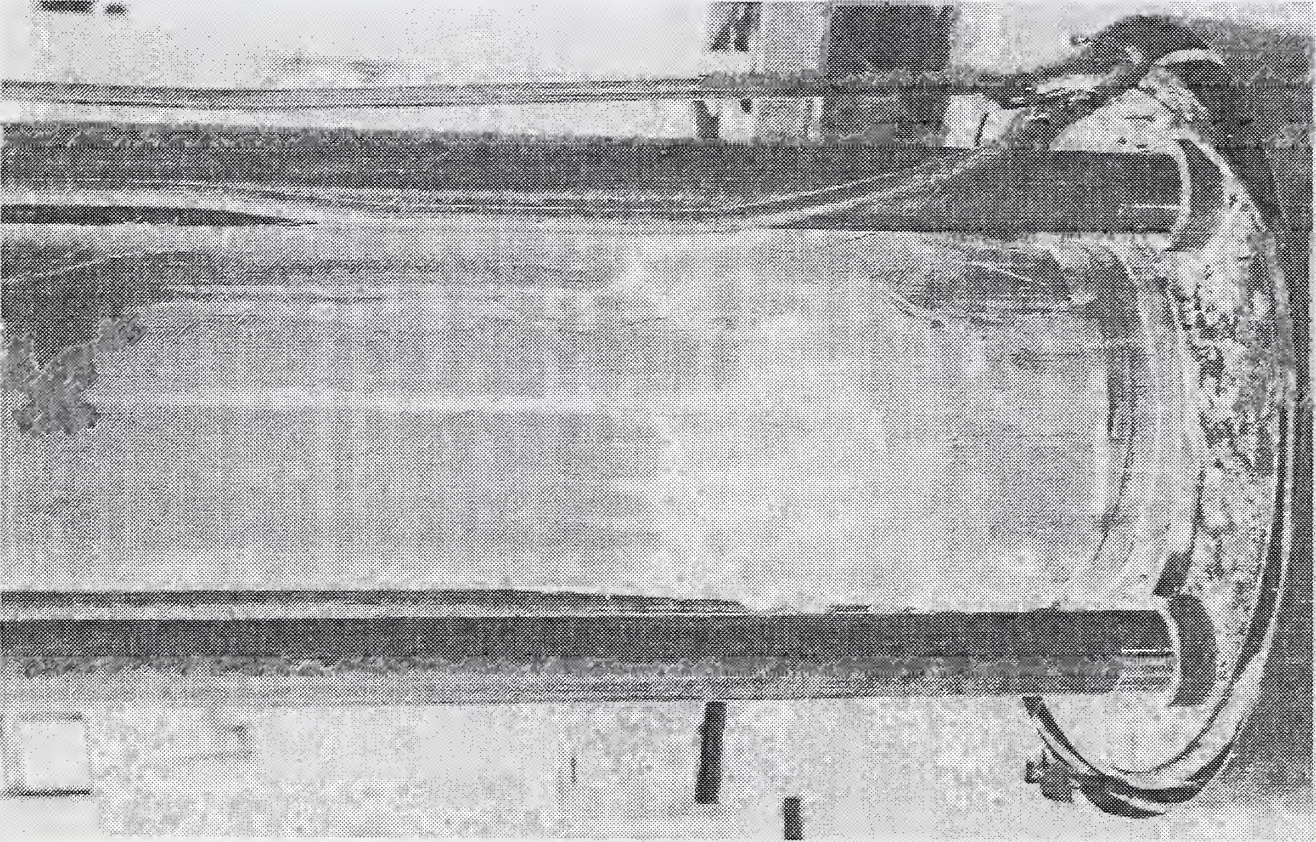
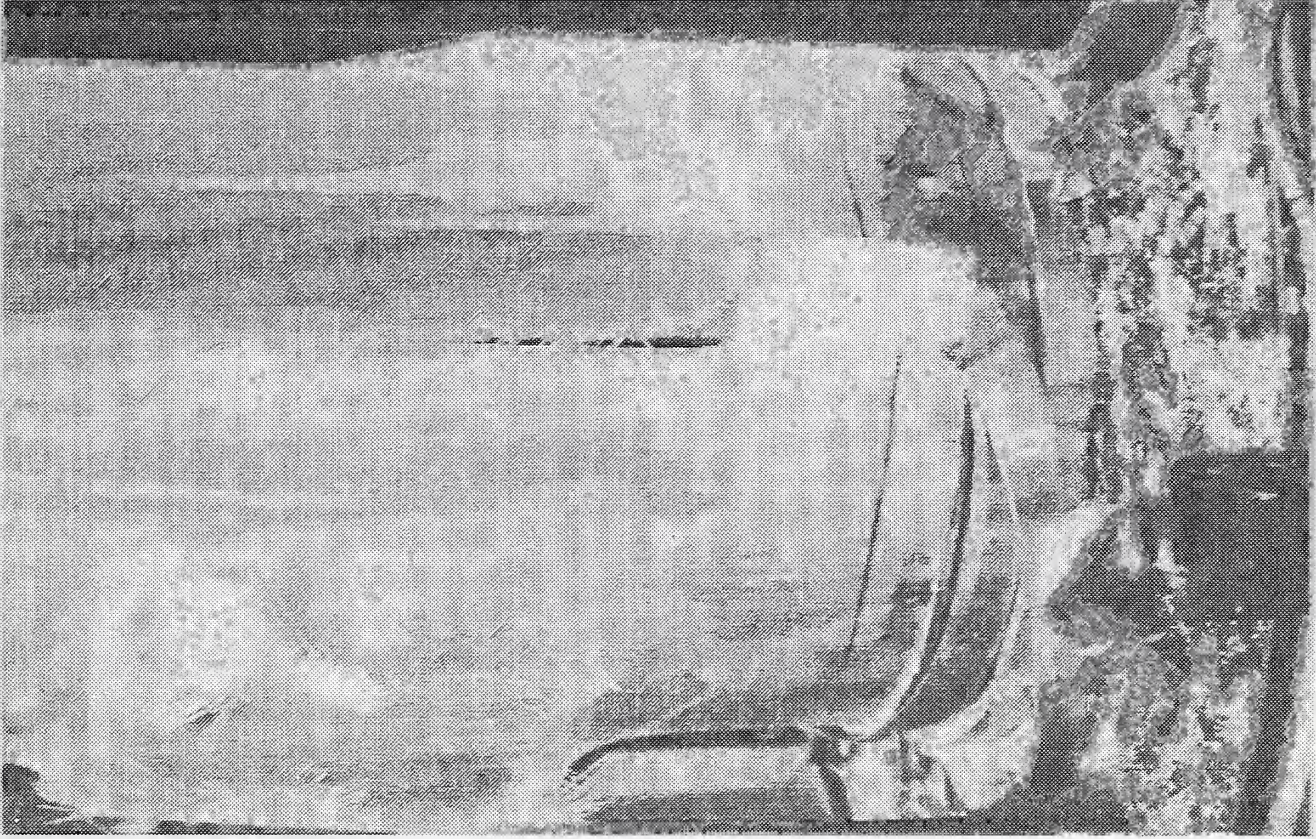
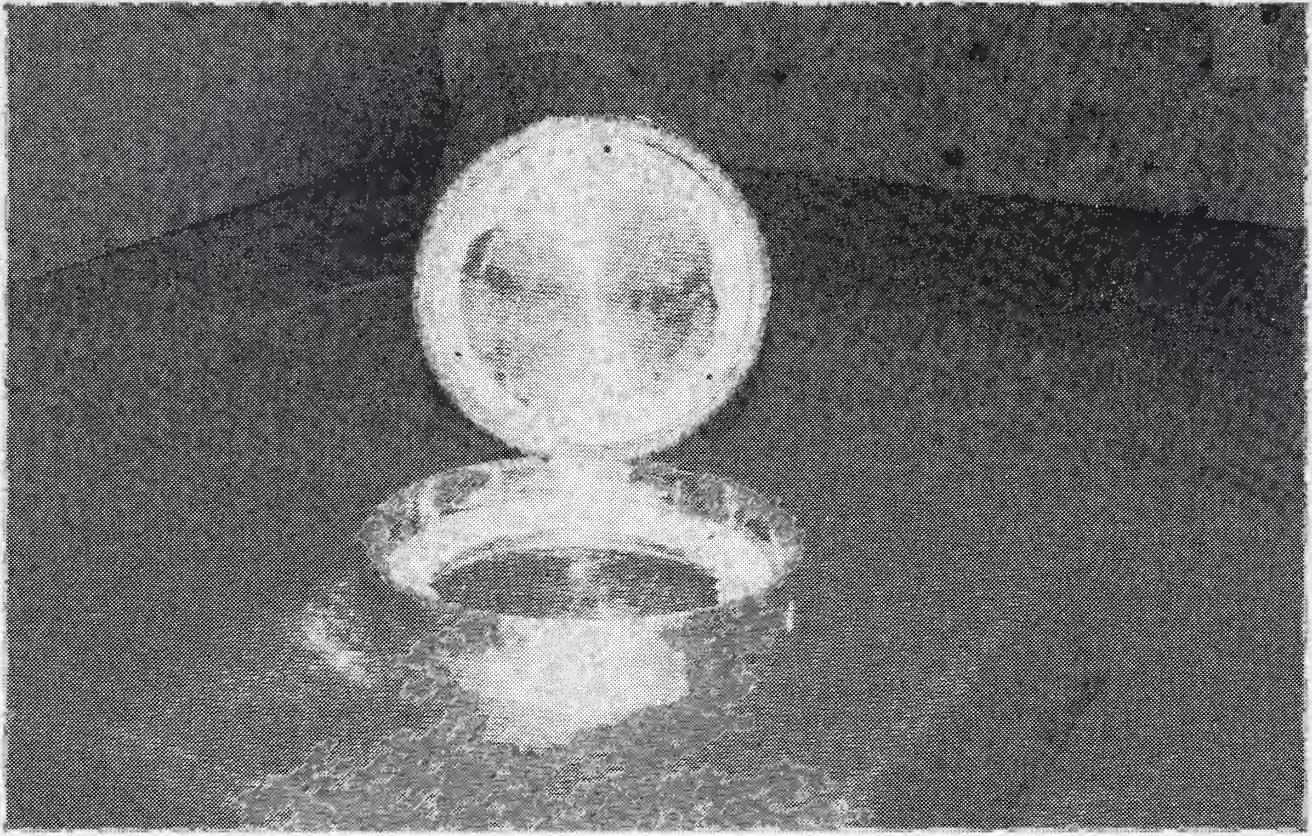
The specimen failed at the bottom (or the cold end) as shown in Figure 15. The failure mode appeared to be shell buckling. The failed area covered about 300 mm (1 ft) of length starting 25 mm (1 in) from the bottom end of the specimen. The specimen also contained numerous longitudinal cracks emanating from the bottom end of the specimen. Examination of the longitudinal cracks revealed approximately ten, 300 to 900 mm (2 to 3 ft) long cracks and many short 50 to 150 mm (2 to 6 in) cracks spaced approximately 13 mm (0.5 in) apart.

The longitudinal cracking of the specimen on the cold end effectively changed the specimen's geometry from a tubular cross-section into a series of independent columns. The ultimate failure of the specimen was local buckling of the slender columns.

Both end fittings on the specimen showed signs of failure as shown in Figure 16. The lower (cold) end fitting completely fractured into multiple pieces as shown in Figure 15. The band of material on the outside of the machined groove in the lower end fitting fractured at the base of the groove and was no longer in place to function as designed. This may be the reason for the initiation of longitudinal cracks in the specimen. The upper (warm) end fitting had radial cracks visible on the outside surface but had not completely fractured as in the lower end fitting. Another problem for both end fittings was the area machined for placement of the lead pad. Both end fittings fractured between a fillet in this machined area and the free surface. The fracture path was slightly different for each end fitting as shown in Figures 15 and 16.

Examination of specimen 007 indicated that the specimen and both end fittings failed. The specimen failed at the cold end as shown in Figures 15 and 16. The end fitting at the cold end had fractured into multiple pieces (Figure 16A) while the warm end fitting fractured into two pieces (Figure 16B).

Figure 15. Fatigue specimen 007, cold end failure.

The most important conclusion from these tests is that the compressive self-aligning end fittings must be redesigned to develop the full strength of the composite tube. Previous tests performed using the rigid aluminum end fittings alluded to a strength problem. The self-aligning end fittings contain more geometric stress concentrations than the rigid end fitting. This combined with the more brittle behavior of the 7075-T6 aluminum alloy at cold temperatures was detrimental to end fitting performance. Both tests failed on the first load cycle at almost identical stresses (186 ± 8.5 MPa). For specimen 007, it was not possible to verify the cold end fitting failure as the first failure but that conclusion was confirmed by the test of specimen 008.
