NISTIR 3966

A CRYOGENIC 4.4 MN MECHANICAL TEST SYSTEM FOR LARGE SCALE TESTS OF COMPOSITE SUPPORT STRUTS

Materials Reliability Division
Materials Science and Engineering Laboratory
National Institute of Standards and Technology
Boulder, Colorado 80303

March 1992

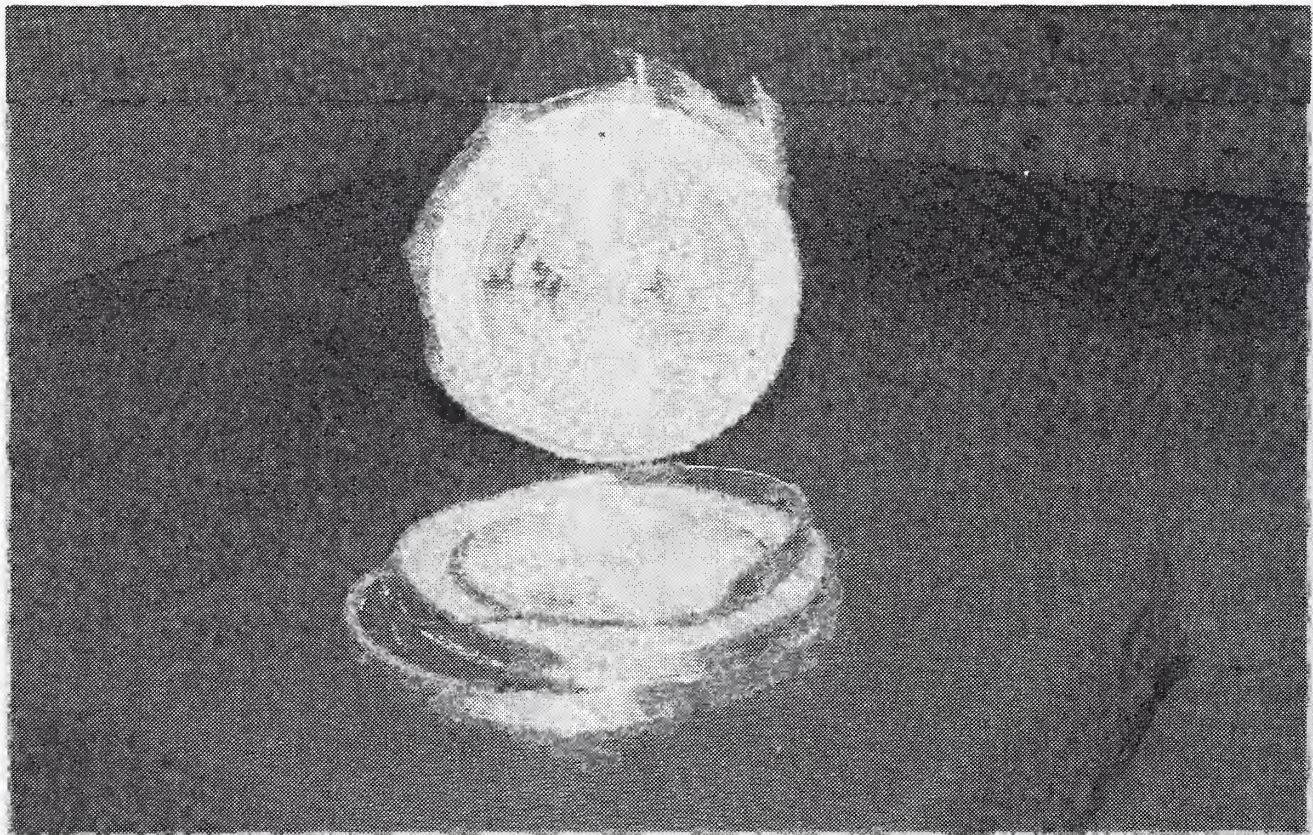
Both end fittings on the specimen showed signs of failure as shown in Figure 16. The lower (cold) end fitting completely fractured into multiple pieces as shown in Figure 15. The band of material on the outside of the machined groove in the lower end fitting fractured at the base of the groove and was no longer in place to function as designed. This may be the reason for the initiation of longitudinal cracks in the specimen. The upper (warm) end fitting had radial cracks visible on the outside surface but had not completely fractured as in the lower end fitting. Another problem for both end fittings was the area machined for placement of the lead pad. Both end fittings fractured between a fillet in this machined area and the free surface. The fracture path was slightly different for each end fitting as shown in Figures 15 and 16.

Examination of specimen 007 indicated that the specimen and both end fittings failed. The specimen failed at the cold end as shown in Figures 15 and 16. The end fitting at the cold end had fractured into multiple pieces (Figure 16A) while the warm end fitting fractured into two pieces (Figure 16B).

Figure 16A.   A failed self-aligning end fitting, cold end of specimen 007.

The most important conclusion from these tests is that the compressive self-aligning end fittings must be redesigned to develop the full strength of the composite tube. Previous tests performed using the rigid aluminum end fittings alluded to a strength problem. The self-aligning end fittings contain more geometric stress concentrations than the rigid end fitting. This combined with the more brittle behavior of the 7075-T6 aluminum alloy at cold temperatures was detrimental to end fitting performance. Both tests failed on the first load cycle at almost identical stresses (186 ± 8.5 MPa). For specimen 007, it was not possible to verify the cold end fitting failure as the first failure but that conclusion was confirmed by the test of specimen 008.
