NATIONAL BUREAU OF STANDARDS REPORT

EVALUATION OF THE BOSTITCH STAPLER METHOD FOR APPLYING ASPHALT SHINGLES

Federal Housing Administration

REPORT NO. 4291

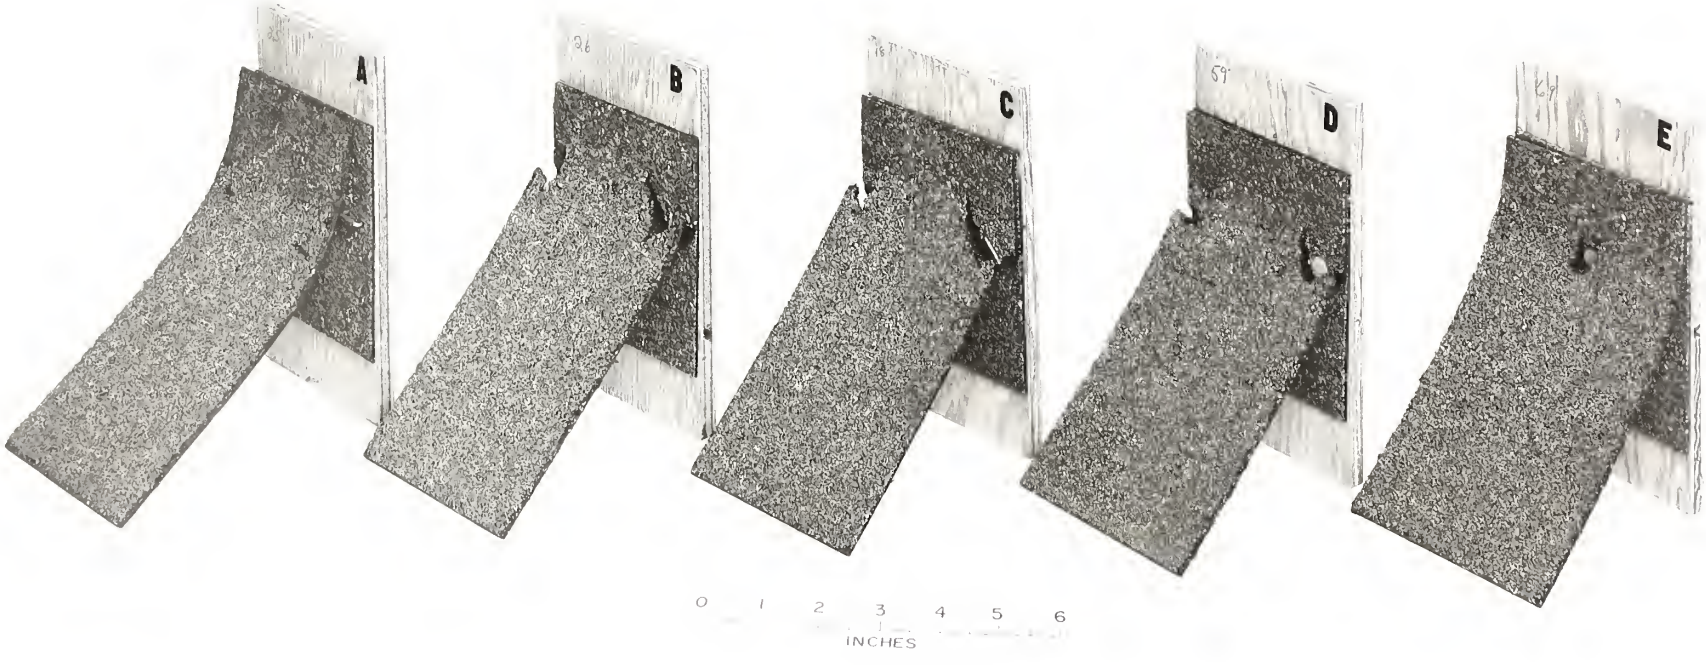
FIGURE 1. RESULTS OF TEARING TESTS

The results of the tearing tests indicate that two staples, however positioned, are roughly equivalent to one nail in resistance to tearing. They also indicate no significant difference in resistance to tear with staples placed parallel, perpendicular and at an angle of 45°.

The kind of tear resulting is shown in Figure 1. When the staples were placed parallel to the base line of the shingle, the shingle strip tore completely from the staple, leaving only a small break the size of the staple crown as shown in specimen A., Figure 1. The kind of tear with the staples placed perpendicular and at an angle of 45°, specimens B and C, was similar to that shown by the nailed specimen D.

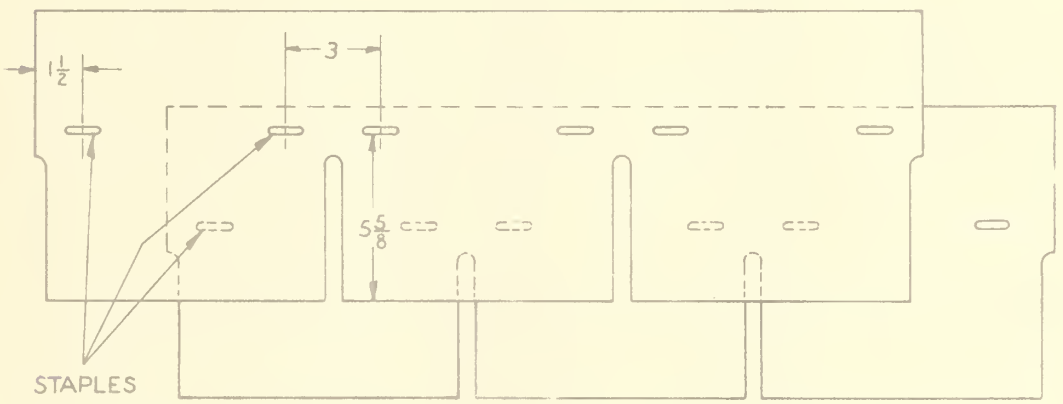
FIGURE 2. INSTRUCTIONS ISSUED WITH STAPLES

1. That asphalt shingles applied in accordance with the instructions of the Bostitch Company, with six staples per shingle (See Figure 2.) will serve as well as nailed shingles in areas where high winds are no hazard.

The number of staples per strip and the placing of the staples are both important for maximum holding power. To provide greatest wind resistance, staples should run parallel to butts. With three tab square butt strip shingles, use 6 staples per strip as shown below. Each staple should penetrate 2 courses of shingles.
