METALLURGICAL EXAMINATION AND MECHANICAL TESTS OF MATERIAL FROM THE POINT PLEASANT, W. VA. BRIDGE

Examination Of Fractured Rivets In
The Bearing Box of Joint U13N
(Revised)

NBS PROJECT		NBS REPORT
3120546	AUG 6 1970	9981

By
I. J. Feinberg
Engineering Metallurgy Section
Metallurgy Division

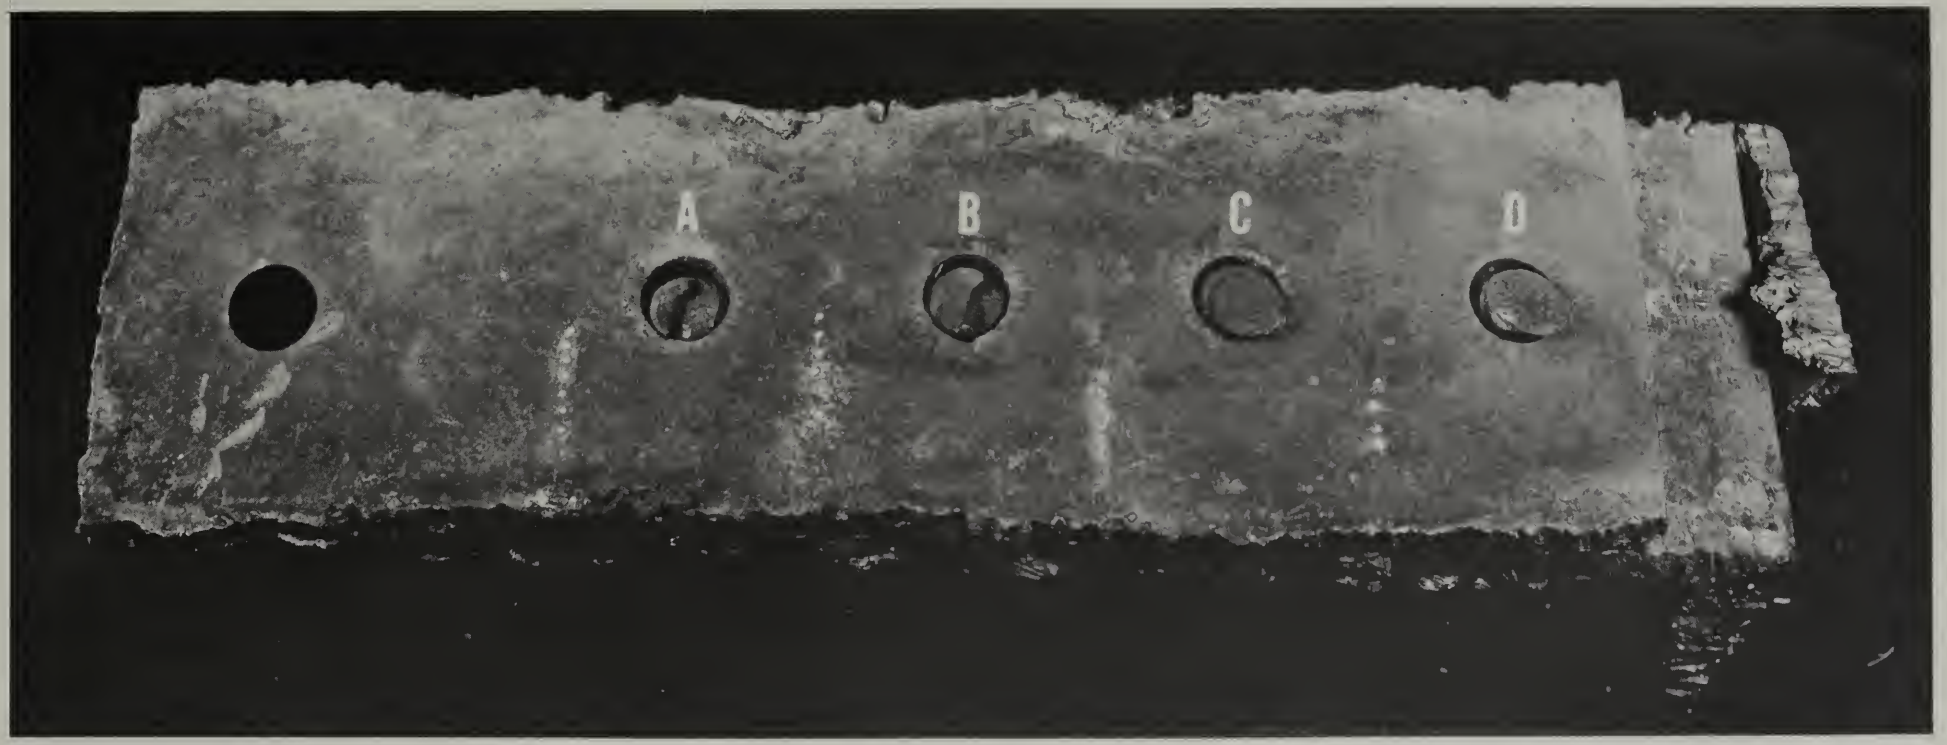
Visual Examination: As received, both sections were twisted and rivet heads were broken-off flush with the outside face of the gusset plates (see Figures 1 and 2). The gusset plates were deformed to a greater extent than their complementary channels. It was evident from the twisted shape of the channels and gusset plates comprising the sections that the rivets could have been subjected to a combination of tension, bending and shear stresses.

Figure 1. Section of U13NN member showing fractured rivets in place. Rivets were labeled A, B, C and D for report purposes. White dots on gusset plate are BRP markings. Approx. X 1/2.

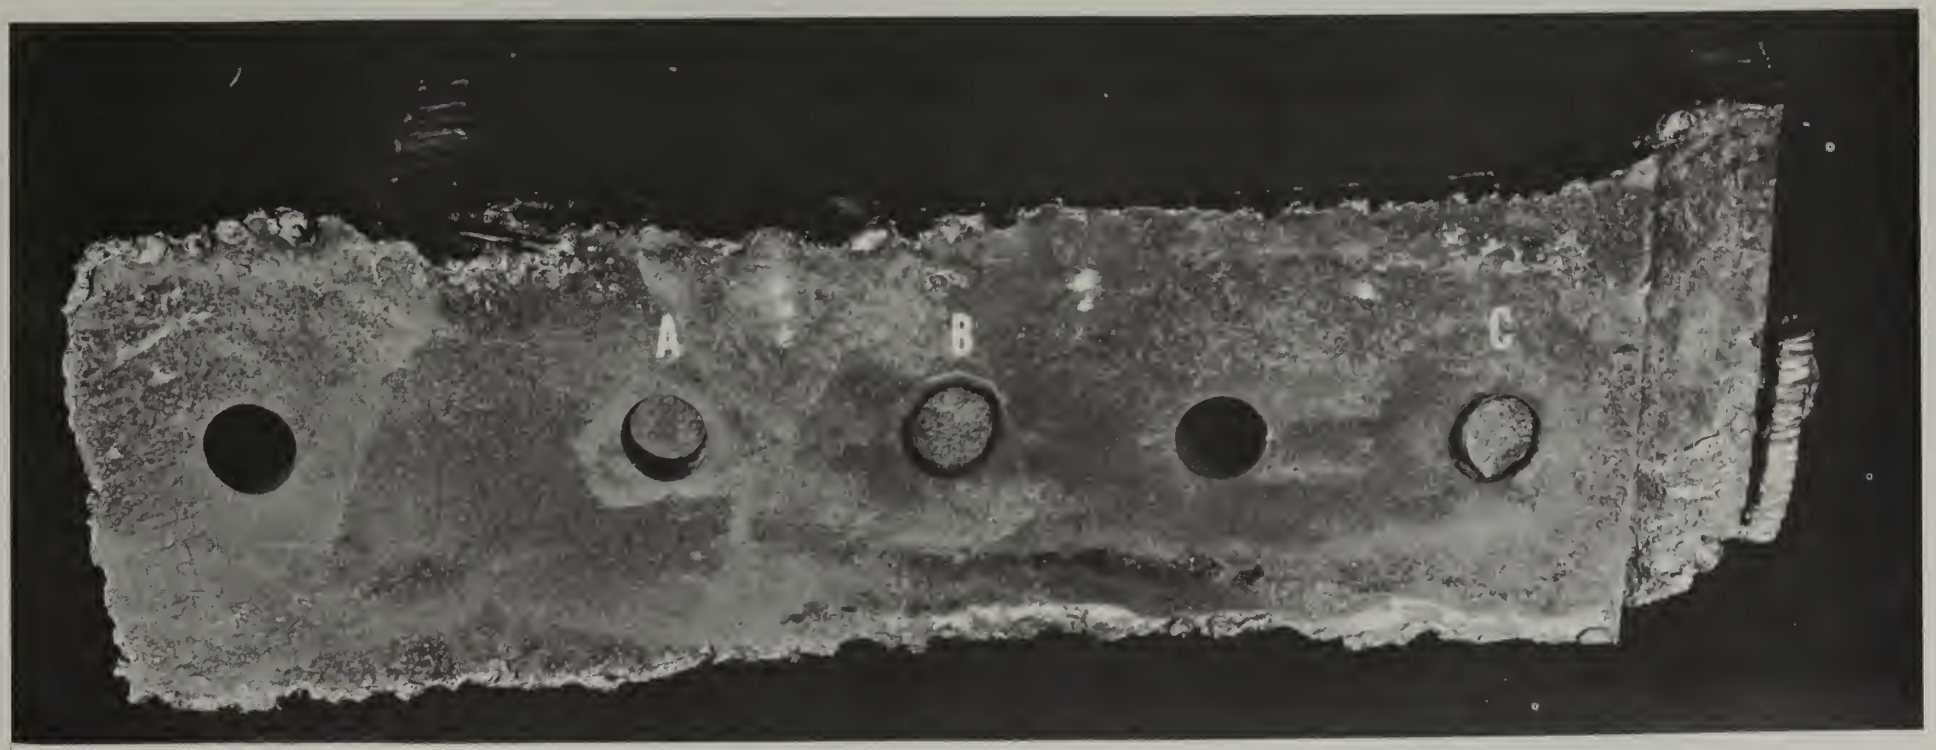
Figure 2. Section of U13NS member showing fractured rivets in place. Rivets in this section were labeled A, B and C for report purposes. White dots on gusset plate are BPR markings. Approx. X 1/2.

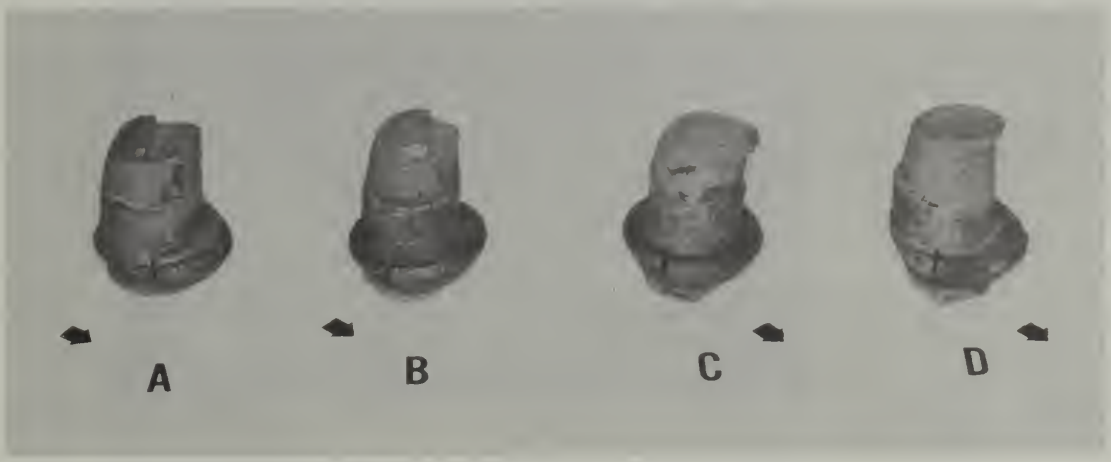
The rivet remnants were removed from the rivet holes and are shown free-standing in Figure 3 in the relative positions they occupied in the sections before their removal. As shown in Figure 3, the halves of the rivet shanks adjacent to the fracture surfaces are slanted and, in general, the peripheries of the fracture surfaces are elliptical. The arrows in Figure 3 point in the probable directions in which the rivet shanks were stressed before fracture occurred. Stress in a given rivet was considered to have been applied parallel to the major axis of the elliptical periphery of the fracture surface and/or in the direction of the slant in the rivet shank.

Figure 3. Rivets are shown free-standing in their relative positions prior to removal from their respective sections. Arrows point to the probable directions in which the rivets were stressed. X 1/2

a. Rivets from section U13NN.

b. Rivets from section U13NS.

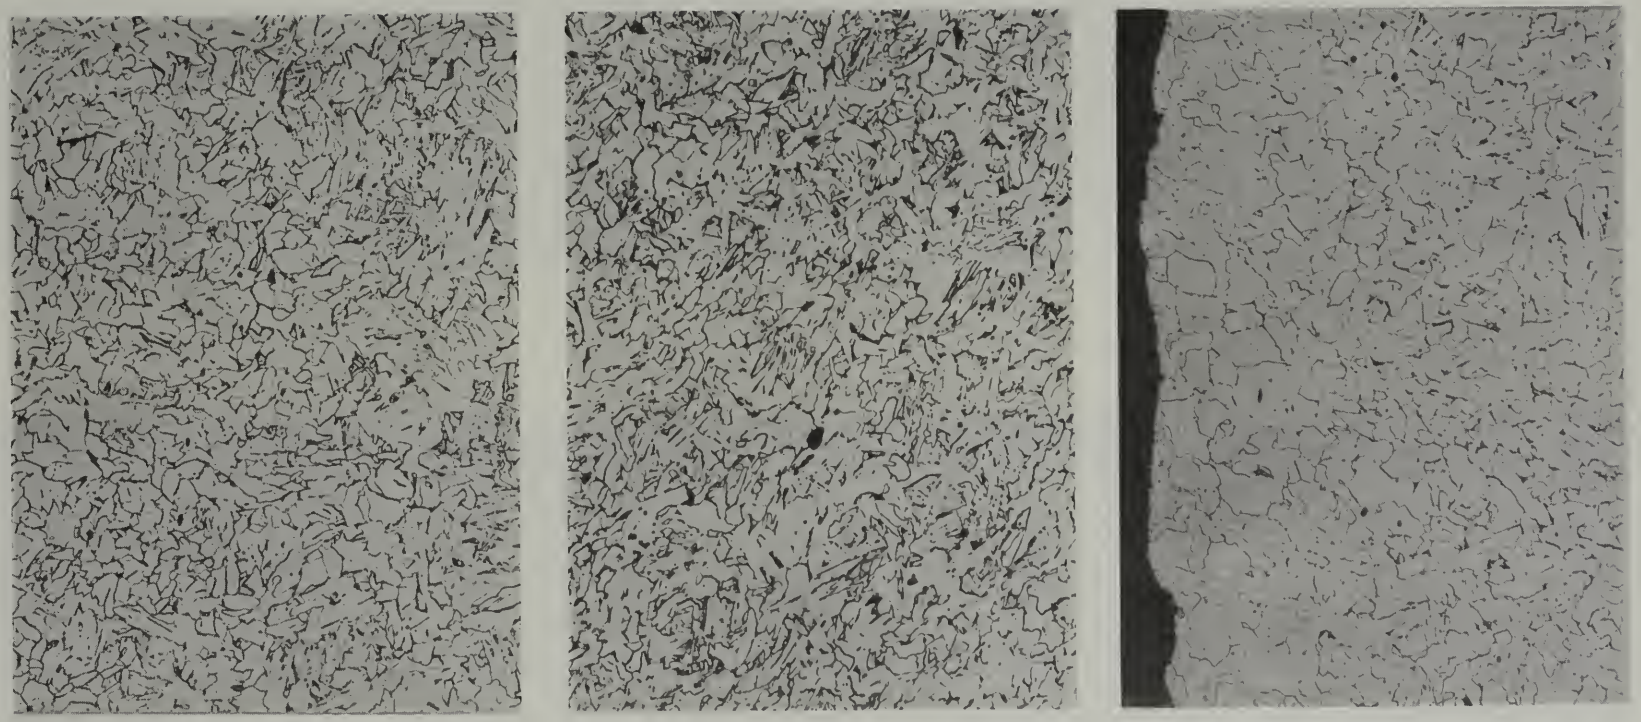
The microstructures of etched sections of these rivets are shown in Figures 4 through 7. Figures 4a and 4b show normal hot-worked microstructures in areas remote from the fracture surfaces of rivets U13NN-D and U13NS-C, respectively. Figure 4c shows decarburization in peripheral areas of the shank of rivet U13NN-A. Peripheral decarburization was present on the shanks of all three rivets.

Figure 4. Microstructures in rivet shanks at approximately 1/2 inch from fracture surface. Etched with 5% Nital. X 100.

a. Normal hot worked structure in U13NN-D.

b. Normal hot worked structure in U13NS-C.

c. Decarburization at periphery of U13NN-D.

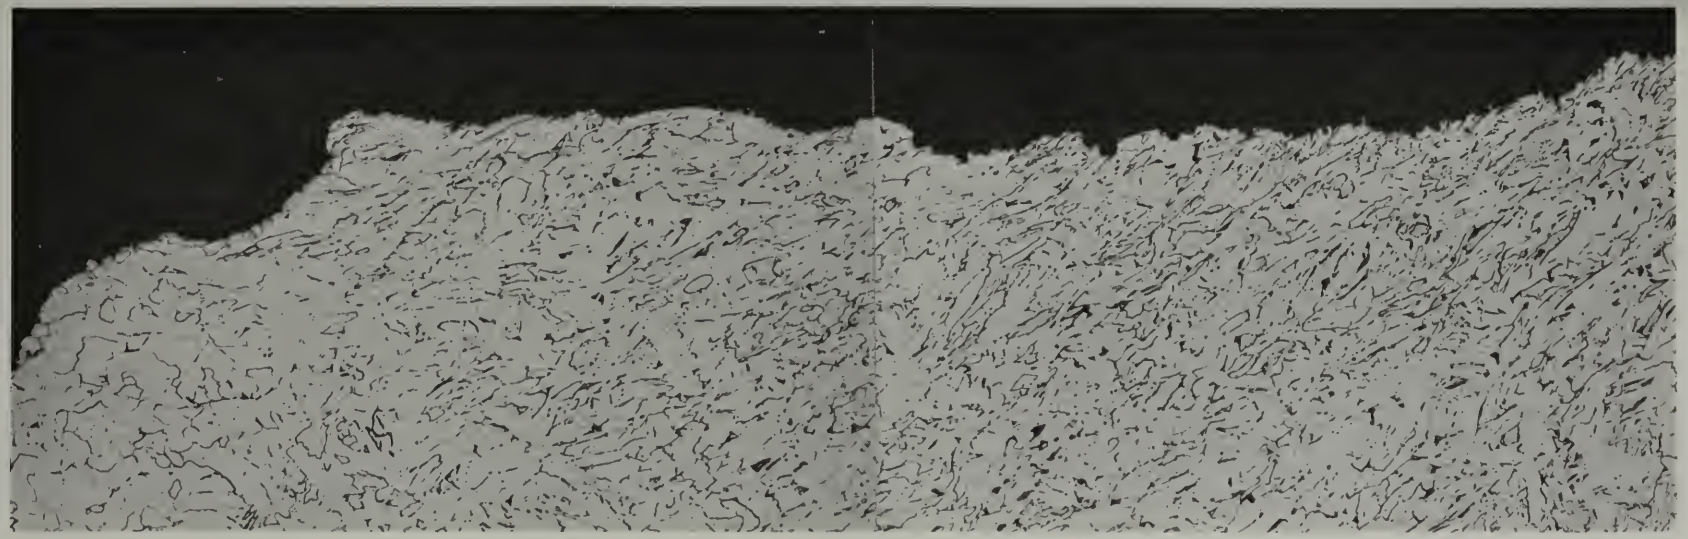
Figures 5, 6, and 7 show the fracture profiles for rivets U13NN-A, U13NN-D and U13NS-C, respectively. Cleavage (transgranular fracture) predominated in the fracture profile of all three rivets immediately adjacent to the fracture origin. Discontinuous cleavage (cleavage plus shear of the grains) was present in the fracture profiles at some distance from the origin. Shear predominated at the fracture mid-path.

Figure 5. Fracture profile of rivet U13NN-A. Etched with 5% Nital. X 100.

a. At origin.
b. At fracture mid-path.

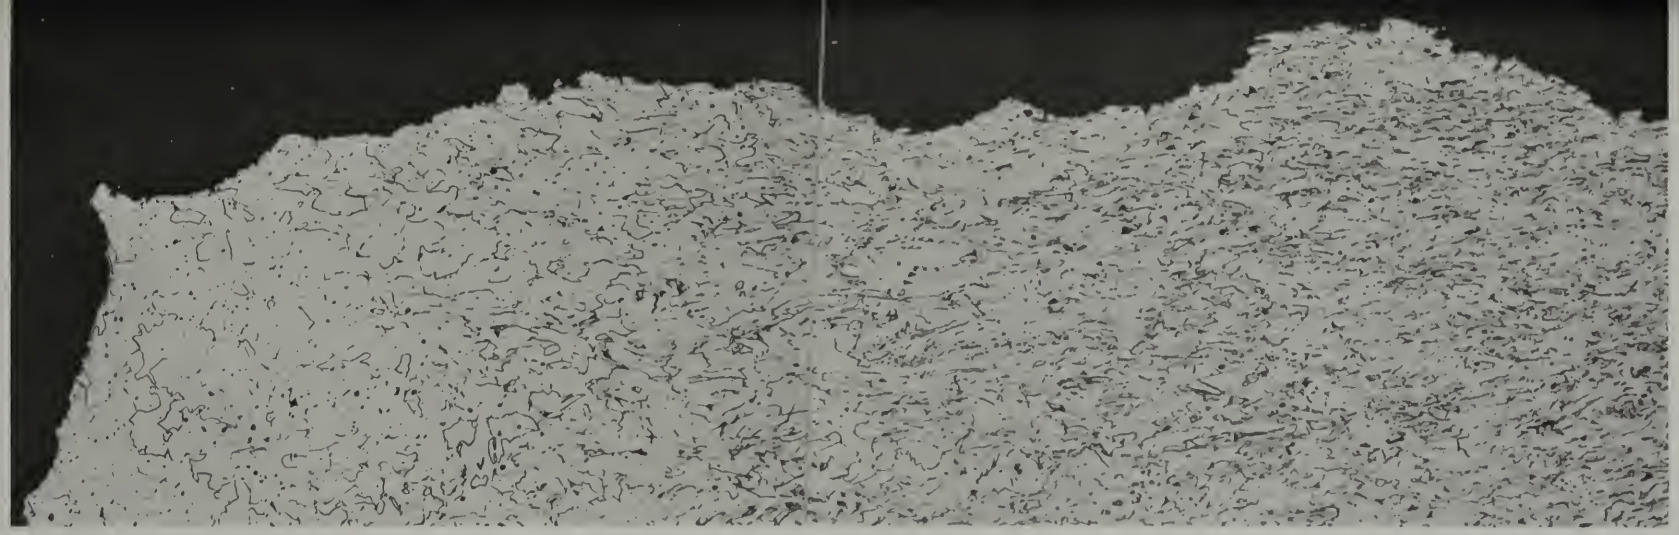
Figure 6. Fracture profile of rivet U13NN-D. Etched with 5% Nital. X 100.

a. At origin.
b. At fracture mid-path.

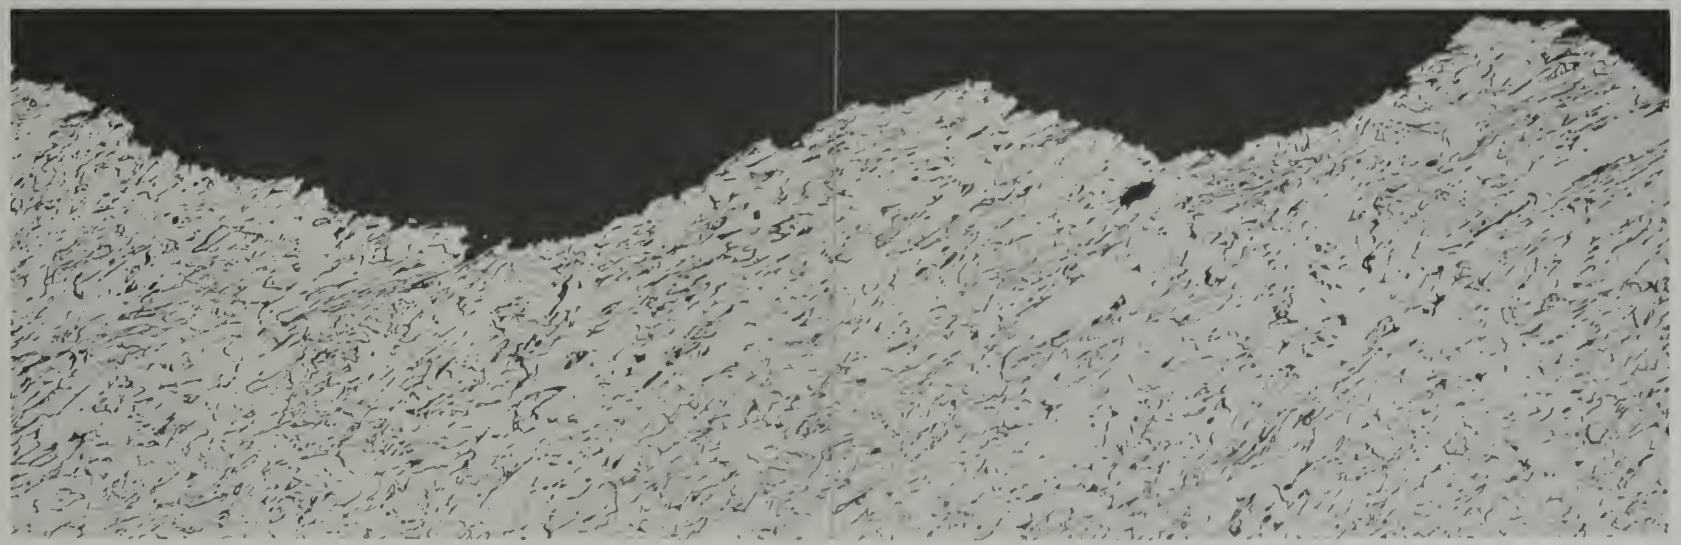
Figure 7. Fracture profile of rivet U13NS-C. Etched with 5% Nital. X 100.

a. At origin.
b. At fracture mid-path.
