NBS CIRCULAR 550

Mechanical Failures of Metals in Service

**UNITED STATES DEPARTMENT OF COMMERCE
NATIONAL BUREAU OF STANDARDS**

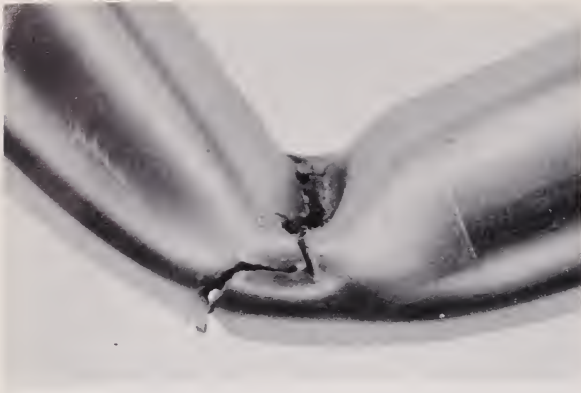
FIGURE 2.1. *Fractured piston parts fitted together in approximately the position they had occupied at the time of final fracture.*

The extensive plastic deformation that had occurred prior to fracture is evident. $\times 1$.

Case 2: Landing-gear retracting-strut piston (steel, chrome-plated). History of material was not available, but it is thought that this fracture was not a primary failure. This example is included to illustrate the characteristics of fractures due to overload. The tubular part, originally straight, had bent through approximately 75° before final fracture occurred. The extent of the plastic deformation can be seen by the checks in the chromium plate.

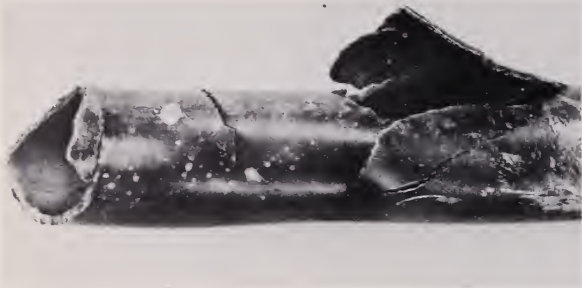
Case 5: Fuel line (aluminum alloy). The metallurgical examination showed that the line had burst while subjected to a high temperature.

FIGURE 5.1. Failed aluminum-alloy fuel line. $\times 1$.

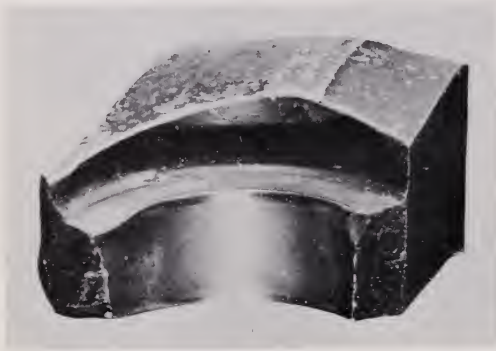
Case 8: Wing hinge fitting (SAE 4340 steel). The extremely coarse grains visible on the fracture surface on one side of the lug, and the intergranular oxidation in this area was apparently caused by severe local overheating after forging but before heat treating. The resultant structure had so little intergranular strength that it fractured under normal service loads.

FIGURE 8.1. *Fractured lug showing a brittle fracture on the right and a normal ductile fracture on the left. $\times 1$.*

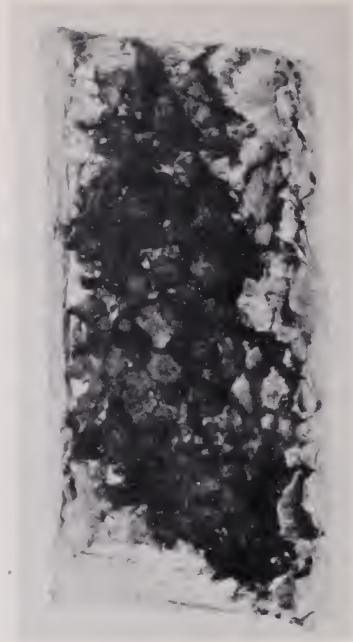
FIGURE 8.2. *Surface of the brittle fracture, showing the extremely coarse grains revealed by the fracture. $\times 5$.*

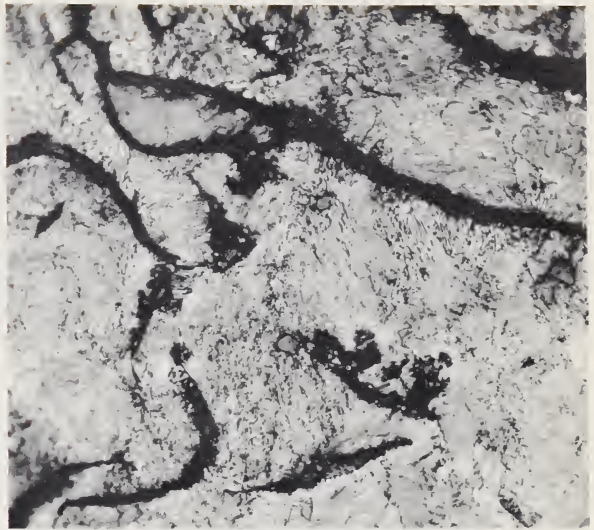
FIGURE 9.3. *Typical microstructure in the interior of the drum.*

Graphite flakes are interspersed through the pearlite matrix. Etched with nitric acid in alcohol. $\times 500$.

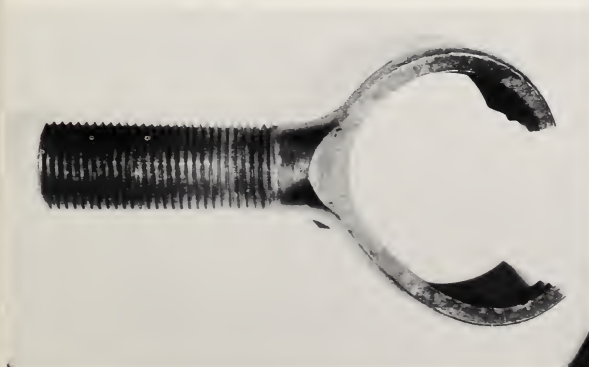
Case 11: Rod end bearing from the wing strut of a light plane (free-machining steel). Fracture of part during apparently normal flight caused a crash. The numerous large inclusions in this material greatly reduce its ductility transverse to the rolling direction. The fitting was cut from bar stock, so that the inclusions were parallel to the length of the shank. Thus the tensile stress at the top of the eye was applied in a transverse direction, and the strength of the thin section was inadequate to support normal flight loads. In order to avoid loading in a transverse direction in a part of this kind, it is generally necessary to use a properly designed forging. The free-machining steels are unsuitable for critical parts subject to high stress in service because of poor transverse properties and great variability.

FIGURE 11.1. Rod end bearing which fractured in service. The fracture showed almost no local ductility. $\times 1$.

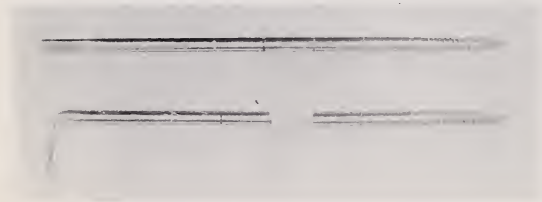
FIGURE 12.1. *Mandibular fracture pin as received (upper) and a similar pin that had been tested in the laboratory.*

The fracture occurred under a bending moment of 5.7 in-lb, and closely resembled the fractures that had occurred in service. There was almost no plastic deformation before fracture. When the pin was clamped near the head, it supported a moment of more than 8 in-lb and bend 90° without fracture. $\times 2$.

Case 12: Mandibular fracture pins (AISI 440C stainless steel). These pins were used by surgeons in setting broken bones. Several cases had been reported of pins breaking while being driven. Circumferential grooves had been machined in the pins to provide an indication of the depth to which they had been driven. These grooves, in a material of high hardness (550 to 600 Vickers), resulted in a great loss of strength, particularly under impact conditions. Laboratory tests indicated that the static bending strength of the pins was reduced about 50 percent by a groove, whereas the resistance to bending impact was reduced about 90 percent. Although no bending load would be required to drive the pin, it is probably very difficult to avoid applying such a load accidentally.

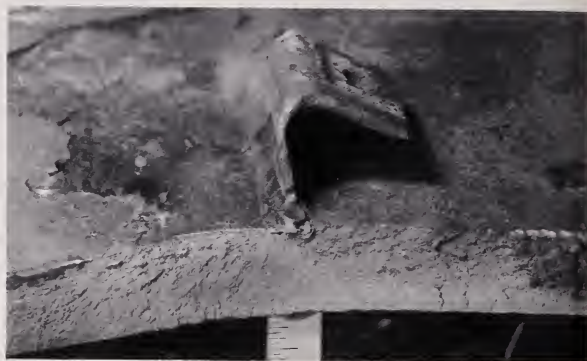
FIGURE 14.2. Starting point of the fracture shown in figure 14.1.

This clip had been welded onto the heavy deck plate very close to a large chock, thus forming a sharp notch. $\times \frac{1}{2}$.

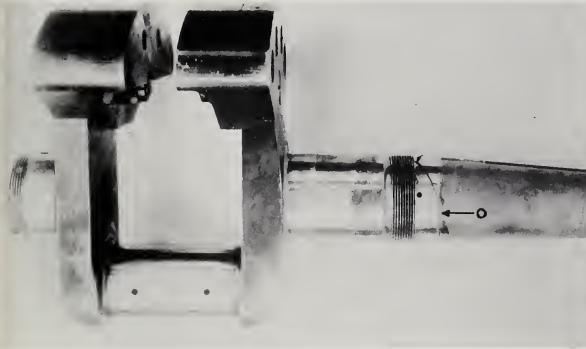
Case 15: Aircraft engine crankshaft (alloy steel). The crankshaft fractured after a total of 220 hours of service. The fatigue crack originated in an area where fretting had occurred under the propeller hub. Fretting is the term given to the action that results in surface damage when there is relative motion between solid surfaces in contact under pressure. The action may be produced by extremely small motions and causes a severely pitted condition of the surface. In this case the pits concentrated the stress to such an extent that the peak stress was greater than the fatigue strength² of the steel.

FIGURE 15.1. Crankshaft with broken parts fitted together.

The fracture originated at arrow "o" in an area where rubbing had occurred. $\times \frac{1}{4}$.

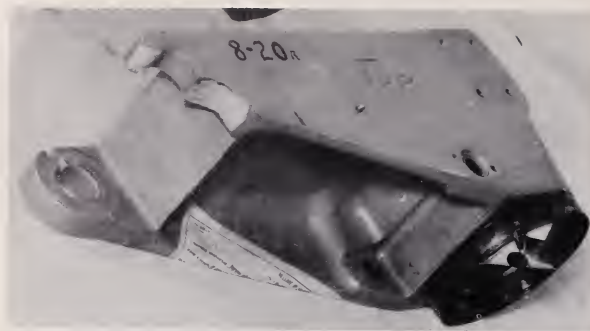
FIGURE 18.1. Failed helicopter rotor link.

The fatigue fracture occurred in the lower lug. The broken piece of this lug has been fitted back in approximately its position at the time of final fracture. The upper lug failed from overload after the fracture of the lower one. $\times 4$.

Case 18: Helicopter rotor link (14S aluminum-alloy forging). The link failed in service, causing a fatal accident. No metallurgical defects were found that might have influenced the failure of the part. The example is shown primarily to illustrate the appearance of a typical fatigue fracture in a light-alloy forging, as it is quite different from that in steel. As there was a steady tensile load on this part in addition to the fluctuating load, the surfaces of the fatigue crack were held apart and the surface features were preserved.

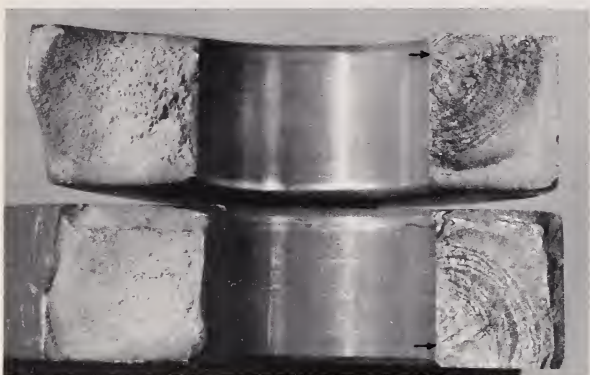
FIGURE 18.2. Lower lug of Fig. 18.1 showing the origin of the fatigue fracture (arrow) on the inside of the hole at the point where the inserted bushing ended.

The surface of the fatigue fracture appears rough at this magnification, but it was actually made up of numerous facets, giving it an appearance similar to the fracture in a brittle substance like coal. The contrast between this fracture and a similar one in a steel forging is apparent when this figure is compared with figure 22.2, which is at the same magnification. The concentric rings were caused by variations in the rate of progress of the crack due to changes in stress. The left side of the lug failed due to overload after the right side had broken. $\times 1$.

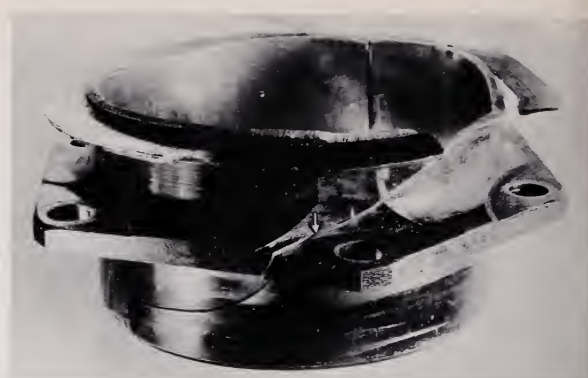
Case 19: Aircraft engine cylinder (steel). The steel was properly hardened and tempered and was of good quality. The sharp notch at the cut-out for the hold-down nut had resulted in sufficient stress concentration to initiate a fatigue fracture.

FIGURE 19.1. Lower part of the failed cylinder, showing the fatigue fracture which originated at the cut-out for the hold-down nut, (arrow) and progressed first diagonally, then circumferentially around the cylinder. $\times \frac{1}{2}$.

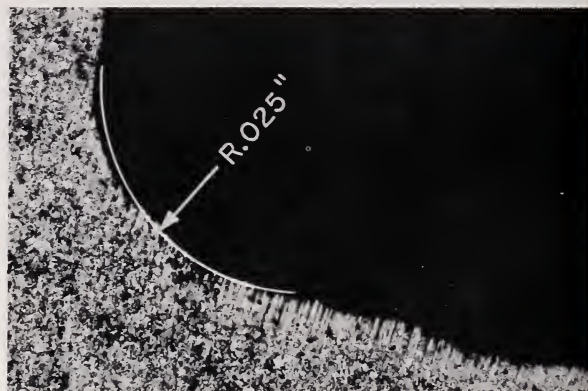
FIGURE 19.2. Section through the intersection of the cut-out and the cylinder, showing the sharp corner with a minimum radius of approximately 0.025 inch. $\times 50$.

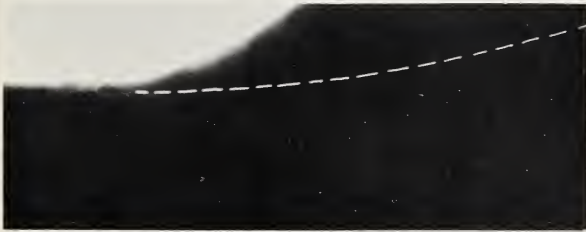
Case 20: Fitting from aircraft nose wheel yoke (aluminum alloy). The fracture of this fitting caused the collapse of the nose gear, with resulting damage to the plane. The fillet at the change of section was so poorly machined that there was a very small radius at the junction with the journal instead of the $\frac{1}{2}$ -inch radius specified in the drawing. This resulted in sufficient stress concentration to cause the initiation of a fatigue crack. The small fatigue crack reduced the strength of the part to such an extent that fracture occurred at the time of high stress on the part during the aircraft landing.

FIGURE 20.2. *Profile of the fillet adjacent to the small diameter (left).*

The dashed arc shows for comparison how a $\frac{1}{2}$ -inch radius fillet would appear at this magnification. $\times 17$.

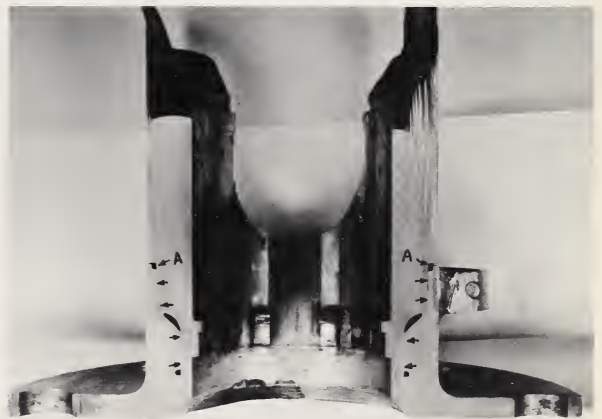
FIGURE 21.2. *Cross section of the hub showing the method of assembly.*

The two parts were brazed along the lines indicated by the arrows, leaving a circumferential notch A. The fatigue fracture started at the root of this notch. $\times \frac{1}{2}$.

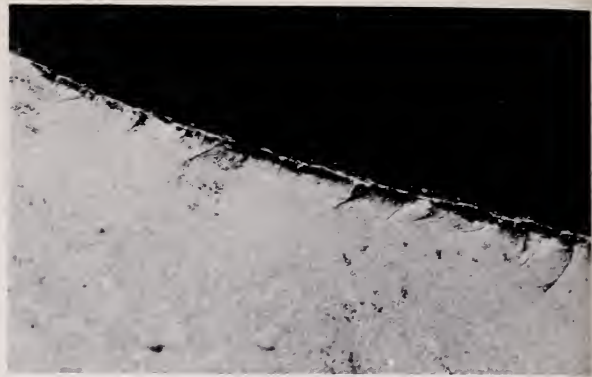
Case 22: Aircraft propeller (SAE 4320 steel). The propeller fractured in flight, causing the engine to be torn from the plane. The hub end of the blade had been formed by an upset forging operation. This operation had not been properly carried out, resulting in a fold and fissures on the inner surface of the blade. The fatigue crack had started at a point where stress was concentrated at these defects.

FIGURE 22.3. Surface of the fatigue crack adjacent to the indentation.

The black band near the surface is oxide scale, showing that the fissures that caused the fatigue crack were present before the final heat treatment of the blade. $\times 10$.

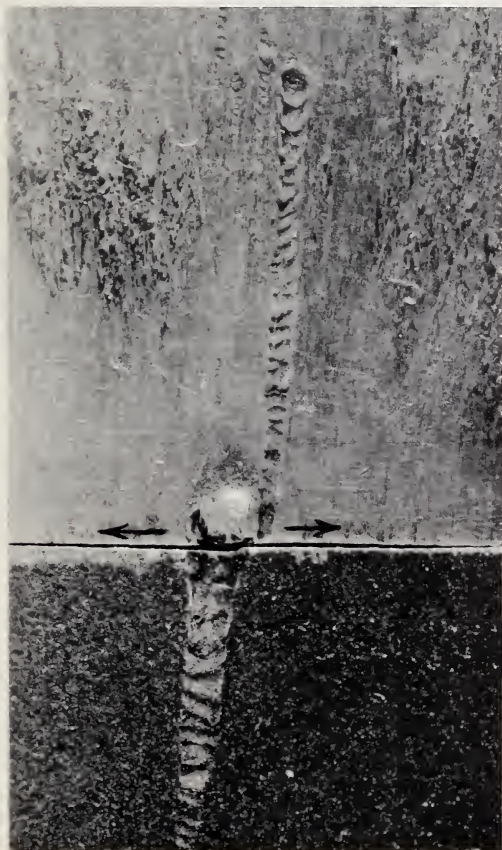
FIGURE 23.4. *Longitudinal section through the defect shown in figure 23.3.*

The serrations were caused by the galling action of another surface being dragged across this one. The action is analogous to the chattering of a machine tool against the work. Etched with nitric acid in alcohol. $\times 100$.

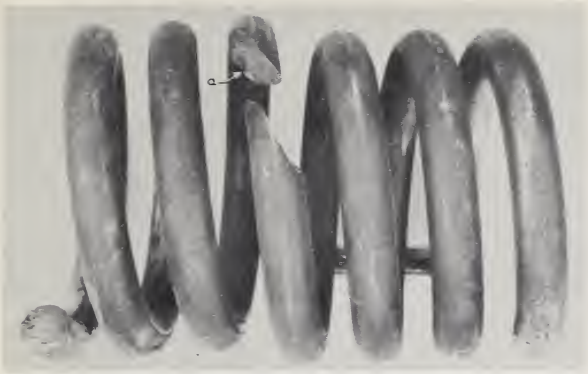
Case 25: Helical spring (steel). This case is included to show a failure typical of fatigue under

torsional stress. In the absence of stress raisers, the first cracking in torsion usually occurs in planes of maximum shearing stress, which are parallel and perpendicular to the length of the rod. Because of the directional properties of the rod from which the spring was wound, the resistance to fatigue was less in the parallel direction than the perpendicular, so the crack developed as shown in figure 25.3. When this crack had progressed to a considerable extent, it caused sufficient stress concentration to initiate a crack due to tensile stress in a direction approximately 45° to the length of the rod. This second crack progressed only a short distance before the rest of the section failed due to overload.

FIGURE 25.1. *Fractured helical spring showing the origin of the diagonal fracture on the inside of the coil at arrow "a".* $\times \frac{1}{2}$.

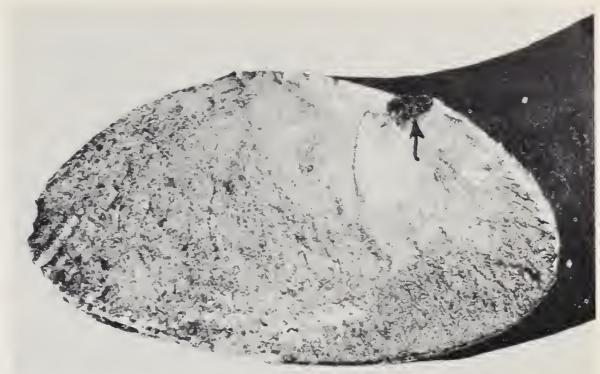
FIGURE 25.2. *Fracture surface on one part of the spring.*
The small dark area (arrow) is the tension fatigue crack which originated at the longitudinal (shear) crack. $\times 3$.

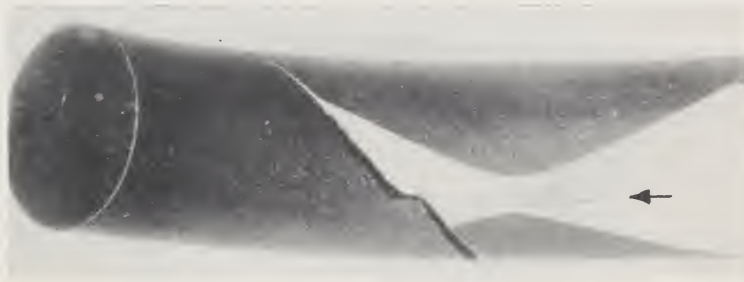
FIGURE 25.3. *The two parts of the fracture fitted together.*
The piece on the right has been ground to show the extent of the longitudinal crack (arrow) away from the fracture. $\times 2$.

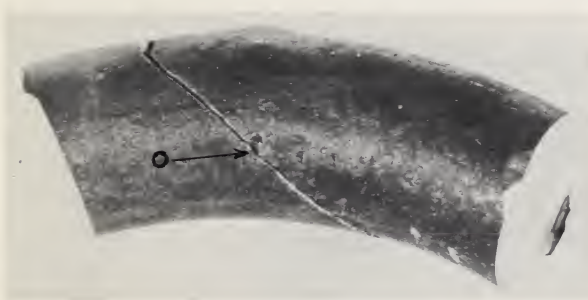
FIGURE 26.1. *Fractured pieces of spring fitted together to show surface pit at nucleus of fatigue fracture, arrow O.* $\times 2$.

Case 26: Helical spring (steel). In contrast to case 25, the fatigue fracture in this spring started on a plane normal to the tensile stress. The surface of the spring was somewhat pitted, and the stress concentration at one of these pits was sufficient to cause the initiation of the fatigue crack. The fatigue crack progressed over nearly half of the cross section of the rod before final fracture

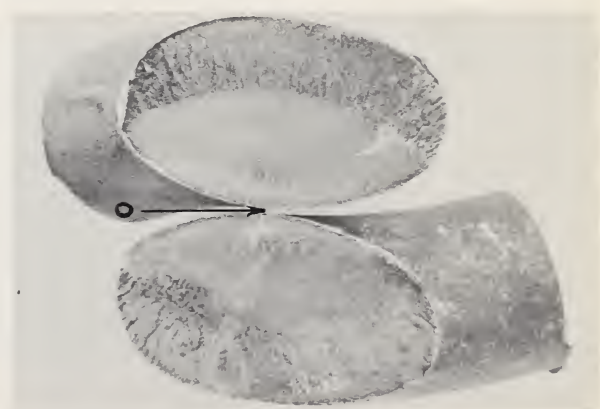
FIGURE 26.2. *Surfaces of the fracture; the fatigue crack progressed from the origin at arrow O across nearly half of the section before overload fracture occurred.* $\times 2$.

occurred, indicating that the applied stress was relatively low and showing the severe decrease in fatigue strength caused by a surface defect.

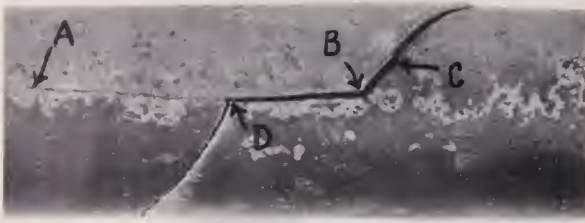
FIGURE 27.1. *Fractured portion of the torsion bar.*

The longitudinal fatigue crack extended from A to B, the tensile fatigue crack from B to C, and the final overload fracture from C around the bar to D. $\times 1$.

Case 27: Torsion bar from a highway bus (steel, heat treated to a tensile strength of about 200,000 lb/in.²). Fracture occurred when the bus was traveling at low speed on city streets. Metallographic examination showed several locations where there were stringers of oxide inclusions in the steel. Apparently these inclusions served as nuclei for a fatigue crack on a shear plane parallel to the length of the rod. After this crack had progressed to a considerable extent, another crack, perpendicular to the tensile stress, started at the end of the longitudinal one. This progressed only a short distance before the remainder

of the area fractured from overload. Torsion bars of this type are among the most highly stressed members in common use, and this failure emphasizes the importance of having material free from large inclusions for such service.

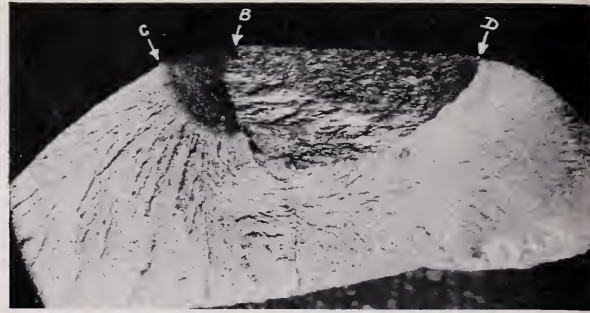
FIGURE 27.2. *Surface of the fracture.*

The dark fatigue crack areas at the top are easily distinguished from the lighter overload portion. The tensile fatigue crack from B to C is on a plane making an angle of approximately 45° to the plane of the paper. $\times 1$.

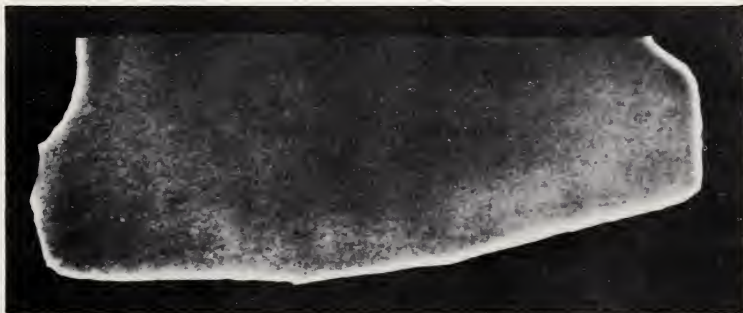
Case 28: Front axle from motor vehicle (forged steel). The axle had failed by fatigue. The surface of the axle was badly decarburized, and in addition there were transverse grooves where the forging flash had been removed. Both of these factors seriously lowered the fatigue strength of the part.

FIGURE 28.3. *Section of the lower part of the axle a short distance from the fracture, showing the extensive decarburization of the surface.*

Etched with nitric acid in alcohol. $\times 1.7$.

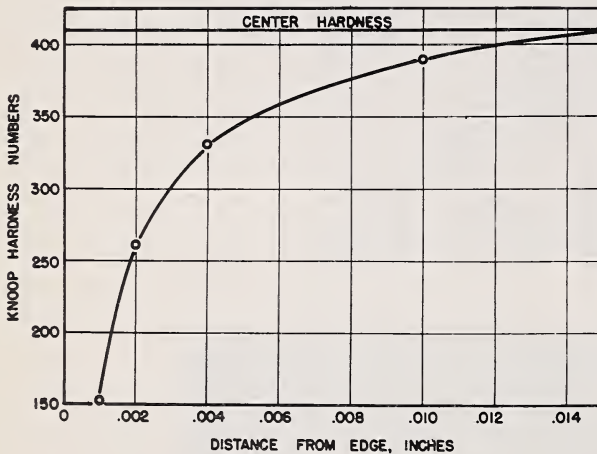
FIGURE 29.3. Results of microhardness measurements made on a cross section of the tube.

The hardness at the center corresponds to a tensile strength of approximately 170,000 lb/in.², whereas that nearest the edge indicates material having a strength of not more than 70,000 lb/in.²

Case 29: Lower flange of tubular wing spar (steel). This plane was used in mail pickup service. It crashed due to the fatigue fracture of the lower flange of the wing spar. The type of service in which this plane was used caused higher fluctuating loads on the wings than would be expected in normal service. In addition, the decarburized condition of the tubing greatly reduced its resistance to fatigue, as fatigue cracks almost invariably start at the surface. Laboratory tests (see Trans. Am. Soc. Metals, vol. 39, p. 45, 1947) on homogeneous and decarburized specimens indicate that the fatigue strength of the fractured tube would be approximately half that of material that had not been decarburized.

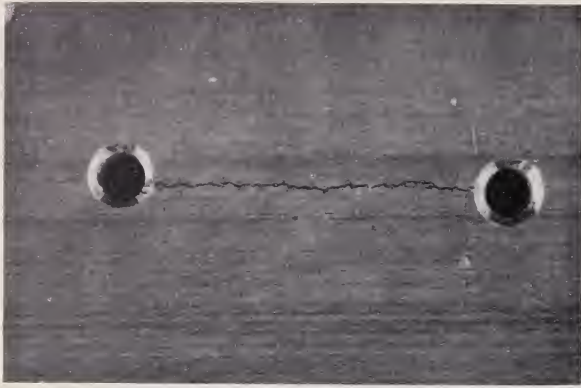
FIGURE 32.2. Crack at right of figure 32.1.

The crack had progressed beyond hole at left, which had been drilled in an effort to stop its progress. The "meandering" nature of the crack is characteristic of stress-corrosion cracking in aluminum alloys. Note the absence of corrosion on the surface. $\times 1$.

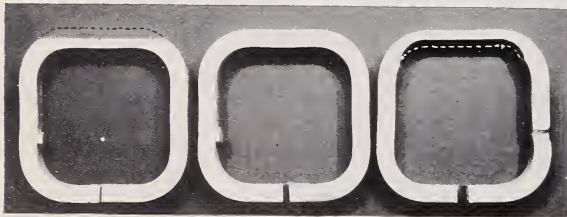
termine the cause and the effect of the cracking on the strength of the part. No fractures of any of these parts occurred. The stress-corrosion cracking resulted from a combination of very high internal stress and mildly corrosive conditions encountered in flying over the ocean. The internal stress apparently resulted from the method of fabricating the tubing.

FIGURE 32.6. Three sections cut from one of the tubes to show the presence of internal stress.

In the section on the left the outside half of the wall thickness was first milled off, then the wall was sawed on the opposite side. No change in the width of the saw cut was observed. Tube expanded on being cut when no milling had been done, (center) and sawing (right). This indicates that there was a tangential tensile stress in the outer half of the tubes and accounts for the failure of the cracks to penetrate completely through the walls (fig. 32.3). $\times 14$.

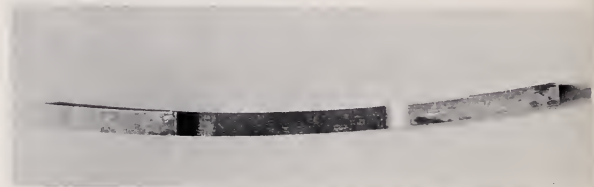
FIGURE 32.5. Specimen that curved when cut from the tube wall as a result of the high internal stress in the part.

The upper side of the specimen is the outer surface of the tube, so the direction of curvature indicates that there was a longitudinal tensile stress in the outer surface of the tube. $\times 14$.

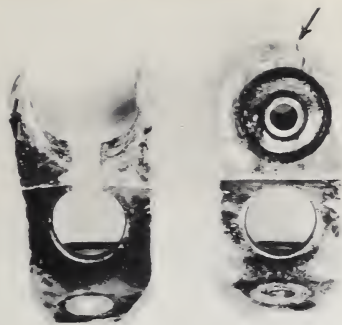
Case 33: Aircraft hinge fitting (24S aluminum alloy). The fitting failed because of stress-corrosion cracking. The stress causing this failure was apparently produced by forcing an oversized bearing into a hole in the fitting. It has been shown that such a force fit can cause tensile stress of sufficient magnitude to cause stress corrosion cracking in material that is susceptible to intercrystalline corrosion. It is possible to heat treat 24S aluminum alloy in such a way that it is not susceptible to intergranular corrosion, and if this had been done, it is unlikely that the part would have failed. However, this heat treatment requires a rapid cooling rate, which could not have been obtained in this part unless the holes had been machined prior to heat treatment, and perhaps not then. The stress in the part could have been reduced by decreasing the tightness of the force fit.

FIGURE 33.1. *Fractured fittings as received.*

The bearing had been lost from the fitting on the left, while that on the right had merely cracked (arrow). $\times 34$.

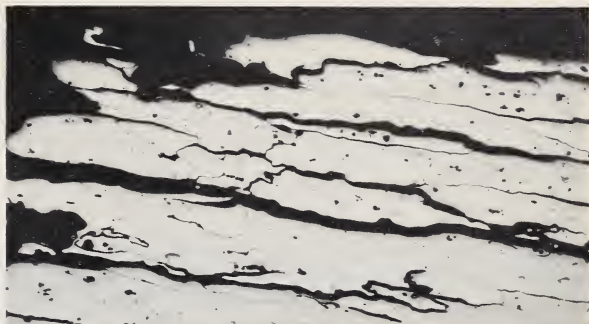
FIGURE 33.2. *Typical intercrystalline corrosion in one of the fittings. Unetched. $\times 100$.*

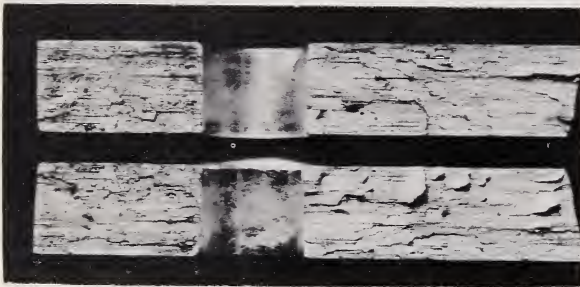
FIGURE 35.2. Portion of one of the cracks shown in figure 35.1 opened to show the fracture surfaces.

Note the flakes which were raised when the surfaces were separated. This is indicative of the typically branching nature of a stress-corrosion crack. $\times 2$.
