2011 Wildland Urban Interface Amarillo Fires Report #2 – Assessment of Fire Behavior and WUI Measurement Science

NIST Technical Note 1909

February 2016

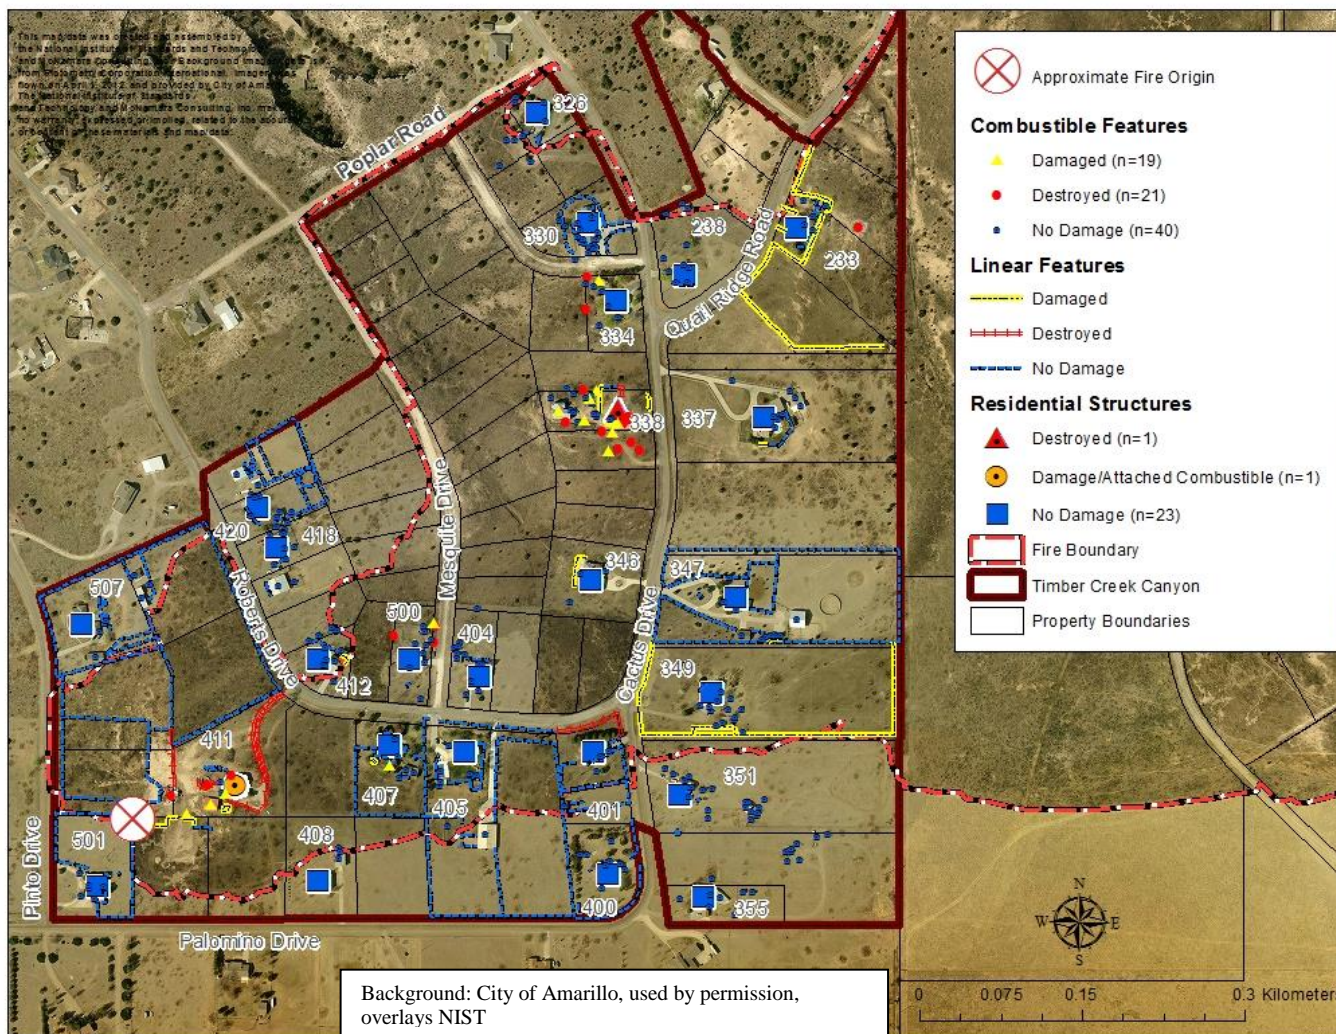
The damage to structural elements found on 411 Roberts Drive, near the origin, indicate the structure would have been destroyed without these defensive actions. These actions, consequently, provide significant clues to the ignition mechanism at this location.

Figure 5 Damage to structural elements in Timber Creek Canyon.

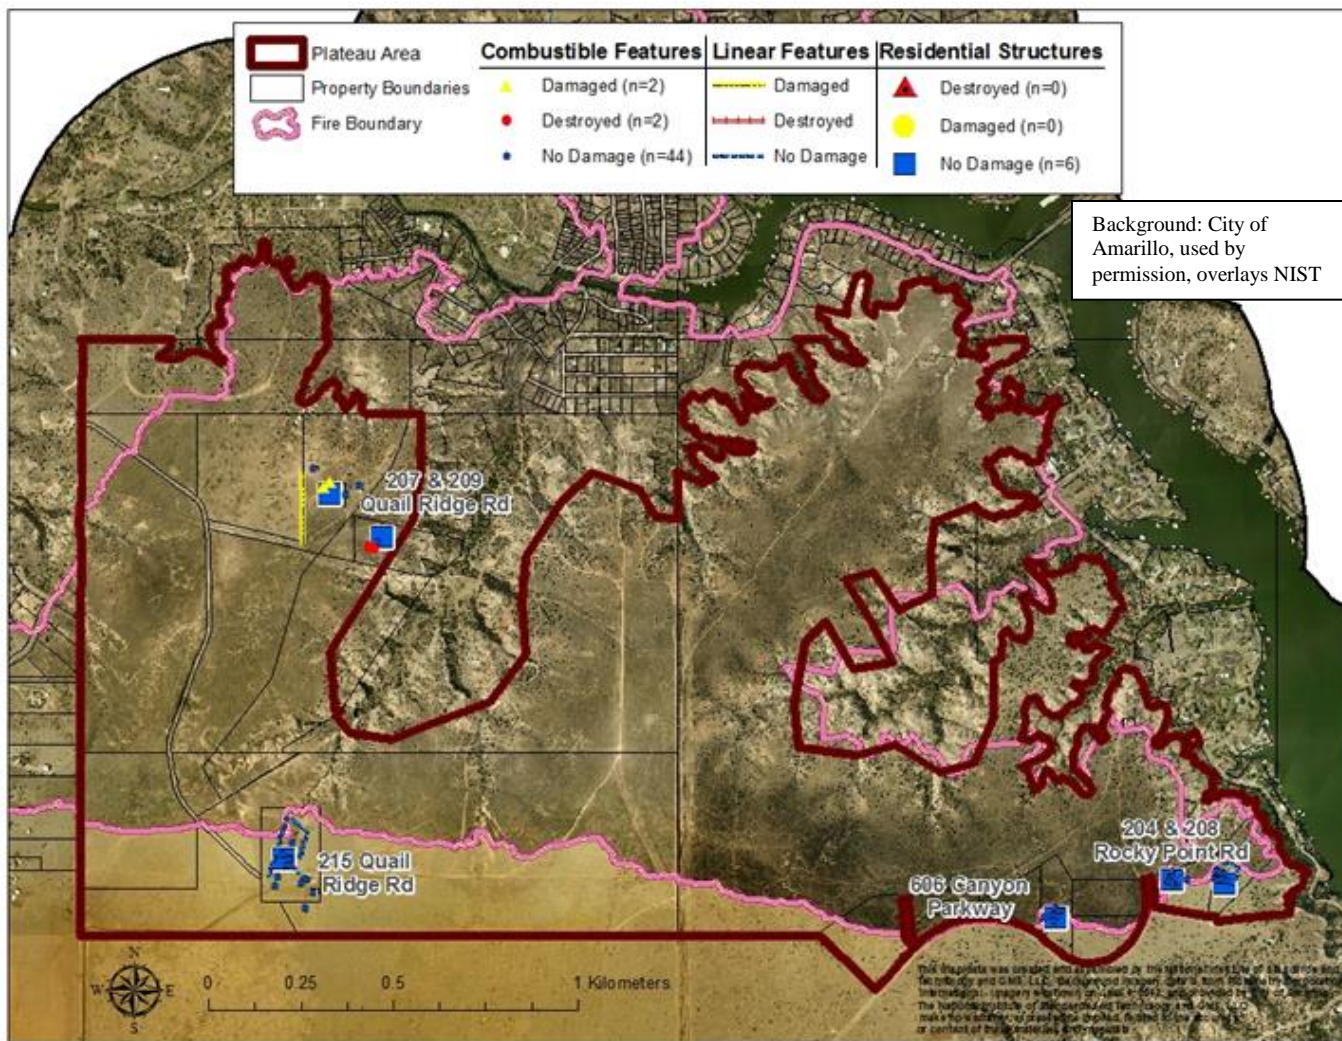
Figure 15 Damage to structural elements in the Plateau Community.

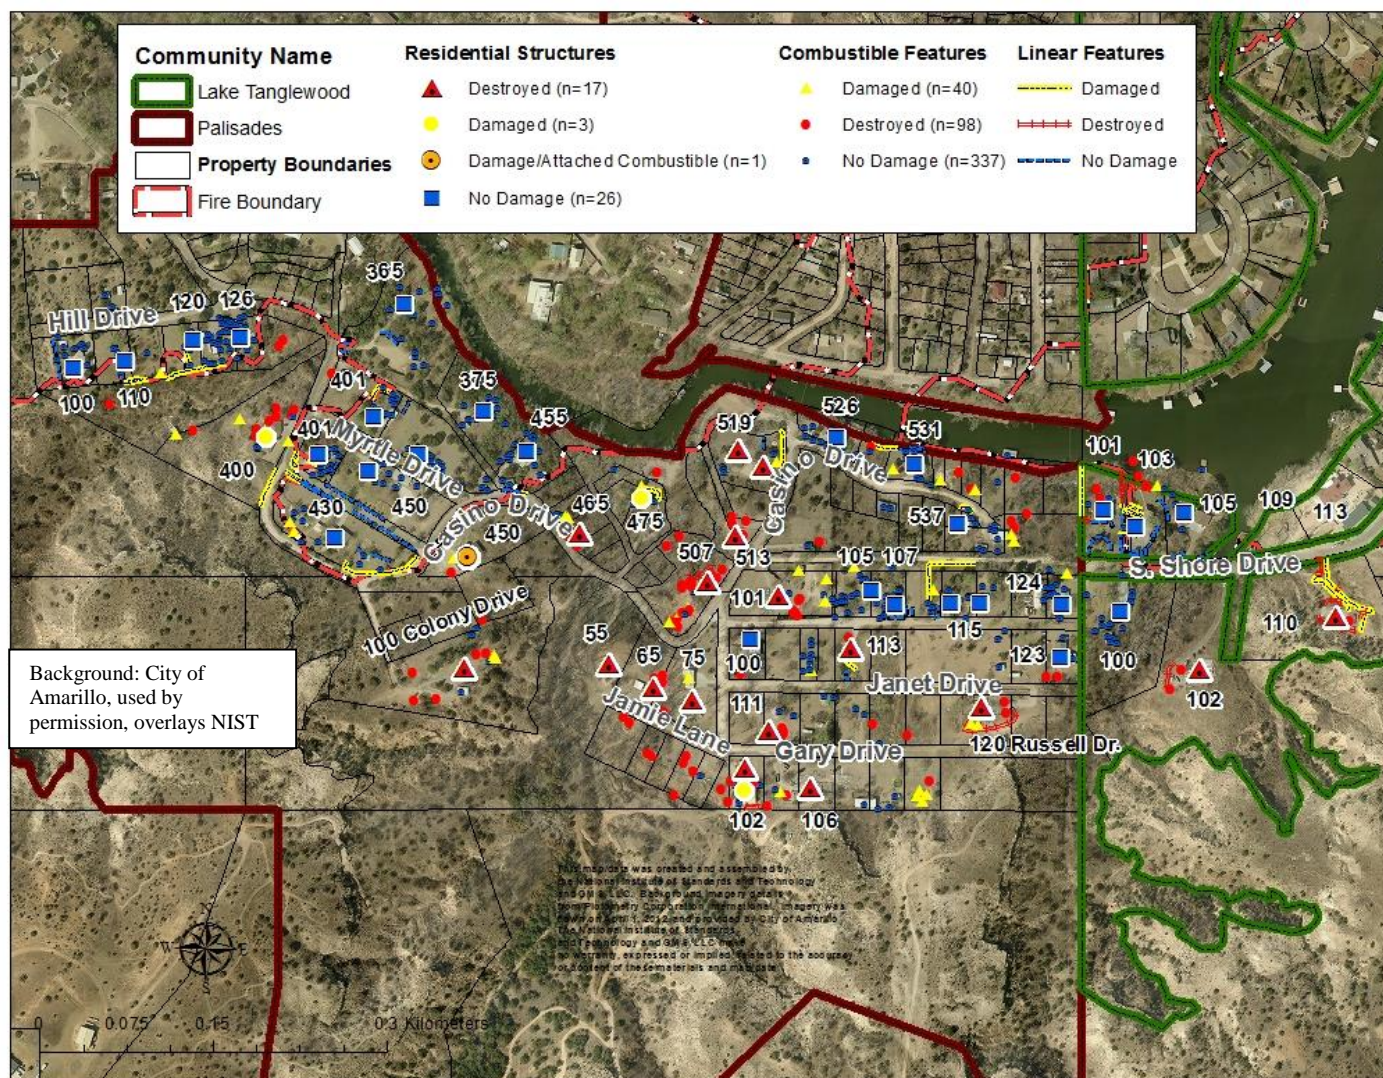
The primary damage close to homes found in this area was to a storage shed located on 110 Hill Drive and railroad tie retaining walls and borders located on the parcels at 110 and 120 Hill Drive and 401 and 430 Casino Drive. These damaged features were close to or directly adjacent to wildlands. The damaged storage shed was over 19 m (62 ft) from the closest primary structure. Damaged railroad tie retaining walls were 9 m (29 ft) away from the residential structure located at 110 Hill Drive and about 19 m (62 ft) away from the residential structure located at 120 Hill Drive.

The primary structure at 400 Casino Drive was also damaged. This was due to a pile of trash bags with unknown debris that burned and melted a vinyl soffit. The radiant heat or flames appeared to be sufficient to melt the vinyl soffit but no scorching to the underlying enclosed wood soffit was document by field observers. The brick siding was scorched.

Figure 22 Damage to structural elements in the southern Palisades Community and selected portions of the South Lake Tanglewood Community.

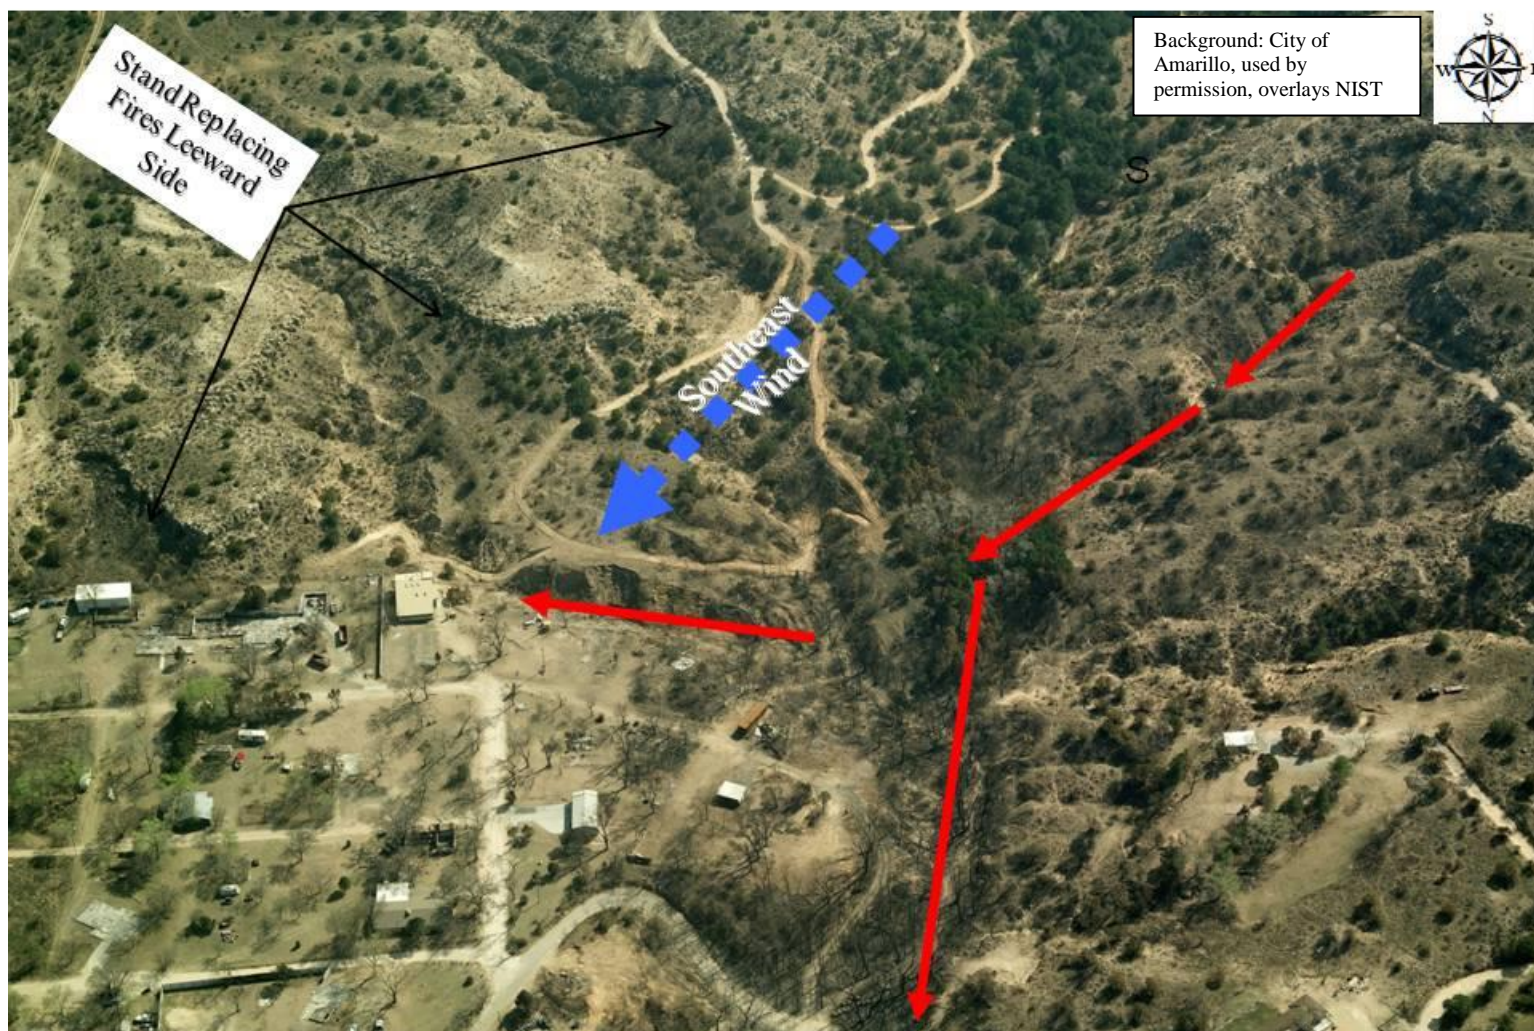
Figure 27 Post-fire south facing oblique imagery showing results of fire behavior in the upper portion of the middle canyon area of Southern Palisades Community.

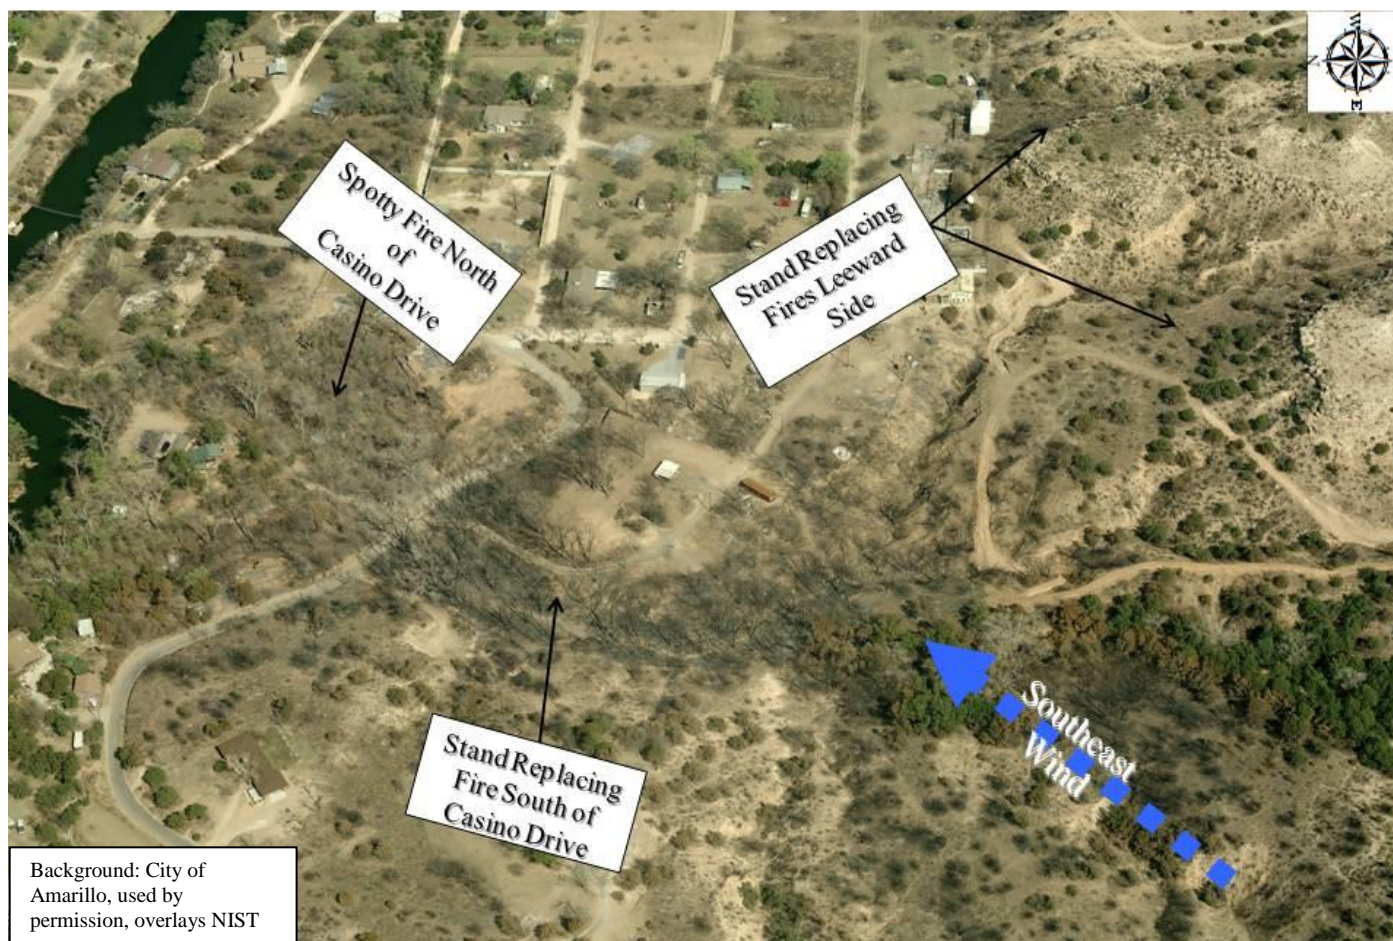
Figure 28 Post-fire east facing oblique imagery showing results of fire behavior in the bottom of the middle canyon area of Southern Palisades Community.

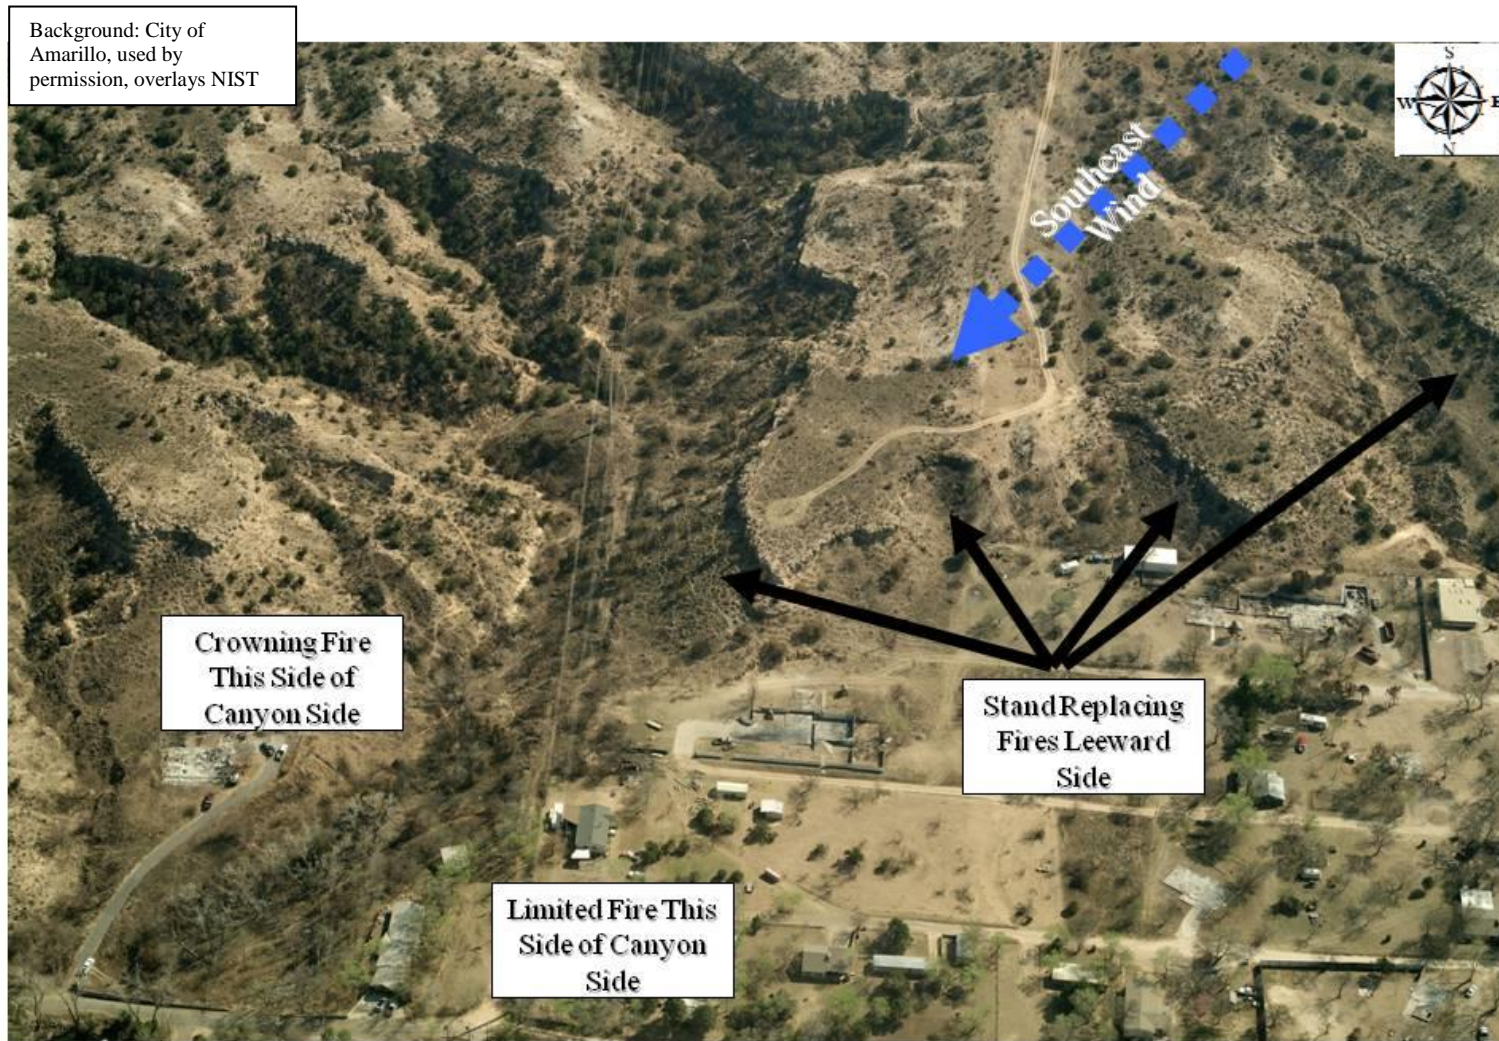
Figure 29 Post-fire south facing oblique imagery showing results of fire behavior in the eastern most canyon area of the Southern Palisades and South Lake Tanglewood Communities.

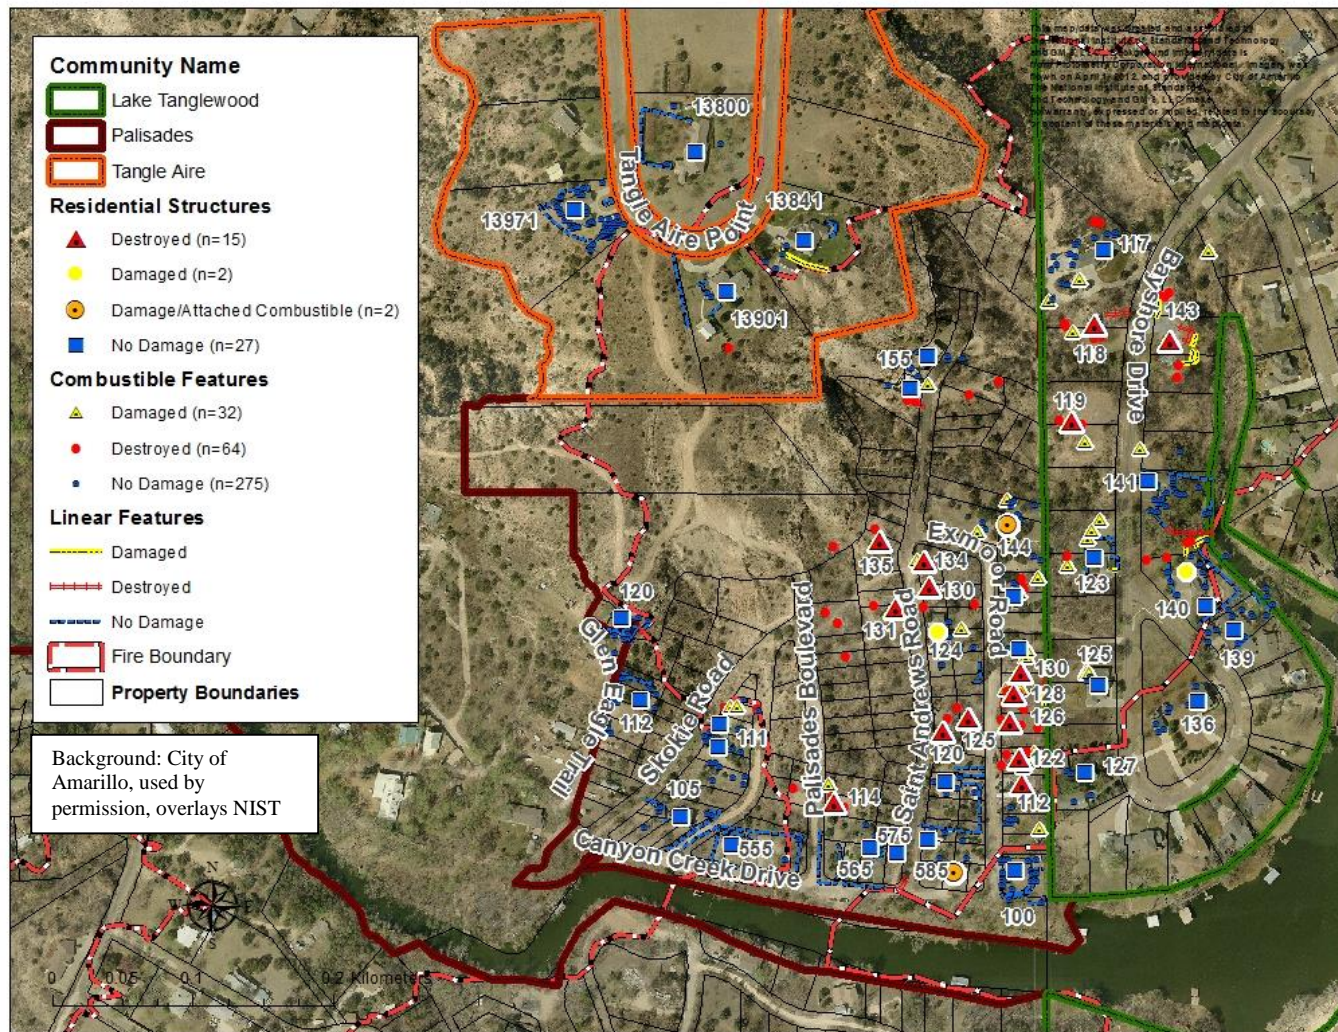
Fences, rail road ties and secondary structures were ignition mechanisms in the Northern Palisades, Tangle Aire and selected portions of Lake Tanglewood communities. As shown in Table 16, there were several fences extinguished by first responders. Additionally, railroad ties were identified as being damaged or destroyed with some identified as being defended, though these could not be linked to a specific feature. Also, a deck was ignited at one location by minor ember accumulation at 144 Exmoor Road and extinguished by homeowners, as shown in Figure 44. Figure 44 demonstrates the need for discussions with first responders and homeowners to determine defensive actions as no signs of actions were present at this home. This also demonstrates that when structural items are damaged, researchers should assume a defensive action as opposed to assuming no defensive action occurred, as stated in Quarles et al⁶ and Foote et al.¹⁴ Fire underneath mobiles homes was also identified as an ignition mechanism.

Figure 37 Damage to structural elements in the northern Palisades, Tangle Aire and selected portions of North Lake Tanglewood Communities.

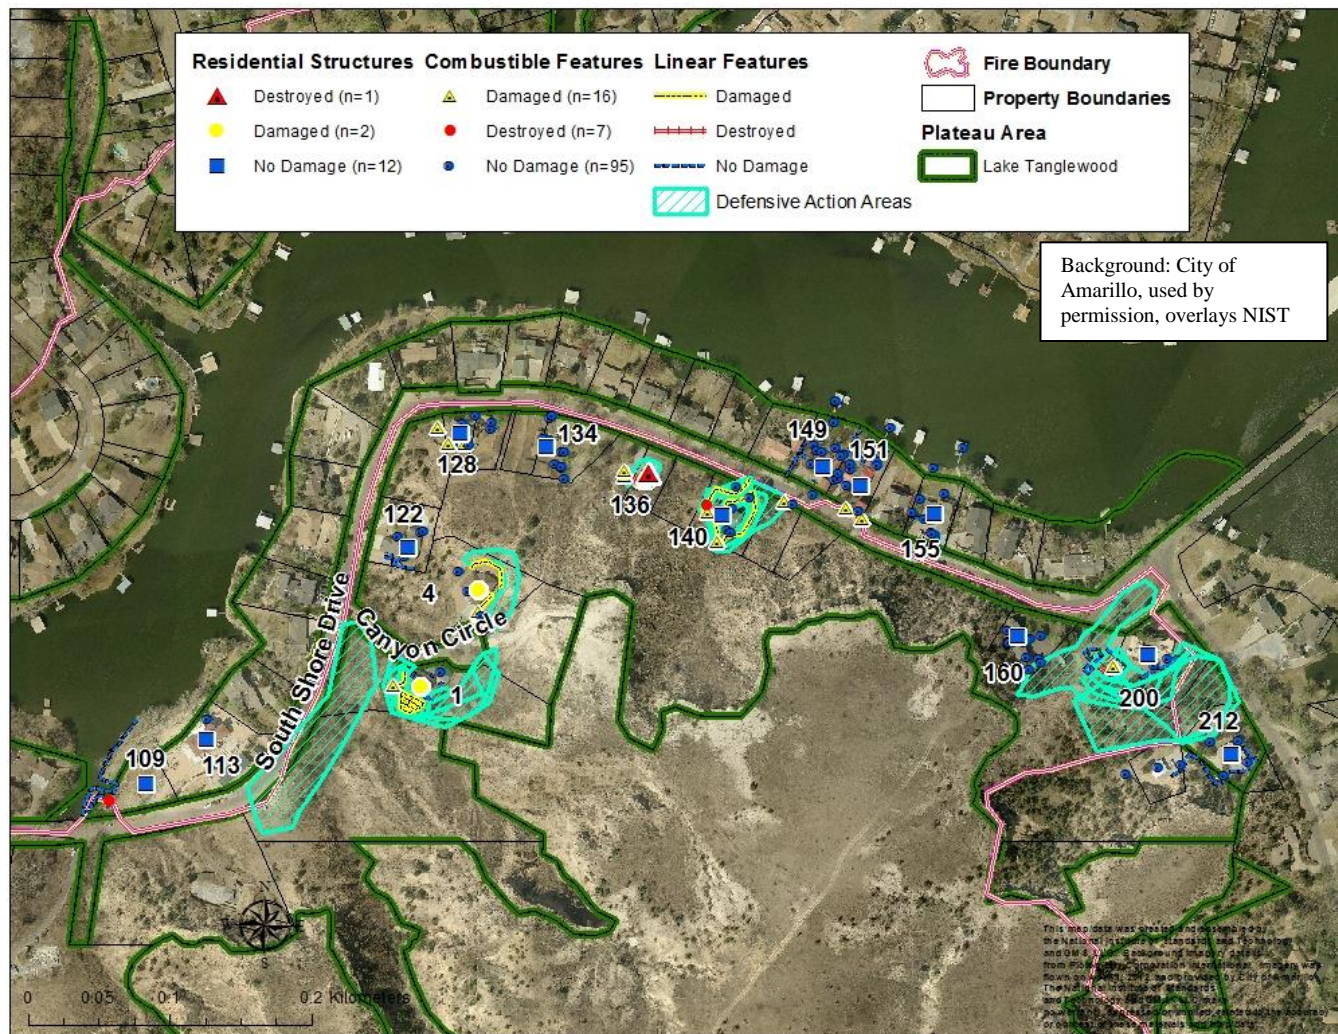
Figure 61 shows damage to structural elements from the Tanglewood Fire within the South Lake Tanglewood Community. There were two damaged residential structures, one

Figure 61 Damage to structural elements in the South Lake Tanglewood Community.

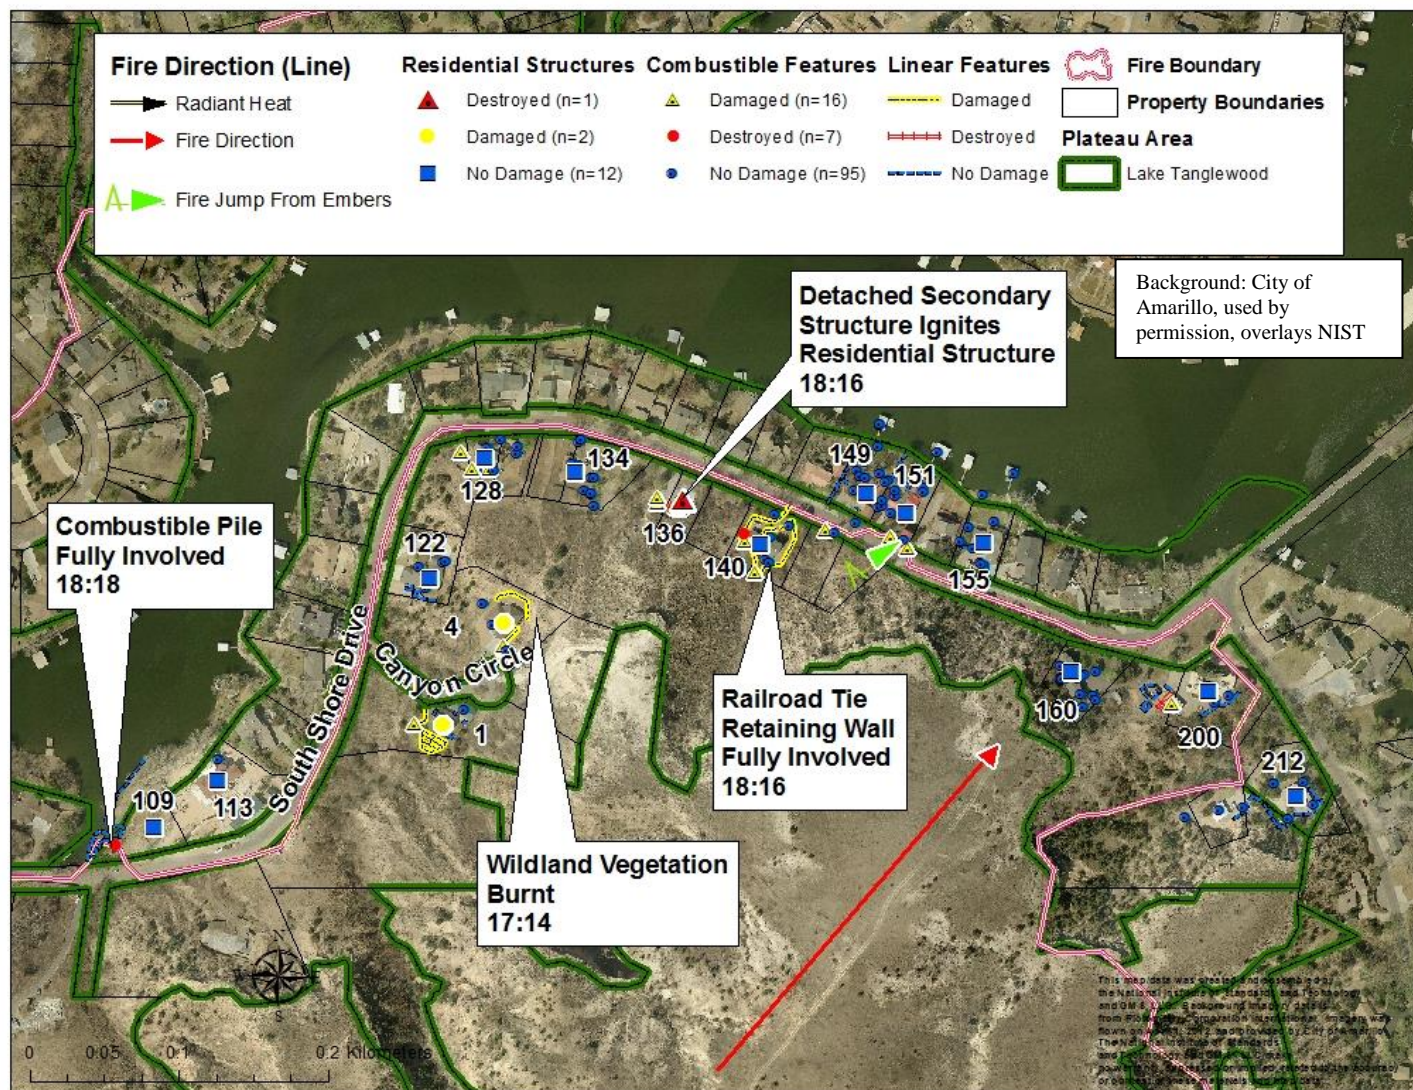
Figure 62 Fire direction and fire timeline in South Lake Tanglewood Community.

Figure 62 shows fire direction in the South Lake Tanglewood Community. Little is known about the behavior of the wildland fire in this area. The wildland fire front appeared to reach the wildlands behind 200 South Shore Drive sometime after 15:30. However, it is not known precisely when the wildland fire front reached the wildlands behind 122 to 140 South Shore Drive, but these areas were already burnt by 18:18, during the Amarillo Sheriff Helicopter flight. A ground image at 17:14 shows the wildlands around 4 Canyon Circle already burnt. Nonetheless, fire behavior in these wildlands continued into the night (February 27 to February 28), as described by first responders. Exact fire direction in these wildlands was difficult to determine in the field.

There was only one location where the fire jumped South Shore Drive, which was on the west side of 109 South Shore Drive, as shown in Figure 62, though other embers might have jumped South Shore Drive and been suppressed by first responders before any ignitions could occur. The time of this fire jump is not known, illustrating one of multiple gaps in the fire timeline. The destroyed secondary structure was shown as igniting the one destroyed residential structure at 136 South Shore Drive at 18:16 during the Amarillo Sheriff Helicopter flight when the secondary structure was fully involved. There was a pile of unknown combustibles at 109 South Shore that was shown as fully involved during this flight also. Finally, a railroad tie retaining wall at 140 South Shore Drive was also shown as fully involved at 18:16.

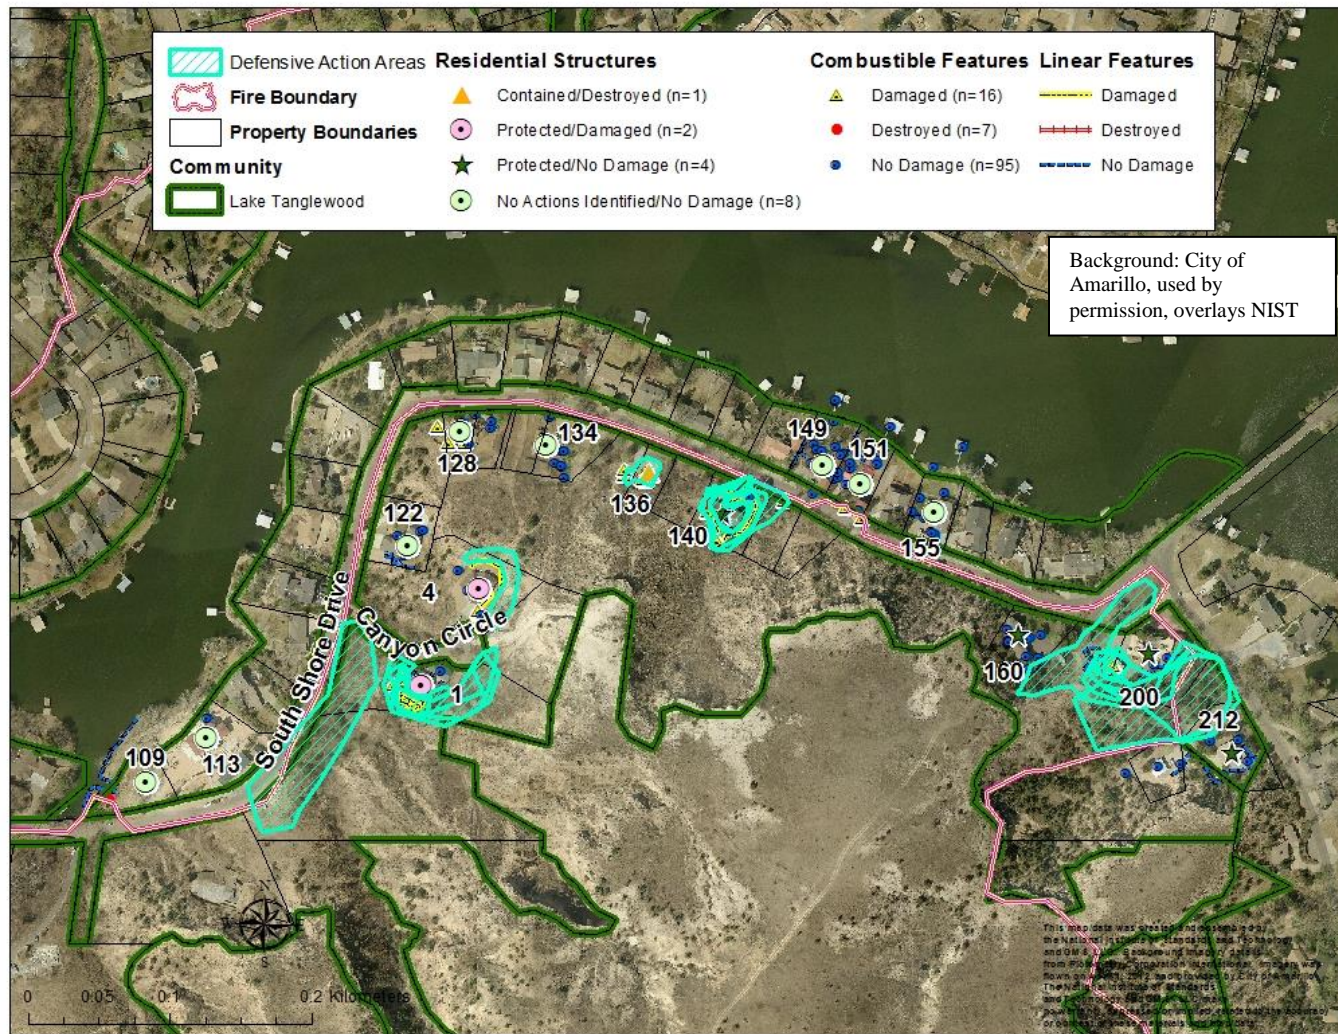
Figure 63 Defensive action locations and primary structure categorizations in South Lake Tanglewood Community.

Figure 63 shows locations of identified defensive actions along with the resulting categorization of structures as to a defended category. First responders extinguished wood fences, railroad tie retaining walls, secondary structures, hot spots in the wildlands, residential grasses and various debris piles. Railroad tie retaining walls and secondary structures directly adjacent to wildlands were defended numerous times by different first responder teams due to multiple re-ignitions. There was a railroad tie retaining wall around treated vegetation at 140 South Shore Drive that was explicitly identified as being defended many times. The log home at 140 South Shore Drive was also explicitly identified as being defended, and it is assumed the home was defended against ember spread from the railroad ties. Finally, 212 South Shore Drive was explicitly identified as having water sprayed on it.

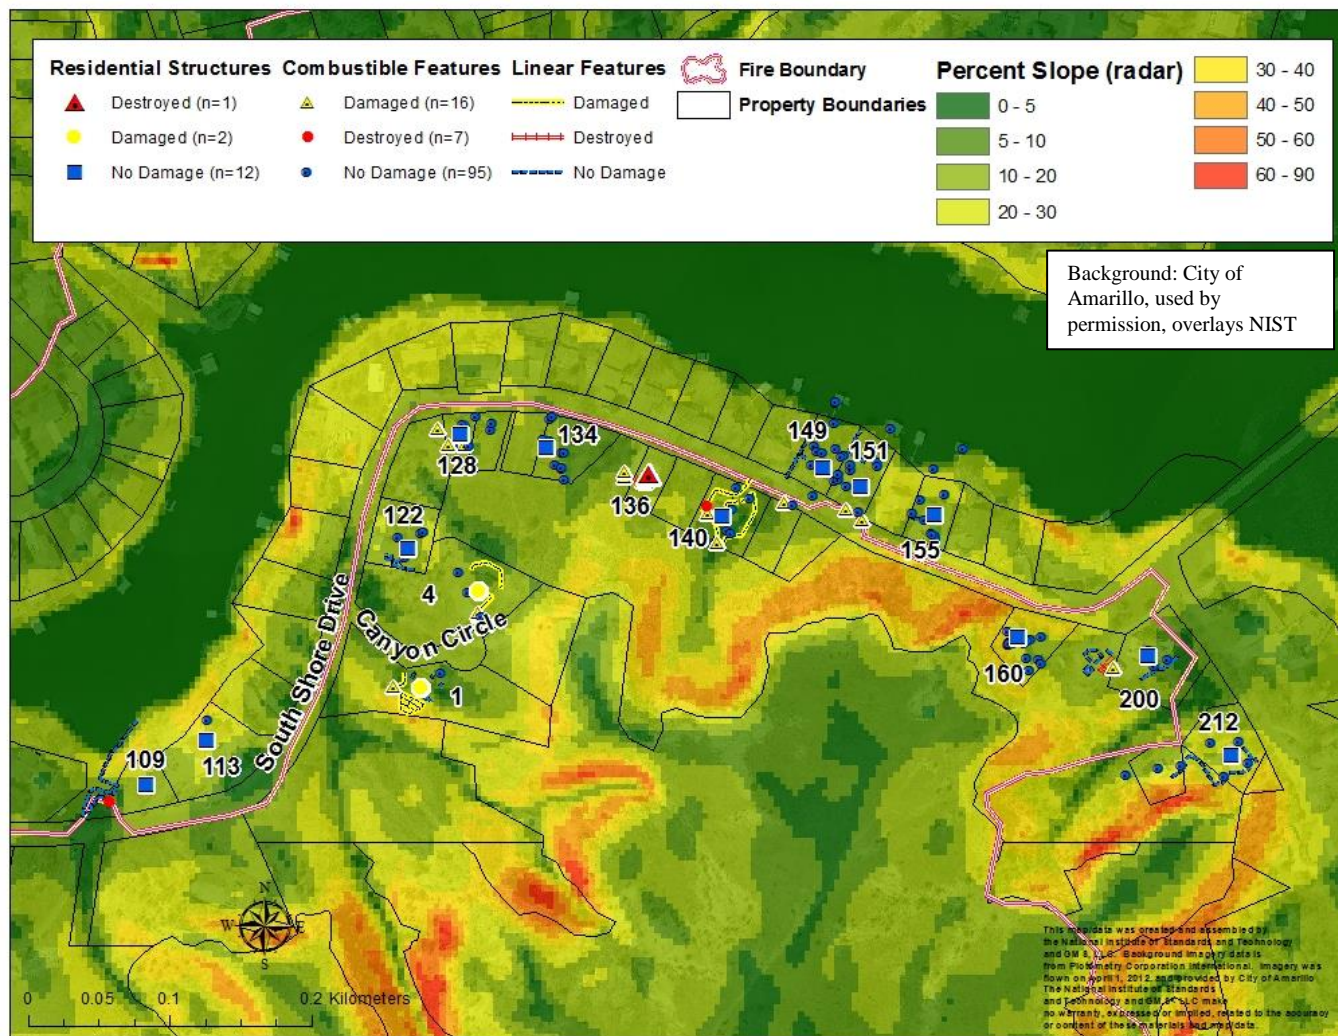
Figure 64 Radar derived percent slope in South Lake Tanglewood Community.

Figure 64 displays radar derived percent slope for the South Lake Tanglewood Community. Figure 65 portrays radar derived aspect for the South Lake Tanglewood Community. As with the Southern Palisades Community the fire appeared to enter some sections of the South Lake Tanglewood Community in areas lacking cliffs. The damaged secondary structure at 200 South Shore Drive appeared to be a result of direct flame contact from burning vegetation, and the topography shown in Figure 64 displays an area between 160 and 200 South Shore Drive of moderate slopes. This area had continuous burned vegetation from the plateau right to the secondary structure. Vegetation in the steeper areas (i.e., cliffs) directly behind 160 and 212 South Shore Drive was not burned.

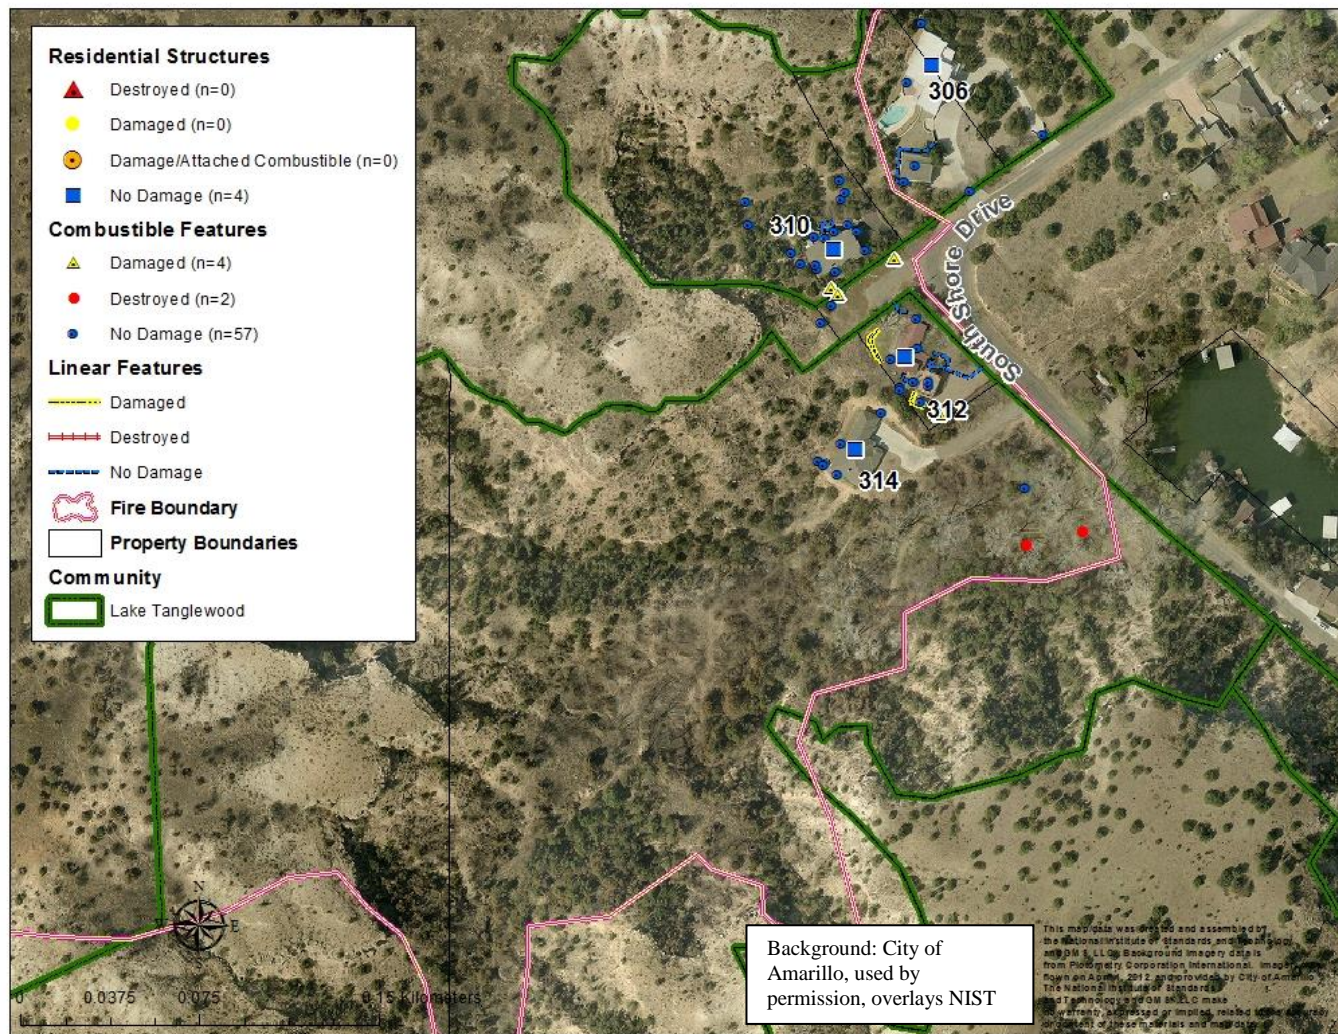
Figure 66 Damage to structural elements in the Southeast Lake Tanglewood Community.

Figure 66 shows damage to structural elements from the Tanglewood Fire within the Southeast Lake Tanglewood Community. No residential structures were damaged or destroyed in this area. Damage and destruction did occur to some detached combustibles and linear features as shown in Table 23. Damage and destruction to linear features by length is shown in Table 24. The exact time of when most of the detached combustibles burned is not known. Figure 67 shows fire direction in the Southeast Lake Tanglewood Community. The fire jumped the circular driveway at 310 South Shore Drive in two locations. As listed in Figure 67, the fire in the wildlands moved through the area sometime prior to 18:21 on February 27.

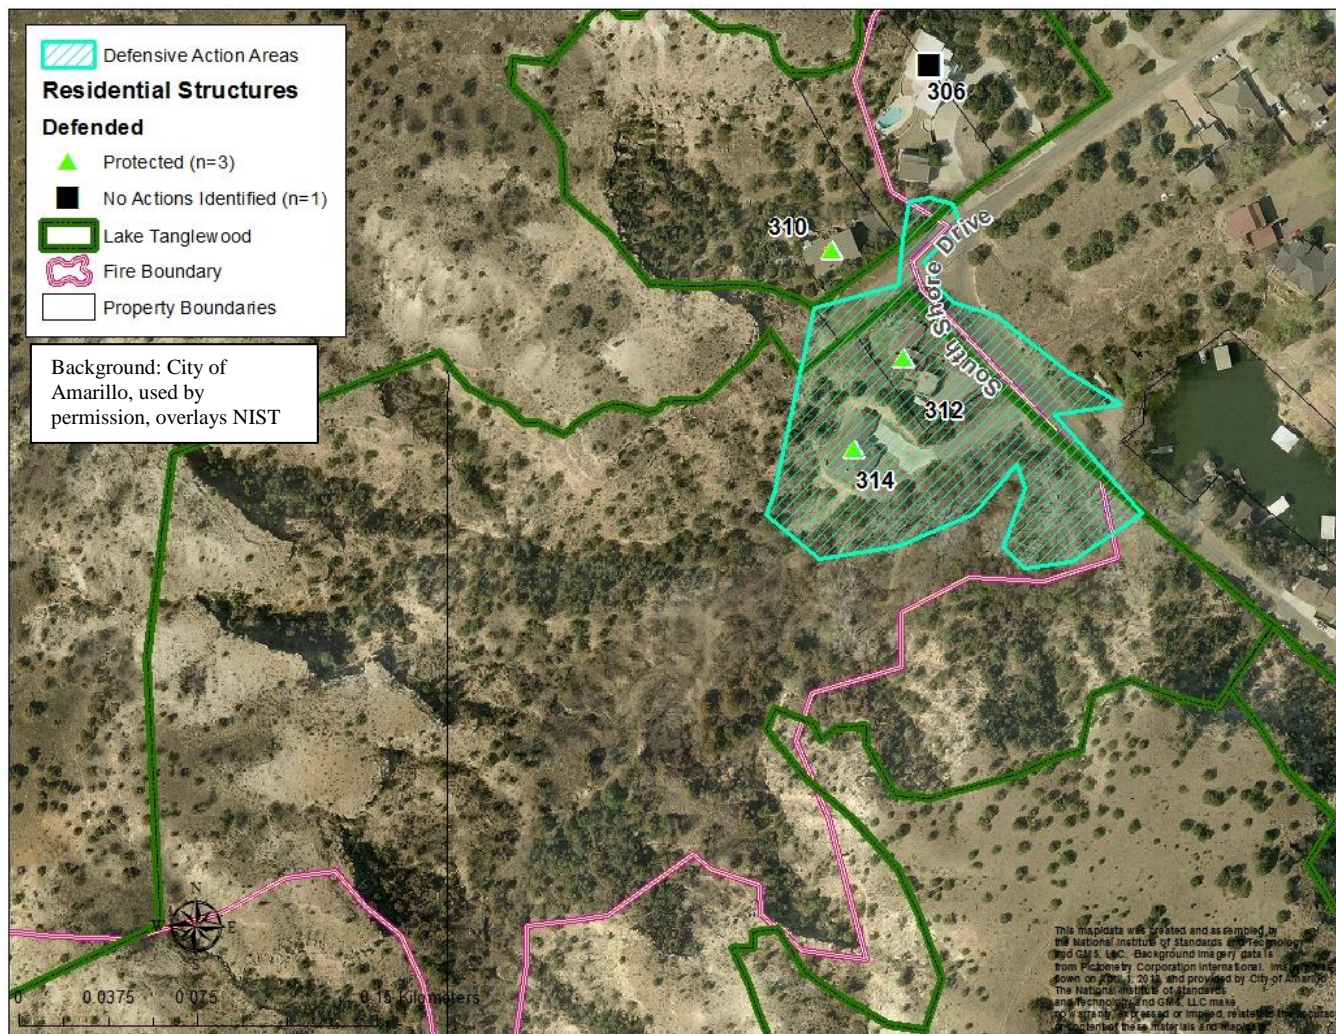
Figure 68 Southeast Lake Tanglewood Community defensive action locations and primary structure categorizations.

Figure 68 shows the locations of identified defensive actions along with the resulting categorization of structures as to a defended category. First responders extinguished railroad tie retaining walls, landscape borders, grass vegetation by South Shore Drive and also suppressed burning wildland vegetation to the west of the residential structures. The damaged combustibles by 310 South Shore Drive were not explicitly identified as defended, but the scorching of these features was minor and suppression of nearby burning vegetation by first responders might have alleviated some of the damage to these features. Table 25 identifies damaged and destroyed linear and combustible features by identified defensive actions.

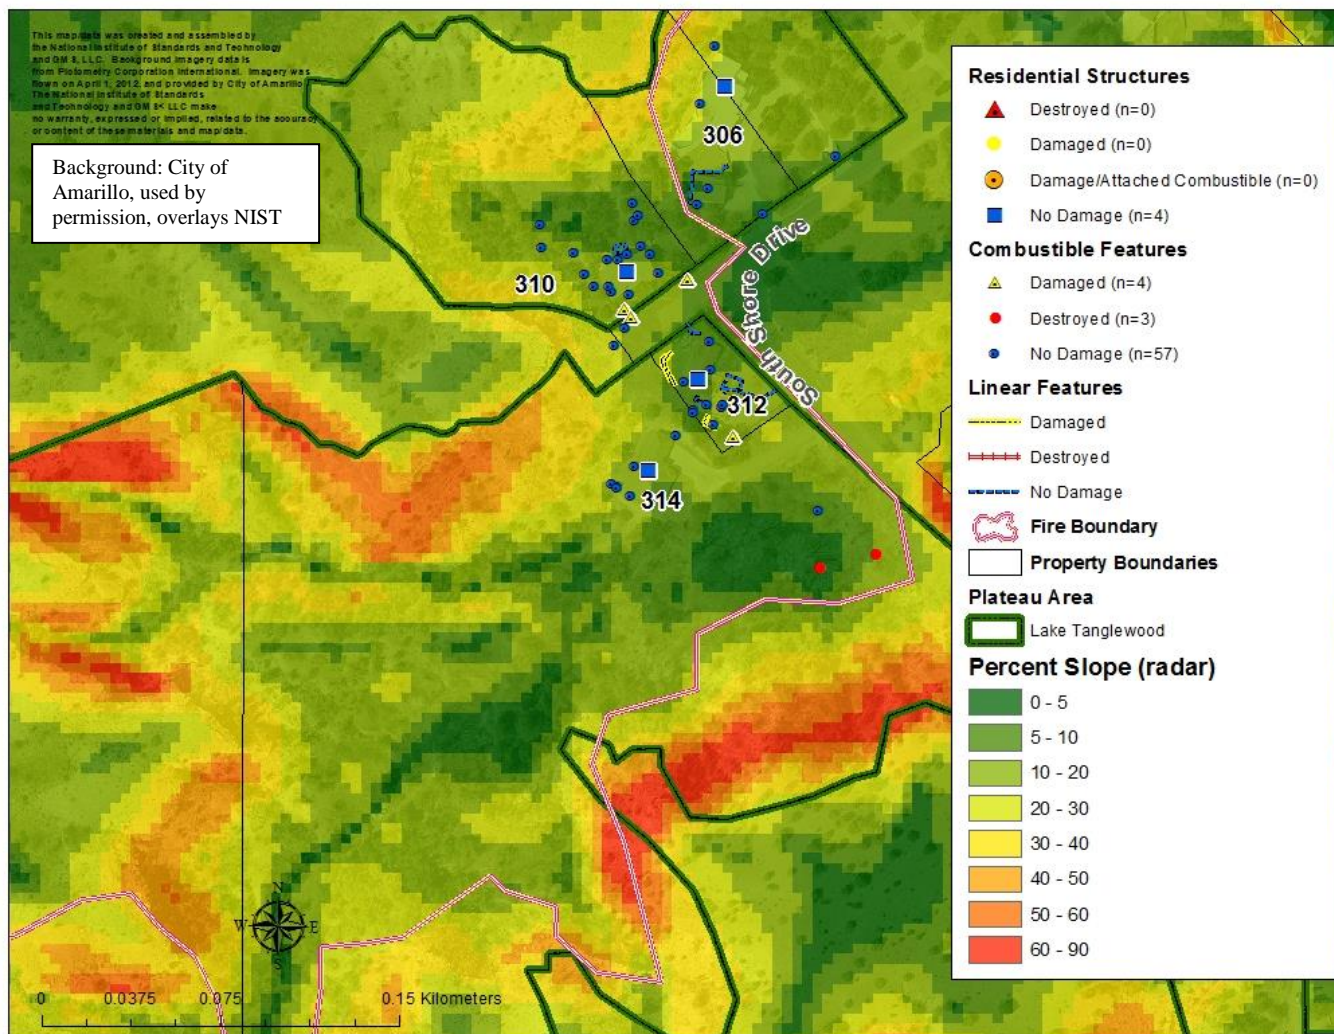
Figure 69 Radar derived percent slope in Southeast Lake Tanglewood Community.

Figure 69 displays radar derived percent slope for the Southeast Lake Tanglewood Community. Figure 70 portrays radar derived aspect for the Southeast Lake Tanglewood Community. As with other areas described above fire behavior was more heavily concentrated on one side of the canyon than the other side. It was more difficult to discern the precise area where the fire traveled from the plateau to the canyon in this area. Nonetheless, steep areas with cliffs have burned vegetation up to the cliffs on the plateau side with green vegetation on the canyon side of the community not being burned.
