2011 Wildland Urban Interface Amarillo Fires Report #2 – Assessment of Fire Behavior and WUI Measurement Science

NIST Technical Note 1909

February 2016

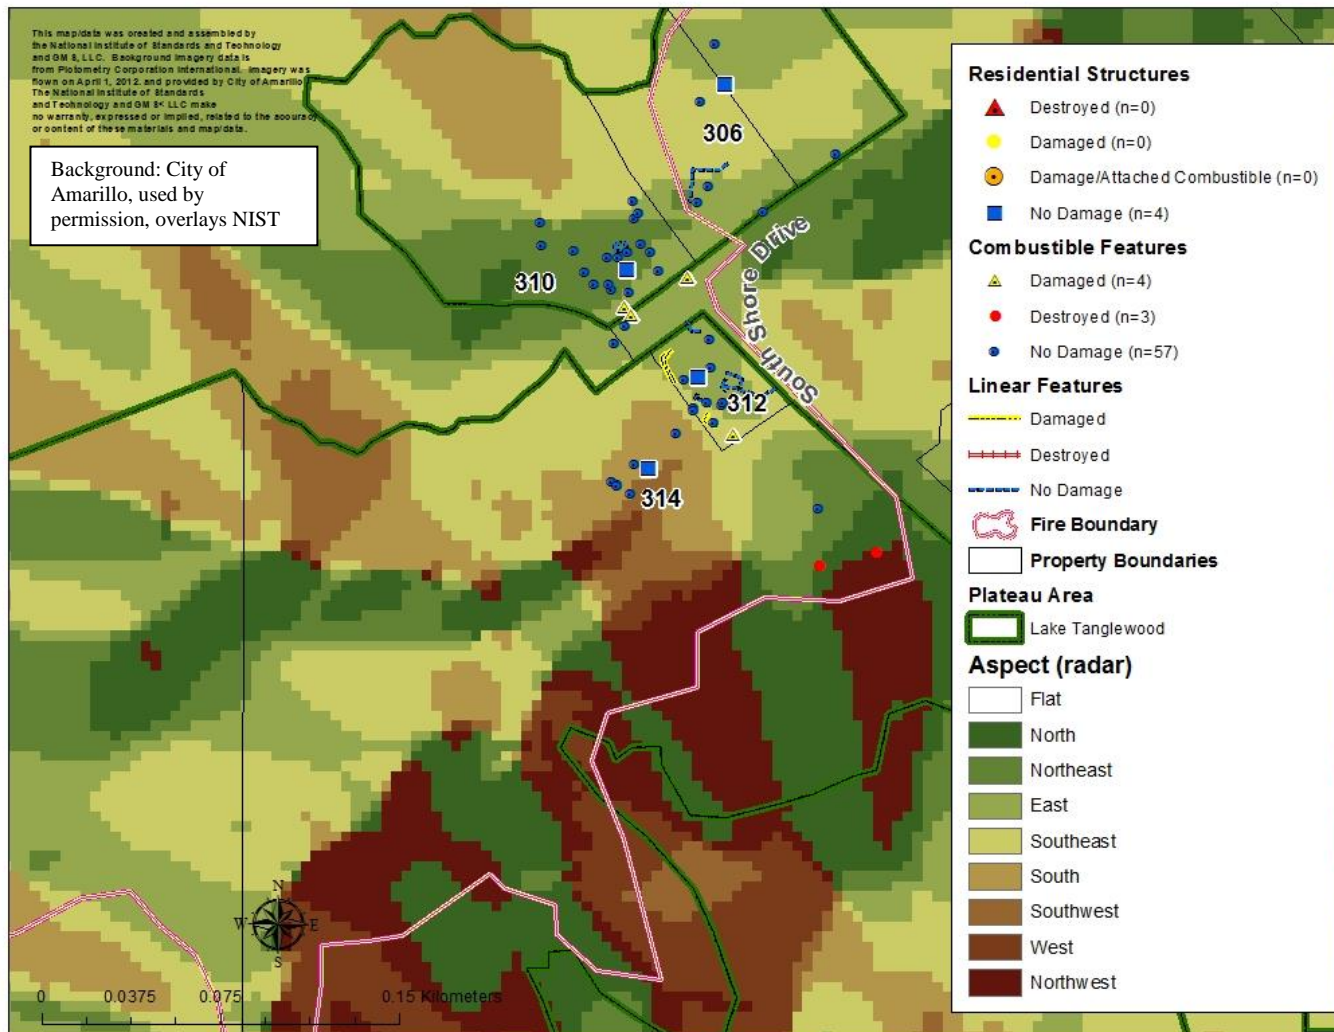
Figure 70 Radar derived aspect in Southeast Lake Tanglewood Community.

Figure 69 displays radar derived percent slope for the Southeast Lake Tanglewood Community. Figure 70 portrays radar derived aspect for the Southeast Lake Tanglewood Community. As with other areas described above fire behavior was more heavily concentrated on one side of the canyon than the other side. It was more difficult to discern the precise area where the fire traveled from the plateau to the canyon in this area. Nonetheless, steep areas with cliffs have burned vegetation up to the cliffs on the plateau side with green vegetation on the canyon side of the community not being burned.

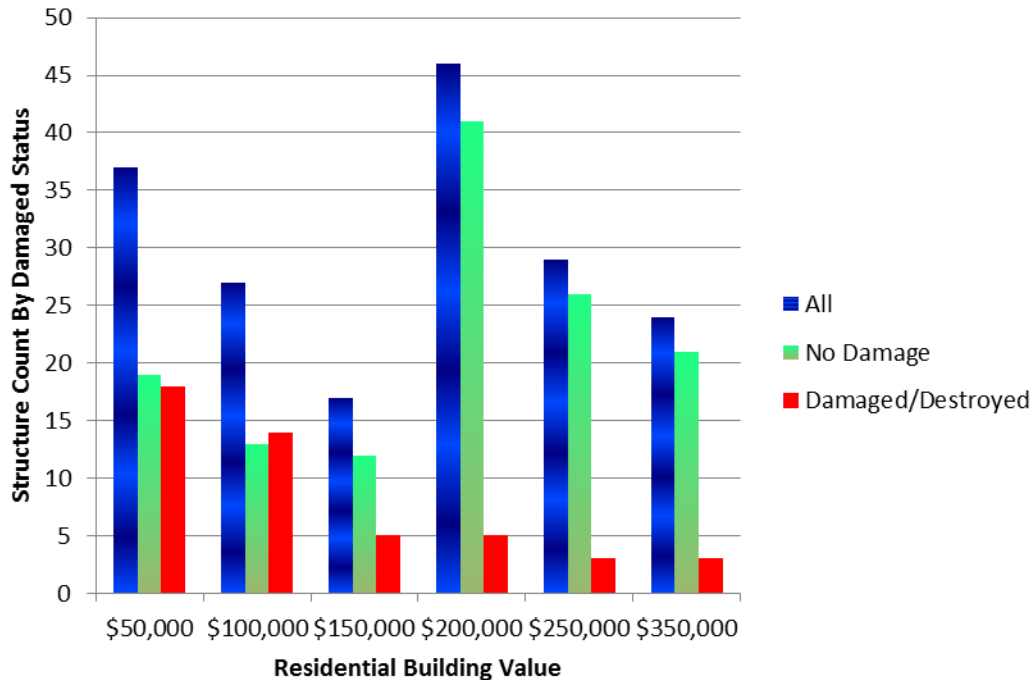
Figure 72 Residential structures by appraised building values and by damage status.

Figure F1 displays damage status by building value^{15, 16}. Figure F2 shows a bar graph displaying damage status by the year built. Table F1 lists damage status of residential structures by structure type.
