RELIABILITY OF FUSIBLE TIN BOILER PLUGS IN SERVICE

By John R. Freeman, Jr., J. A. Scherrer, and S. J. Rosenberg

In cooperation with the Steamboat Inspection Service a study has been made of the reliability of fusible boiler plugs of the type installed in ships boilers under the jurisdiction of the Inspection Service. It has been found that under certain conditions fusible plugs would not operate due to the formation in service of a refractory oxide replacing the tin in the fire end of the plug. Apparatus is described in which plugs may be tested under simulated service conditions. The results of examination and tests of 184 plugs returned from service indicated that 10 per cent of all plugs in service would not operate when and if required. Recommendations regarding specifications and design of plugs to eliminate this dangerous condition are made.

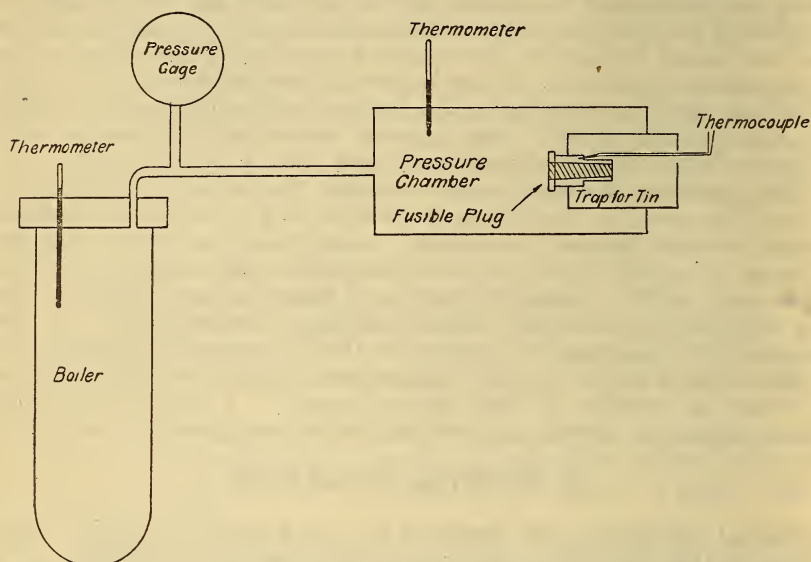
FIGURE 3.—Schematic representation of testing apparatus shown in Figure 2

Special equipment was designed for the purpose of testing these plugs in the laboratory under simulated service conditions. The apparatus used for the so-called "blow-out" tests is shown in Figure 2 and is illustrated diagrammatically in Figure 3. A pressure of over 200 lbs./in.² and simultaneous temperature of over 300° C. can be obtained. In general, for reasons of safety, the pressure was kept low.

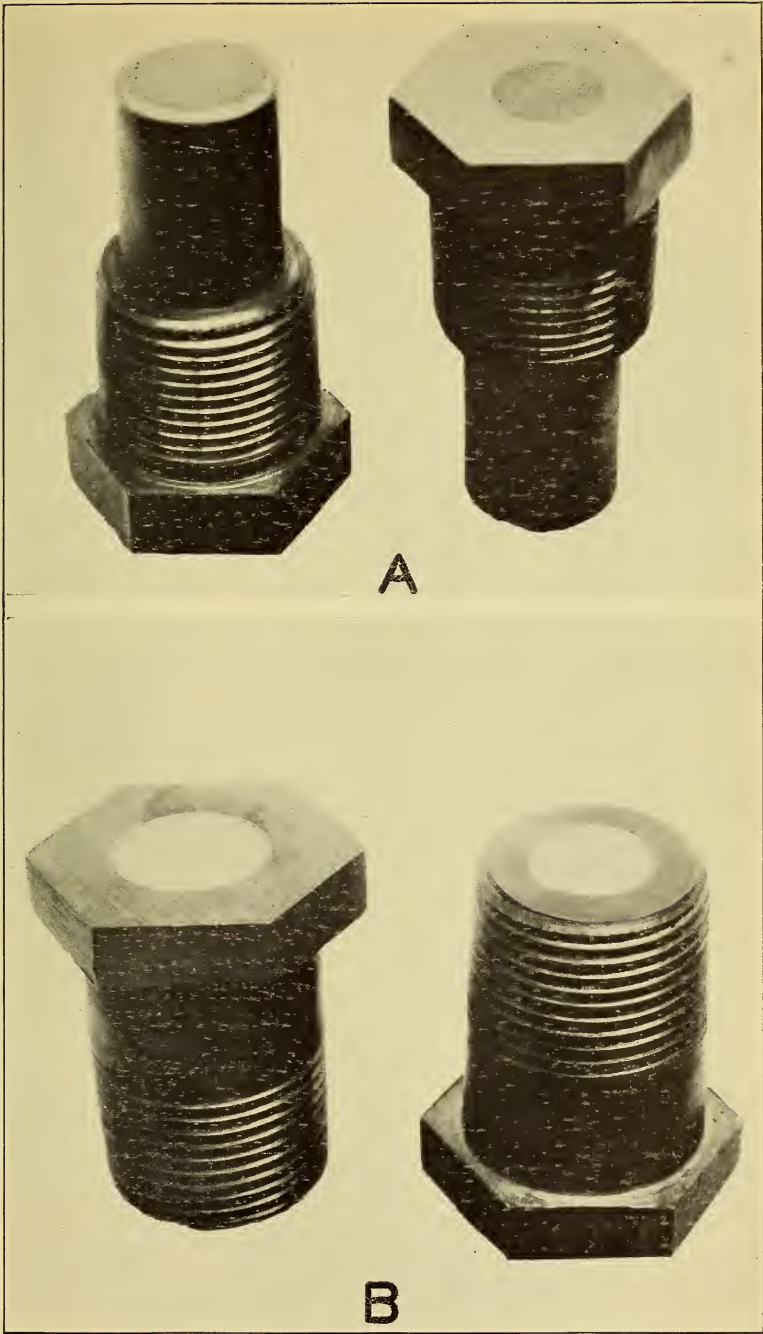
FIGURE 1.—Fusible tin boiler plugs

A, Outside type; B, inside type.

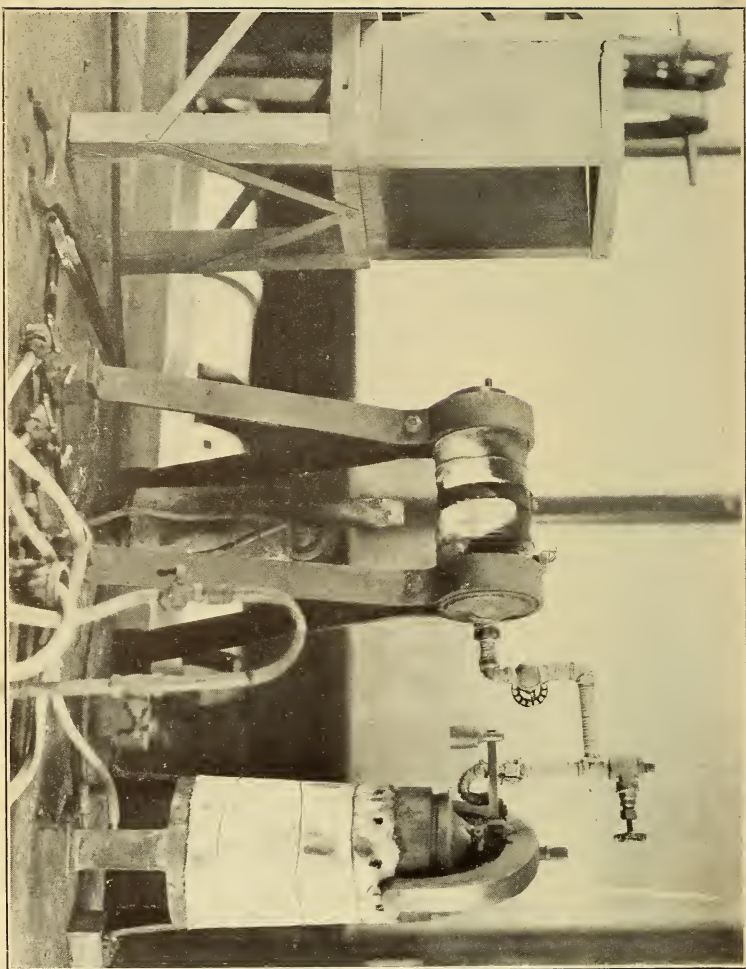
FIGURE 2.—Apparatus used for testing boiler plugs under simulated service conditions

The temperature of the plug was determined in some cases by inserting a thermocouple in the casing, as indicated in Figure 2. A temperature difference of as much as 80°C . was noted in one instance between the temperature of the steam in the pressure chamber and the temperature of the casing of the plug; the latter was always cooler. In general, however, the temperature difference was much less than this. The difference noted depended largely upon the rate of heating. In case a plug did not blow, the temperature of the pressure chamber was maintained a sufficient length of time to permit a more even distribution of temperature to be established. Also, in all cases where a plug failed to blow, except as noted in Table 1, the tin was found to have been melted during the test which proved
